# **A Guide for W-Beam Guardrail Damage Assessment**

A Field Manual for  
Highway Maintenance Personnel

National Cooperative  
Highway Research  
Program  
Project 22-28

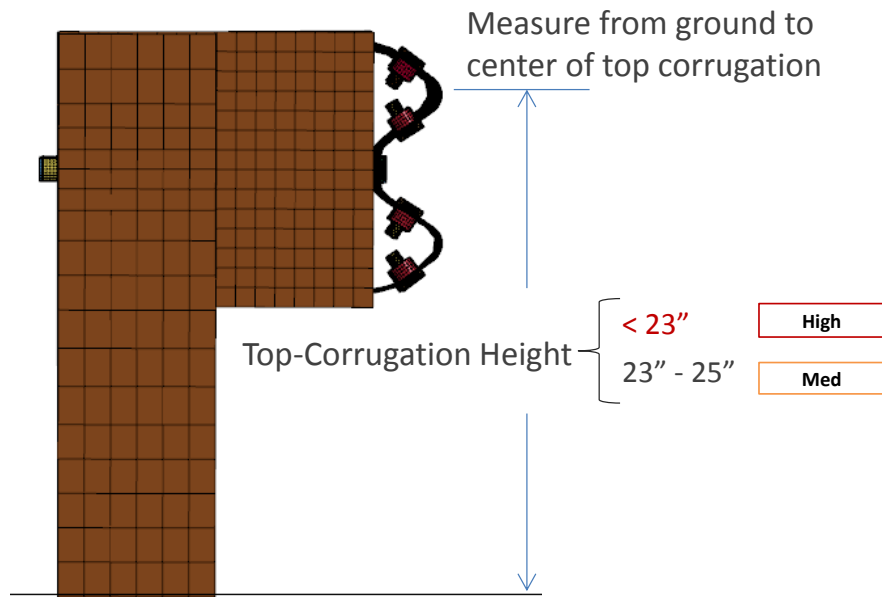
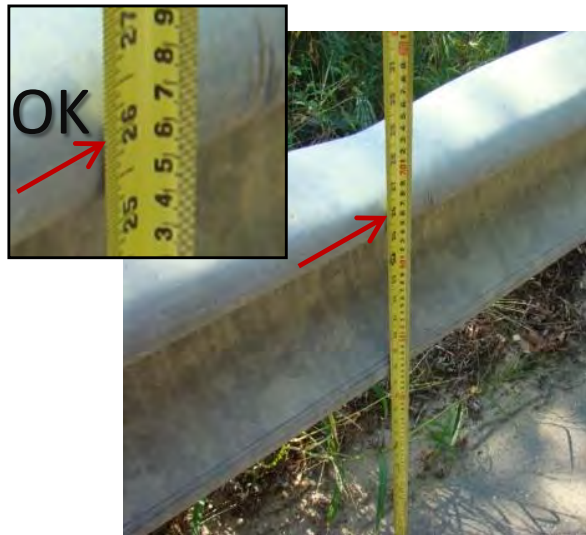
## Rail Height Condition

Rail height has traditionally been measured with respect to the top of the rail; however, for crash damaged guardrail it may be more appropriate to measure height with respect to the top corrugation of the rail. For example, a guardrail with standard top-of-rail height of 27  $\frac{3}{4}$  inch with a dent on the top of the rail that reduces (locally) the top-of-rail height by 4 inches may not significantly affect guardrail performance as long as the top corrugation is more than 23 inches above grade (also see Rail Crush criterion).

Analyses and full-scale tests have shown that there is a high probability for vaulting over the rail when rail height, as measured from the ground to the center of the top corrugation of the w-beam, is less than 23 inches. Therefore, when the top-corrugation-height is less than 23 inches the relative priority for repair is high.

Note that a top-of-rail height of 27  $\frac{3}{4}$  inches corresponds to a top-corrugation-height of 25  $\frac{1}{4}$  inches. Thus, based on the memorandum, when the top-corrugation-height 23 to 25 inches, the relative priority for repair is classified as medium.

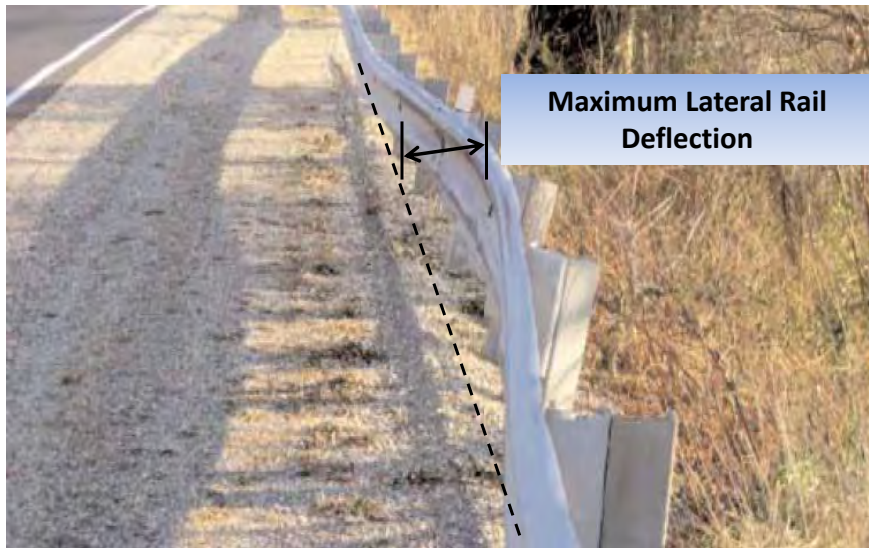
## Lateral Rail Deflection

Maximum lateral deflection =	> 9 inches	High
	6 – 9 inches	Med
	< 6 inches	Low

Although the effects of rail damage differ between the modified G4(1S) steel post guardrail and the G4(2W) wood post guardrail, the threshold of damage that constitutes the need for repair is essentially the same for both systems; thus the relative repair thresholds defined by Gabler *et al.* in NCHRP Report 656 are considered valid for both systems and are adopted here.

Rail deflections exceeding 9 inches may significantly affect the ability of the guardrail systems to contain and redirect vehicles. Beyond this critical deflection, the G4(2W) was shown to be susceptible to rail rupture, while the modified G4(1S) had an increased probability of barrier override. The relative priority for repair is high for those cases.

Rail deflections of 6 to 9 inches were found to compromise system performance, but the guardrails should function adequately under a majority of impacts. The relative priority for repair is medium for those cases.

At rail deflections less than 6 inches, the guardrails are expected to remain fully functional.

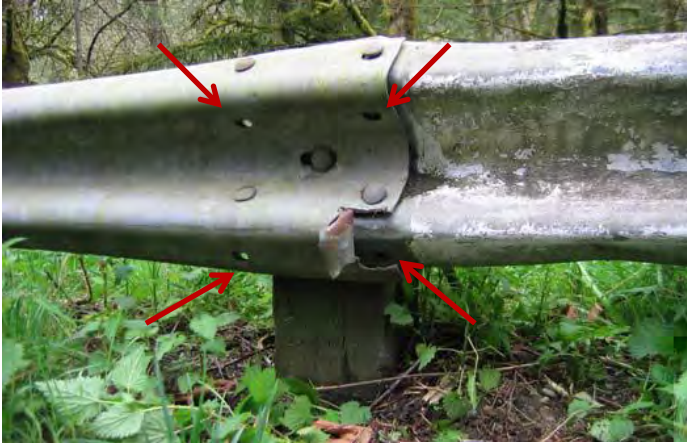
## Splice Damage

Field Example

- Missing bolt
- Visibly missing underlying rail material at bolt location
- Bolt severely gouging rail
- Bolt torn through rail
- Loose bolt

- Damage at two or more splice-bolt locations High
- Damage at a single splice-bolt location Medium

It is recommended that the repair threshold for splice damage include splice-bolts: missing, loose, damaged, severely gouging or torn through the rail, or visibly missing any rail material under the bolt. When any of these damages occur at a single splice-bolt location the recommended repair priority is medium. When any of these conditions occur at two or more splice-bolt locations the recommended repair priority is high.

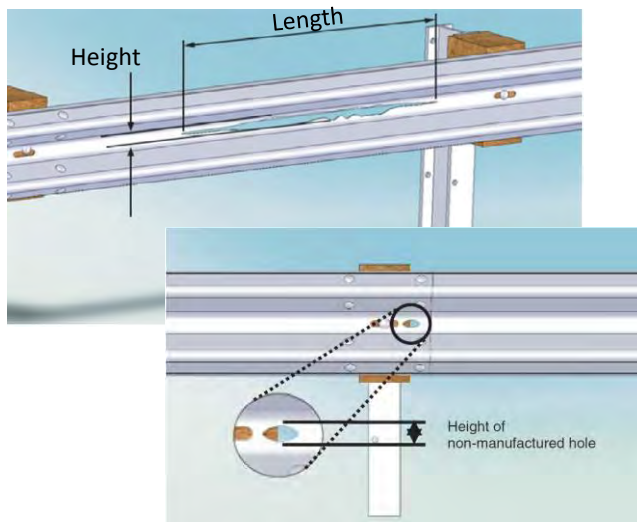
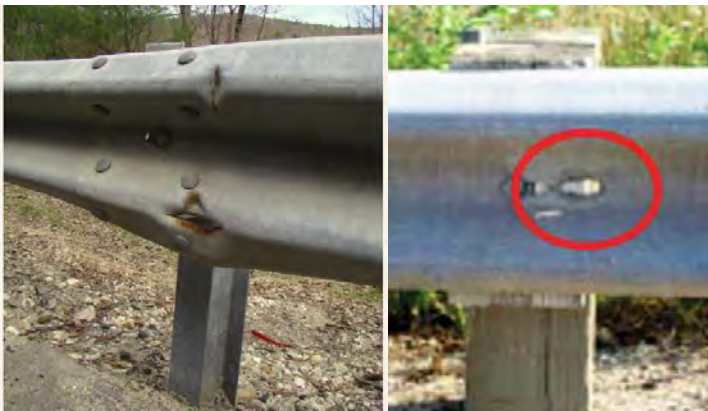
## Rail Holes / Horizontal Tears

- Any size hole or tear at top or bottom edge
- Hole with height > 1"
- Three or more holes or tears on a panel
  - 1 to 2 holes with height < 1"
  - Horz. Tears with Length > 12"
  - Horz. Tears with height 0.5 – 1"

Any size hole or horizontal tear (e.g., from weathering, rust, or impact damage) located at the top or bottom edge of the rail has the potential for causing a tear to propagate vertically and is therefore considered high priority for repair. Also, for holes with heights greater than 1 inch, or when there are three or more holes or horizontal tears on a w-beam panel, the relative priority for repair is classified as high.

Pendulum tests have shown that horizontal tears located between the top and bottom corrugations of a w-beam rail do not notably reduce the tensile capacity of the rail. Such tears, however, can result in a part of the vehicle (e.g., front bumper) passing through the tear, exposing the component to direct impact against the guardrail posts, or further extending the tear as the vehicle progresses forward along the rail, increasing the potential for rail rupture.

For horizontal tears located between the top and bottom corrugations with lengths greater than 12 inches, or with heights between 0.5 – 1 inch, or when there are 1 to 2 holes with height less than 1 inch on a single panel, the performance of the guardrail may be compromised but should function adequately under a majority of impacts. Thus the relative priority for repair is classified as medium for those cases.

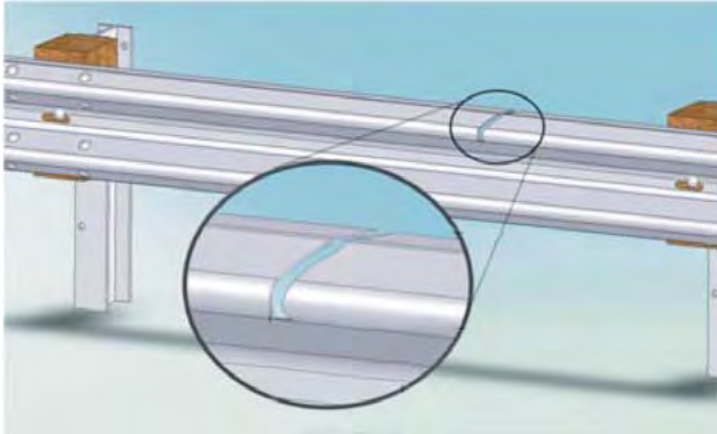
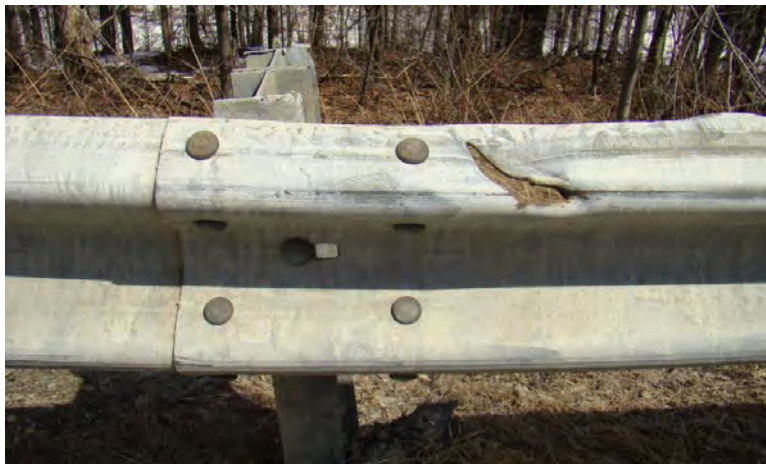
## Vertical Tears

Any size vertical tear → **High**

A vertical tear on any part of a w-beam rail may significantly affect the ability of the guardrail system to contain and redirect vehicles. A vertical tear, particularly on or near the edge of the rail, has a high probability of propagating (i.e., extending/growing) during impact and resulting in complete rupture of the rail. All vertical rail tears, therefore, indicate high priority for repair.

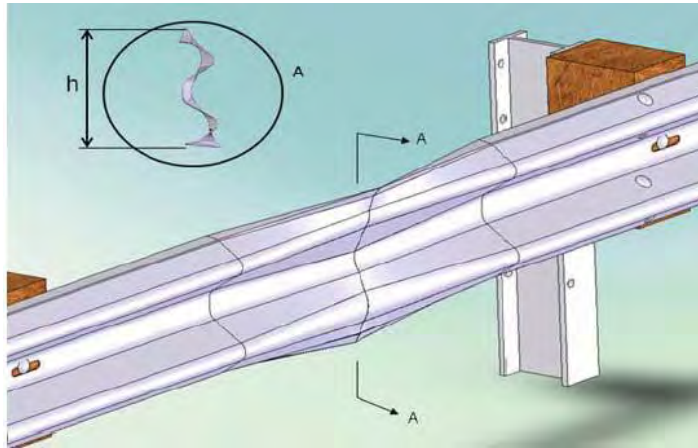
## Rail Flattening and Rail Crush

**Height of Rail  
Cross-Section**

> 17"	Med
9 - 17"	Low
< 9"	Med

However, when the cross-section height of the rail, as illustrated in the figure to the left, is less than 9 inches (e.g., crushed) or greater than 17 inches (e.g., flattened), the performance of the guardrail is likely reduced, but it should function adequately under a majority of impacts. The priority for repair is classified as medium for these cases.

For rail damage resulting in a cross-section height of 9 to 17 inches, the guardrail is expected to remain fully functional; thus these cases are considered as low priority for repair.

Note that the baseline cross-section height of an undamaged w-beam rail is 12 inches.

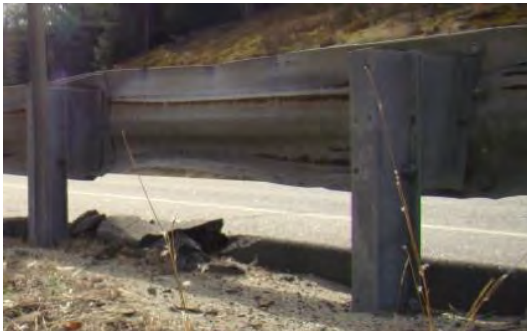
Field Example of  
Rail Flattening

Rail flattening and rail crush have not been shown to significantly affect guardrail performance, and therefore are not considered as high priority for repair.

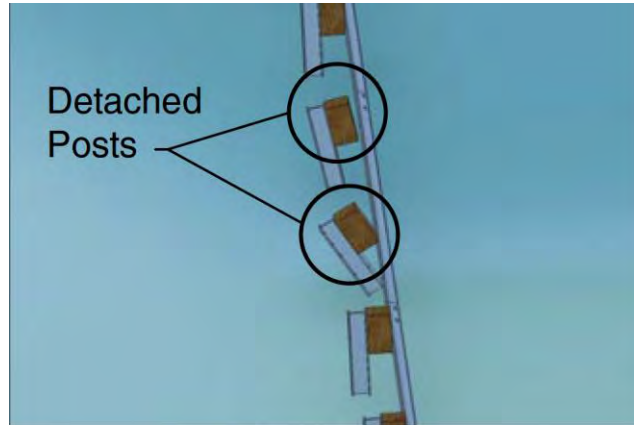
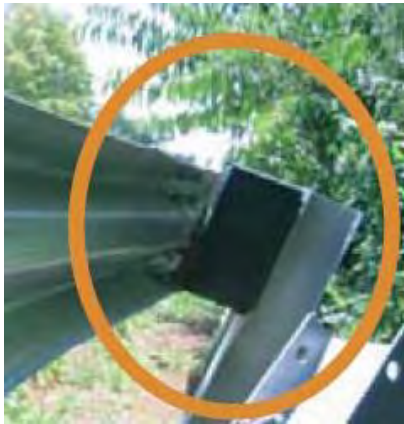
## Posts Separated from Rail

- Post/rail separation > 3"
- 2 or more posts separated from rail

Field Example

1. If the blockout is not firmly attached to the post, count as missing blockout.
2. Lateral deflection guidelines may apply for this damage mode.

This damage mode has not been shown to significantly affect guardrail performance and, therefore, is not considered to warrant high priority for repair. However, engineering judgment should be used on a case by case basis.

For the case of a single post separated less than 3 inches from the rail, the system should remain fully functional. However, when two or more consecutive posts are separated, or when post/rail separation for a single post exceeds 3 inches, guardrail performance may be compromised. The relative priority for repair in such cases is generally medium; however, such damage often denotes the existence of other damage modes.

Post and rail separation rarely occurs without post and rail deflection or damage to other components. When post/rail separation greatly exceeds 3 inches or if multiple posts are separated from the rail, it is recommended that other aspects of the system be critically evaluated (e.g., lateral deflection, missing or damaged blockouts, etc.).

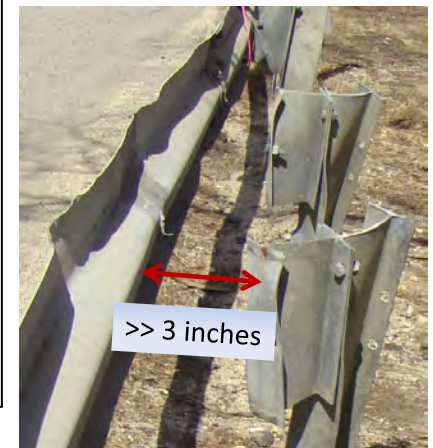
The photo shown to the right is an example of rail-post separation that warrants high priority for repair. Although the rail deflection is negligible, the extreme deformation and separation of the posts in this case render them nonfunctional.

The case of bent or twisted posts has not been evaluated as an isolated damage mode, thus engineering judgement must be used for those cases. (See also the criteria for rail deformation and for post-rail separation on pages 4 and 9, respectively.) The photo below was shown earlier on page 9 and is shown again here for its relevancy to this damage mode. The deformation of the posts, as well as their separation distance from the rail as shown in this photo, renders them nonfunctional. Thus, this damage would warrant high priority for repair.

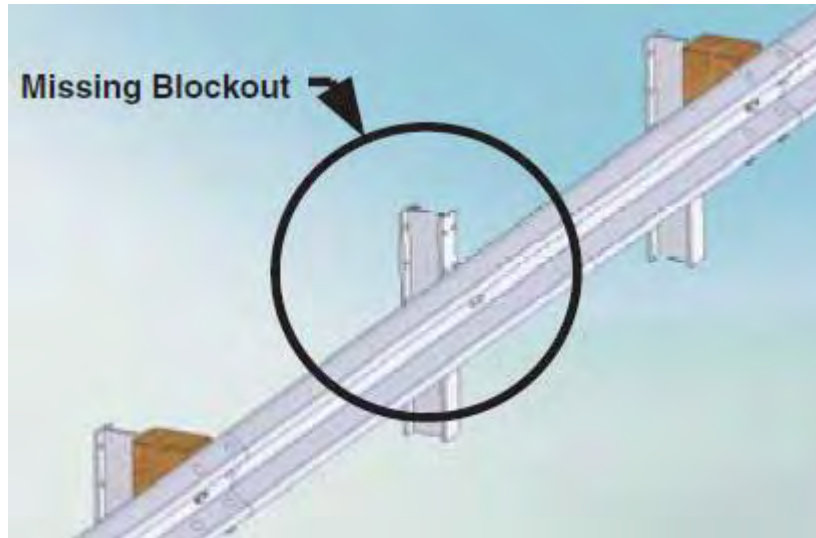
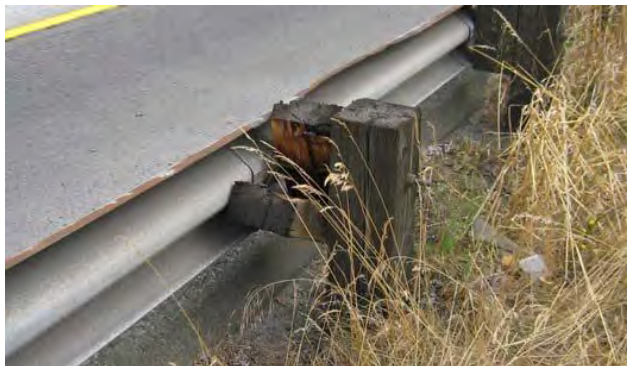
## Blockout Condition

### Any blockouts:

- Missing
- Cracked across grain
- Split through post hole
- Rotted

Field Example

This damage mode has not been shown to significantly affect guardrail performance and, therefore, is not considered to warrant high priority for repair. However, when one or more blockouts are missing, cracked across the grain, split vertically through the post-bolt hole or rotted, there is an increased potential for the rail to directly contact the posts during a collision, which may increase the propensity for rail tears (particularly for rail contact with steel wide-flange posts).

For this damage mode, the guardrail is expected to perform adequately for the majority of impact cases. The relative priority for repair is classified as medium.

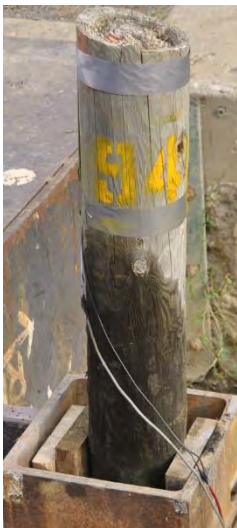
**DL3**  
Score Criteria

Force (k): 3.8 < 9  
Energy (k-in): 5.3 < 20  
Resi: 0.24 < 0.57

Four levels of deterioration for wood guardrail posts are defined in terms of load and energy capacity of the post data, as well as in terms of relative capacity. Therefore, if post strength is measured or otherwise determined in the field (e.g., stress wave techniques, force-deflection techniques, resistograph, etc.) then the relative capacity may be used to identify damage level.

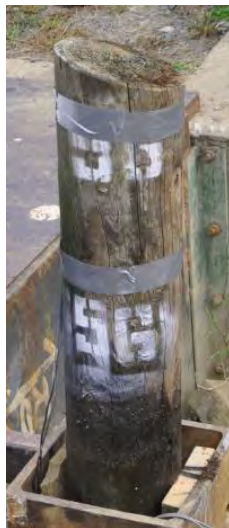
**DL2**  
Score Criteria

7.6 7-13  
21.3 20-30  
0.67 0.57 - 0.83

**DL2:** Often marked by shallow deterioration at top of post (<1”), extending over most if not all the cross-section. Post is audibly soft but not punky when struck by a hammer.

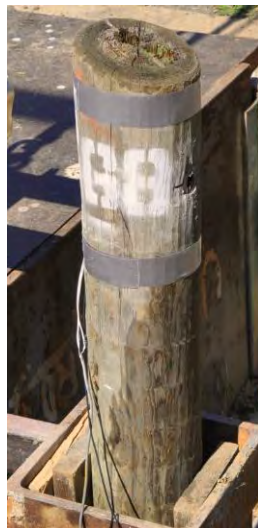
**DL1**  
Score Criteria

14.8 12-15  
32 26-40  
0.95 0.83 - 1.0

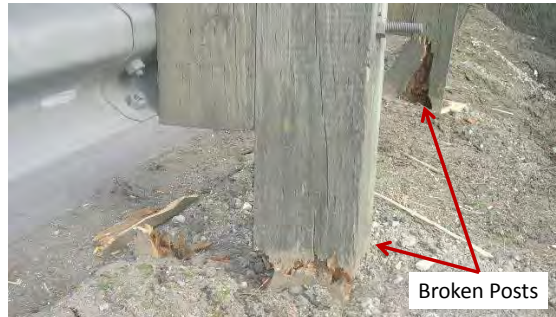
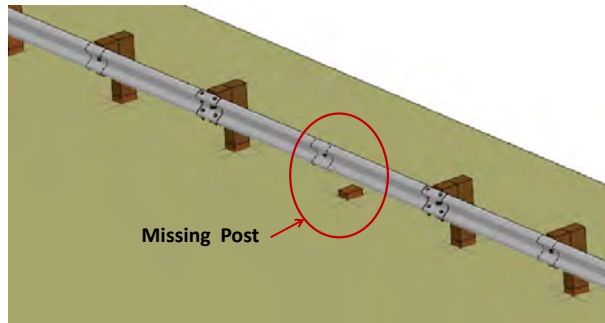
*Missing / Broken:*

High

If any wood posts are missing, broken or cracked across the grain the guardrail will not function properly and should be replaced. Also, any posts with deterioration level 3 (DL3) are essentially non-functional and are considered to be of high priority for replacement.

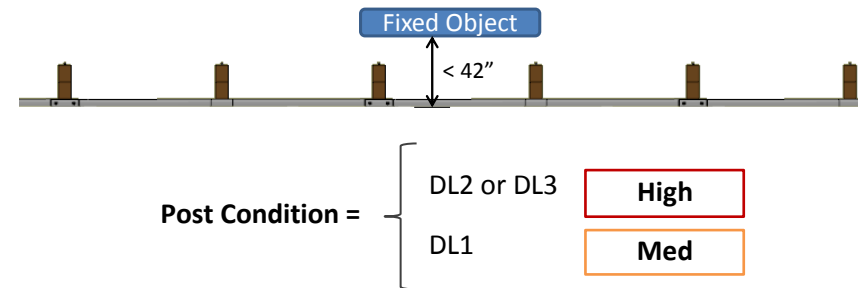
If a fixed-object is located less than 42" behind face of rail:

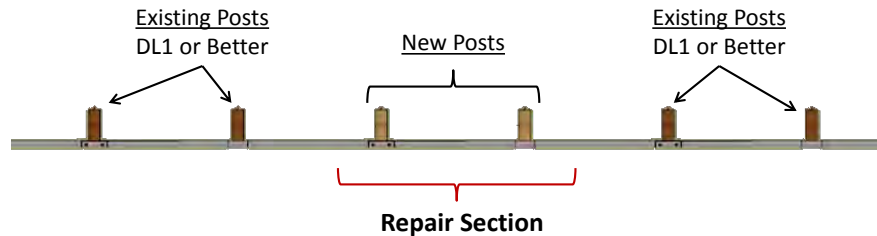
If posts adjacent to the repair section are DL1 or better:

- If the adjacent posts are DL1 or better, then only the posts in the damage region need to be replaced.
- If the adjacent posts are DL2, then either: (1) all posts in the system should be replaced with new posts or (2) the damaged posts in the immediate repair section should be replaced with posts of equivalent strength to DL1 (e.g., new posts with reduced cross-section). From available test data, new round posts with a diameter of 7.2 to 7.6 inches meet this condition. Moreover, these reduced post diameters also meet the minimum size criteria for round posts (i.e.,  $8 \pm 1$  inches).
- If the adjacent posts are DL3, then according to the aforementioned criteria, those posts should also be included in the repair since they render the guardrail non-functional.

If it is determined that replacement of guardrail post(s) is warranted, (e.g., in a crash damaged section), then the posts immediately upstream and downstream of the repair section should be checked for deterioration to ensure stiffness compatibility between the repair section and the existing guardrail.

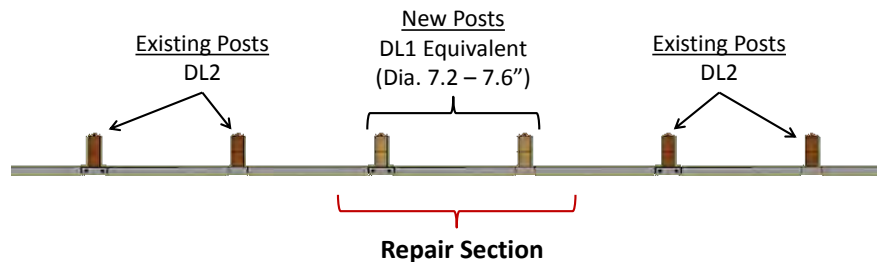
If posts adjacent to the repair section are DL2:

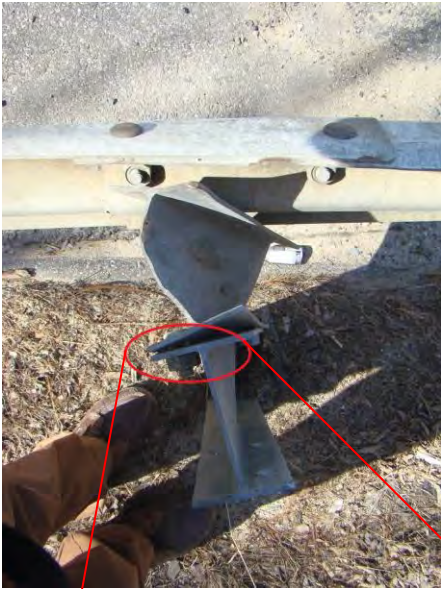
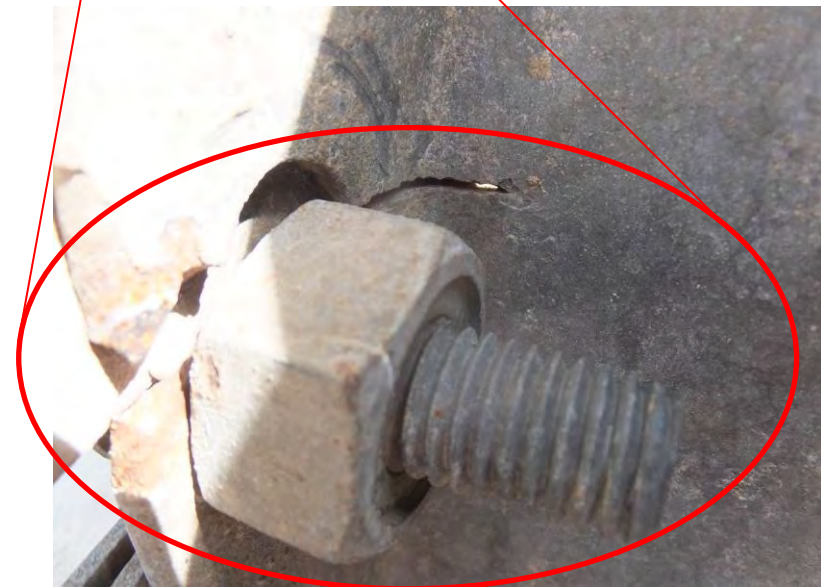
## Steel Post Condition

One or more posts missing or with metal tears

For the steel posts of the G4(1S) guardrail, the relative priority for repair is classified as high when any posts are missing or have metal tears in them. The guardrail will not function properly with these damages and the posts must be replaced.

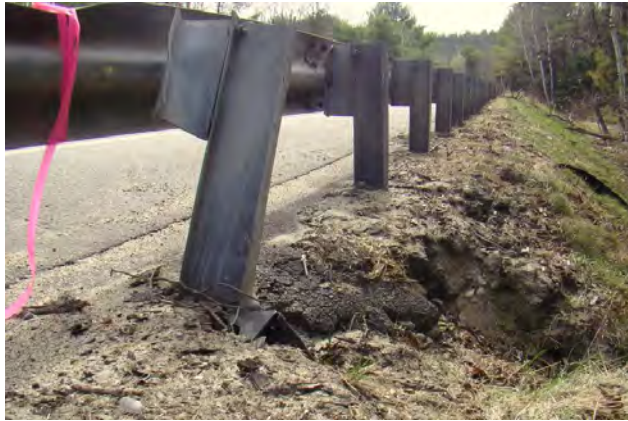
### *Erosion at a Single Post within a Four-Post Span:*

$$\text{Erosion} = \begin{cases} \geq 12'' & \text{High} \\ 9 - 12'' & \text{Med} \end{cases}$$

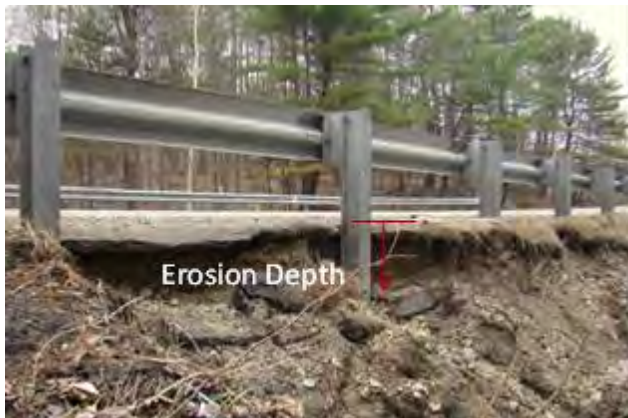
### *Erosion at Multiple Posts within a Four-Post Span:*

$$\text{Erosion} = \begin{cases} \geq 6'' & \text{High} \\ 4 - 6'' & \text{Med} \end{cases}$$

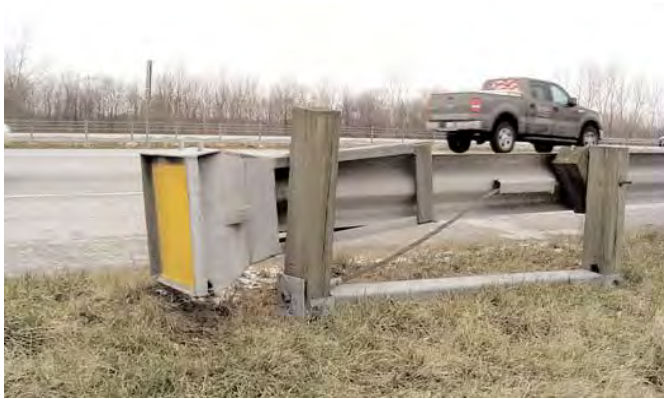
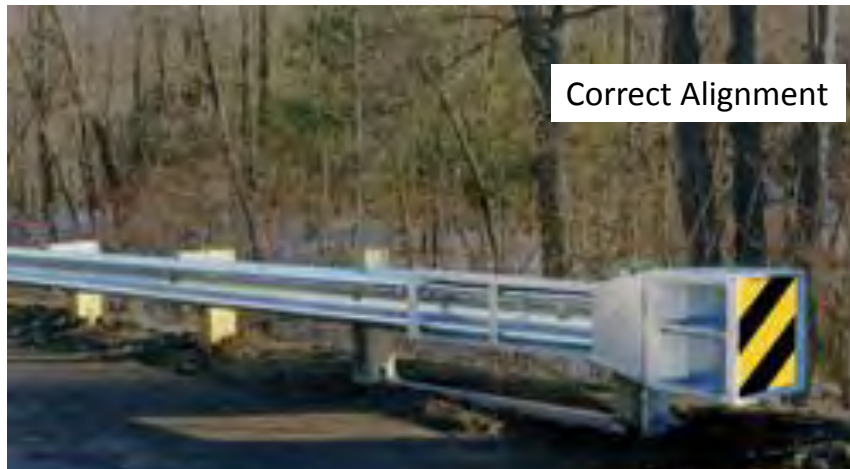
*Misaligned or missing screws:*

**High**

Note: Attachment hardware for the impact head will vary depending on manufacturer.

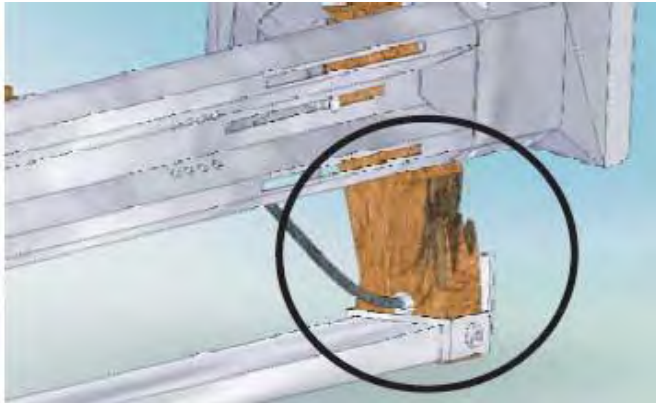
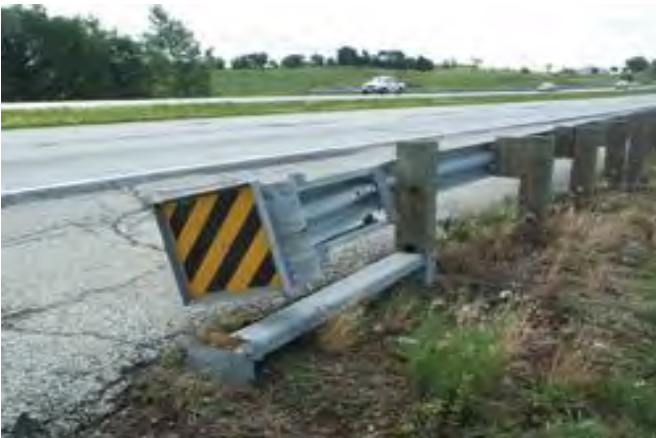
*Damaged, Severely Cracked, Rotted or Missing End-Post:*

High

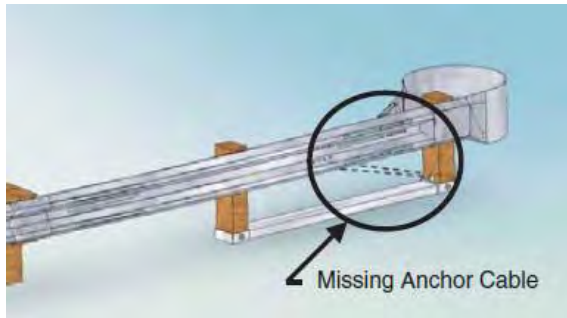
#### *Missing Cable:*

**High**

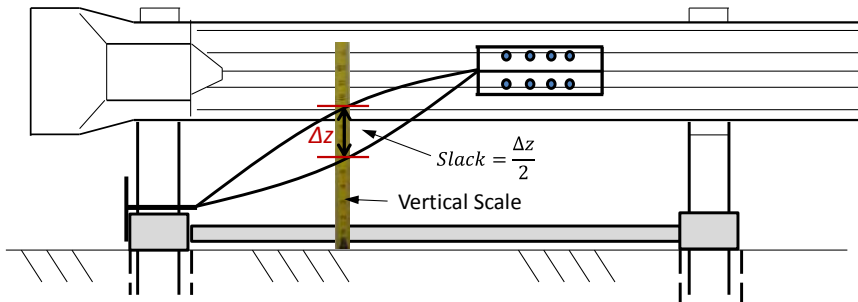
#### *Loose Cable:*

$$Slack = \frac{\Delta z}{2} = \begin{cases} >3'' & \text{High} \\ 2''-3'' & \text{Med} \end{cases}$$

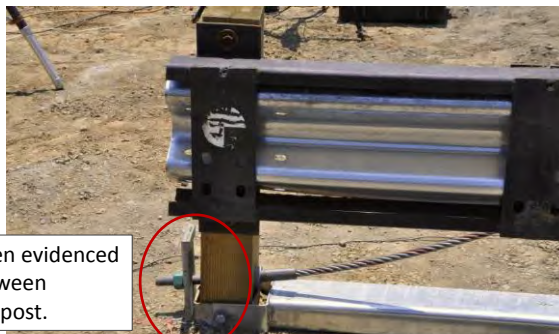
Loose cable is often evidenced by separation between bearing plate and post.

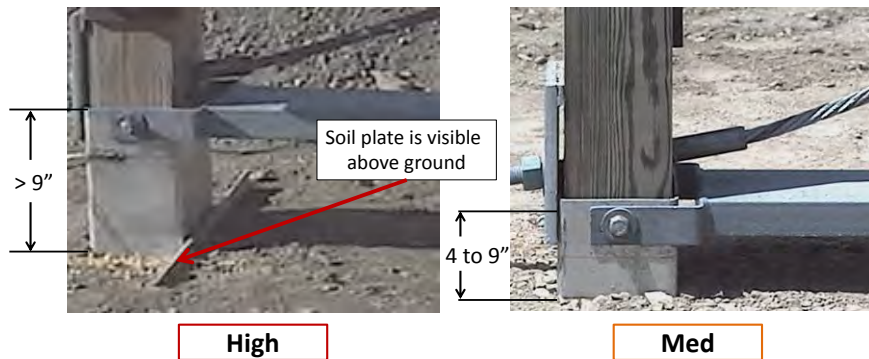
#### Stub Height:

$$\text{Stub Height} = \begin{cases} > 9" & \text{High} \\ 4-9" & \text{Med} \end{cases}$$

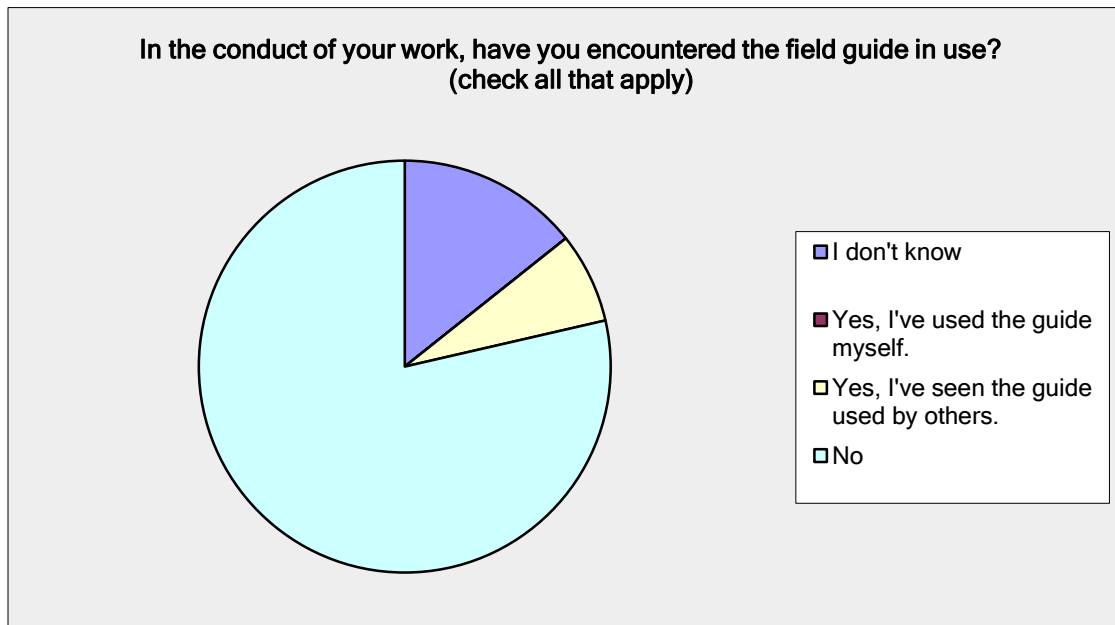
**Figure 3. Survey Group 1, Question 4 Responses.**

Table 6 shows the responses from Survey Group 1, and Figure 3 shows the percentages of the responses graphically. Most respondents have never encountered the field guide in use at all, and none of the respondents have used the field guide themselves. The one respondent that chose to express their impressions with the guide responded with simply, “I have reviewed the Field Guide.”

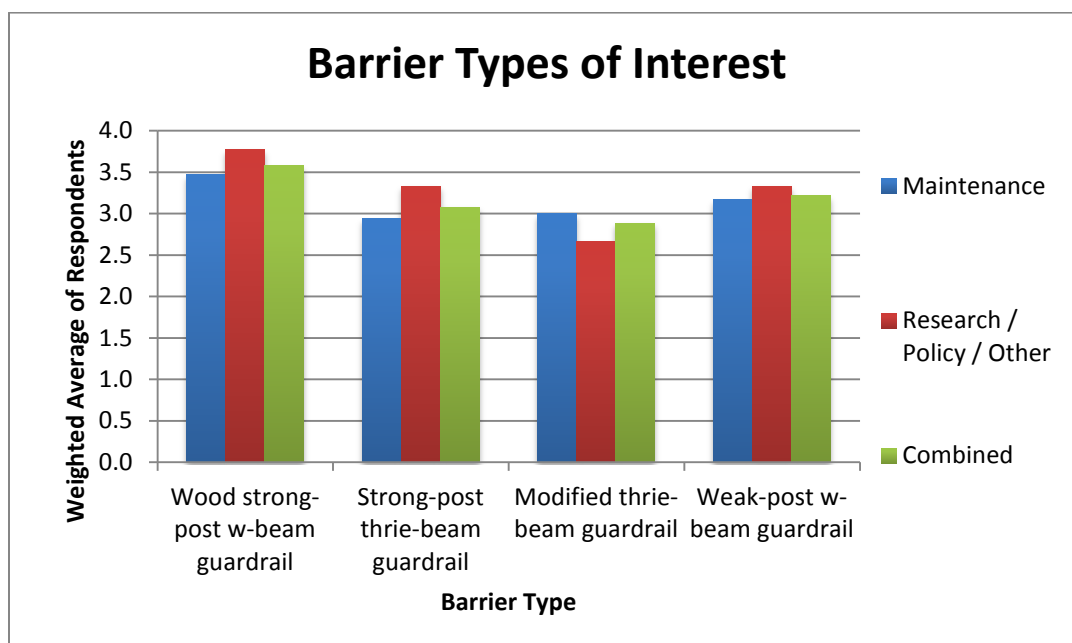
**Figure 4. Barrier Types of Interest 1, Reorganized Groups.**

From Figure 4, it can be seen that the Research/Policy/Other group has more interest in the wood strong-post w-beam, strong-post thrie-beam, and weak-post w-beam guardrails than the Maintenance group, while the Maintenance group showed more interest in the modified thrie-beam guardrail than the Research/Policy/Other group.

Respondents were asked to rate their interest in each barrier type using the scale of “very low”, “low”, “medium”, “high”, and “very high”. The responses from both reorganized groups were then averaged using a weighted scale where “very low” = 1 and “very high” = 5. The results can be seen below in Figure 4 and Figure 5.

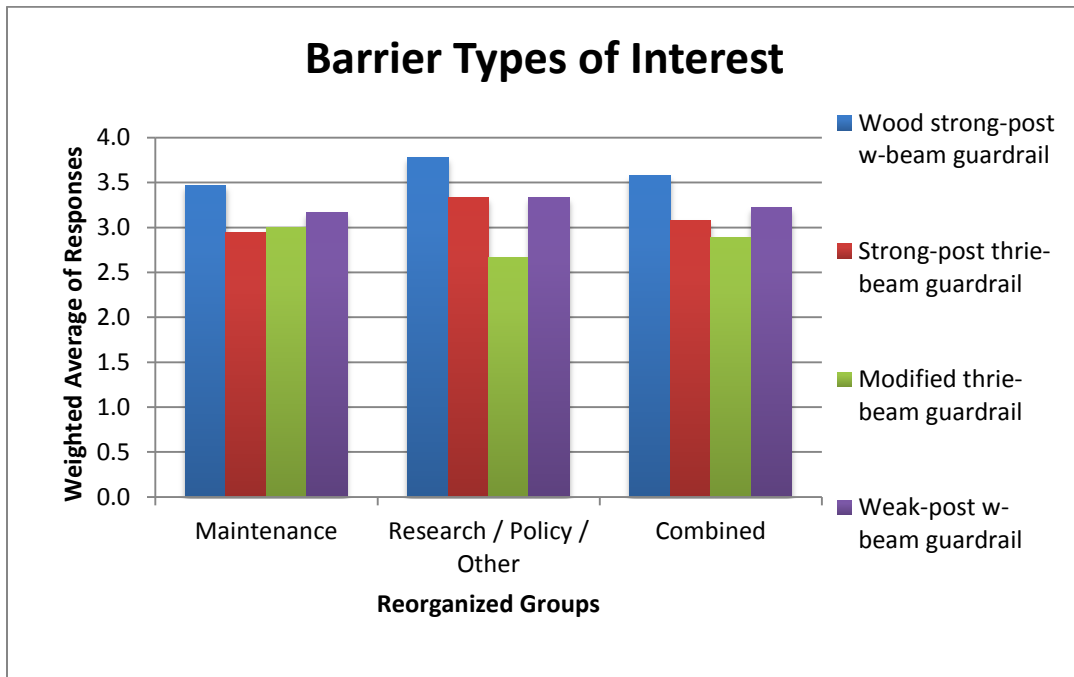
**Figure 5. Barrier Types of Interest 2, Reorganized Groups.**

From Figure 5, it is evident that the wood strong-post w-beam is the guardrail that both profession groups are the most interested in, followed by the weak-post w-beam guardrail. The Maintenance group was interested in the strong-post thrie-beam guardrail the least, while the Research/Policy/Other group had the least interest in the modified thrie-beam guardrail. The modified thrie-beam guardrail was the barrier with the least amount of interest when the two reorganized groups were combined.

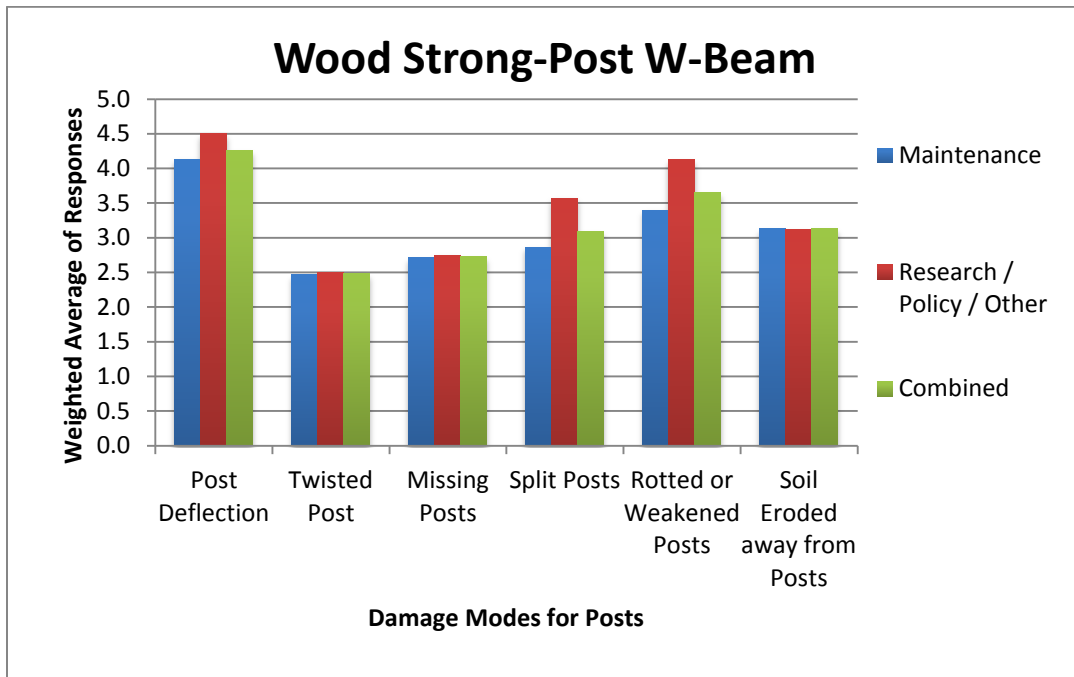
**Figure 6. Wood Strong-Post W-Beam Damage Modes for Posts 1, Reorganized Groups.**

From Figure 6 it can be seen that the Research/Policy/Other group showed more concern than the Maintenance group for every type of damage mode for posts in the wood strong-post w-beam guardrail except for “soil eroded away from posts”. The weighted average of responses for the reorganized groups were very close to one another for three of the damage modes; “twisted posts”, “missing posts”, and “soil eroded away from posts”.

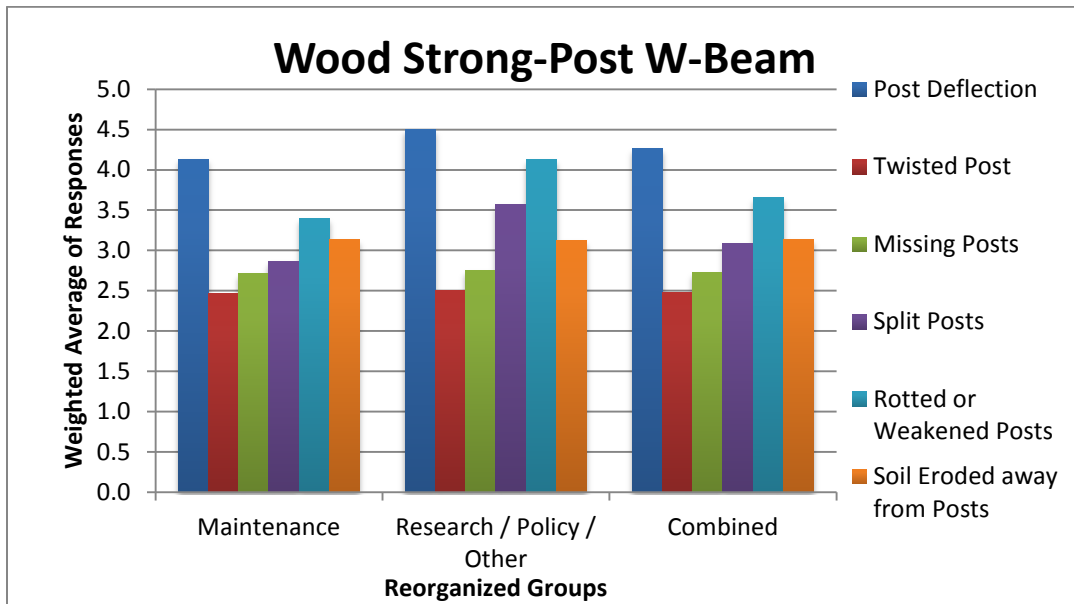
**Figure 7. Wood Strong-Post W-Beam Damage Modes for Posts 2, Reorganized Groups.**

From Figure 7, “post deflection” is clearly the damage mode considered most common for the wood strong-post w-beam guardrail by both profession groups, followed by “rotted or weakened posts”. “Twisted post” and “missing posts” were the two damage modes of least common occurrence for both groups. Those were the only two damage modes that the two groups did not agree on; the Maintenance group felt that “soil eroded away from posts” was more common than “split posts”, while the Research/Policy/Other group felt it was the other way around. When combining the two groups, the weighted averages of responses for those two damage modes were about the same.

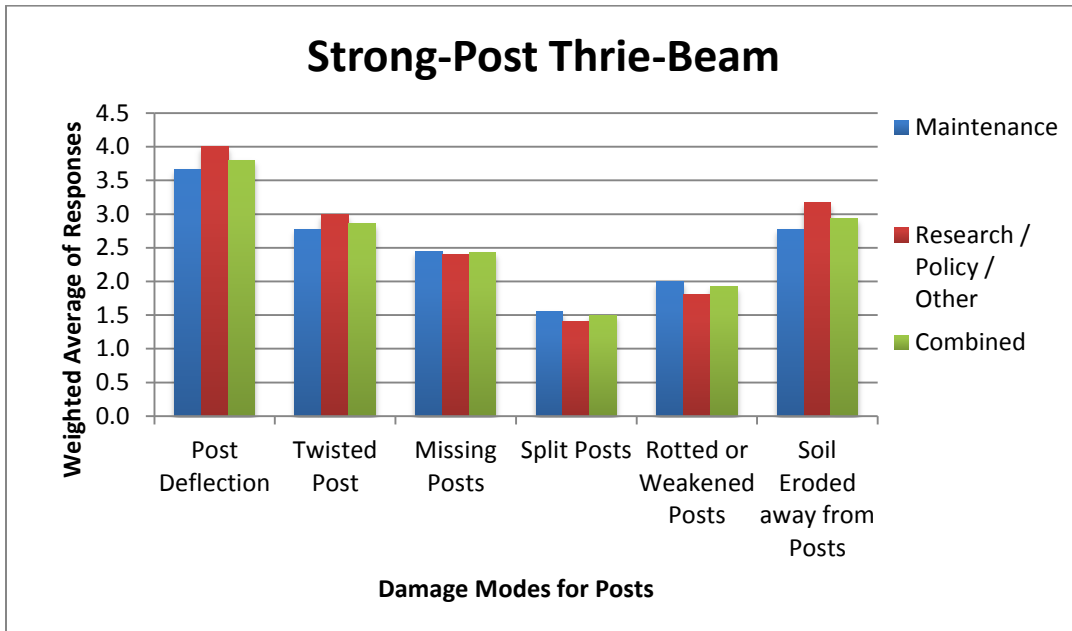
**Figure 8. Strong-Post Thrie-Beam Damage Modes for Posts 1, Reorganized Groups.**

With regards to the strong-post thrie-beam barrier, Figure 8 shows that the Research/Policy/Other group had more concern for “post deflection”, “twisted post”, and “soil eroded away from posts” than the Maintenance group. The Maintenance group showed more concern than the Research/Policy/Other group for “split posts” and “rotted or weakened posts”, and the results were about the same for both groups in regards to “missing posts”.

With regards to damage modes for guardrail posts of the modified thrie-beam, the responses from the different profession groups (Figure 10) were very similar to those for the strong-post thrie-beam (Figure 8), only more skewed. The Research/Policy/Other group showed much more concern for the “post deflection”, “twisted post”, “missing posts”, and “soil eroded away from posts” than the Maintenance group, who showed more concern with “split posts” and “rotted or weakened posts”.

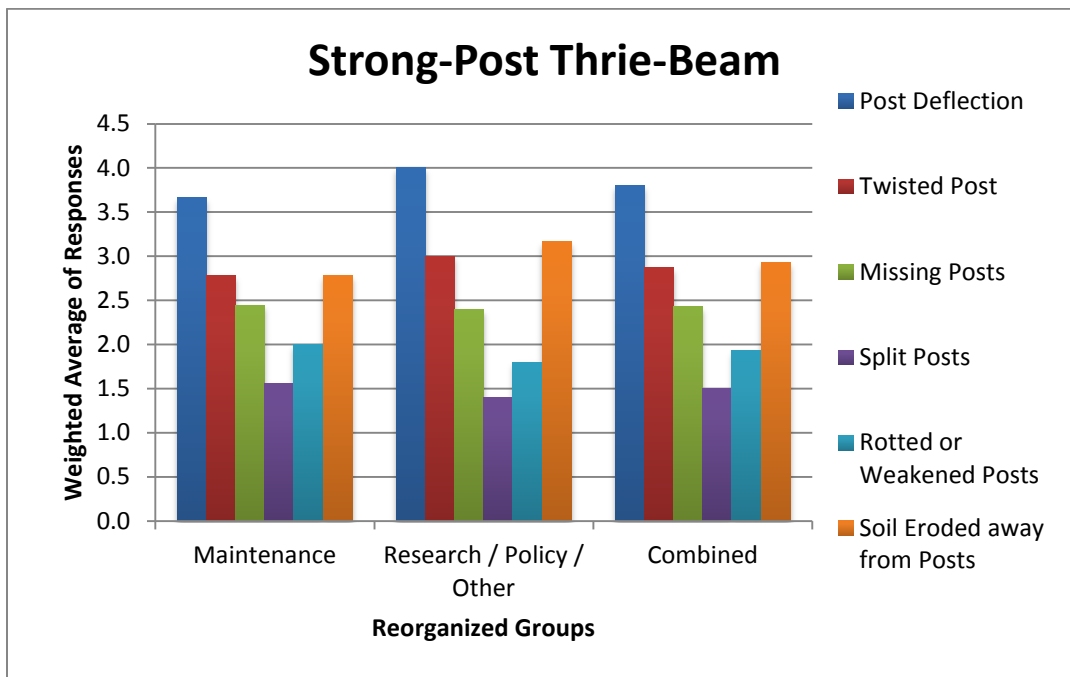
**Figure 9. Strong-Post Thrie-Beam Damage Modes for Posts 2, Reorganized Groups.**

Figure 9 shows that both profession groups mostly agree with each other as to the frequency of each damage mode for the strong-post thrie-beam barrier. In descending order of occurrence frequency, the damage modes identified were: “post deflection”, “soil eroded away from posts”, “twisted post”, “missing posts”, “rotted or weakened posts”, and “split posts”.

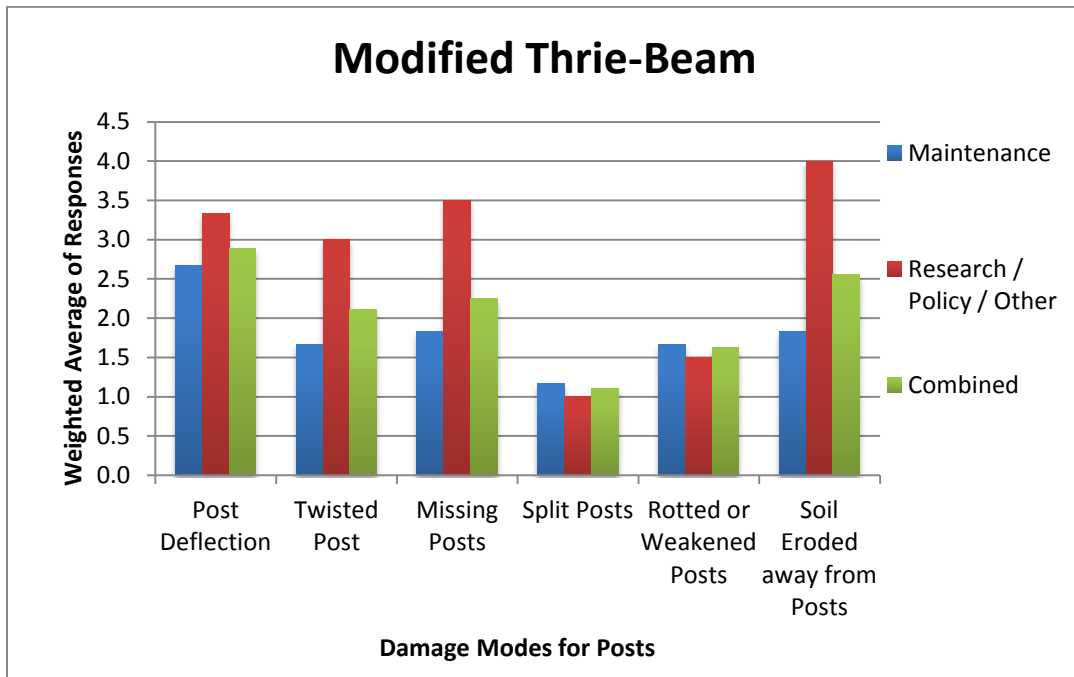
**Figure 10. Modified Thrie-Beam Damage Modes for Posts 1, Reorganized Groups.**

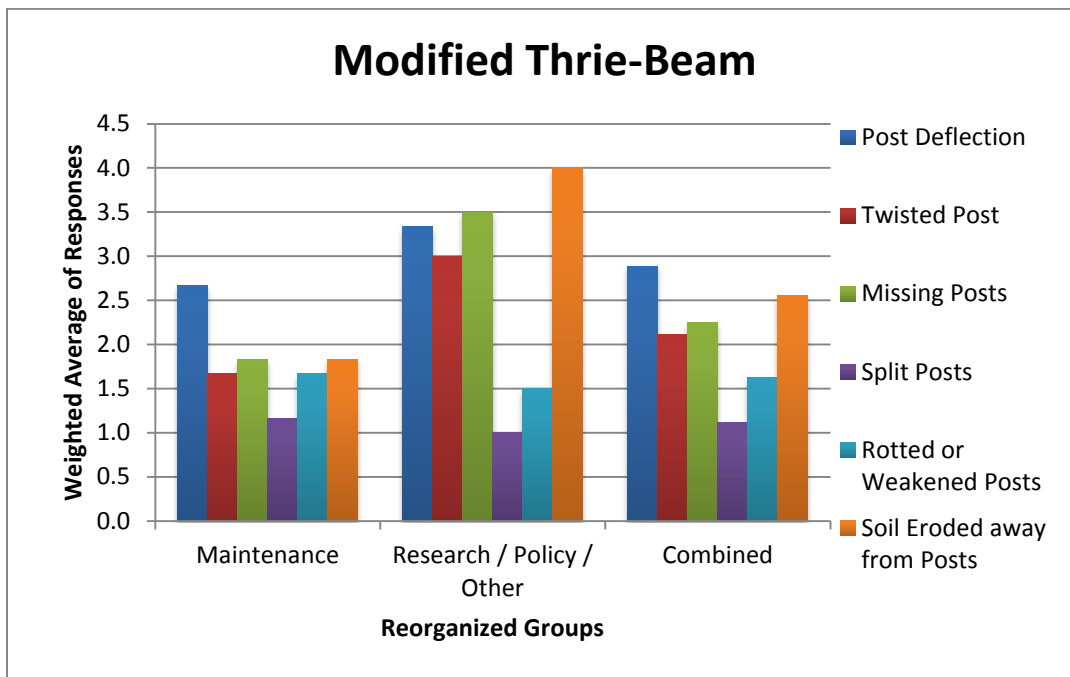
Figure 11 shows that the Maintenance group considered “post deflection” to be the most frequently occurring damage mode for posts in regards to the modified thrie-beam guardrail, while the Research/Policy/Other group considered “soil eroded away from posts” to be the most frequently occurring damage mode. Both profession groups felt “split posts” was the least frequently occurring damage mode, followed by “rotted or weakened posts” as the second least frequently occurring damage mode.

**Figure 11. Modified Thrie-Beam Damage Modes for Posts 2, Reorganized Groups.**

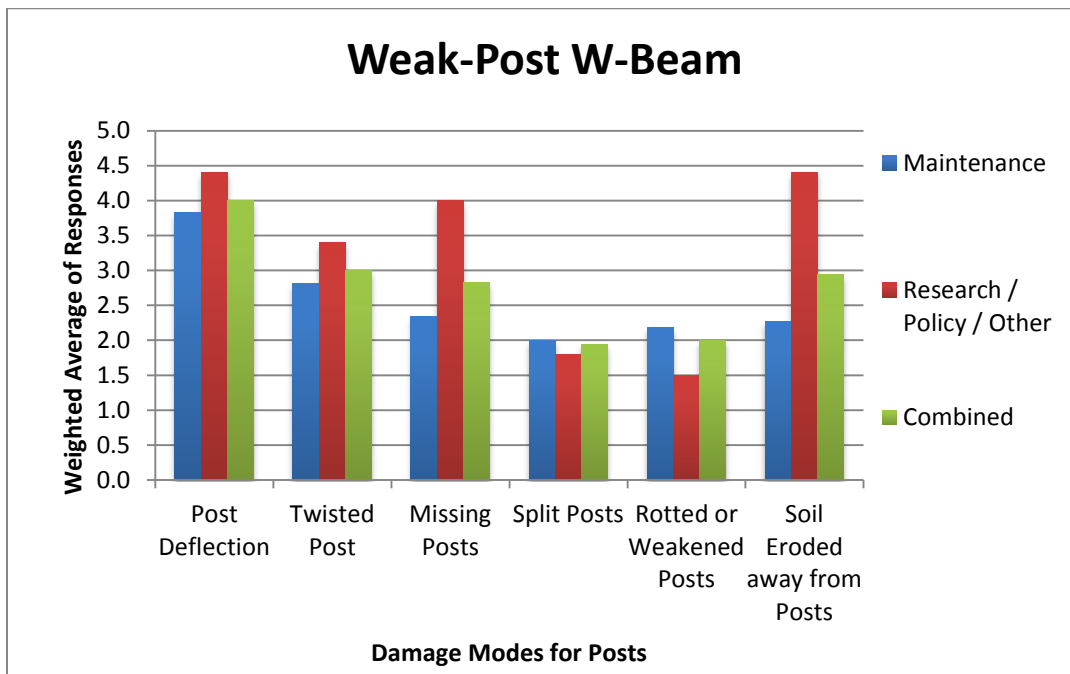
**Figure 12. Weak-Post W-Beam Damage Modes for Posts 1, Reorganized Groups.**

With regards to damage modes for posts of the weak-post w-beam guardrail, the responses from the different profession groups (Figure 10) were very similar to those for the strong-post thrie-beam (Figure 8) and modified thrie-beam (Figure 10). The Research/Policy/Other group showed more concern for the “post deflection”, “twisted post”, “missing posts”, and “soil eroded

away from posts” than the Maintenance group, who showed more concern with “split posts” and “rotted or weakened posts”.

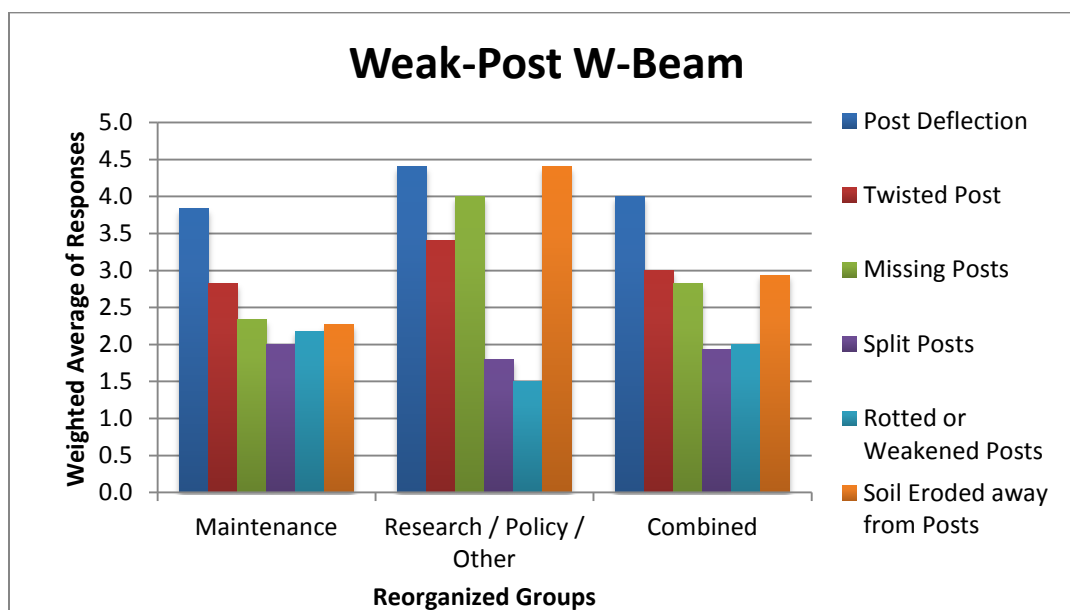
**Figure 13. Weak-Post W-Beam Damage Modes for Posts 2, Reorganized Groups.**

For the weak-post w-beam barrier (Figure 13), the Maintenance group considered “post deflection” to be the most frequently occurring damage mode for posts. The Research/Policy/Other group considered both “post deflection” and “soil eroded away from posts” to be the most frequently occurring damage mode for posts, and both profession groups considered both “split posts” and “rotted or weakened posts” to be the two least-occurring damage modes.
