# **A Guide for W-Beam Guardrail Damage Assessment**

A Field Manual for  
Highway Maintenance Personnel

National Cooperative  
Highway Research  
Program  
Project 22-28

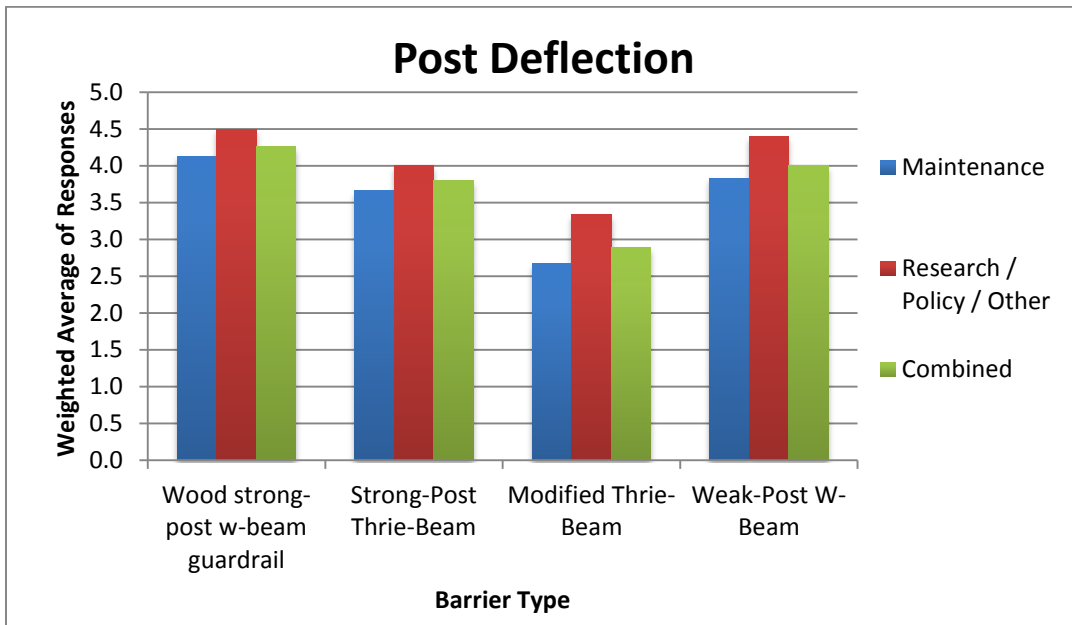
**Figure 14. Post Deflection Damage Mode Frequency for Barrier Types, Reorganized Groups.**

When looking at just the “post deflection” damage mode (Figure 14), both groups considered this mode of damage to occur more frequently in the wood strong-post w-beam guardrail, followed by the weak-post w-beam, the strong-post thrie-beam, and finally the modified thrie-beam guardrail.

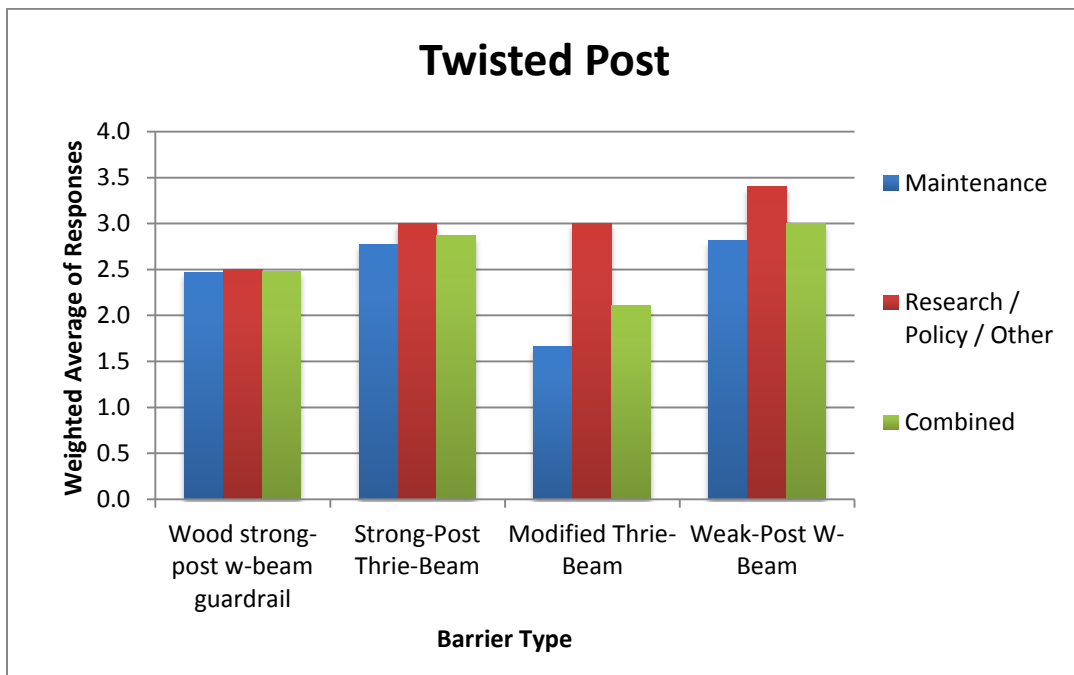
**Figure 15. Twisted Post Damage Mode Frequency for Barrier Types, Reorganized Groups.**

The Maintenance group considered both the strong-post thrie-beam and weak-post w-beam guardrails to have the highest occurrence of twisted posts, while the Research/Policy/Other group considered the weak-post w-beam guardrail alone to be the barrier that experienced this damage mode the most often.

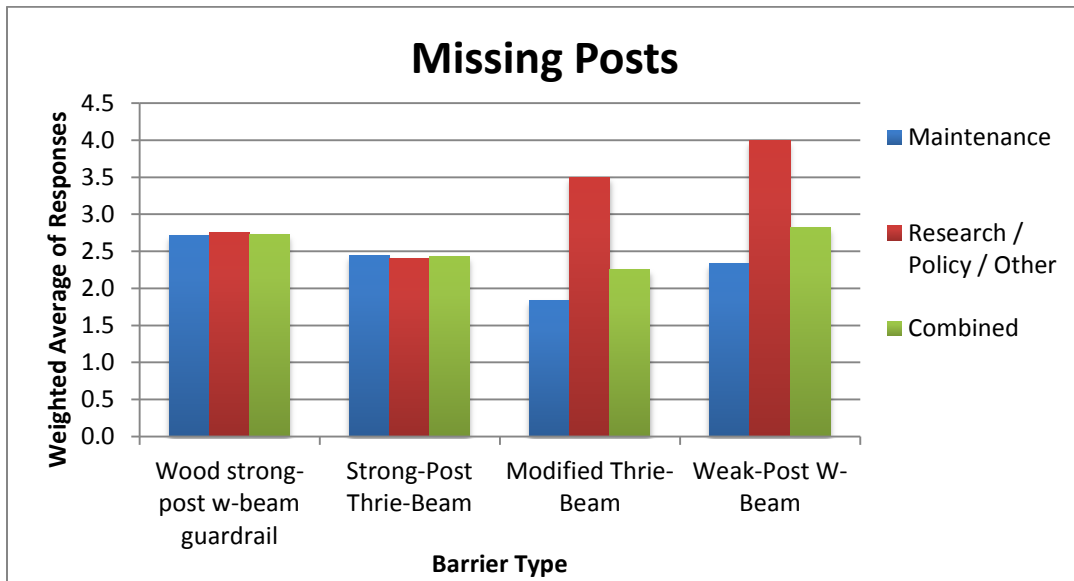
**Figure 16. Missing Posts Damage Mode Frequency for Barrier Types, Reorganized Groups.**

For the “missing posts” damage mode (Figure 16), the two profession groups were in complete disagreement as to which barrier types experienced the highest frequency of this damage mode. The Maintenance group thought this damage mode occurred mostly with the wood strong-post w-beam and strong-post thrie-beam guardrails, while the Research/Policy/Other group thought it occurred most frequently with the modified thrie-beam and weak-post w-beam guardrails.

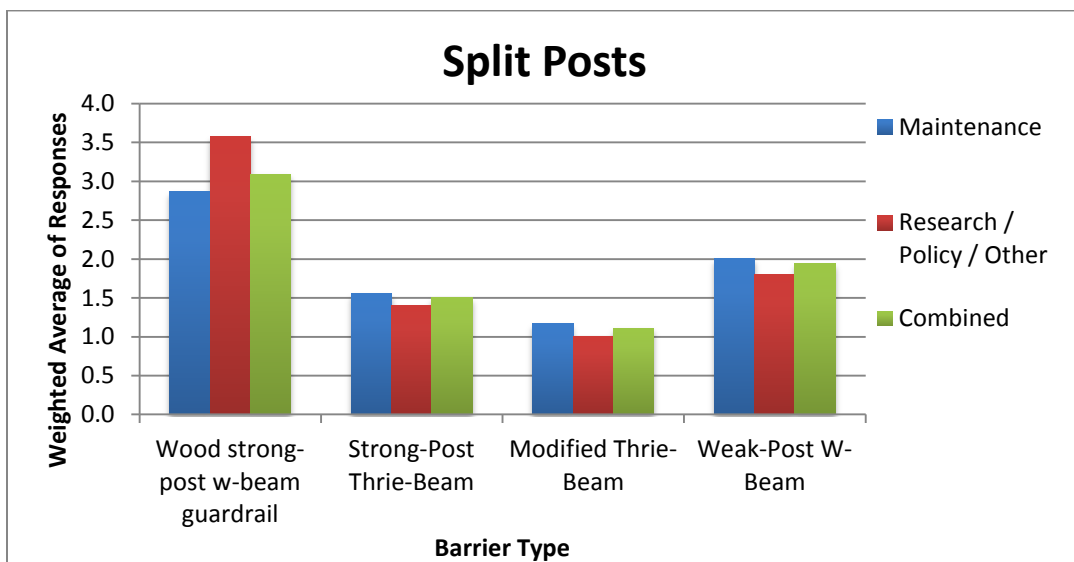
**Figure 17. Split Posts Damage Mode Frequency for Barrier Types, Reorganized Groups.**

For the “split posts” damage mode (Figure 17), both profession groups agreed with each other on every barrier type. They felt that the wood strong-post w-beam guardrail was the barrier that experienced this damage mode the most often. It is surprising that the modified thrie-beam guardrail received any responses, since this system does not have wooden posts; however, it may be that those respondents confused the wood-post thrie-beam with the modified thrie-beam system. Similarly, the TL-3 weak-post w-beam system also only has steel posts, although there are several TL-2 wooden weak-post guardrail systems.

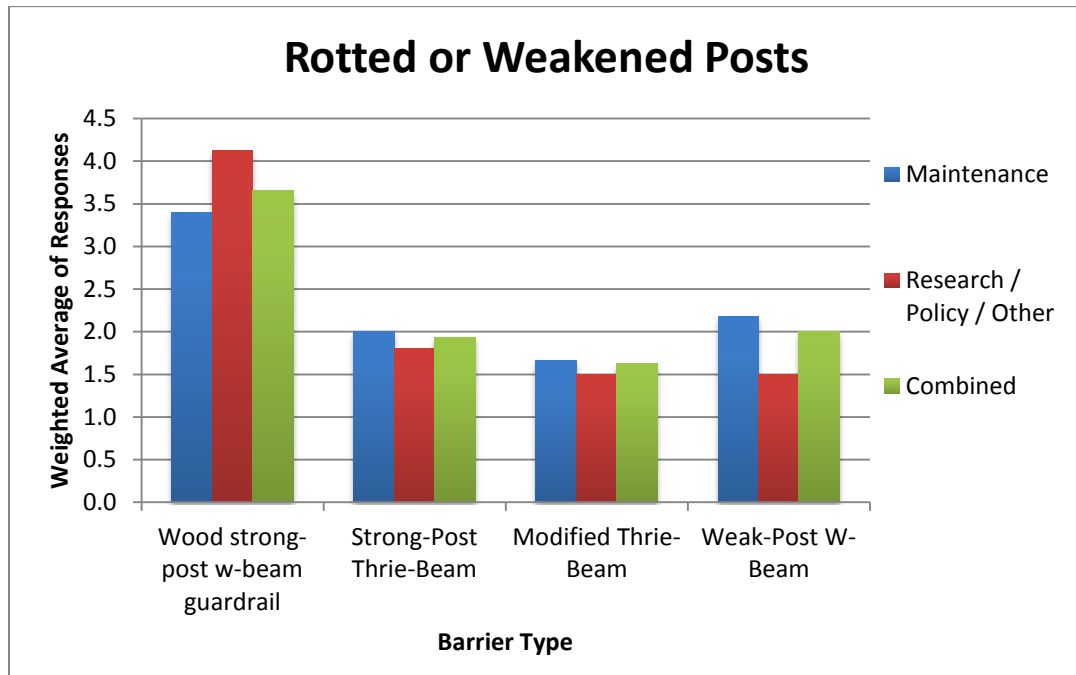
**Figure 18. Rotted or Weakened Posts Damage Mode Frequency for Barrier Types, Reorganized Groups.**

As with the “split posts” damage mode, the “rotted or weakened posts” damage mode (Figure 18) also had both profession groups cite the wood strong-post w-beam guardrail as the barrier having the highest frequency of occurrence.

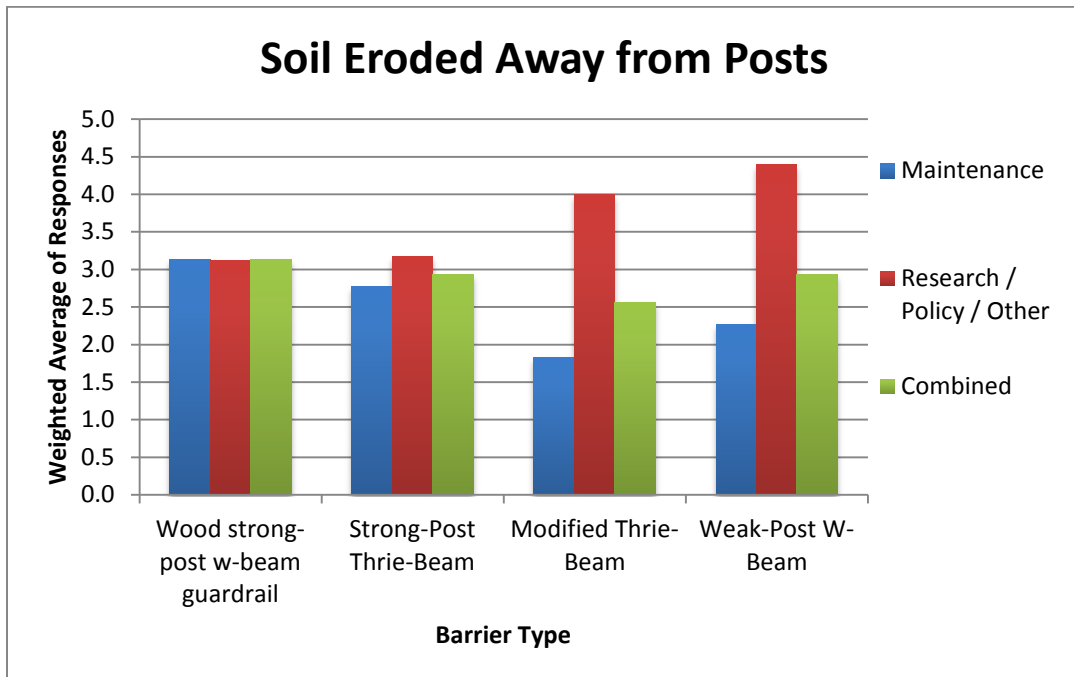
**Figure 19. Soil Eroded Away from Posts Damage Mode Frequency for Barrier Types, Reorganized Groups.**

“Soil eroded away from posts” (Figure 19) was another damage mode for posts that the two reorganized groups disagreed on in respect to barrier type frequency of occurrence. The Maintenance group identified the wood strong-post w-beam and the strong-post thrie-beam guardrails as the two barriers with the highest frequency of occurrence for this damage mode, whereas the Research/Policy/Other group identified the weak-post w-beam and the modified thrie-beam guardrails.

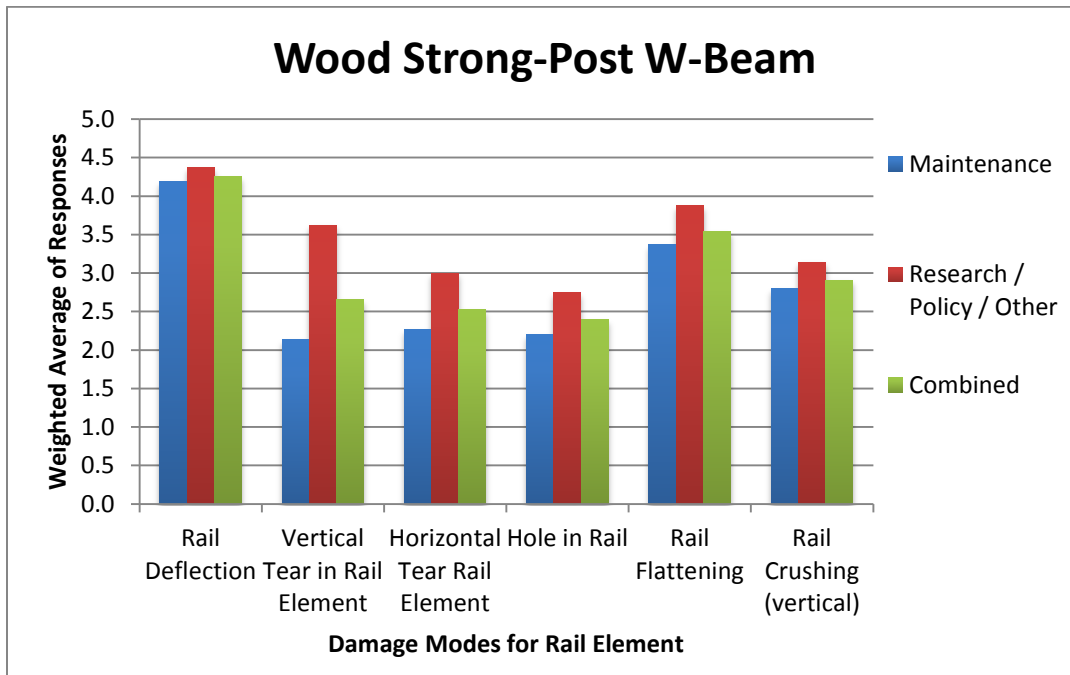
**Figure 20. Wood Strong-Post W-Beam Damage Modes for Rail Element 1, Reorganized Groups.**

As can be seen in Figure 20, the Research/Policy/Other group had a higher weighted average value of responses for every damage mode for rail element than the Maintenance group for the wood strong-post w-beam guardrail. “Rail deflection” had the least amount of difference, while “vertical tear in rail element” had the most.

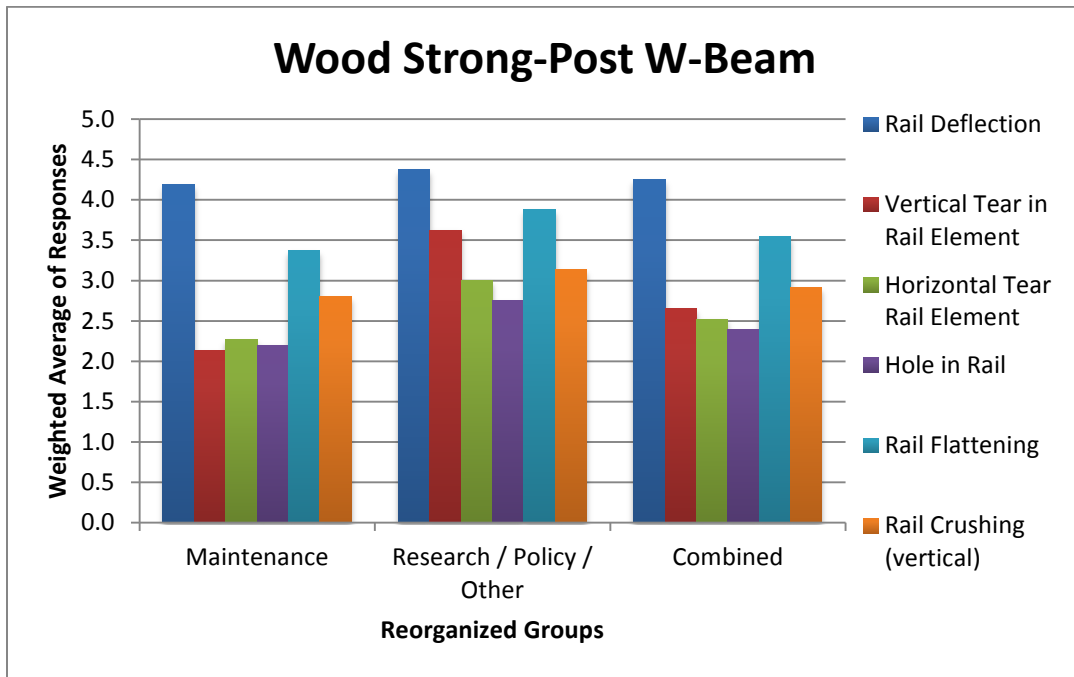
**Figure 21. Wood Strong-Post W-Beam Damage Modes for Rail Element 2, Reorganized Groups.**

From Figure 21, both profession groups considered “rail deflection” to be the most frequently occurring damage mode for rail elements in regards to the wood strong-post w-beam guardrail. They also agree that “rail flattening” was the second most frequently occurring damage mode for the barrier but did not agree on “vertical tear in rail element”, which was considered more common by the Research/Policy/Other group than the Maintenance group.

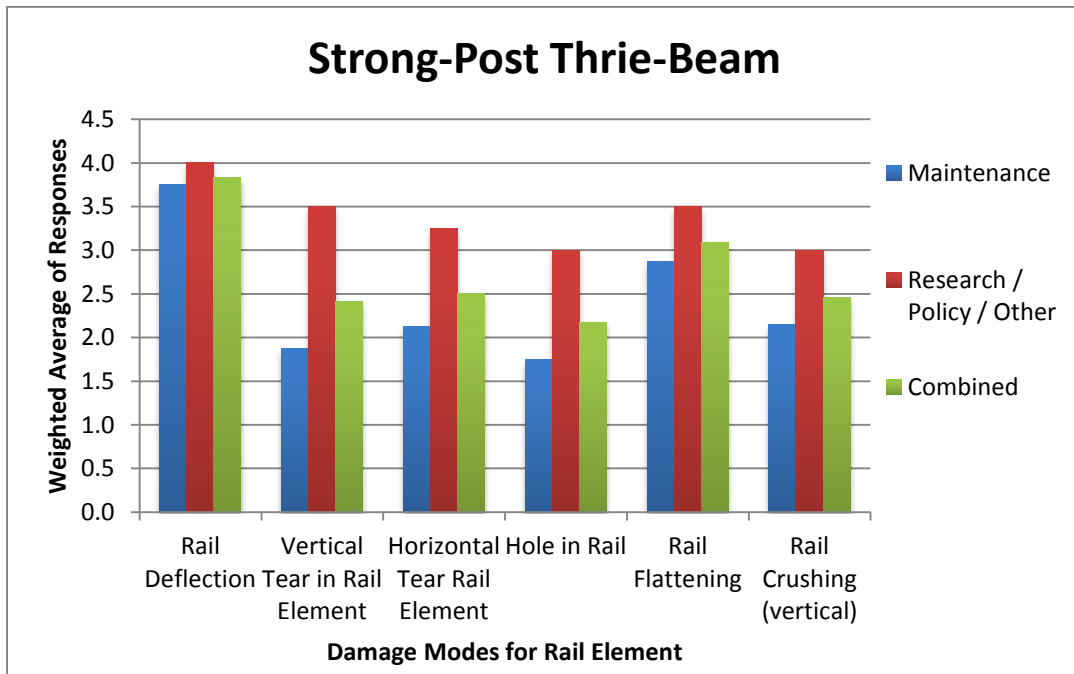
**Figure 22. Strong-Post Thrie-Beam Damage Modes for Rail Element 1, Reorganized Groups.**

The Research/Policy/Other group rated every rail element damage mode higher for this barrier than the Maintenance group (Figure 22). The two profession groups agreed the most on the frequency of occurrence for the “rail deflection” rail element damage mode for the strong-post thrie-beam guardrail, and both groups rated it as the most common of the damage modes.

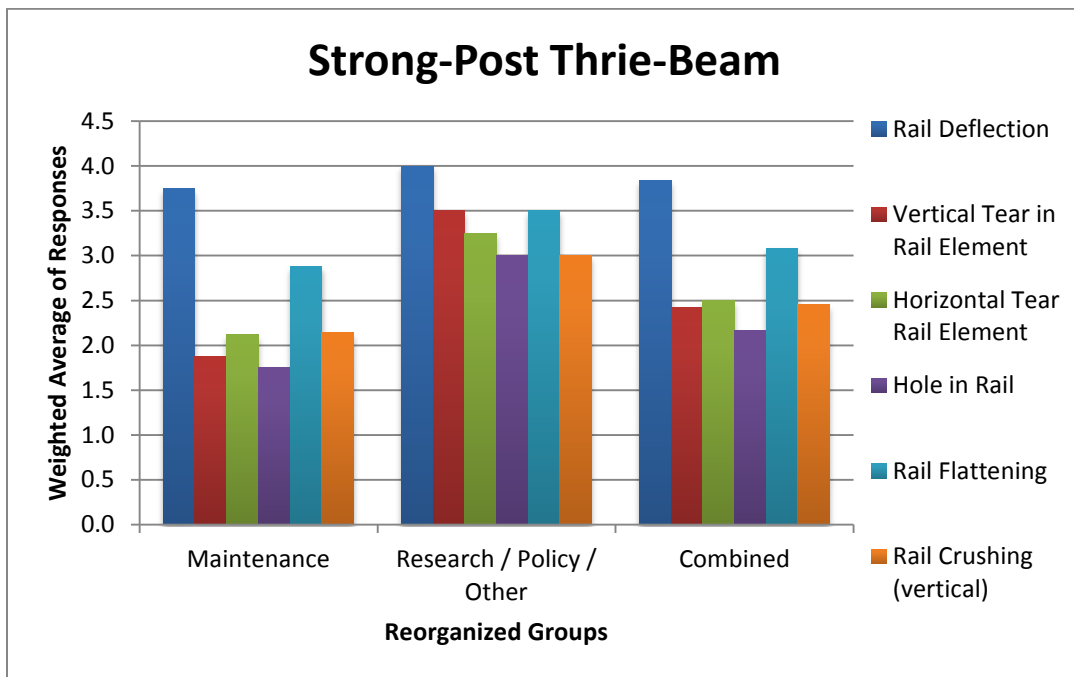
**Figure 23. Strong-Post Thrie-Beam Damage Modes for Rail Element 2, Reorganized Groups.**

As with the wood strong-post w-beam guardrail, respondents from both profession groups considered “rail deflection” to be the most commonly occurring damage mode for rail elements for the strong-post thrie-beam guardrail (Figure 23). “Rail flattening” was also once again considered the second most common damage mode for rail elements, but the two groups did not agree on two of the damage modes. The Maintenance groups felt that “horizontal tear in rail element” occurred more frequently than the “vertical tear in rail element”, while the Research/Policy/Other group felt the opposite.

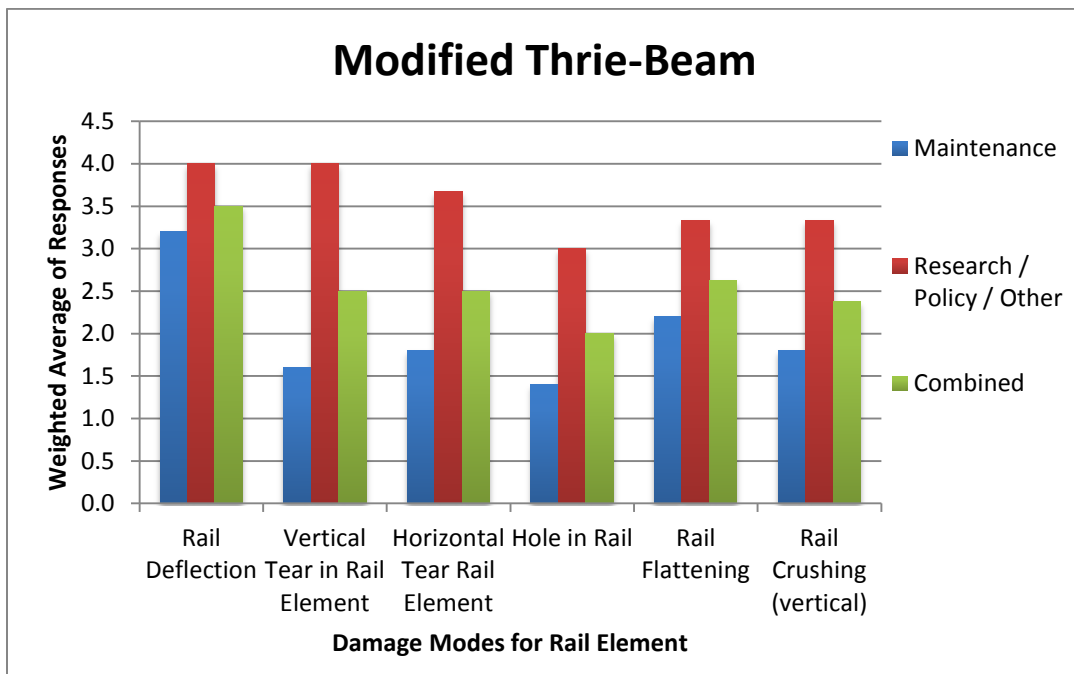
**Figure 24. Modified Thrie-Beam Damage Modes for Rail Element 1, Reorganized Groups.**

For the rail element damage modes for the modified thrie-beam guardrail (Figure 24), the Maintenance and Research/Policy/Other groups agreed the most on the “rail deflection” and the least on the “vertical tear in rail element” damage modes. The Research/Policy/Other group rated “vertical tear in rail element as tied with “rail deflection” as the most frequent damage mode for rail elements, while the Maintenance group rated it as the second least frequent.

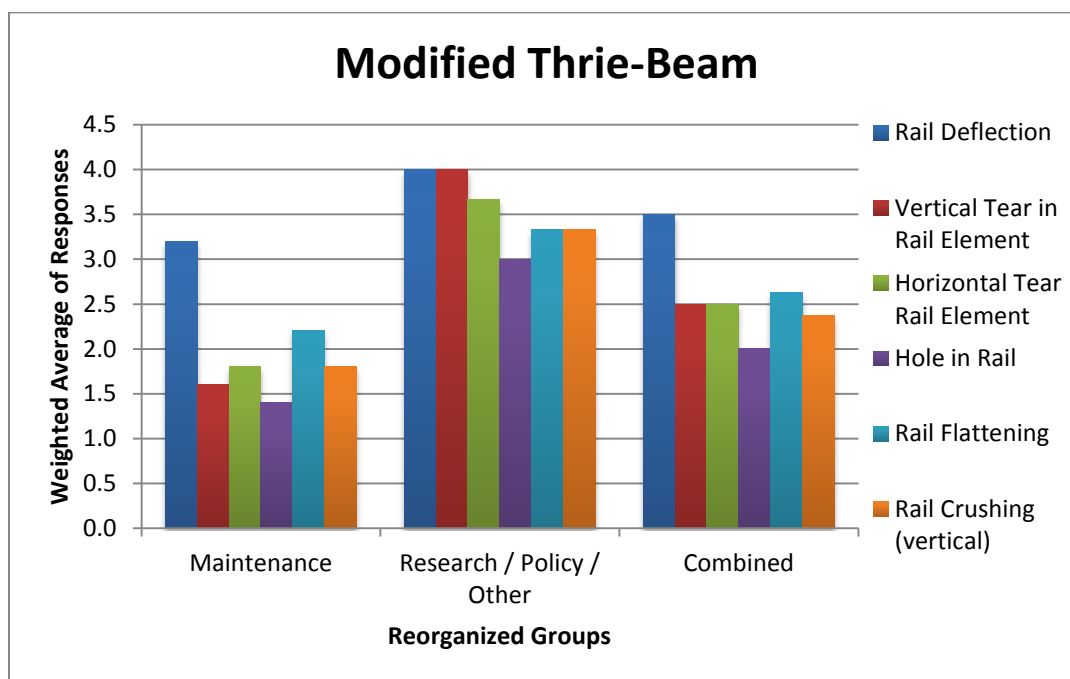
**Figure 25. Modified Thrie-Beam Damage Modes for Rail Element 2, Reorganized Groups.**

Figure 25 shows the reorganized groups’ weighted averages of responses for rail element damage modes for the modified thrie-beam guardrail. The Maintenance group clearly considered “rail deflection” to be the rail element damage mode that occurred with the highest frequency, while the Research/Policy/Other group considered both “rail deflection” and “vertical tear in rail element” to be the most common damage modes. Both groups considered “hole in rail” to be the least common of the rail element damage modes for this barrier type.

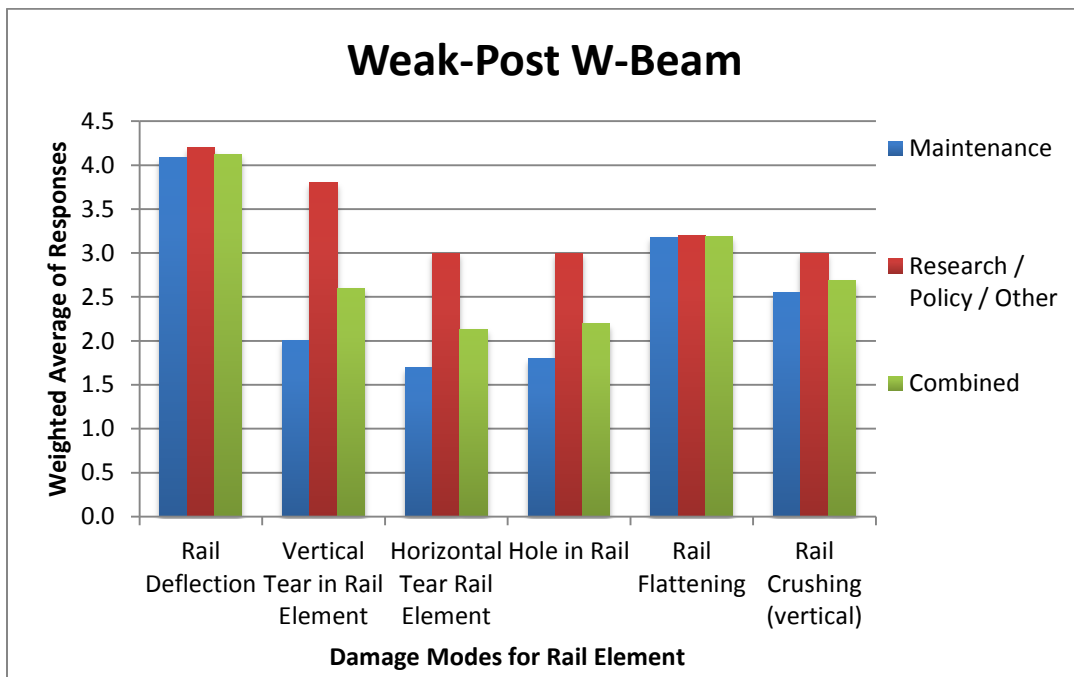
**Figure 26. Weak-Post W-Beam Damage Modes for Rail Element 1, Reorganized Groups.**

Figure 26 shows the reorganized groups’ responses regarding the damage modes for rail element on the weak-post w-beam guardrail. The two profession groups mostly agree on the frequency of “rail deflection” and “rail flattening”, somewhat agree on the frequency of “rail crushing (vertical)”, and disagree on the frequency of “vertical tear in rail element”, “horizontal tear in rail element”, and “hole in rail”.

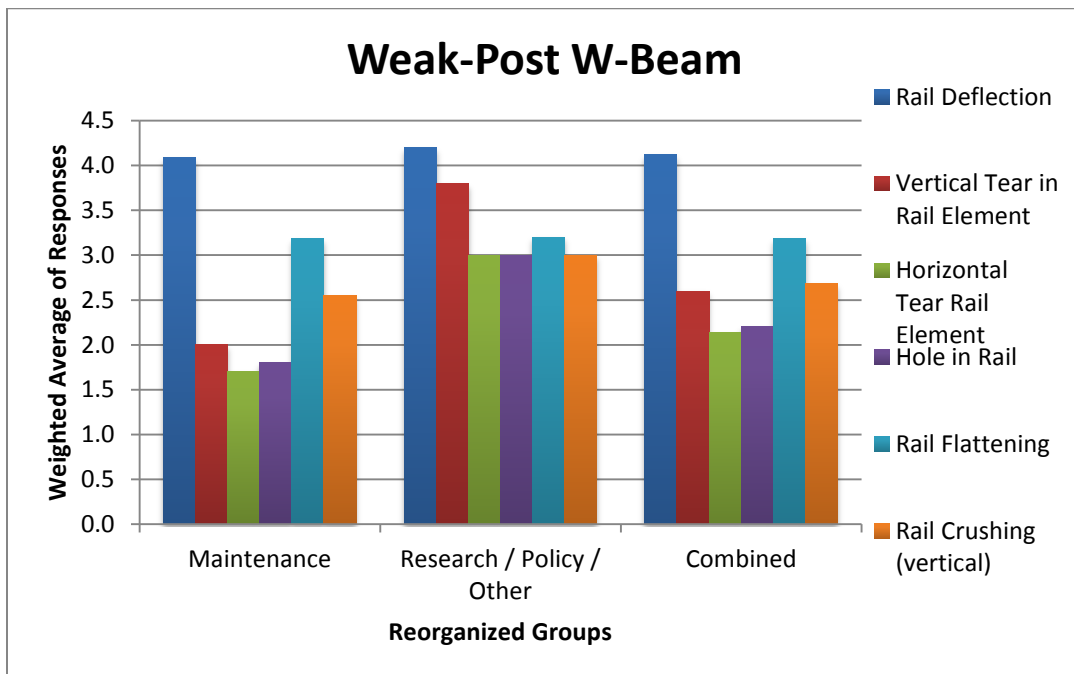
**Figure 27. Weak-Post W-Beam Damage Modes for Rail Element 2, Reorganized Groups.**

Both the Maintenance group and the Research/Policy/Other group considered “rail deflection” to be the most frequently occurring rail element damage mode for the weak-post w-beam guardrail (Figure 27). Once again, “vertical tear in rail element” was considered more common by the Research/Policy/Other group than by the Maintenance group.

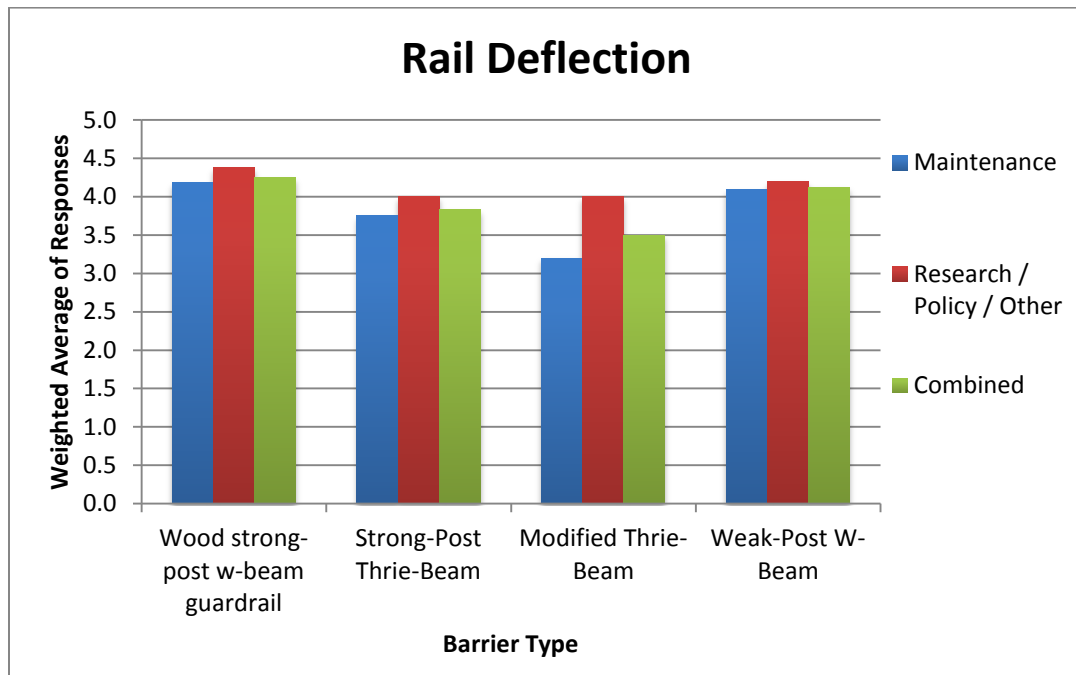
**Figure 28. Rail Deflection Damage Mode Frequency for Barrier Types, Reorganized Groups.**

Both profession groups consider the frequency of occurrence for “rail deflection” to be highest in the wood strong-post w-beam and weak-post w-beam guardrails (Figure 28). Although the weighted averages from both groups are lower for the two thrie-beam barriers than they are for the w-beam barriers, the weighted-average scores are high enough in all cases to signify that this damage mode is the most frequently occurring damage mode for all guardrail types.

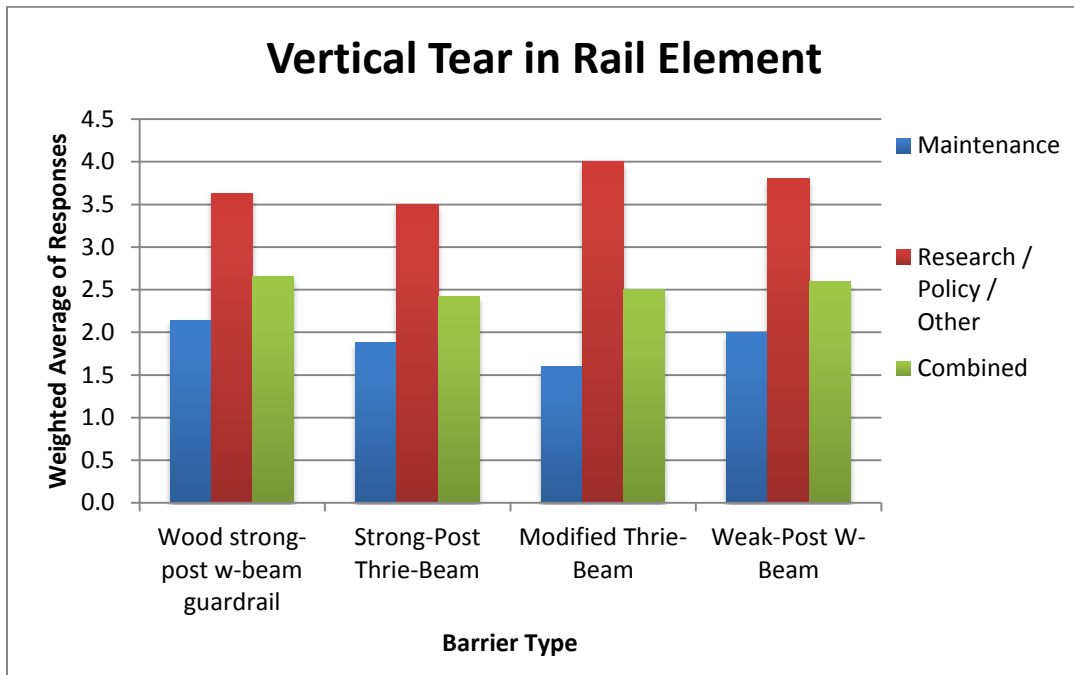
**Figure 29. Vertical Tear in Rail Element Damage Mode Frequency for Barrier Types, Reorganized Groups.**

The “vertical tear in rail element” was considered a much more common damage mode by the Research/Policy/Other group than it was by the Maintenance group. Also, the modified thrie-beam guardrail was rated as the barrier with the highest frequency of occurrence by the Research/Policy/Other group, while it was rated the barrier type with the lowest frequency of occurrence by the Maintenance group (Figure 29). When the responses from the two reorganized groups are combined, the weighted average values are essentially the same for all the barrier types, which indicates that vertical rail tear is equally common among all the barrier types explored in the survey.

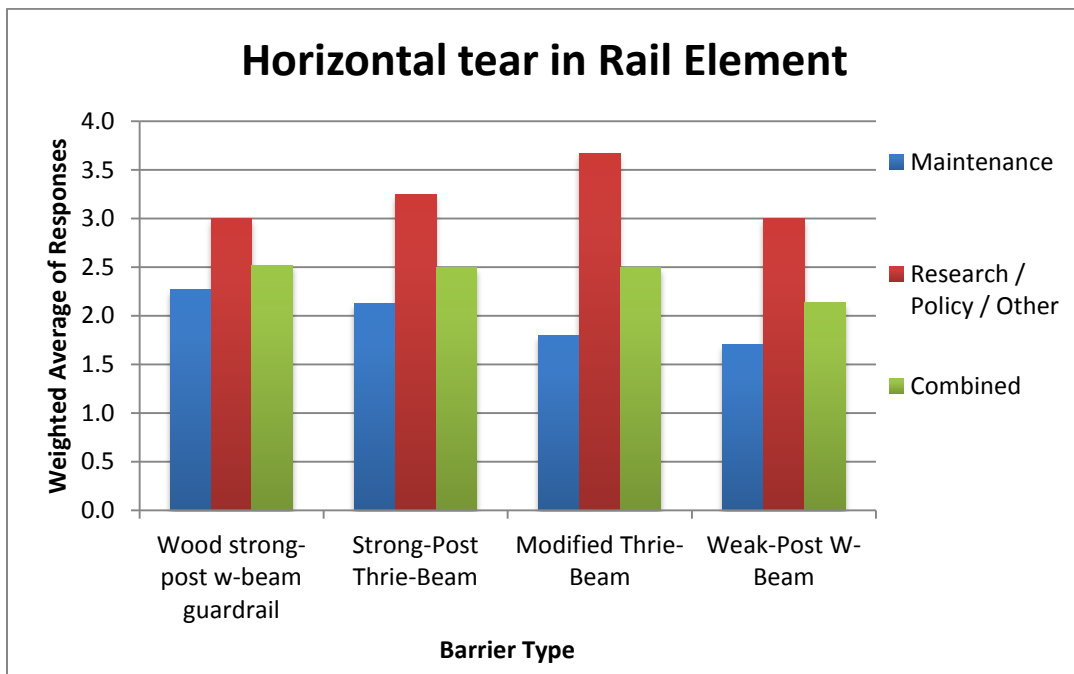
**Figure 30. Horizontal Tear in Rail Element Damage Mode Frequency for Barrier Types, Reorganized Groups.**

As with the “vertical tear in rail element,” the largest difference in perceived frequency of occurrence between the two profession groups was in regards to the modified thrie-beam guardrail (Figure 30). The Research/Policy/Other group identified this barrier type to have the highest frequency of horizontal rail tears, while the Maintenance group considered this barrier type to have the second lowest frequency of occurrence.

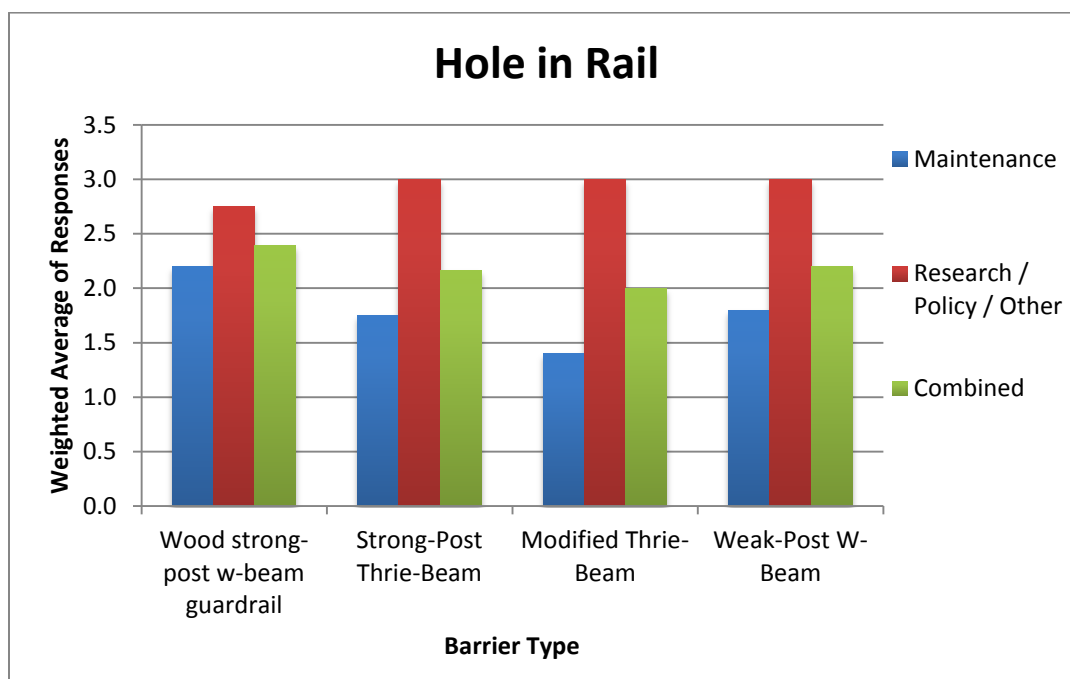
**Figure 31. Hole in Rail Element Damage Mode Frequency for Barrier Types, Reorganized Groups.**

The Research/Policy/Other group rated the “hole in rail” damage mode to be of roughly the same frequency of occurrence for all barrier types, with the wood strong-post w-beam barrier as having a slightly lower frequency. Conversely, the Maintenance group rated the wood strong-post w-beam guardrail as having the highest frequency of occurrence of the “hole in rail” damage mode, and the modified thrie-beam as having the lowest. (Figure 31)

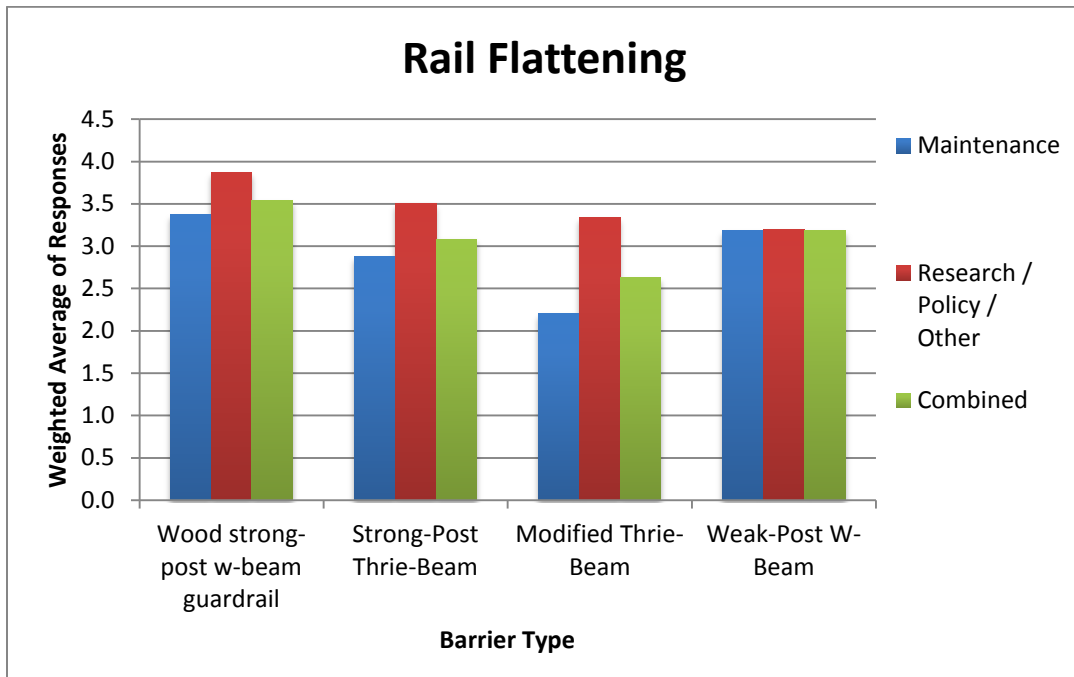
**Figure 32. Rail Flattening Damage Mode Frequency for Barrier Types, Reorganized Groups.**

Both profession groups rated the wood strong-post w-beam guardrail as the barrier type with the highest frequency of occurrence of the “rail flattening” damage mode. As with other damage modes, the modified thrie-beam was again the barrier type with the biggest discrepancy between the reorganized groups. (Figure 32)

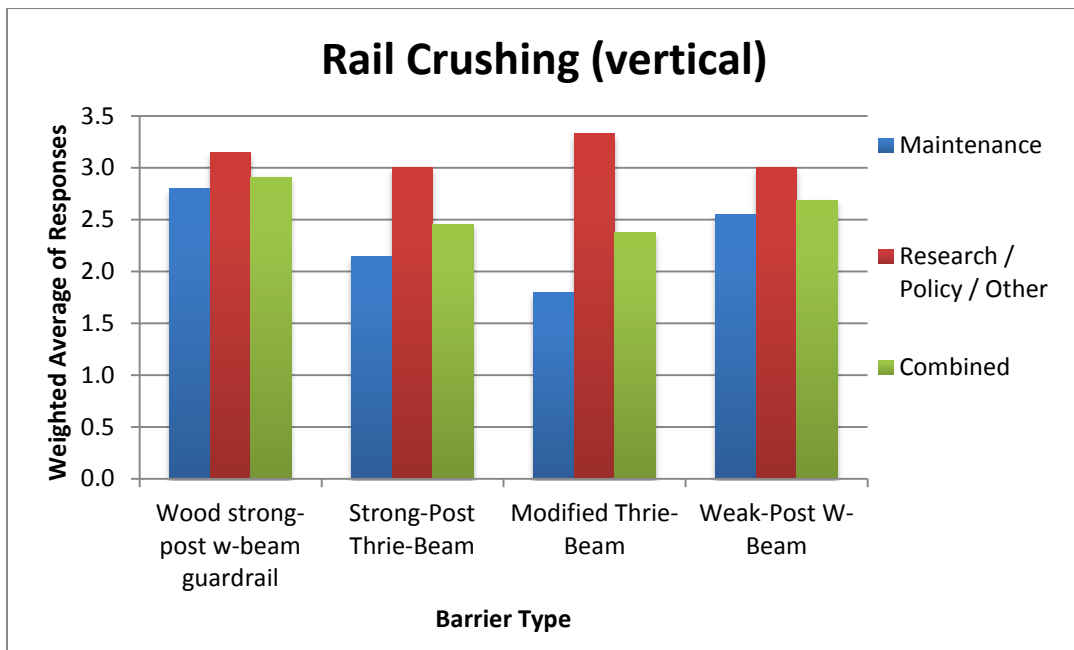
**Figure 33. Rail Crushing (vertical) Damage Mode Frequency for Barrier Types, Reorganized Groups.**

From Figure 33, “rail crushing (vertical)” is another damage mode where the two profession groups disagree on frequency of occurrence across barrier types. Where the Research/Policy/Other group thought the modified thrie-beam was the barrier that experienced the highest frequency of this damage mode, the Maintenance group thought the modified thrie-beam had the lowest frequency.

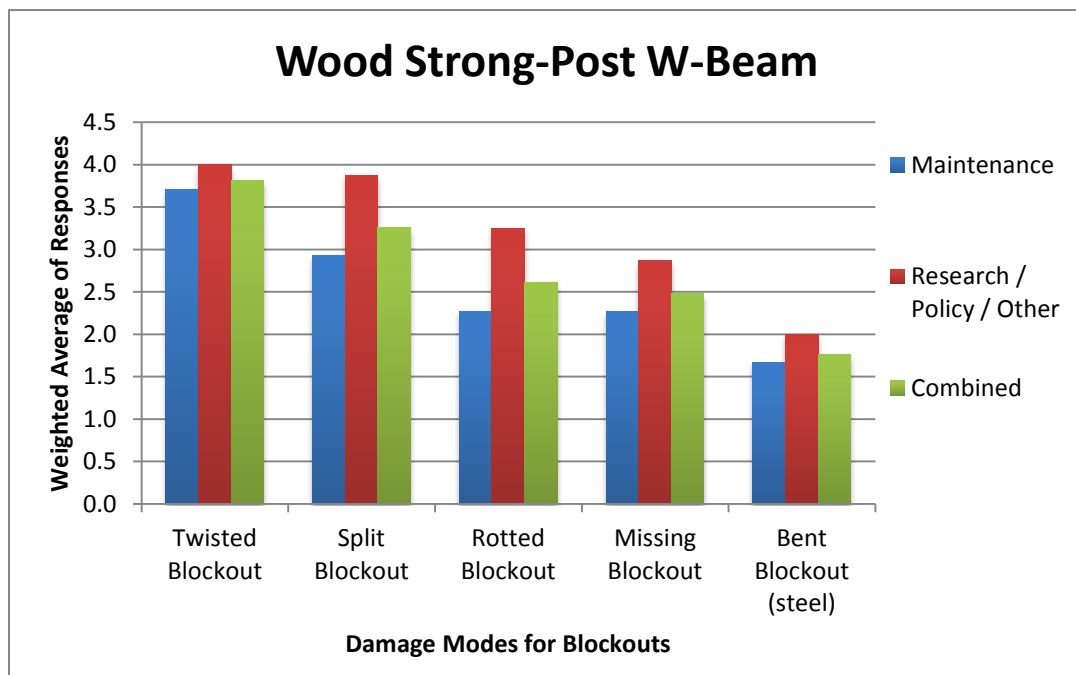
**Figure 34. Wood Strong-Post W-Beam Damage Modes for Blockouts 1, Reorganized Groups.**

The two profession groups were for the most part in agreement with each other regarding the frequency of the various damage modes for the blockout on the wood strong-post w-beam guardrail. For both groups, “twisted blockout” was rated as having the highest frequency, while “bent blockout (steel)” was rated as having the lowest. (Figure 34, Figure 35)

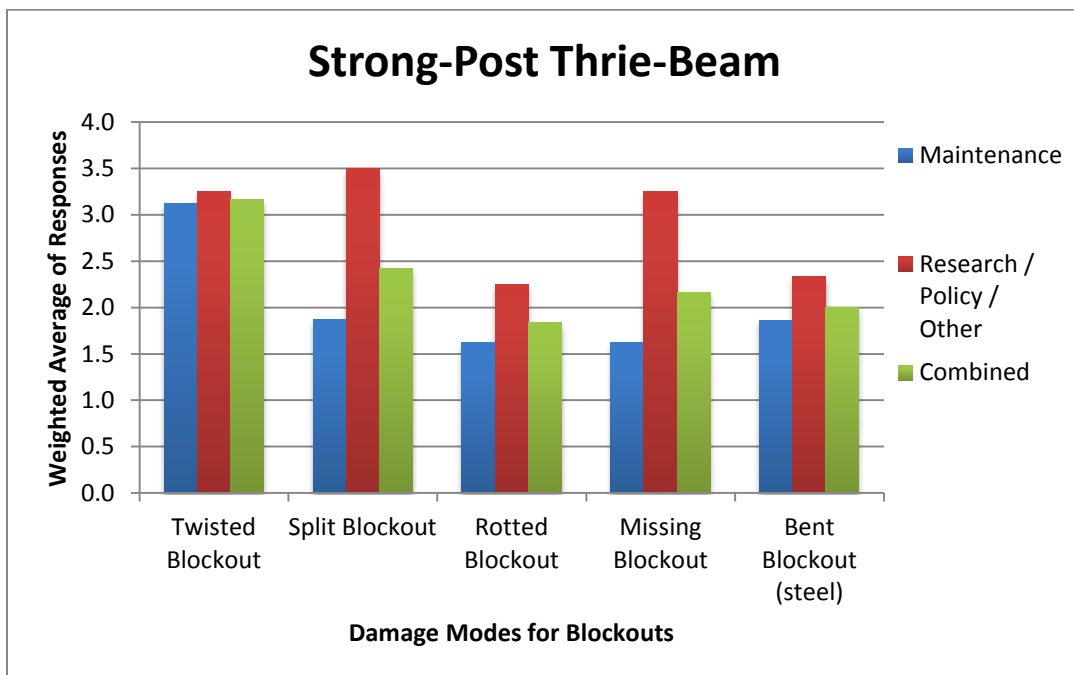
**Figure 36. Strong-Post Thrie-Beam Damage Modes for Blockouts 1, Reorganized Groups.**

For the strong-post thrie-beam, the both profession groups agreed on the frequency of occurrence for the “twisted blackout” and “rotted blackout” damage modes, but disagreed on the frequency of occurrence for the “split blackout”, “missing blackout”, and “bent blackout” damage modes. (Figure 36)

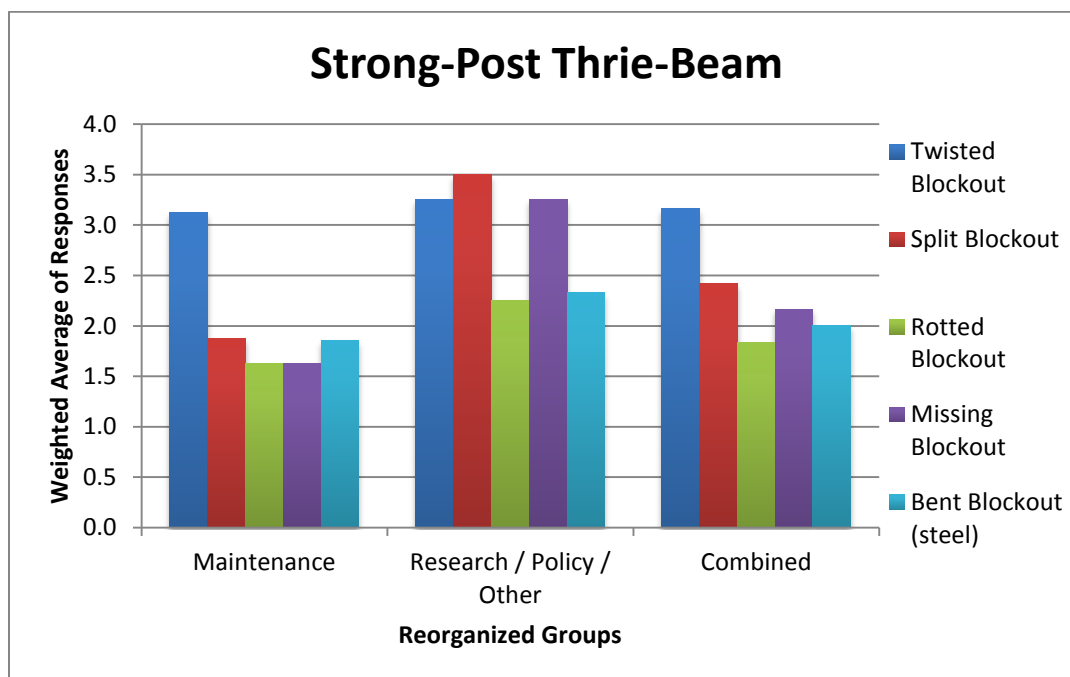
**Figure 37. Strong-Post Thrie-Beam Damage Modes for Blockouts 2, Reorganized Groups.**

The two groups had somewhat differing opinions regarding damage modes for blockouts in on the strong-post thrie-beam barrier (Figure 37). The Maintenance group rated “twisted blackout” to be the most common damage mode for blockouts, followed by “split blackout” and “bent blackout (steel)”. In contrast, the Research/Policy/Other group rated “split blackout” to be the most common, followed by “twisted blackout” and “missing blackout”. “Missing blackout” was the damage mode that the two groups most strongly disagreed on (Figure 37) .

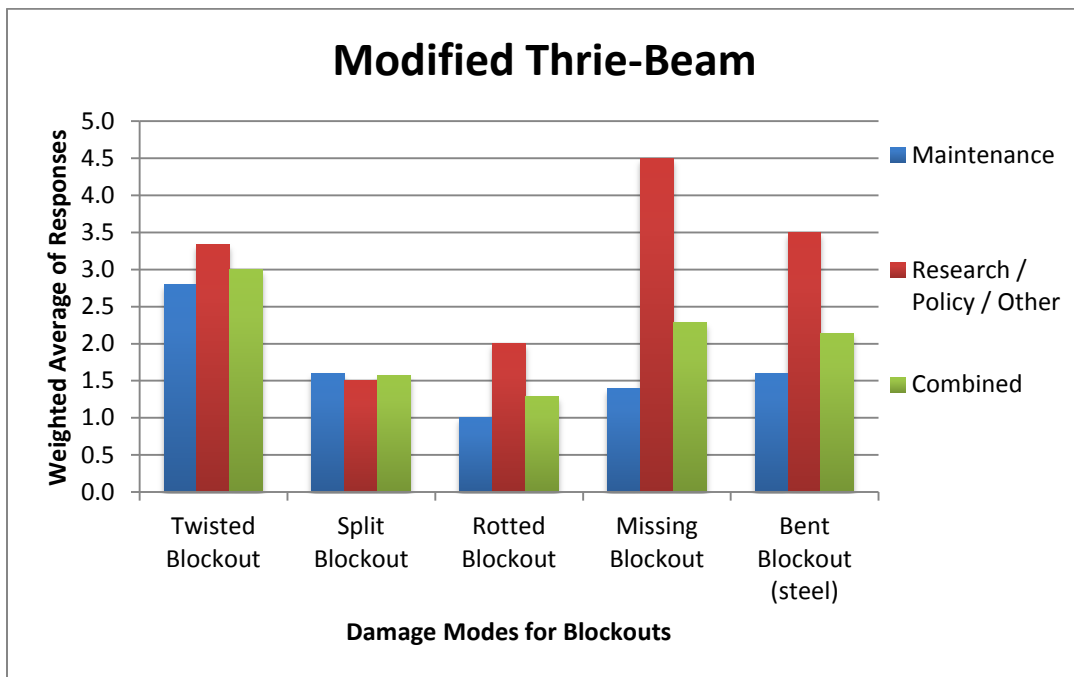
**Figure 38. Modified Thrie-Beam Damage Modes for Blockouts 1, Reorganized Groups.**

For the modified thrie-beam guardrail, the two profession groups generally agreed that the “twisted blackout” occurred with moderate frequency and that the “split blackout” and the “rotted blackout” occurred with very low frequency. Regarding “missing blockouts” and “bent blockouts,” however, the Research/Policy/Other group indicated that these damage modes occur with relatively high frequency, while the maintenance group indicated a very low frequency of occurrence (Figure 38).

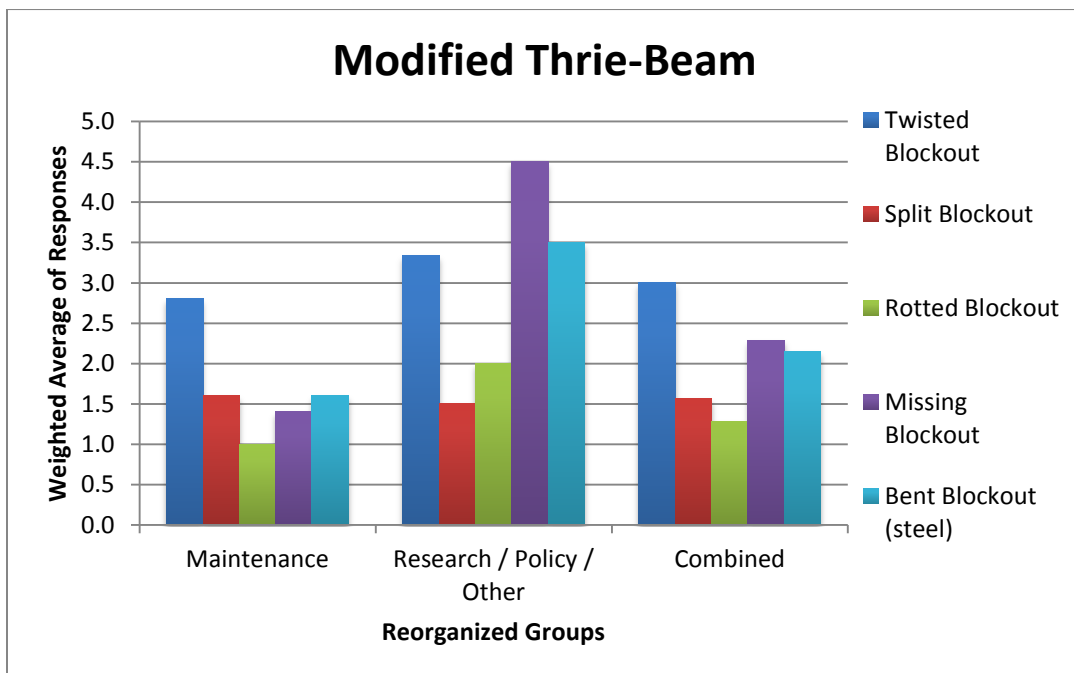
**Figure 39. Modified Thrie-Beam Damage Modes for Blockouts 2, Reorganized Groups.**

The Maintenance group considered “twisted blackout” to be the most common damage mode for blockouts. The remaining damage modes for blockouts all had low average occurrence ratings by the Maintenance group. The Research/Policy/Other group considered “missing blackout” to be the most frequently occurring damage mode for blockouts, followed by “bent blackout (steel)” and “twisted blackout”. Although “twisted blackout” was the third highest rated damage mode for blockouts according to the Research/Policy/Other group, the weighted average rating was still higher than it was for the Maintenance group, who listed this damage mode as the most common (Figure 39).

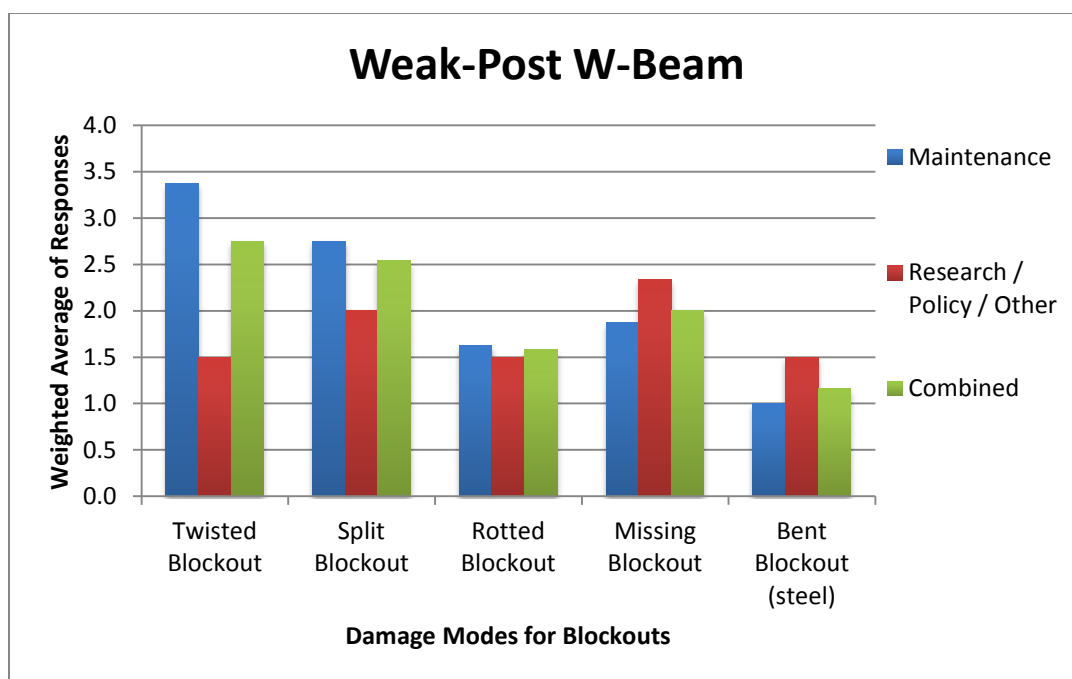
**Figure 40. Weak-Post W-Beam Damage Modes for Blockouts 1, Reorganized Groups.**

Interestingly, for the weak-post w-beam guardrail (Figure 40), the Maintenance groups rated “twisted blackout” and “split blackout” higher than the Research/Policy/Other group did. The G2 guardrail, however, does not actually include blockouts so it is unclear why the respondents included this information. It may have been due to the manner in which the survey form was constructed but, in any case, the information in Figure 40 and Figure 41 is not correct but is included since these are the responses generated by the survey. The same incorrect results for the weak-post w-beam appear in Figure 42 through Figure 46.
