# **A Guide for W-Beam Guardrail Damage Assessment**

A Field Manual for  
Highway Maintenance Personnel

National Cooperative  
Highway Research  
Program  
Project 22-28

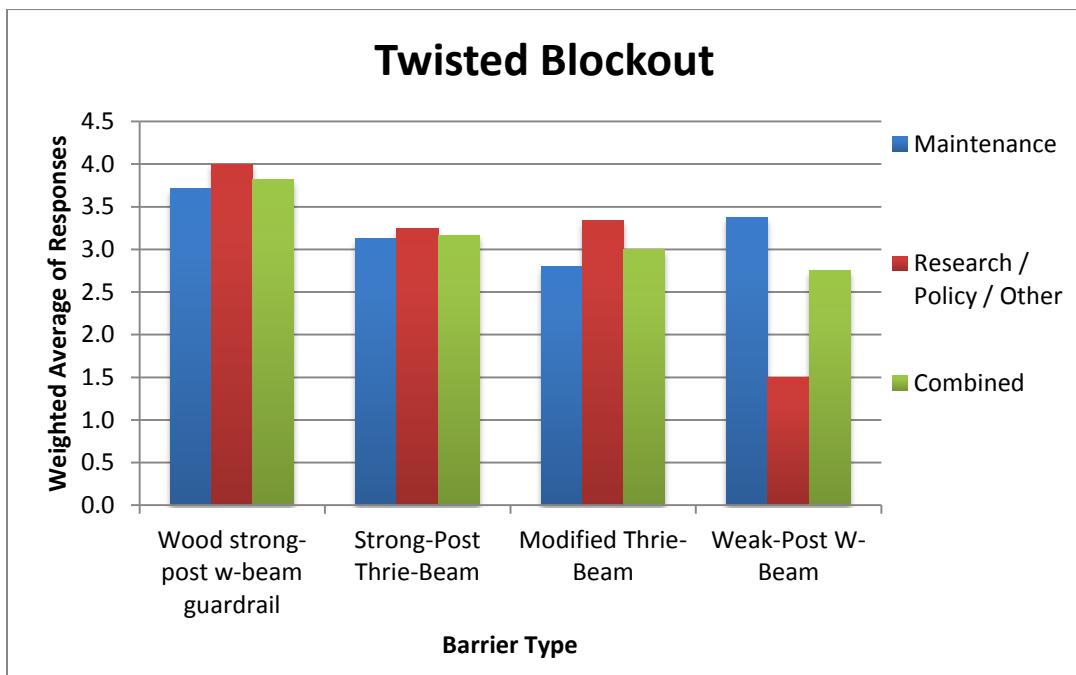
**Figure 42. Twisted Blockout Damage Mode Frequency for Barrier Types, Reorganized Groups.**

The two profession groups agreed with each other for the most part about the frequency of occurrence of the “twisted blackout” damage mode among the different barrier types. The one barrier type where they disagreed on was the weak-post w-beam guardrail. The Maintenance group felt it occurred more often than the Research/Policy/Other group did. Both groups consider the wood strong-post w-beam guardrail as the barrier type that experiences twisted blockouts the most often (Figure 42).

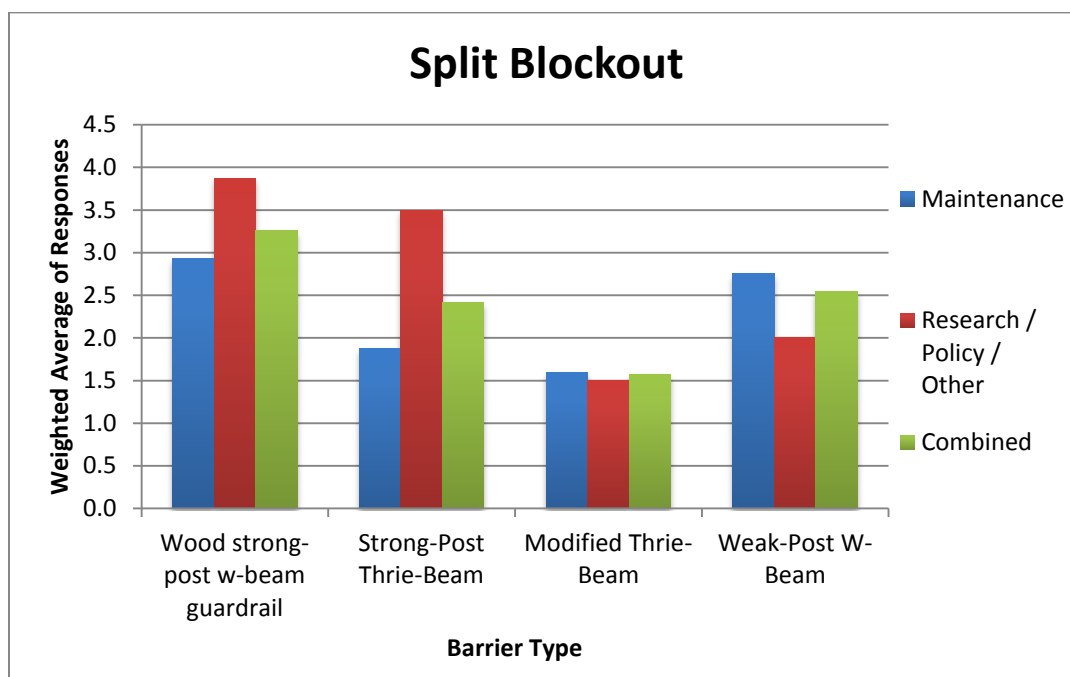
**Figure 43. Split Blockout Damage Mode Frequency for Barrier Types, Reorganized Groups.**

Both profession groups considered the wood strong-post w-beam guardrail to be the barrier with the highest frequency of occurrence of the “split blackout” damage mode. The Maintenance group thought the weak-post w-beam came next, followed by both types of thrie-beam guardrails. The Research/Policy/Other group thought the strong-post thrie-beam was the barrier with the second highest frequency of occurrence, followed by the weak-post w-beam, and finally the modified thrie-beam guardrail (Figure 43).

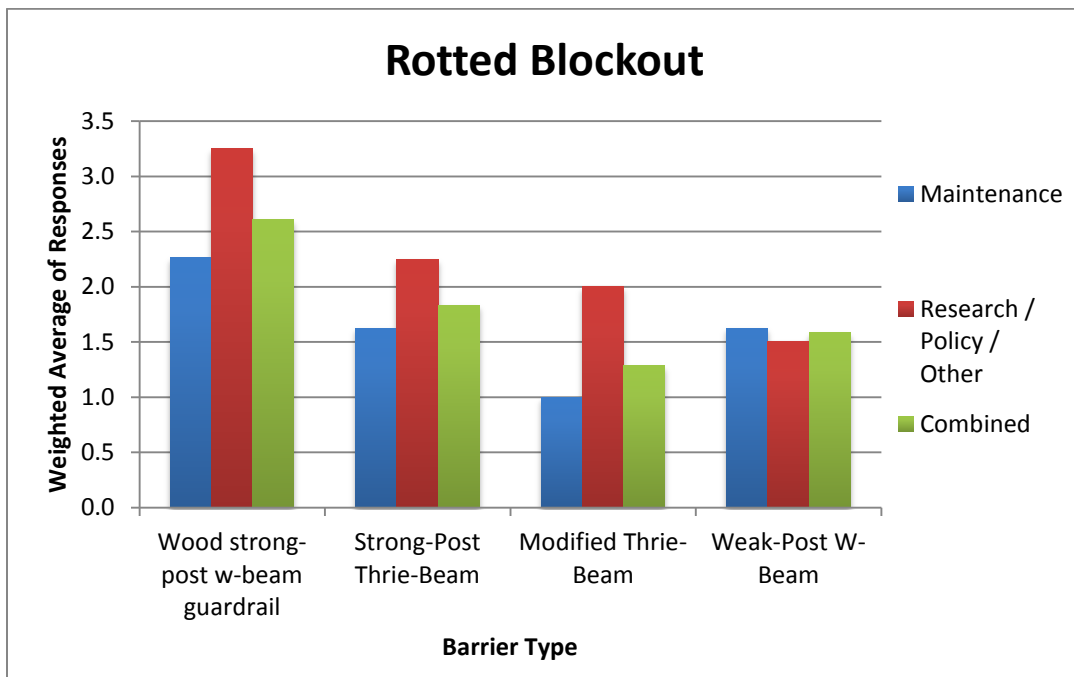
**Figure 44. Rotted Blockout Damage Mode Frequency for Barrier Types, Reorganized Groups.**

Both profession groups considered the wood strong-post w-beam guardrail to be the barrier type that experiences the highest frequency of the “rotted blackout” damage mode. The Research/Policy/Other group considered the weak-post w-beam to be the barrier type that experienced the least amount of this damage mode, while the Maintenance group gave that distinction to the modified thrie-beam guardrail. It is worth noting that both groups had roughly the same weighted average rating of the weak-post w-beam guardrail (Figure 44).

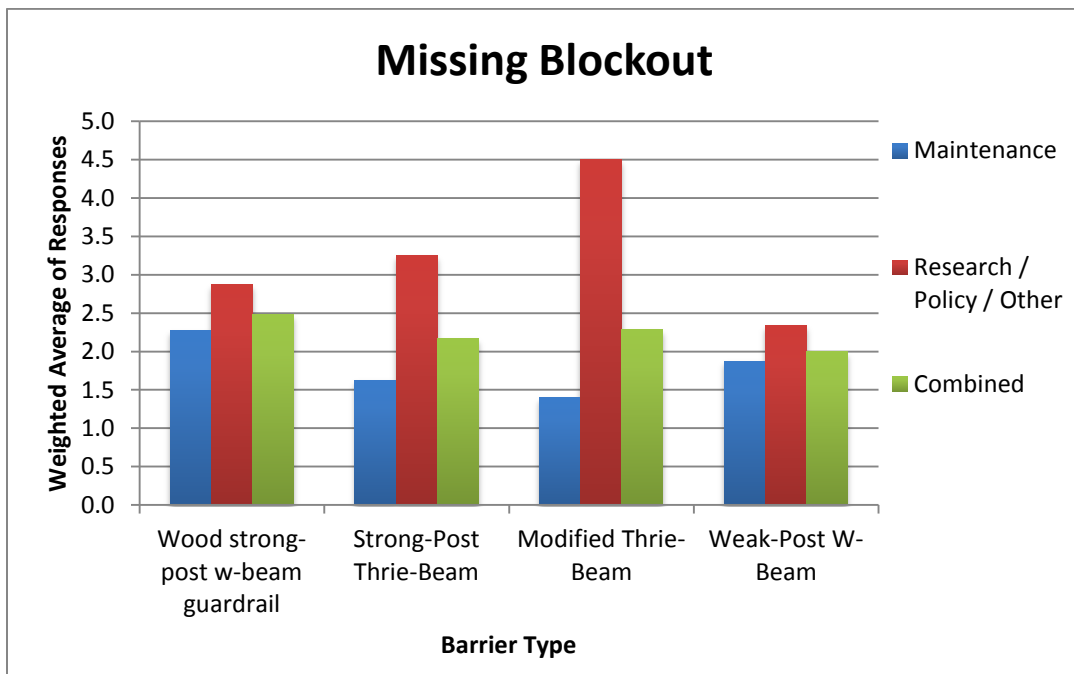
**Figure 45. Missing Blockout Damage Mode Frequency for Barrier Types, Reorganized Groups.**

The “missing blackout” damage mode had a large discrepancy between the ratings given by the two reorganized groups for both of the thrie-beam barriers. The modified thrie-beam guardrail in particular has the greatest difference, as the Research/Policy/Other group rated it as being the barrier type that experienced the highest frequency of occurrence while the Maintenance group rated it as having the lowest frequency of occurrence. (Figure 45)

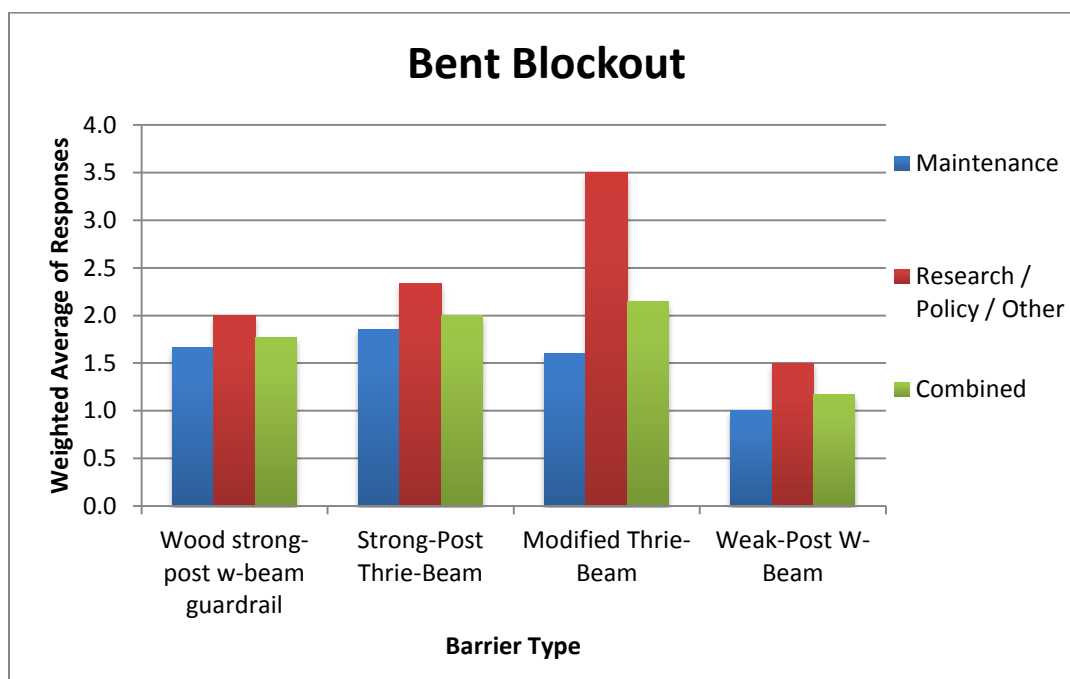
**Figure 46. Bent Blockout Damage Mode Frequency for Barrier Types, Reorganized Groups.**

As with the “missing blackout” damage mode, the “bent blackout” also shows the largest discrepancy between the two group average ratings for the modified thrie-beam guardrail. The Research/Policy/Other group rated this barrier as having the highest frequency of occurrence of bent blackout, while the Maintenance group considered this barrier type as having the second to lowest frequency of occurrence. The remaining barriers had average ratings from the reorganized groups that were relatively close to each other (Figure 46).

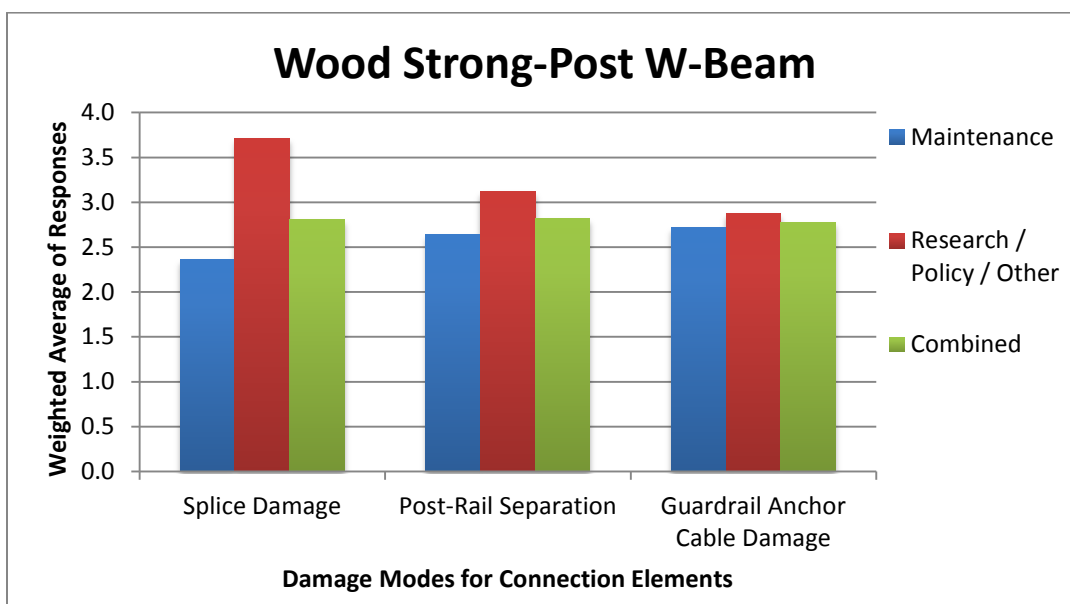
**Figure 47. Wood Strong-Post W-Beam Damage Modes for Connection Elements 1, Reorganized Groups.**

The largest discrepancy between the two reorganized groups for damage modes for connection elements with the wood strong-post w-beam guardrail was for “splice damage”. “Guardrail anchor cable damage” was the damage mode that the two groups agreed on the most (Figure 47).

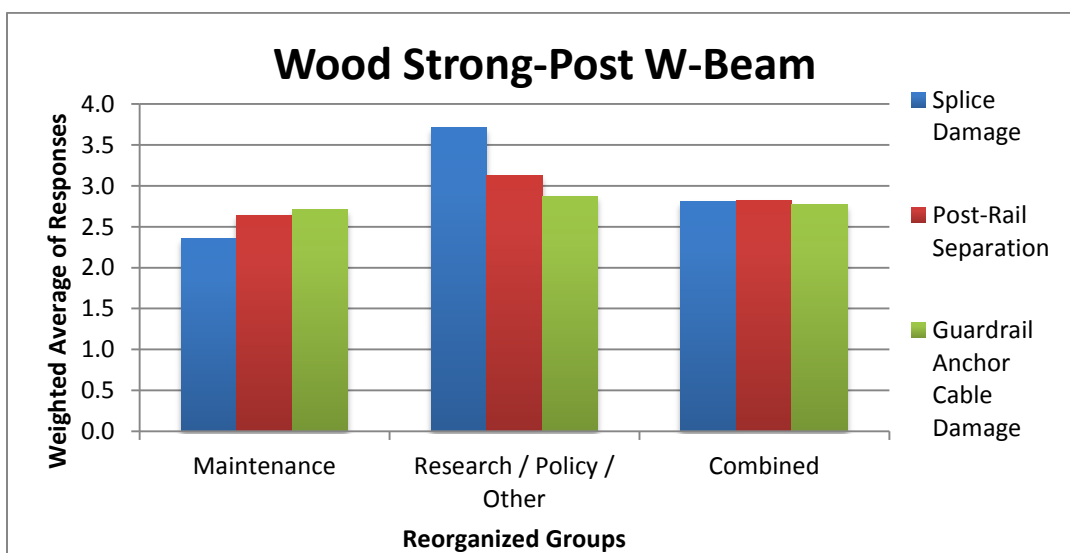
**Figure 48. Wood Strong-Post W-Beam Damage Modes for Connection Elements 2, Reorganized Groups.**

The Research/Policy/Other group rated “splice damage” as the most common connection element damage mode for the wood strong-post w-beam guardrail. In contrast, the Maintenance group considered “splice damage” the least common; the most common being “guardrail anchor cable damage” in their opinion (Figure 48).

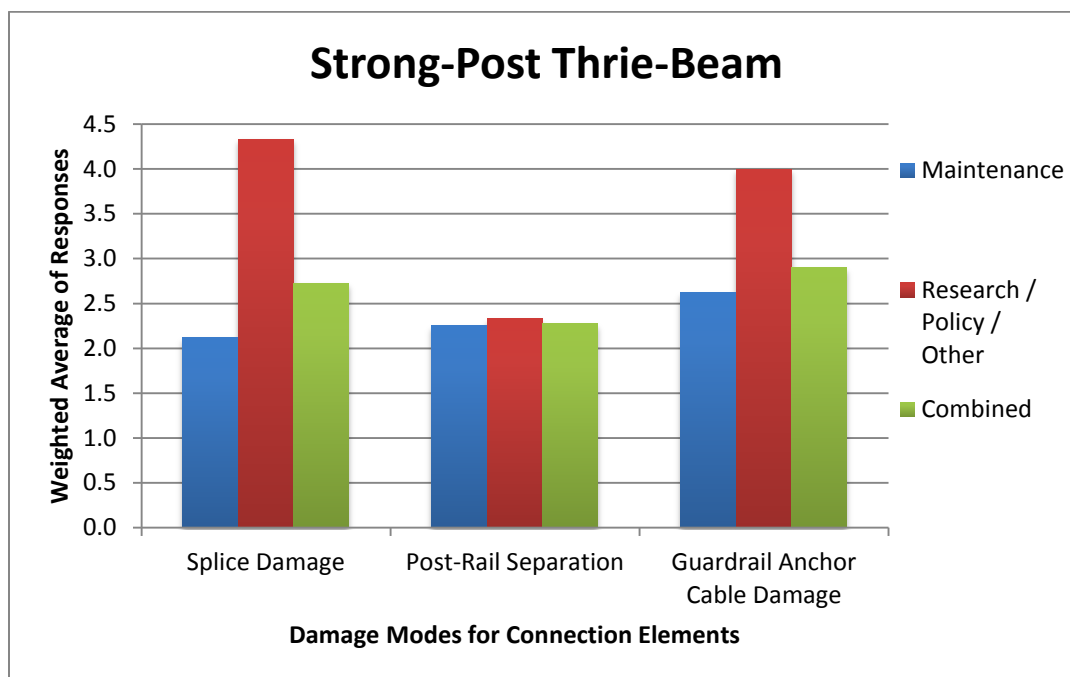
**Figure 49. Strong-Post Thrie-Beam Damage Modes for Connection Elements 1, Reorganized Groups.**

For the strong-post thrie-beam guardrail, the two profession groups agreed on the frequency of occurrence for the “post-rail separation” damage mode, but disagreed on the “splice damage” and “guardrail anchor cable” damage modes (Figure 49).

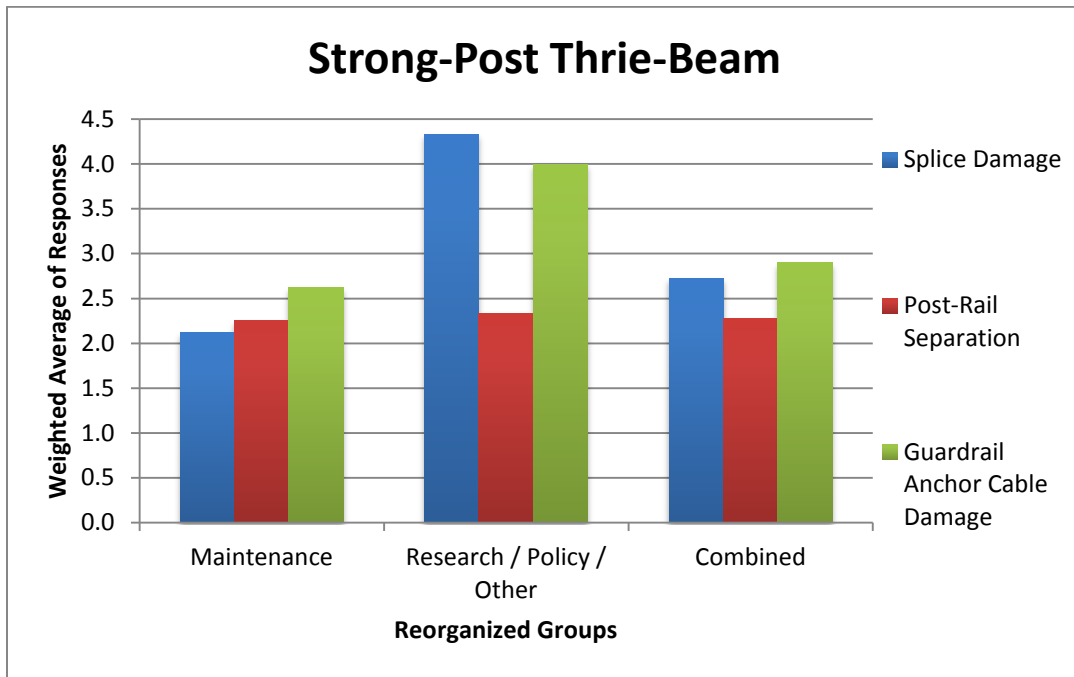
**Figure 50. Strong-Post Thrie-Beam Damage Modes for Connection Elements 2, Reorganized Groups.**

For the strong-post thrie-beam guardrail, the Research/Policy/Other group considered the “splice damage” damage mode to be the most common damage mode for connection elements, followed closely by “guardrail anchor cable damage”. The Maintenance group considered the “guardrail anchor cable damage” damage mode for connection elements to be the most common, followed by “post-rail separation” and lastly, “splice damage” (Figure 50).

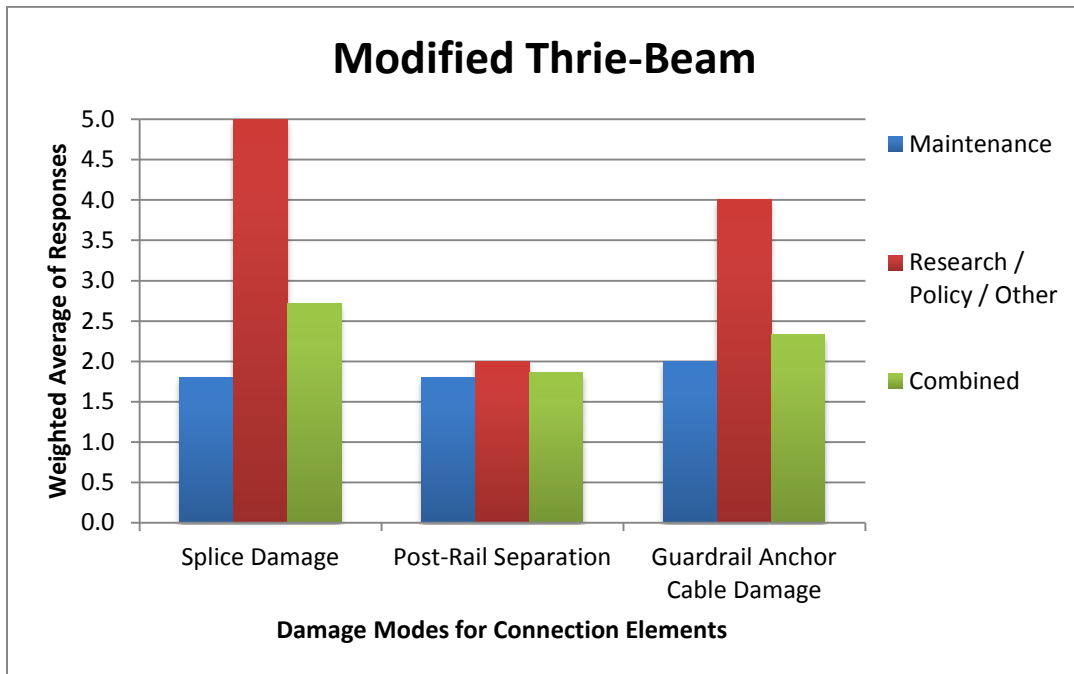
**Figure 51. Modified Thrie-Beam Damage Modes for Connection Elements 1, Reorganized Groups.**

For the modified thrie-beam guardrail, “post-rail separation” was the only damage mode for connection elements that the reorganized groups agreed on in regards to frequency of occurrence. The Research/Policy/Other group rated both “splice damage” and “guardrail anchor cable damage” higher than the Maintenance group. (Figure 51)

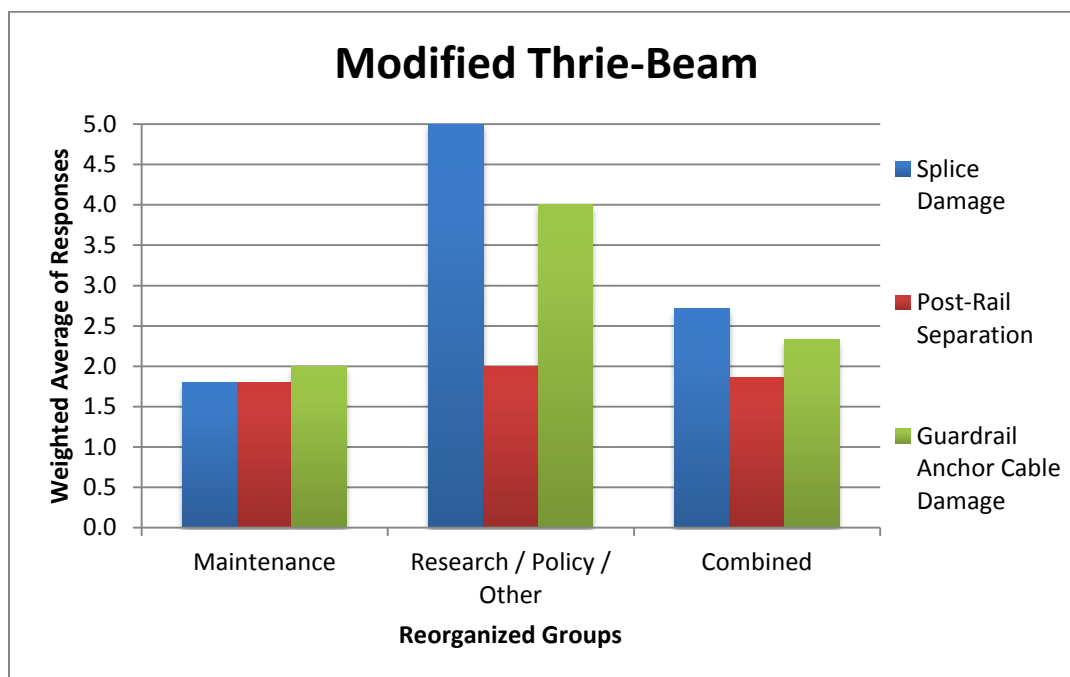
**Figure 52. Modified Thrie-Beam Damage Modes for Connection Elements 2, Reorganized Groups.**

The Maintenance group indicated that all three damage modes for connection elements were relatively uncommon for the modified thrie-beam guardrail, whereas the Research/Policy/Other group gave the “splice damage” damage mode a rating of 5, which is the highest rating possible. The Research/Policy/Other group also rated the “guardrail anchor cable” damage mode quite high, meaning the group felt this damage mode was also common for the modified thrie-beam guardrail (Figure 52).

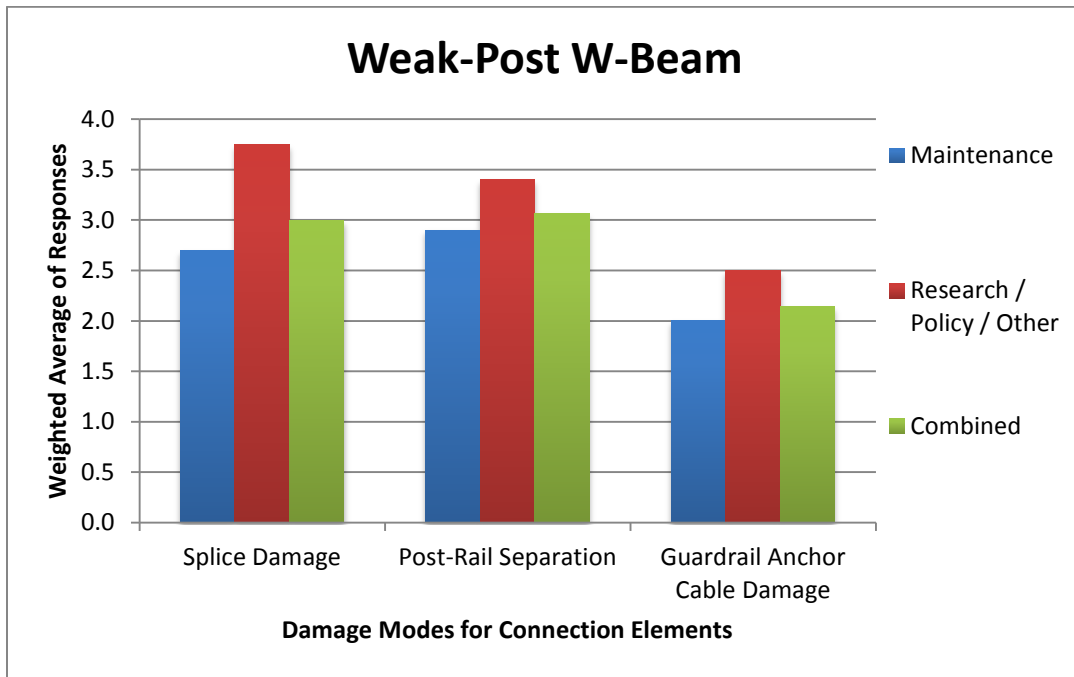
**Figure 53. Weak-Post W-Beam Damage Modes for Connection Elements 1, Reorganized Groups.**

For the weak-post w-beam guardrail, the Research/Policy/Other group rated all three connection element damage modes higher than the Maintenance group (Figure 53).

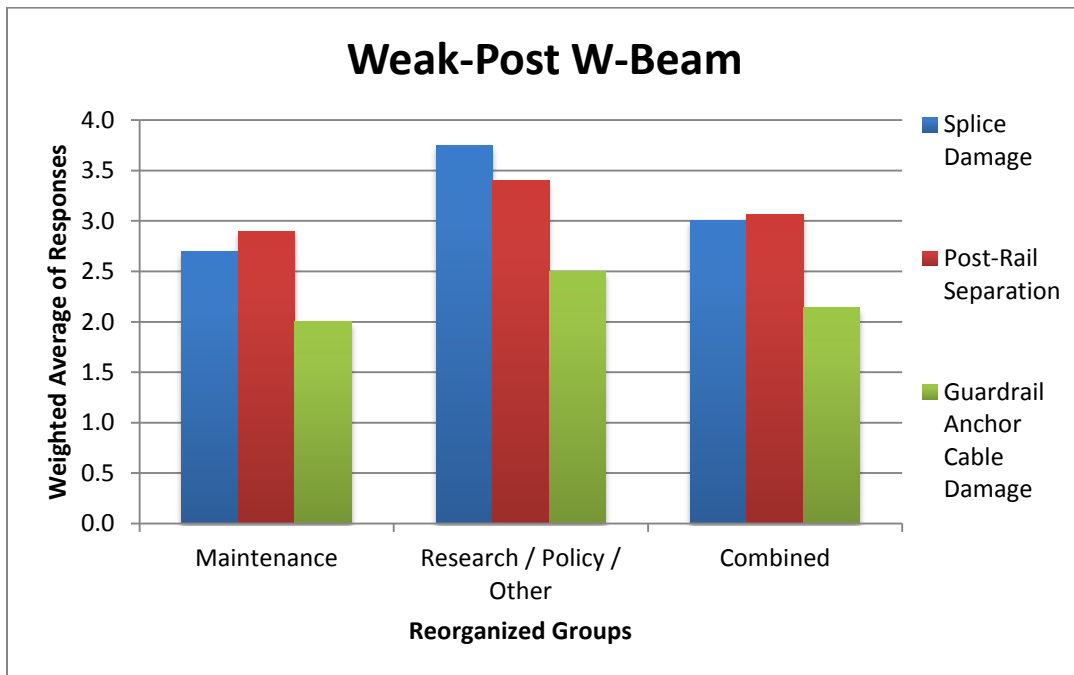
**Figure 54. Weak-Post W-Beam Damage Modes for Connection Elements 2, Reorganized Groups.**

The Research/Policy/Other group rated “splice damage” as the most common connection element damage mode for the weak-post w-beam guardrail, followed by “post-rail separation”. The Maintenance group has it the other way around, with “post-rail separation” first, followed by “splice damage”. Both profession groups consider “guardrail anchor cable damage” to be the least occurring connection element damage mode for the weak-post w-beam guardrail (Figure 54).

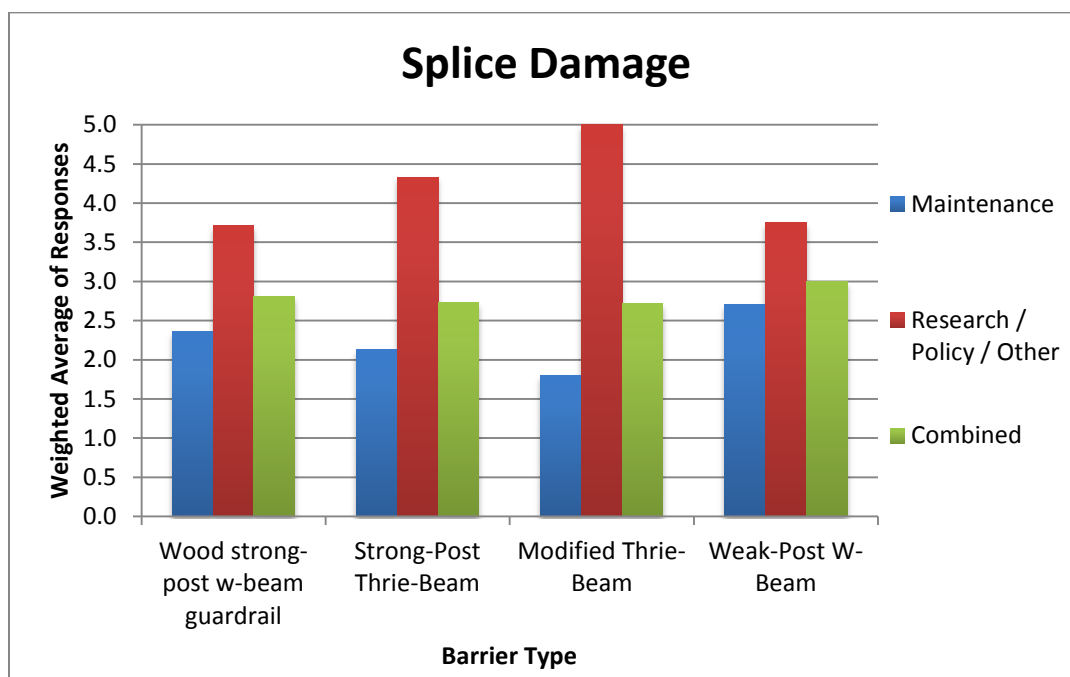
**Figure 55. Splice Damage Mode Frequency for Barrier Types, Reorganized Groups.**

The Research/Policy/Other group rated all of the barrier types as having a higher frequency of “splice damage” than the Maintenance group did. Of these, they considered this damage mode to be most common for the modified thrie-beam barrier. Conversely, the Maintenance group indicated that “splice damage” was least common with the modified thrie-beam, and most common with the weak-post w-beam guardrail (Figure 55).

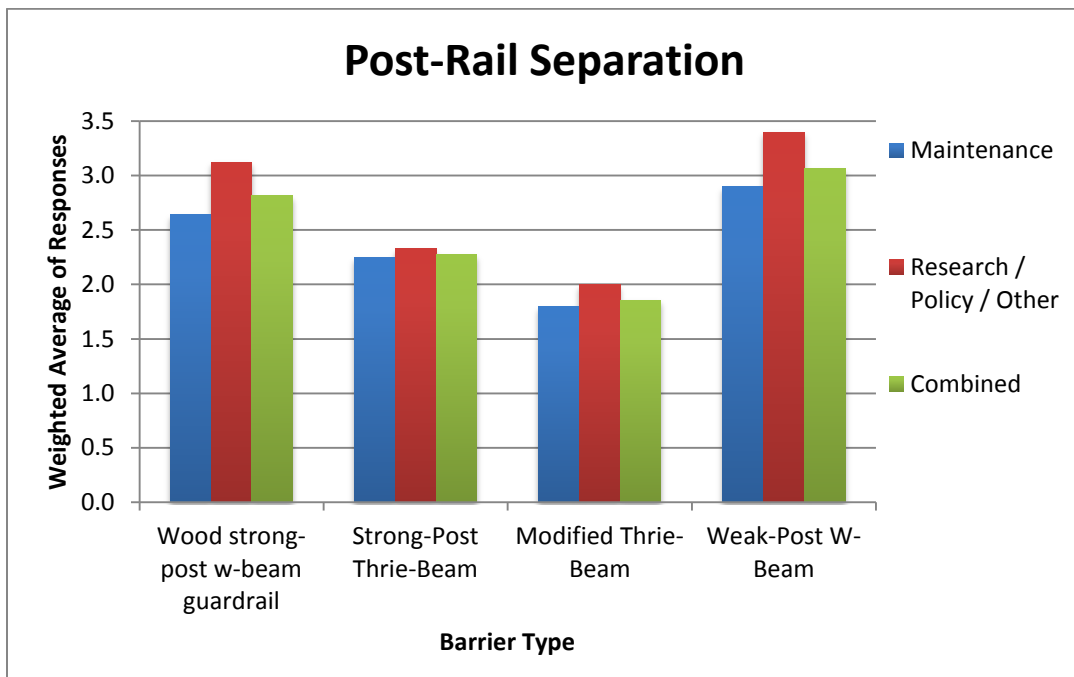
“Post-rail separation” is a damage mode that both profession groups agree on completely. They both consider this damage mode most common in the weak-post w-beam guardrail and least common in the modified thrie-beam guardrail (Figure 56).

**Figure 56. Post-Rail Separation Damage Mode Frequency for Barrier Types, Reorganized Groups.**

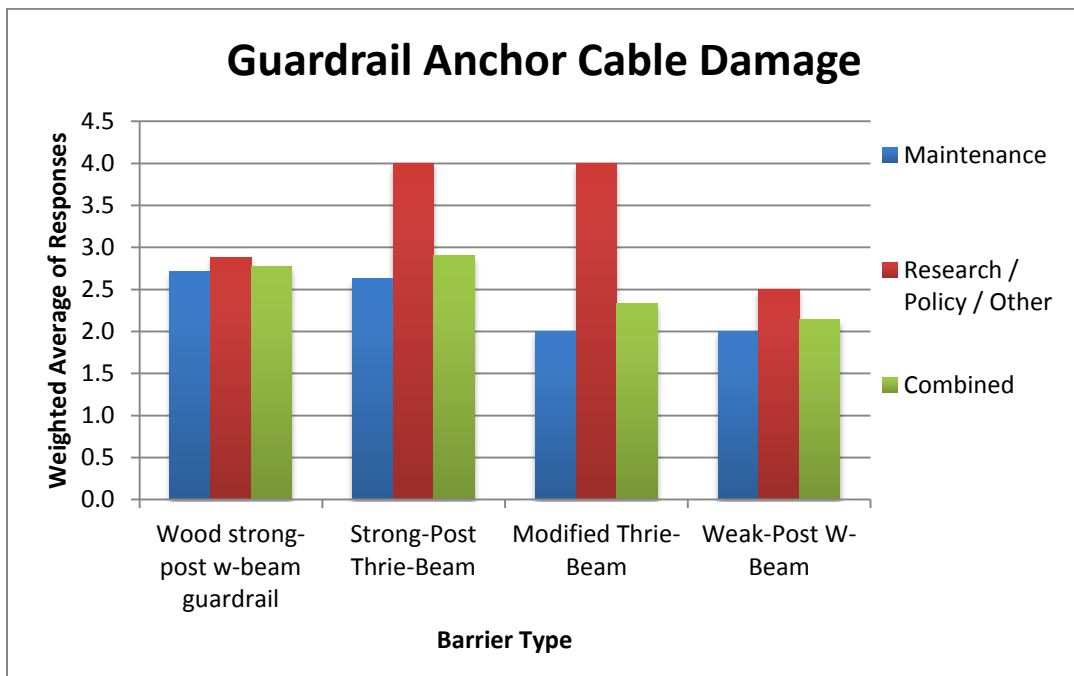
**Figure 57. Guardrail Anchor Cable Damage Mode Frequency for Barrier Types, Reorganized Groups**

The Maintenance group considers “guardrail anchor cable damage” to be most common damage mode for the strong-post thrie-beam guardrail and the wood strong-post w-beam guardrails. The Research/Policy/Other group indicated that the strong-post thrie-beam and the modified thrie-beam guardrails had a very high occurrence of anchor cable damage. (Figure 57)

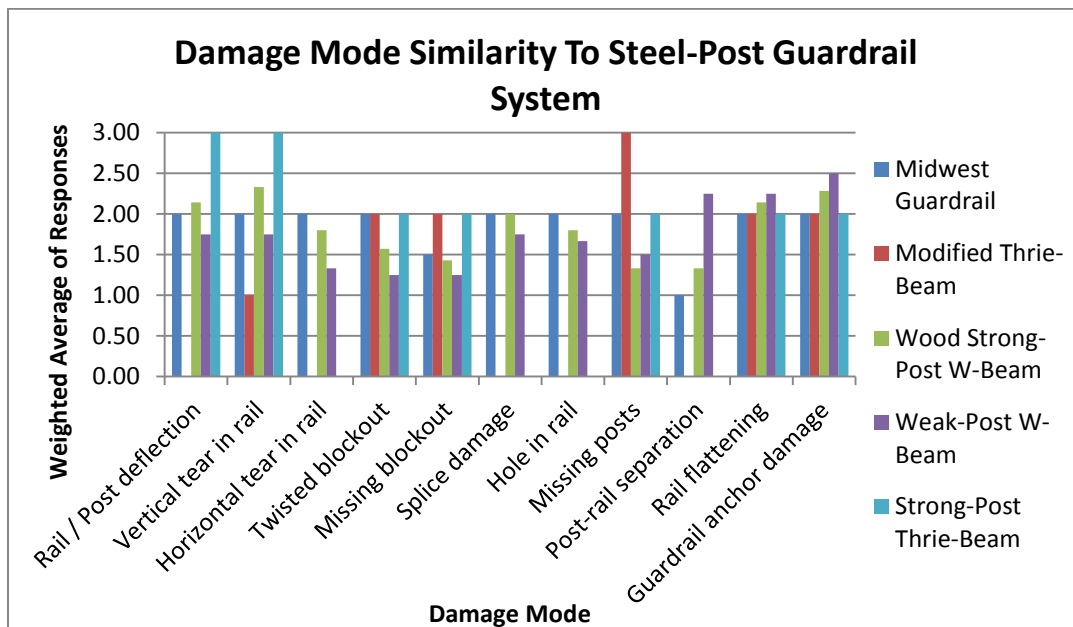
**Figure 60. Damage Mode Similarity To Report 656 Field Guide (1)**

From Figure 60, it can be seen that the Survey Group 2 respondents felt that “rail flattening” and “guardrail anchor damage” were two damage modes that would have similar behavior as the steel strong-post w-beam barrier used in Report 656; regardless of barrier type.

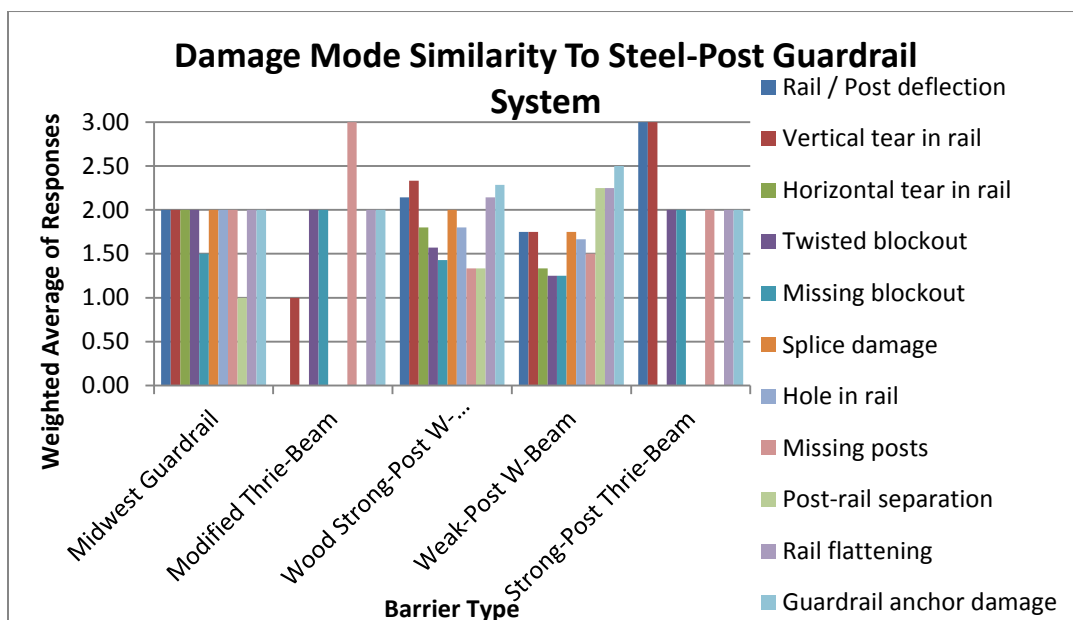
The wood strong-post w-beam and the weak-post w-beam were two barrier types that the respondents felt would not generally behave similarly to the steel strong-post w-beam, as can be seen in Figure 61.

**Figure 61. Damage Mode Similarity To Report 656 Field Guide. (2)**

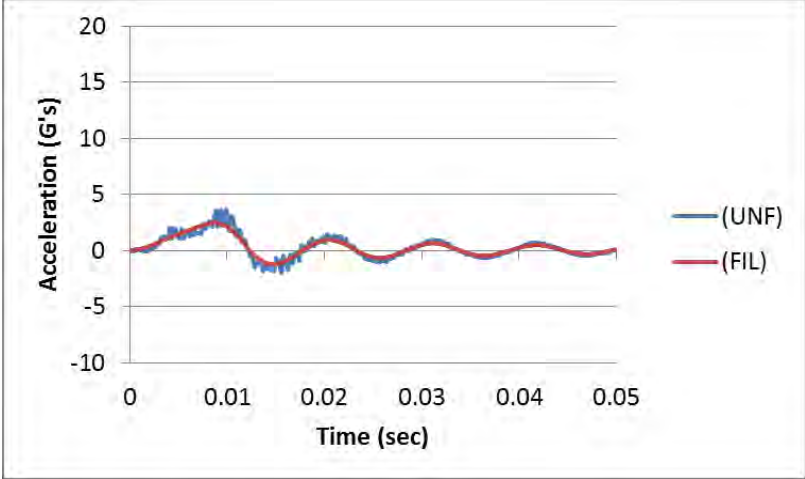
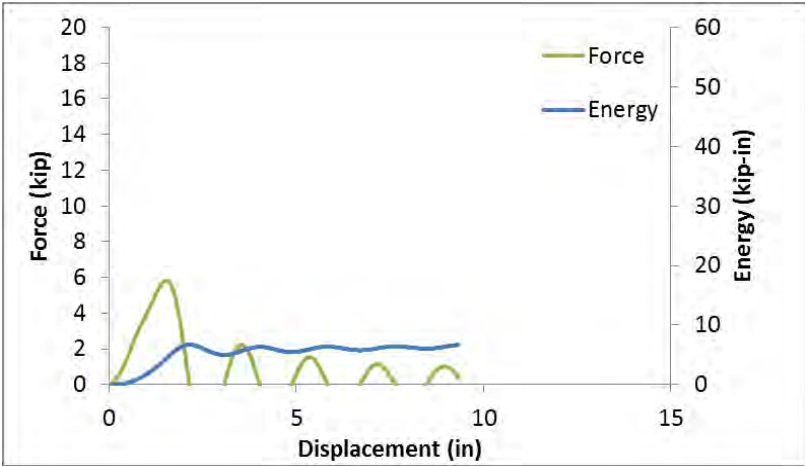
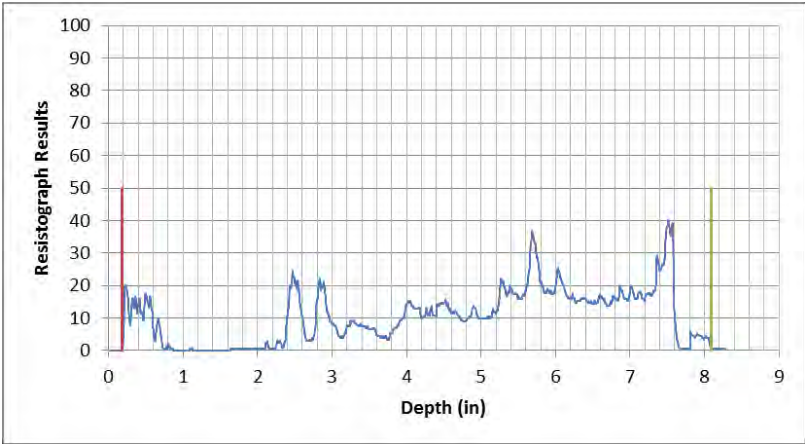
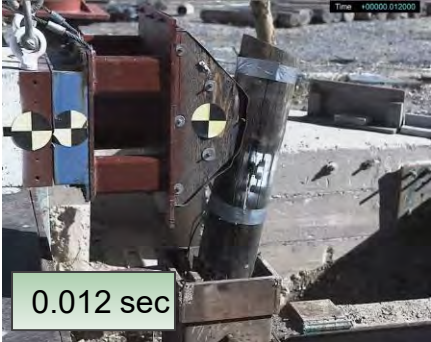
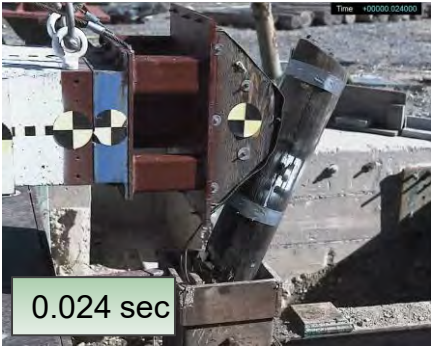
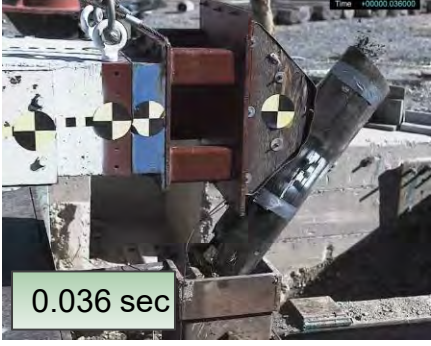
**Pendulum Properties**

Weight:	2,372 lb
Impact Speed:	20 mph
Impact Height:	21.5 inches

Fractured Post

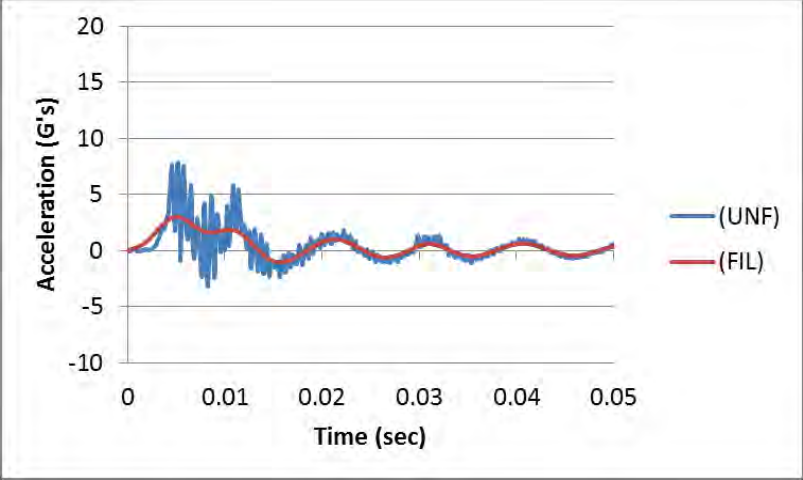
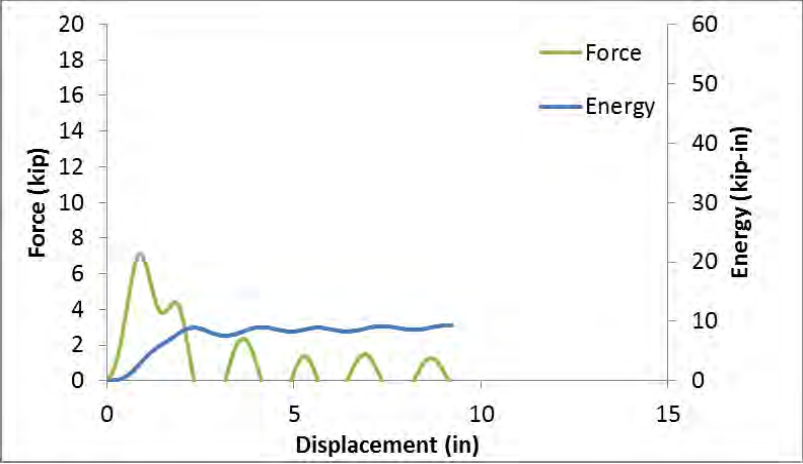
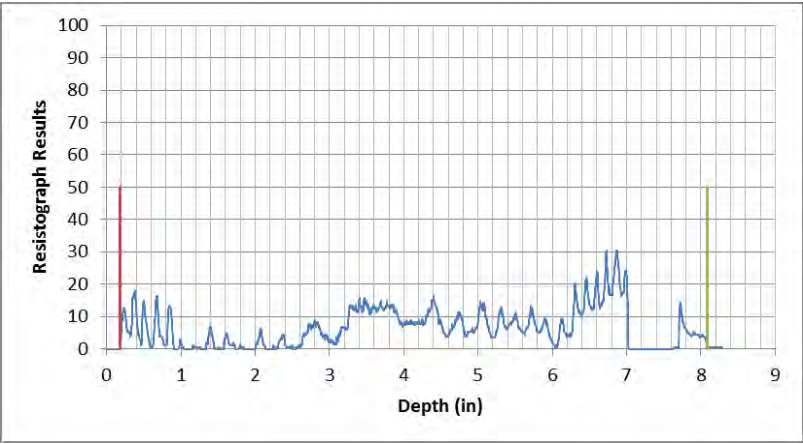
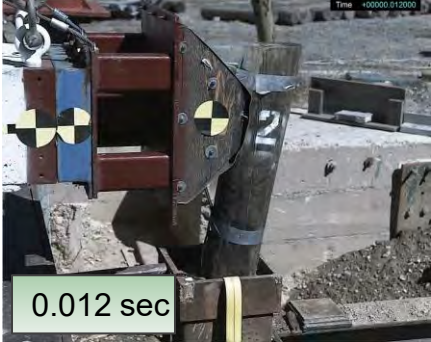
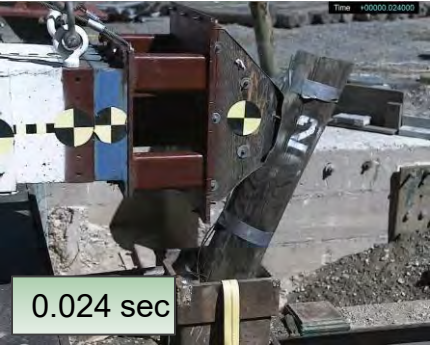
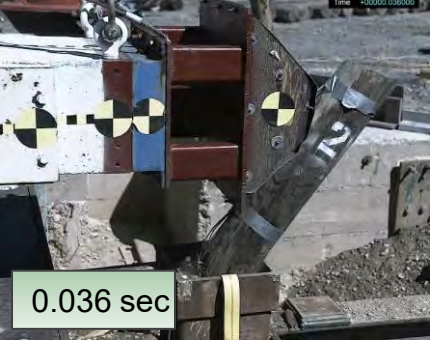
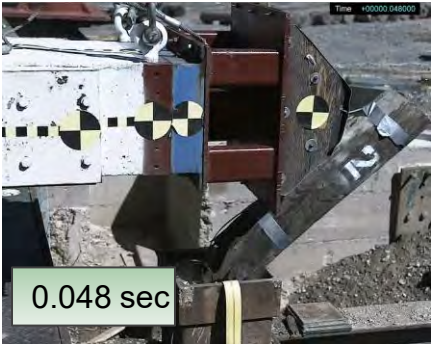
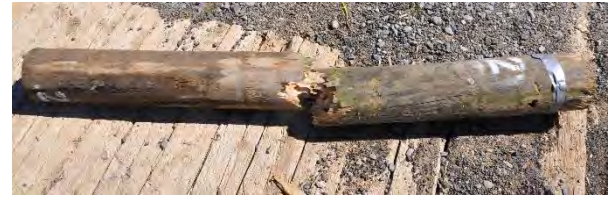
Post Number:	2
Post Type:	Round SYP
Post Length:	66 inches
Post Diameter:	7.01 inches
Moisture Content:	39.82%
Ring Density (avg.):	3.9 per inch
Resi Score $S_{MOR}$ :	0.12
Resi Score $S_U$ :	0.12

Weight:	2,372 lb
Impact Speed:	20 mph
Impact Height:	21.5 inches

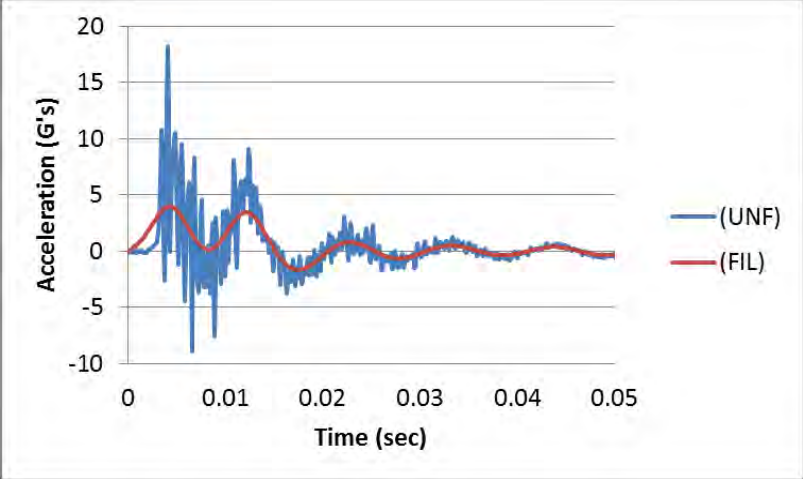
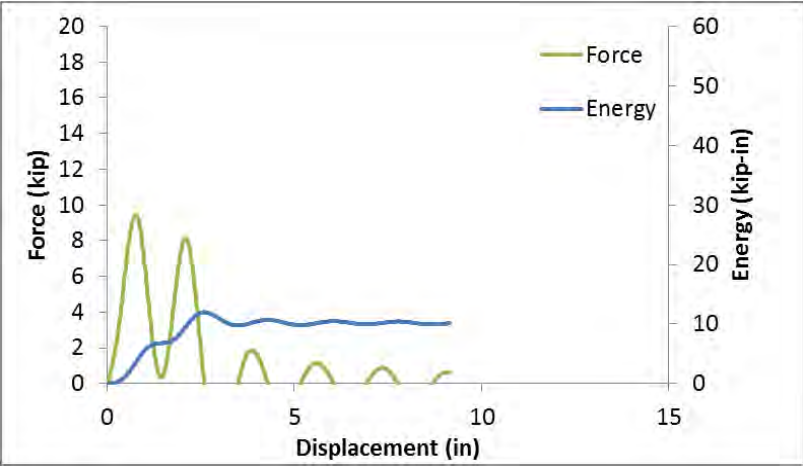
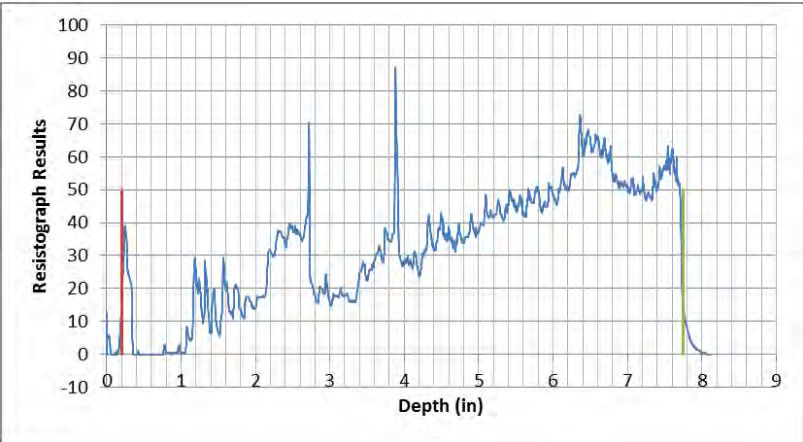
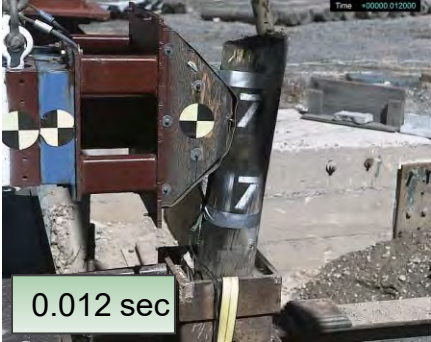
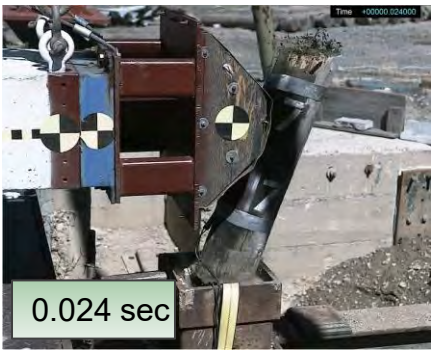
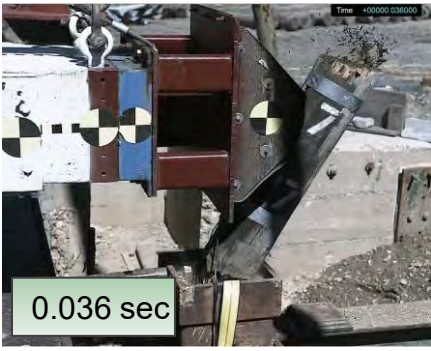
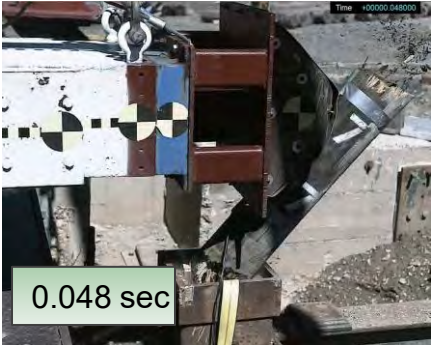
Test Number:	13009E
Test Date:	24-Sept-2013

Post Number:	7
Post Type:	Round SYP
Post Length:	66 inches
Post Diameter:	7.32 inches
Moisture Content:	N/A
Ring Density (avg.):	8 per inch
Resi Score $S_{MOR}$ :	0.63
Resi Score $S_U$ :	0.64

Weight:	2,372 lb
Impact Speed:	20 mph
Impact Height:	21.5 inches

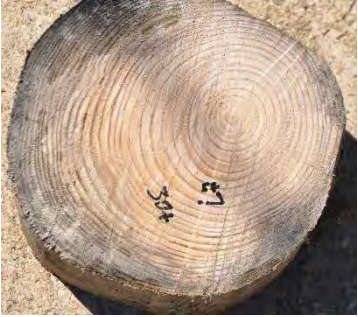
Ring density at bottom of post

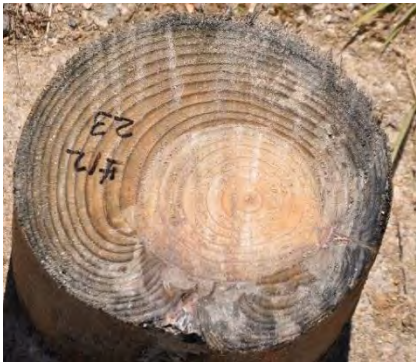
Ring density at bottom of post

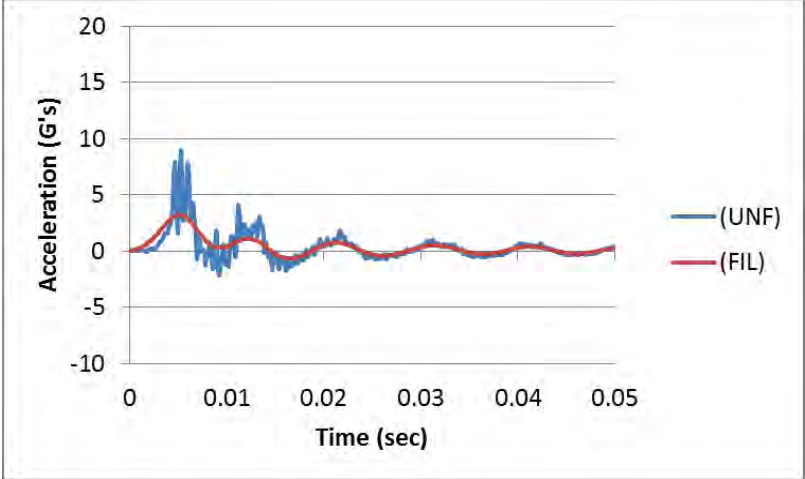
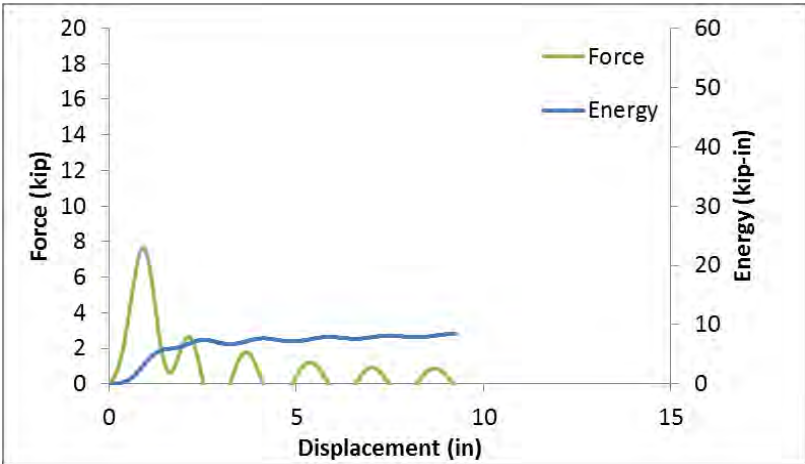
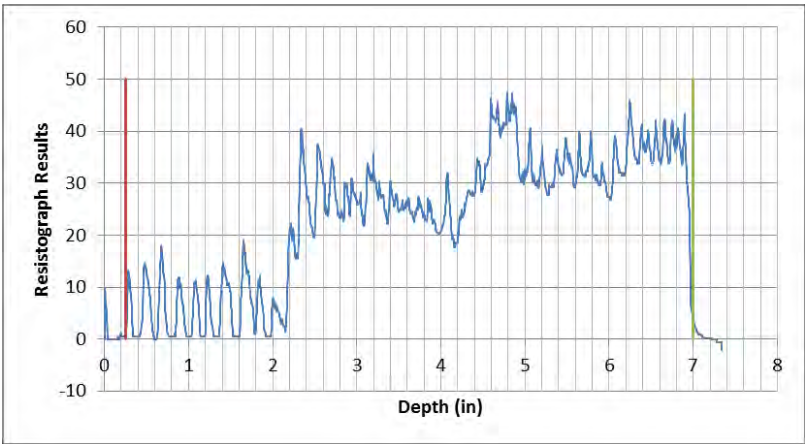
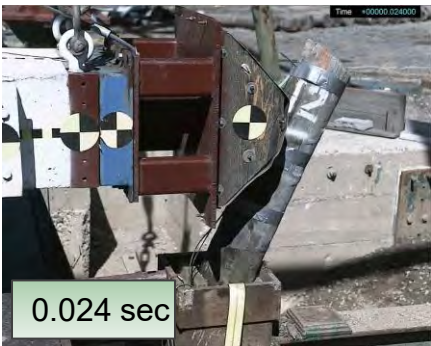
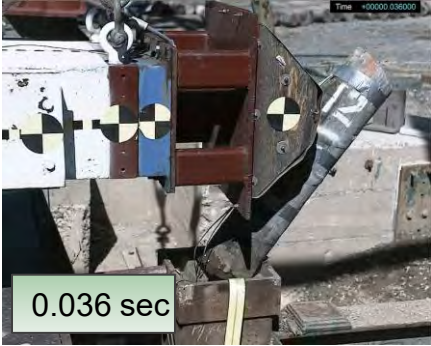
Test Number:	13009G
Test Date:	24-Sept-2013

Post Number:	4
Post Type:	Round SYP
Post Length:	66 inches
Post Diameter:	7.64 inches
Moisture Content:	N/A
Ring Density (avg.):	4.7 per inch
Resi Score $S_{MOR}$ :	0.77
Resi Score $S_U$ :	0.73

Weight:	2,372 lb
Impact Speed:	20 mph
Impact Height:	21.5 inches

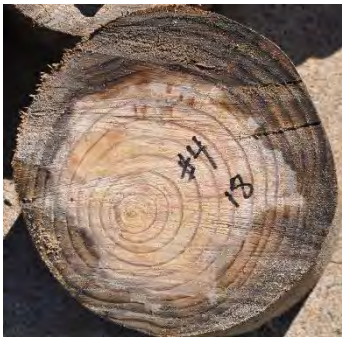
Ring density at bottom of post
