# **A Guide for W-Beam Guardrail Damage Assessment**

A Field Manual for  
Highway Maintenance Personnel

National Cooperative  
Highway Research  
Program  
Project 22-28

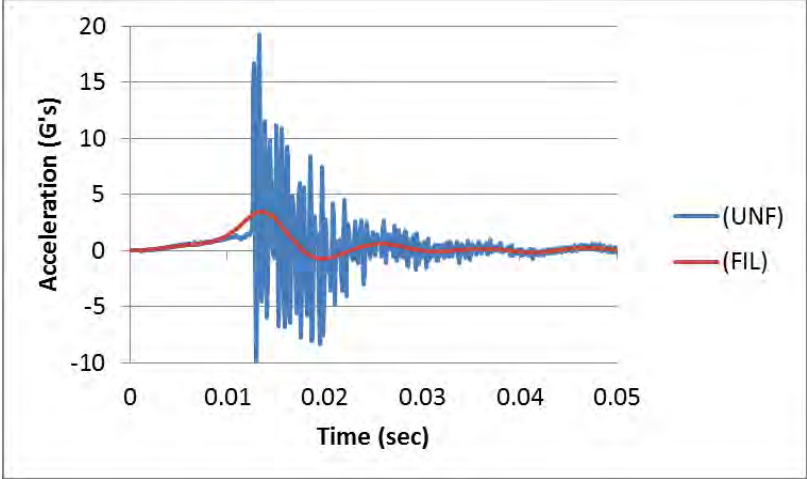
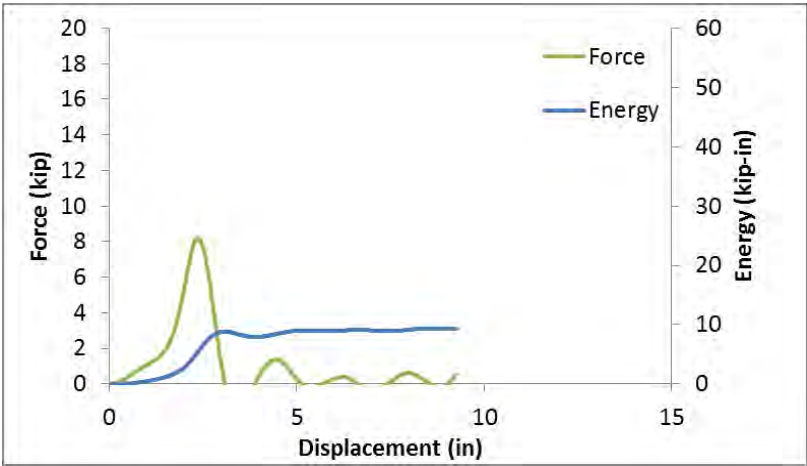
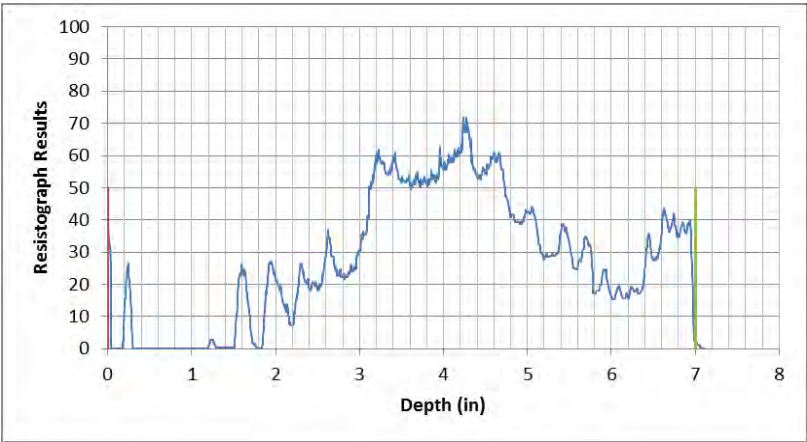
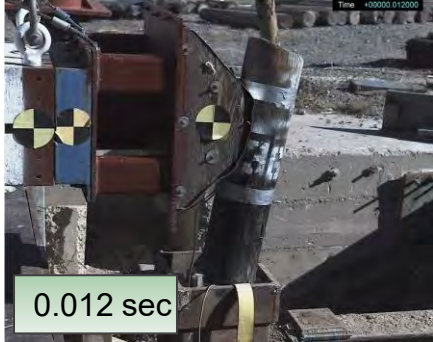
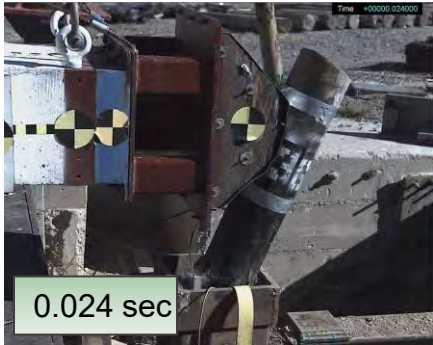
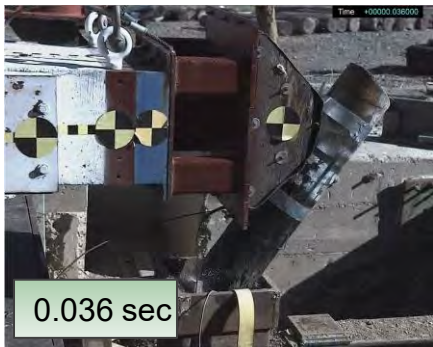
Post Number:	36
Post Type:	Round SYP
Post Length:	66 inches
Post Diameter:	7.17 inches
Moisture Content:	>50%
Ring Density (avg.):	7.7 per inch
Resi Score $S_{MOR}$ :	0.27
Resi Score $S_U$ :	0.30

Weight:	2,372 lb
Impact Speed:	20 mph
Impact Height:	21.5 inches

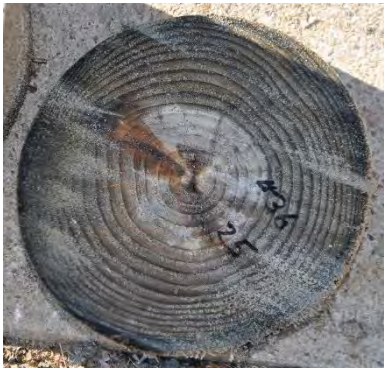
Ring density at bottom of post

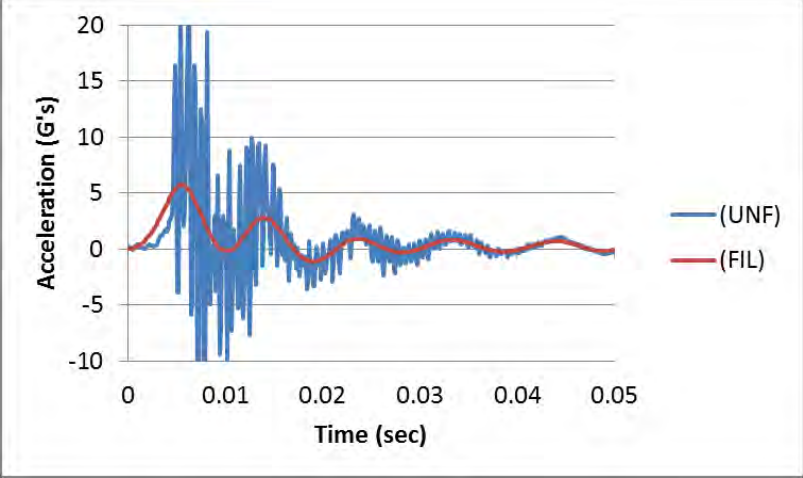
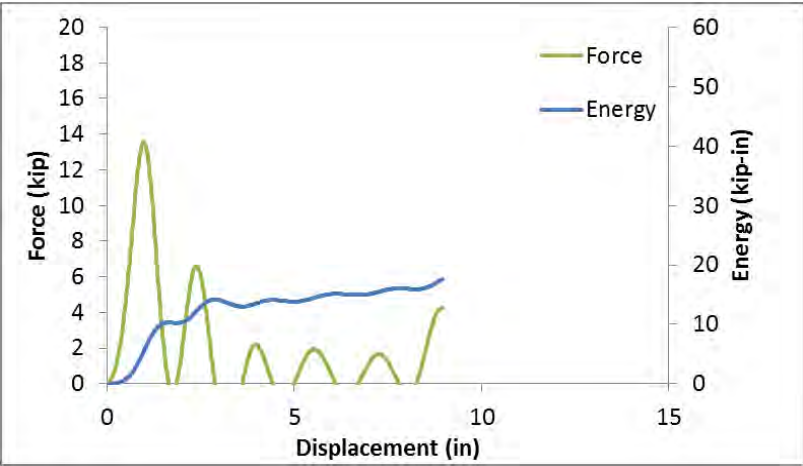
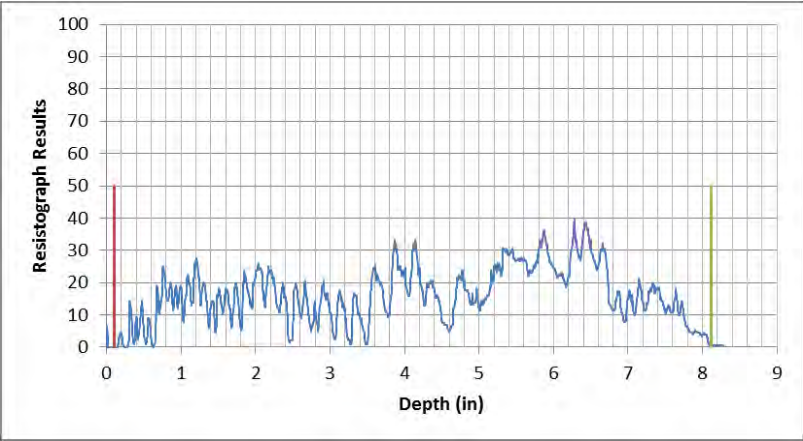
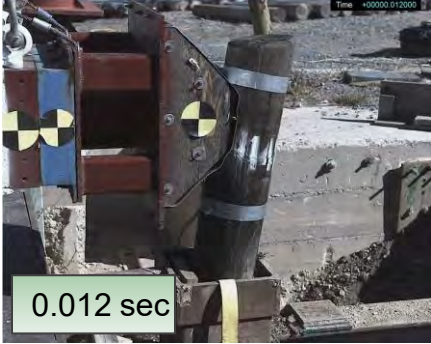
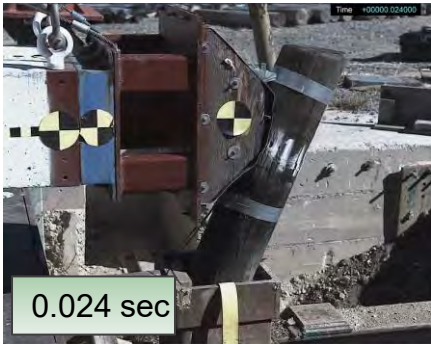
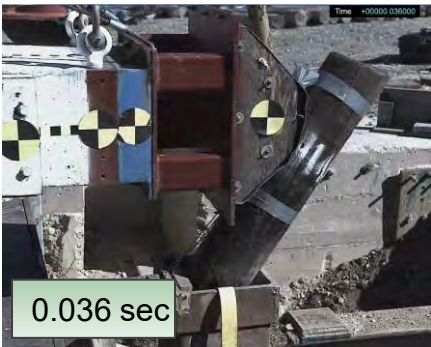
Post Number:	14
Post Type:	Round SYP
Post Length:	66 inches
Post Diameter:	8.04 inches
Moisture Content:	>50%
Ring Density (avg.):	7.4 per inch
Resi Score $S_{MOR}$ :	0.29
Resi Score $S_U$ :	0.28

Weight:	2,372 lb
Impact Speed:	20 mph
Impact Height:	21.5 inches

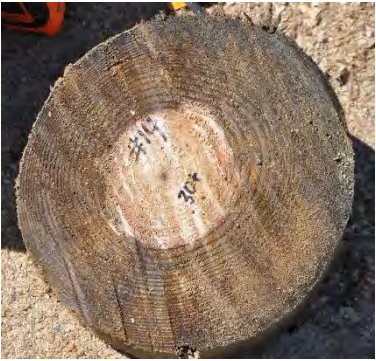
Ring density at bottom of post

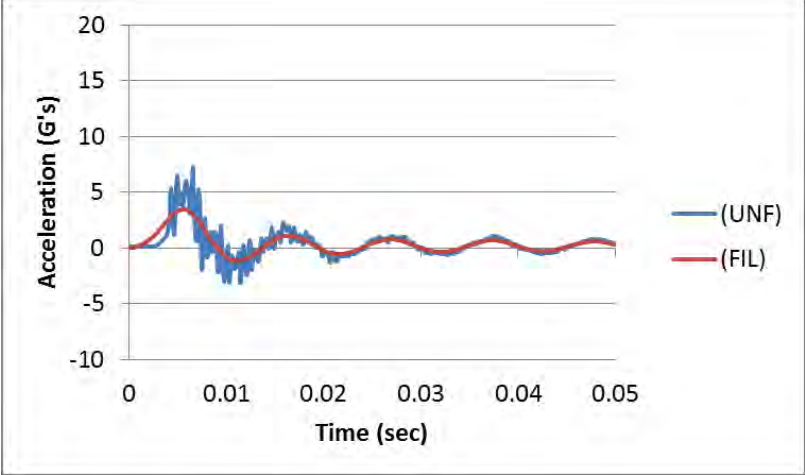
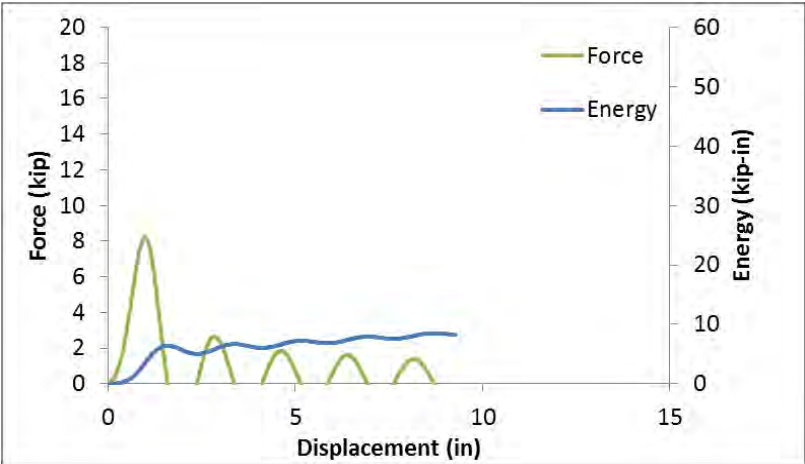
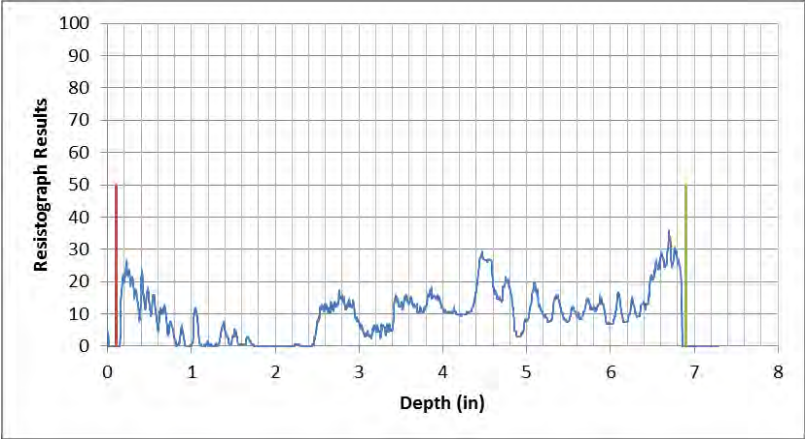
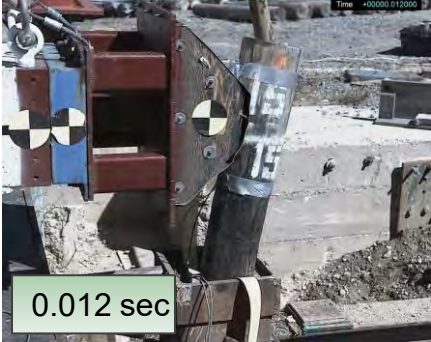
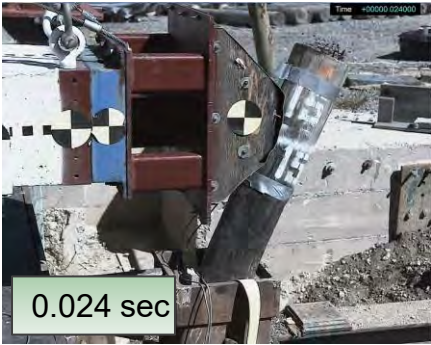
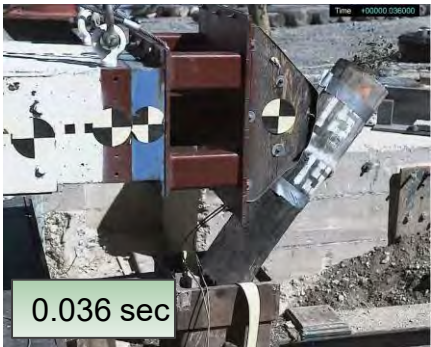
Post Number:	15
Post Type:	Round SYP
Post Length:	66 inches
Post Diameter:	7.00 inches
Moisture Content:	>50%
Ring Density (avg.):	5.1 per inch
Resi Score $S_{MOR}$ :	0.18
Resi Score $S_U$ :	0.21

Weight:	2,372 lb
Impact Speed:	20 mph
Impact Height:	21.5 inches

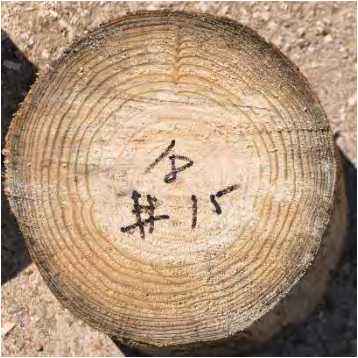
Ring density at bottom of post

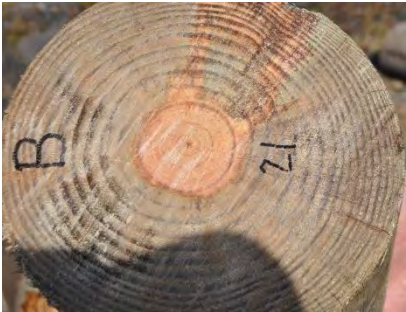
Ring density at bottom of post

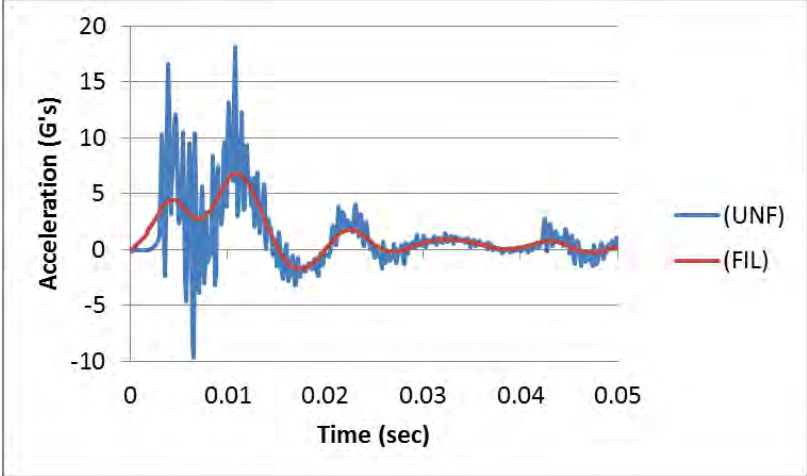
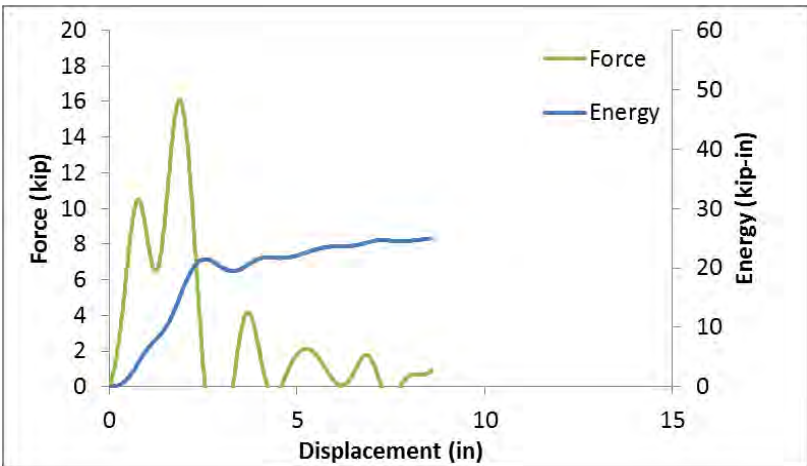
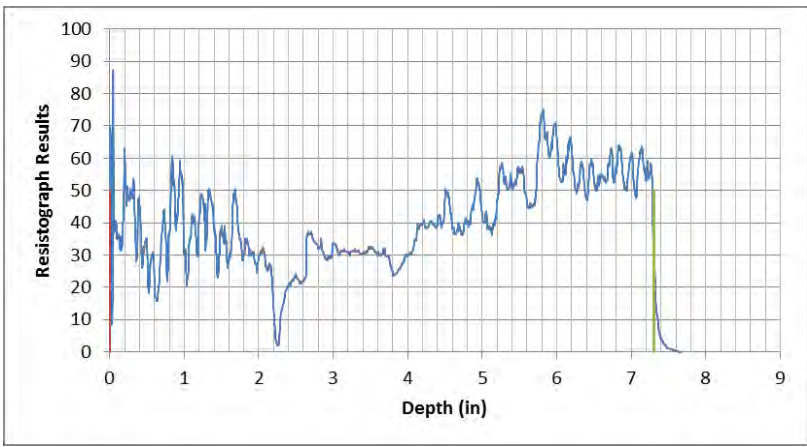
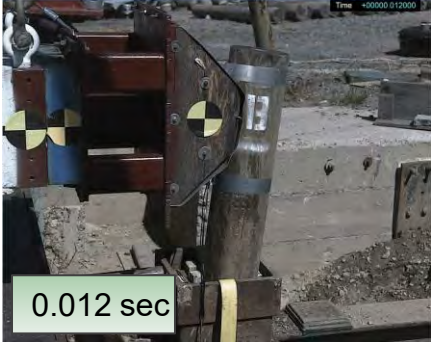
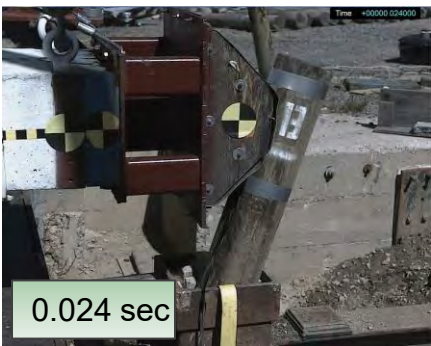
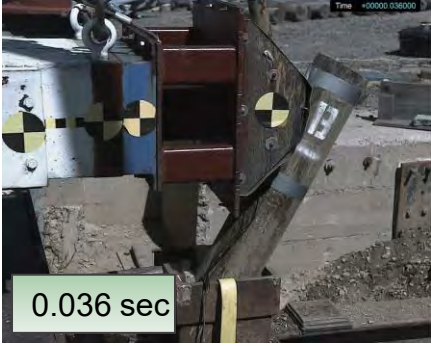
Post Number:	B
Post Type:	Round SYP
Post Length:	66 inches
Post Diameter:	7.32 inches
Moisture Content:	N/A
Ring Density (avg.):	5.8 per inch
Resi Score $S_{MOR}$ :	0.84
Resi Score $S_U$ :	0.88

Weight:	2,372 lb
Impact Speed:	20 mph
Impact Height:	21.5 inches

Fractured Post

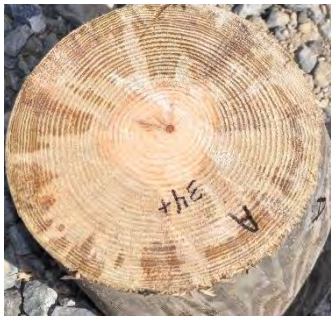
Ring density at bottom of post

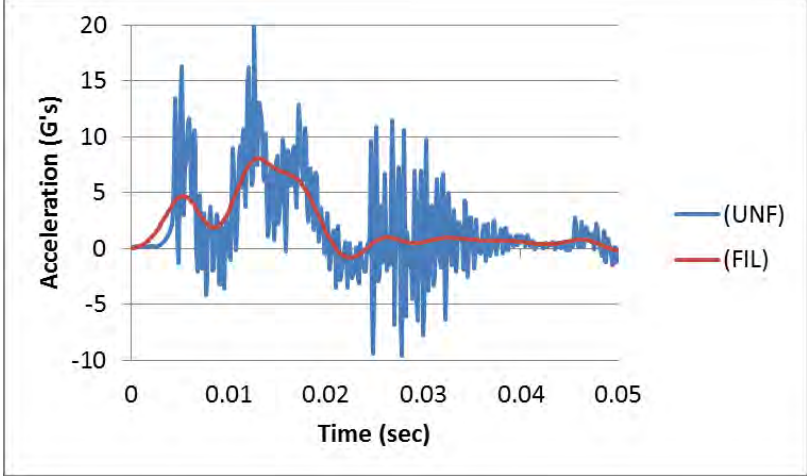
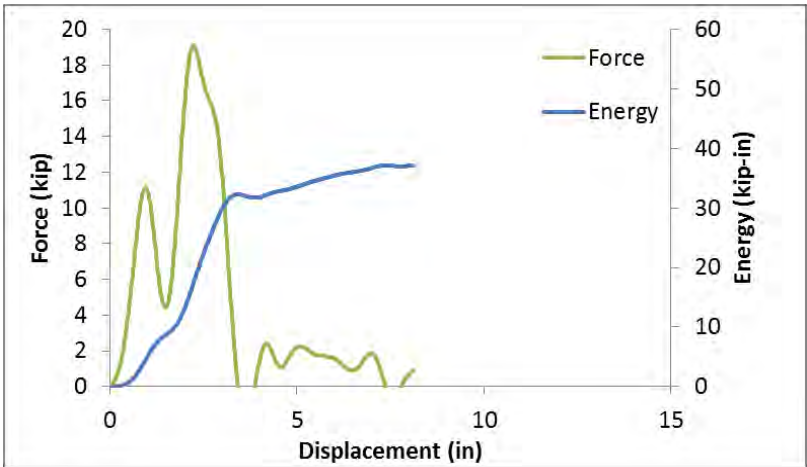
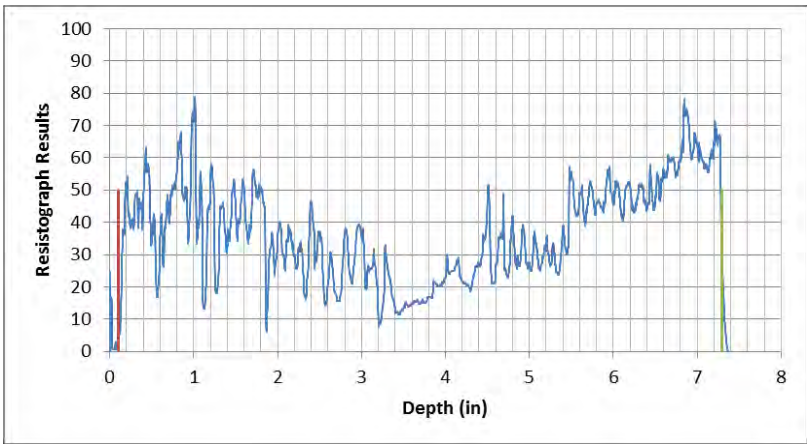
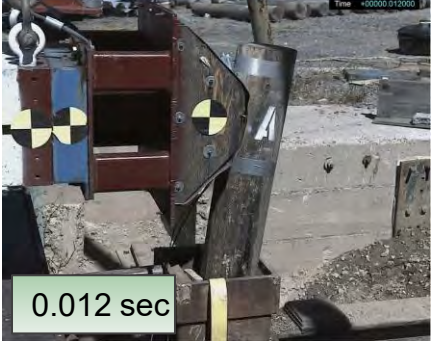
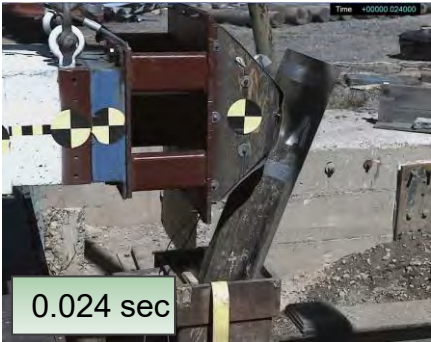
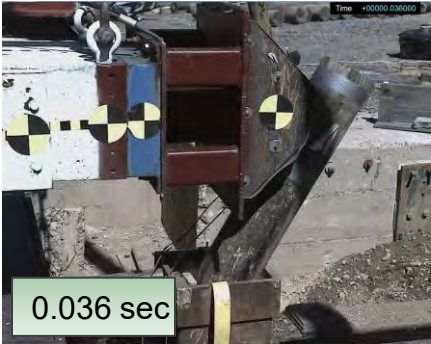
Post Number:	A
Post Type:	Round SYP
Post Length:	66 inches
Post Diameter:	7.32 inches
Moisture Content:	N/A
Ring Density (avg.):	9.4 per inch
Resi Score $S_{MOR}$ :	0.83
Resi Score $S_U$ :	0.89

Weight:	2,372 lb
Impact Speed:	20 mph
Impact Height:	21.5 inches

Fractured Post

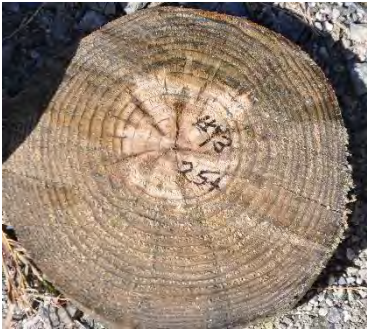
Ring density at bottom of post

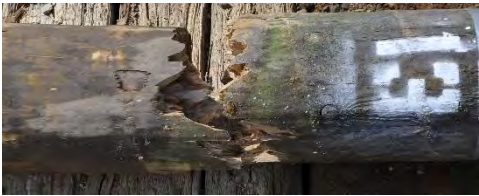
Fractured Post

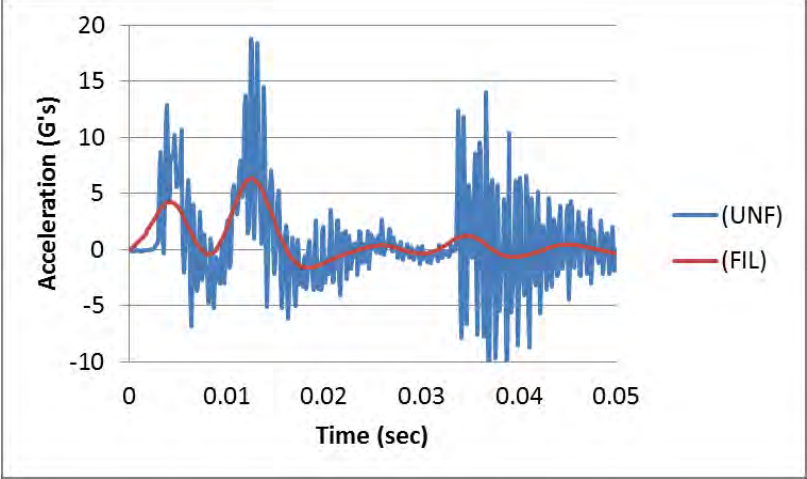
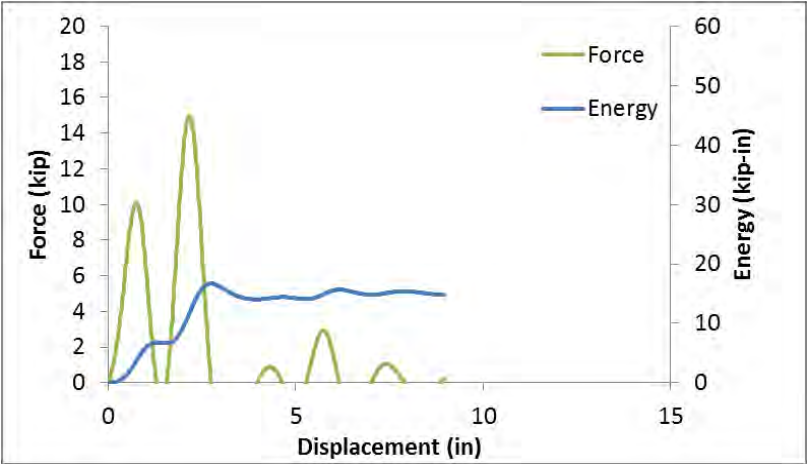
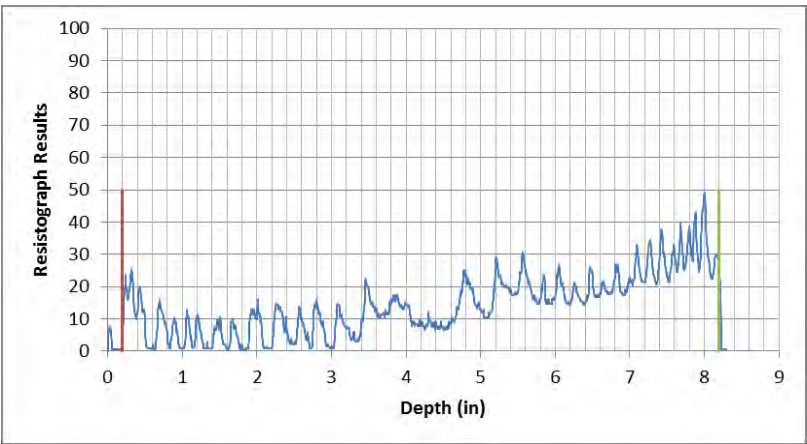
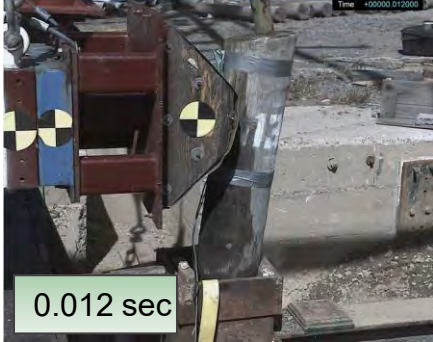
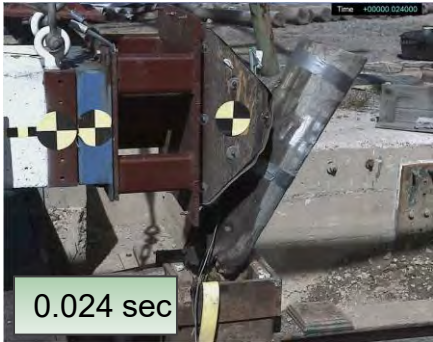
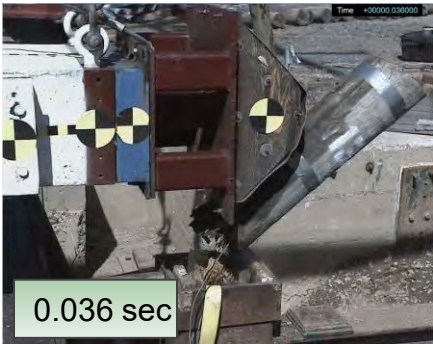
Test Number:	13009O
Test Date:	26-Sept-2013

Post Number:	13
Post Type:	Round SYP
Post Length:	66 inches
Post Diameter:	8.12 inches
Moisture Content:	>50%
Ring Density (avg.):	6.4 per inch
Resi Score $S_{MOR}$ :	0.42
Resi Score $S_U$ :	0.40

Weight:	2,372 lb
Impact Speed:	20 mph
Impact Height:	21.5 inches

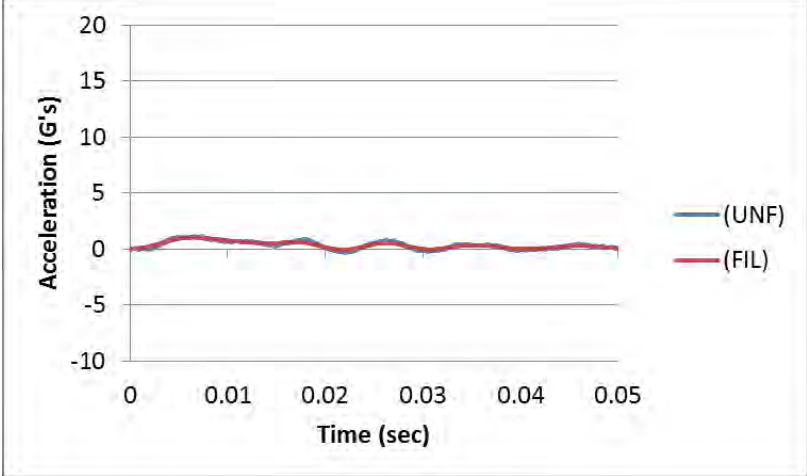
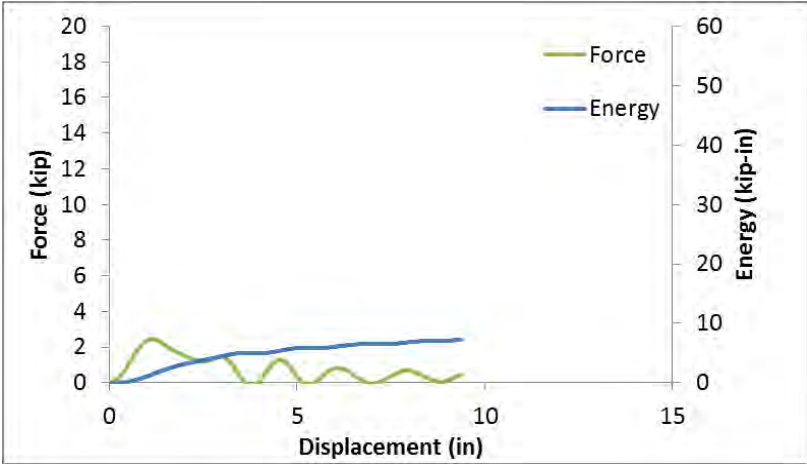
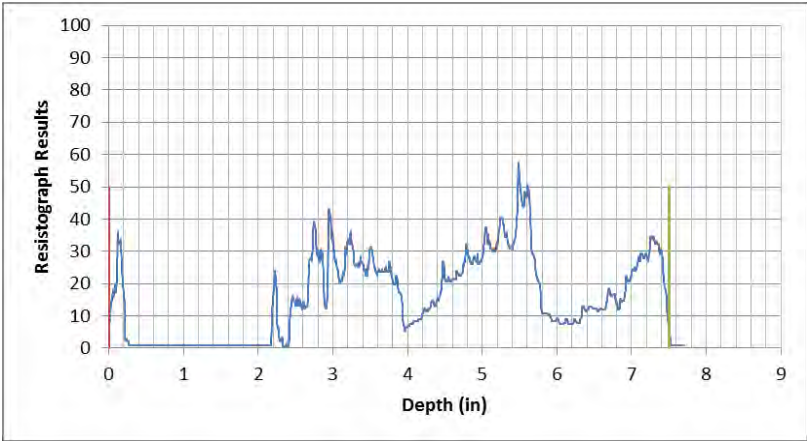
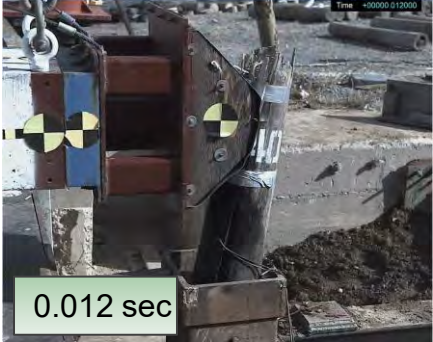
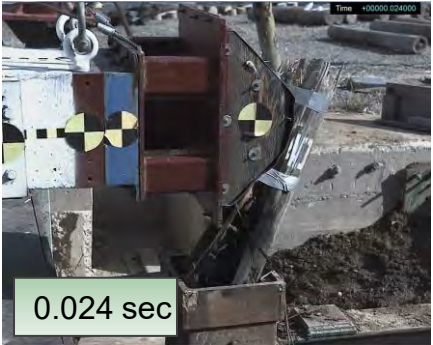
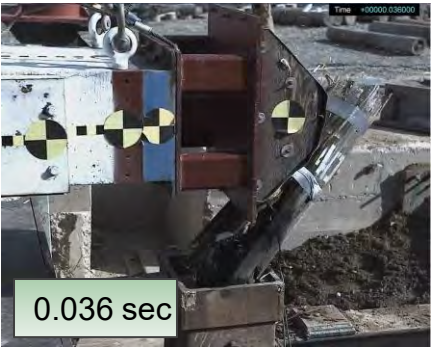
Post Number:	40
Post Type:	Round SYP
Post Length:	66 inches
Post Diameter:	7.56 inches
Moisture Content:	>50%
Ring Density (avg.):	7.2 per inch
Resi Score $S_{MOR}$ :	0.26
Resi Score $S_U$ :	0.27

Weight:	2,372 lb
Impact Speed:	20 mph
Impact Height:	21.5 inches

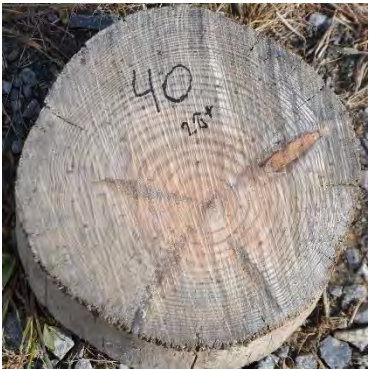
Ring density at bottom of post

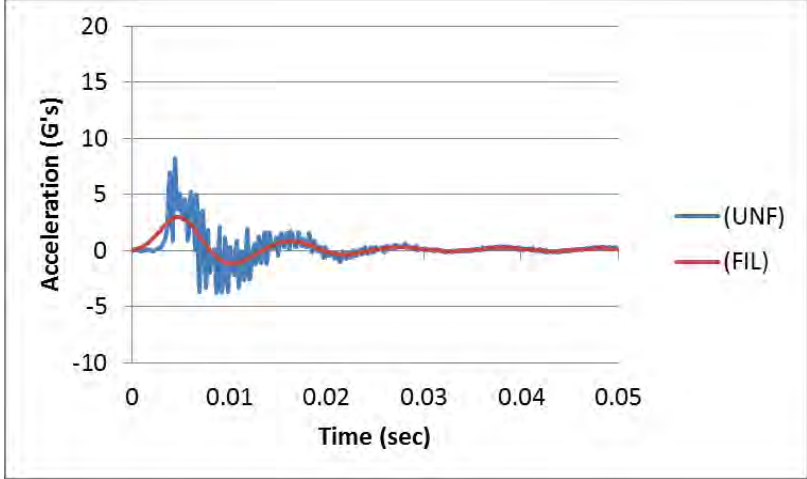
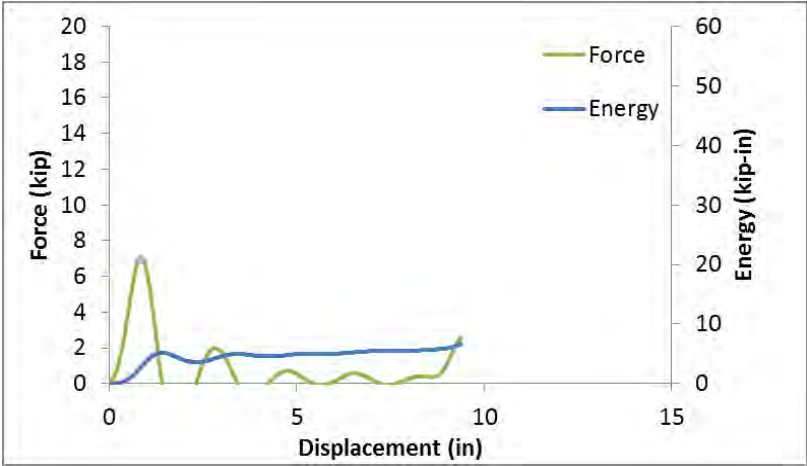
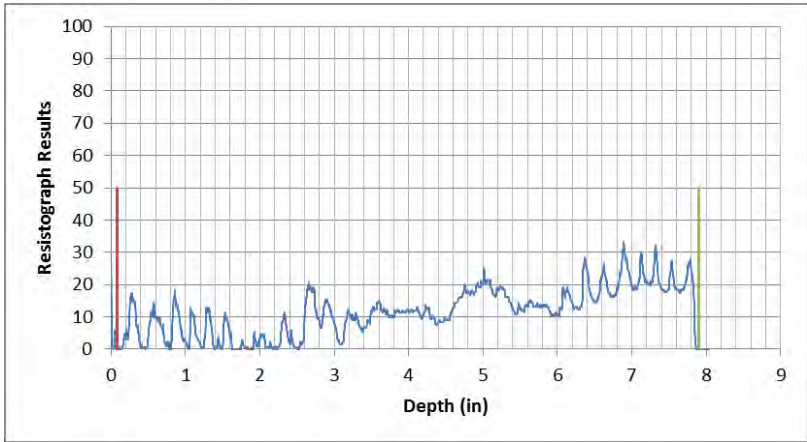
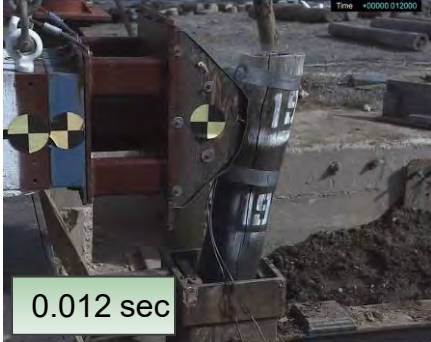
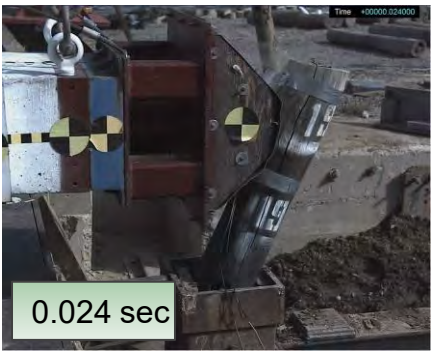
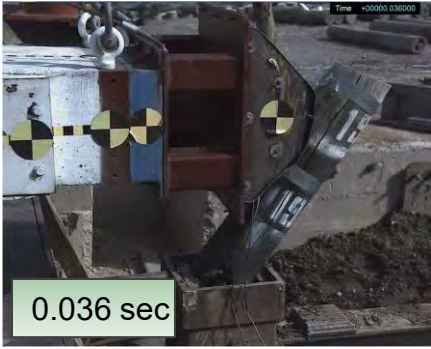
Post Number:	19
Post Type:	Round SYP
Post Length:	66 inches
Post Diameter:	7.80 inches
Moisture Content:	>50%
Ring Density (avg.):	4.6 per inch
Resi Score $S_{MOR}$ :	0.27
Resi Score $S_U$ :	0.27

Weight:	2,372 lb
Impact Speed:	20 mph
Impact Height:	21.5 inches

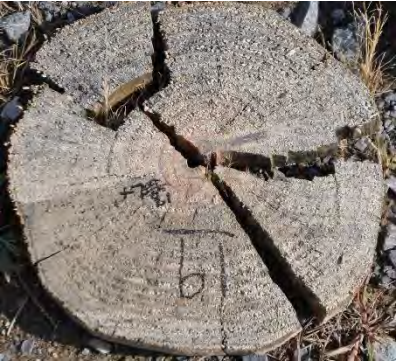
Ring density at bottom of post

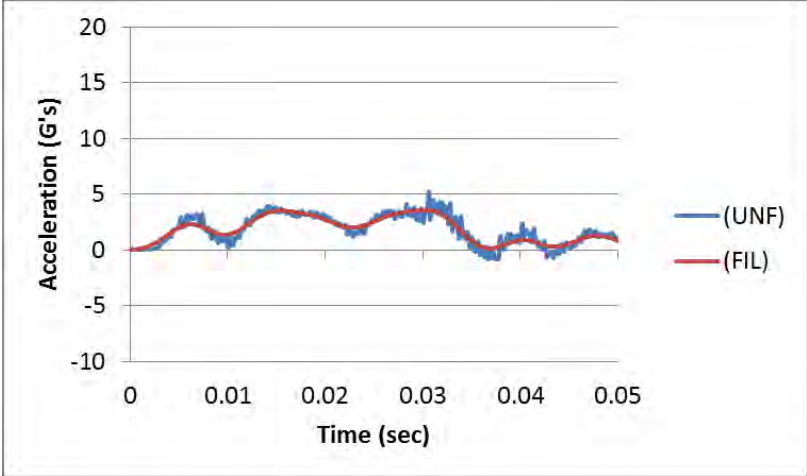
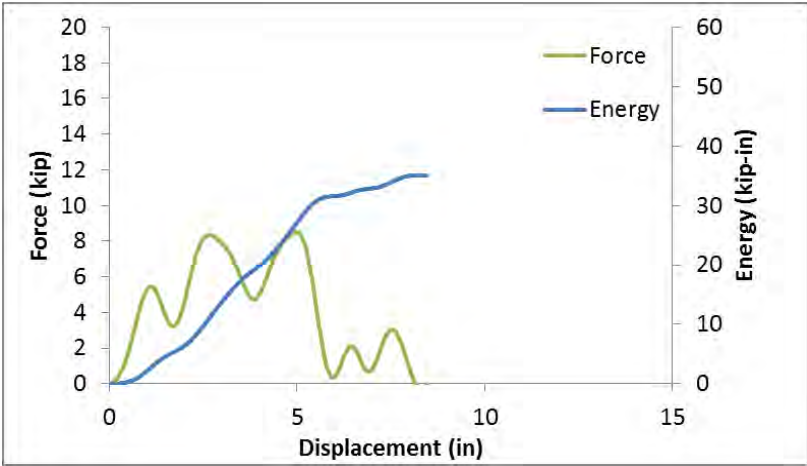
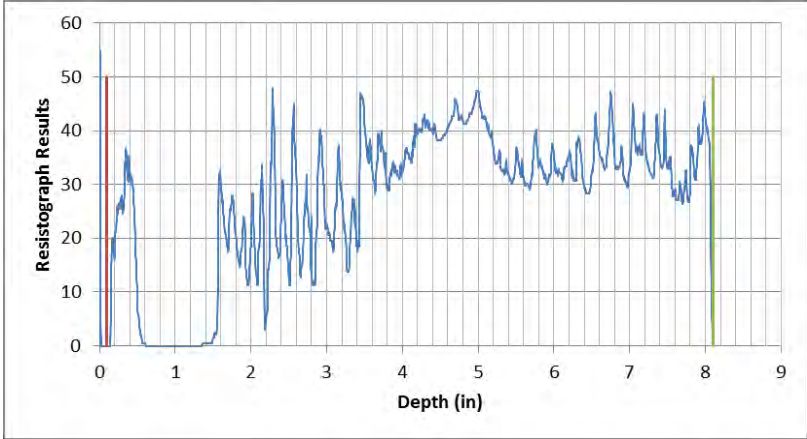
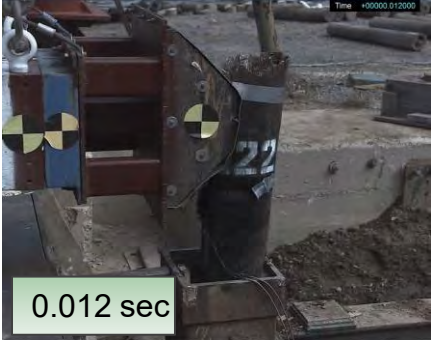
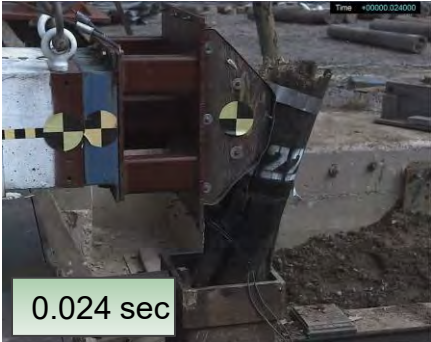
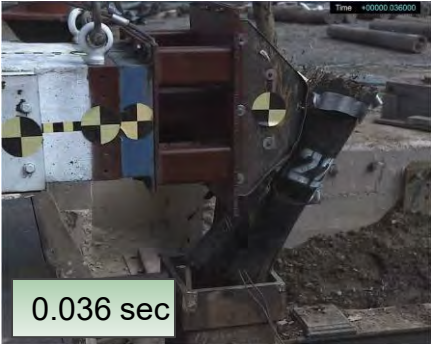
Post Number:	22
Post Type:	Round SYP
Post Length:	66 inches
Post Diameter:	8.92 inches
Moisture Content:	47.7%
Ring Density (avg.):	6.7 per inch
Resi Score $S_{MOR}$ :	0.54
Resi Score $S_U$ :	0.52

Weight:	2,372 lb
Impact Speed:	20 mph
Impact Height:	21.5 inches

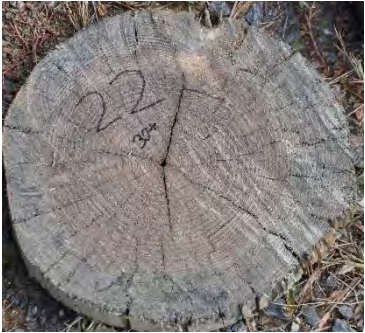
Ring density at bottom of post

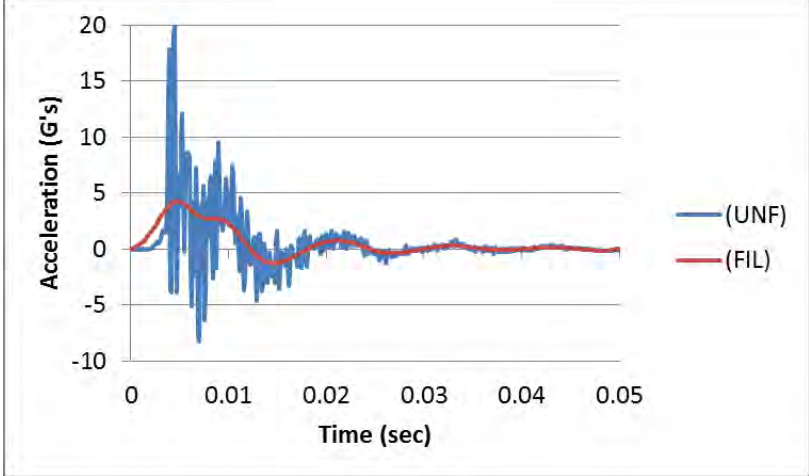
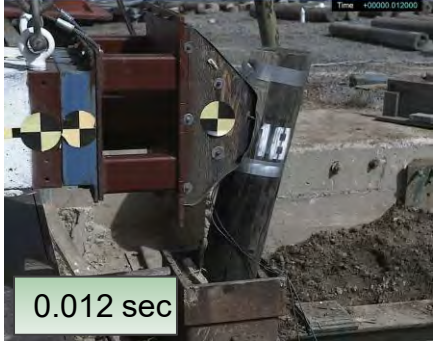
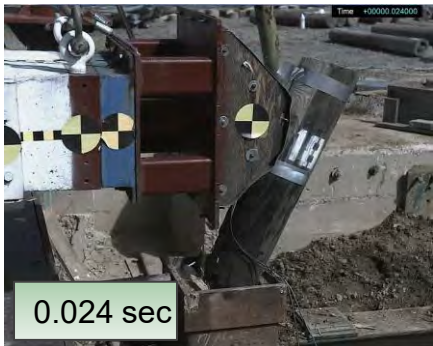
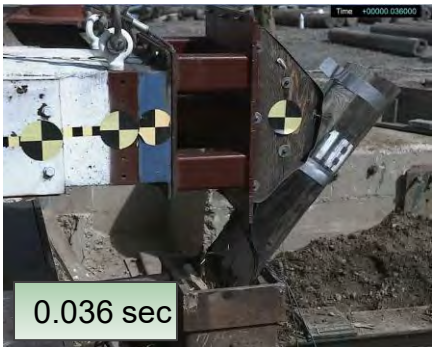
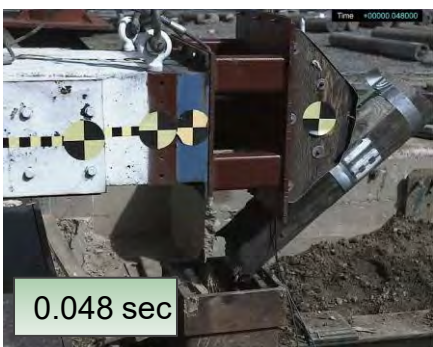
Post Number:	18
Post Type:	Round SYP
Post Length:	66 inches
Post Diameter:	7.80 inches
Moisture Content:	>50%
Ring Density (avg.):	6.2 per inch
Resi Score $S_{MOR}$ :	0.61
Resi Score $S_U$ :	0.62

Weight:	2,372 lb
Impact Speed:	20 mph
Impact Height:	21.5 inches

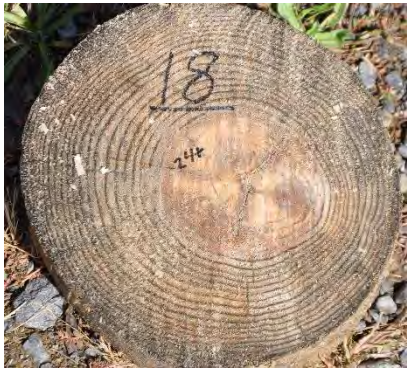
Ring density at bottom of post

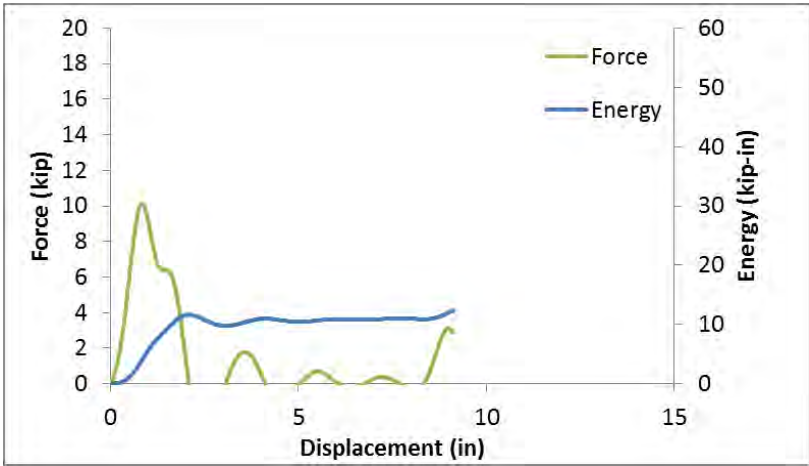
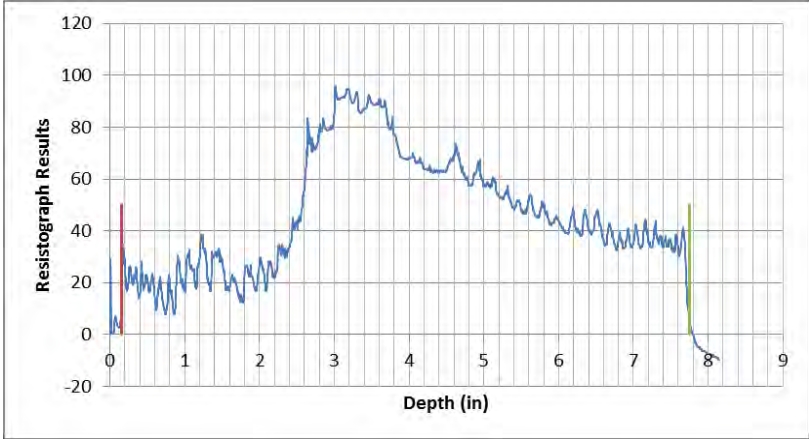
Fractured Post

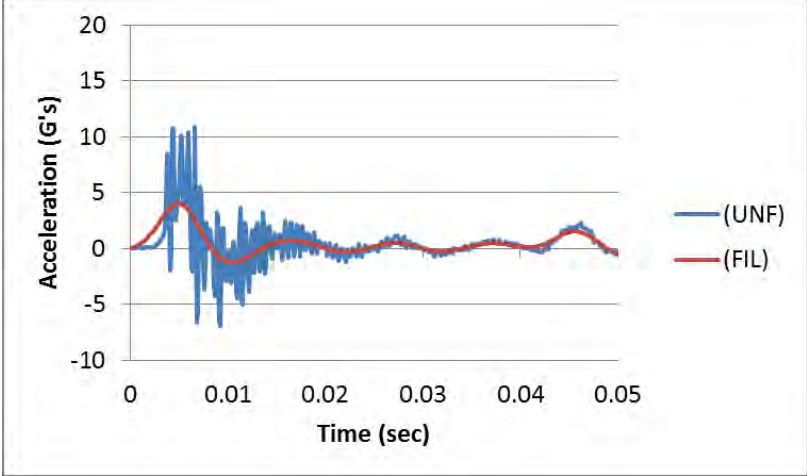
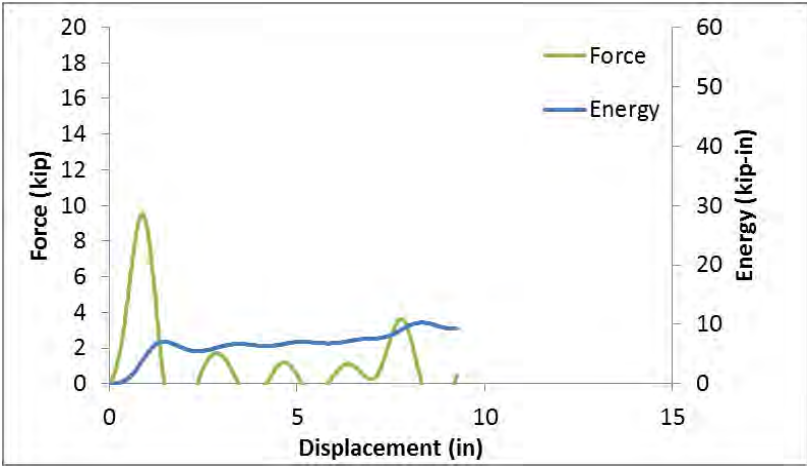
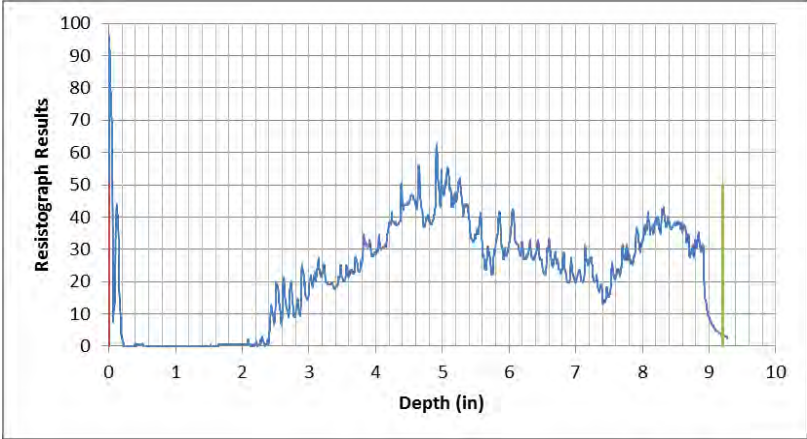
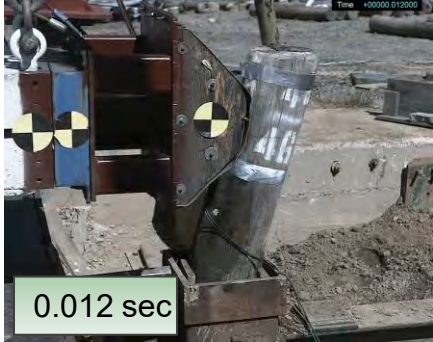
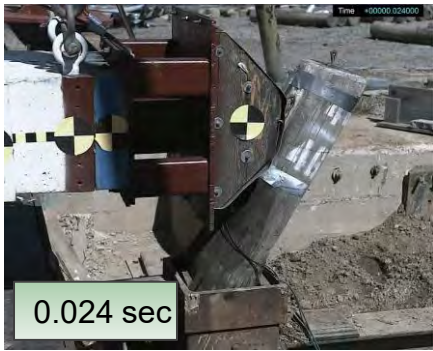
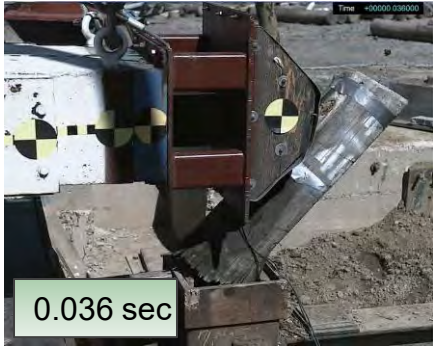
Post Number:	46
Post Type:	Round SYP
Post Length:	66 inches
Post Diameter:	9.08 inches
Moisture Content:	< 50%
Ring Density (avg.):	8.7 per inch
Resi Score $S_{MOR}$ :	0.60
Resi Score $S_U$ :	0.50

Weight:	2,372 lb
Impact Speed:	20 mph
Impact Height:	21.5 inches

Ring density at bottom of post

Fractured Post

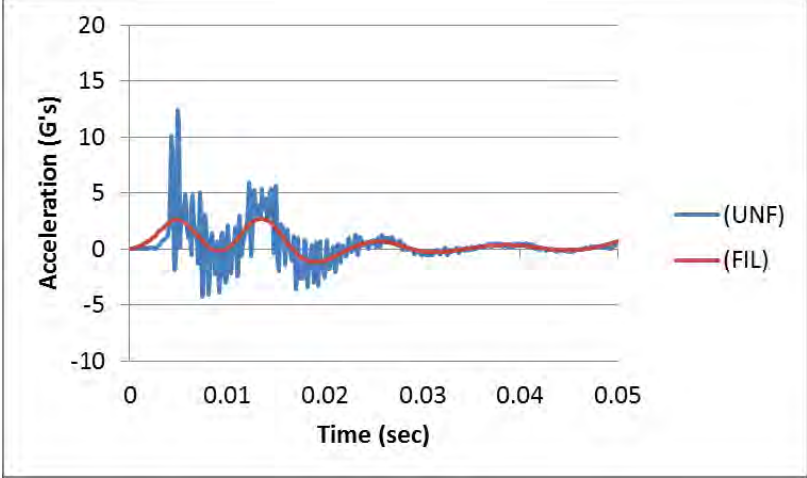
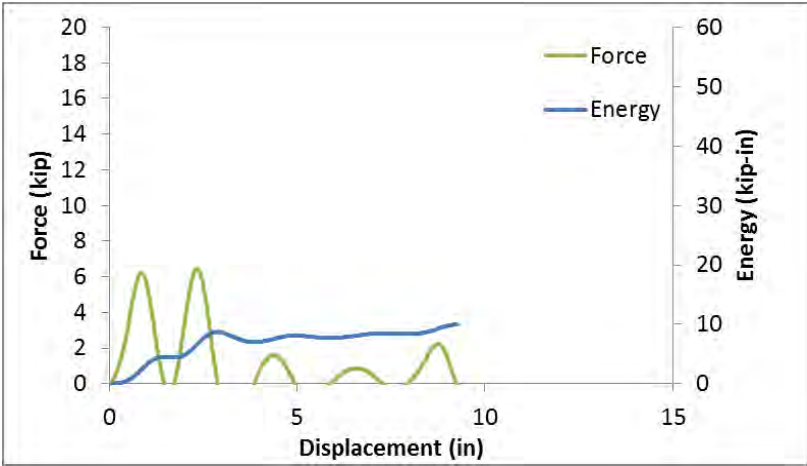
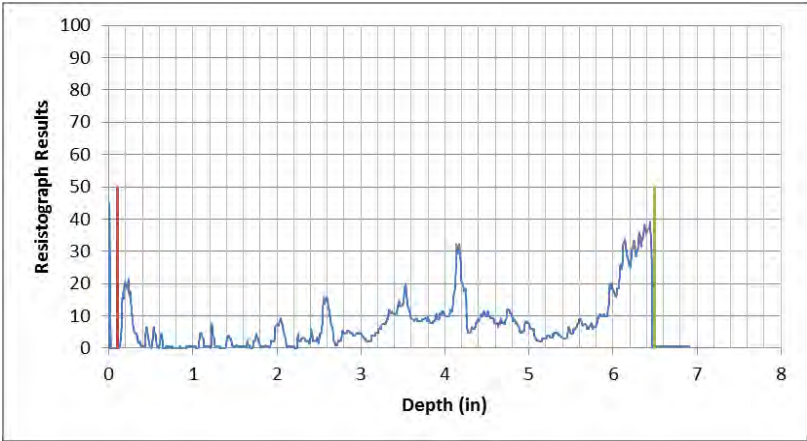
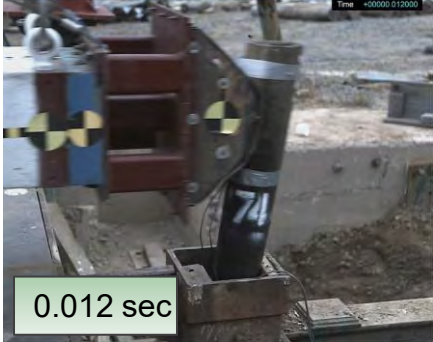
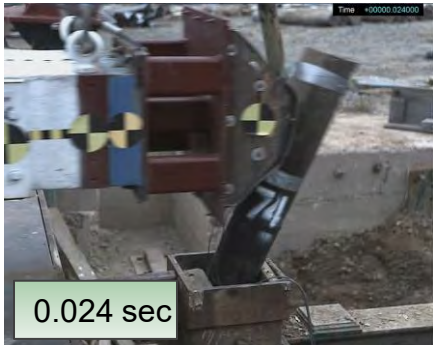
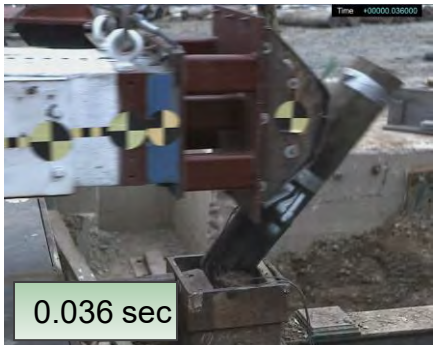
Post Number:	74
Post Type:	Round SYP
Post Length:	66 inches
Post Diameter:	6.37 inches
Moisture Content:	< 50%
Ring Density (avg.):	7 per inch
Resi Score $S_{MOR}$ :	0.13
Resi Score $S_U$ :	0.16

Weight:	2,372 lb
Impact Speed:	20 mph
Impact Height:	21.5 inches

Ring density at bottom of post

Fractured Post

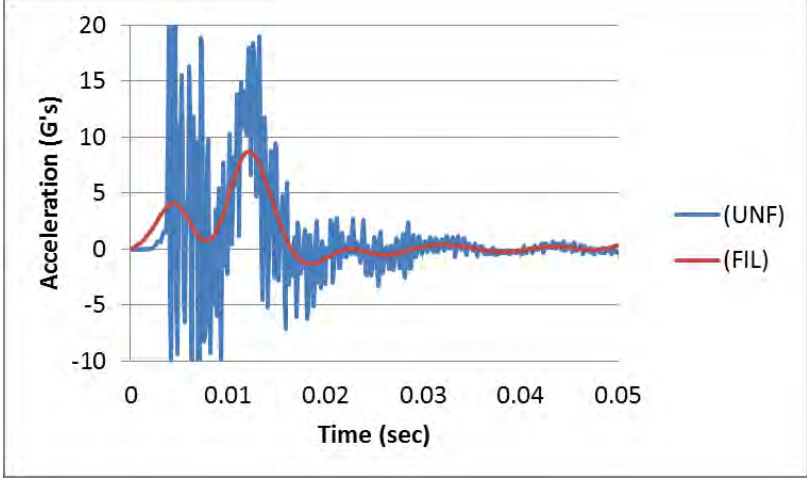
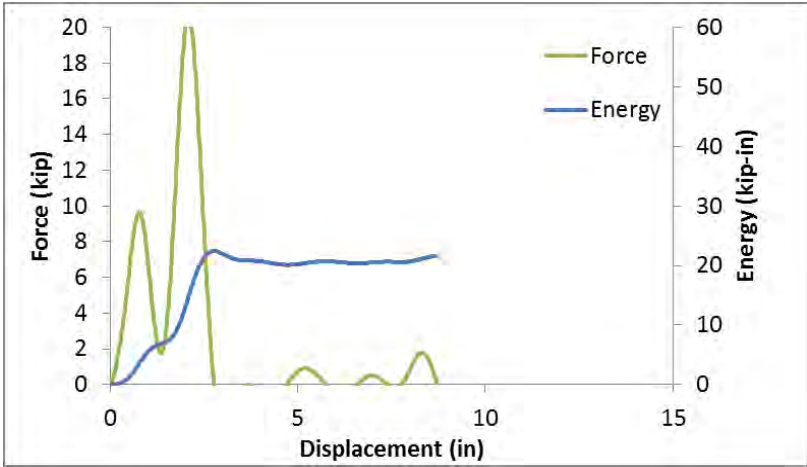
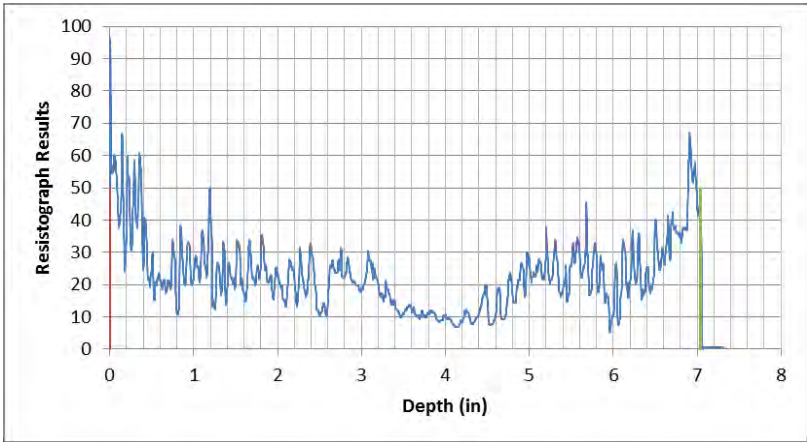
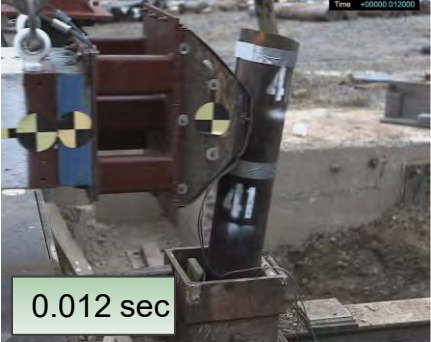
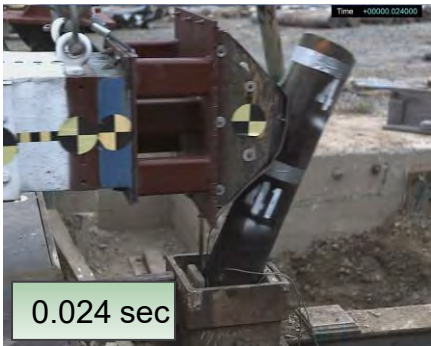
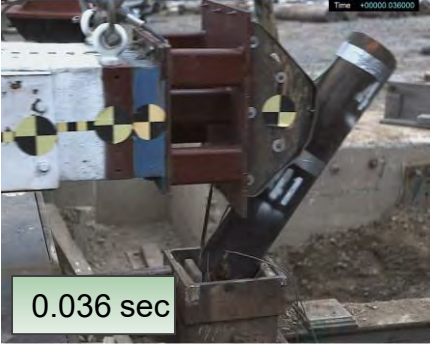
Post Number:	41
Post Type:	Round SYP
Post Length:	66 inches
Post Diameter:	7.17 inches
Moisture Content:	28.13%
Ring Density (avg.):	7.0 per inch
Resi Score $S_{MOR}$ :	0.52
Resi Score $S_U$ :	0.57

Weight:	2,372 lb
Impact Speed:	20 mph
Impact Height:	21.5 inches

Fractured Post
