# **A Guide for W-Beam Guardrail Damage Assessment**

A Field Manual for  
Highway Maintenance Personnel

National Cooperative  
Highway Research  
Program  
Project 22-28

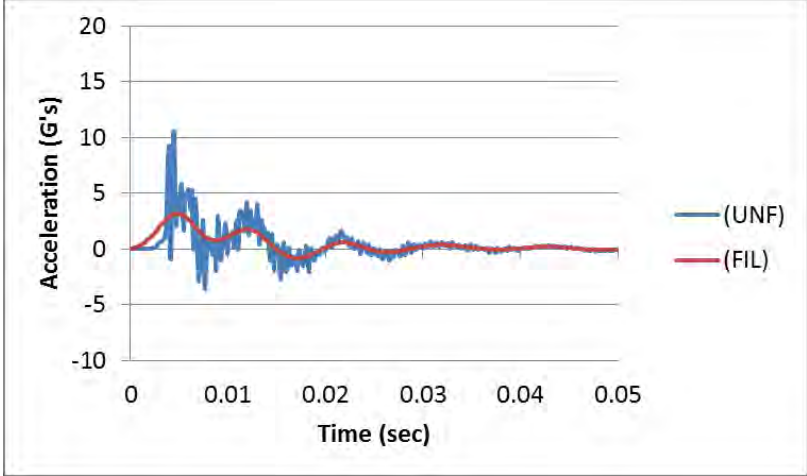
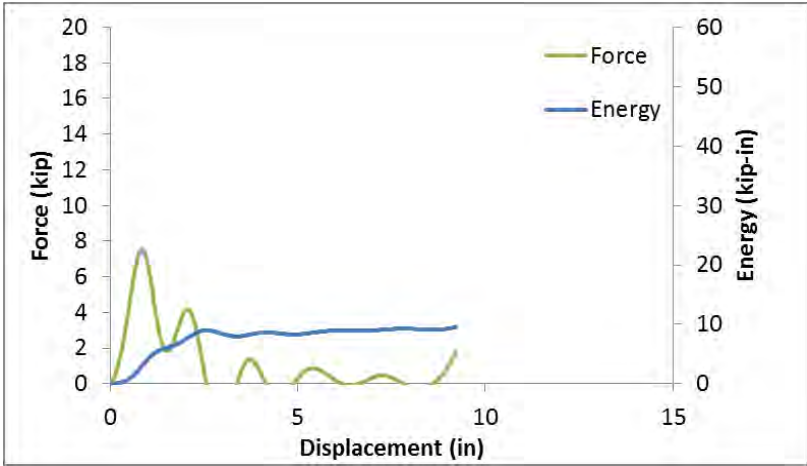
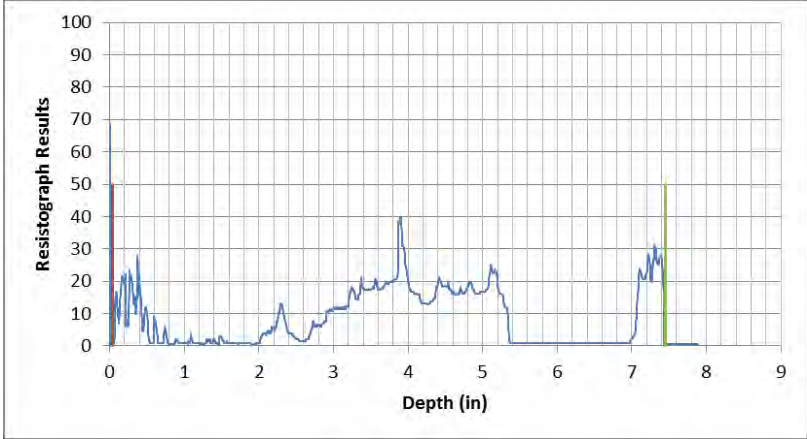
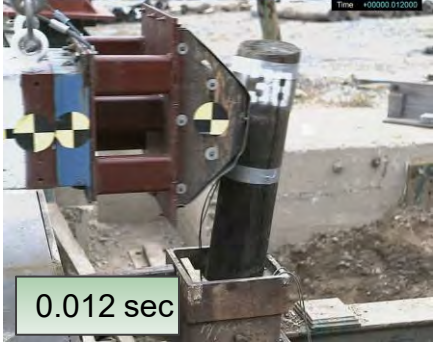
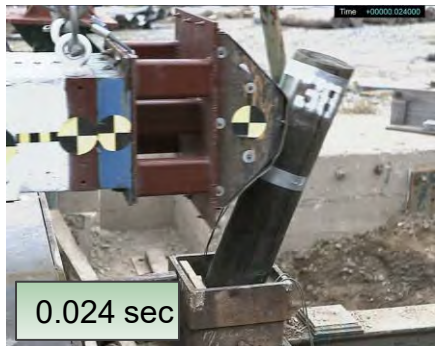
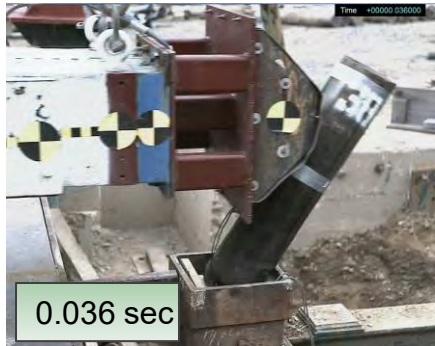
Test Number:	13009V
Test Date:	27-Sept-2013

Post Number:	38
Post Type:	Round SYP
Post Length:	66 inches
Post Diameter:	7.64 inches
Moisture Content:	< 50%
Ring Density (avg.):	5.6 per inch
Resi Score $S_{MOR}$ :	0.15
Resi Score $S_U$ :	0.16

Weight:	2,372 lb
Impact Speed:	20 mph
Impact Height:	21.5 inches

Fractured Post

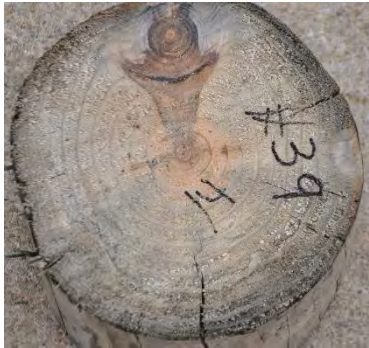
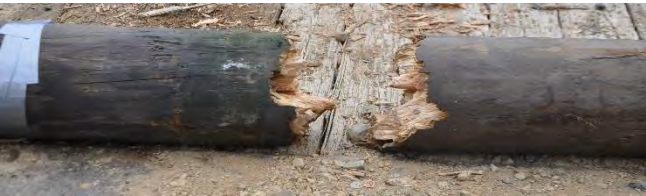
Post Number:	39
Post Type:	Round SYP
Post Length:	66 inches
Post Diameter:	7.00 inches
Moisture Content:	< 50%
Ring Density (avg.):	4.3 per inch
Resi Score $S_{MOR}$ :	0.36
Resi Score $S_U$ :	0.39

Weight:	2,372 lb
Impact Speed:	20 mph
Impact Height:	21.5 inches

Ring density at bottom of post

Fractured Post

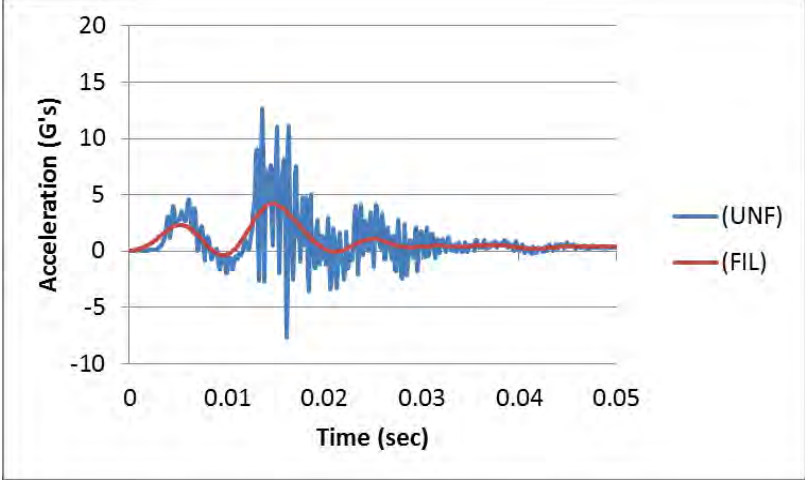
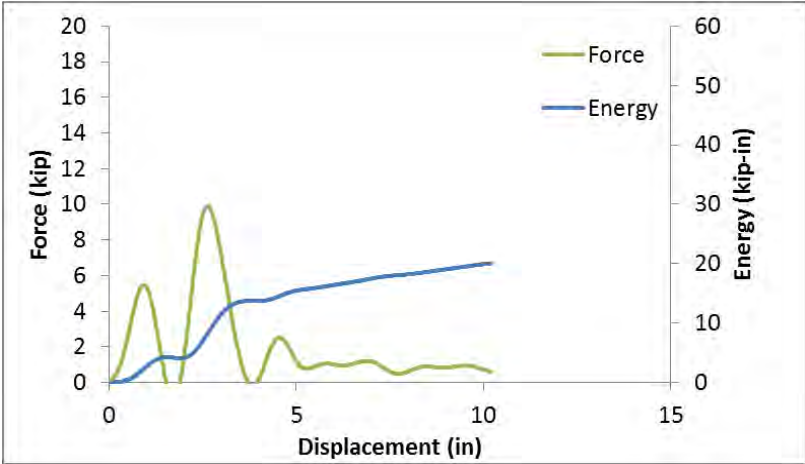
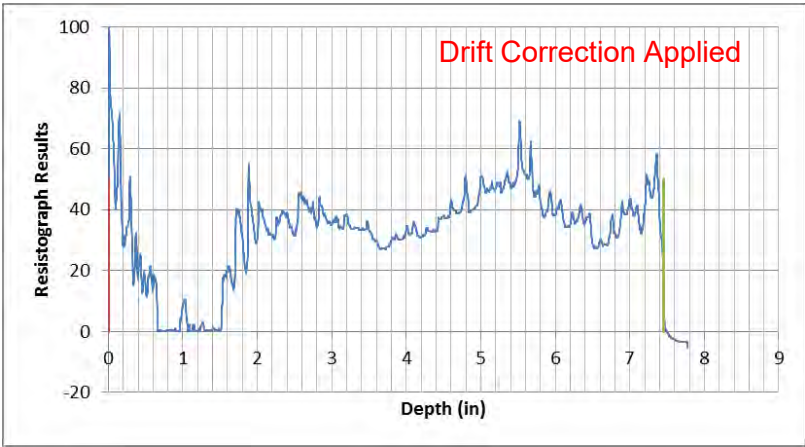
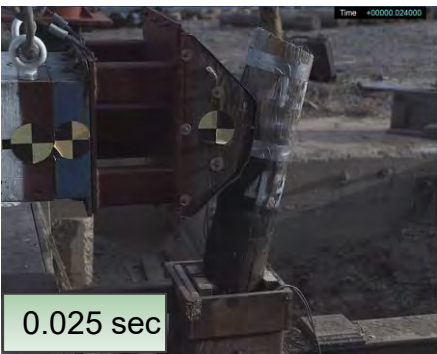
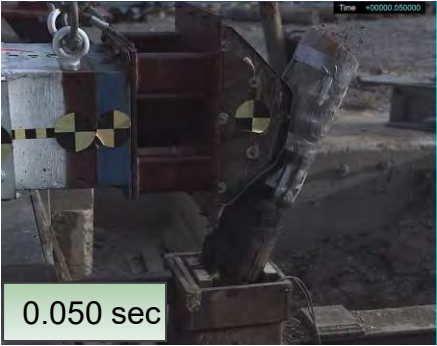
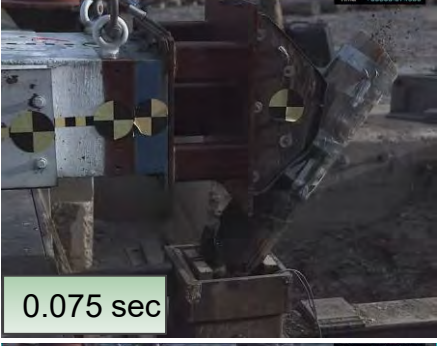
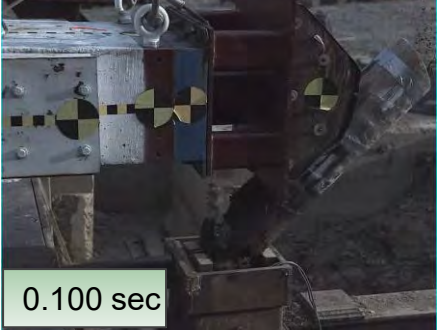
Post Number:	43
Post Type:	Round SYP
Post Length:	66 inches
Post Diameter:	7.64 inches
Moisture Content:	>50%
Ring Density (avg.):	7.0 per inch
Resi Score $S_{MOR}$ :	0.60
Resi Score $S_U$ :	0.63

**Pendulum Properties**

Weight:	2,372 lb
Impact Speed:	10 mph
Impact Height:	21.5 inches

Fractured Post

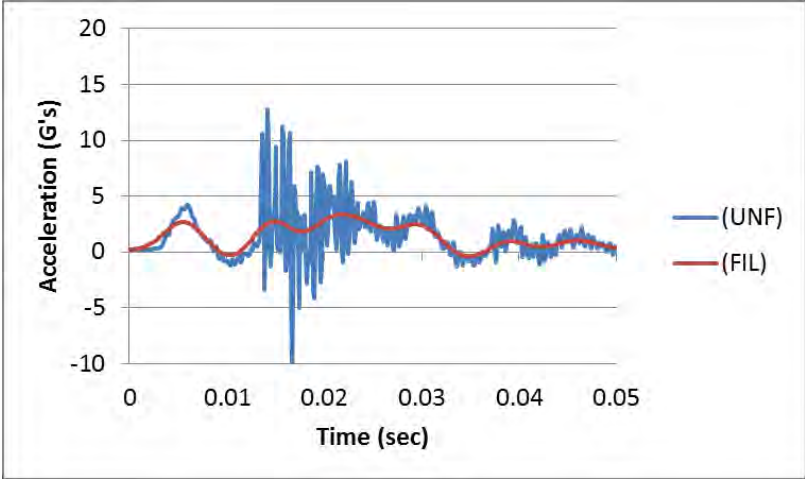
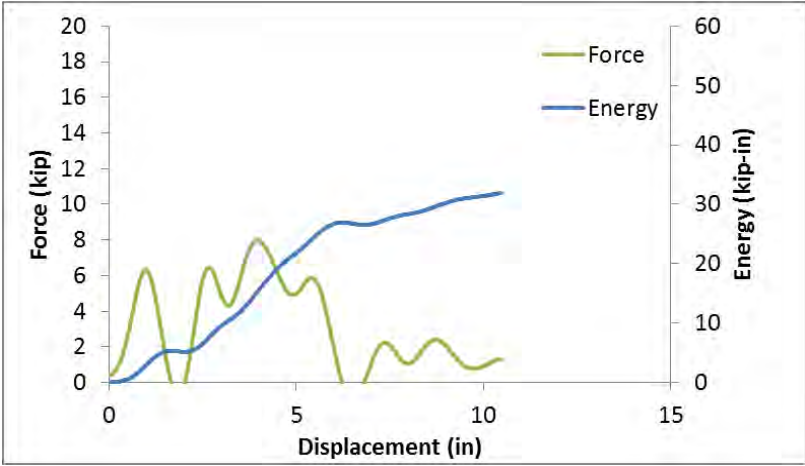
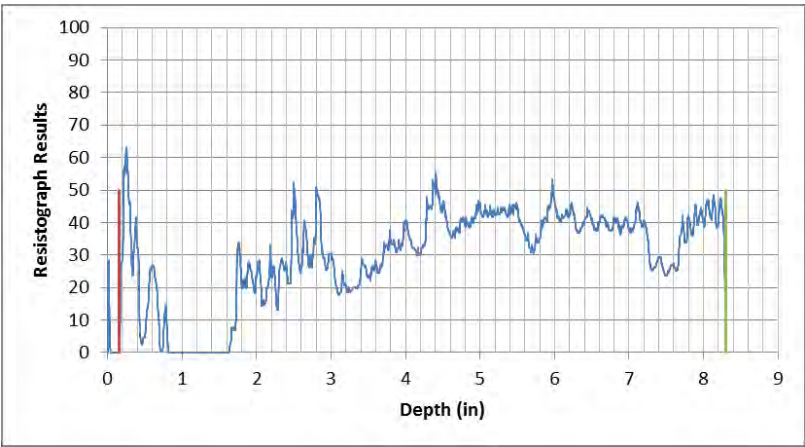
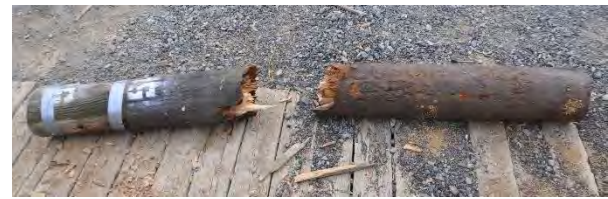
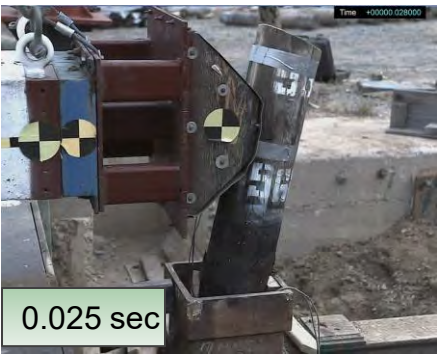
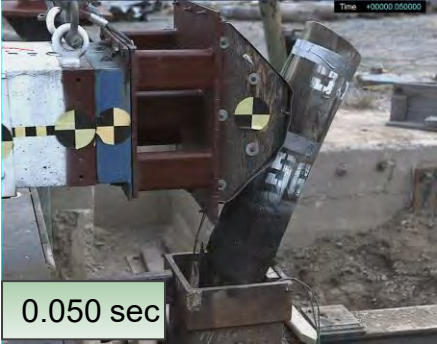
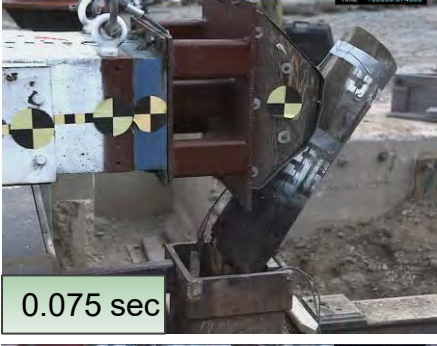
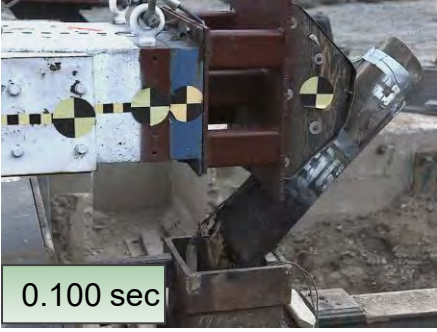
Test Number:	13009Z
Test Date:	01-Oct-2013

Post Number:	56
Post Type:	Round SYP
Post Length:	66 inches
Post Diameter:	8.12 inches
Moisture Content:	45.1%
Ring Density (avg.):	7.3 per inch
Resi Score $S_{MOR}$ :	0.67
Resi Score $S_U$ :	0.64

**Pendulum Properties**

Weight:	2,372 lb
Impact Speed:	10 mph
Impact Height:	21.5 inches

Fractured Post

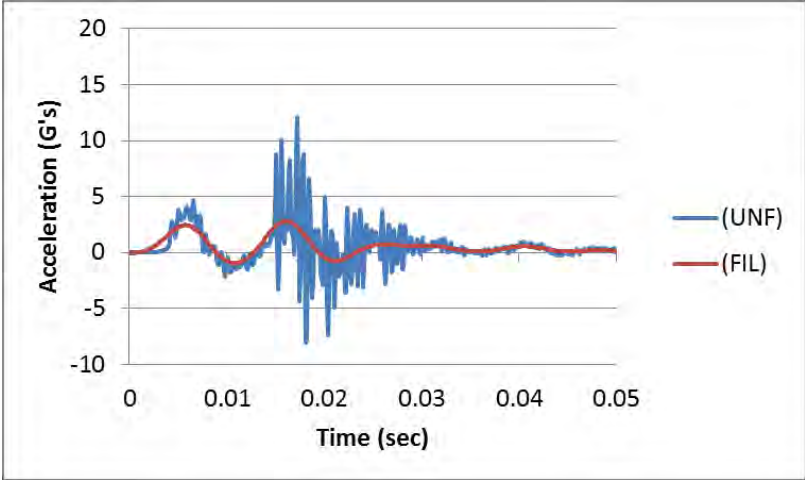
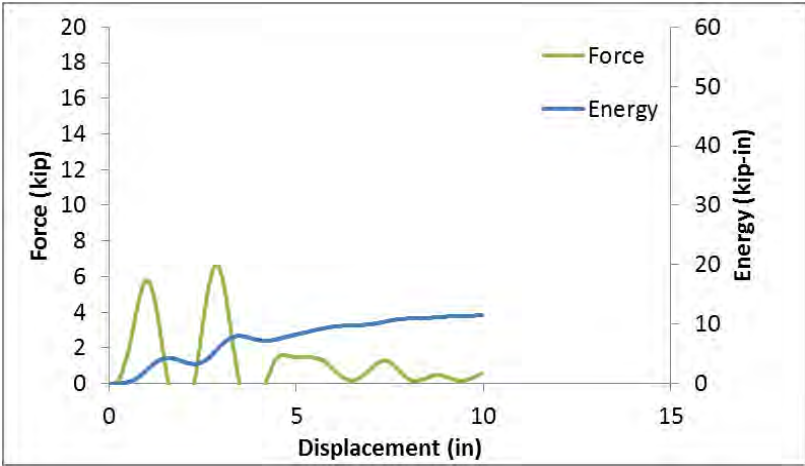
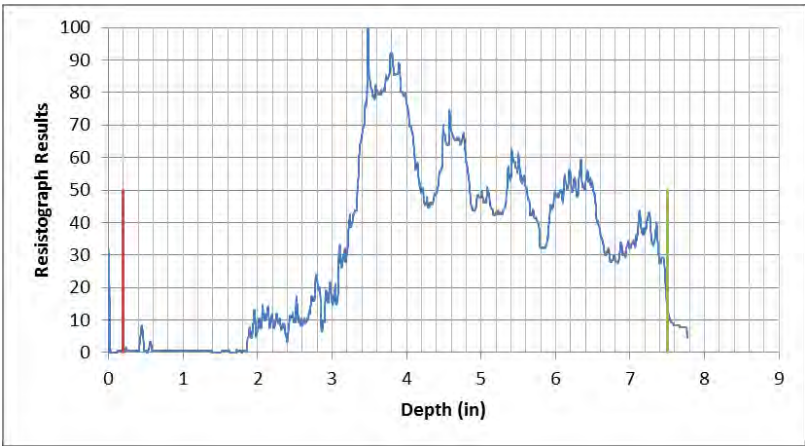
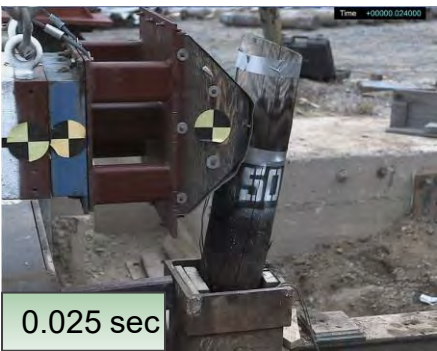
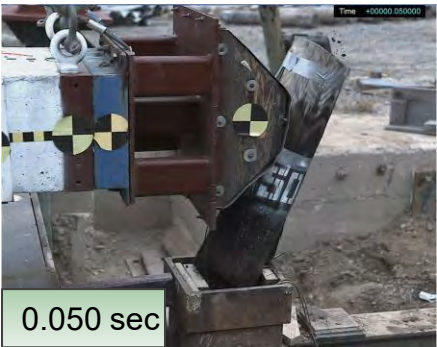
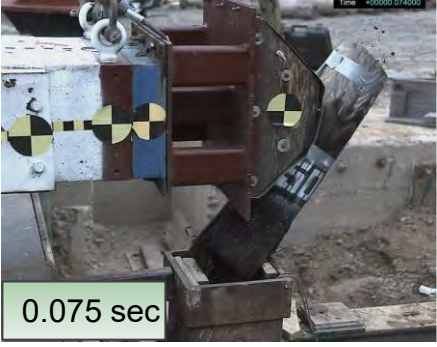
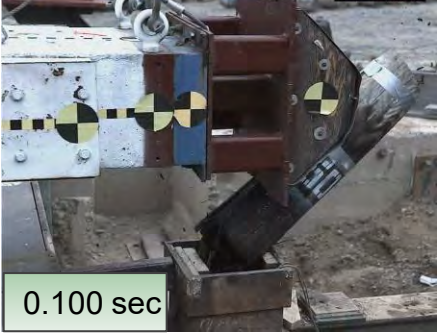
Test Number:	13009A1
Test Date:	01-Oct-2013

Post Number:	50
Post Type:	Round SYP
Post Length:	66 inches
Post Diameter:	7.4 inches
Moisture Content:	>50%
Ring Density (avg.):	12.8 per inch
Resi Score $S_{MOR}$ :	0.36
Resi Score $S_U$ :	0.37

**Pendulum Properties**

Weight:	2,372 lb
Impact Speed:	10 mph
Impact Height:	21.5 inches

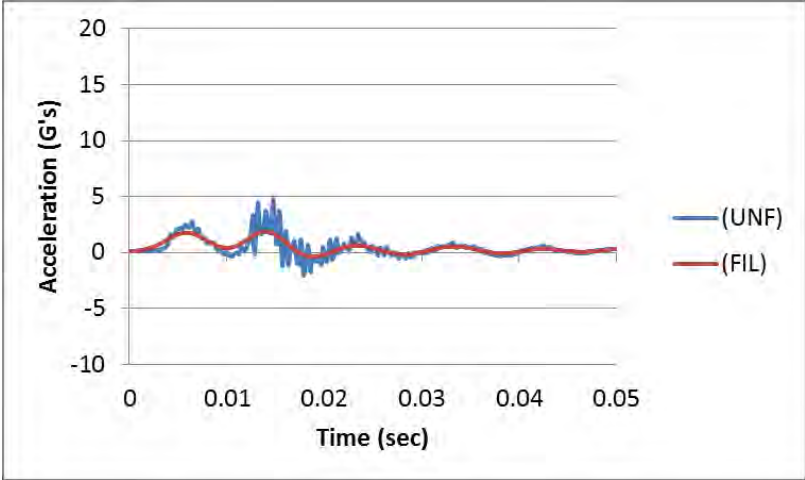
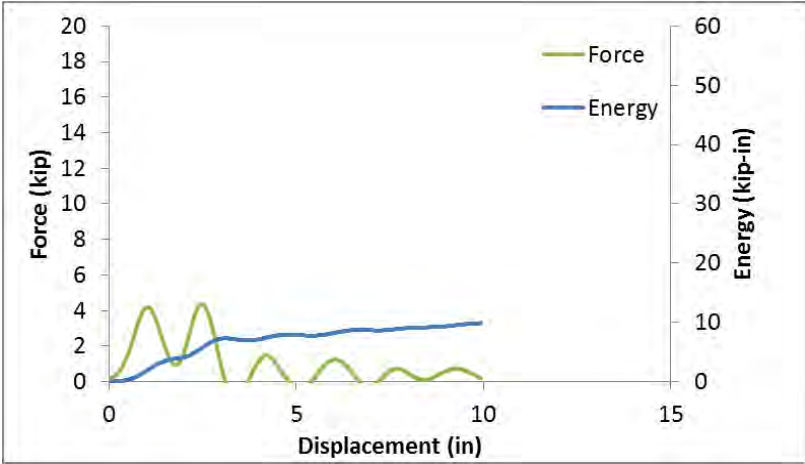
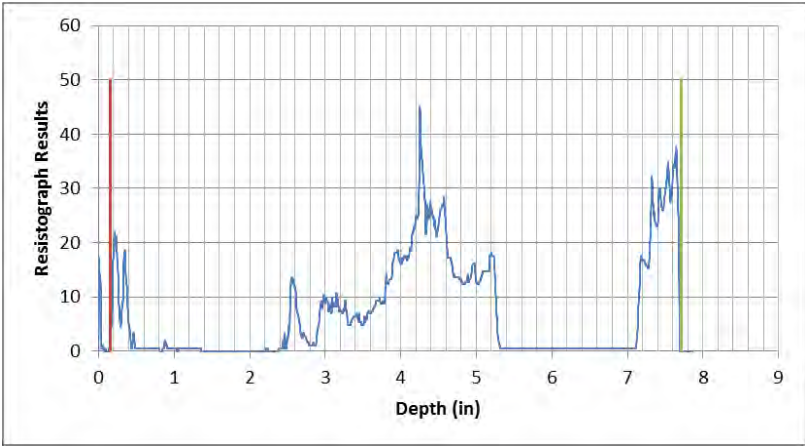
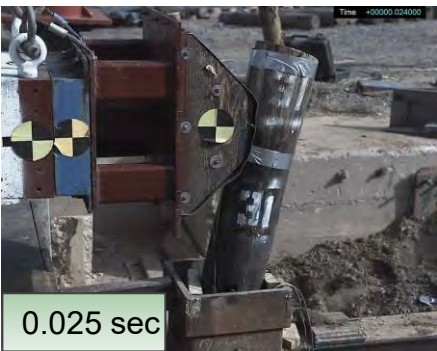
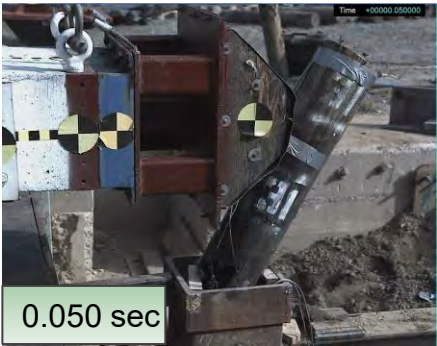
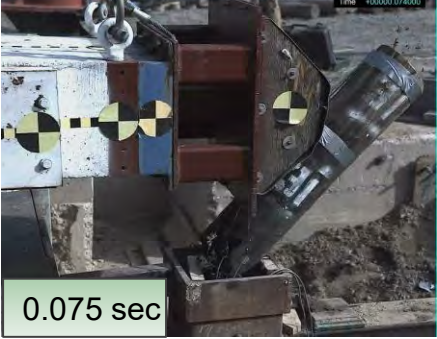
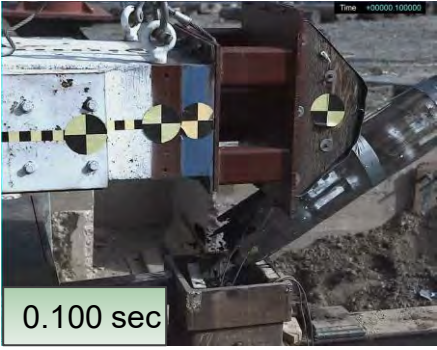
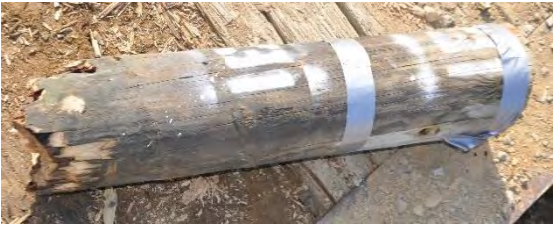
Test Number:	13009B1
Test Date:	01-Oct-2013

Post Number:	31
Post Type:	Round SYP
Post Length:	66 inches
Post Diameter:	7.64 inches
Moisture Content:	>50%
Ring Density (avg.):	7.7 per inch
Resi Score $S_{MOR}$ :	0.16
Resi Score $S_U$ :	0.16

**Pendulum Properties**

Weight:	2,372 lb
Impact Speed:	10 mph
Impact Height:	21.5 inches

Fractured Post

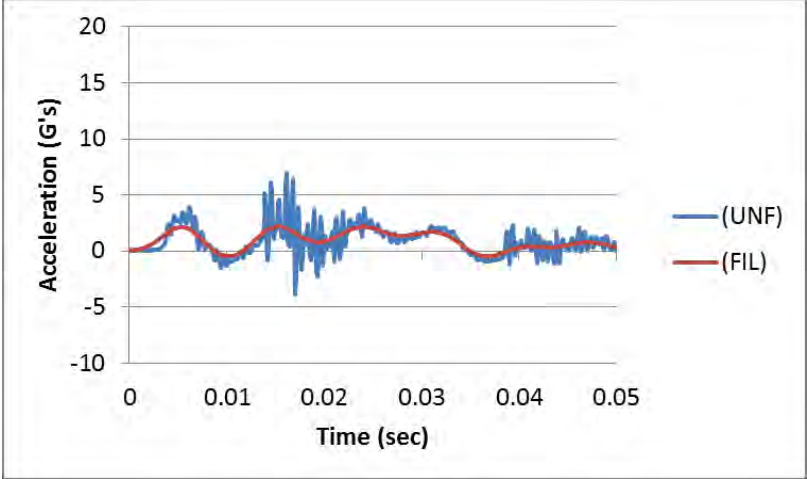
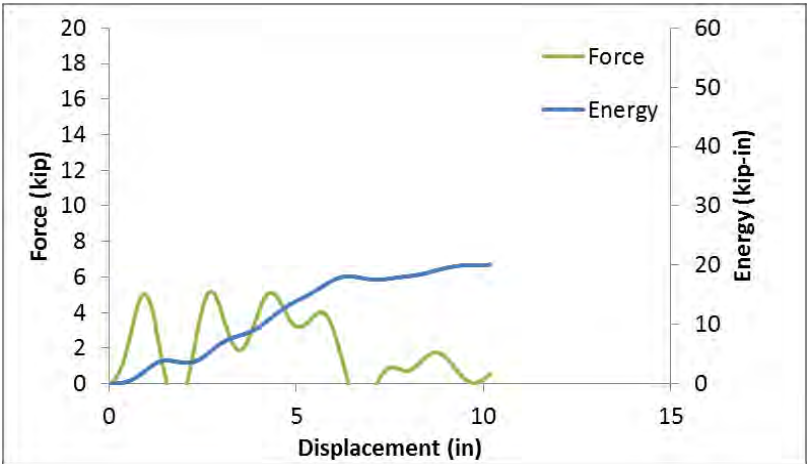
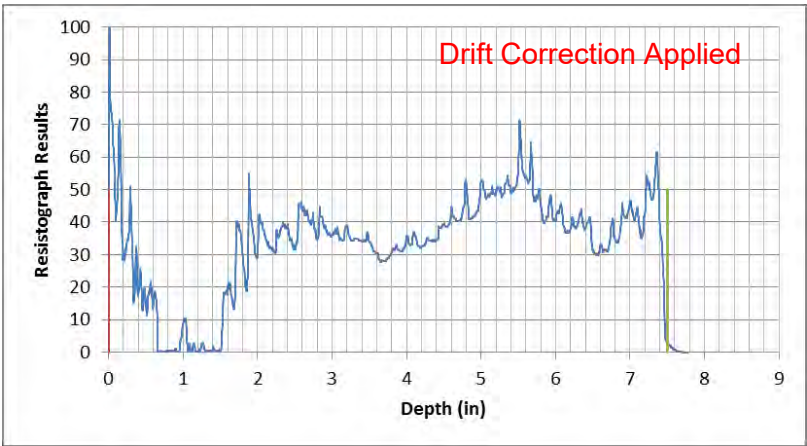
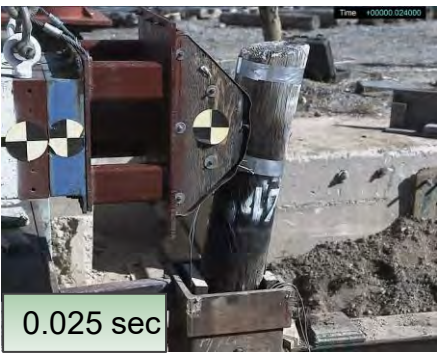
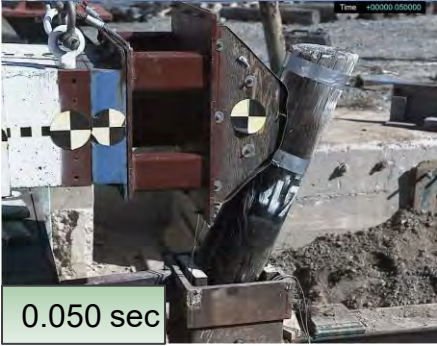
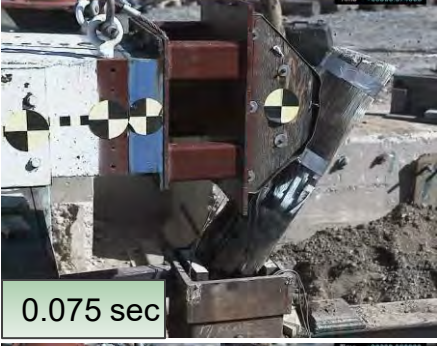
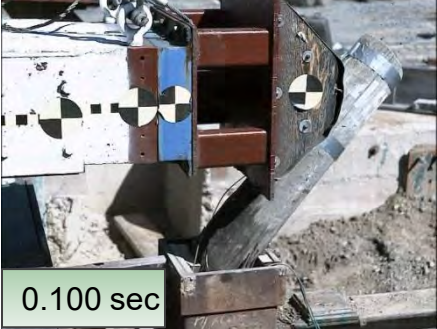
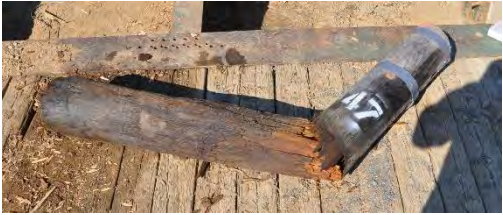
Post Number:	47
Post Type:	Round SYP
Post Length:	66 inches
Post Diameter:	7.96 inches
Moisture Content:	N/A
Ring Density (avg.):	6.6 per inch
Resi Score $S_{MOR}$ :	0.63
Resi Score $S_U$ :	0.64

Weight:	2,372 lb
Impact Speed:	10 mph
Impact Height:	21.5 inches

Fractured Post

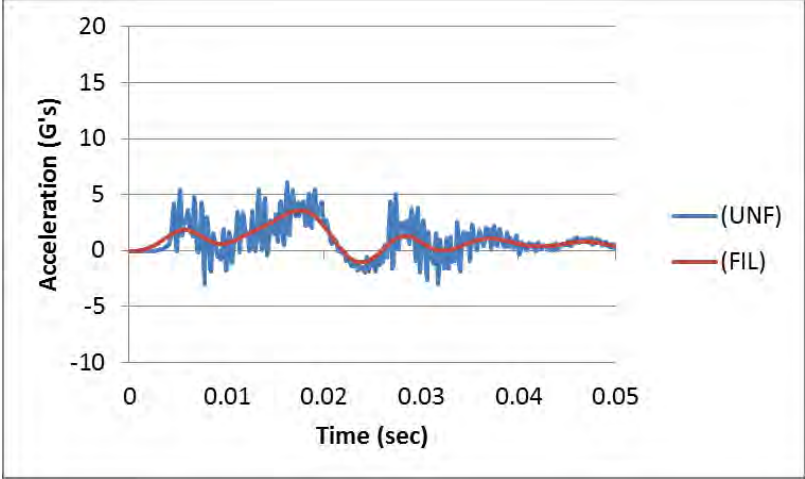
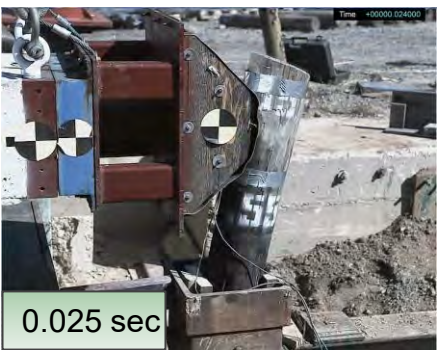
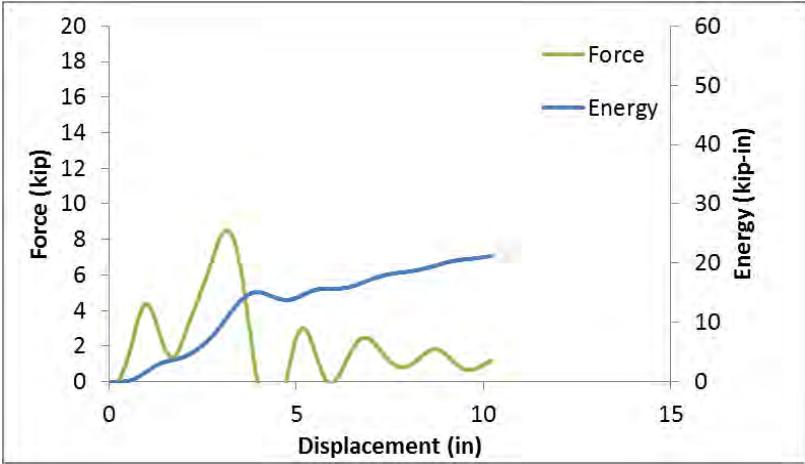
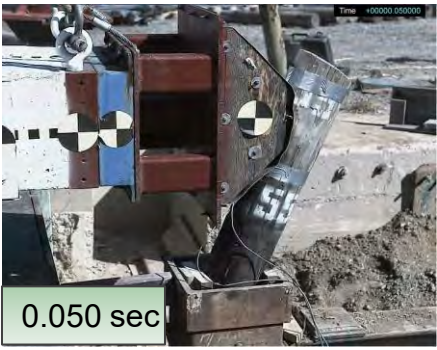
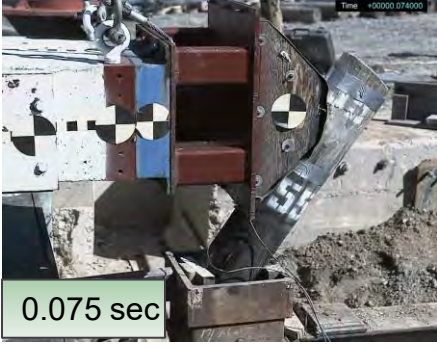
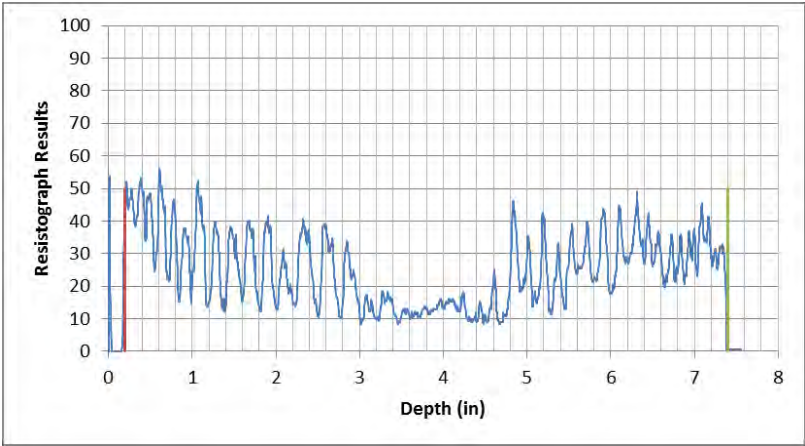
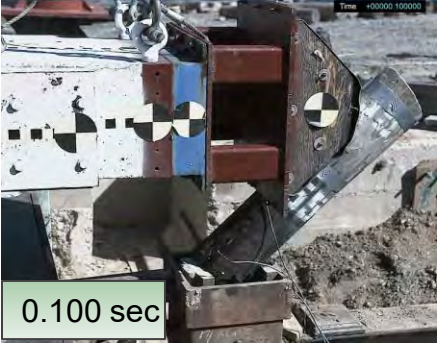
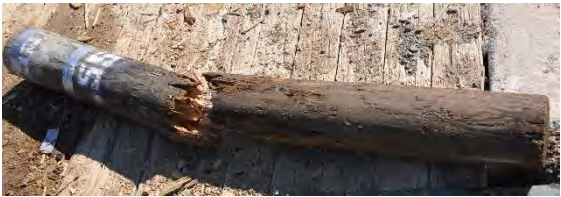
Post Number:	55
Post Type:	Round SYP
Post Length:	66 inches
Post Diameter:	7.32 inches
Moisture Content:	37.7%
Ring Density (avg.):	7.3 per inch
Resi Score $S_{MOR}$ :	0.57
Resi Score $S_U$ :	0.60

Weight:	2,372 lb
Impact Speed:	10 mph
Impact Height:	21.5 inches

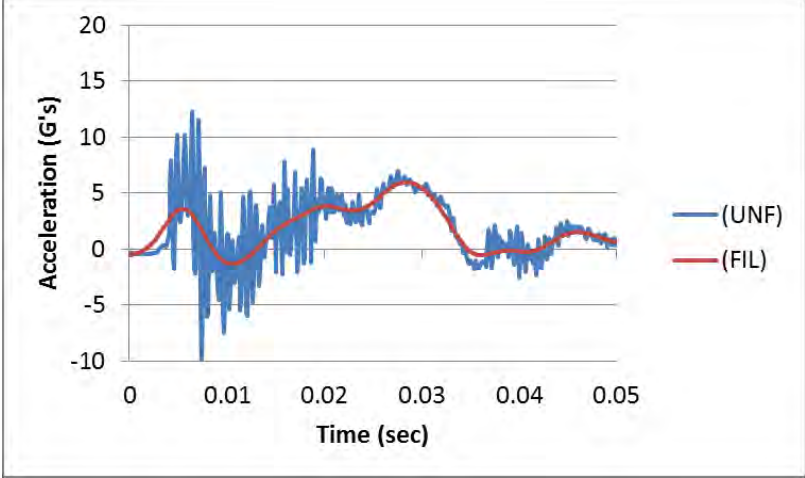
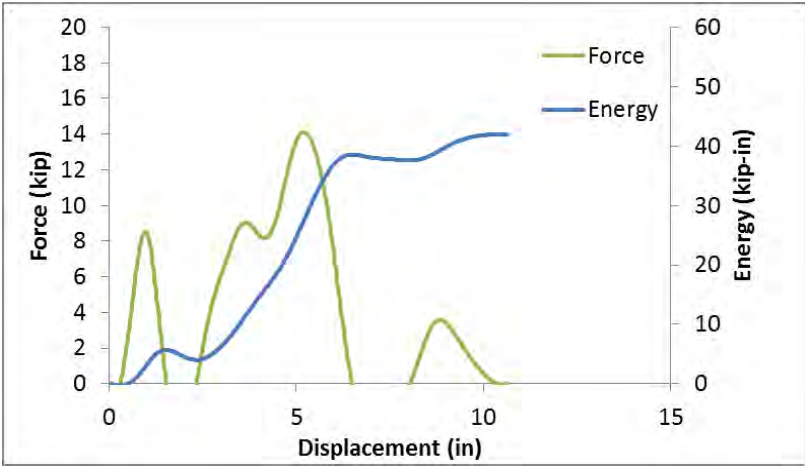
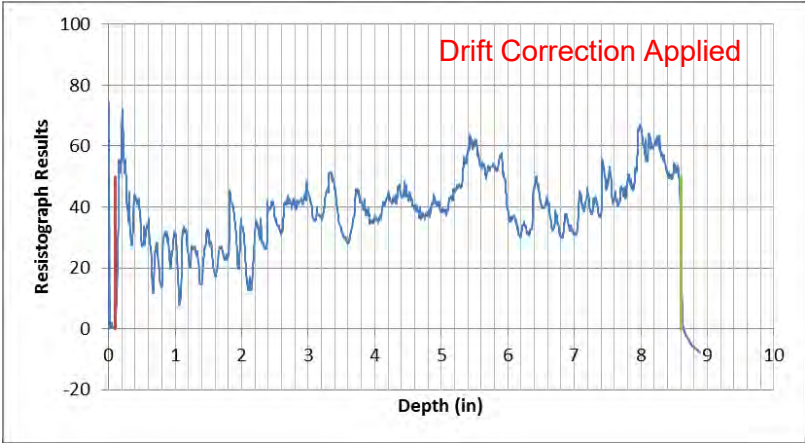
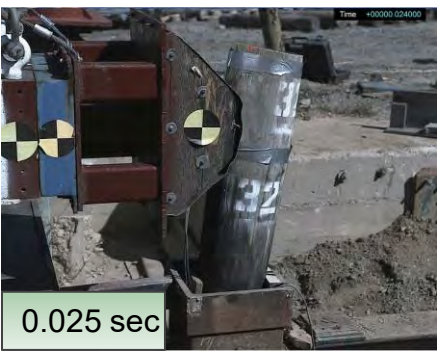
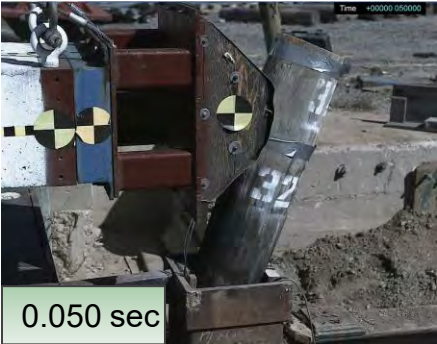
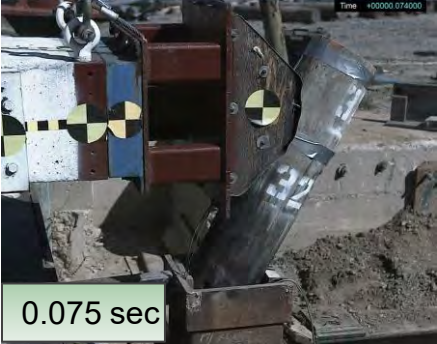
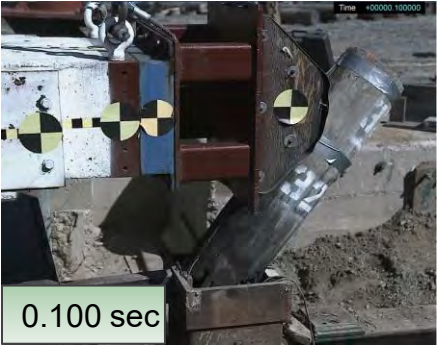
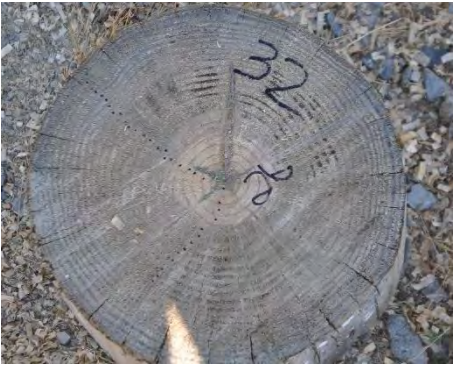
Test Number:	13009E1
Test Date:	01-Oct-2013

Post Number:	32
Post Type:	Round SYP
Post Length:	60 inches
Post Diameter:	8.76 inches
Moisture Content:	>50%
Ring Density (avg.):	6.1 per inch
Resi Score $S_{MOR}$ :	1.15
Resi Score $S_U$ :	1.04

Weight:	2,372 lb
Impact Speed:	10 mph
Impact Height:	21.5 inches

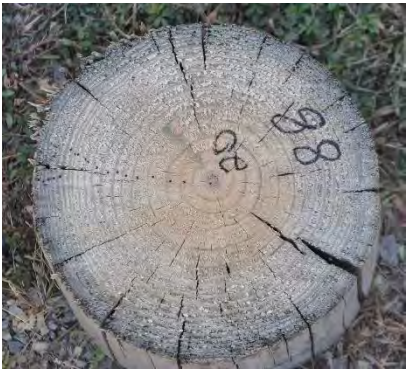
Ring density at bottom of post

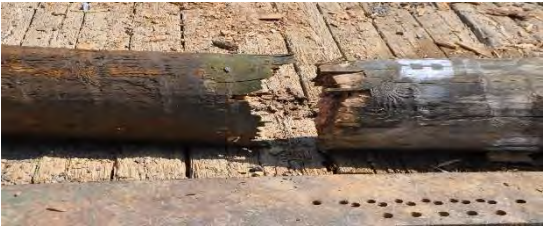
Fractured Post

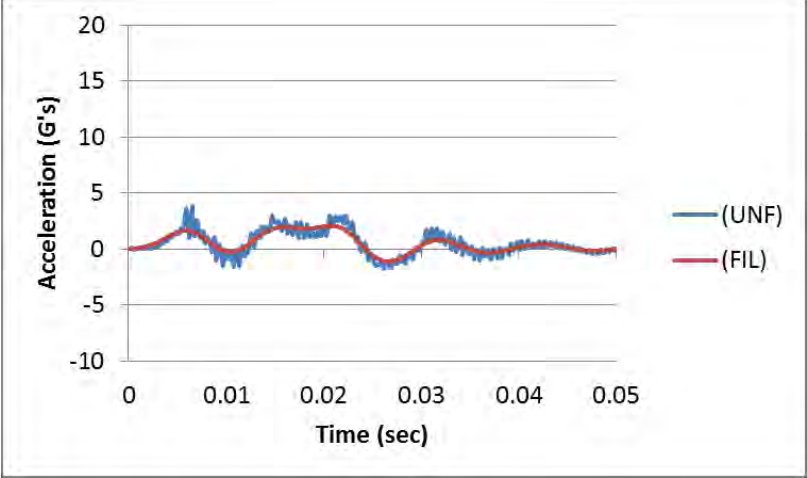
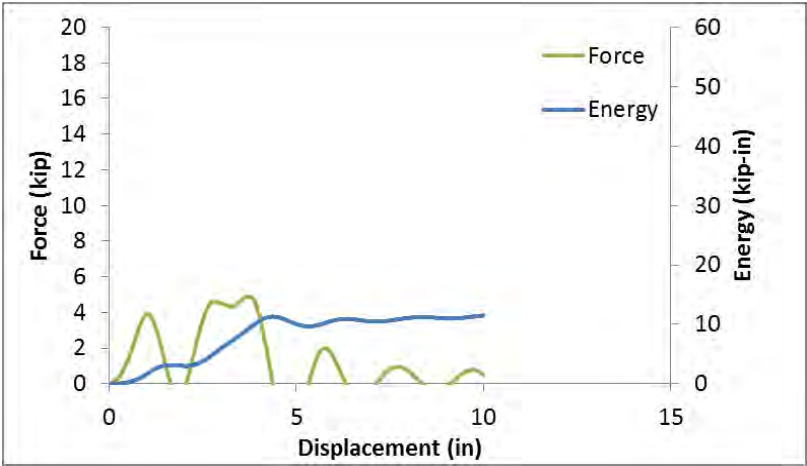
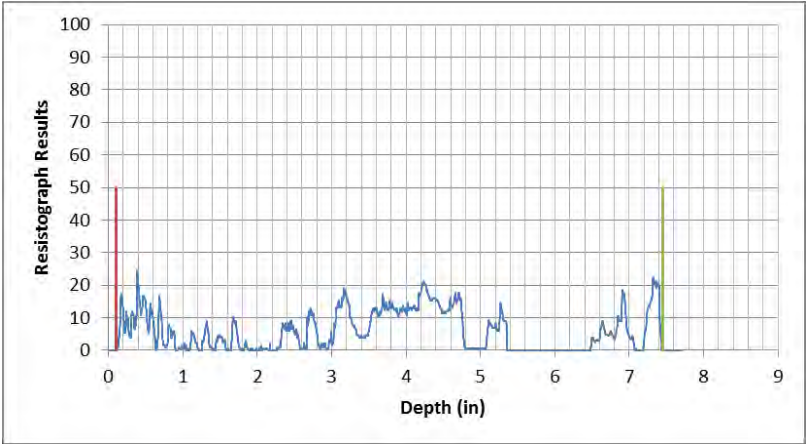
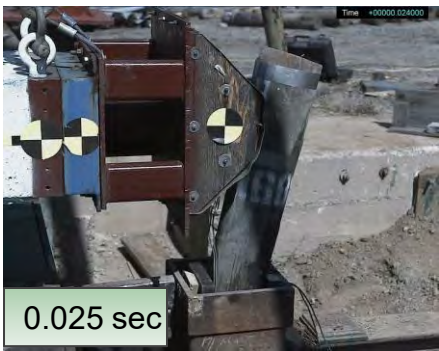
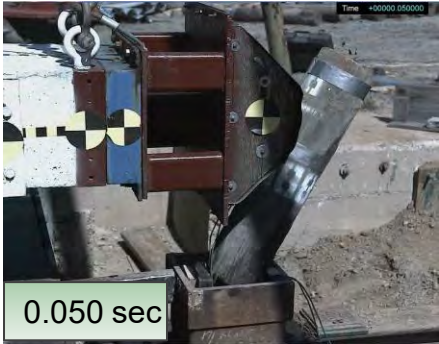
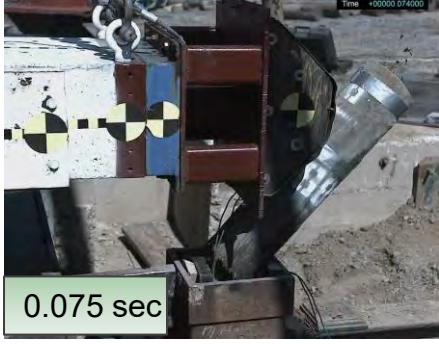
Test Number:	13009F1
Test Date:	01-Oct-2013

Post Number:	88
Post Type:	Round SYP
Post Length:	60 inches
Post Diameter:	7.56 inches
Moisture Content:	>50%
Ring Density (avg.):	5.3 per inch
Resi Score $S_{MOR}$ :	0.11
Resi Score $S_U$ :	0.12

Weight:	2,372 lb
Impact Speed:	10 mph
Impact Height:	21.5 inches

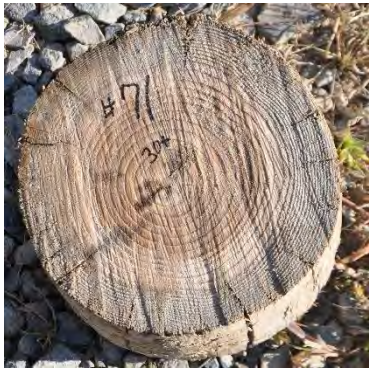
Ring density at bottom of post

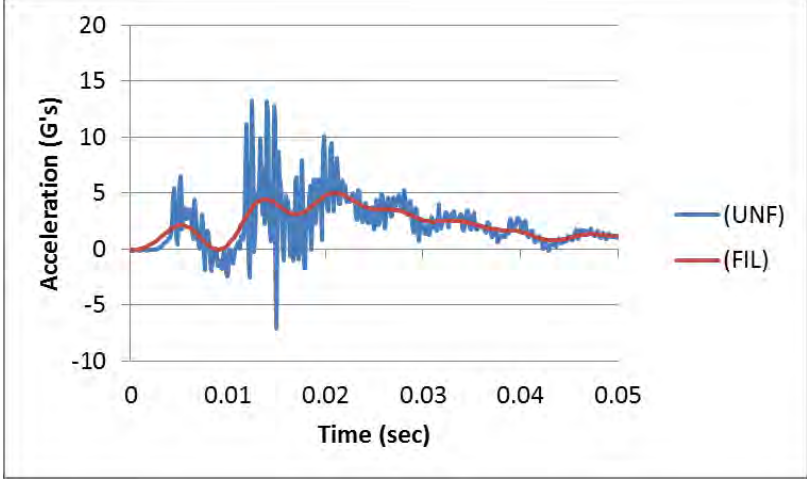
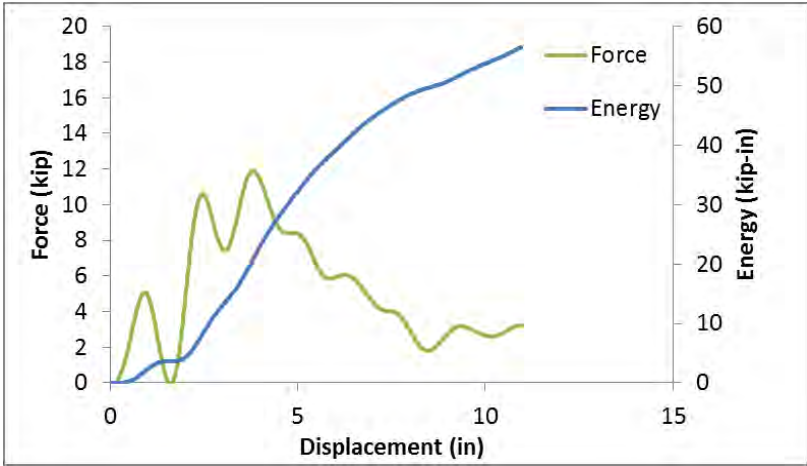
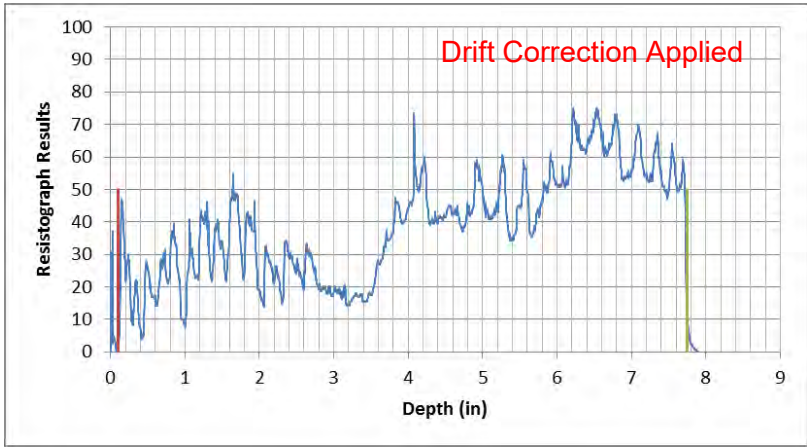
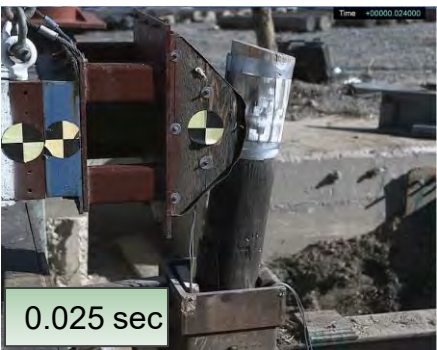
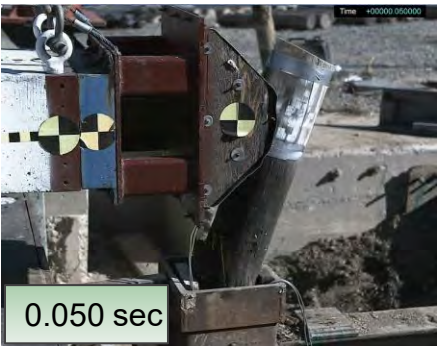
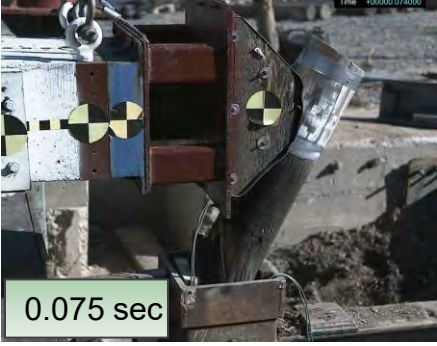
**Test Information**

Test Number:	13009H1
Test Date:	02-Oct-2013

Post Number:	30
Post Type:	Round SYP
Post Length:	60 inches
Post Diameter:	7.96 inches
Moisture Content:	43.6%
Ring Density (avg.):	7.0 per inch
Resi Score $S_{MOR}$ :	0.84
Resi Score $S_U$ :	0.85

Weight:	2,372 lb
Impact Speed:	10 mph
Impact Height:	21.5 inches

Fractured Post

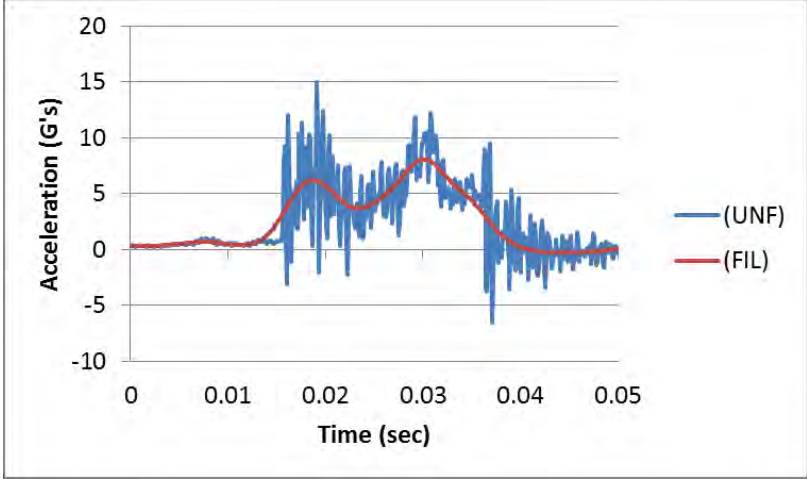
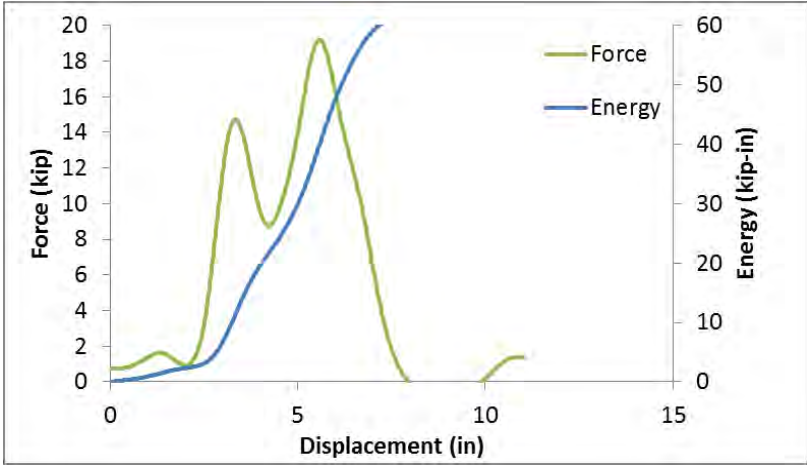
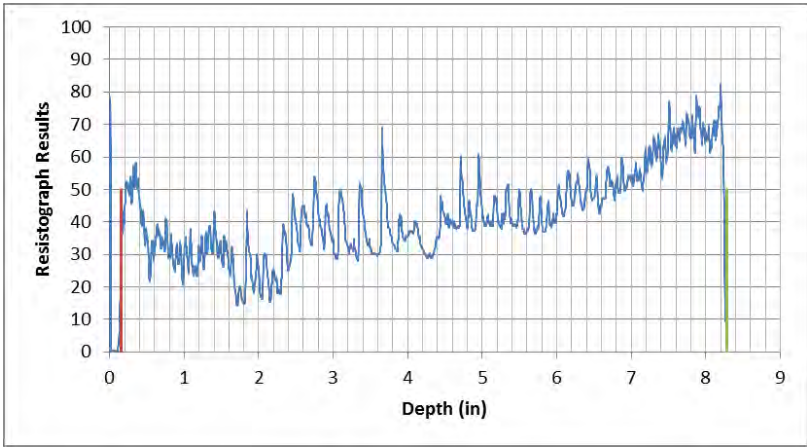
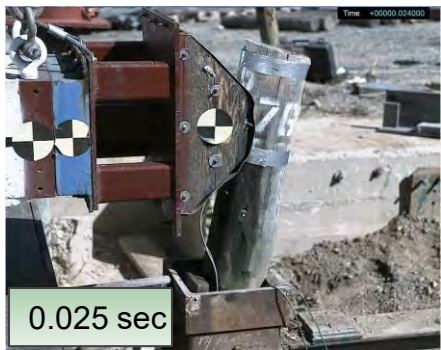
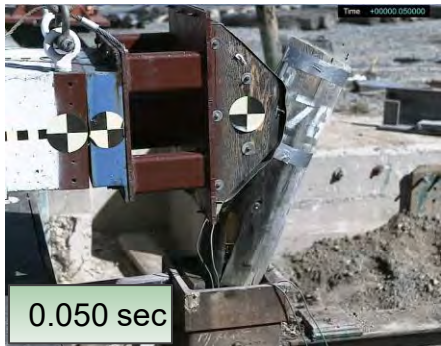
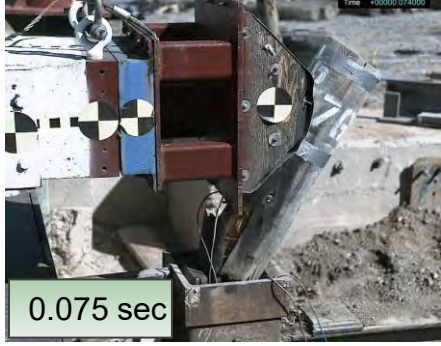
Test Number:	13009I1
Test Date:	02-Oct-2013

Post Number:	76
Post Type:	Round SYP
Post Length:	60 inches
Post Diameter:	8.36 inches
Moisture Content:	47.6%
Ring Density (avg.):	7.2 per inch
Resi Score $S_{MOR}$ :	1.19
Resi Score $S_U$ :	1.13

Weight:	2,372 lb
Impact Speed:	10 mph
Impact Height:	21.5 inches

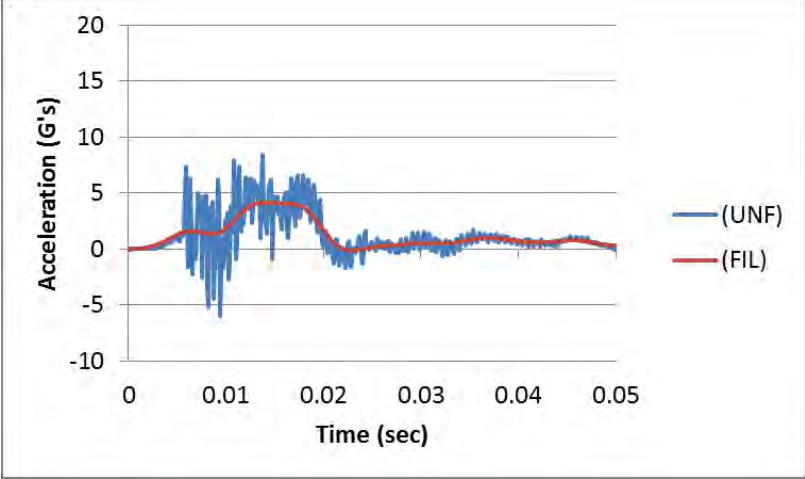
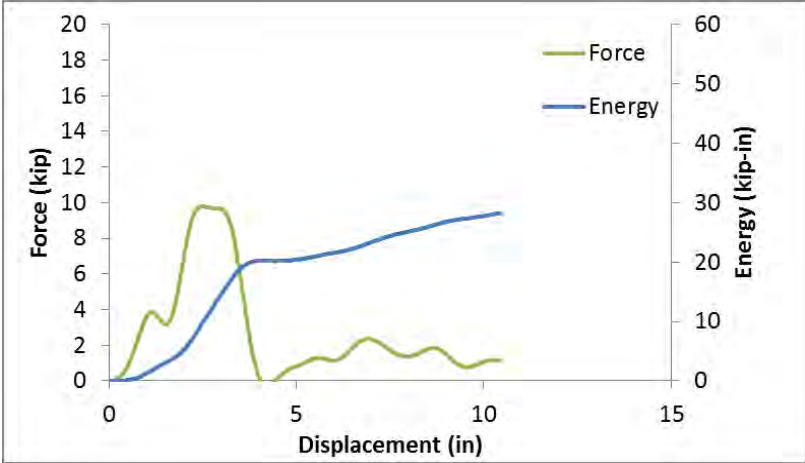
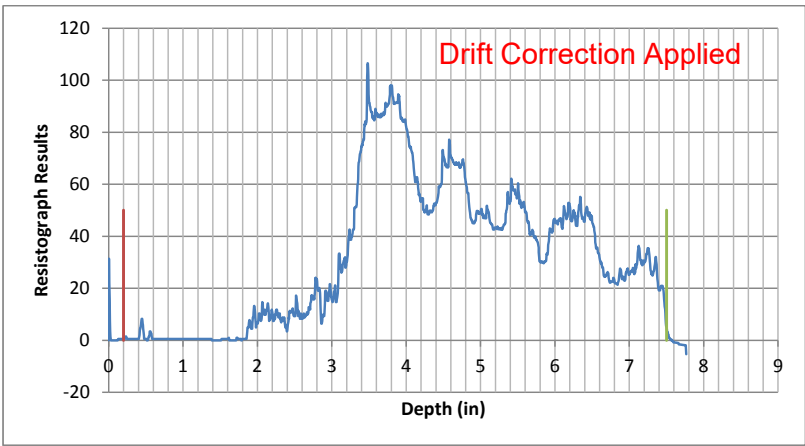
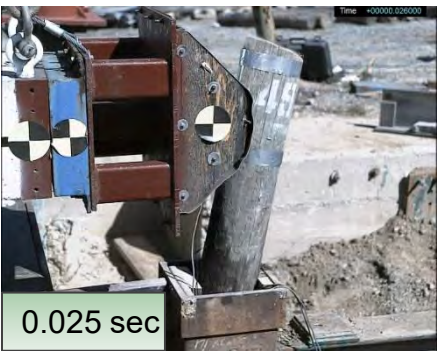
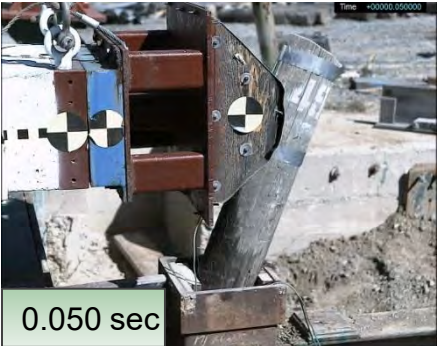
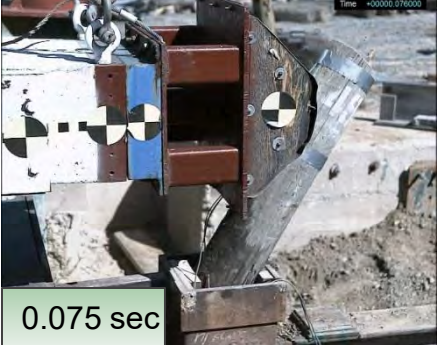
Test Number:	13009J1
Test Date:	02-Oct-2013

Post Number:	49
Post Type:	Round SYP
Post Length:	66 inches
Post Diameter:	7.48 inches
Moisture Content:	36.6%
Ring Density (avg.):	7.8 per inch
Resi Score $S_{MOR}$ :	0.30
Resi Score $S_U$ :	0.32

Weight:	2,372 lb
Impact Speed:	10 mph
Impact Height:	21.5 inches

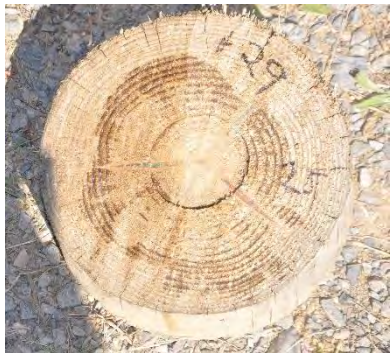
Ring density at bottom of post
