# **A Guide for W-Beam Guardrail Damage Assessment**

A Field Manual for  
Highway Maintenance Personnel

National Cooperative  
Highway Research  
Program  
Project 22-28

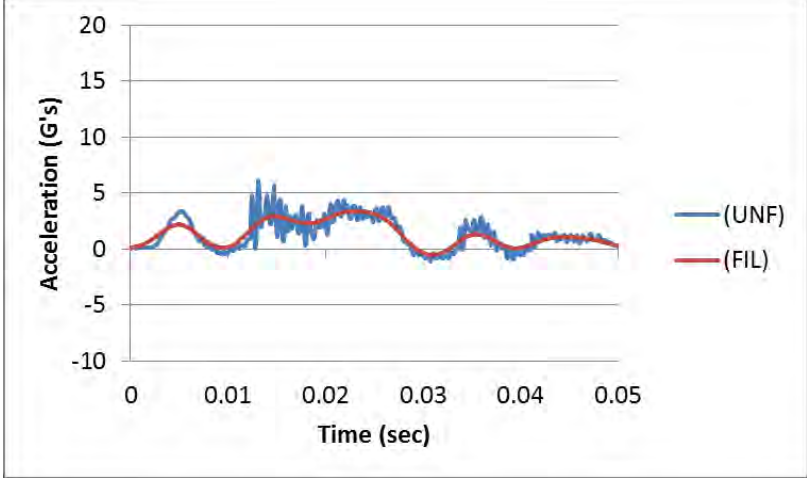
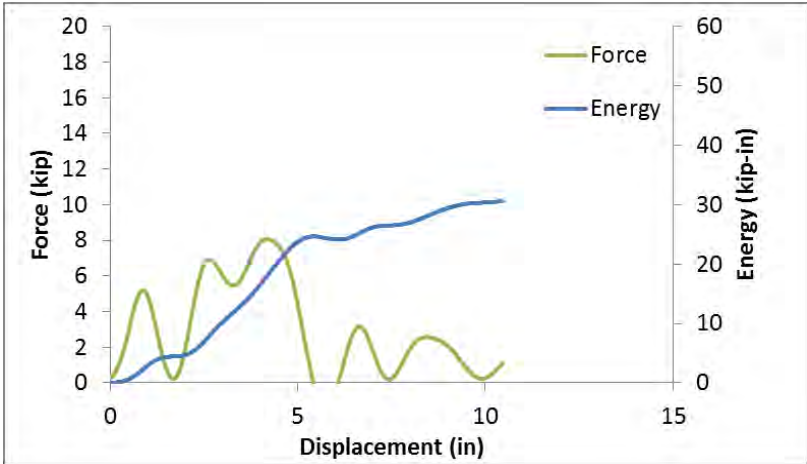
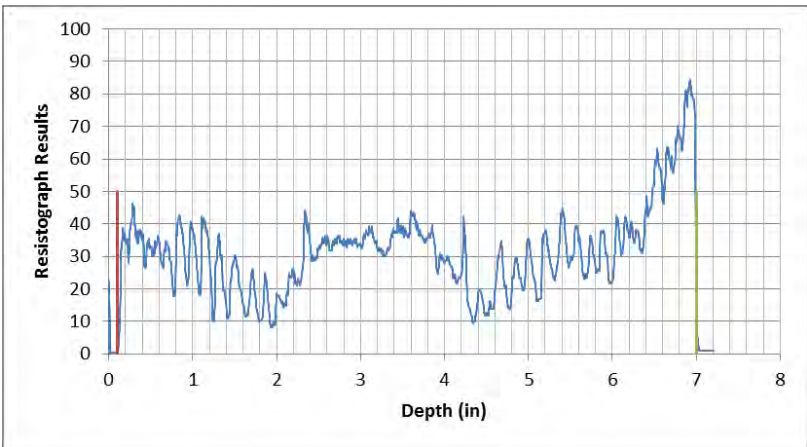
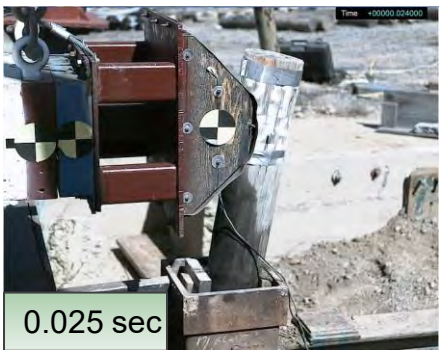
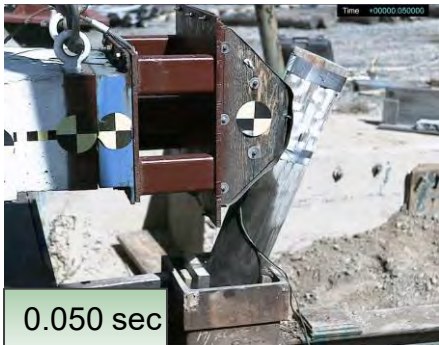
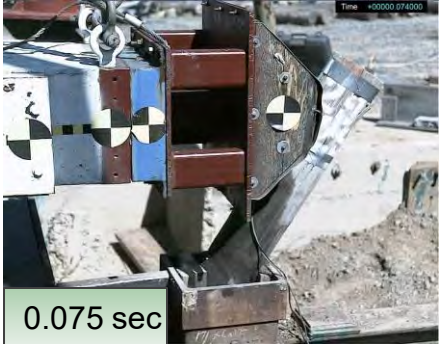
Test Number:	13009K1
Test Date:	02-Oct-2013

Post Number:	29
Post Type:	Round SYP
Post Length:	66 inches
Post Diameter:	7.01 inches
Moisture Content:	50%
Ring Density (avg.):	7.1 per inch
Resi Score $S_{MOR}$ :	0.60
Resi Score $S_U$ :	0.67

Weight:	2,372 lb
Impact Speed:	10 mph
Impact Height:	21.5 inches

Fractured Post

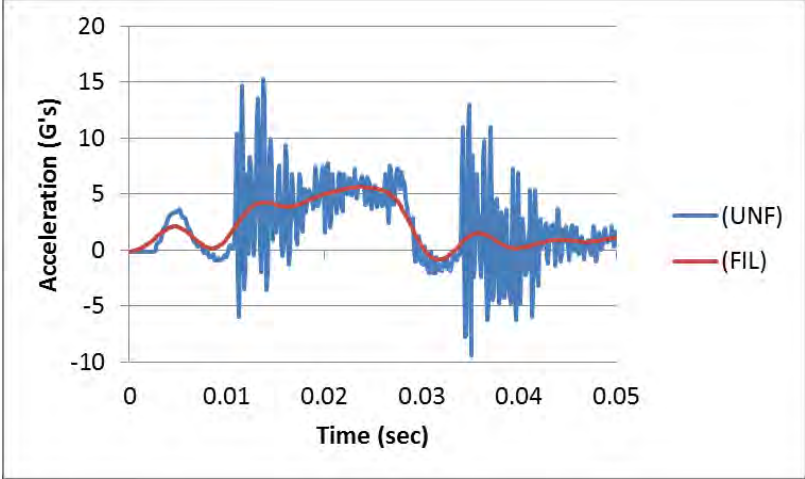
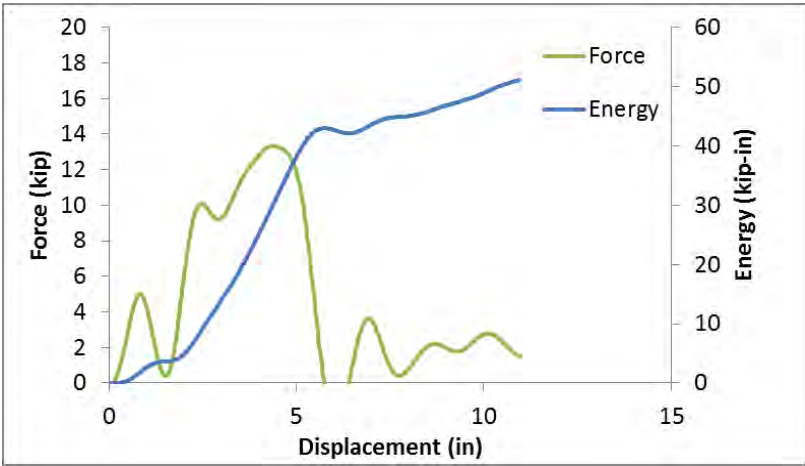
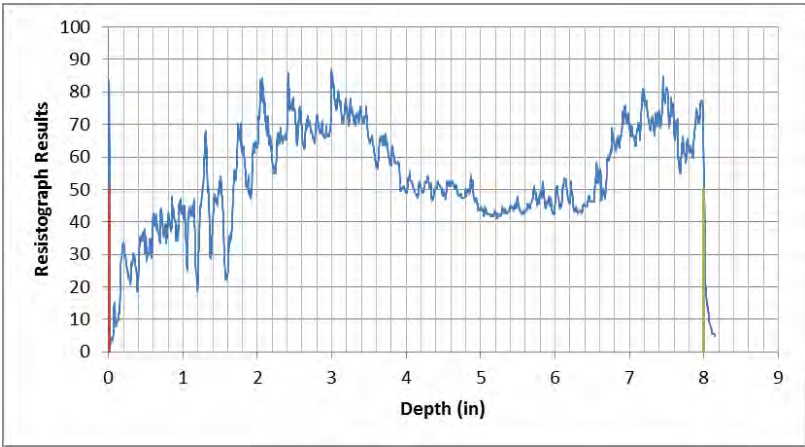
Test Number:	13009L1
Test Date:	02-Oct-2013

Post Number:	92
Post Type:	Round SYP
Post Length:	66 inches
Post Diameter:	8.04 inches
Moisture Content:	44.5%
Ring Density (avg.):	8.0 per inch
Resi Score $S_{MOR}$ :	1.18
Resi Score $S_U$ :	1.14

Weight:	2,372 lb
Impact Speed:	10 mph
Impact Height:	21.5 inches

Fractured Post

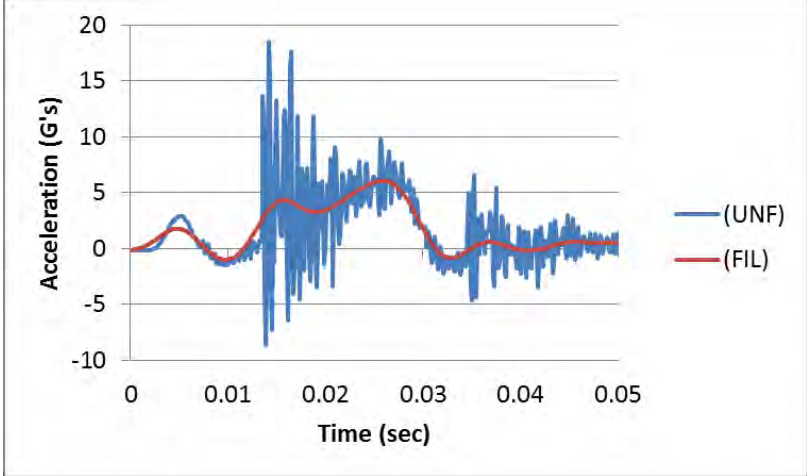
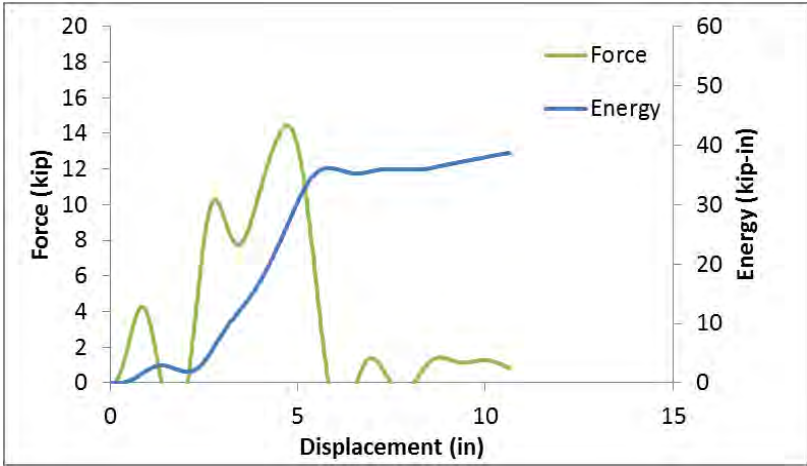
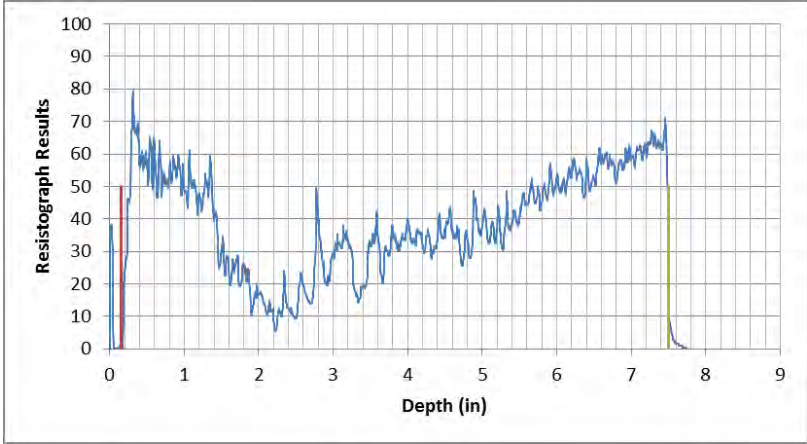
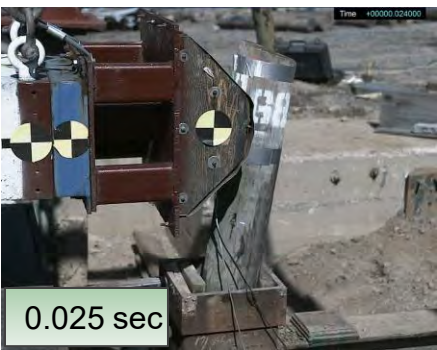
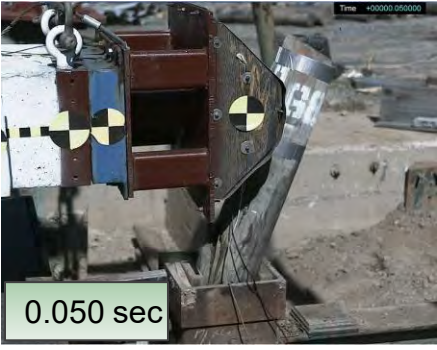
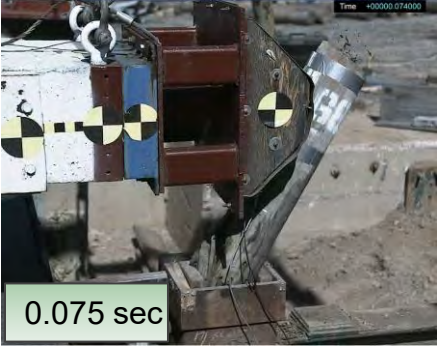
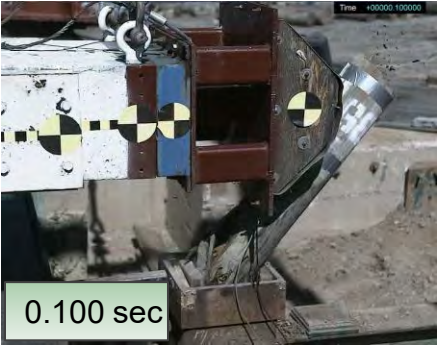
Test Number:	13009M1
Test Date:	02-Oct-2013

Post Number:	68
Post Type:	Round SYP
Post Length:	66 inches
Post Diameter:	7.4 inches
Moisture Content:	47.2%
Ring Density (avg.):	9.5 per inch
Resi Score $S_{MOR}$ :	0.95
Resi Score $S_U$ :	0.99

Weight:	2,372 lb
Impact Speed:	10 mph
Impact Height:	21.5 inches

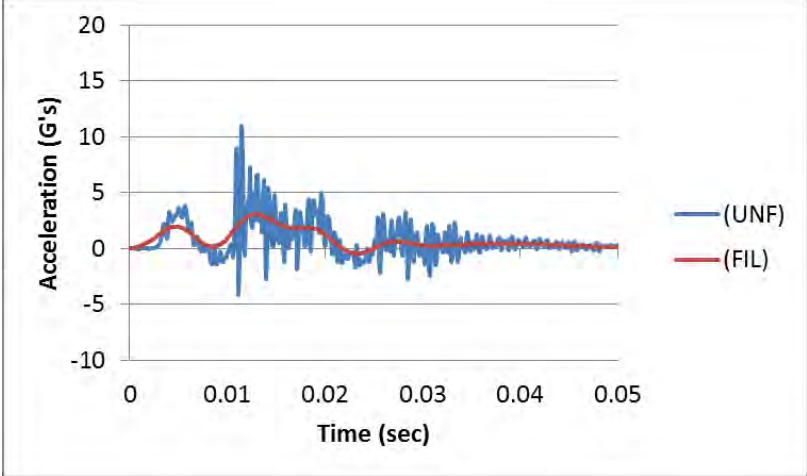
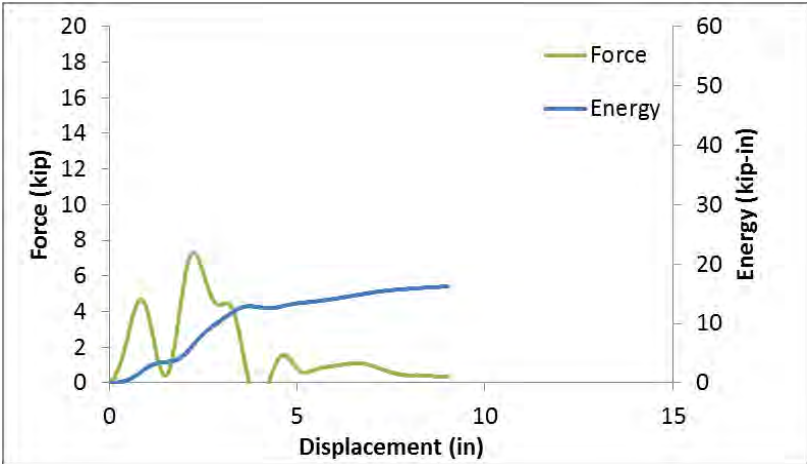
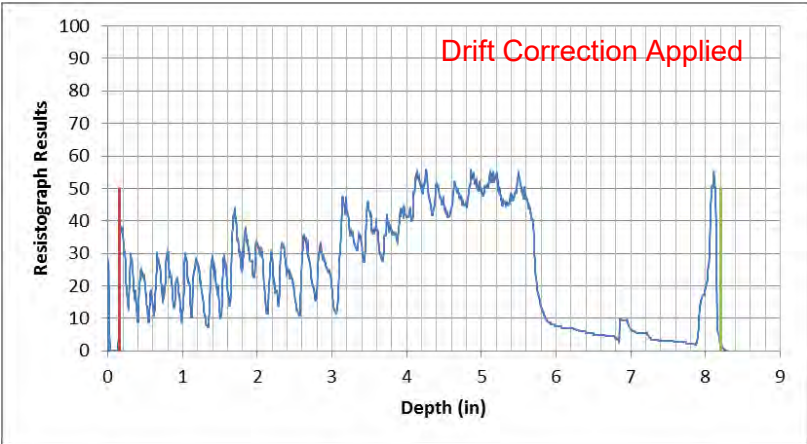
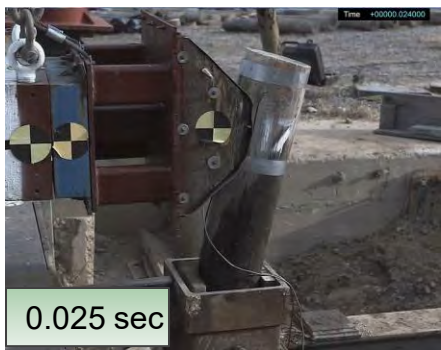
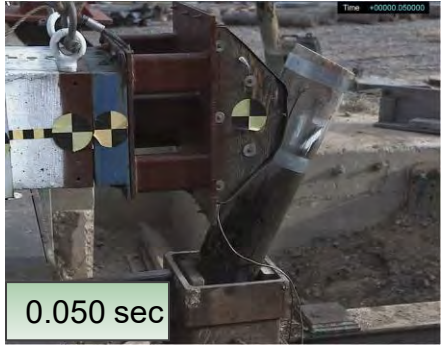
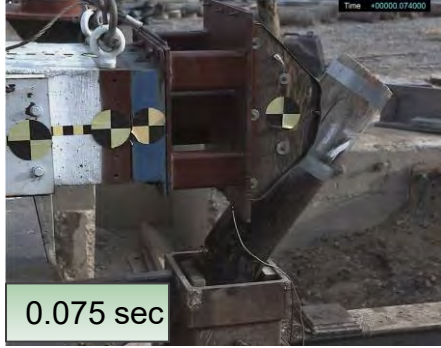
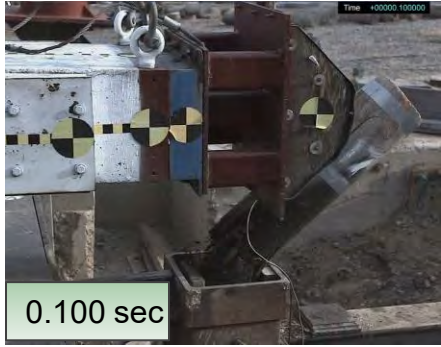
Test Number:	13009N1
Test Date:	03-Oct-2013

Post Number:	17
Post Type:	Round SYP
Post Length:	66 inches
Post Diameter:	8.0 inches
Moisture Content:	48%
Ring Density (avg.):	7.4 per inch
Resi Score $S_{MOR}$ :	0.40
Resi Score $S_U$ :	0.38

Weight:	2,372 lb
Impact Speed:	10 mph
Impact Height:	21.5 inches

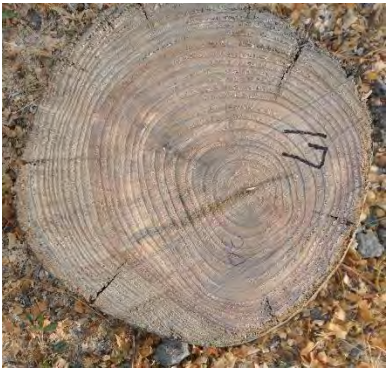
Ring density at bottom of post

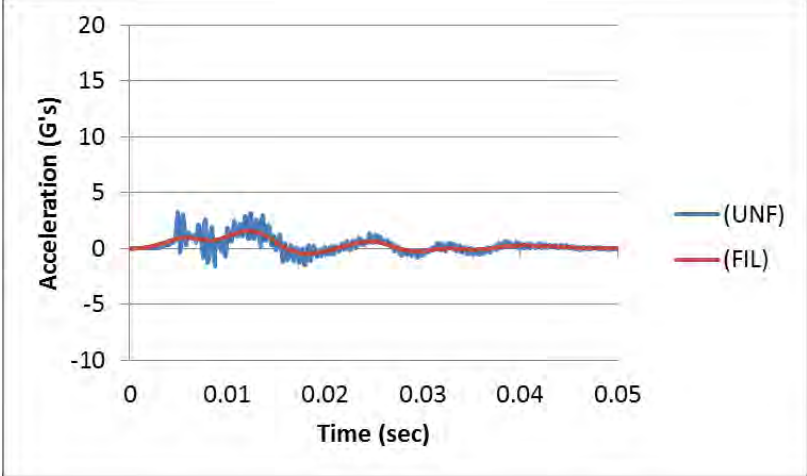
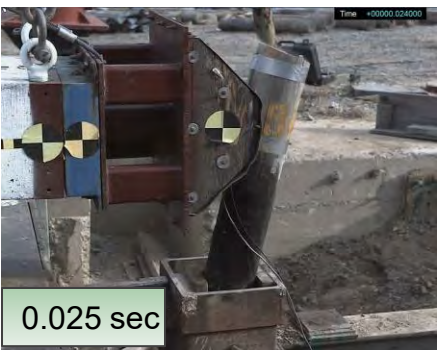
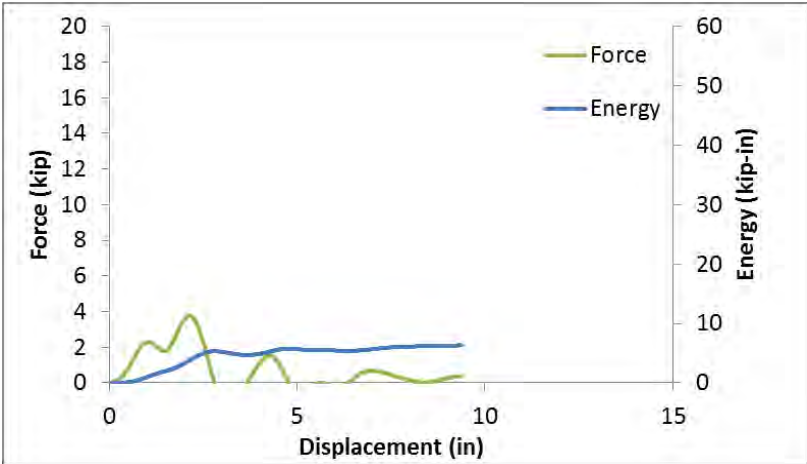
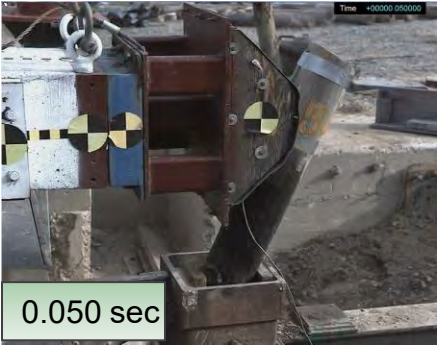
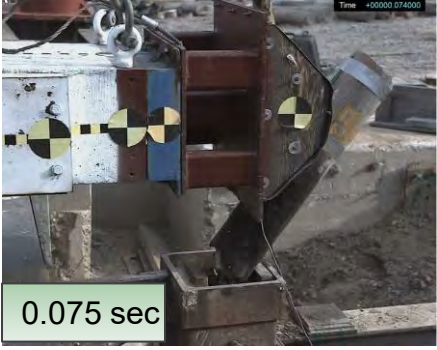
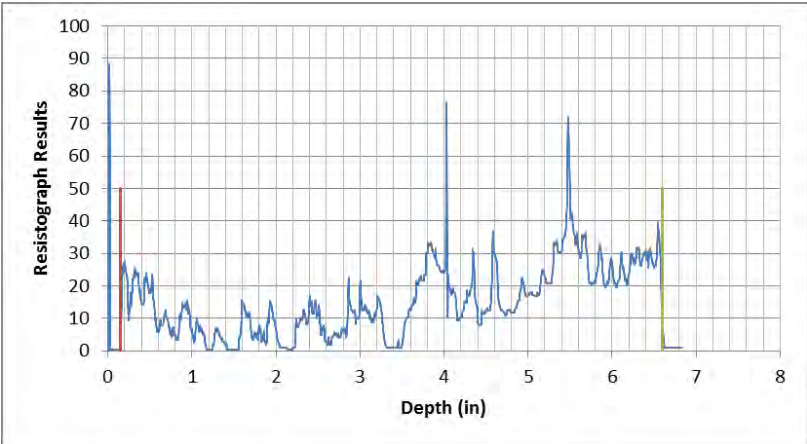
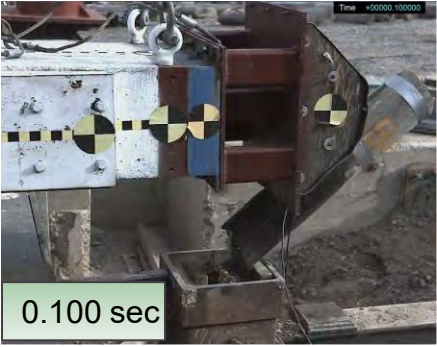
Post Number:	94
Post Type:	Round SYP
Post Length:	66 inches
Post Diameter:	6.61 inches
Moisture Content:	< 50%
Ring Density (avg.):	6.1 per inch
Resi Score $S_{MOR}$ :	0.24
Resi Score $S_U$ :	0.29

Weight:	2,372 lb
Impact Speed:	10 mph
Impact Height:	21.5 inches

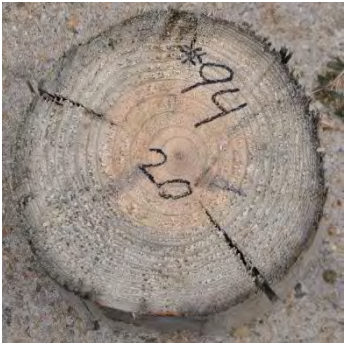
Ring density at bottom of post

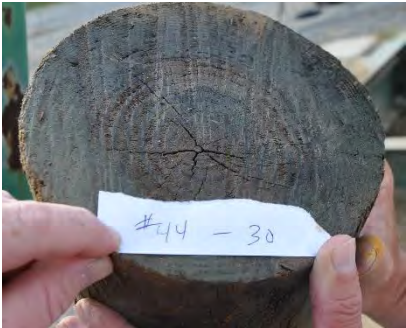
Ring density at bottom of post

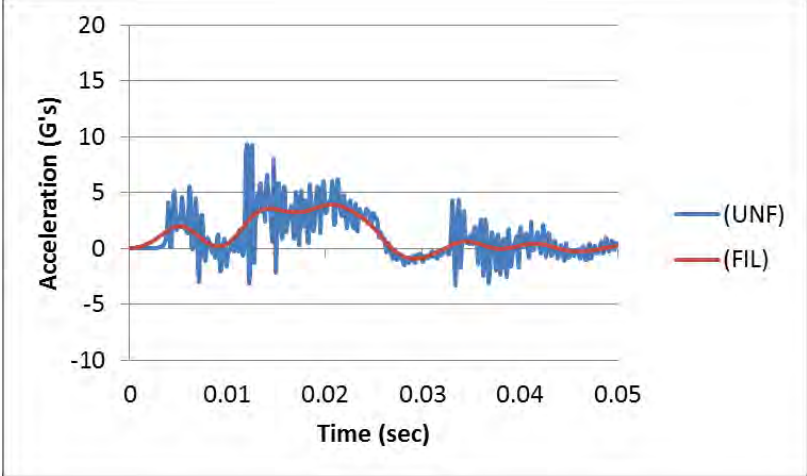
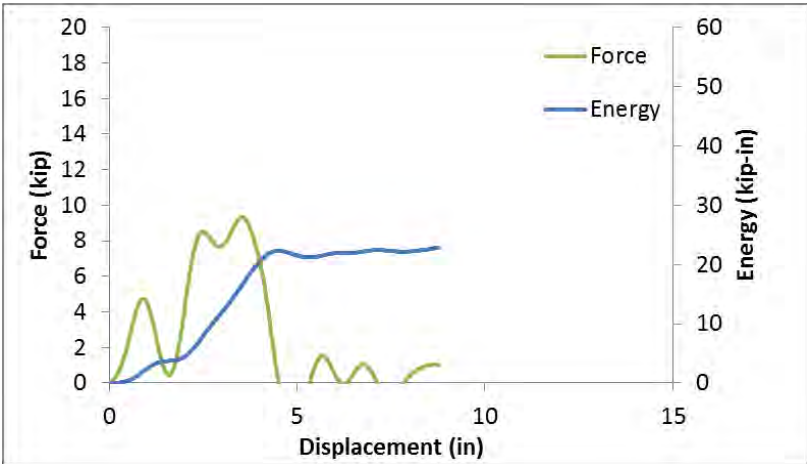
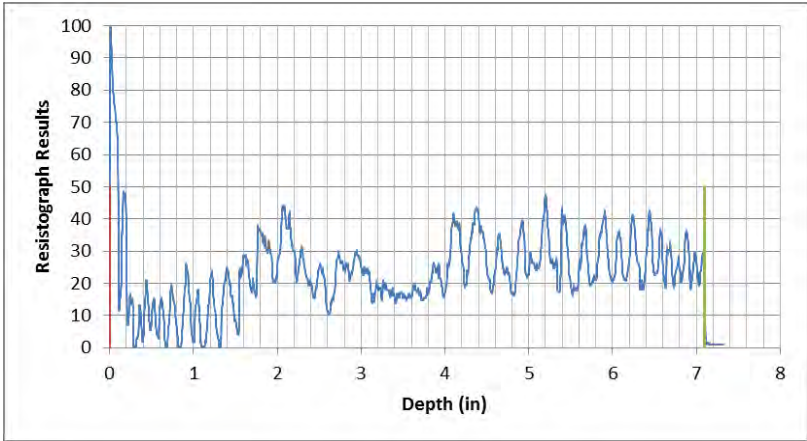
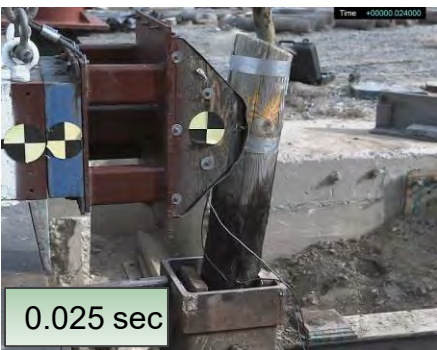
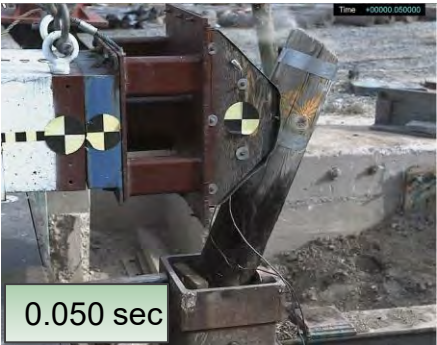
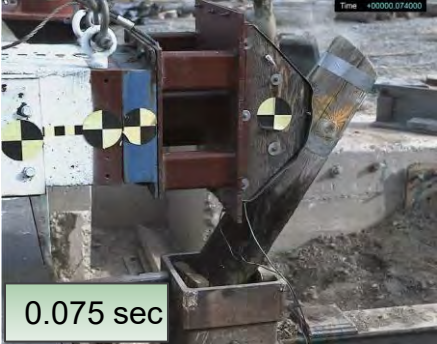
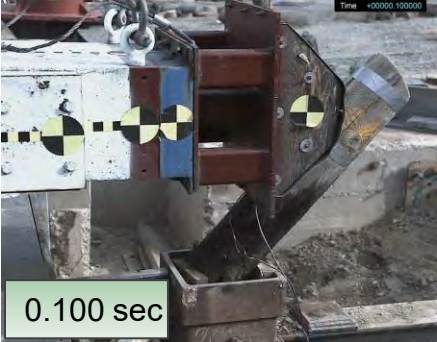
Post Number:	44
Post Type:	Round SYP
Post Length:	66 inches
Post Diameter:	7.56 inches
Moisture Content:	< 50%
Ring Density (avg.):	8.1 per inch
Resi Score $S_{MOR}$ :	0.40
Resi Score $S_U$ :	0.43

Weight:	2,372 lb
Impact Speed:	10 mph
Impact Height:	21.5 inches

Fractured Post

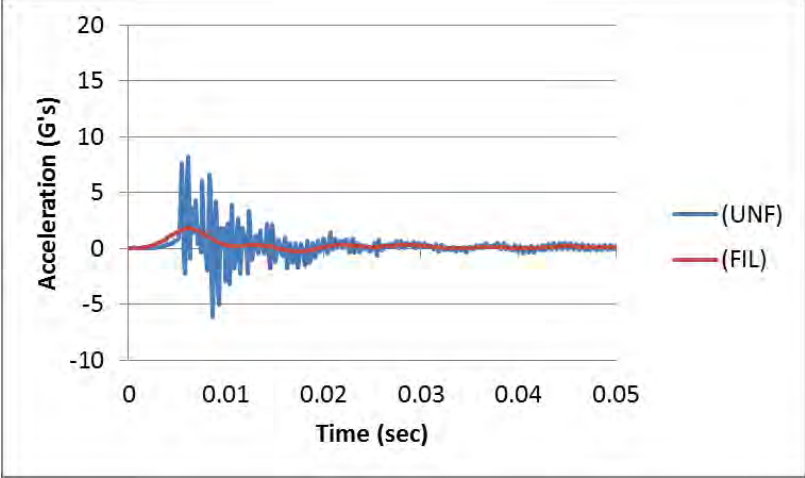
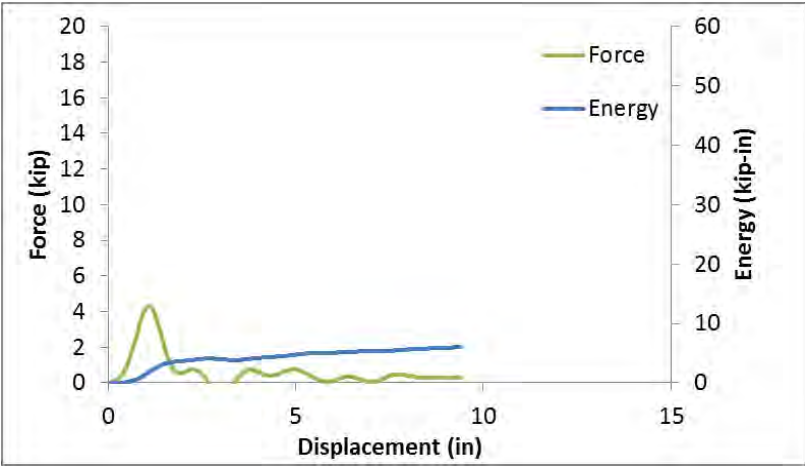
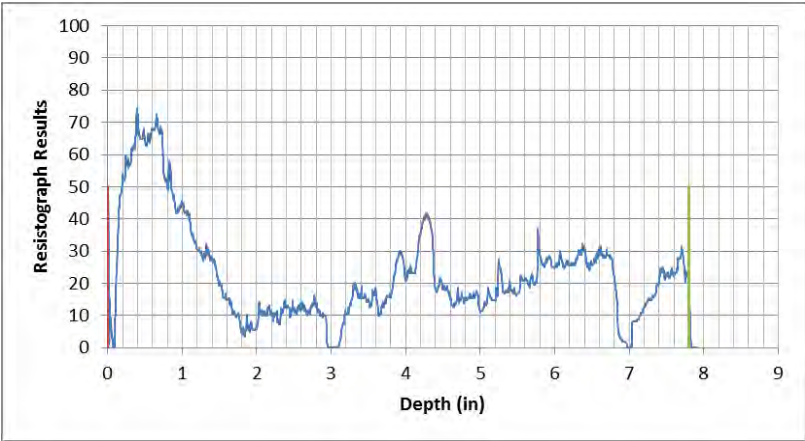
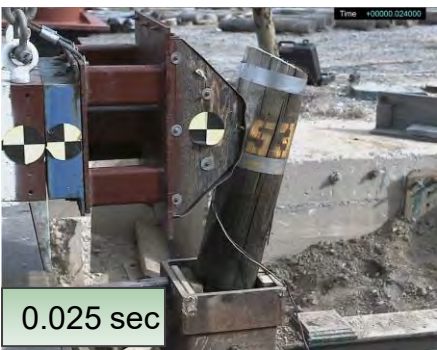
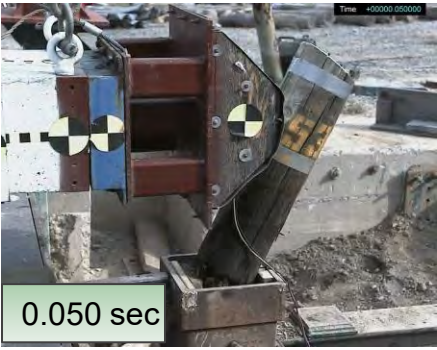
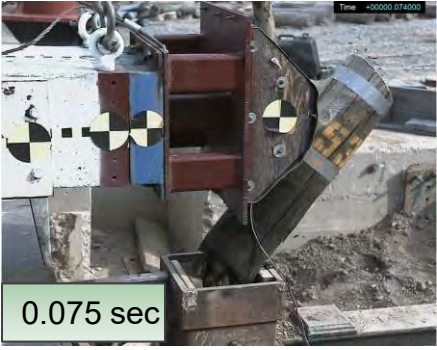
Post Number: 53  
Post Type: Round SYP  
Post Length: 66 inches  
Post Diameter: 7.64 inches  
Moisture Content: 47.62%  
Ring Density (avg.): 6.2 per inch  
Resi Score  $S_{MOR}$ : 0.68  
Resi Score  $S_U$ : 0.67

Weight: 2,372 lb  
Impact Speed: 10 mph  
Impact Height: 21.5 inches

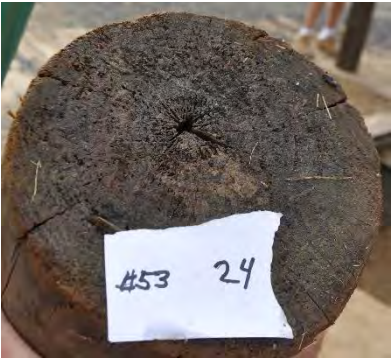
Ring density at bottom of post

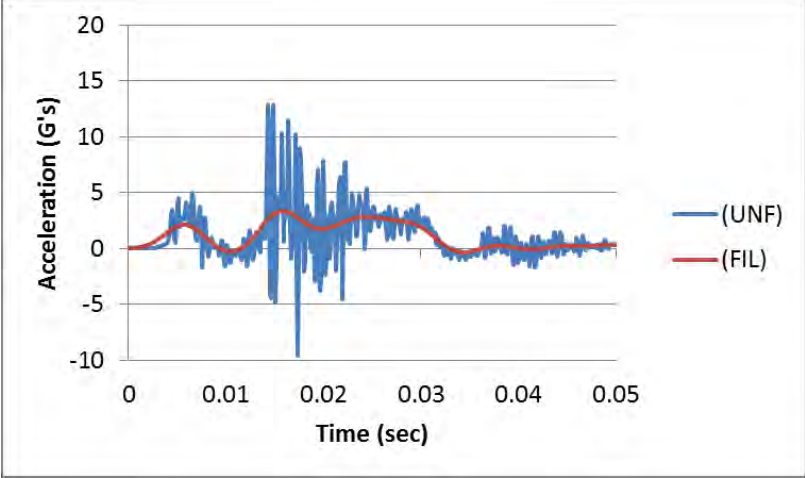
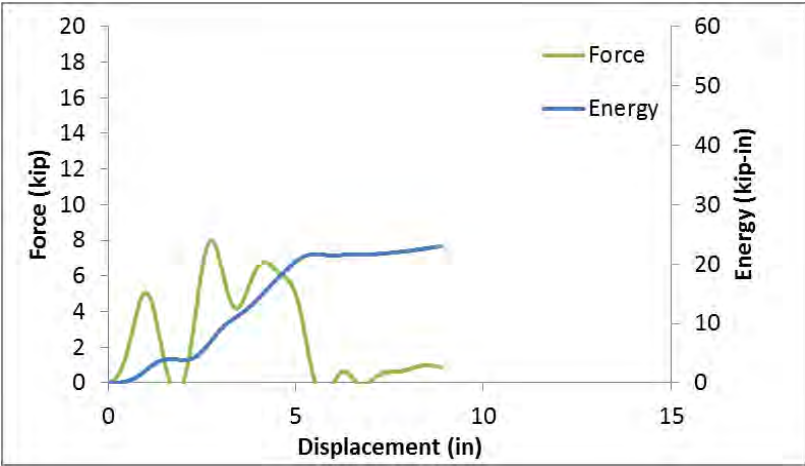
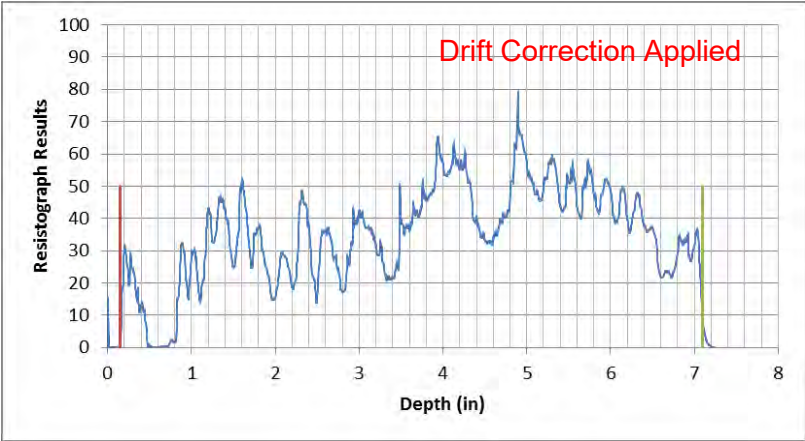
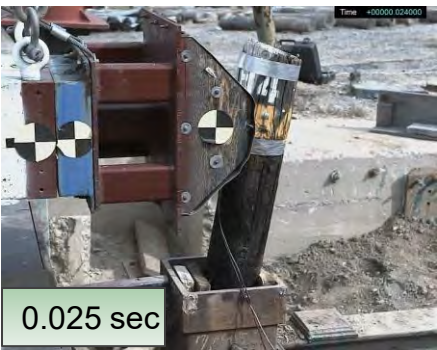
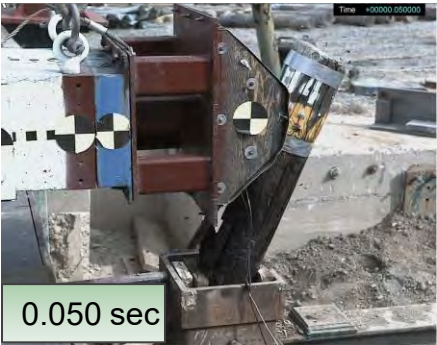
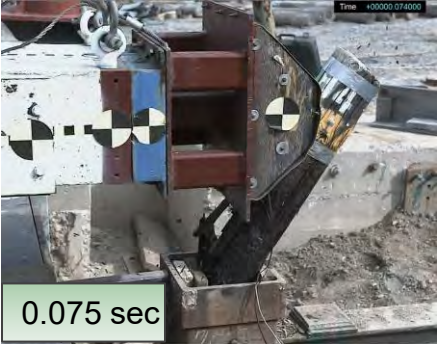
Post Number:	84
Post Type:	Round SYP
Post Length:	66 inches
Post Diameter:	6.61 inches
Moisture Content:	49.72%
Ring Density (avg.):	8.5 per inch
Resi Score $S_{MOR}$ :	0.43
Resi Score $S_U$ :	0.47

Weight:	2,372 lb
Impact Speed:	10 mph
Impact Height:	21.5 inches

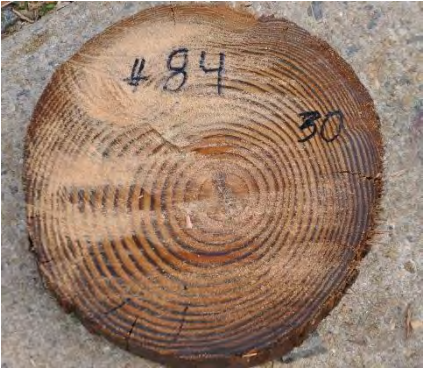
Ring density at bottom of post

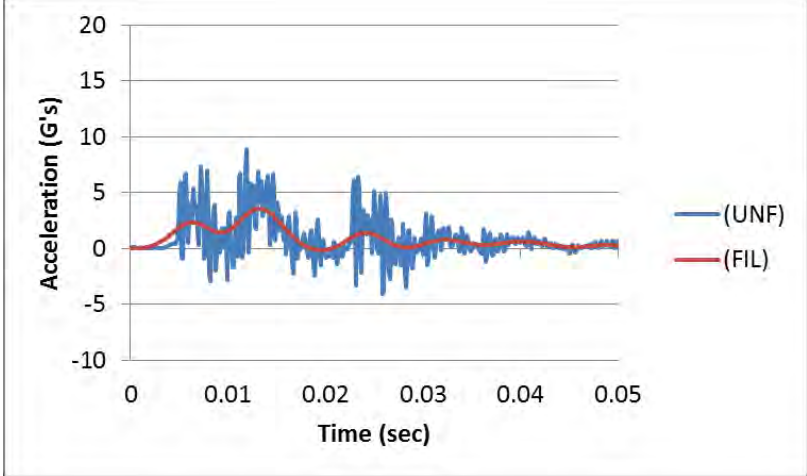
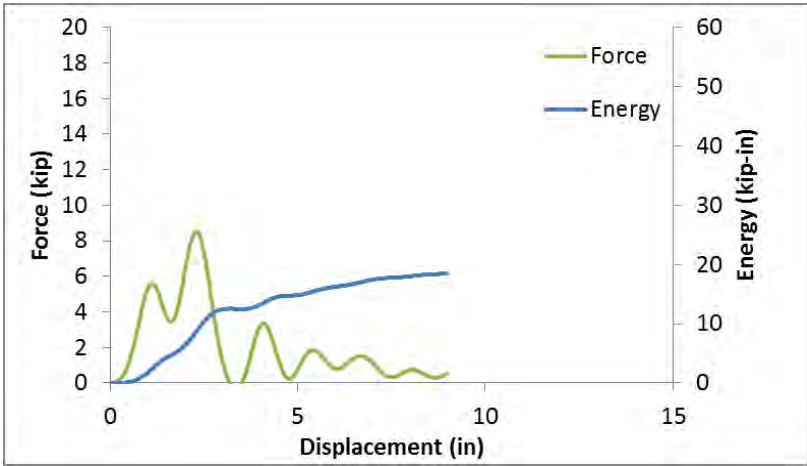
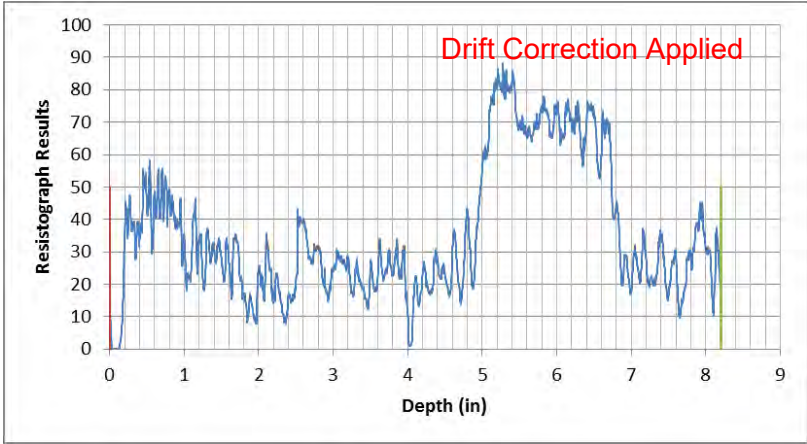
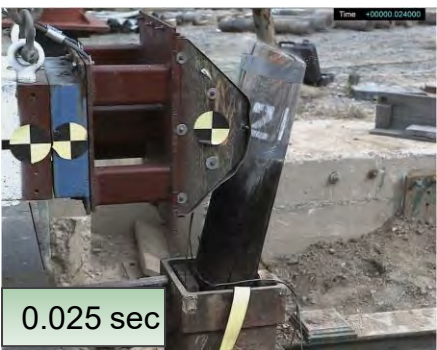
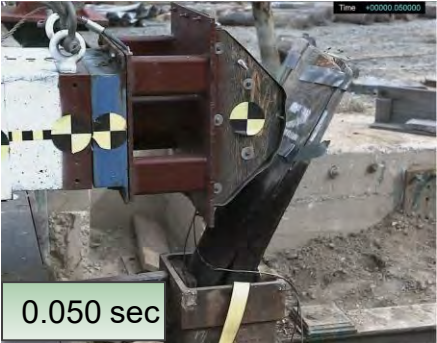
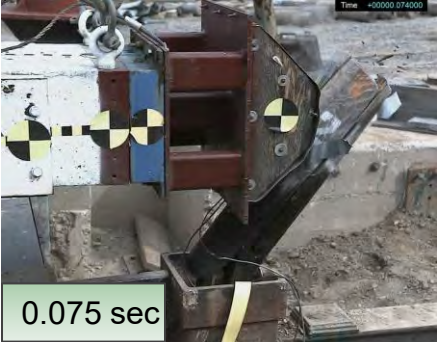
Post Number:	21
Post Type:	Round SYP
Post Length:	66 inches
Post Diameter:	7.96 inches
Moisture Content:	< 50%
Ring Density (avg.):	12.2 per inch
Resi Score $S_{MOR}$ :	0.82
Resi Score $S_U$ :	0.77

Weight:	2,372 lb
Impact Speed:	10 mph
Impact Height:	21.5 inches

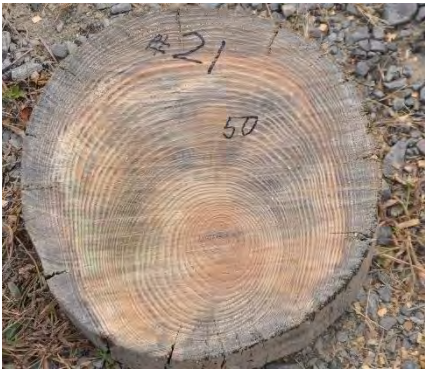
Ring density at bottom of post

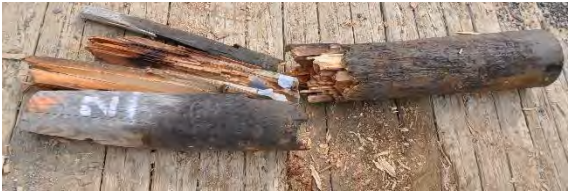
Fractured Post

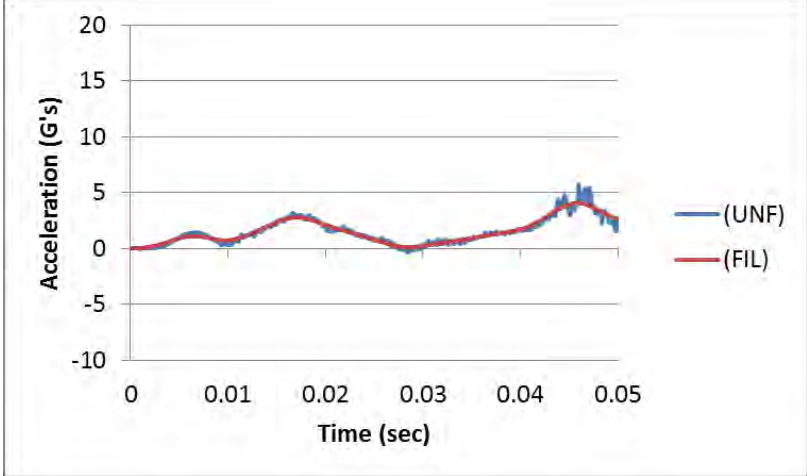
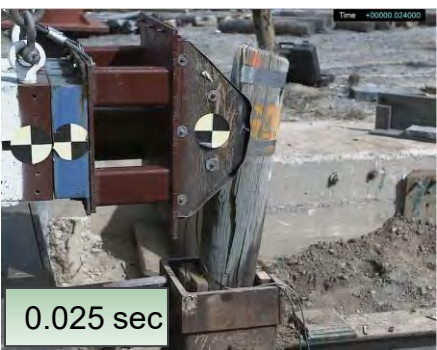
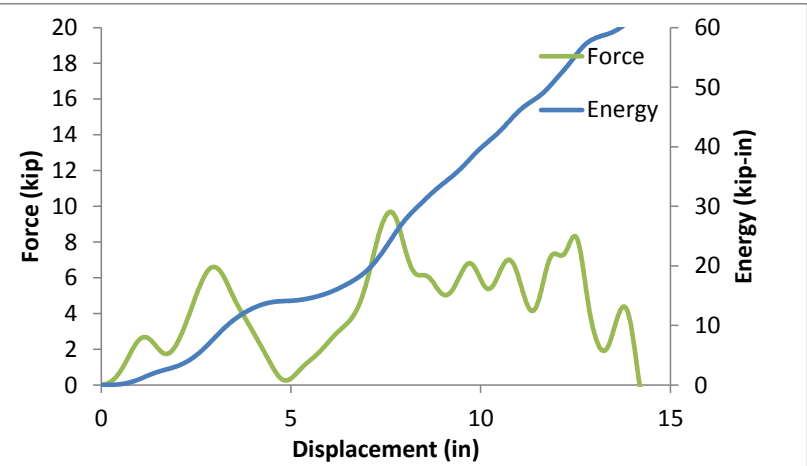
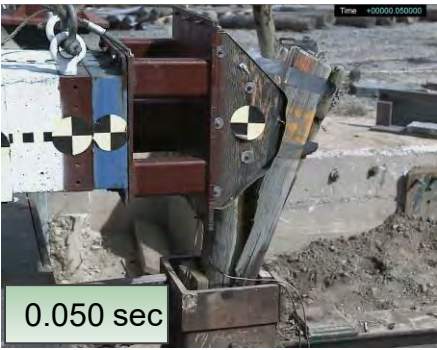
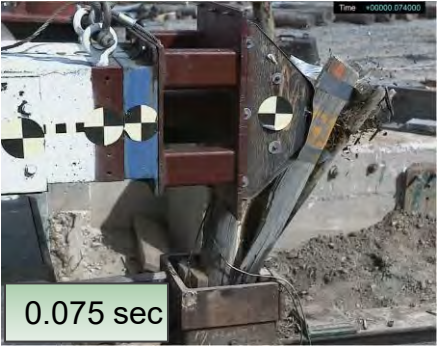
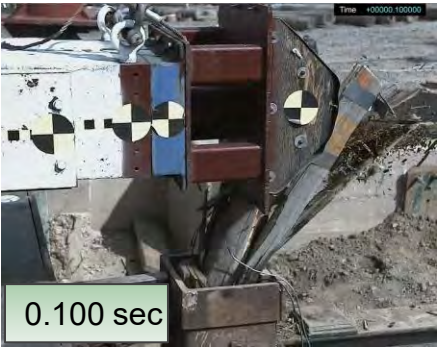
Post Number:	63
Post Type:	Round SYP
Post Length:	66 inches
Post Diameter:	7.48 inches
Moisture Content:	37.26%
Ring Density (avg.):	8.0 per inch
Resi Score $S_{MOR}$ :	0.69
Resi Score $S_U$ :	0.75

Weight:	2,372 lb
Impact Speed:	10 mph
Impact Height:	21.5 inches

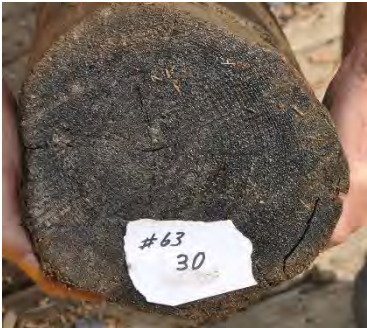
Ring density at bottom of post

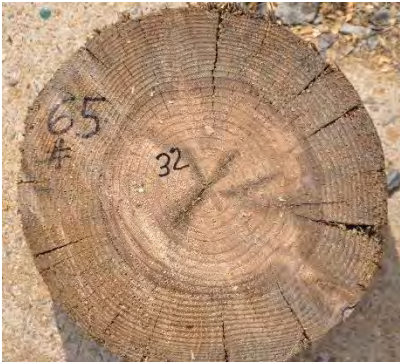
Ring density at bottom of post

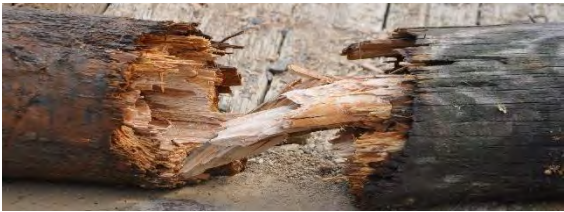
Fractured Post

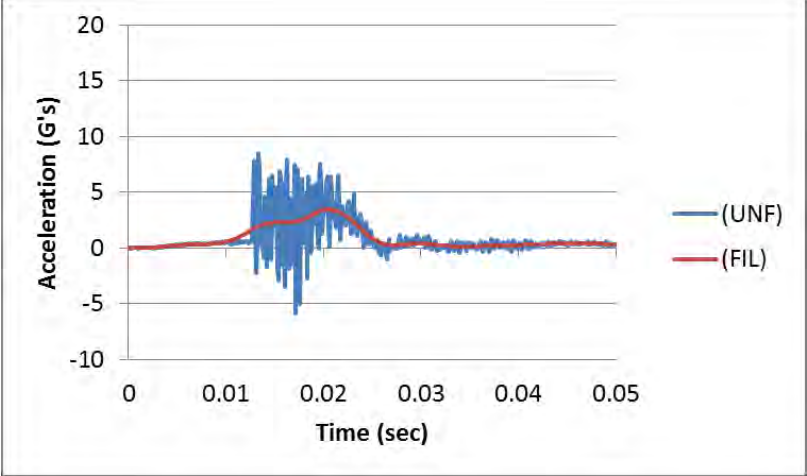
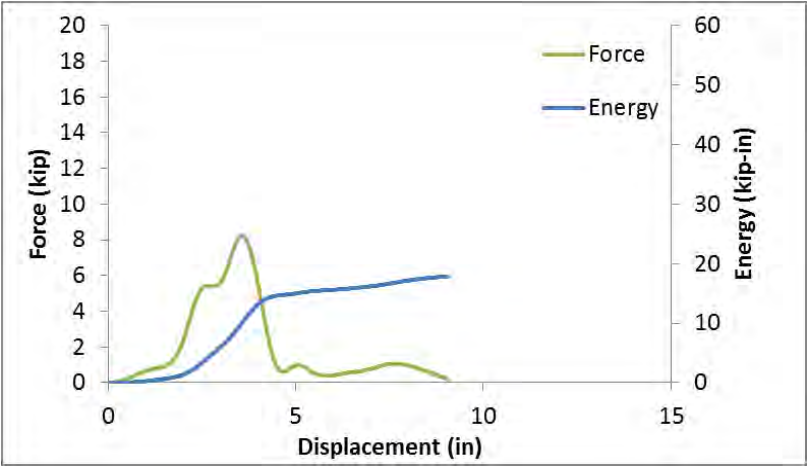
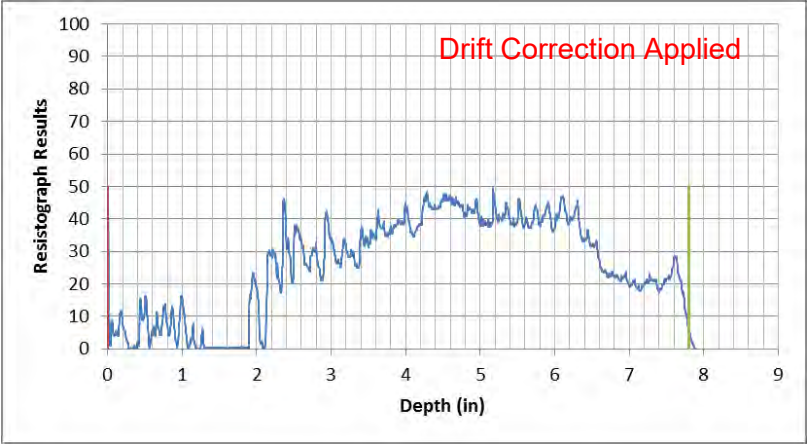
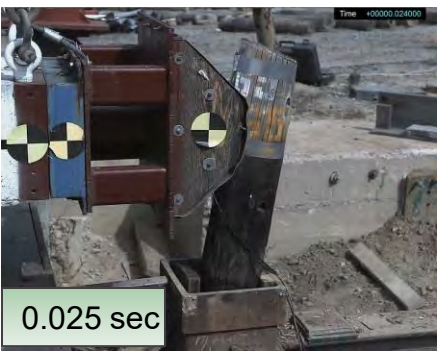
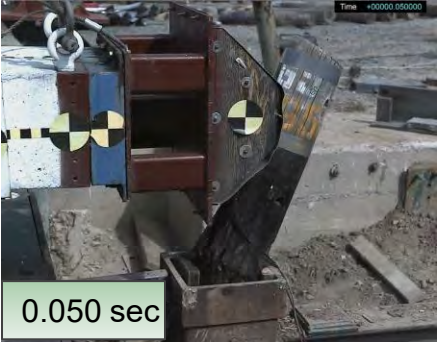
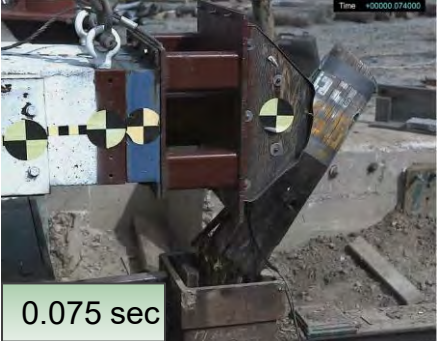
Test Number:	13009V1
Test Date:	08-Oct-2013

Post Number:	90
Post Type:	Round SYP
Post Length:	66 inches
Post Diameter:	7.01 inches
Moisture Content:	< 50%
Ring Density (avg.):	4.5 per inch
Resi Score $S_{MOR}$ :	0.12
Resi Score $S_U$ :	0.13

Weight:	2,372 lb
Impact Speed:	10 mph
Impact Height:	21.5 inches

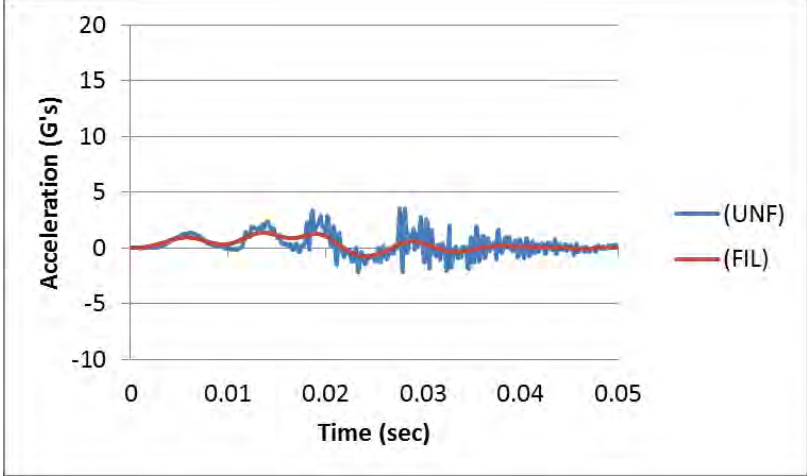
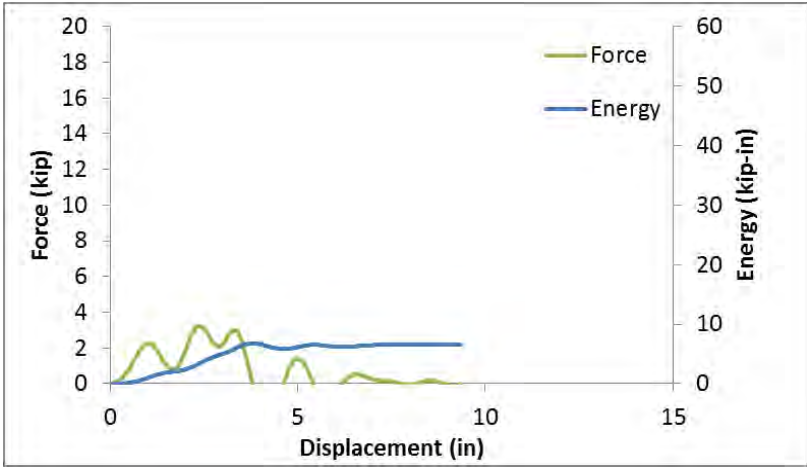
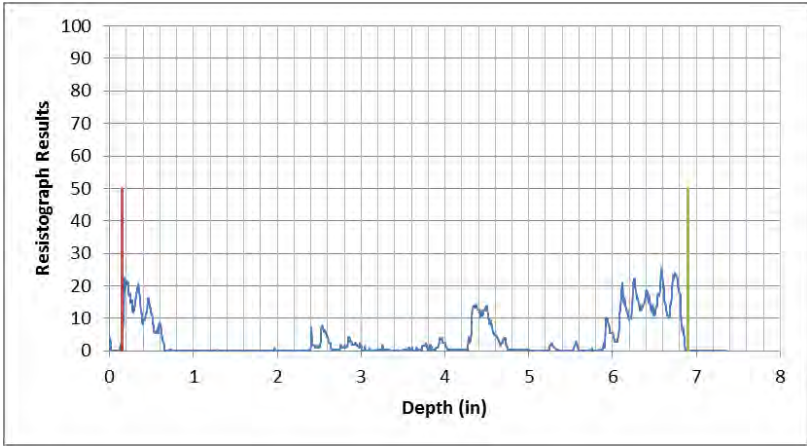
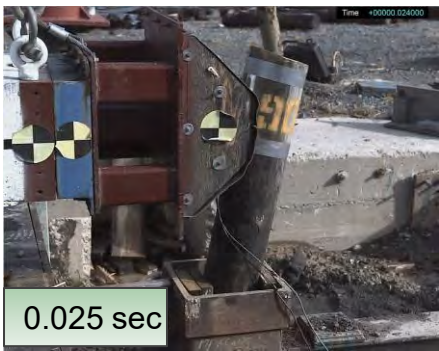
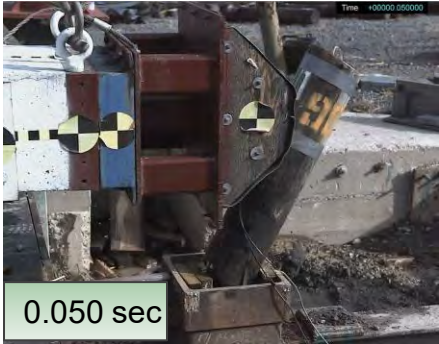
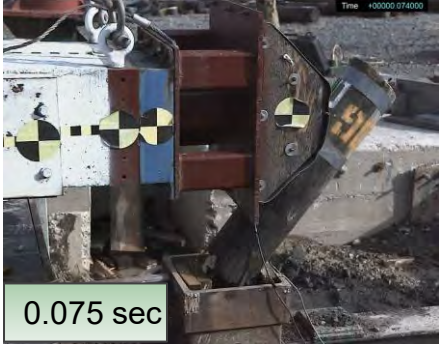
Ring density at bottom of post

Fractured Post

Post Number:	118
Post Type:	Round SYP
Post Length:	66 inches
Post Diameter:	7.72 inches
Moisture Content:	< 50%
Ring Density (avg.):	6.9 per inch
Resi Score $S_{MOR}$ :	0.34
Resi Score $S_U$ :	0.34

Weight:	2,372 lb
Impact Speed:	10 mph
Impact Height:	21.5 inches

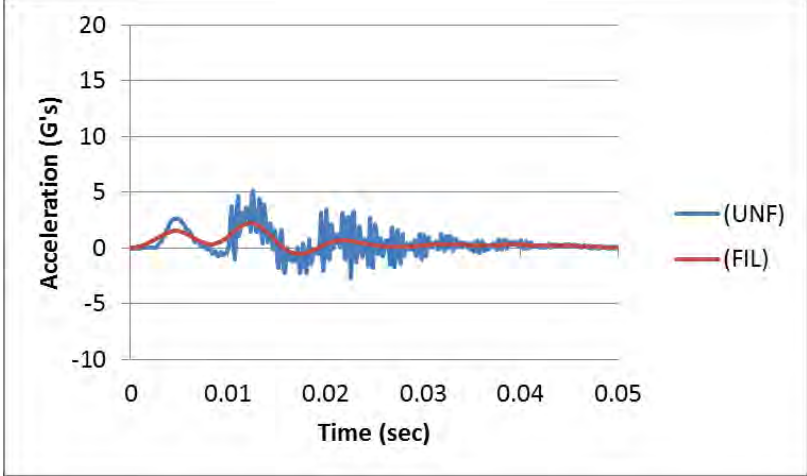
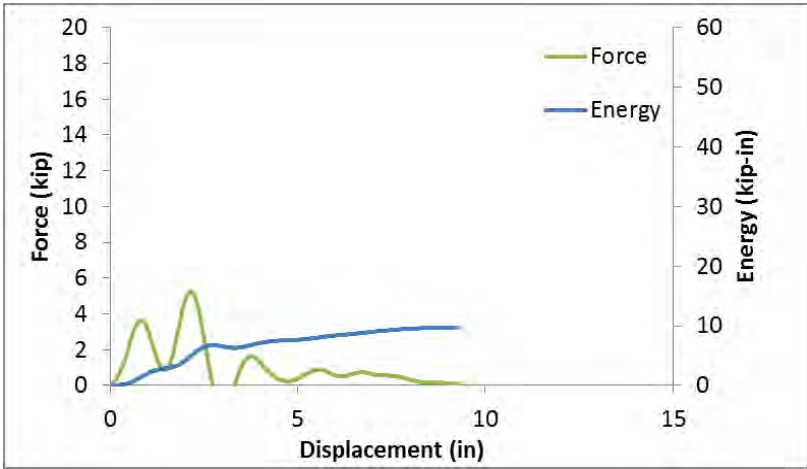
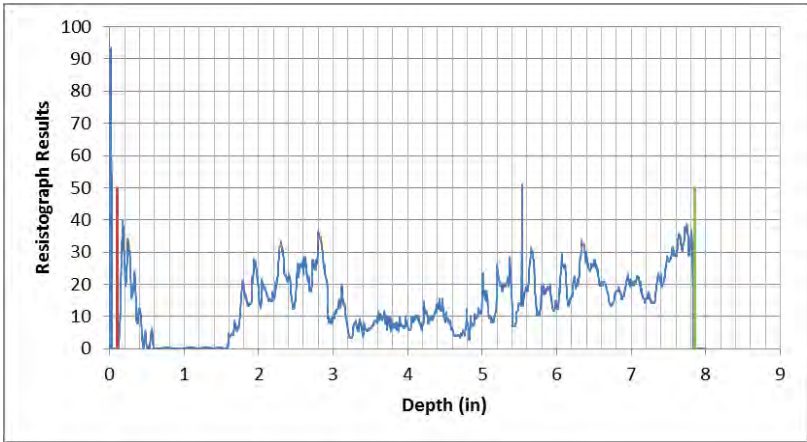
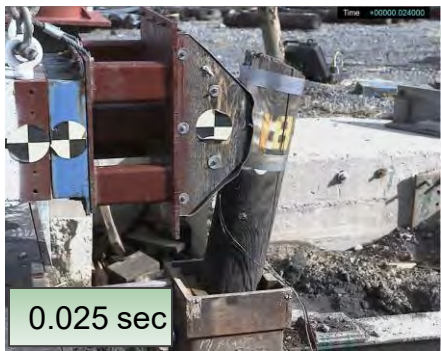
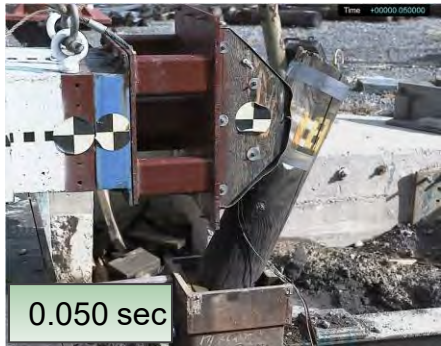
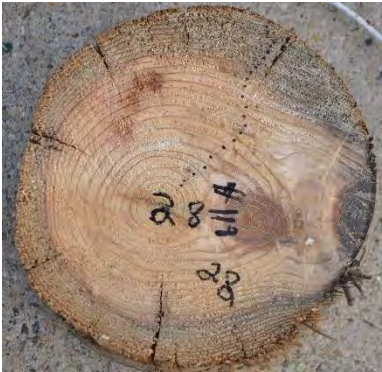
Ring density at bottom of post

Fractured Post

Post Number:	81
Post Type:	Round SYP
Post Length:	66 inches
Post Diameter:	6.69 inches
Moisture Content:	< 50%
Ring Density (avg.):	6.1 per inch
Resi Score $S_{MOR}$ :	0.33
Resi Score $S_U$ :	0.38

Weight:	2,372 lb
Impact Speed:	10 mph
Impact Height:	21.5 inches
