# **A Guide for W-Beam Guardrail Damage Assessment**

A Field Manual for  
Highway Maintenance Personnel

National Cooperative  
Highway Research  
Program  
Project 22-28

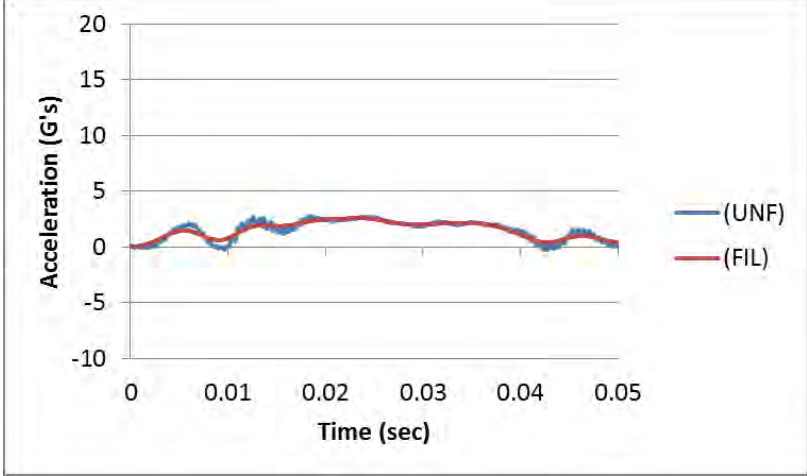
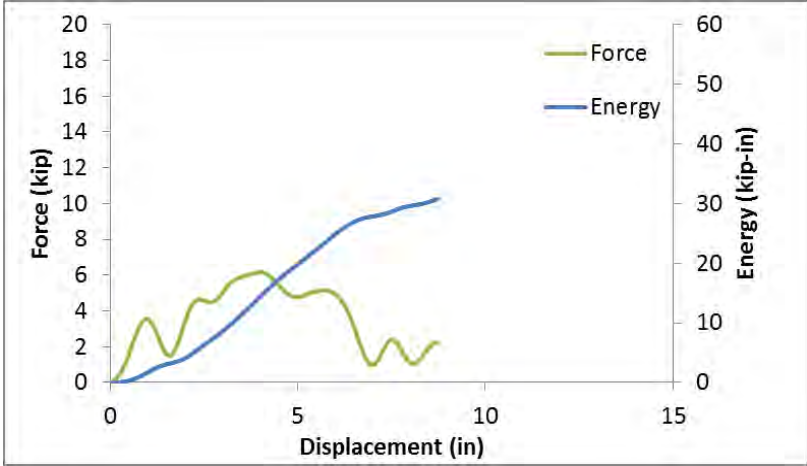
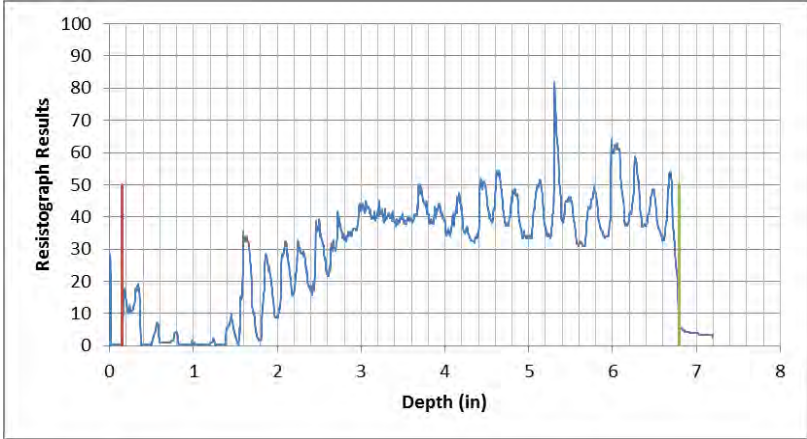
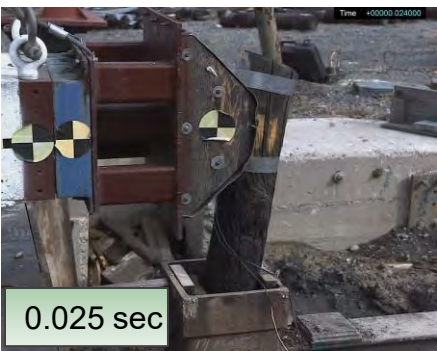
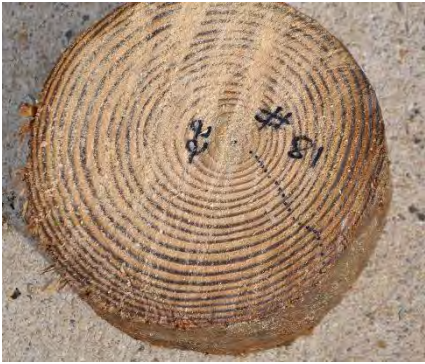
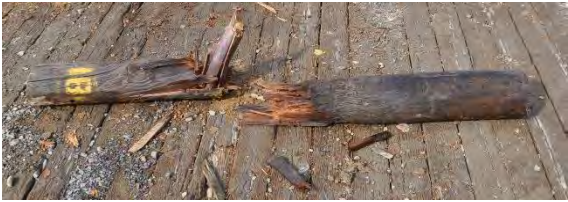
Test Number:	13009Y1
Test Date:	08-Oct-2013

Post Number:	123
Post Type:	Round SYP
Post Length:	66 inches
Post Diameter:	8.28 inches
Moisture Content:	< 50%
Ring Density (avg.):	4.6 per inch
Resi Score $S_{MOR}$ :	0.66
Resi Score $S_U$ :	0.61

Weight:	2,372 lb
Impact Speed:	10 mph
Impact Height:	21.5 inches

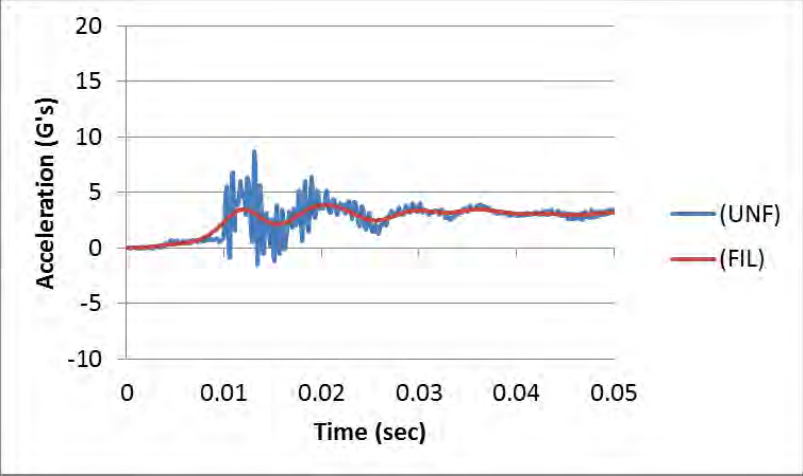
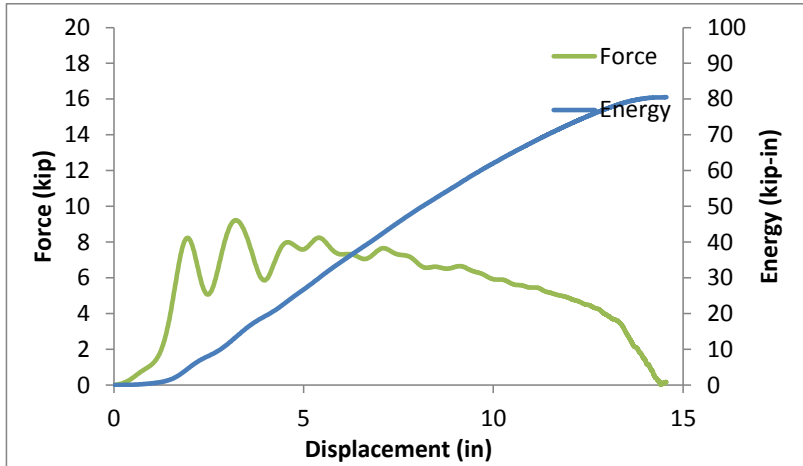
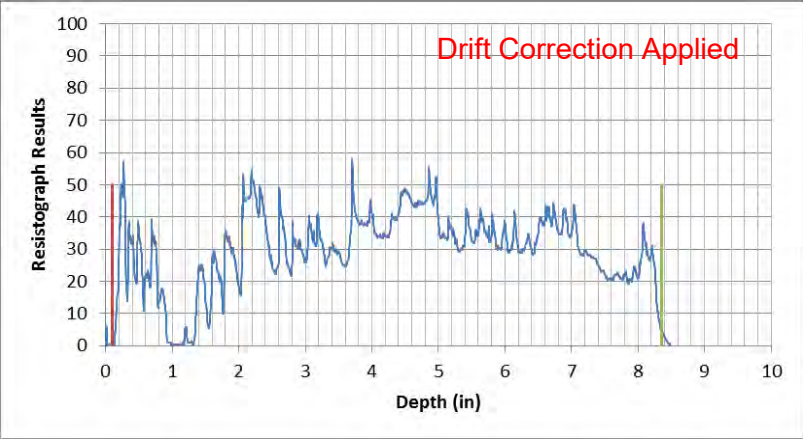
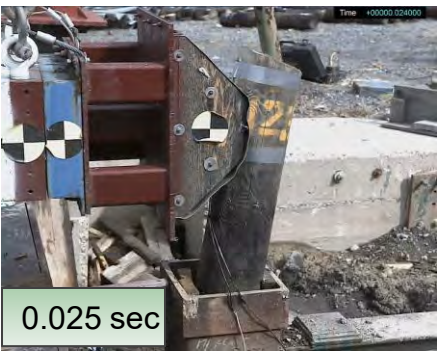
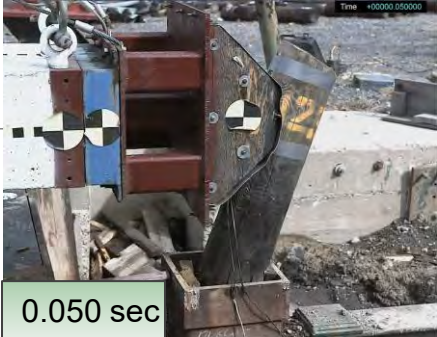
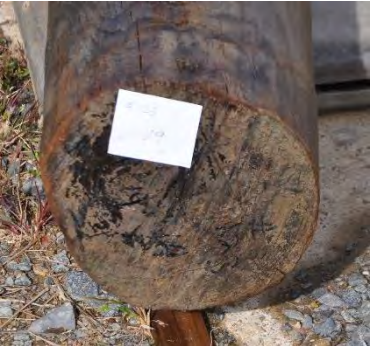
Test Number:	13009Z1
Test Date:	08-Oct-2013

Post Number:	61
Post Type:	Round SYP
Post Length:	66 inches
Post Diameter:	8.2 inches
Moisture Content:	45.5%
Ring Density (avg.):	6.0 per inch
Resi Score $S_{MOR}$ :	0.71
Resi Score $S_U$ :	0.68

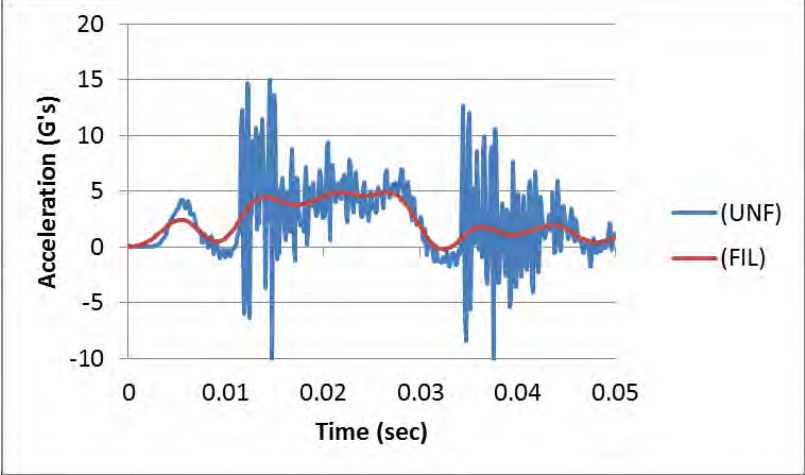
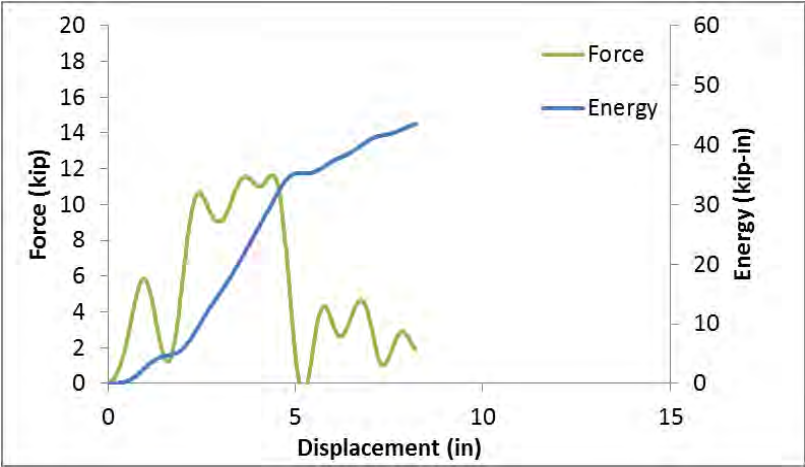
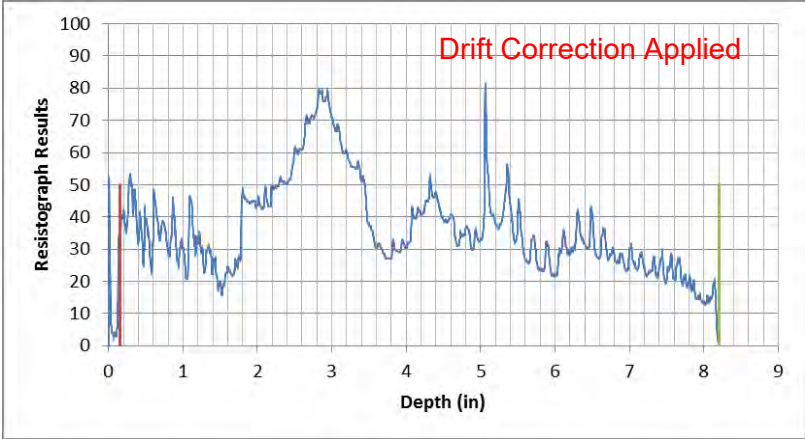
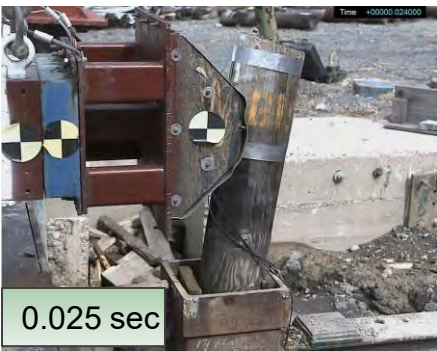
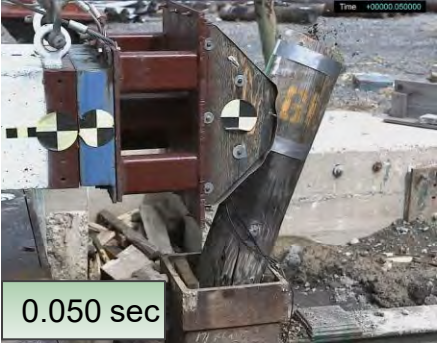
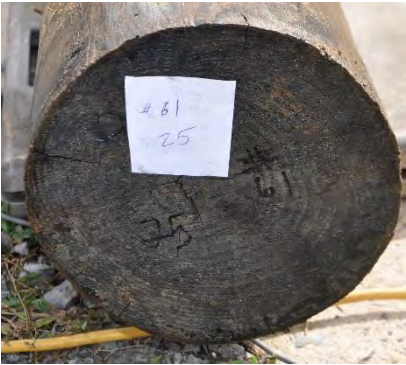
Weight:	2,372 lb
Impact Speed:	10 mph
Impact Height:	21.5 inches

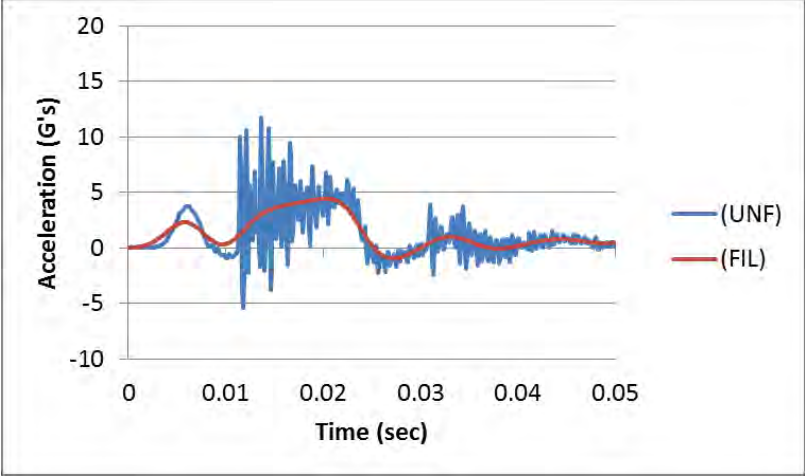
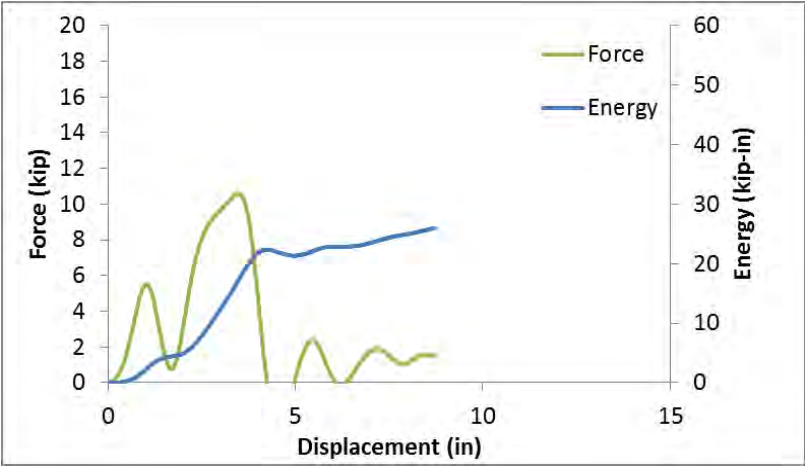
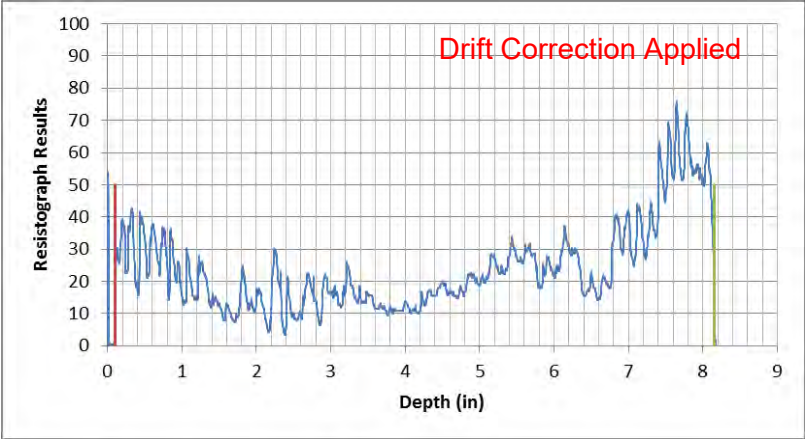
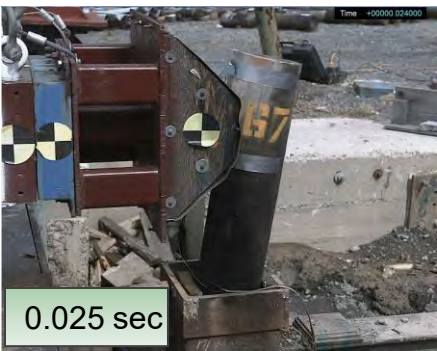
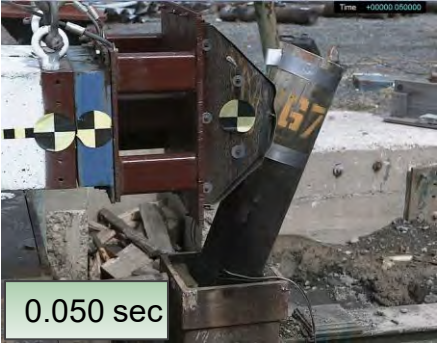
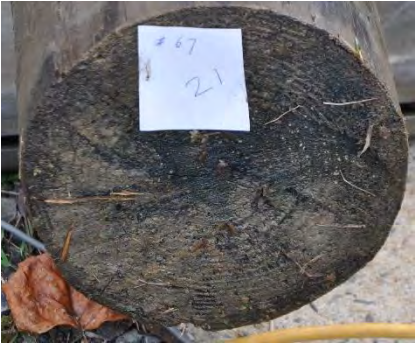
Test Number:	13009A2
Test Date:	08-Oct-2013

Post Number:	67
Post Type:	Round SYP
Post Length:	66 inches
Post Diameter:	8.2 inches
Moisture Content:	< 50%
Ring Density (avg.):	5.2 per inch
Resi Score $S_{MOR}$ :	0.83
Resi Score $S_U$ :	0.80

Weight:	2,372 lb
Impact Speed:	10 mph
Impact Height:	21.5 inches

Ring density at bottom of post

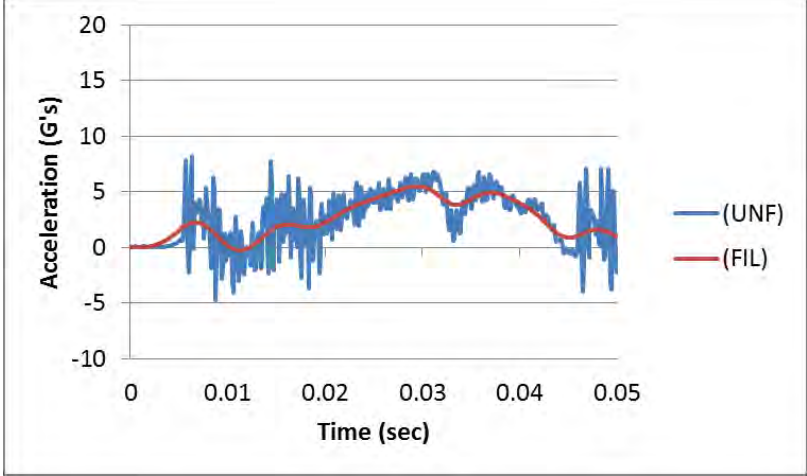
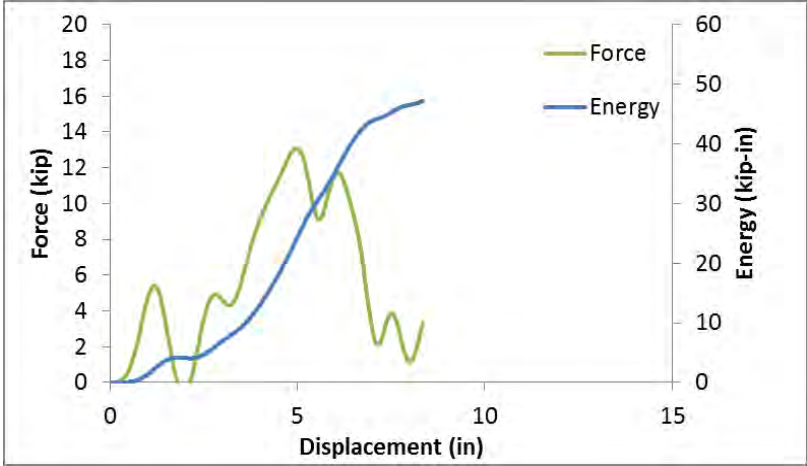
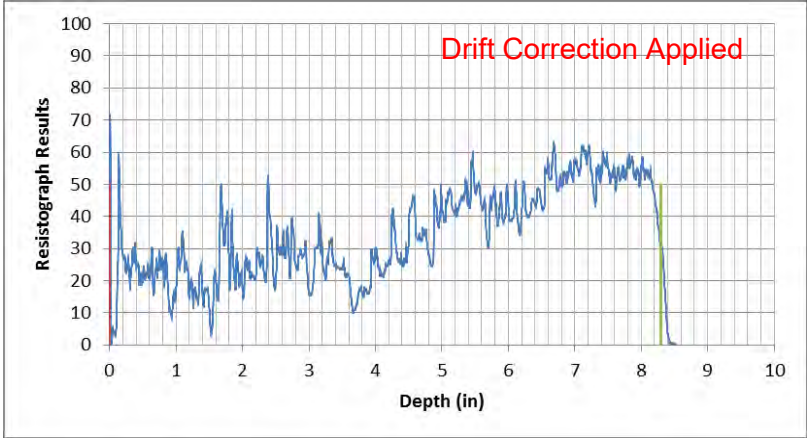
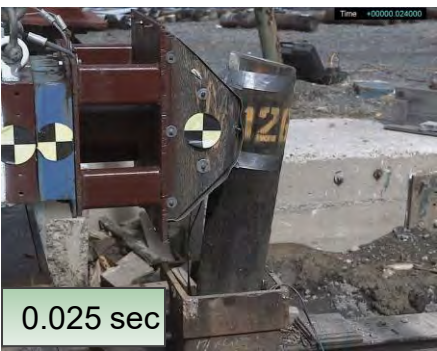
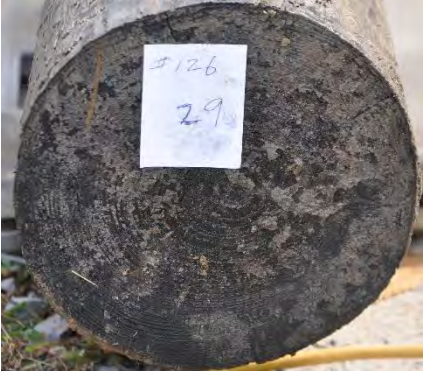
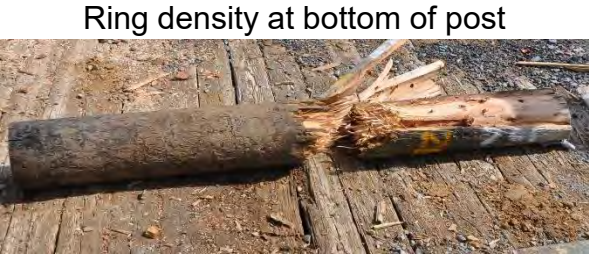
Post Number:	126
Post Type:	Round SYP
Post Length:	66 inches
Post Diameter:	8.28 inches
Moisture Content:	< 50%
Ring Density (avg.):	6.9 per inch
Resi Score $S_{MOR}$ :	0.98
Resi Score $S_U$ :	0.91

Weight:	2,372 lb
Impact Speed:	10 mph
Impact Height:	21.5 inches

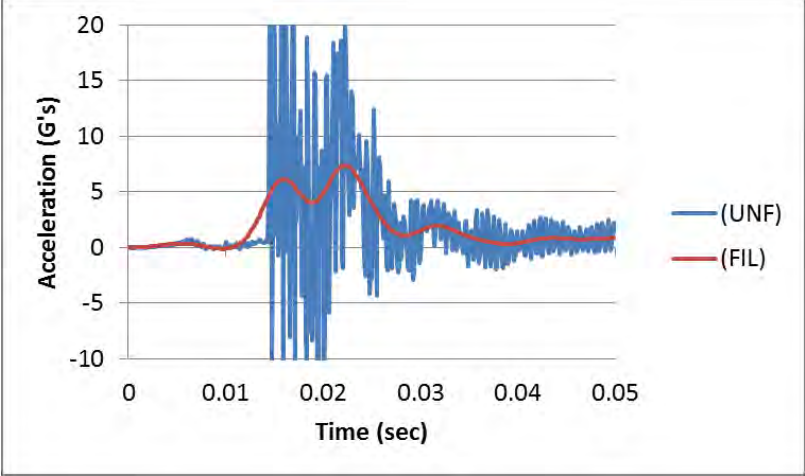
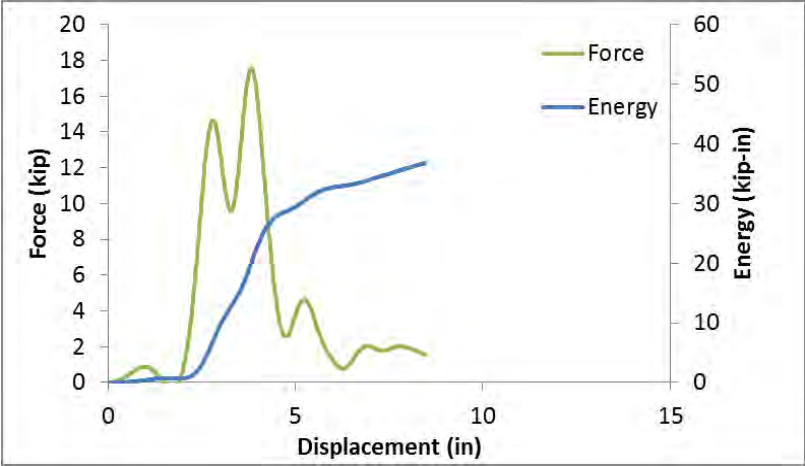
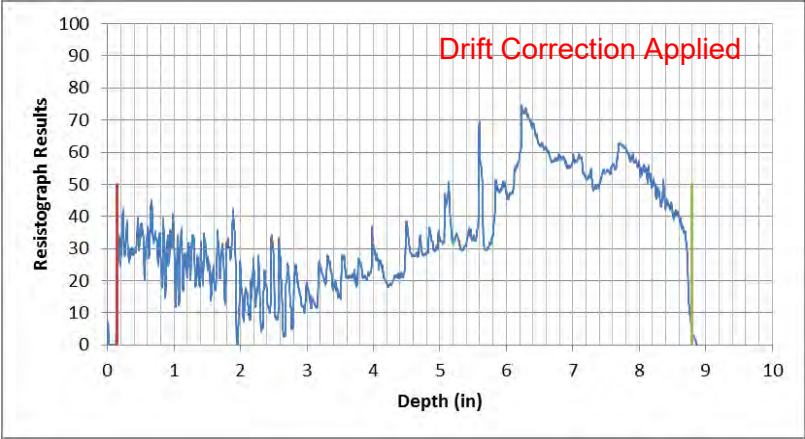
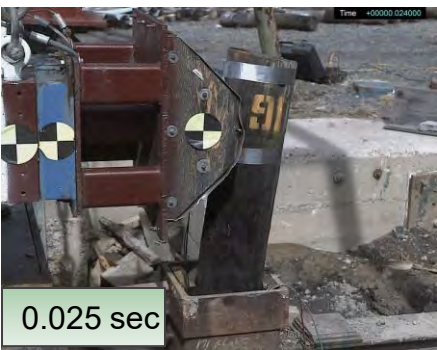
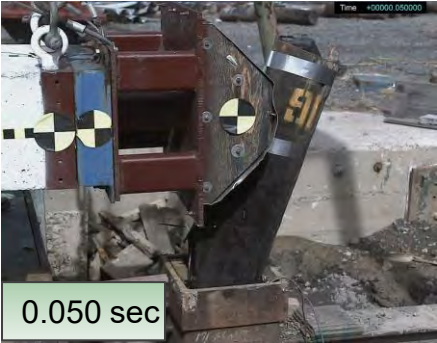
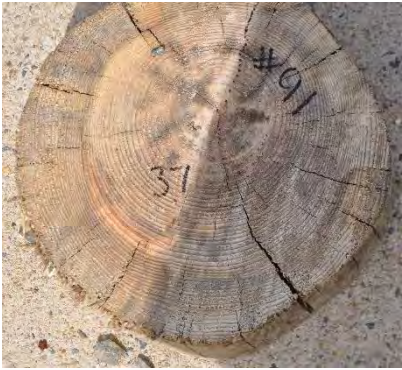
Test Number:	13009C2
Test Date:	08-Oct-2013

Post Number:	91
Post Type:	Round SYP
Post Length:	66 inches
Post Diameter:	8.6 inches
Moisture Content:	46.16%
Ring Density (avg.):	8.6 per inch
Resi Score $S_{MOR}$ :	1.14
Resi Score $S_U$ :	1.01

Weight:	2,372 lb
Impact Speed:	10 mph
Impact Height:	21.5 inches

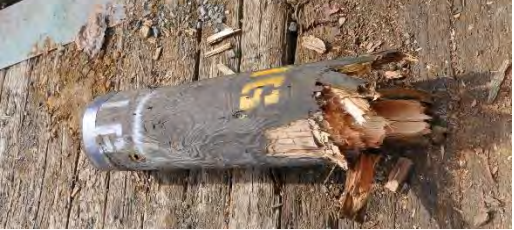
Ring density at bottom of post

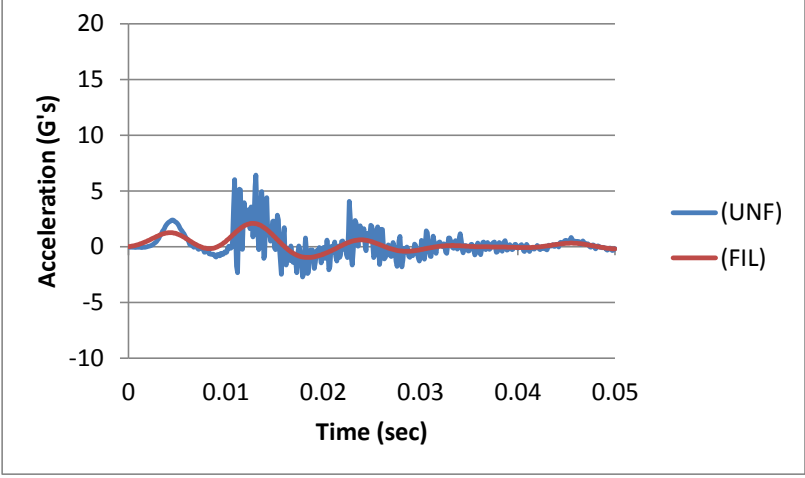
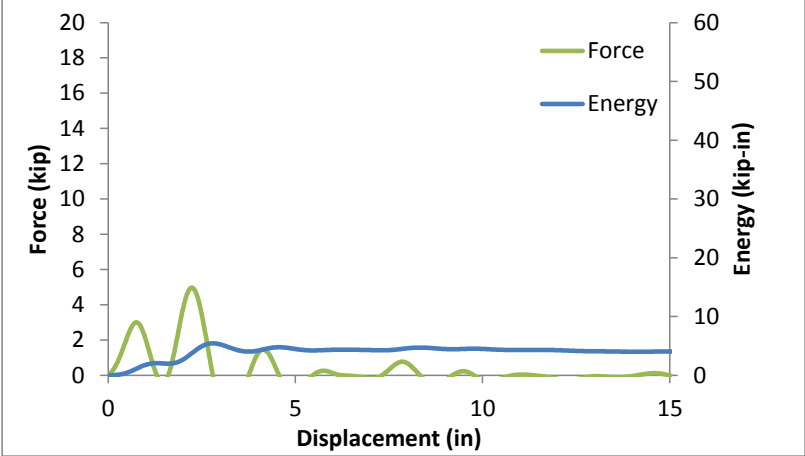
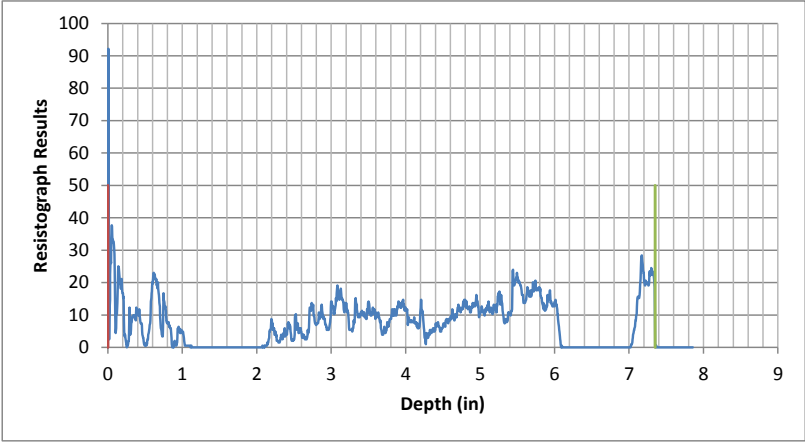
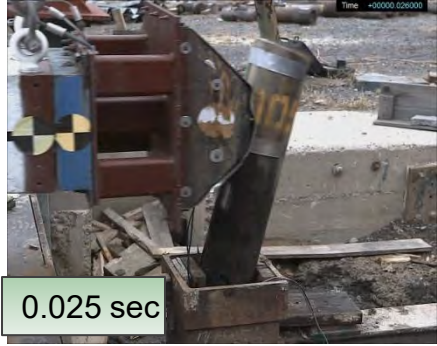
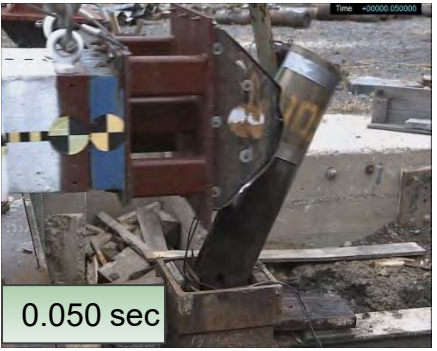
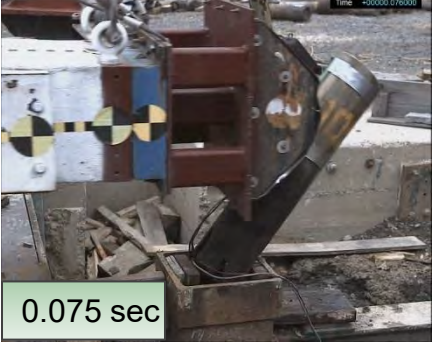
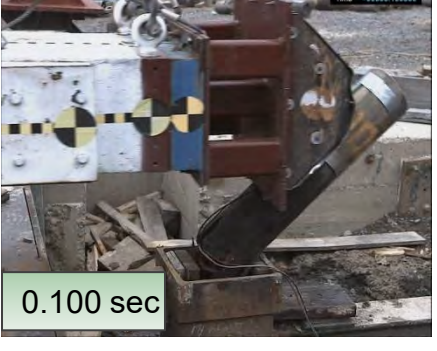
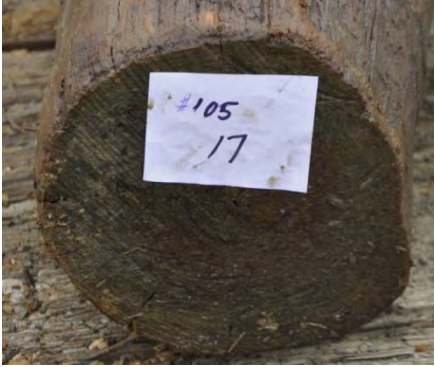
Post Number:	105
Post Type:	Round SYP
Post Length:	66 inches
Post Diameter:	7.4 inches
Moisture Content:	>50%
Ring Density (avg.):	4.9 per inch
Resi Score $S_{MOR}$ :	0.16
Resi Score $S_U$ :	0.16

**Pendulum Properties**

Weight:	2,372 lb
Impact Speed:	10 mph
Impact Height:	21.5 inches

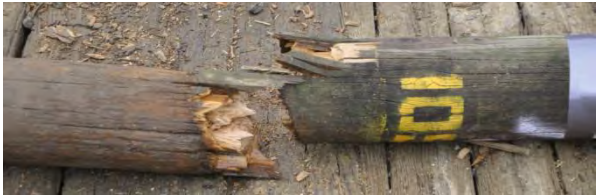
Ring density at bottom of post

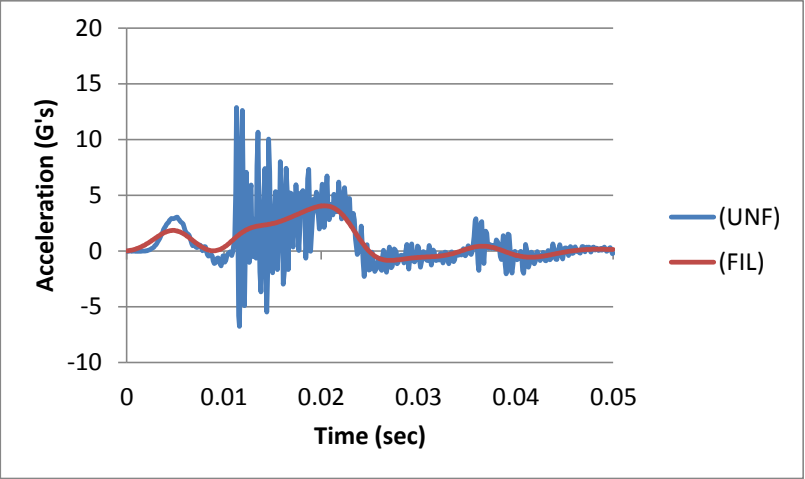
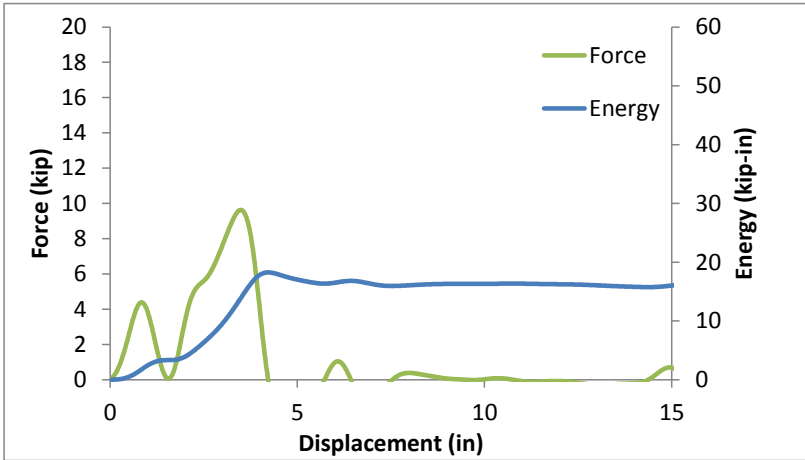
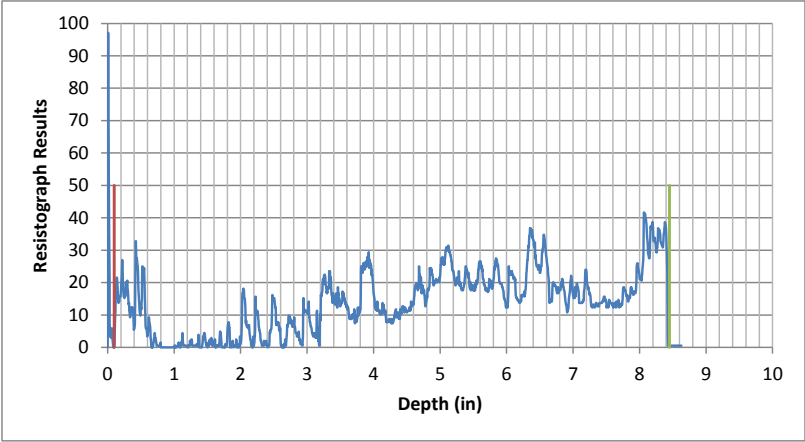
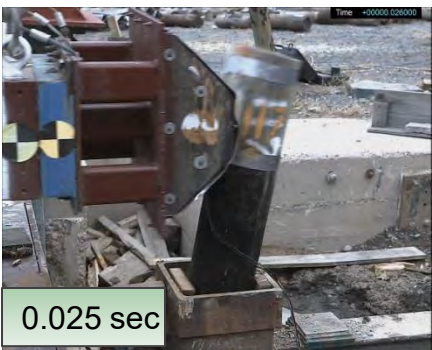
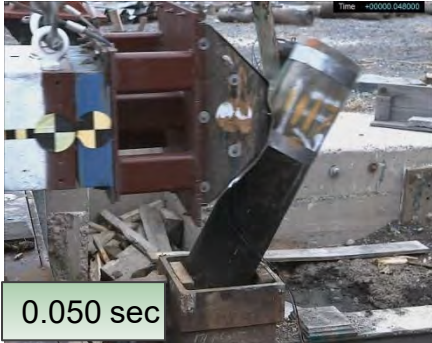
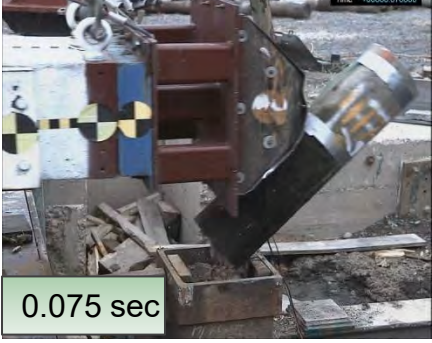
Test Number:	13009E2
Test Date:	9-Oct-2013

Post Number:	117
Post Type:	Round SYP
Post Length:	66 inches
Post Diameter:	8.6 inches
Moisture Content:	46.2%
Ring Density (avg.):	5.8 per inch
Resi Score $S_{MOR}$ :	0.40
Resi Score $S_U$ :	0.37

**Pendulum Properties**

Weight:	2,372 lb
Impact Speed:	10 mph
Impact Height:	21.5 inches

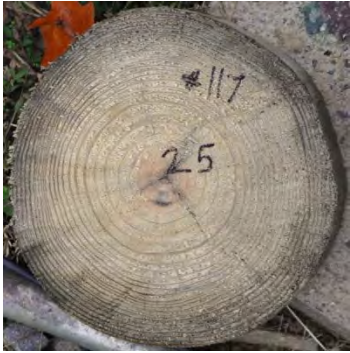
Ring density at bottom of post

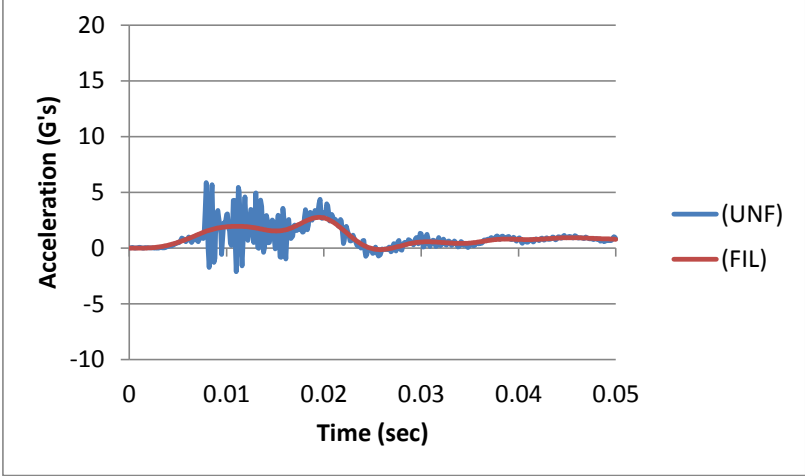
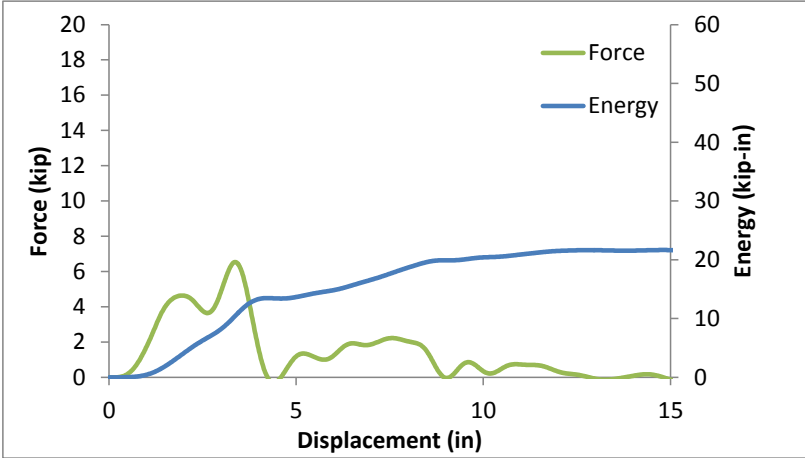
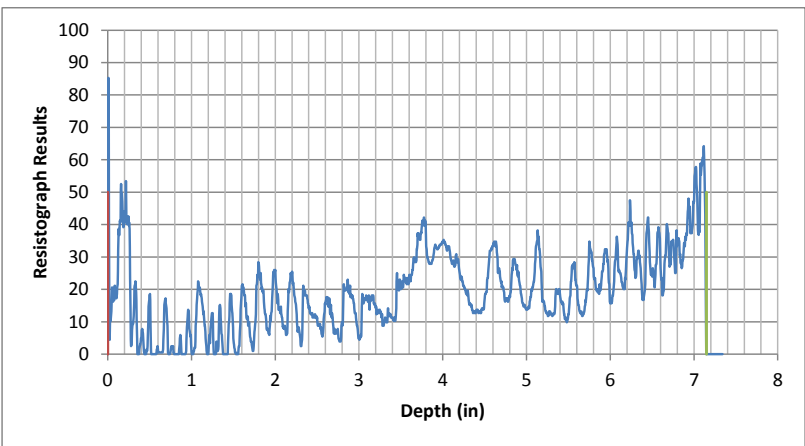
Post Number:	129
Post Type:	Round SYP
Post Length:	66 inches
Post Diameter:	8.6 inches
Moisture Content:	>50%
Ring Density (avg.):	7.7 per inch
Resi Score $S_{MOR}$ :	0.38
Resi Score $S_U$ :	0.41

**Pendulum Properties**

Weight:	2,372 lb
Impact Speed:	10 mph
Impact Height:	21.5 inches

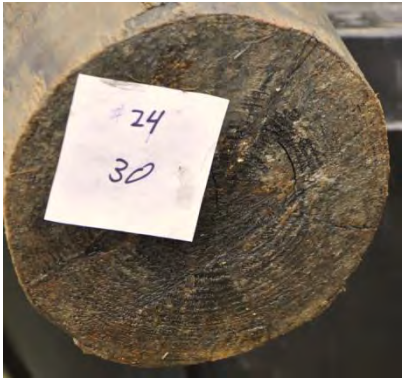
Post Number:	24
Post Type:	Round SYP
Post Length:	66 inches
Post Diameter:	8.4 inches
Moisture Content:	>50%
Ring Density (avg.):	7.1 per inch
Resi Score $S_{MOR}$ :	0.60
Resi Score $S_U$ :	0.57

**Pendulum Properties**

Weight:	2,372 lb
Impact Speed:	10 mph
Impact Height:	21.5 inches

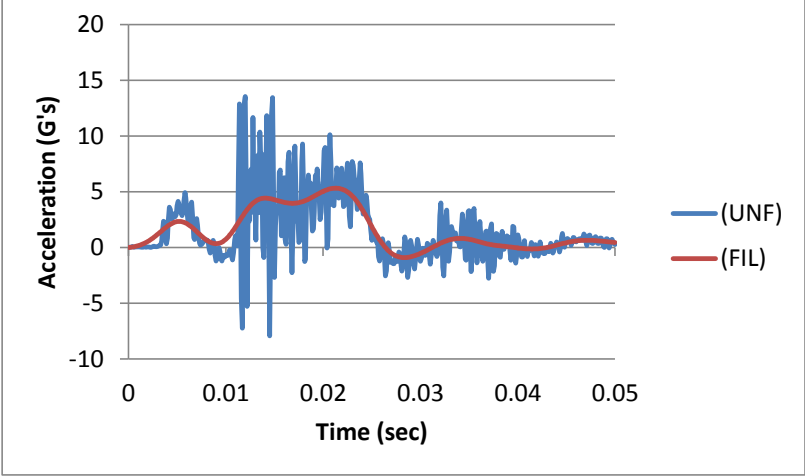
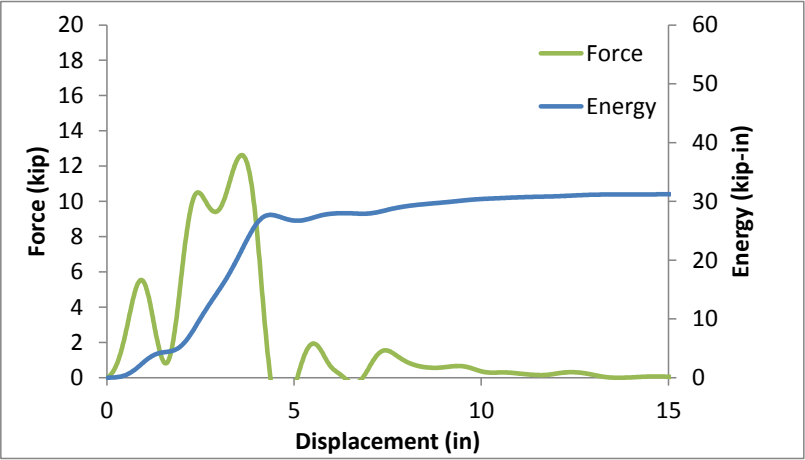
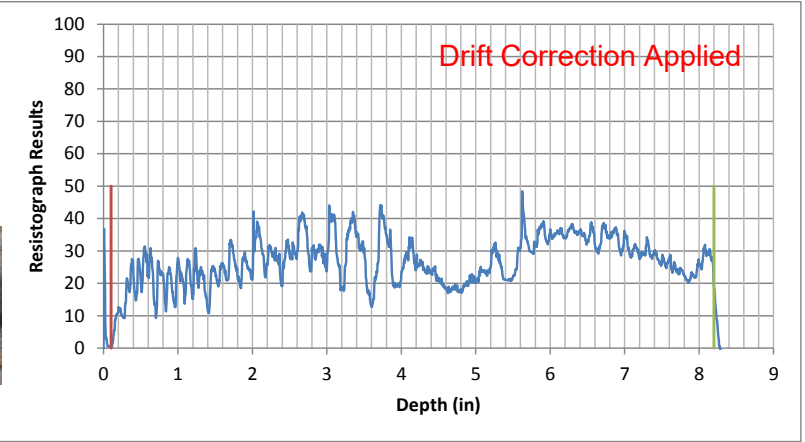
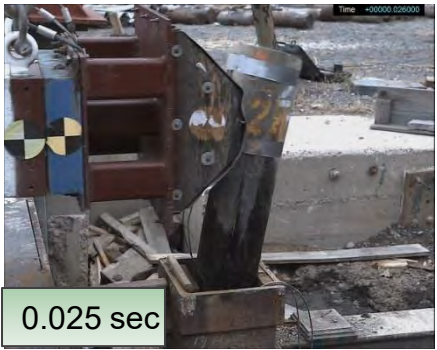
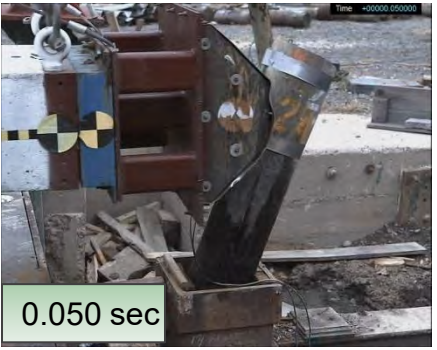
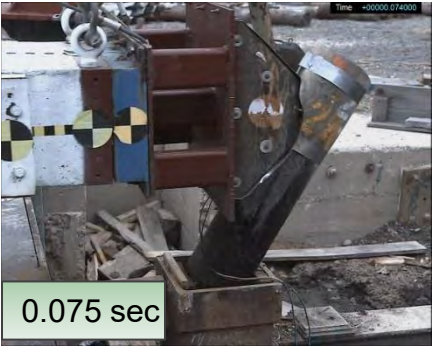
Fractured Post

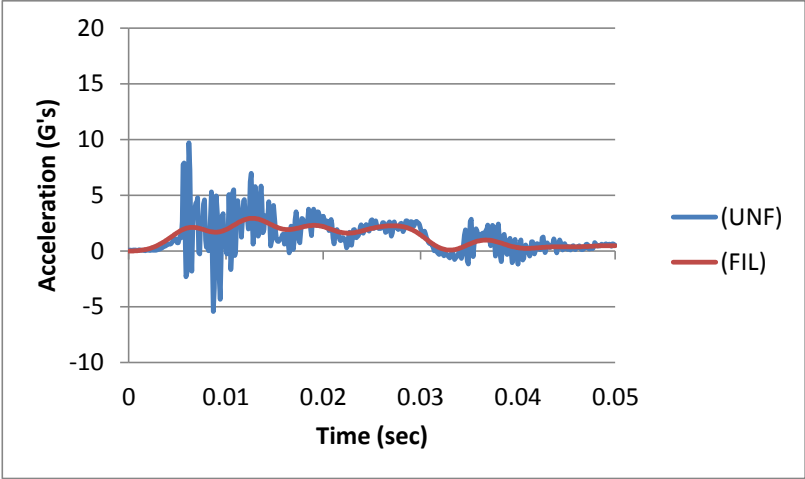
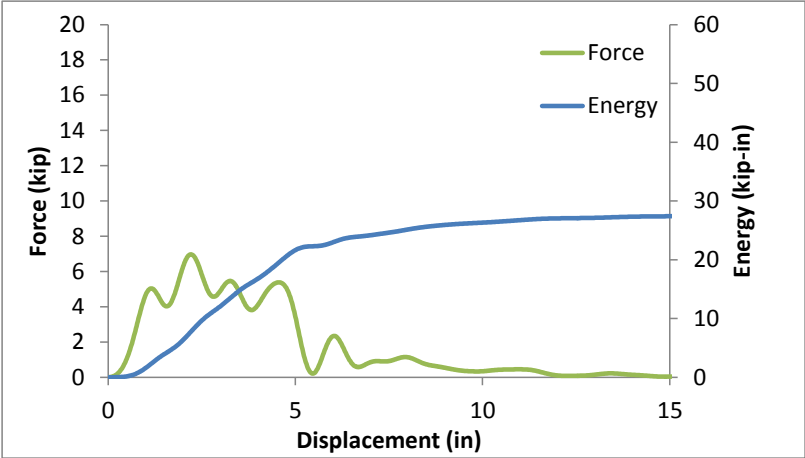
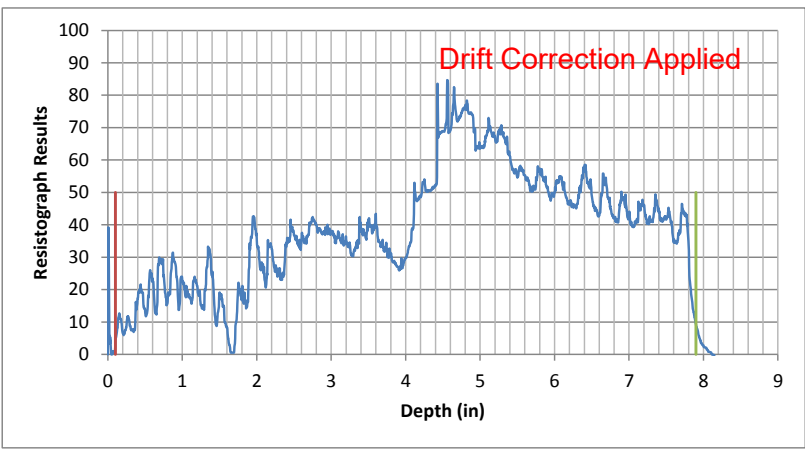
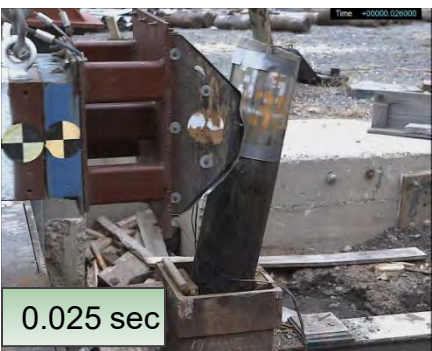
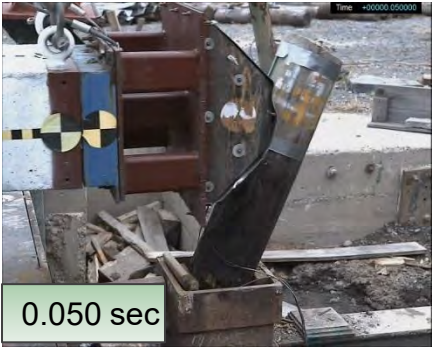
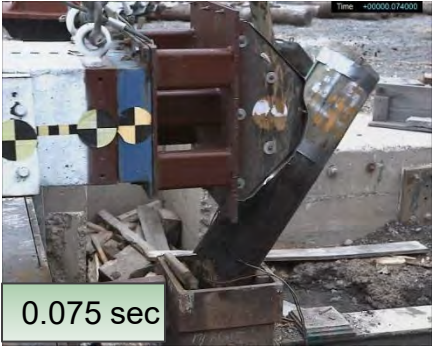
Post Number:	35
Post Type:	Round SYP
Post Length:	66 inches
Post Diameter:	8.1 inches
Moisture Content:	36.3%
Ring Density (avg.):	5.4 per inch
Resi Score $S_{MOR}$ :	0.66
Resi Score $S_U$ :	0.65

Weight:	2,372 lb
Impact Speed:	10 mph
Impact Height:	21.5 inches

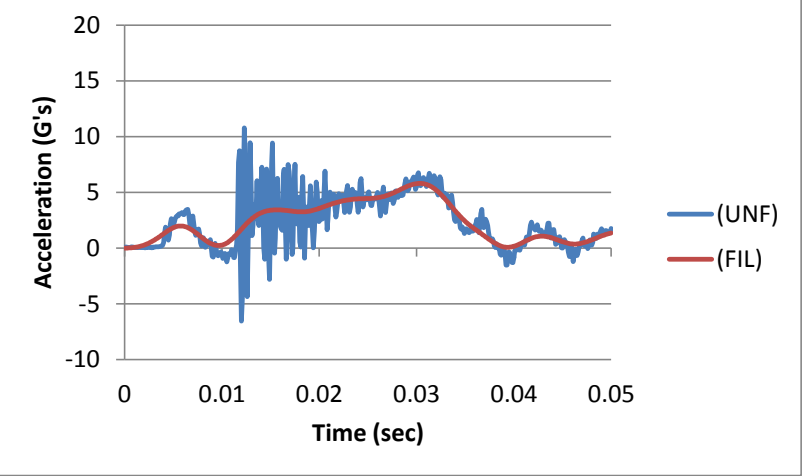
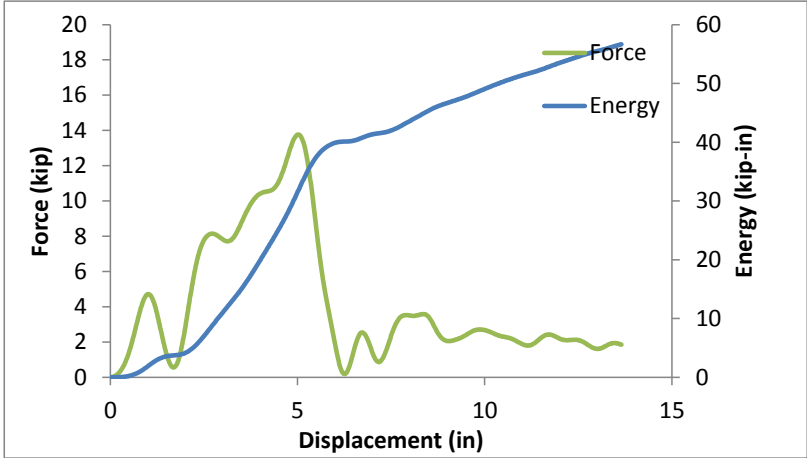
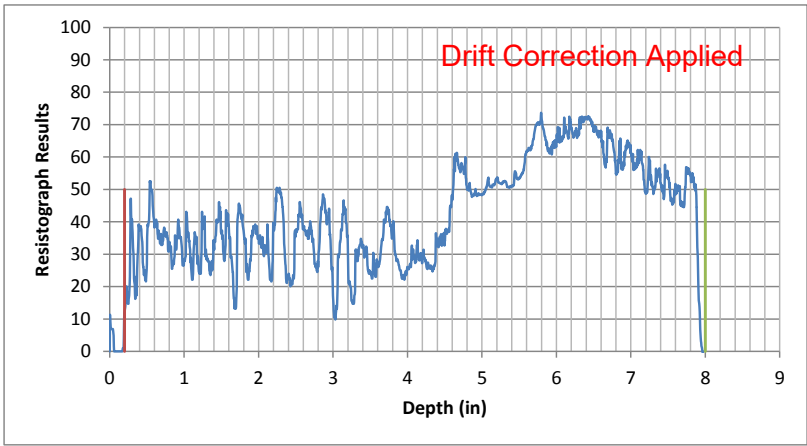
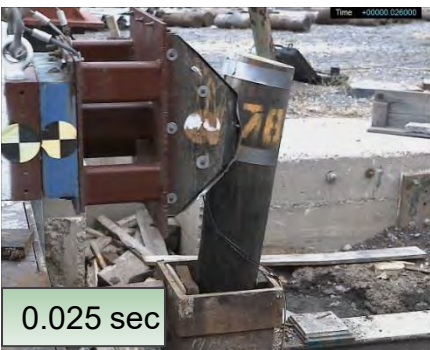
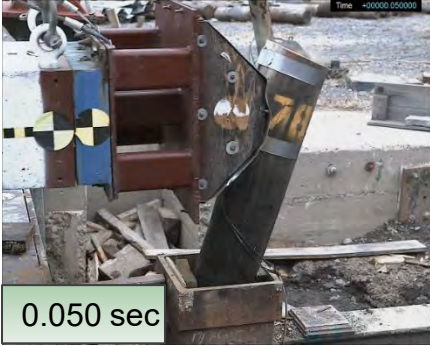
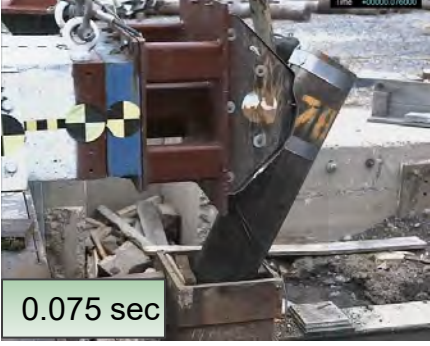
Post Number:	78
Post Type:	Round SYP
Post Length:	66 inches
Post Diameter:	7.6 inches
Moisture Content:	>50%
Ring Density (avg.):	6.3 per inch
Resi Score $S_{MOR}$ :	0.92
Resi Score $S_U$ :	0.91

Weight:	2,372 lb
Impact Speed:	10 mph
Impact Height:	21.5 inches

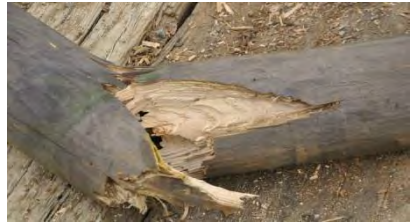
Ring density at bottom of post

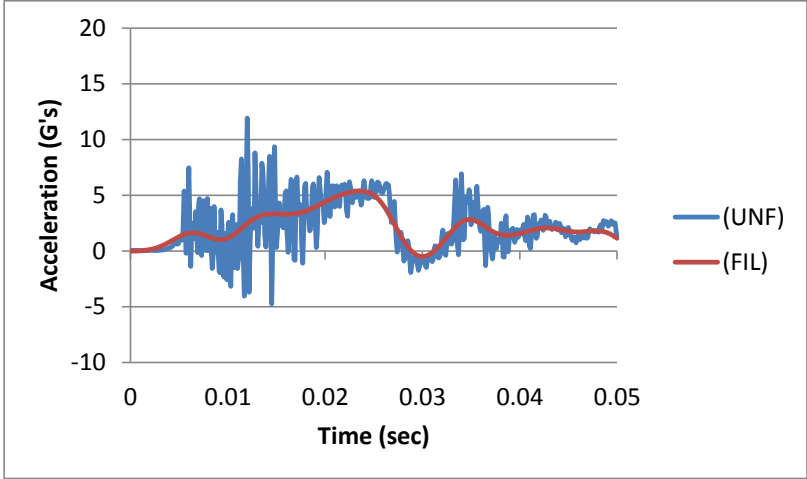
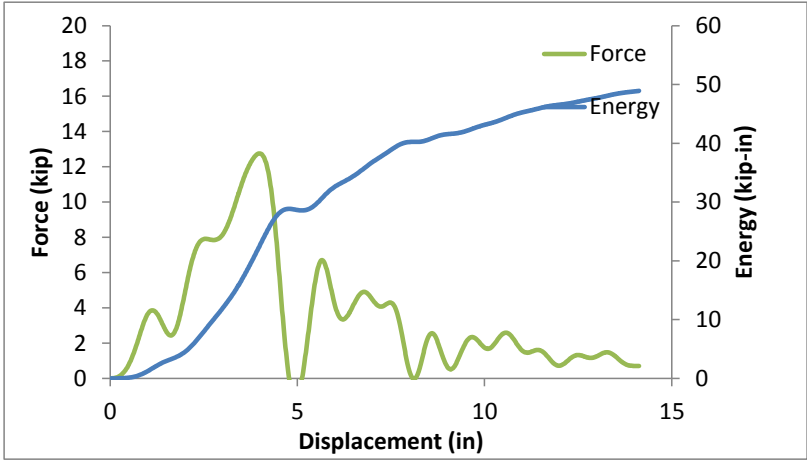
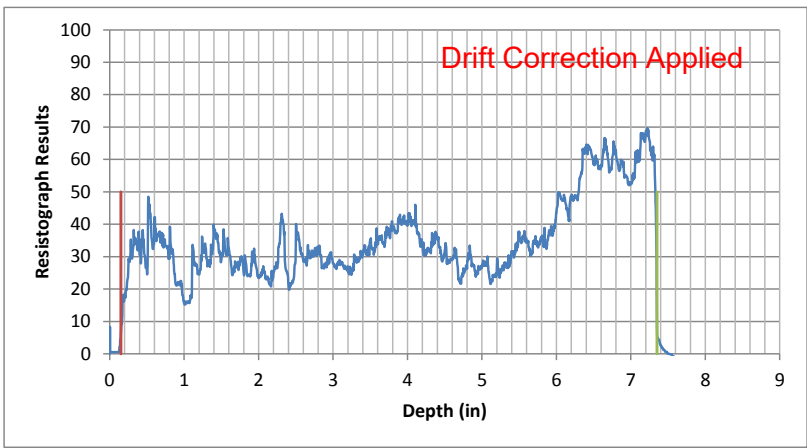
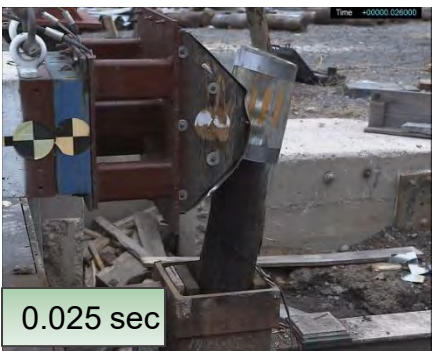
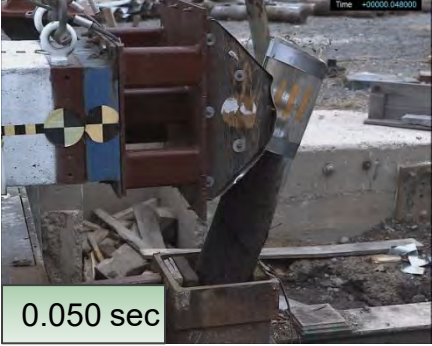
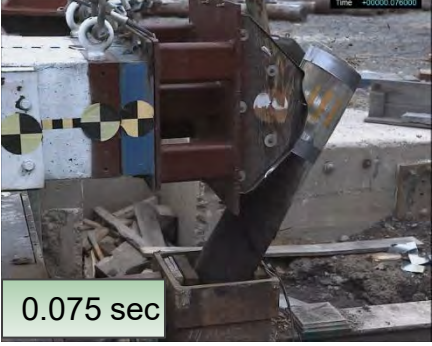
Post Number:	111
Post Type:	Round SYP
Post Length:	66 inches
Post Diameter:	7.6 inches
Moisture Content:	>50%
Ring Density (avg.):	7.4 per inch
Resi Score $S_{MOR}$ :	0.72
Resi Score $S_U$ :	0.77

Weight:	2,372 lb
Impact Speed:	10 mph
Impact Height:	21.5 inches
