# **A Guide for W-Beam Guardrail Damage Assessment**

A Field Manual for  
Highway Maintenance Personnel

National Cooperative  
Highway Research  
Program  
Project 22-28

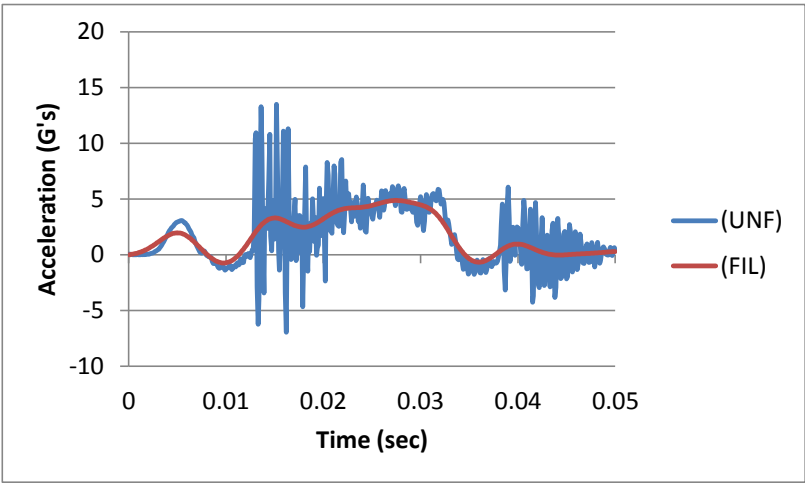
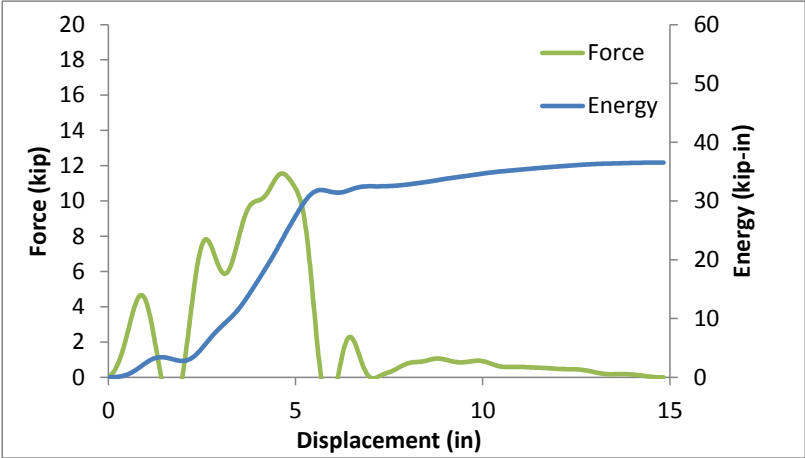
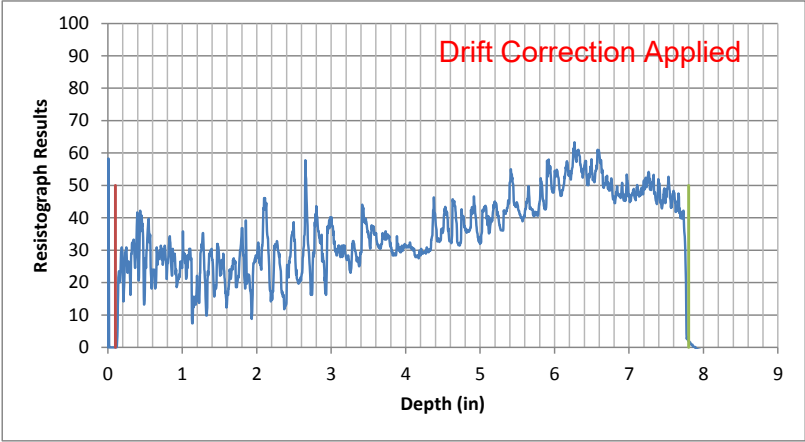
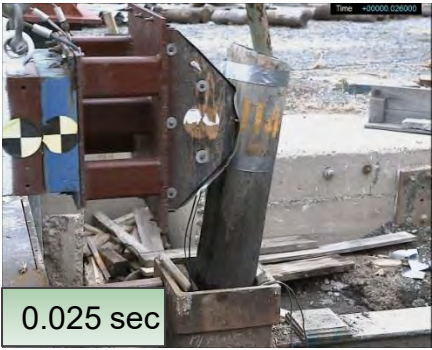
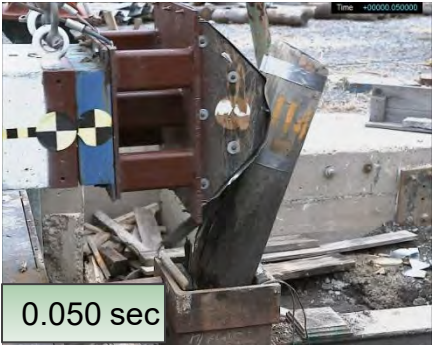
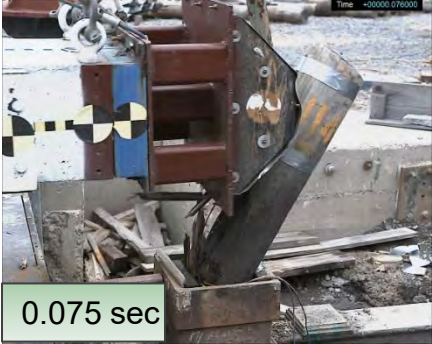
Post Number:	114
Post Type:	Round SYP
Post Length:	66 inches
Post Diameter:	8.0 inches
Moisture Content:	48%
Ring Density (avg.):	8.8 per inch
Resi Score $S_{MOR}$ :	0.76
Resi Score $S_U$ :	0.76

Weight:	2,372 lb
Impact Speed:	10 mph
Impact Height:	21.5 inches

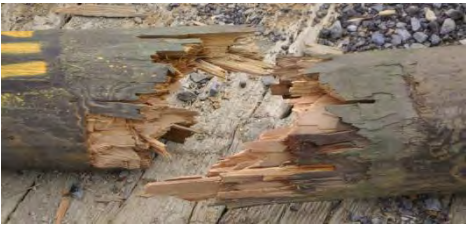
Ring density at bottom of post

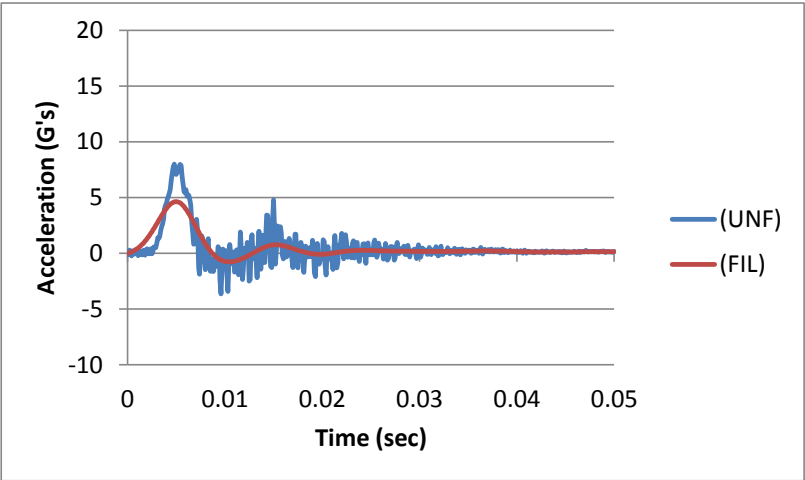
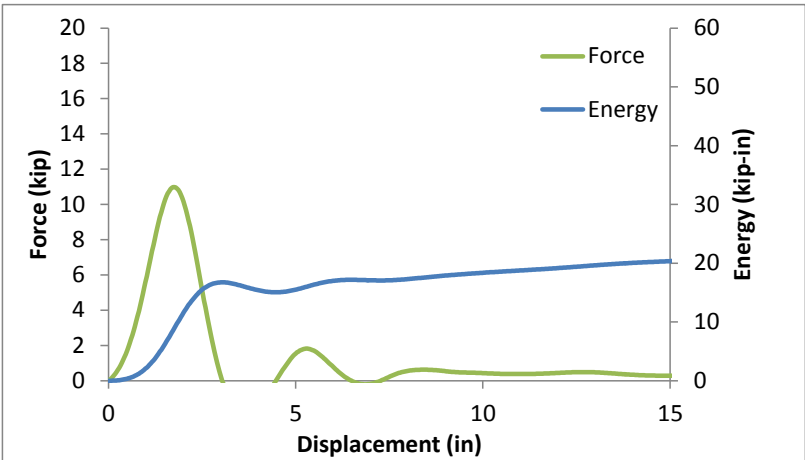
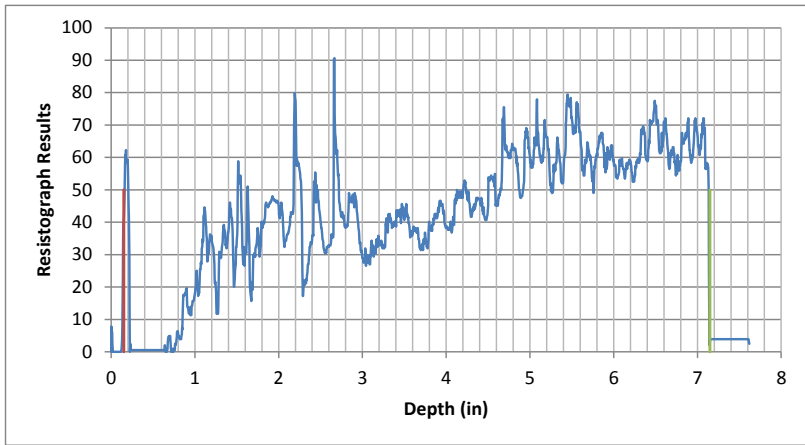
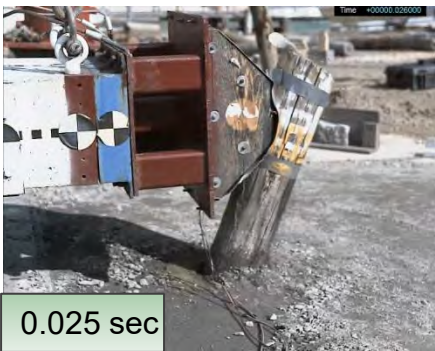
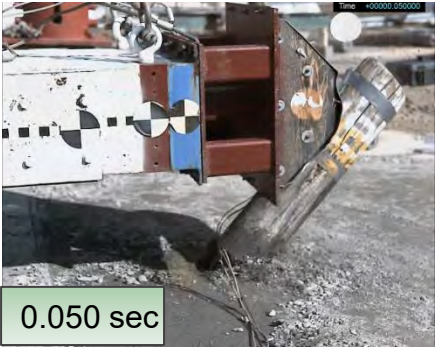
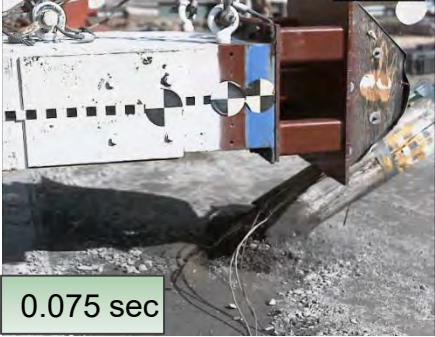
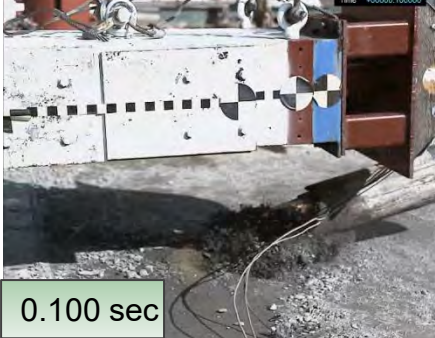
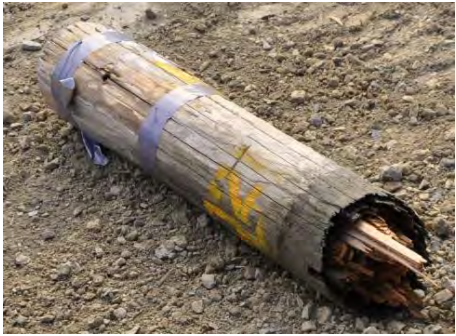
Post Number:	102
Post Type:	Round SYP
Post Length:	68 inches
Post Diameter:	7.6 inches
Embedment Depth:	40 inches
Moisture Content:	>50%
Ring Density (avg.):	8.4 per inch
Resi Score $S_M$ :	0.63
Resi Score $S_U$ :	0.69

Dry Density:	148.3 pcf
Moisture Content:	4.0 percent
Compaction:	98.7 percent

Weight:	2,372 lb
Impact Speed:	20 mph
Impact Height:	21.5 inches

Fractured Post

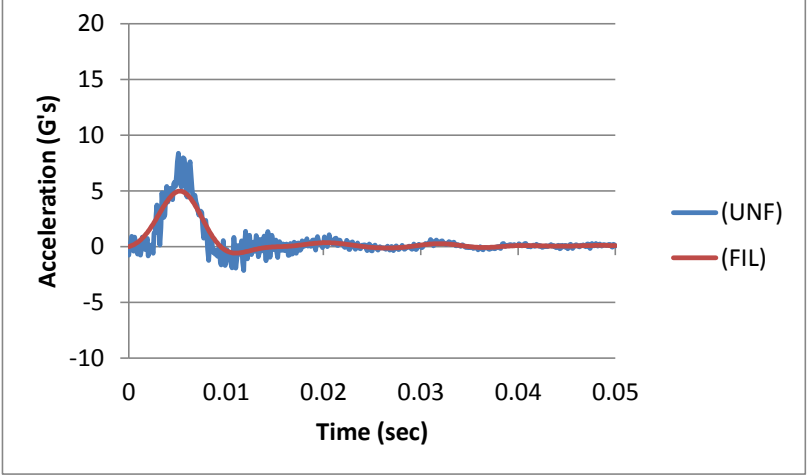
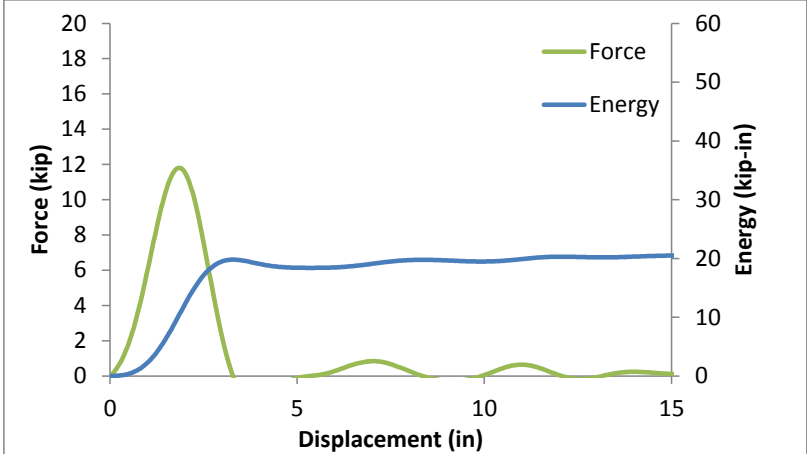
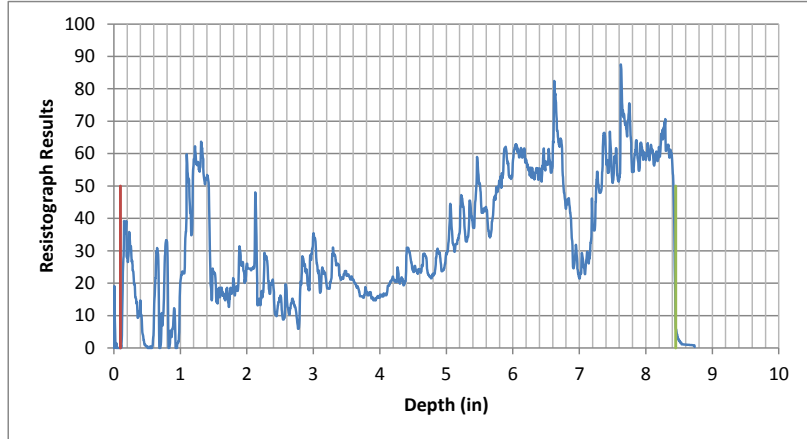
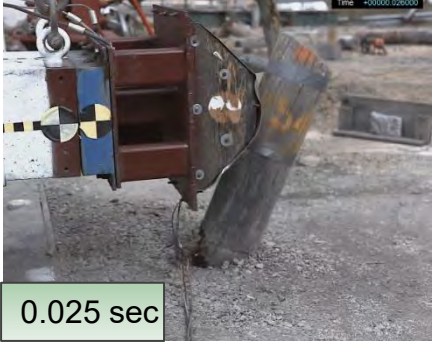
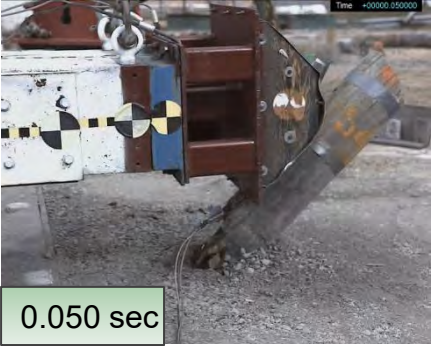
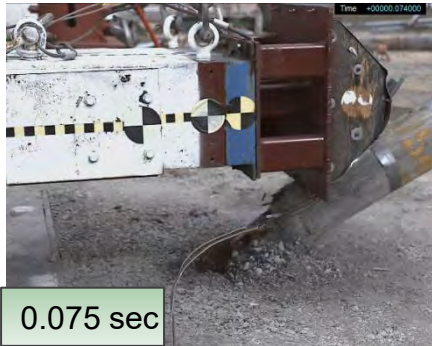
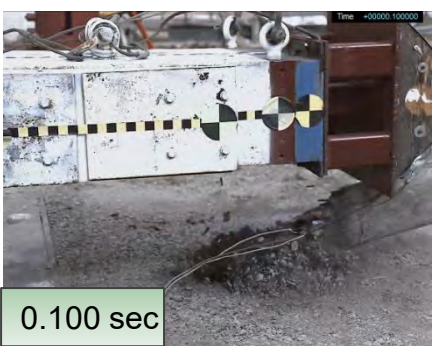
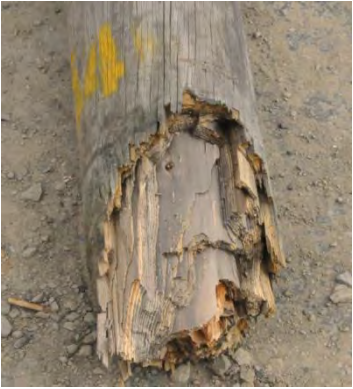
Post Number:	54
Post Type:	Round SYP
Post Length:	68 inches
Post Diameter:	8.4 inches
Embedment Depth:	40 inches
Moisture Content:	38 percent
Ring Density (avg.):	12.0 per inch
Resi Score $S_{MOR}$ :	1.04
Resi Score $S_U$ :	0.95

Weight:	2,372 lb
Impact Speed:	20 mph
Impact Height:	21.5 inches

Fractured Post

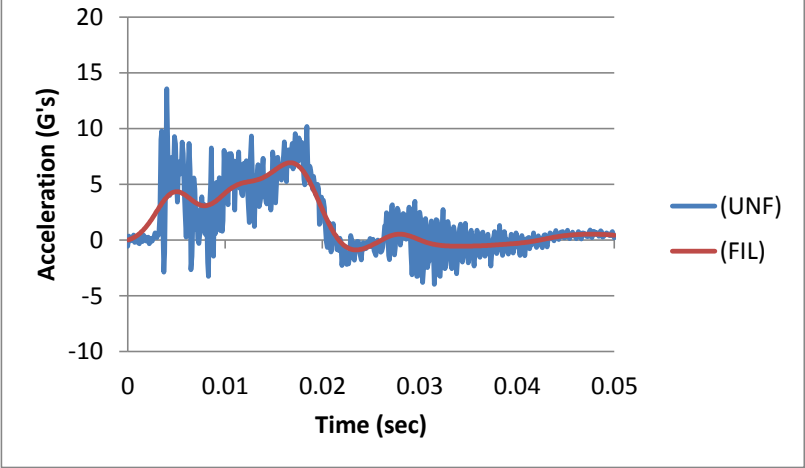
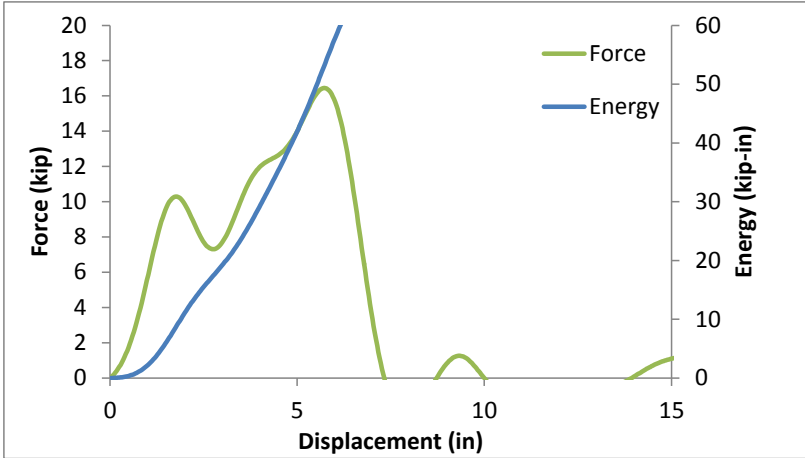
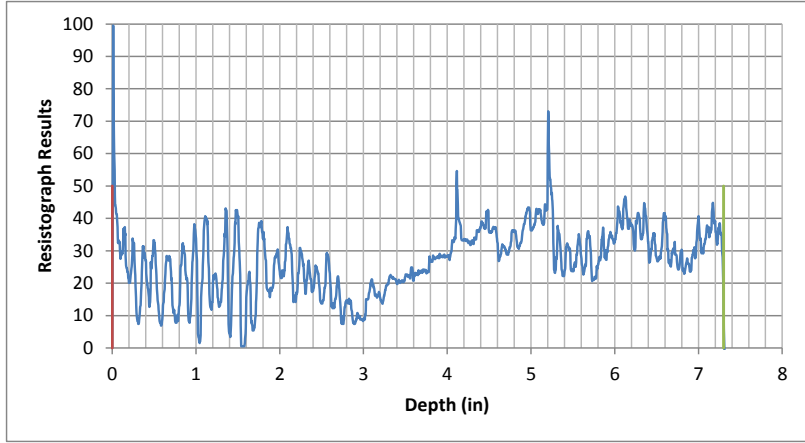
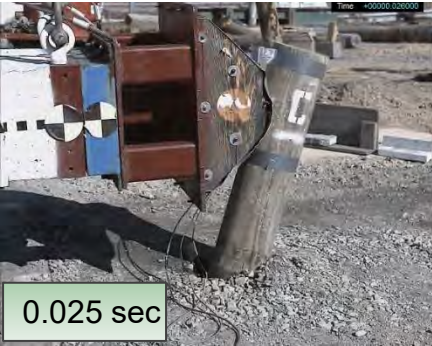
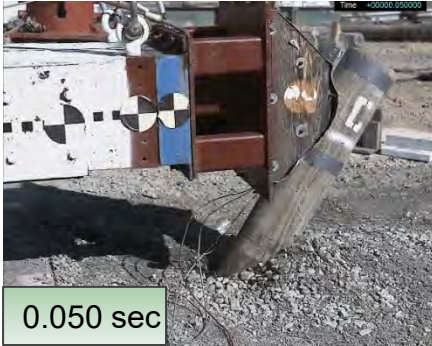
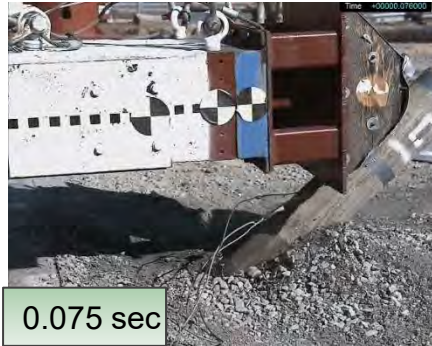
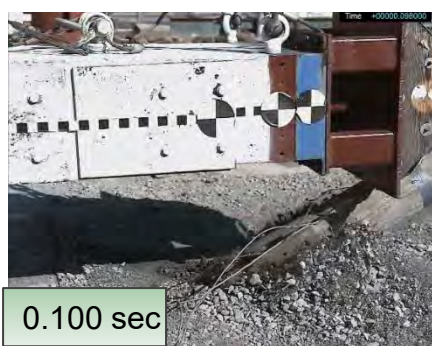
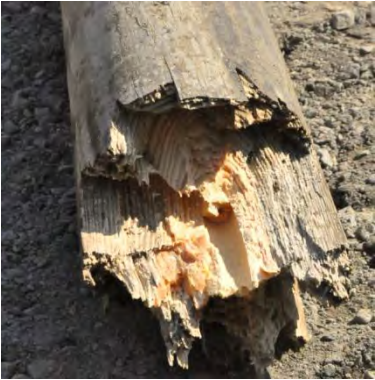
Post Number:	C
Post Type:	Round SYP
Post Length:	68 inches
Post Diameter:	7.3 inches
Embedment Depth:	40 inches
Moisture Content:	25 percent
Ring Density (avg.):	8.2 per inch
Resi Score $S_{MOR}$ :	0.51
Resi Score $S_U$ :	0.54

Dry Density:	142.1 pcf
Moisture Content:	3.6 percent
Compaction:	94.7 percent

Weight:	2,372 lb
Impact Speed:	20 mph
Impact Height:	21.5 inches

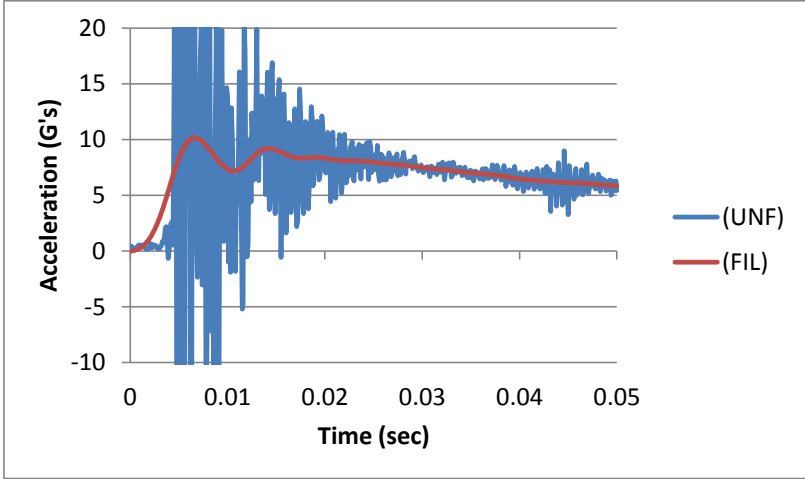
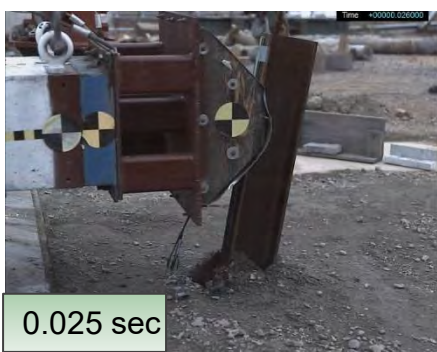
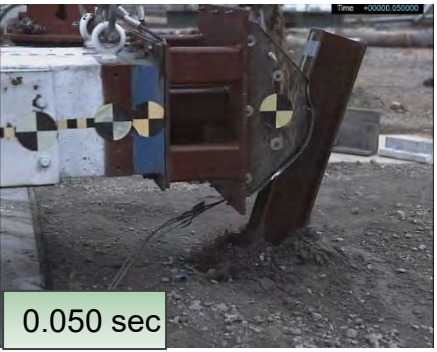
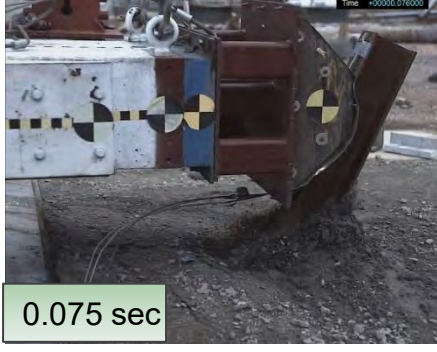
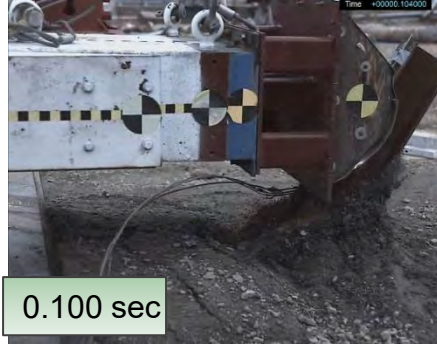
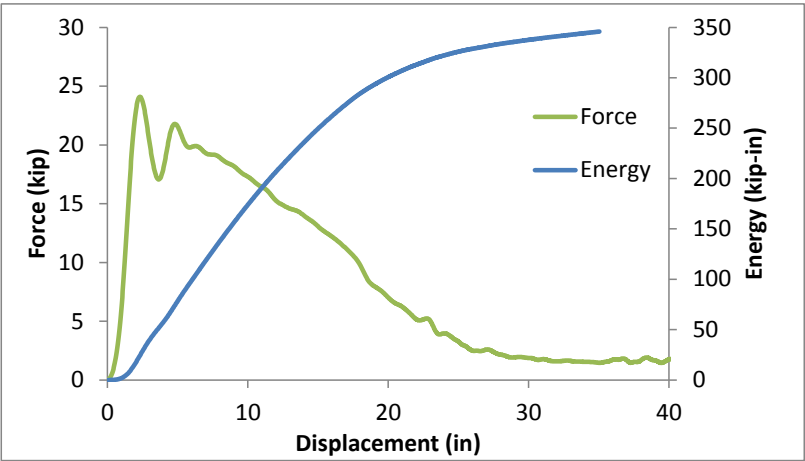
Test Number:	13010D
Test Date:	29-Oct-2013

Post Number:	
Post Type:	W6x16
Post Length:	72 inches
Post Diameter:	N/A
Embedment Depth:	40 inches
Moisture Content:	N/A
Ring Density (avg.):	N/A
Resi Score $S_{MOR}$ :	N/A
Resi Score $S_U$ :	N/A

Dry Density:	143.5 pcf
Moisture Content:	3.8 percent
Compaction:	95.6 percent

Weight:	2,372 lb
Impact Speed:	20 mph
Impact Height:	24.9 inches

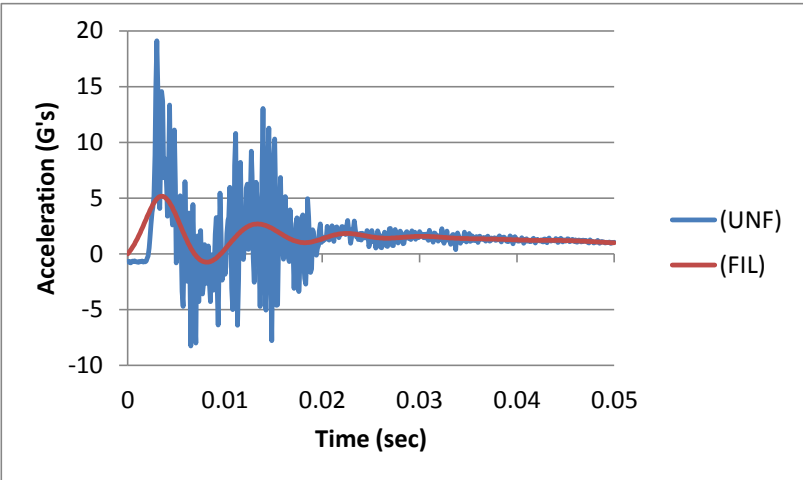
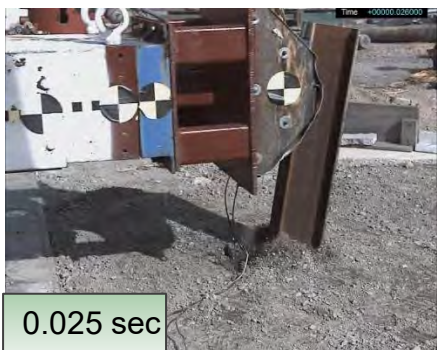
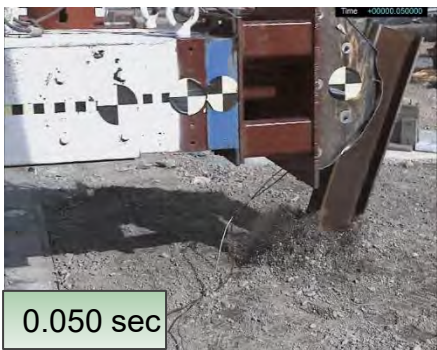
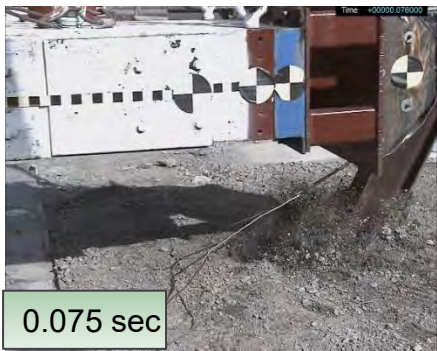
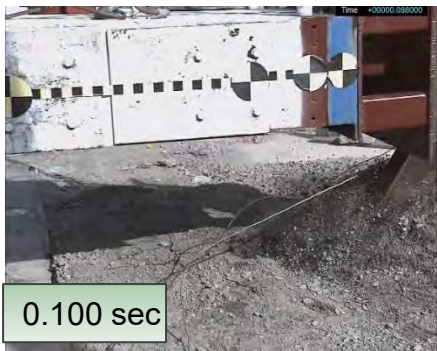
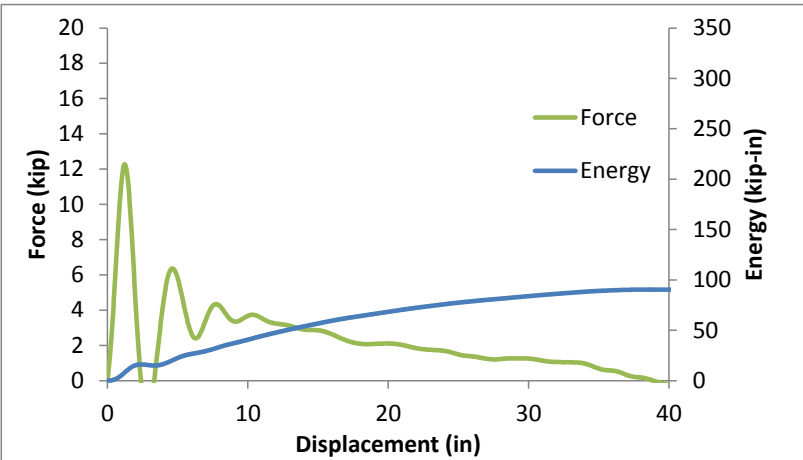
Test Number:	13010E
Test Date:	4-Nov-2013

Post Number:	
Post Type:	W6x16
Post Length:	72 inches
Post Diameter:	N/A
Embedment Depth:	40 inches
Moisture Content:	N/A
Ring Density (avg.):	N/A
Resi Score $S_{MOR}$ :	N/A
Resi Score $S_U$ :	N/A

Dry Density:	132.4 pcf
Moisture Content:	3.1 percent
Compaction:	88.1 percent

Weight:	2,372 lb
Impact Speed:	20 mph
Impact Height:	24.9 inches

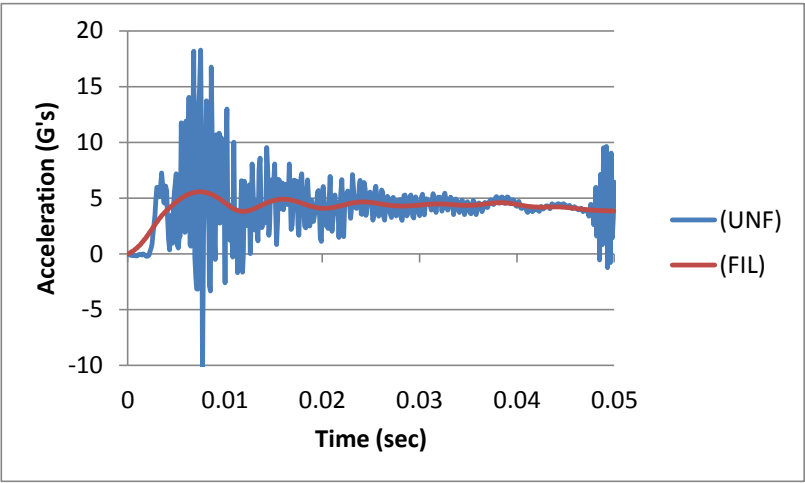
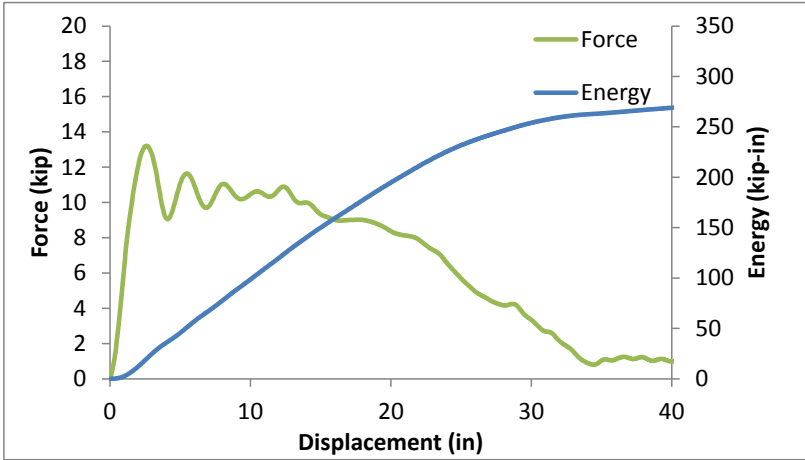
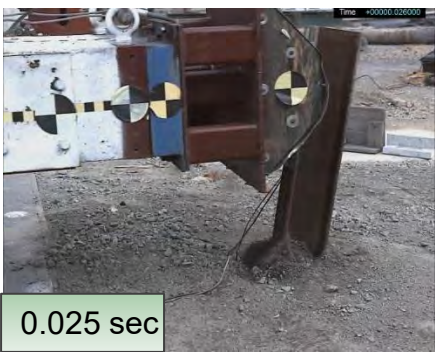
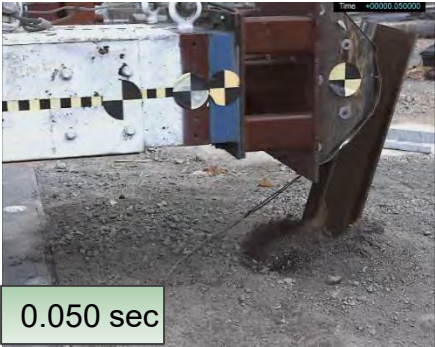
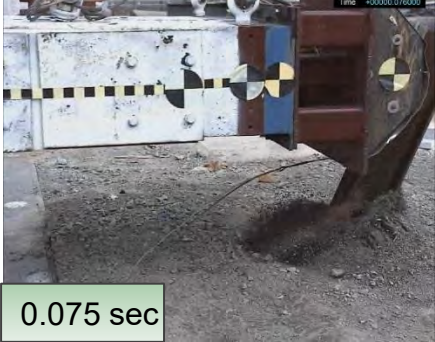
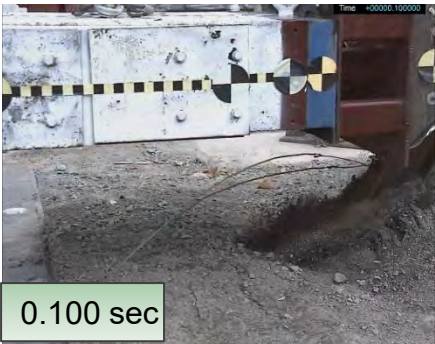
Post Number:	
Post Type:	W6x16
Post Length:	72 inches
Post Diameter:	N/A
Embedment Depth:	40 inches
Moisture Content:	N/A
Ring Density (avg.):	N/A
Resi Score $S_{MOR}$ :	N/A
Resi Score $S_U$ :	N/A

Dry Density:	138.4 pcf
Moisture Content:	3.3 percent
Compaction:	92.1 percent

**Pendulum Properties**

Weight:	2,372 lb
Impact Speed:	20 mph
Impact Height:	24.9 inches

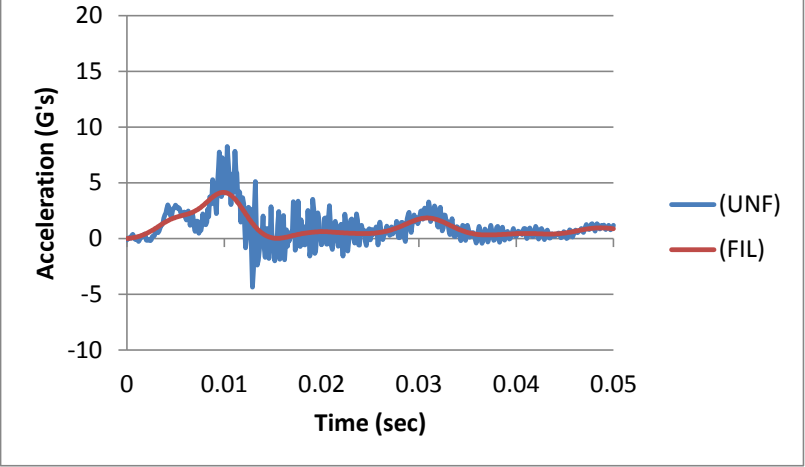
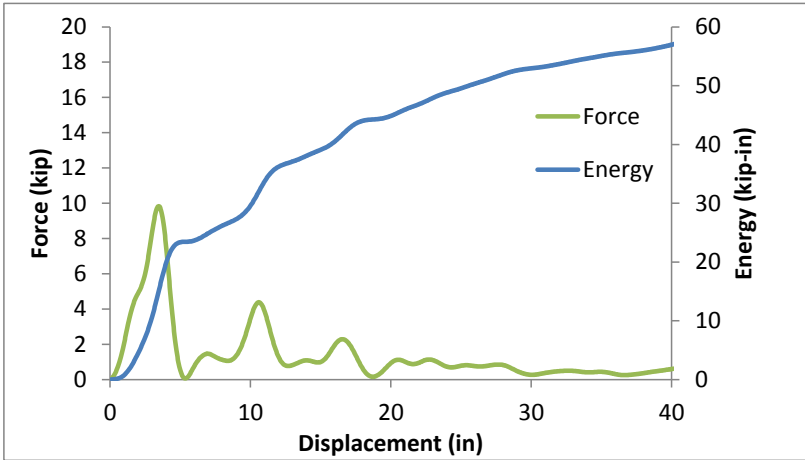
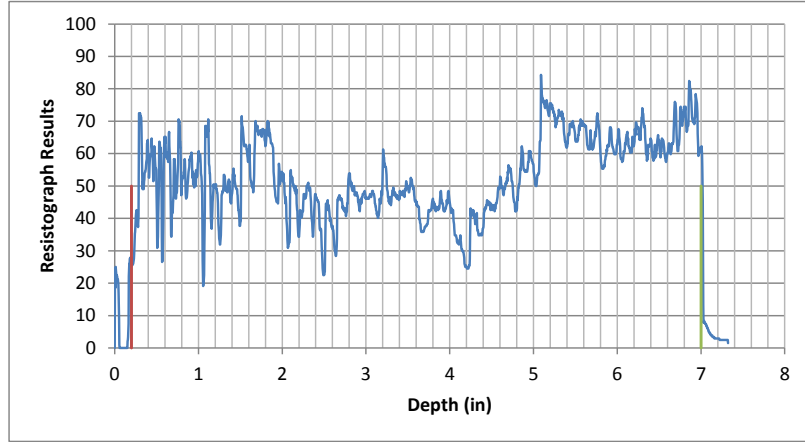
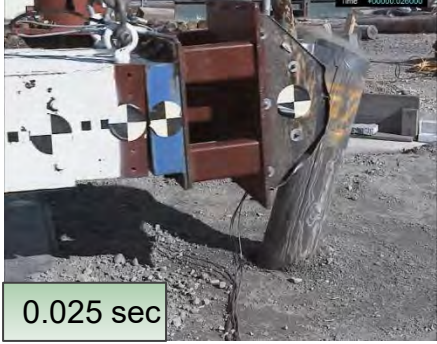
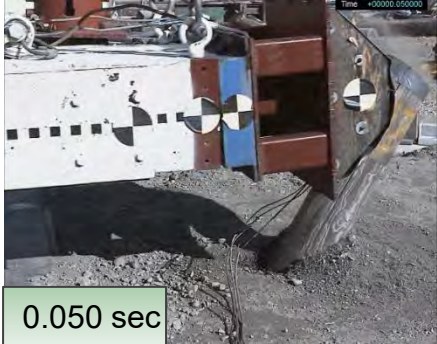
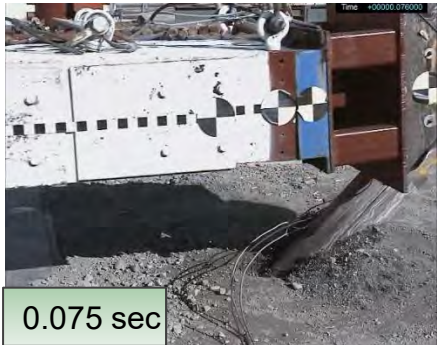
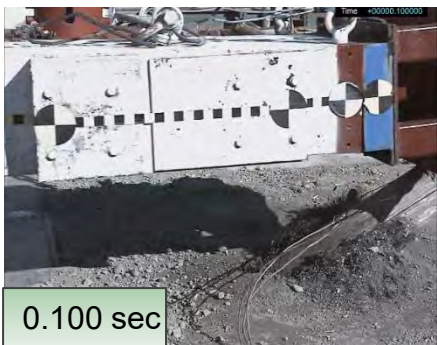
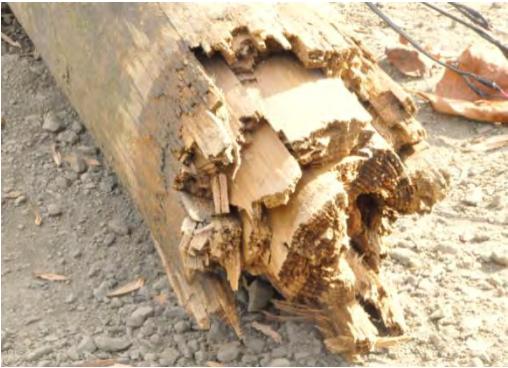
Test Number:	13010G
Test Date:	8-Nov-2013

Post Number:	57
Post Type:	Round SYP
Post Length:	68 inches
Post Diameter:	7.2 inches
Embedment Depth:	40 inches
Moisture Content:	39 percent
Ring Density (avg.):	9.2 per inch
Resi Score $S_M$ :	0.86
Resi Score $S_U$ :	0.97

Dry Density:	138.6 pcf
Moisture Content:	3.4 percent
Compaction:	92.3 percent

**Pendulum Properties**

Weight:	2,372 lb
Impact Speed:	20 mph
Impact Height:	24.8 inches

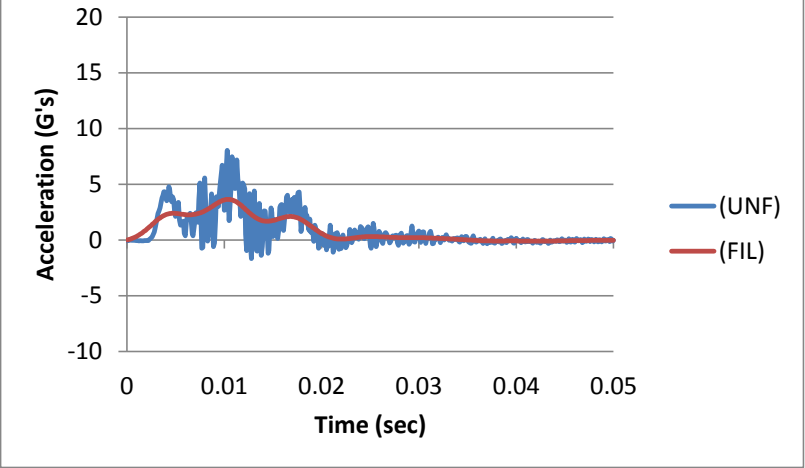
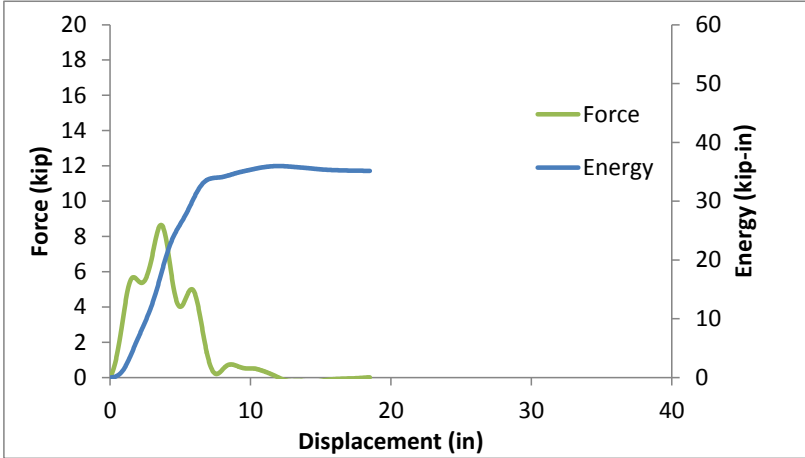
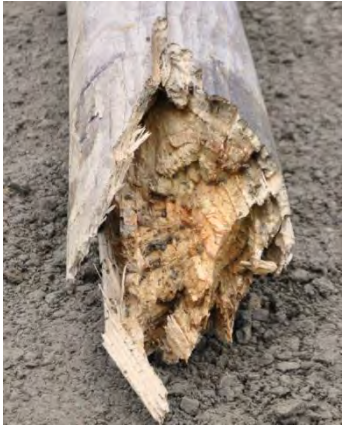
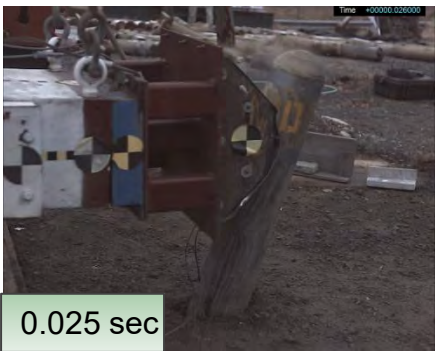
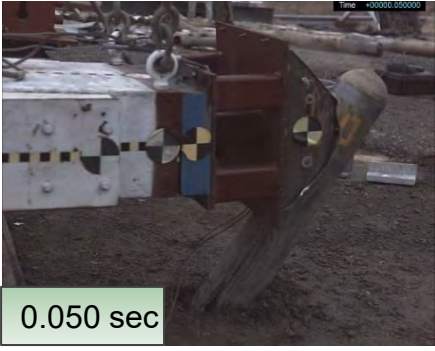
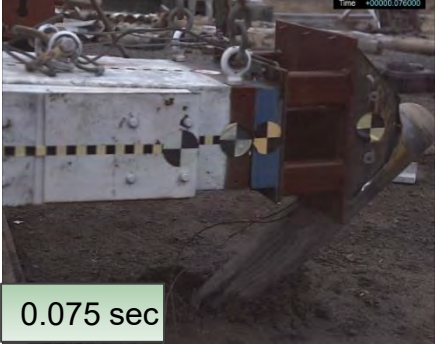
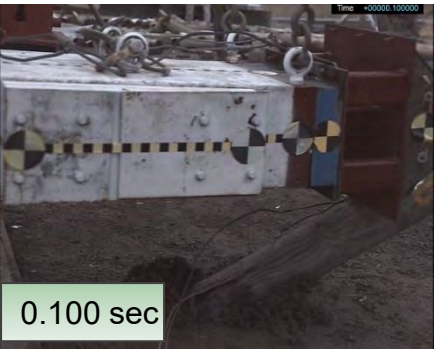
Test Number:	13010H
Test Date:	16-Dec-2013

Post Number:	D
Post Type:	Round SYP
Post Length:	72 inches
Post Diameter:	7.5 inches
Embedment Depth:	40 inches
Moisture Content:	35 percent
Ring Density (avg.):	6.4 per inch
Resi Score $S_M$ :	
Resi Score $S_U$ :

Dry Density:	142.4 pcf
Moisture Content:	6.2 percent
Compaction:	94.8 percent

**Pendulum Properties**

Weight:	2,372 lb
Impact Speed:	20 mph
Impact Height:	24.8 inches

Fractured Post

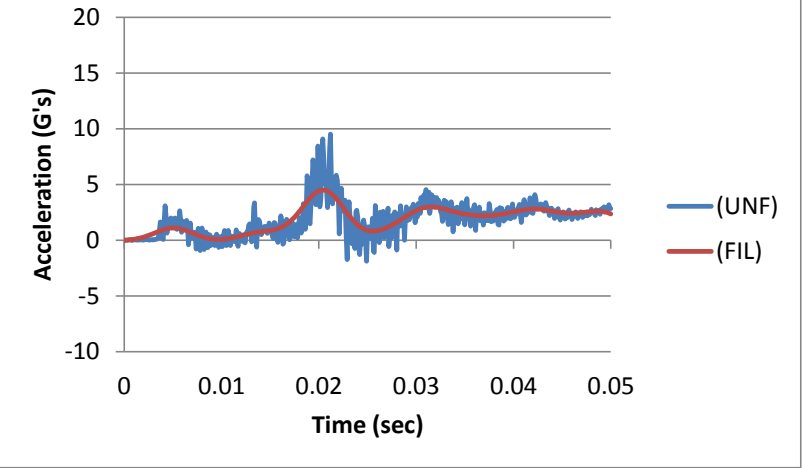
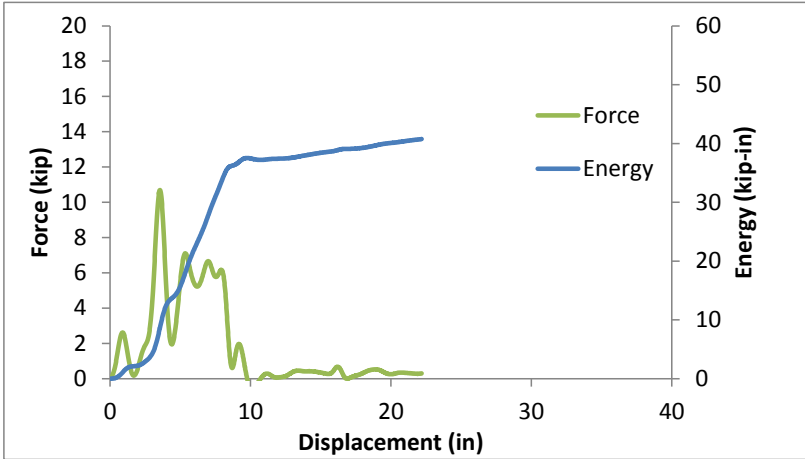
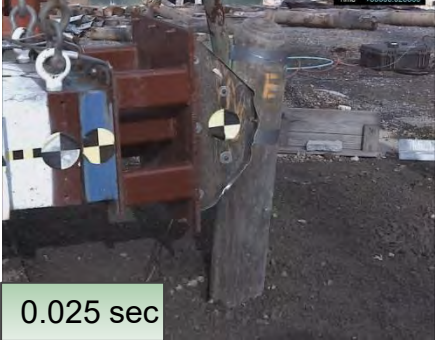
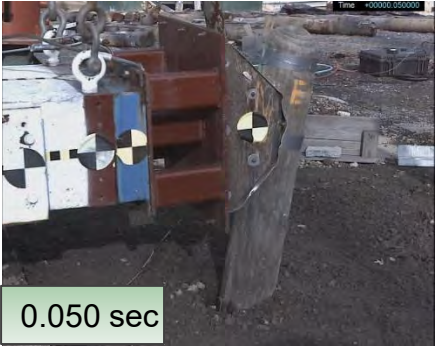
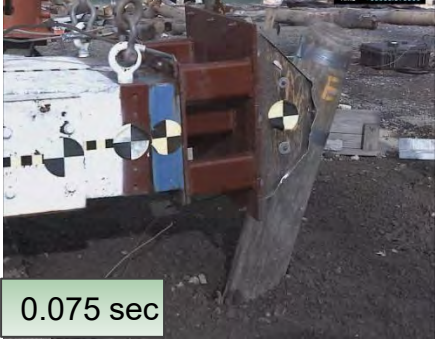
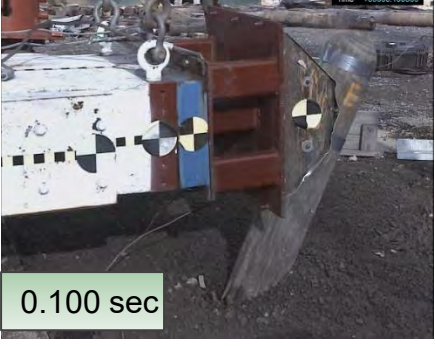
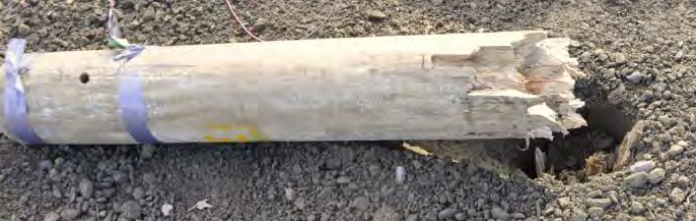
Test Number:	13010I
Test Date:	18-Dec-2013

Post Number:	E
Post Type:	Round SYP
Post Length:	72 inches
Post Diameter:	7.4 inches
Embedment Depth:	40 inches
Moisture Content:	19 percent
Ring Density (avg.):	4.1 per inch
Resi Score $S_M$ :	
Resi Score $S_U$ :

Dry Density:	- pcf
Moisture Content:	- percent
Compaction:	- percent

**Pendulum Properties**

Weight:	2,372 lb
Impact Speed:	10 mph
Impact Height:	24.8 inches

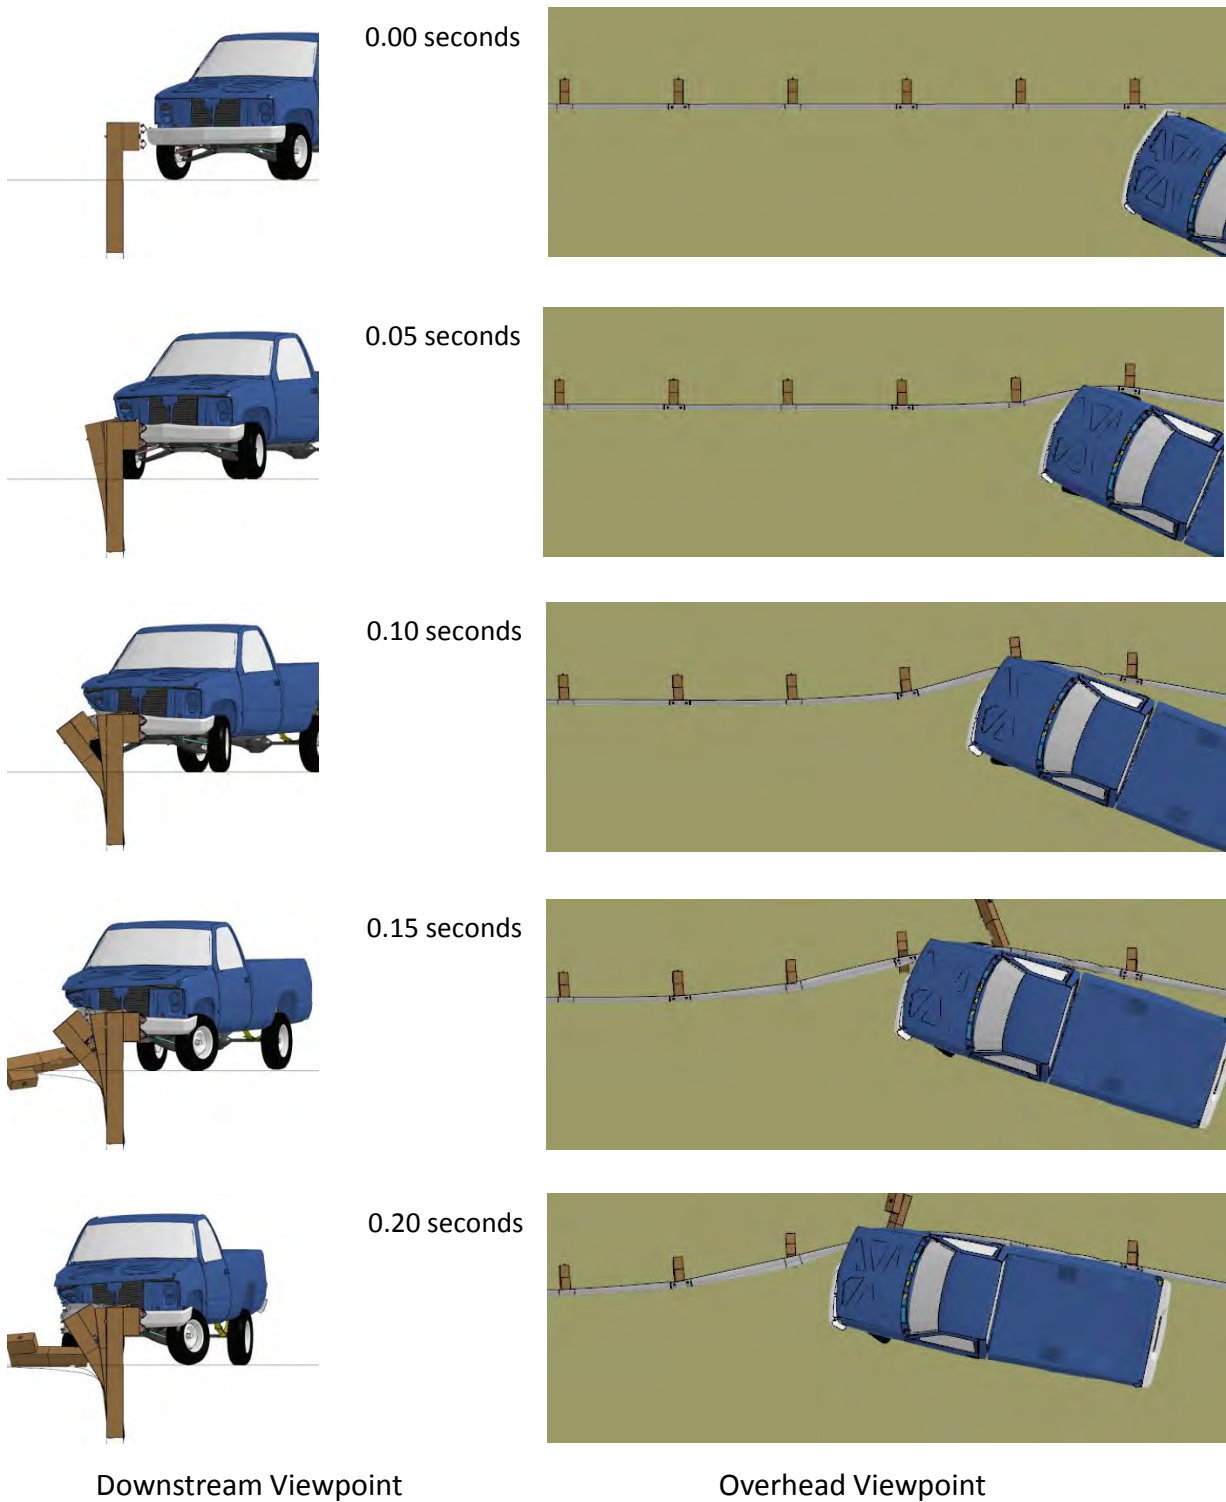
**Figure F-1: Sequential views from Analysis Case DL1 from a downstream and overhead viewpoint.**

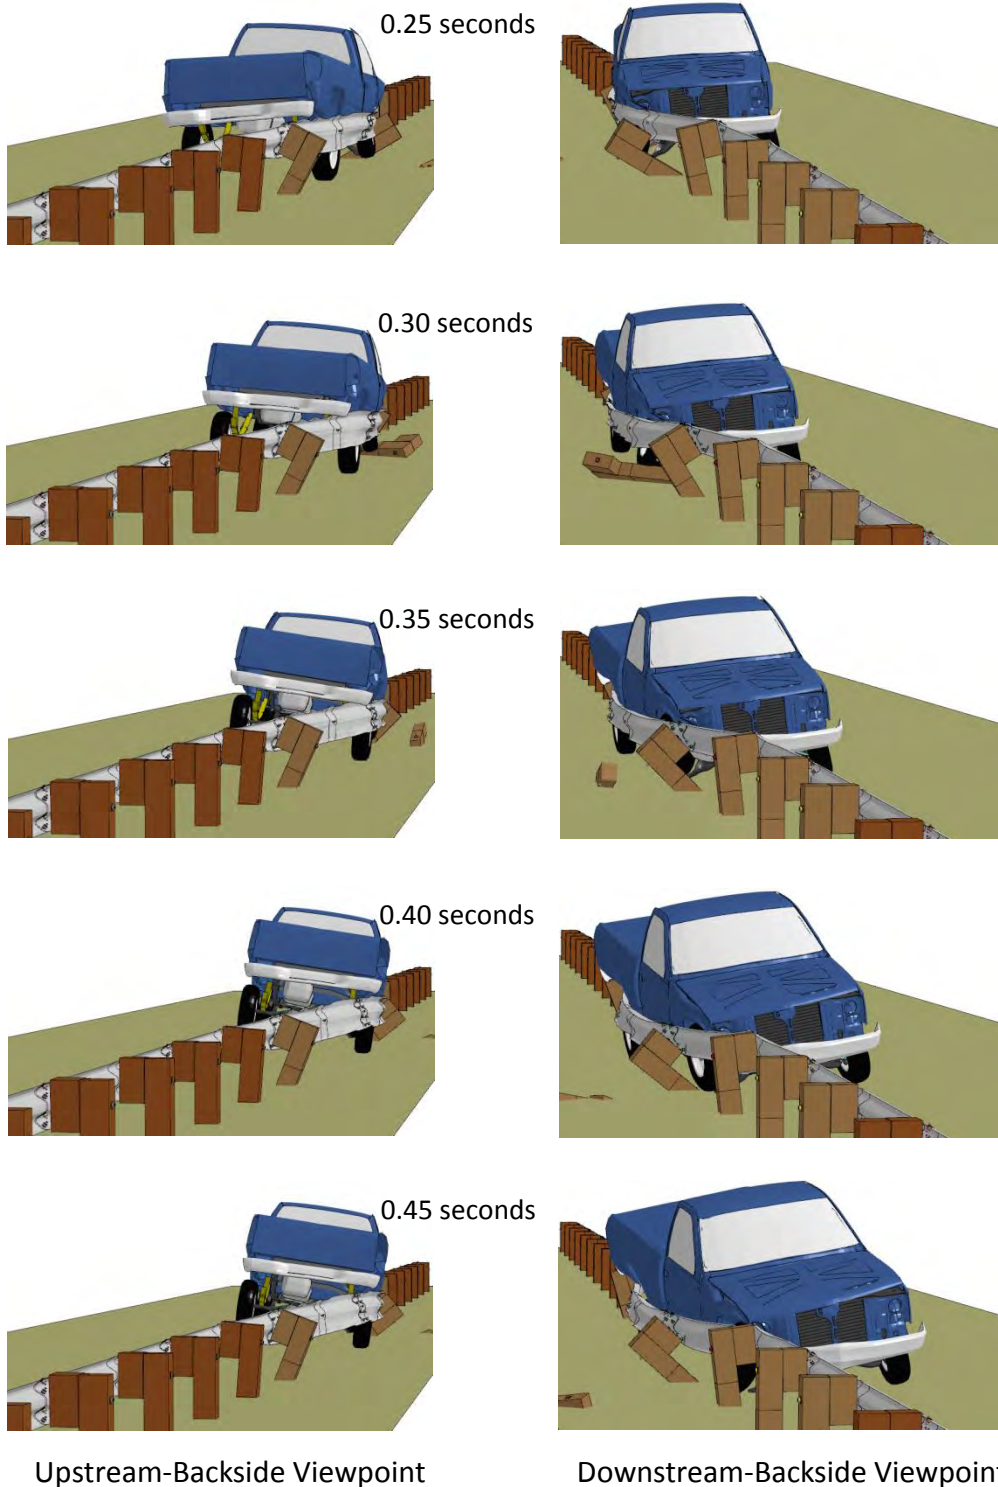
**Figure F-2: [CONTINUED] Sequential views from Analysis Case DL1 from an upstream-backside and downstream-backside viewpoint.**

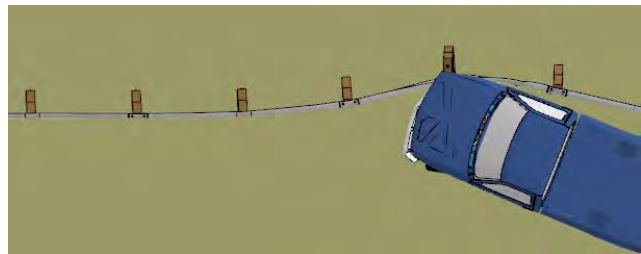
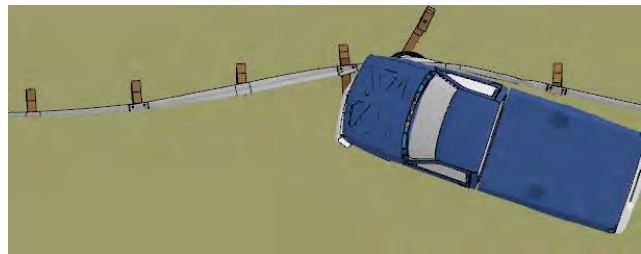
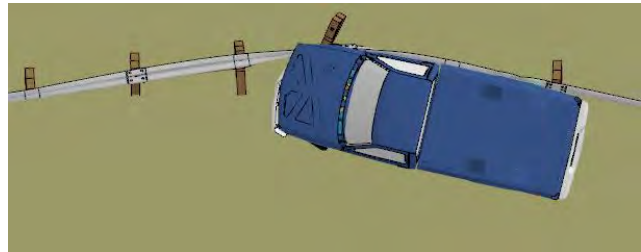
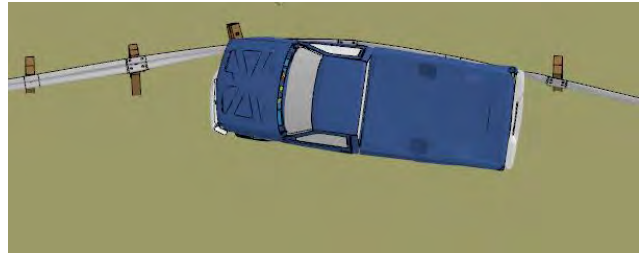
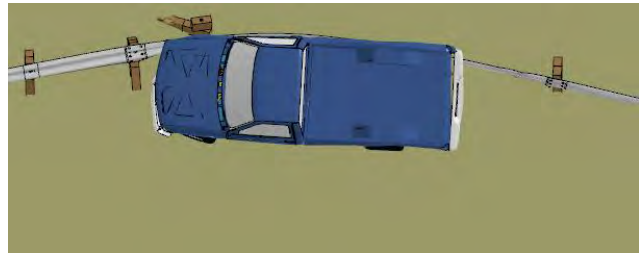
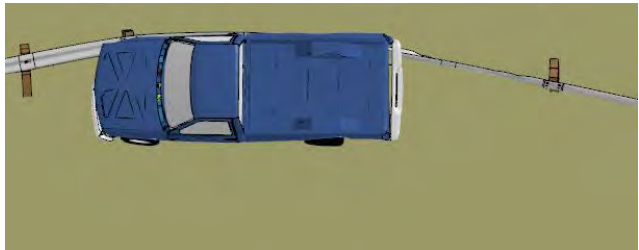
**Figure F-3: [CONTINUED] Sequential views from Analysis Case DL2 from a downstream and overhead viewpoint.**

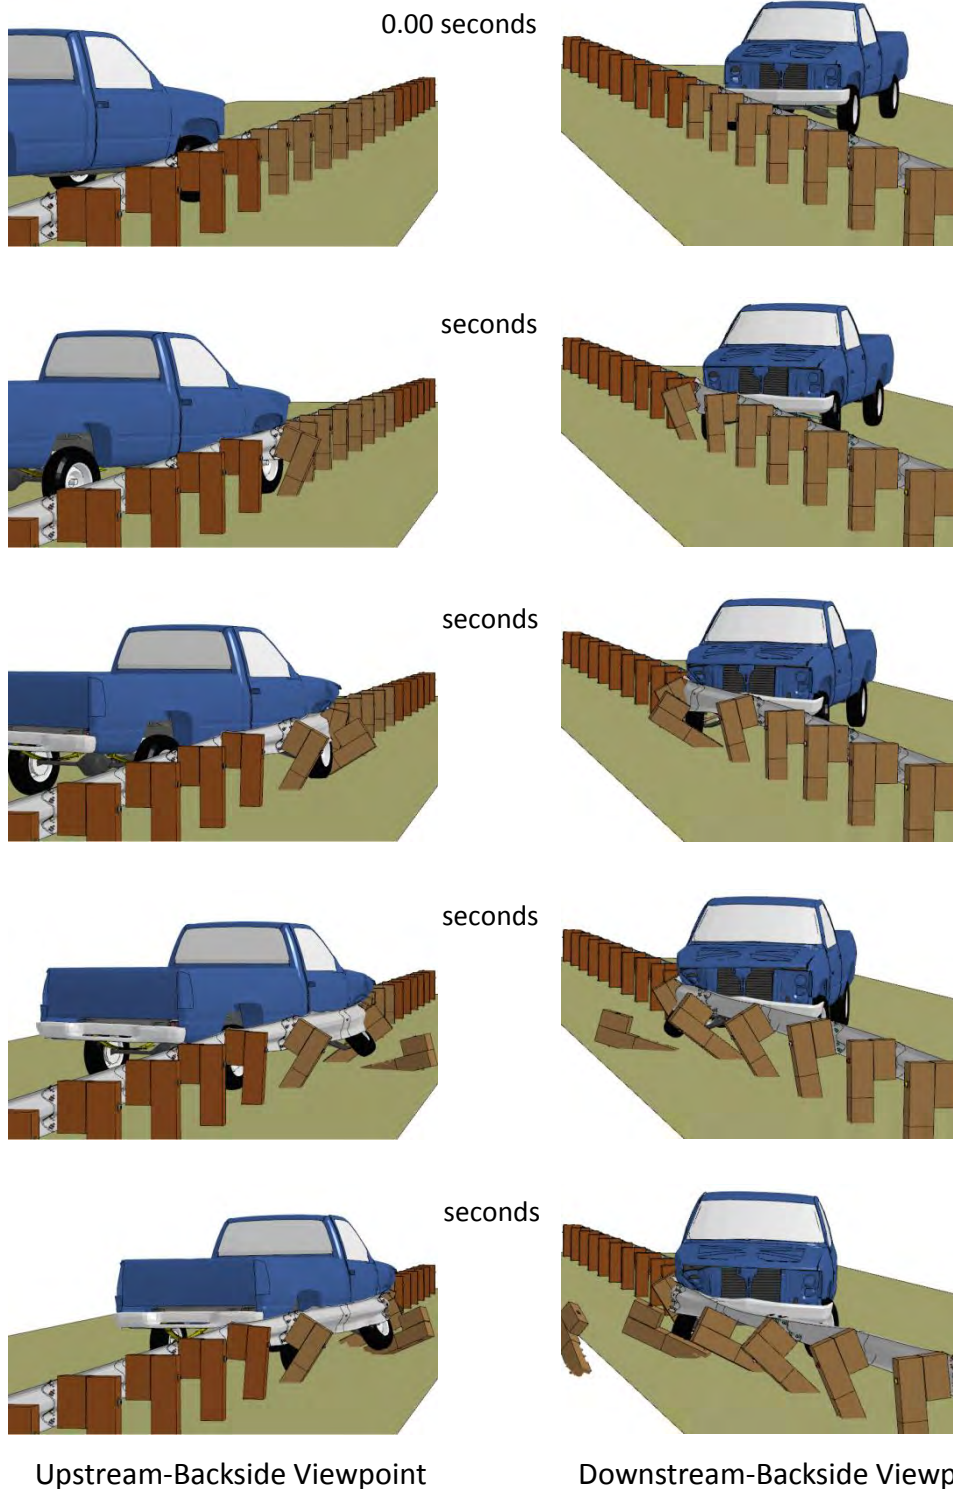
**Figure F-4: Sequential views from Analysis Case DL2 from an upstream-backside and downstream-backside viewpoint.**
