# **A Guide for W-Beam Guardrail Damage Assessment**

A Field Manual for  
Highway Maintenance Personnel

National Cooperative  
Highway Research  
Program  
Project 22-28

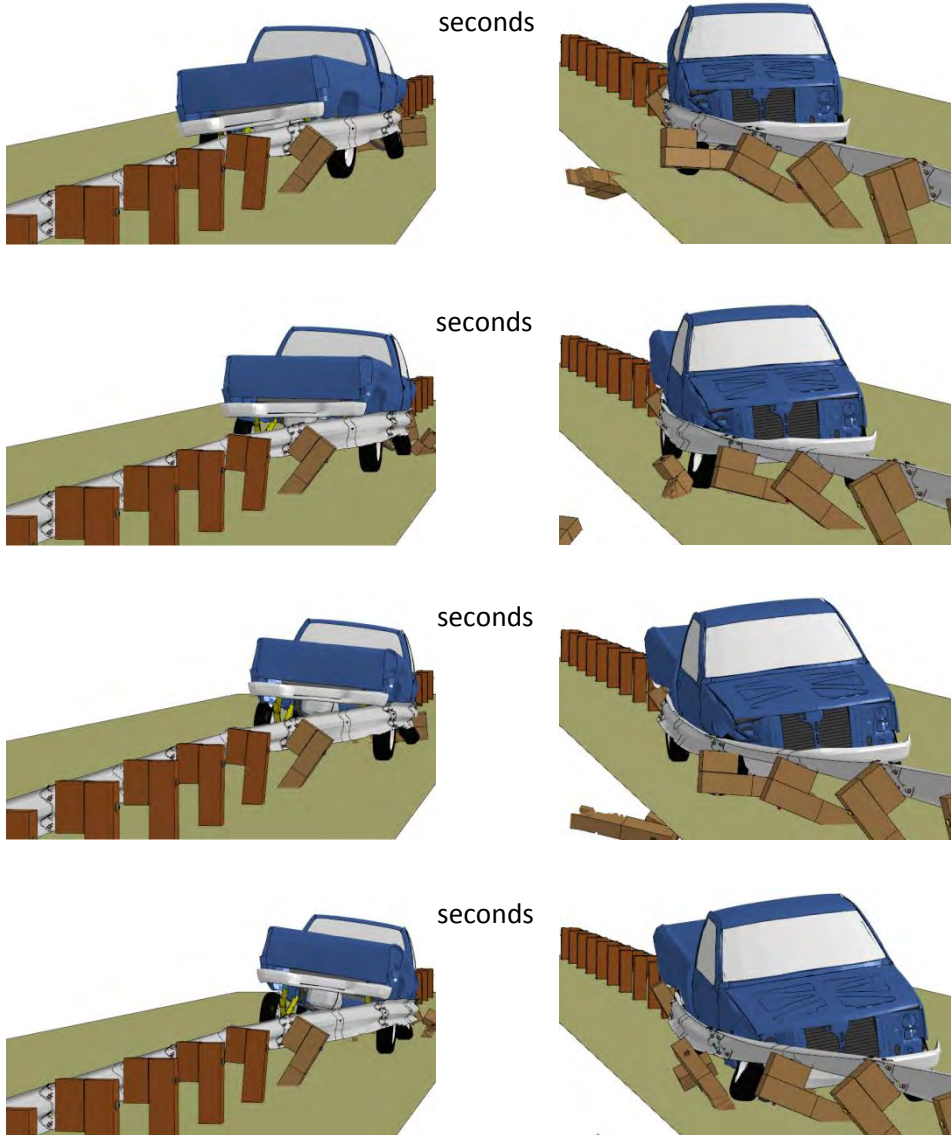
**Figure F-4: [CONTINUED] Sequential views from Analysis Case DL2 from an upstream-backside and downstream-backside viewpoint.**

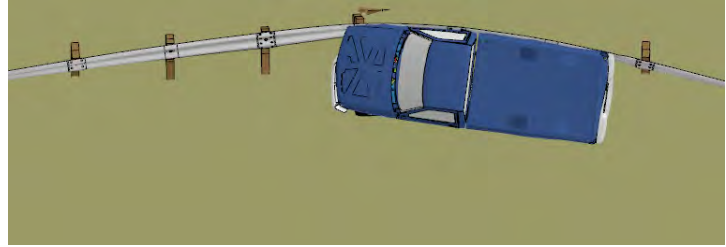
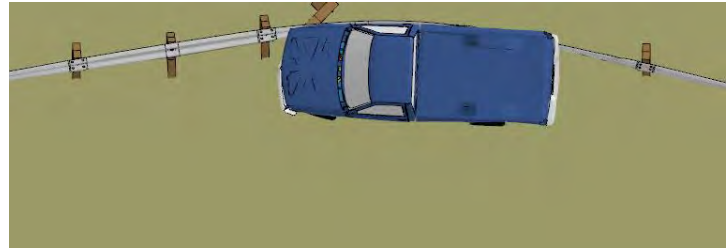
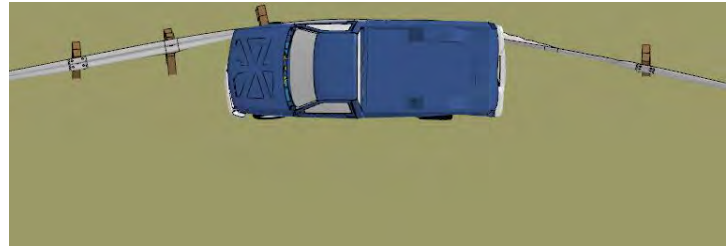
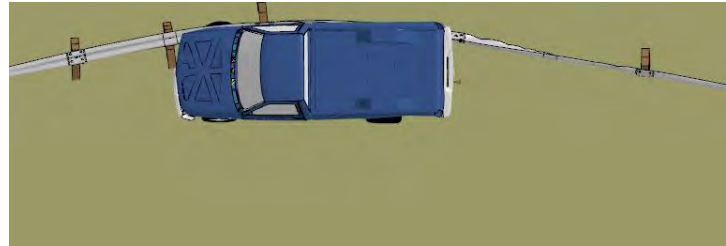
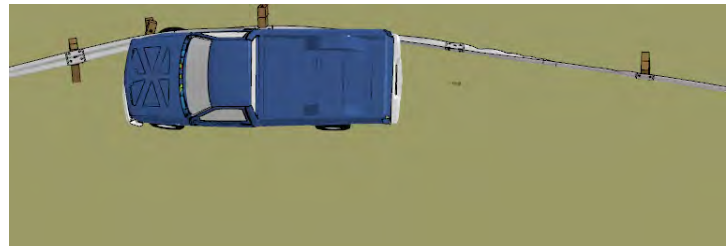
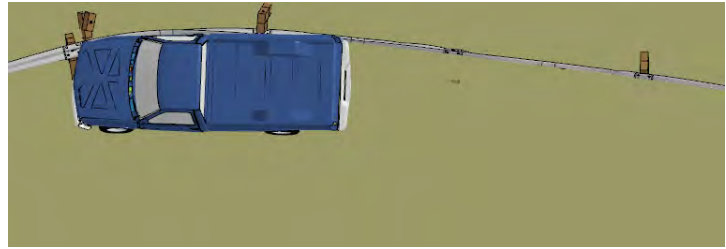
**Figure F-5: [CONTINUED] Sequential views from Analysis Case DL3 from a downstream and overhead viewpoint.**

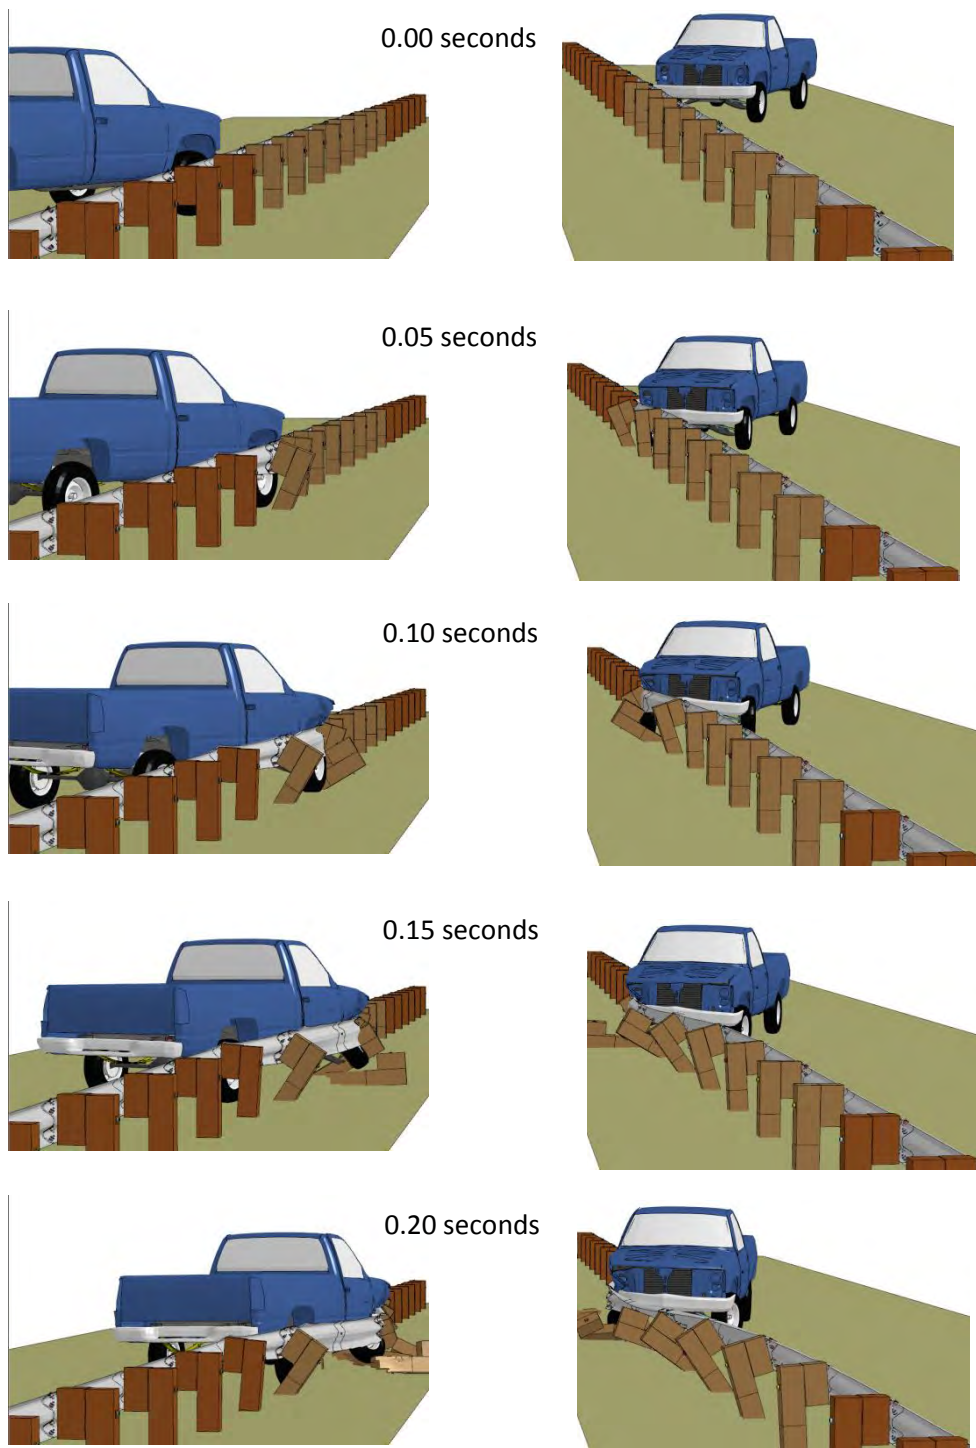
**Figure F-6: Sequential views from Analysis Case DL3 from an upstream-backside and downstream-backside viewpoint.**

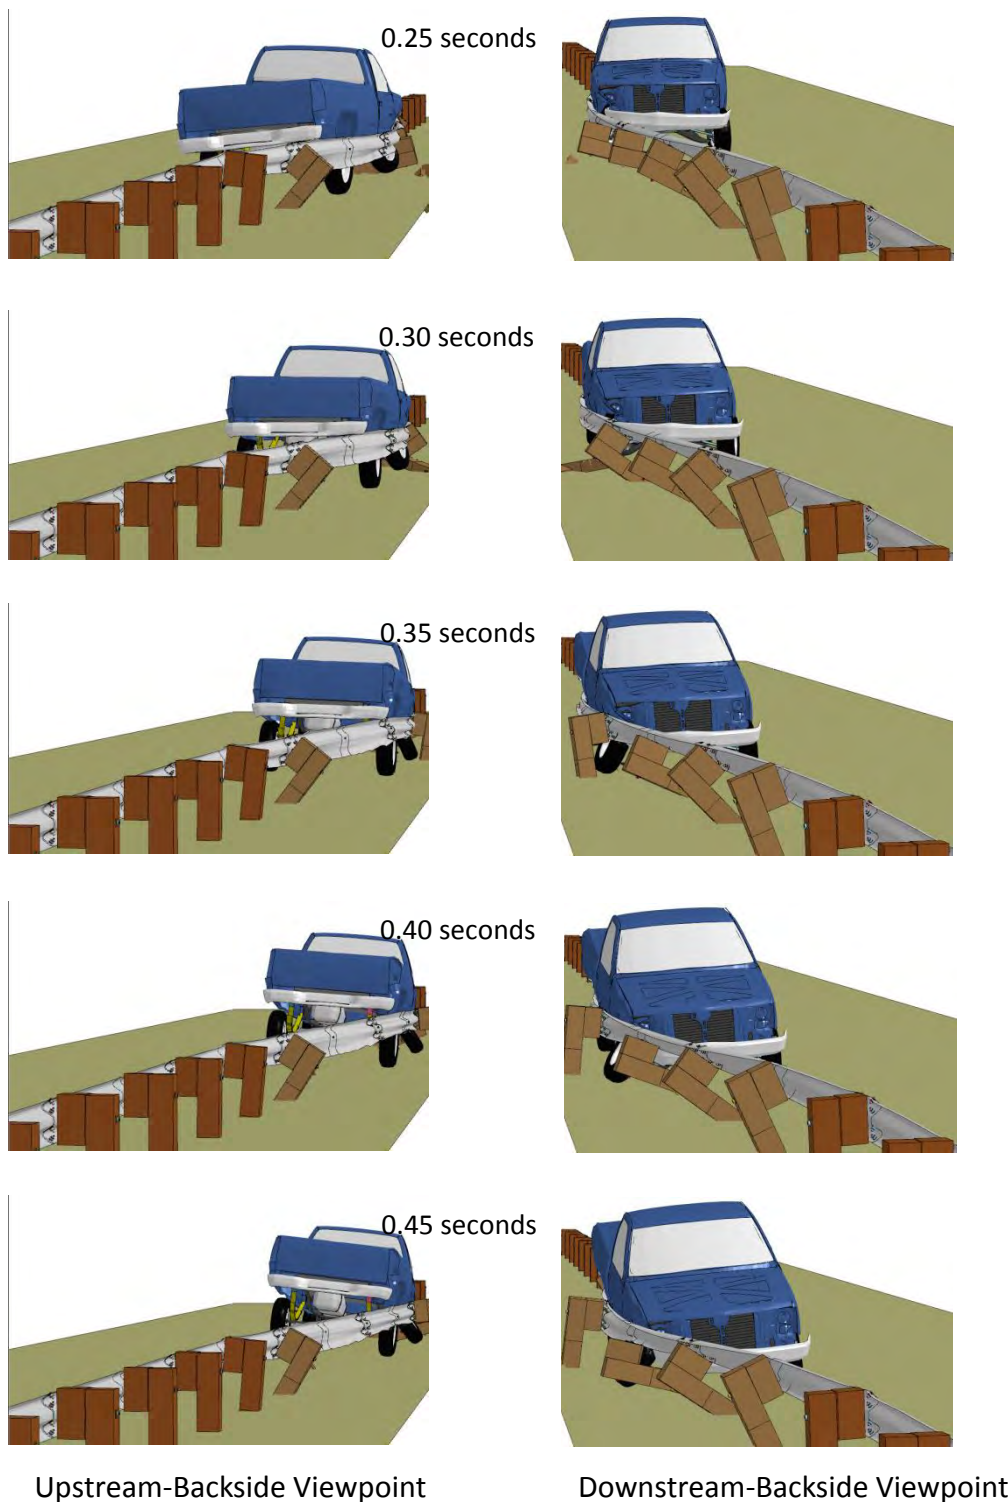
**Figure F-6: [CONTINUED] Sequential views from Analysis Case DL3 from an upstream-backside and downstream-backside viewpoint.**

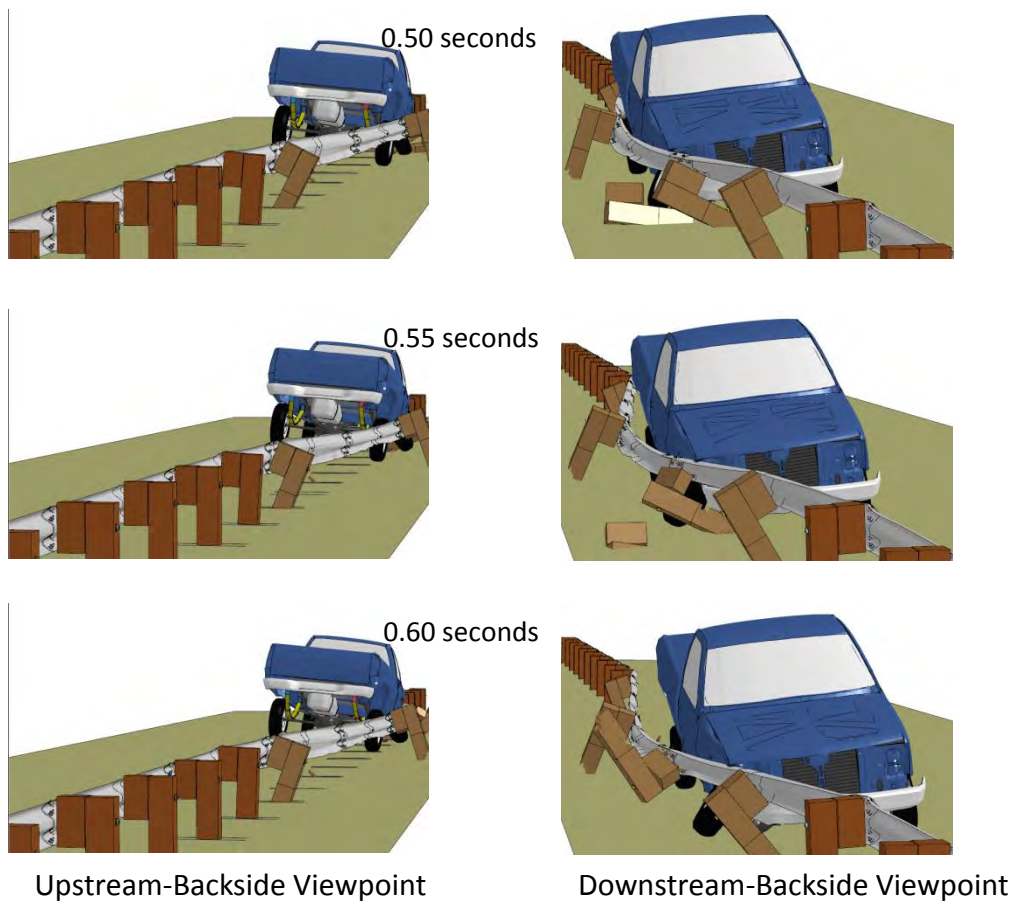
**Figure F-6: [CONTINUED] Sequential views from Analysis Case DL3 from an upstream-backside and downstream-backside viewpoint.**

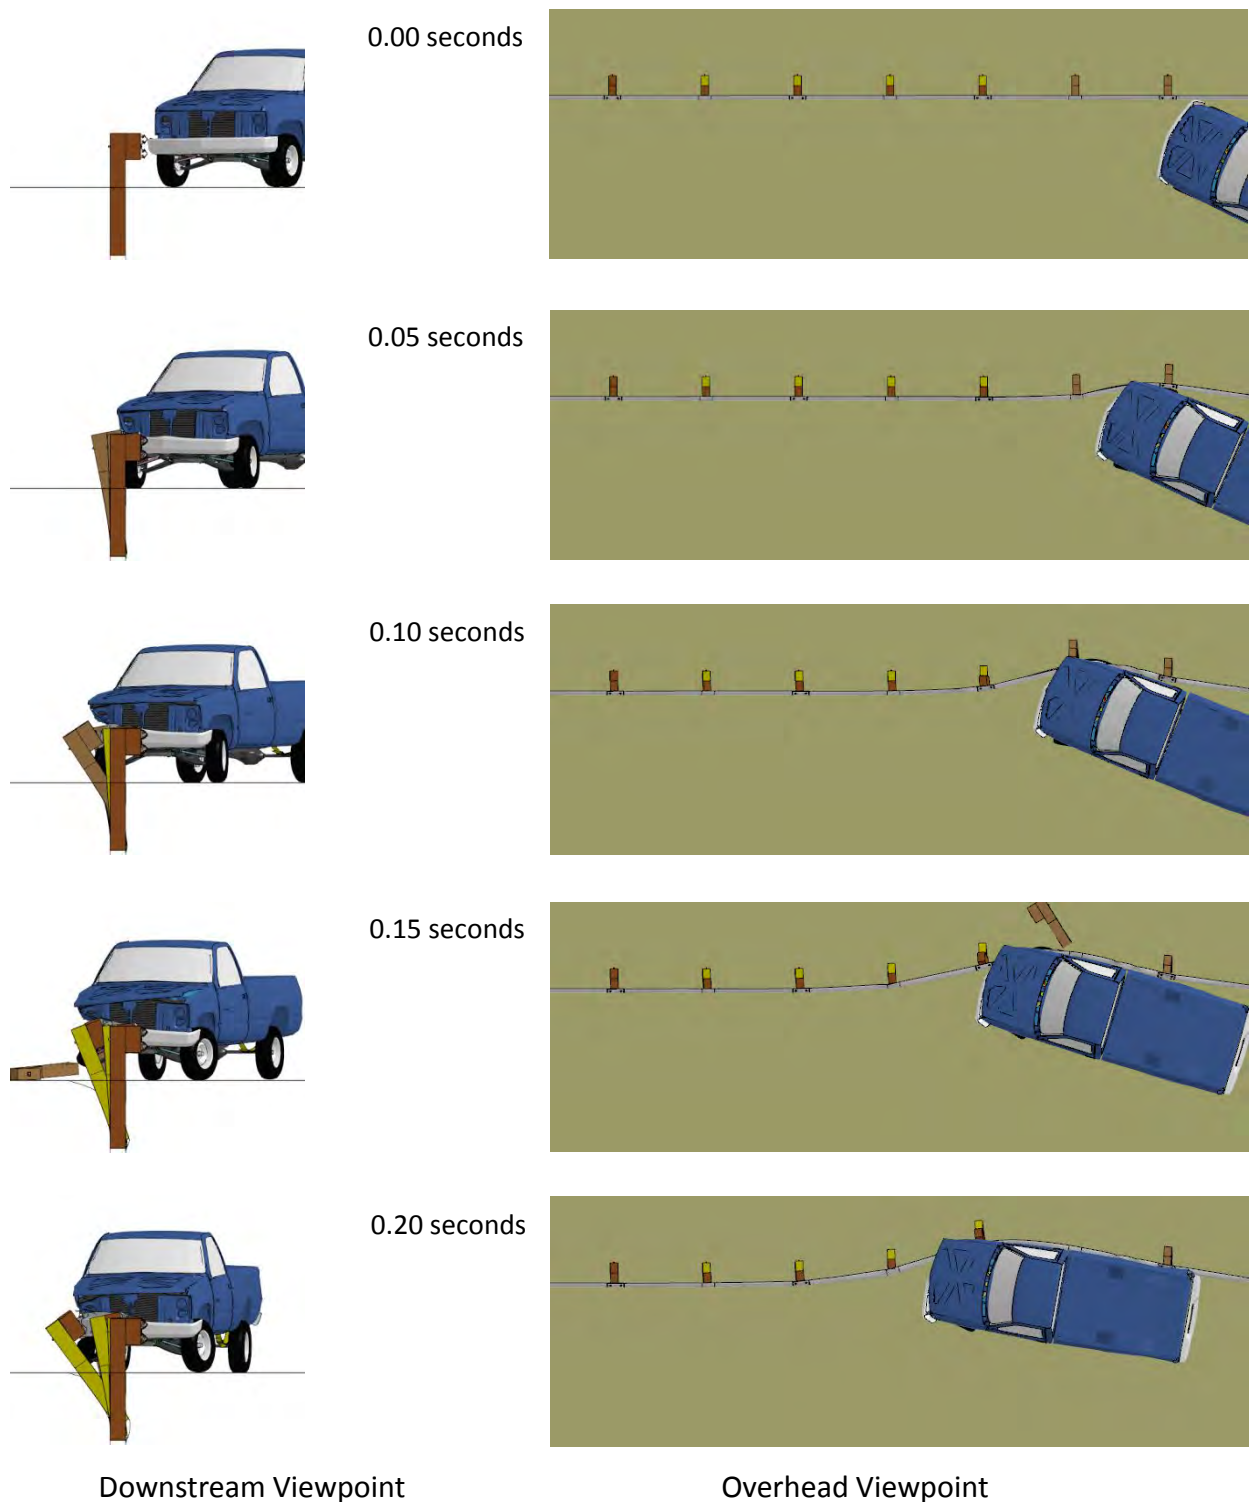
**Figure G-1: Sequential views from Analysis Case DL1-DL0 from a downstream and overhead viewpoint.**

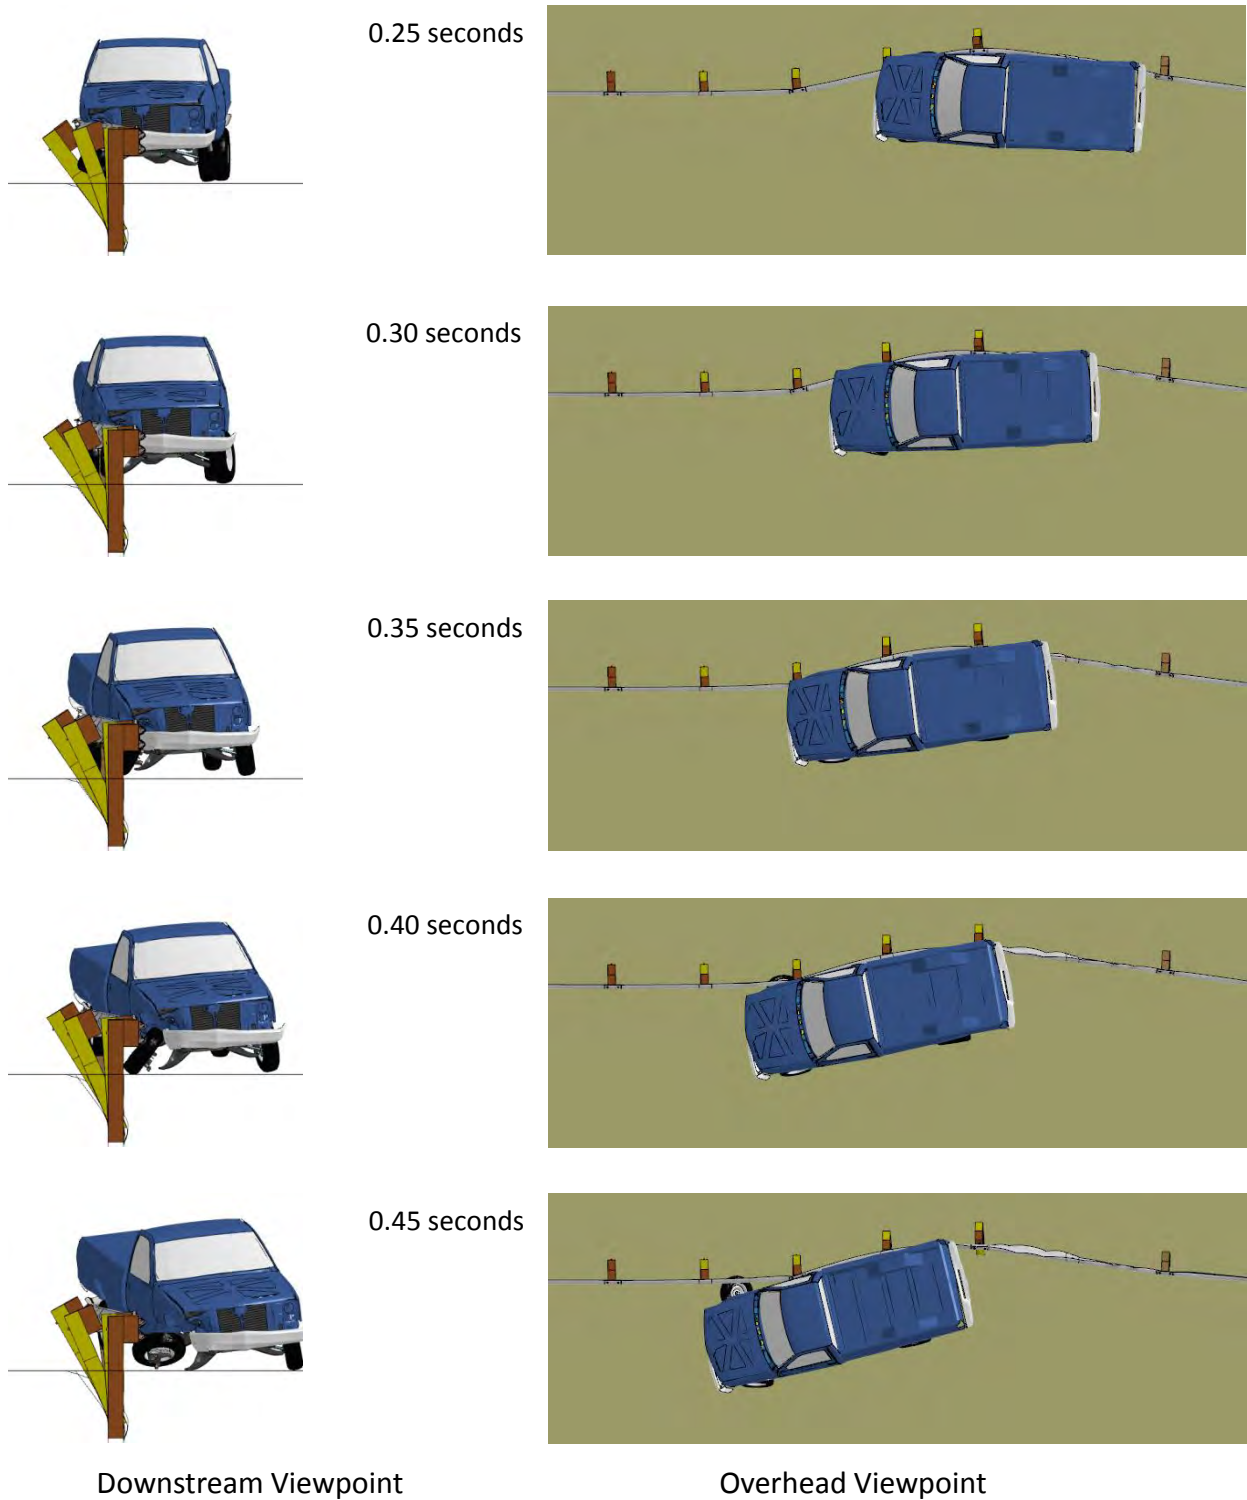
**Figure G-1: [CONTINUED] Sequential views from Analysis Case DL1-DL0 from a downstream and overhead viewpoint.**

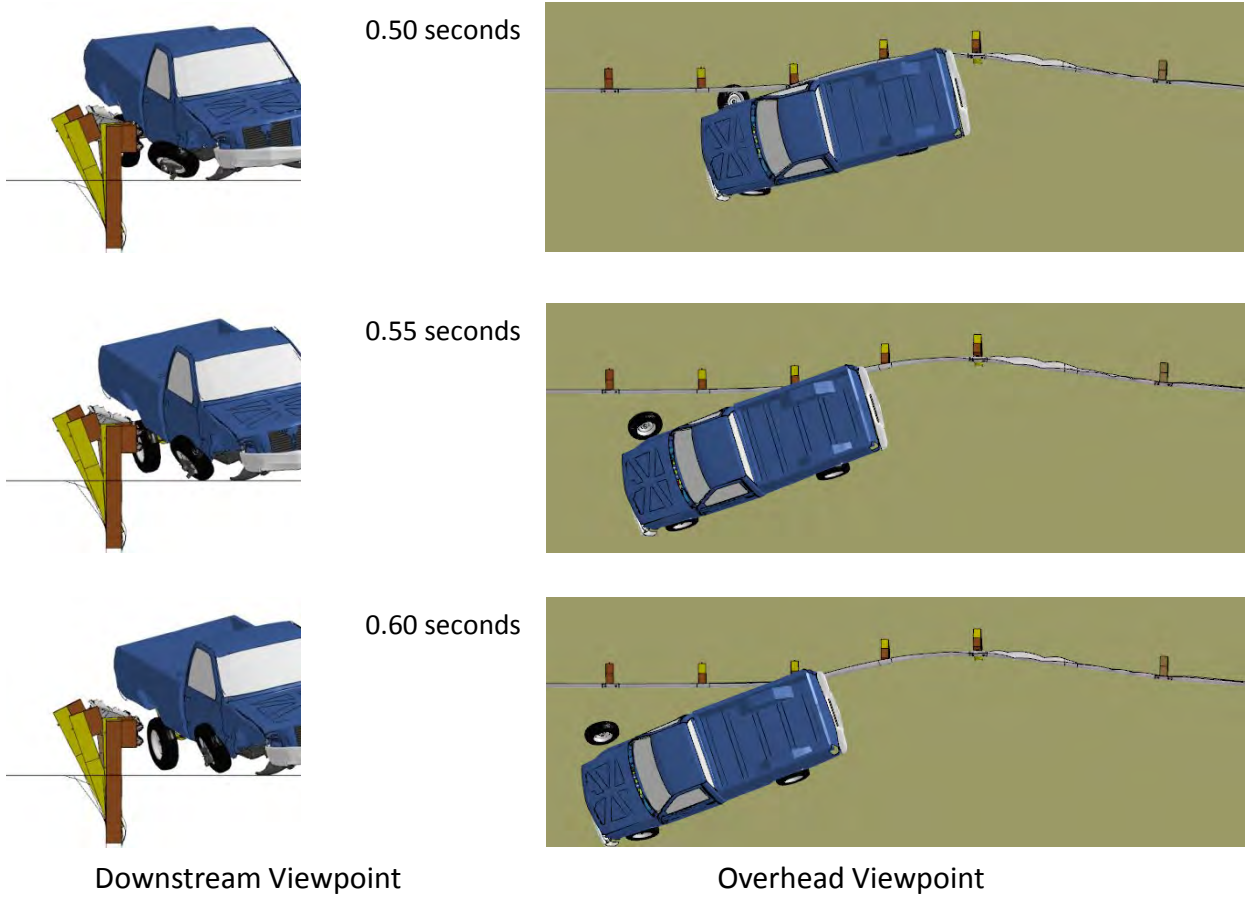
**Figure G-1: [CONTINUED] Sequential views from Analysis Case DL1-DL0 from a downstream and overhead viewpoint.**

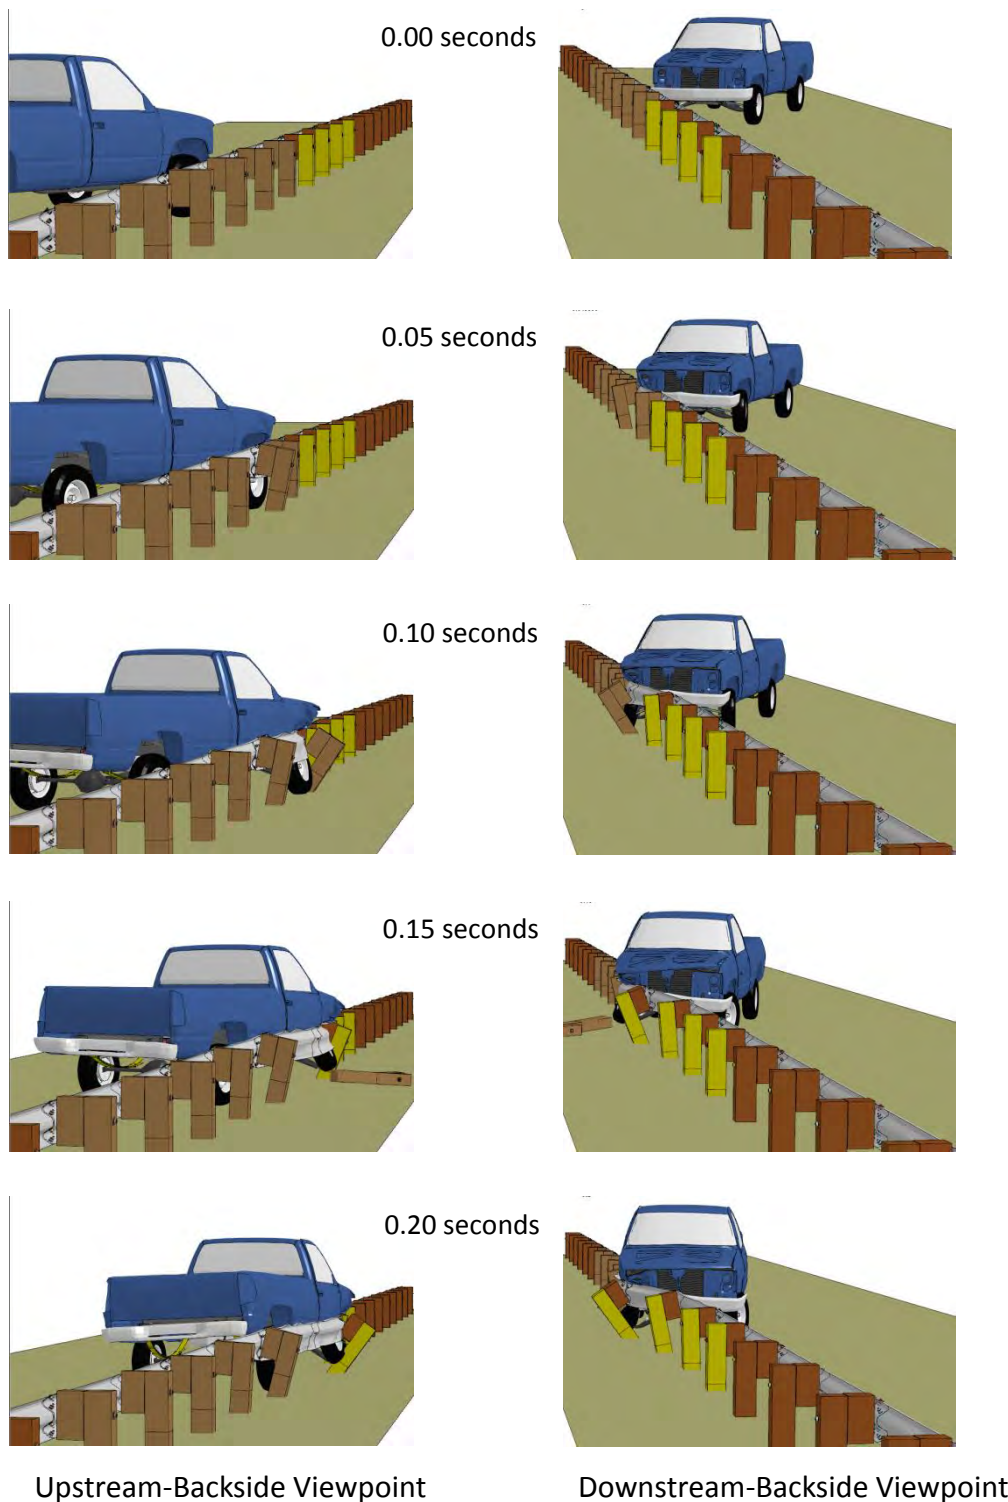
**Figure G-2: Sequential views from Analysis Case DL1-DL0 from an upstream-backside and downstream-backside viewpoint.**

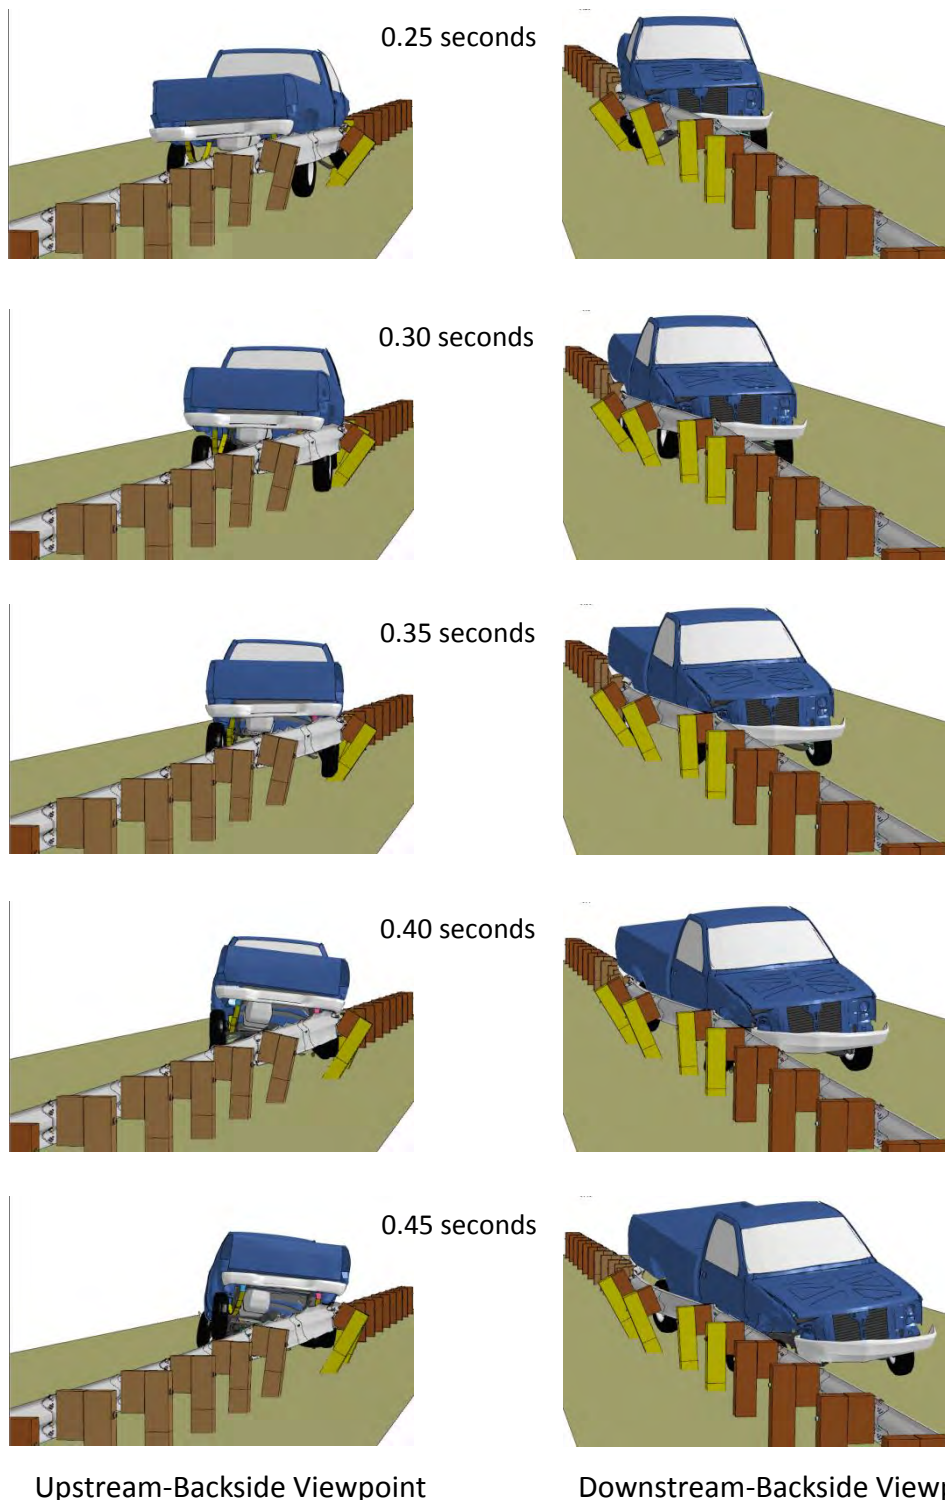
**Figure G-2: [CONTINUED] Sequential views from Analysis Case DL1-DL0 from an upstream-backside and downstream-backside viewpoint.**

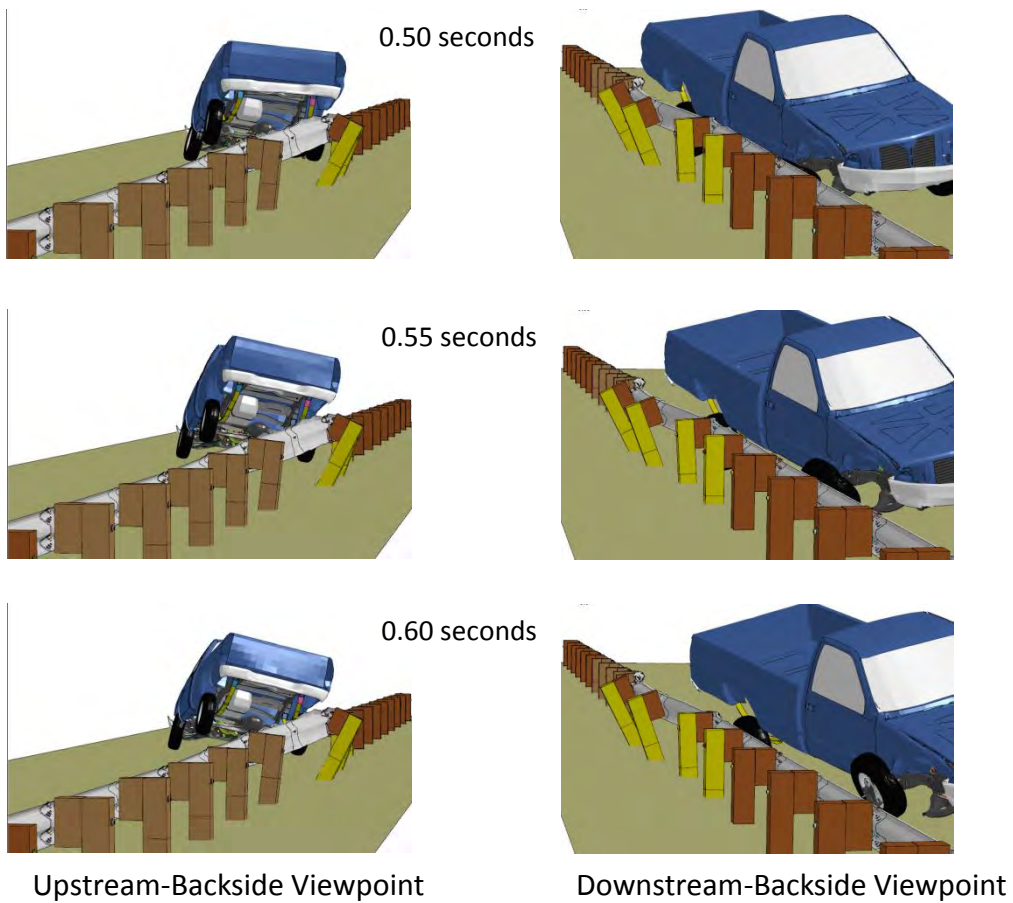
**Figure G-2: [CONTINUED] Sequential views from Analysis Case DL1-DL0 from an upstream-backside and downstream-backside viewpoint.**

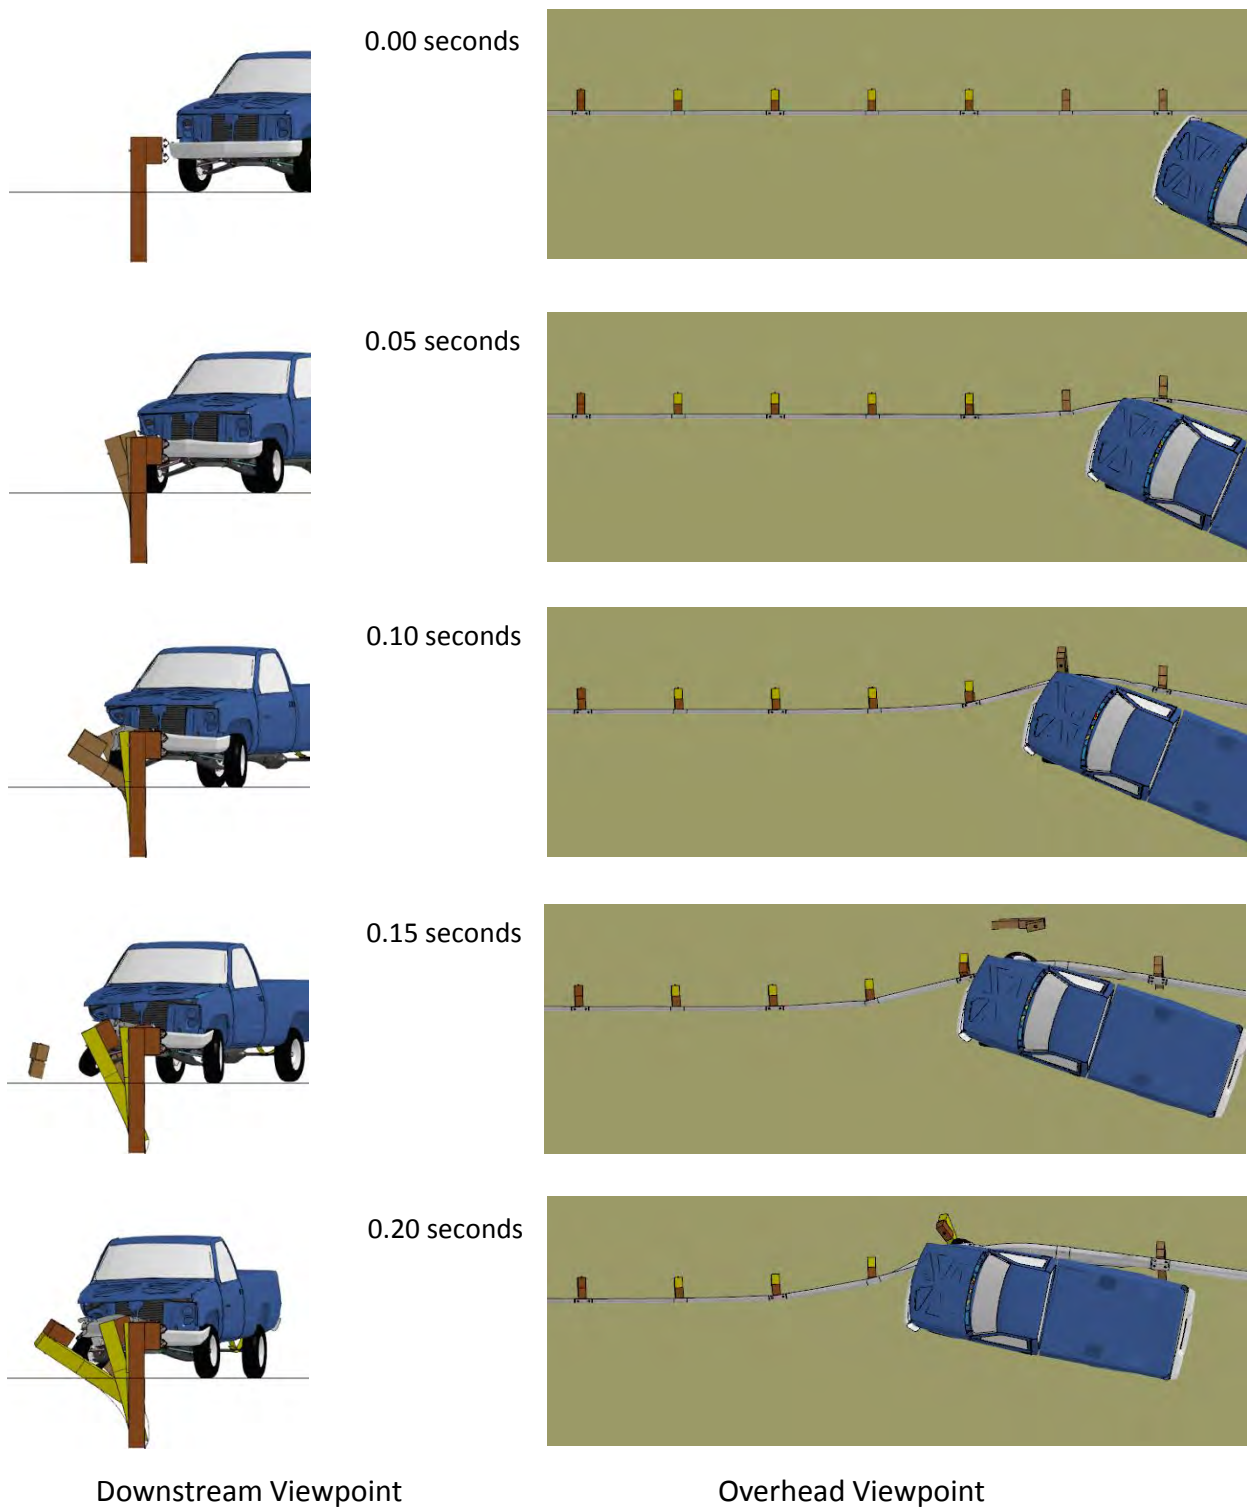
**Figure G-3: Sequential views from Analysis Case DL2-DL0 from a downstream and overhead viewpoint.**

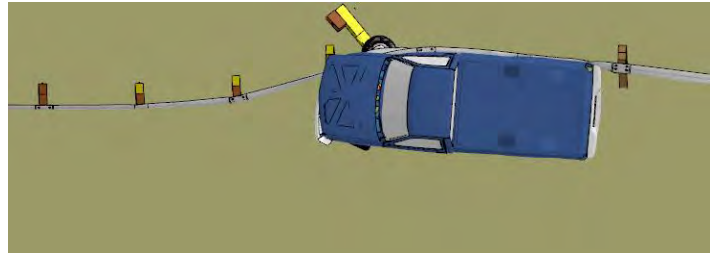
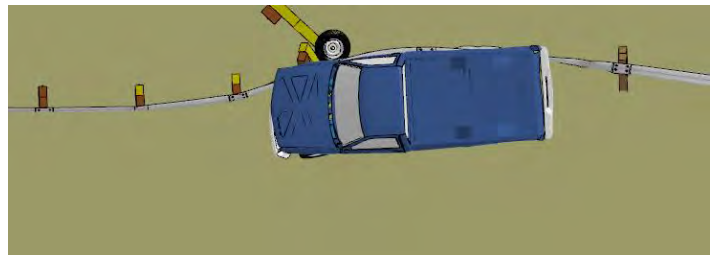
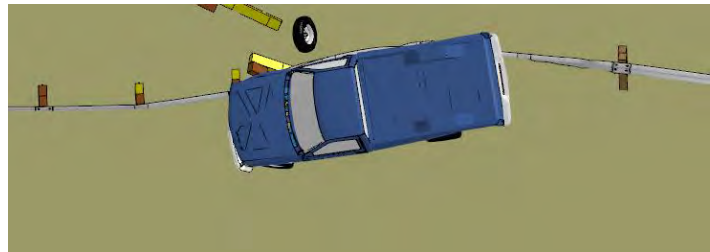
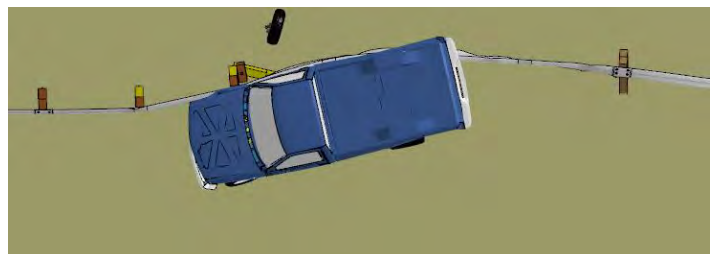
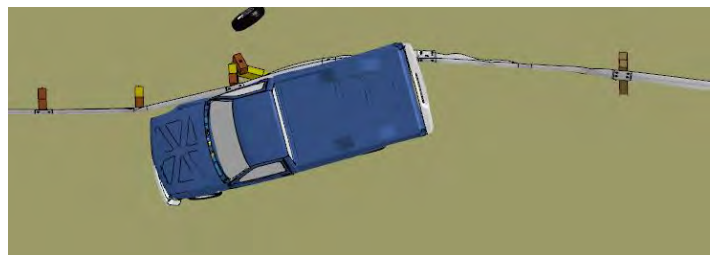
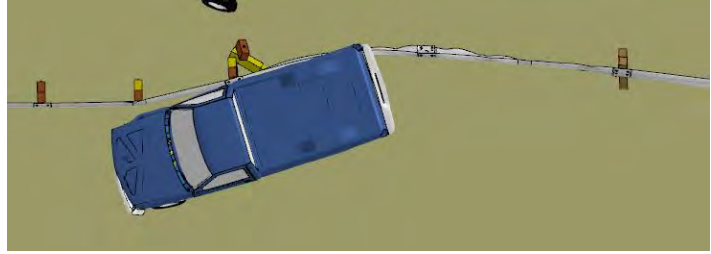
**Figure G-3: [CONTINUED] Sequential views from Analysis Case DL2-DL0 from a downstream and overhead viewpoint.**

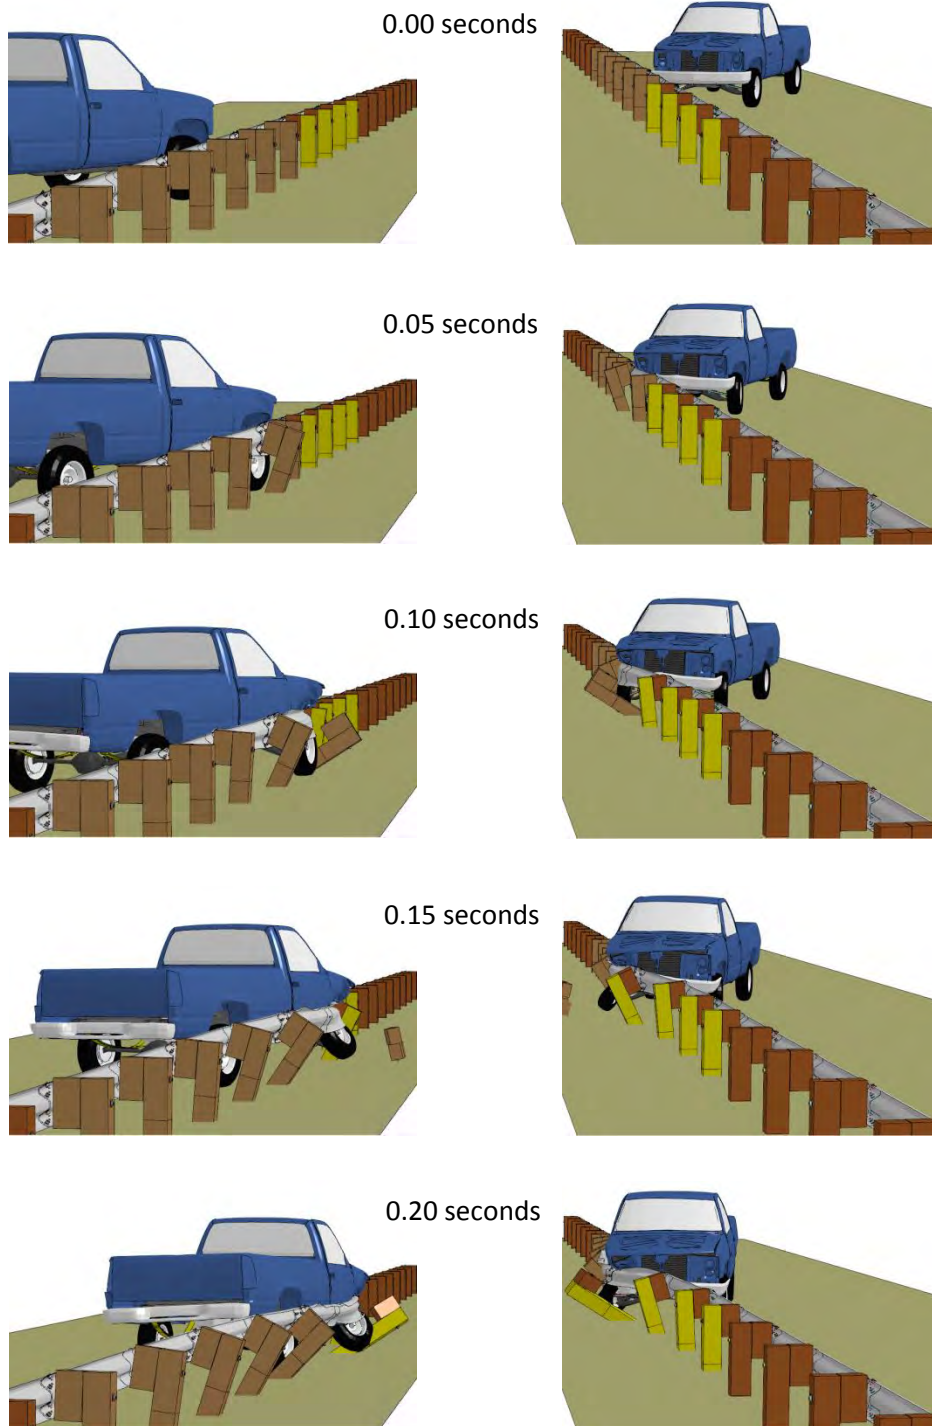
**Figure G-4: Sequential views from Analysis Case DL2-DL0 from an upstream-backside and downstream-backside viewpoint.**

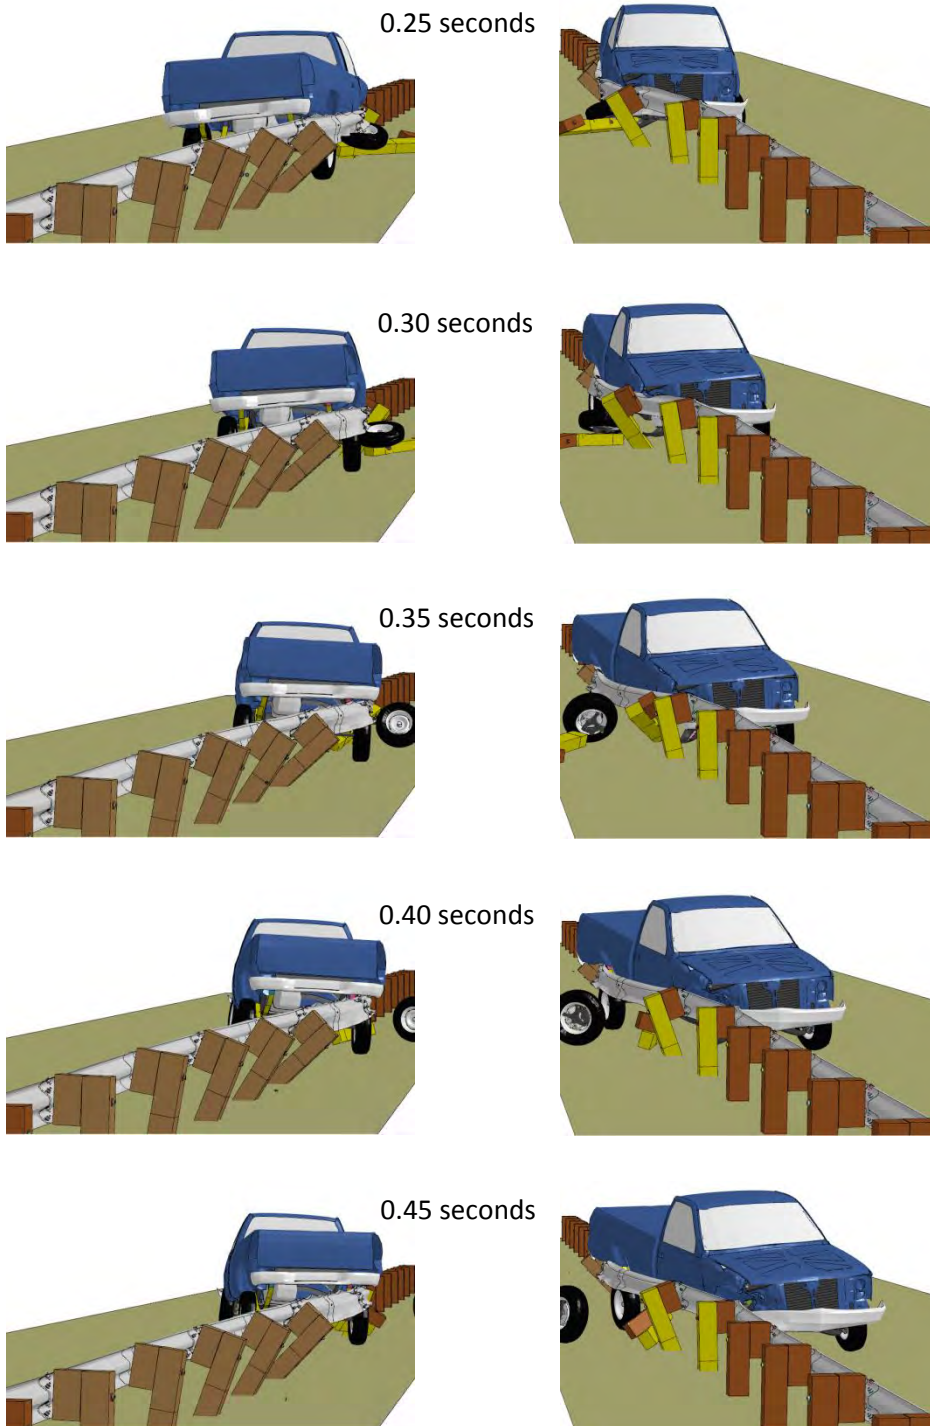
**Figure G-4: [CONTINUED] Sequential views from Analysis Case DL2-DL0 from an upstream-backside and downstream-backside viewpoint.**

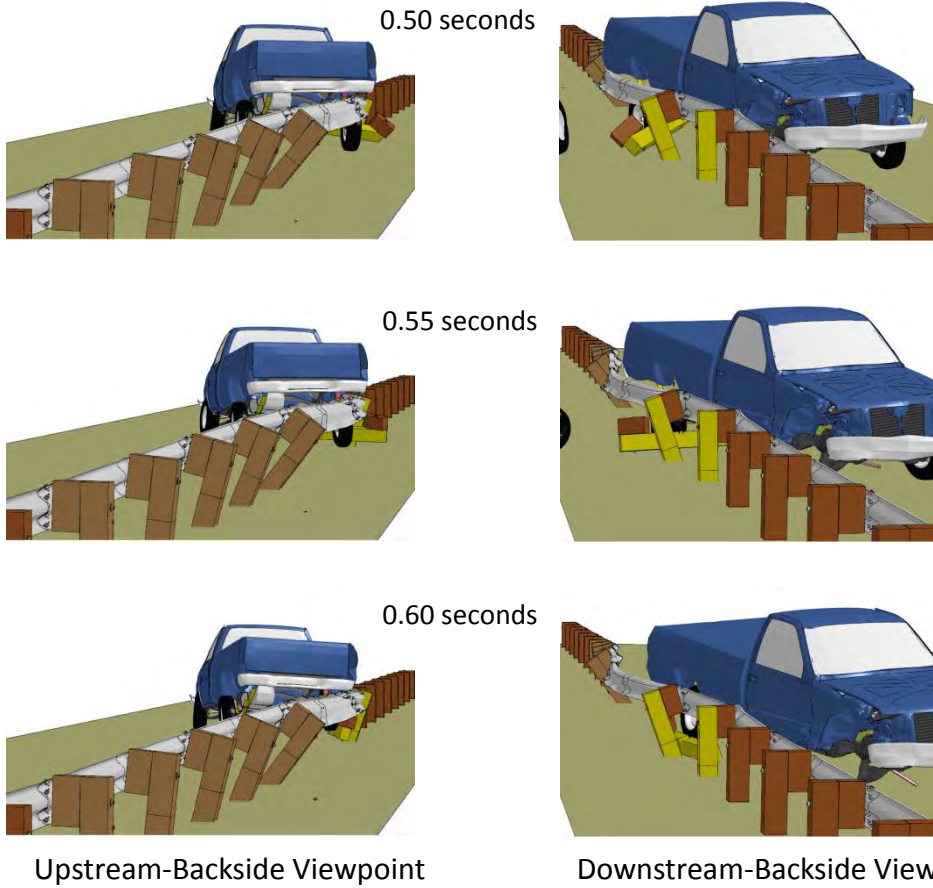
**Figure G-4: [CONTINUED] Sequential views from Analysis Case DL2-DL0 from an upstream-backside and downstream-backside viewpoint.**

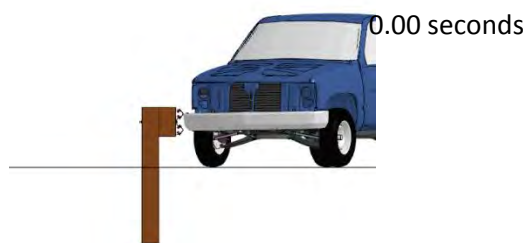
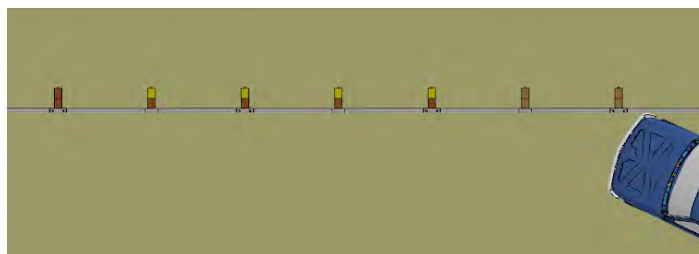
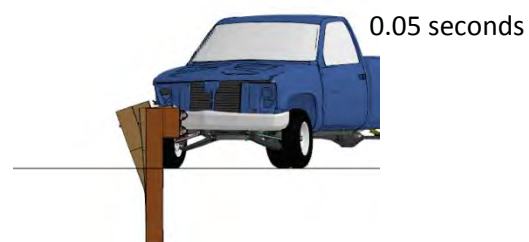
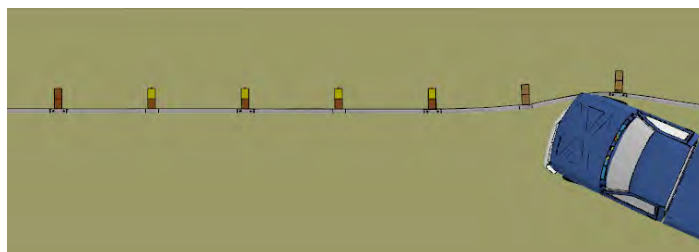
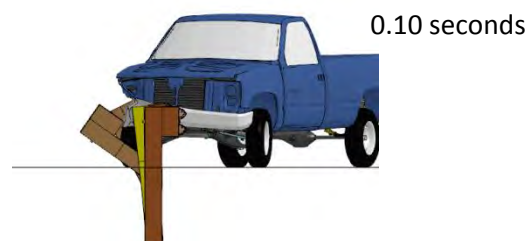
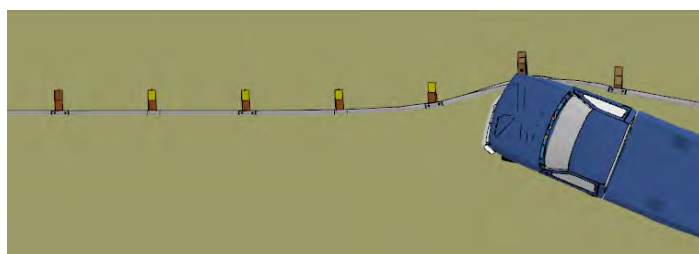
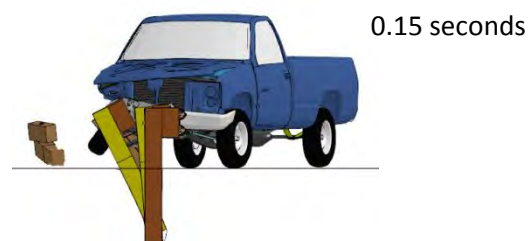
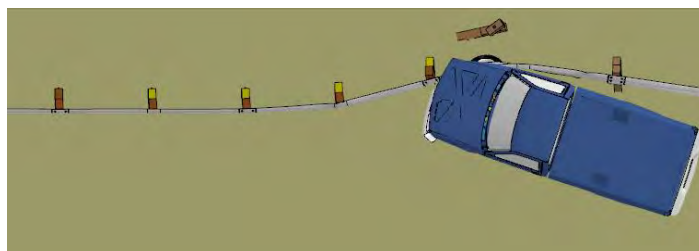
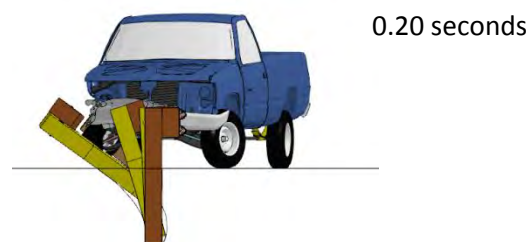
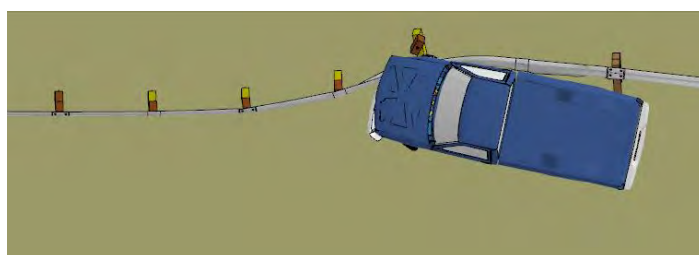
**Figure G-5: Sequential views from Analysis Case DL3-DL0 from a downstream and overhead viewpoint.**
