# **A Guide for W-Beam Guardrail Damage Assessment**

A Field Manual for  
Highway Maintenance Personnel

National Cooperative  
Highway Research  
Program  
Project 22-28

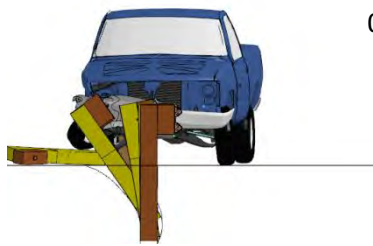
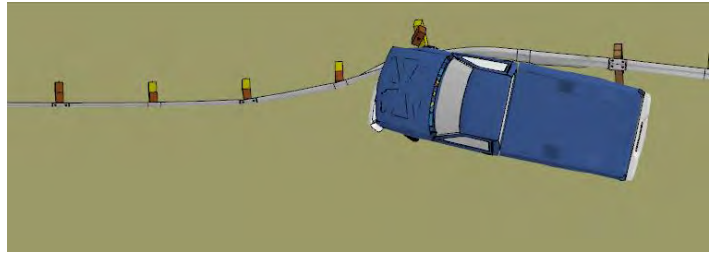
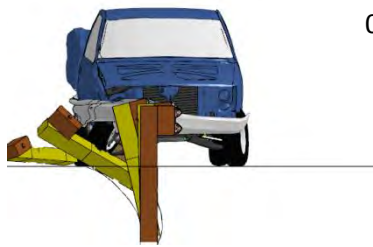
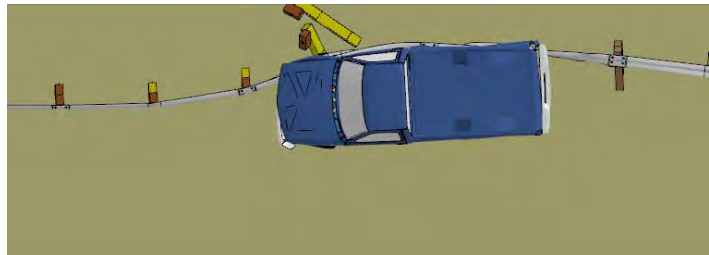
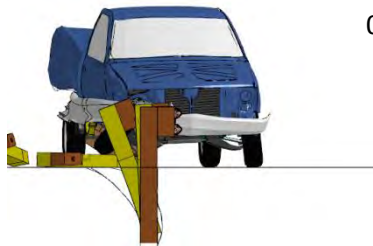
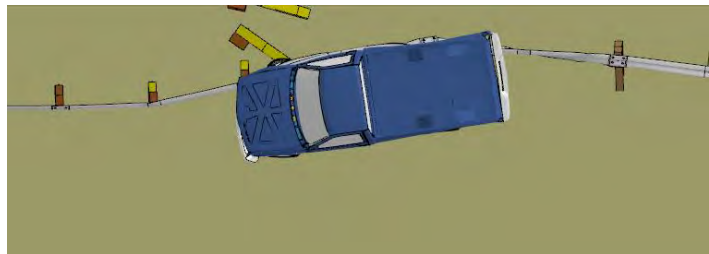
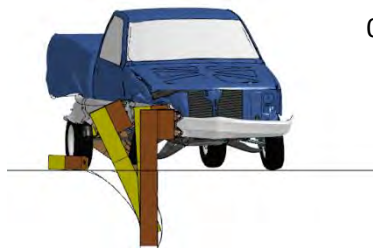
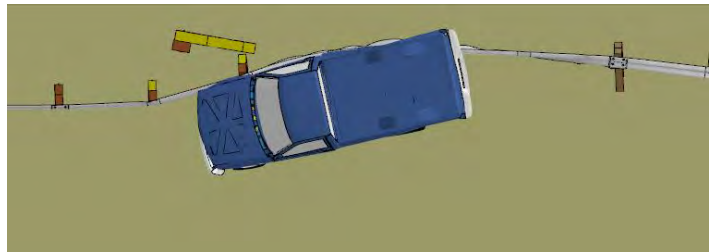
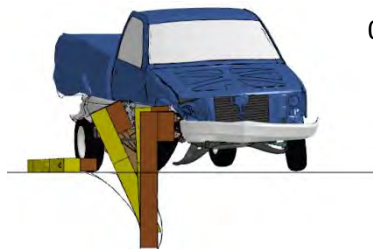
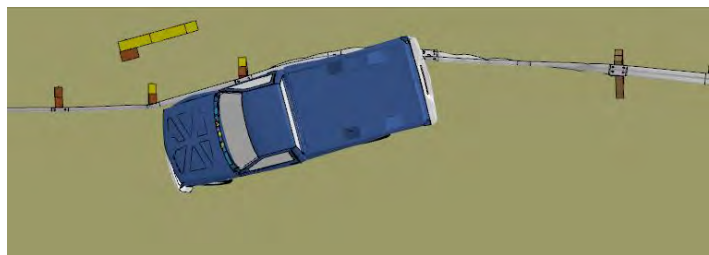
**Figure G-5: [CONTINUED] Sequential views from Analysis Case DL3-DL0 from a downstream and overhead viewpoint.**

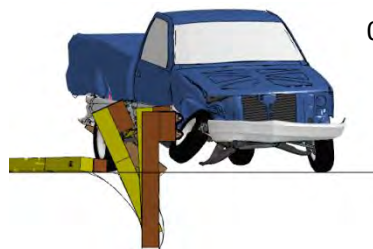
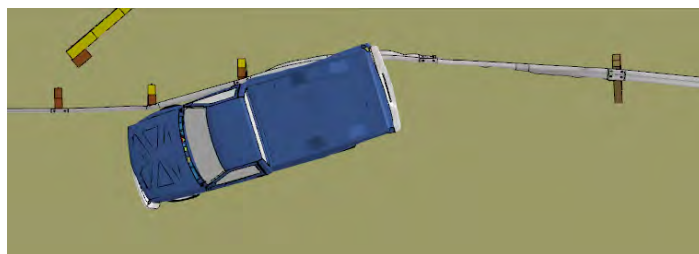
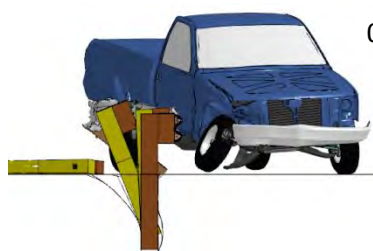
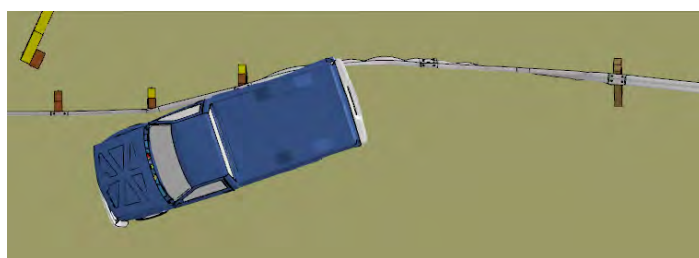
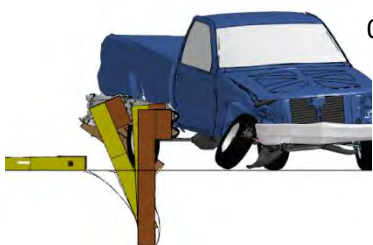
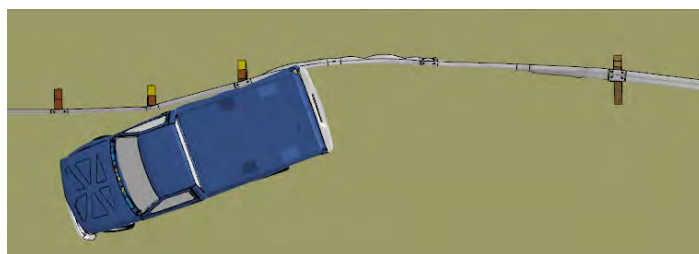
**Figure G-5: [CONTINUED] Sequential views from Analysis Case DL3-DL0 from a downstream and overhead viewpoint.**

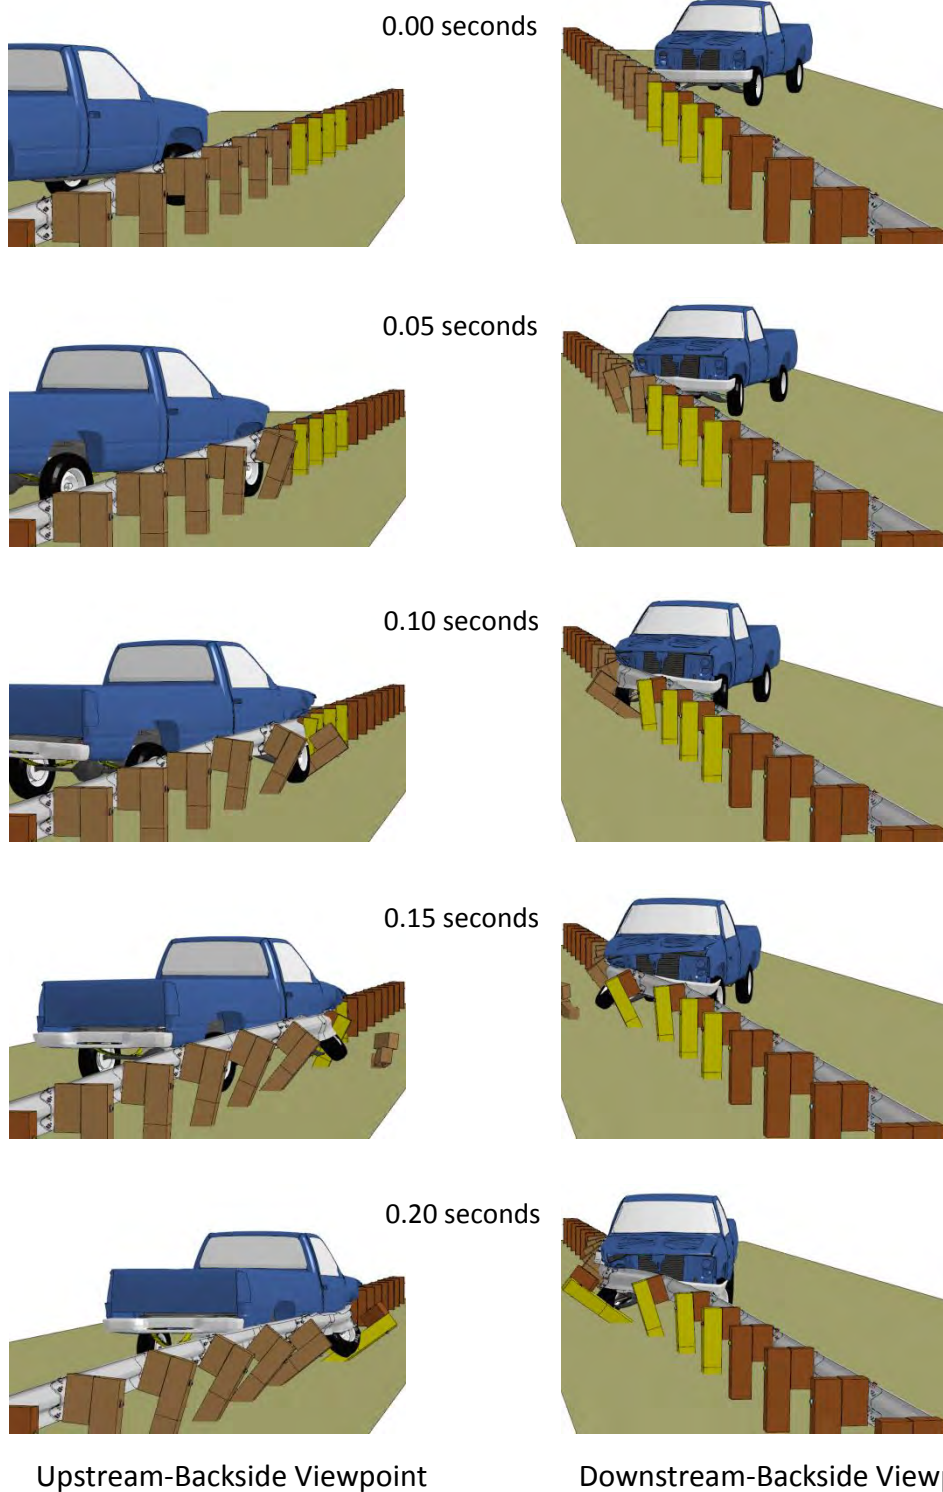
**Figure G-6: Sequential views from Analysis Case DL3-DL0 from an upstream-backside and downstream-backside viewpoint.**

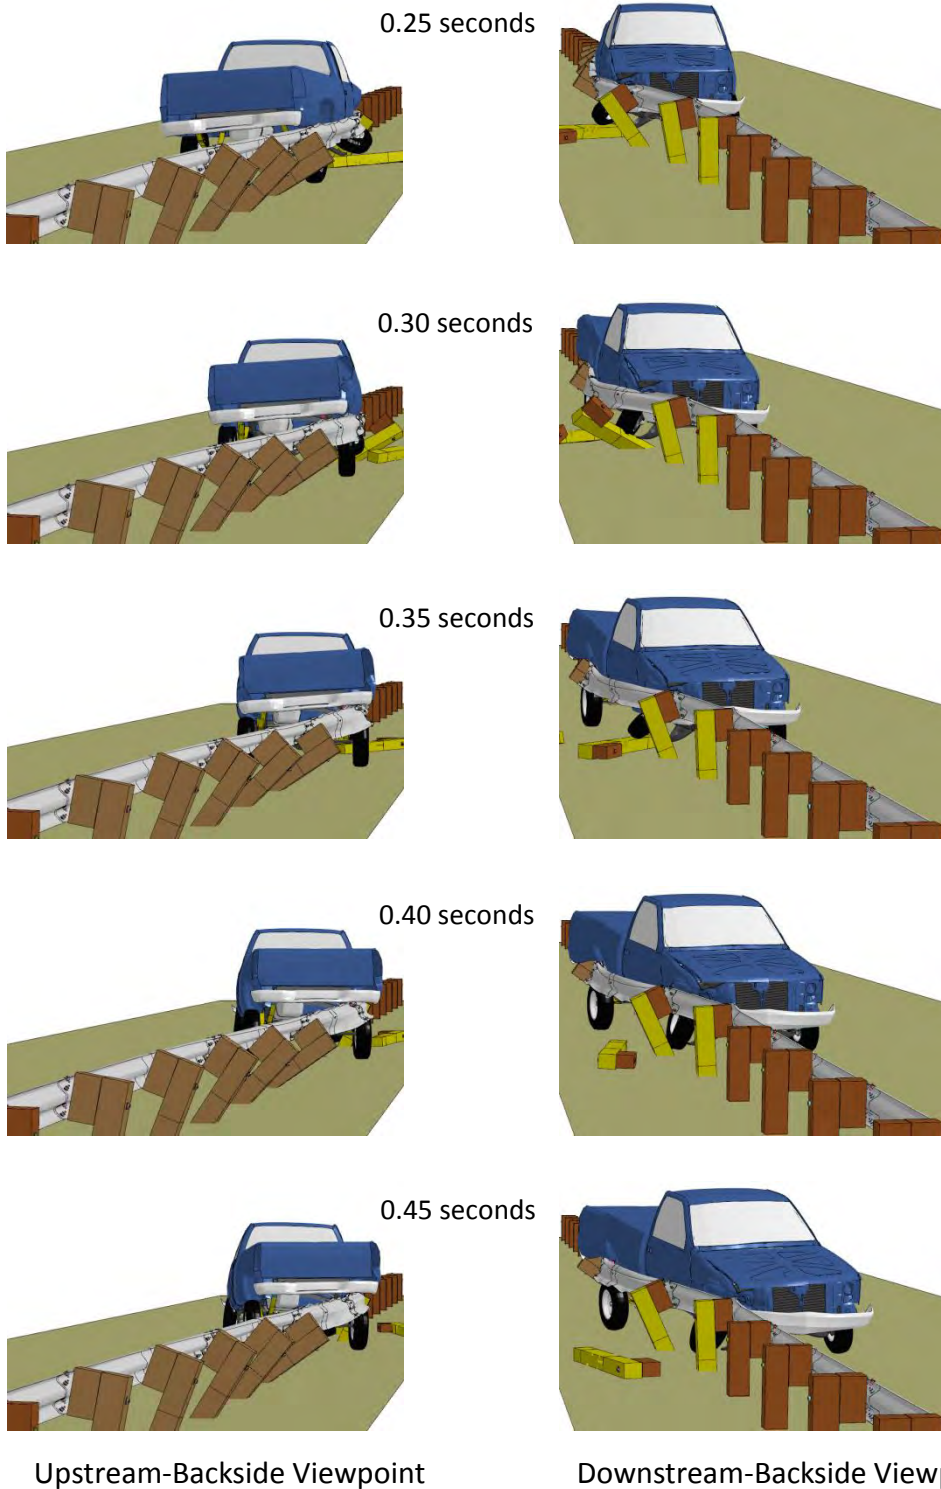
**Figure G-6: [CONTINUED] Sequential views from Analysis Case DL3-DL0 from an upstream-backside and downstream-backside viewpoint.**

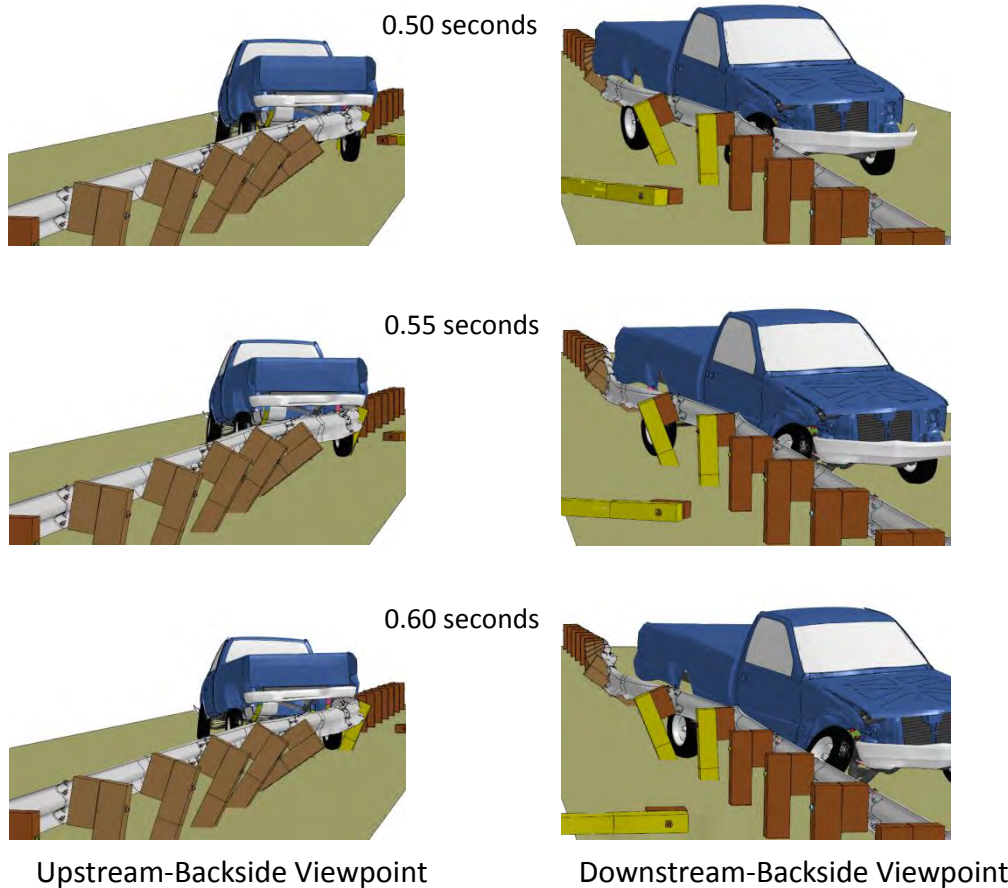
**Figure G-6: [CONTINUED] Sequential views from Analysis Case DL3-DL0 from an upstream-backside and downstream-backside viewpoint.**

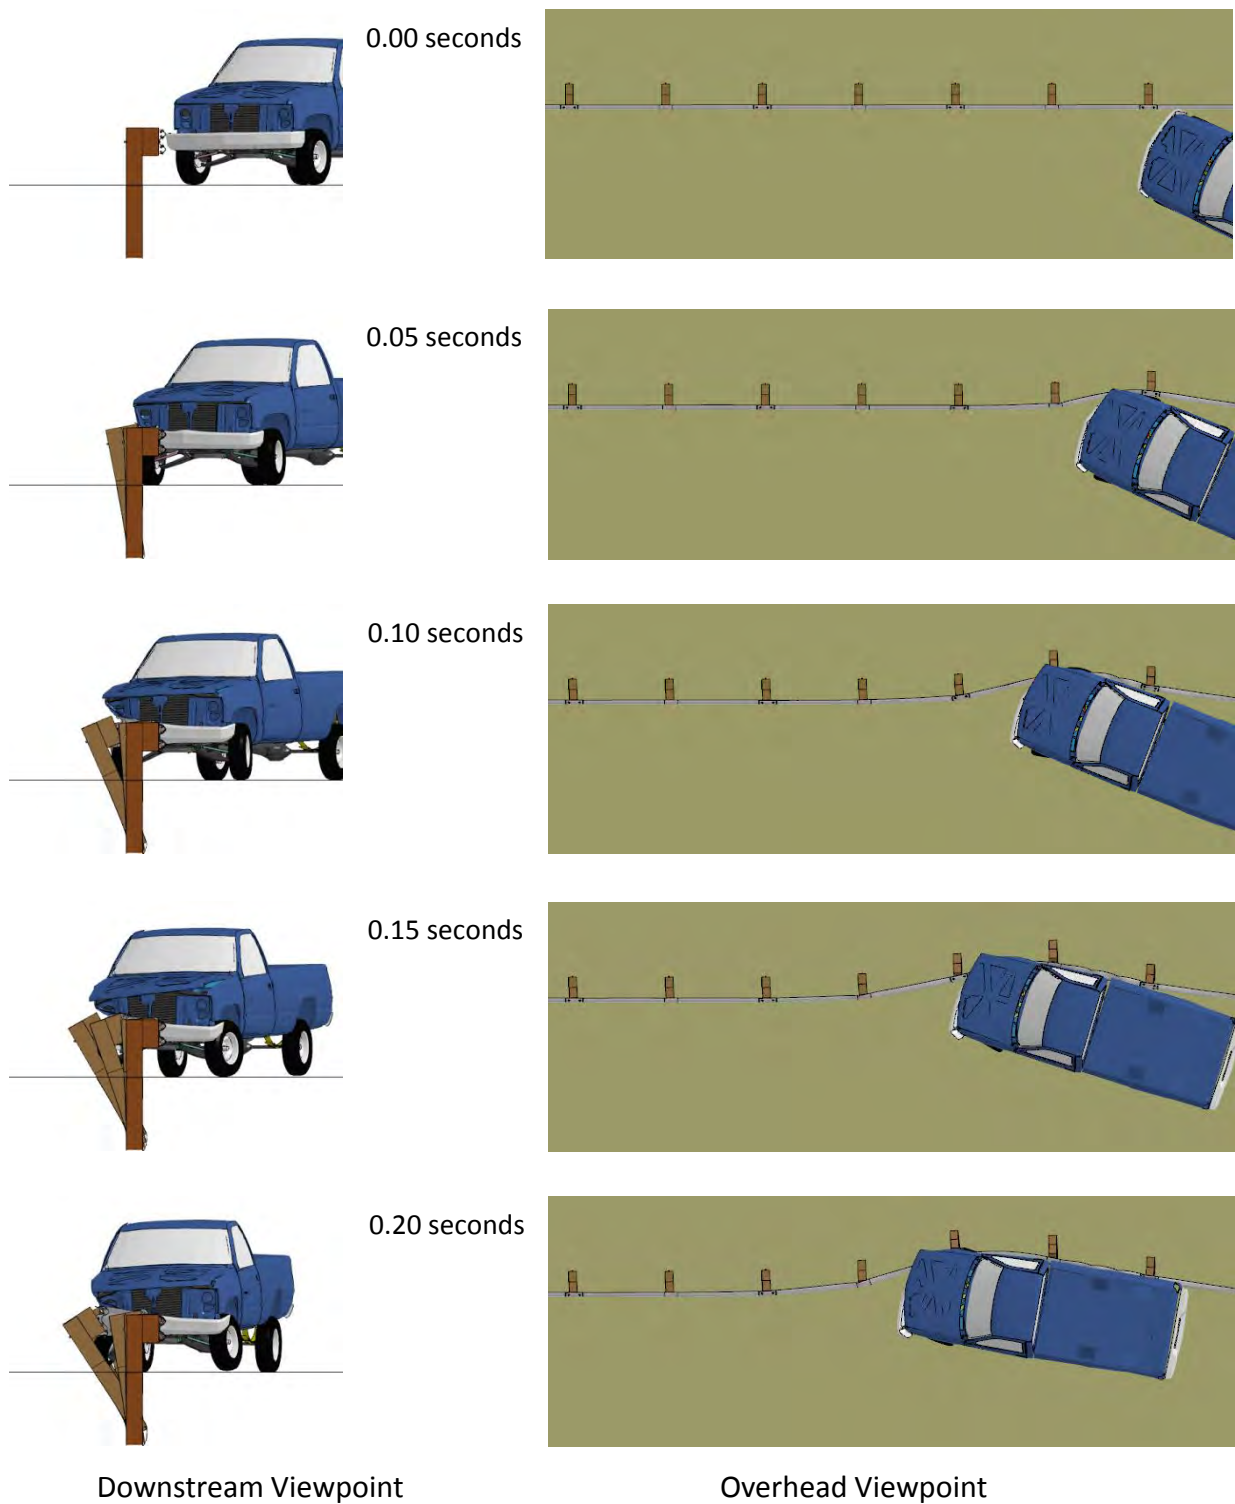
**Figure C-1. Sequential views from a downstream and overhead viewpoint for analysis case: 167% baseline anchor strength.**

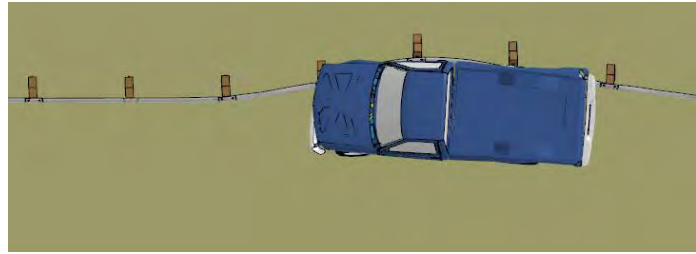
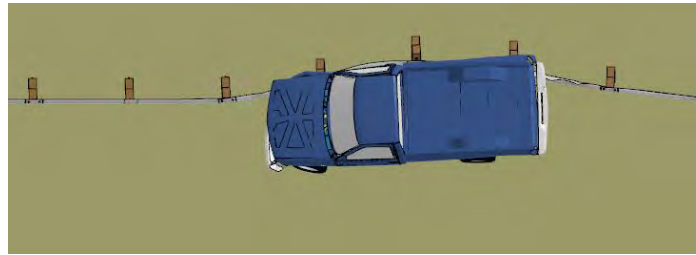
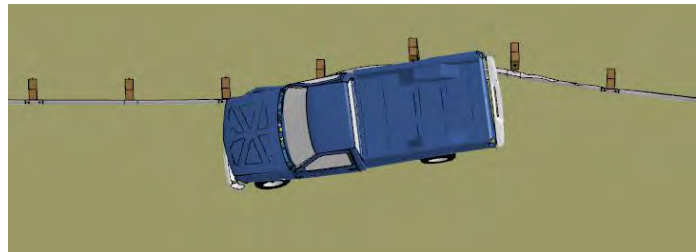
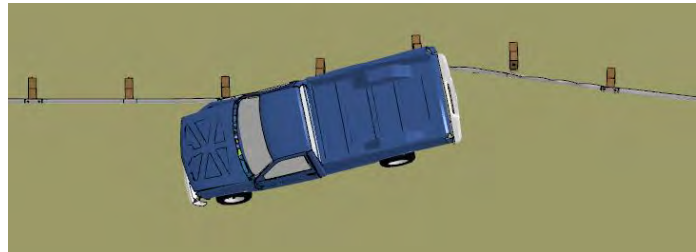
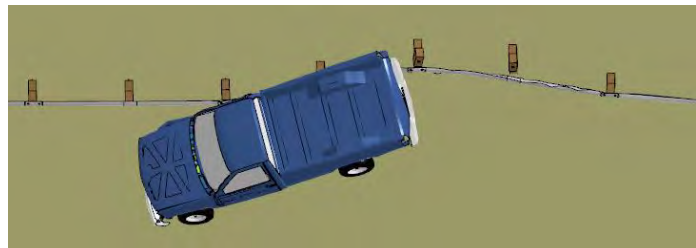
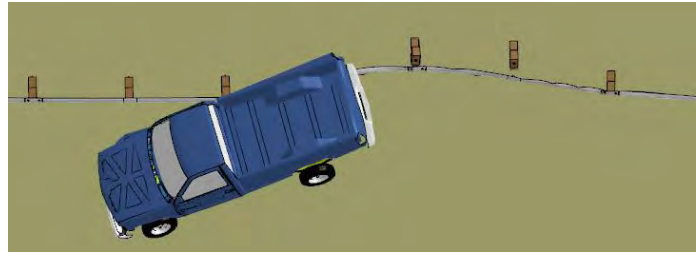
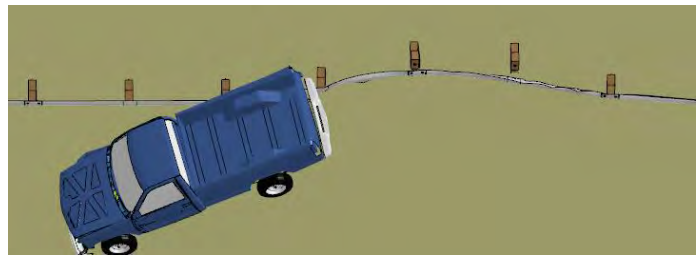
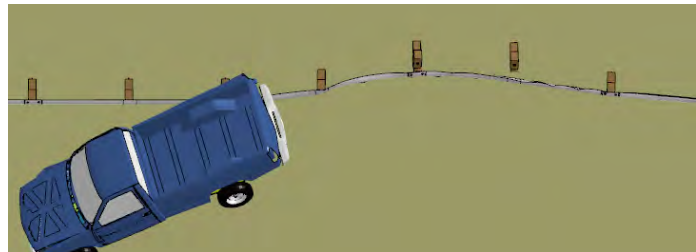
**Figure C-1. [CONTINUED] Sequential views from a downstream and overhead viewpoint for analysis case: 167% baseline anchor strength.**

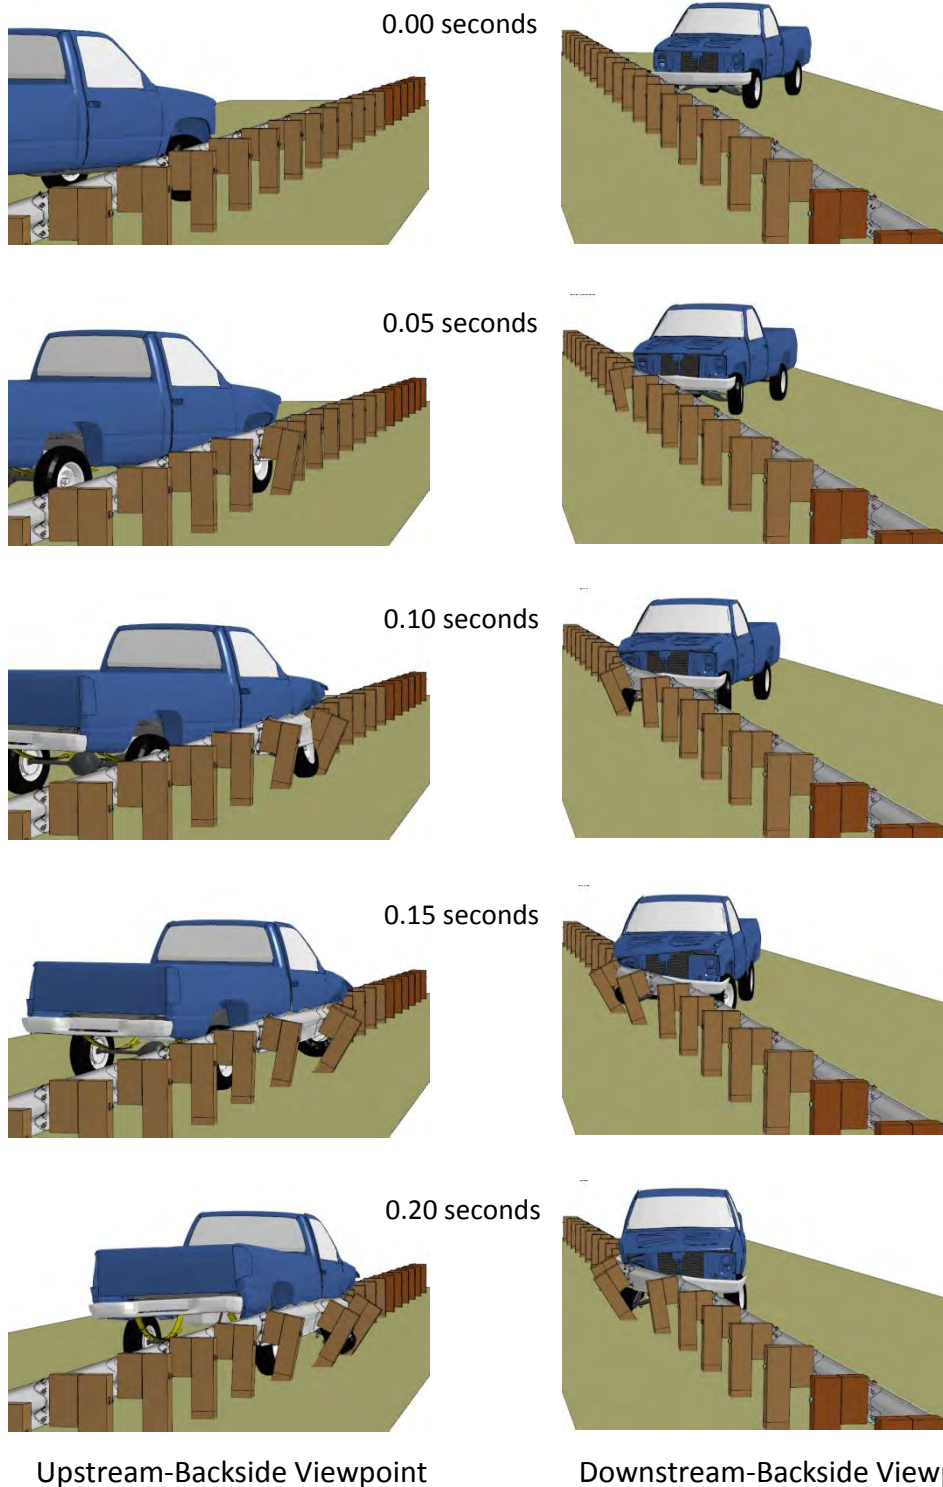
**Figure C-2. Sequential views from an upstream-backside and a downstream-backside viewpoint for analysis case: 167% baseline anchor strength.**

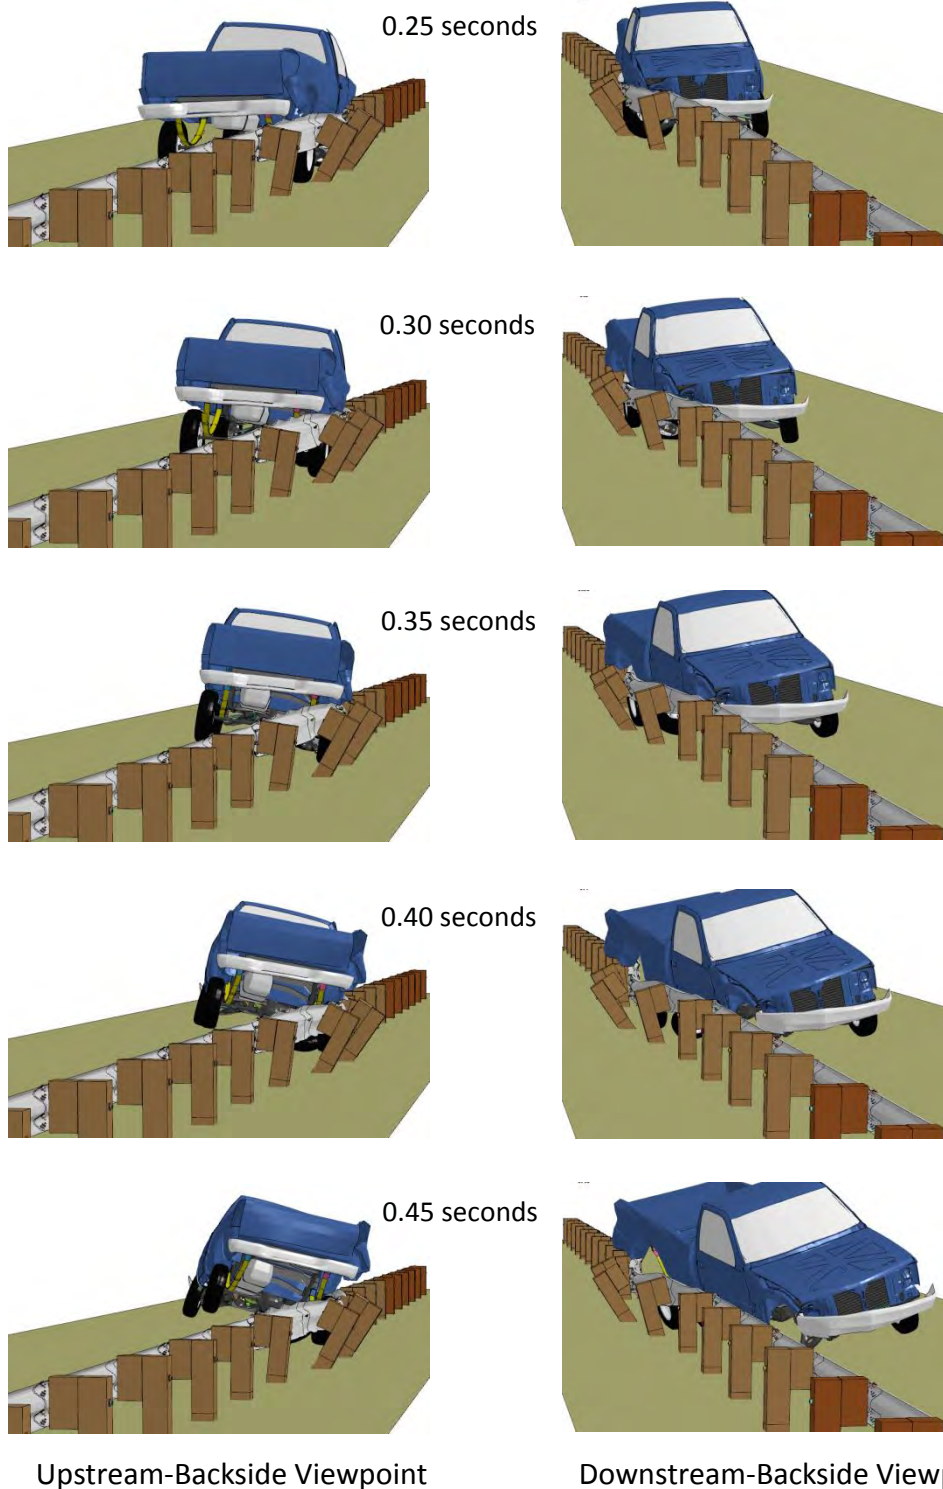
**Figure C-2. [CONTINUED] Sequential views from an upstream-backside and a downstream-backside viewpoint for analysis case: 167% baseline anchor strength.**

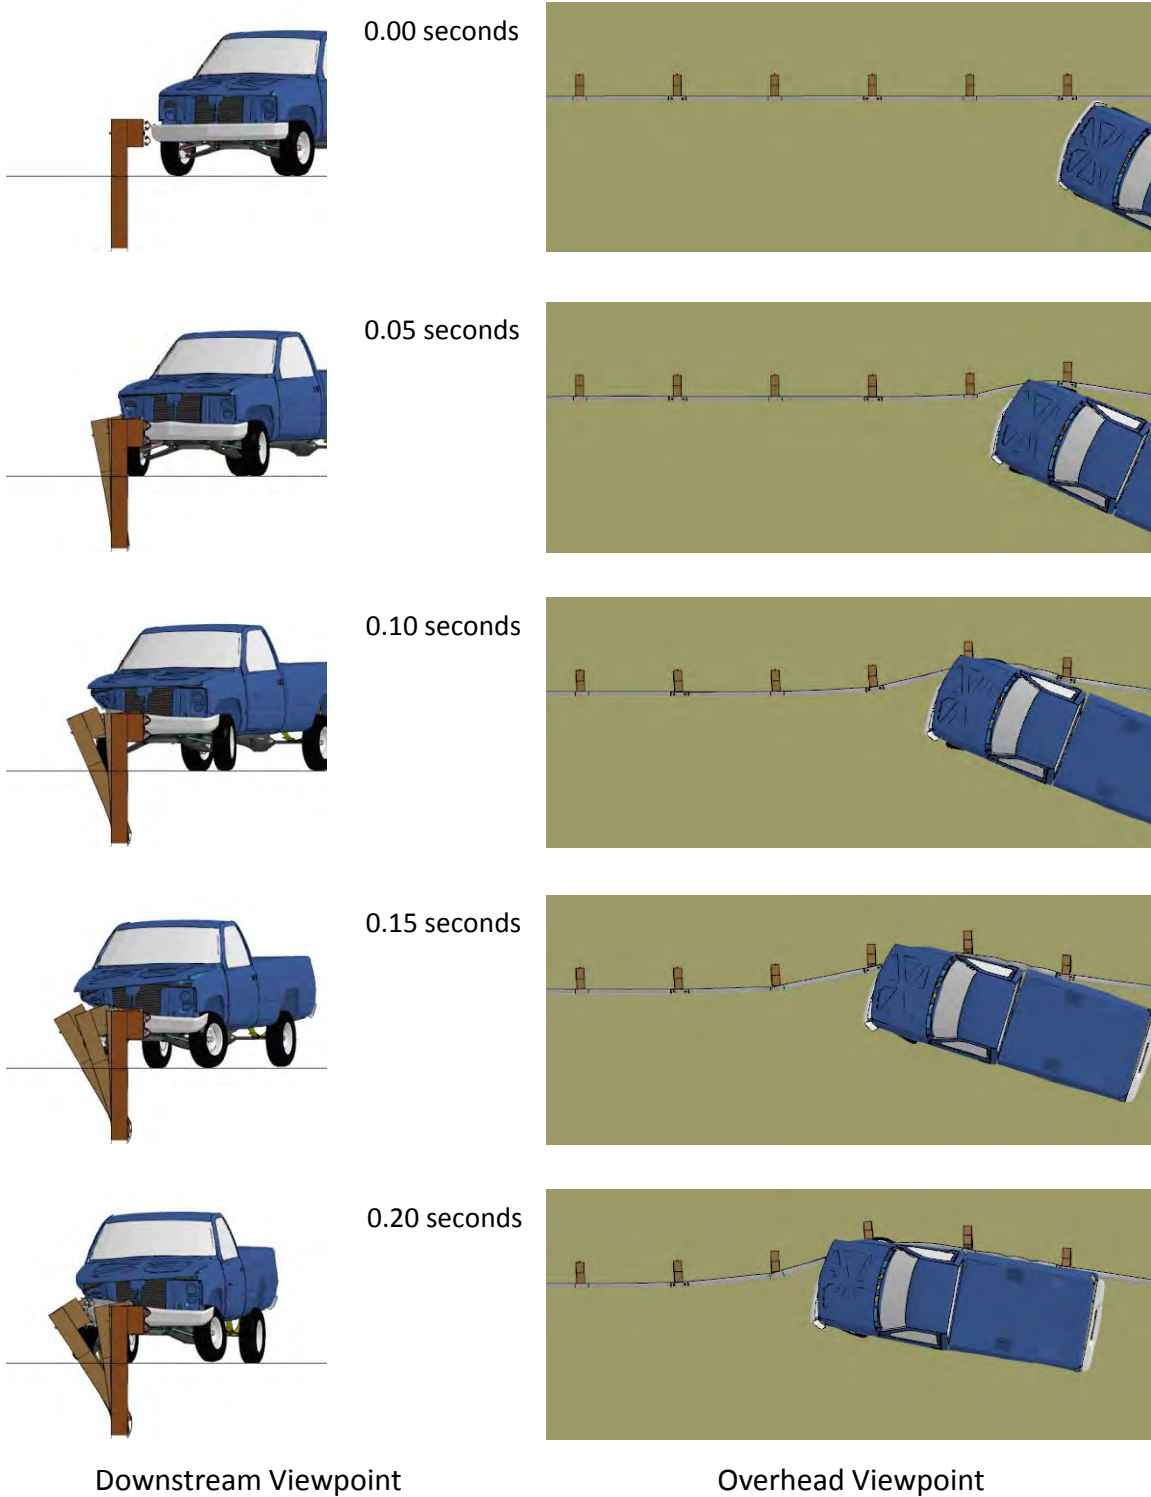
**Figure C-3. Sequential views from a downstream and overhead viewpoint for analysis case: 133% baseline anchor strength.**

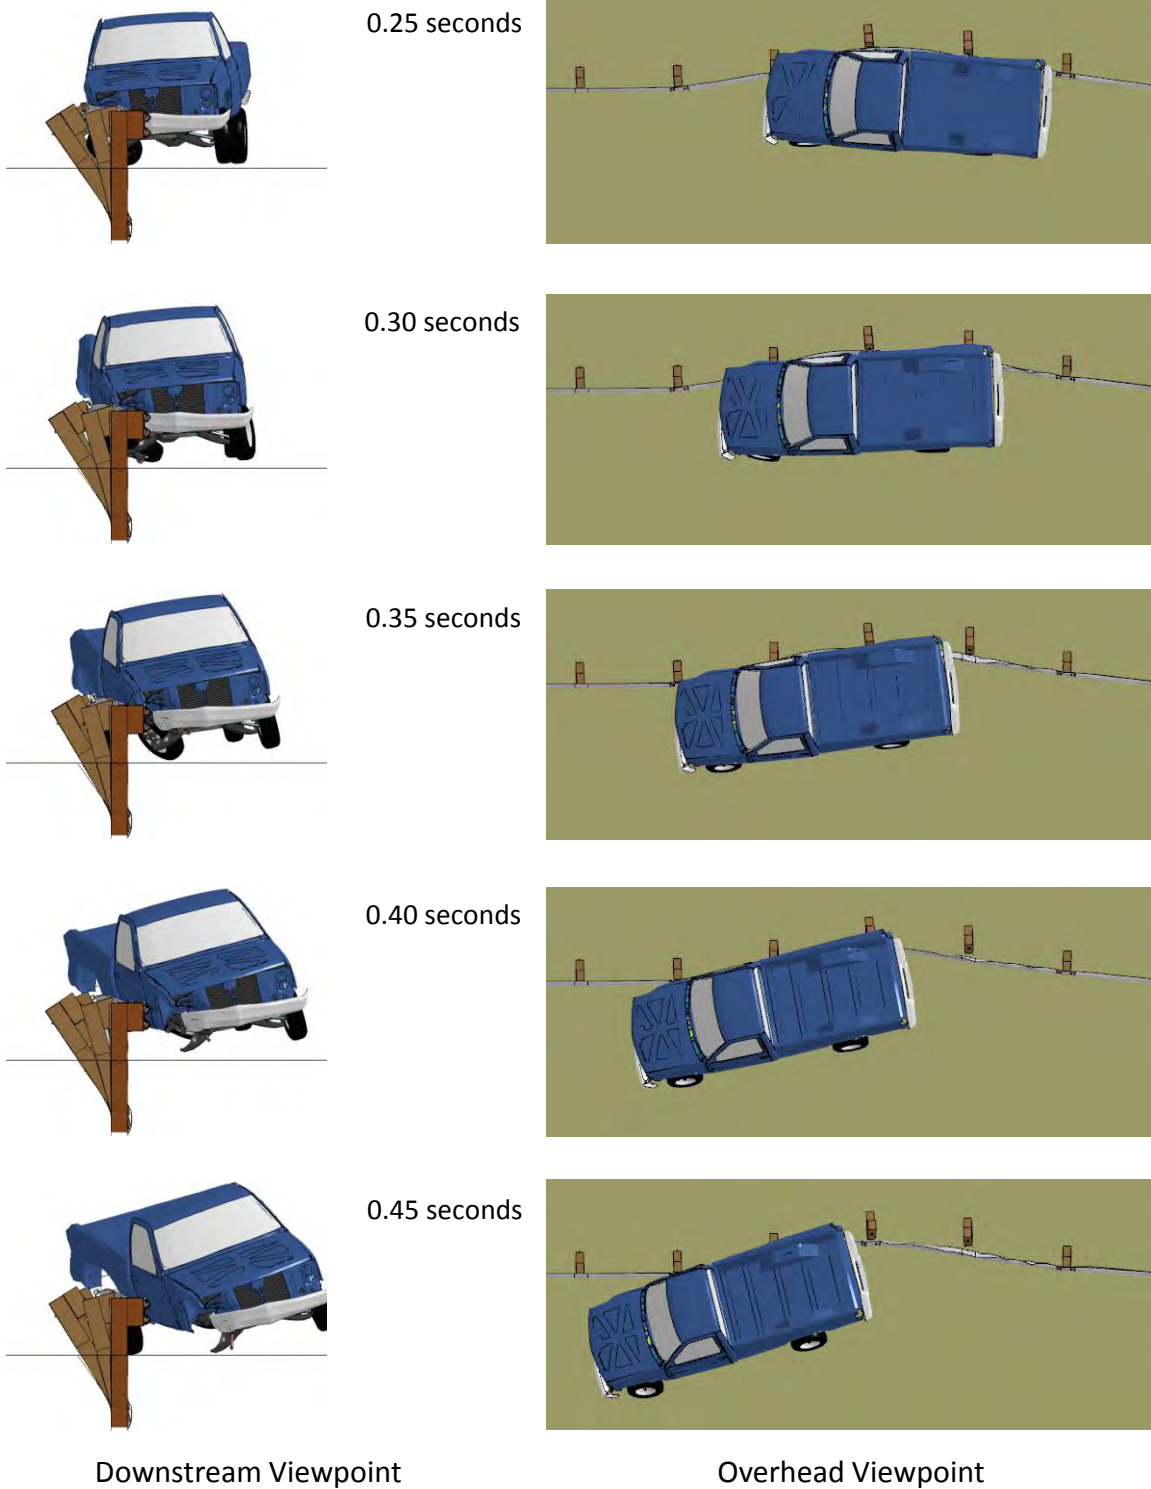
**Figure C-3. [CONTINUED] Sequential views from a downstream and overhead viewpoint for analysis case: 133% baseline anchor strength.**

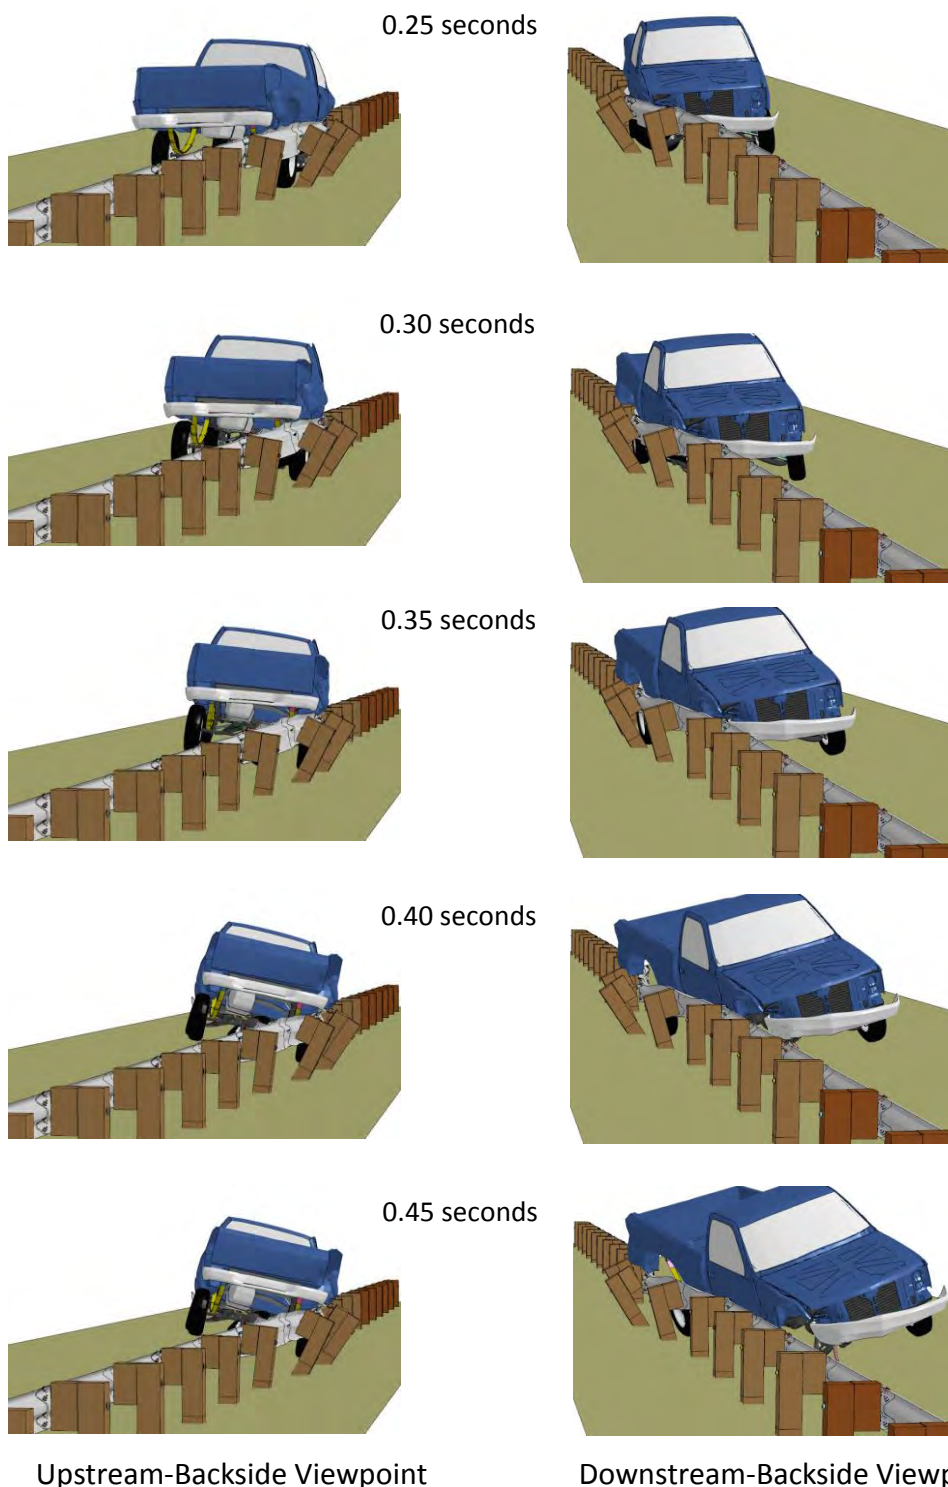
**Figure C-4. [CONTINUED] Sequential views from an upstream-backside and a downstream-backside viewpoint for analysis case: 133% baseline anchor strength.**

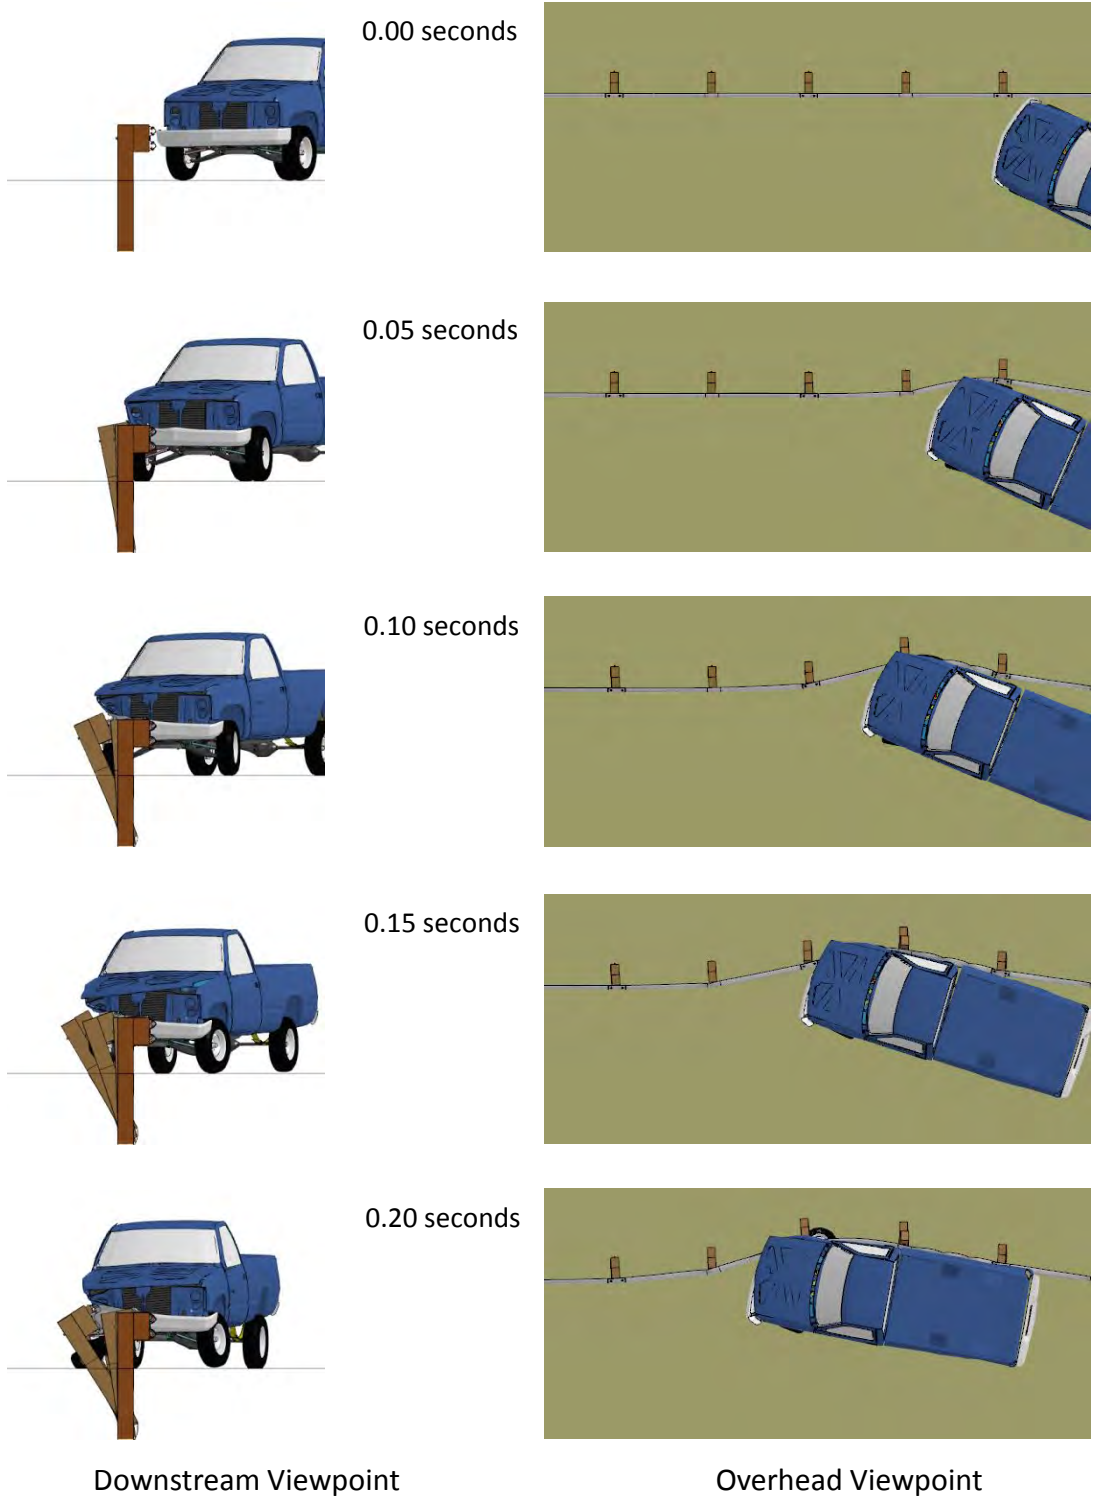
**Figure C-5. Sequential views from a downstream and overhead viewpoint for analysis case: 67% baseline anchor strength.**

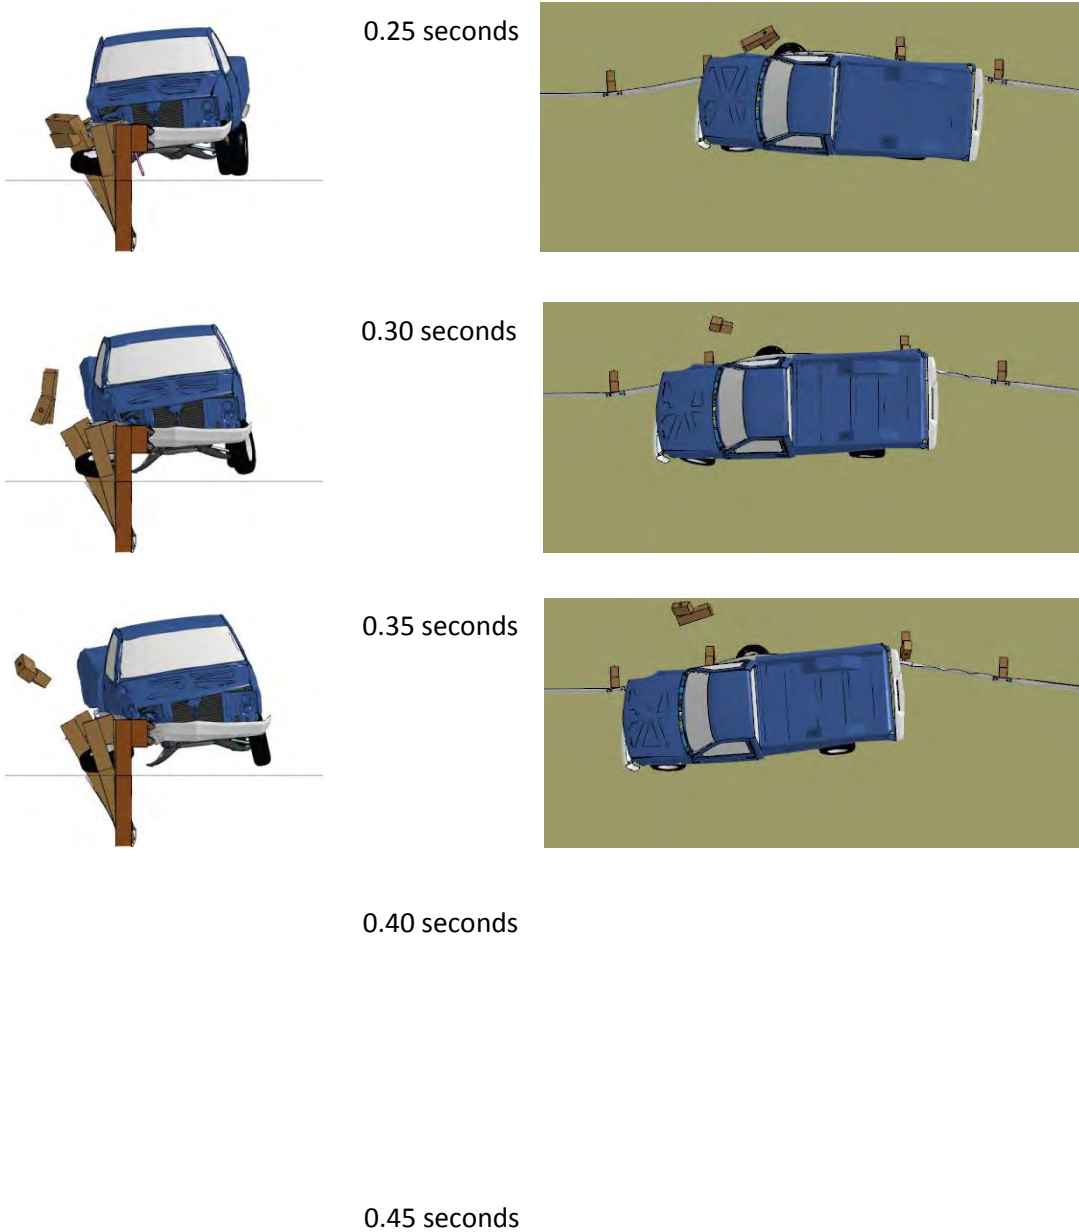
**Figure C-5. [CONTINUED] Sequential views from a downstream and overhead viewpoint for analysis case: 67% baseline anchor strength.**

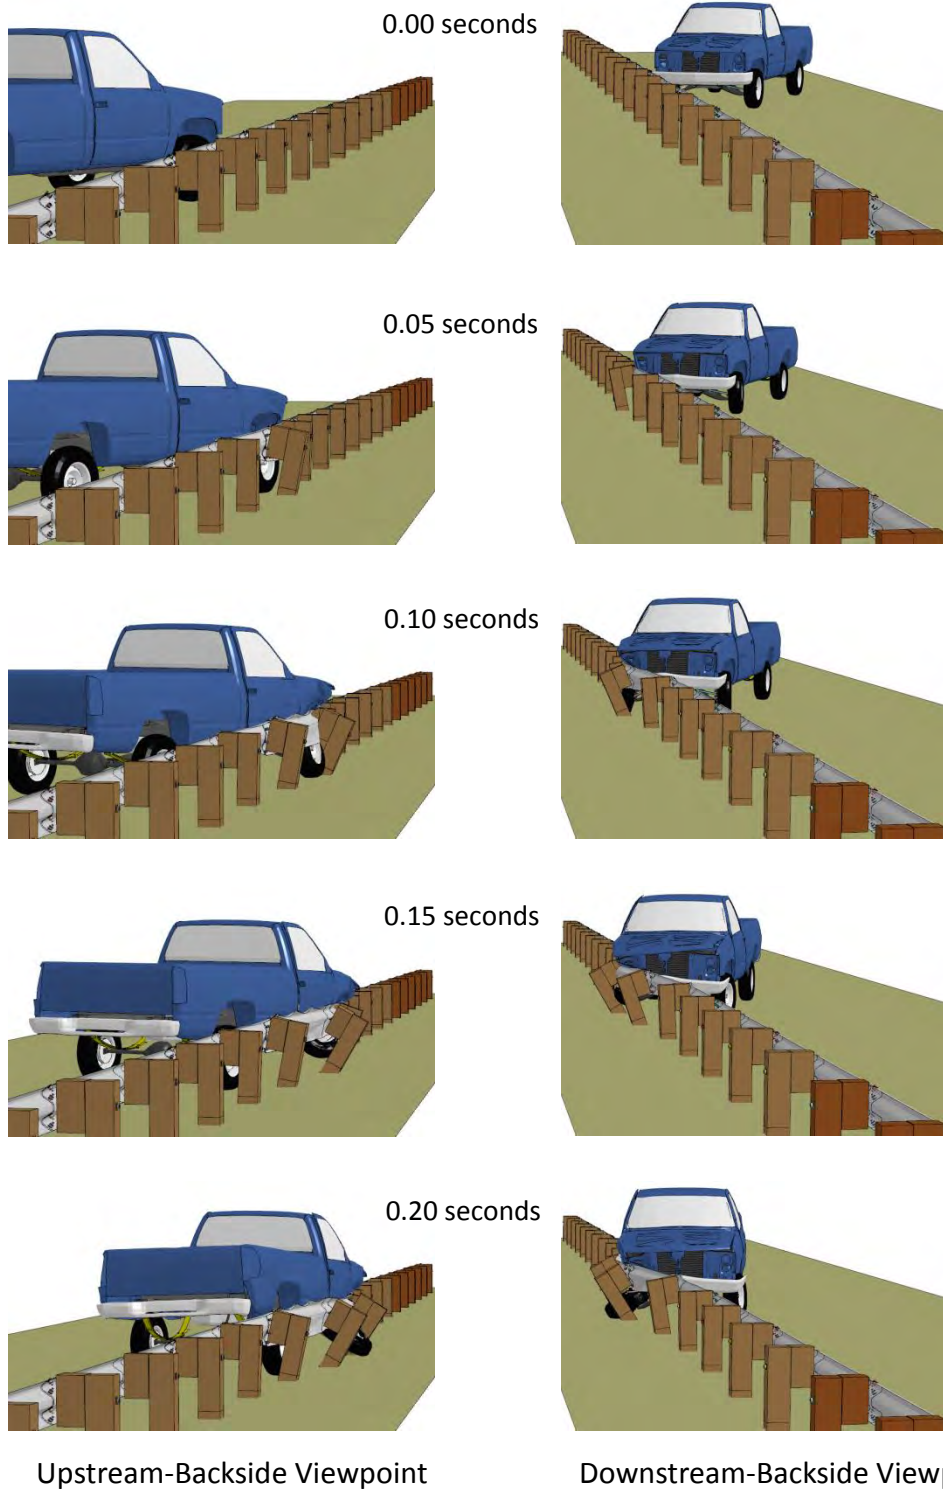
**Figure C-6. Sequential views from an upstream-backside and a downstream-backside viewpoint for analysis case: 67% baseline anchor strength.**

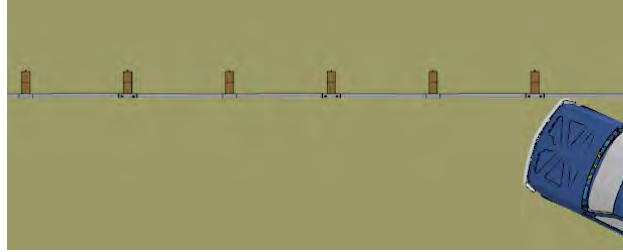
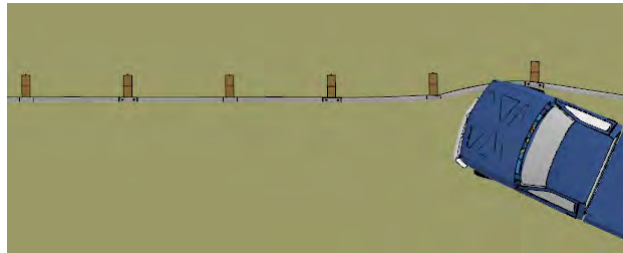
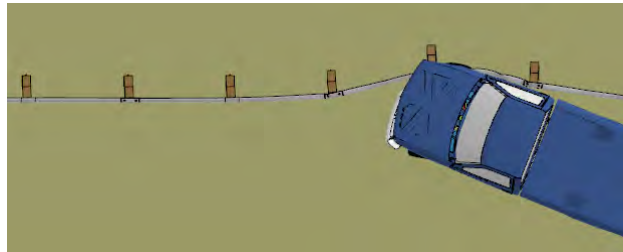
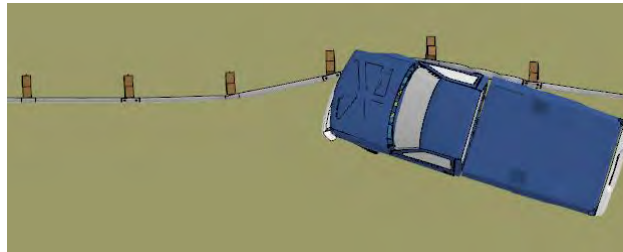
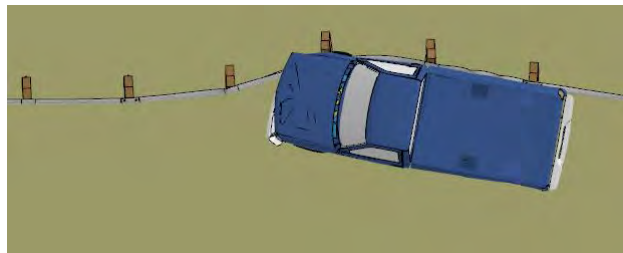
**Figure C-7. Sequential views from a downstream and overhead viewpoint for analysis case: 47% baseline anchor strength.**
