# **A Guide for W-Beam Guardrail Damage Assessment**

A Field Manual for  
Highway Maintenance Personnel

National Cooperative  
Highway Research  
Program  
Project 22-28

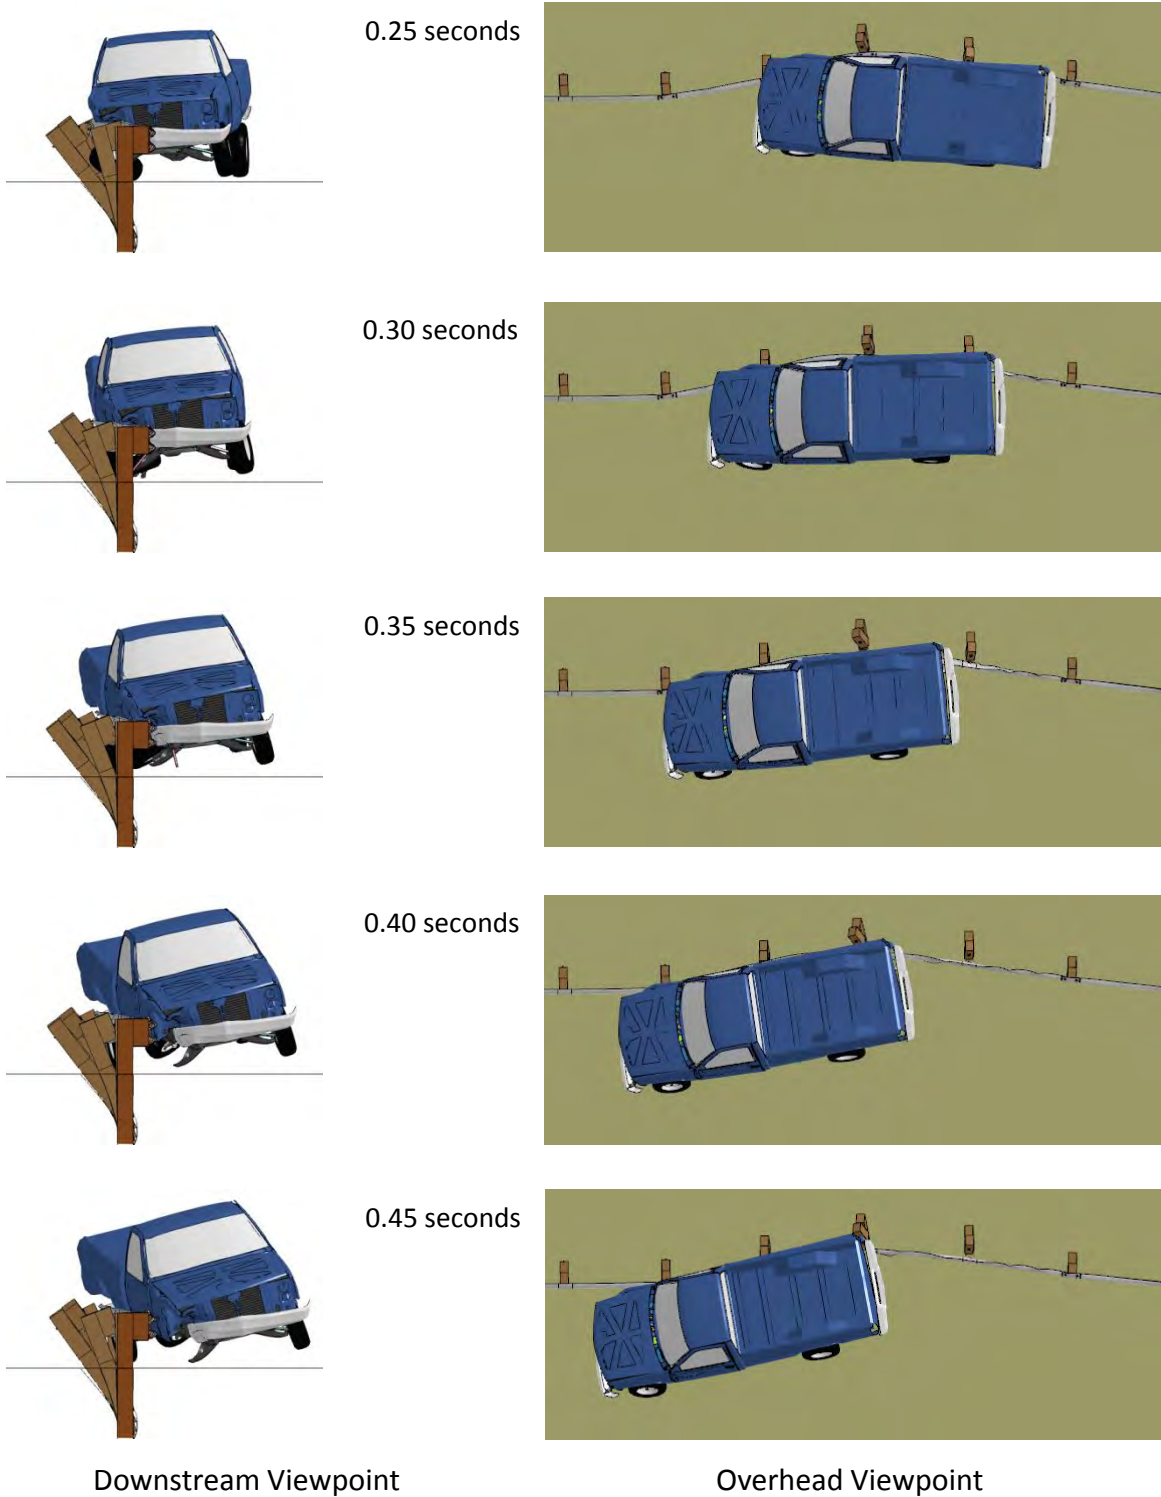
**Figure C-7. [CONTINUED] Sequential views from a downstream and overhead viewpoint for analysis case: 47% baseline anchor strength.**

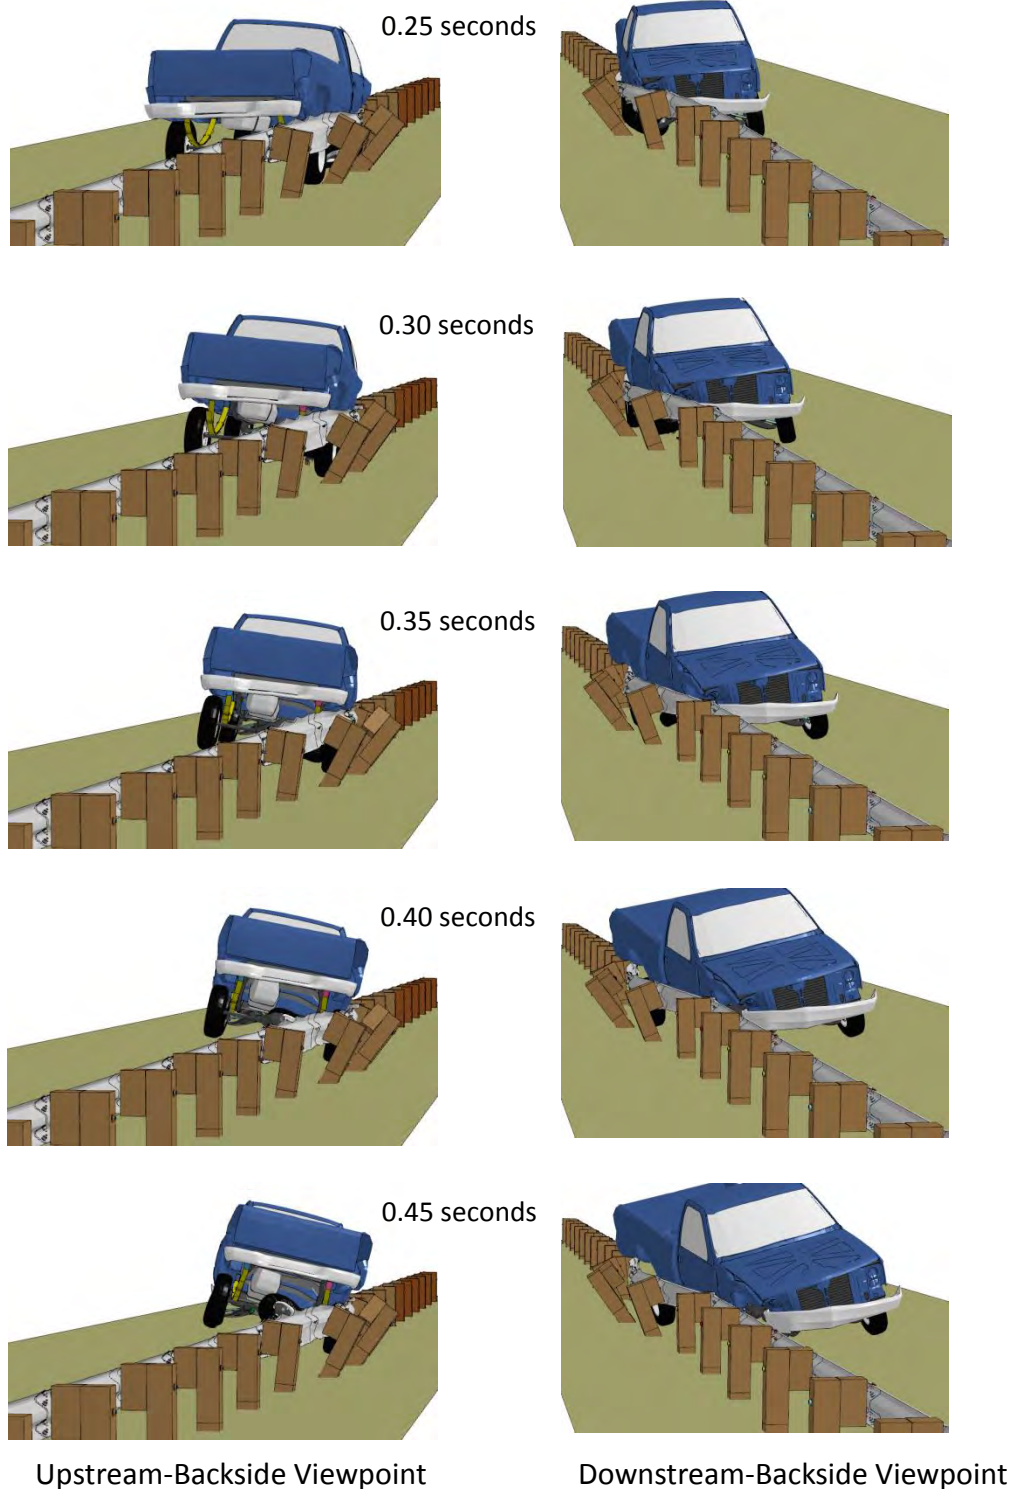
**Figure C-8. [CONTINUED] Sequential views from an upstream-backside and a downstream-backside viewpoint for analysis case: 47% baseline anchor strength.**

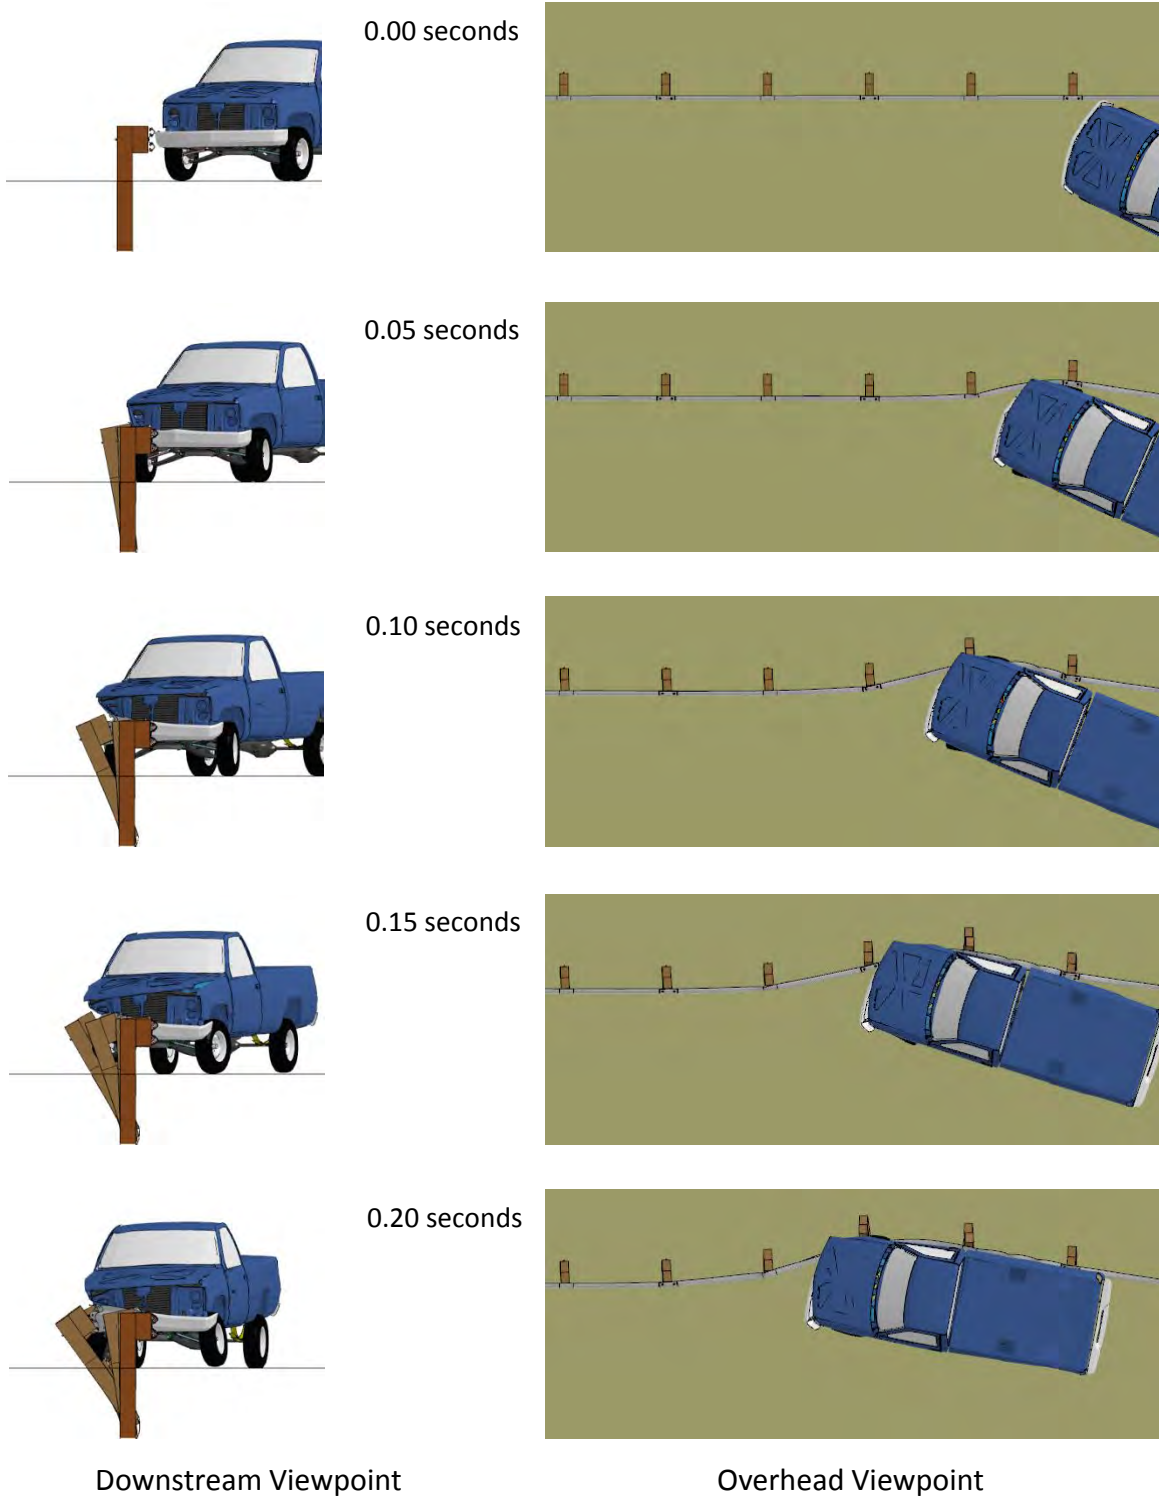
**Figure D-1. Sequential views from a downstream and overhead viewpoint for analysis case: 47% baseline anchor strength and DL0 posts.**

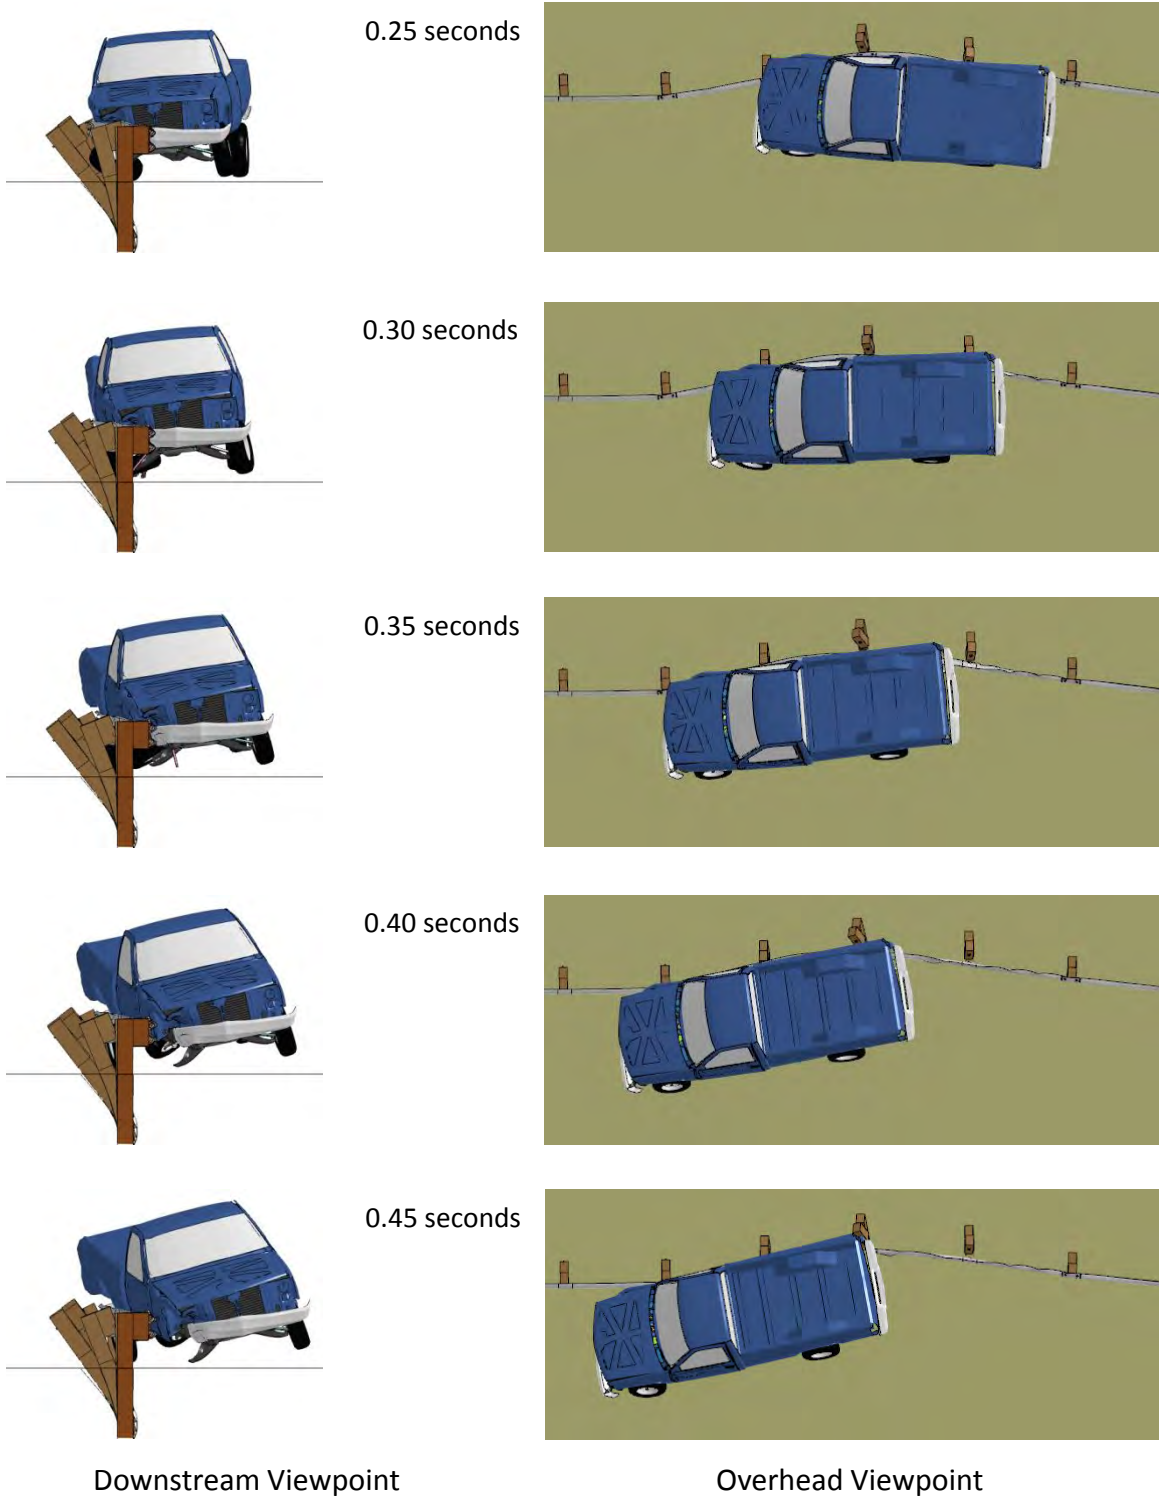
**Figure D-1. [CONTINUED] Sequential views from a downstream and overhead viewpoint for analysis case: 47% baseline anchor strength and DL0 posts.**

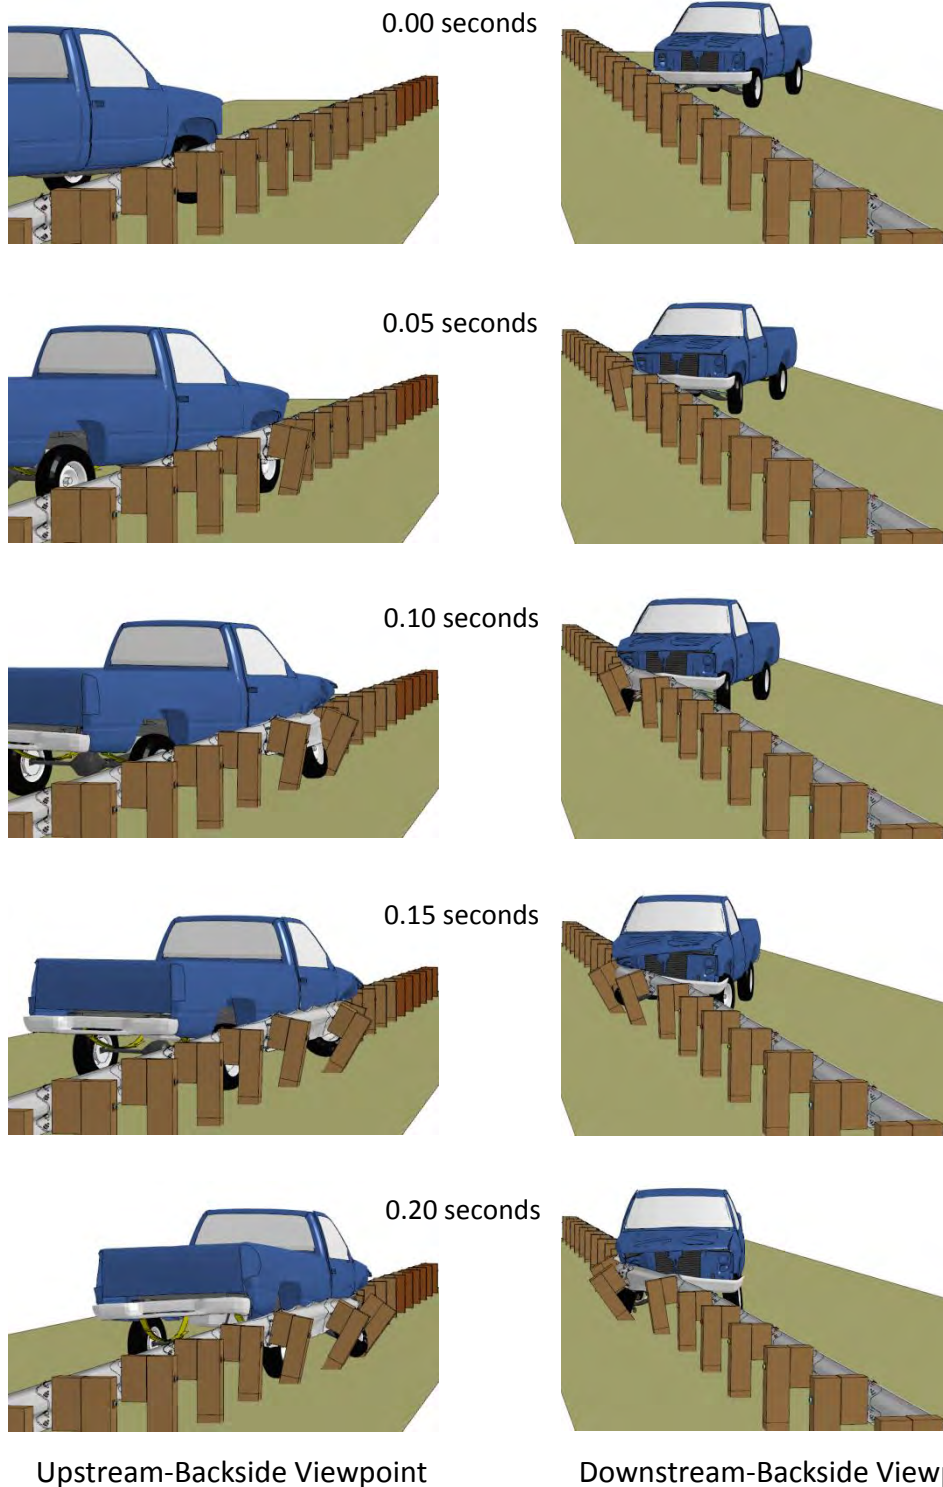
**Figure D-2. Sequential views from an upstream-backside and a downstream-backside viewpoint for analysis case: 47% baseline anchor strength and DL0 posts.**

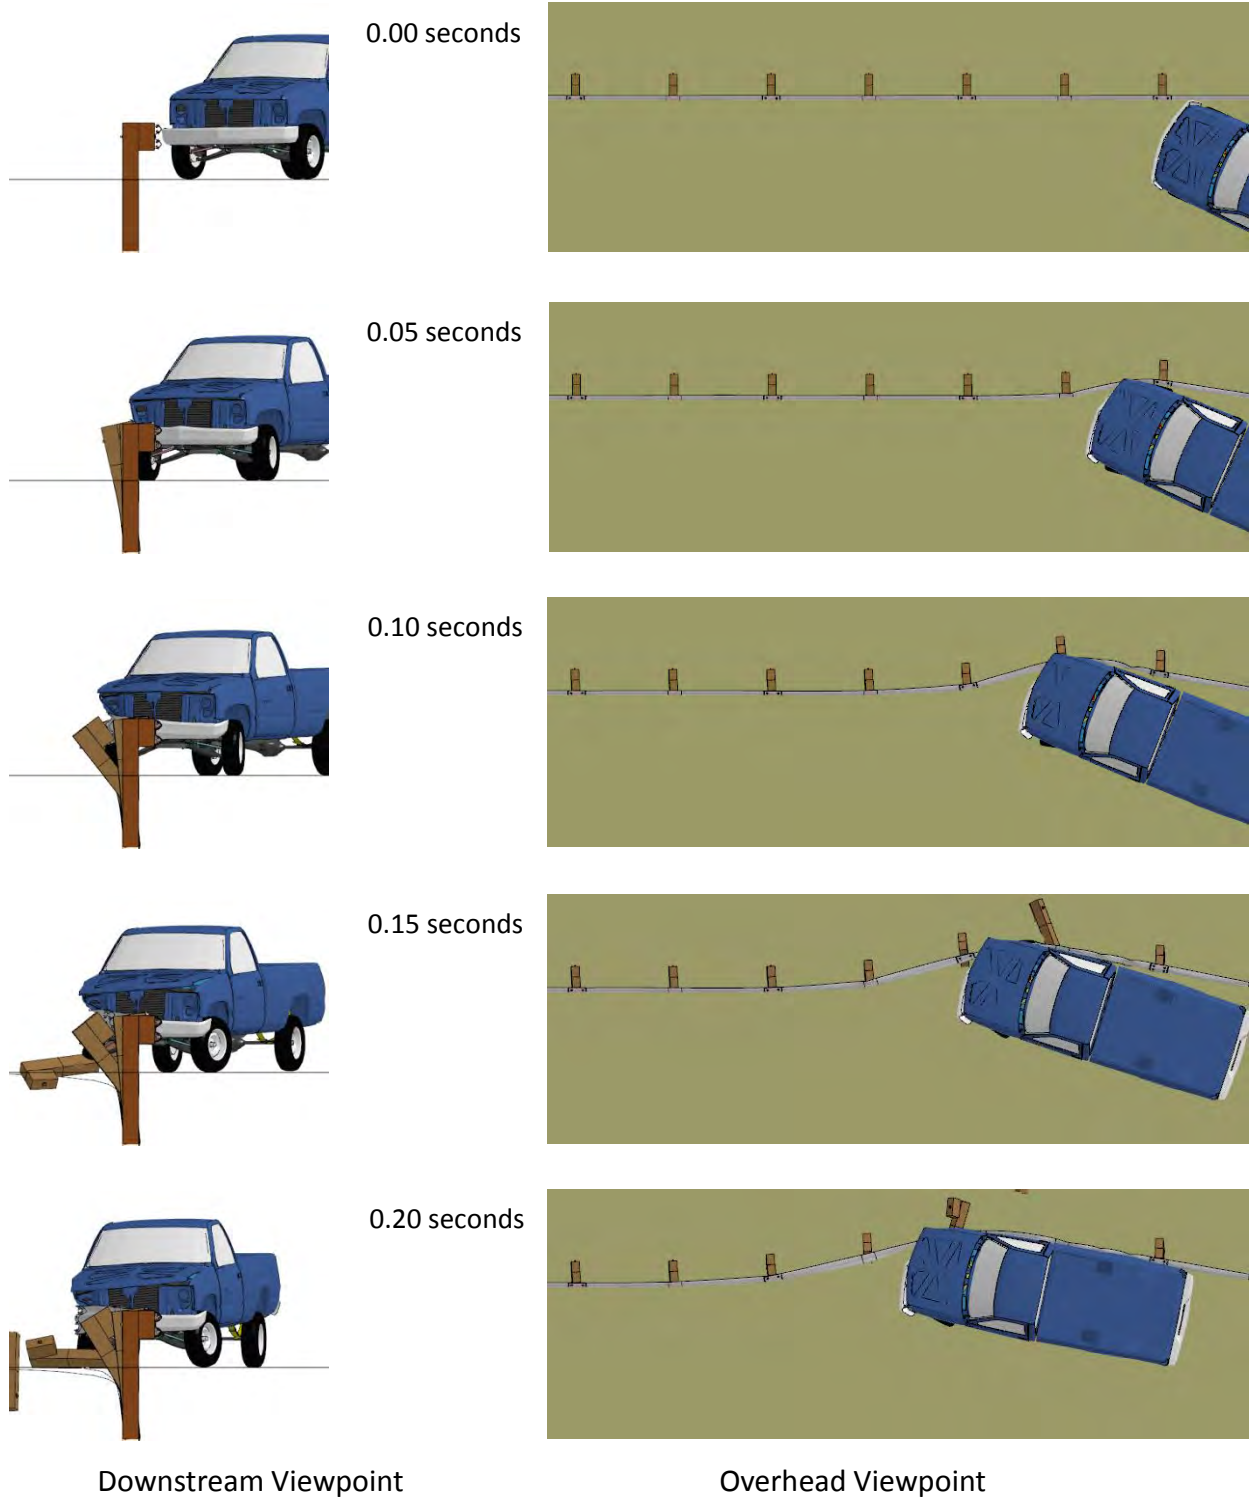
**Figure D-3. Sequential views from a downstream and overhead viewpoint for analysis case: 47% baseline anchor strength and DL1 posts.**

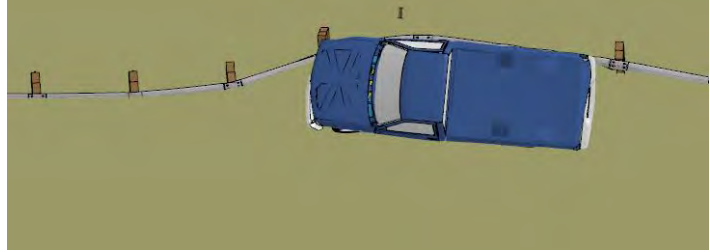
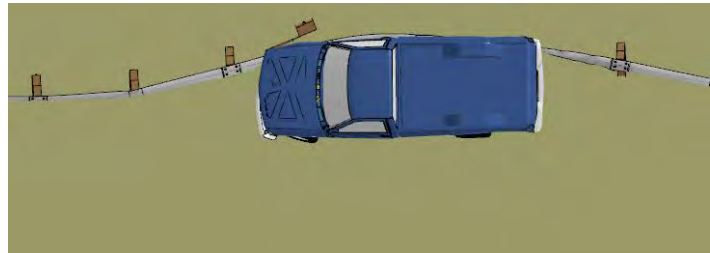
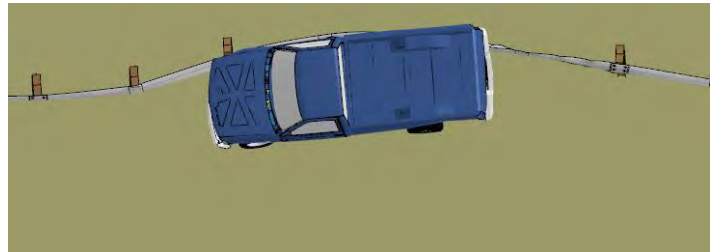
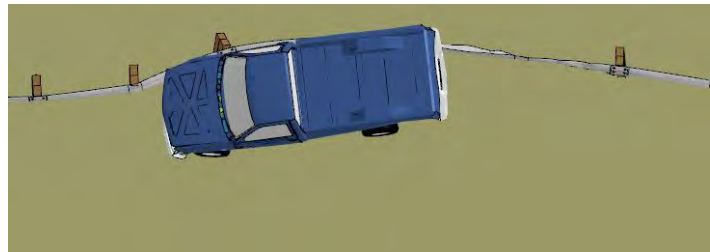
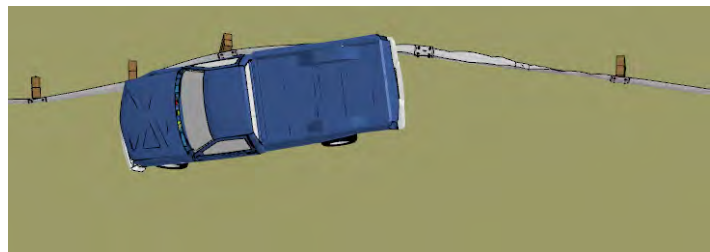
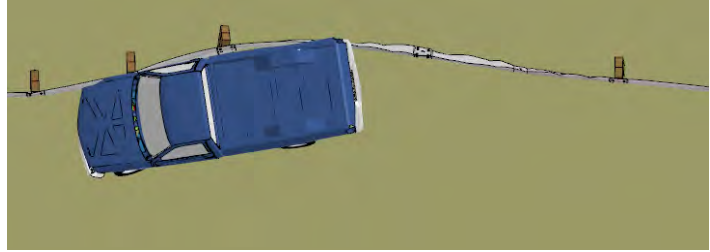
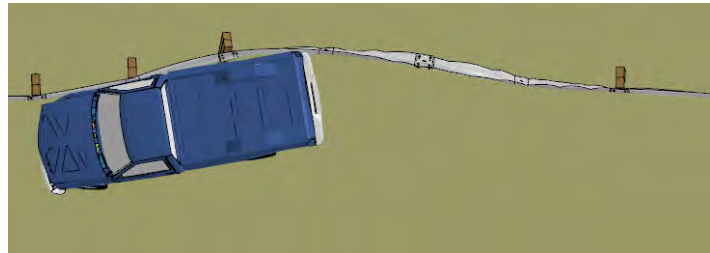
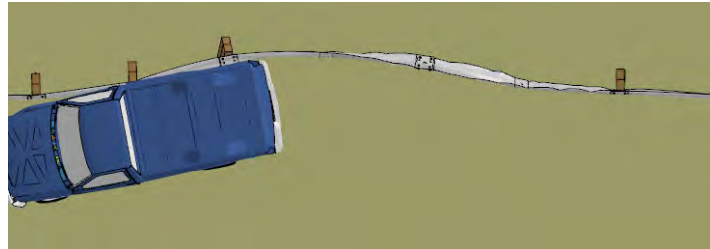
**Figure D-3. [CONTINUED] Sequential views from a downstream and overhead viewpoint for analysis case: 47% baseline anchor strength and DL1 posts.**

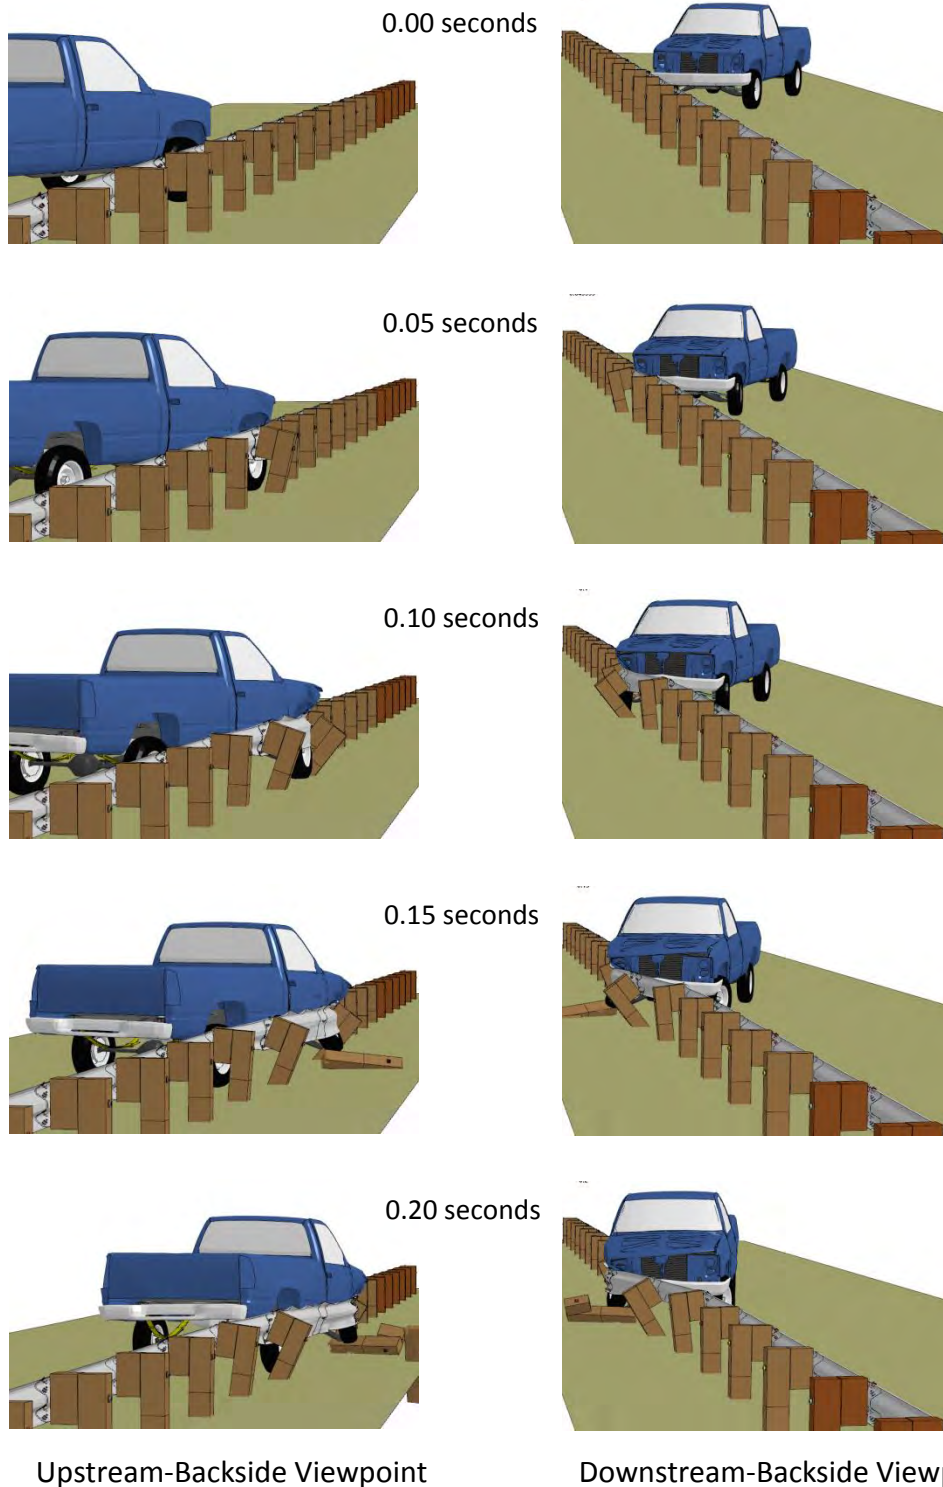
**Figure D-4. Sequential views from an upstream-backside and a downstream-backside viewpoint for analysis case: 47% baseline anchor strength and DL1 posts.**

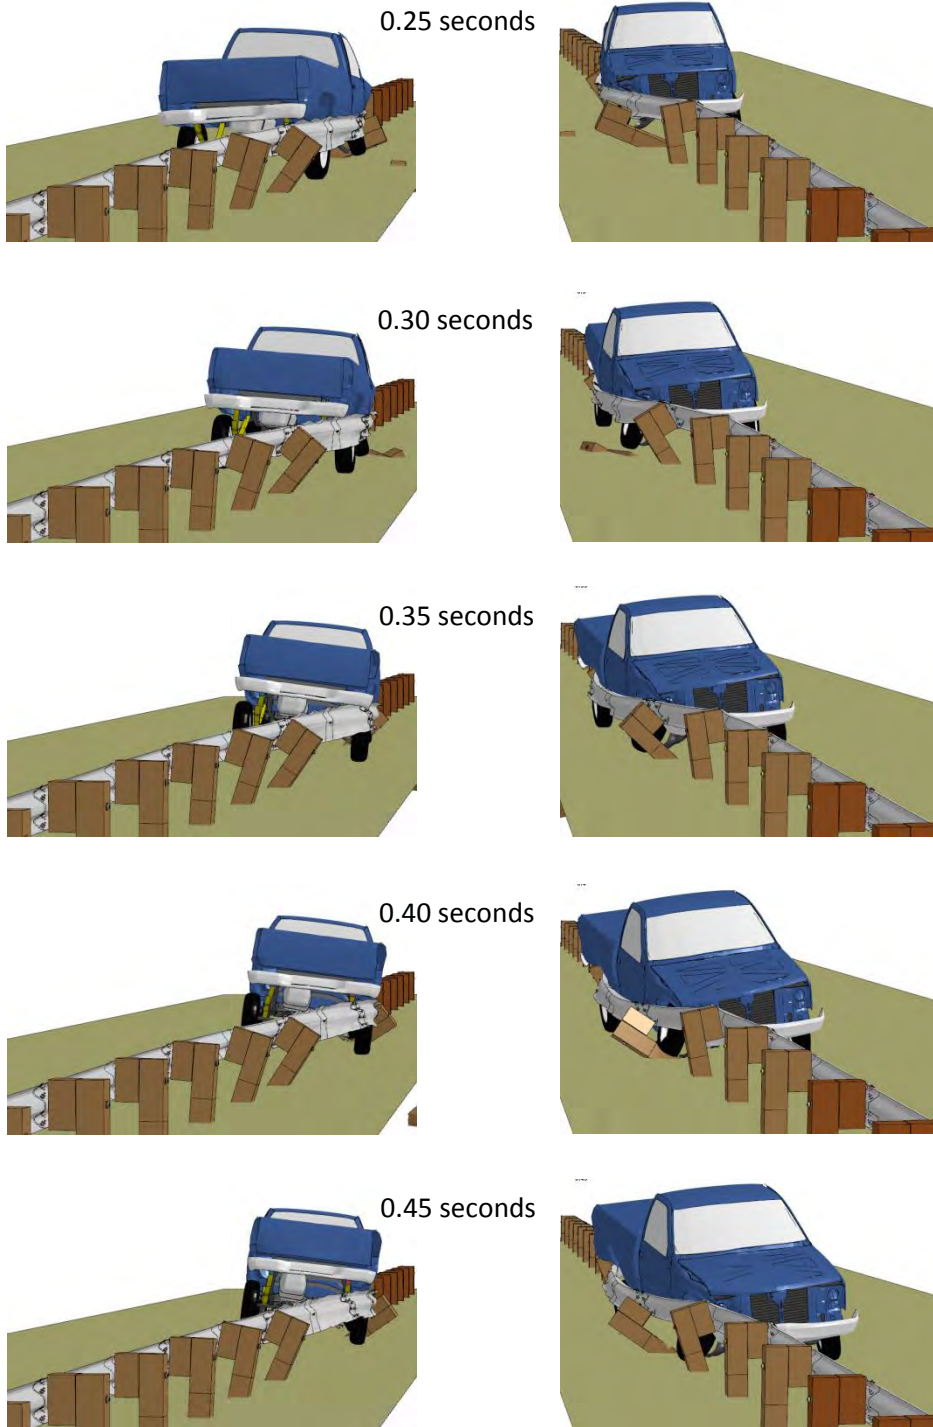
**Figure D-4. [CONTINUED] Sequential views from an upstream-backside and a downstream-backside viewpoint for analysis case: 47% baseline anchor strength and DL1 posts.**

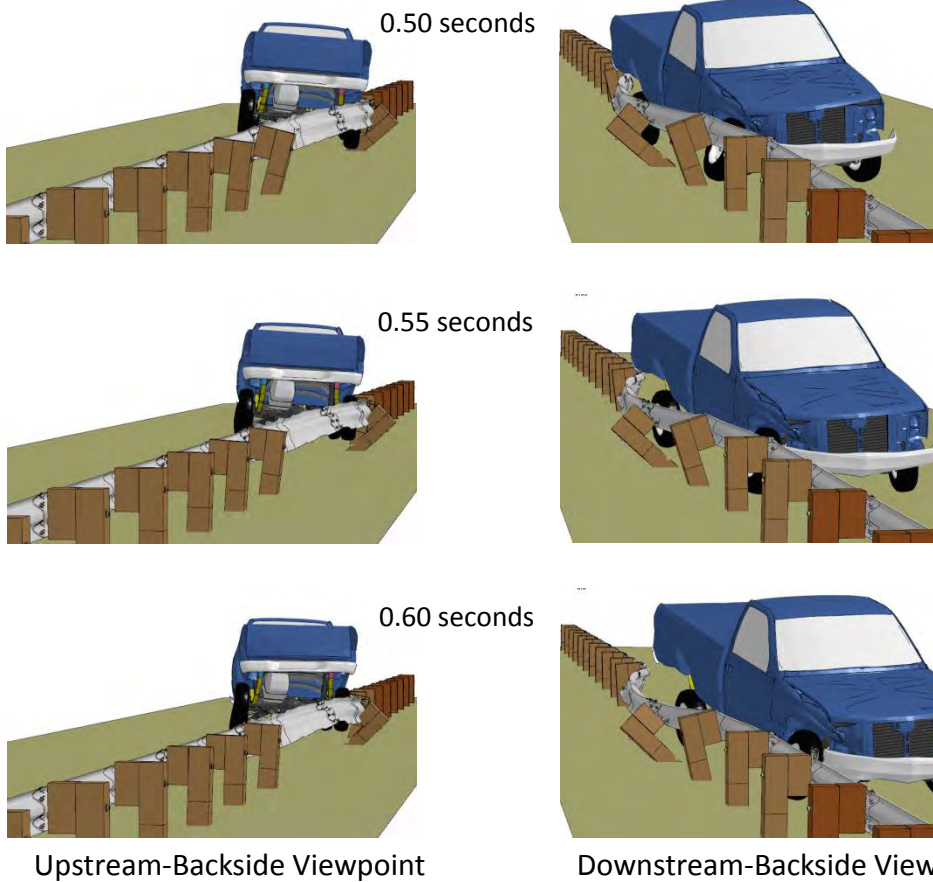
**Figure D-4. [CONTINUED] Sequential views from an upstream-backside and a downstream-backside viewpoint for analysis case: 47% baseline anchor strength and DL1 posts.**

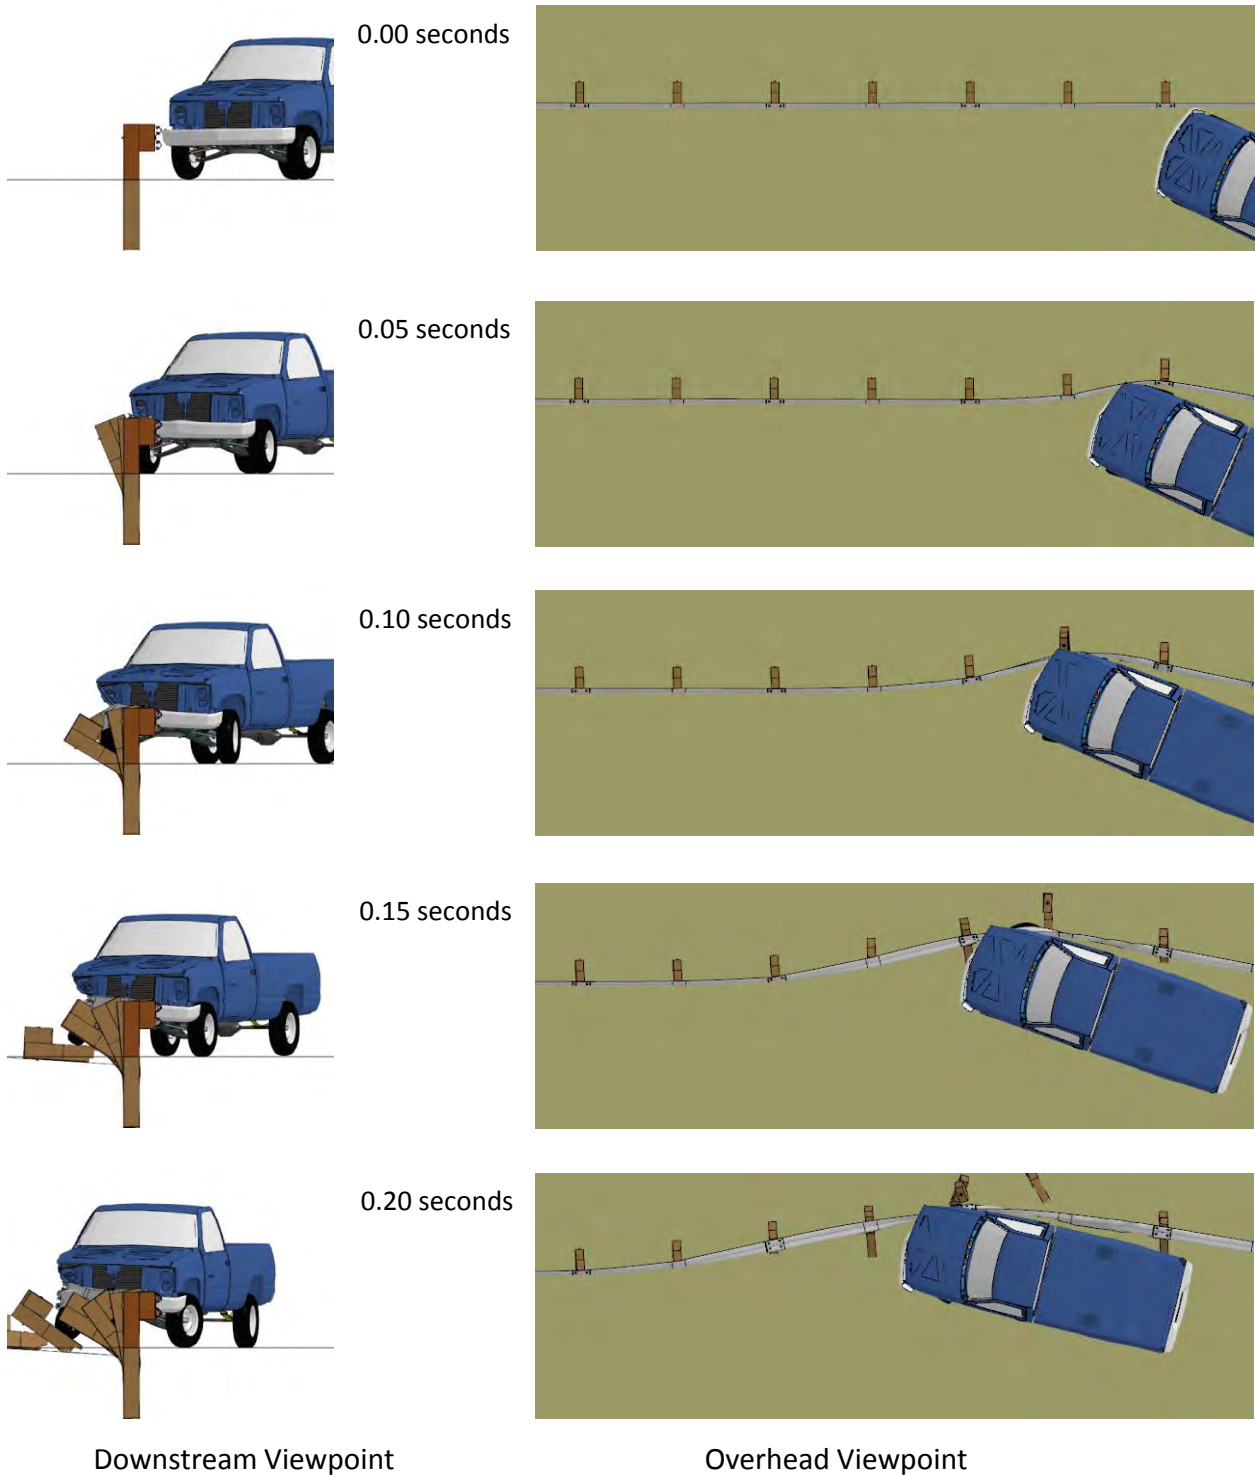
**Figure D-5. Sequential views from a downstream and overhead viewpoint for analysis case: 47% baseline anchor strength and DL1 posts.**

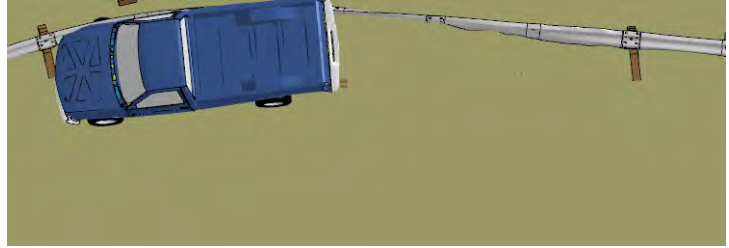
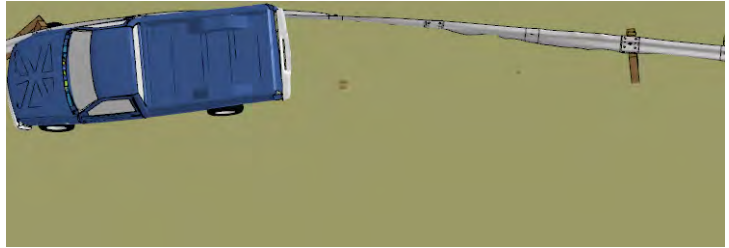
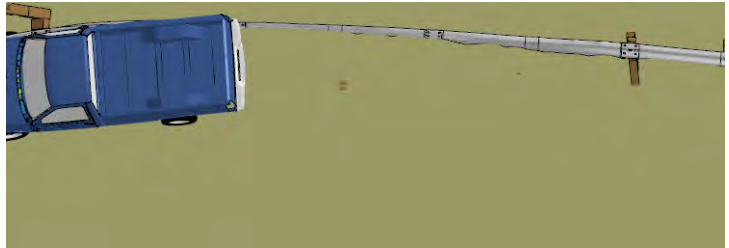
**Figure D-5. [CONTINUED] Sequential views from a downstream and overhead viewpoint for analysis case: 47% baseline anchor strength and DL1 posts.**

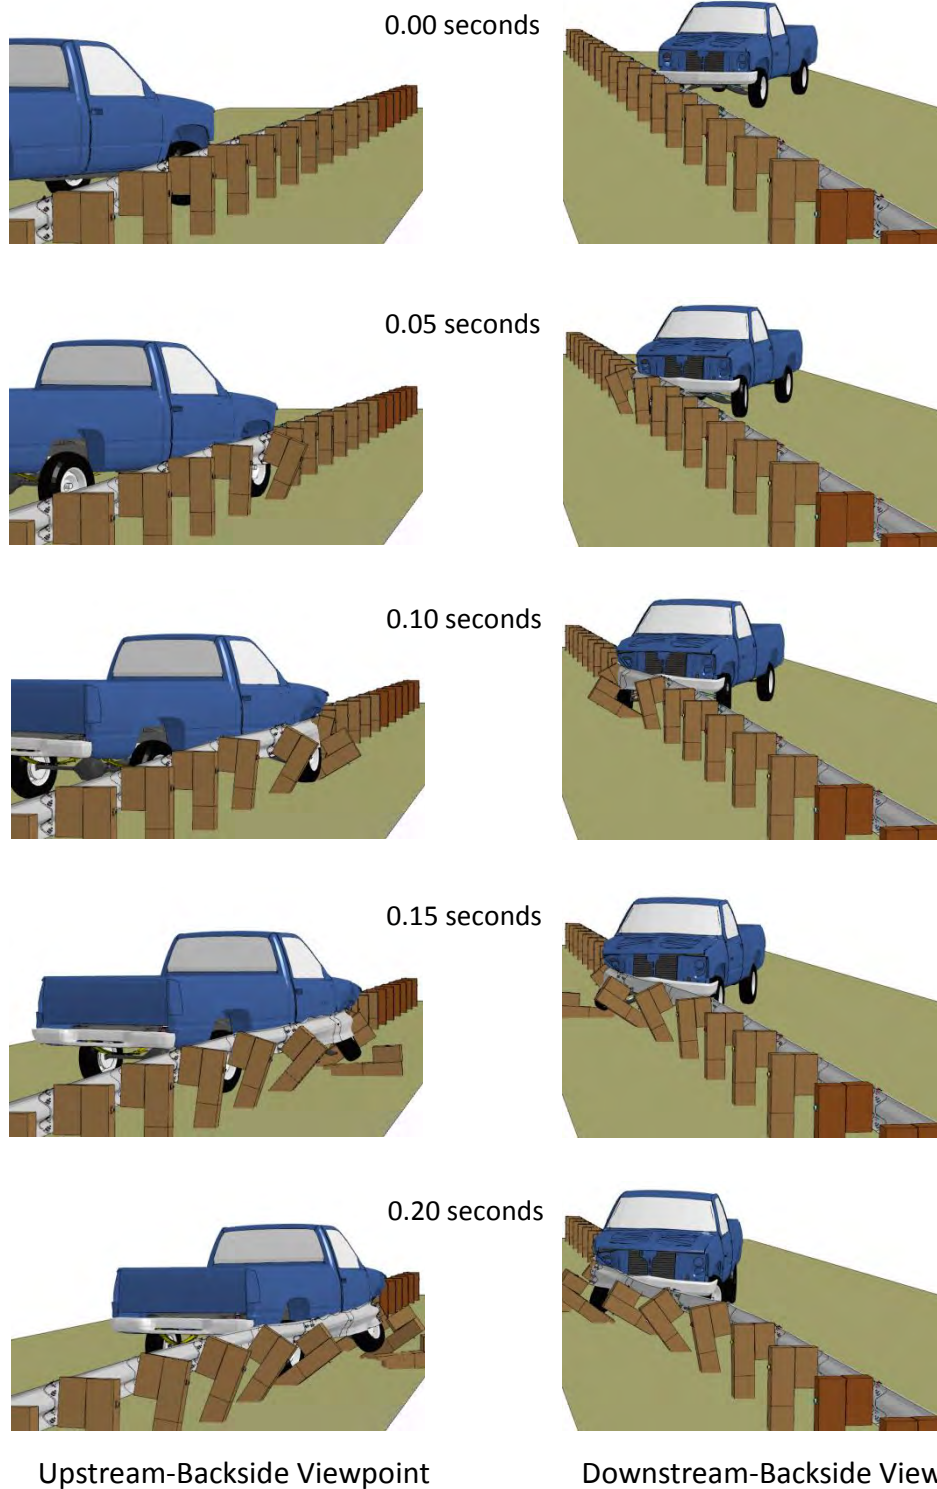
**Figure D-6. Sequential views from an upstream-backside and a downstream-backside viewpoint for analysis case: 47% baseline anchor strength and DL2 Posts.**

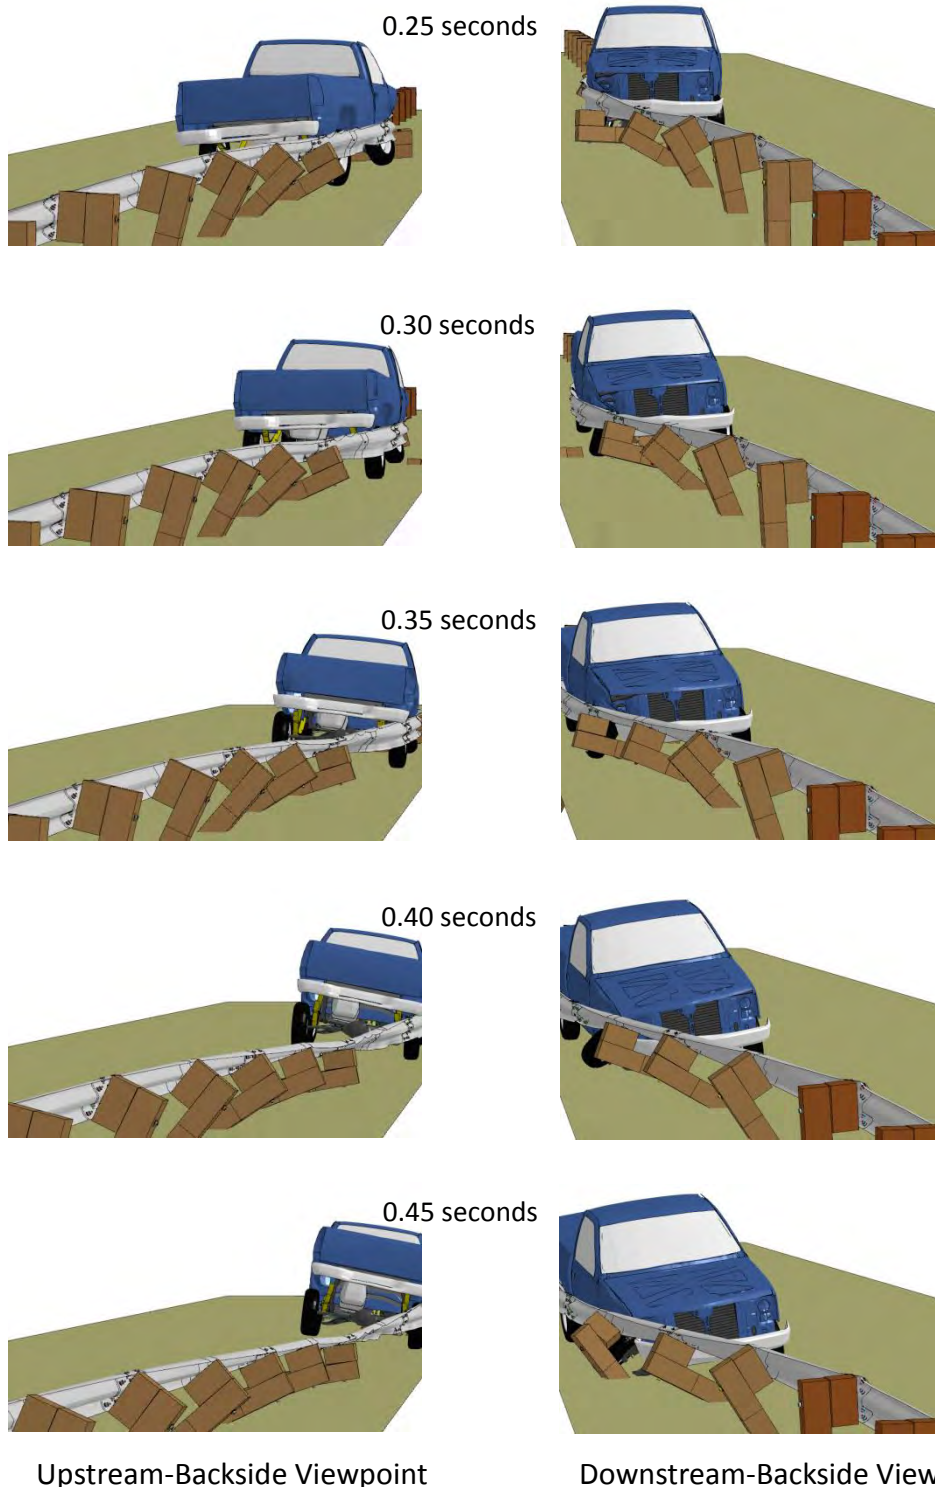
**Figure D-6. [CONTINUED] Sequential views from an upstream-backside and a downstream-backside viewpoint for analysis case: 47% baseline anchor strength and DL2 Posts.**

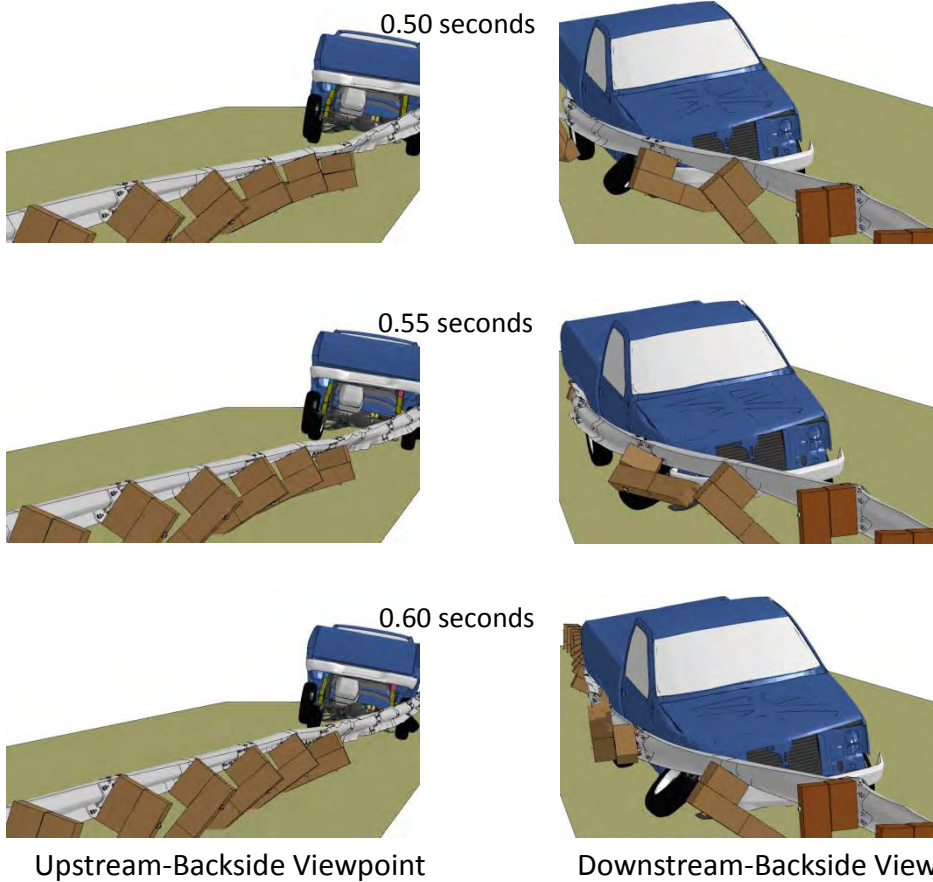
**Figure D-6. [CONTINUED] Sequential views from an upstream-backside and a downstream-backside viewpoint for analysis case: 47% baseline anchor strength and DL2 Posts.**
