# **A Guide for W-Beam Guardrail Damage Assessment**

A Field Manual for  
Highway Maintenance Personnel

National Cooperative  
Highway Research  
Program  
Project 22-28

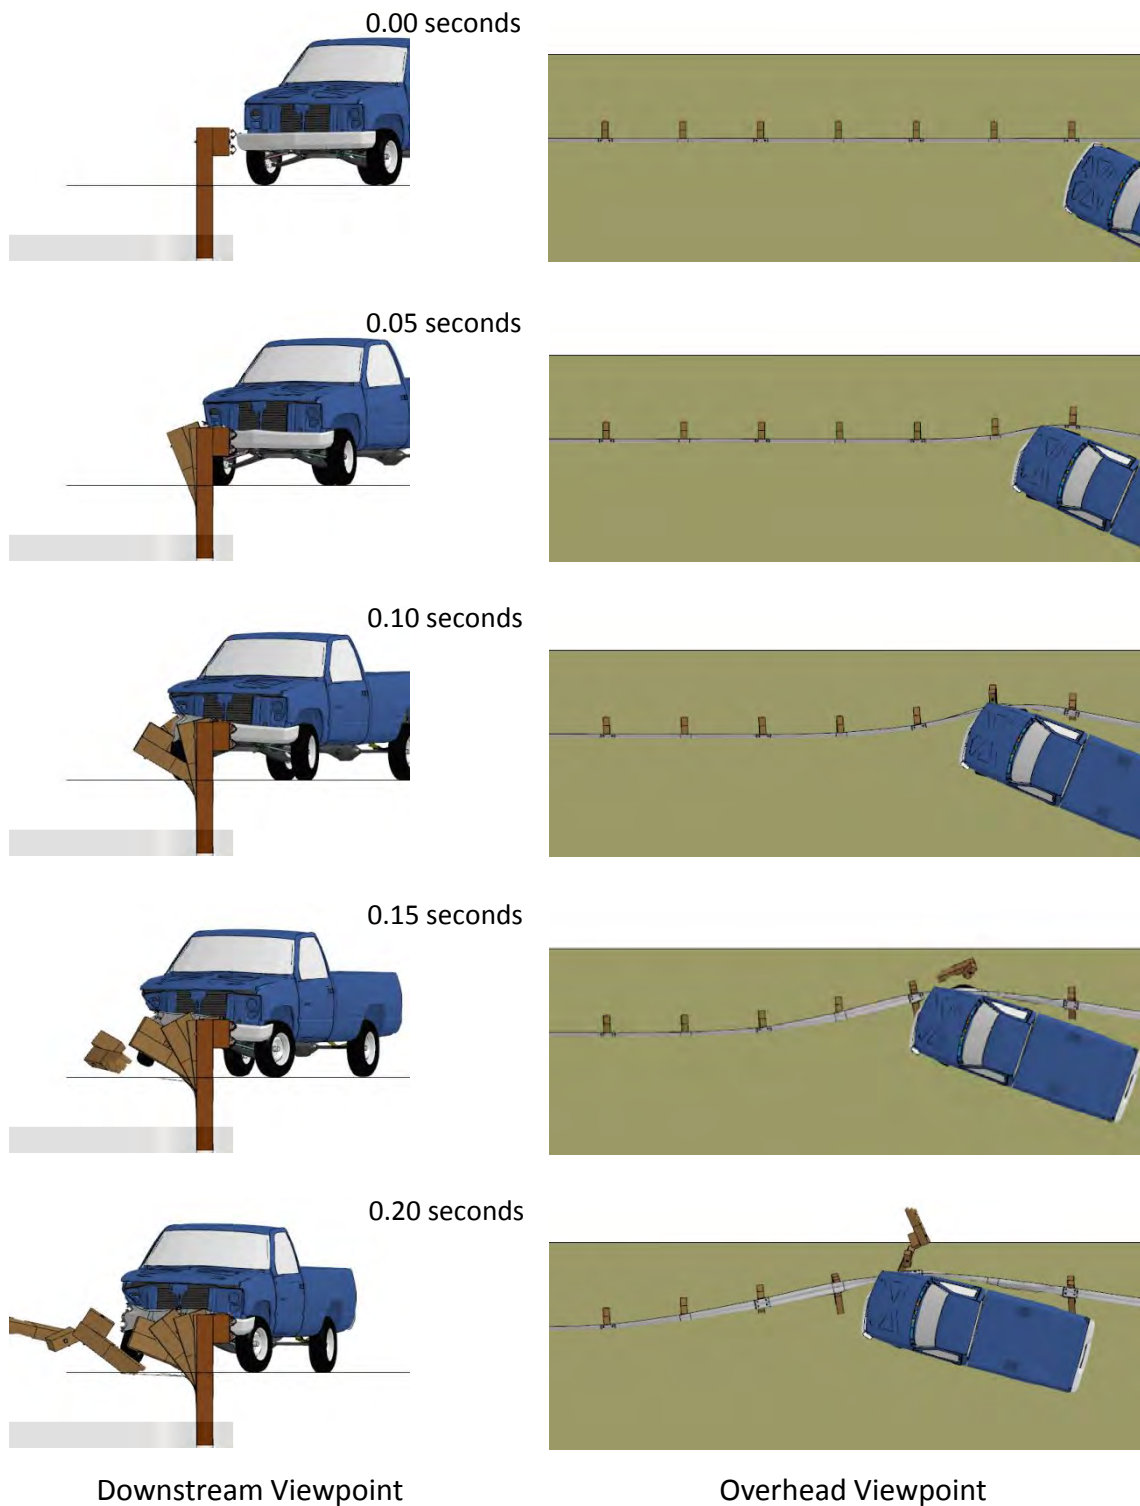
**Figure D-7. Sequential views from a downstream and overhead viewpoint for analysis case: 47% baseline anchor strength and DL3 posts.**

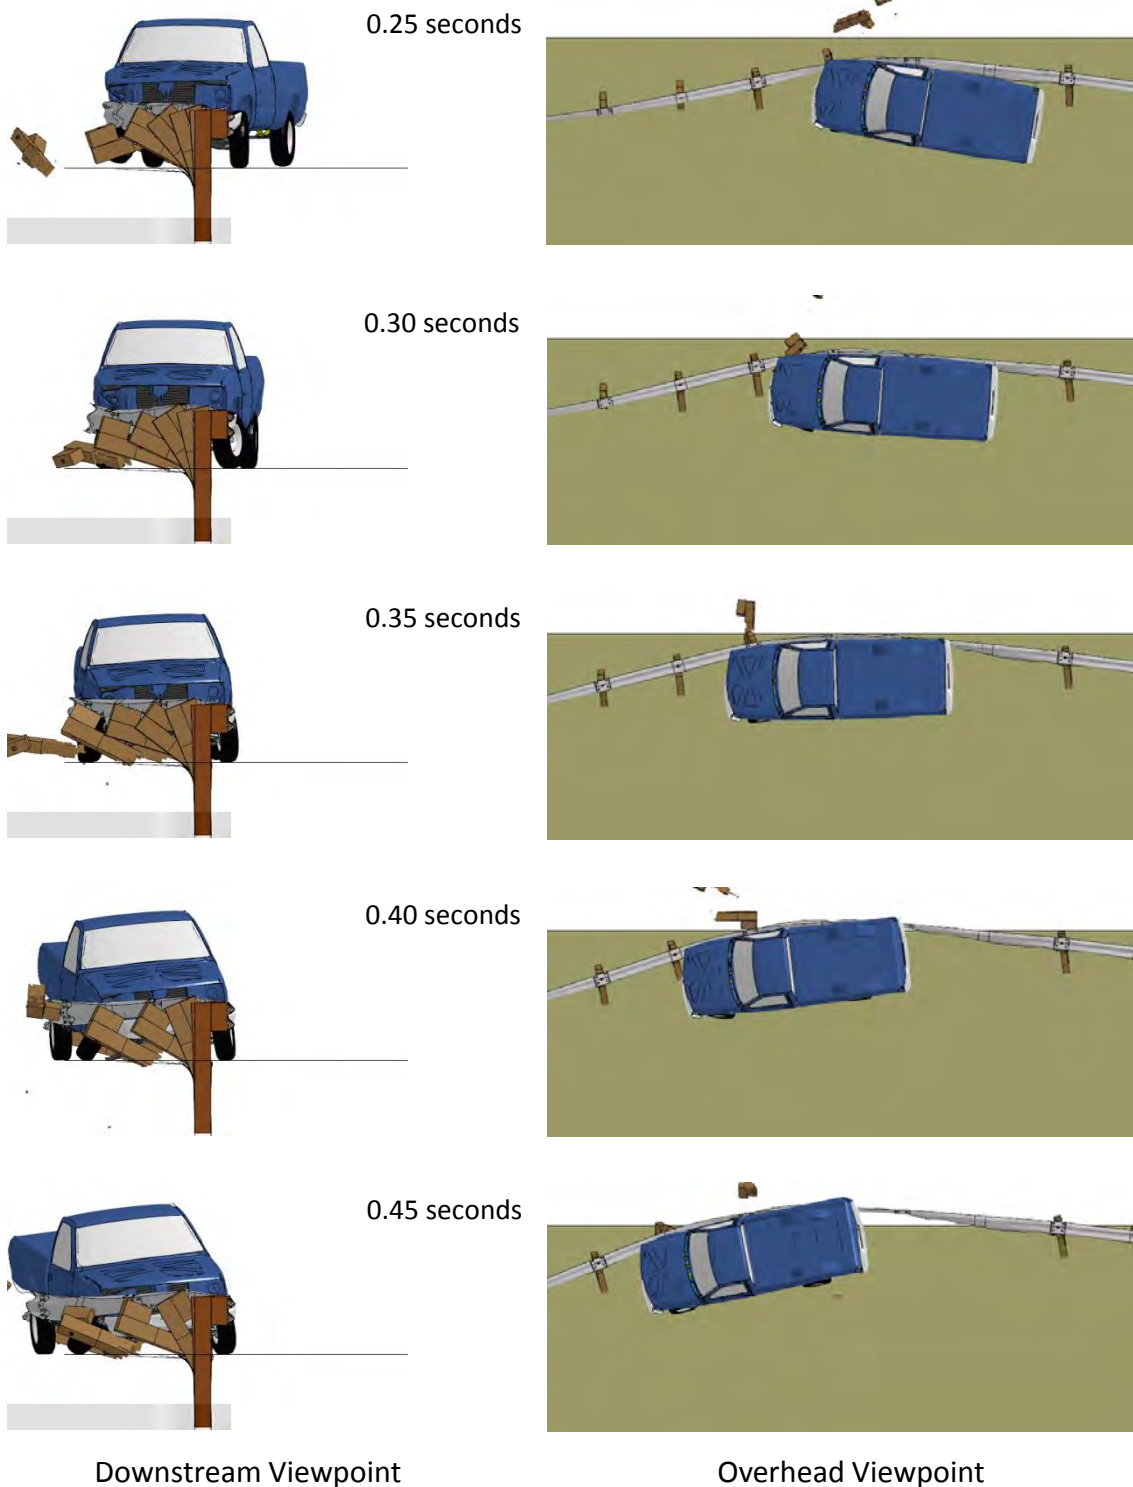
**Figure D-7. [CONTINUED] Sequential views from a downstream and overhead viewpoint for analysis case: 47% baseline anchor strength and DL3 posts.**

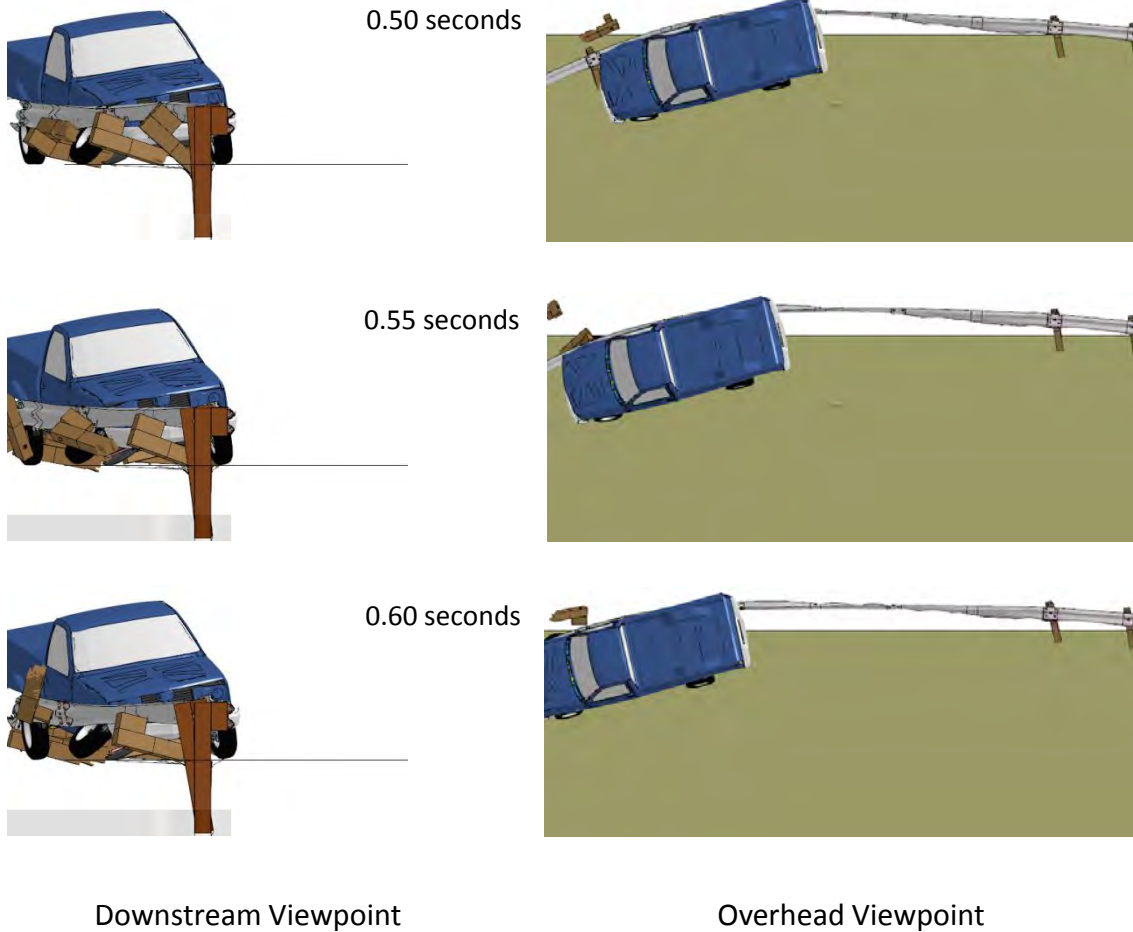
**Figure D-7. [CONTINUED] Sequential views from a downstream and overhead viewpoint for analysis case: 47% baseline anchor strength and DL3 posts.**

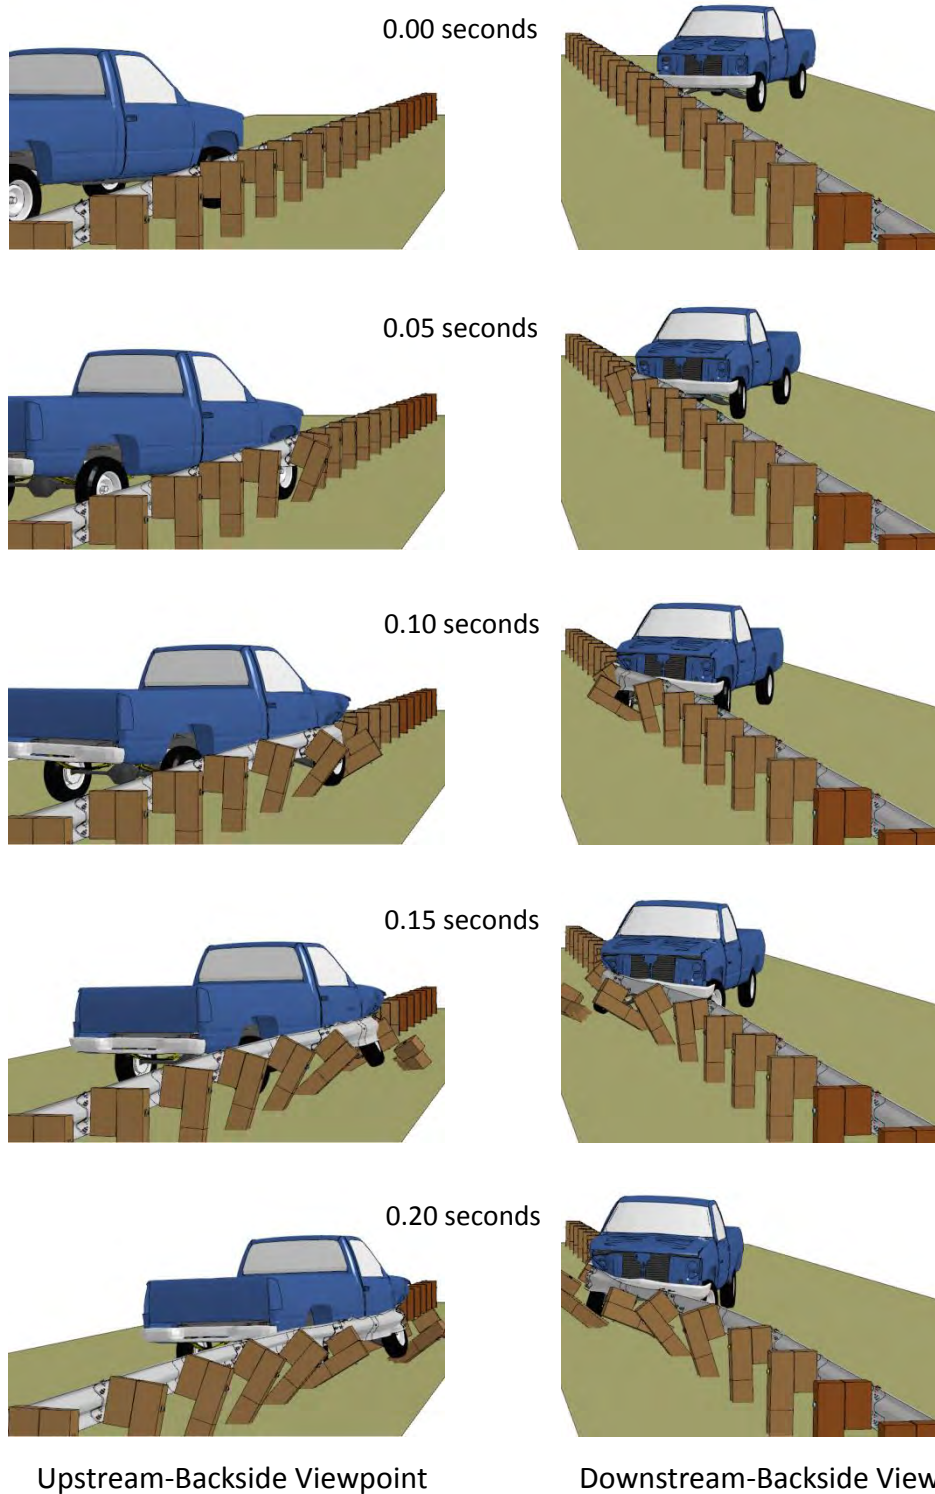
**Figure D-8. Sequential views from an upstream-backside and a downstream-backside viewpoint for analysis case: 47% baseline anchor strength and DL3 posts.**

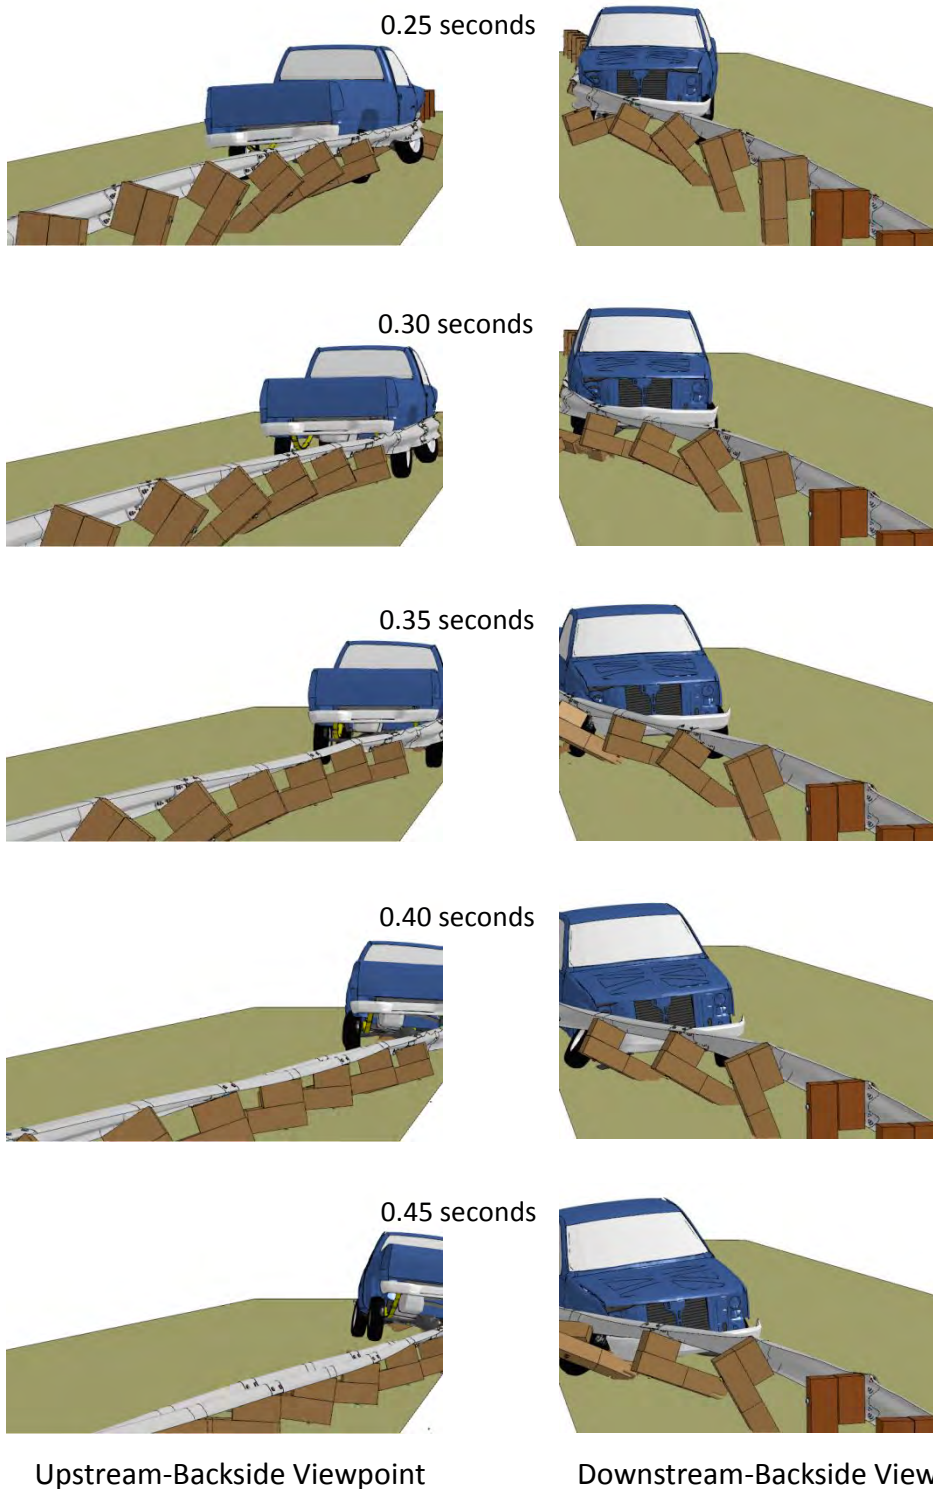
**Figure D-8. [CONTINUED] Sequential views from an upstream-backside and a downstream-backside viewpoint for analysis case: 47% baseline anchor strength and DL3 posts.**

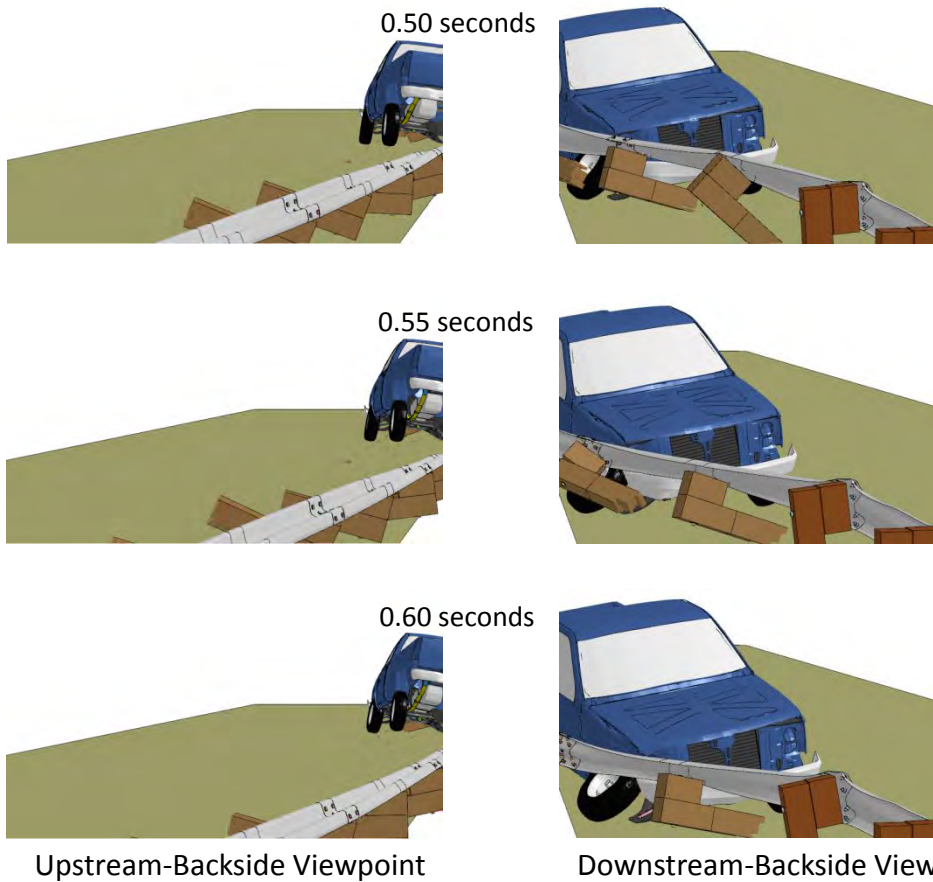
**Figure D-8. [CONTINUED] Sequential views from an upstream-backside and a downstream-backside viewpoint for analysis case: 47% baseline anchor strength and DL3 posts.**

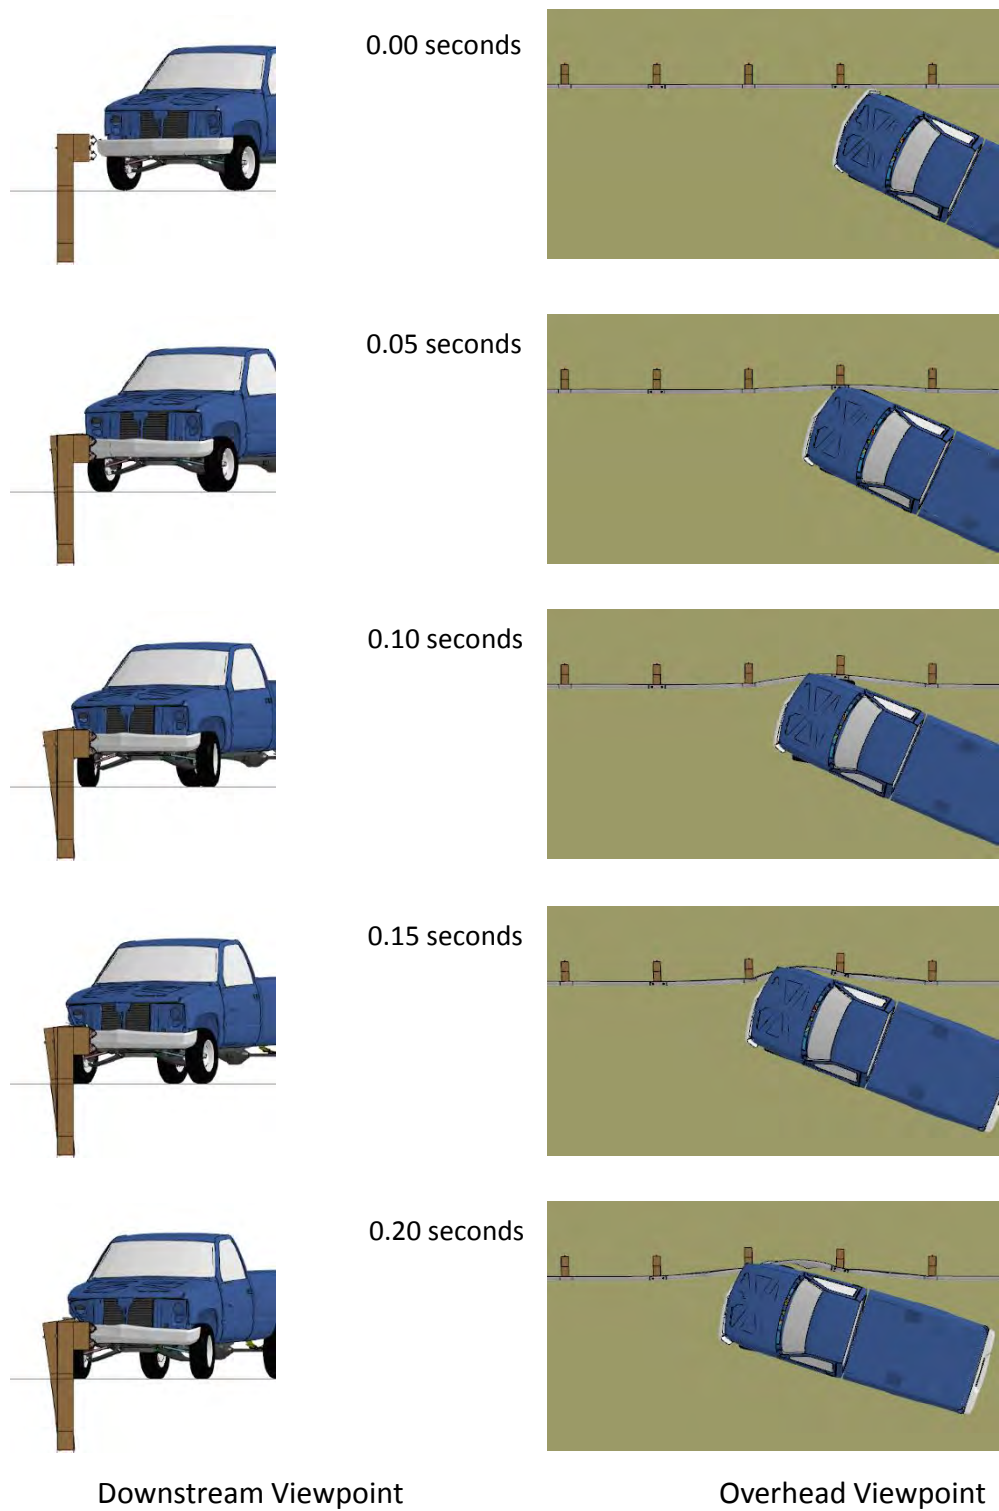
**Figure J-1. Sequential views from a downstream and overhead viewpoint for analysis case: 30 mph at Impact Point 1.**

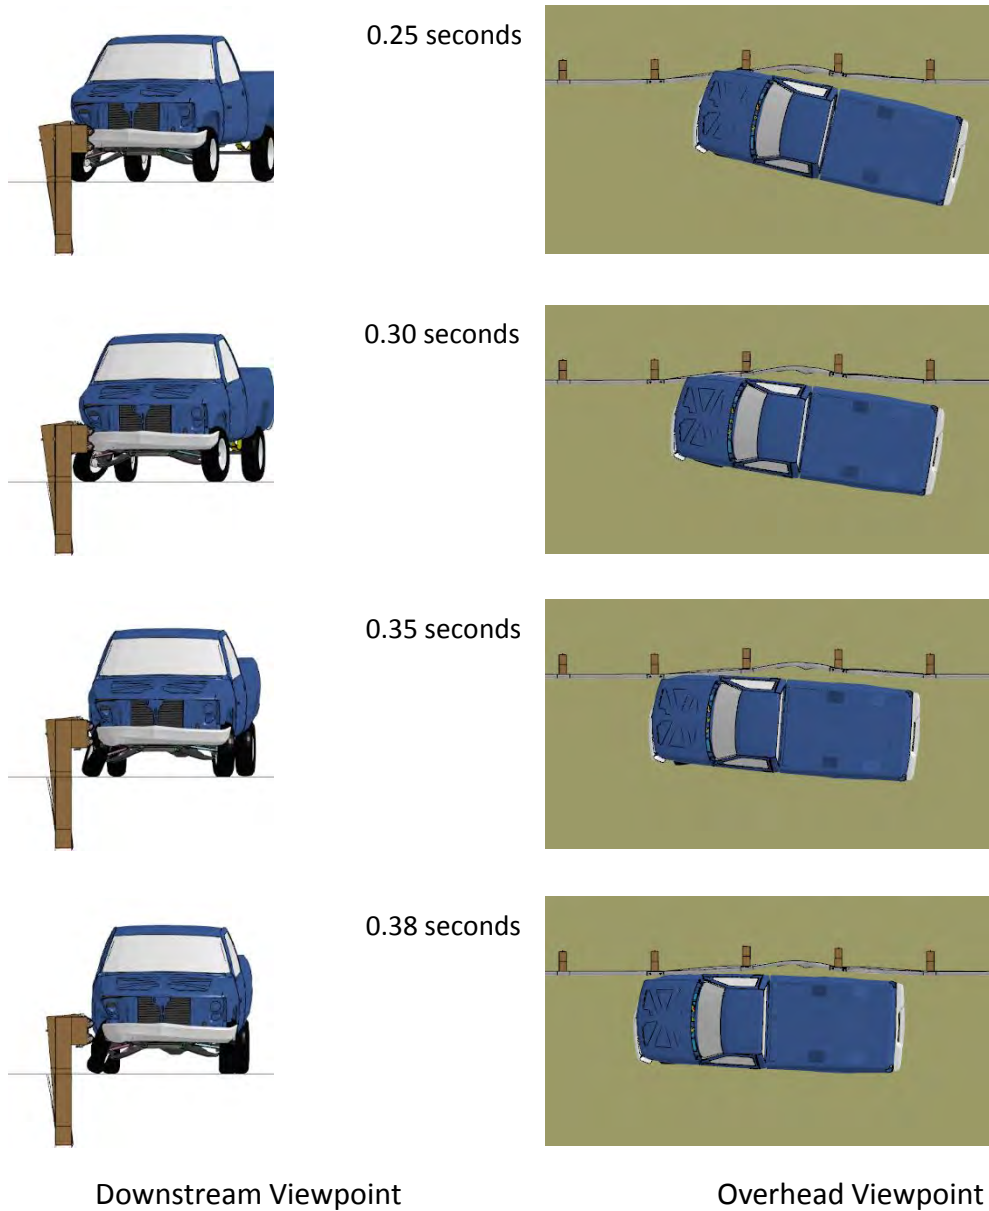
**Figure J-1. [CONTINUED] Sequential views from a downstream and overhead viewpoint for analysis case: 30 mph at Impact Point 1.**

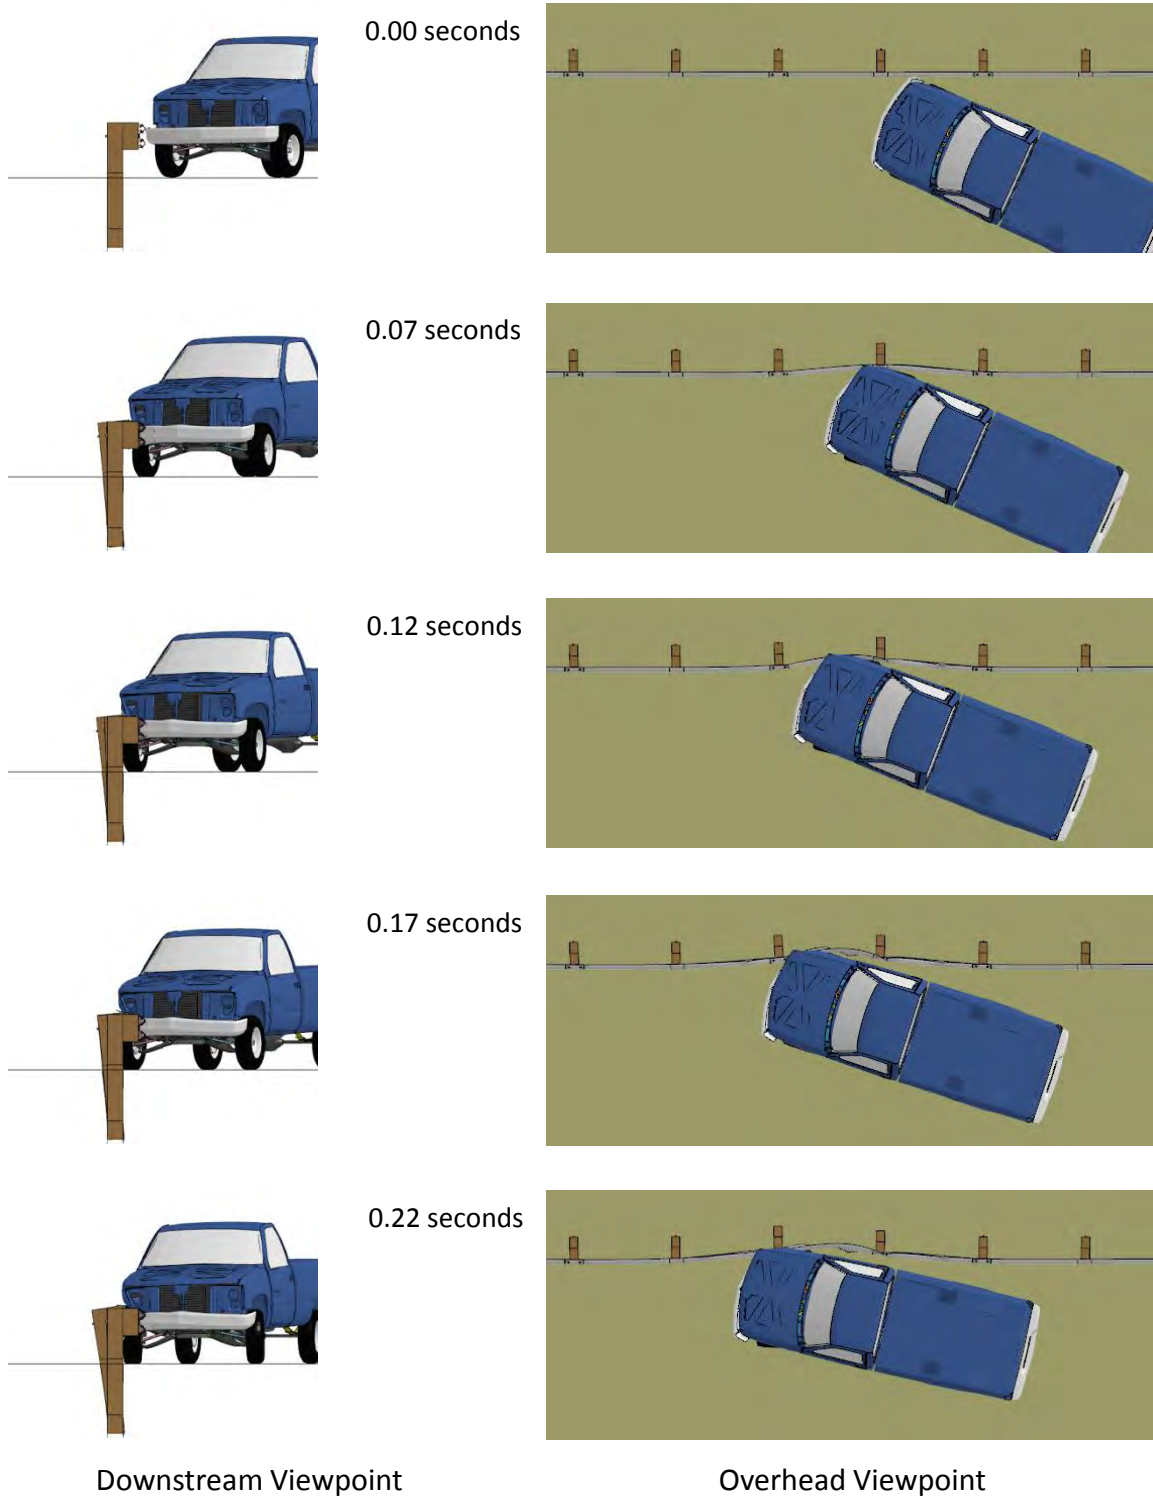
**Figure J-2. Sequential views from a downstream and overhead viewpoint for analysis case: 30 mph at Impact Point 2.**

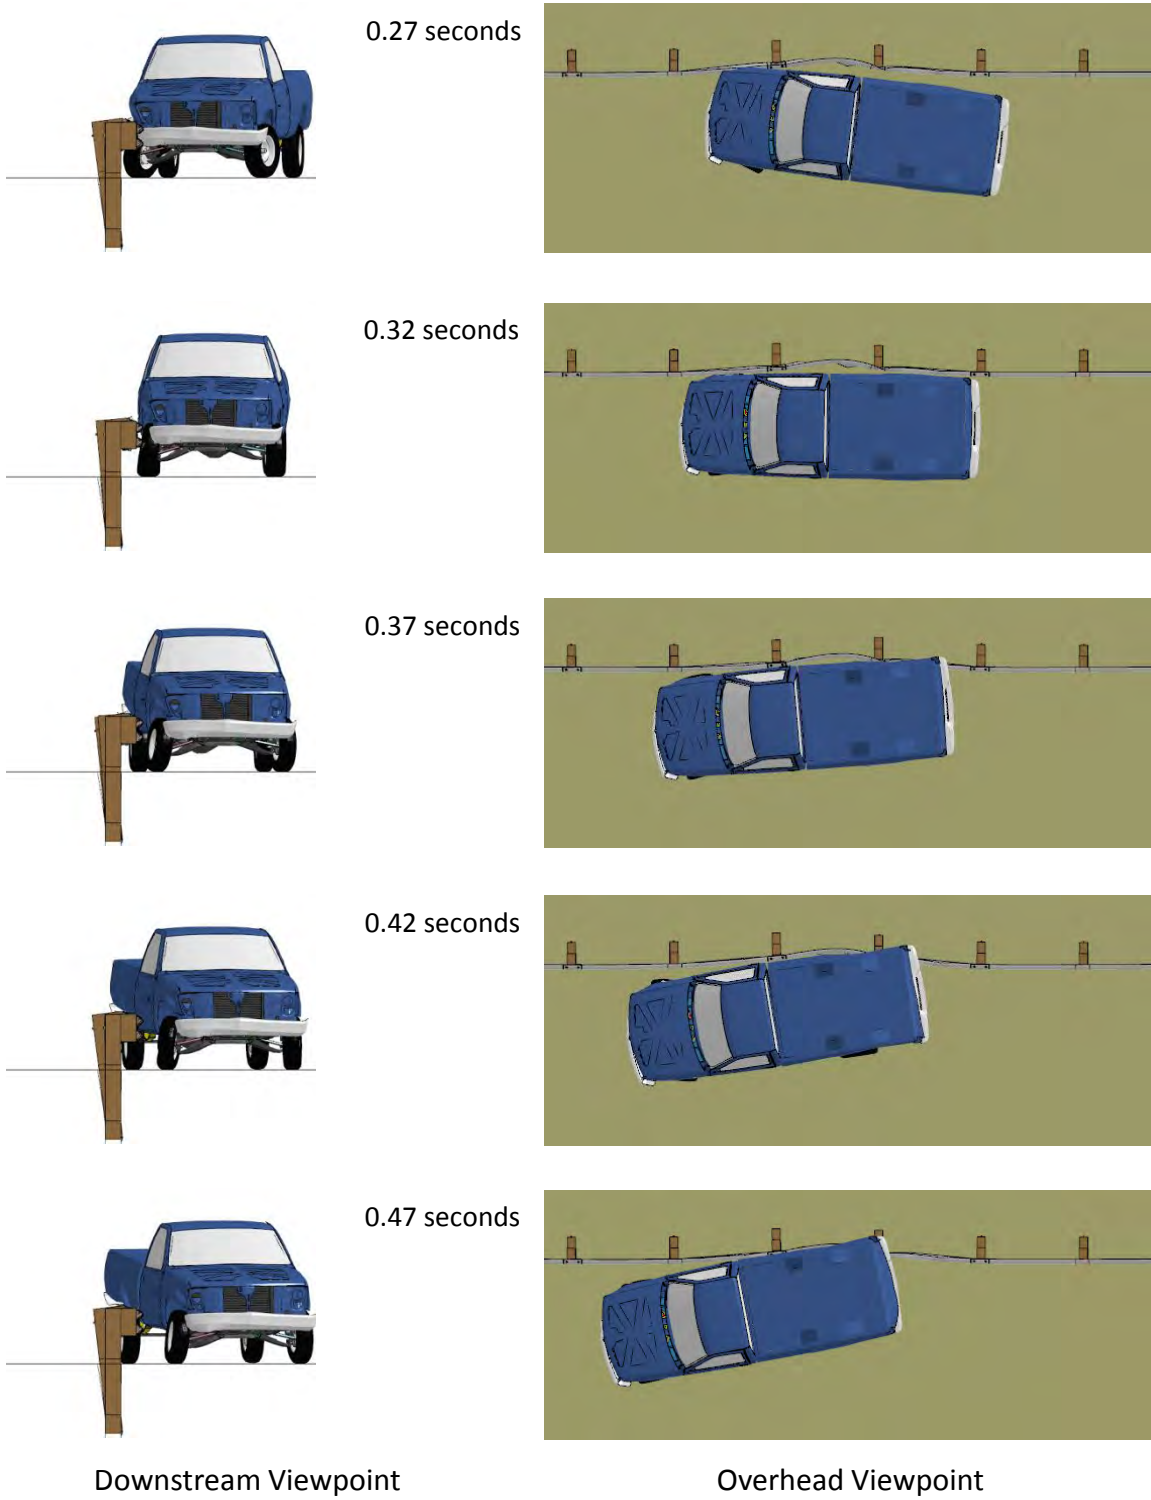
**Figure J-2 [CONTINUED] Sequential views from a downstream and overhead viewpoint for analysis case: 30 mph at Impact Point 2.**

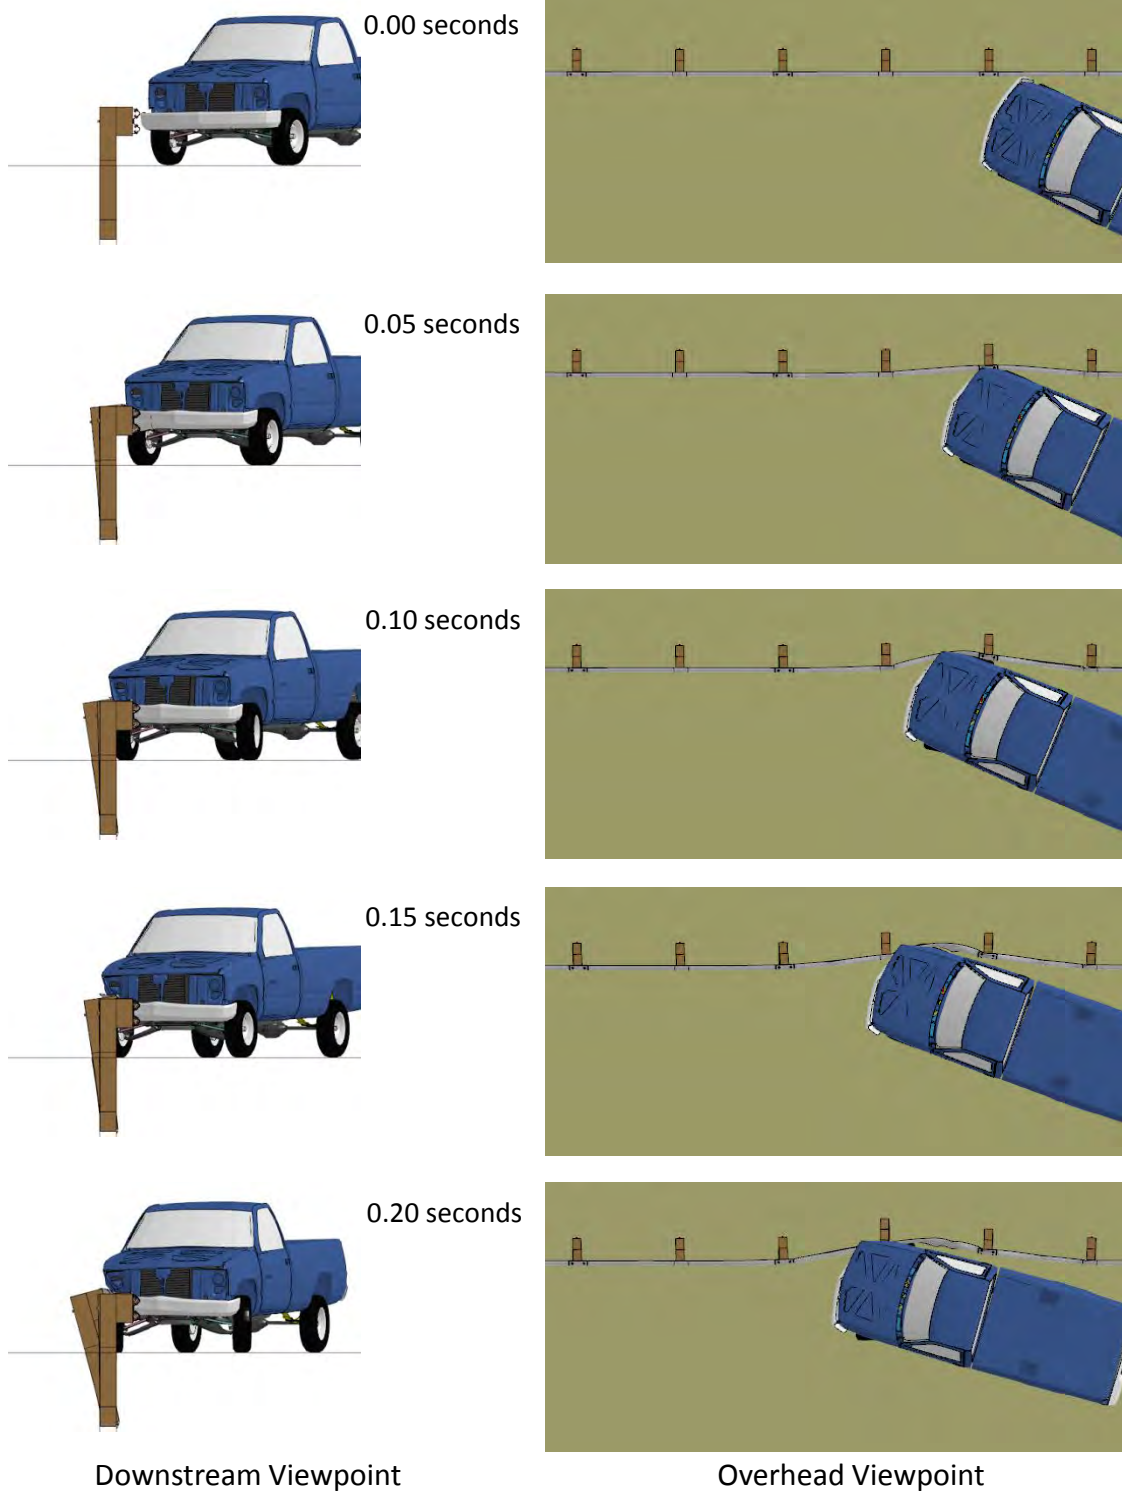
**Figure J-3. Sequential views from a downstream and overhead viewpoint for analysis case: 35 mph at Impact Point 1.**

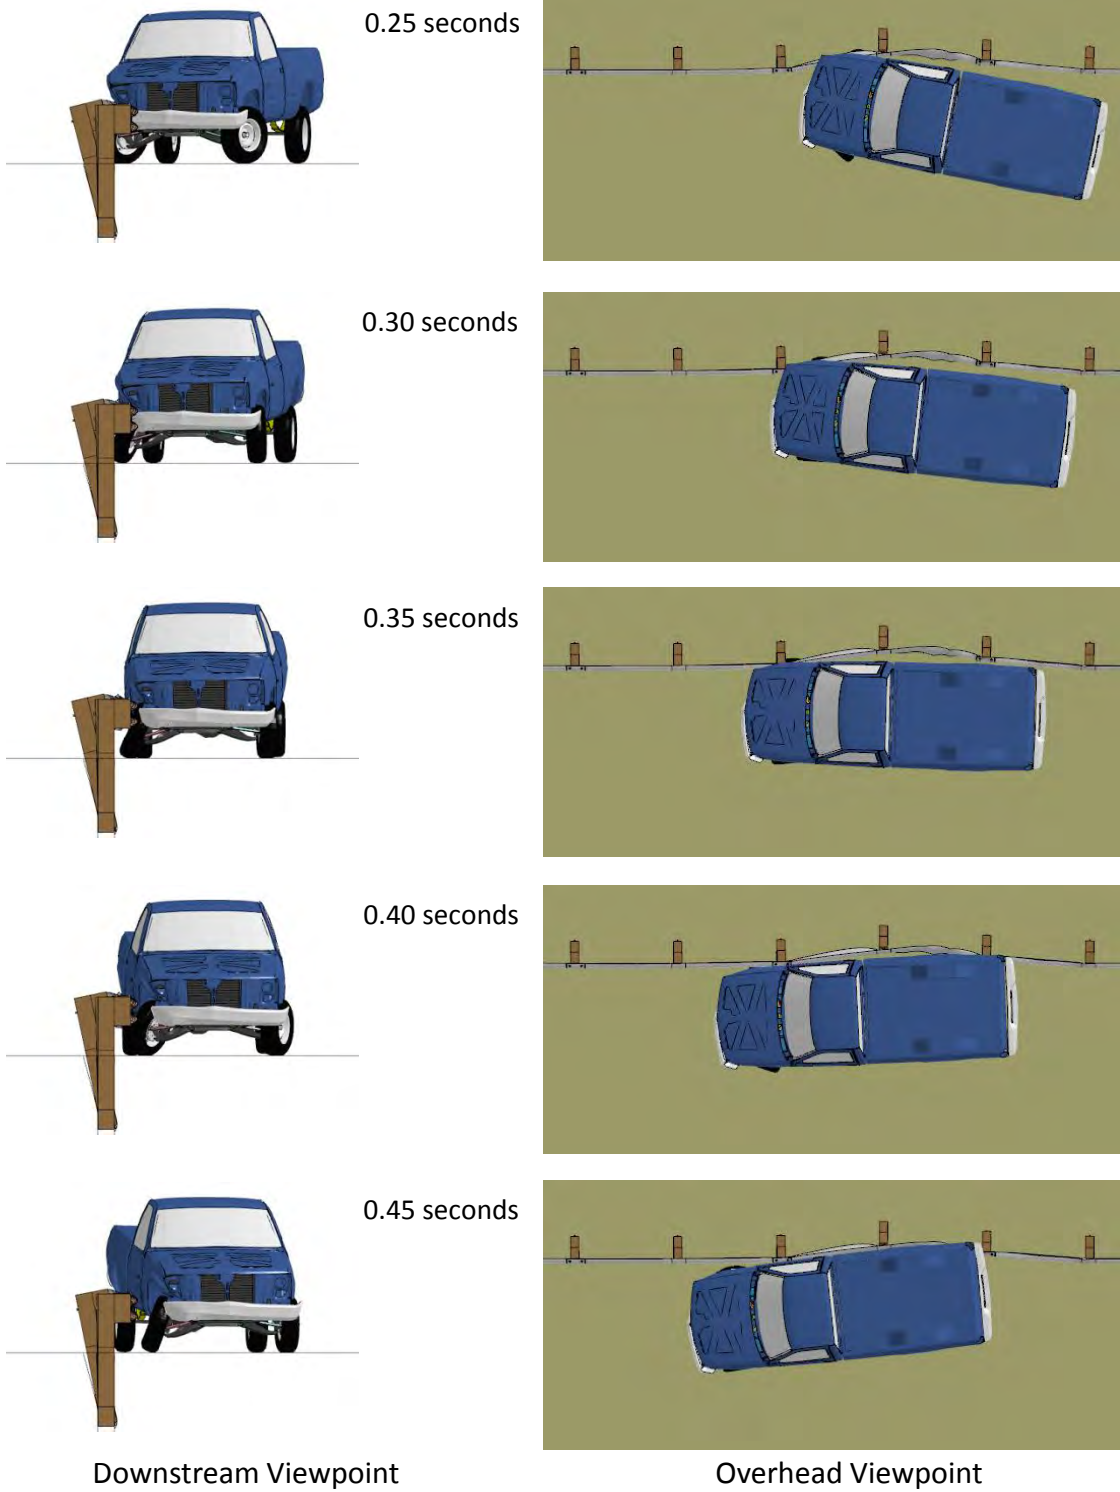
**Figure J-3. [CONTINUED] Sequential views from a downstream and overhead viewpoint for analysis case: 35 mph at Impact Point 1.**

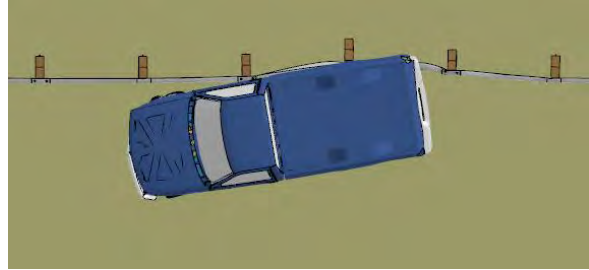
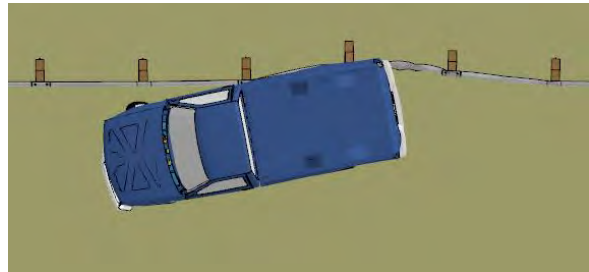
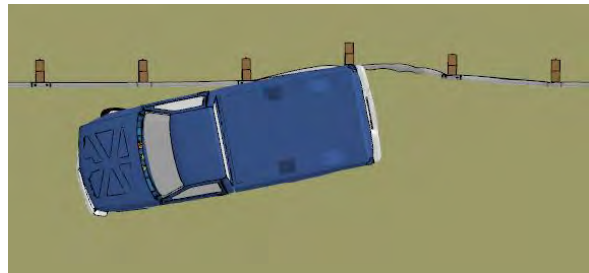
**Figure J-3. [CONTINUED] Sequential views from a downstream and overhead viewpoint for analysis case: 35 mph at Impact Point 1.**

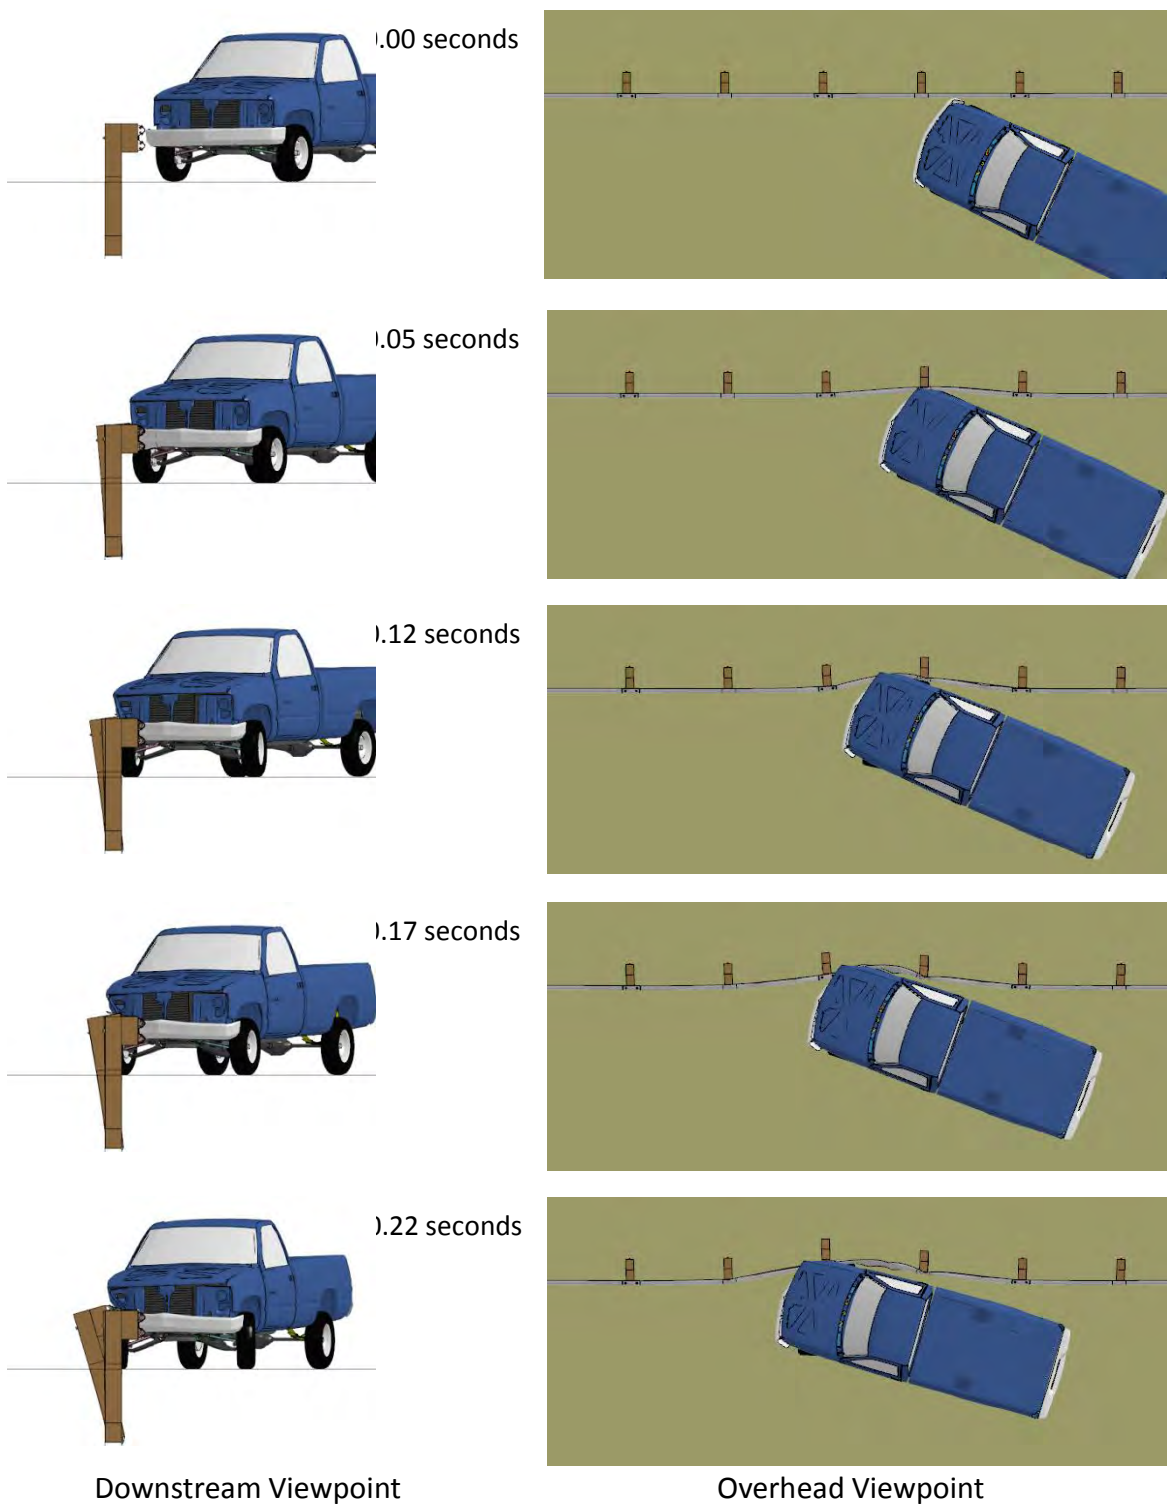
**Figure J-4. Sequential views from a downstream and overhead viewpoint for analysis case: 35 mph at Impact Point 2.**

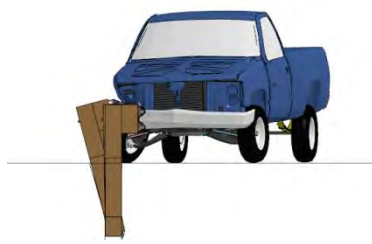
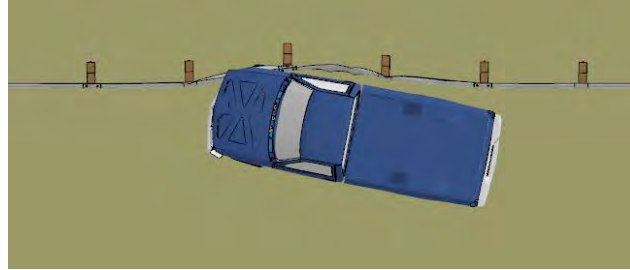
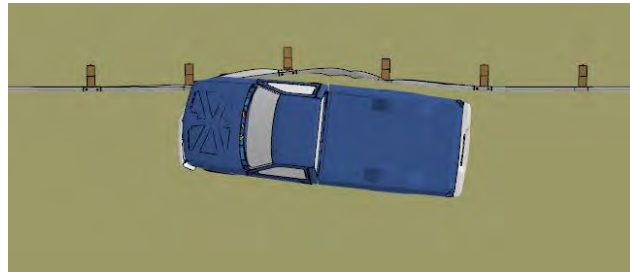
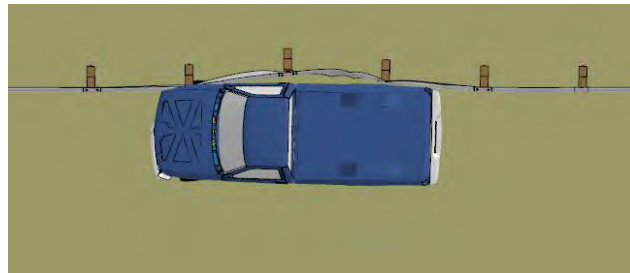
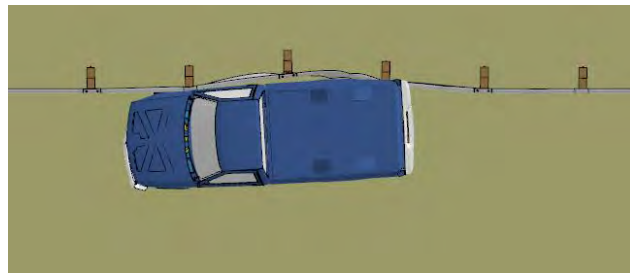
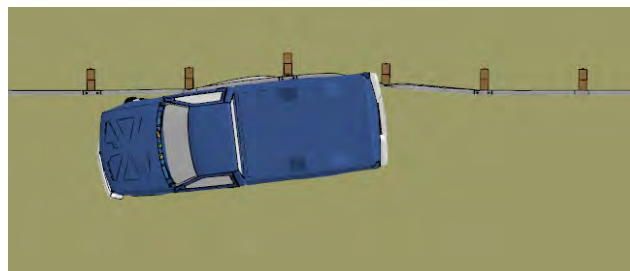
**Figure J-4. [CONTINUED] Sequential views from a downstream and overhead viewpoint for analysis case: 35 mph at Impact Point 2.**

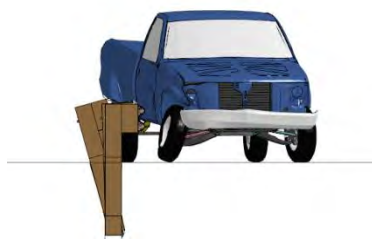
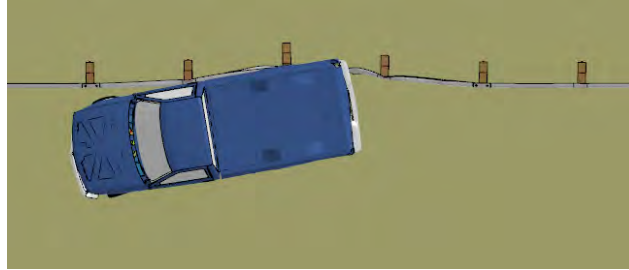
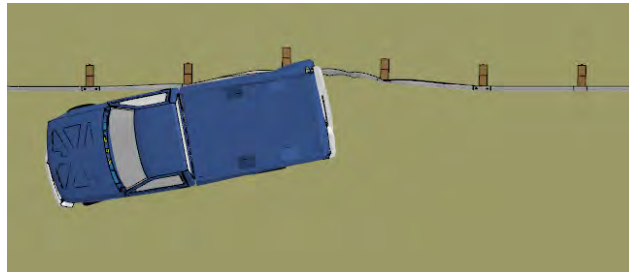
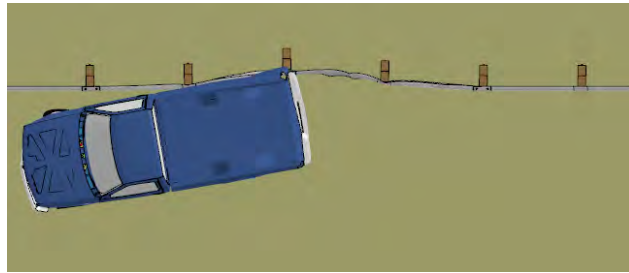
**Figure J-4. [CONTINUED] Sequential views from a downstream and overhead viewpoint for analysis case: 35 mph at Impact Point 2.**
