# **A Guide for W-Beam Guardrail Damage Assessment**

A Field Manual for  
Highway Maintenance Personnel

National Cooperative  
Highway Research  
Program  
Project 22-28

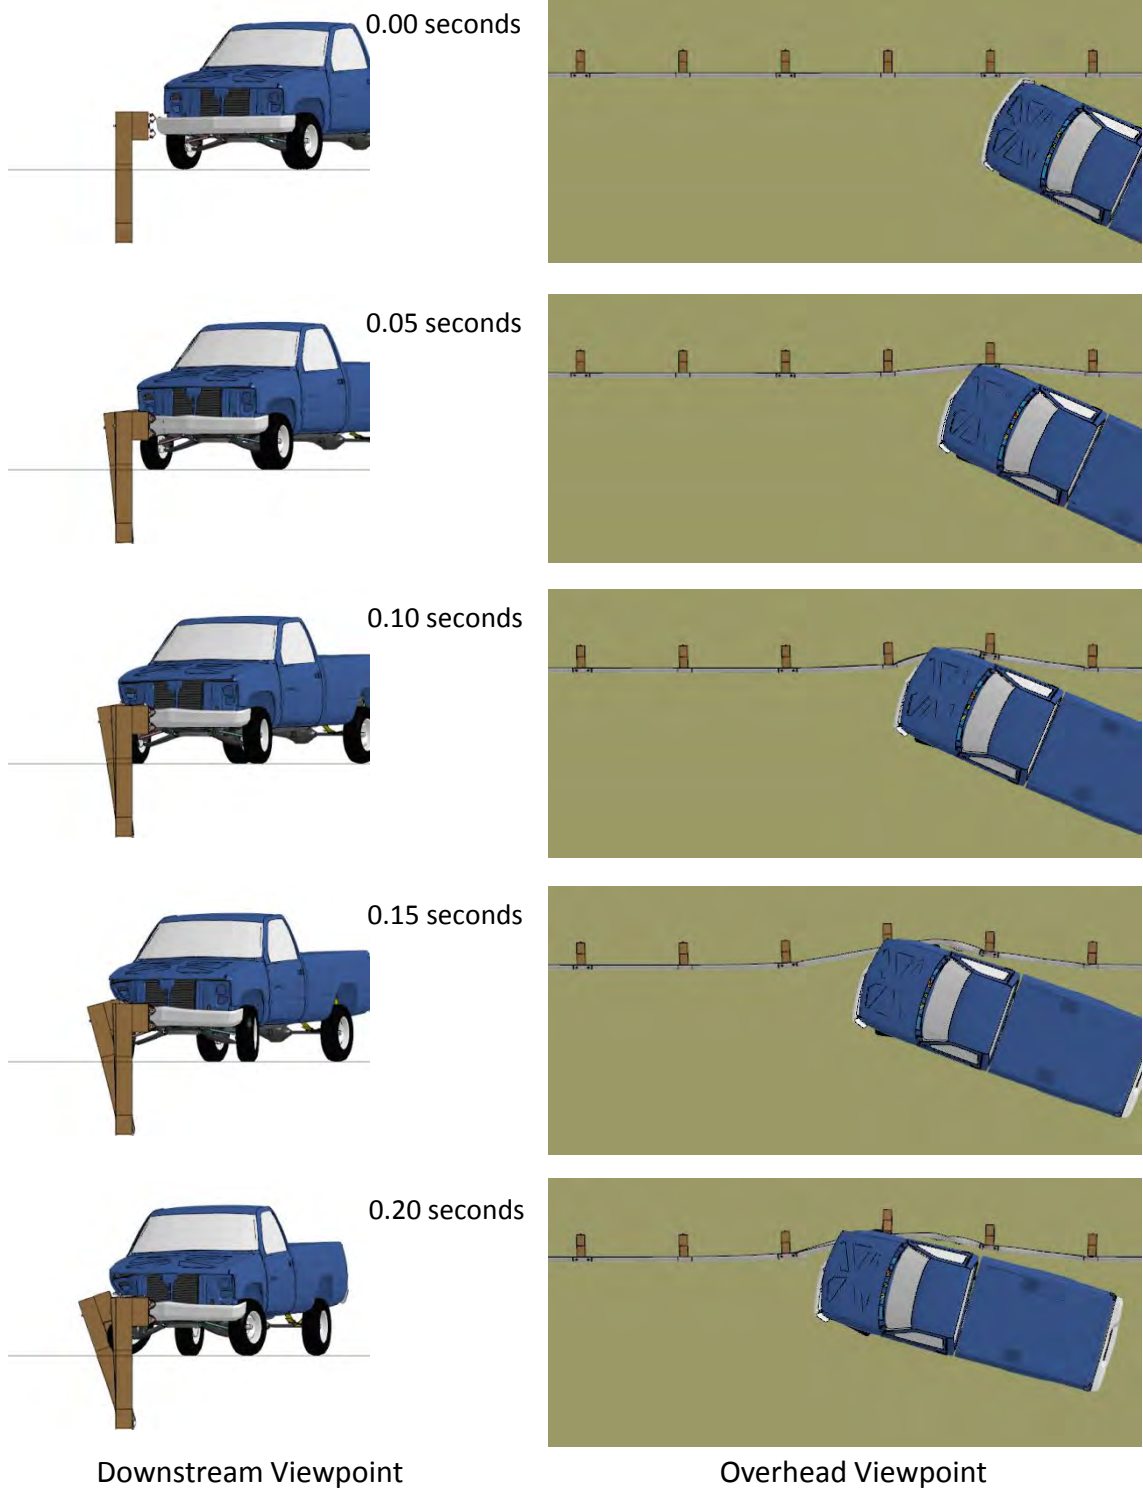
**Figure J-5. Sequential views from a downstream and overhead viewpoint for analysis case: 40 mph at Impact Point 1.**

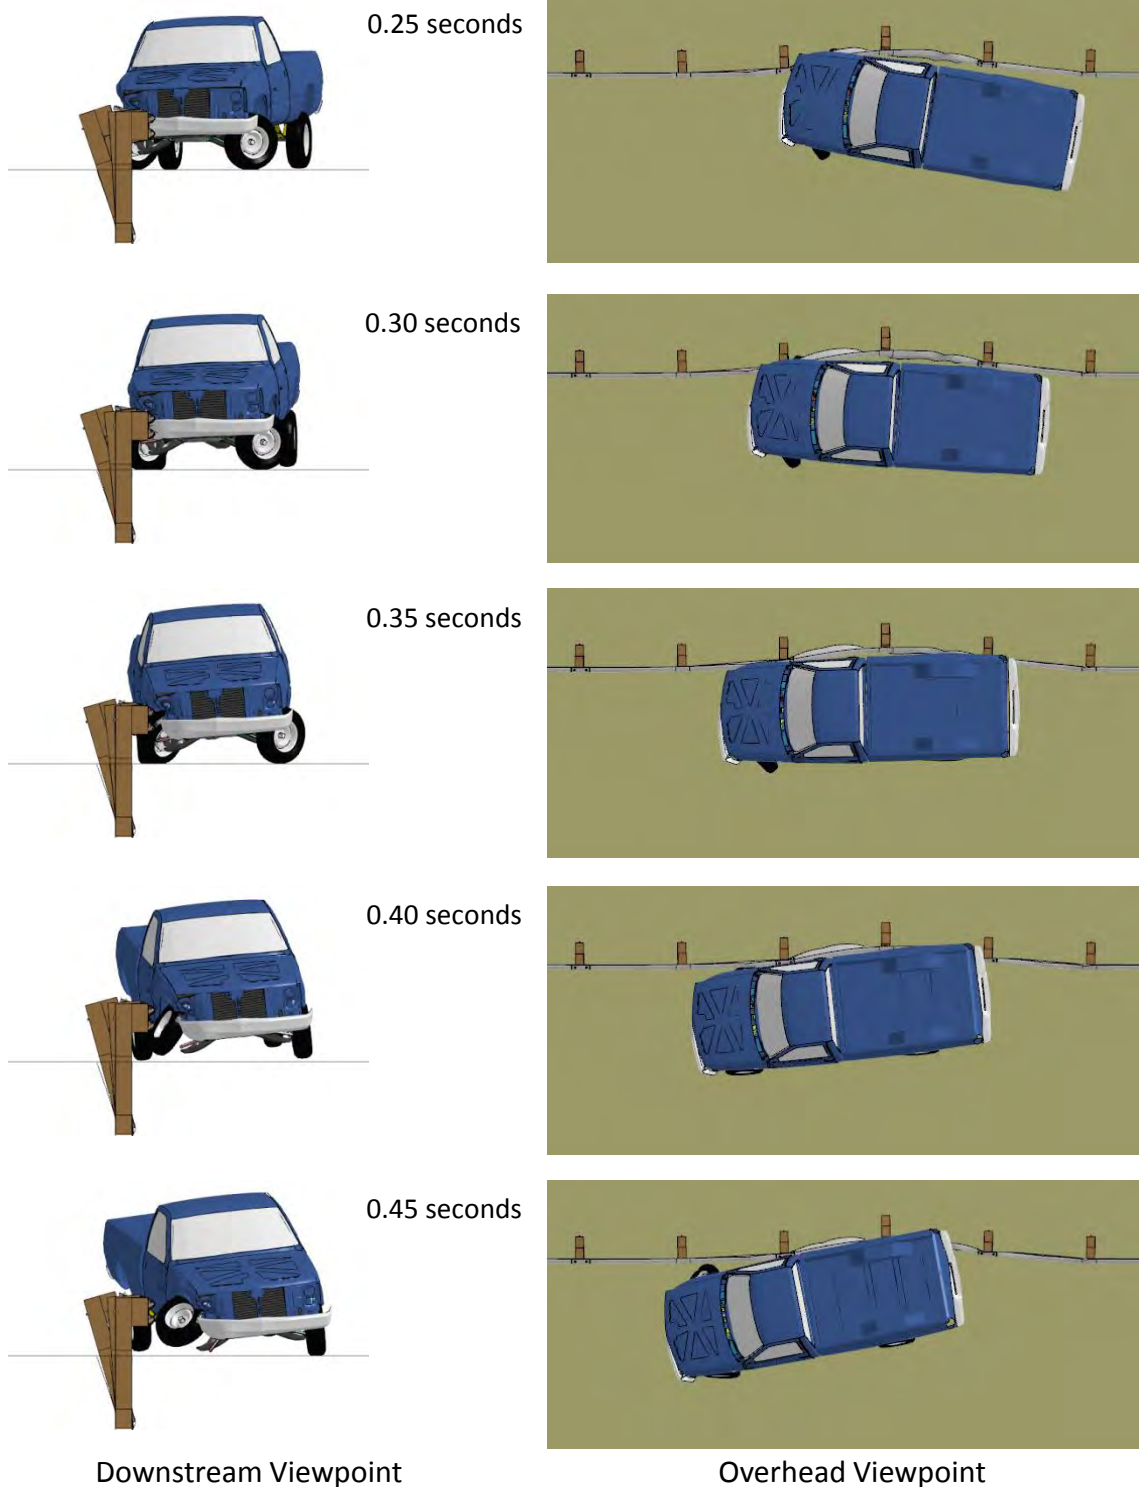
**Figure J-5. [CONTINUED] Sequential views from a downstream and overhead viewpoint for analysis case: 40 mph at Impact Point 1.**

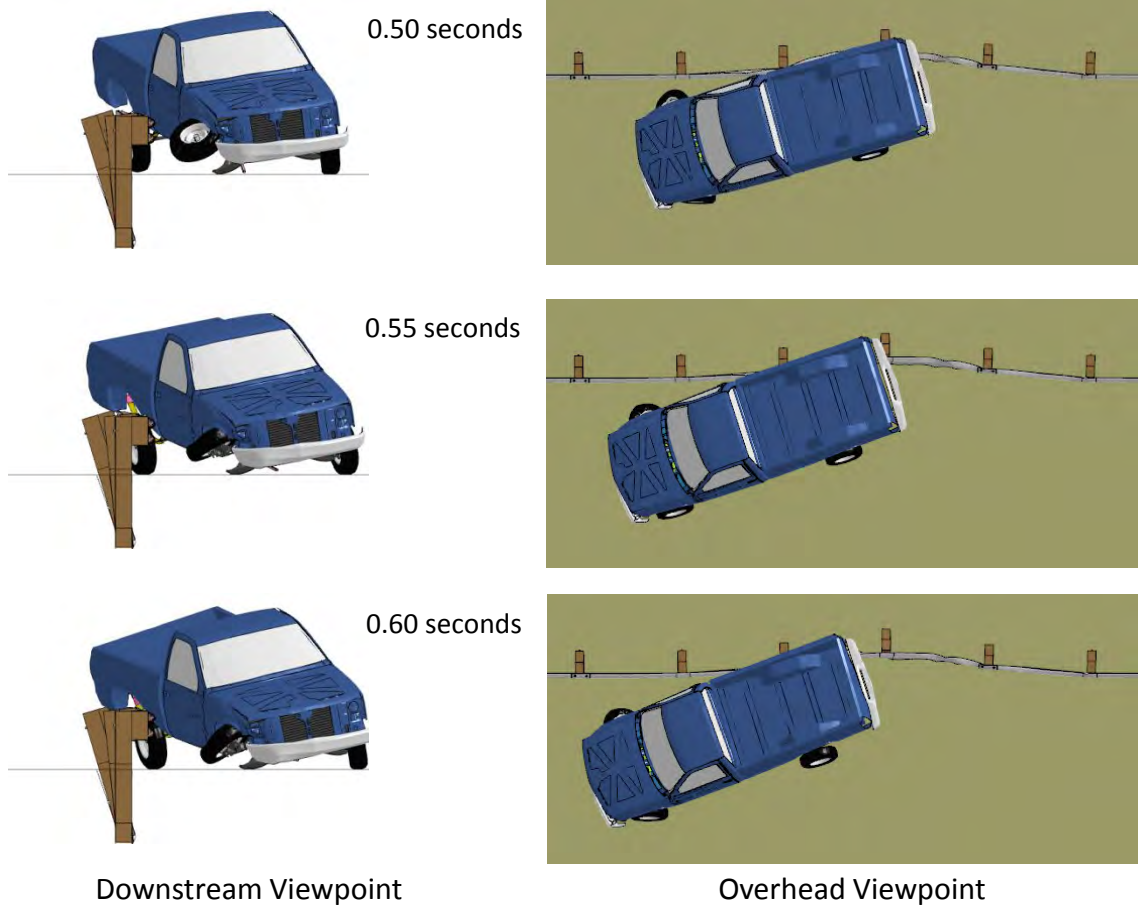
**Figure J-5. [CONTINUED] Sequential views from a downstream and overhead viewpoint for analysis case: 40 mph at Impact Point 1.**

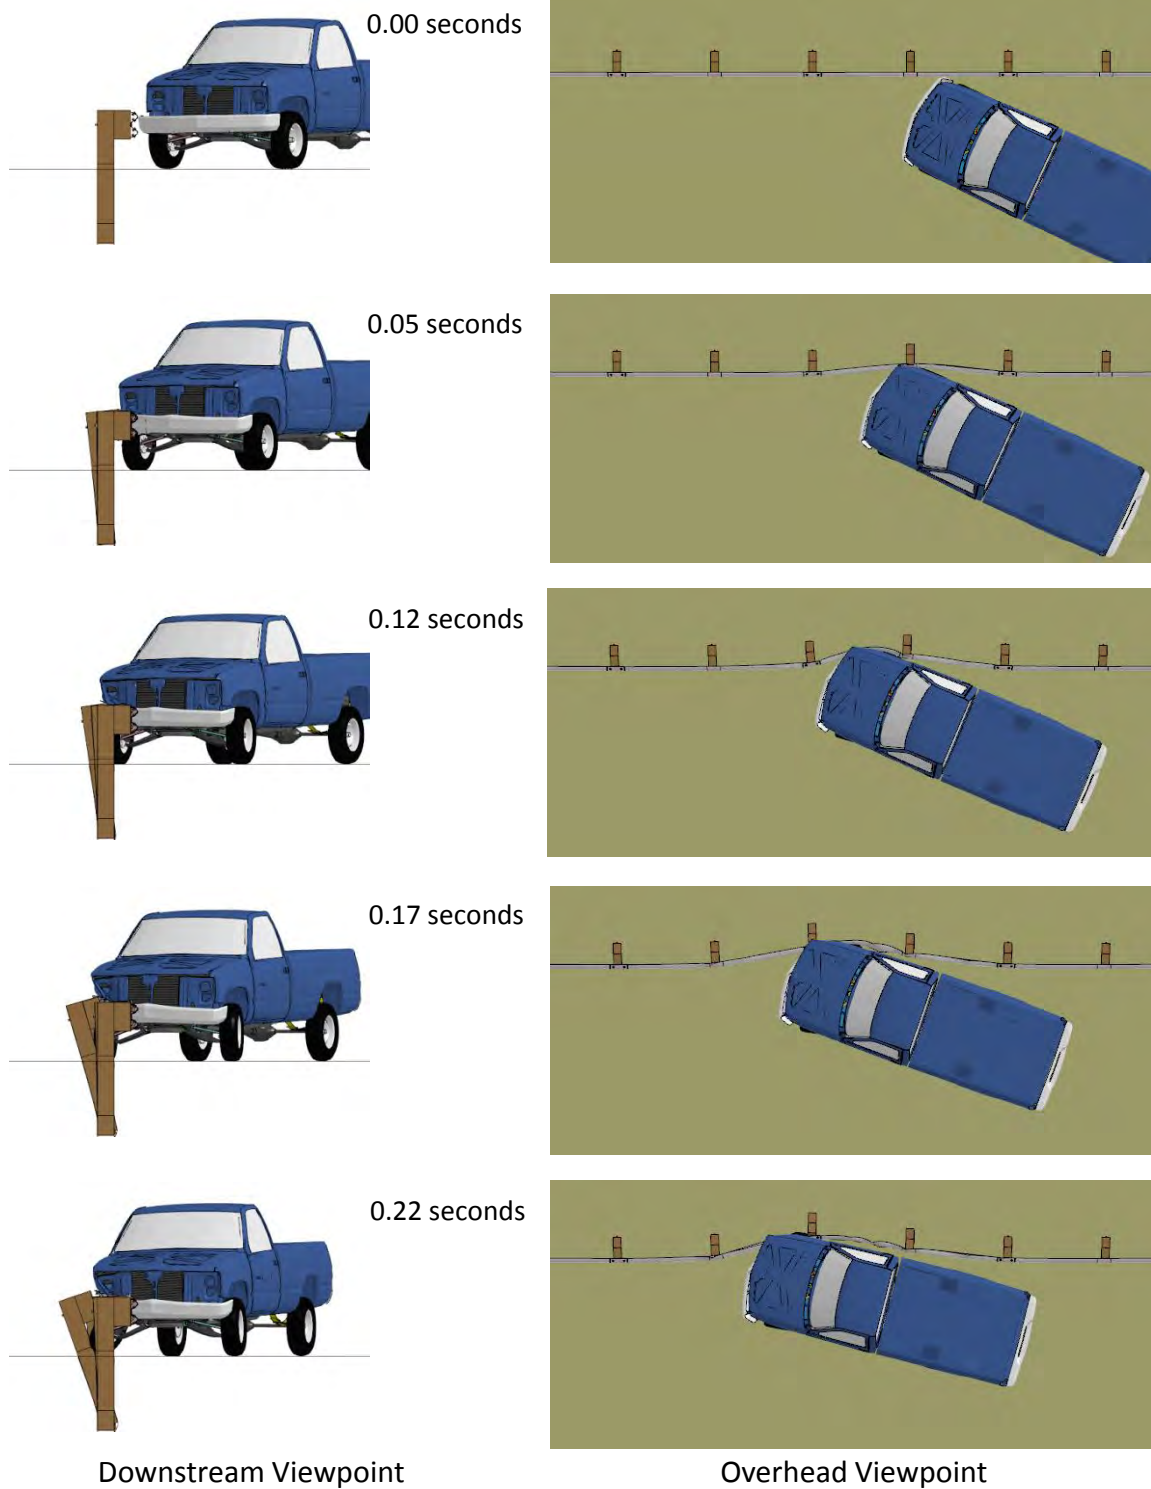
**Figure J-6. Sequential views from a downstream and overhead viewpoint for analysis case: 40 mph at Impact Point 2.**

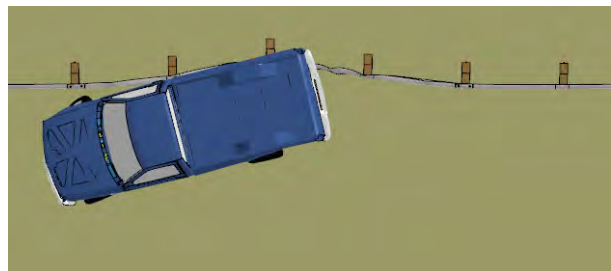
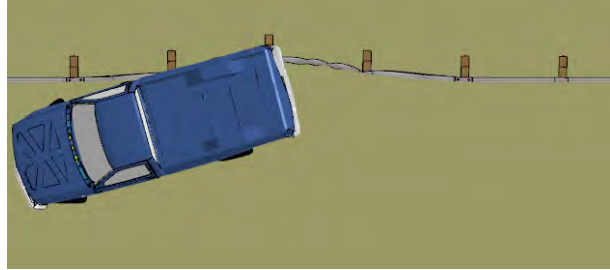
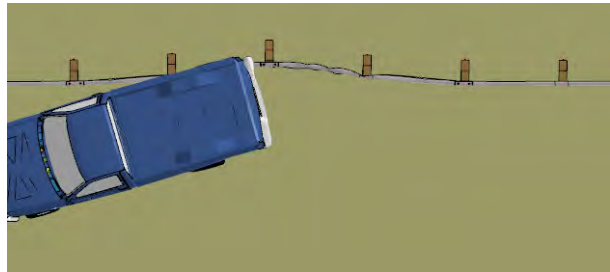
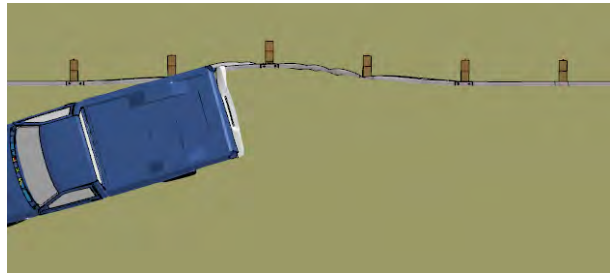
**Figure J-6. [CONTINUED] Sequential views from a downstream and overhead viewpoint for analysis case: 40 mph at Impact Point 2.**

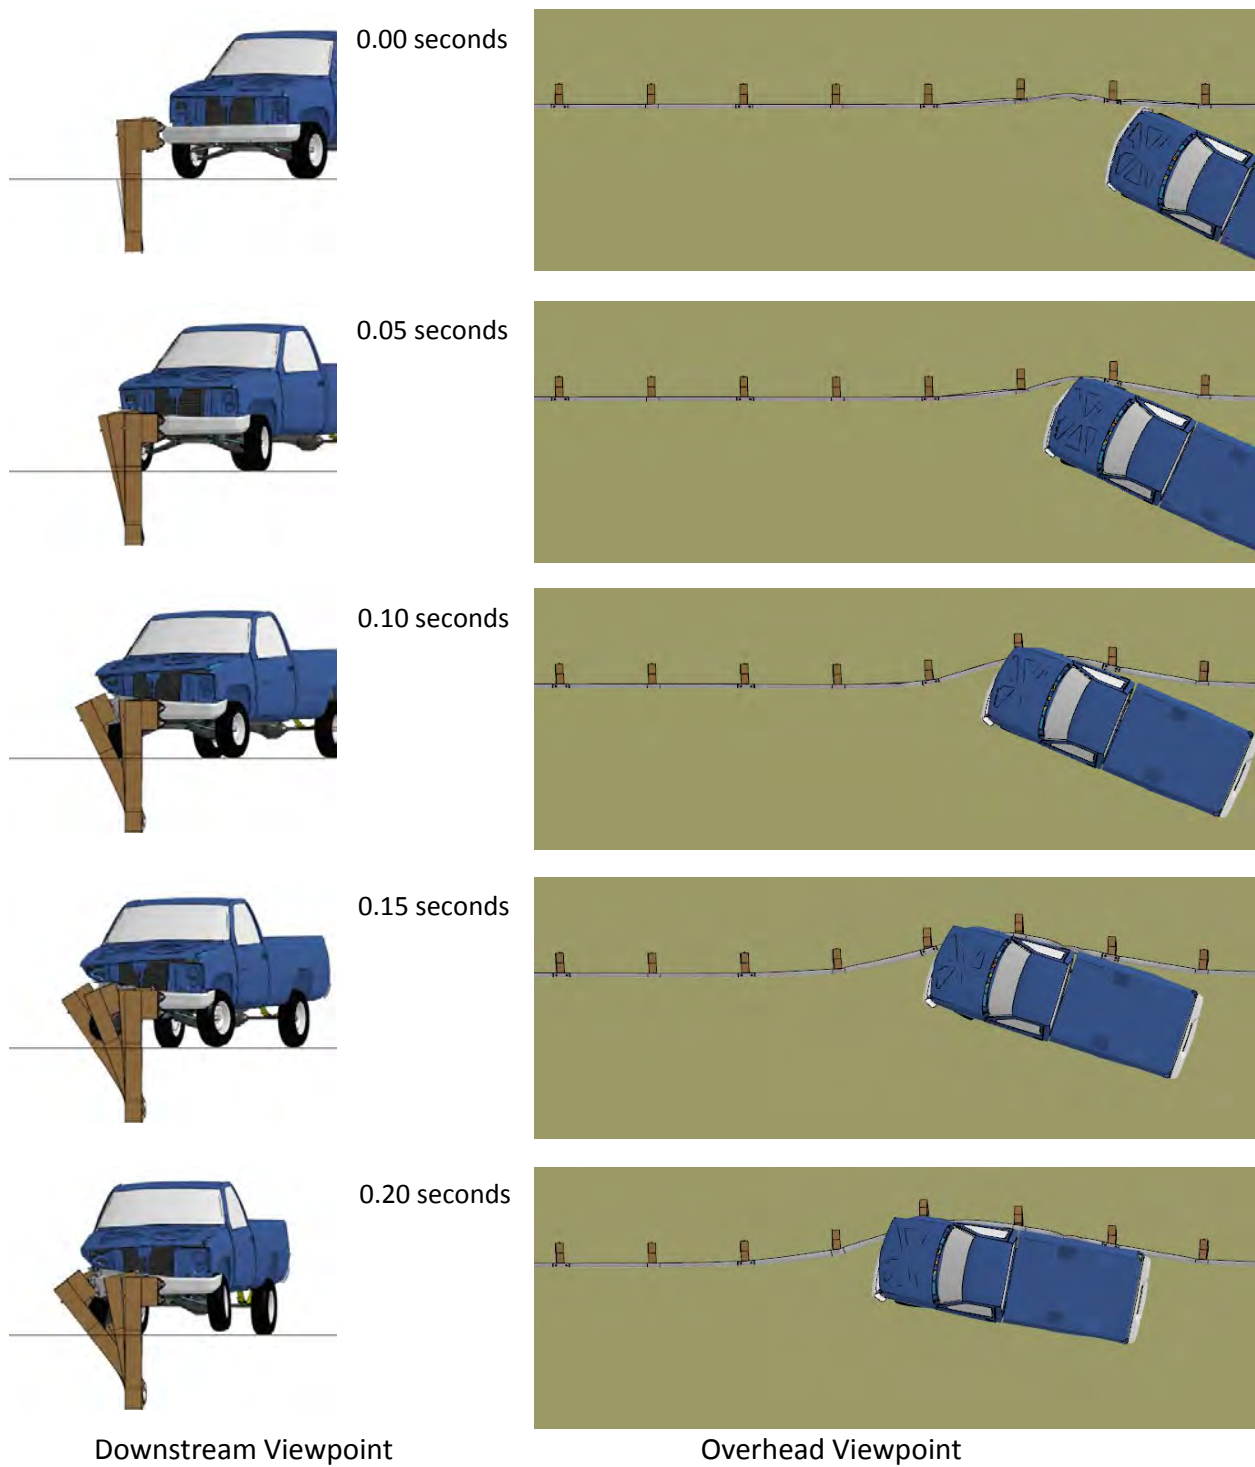
**Figure K-1. Sequential views from a downstream and overhead viewpoint for analysis case: Test 3-11 of 30 mph-Damaged G4(2W) at Impact Point 1.**

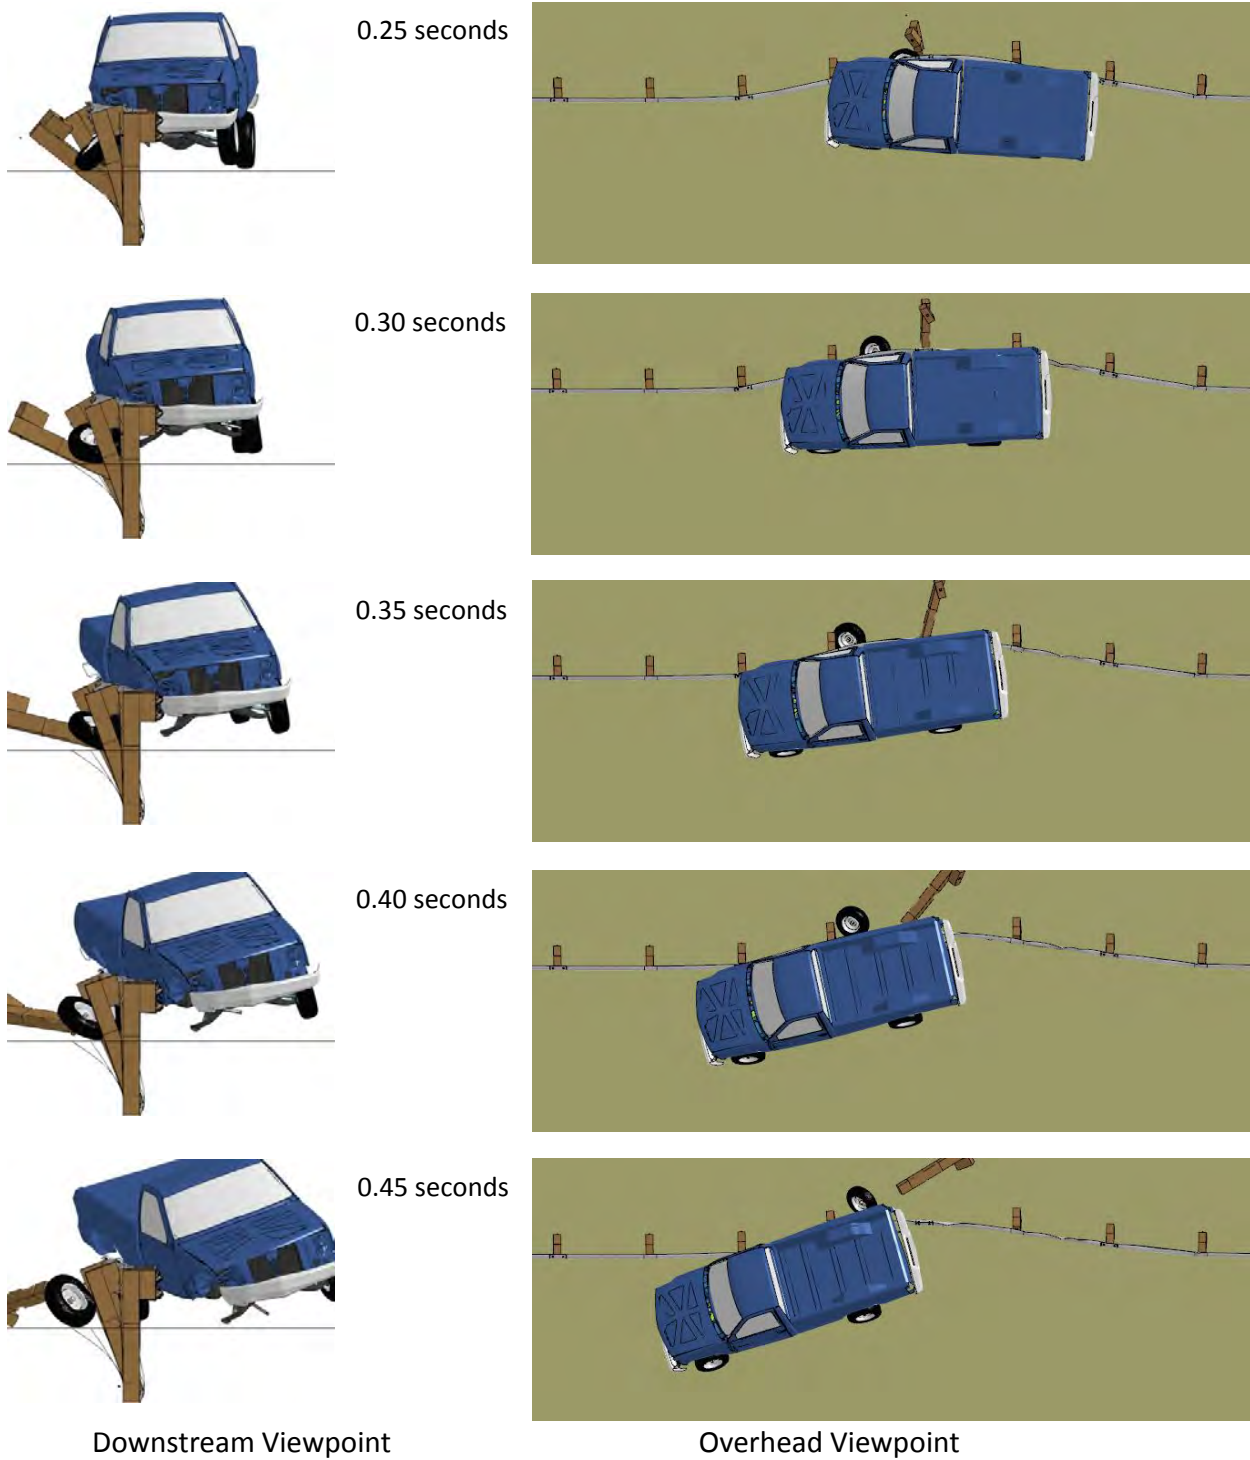
**Figure K-1. [CONTINUED] Sequential views from a downstream and overhead viewpoint for analysis case: Test 3-11 of 30 mph-Damaged G4(2W) at Impact Point 1.**

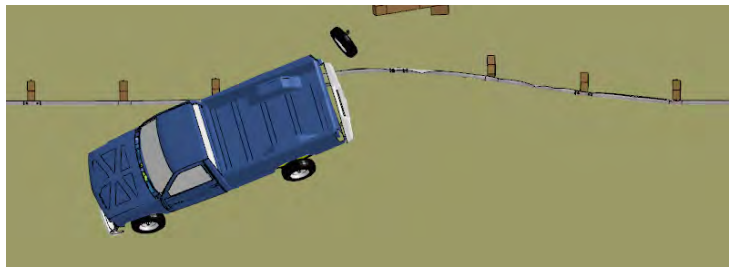
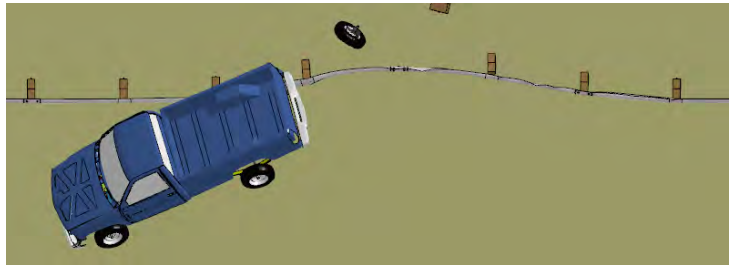
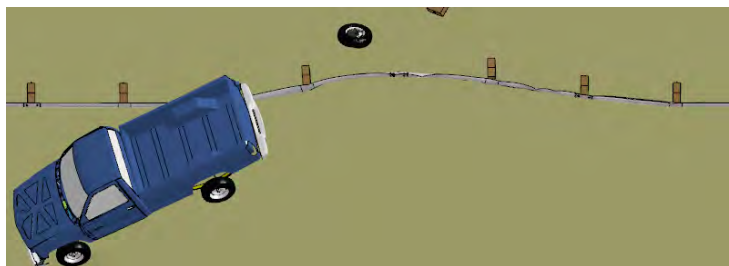
**Figure K-1. [CONTINUED] Sequential views from a downstream and overhead viewpoint for analysis case: Test 3-11 of 30 mph-Damaged G4(2W) at Impact Point 1.**

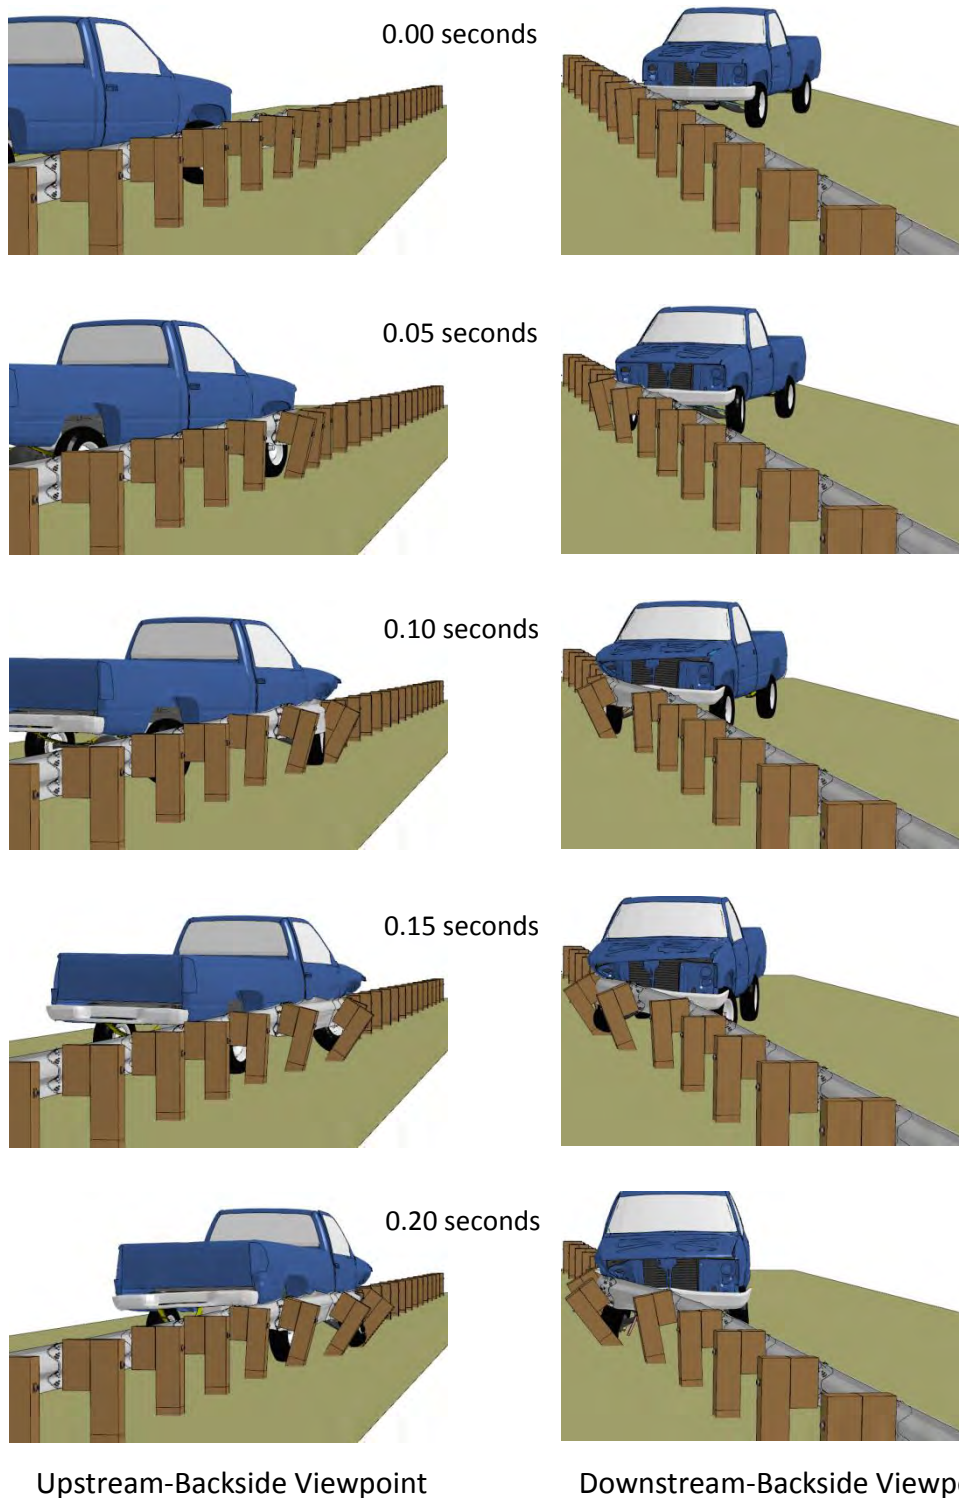
**Figure K-2. Sequential views from an upstream-backside and a downstream-backside viewpoint for analysis case: Test 3-11 of 30 mph-Damaged G4(2W) at Impact Point 1.**

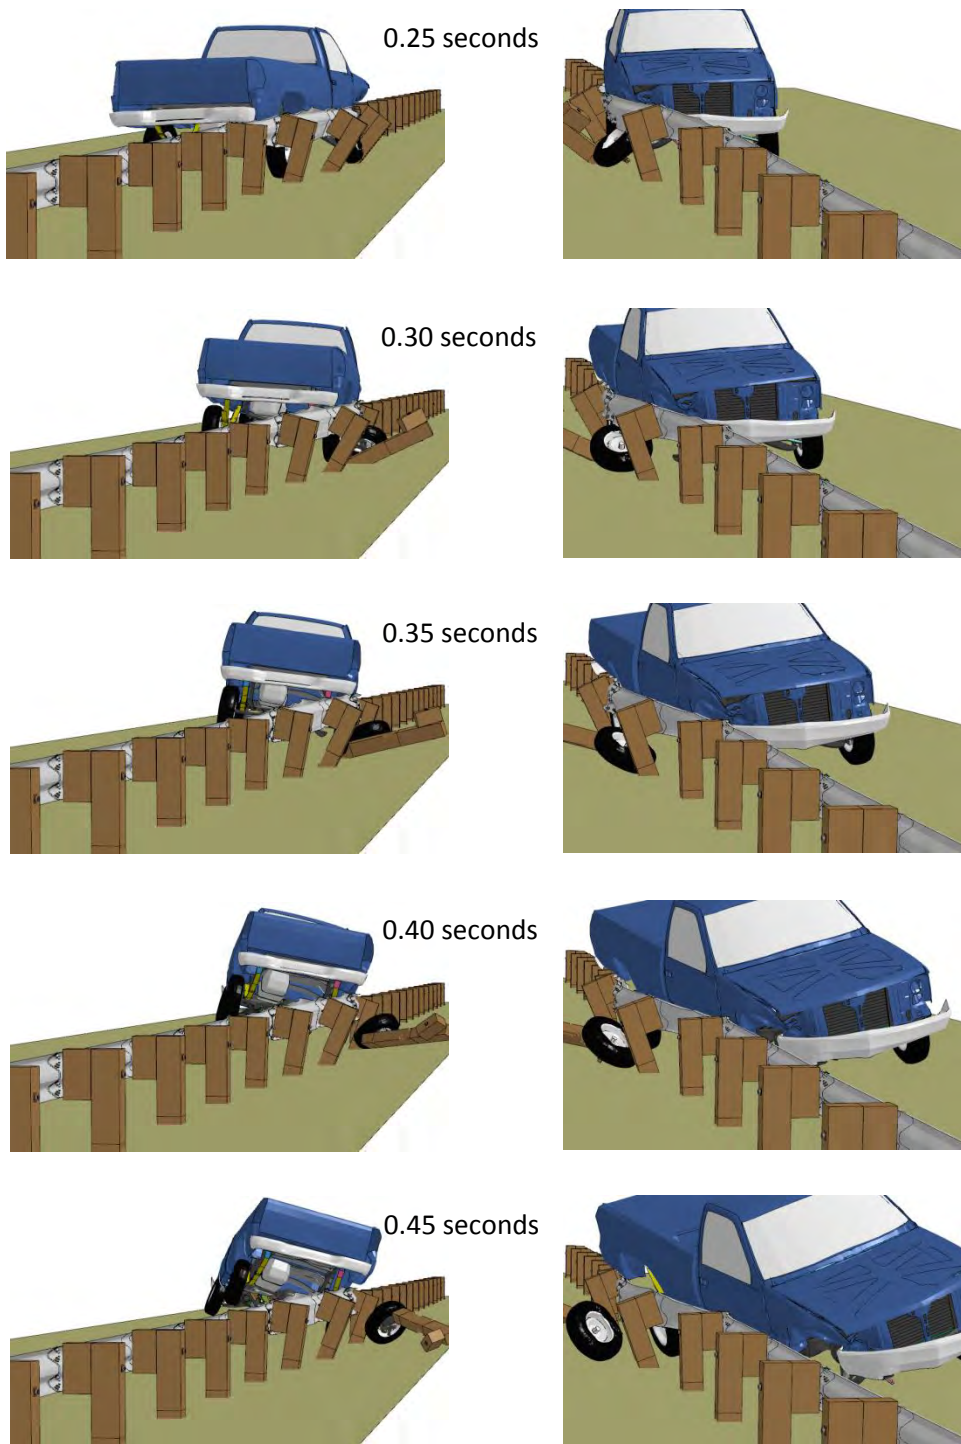
**Figure K-2. [CONTINUED] Sequential views from an upstream-backside and a downstream-backside viewpoint for analysis case: Test 3-11 of 30 mph-Damaged G4(2W) at Impact Point 1.**

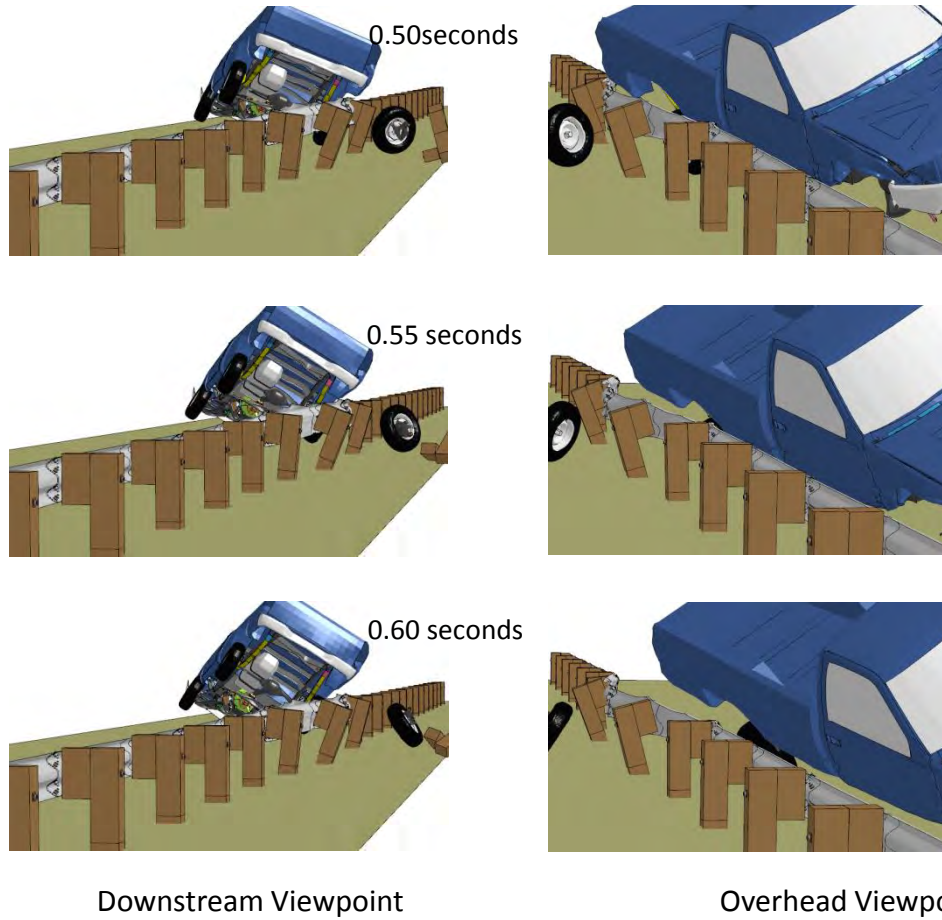
**Figure K-2. [CONTINUED] Sequential views from an upstream-backside and a downstream-backside viewpoint for analysis case: Test 3-11 of 30 mph-Damaged G4(2W) at Impact Point 1.**

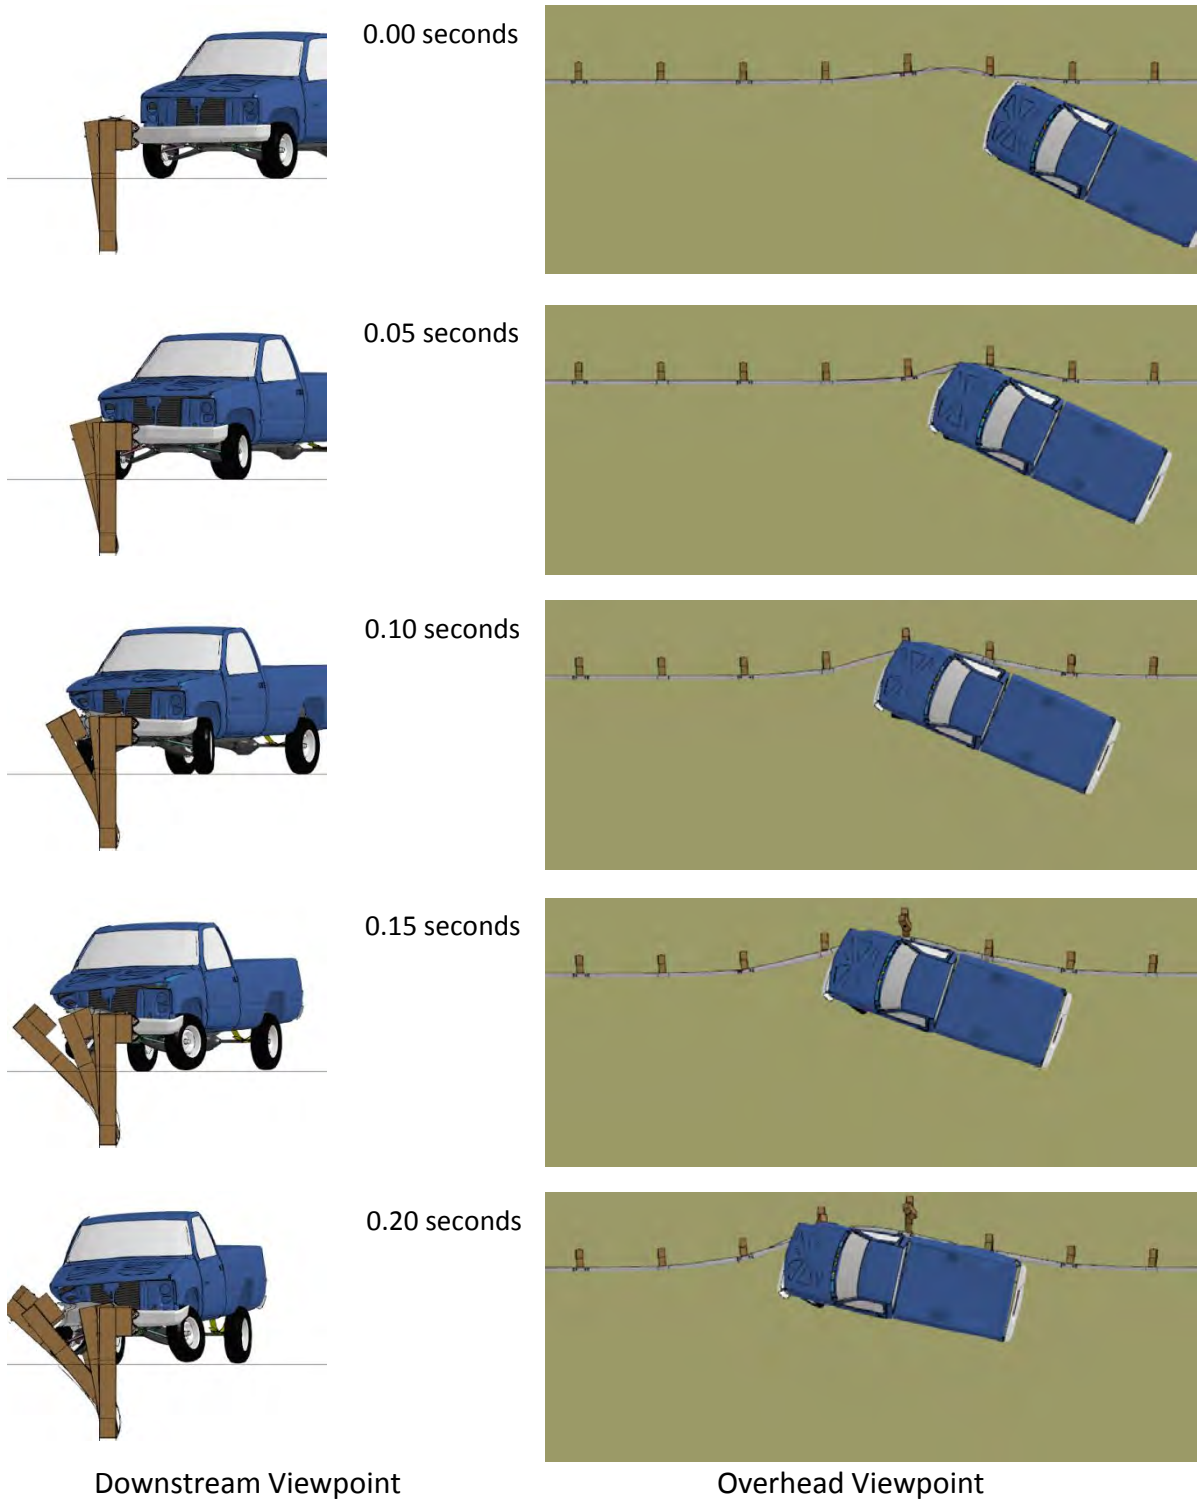
**Figure K-3. Sequential views from a downstream and overhead viewpoint for analysis case: Test 3-11 of 30 mph-Damaged G4(2W) at Impact Point 2.**

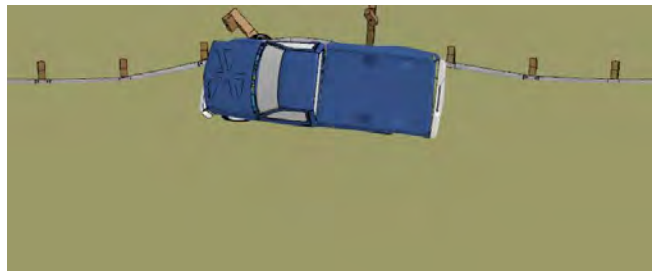
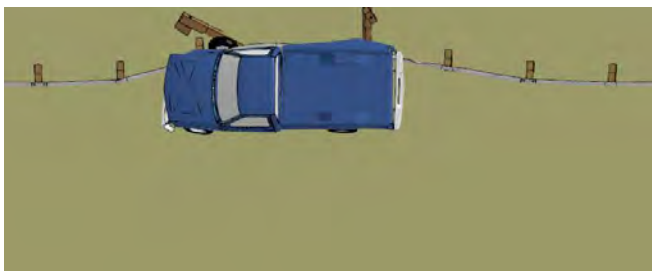
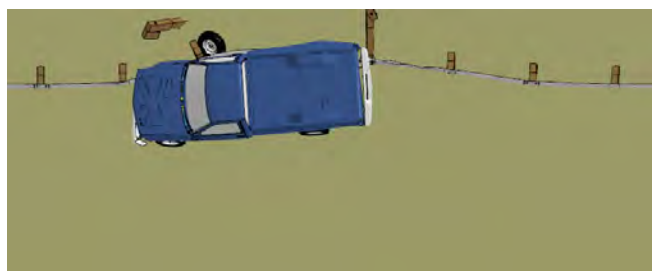
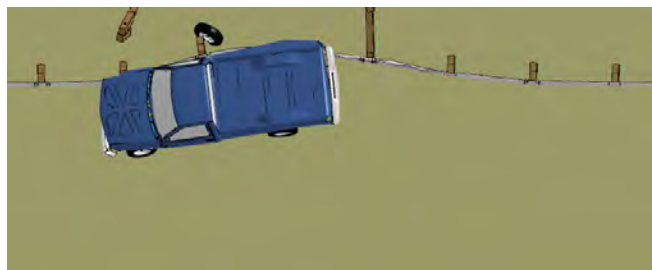
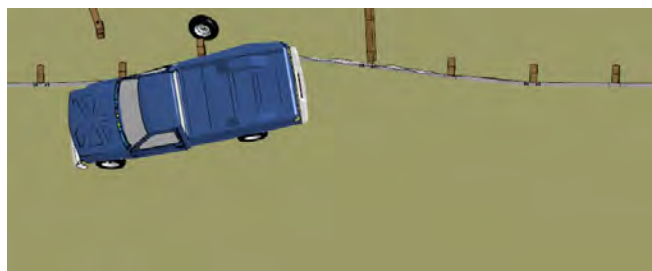
**Figure K-3. [CONTINUED] Sequential views from a downstream and overhead viewpoint for analysis case: Test 3-11 of 30 mph-Damaged G4(2W) at Impact Point 2.**

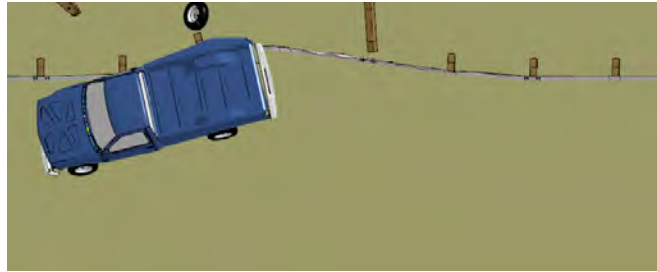
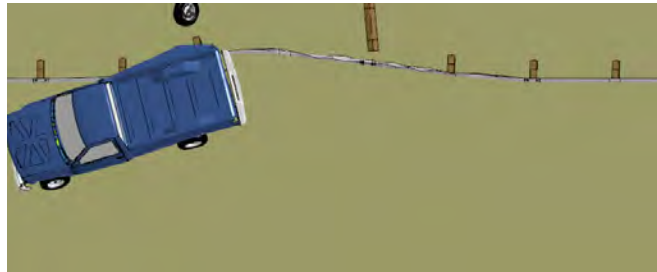
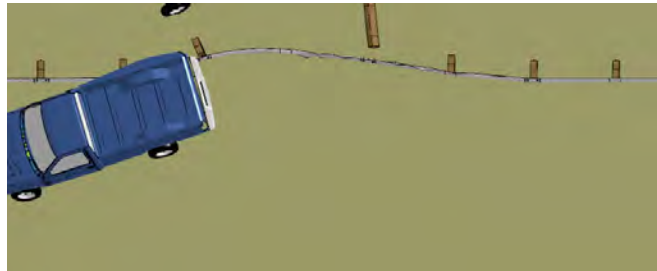
**Figure K-3. [CONTINUED] Sequential views from a downstream and overhead viewpoint for analysis case: Test 3-11 of 30 mph-Damaged G4(2W) at Impact Point 2.**

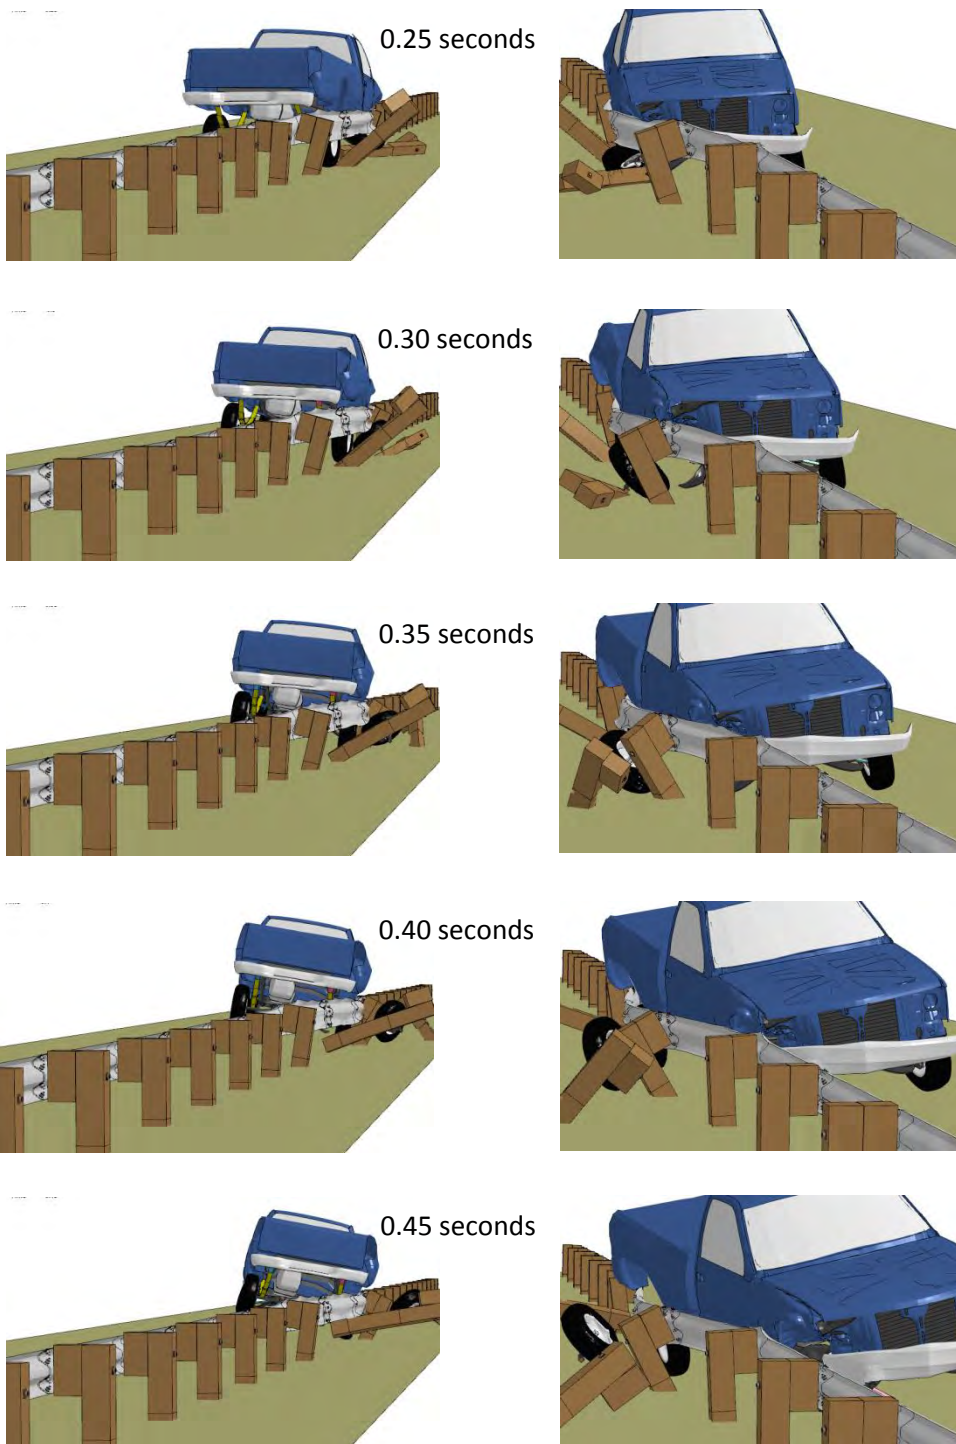
**Figure K-4. [CONTINUED] Sequential views from an upstream-backside and a downstream-backside viewpoint for analysis case: Test 3-11 of 30 mph-Damaged G4(2W) at Impact Point 2.**

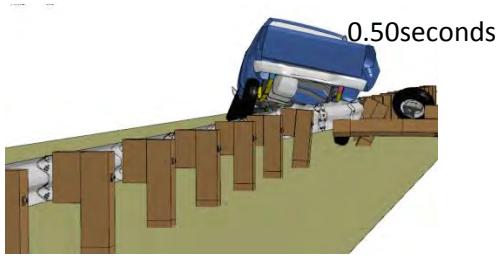
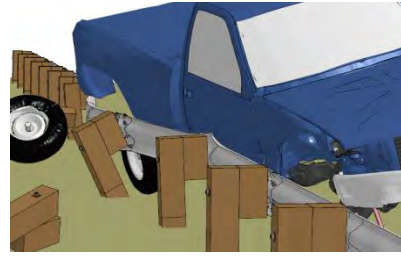
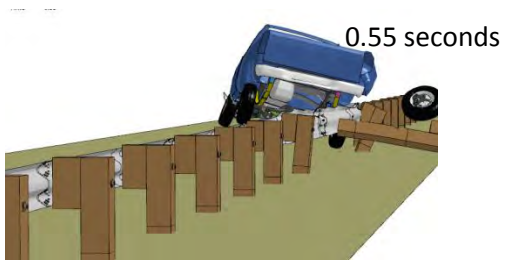
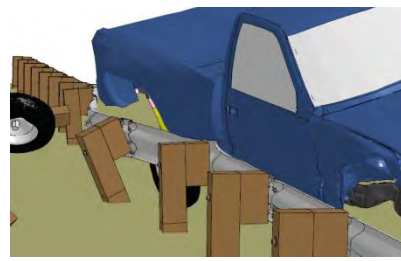
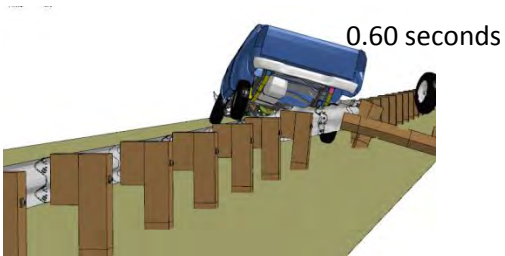
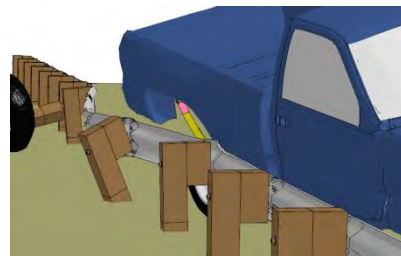
**Figure K-4. [CONTINUED] Sequential views from an upstream-backside and a downstream-backside viewpoint for analysis case: Test 3-11 of 30 mph-Damaged G4(2W) at Impact Point 2.**

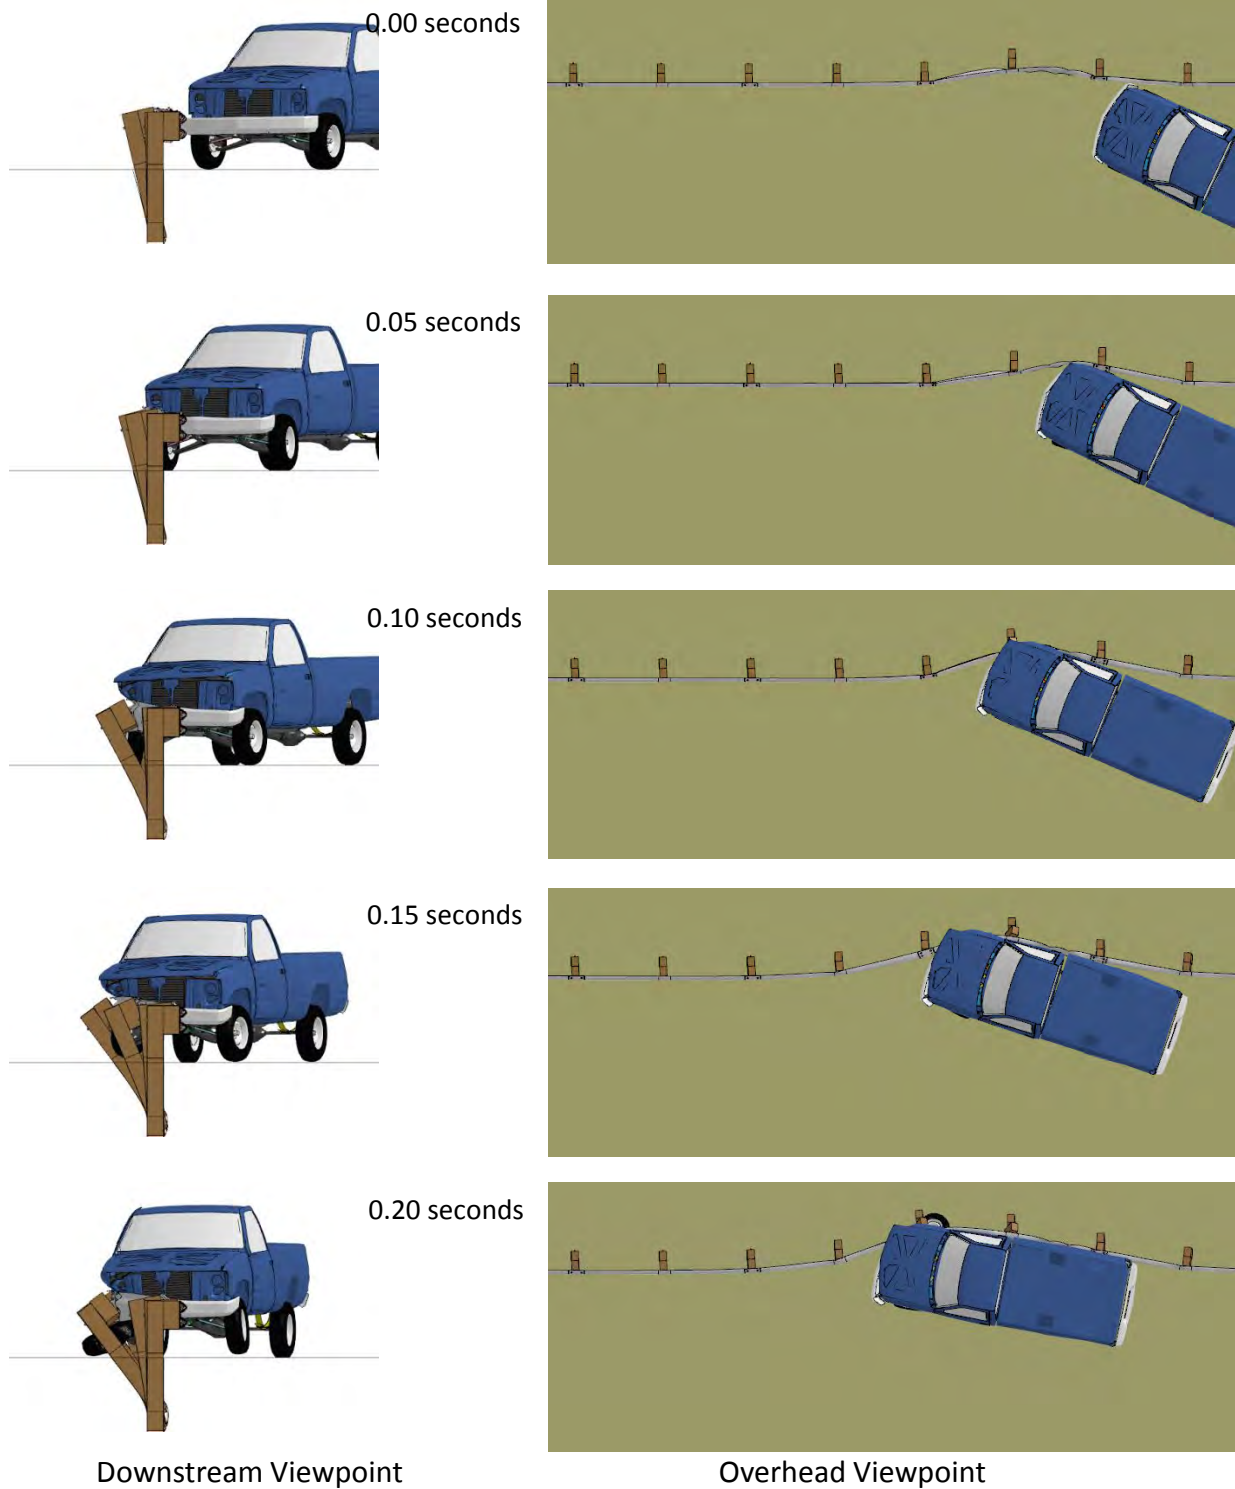
**Figure K-5. Sequential views from a downstream and overhead viewpoint for analysis case: Test 3-11 of 35 mph-Damaged G4(2W) at Impact Point 1.**
