# **A Guide for W-Beam Guardrail Damage Assessment**

A Field Manual for  
Highway Maintenance Personnel

National Cooperative  
Highway Research  
Program  
Project 22-28

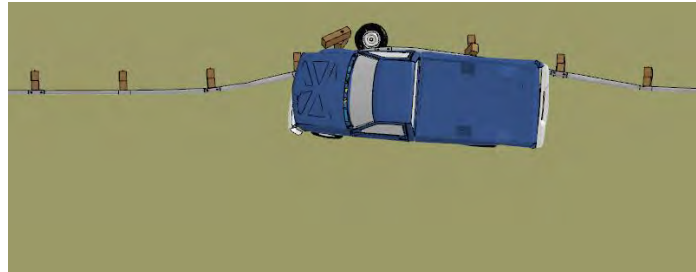
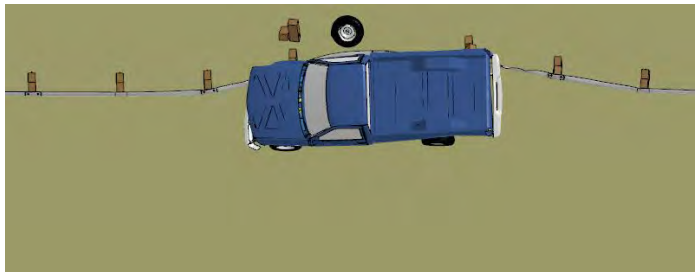
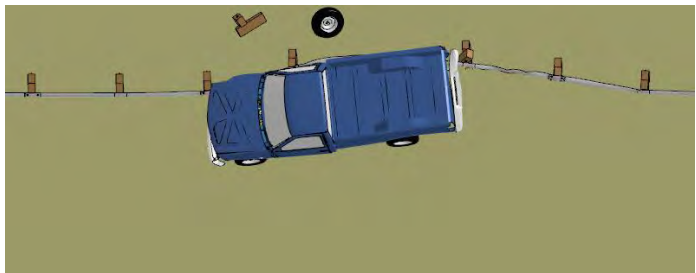
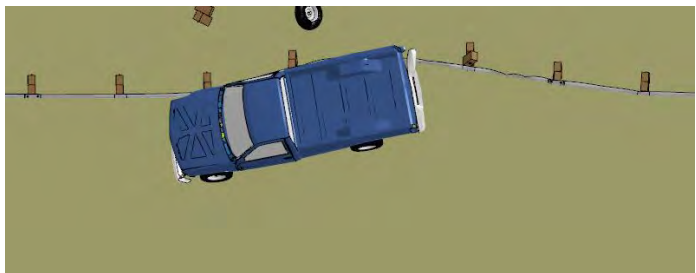
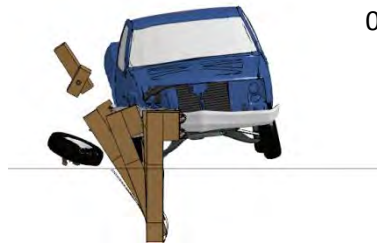
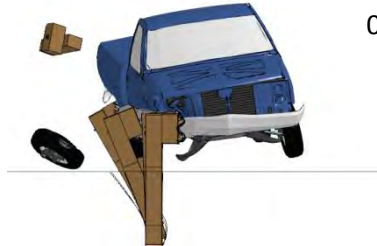
**Figure K-5. [CONTINUED] Sequential views from a downstream and overhead viewpoint for analysis case: Test 3-11 of 35 mph-Damaged G4(2W) at Impact Point 1.**

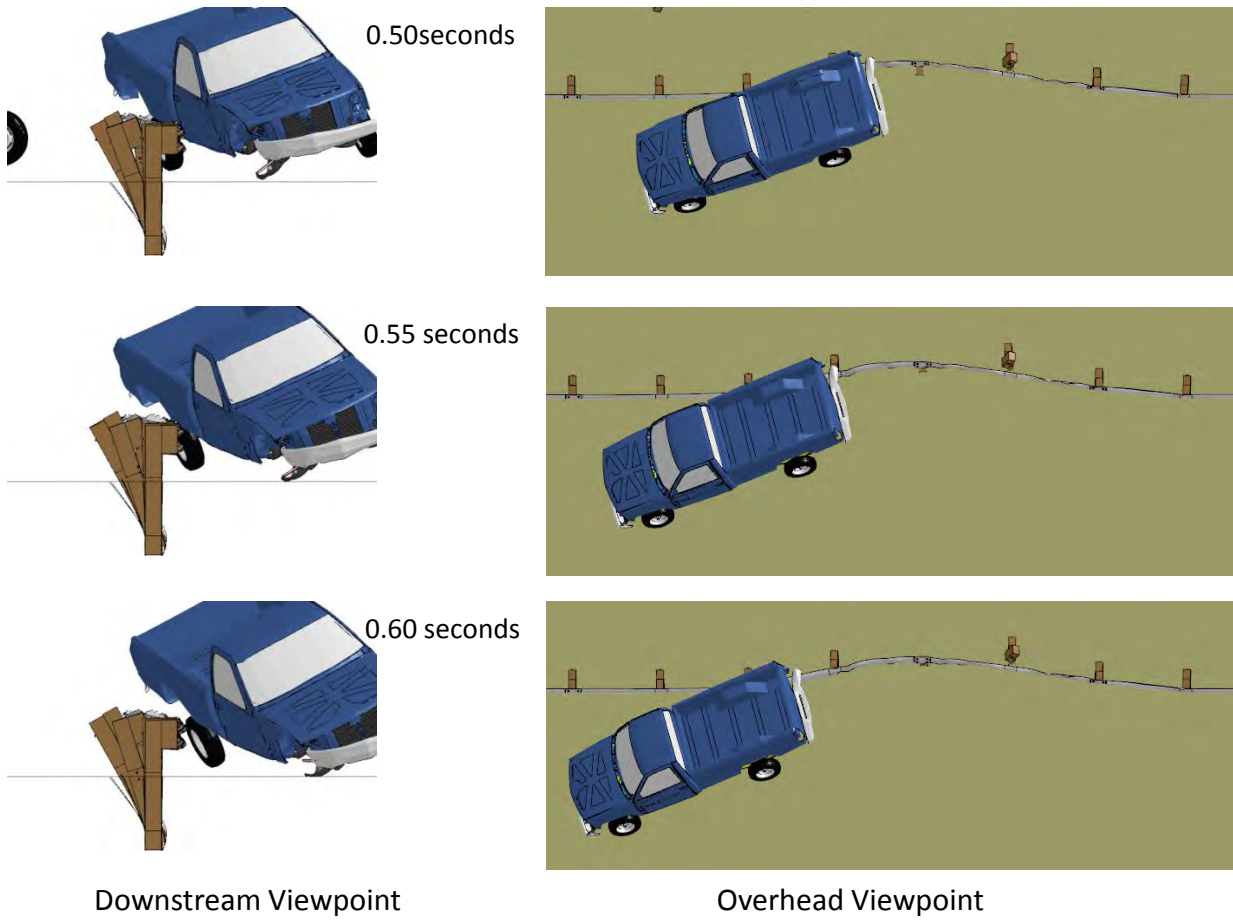
**Figure K-5. [CONTINUED] Sequential views from a downstream and overhead viewpoint for analysis case: Test 3-11 of 35 mph-Damaged G4(2W) at Impact Point 1.**

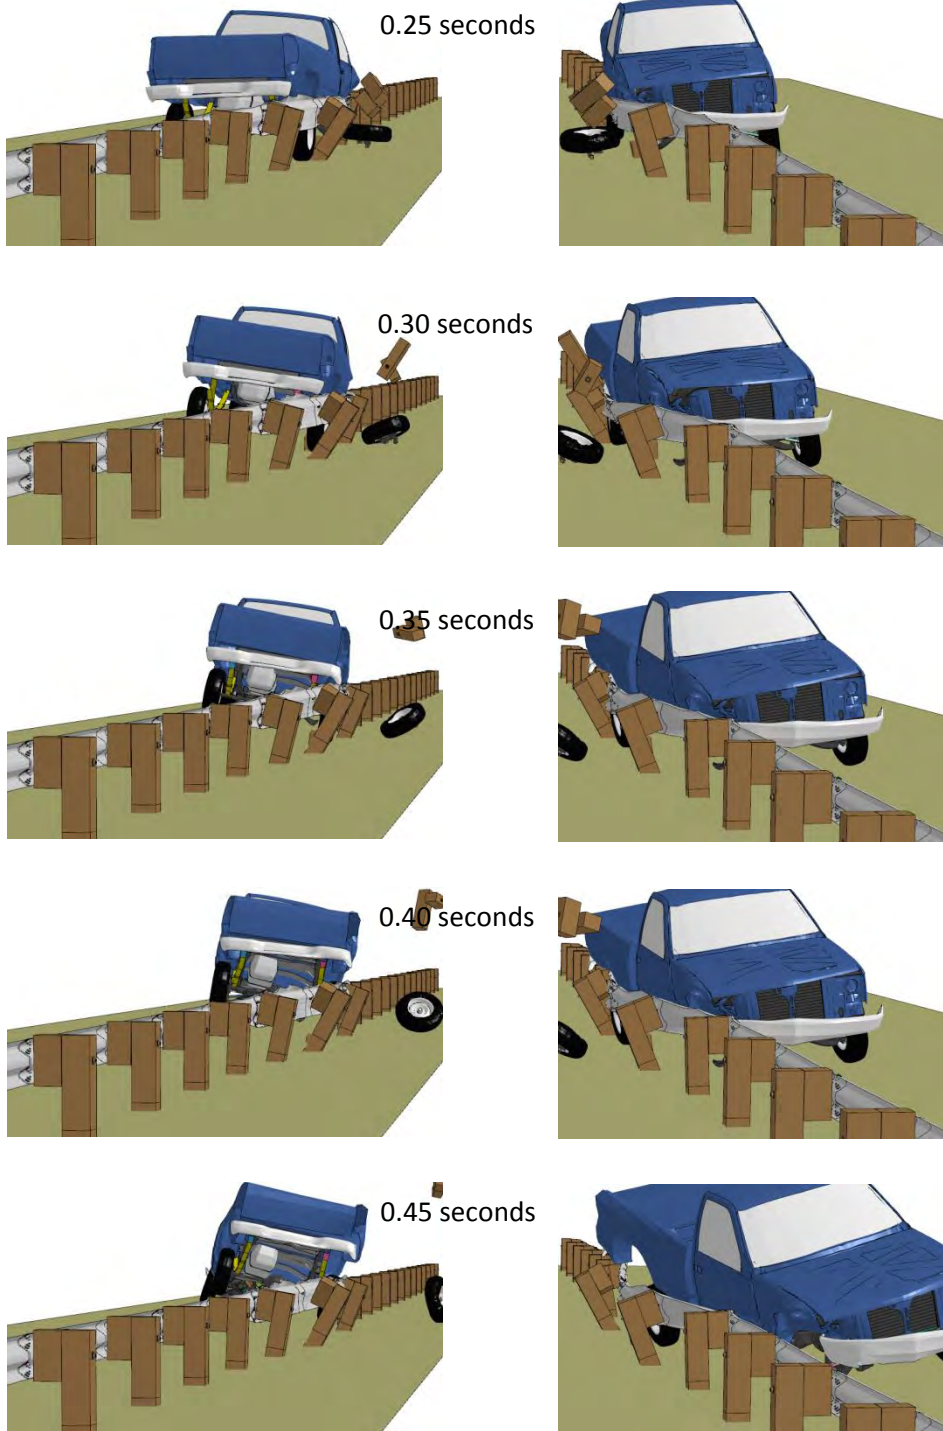
**Figure K-6. [CONTINUED] Sequential views from an upstream-backside and a downstream-backside viewpoint for analysis case: Test 3-11 of 35 mph-Damaged G4(2W) at Impact Point 1.**

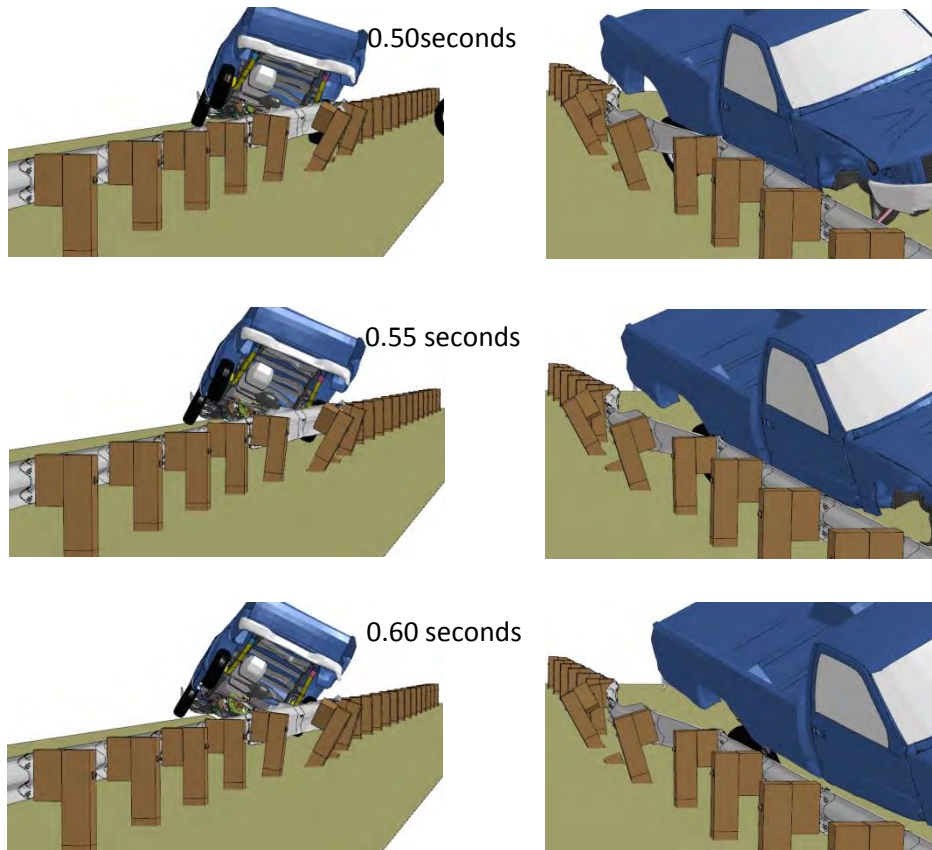
**Figure K-6. [CONTINUED] Sequential views from an upstream-backside and a downstream-backside viewpoint for analysis case: Test 3-11 of 35 mph-Damaged G4(2W) at Impact Point 1.**

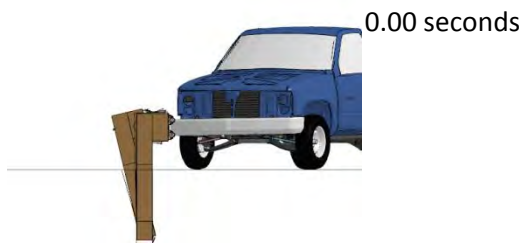
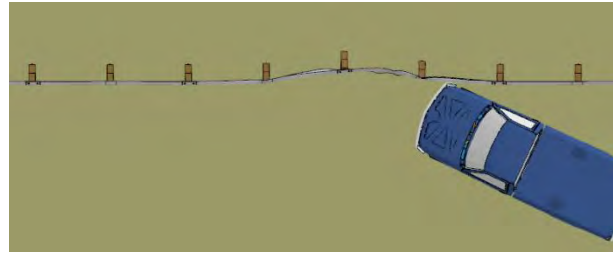
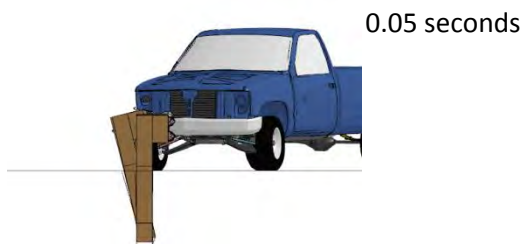
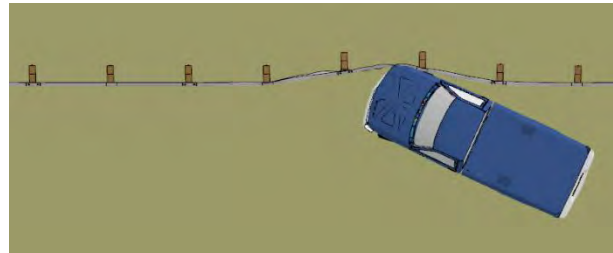
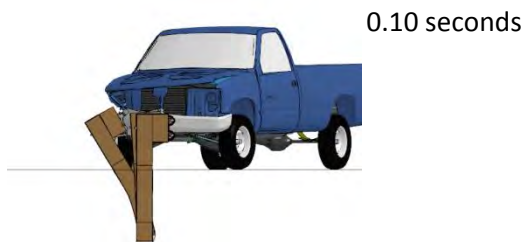
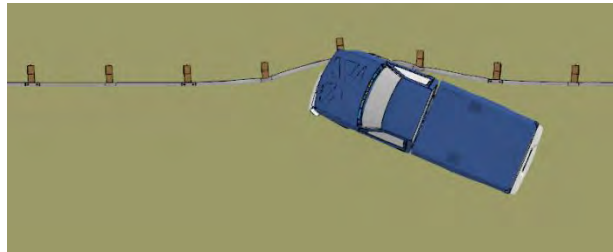
**Figure K-7. Sequential views from a downstream and overhead viewpoint for analysis case: Test 3-11 of 35 mph-Damaged G4(2W) at Impact Point 2.**

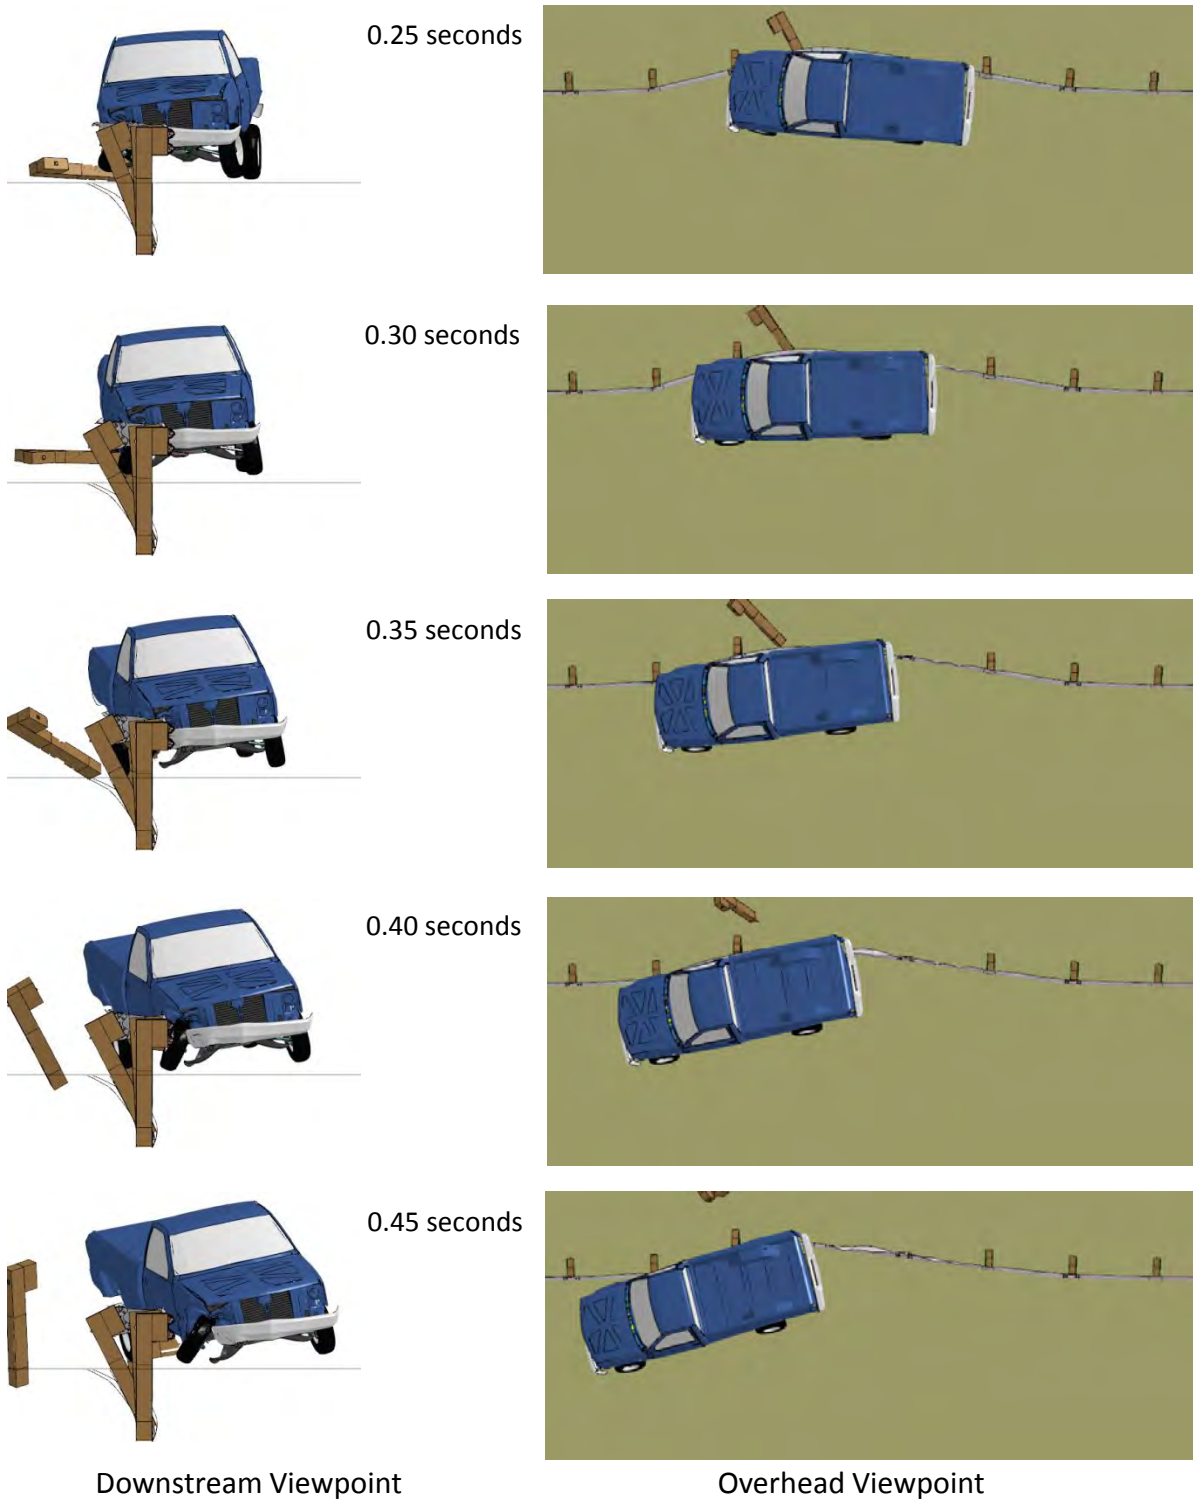
**Figure K-7. [CONTINUED] Sequential views from a downstream and overhead viewpoint for analysis case: Test 3-11 of 35 mph-Damaged G4(2W) at Impact Point 2.**

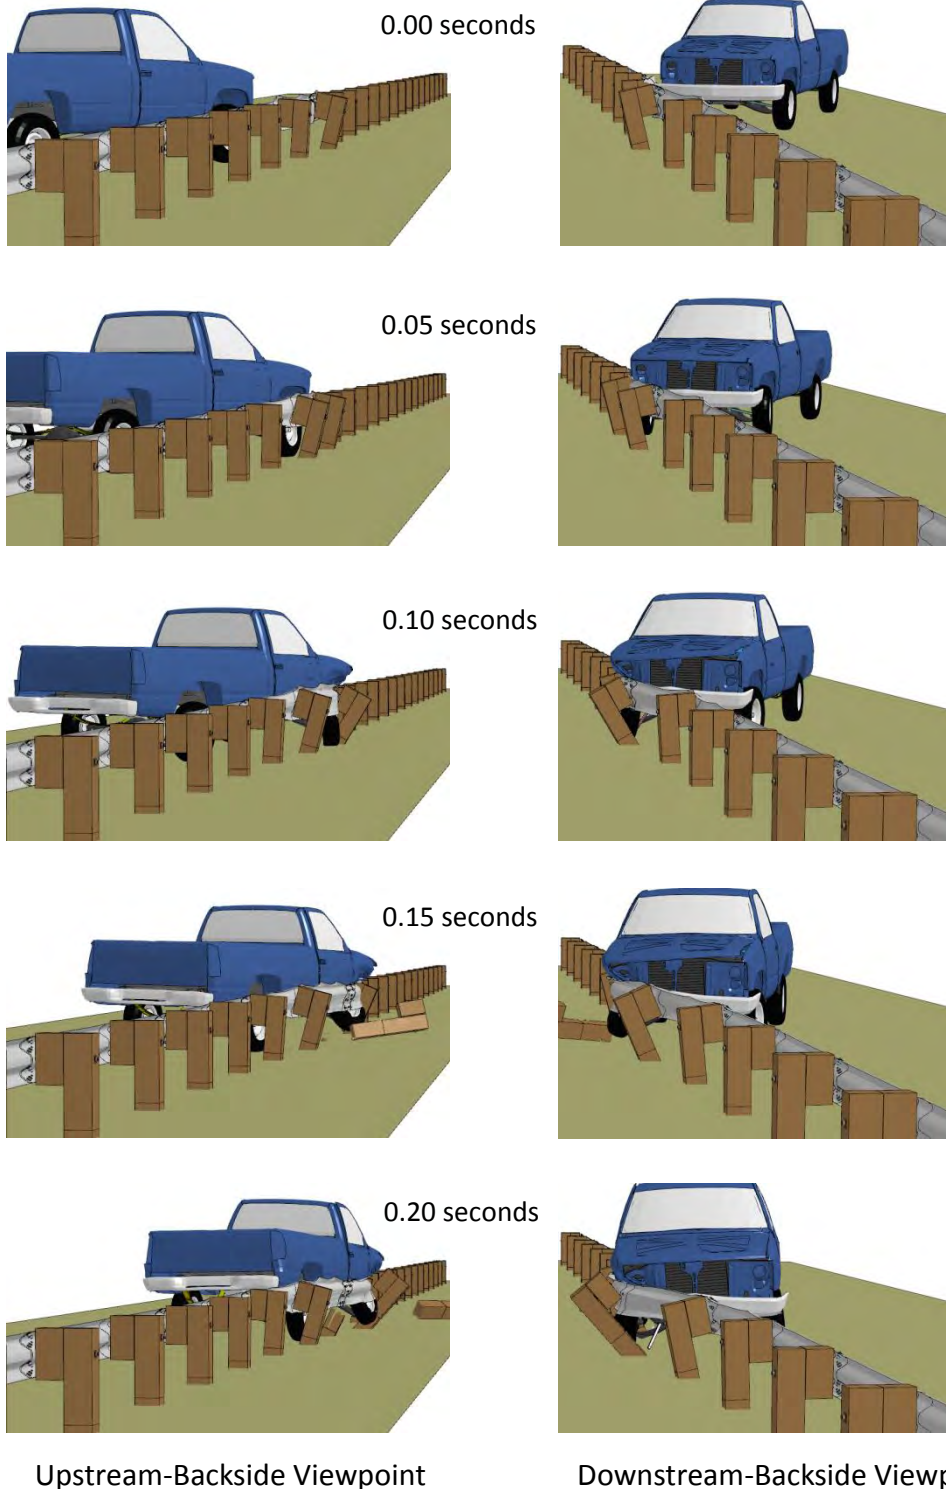
**Figure K-8. Sequential views from an upstream-backside and a downstream-backside viewpoint for analysis case: Test 3-11 of 35 mph-Damaged G4(2W) at Impact Point 2.**

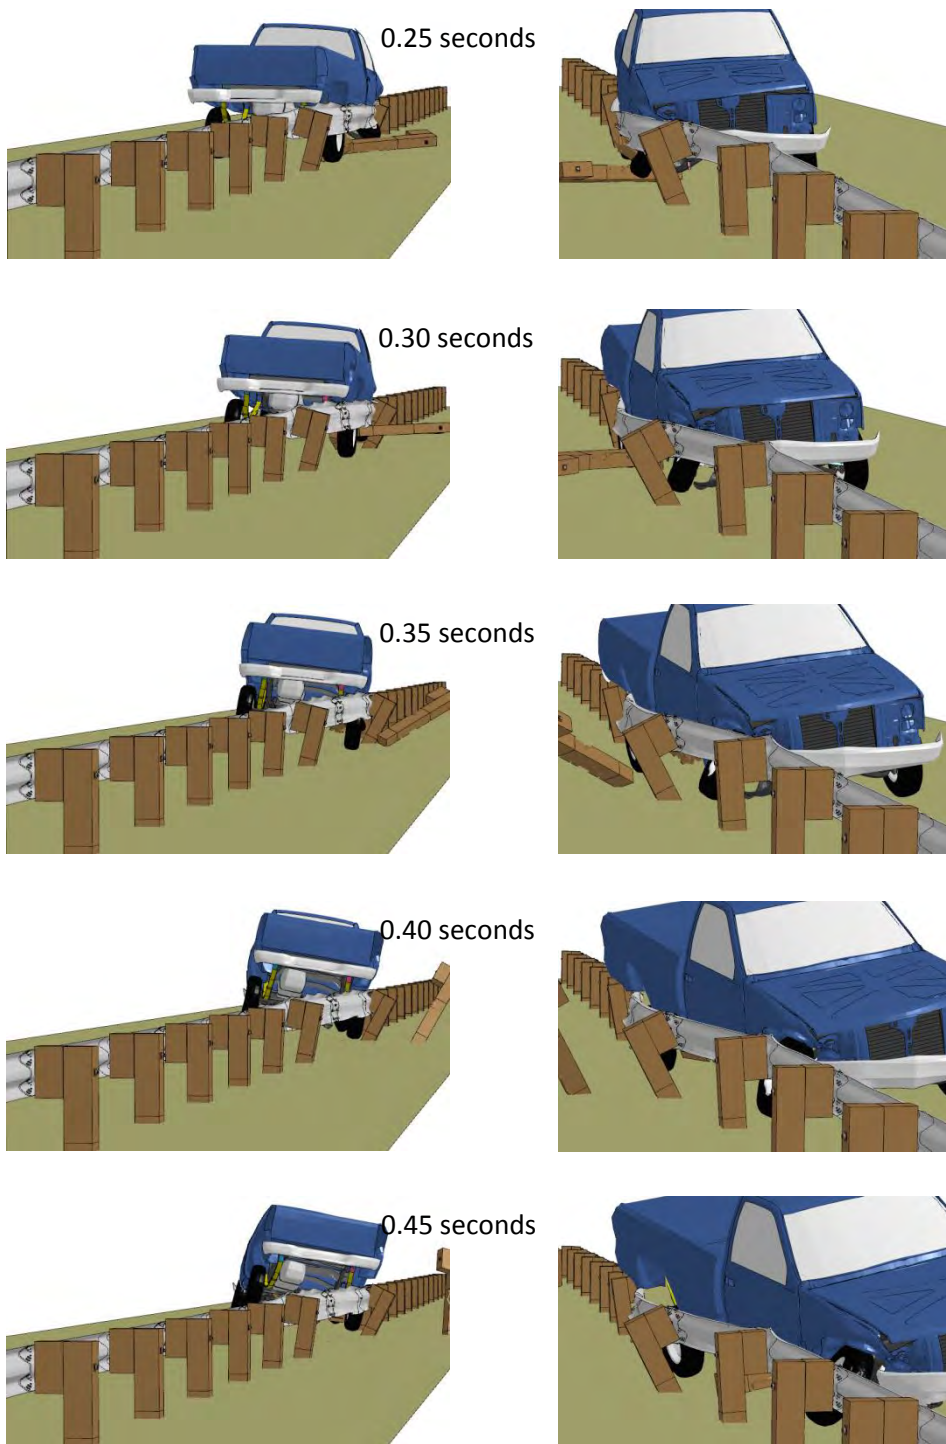
**Figure K-8. [CONTINUED] Sequential views from an upstream-backside and a downstream-backside viewpoint for analysis case: Test 3-11 of 35 mph-Damaged G4(2W) at Impact Point 2.**

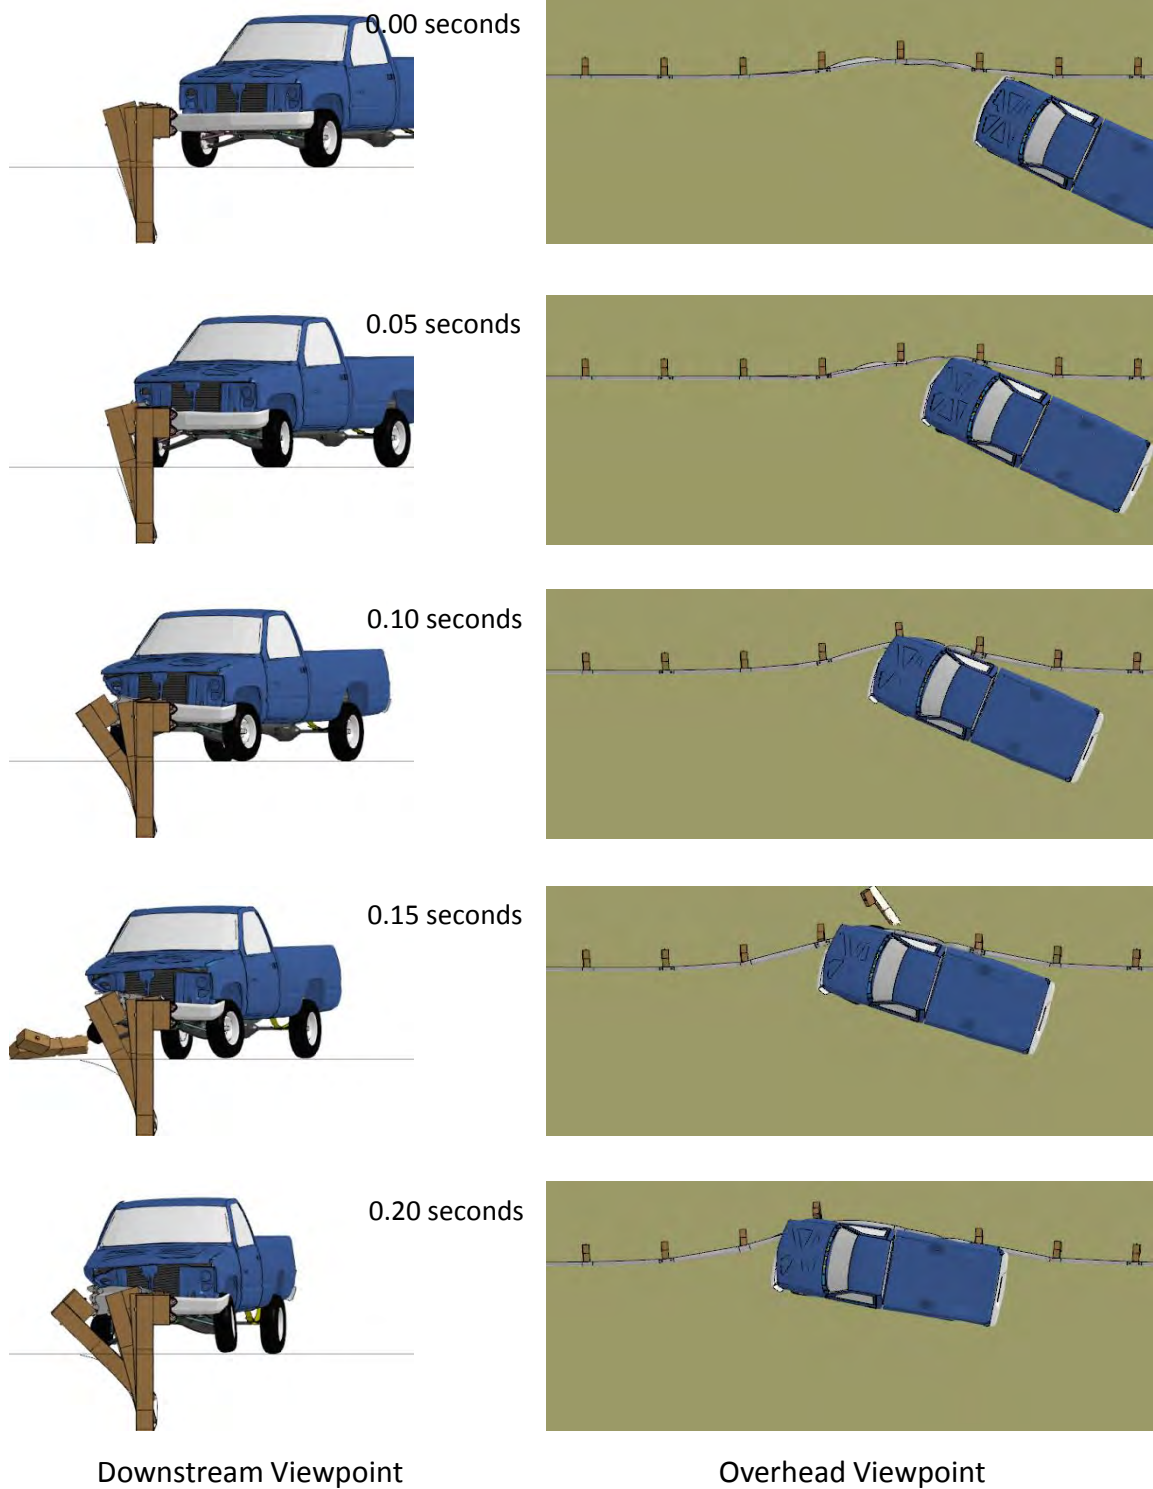
**Figure K-9. Sequential views from a downstream and overhead viewpoint for analysis case: Test 3-11 of 40 mph-Damaged G4(2W) at Impact Point 1.**

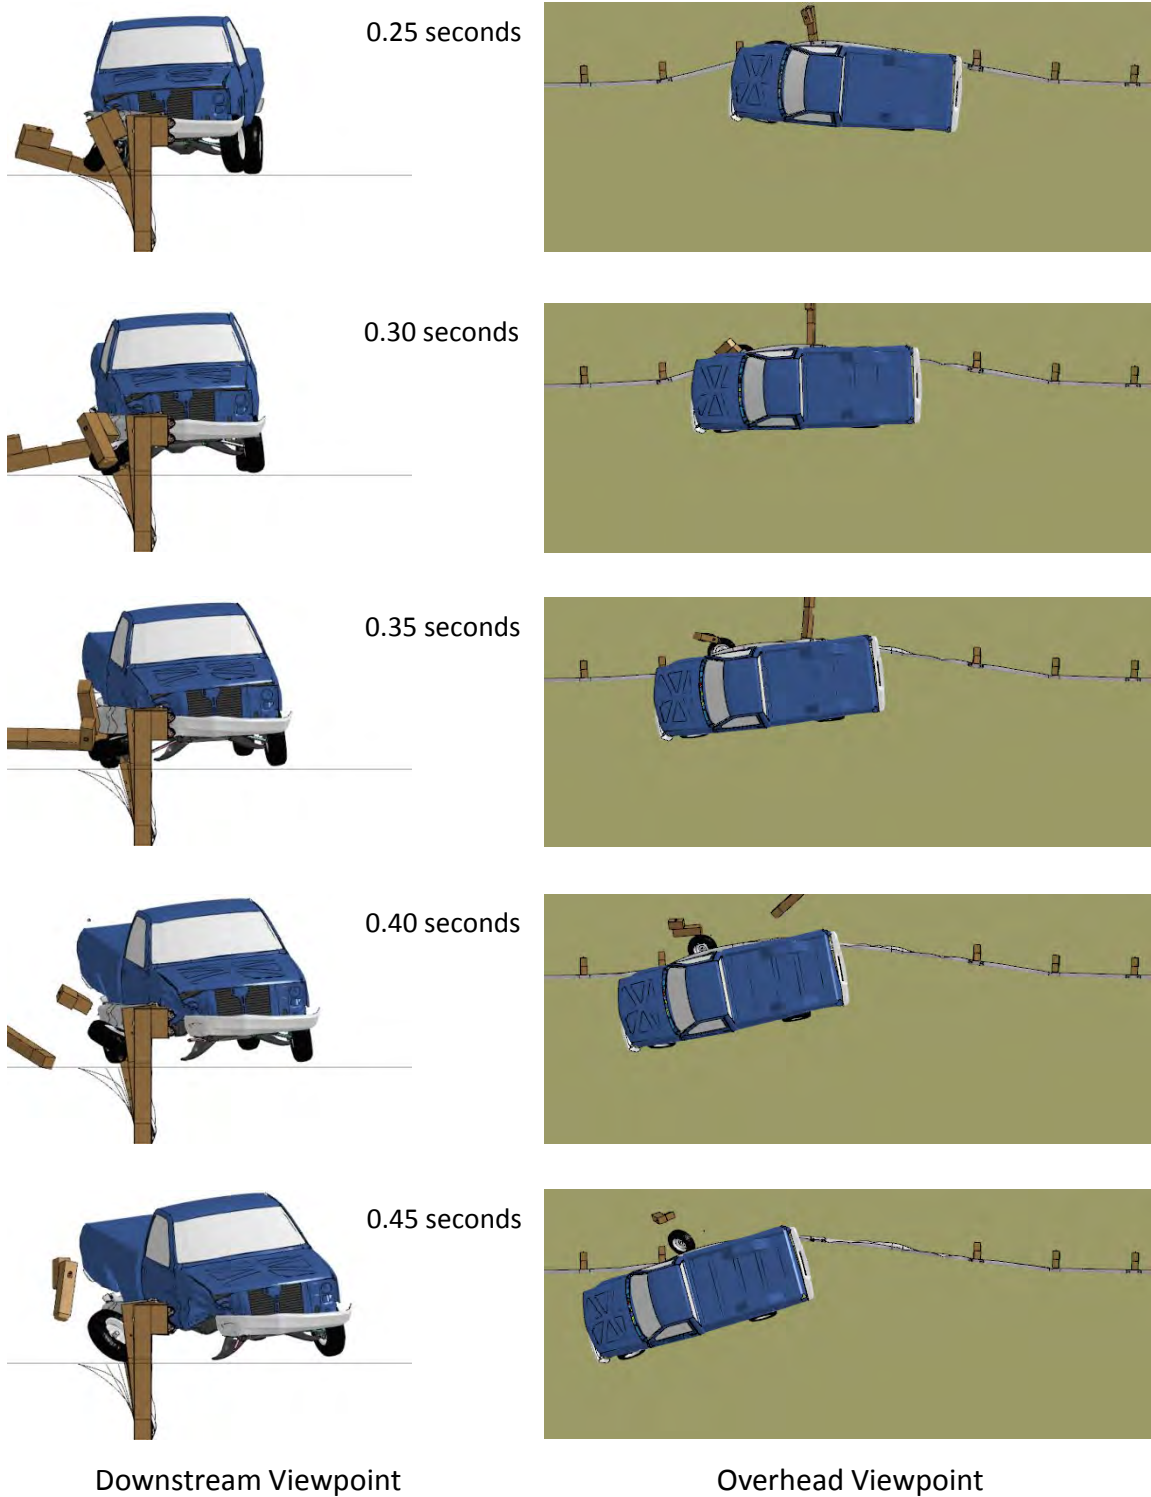
**Figure K-9. [CONTINUED] Sequential views from a downstream and overhead viewpoint for analysis case: Test 3-11 of 40 mph-Damaged G4(2W) at Impact Point 1.**

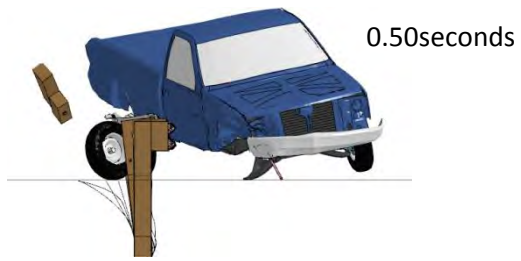
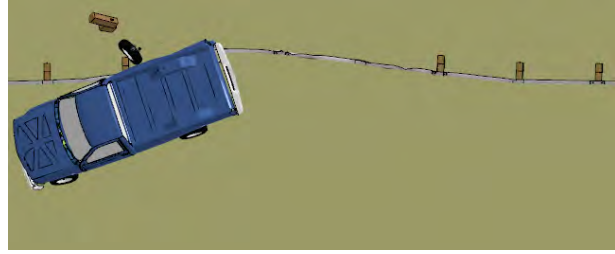
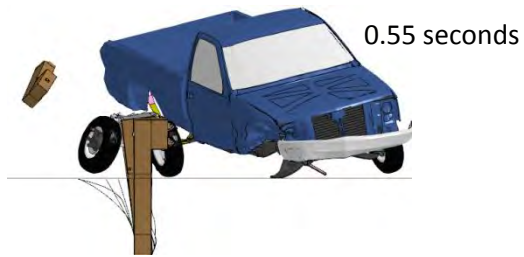
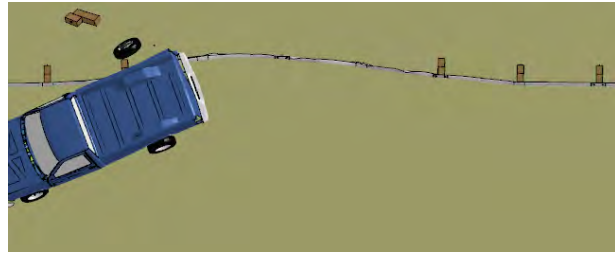
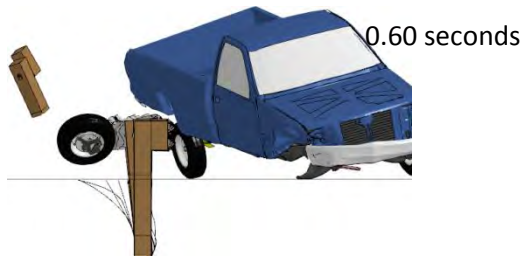
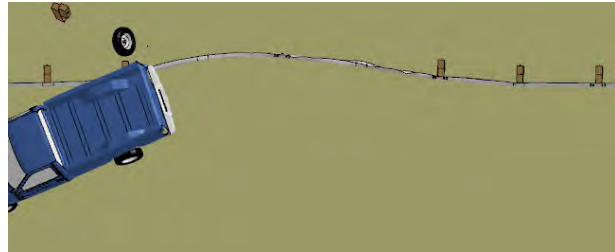
**Figure K-9. [CONTINUED] Sequential views from a downstream and overhead viewpoint for analysis case: Test 3-11 of 40 mph-Damaged G4(2W) at Impact Point 1.**

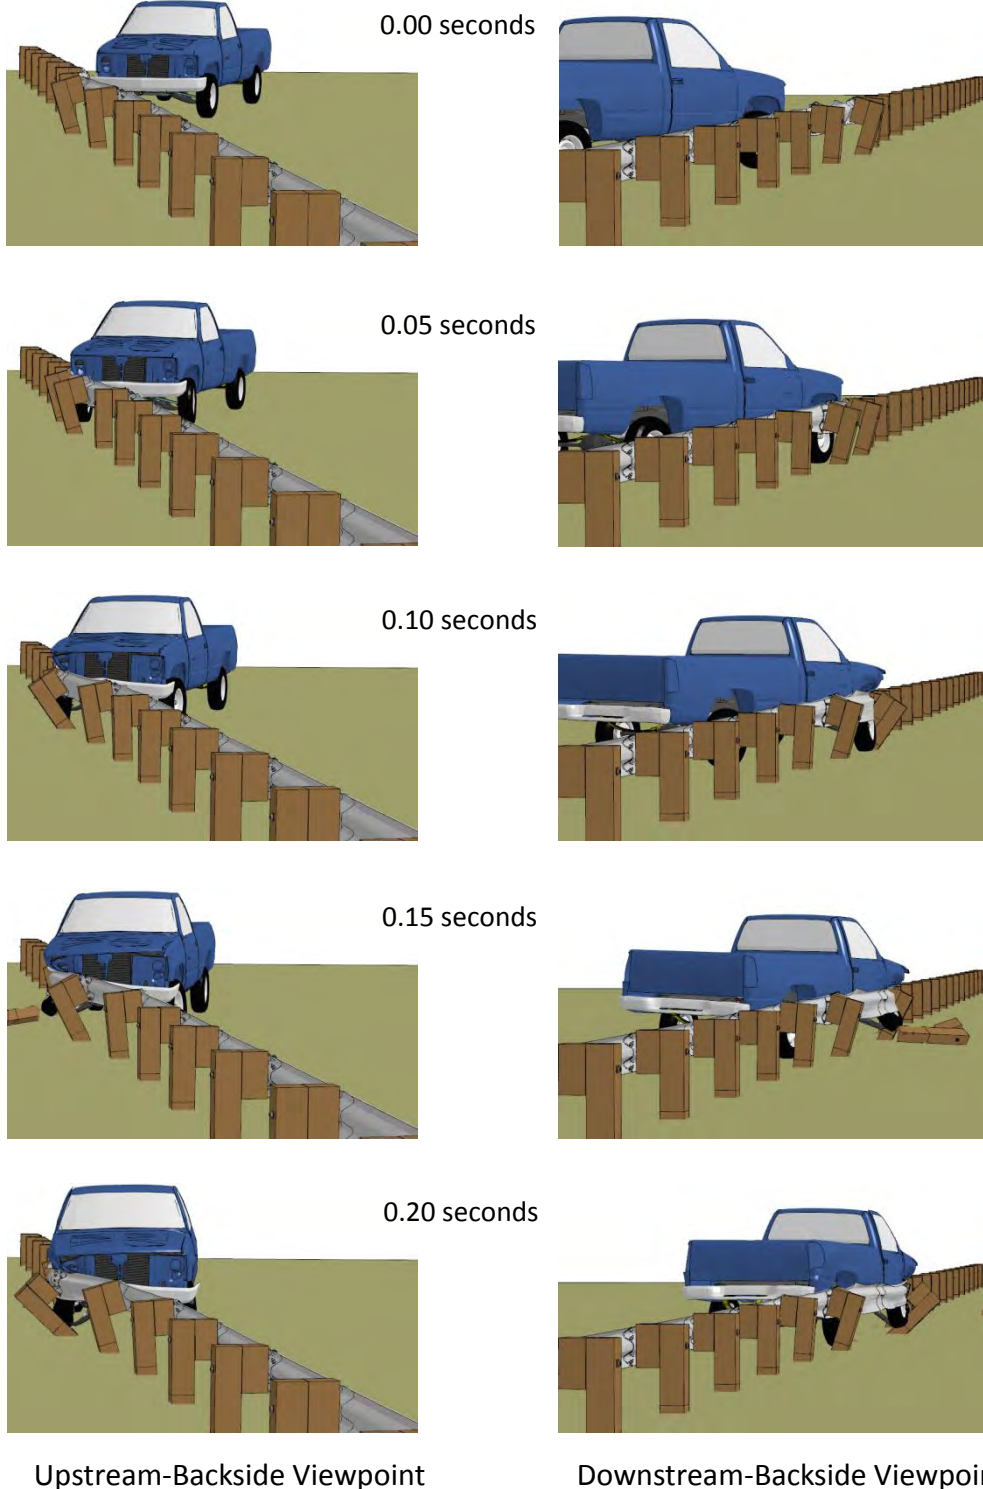
**Figure K-10. Sequential views from an upstream-backside and a downstream-backside viewpoint for analysis case: Test 3-11 of 40 mph-Damaged G4(2W) at Impact Point 1.**

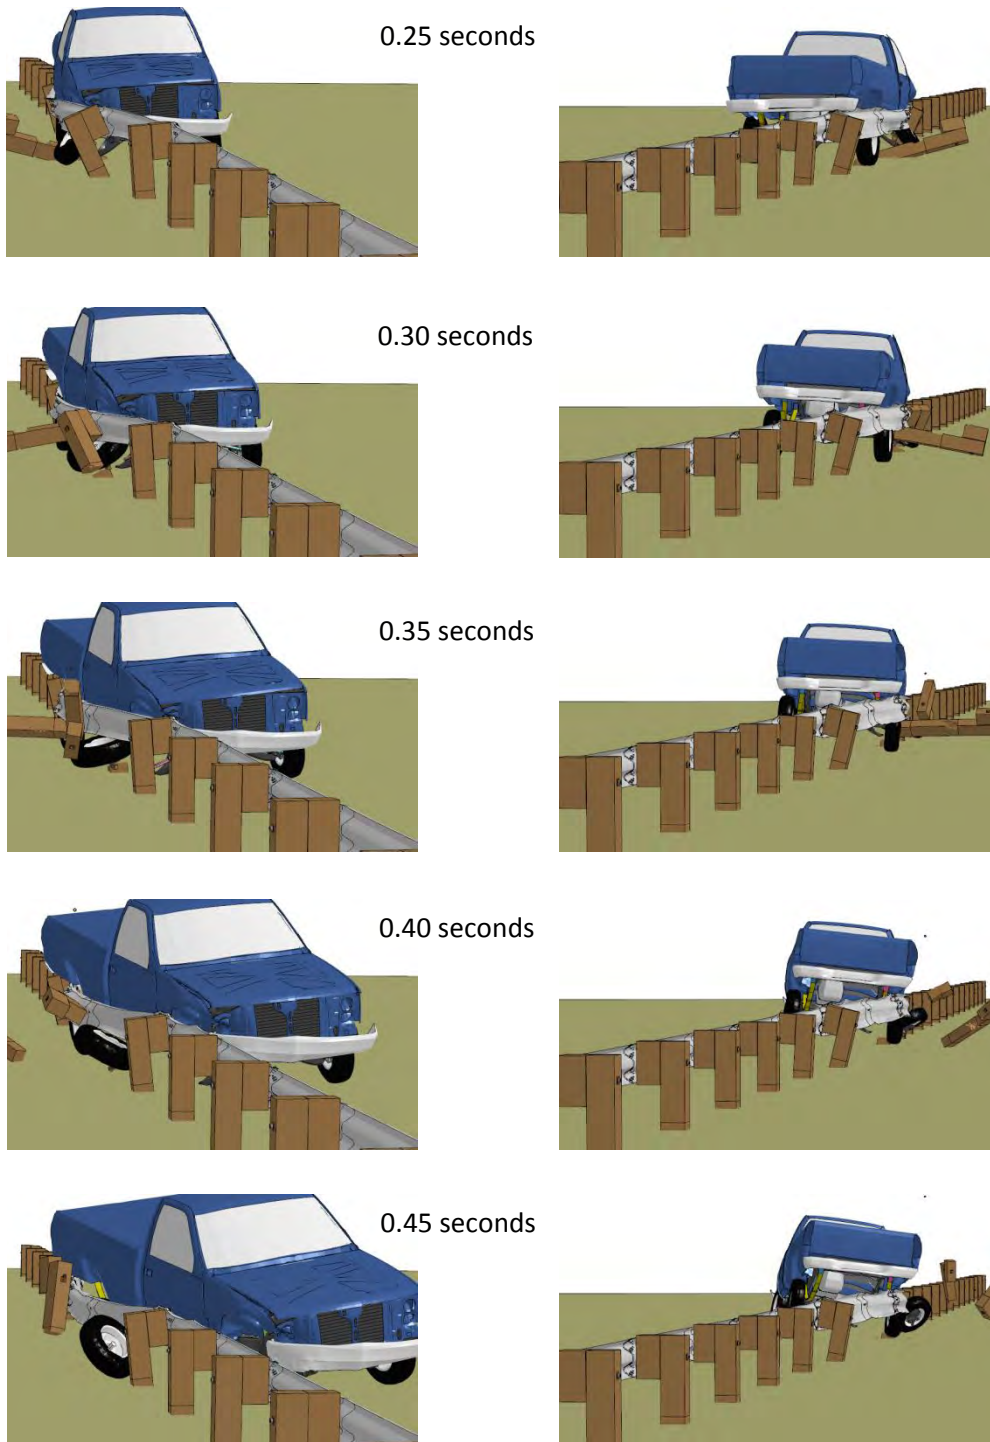
**Figure K-10. [CONTINUED] Sequential views from an upstream-backside and a downstream-backside viewpoint for analysis case: Test 3-11 of 40 mph-Damaged G4(2W) at Impact Point 1.**

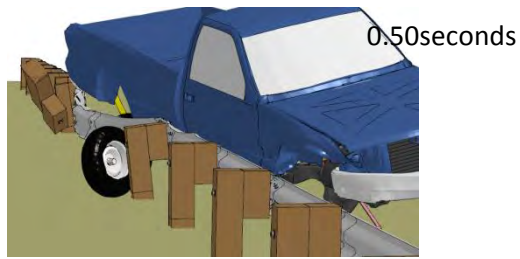
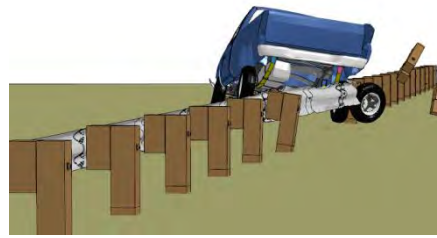
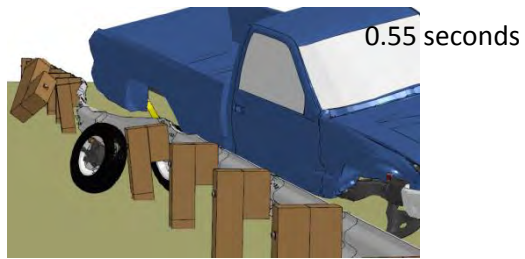
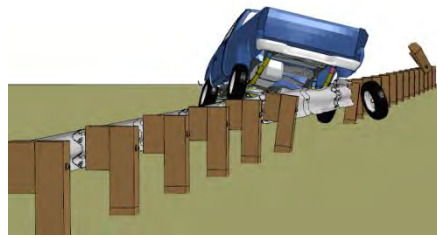
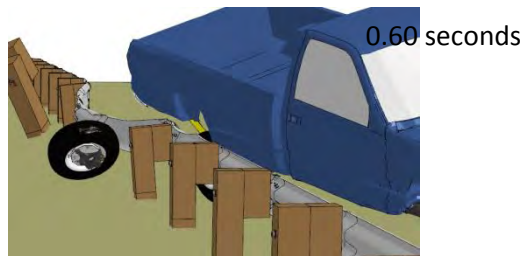
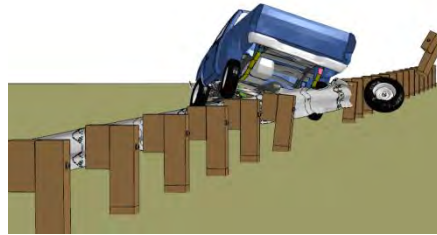
**Figure K-10. [CONTINUED] Sequential views from an upstream-backside and a downstream-backside viewpoint for analysis case: Test 3-11 of 40 mph-Damaged G4(2W) at Impact Point 1.**

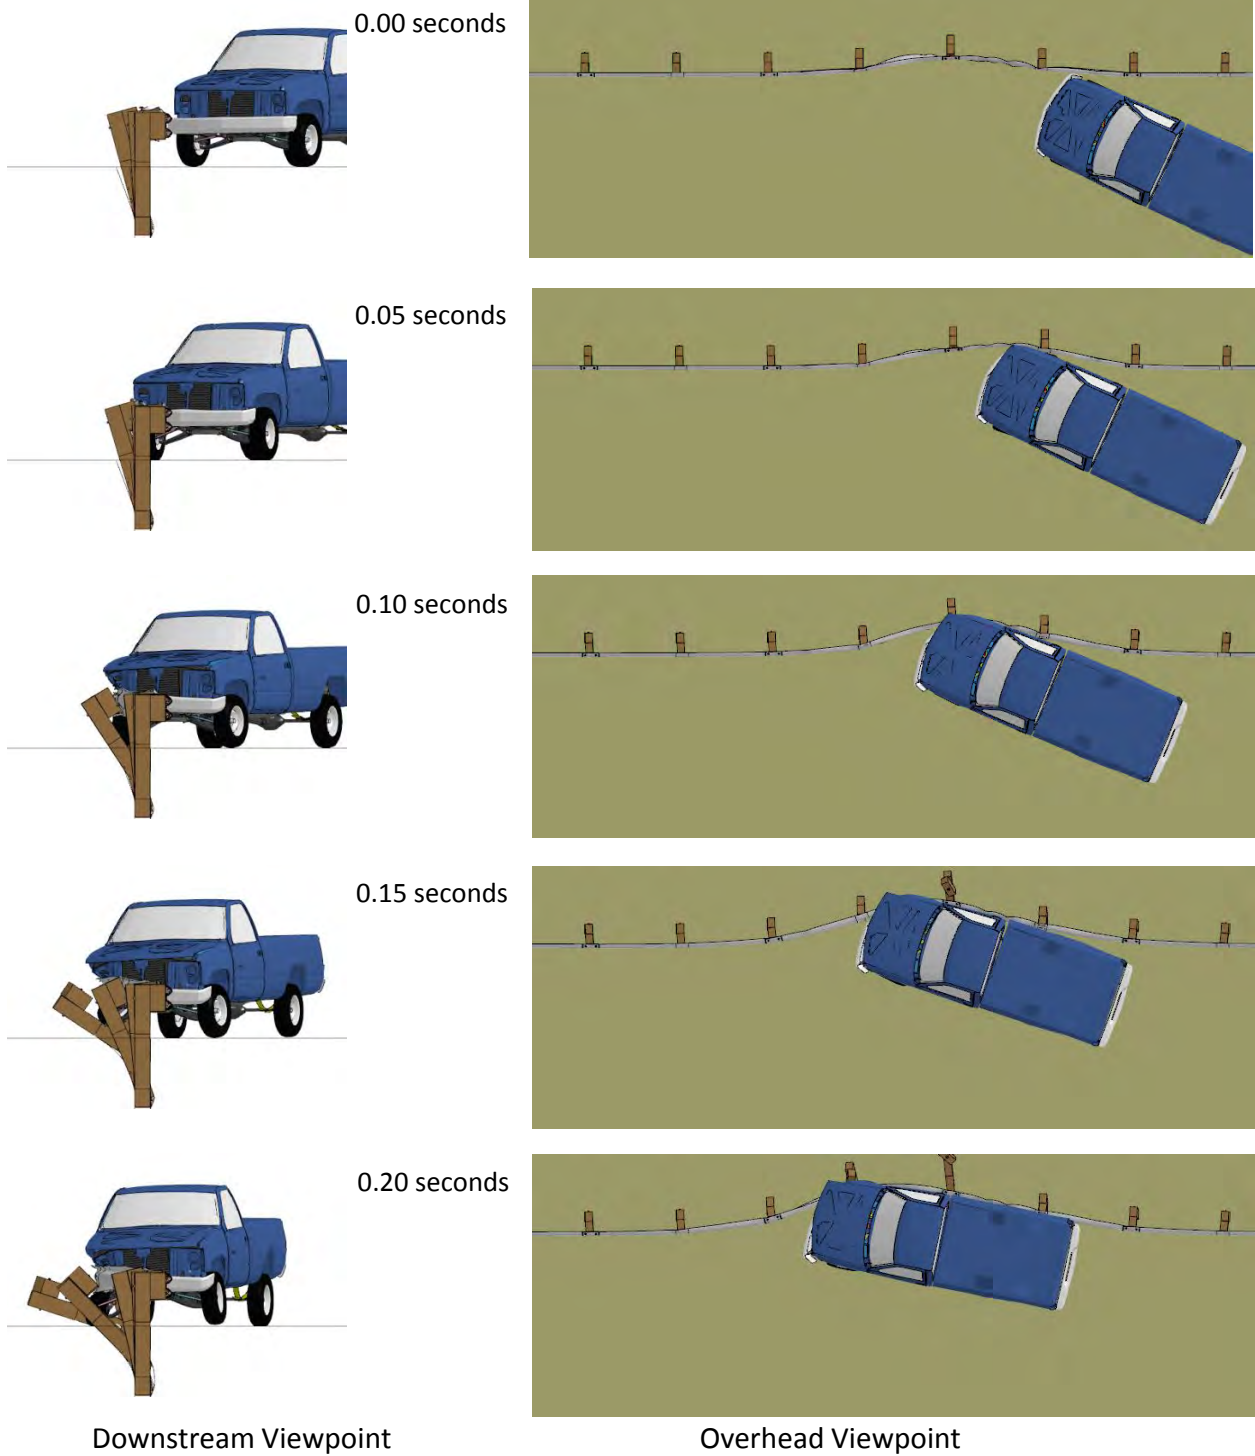
**Figure K-11. Sequential views from an upstream-backside and a downstream-backside viewpoint for analysis case: Test 3-11 of 40 mph-Damaged G4(2W) at Impact Point 2.**

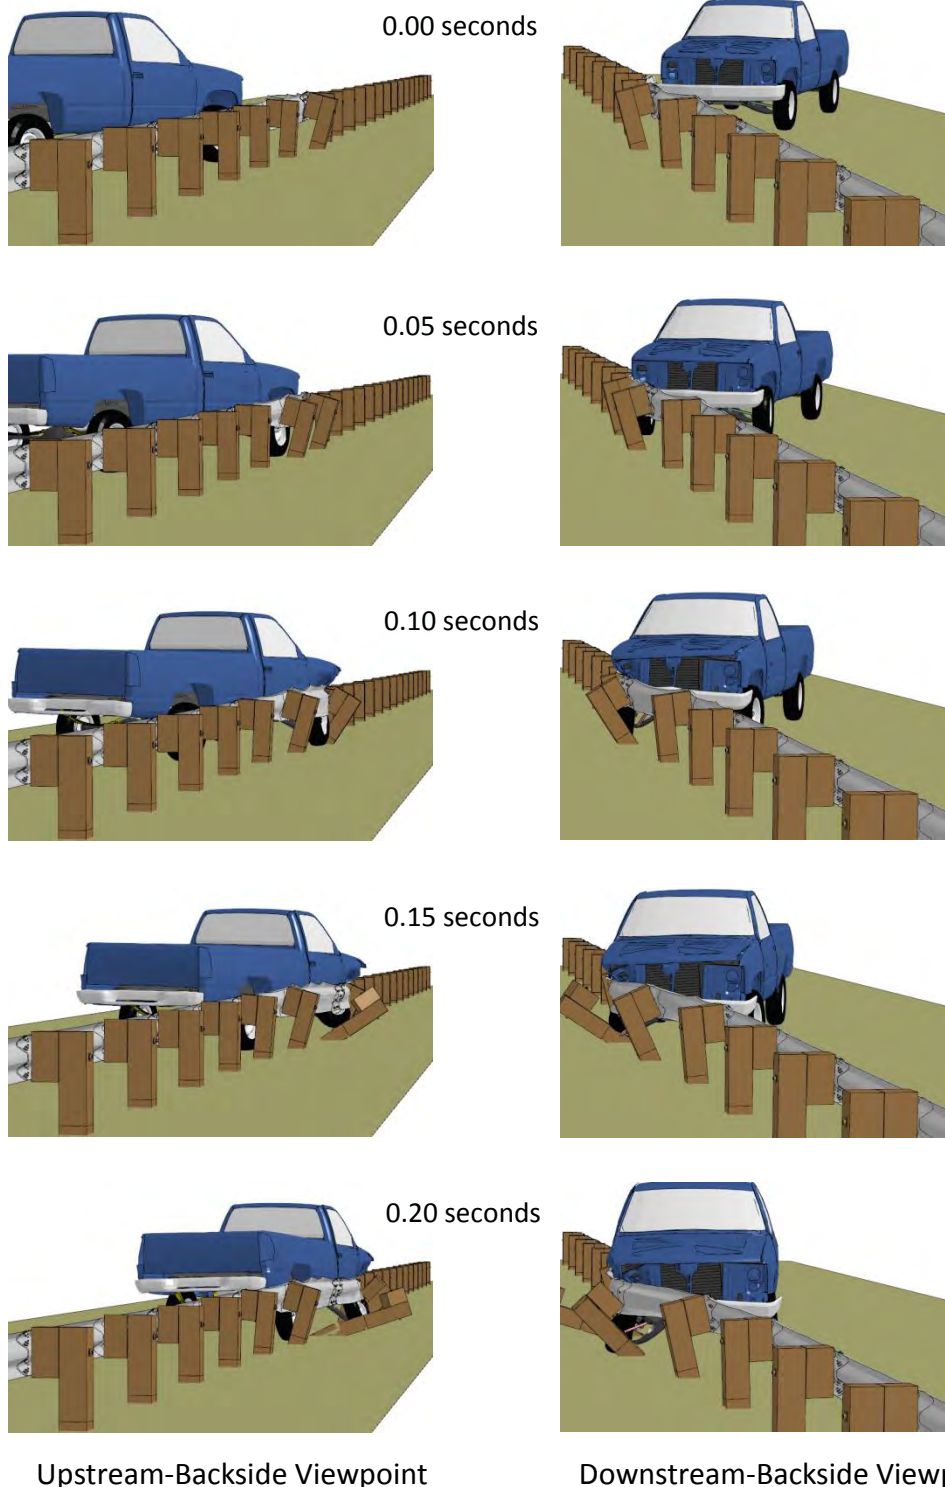
**Figure B-12. Sequential views from an upstream-backside and a downstream-backside viewpoint for analysis case: Test 3-11 of 40 mph-Damaged G4(2W) at Impact Point 2.**

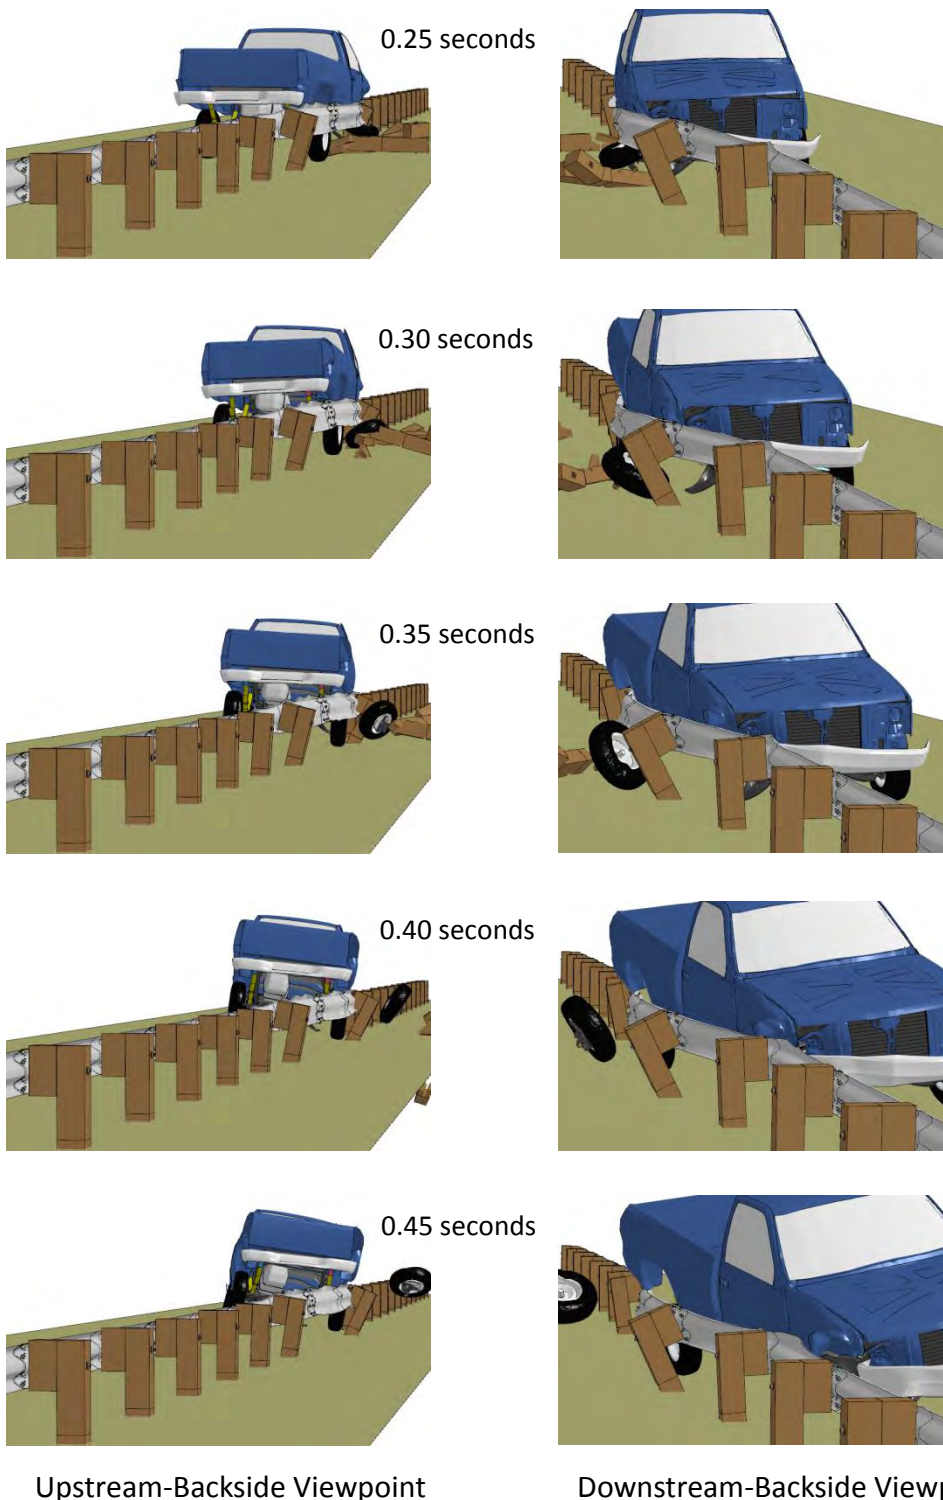
Figure B-12. [CONTINUED] Sequential views from an upstream-backside and a downstream-backside viewpoint for analysis case: Test 3-11 of 40 mph-Damaged G4(2W) at Impact Point 2.
