# **A Guide for W-Beam Guardrail Damage Assessment**

A Field Manual for  
Highway Maintenance Personnel

National Cooperative  
Highway Research  
Program  
Project 22-28

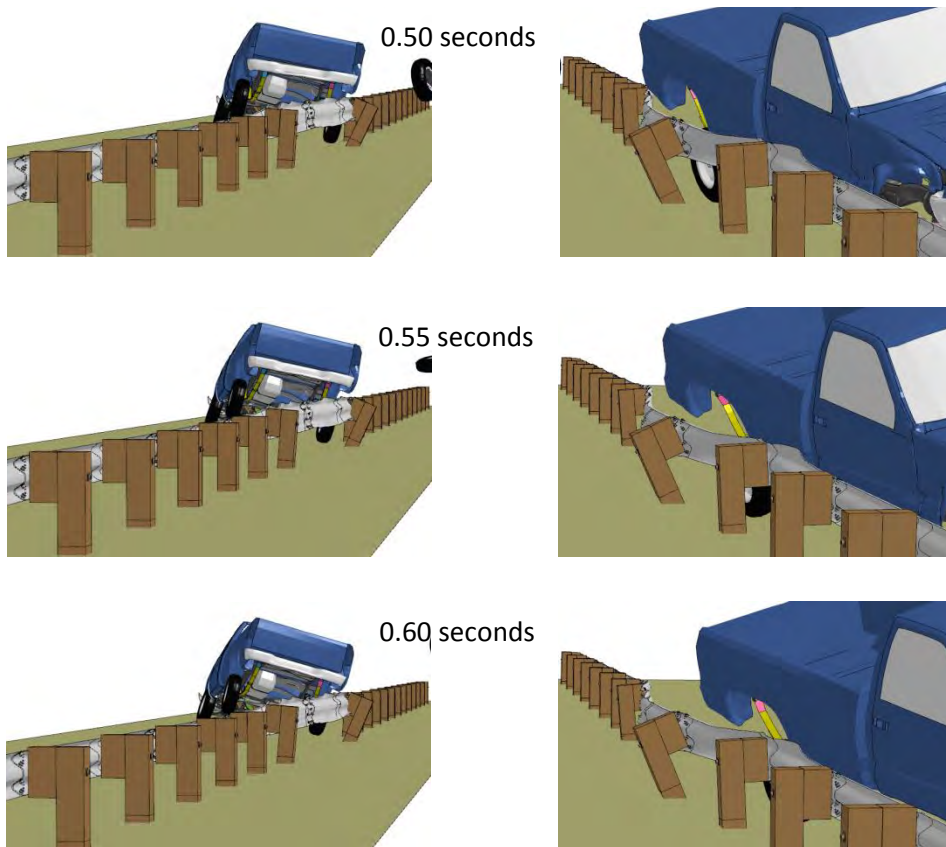
Figure B-12. [CONTINUED] Sequential views from an upstream-backside and a downstream-backside viewpoint for analysis case: Test 3-11 of 40 mph-Damaged G4(2W) at Impact Point 2.

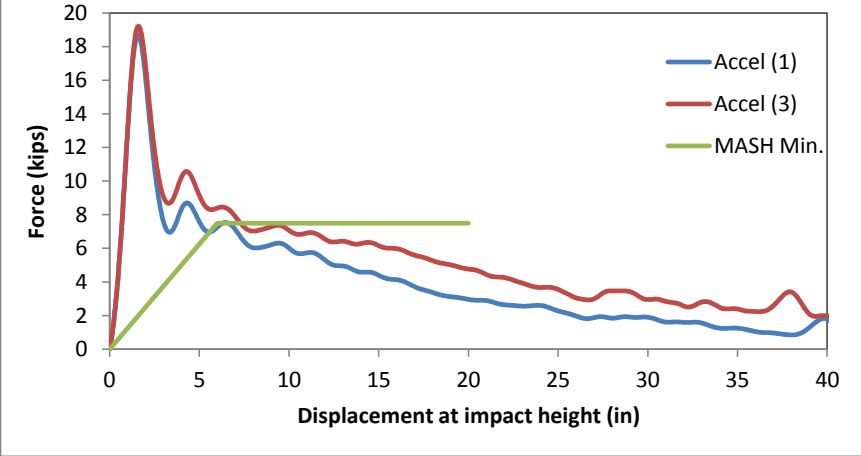
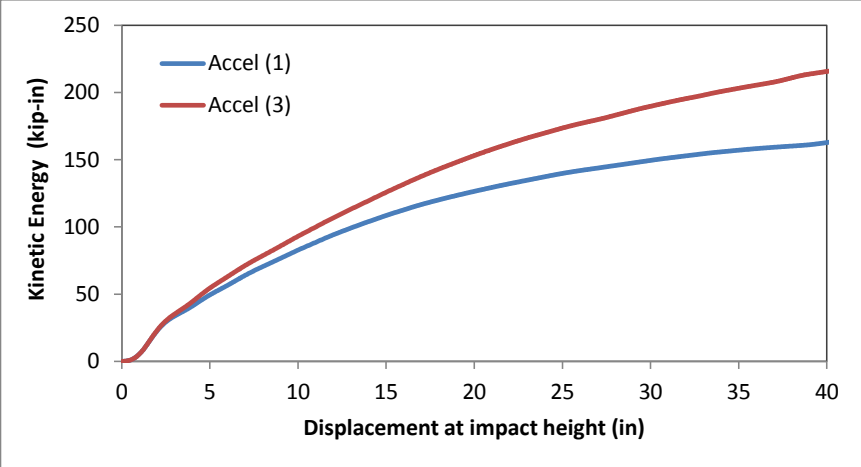
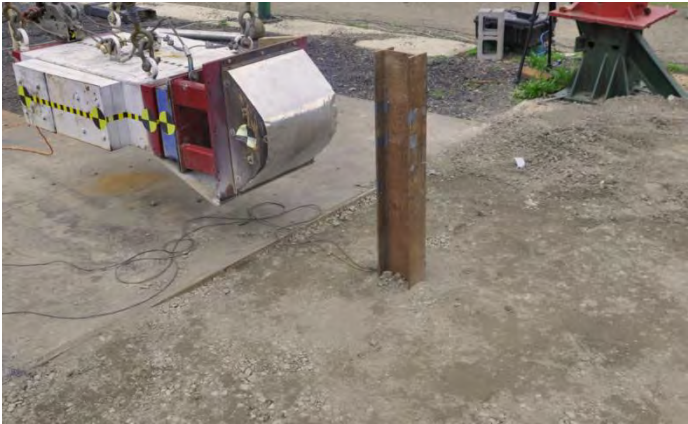
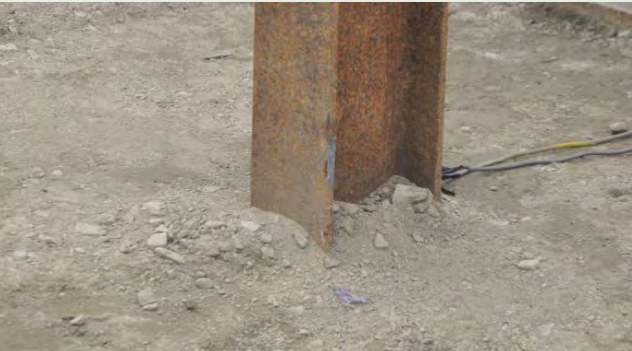
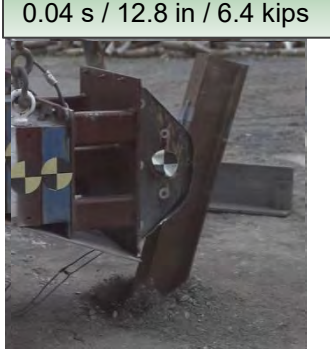
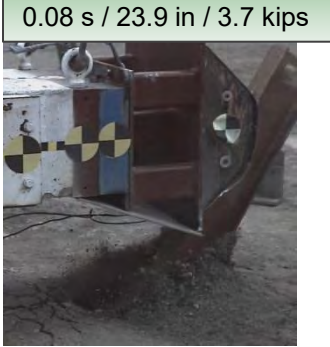
Project Case Number:	4A6_000b
FOIL Test Number:	14003F
Test Date:	23-May-2014

Dry Density (pcf):	145.6
Wet Density (pcf):	149.9
Moisture Content (%):	3.0
Compaction (%):	94.2

Peak Load (kips):	21.6
Avg. Tot. Energy (kip-in):	183.4

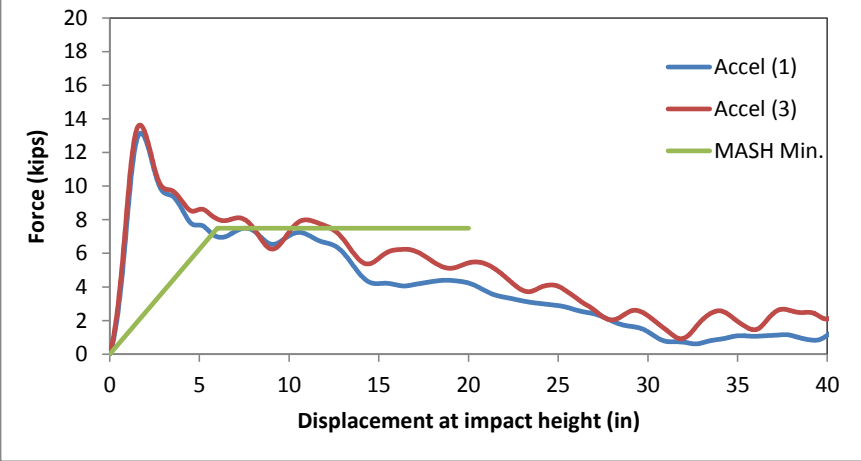
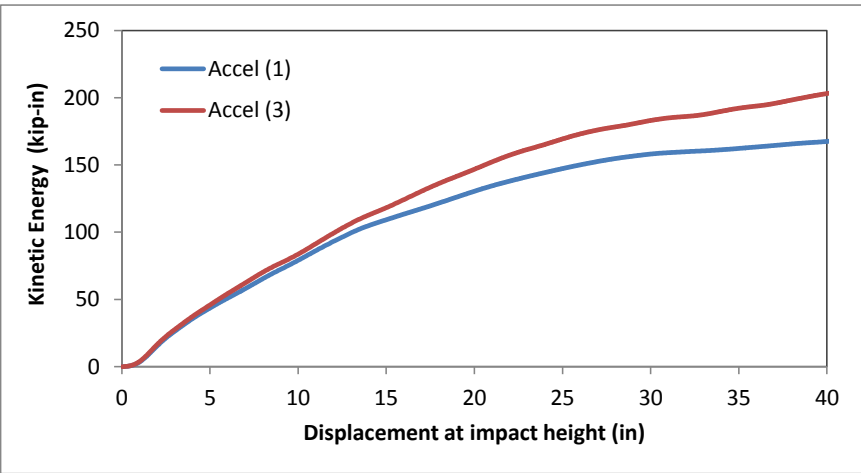
Dry Density (pcf):	143.9
Wet Density (pcf):	149.8
Moisture Content (%):	4.1
Compaction (%):	93.1

Peak Load (kips):	13.6
Avg. Tot. Energy (kip-in):	169.6

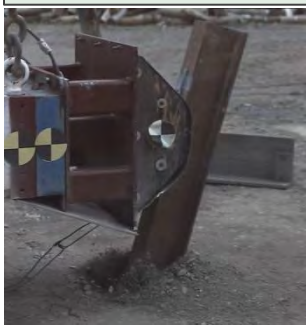
0.04 s / 12.9 in / 7.5 kips

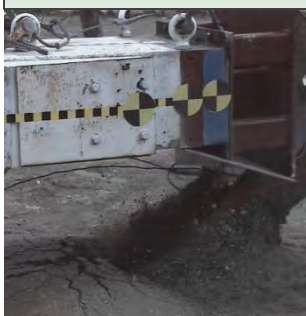
0.12 s / 33.6 in / 3.1 kips

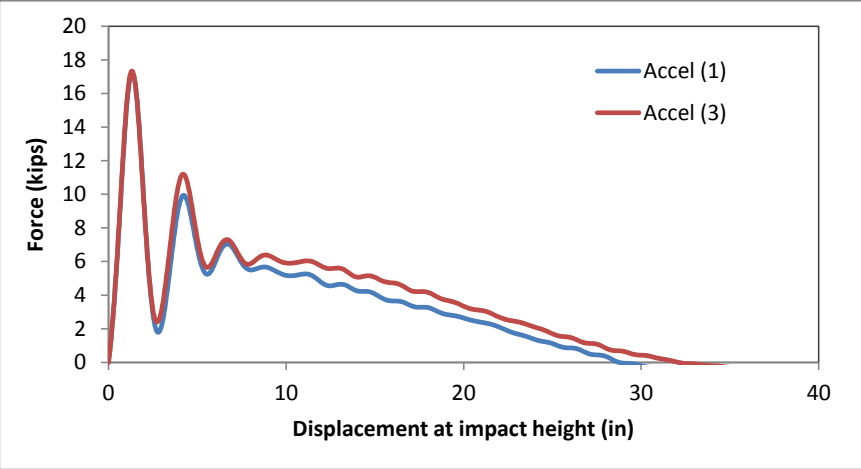
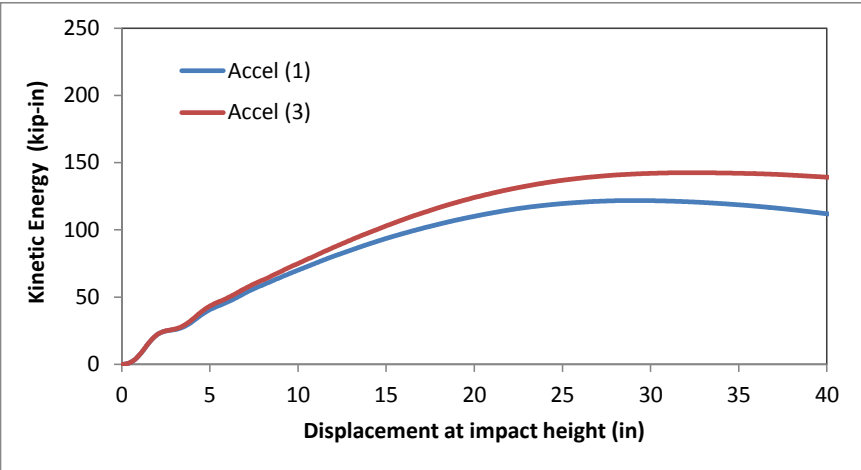
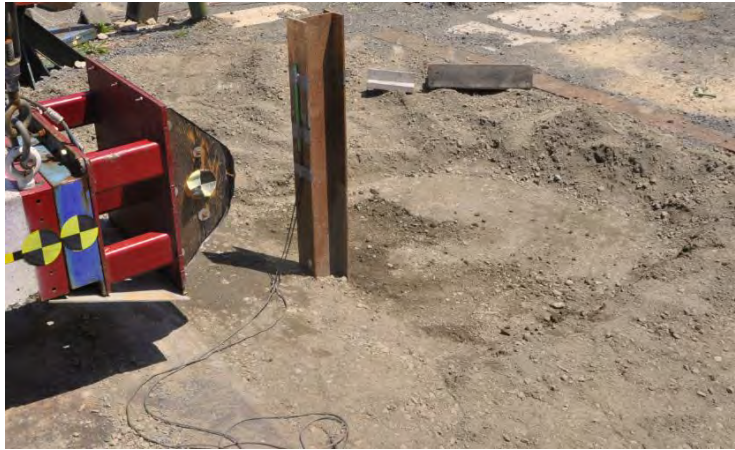
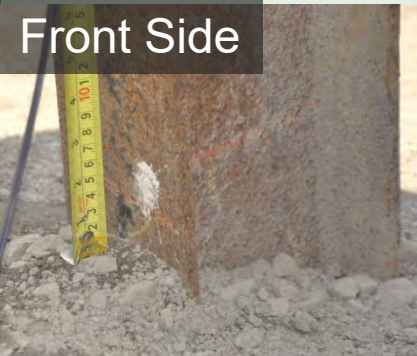
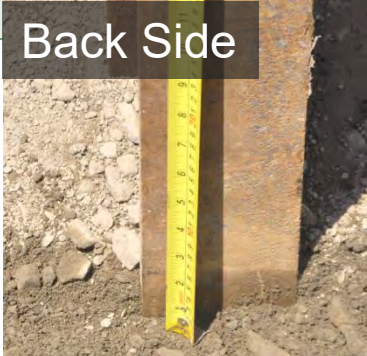
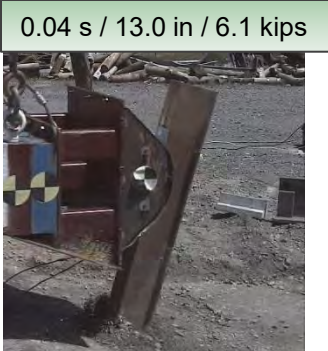
Project Case Number:	4A6_006
FOIL Test Number:	14003C
Test Date:	19-May-2014

Dry Density (pcf):	144.1
Wet Density (pcf):	150.1
Moisture Content (%):	4.2
Compaction (%):	93.3

Peak Load (kips):	17.3
Avg. Tot. Energy (kip-in):	132.0

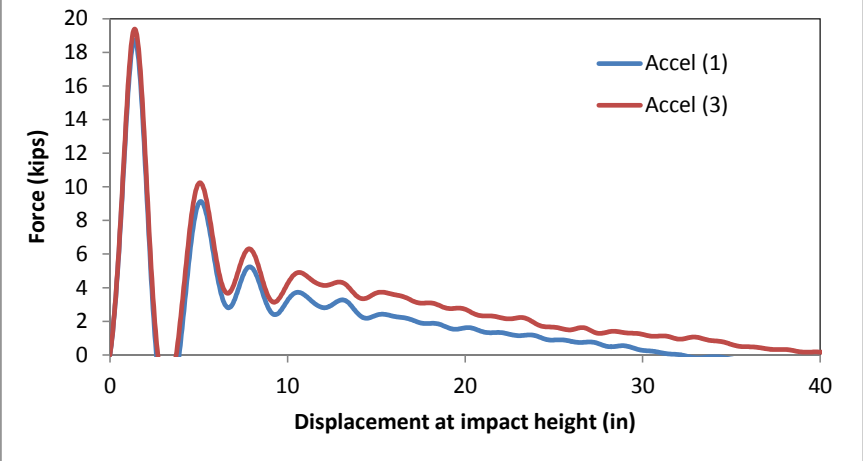
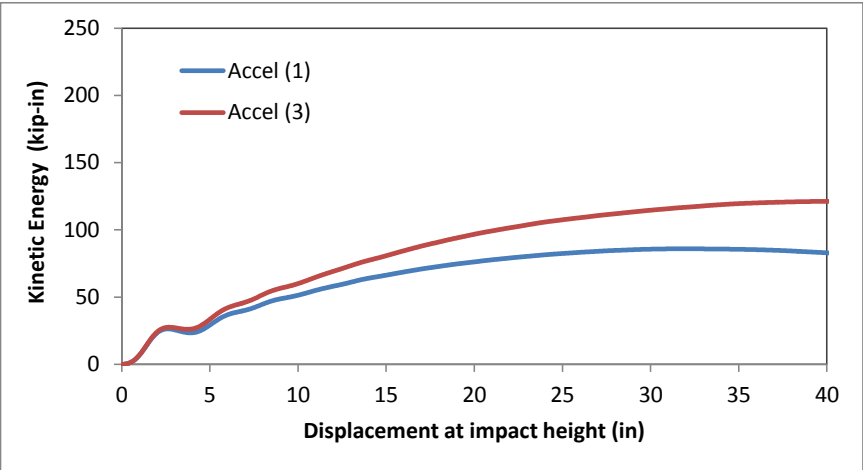
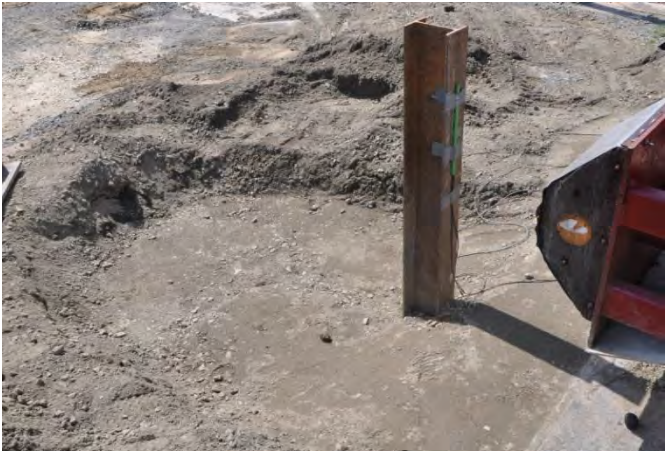
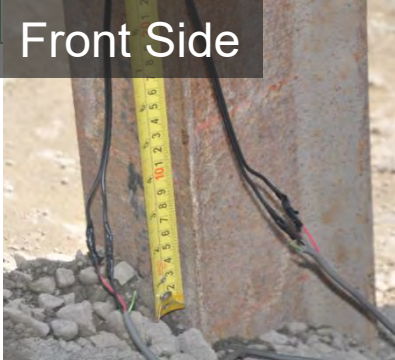
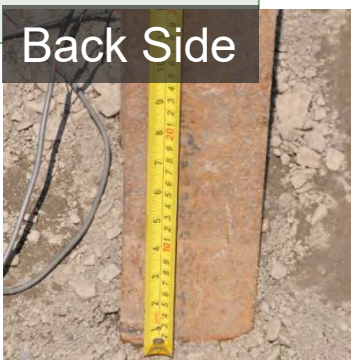
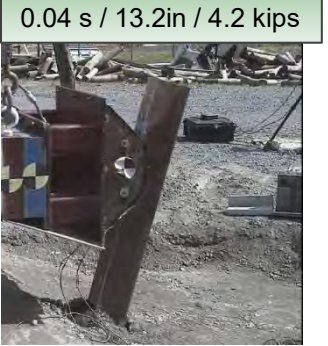
Project Case Number:	4A6_009
FOIL Test Number:	14003D
Test Date:	20-May-2014

Dry Density (pcf):	143.6
Wet Density (pcf):	148.9
Moisture Content (%):	3.8
Compaction (%):	92.9

Peak Load (kips):	19.4
Avg. Tot. Energy (kip-in):	101.0

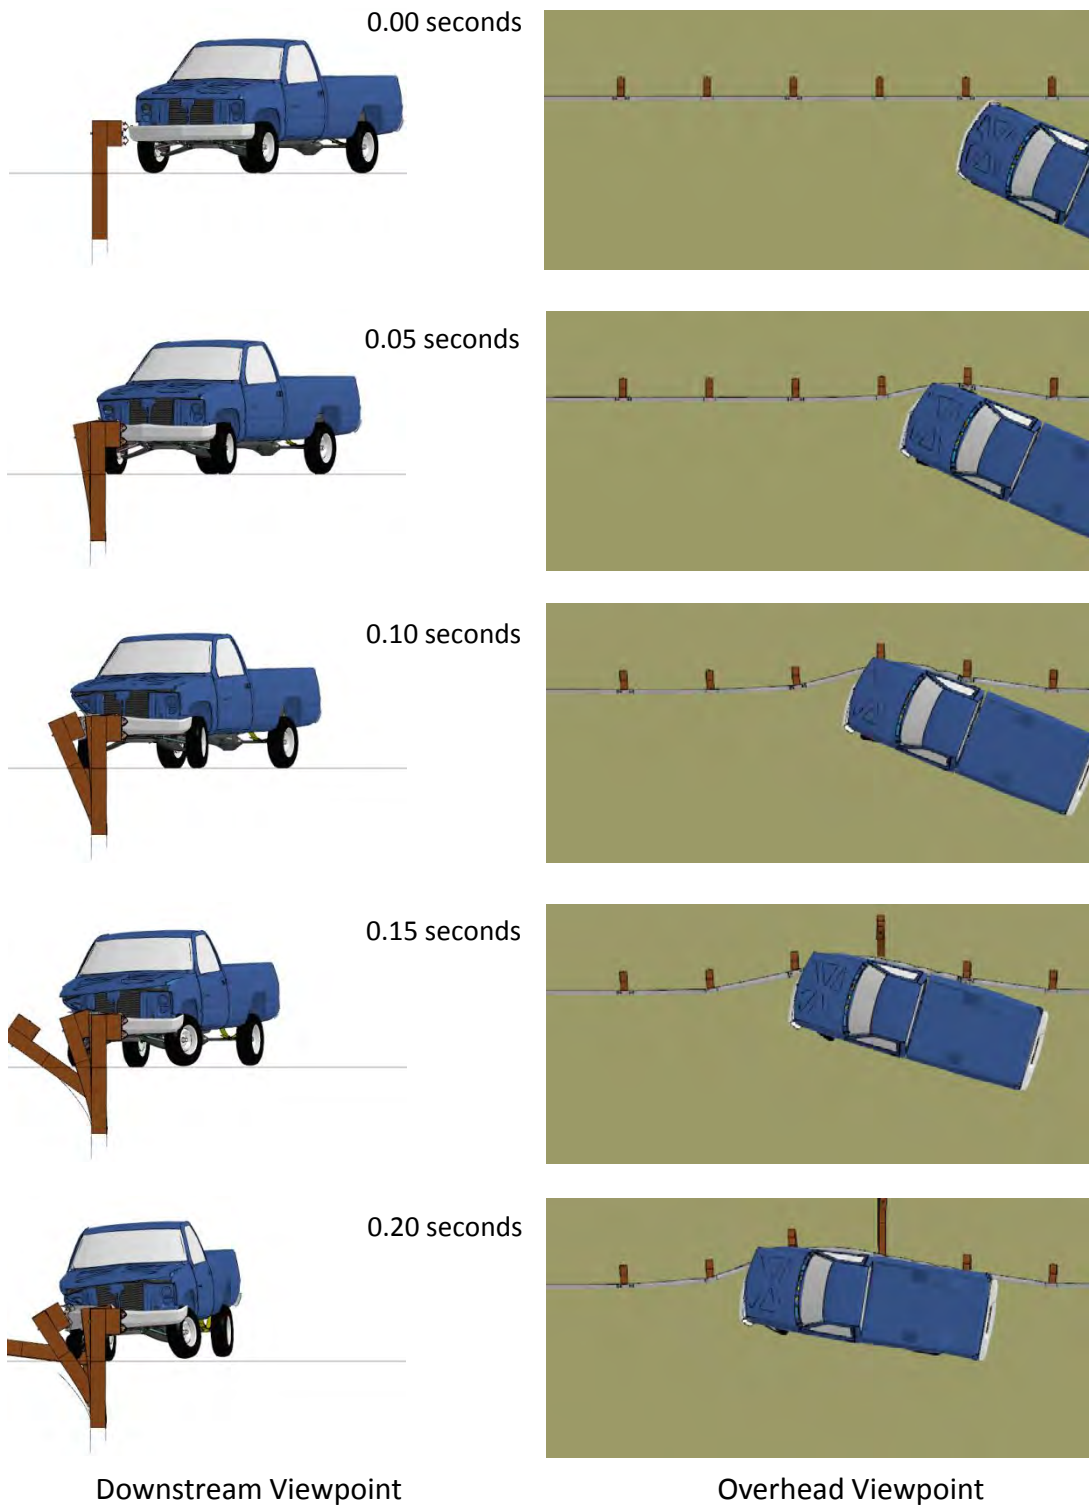
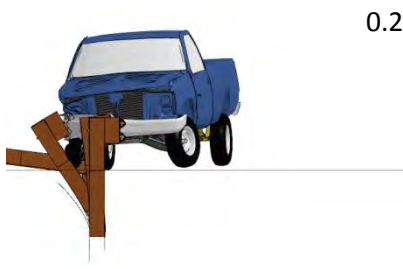
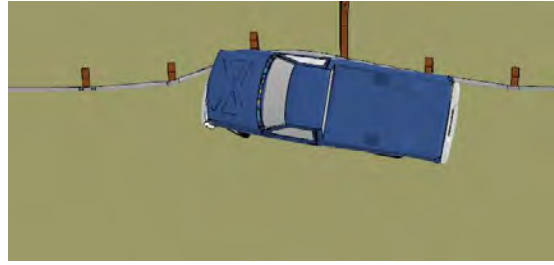
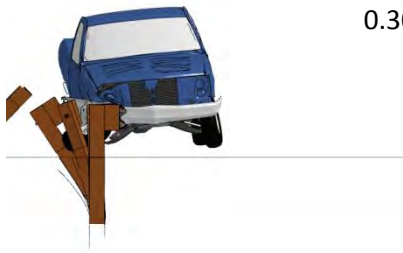
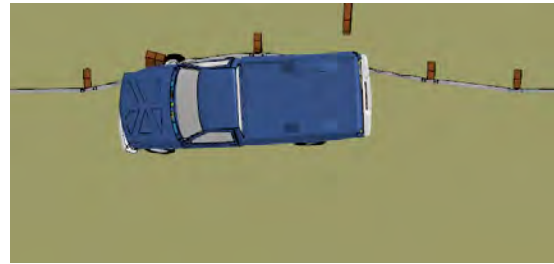
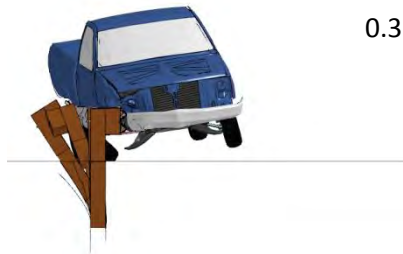
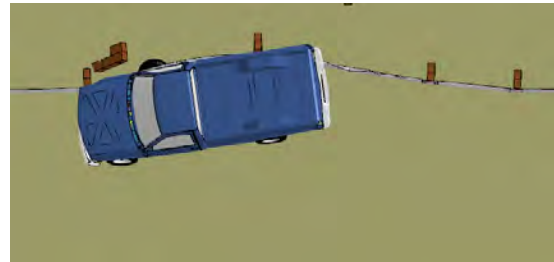
**Figure M-1: Sequential views from a downstream and overhead viewpoint for 6-inch erosion at a single post analysis case.**

**Figure M-1: [CONTINUED] Sequential views from a downstream and overhead viewpoint for 6-inch erosion a single post analysis case.**

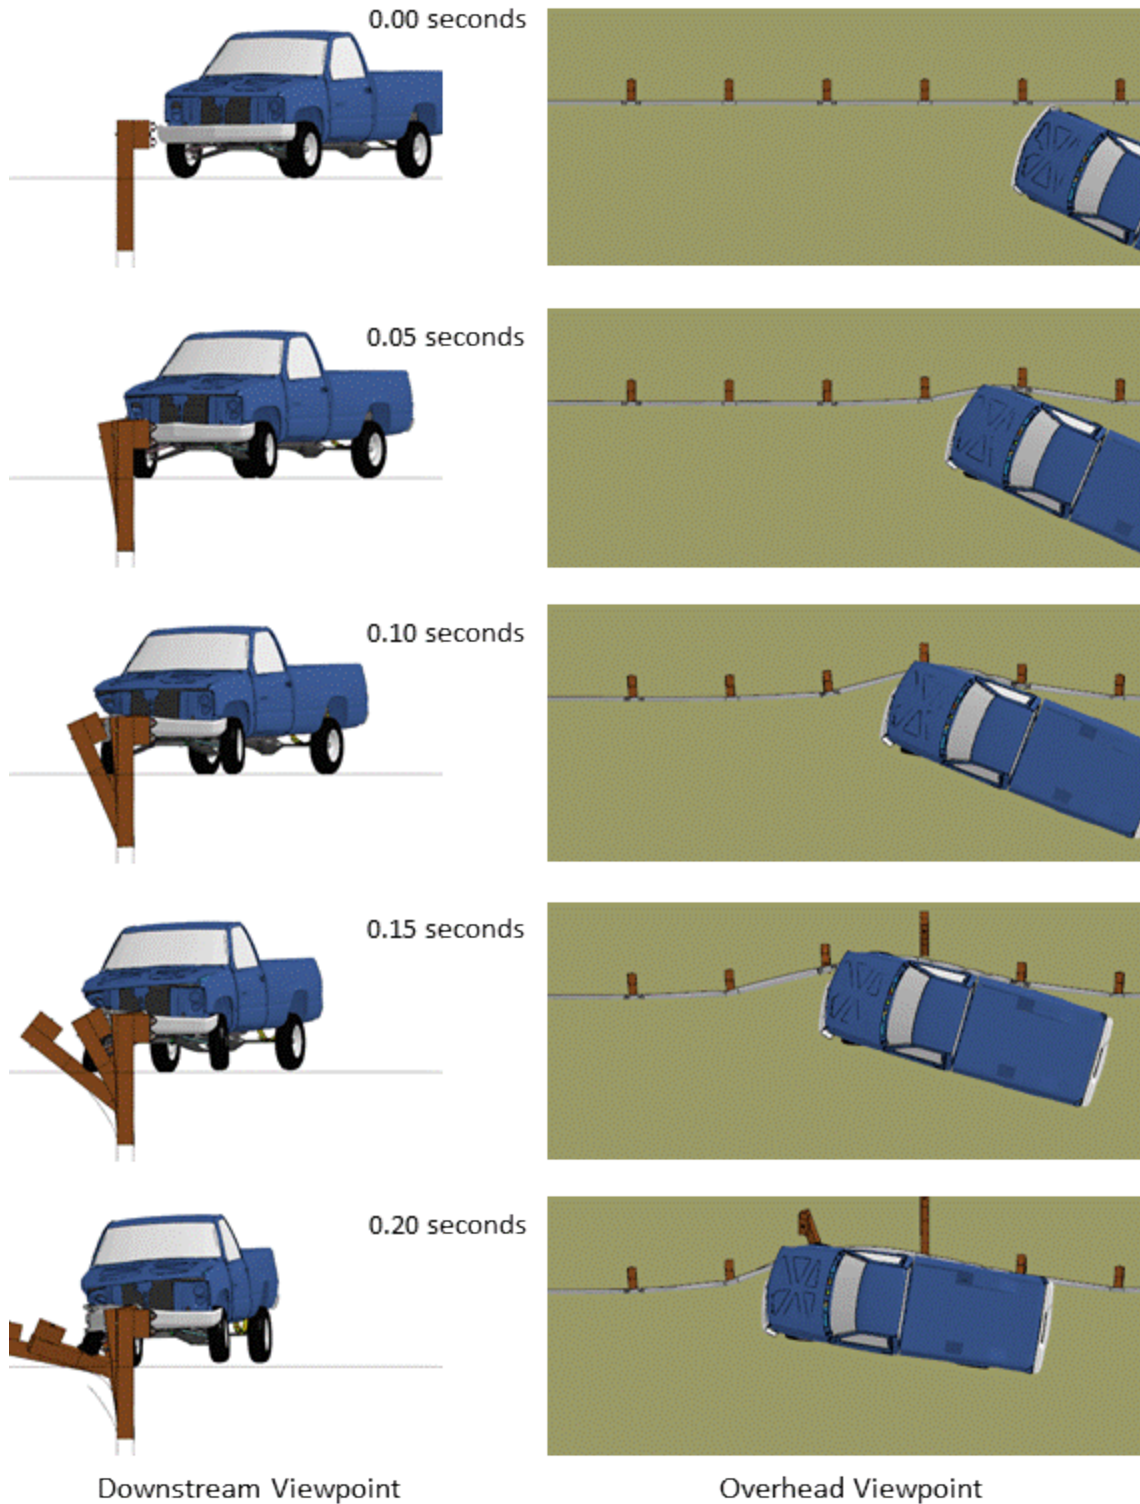
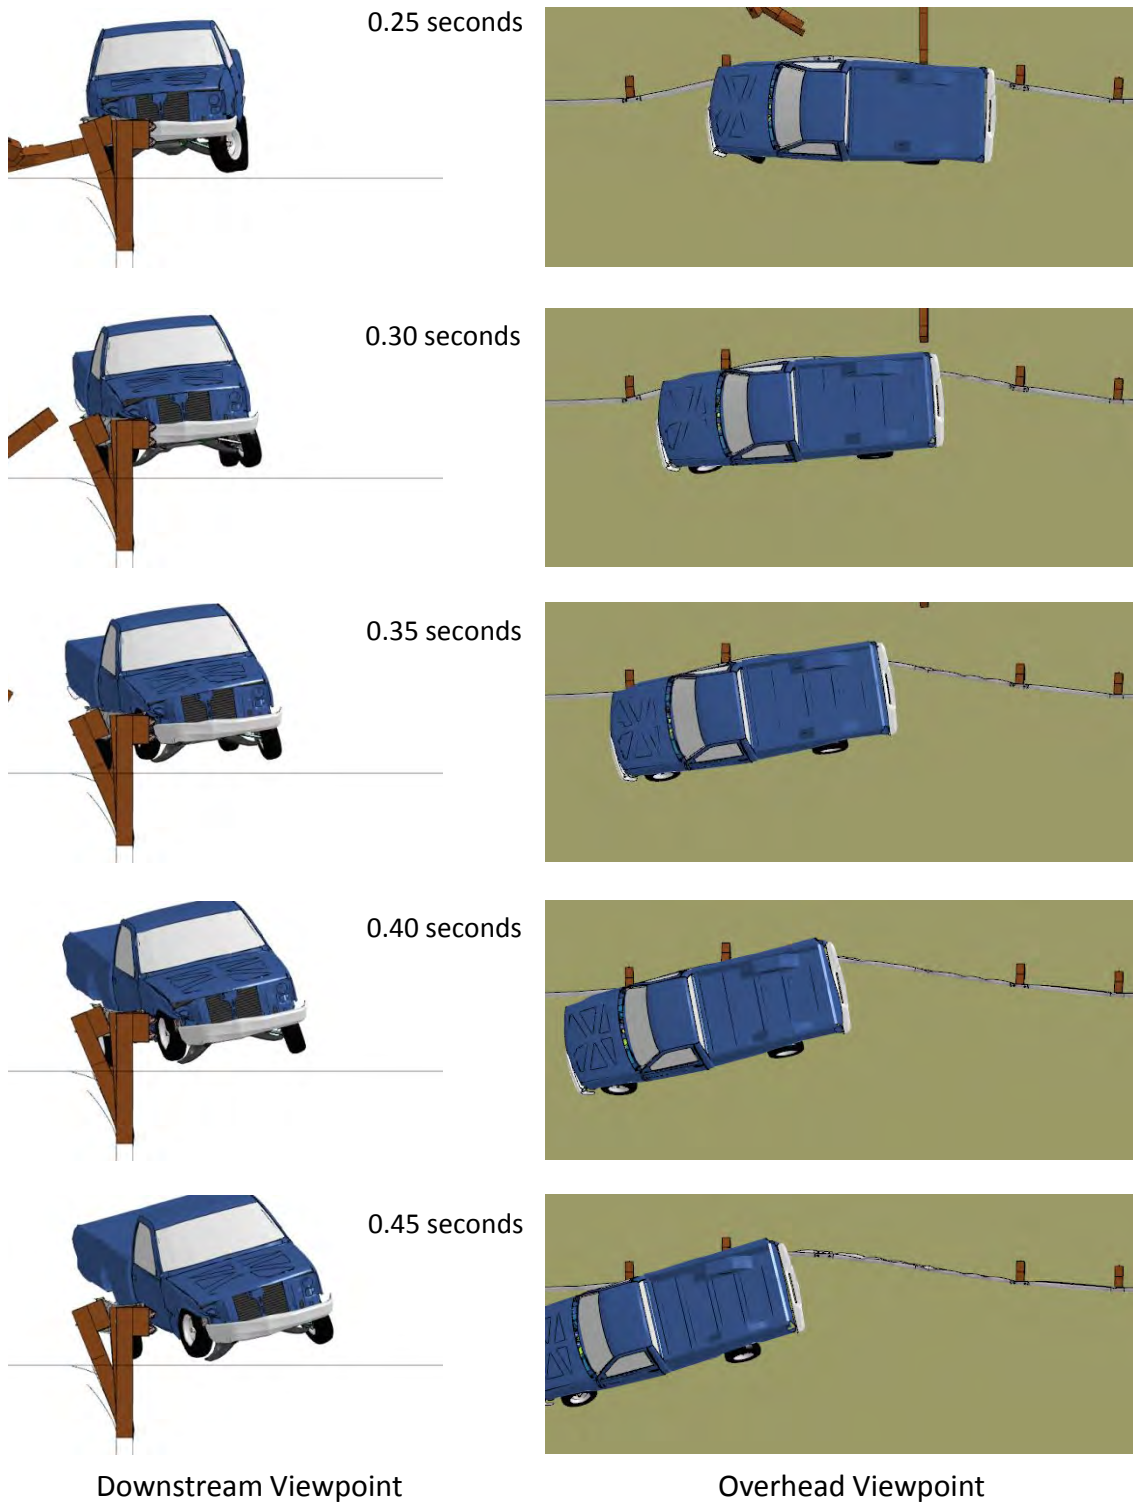
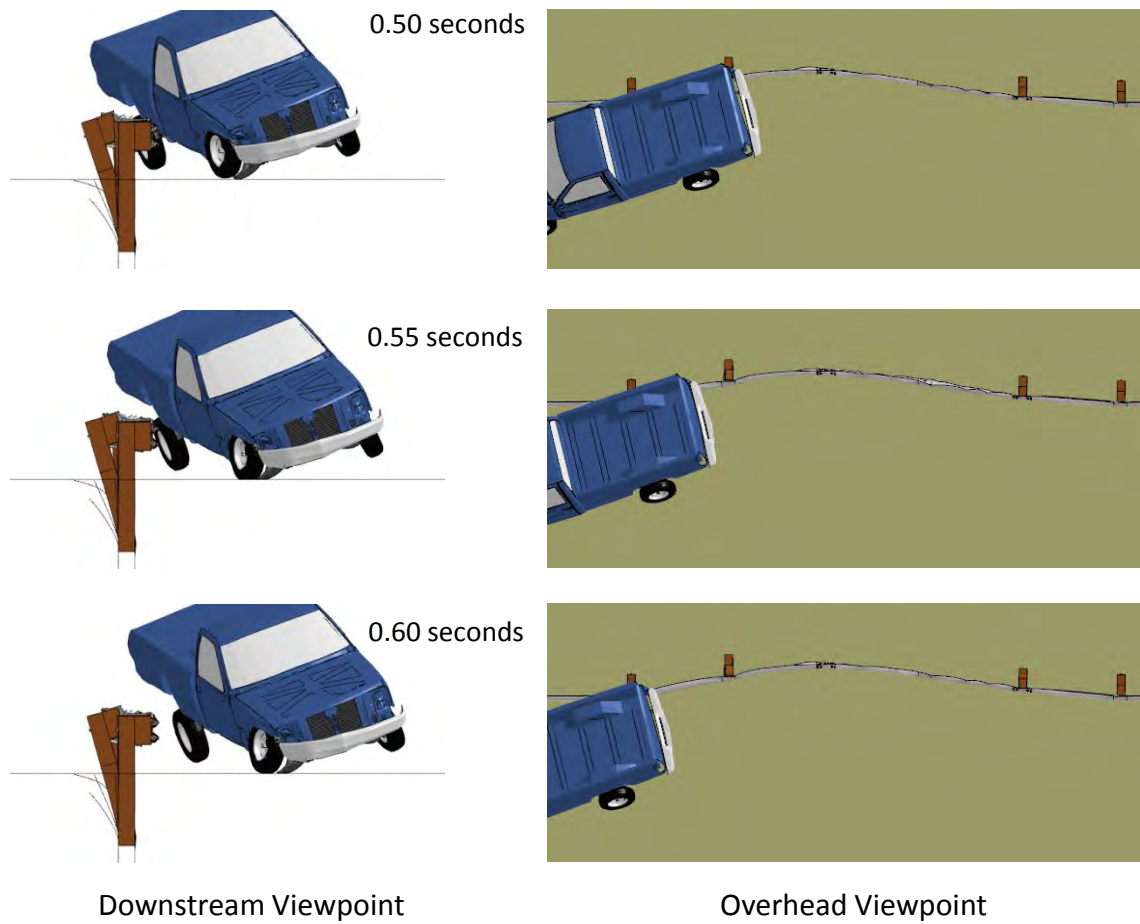
**Figure M-3: Sequential views from a downstream and overhead viewpoint for 9-inch erosion at a single post analysis case.**

**Figure M-3. [CONTINUED]** Sequential views from a downstream and overhead viewpoint for 9-inch erosion a single post analysis case.

**Figure M-3.** [CONTINUED] Sequential views from a downstream and overhead viewpoint for 9-inch erosion at a single post analysis case.

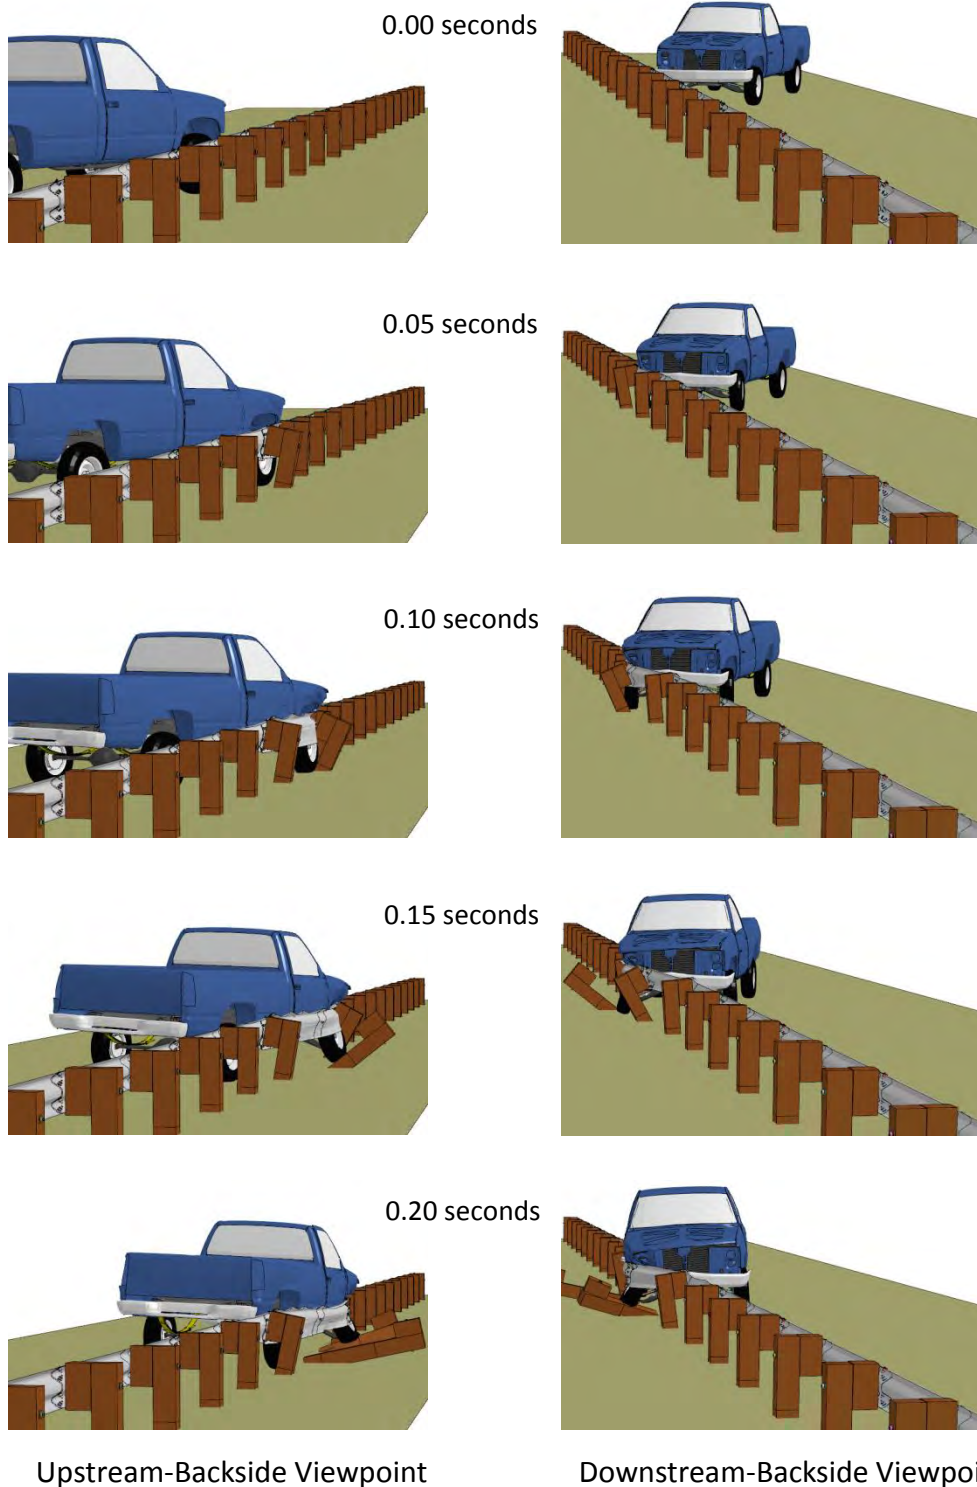
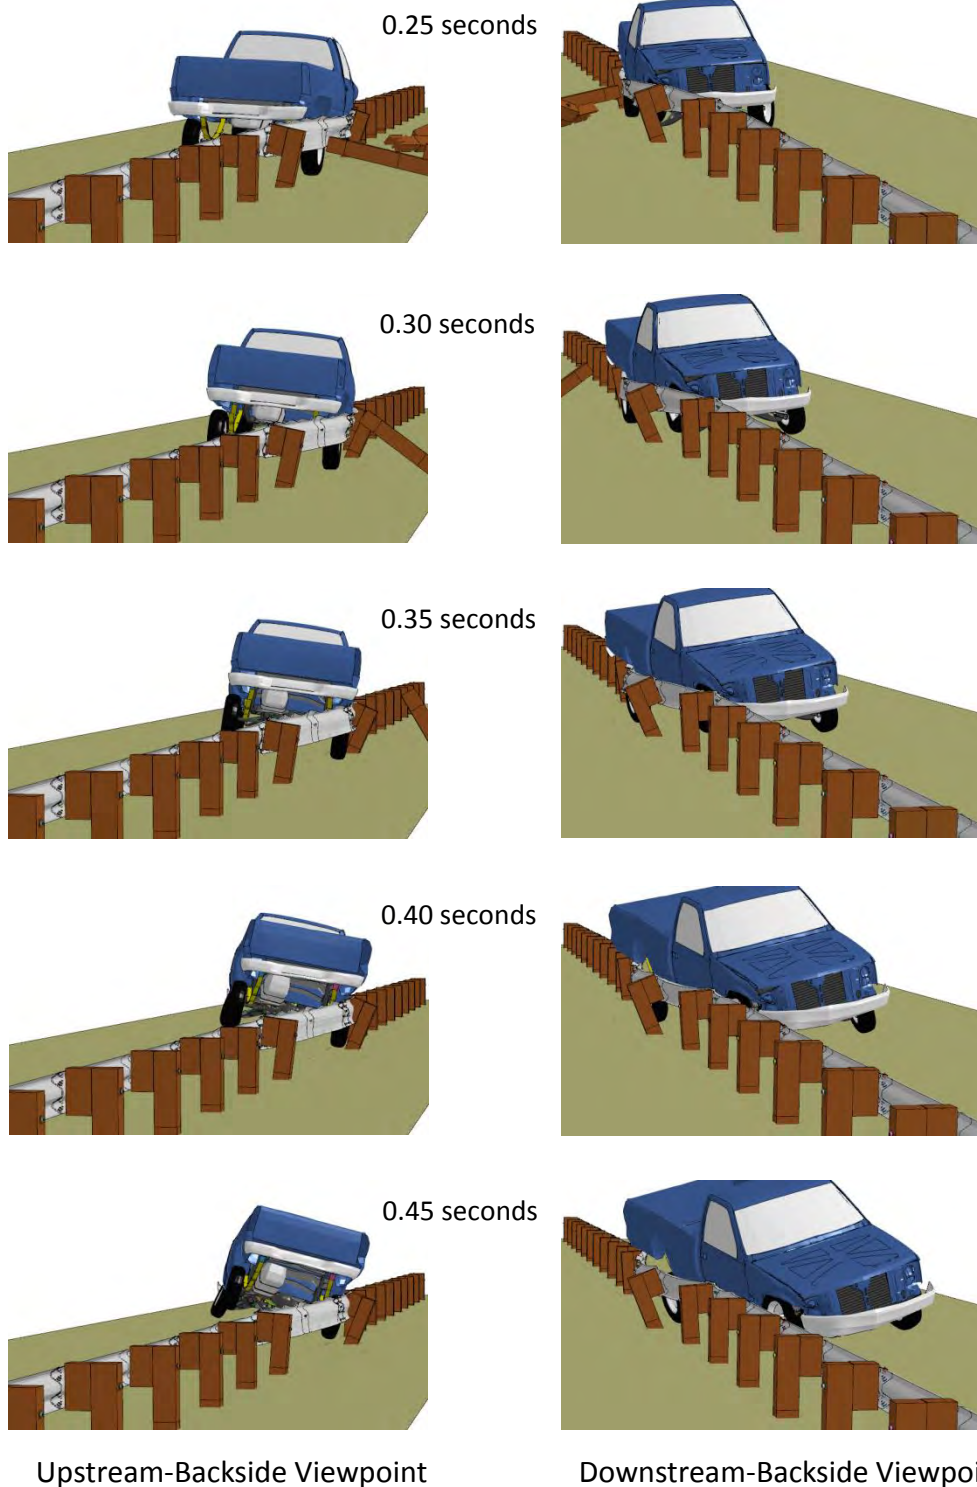
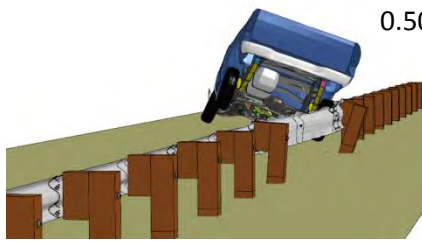
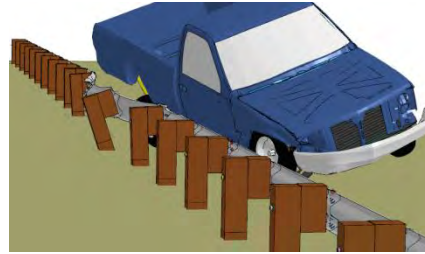
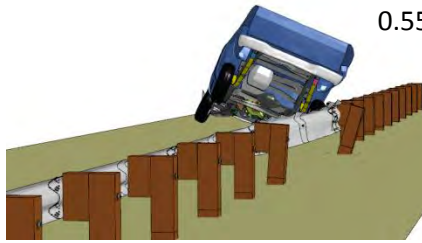
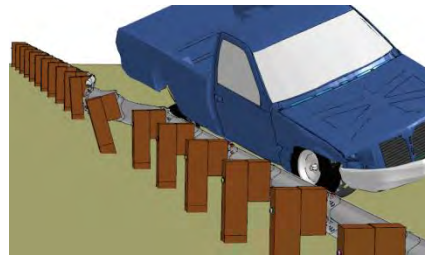
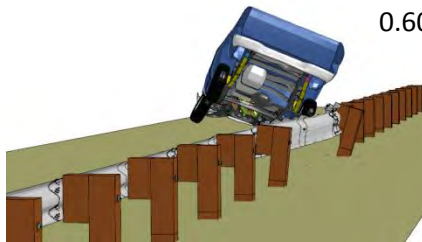
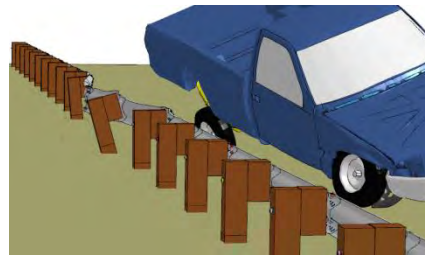
**Figure M-4: Sequential views from an upstream-backside and a downstream-backside viewpoint for 9-inch erosion at a single post analysis case.**

**Figure M-4: [CONTINUED] Sequential views from an upstream-backside and a downstream-backside viewpoint for 9-inch erosion at a single post analysis case.**

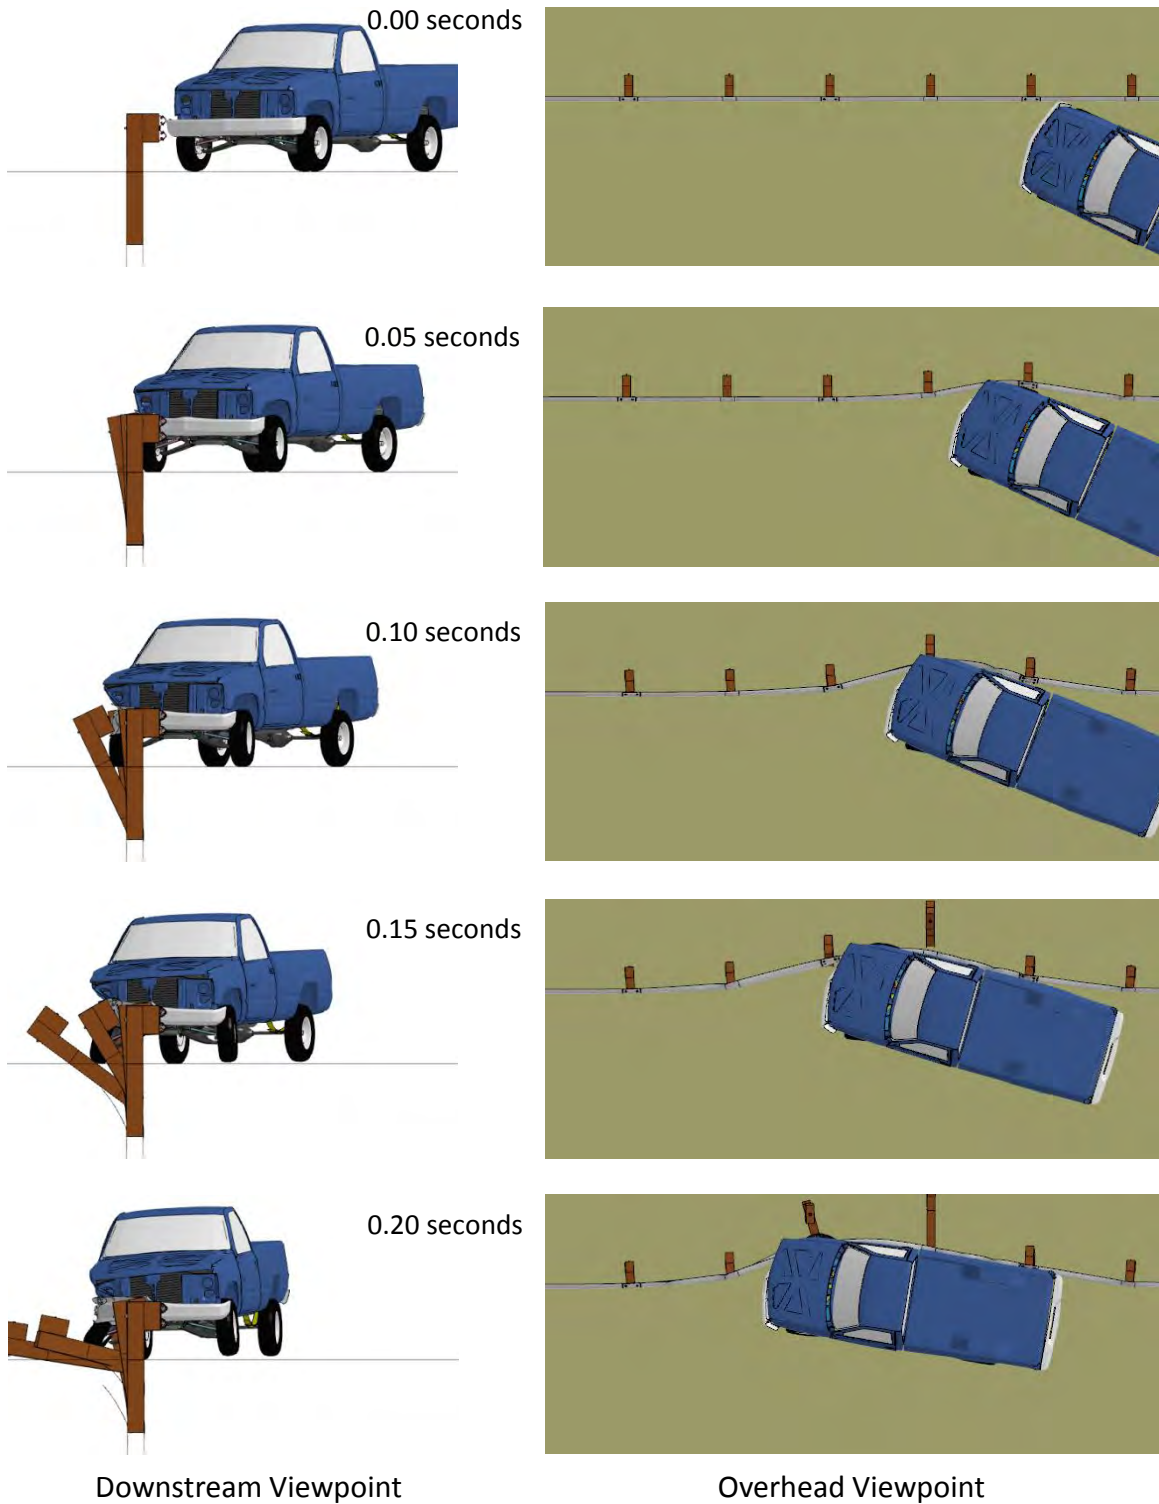
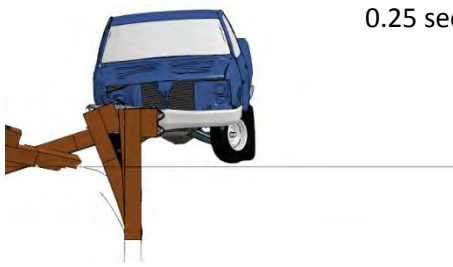
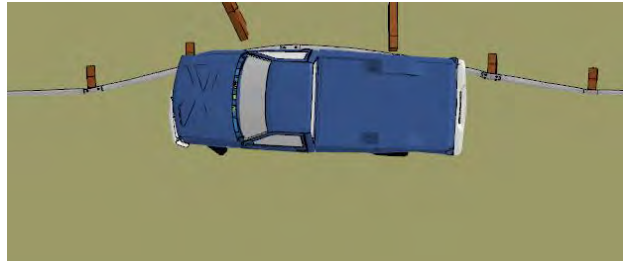
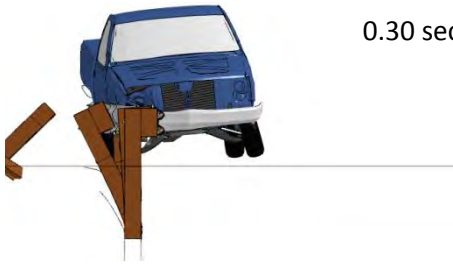
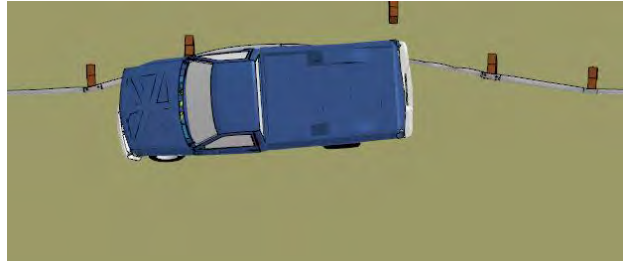
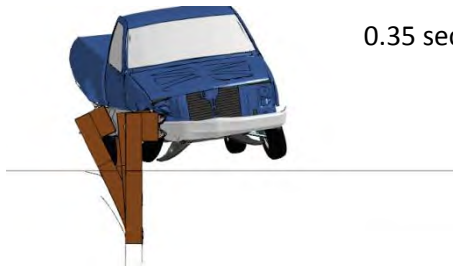
**Figure M-5: Sequential views from a downstream and overhead viewpoint for 12-inch erosion at a single post analysis case.**

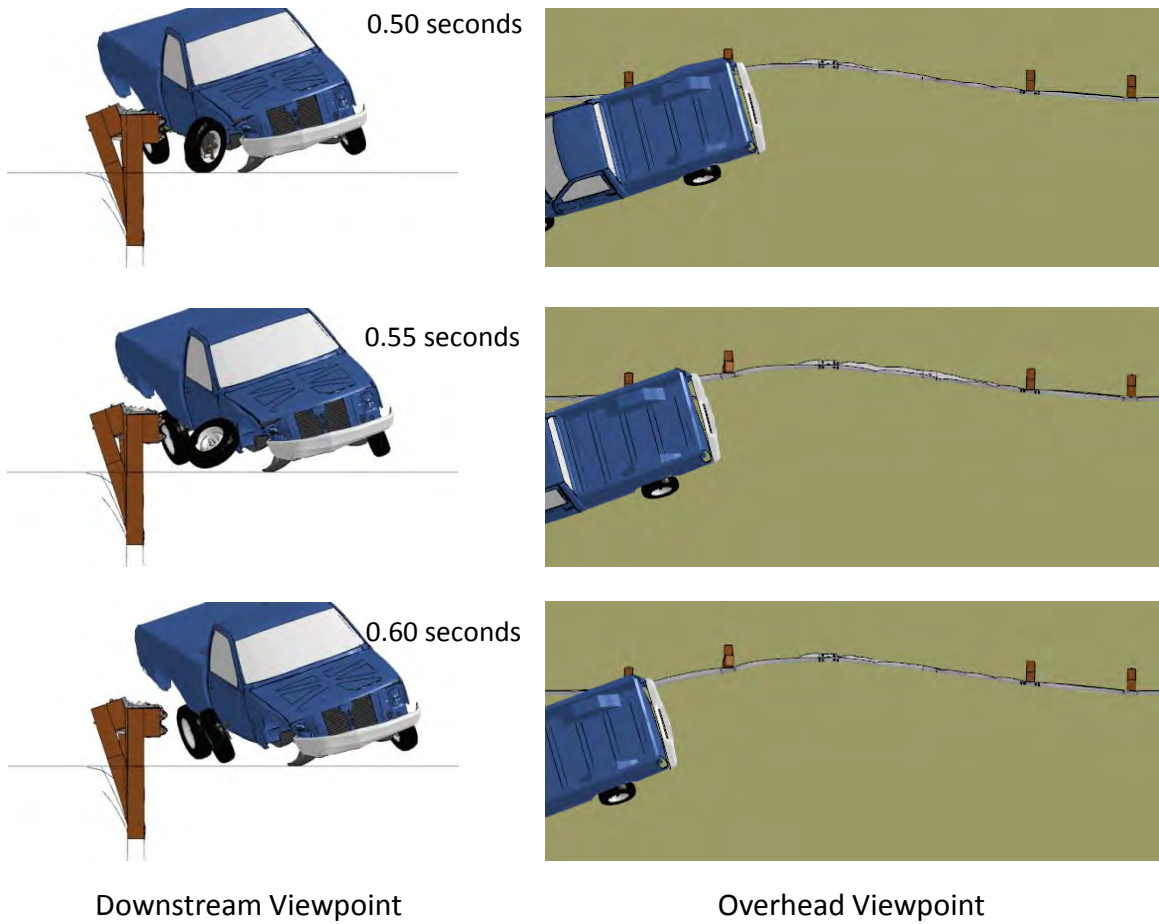
**Figure M-5: [CONTINUED] Sequential views from a downstream and overhead viewpoint for 12-inch erosion at a single post analysis case.**

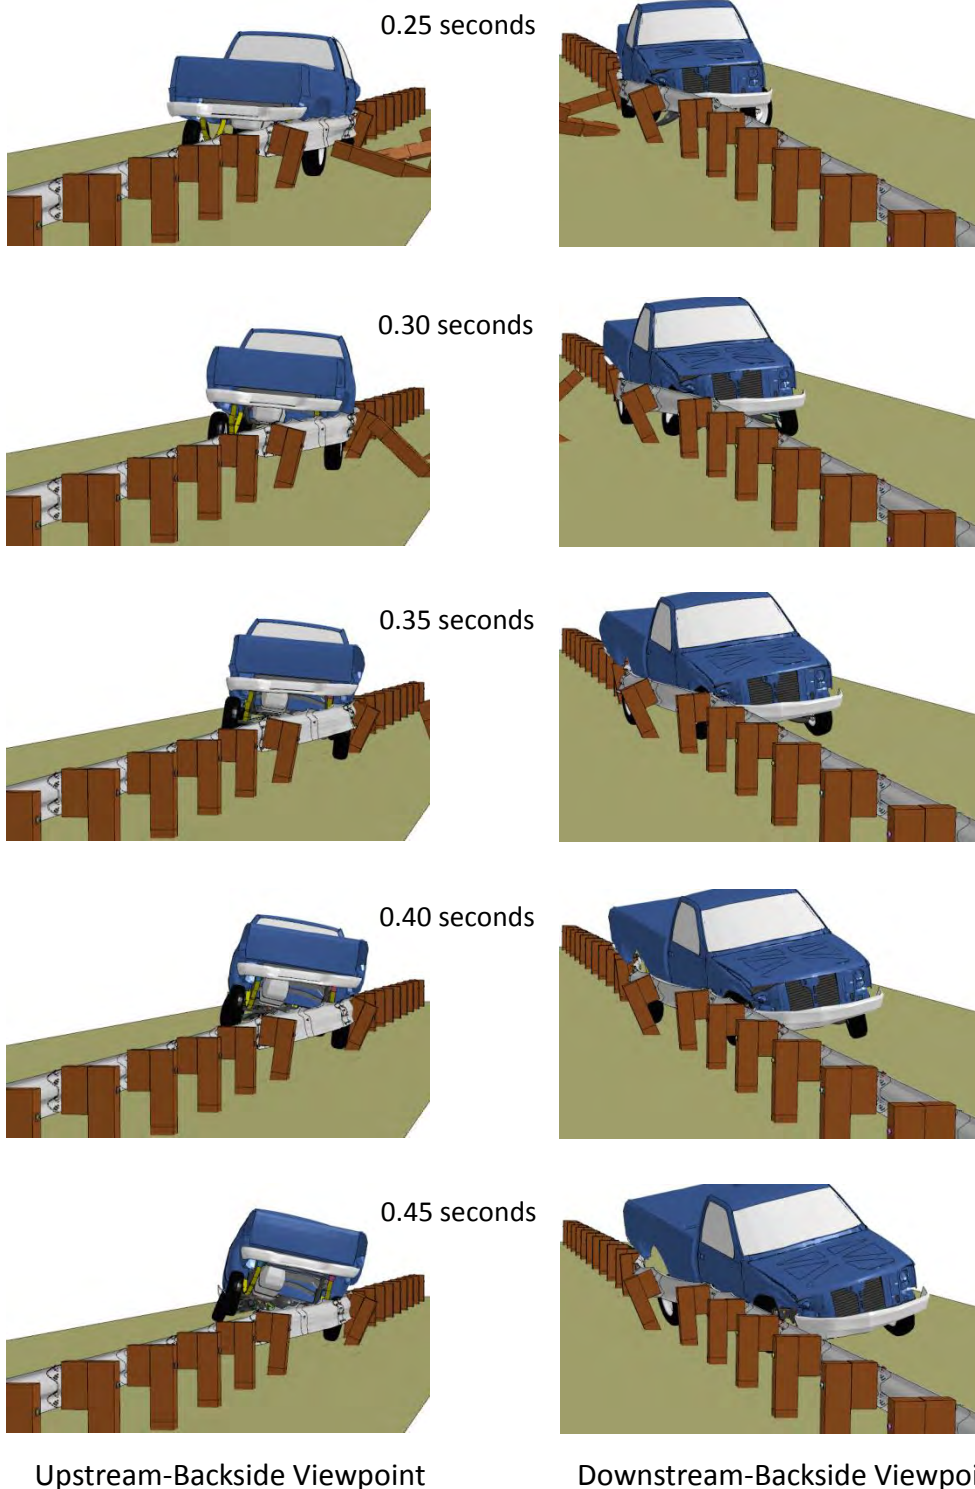
**Figure M-6: Sequential views from an upstream-backside and a downstream-backside viewpoint for 12-inch erosion at a single post analysis case.**

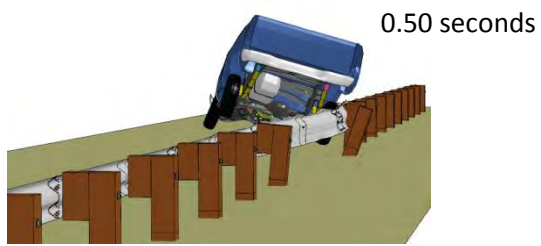
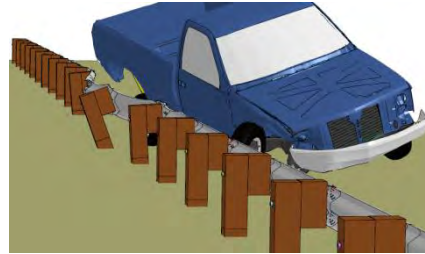
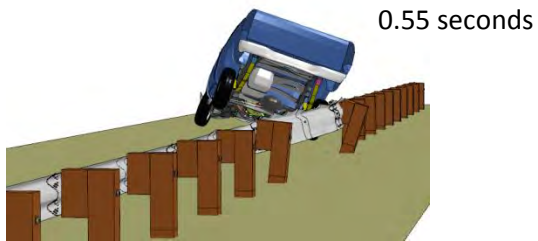
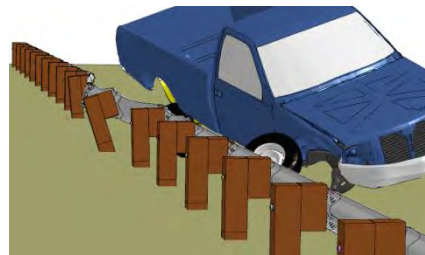
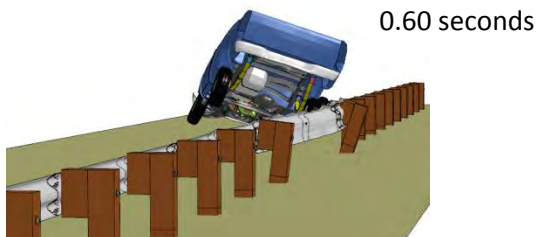
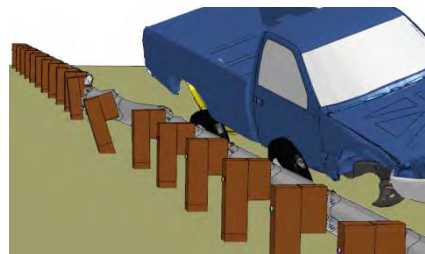
**Figure M-6: [CONTINUED] Sequential views from an upstream-backside and a downstream-backside viewpoint for 12-inch erosion at a single post analysis case.**

Upstream-Backside Viewpoint

Downstream-Backside Viewpoint
