# **A Guide for W-Beam Guardrail Damage Assessment**

A Field Manual for  
Highway Maintenance Personnel

National Cooperative  
Highway Research  
Program  
Project 22-28

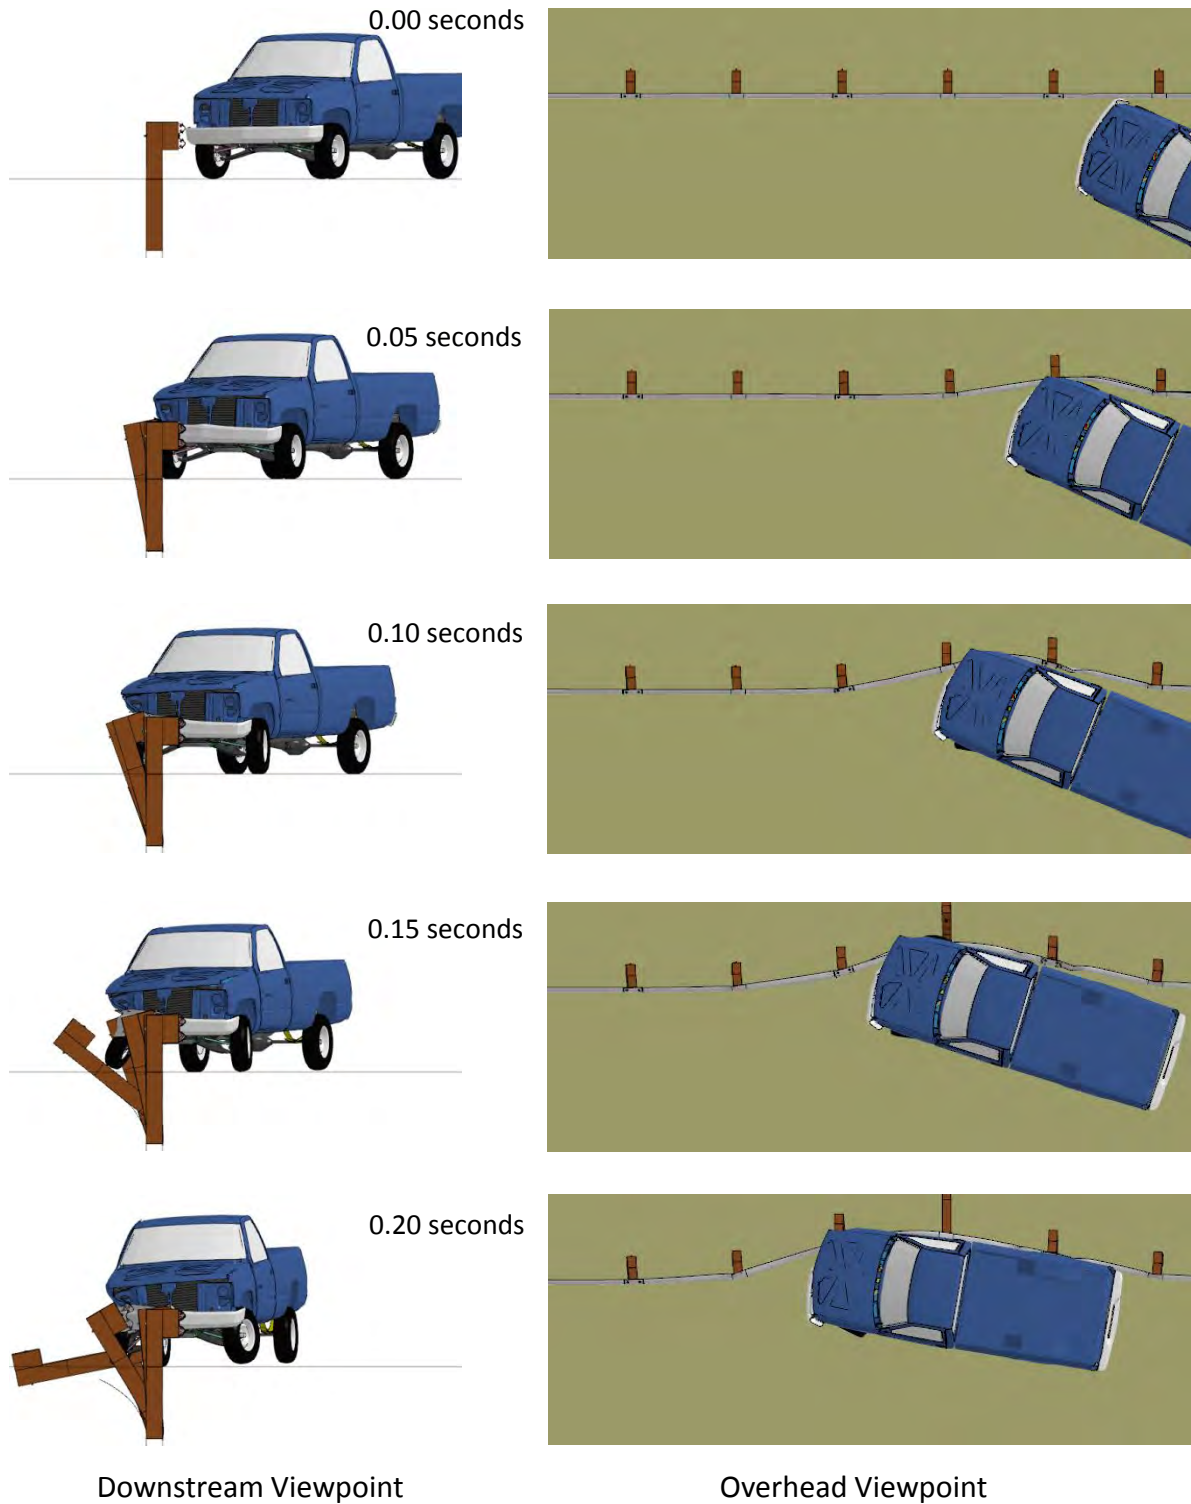
**Figure N-1: Sequential views from a downstream and overhead viewpoint for 6-inch erosion at two posts analysis case.**

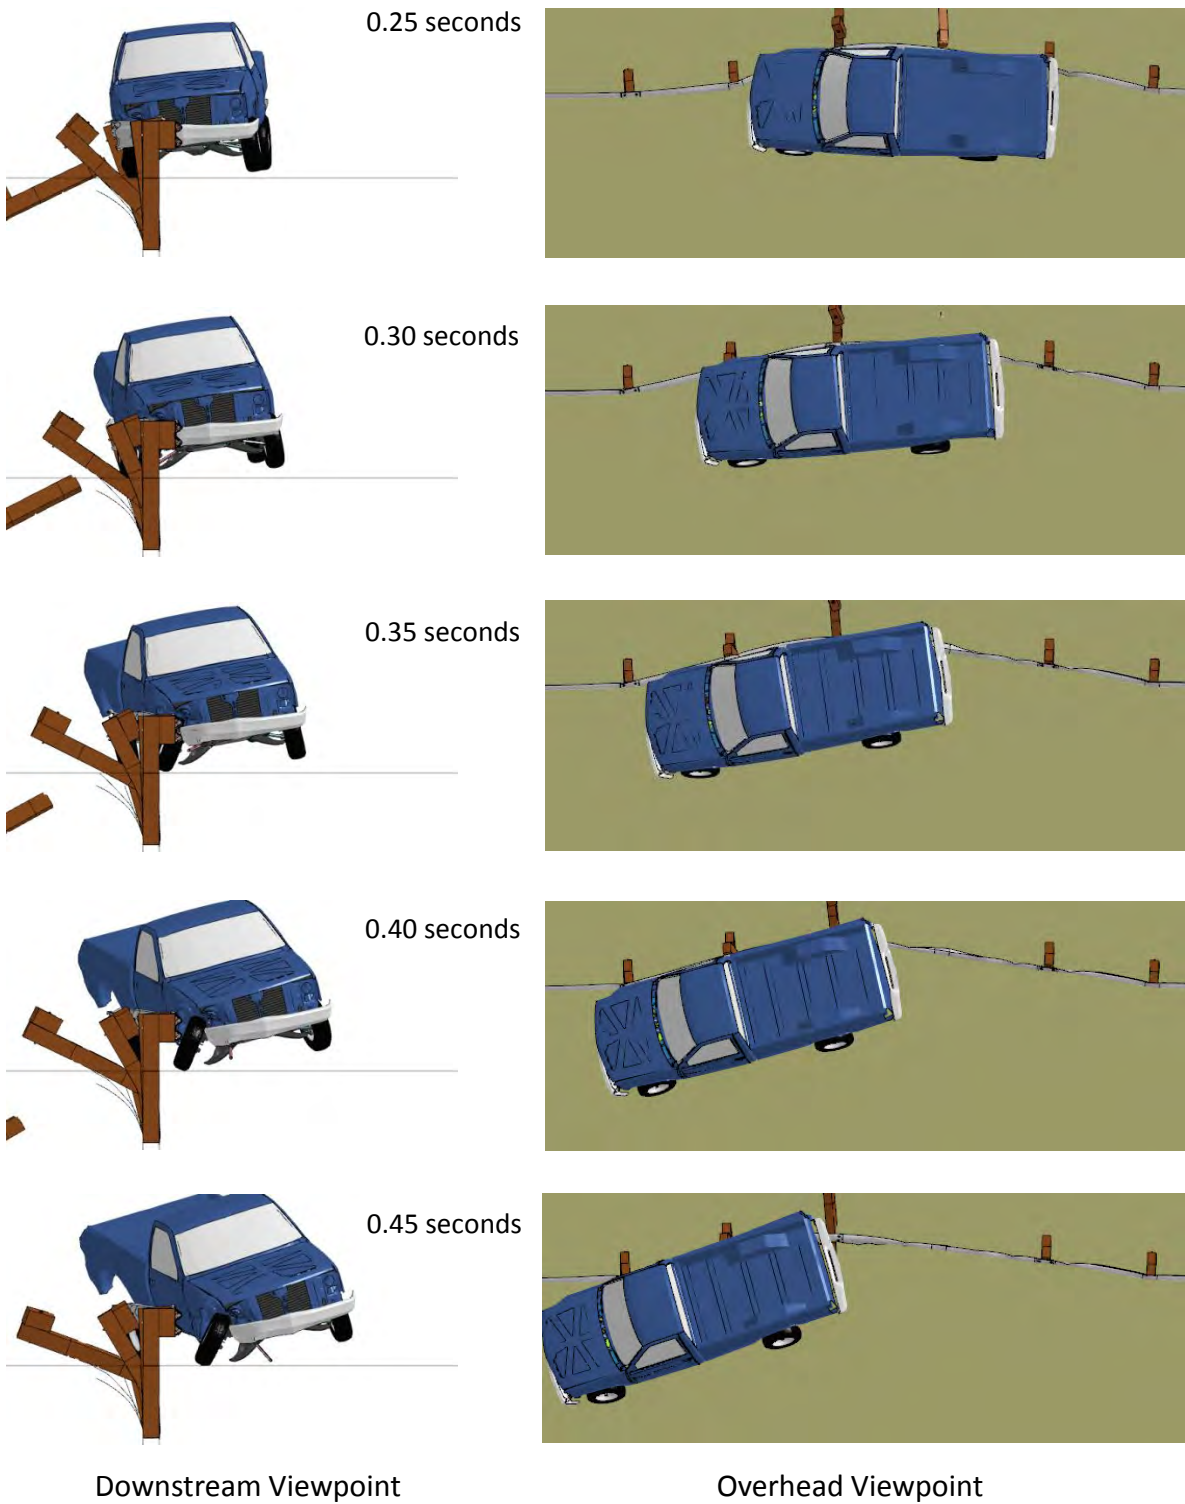
**Figure N-1: [CONTINUED] Sequential views from a downstream and overhead viewpoint for 6-inch erosion at two posts analysis case.**

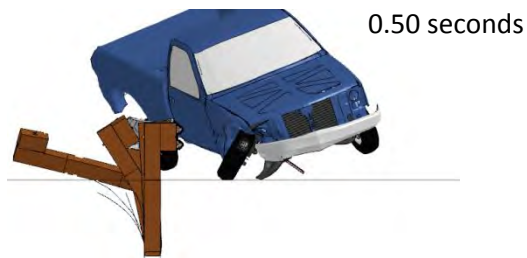
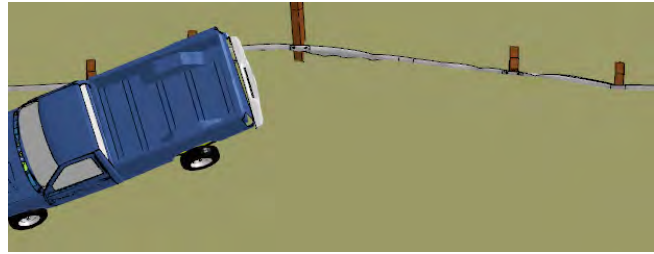
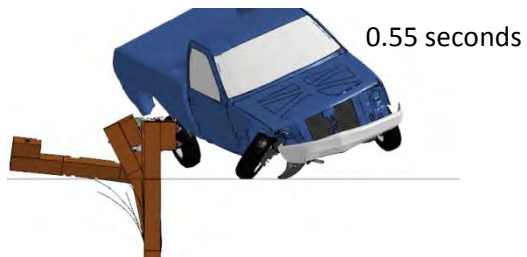
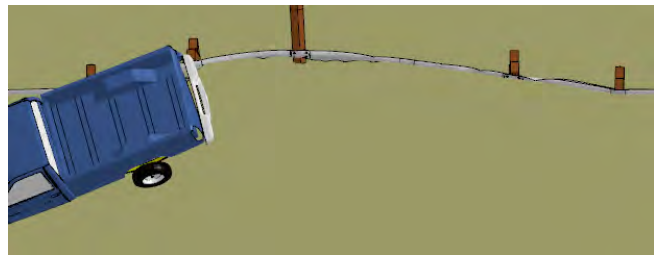
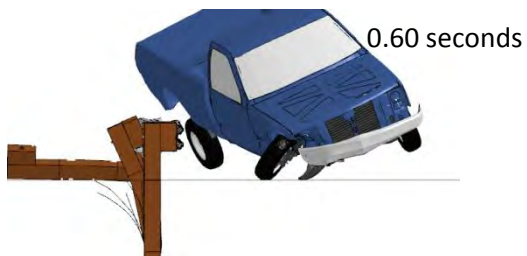
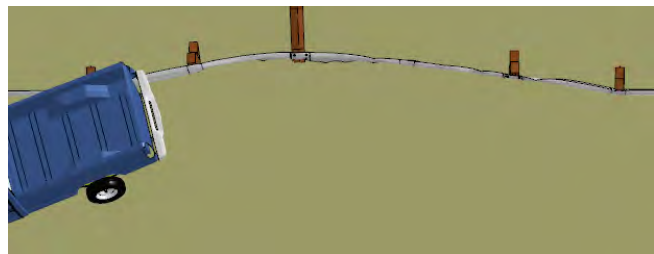
Downstream Viewpoint

Overhead Viewpoint

**Figure N-1: [CONTINUED] Sequential views from a downstream and overhead viewpoint for 6-inch erosion at two posts analysis case.**

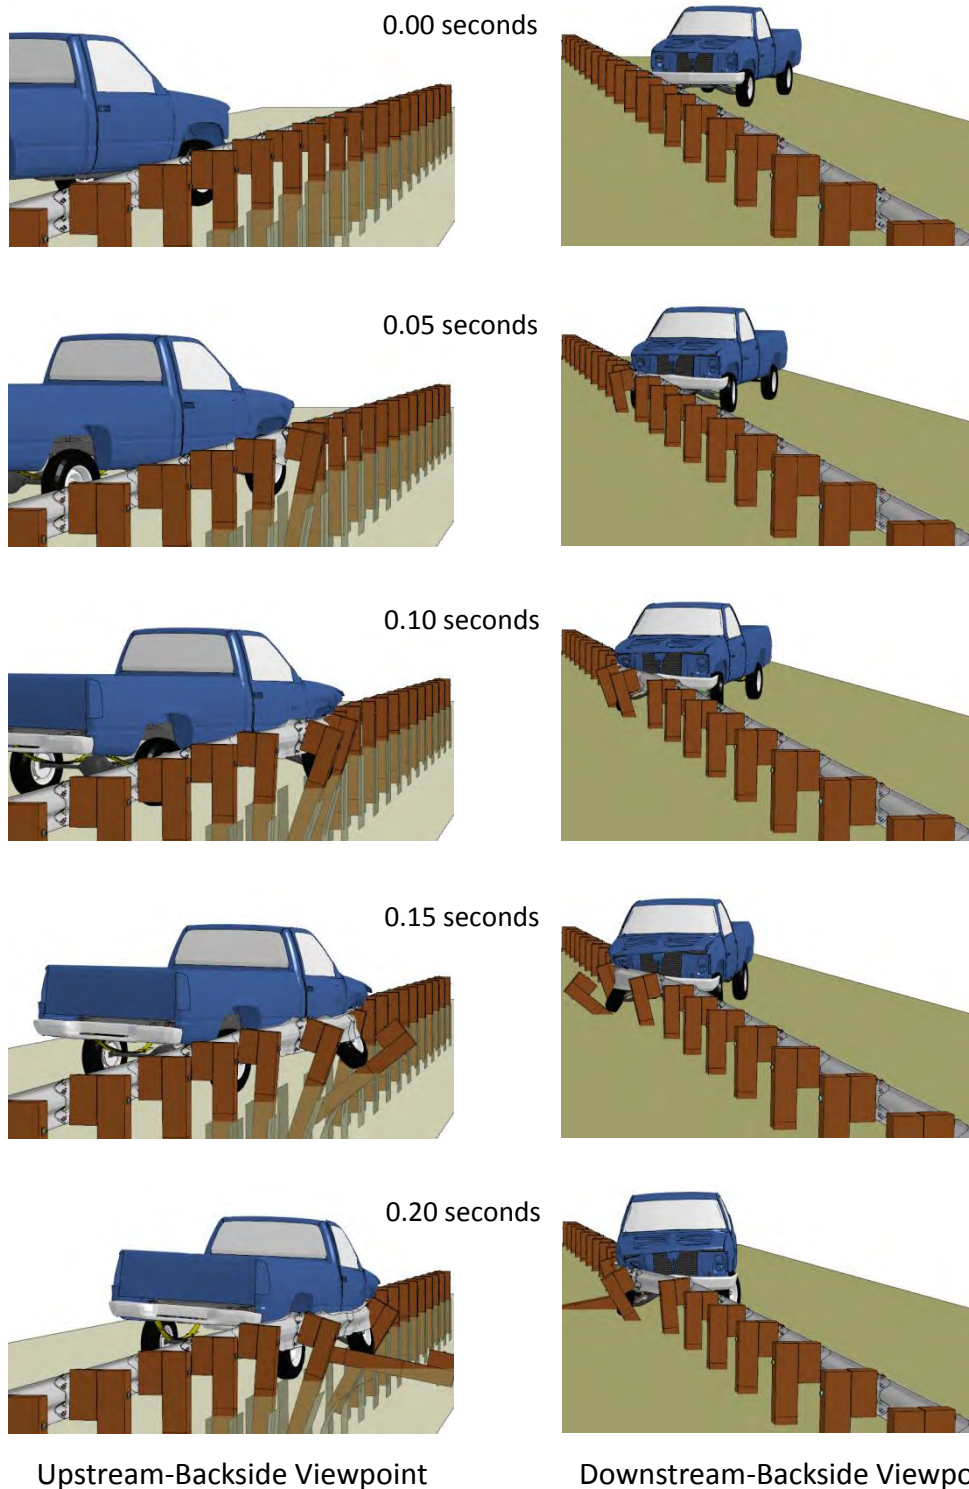
**Figure N-2: Sequential views from an upstream-backside and a downstream-backside viewpoint for 6-inch erosion at two posts analysis case.**

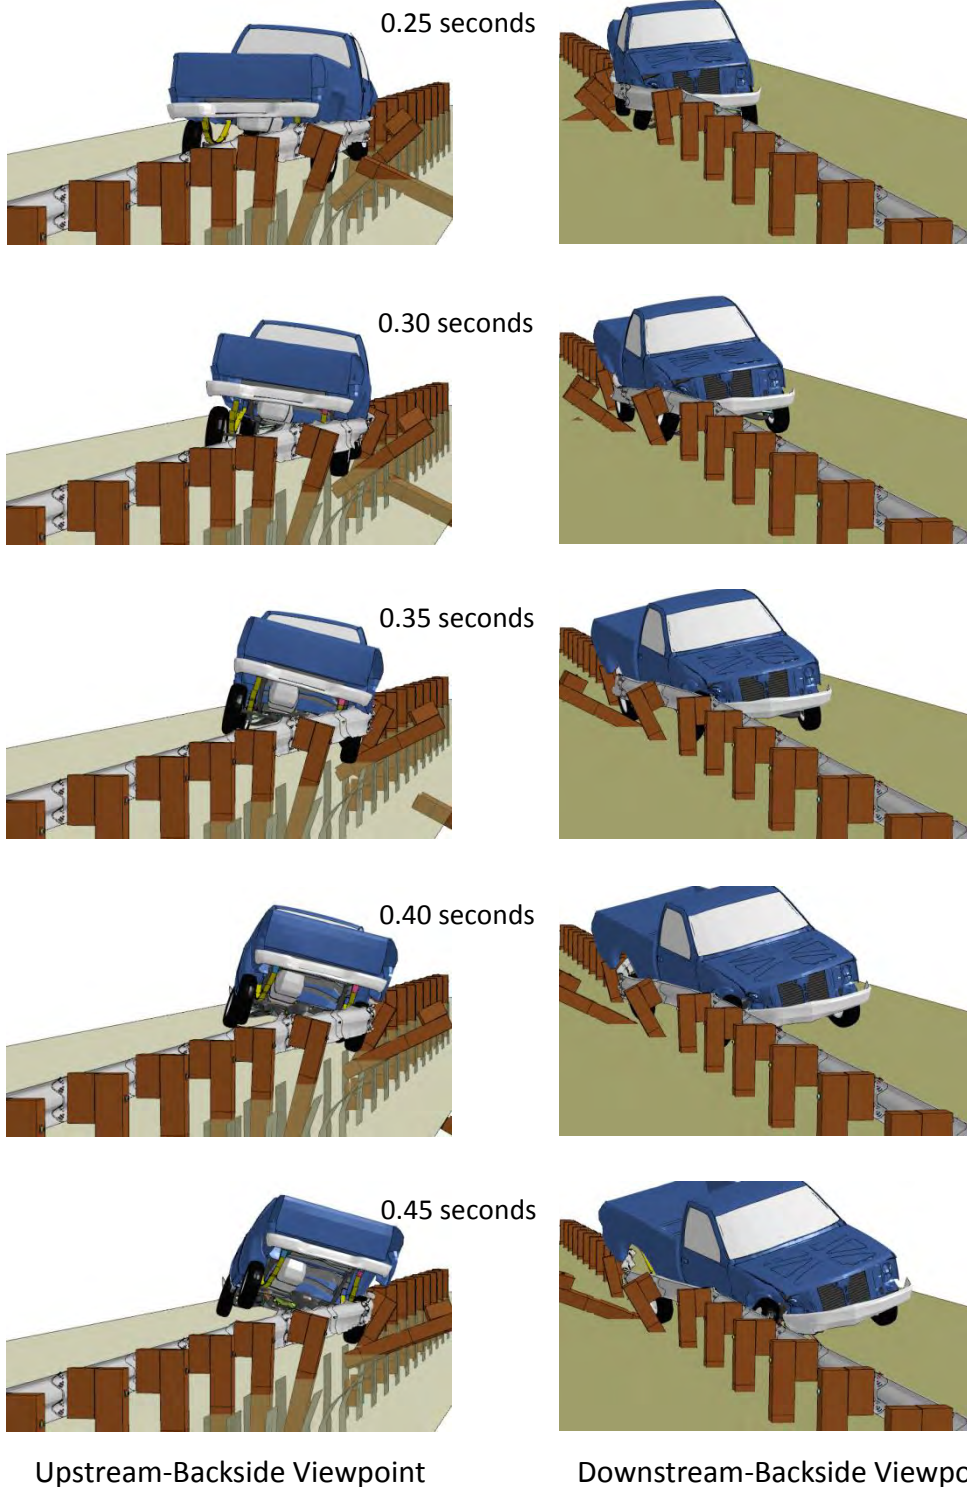
**Figure N-2: [CONTINUED] Sequential views from an upstream-backside and a downstream-backside viewpoint for 6-inch erosion at two posts analysis case.**

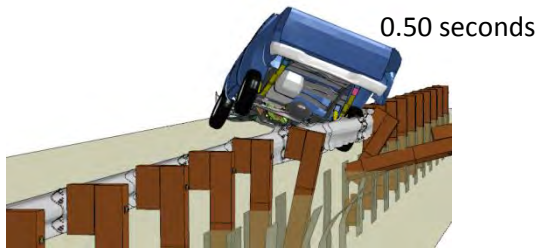
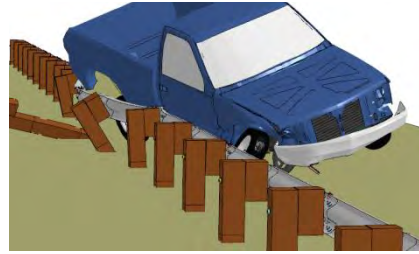
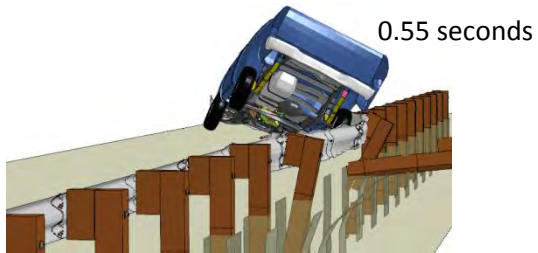
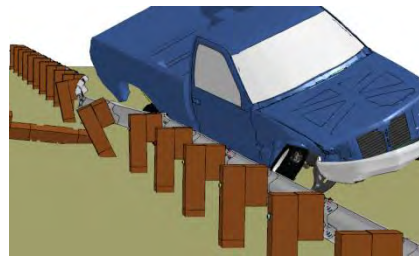
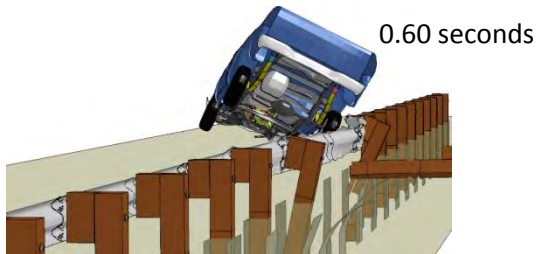
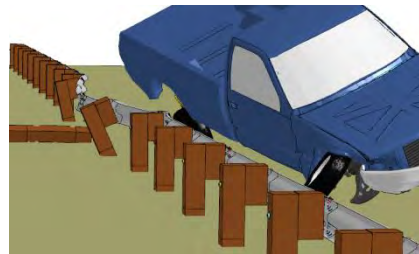
Upstream-Backside Viewpoint

Downstream-Backside Viewpoint

**Figure N-2: [CONTINUED] Sequential views from an upstream-backside and a downstream-backside viewpoint for 6-inch erosion at two posts analysis case.**

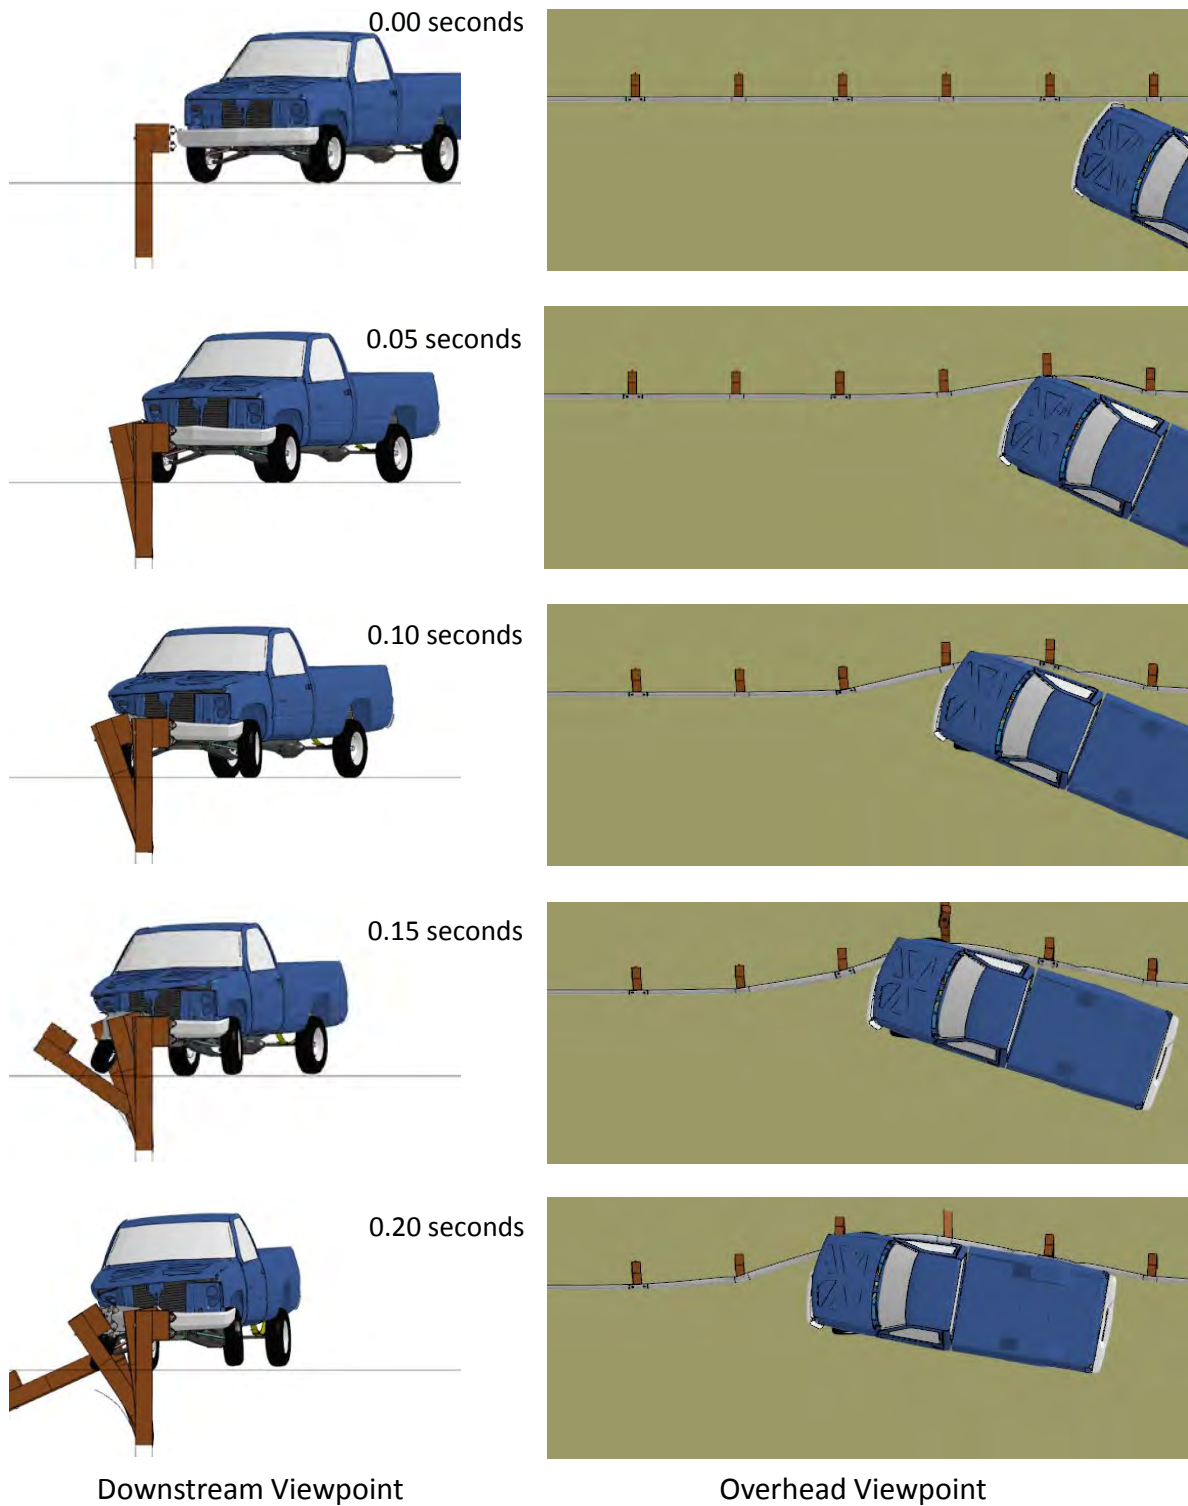
**Figure N-3: Sequential views from a downstream and overhead viewpoint for 9-inch erosion at two posts analysis case.**

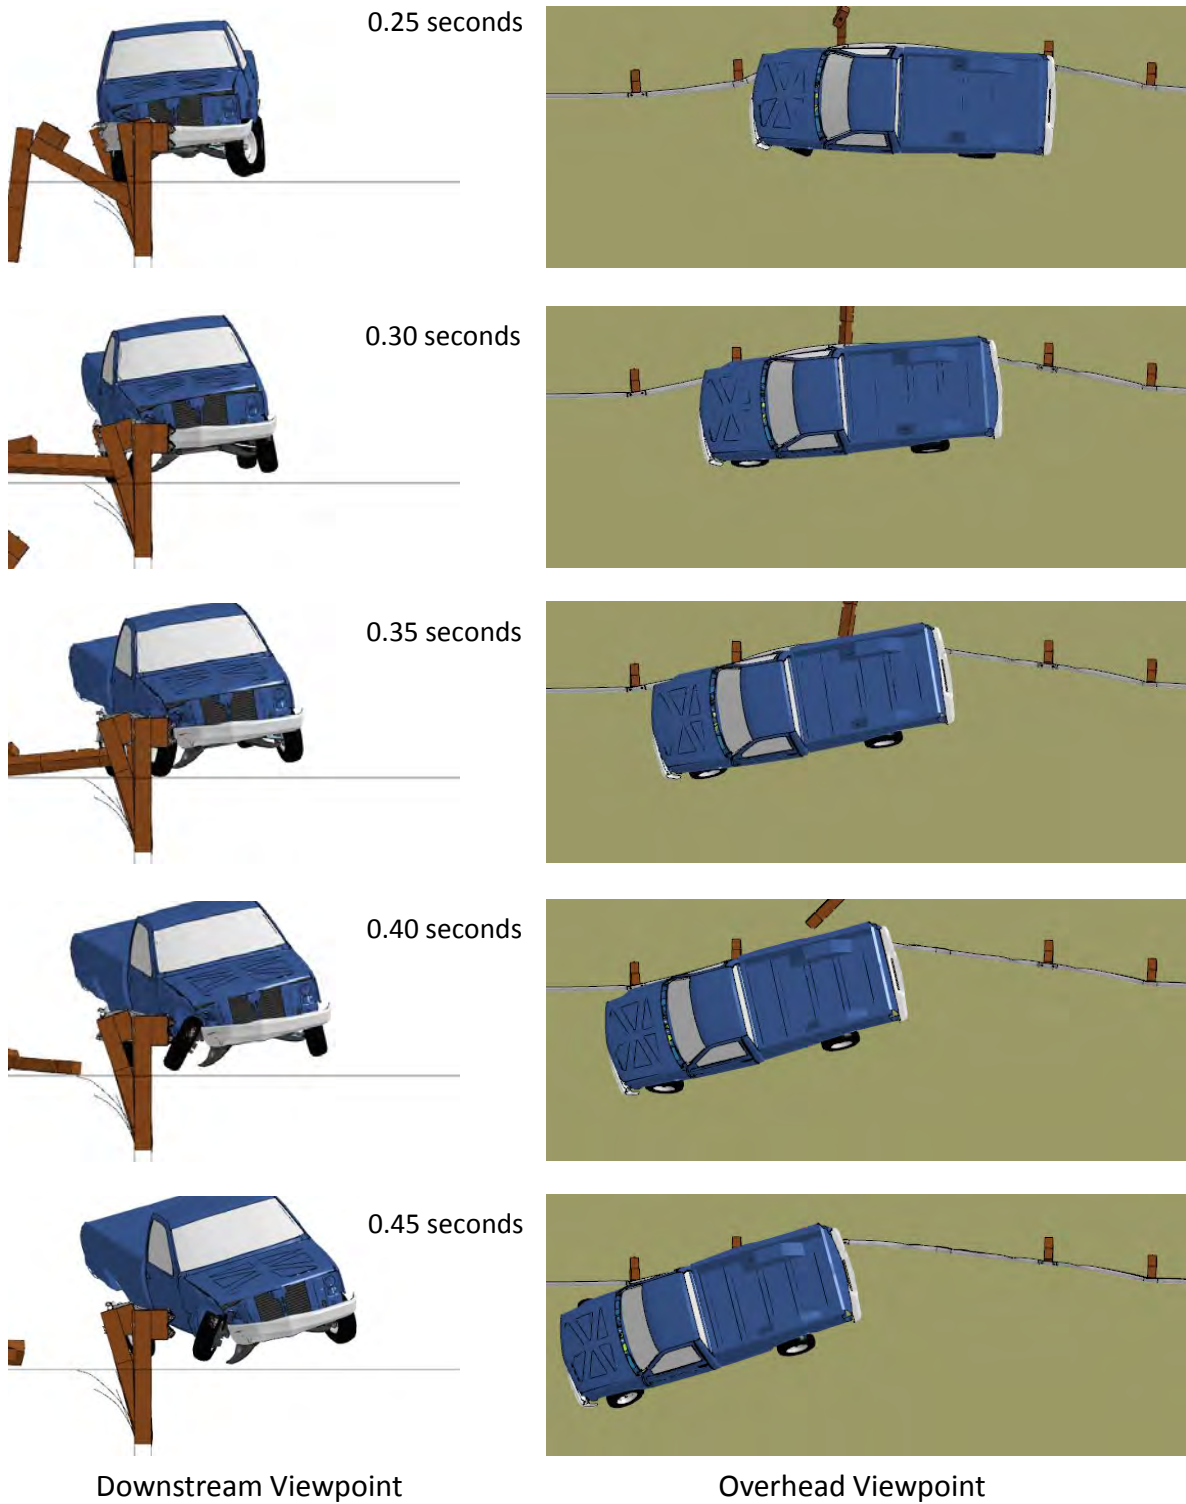
**Figure N-3.** [CONTINUED] Sequential views from a downstream and overhead viewpoint for 9-inch erosion at two posts analysis case.

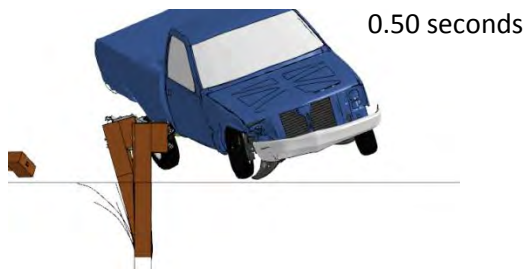
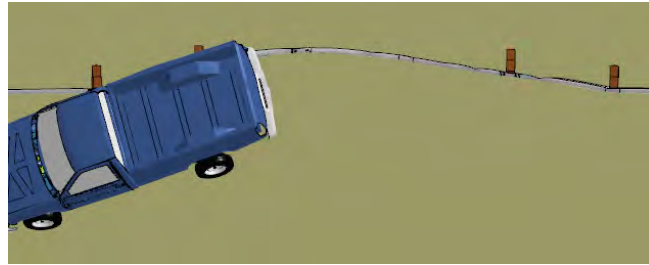
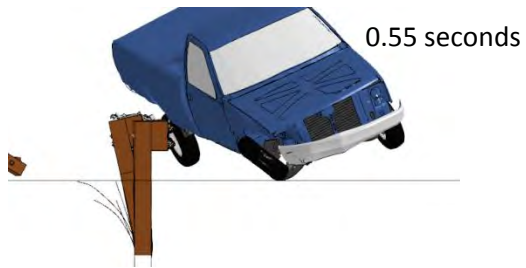
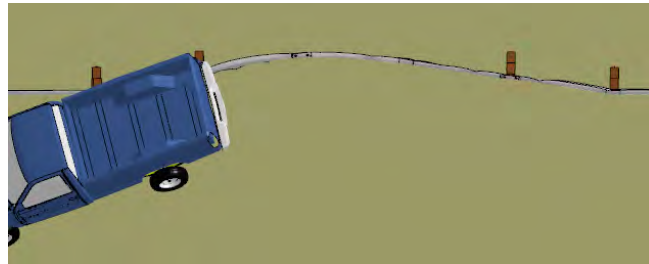
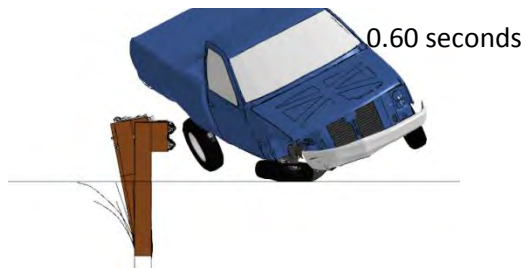
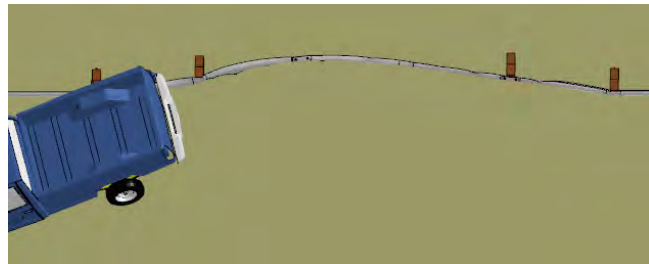
Downstream Viewpoint

Overhead Viewpoint

**Figure N-3.** [CONTINUED] Sequential views from a downstream and overhead viewpoint for 9-inch erosion at two posts analysis case.

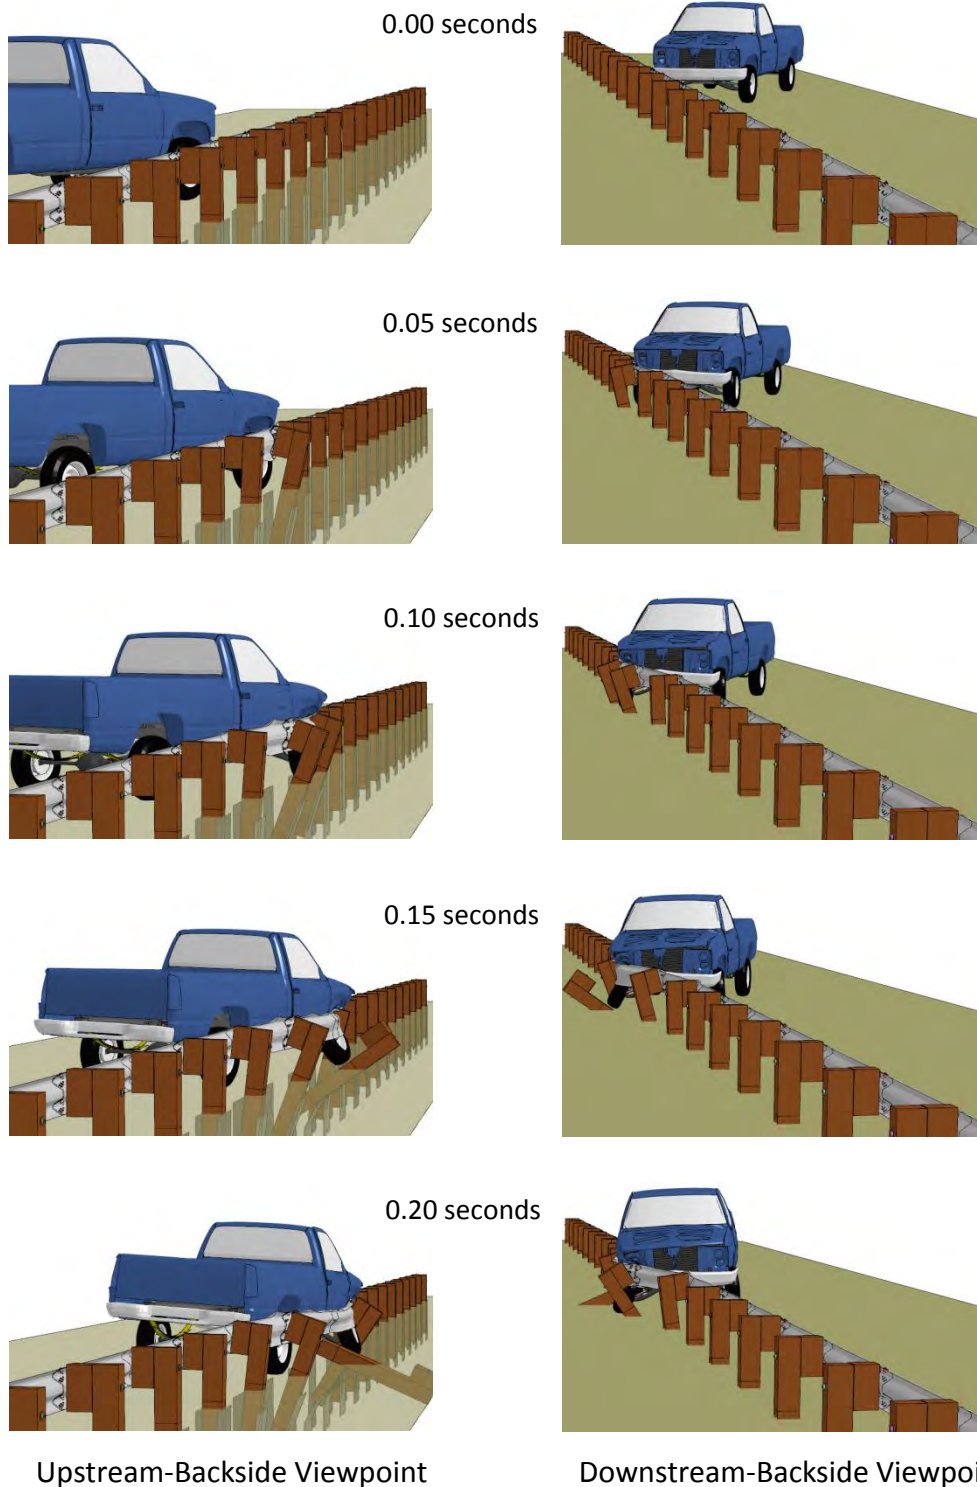
**Figure N-4: Sequential views from an upstream-backside and a downstream-backside viewpoint for 9-inch erosion at two posts analysis case.**

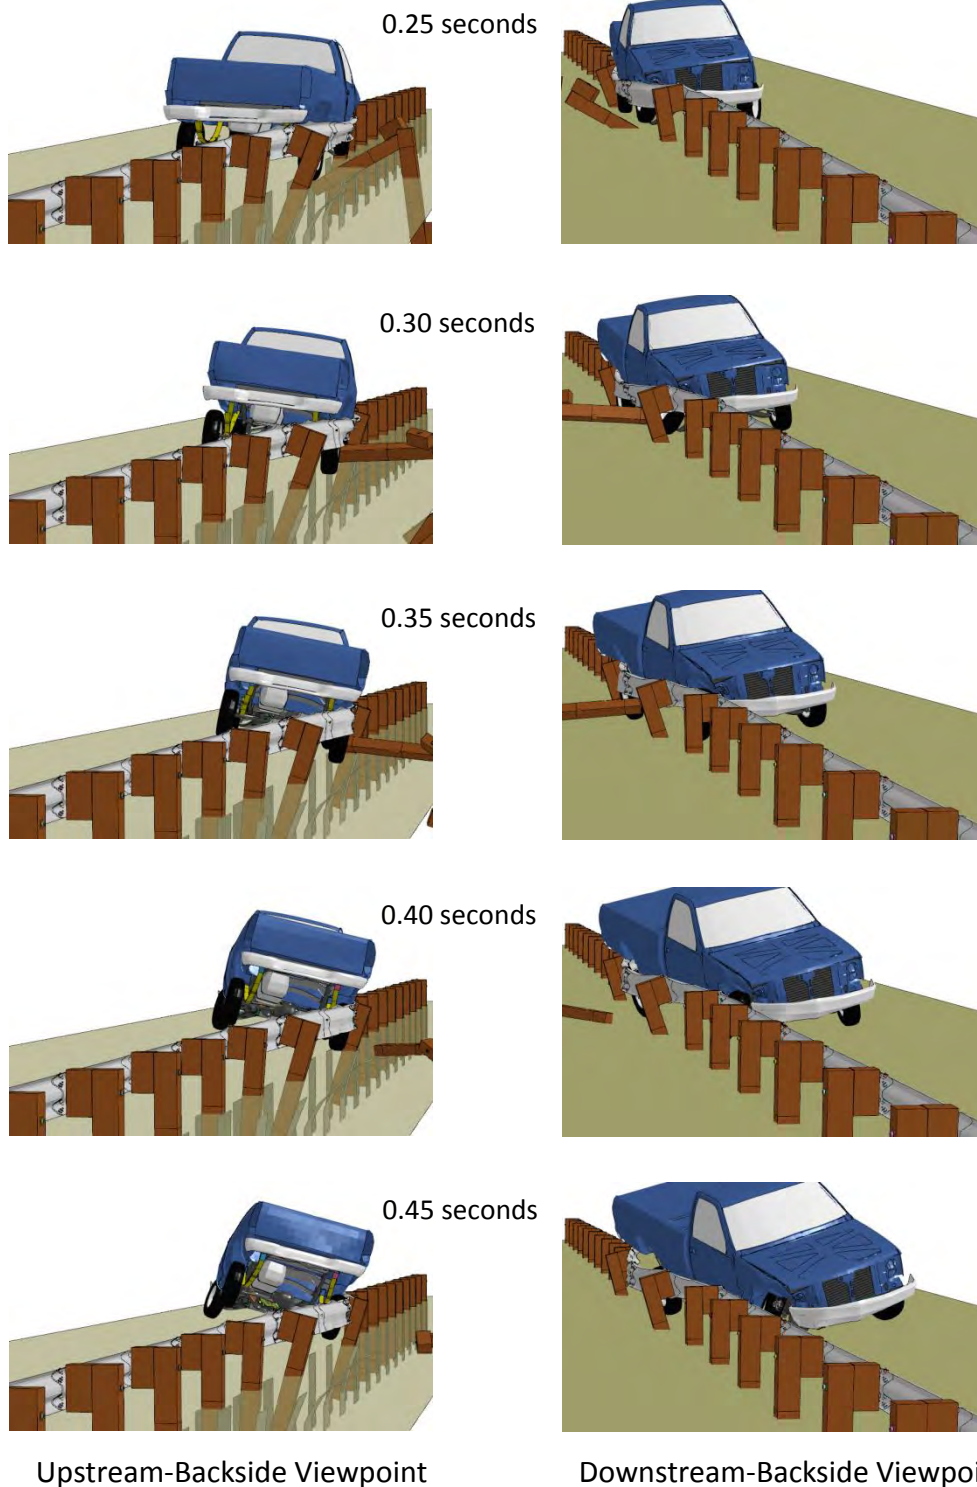
**Figure N-4: [CONTINUED] Sequential views from an upstream-backside and a downstream-backside viewpoint for 9-inch erosion at two posts analysis case.**

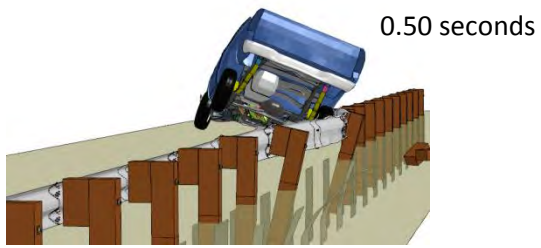
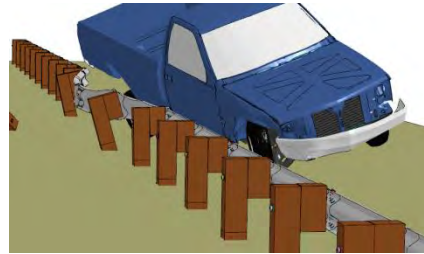
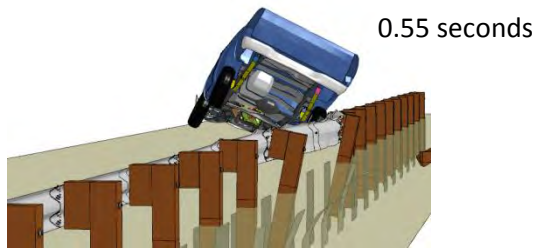
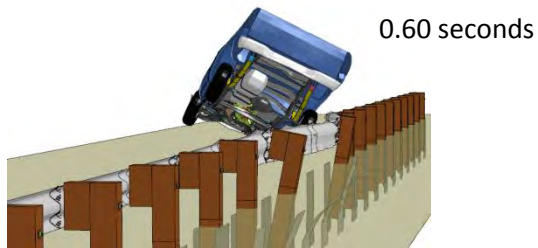
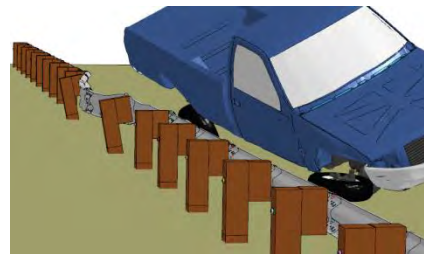
Upstream-Backside Viewpoint

Downstream-Backside Viewpoint

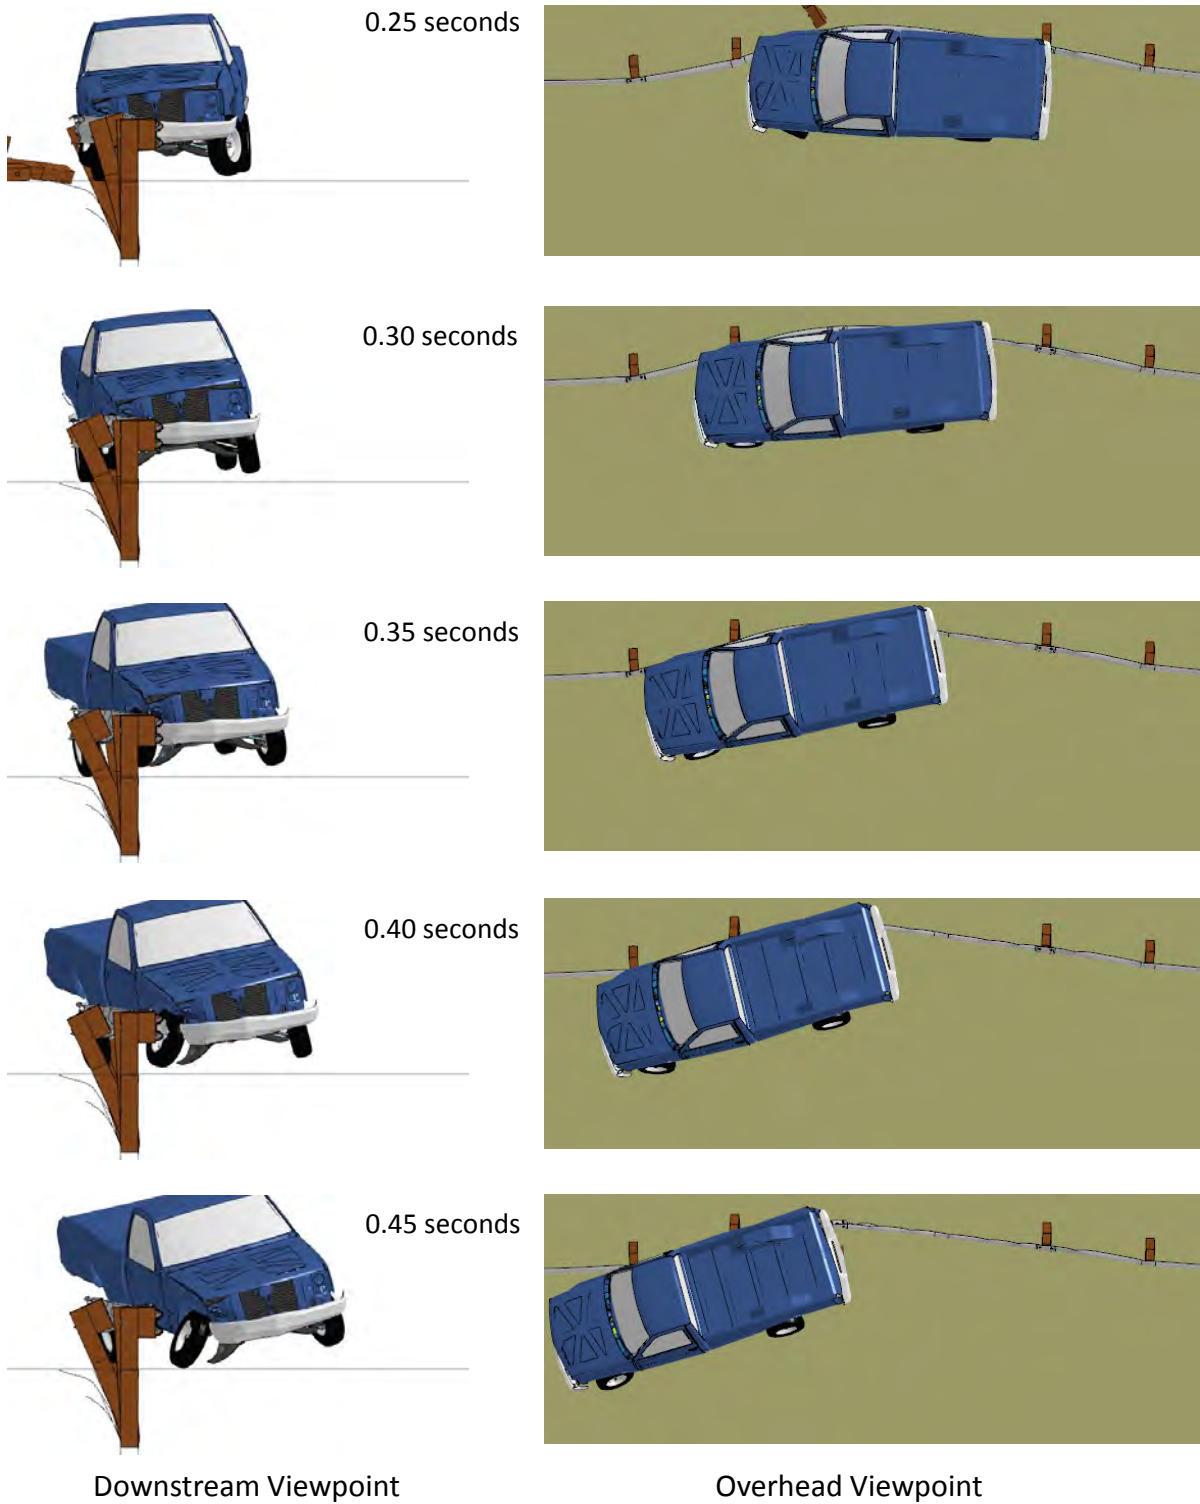
**Figure N-5: Sequential views from a downstream and overhead viewpoint for 12-inch erosion at two posts analysis case.**

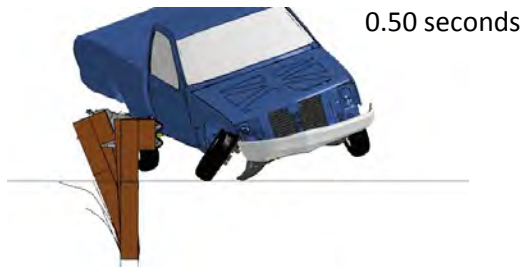
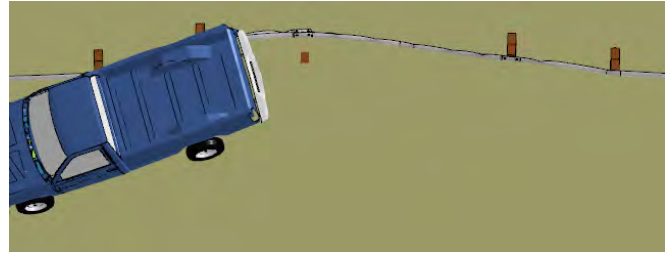
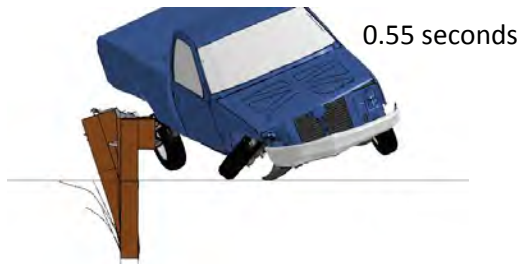
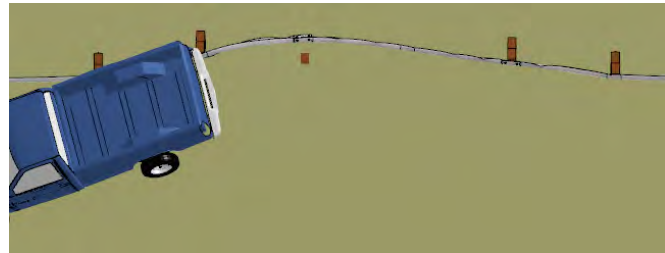
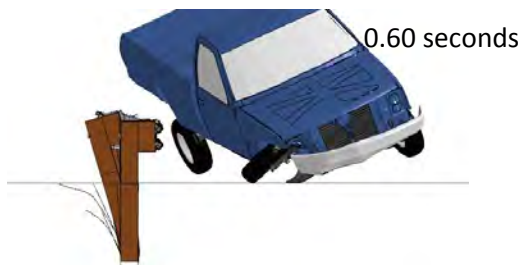
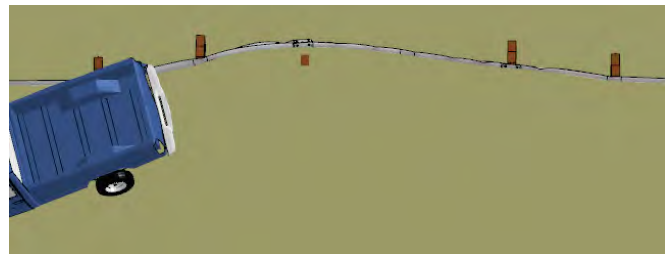
Downstream Viewpoint

Overhead Viewpoint

**Figure N-5: [CONTINUED] Sequential views from a downstream and overhead viewpoint for 12-inch erosion at two posts analysis case.**

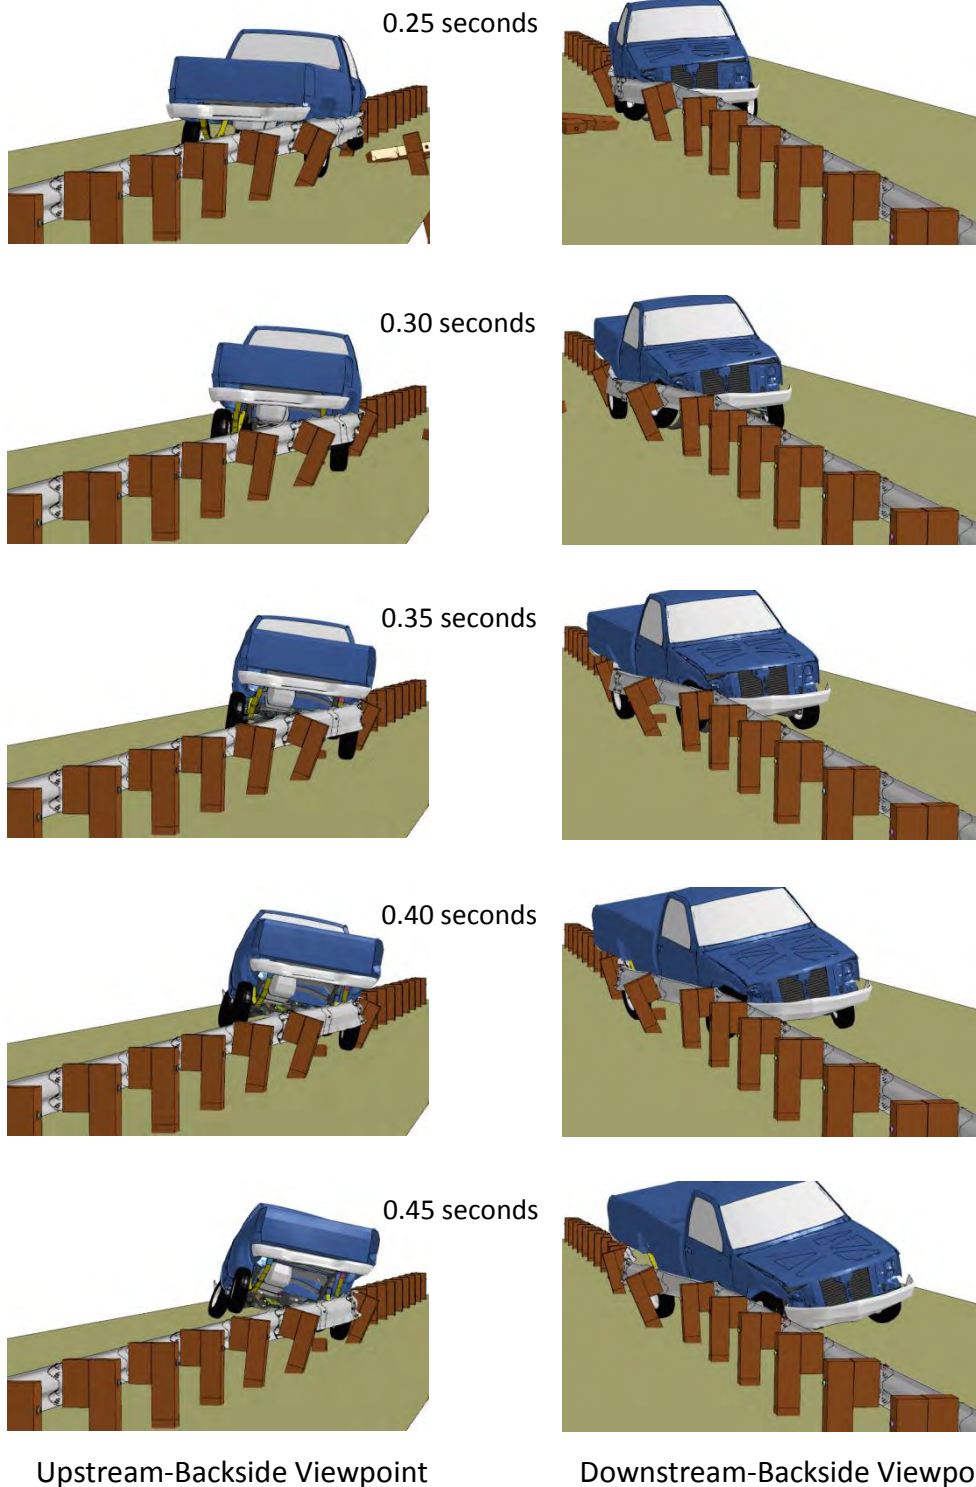
**Figure N-6: Sequential views from an upstream-backside and a downstream-backside viewpoint for 12-inch erosion at two posts analysis case.**

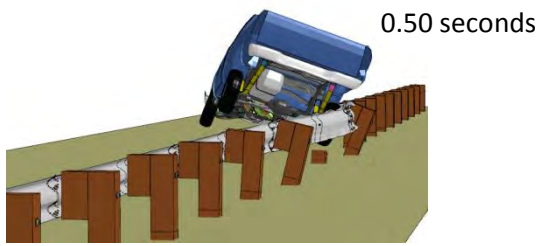
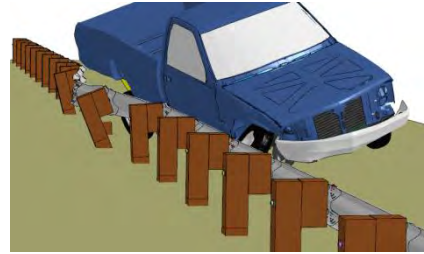
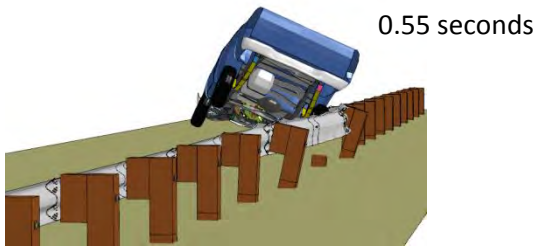
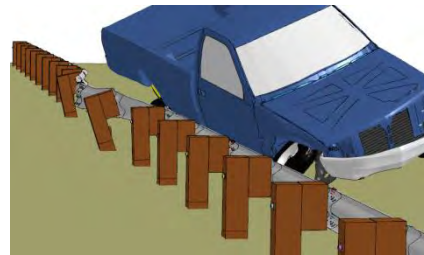
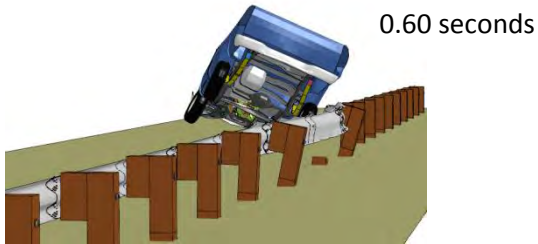
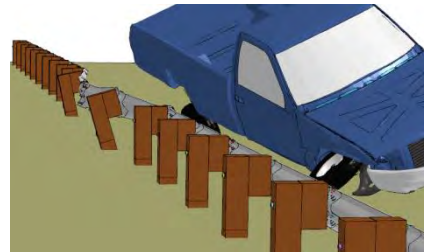
**Figure N-6: [CONTINUED] Sequential views from an upstream-backside and a downstream-backside viewpoint for 12-inch erosion at two posts analysis case.**

Upstream-Backside Viewpoint

Downstream-Backside Viewpoint
