# **A Guide for W-Beam Guardrail Damage Assessment**

A Field Manual for  
Highway Maintenance Personnel

National Cooperative  
Highway Research  
Program  
Project 22-28

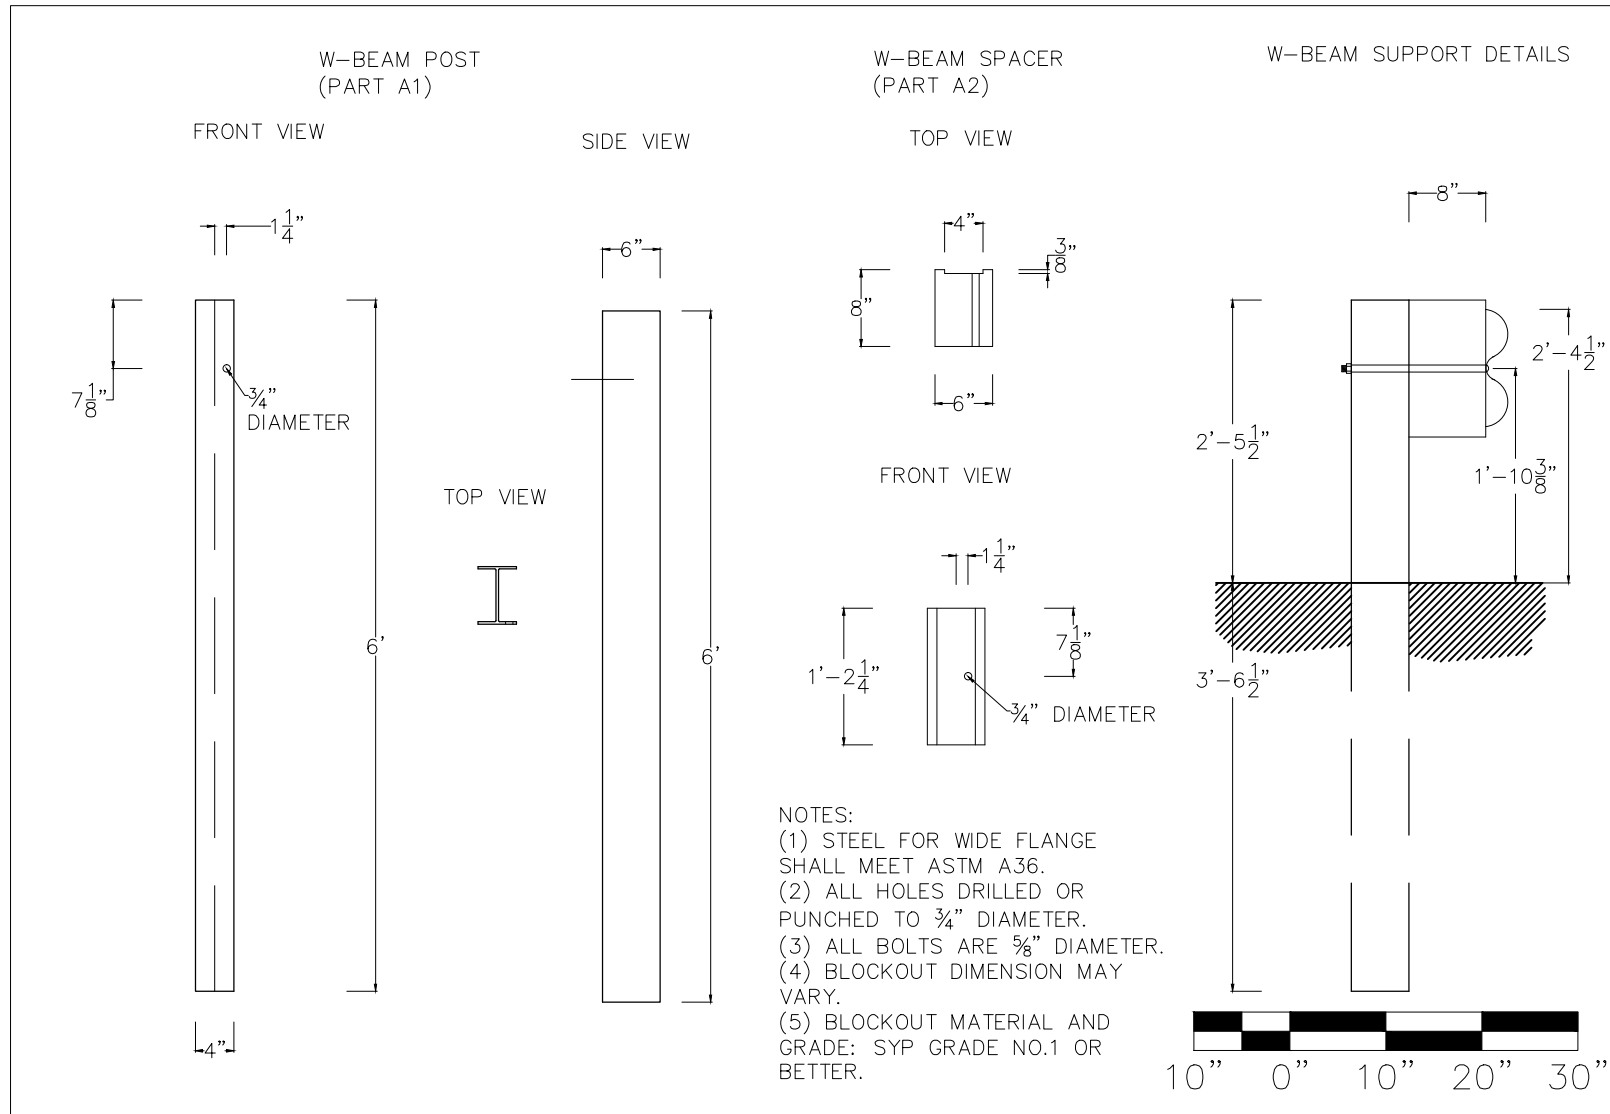
DRAWN BY: ROADSAFE LLC. AMR DATE: JUNE 25, 2014	SCALE: 20/1	W6X9 POST AND BLOCK OUT PART A1 AND A2	SHEET NO. 2/6
----------------------------------------------------	-------------	-------------------------------------------	------------------

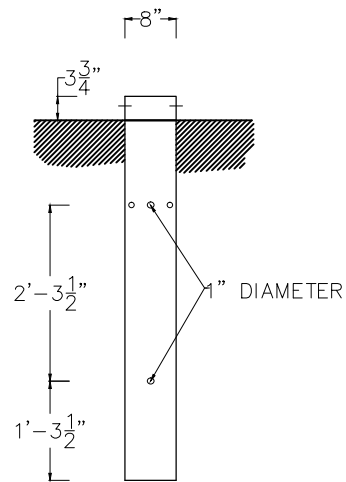
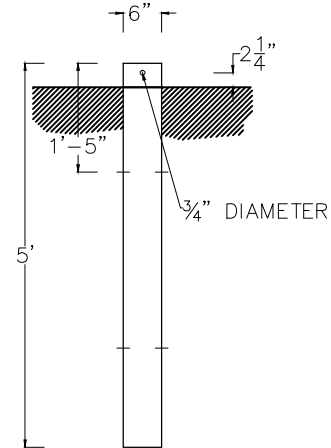
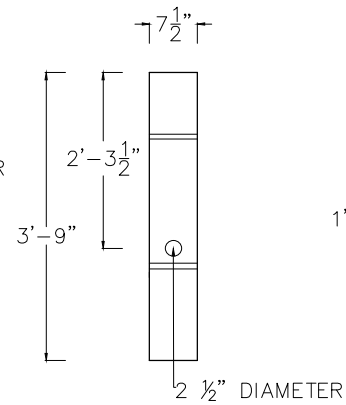
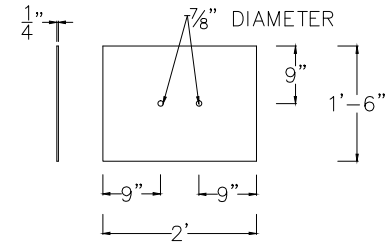
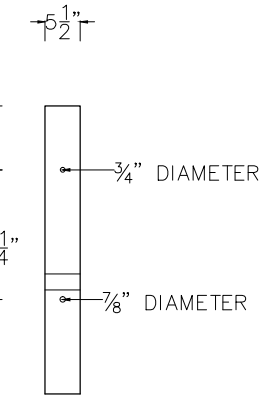
3/6

FOUNDATION TUBE  
(PART B1)

SOIL PLATE  
(PART B3)

FOUNDATION TUBE, WOOD POST, AND SOIL PLATE  
PART B1, B2, AND B3

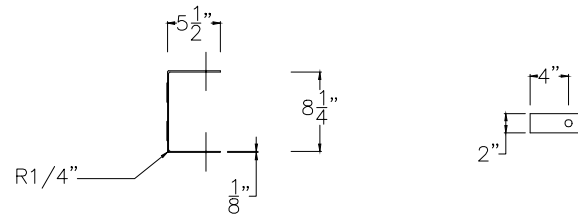
# YOKE DETAILS

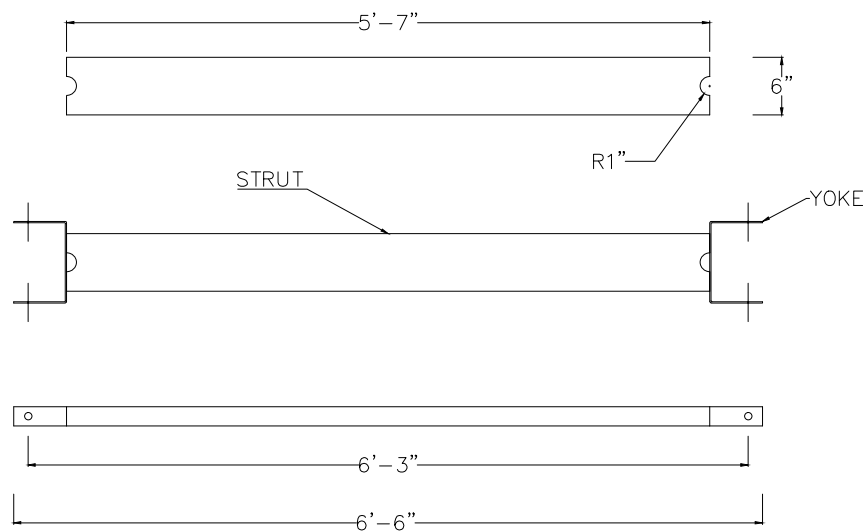
# STRUT DETAILS

CABLE STRUT  
(PART C1)

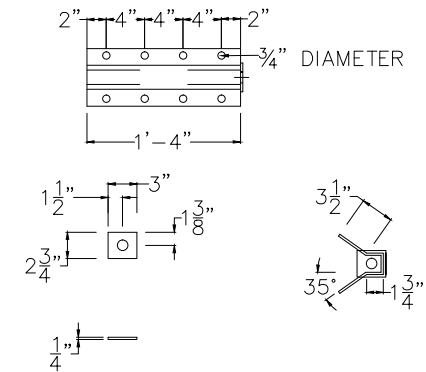
# ANCHOR BRACKET (PART C2)

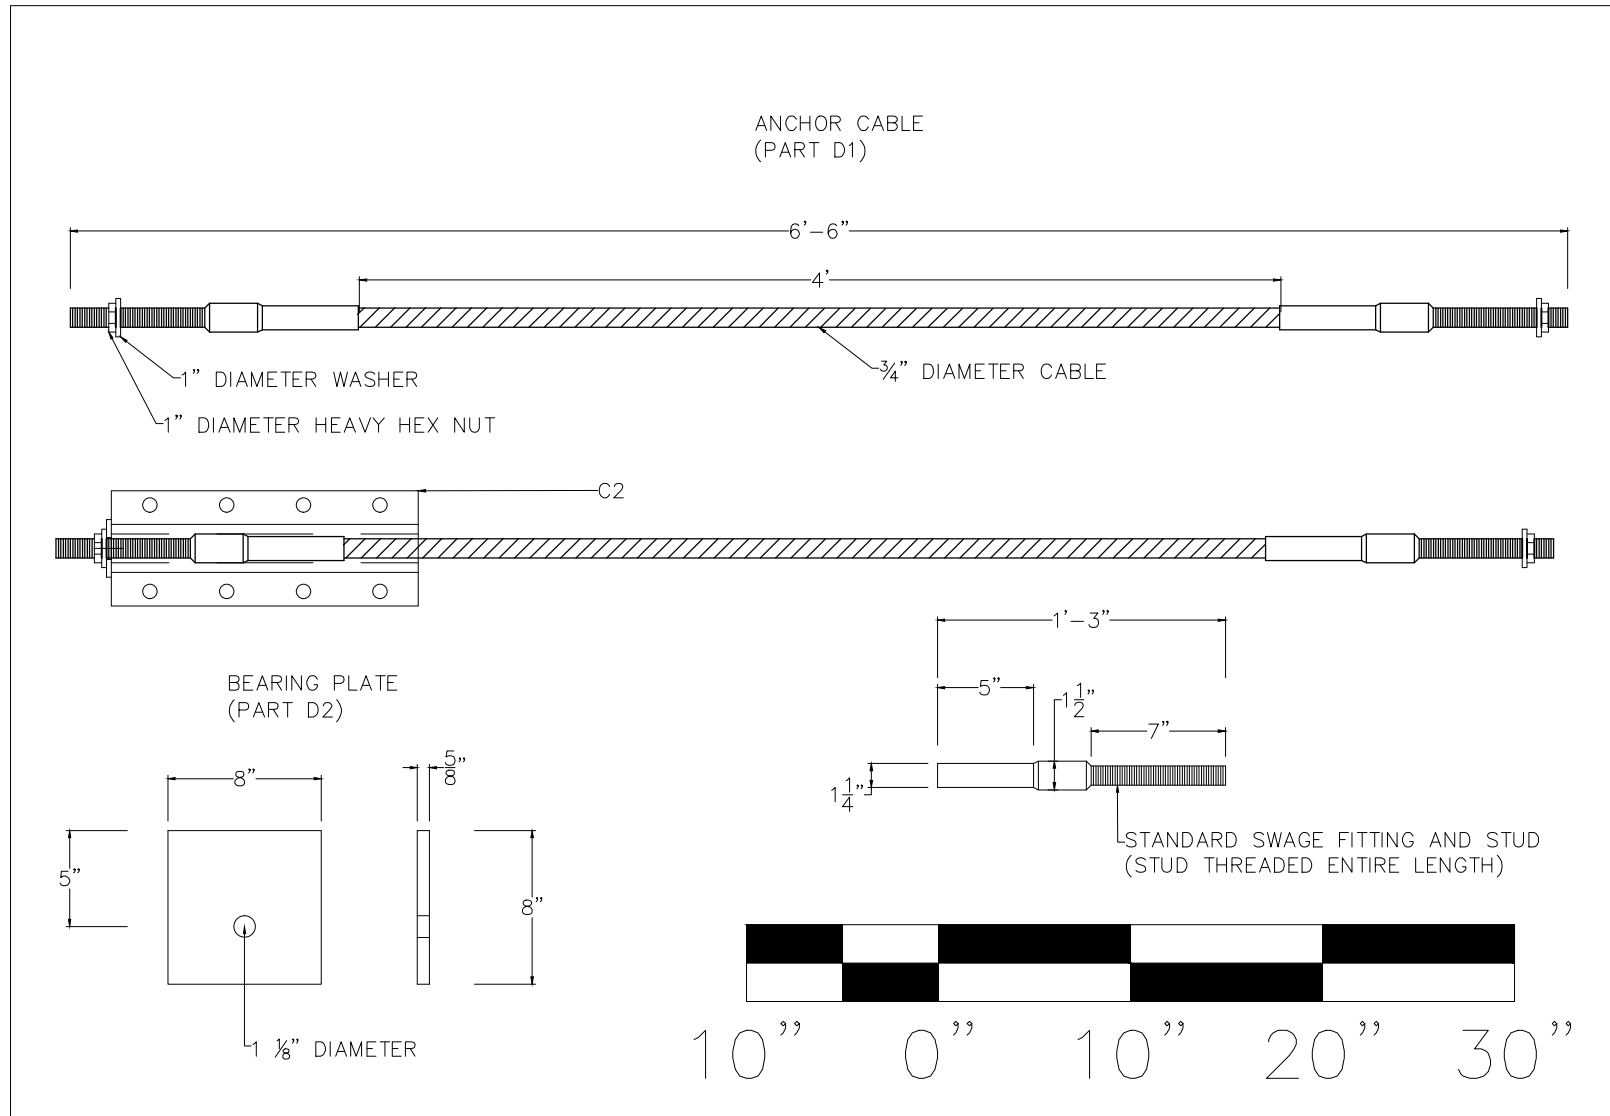
DRAWN BY: ROADSAFE LLC. AMR DATE: JUNE 25, 2014	SCALE: 10/1	ANCHOR CABLE AND BEARING PLATE PART D1 AND D2	SHEET NO. 5/6
----------------------------------------------------	-------------	--------------------------------------------------	------------------

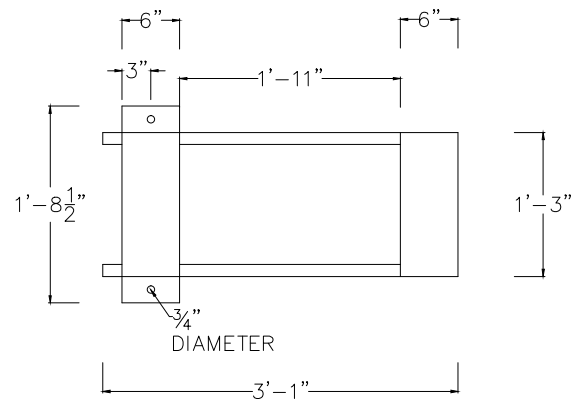
SIMULATED IMPACT HEAD  
(PART E1)

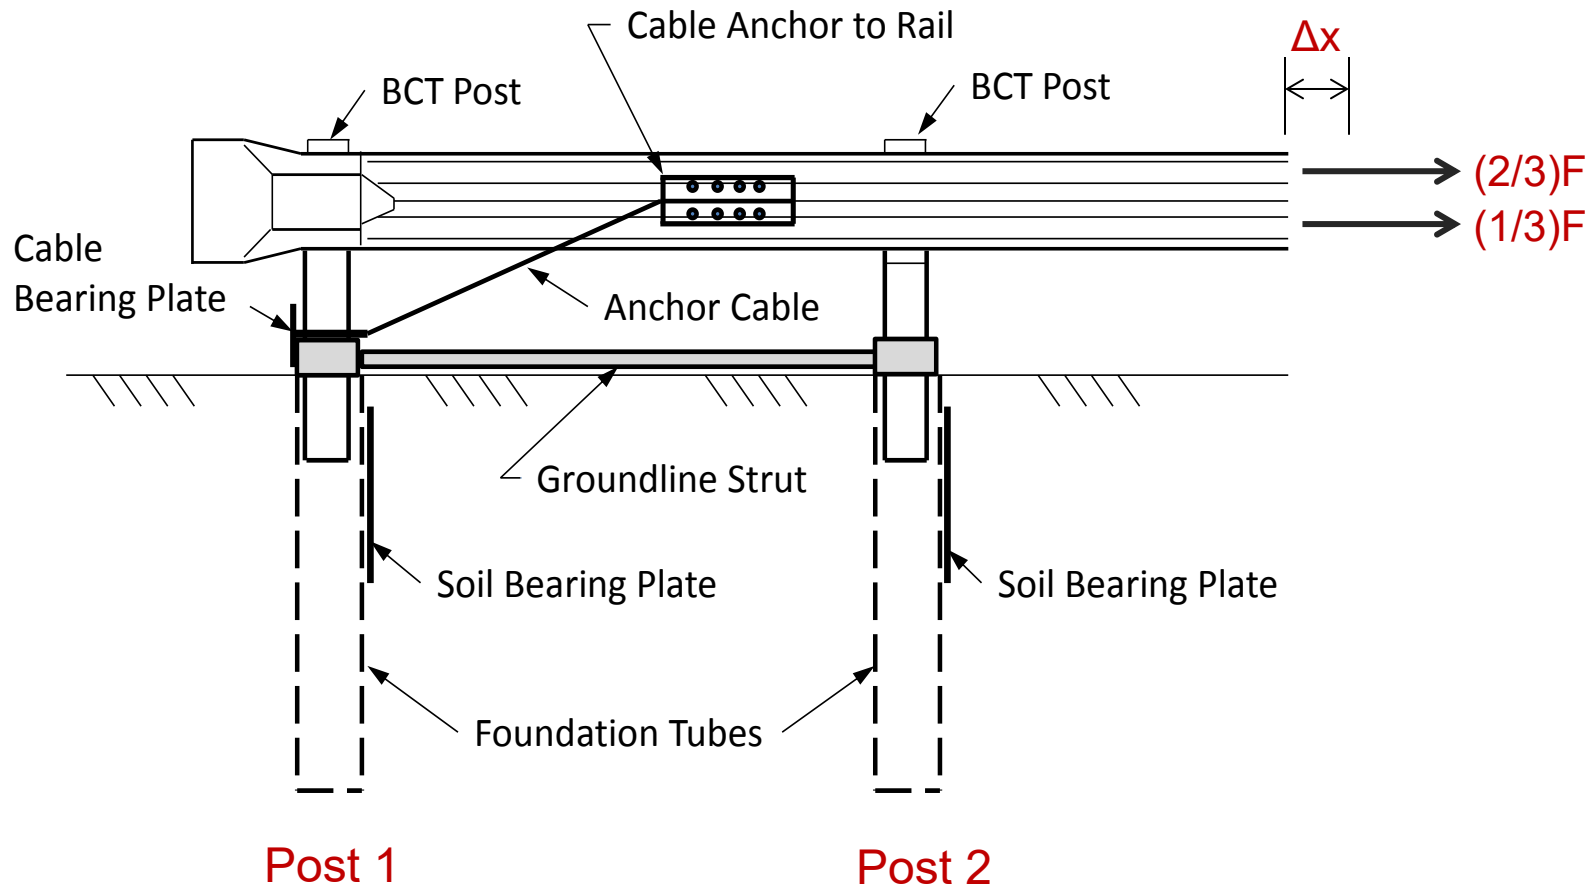
# Test Setup

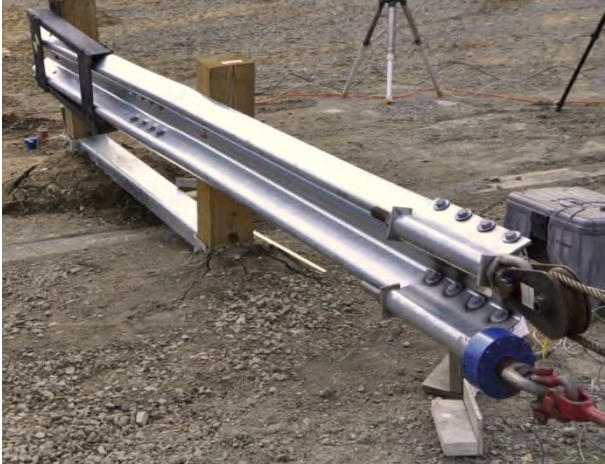
Test Information			
Project Case Number:	4B1_001		
FOIL Test Number:	14001E		
Test Date:	18-April-2014		
System Properties			
Rail Height (in):	28.5		
Post Type:	BCT		
Rail-to-Post 1:	Not Bolted		
Rail-to-Post 2:	Bolted		
Foundation Tube Type:	FMM02 (AASHTO-AGC-ARTB)		
Embedment Depth (in):	57.0		
Damage Type			
Category:	Undamaged		
Level:	0		
Soil Properties			
	@Post 1	@Post 2	
Dry Density (pcf):	142.1	144.0	
Wet Density (pcf):	151.1	150.6	
Moisture Content (%):	6.4	4.6	
Compaction (%):	94.6	93.2	
Load Properties			
Quasi-Static Rate (in/s):	≈ 1.0		
Method:	Winch & Cable		
Load Point 1 (in):	25.5		
Load Point 2 (in):	17.5		
Result			
Anchor condition:	Soil Disp. Only		
Max Load (kips):	22.0		
Max Disp. at Max Load (in):	8.0		
	@2 in.	@4 in.	@6 in.
Force (kip):	12.0	16.8	21
Stiffness (k/in):	4.9	4.5	1.7
Post Test:	@Post 1	@Post 2	
Groundline Displacement (in)	5.8	4.0

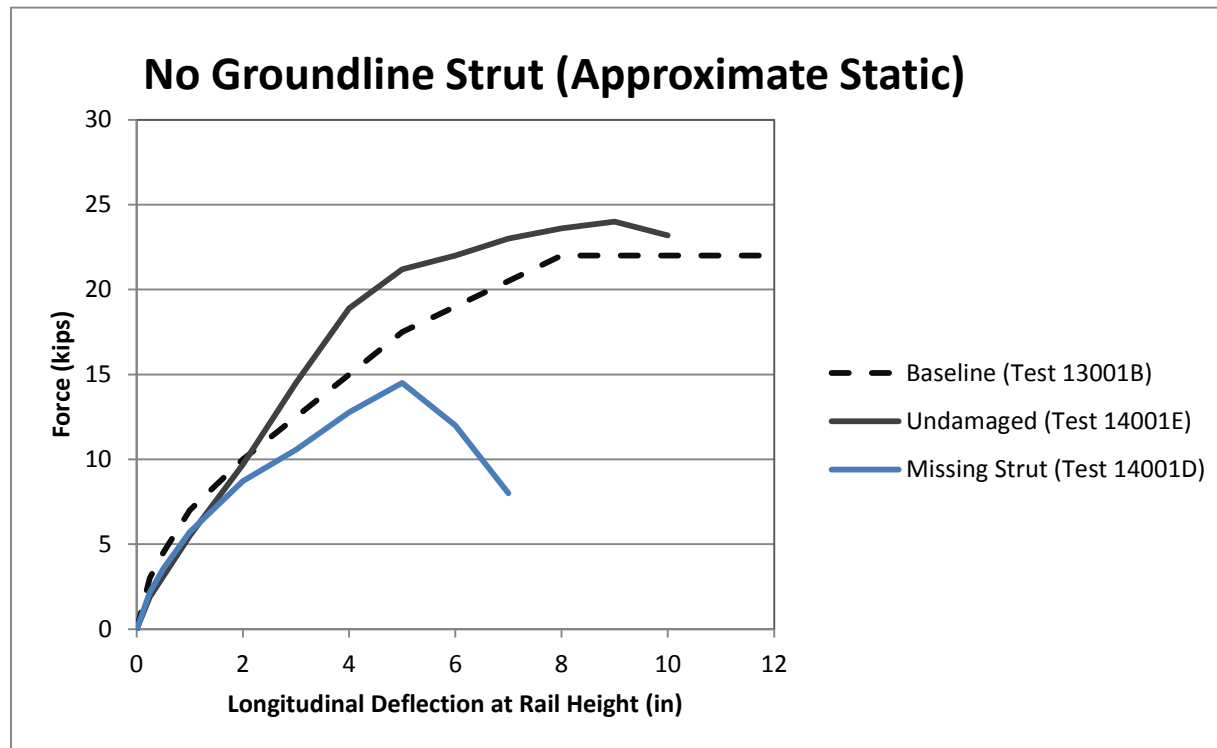
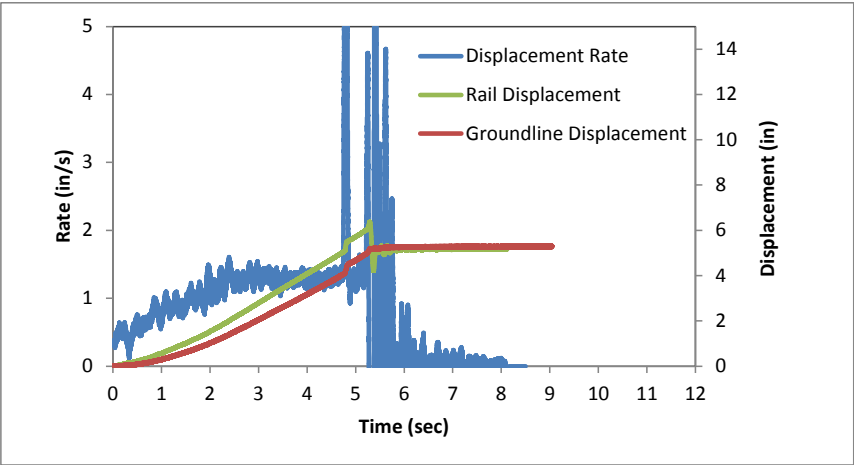
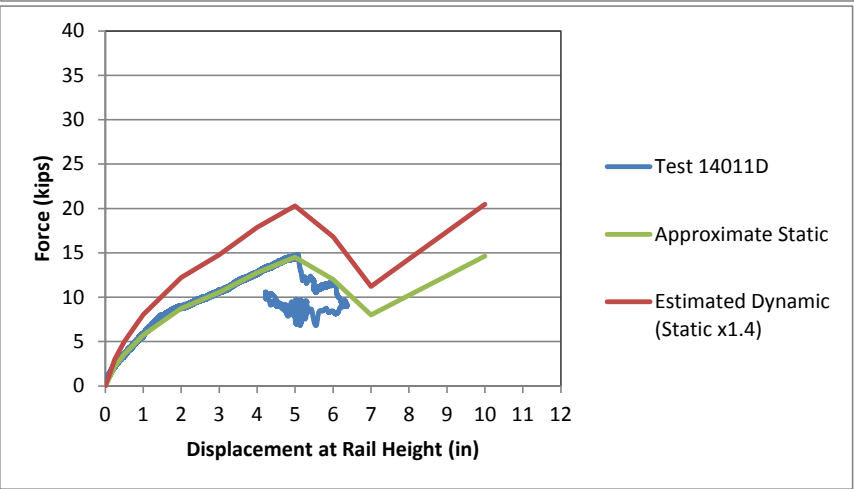
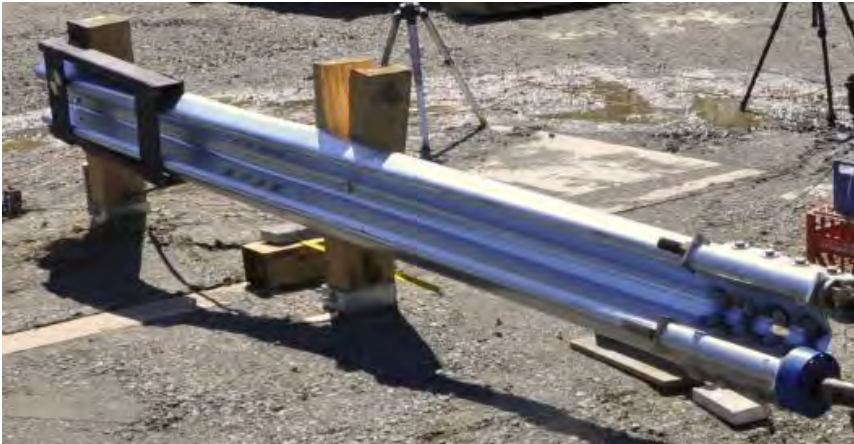
# No Groundline Strut

<u>Test Information</u>	
Project Case Number:	4B_001
FOIL Test Number:	14001D
Test Date:	16-April-2014

<u>System Properties</u>	
Rail Height (in):	Not Measured
Post Type:	BCT
Rail-to-Post 1:	Not Bolted
Rail-to-Post 2:	Bolted
Foundation Tube Type:	FMM02 (AASHTO-AGC-ARTB)
Embedment Depth:	Not Measured

<u>Damage Type</u>	
Category:	Groundline Strut
Level:	Missing

<u>Result</u>			
Anchor condition:	Post 2 Split @ 5” disp Soil Disp.		
Max Load (kips):	14.8		
Disp. at Peak Load (in):	5		
	<u>@2 in.</u>	<u>@4 in.</u>	<u>@6 in.</u>
Force (kip):	8.7	12.8	12.0
Stiffness (k/in):	4.5	1.9	1.8
Post test:	<u>@Post 1</u>	<u>@Post 2</u>	
Groundline Displacement (in)	4.3	0.0

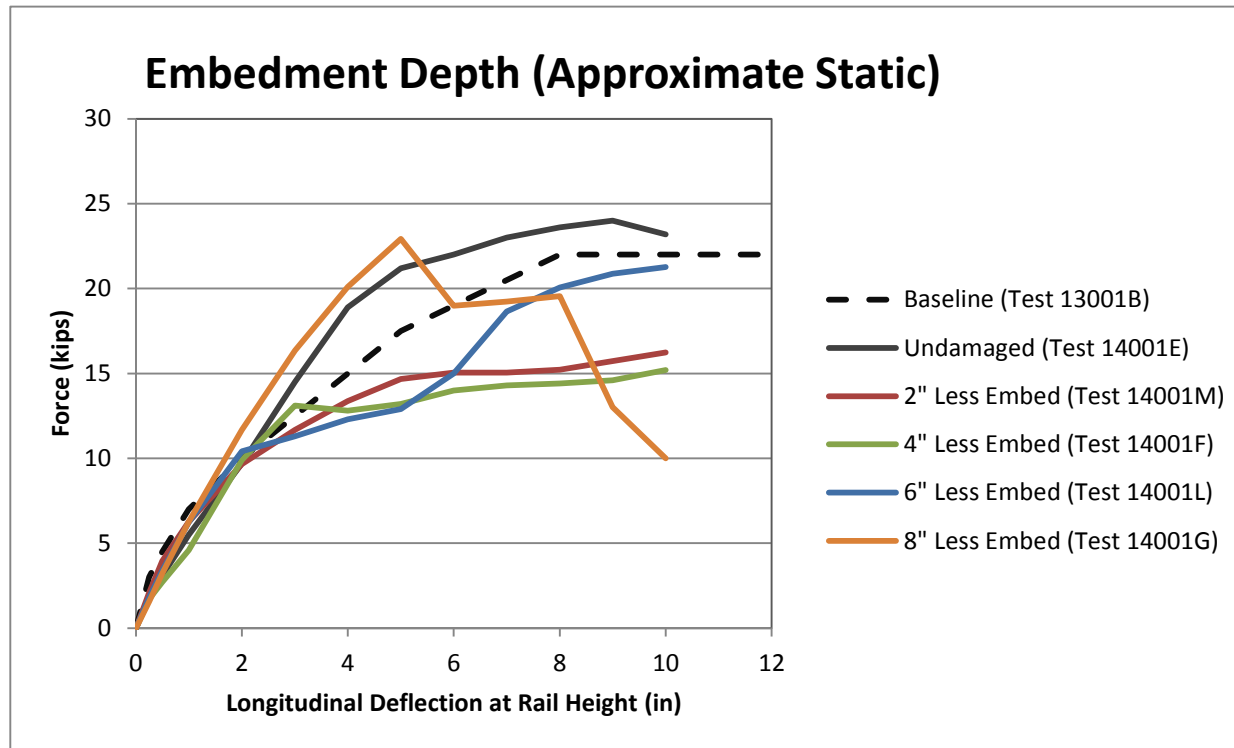
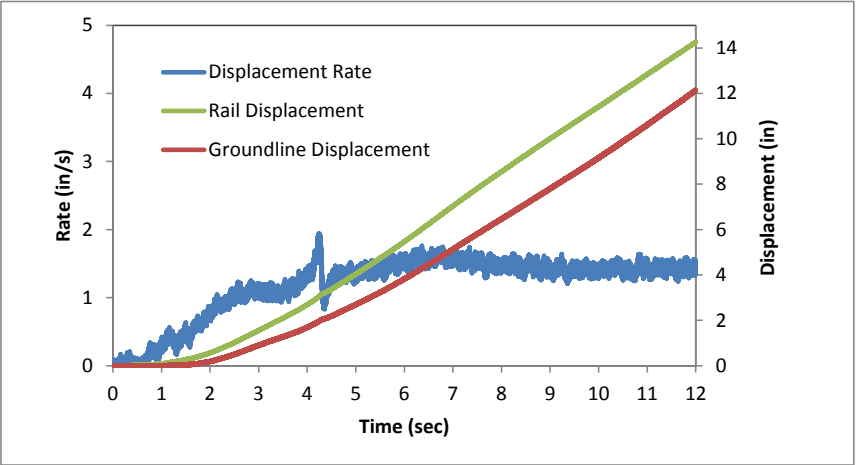
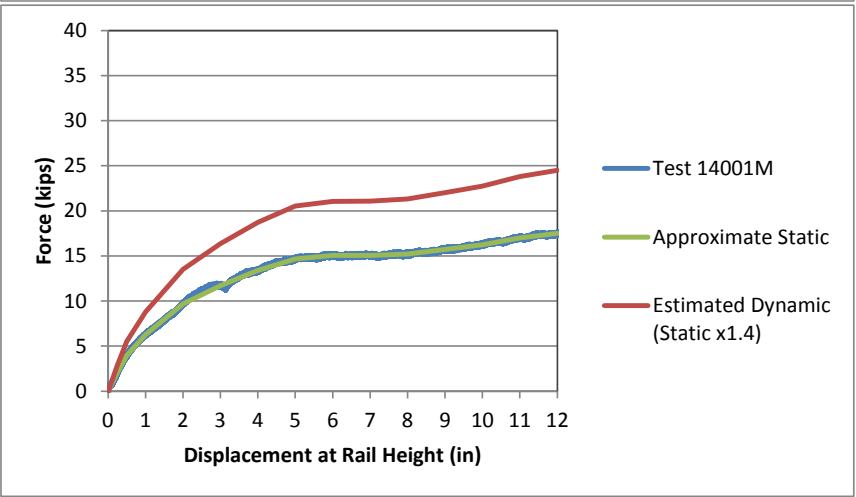
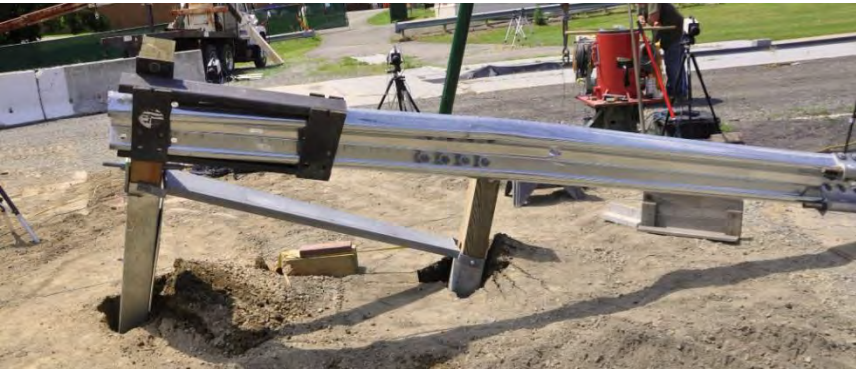
# Reduced Embedment Depth

Project Case Number:	4B1_002
FOIL Test Number:	14001M
Test Date:	23-June-2014

Rail Height (in):	29.5
Post Type:	BCT
Rail-to-Post 1:	Not Bolted
Rail-to-Post 2:	Bolted
Foundation Tube Type:	FMM02 (AASHTO-AGC-ARTB)
Embedment Depth:	55.0

Anchor condition:	Post 1 full extraction at > 12 inches rail deflec. Soil Disp.		
Max Load (kips):	18.4		
Disp. at Peak Load (in):	16.0		
	@2 in.	@4 in.	@6 in.
Force (kip):	9.7	13.4	15.0
Stiffness (k/in):	4.8	1.9	0.8
Post Test:	@Post 1	@Post 2	
Groundline Displacement (in)	8.0	7.0

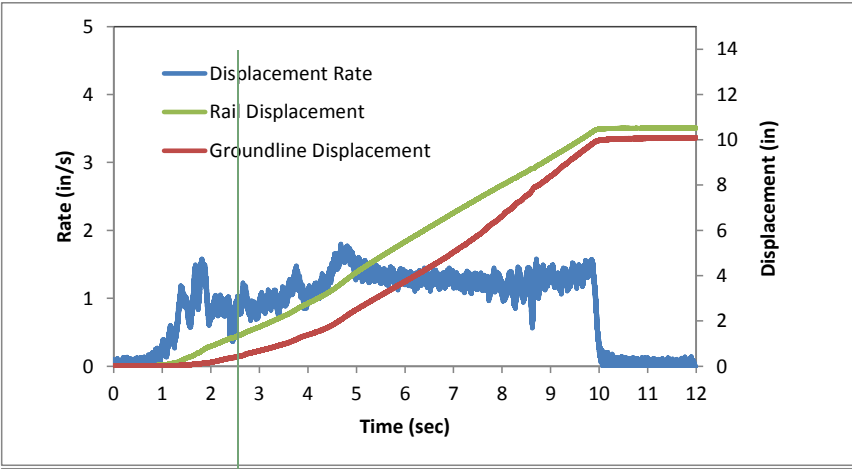
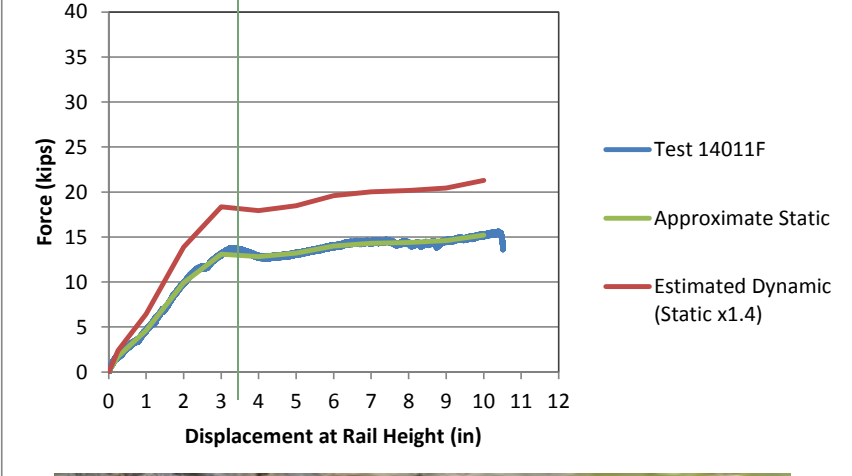
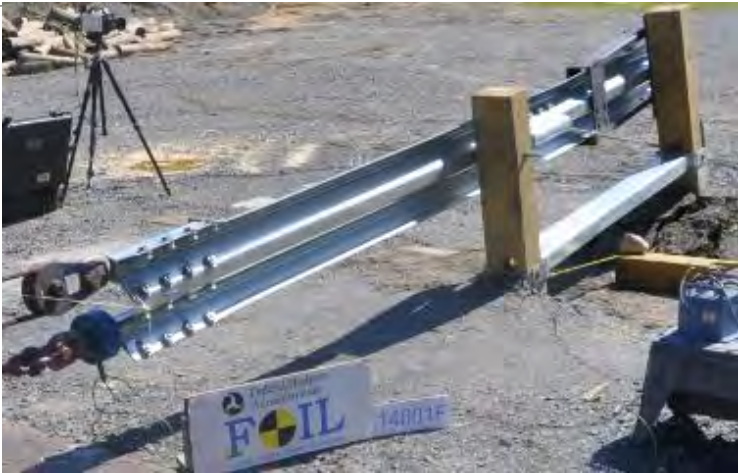
Test Information	
Project Case Number:	4B1_003
FOIL Test Number:	14001F
Test Date:	5-May-2014

System Properties	
Rail Height (in):	31.5
Post Type:	BCT
Rail-to-Post 1:	Not Bolted
Rail-to-Post 2:	Bolted
Foundation Tube Type:	FMM02 (AASHTO-AGC-ARTB)
Embedment Depth:	53.0

Damage Type	
Category:	Reduced Embed. Depth
Level:	4 inches

Result			
Anchor condition:	Post 1 Partial Extraction Soil Disp.		
Max Load (kips):	15.7		
Max Disp. at Max Load (in):	10.5		
	@2 in.	@4 in.	@6 in.
Force (kip):	9.9	12.8	14.0
Stiffness (k/in):	5.0	1.5	0.6
Post Test:	@Post 1	@Post 2	
Groundline Displacement (in)	4.8	4.0

Test No.	Test Date	Damage Mode	PRE-TEST MEASUREMENTS									POST-TEST RESULTS		
			Distance Post 2 to Soil Pit Front (in)	Distance Post 2 to Soil Pit Rear (in)	Distance Post 1 to Soil Pit Front (in)	Distance Post 1 to Soil Pit Rear (in)	Distance Center to Center Posts (in)	Height to Top of Rail (in)	Height to Load Point Top (in)	Height to Load Point Bottom (in)	Post Embedment Depth (in)	Distance Center to Center Posts (in)	Groundline Deflection Post #1 (in)	Post #2 (in)
13011B	12/16/2013	Baseline Test (used in Task 4A-2)												
14001E	4/18/2014	Undamaged System Test	88.0	16.0	43.0	30.0	75.5	28.5	25.5	17.5	57.0	74.0	5.8	4.0
14001D	4/16/2014	No groundline strut	86.0	18.0	45.0	28.0	74.0	-	-	-	-	70.0	4.3	< 0.125
14001L	5/20/2014	2" reduced embedment	88.5	17.8	42.0	30.5	75.3	29.5	26.5	18.5	55.0	75.0	8.0	7.0
14001F	5/6/2014	4" reduced embedment	85.8	18.3	41.3	31.8	74.5	31.5	28.5	17.3	53.0	73.3	4.8	4.0

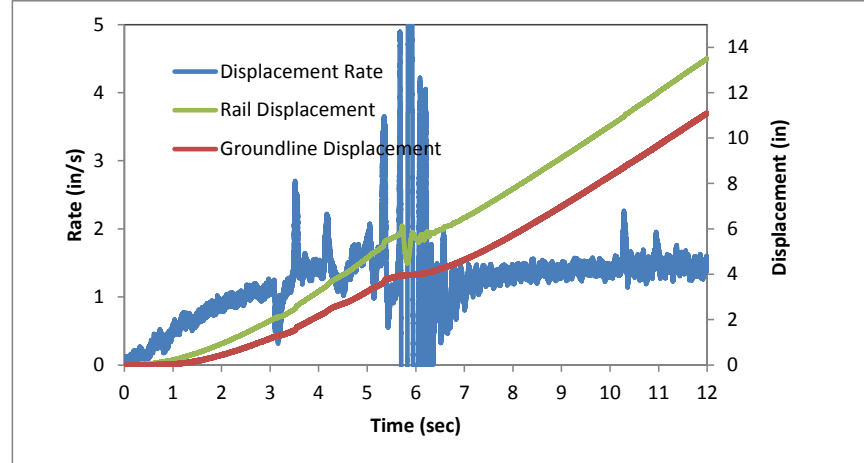
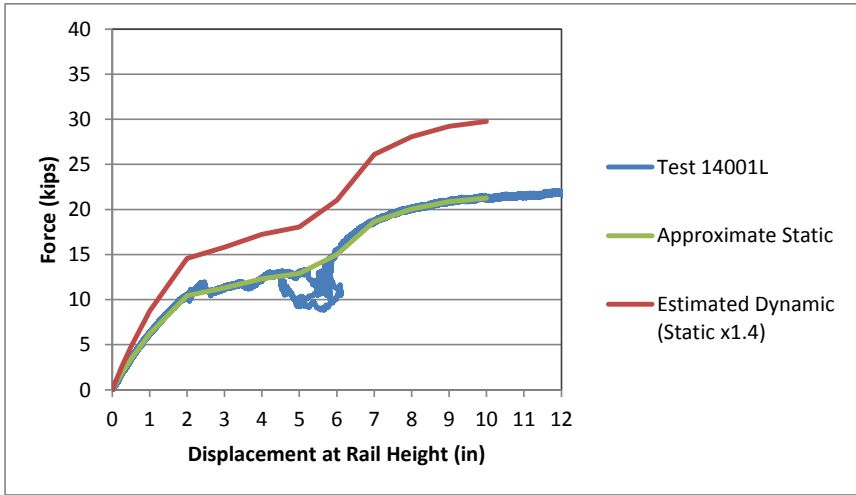
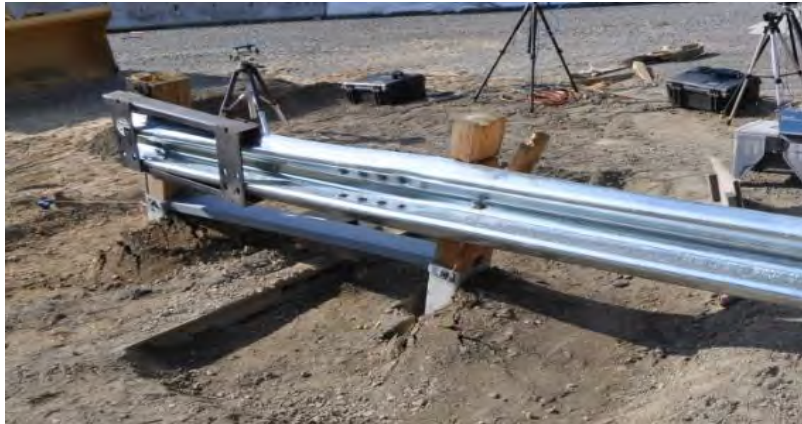
Rail Height (in):	34.5
Post Type:	BCT
Rail-to-Post 1:	Not Bolted
Rail-to-Post 2:	Bolted
Foundation Tube Type:	FMM02 (AASHTO-AGC-ARTB)
Embedment Depth:	51.0

Anchor condition:	Post 2 Split @ 5.1” disp. Soil Disp.		
Max Load (kips):	22.6		
Max Disp. at Max Load (in):	12		
	@2 in.	@4 in.	@6 in.
Force (kip):	10.4	12.3	15.0
Stiffness (k/in):	5.2	0.9	1.3
Post Test:	@Post 1	@Post 2	
Groundline Displacement (in)	6.5	4.0

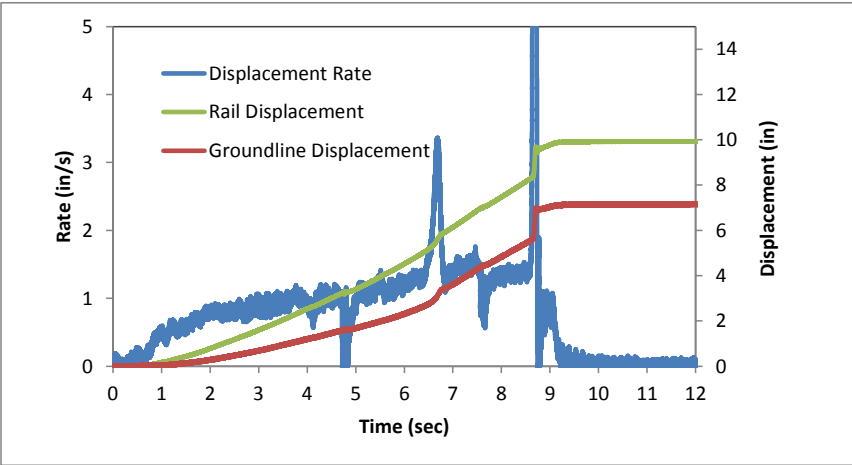
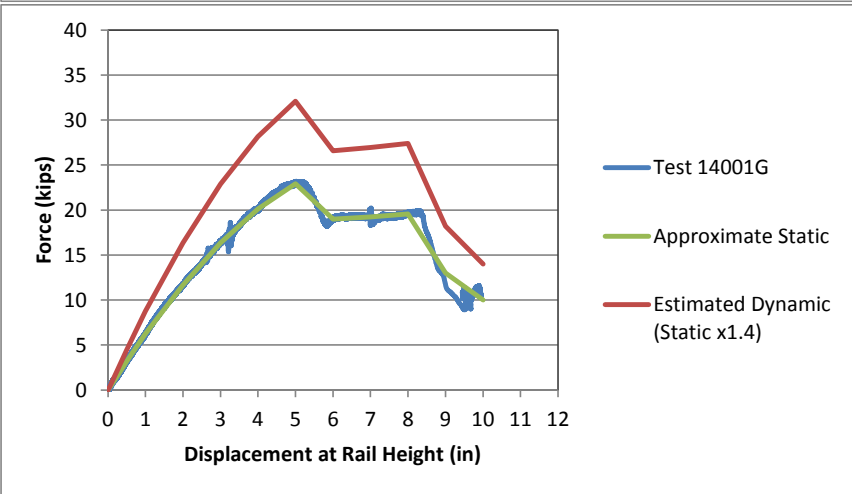
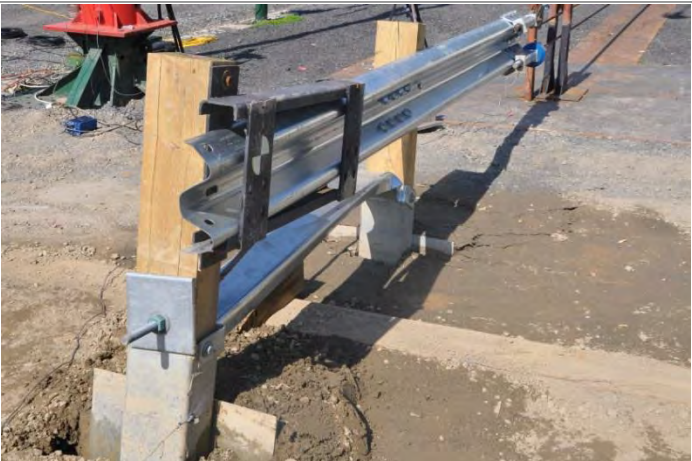
Project Case Number:	4B1_005
FOIL Test Number:	14001G
Test Date:	12-May-2014

Anchor condition:	Post 1 Partial Extraction at 5.1 in deflec. Strut Buckled @ 8 in. Soil Disp.		
Max Load (kips):	23.2		
Max Disp. at Max Load (in):	5.0		
	@2 in.	@4 in.	@6 in.
Force (kip):	11.7	20.1	19.0
Stiffness (k/in):	5.8	4.2	2.8
Post Test:	@Post 1	@Post 2

14001L	6/20/2014	6" reduced embedment	87.0	19.3	42.0	30.5	76.5	34.5	31.5	23.5	51.0	73.3	9.0	6.5
14001G	5/12/2014	8" reduced embedment	85.5	18.5	44.5	28.5	75.0	31.0	28.0	20.0	49.0	71.5	4.5	3.0
14001H	6/4/2014	1" slack in anchor cable	87.5	18.3	41.5	25.0	75.3	26.0	23.0	16.0	57.0	69.0	9.5	3.0
14001I	6/6/2014	2" slack in anchor cable	86.8	19.5	40.8	31.8	75.5	26.5	22.8	15.0	57.0	69.5	9.8	5.0
14001K	6/18/2014	3" slack in anchor cable	87.0	19.3	42.0	30.5	75.0	29.0	26.0	18.0	57.0	72.8	8.0	6.5
14001J	6/16/2014	4" slack in anchor cable	86.8	19.5	40.8	31.8	76.3	27.3	24.3	17.0	57.0	68.8	9.5	3.0

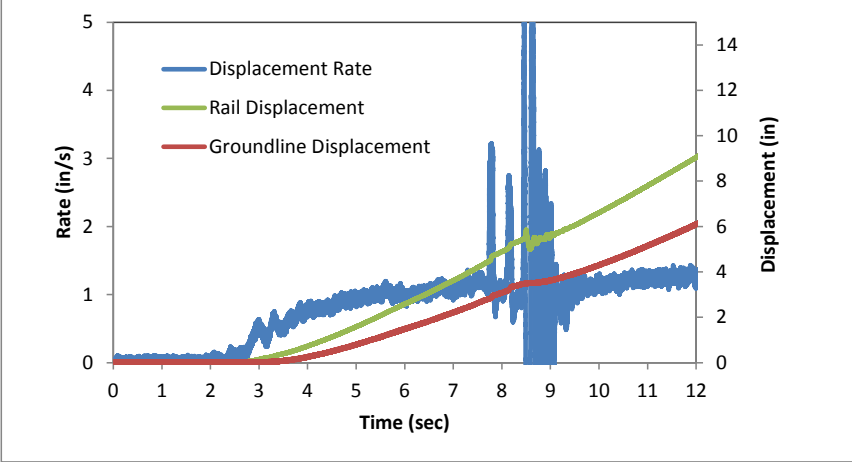
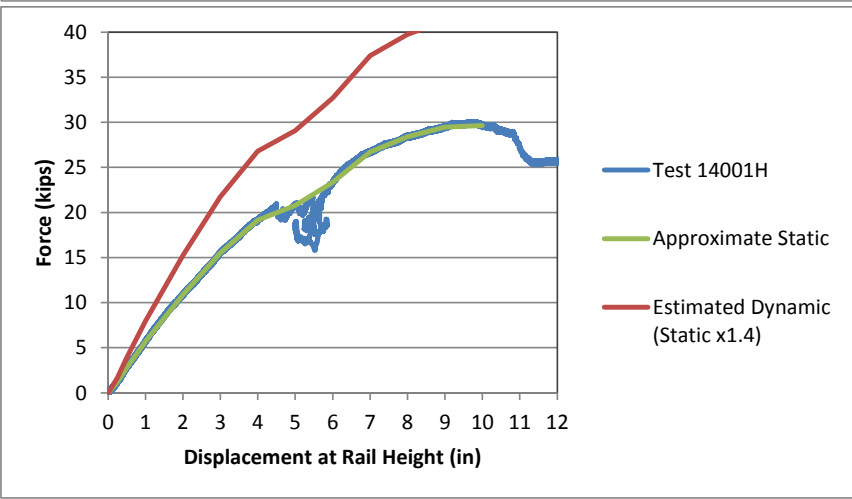
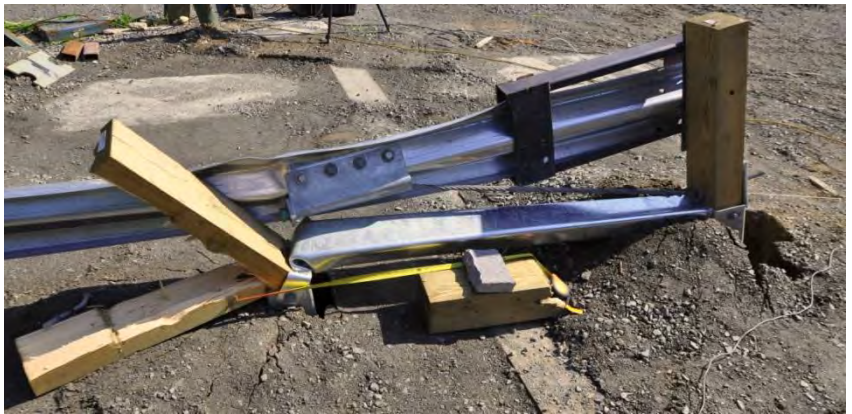
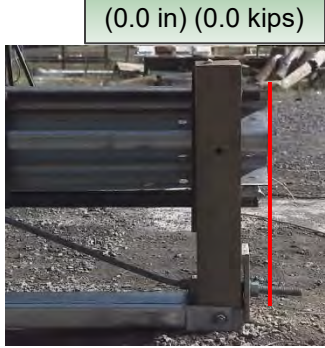
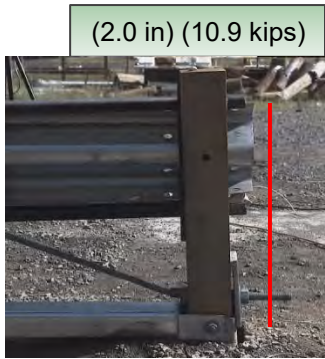
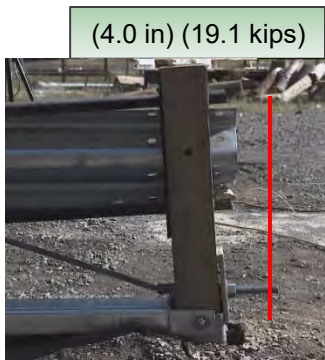
Project Case Number:	4B3_001
FOIL Test Number:	14001H
Test Date:	4-June-2014

Rail Height (in):	26.0
Post Type:	BCT
Rail-to-Post 1:	Not Bolted
Rail-to-Post 2:	Bolted
Foundation Tube Type:	FMM02 (AASHTO-AGC-ARTB)
Embedment Depth (in):	57

Anchor condition:	Post 2 Split @ 4" disp. Strut Bent @ > 10" disp. Soil Disp.		
Max Load (kips):	29.9		
Max Disp. at Max Load (in):	10		
	@2 in.	@4 in.	@6 in.
Force (kip):	10.9	19.1	23.3
Stiffness (k/in):	5.4	4.1	2.1
Post Test:	@Post 1	@Post 2	
Groundline Displacement (in)	9.5	3.0

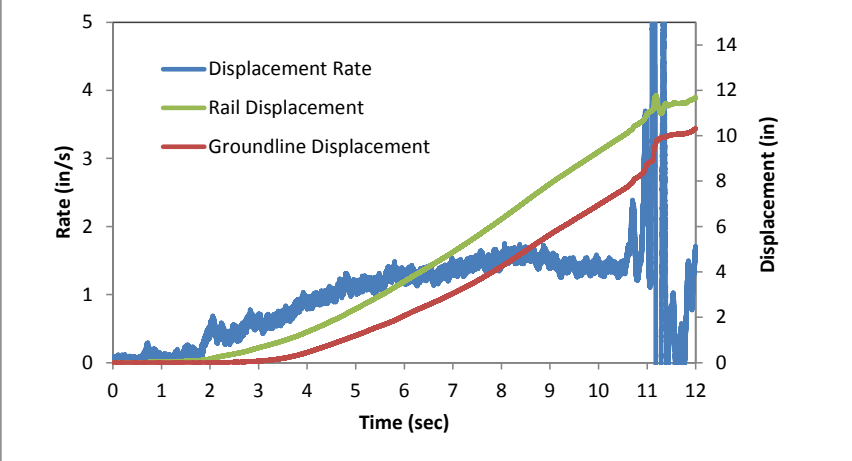
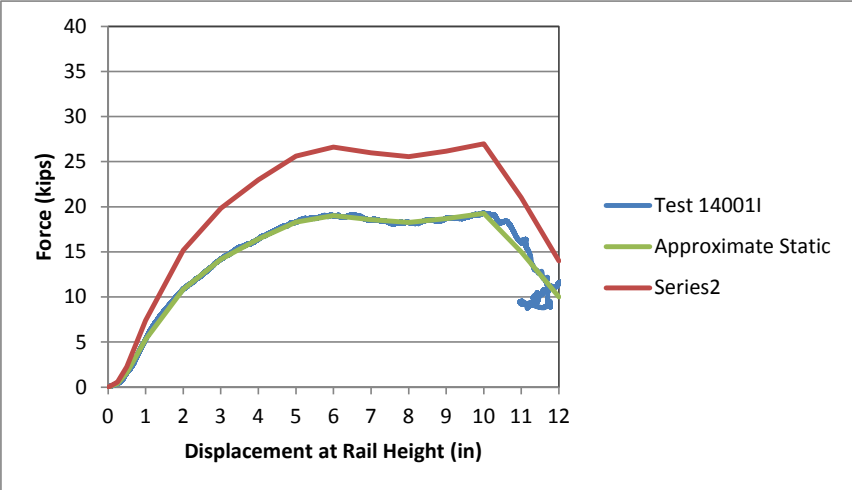
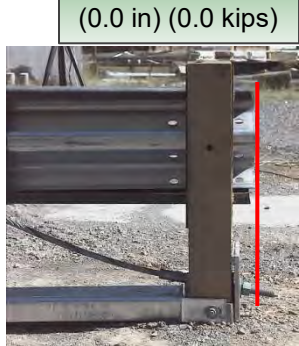
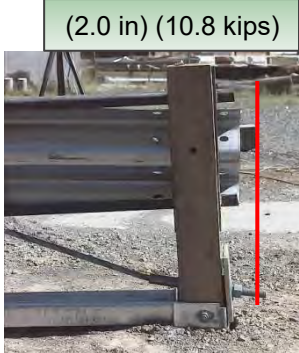
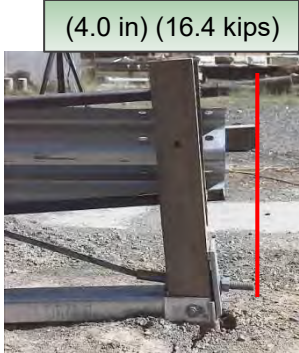
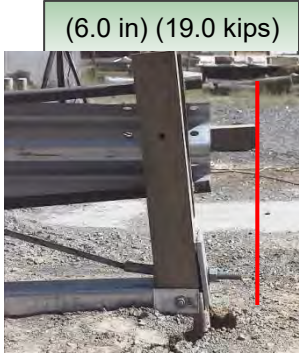
Project Case Number:	4B3_002
FOIL Test Number:	14001I
Test Date:	6-June-2014

Rail Height (in):	26.5
Post Type:	BCT
Rail-to-Post 1:	Not Bolted
Rail-to-Post 2:	Bolted
Foundation Tube Type:	FMM02 (AASHTO-AGC-ARTB)
Embedment Depth (in):	57

Mode of failure:	Post 2 Split @ 11" disp.		
Anchor condition:	Strut Bent @ 10.6" disp.		
	Soil Disp.		
Max Load (kips):	19.3		
Max Disp. at Max Load (in):	10		
	@2 in.	@4 in.	@6 in.
Force (kip):	10.8	16.4	19.0
Stiffness (k/in):	5.4	2.8	1.3

Post Test:	@Post 1	@Post 2
Groundline Displacement (in)	9.8	5.0

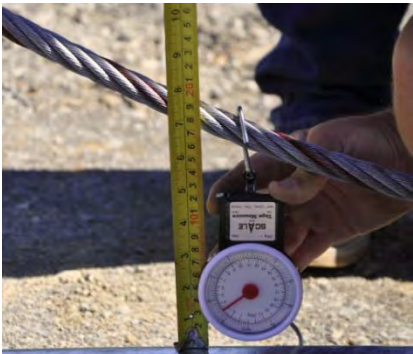
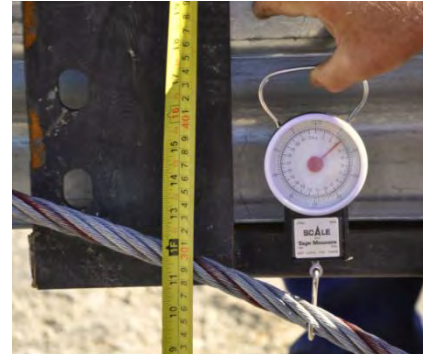
Pre-test measurements for cable slack

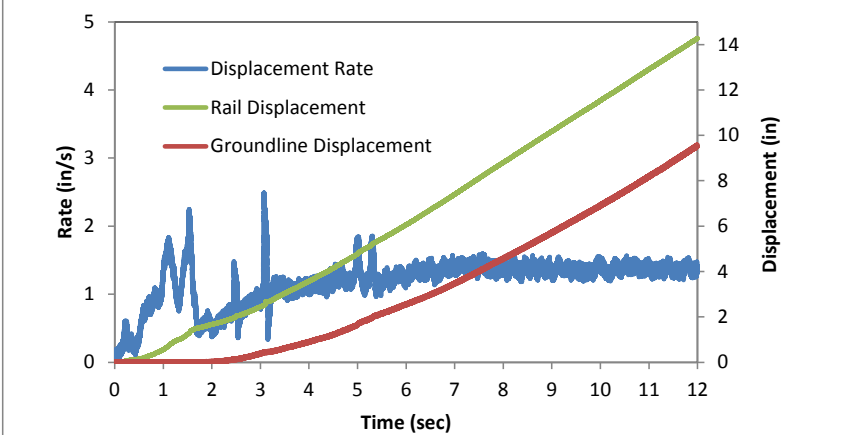
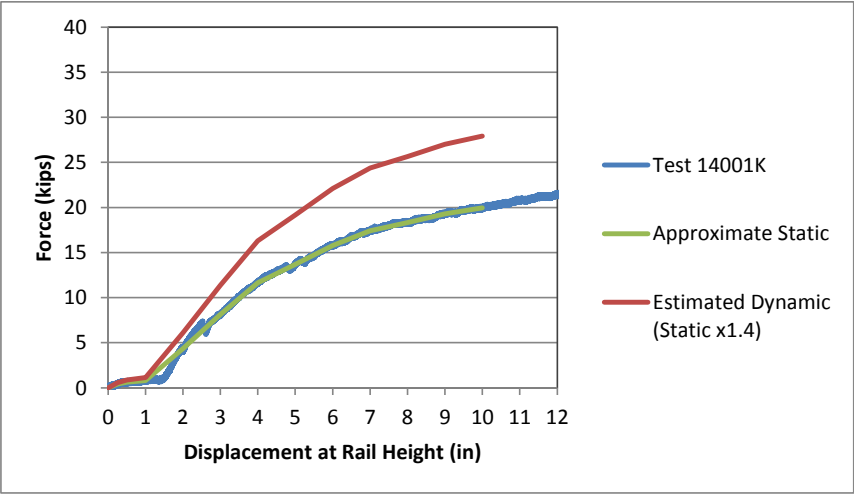
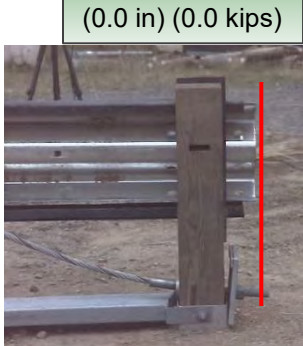
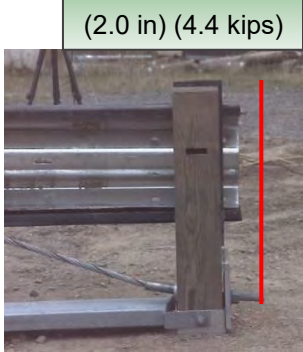
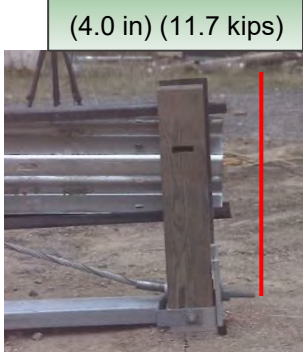
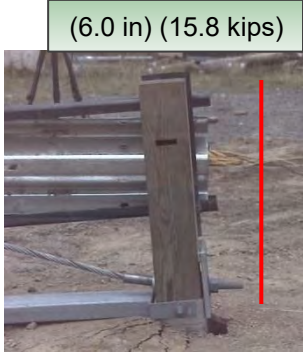
Test Information			
Project Case Number:	4B3_003		
FOIL Test Number:	14001K		
Test Date:	18-June-2014		
System Properties			
Rail Height (in):	29.0		
Post Type:	BCT		
Rail-to-Post 1:	Not Bolted		
Rail-to-Post 2:	Bolted		
Foundation Tube Type:	FMM02 (AASHTO-AGC-ARTB)		
Embedment Depth (in):	57		
Damage Type			
Category:	Slack Cable		
Level:	3"		
Soil Properties			
	@Post 1	@Post 2	
Dry Density (pcf):	140.2	144.6	
Wet Density (pcf):	148.3	151.2	
Moisture Content (%):	5.8	4.6	
Compaction (%):	93.3	93.5	
Load Properties			
Quasi-Static Rate (in/s):	≈ 1-1.4		
Method:	Winch & Cable		
Load Point 1 (in):	26.0		
Load Point 2 (in):	18.0		
Result			
Anchor condition:	Post 2 Crack @ 6.8" disp Soil Disp.		
Max Load (kips):	22.5		
Max Disp. at Max Load (in):	12		
	@2 in.	@4 in.	@6 in.
Force (kip):	4.4	11.6	15.8
Stiffness (k/in):	2.2	3.6	2.1
Post Test:	@Post 1	@Post 2	
Groundline Displacement (in)	8.0	3.0

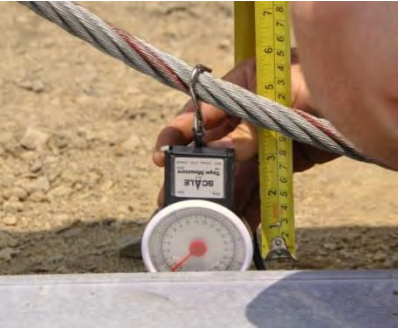
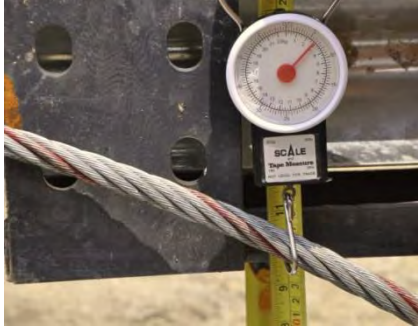
Pre-test measurements for cable slack

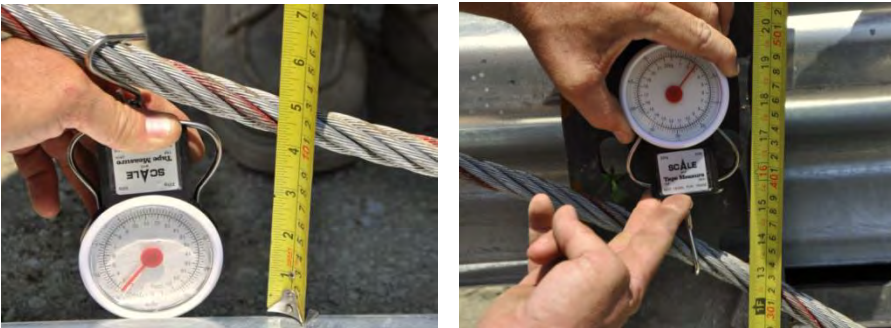
Pre-test measurements for cable slack

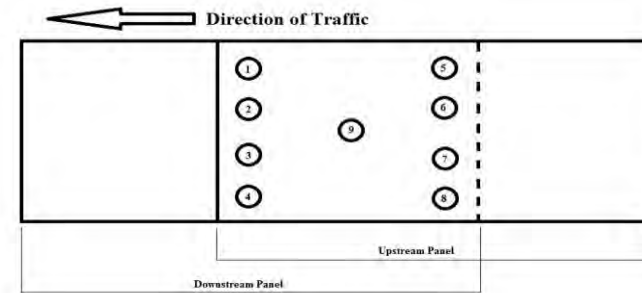
Date: 6/3/2014  
 Specimen #: 4A5\_ME001  
 Specimen ID: 108\_A  
 Specimen ID 2: panel 1-2  
 Pendulum Test No. : 14004F  
 Comment:

Location	Rail separation			Splice Bolts	Visible Hole Condition		Rail Flattening		Horizontal Tear		Verticle tear	
	Max Slip (Long.)	Traffic Face (Lat.)	Back Face (Lat.)	Condition	Upstream Panel	Downstream Panel	Upstream End	Downstream End	Upstream Panel	Downstream Panel	Upstream Panel	Downstream Panel
1	0.20											
2												
3				Loose								
4		0.125										
5												
6												
7				Loose								
8				Loose								
9						H-Tear						
Top section							8.5	8.5				
Bottom section							6.25	5.25				
Middle section												
Top edge												
Bottom edge												
Downstream edge												
Upstream edge

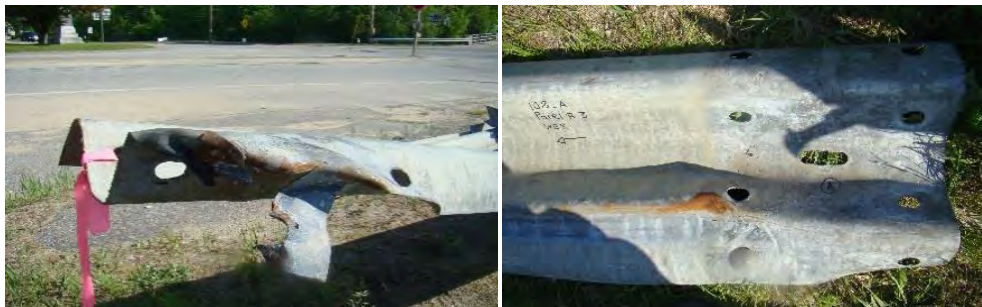
Date: 6/3/2014  
 Specimen #: 4A5\_ME003  
 Specimen ID: 108\_B  
 Specimen ID 2:  
 Pendulum Test No. : 14004A  
 Comment:

Other Damages Noted:  
 Rail Fold at top, downstream corner.

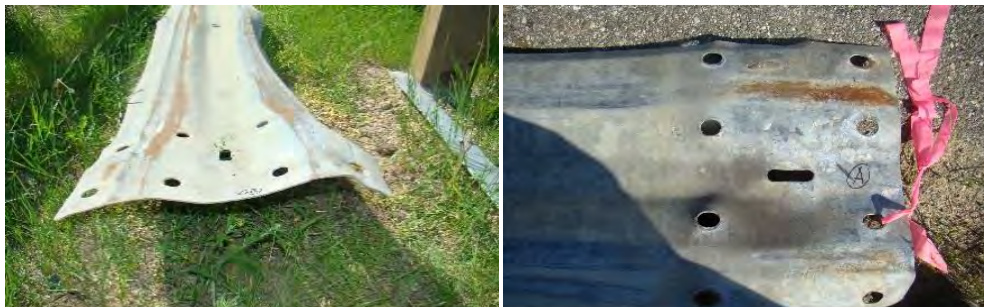
Date: 6/3/2014  
 Specimen #: 4A5\_ME007  
 Specimen ID: 108\_E  
 Specimen ID 2: Panel 2-3  
 Pendulum Test No. : 14004L  
 Comment:

**Other Damages Noted:**  
 Visible bolt rotation at num. 2, 5 and 6.
