# **A Guide for W-Beam Guardrail Damage Assessment**

A Field Manual for  
Highway Maintenance Personnel

National Cooperative  
Highway Research  
Program  
Project 22-28

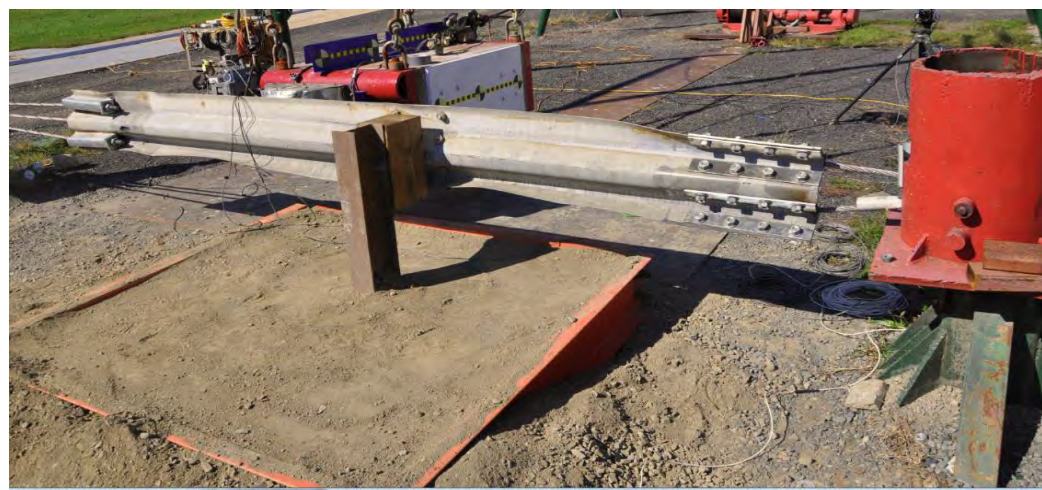
# Test Setup

- ▶ The test article was a 13-ft long section of w-beam rail with a w-beam splice located at 65 inches from the downstream end.
- ▶ Each end of the rail was constrained from longitudinal displacement using two 0.75-inch diameter cables (i.e., AASHTO-AGC-ARTBA FCA01) fastened onto the ends of the rail.

- ▶ On the downstream end, the cables were fastened to two standard cable anchor brackets (i.e., AASHTO-AGC-ARTBA FPA01). Each bracket was bolted onto the rail using eight  $\frac{1}{2}$ -inch bolts and nuts with  $1\frac{1}{16}$  inch diameter washers under the bolt heads and two  $2.5 \times 15 \times \frac{1}{4}$ -inch steel bearing plates under the nuts.

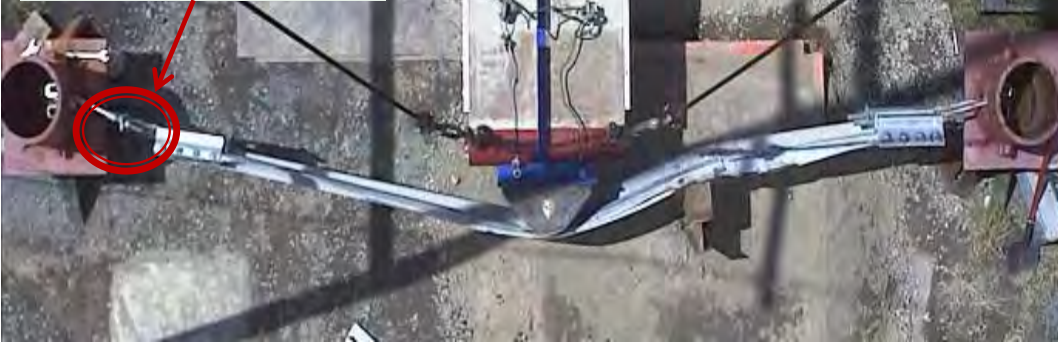
<b>Test Information</b>	
Project Case Number:	4A5_ME003
FOIL Test Number:	14004A
Test Date:	13-August-2014
<b>System Properties</b>	
Rail Height:	27.25 inches
Post Type:	W6x16
Blockout Type:	6x8x10"Routed Wood
Foundation Type:	Grading B of AASHTO M147-95
Embedment Depth (in):	44
<b>Damage Type</b>	
Category:	Pre-Test
Level:	N.A.
<b>Soil Properties</b>	
Dry Density :	xpcf
Wet Density :	xpcf
Moisture Content:	x%
Compaction:	x%
<b>Impact Conditions</b>	
Pendulum Mass:	4,360 lb
Impact Velocity:	17.7 mph
Impact Energy:	545.0 kip-in
Load Point :	37.5 inches upstream of splice
Impact Orientation:	Perpendicular to rail
<b>Result</b>	
Groundline Post Deflection	
Splice Slip	
Splice Rupture	
Rail Tear	
Boundary Failure	Cable bracket failure
Max Force	35.6 kip
Max Deflection	
Total Energy	475 kip-in

End of Anchor  
Bracket Pulled off

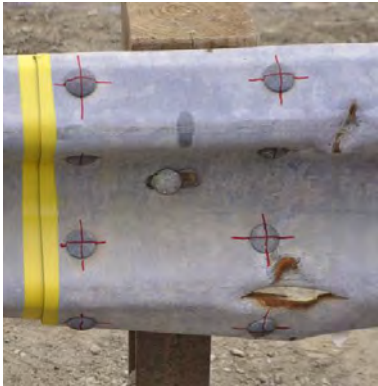
<b>Test Information</b>	
Project Case Number:	4A5_ME005
FOIL Test Number:	14004B
Test Date:	14-August-2014
<b>System Properties</b>	
Rail Height:	27.25 inches
Post Type:	W6x16
Blockout Type:	6x8x10"Routed Wood
Foundation Type:	Grading B of AASHTO M147-95
Embedment Depth (in):	44
<b>Damage Type</b>	
Category:	Pre-Test
Level:	N.A.
<b>Soil Properties</b>	
Dry Density :	x %
Wet Density :	x %
Moisture Content:	x %
Compaction:	x %
<b>Impact Conditions</b>	
Pendulum Mass:	4,360 lb
Impact Velocity:	20.2 mph
Impact Energy:	711.7 kip-in
Load Point :	37.5 inches upstream of splice
Impact Orientation:	Perpendicular to rail
<b>Result</b>	
Groundline Post Deflection	
Splice Slip	
Splice Rupture	
Rail Tear	
Boundary Failure	Cable rupture
Max Force	54.2 kip
Max Deflection	
Total Energy	661.6 kip-in

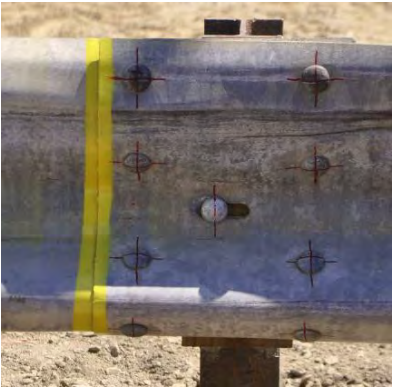
<b>Test Information</b>	
Project Case Number:	4A5_ME008
FOIL Test Number:	14004C
Test Date:	15-August-2014
<b>System Properties</b>	
Rail Height:	27.25 inches
Post Type:	W6x16
Blockout Type:	6x8x10"Routed Wood
Foundation Type:	Grading B of AASHTO M147-95
Embedment Depth (in):	44
<b>Damage Type</b>	
Category:	Pre-Test
Level:	N.A.
<b>Soil Properties</b>	
Dry Density :	x %
Wet Density :	x %
Moisture Content:	x %
Compaction:	x %
<b>Impact Conditions</b>	
Pendulum Mass:	4,360 lb
Impact Velocity:	18.6 mph
Impact Energy:	604.6 kip-in
Load Point :	37.5 inches upstream of splice
Impact Orientation:	Perpendicular to rail
<b>Result</b>	
Groundline Post Deflection	
Splice Slip	
Splice Rupture	
Rail Tear	Yes
Boundary Failure	Rail tear at upstream boundary
Max Force	48.7 kip
Max Deflection	
Total Energy	604.6 kip-in

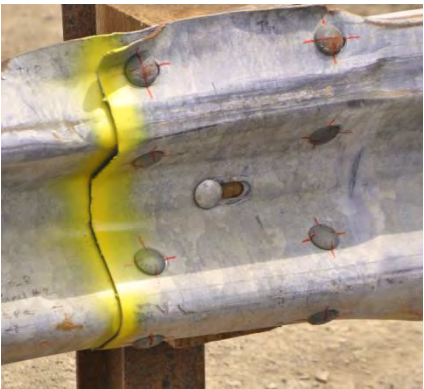
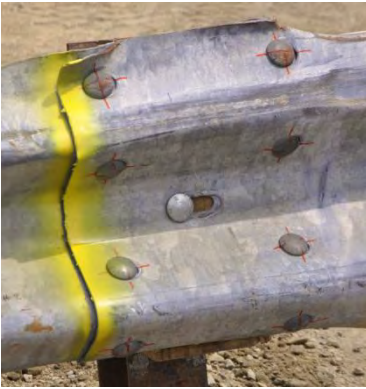
<u>Impact Conditions</u>	
Pendulum Mass:	4,360 lb
Impact Velocity:	18.9 mph
Impact Energy:	623.6 kip-in
Load Point :	37.5 inches upstream of splice
Impact Orientation:	Perpendicular to rail

<u>Result</u>	
Groundline Post Deflection	
Splice Slip	
Splice Rupture	
Rail Tear	
Boundary Failure	Friction slip of anchor cables
Max Force	37.9 kip
Max Deflection	
Total Energy	623.6 kip-in

Pre-Test

Post-Test

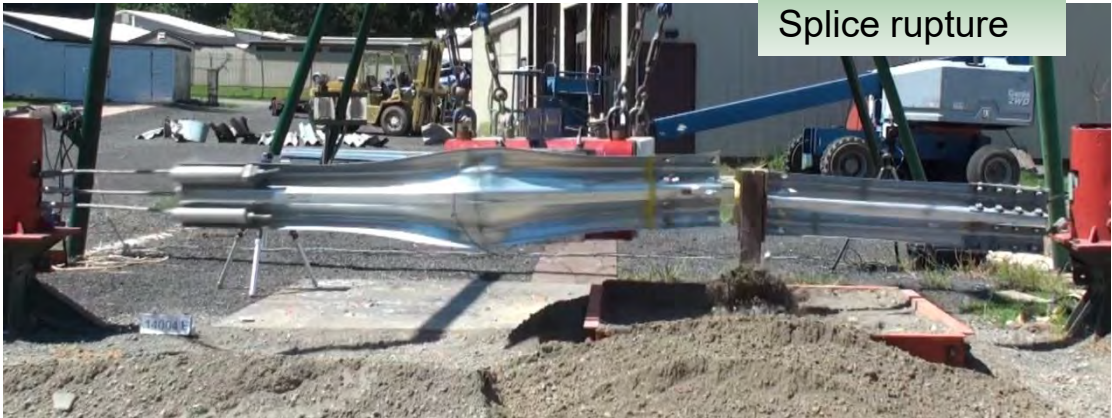
<b>Test Information</b>	
Project Case Number:	4A5_NEW01
FOIL Test Number:	14004E
Test Date:	25-August-2014
<b>System Properties</b>	
Rail Height:	27.25 inches
Post Type:	W6x16
Blockout Type:	6x8x10"Routed Wood
Foundation Type:	Grading B of AASHTO M147-95
Embedment Depth (in):	44
<b>Damage Type</b>	
Category:	Undamaged Rail
Level:	N.A.
<b>Soil Properties</b>	
Dry Density :	116.9 pcf
Wet Density :	135.5 pcf
Moisture Content:	4.4%
Compaction:	97.8%
<b>Impact Conditions</b>	
Pendulum Mass:	4,360 lb
Impact Velocity:	20.6 mph
Impact Energy:	738.7
Load Point :	37.5 inches upstream of splice
Impact Orientation:	Perpendicular to rail
<b>Result</b>	
Groundline Post Deflection	
Splice Slip	
Splice Rupture	Bolt tear out
Rail Tear	
Boundary Failure	
Max Force	40.4 kip
Max Deflection	
Total Energy	425.2 kip-in

Splice rupture

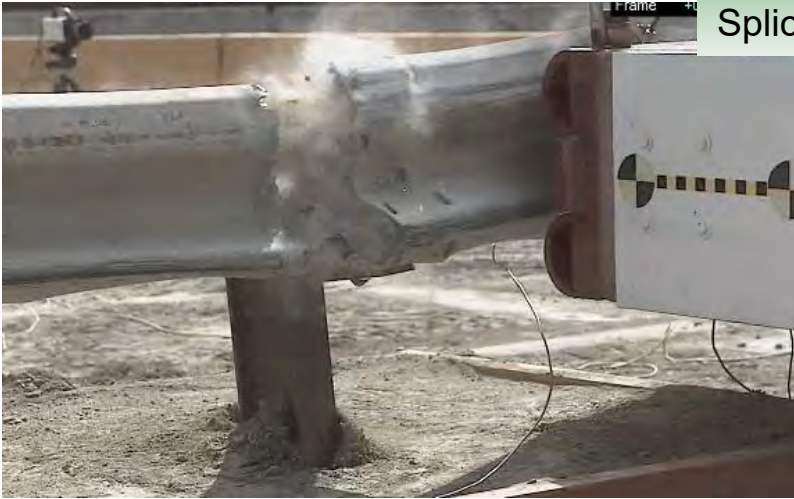
Groundline Post Deflection	
Splice Slip	
Splice Rupture	Tear at downstream bolt-holes
Rail Tear	
Boundary Failure	
Max Force	43.2 kip
Max Deflection	
Total Energy	436.8 kip-in

Splice rupture

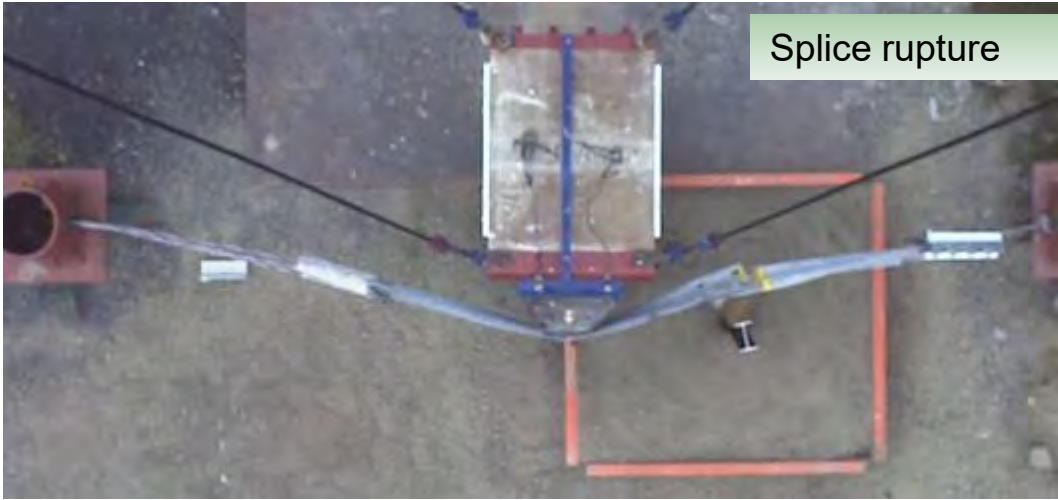
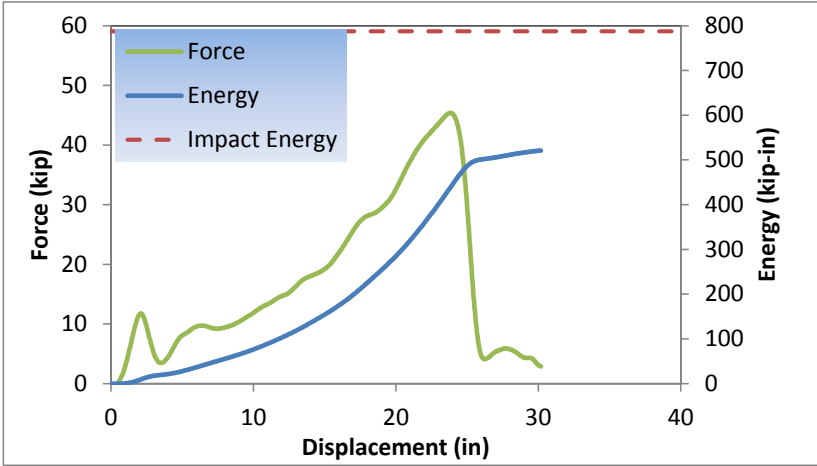
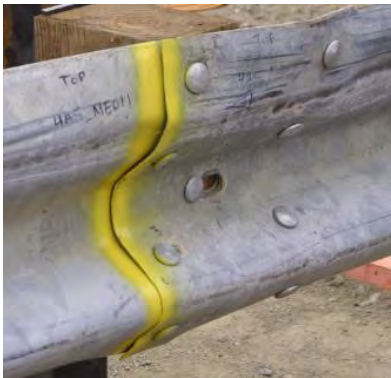
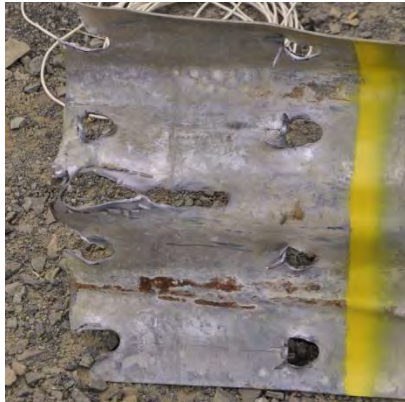
Groundline Post Deflection	
Splice Slip	
Splice Rupture	Bolt tear out
Rail Tear	
Boundary Failure	
Max Force	45.4 kip
Max Deflection	
Total Energy	550.0 kip-in

Pre-Test

Post-Test

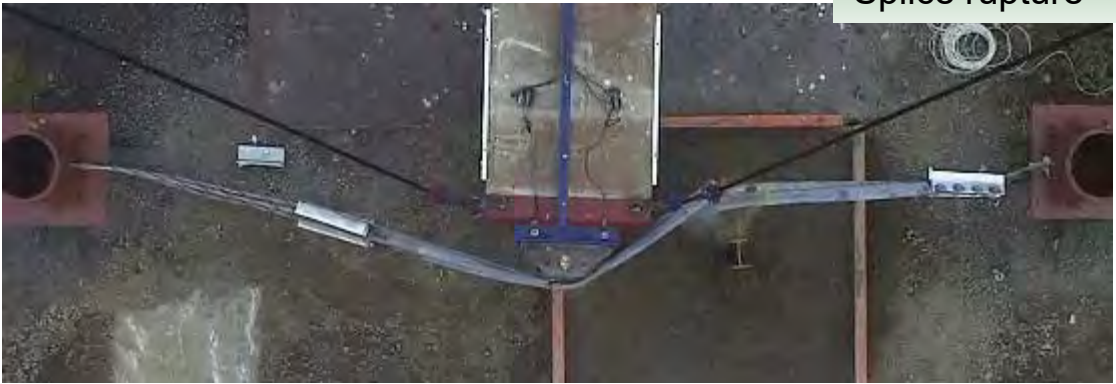
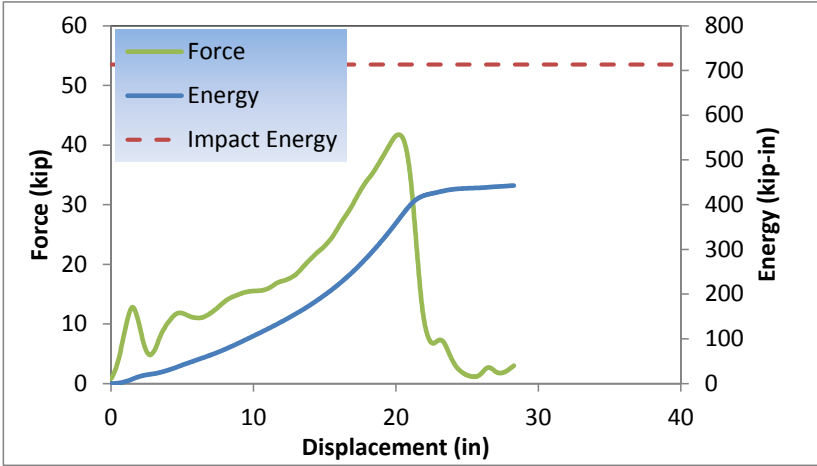
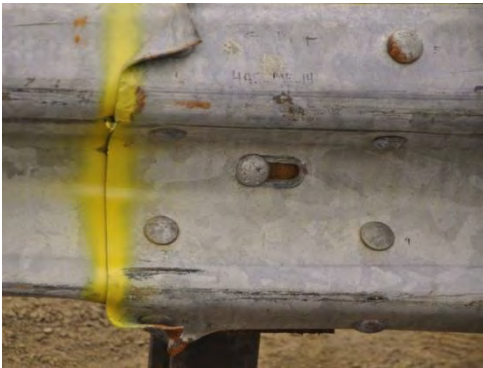
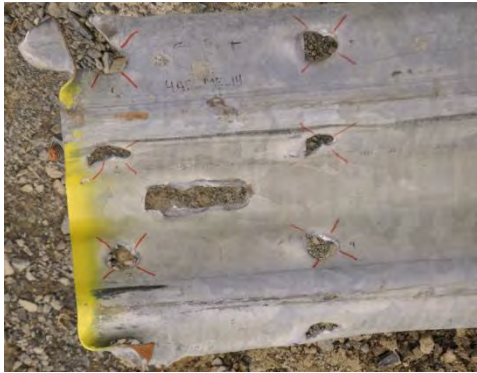
Groundline Post Deflection	
Splice Slip	
Splice Rupture	Bolt tear out
Rail Tear	
Boundary Failure	
Max Force	41.7 kip
Max Deflection	
Total Energy	442.9 kip-in

Pre-Test

Post-Test

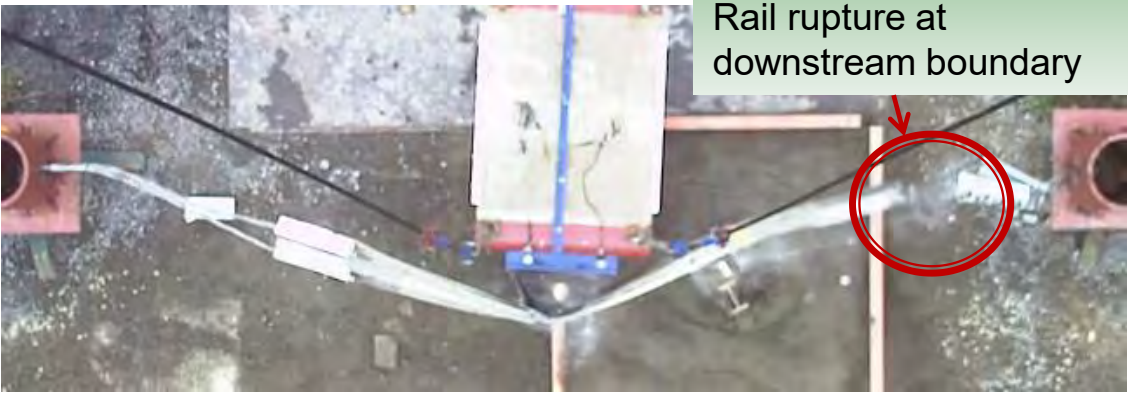
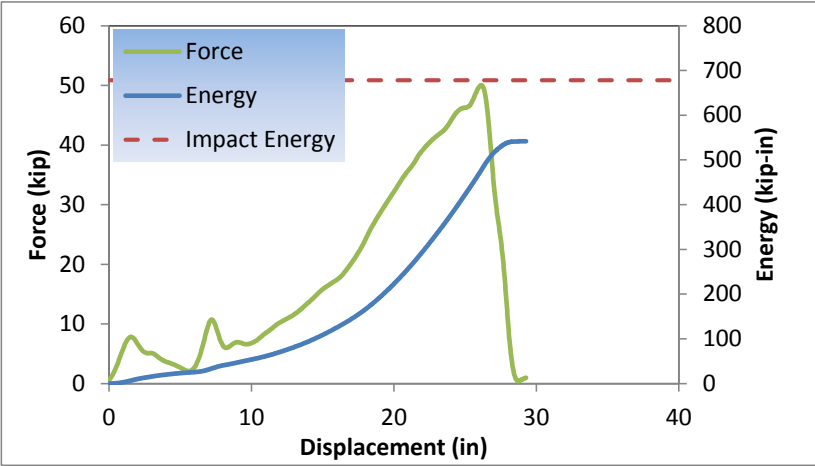
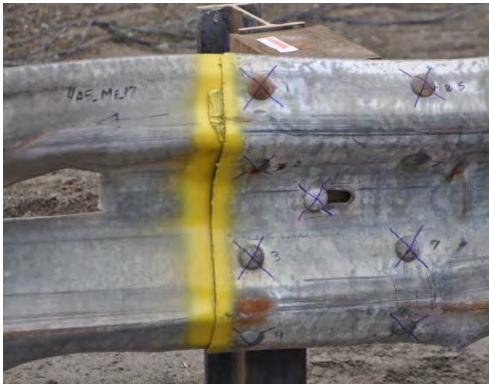
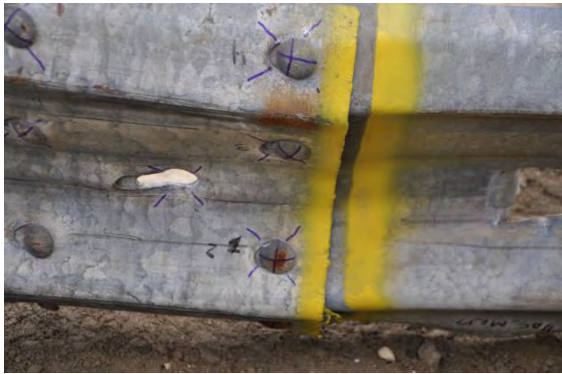
Test Information	
Project Case Number:	4A5_ME0017
FOIL Test Number:	14004I
Test Date:	1-October-2014

Damage Type	
Category:	Longitudinal Slip
Level:	0.25 inches

Impact Conditions	
Pendulum Mass:	4,360 lb
Impact Velocity:	19.7 mph
Impact Energy:	678.2 kip-in
Load Point :	37.5 inches upstream of splice
Impact Orientation:	Perpendicular to rail

Result	
Groundline Post Deflection	
Splice Slip	
Splice Rupture	
Rail Tear	Yes
Boundary Failure	Rail tear at downstream boundary
Max Force	50.1 kip
Max Deflection	
Total Energy	541.8 kip-in

Pre-Test

Post-Test

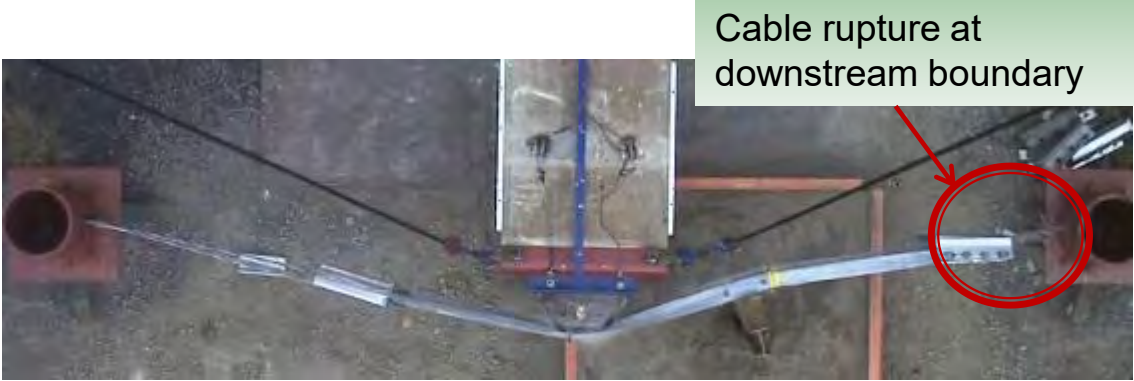
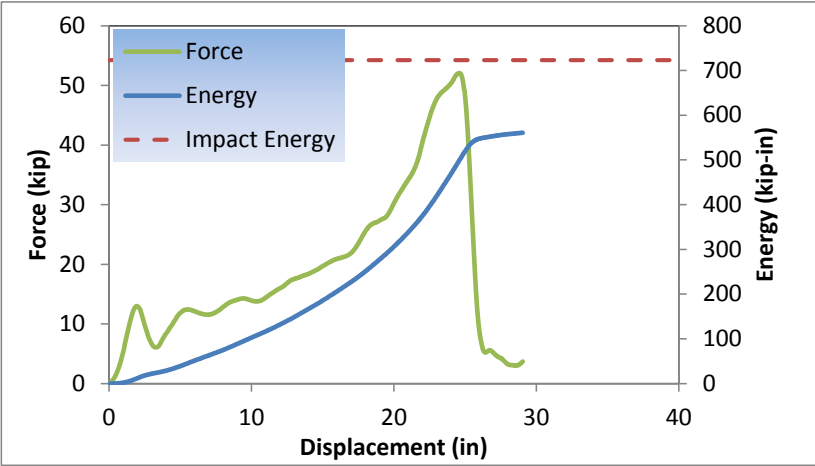
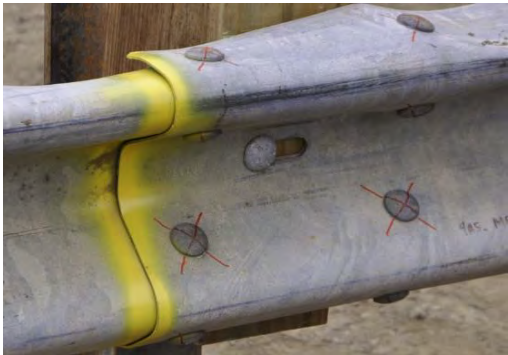
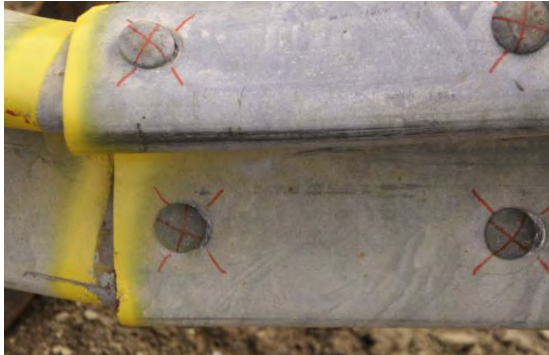
<b>Test Information</b>	
Project Case Number:	4A5_ME004
FOIL Test Number:	14004J
Test Date:	7-October-2014
<b>System Properties</b>	
Rail Height:	27.25 inches
Post Type:	W6x16
Blockout Type:	6x8x10"Routed Wood
Foundation Type:	Grading B of AASHTO M147-95
Embedment Depth (in):	44
<b>Damage Type</b>	
Category:	Rail Crush
Level:	30.6%
<b>Soil Properties</b>	
Dry Density :	144.9 pcf
Wet Density :	150.4 pcf
Moisture Content:	3.8%
Compaction:	96.5%
<b>Impact Conditions</b>	
Pendulum Mass:	4,360 lb
Impact Velocity:	20.3 mph
Impact Energy:	723.0 kip-in
Load Point :	37.5 inches upstream of splice
Impact Orientation:	Perpendicular to rail
<b>Result</b>	
Groundline Post Deflection	
Splice Slip	
Splice Rupture	
Rail Tear	
Boundary Failure	Cable rupture at downstream boundary
Max Force	52.1 kip
Max Deflection	
Total Energy	561.0 kip-in

Pre-Test

Post-Test

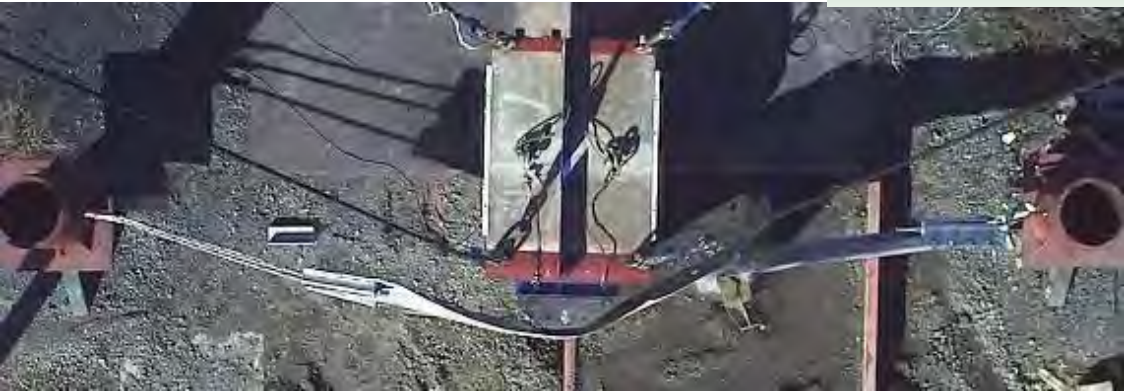
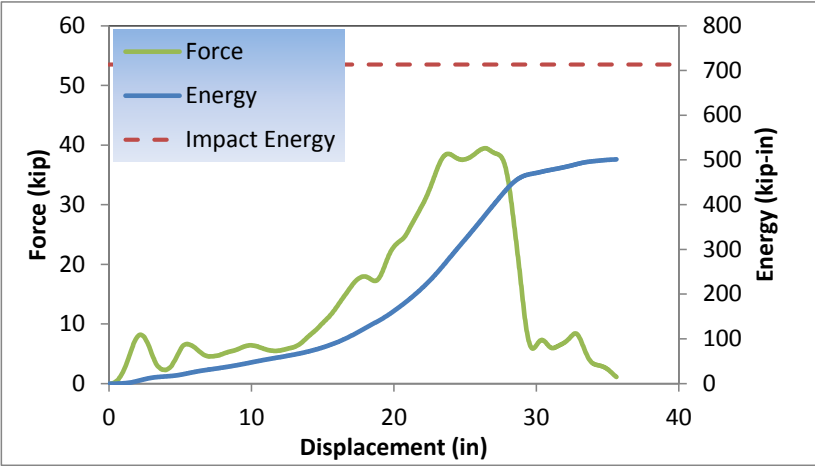
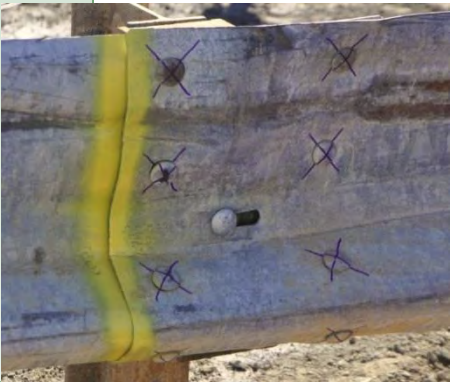
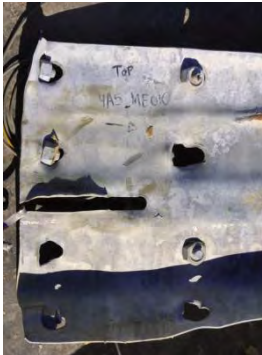
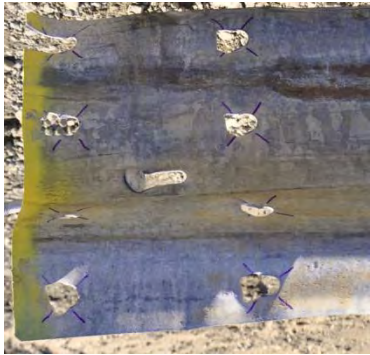
Test Information	
Project Case Number:	4A5_ME010
FOIL Test Number:	14004K
Test Date:	9-October-2014

Damage Type	
Category:	Splice Lateral Separation
Level:	0.55 inches

Impact Conditions	
Pendulum Mass:	4,360 lb
Impact Velocity:	20.2 mph
Impact Energy:	713.1 kip-in
Load Point :	37.5 inches upstream of splice
Impact Orientation:	Perpendicular to rail

Result	
Groundline Post Deflection	
Splice Slip	
Splice Rupture	Bolt teat out
Rail Tear	
Boundary Failure	
Max Force	39.5 kip
Max Deflection	
Total Energy	501.2 kip-in

Splice rupture

Pre-Test

Downstream Panel

Upstream Panel

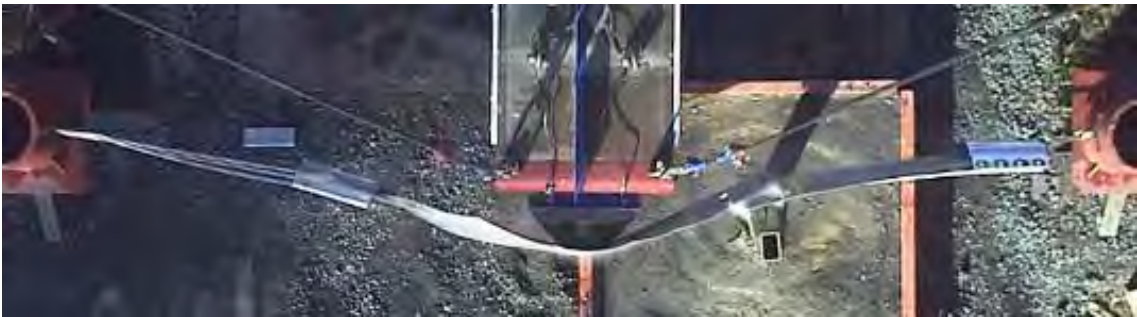
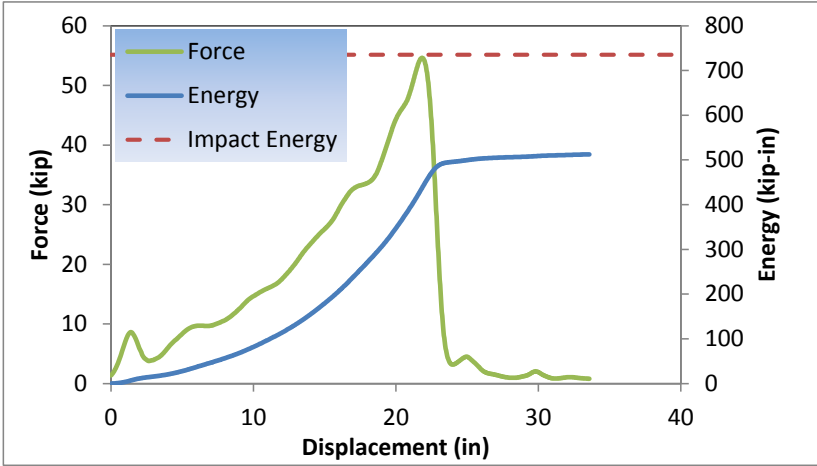
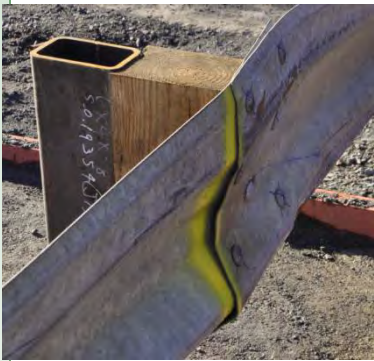
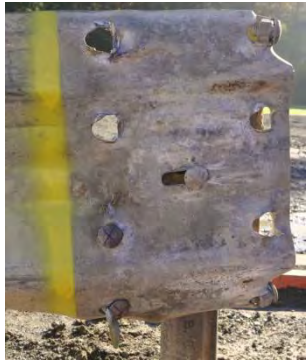
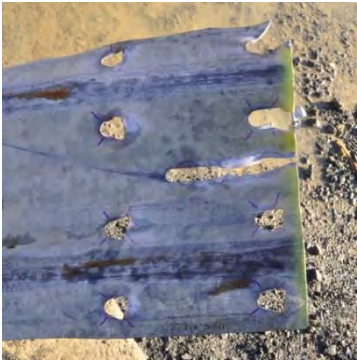
Groundline Post Deflection	
Splice Slip	
Splice Rupture	Bolt teat out
Rail Tear	
Boundary Failure	
Max Force	54.6 kip
Max Deflection	
Total Energy	512.5 kip-in

Splice rupture

Pre-Test

Downstream Panel

Upstream Panel

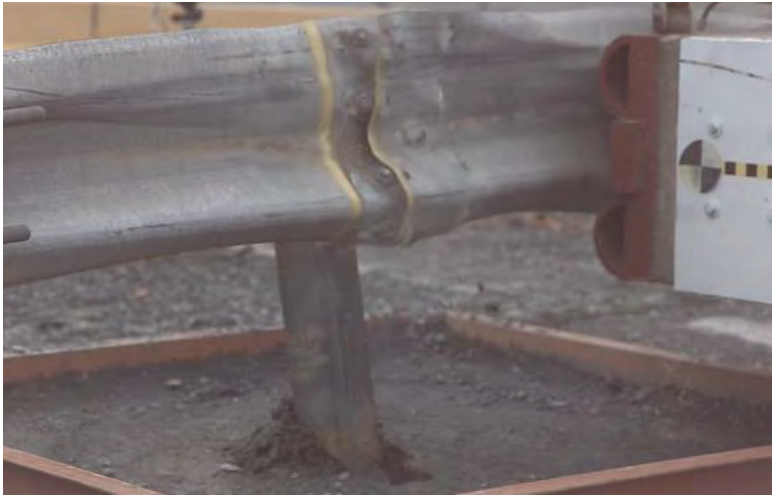
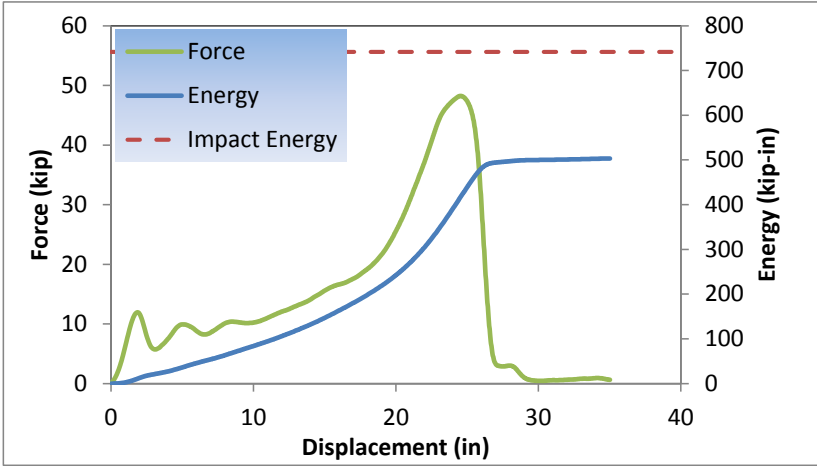
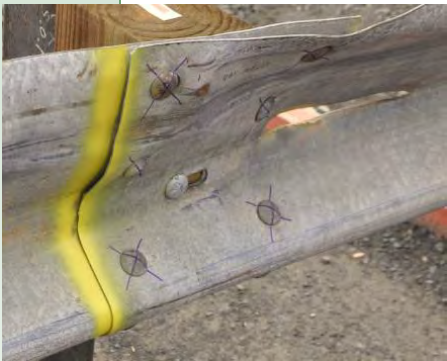
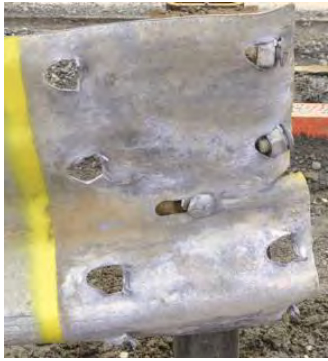
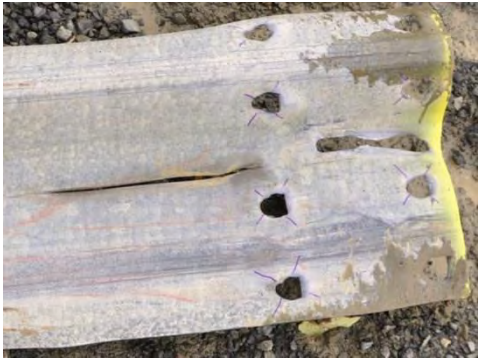
Splice rupture

Pre-Test

Downstream Panel

Upstream Panel

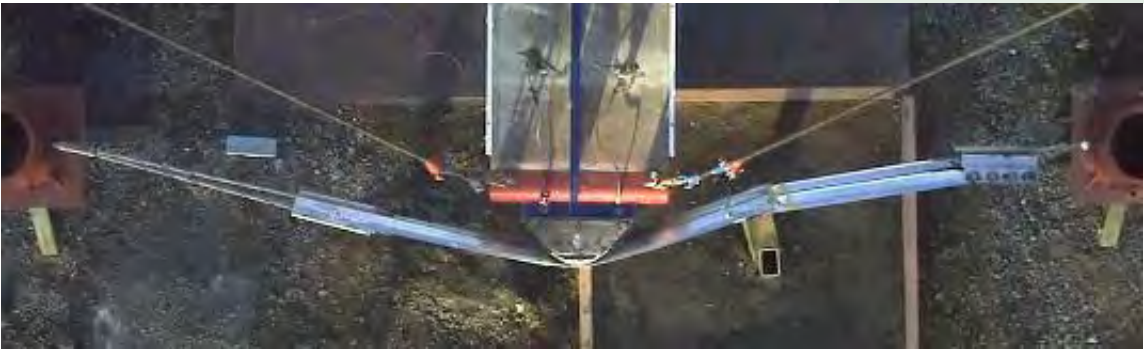
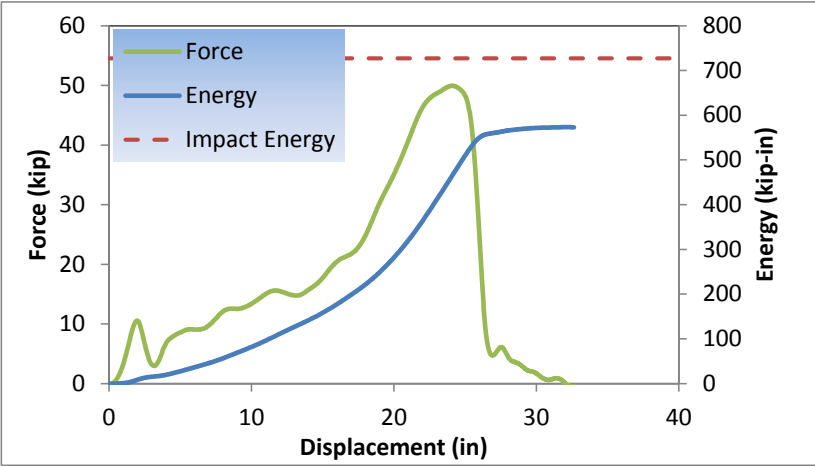
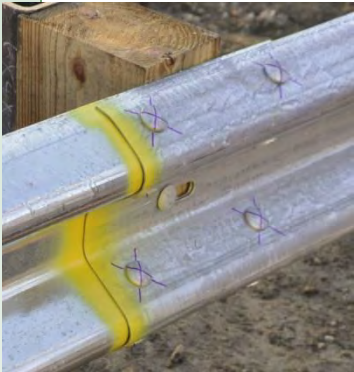
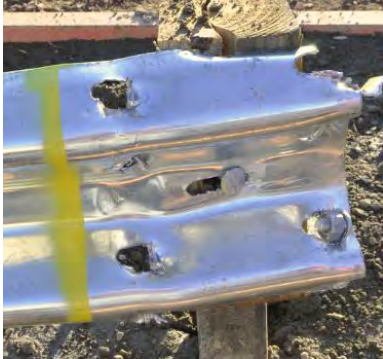
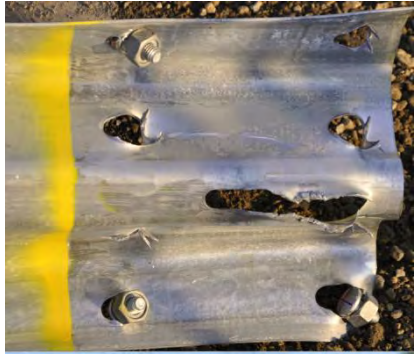
Splice rupture

Pre-Test

Downstream Panel

Upstream Panel

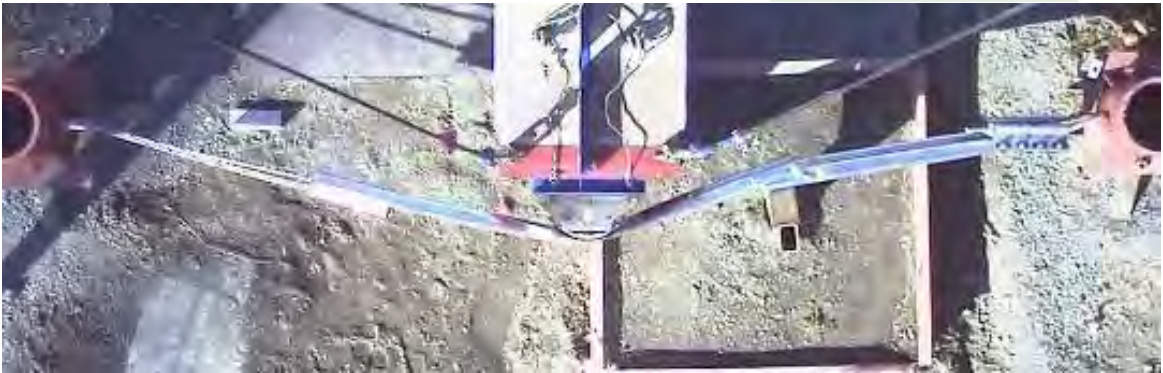
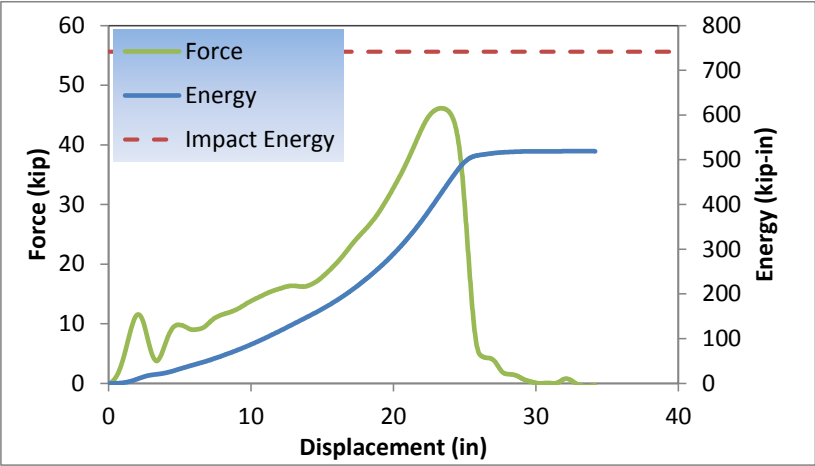
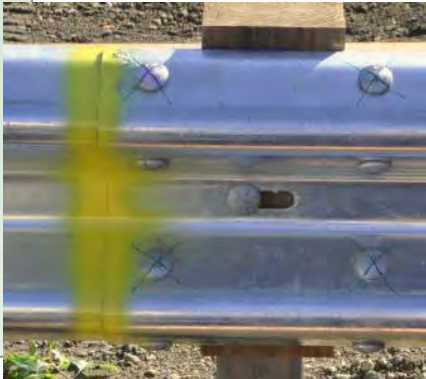
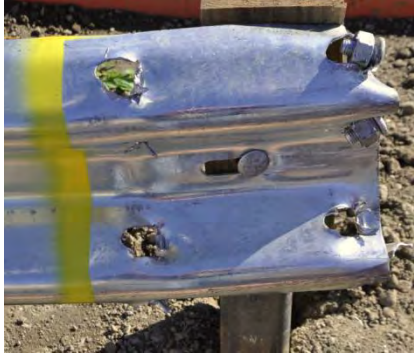
<b>Test Information</b>	
Project Case Number:	4A5_NEW03
FOIL Test Number:	14004O
Test Date:	30-October-2014
<b>System Properties</b>	
Rail Height:	27.25 inches
Post Type:	W6x16
Blockout Type:	6x8x10"Routed Wood
Foundation Type:	Grading B of AASHTO M147-95
Embedment Depth (in):	44
<b>Damage Type</b>	
Category:	Undamaged Rail
Level:	N.A.
<b>Soil Properties</b>	
Dry Density :	147.5 pcf
Wet Density :	155.1 pcf
Moisture Content:	5.1%
Compaction:	98.2%
<b>Impact Conditions</b>	
Pendulum Mass:	4,360 lb
Impact Velocity:	20.6 mph
Impact Energy:	741.6
Load Point :	37.5 inches upstream of splice
Impact Orientation:	Perpendicular to rail
<b>Result</b>	
Groundline Post Deflection	
Splice Slip	
Splice Rupture	Bolt tear out
Rail Tear	
Boundary Failure	
Max Force	46.1 kip
Max Deflection	
Total Energy	519.5 kip-in

Splice rupture

Pre-Test

Downstream Panel

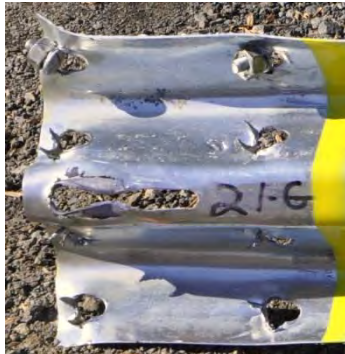
Post-Test
