SHRP-H-352

Innovative Materials Development and Testing

Volume 1: Project Overview

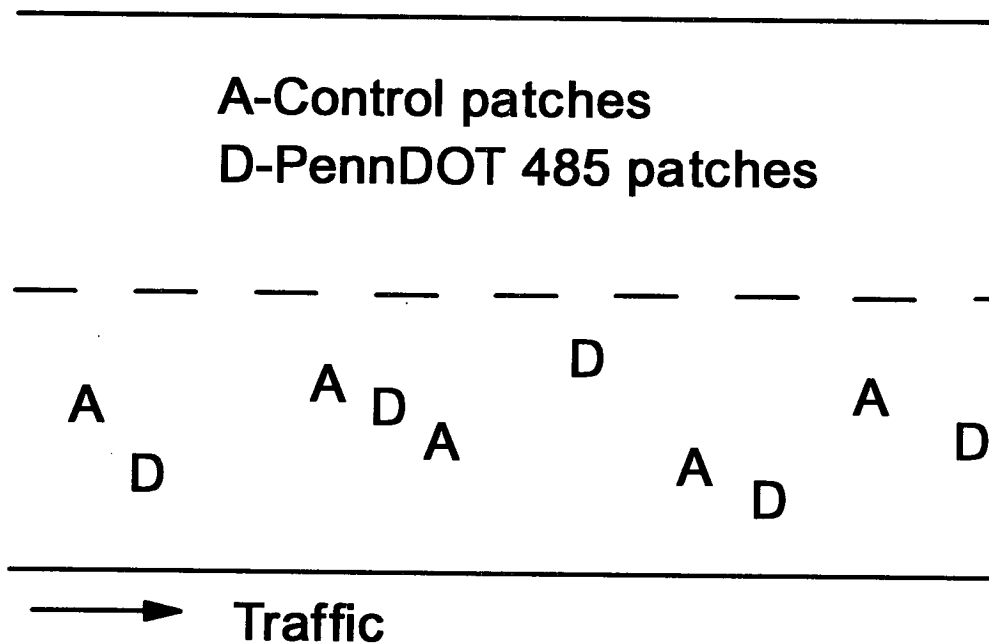
Figure 3. Repair placement order for pothole repair project

The UPM High Performance Cold Mix, placed using the rapid placement method, was the "control" at all sites. The placement of these patches, as well as one other patch type (material and procedure), was to be alternated in such a way that each day's production would consist of 10 control and 10 experimental patches placed as shown in figure 3. A direct comparison could then be made between the control and experimental repairs without its being confounded by other factors, such as temperature at the time of placement.

Ideally, each of the experimental materials would have been placed using each of the repair procedures. Due to budgetary considerations (and to limit the number of patches needed from the participating agencies) it was decided that only one material, UPM High Performance Cold Mix, would be used with all the procedures. This approach would provide a comparison among the three procedures and would allow for evaluation of all of the materials under the harshest placement procedure, the throw-and-roll.
