Concrete Overlays of Asphalt

TRB Webinar: Concrete Overlays of Asphalt

Julie M. Vandebossche, P.E., Ph.D.

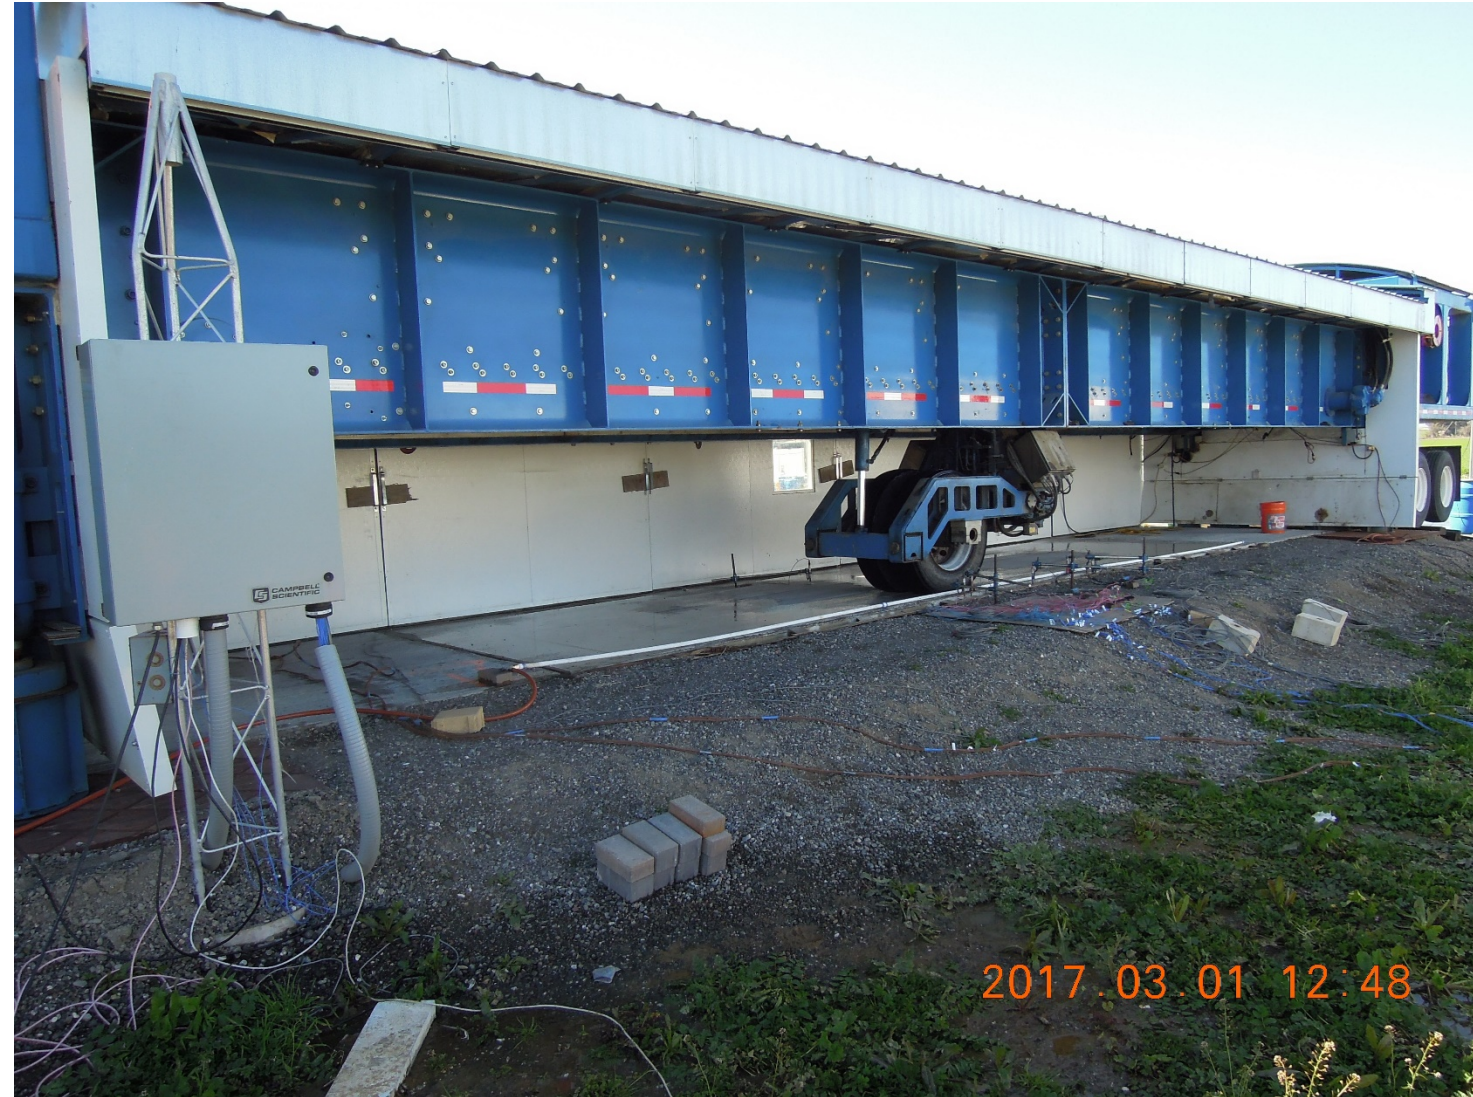
What is the HVS?

- 800 load repetitions per hour
- Up to 25 kip (110 kN) wheel load

...the HVS intends to reproduce long-term in-service traffic damage in a compressed time period.

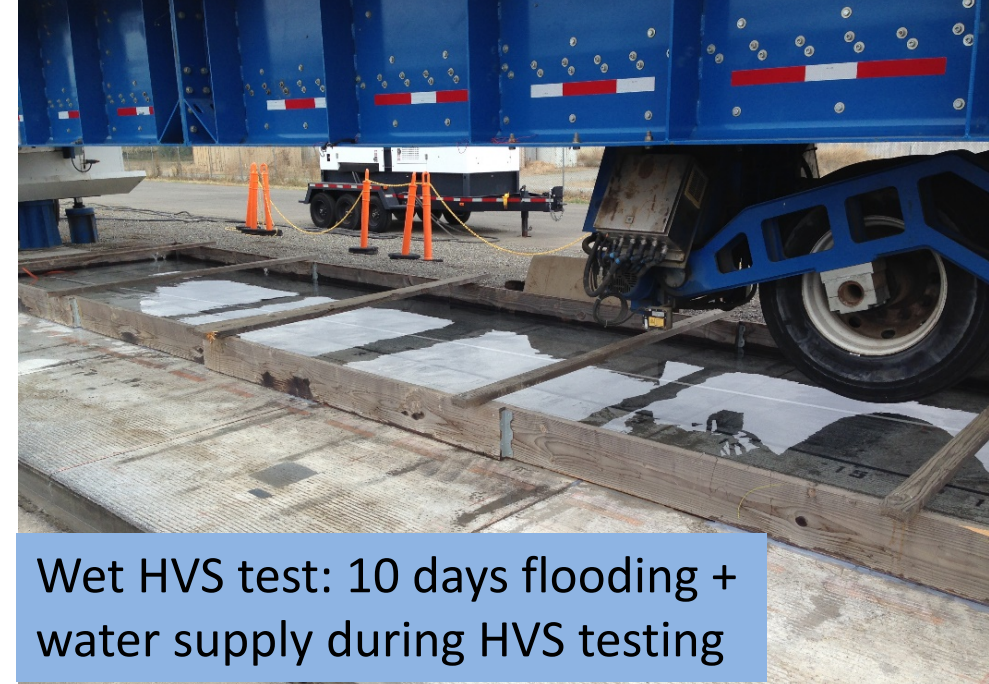
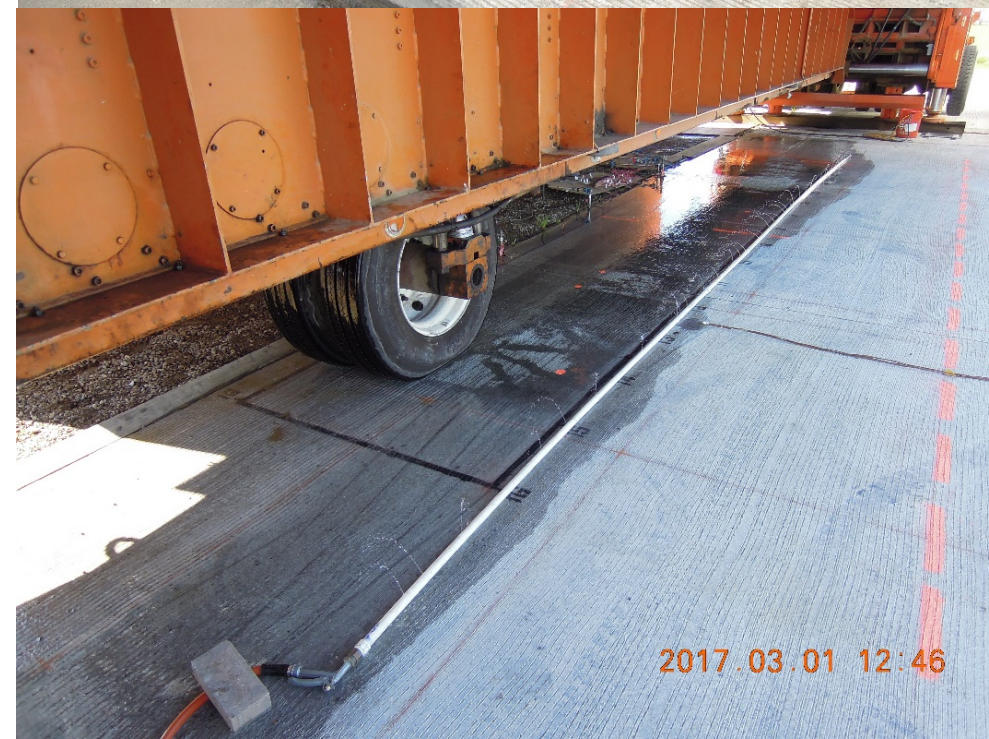
How did we test the COA sections?

- “Dry” testing: 210,000 repetitions up to 18 kip wheel load (36 kip single axle)
- “Wet” testing: 140,000 repetitions up to 22.5 kip wheel load (45 kip single axle)... plus flooded conditions and channelized traffic

1. Do not underestimate the structural capacity of a “relatively thin” (4.5 in.) concrete overlay
 - Despite the high load level (over twice the legal limit in California),
 - ...despite the flooding conditions...
 - ...despite the channelized traffic at slab shoulder edge...
 - ...the HVS loading (over 6 mill. ESALs) did not produce any cracking in any section.

A third phase of the HVS testing focused on the weakest section of the test track (with 12×12 ft. slabs). The test continued at 22.5 kip wheel load, flooded conditions, and channelized traffic at slab shoulder edge... Corner cracking occurred after 13.3 million ESALs.

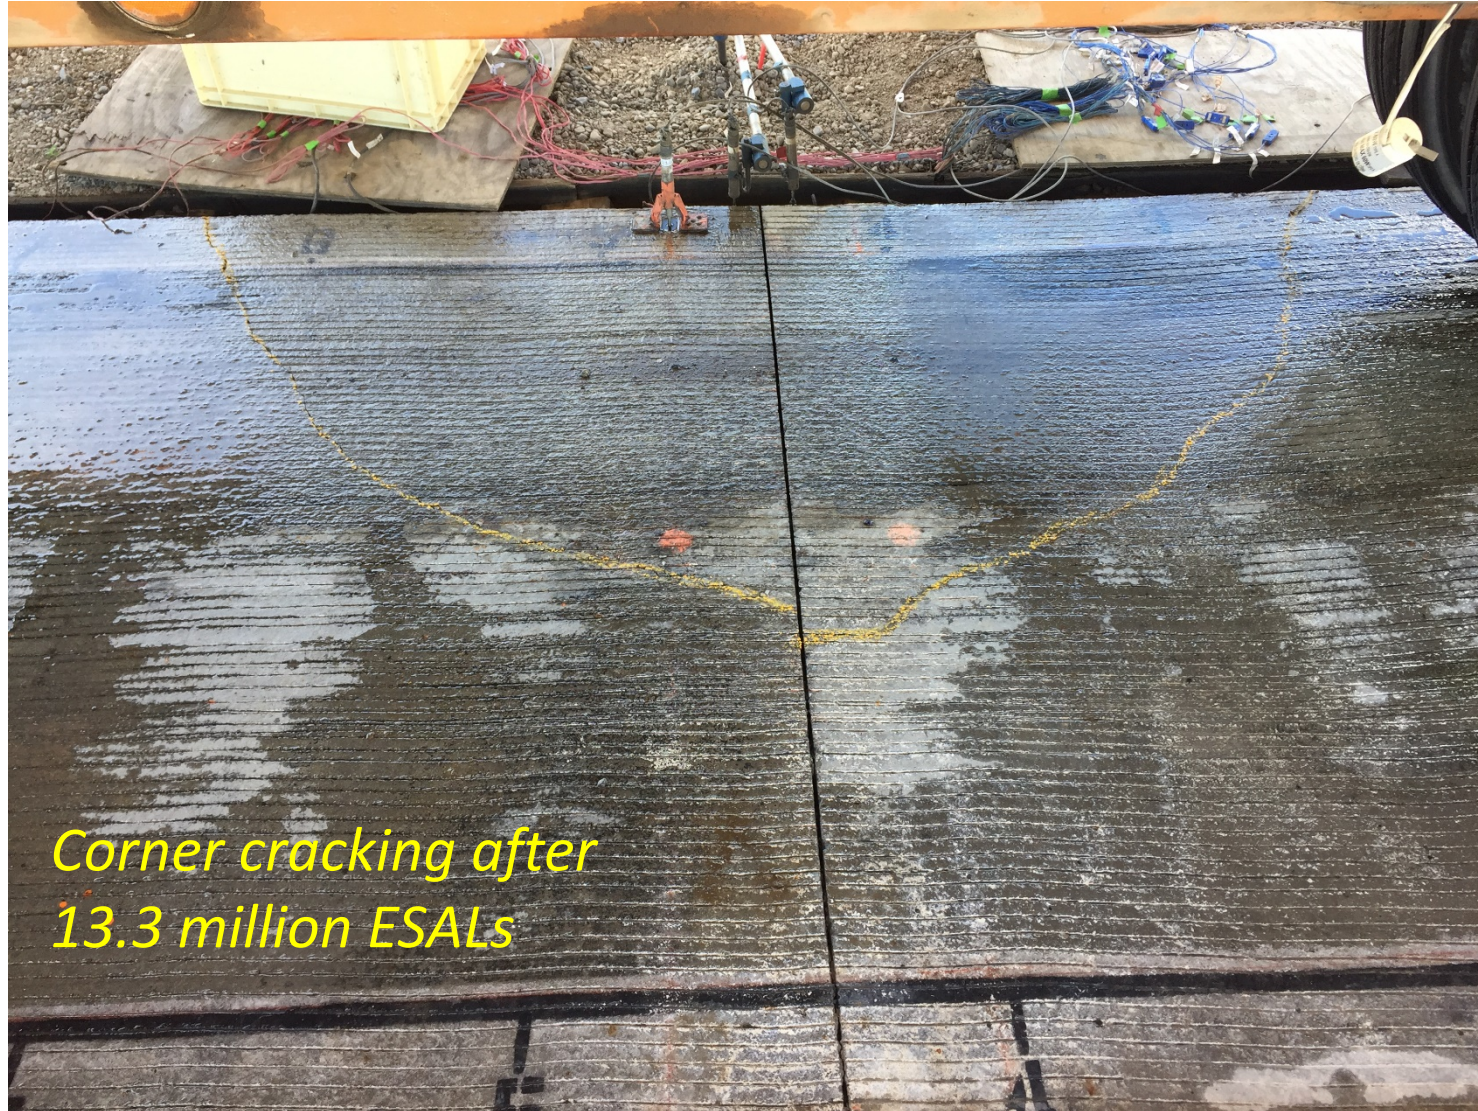
*Corner cracking after
13.3 million ESALs*

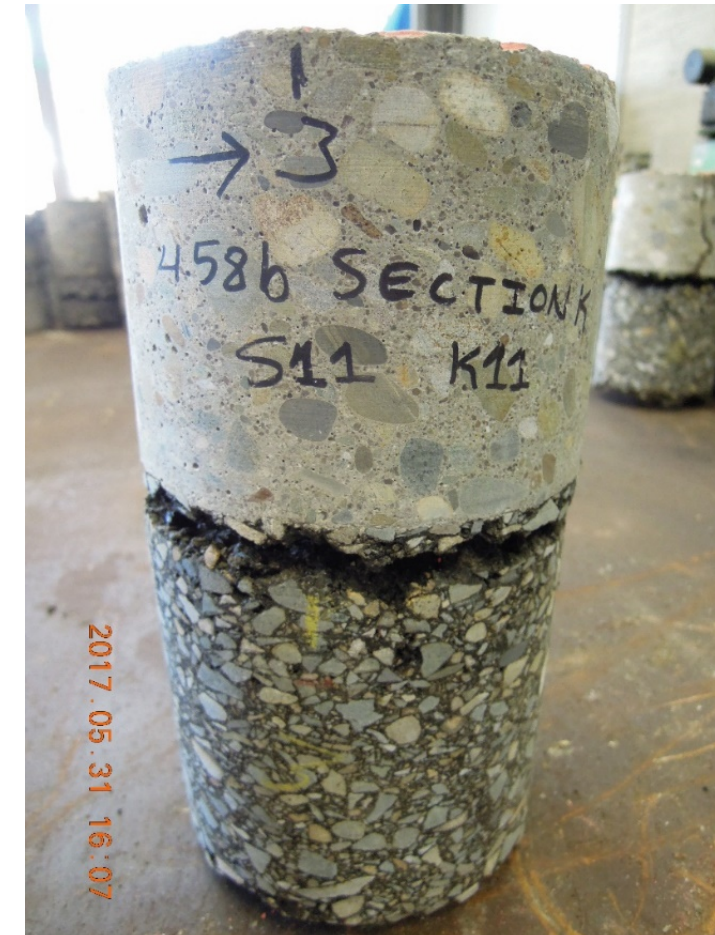
2. In dry climates like Californian, COA performs better with half-lane width slabs than with full-lane width slabs: 6×6 ft. better than 12×12 ft.

- The 12×12 ft. slabs presented delamination around the perimeter (no delamination observed in 6×6 ft. slabs)
- For the 12×12 ft. slabs, the LTE was relatively poor before the HVS testing (for 6×6 ft. slabs, the LTE was stable over 80%, unaffected by HVS testing in most sections)
- Delamination and poor LTE (12×12 ft. slabs) were NOT related to traffic but to environment

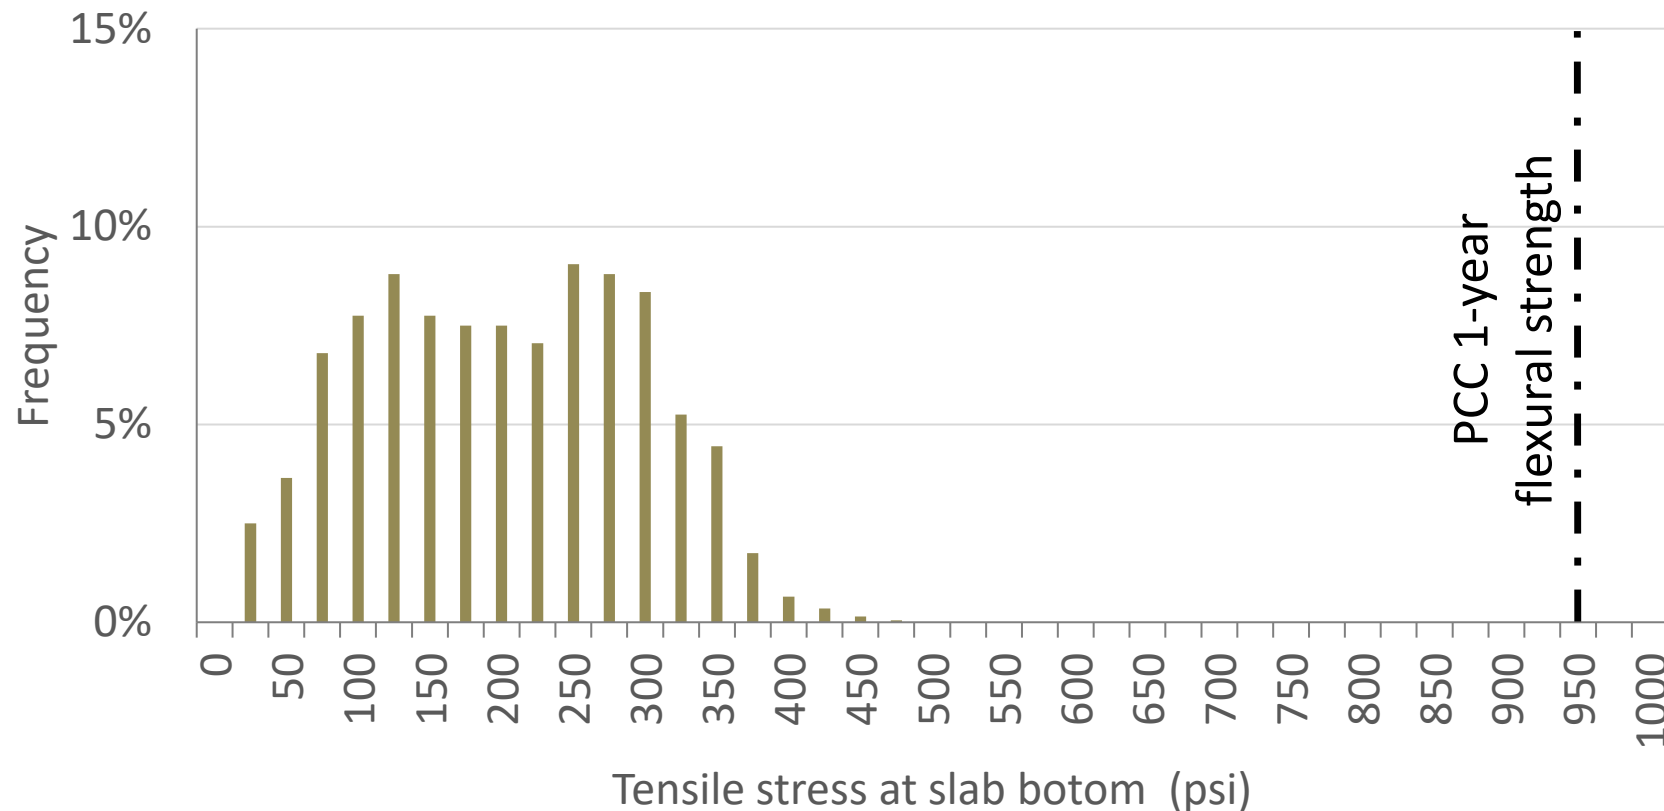
- COA structure can be strong despite having barely any contribution from the asphalt base.
 - Mechanistic-empirical analysis, based on strain measured with resistive gages, combined with Monte Carlo simulation (variability of strain and strength), indicated that the tensile stresses created by heavy trucks are much lower than concrete strength.

Monte Carlo simulation of the pass of a single axle overloaded 10% during winter time (lowest LTE)

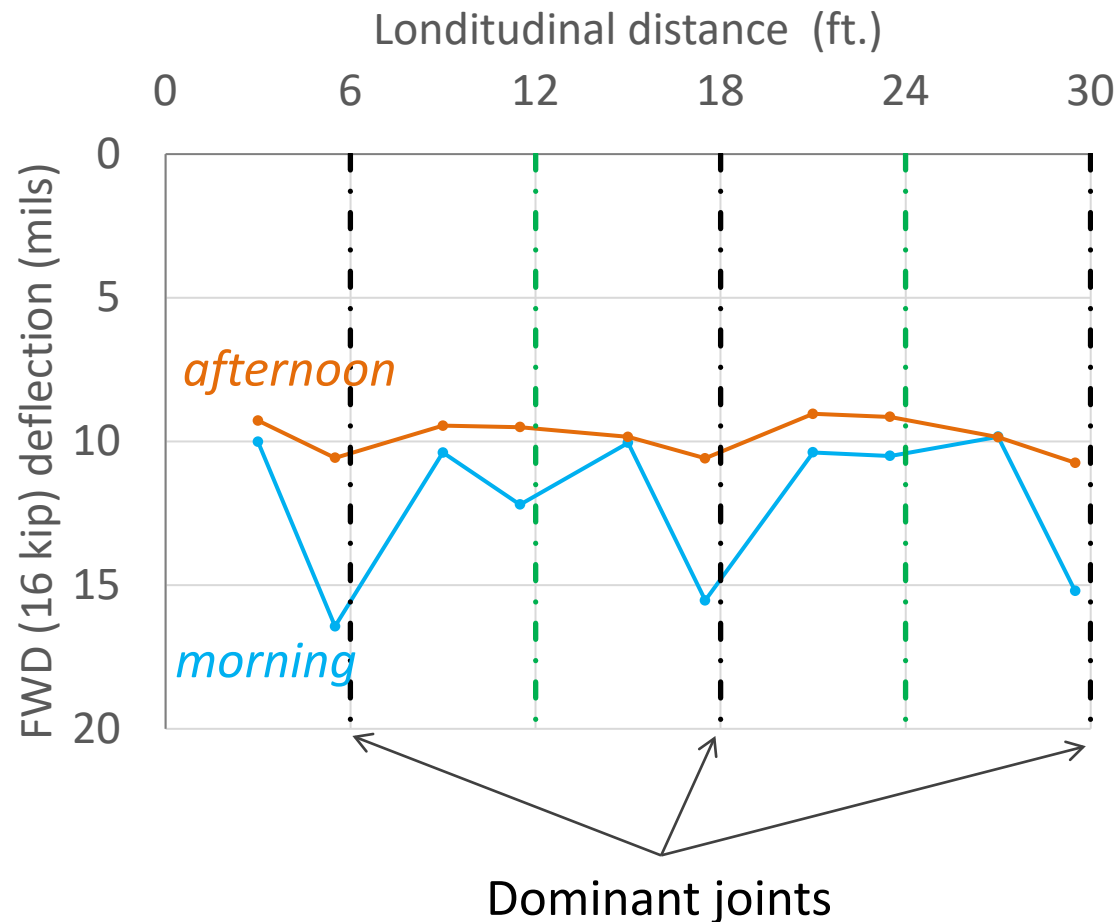
2. Alternation of “dominant” and “passive” transverse joints. California is not immune to this issue of COA with short slabs (e.g. 6×6).

- The outcome is not necessarily due to lack of transverse joint deployment
- The dominant joints are the joints that deploy first
- The dominant joints match in the two lanes paved in different days (sympathy transverse joint deployment)
- Slab thickness may be an important factor
- The impact on structural capacity is not minor: PCC tensile stress doubles in *dominant* compared to *passive* transverse joints

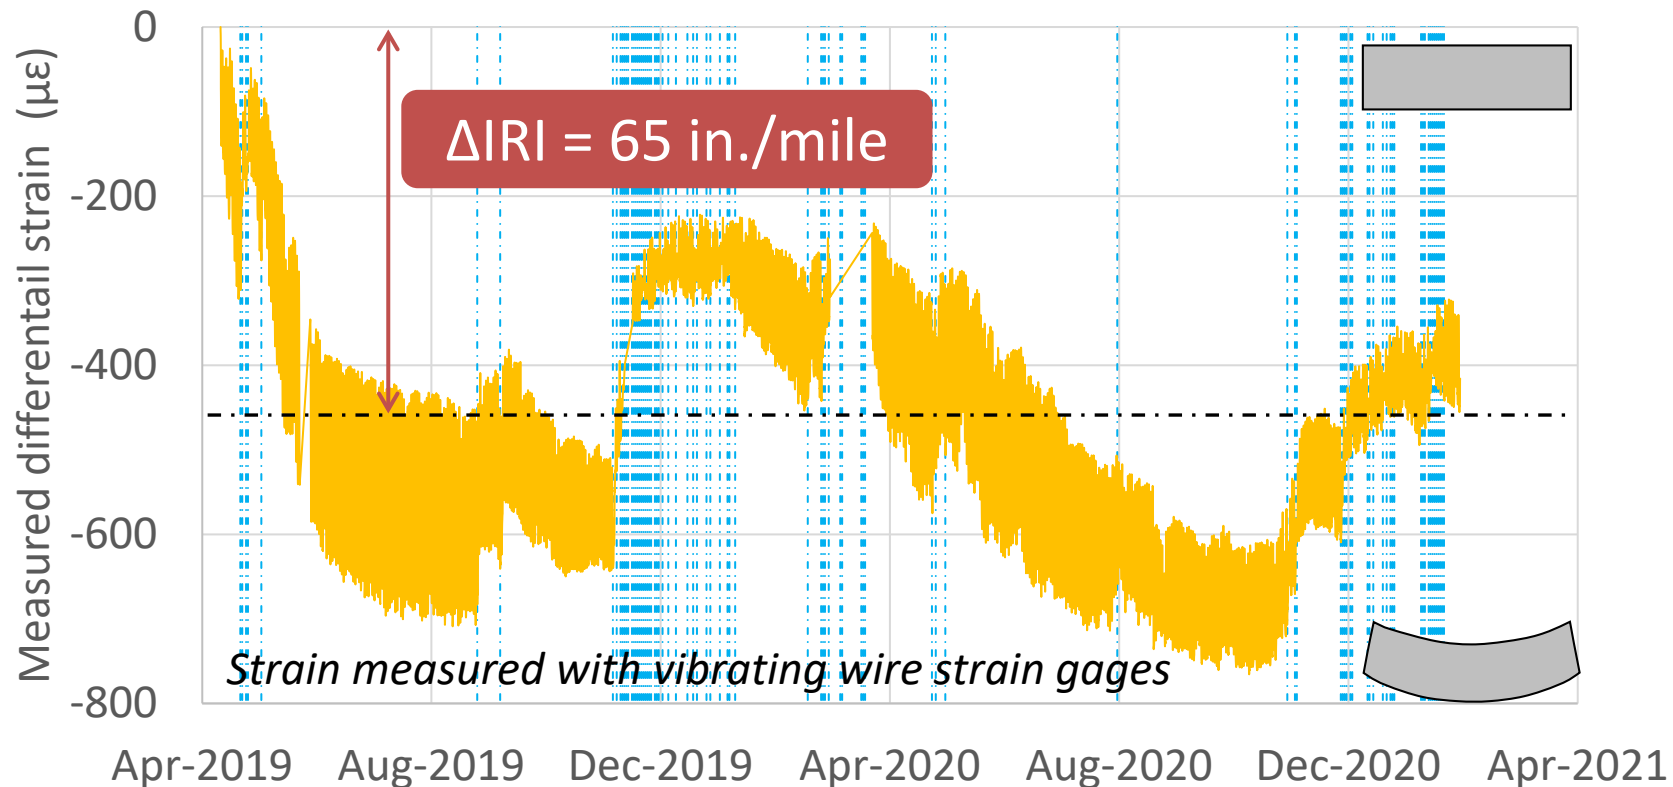
3. Conducting blanket grinding right after construction is not the optimum, especially in dry climates with thin slabs.

- Blanket grinding is not uncommon in California due to strict post-construction IRI requirements (60 to 75 in./mile target)
- Ideally, we want to wait one summer before conducting the grinding operation

Drying shrinkage trend: top shrinks versus bottom.

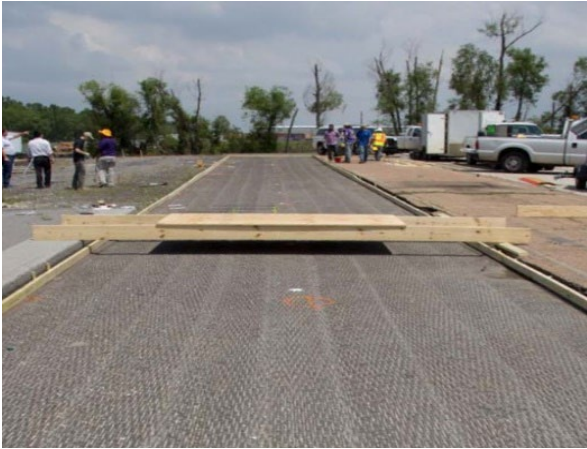
Milling and Surface preparation

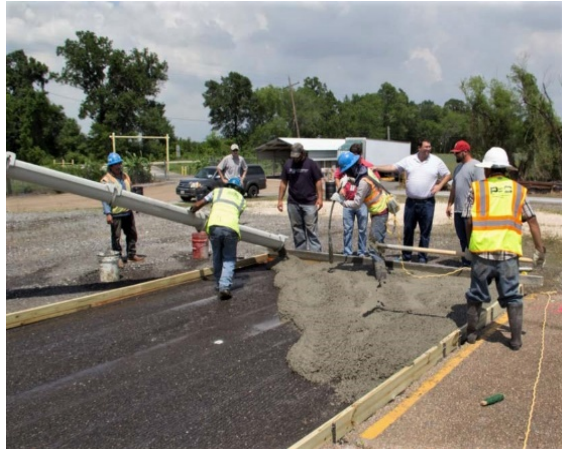
Placement of concrete overlay

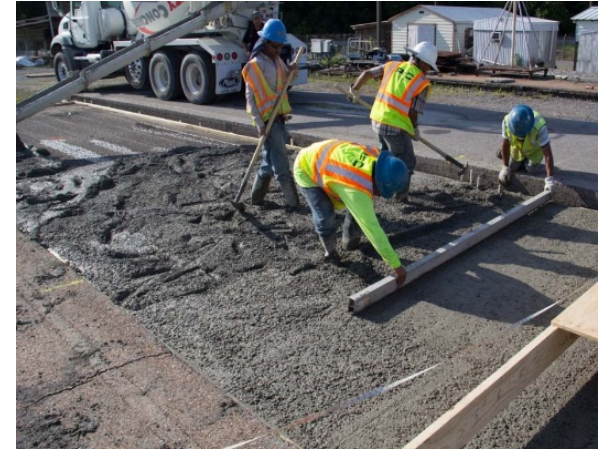
Levelling and Troweling of concrete

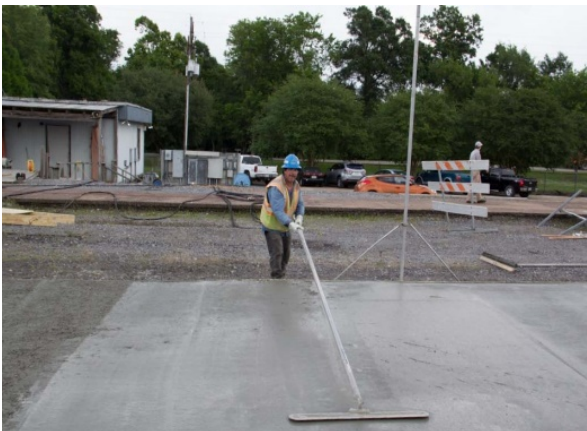
Broom Finish of COA sections

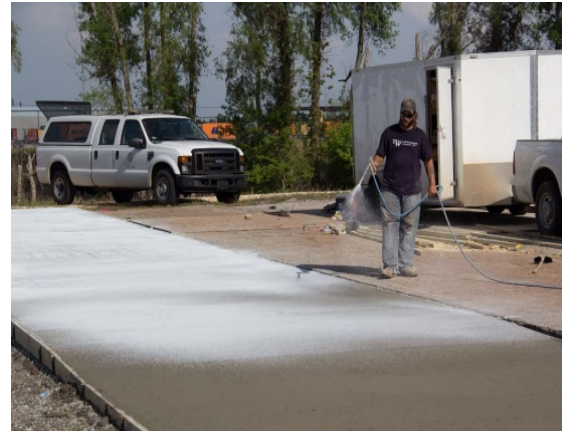
Curing of COA sections

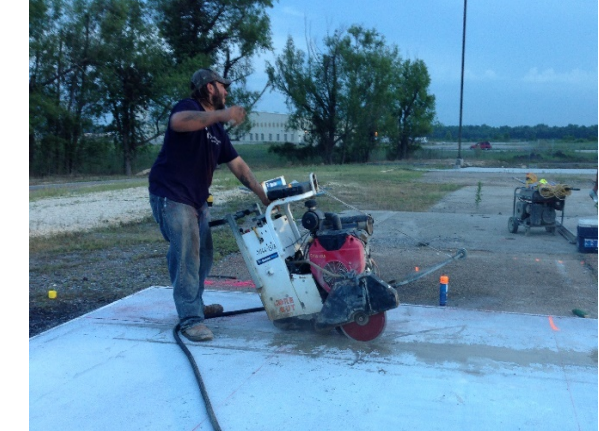
Saw Cut Joints

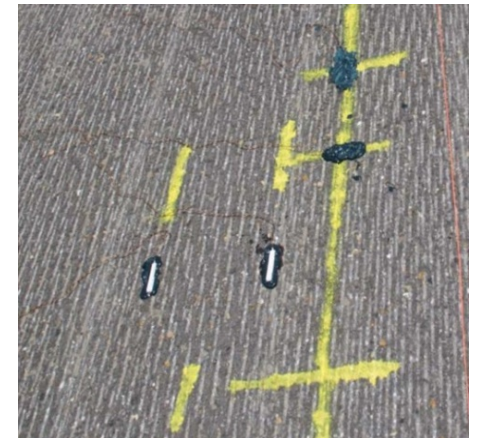
Strain gages used:

- Concrete strain gage (Tokyo Sokki PML-60-2L)
- Interface strain gage (WFLM-60-11-2LT)
- Surface strain gage (Tokyo Sokki PL-120-11)
- Corner strain gage (PLR-60-11)

Figure: Instrumentation of COA Sections

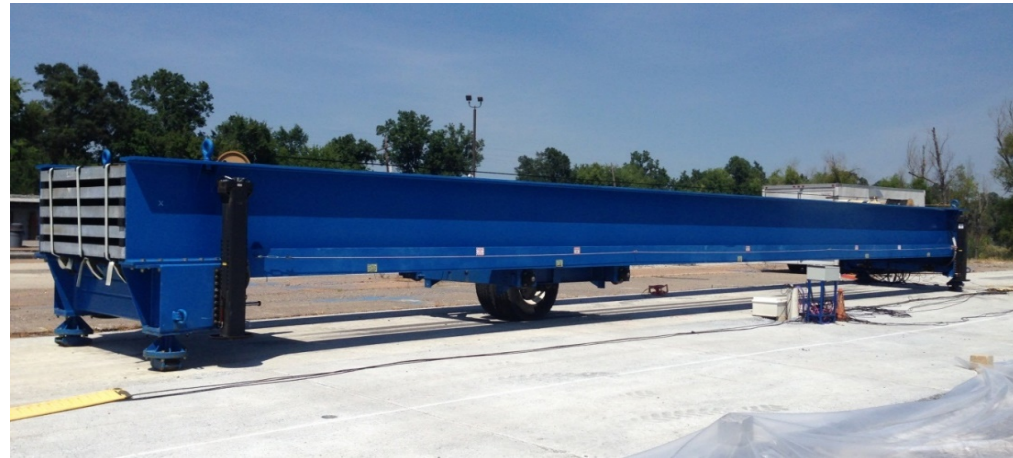
❑ ATLaS 30

- Dual-tire load
- Load: up to 30 kips
- Speed: 3~6 mph
- Bi-directional loading
- Effective loading length: 42 ft.
- About 10,000 passes/day

- ❑ Overall, one and half million-load repetitions (9 kip & 16 kip) were applied on the 6-in. COA section; 560,000 repetitions were loaded on the 4-in. sections; and 210,000 repetitions were added on the 2-in. section

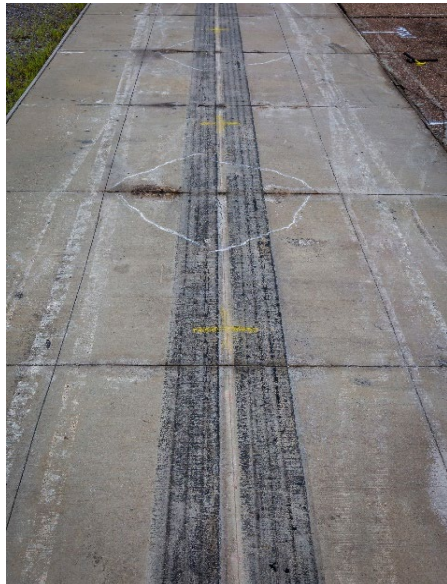
6-in. Section

- In situ failure conditions of each COA test section tested in this study

- A total of one and half million-load repetitions (i.e., 750,000 of 9-kip and 750,000 of 16-kip) were applied on the 6-in. BOCA section
- The crack was initiated in longitudinal direction initially followed by random fatigue cracking.
- Cracks initiated near the joint location and at the weakest subgrade location.
- Load repetitions are equivalent to **8.9 million ESALs** for the 6-in COA sections and approximately 51% of the loaded area was cracked.

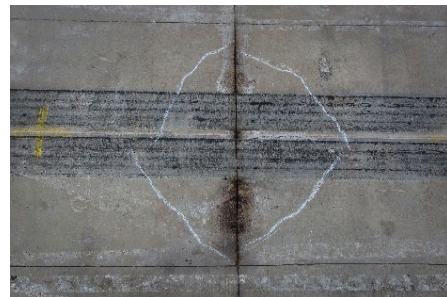
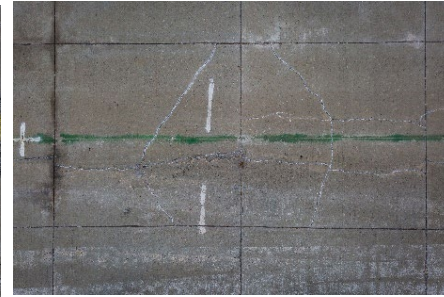
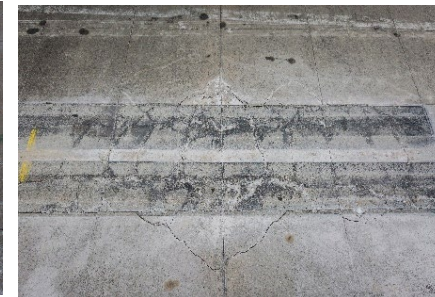
2-in. Section

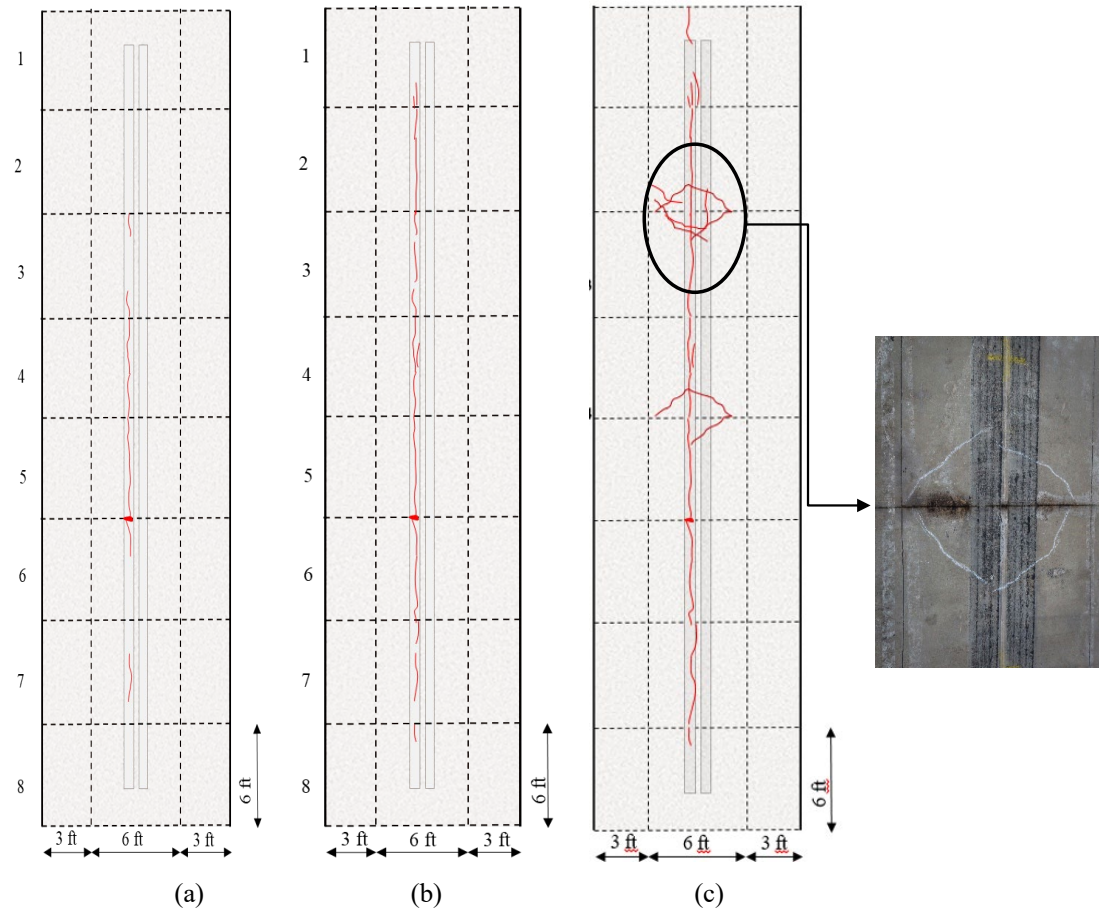
Crack Propagation of 6in. COA Sections

Crack mapping of the 6-in. COA section at load repetition of (a) 1,100,000; (b) 1,500,000; and (c) 1,700,000

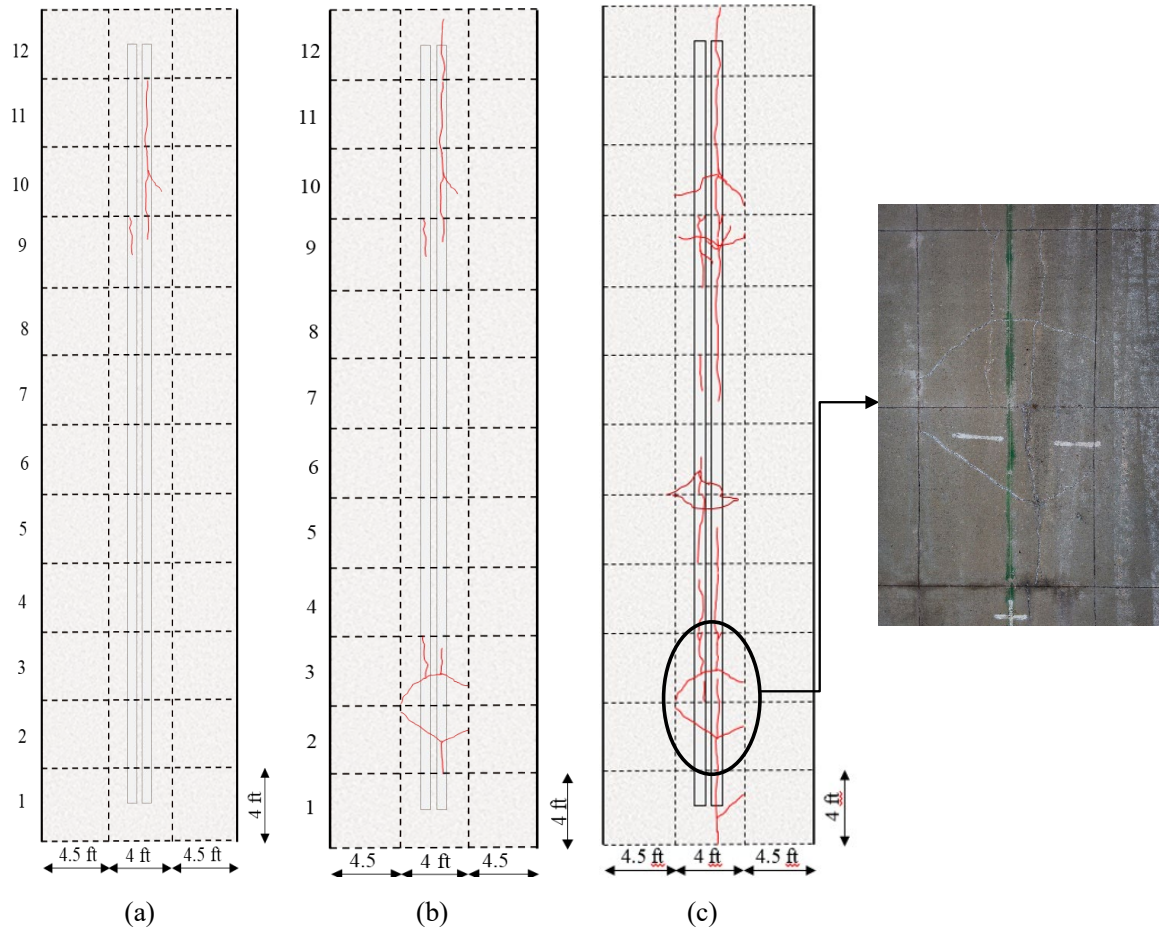
Crack Propagation of 4in. COA Sections

- A total of 560,000 repetitions (i.e., 310,000 of 9-kip and 250,000 of 16-kip) were loaded on the 4-in. sections.
- The crack was initiated in longitudinal direction initially followed by corner cracks.
- Cracks initiated near the joint location and at the weakest subgrade location
- Load repetitions are equivalent to **3.5 million ESALs** for the 4-in COA sections and approximately 54% of the loaded area was cracked.

Crack mapping of the 4-in. COA section at load repetition of (a) 200,000; (b) 350,000; and (c) 550,000

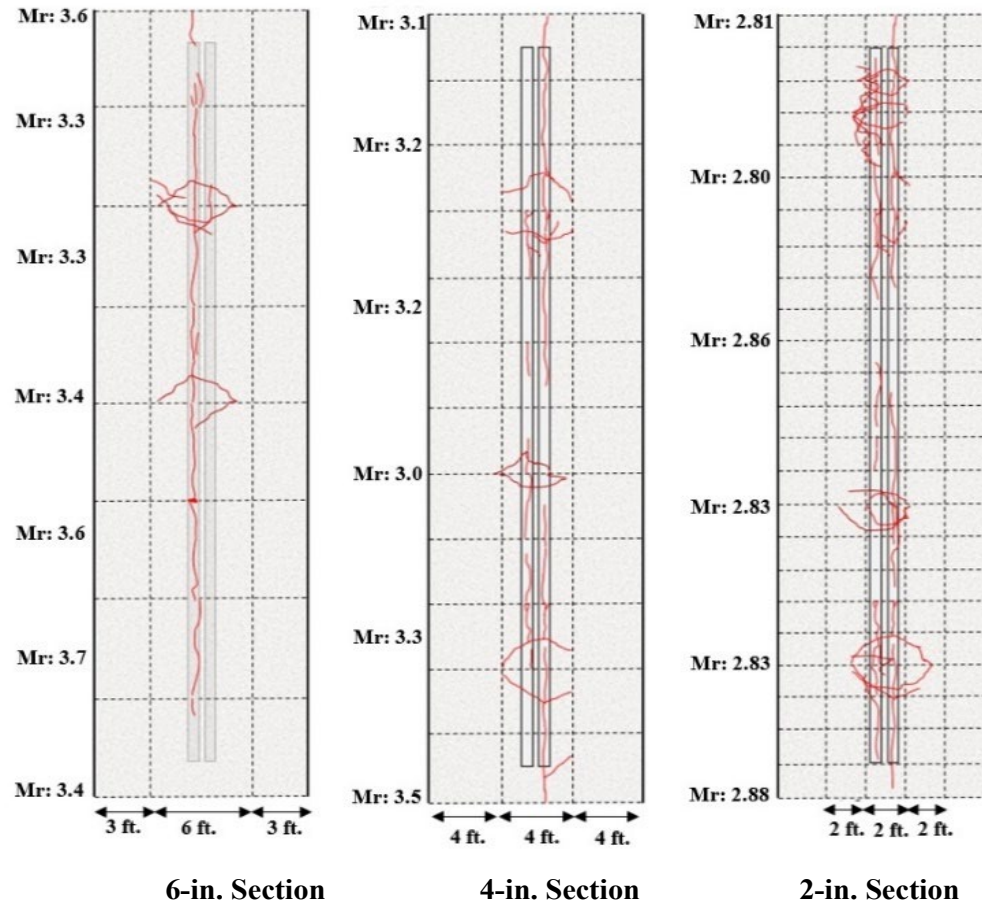
Crack Mapping of Failed COA Sections

- The majority of the cracks found in the 6-in. section were longitudinal cracks, followed by random cracks.
- On the other hand, more corner cracks were found on the 2-in. and 4-in. sections.
- This supports the current mechanical-empirical COA design guideline

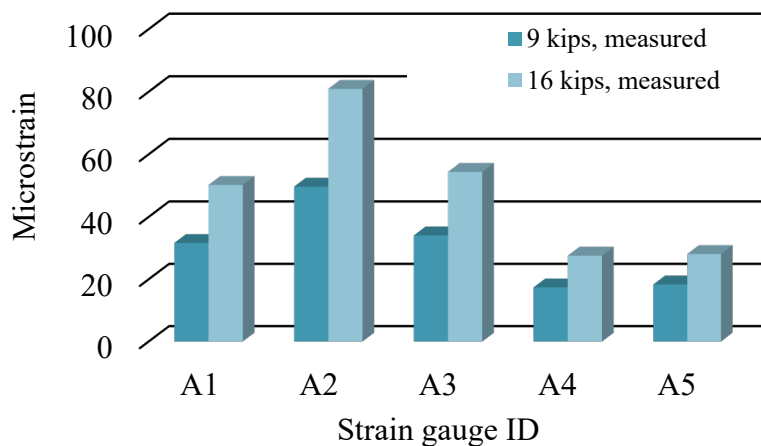
- Strain gauge **A2** measured the most **critical transverse strain** underneath a saw-cut joint
- A **higher transverse strain** indicates a **longitudinal cracking potential**, which resulted in the cracking pattern
- The strain Gauges A4 and A5, which were installed adjacent to each other, showed much **lower longitudinal strain** readings as compared with others at the bottom of saw-cut joints

Figure: Instrumentation responses under accelerated loading

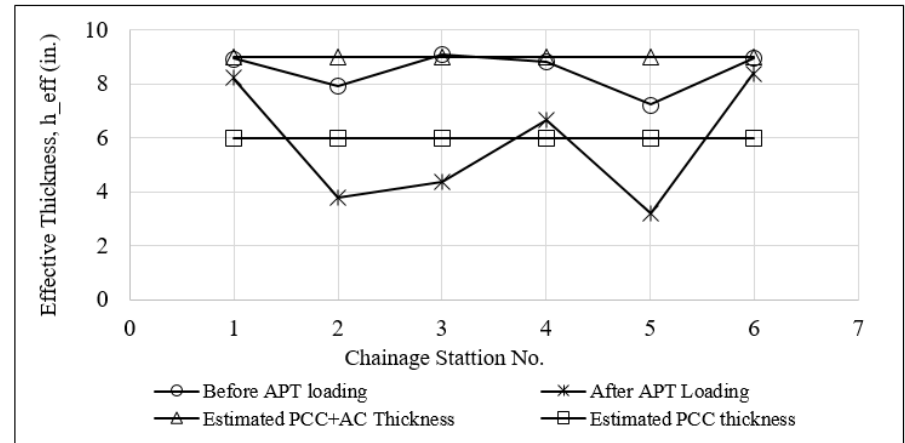
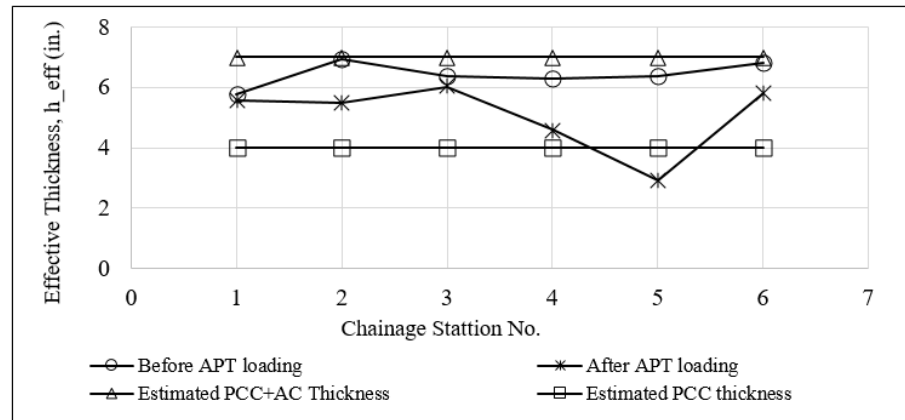
- At the beginning of the APT testing, the calculated effective thickness for both pavement test section indicates sufficient support stiffness
- At the end of the APT testing, a decrease in effective thickness was observed at multiple location on both COA pavement section.
- This decrease may be due to the deterioration in the asphalt and PCC layer or could be due to the debonding at the PCC asphalt interface.

(a) 6-in. COA with 6 by 6 slabs

(b) 4-in. COA with 4 by 4 slabs

Figure: Effective slab thickness before and after APT testing

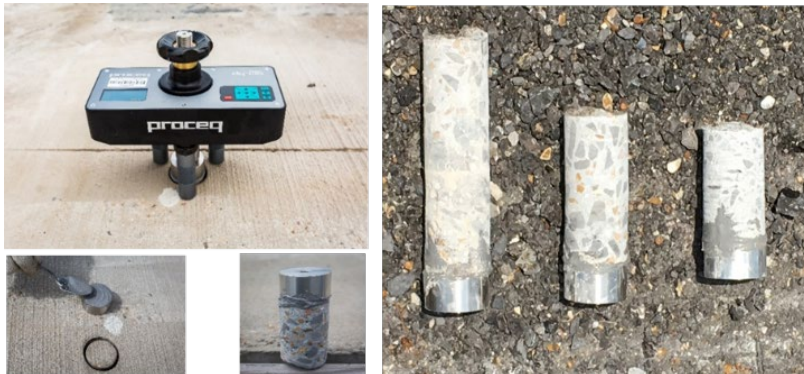
- The pull-off test was conducted after 2 years of overlay placement and the bond strength could be affected by the differential movements between substrate and overlay due to temperature and shrinkage

Figure: Pull-off Test of COA Sections

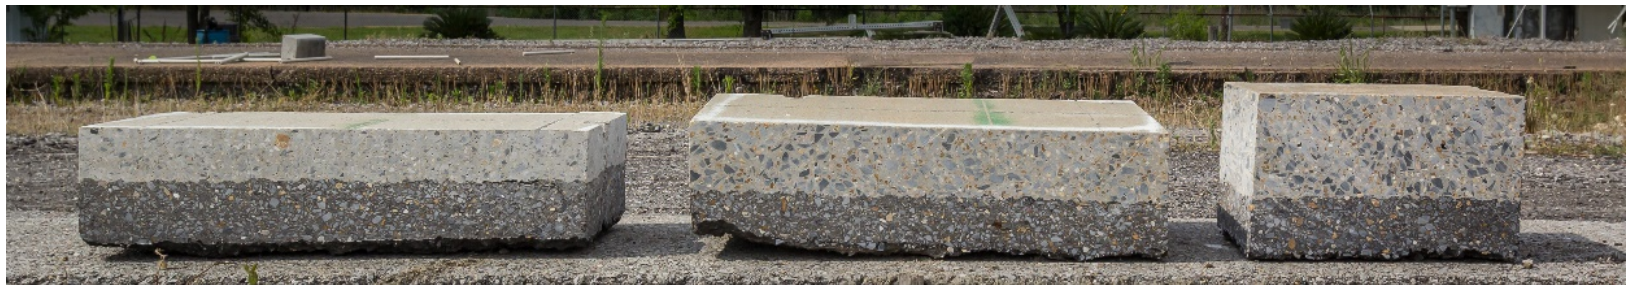
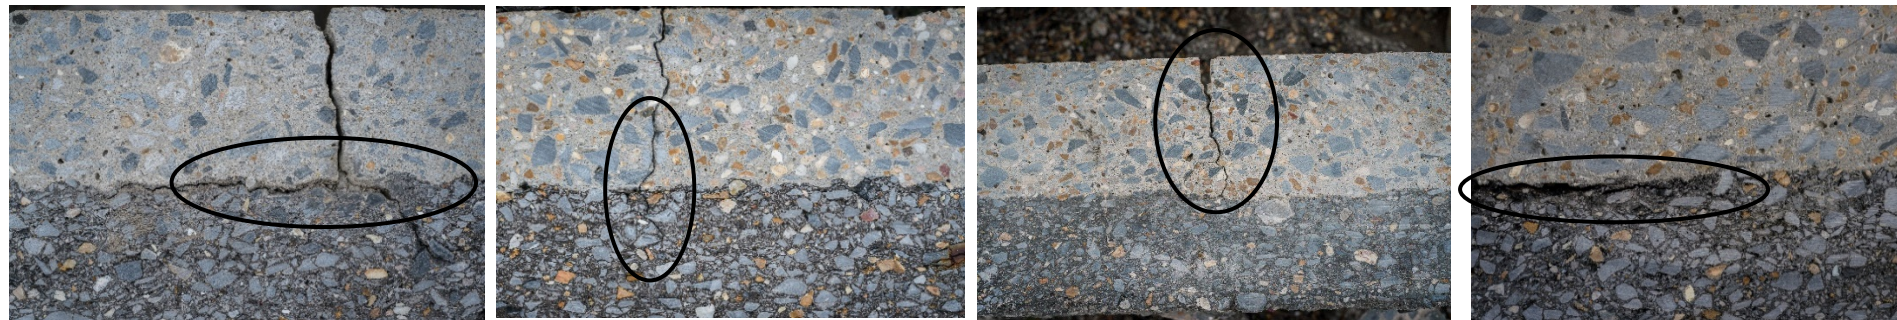
- A post mortem transverse trench slab was cut on a failure area of each test section after the APT testing
 - The majority of longitudinal cracks under the wheel path are bottom-up cracking.
 - It also revealed that the saw cutting joints were cracked through along the PCC slab thickness at the end of APT loading.

2in. COA

4in. COA

6in. COA

(a) Crack initiating debonding (b) Crack propagating to AC (c) Saw cut joint cracked through (d) Debonding at interface

Forensic Trenches of COA pavement sections

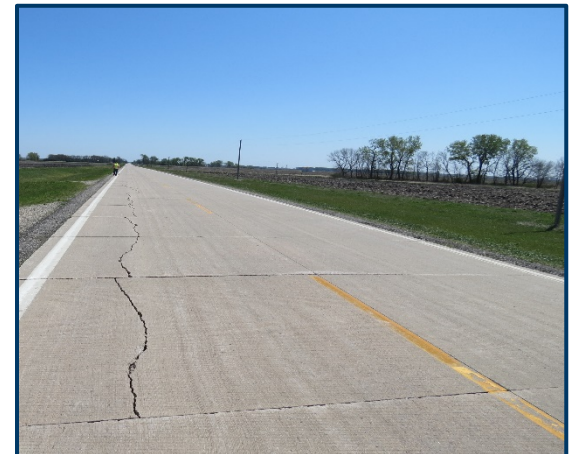
■ TH30 Amboy, MN - 1993

- MnDOT's first modern whitetopping
- 8.5 mile project: 4 COA test sections (2.5 miles total length)
- Very low volume rural road
- 6" JPCP, 12'x12' panels, on 4.25" HMA over cement treated soil base
- Variables: doweled joints, milled vs unmilled HMA, bond breaker

- Perfect application, still in service – very low volume road
- Easily rehabbed (@age 18 yrs)
- Section with bond breaker = worst performance

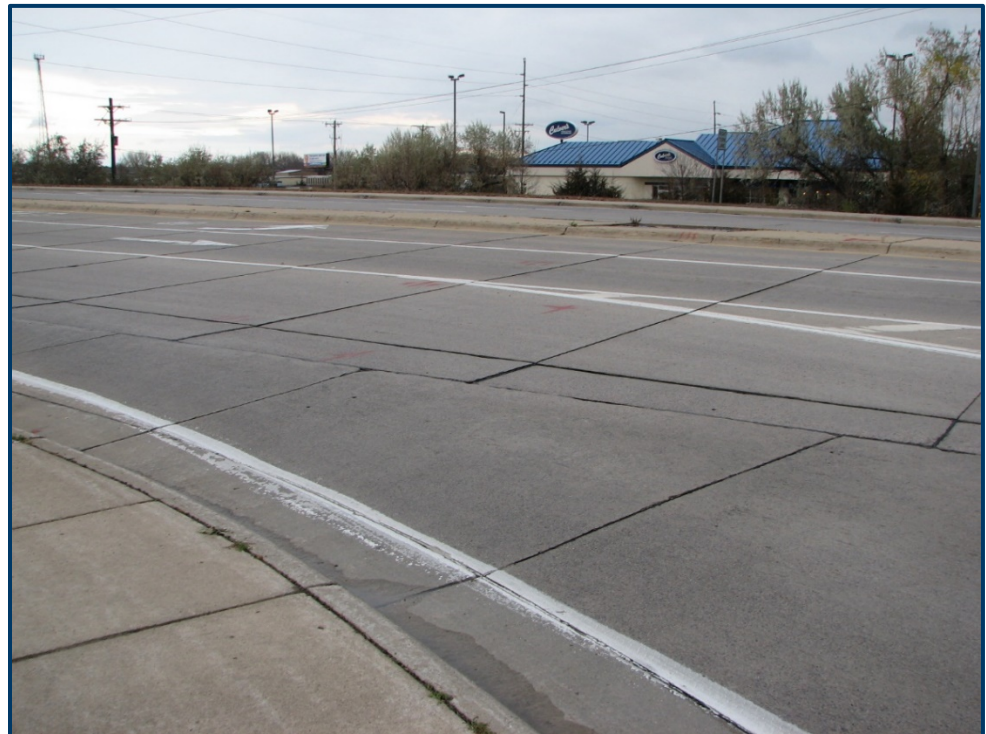
■ TH14 North Mankato, MN – 1996

- Lower volume, heavy truck traffic route
- 6", 4.5" & 3" FRC (structural fibers), on 5.5" to 8.5" of milled HMA
- Variables: panel size (5'Lx6'W, 4.5'Lx6'W, 10'Lx12'W), fiber type (25 lbs/yd³ polyolefin)

- Short lived - significant faulting
- Structural fibers did not prevent joint faulting
- Some panel buckling

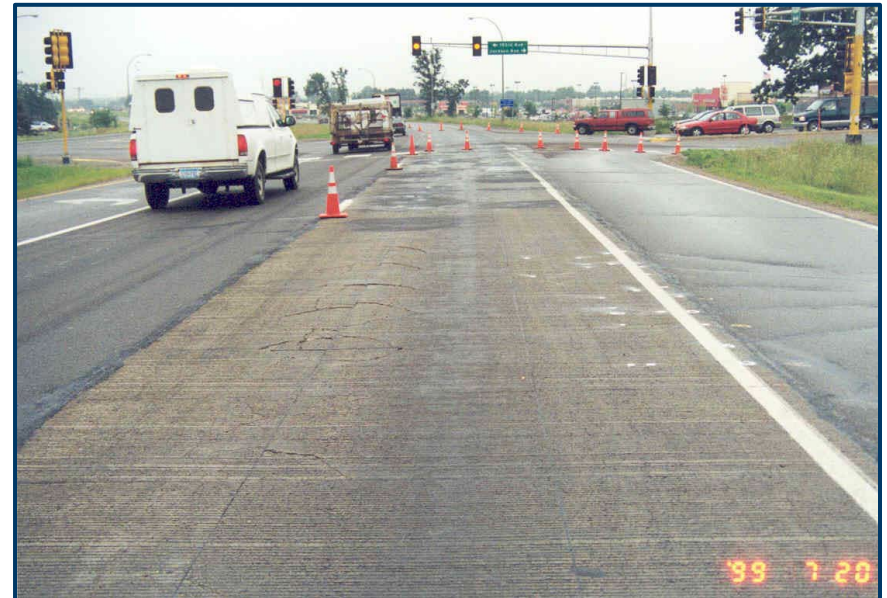
▪ Elk River, MN - 1997

- 3 Medium volume intersections
- Heavy truck loadings (frequent stopping)
- 3" JPCP/FRC, 3" remaining HMA (marginal condition)
- Variables: panel size (4'x4', 6'x6'), fiber type and dosage (3 lbs/yd³ polypropylene, 25 lbs/yd³ polyolefin)

- Short lived – significant cracking
- Need minimum 3" of good HMA

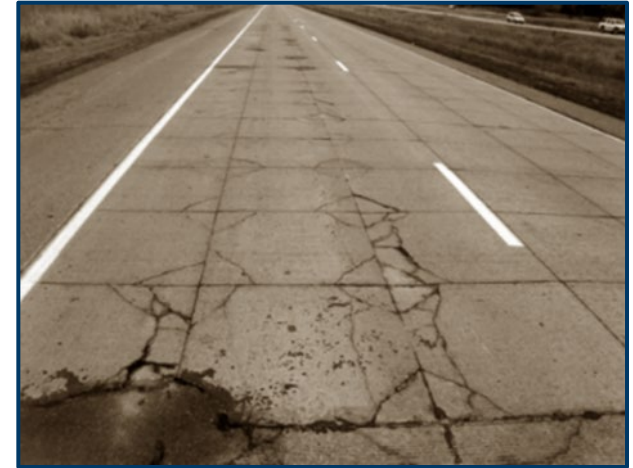
■ MnROAD – 1997

- Test Cells 92-97
- Medium volume interstate traffic
- Inlays into full depth 13" HMA (4 years old at time)
- Variables
 - Thicknesses: 3", 4", 6"
 - Panel sizes: 4'x4', 5'Lx6'W, 10'Lx12'W
 - Doweled, undoweled (larger panel thicker cells)
 - Fiber: 3 lbs/yd³ polypropylene, 25 lbs/yd³ polyolefin

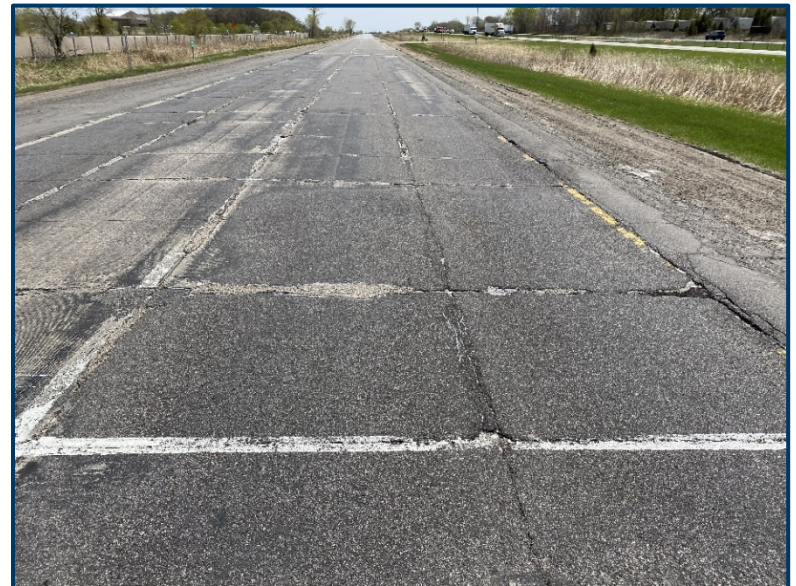
- Keep longitudinal joints away from wheel paths
- Shrinkage fibers do not contribute to load capacity
- Ultra-thin sections failed in cracking before faulting
- 10'Lx12'W undoweled joints faulted significantly
- 10'Lx12'W panels cracked in half longitudinally (seeking 6'width)

❖ Cell 96", 6" FRC, 5'Lx6'W panels with heavy fiber dosage still in service (24 yrs);
Multiple HMA surface treatments
due to ongoing severe joint deterioration

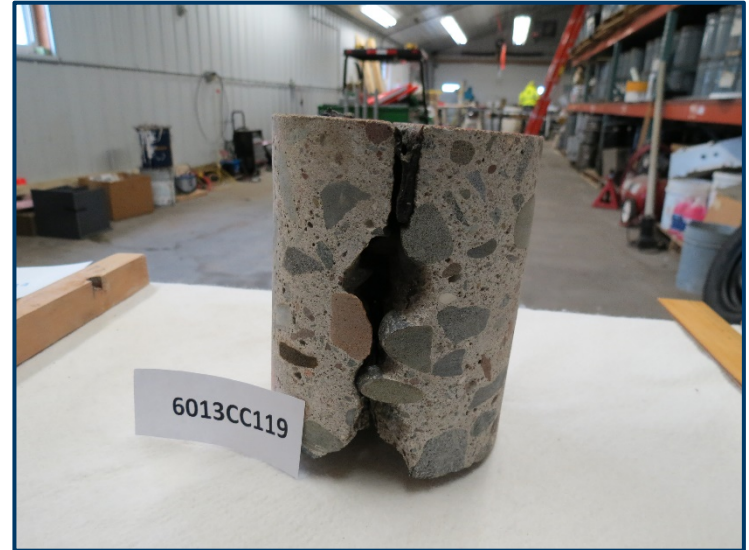
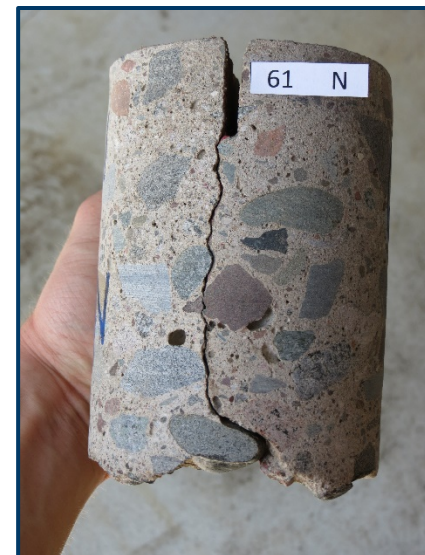
■ MnROAD – 2004

- Test Cells 60-63
- Medium volume interstate traffic
- 7" and 8" remaining HMA
- Panel size: 5'Lx6'W
- Variables
 - Thicknesses: 4", 5"
 - Joints sealed, unsealed

- 4" unsealed section failed first (loss of bond)
- Joint faulting began after 5 years
- Some breached joint seals performed worse than unsealed joints
