Concrete Overlays of Asphalt

TRB Webinar: Concrete Overlays of Asphalt

Julie M. Vandebossche, P.E., Ph.D.

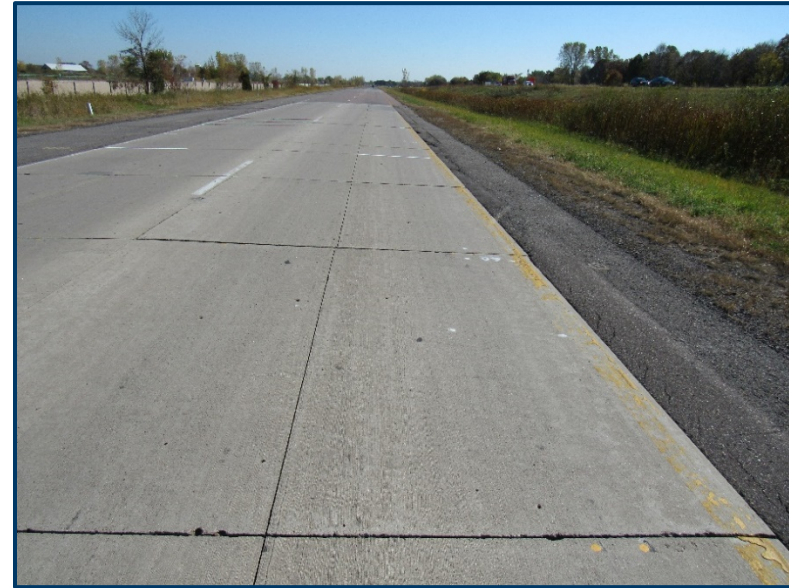
- Test Cells 114-914
- Medium volume interstate traffic
- Thickness: 6"
- Unsealed joints
- Variables
 - 5" to 8" remaining HMA (15 yrs. old)
 - Panel size: 6'Lx6'W, 12'Lx6'W
 - Dowels: None, 1" dia. 2 ft o.c., thin plates (in 12'L panels)

- Minimal panel cracks (including no reflective cracks)
- Significant faulting in undoweled cells
- Some distress over widely spaced dowels
- Panel migration (loss of bond)

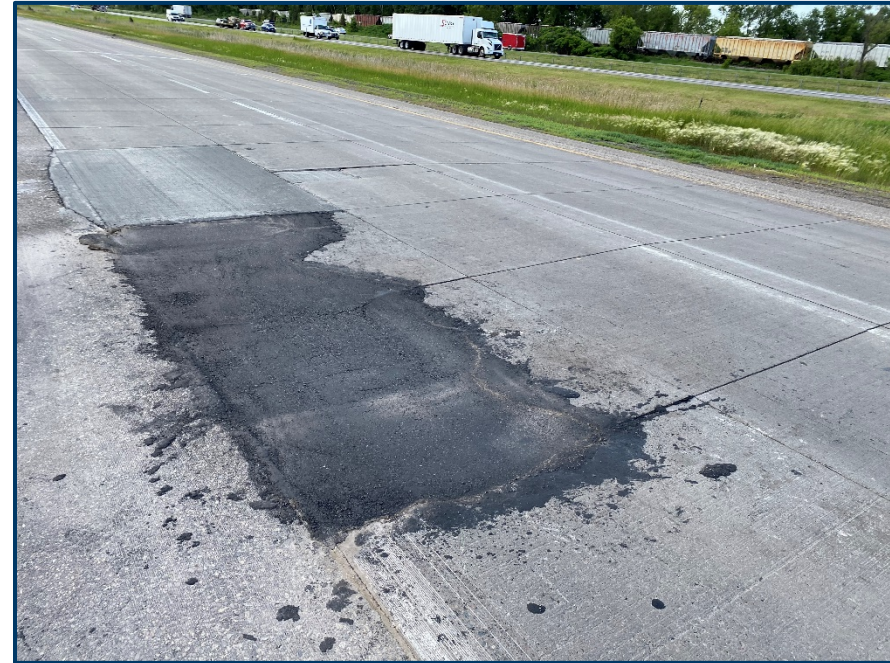
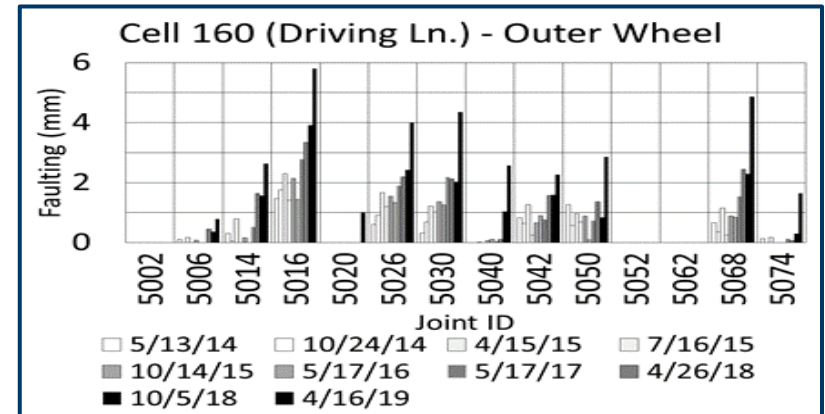
- Test Cells 160 and 162
- Medium volume interstate traffic
- Synthetic structural fibers (20% RSR)
- 6'x6' panels, sealed joints
- Variables
 - 4" and 5" (6.5 lbs/yd³ structural fibers)
 - Remaining HMA 6"- 7"

- Less cracking than non-fiber Cells 60-63
- Noticeable faulting after 5 years
 - 4+ million ESALs
 - Fibers struggle to slow faulting

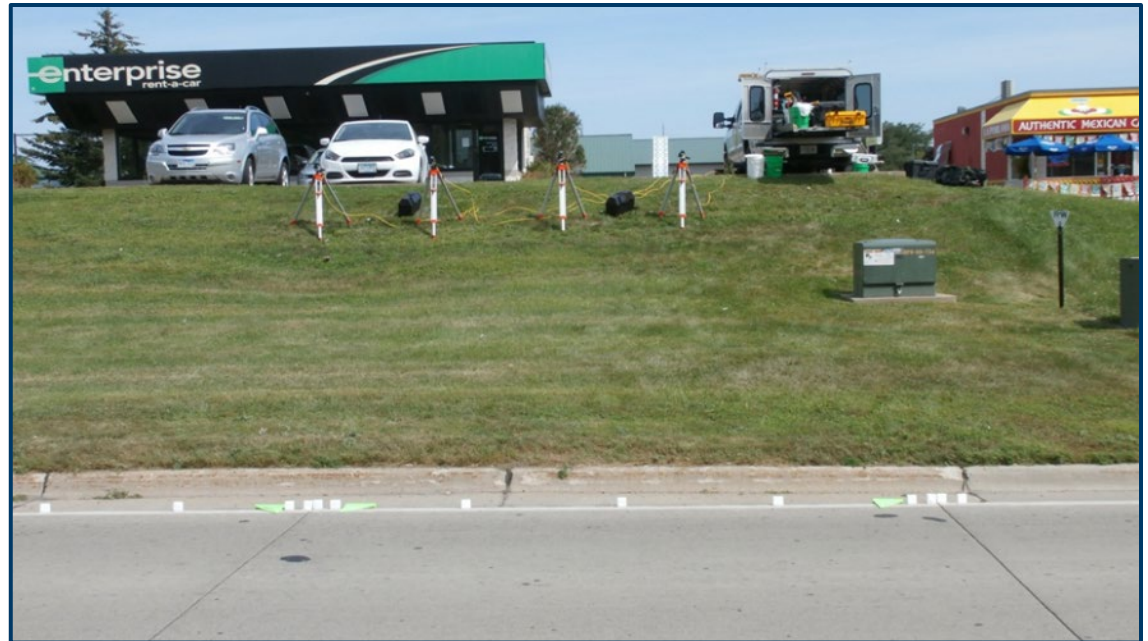
- Characterization of COA panel movement

Findings: COA panels bend, not rock

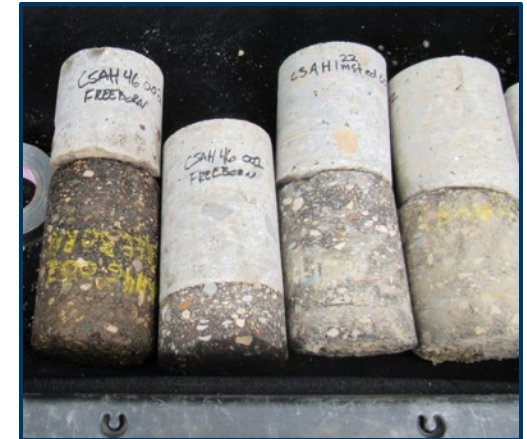
- **GPR for thickness variation**
- **3 core samples**
 - Assess bond quality
 - GPR thickness calibration
 - HMA assessment (associated project selection study)
- **Profiled for IRI (multiple times)**
- **Visual distress surveys (multiple times)**
- **Fault measurements (limited # joints)**

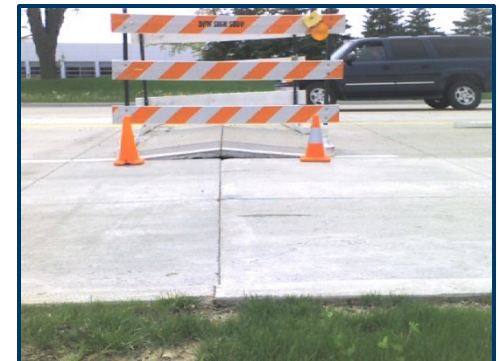
- Most are still “young” (8 or less yrs. old)
- Some longitudinal cracking
- Surprising lack of transverse reflective cracks
 - I-35 cracked early, but has stabilized (no repairs)
- Little to no maintenance on most projects

- Construction practices (thickness variation due to milling)
- Design (matching joints to HMA cracks)
- Buckled panels (“light” panels, incompressibles)

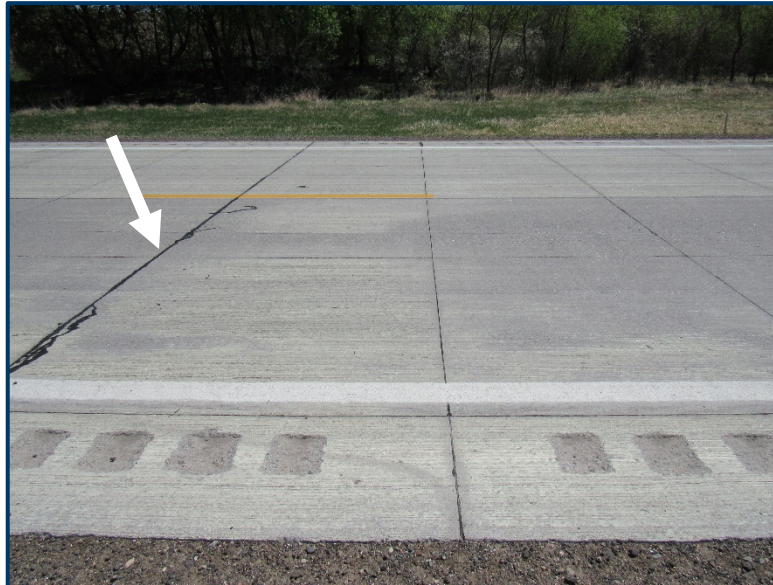
- **Faulted transverse joints in projects with heavy truck volumes/loads**
 - Attempts to match overlay joints to underlying HMA cracks seems to lead to early faulting (full-depth vertical movement)
 - TH22 Olmsted County project had to be diamond ground after 5 years of service
- **With shorter joint spacing, not all joints deploy**

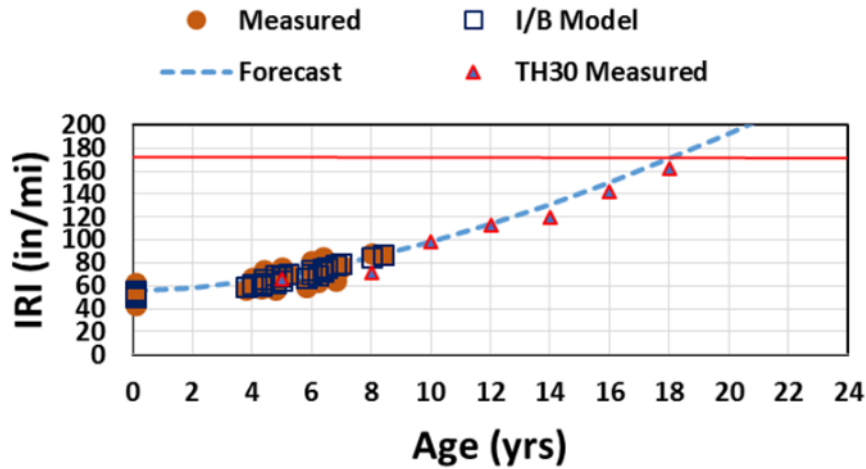
I/B Model - LVR Undoweled

For Minnesota conditions: ~ 18 to 20 years to IRI =170 in/mi
 (assuming no maintenance or rehab)

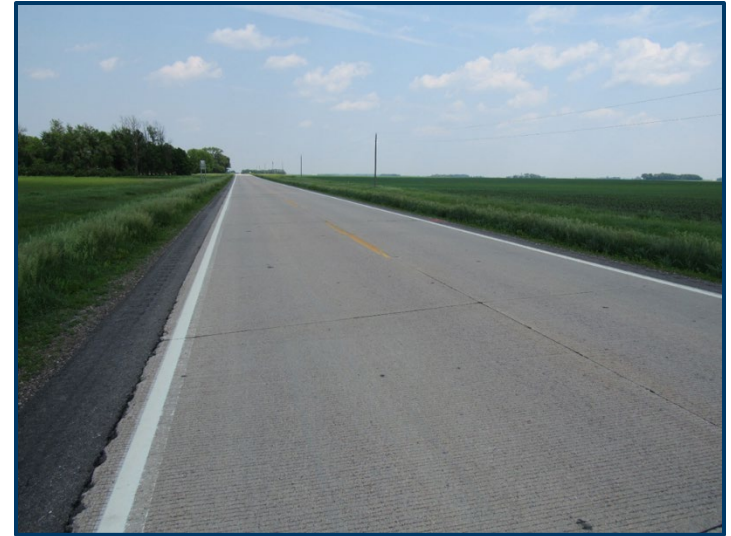
TH 30 Amboy: 27 years old

- Very low maintenance
- 20+ years life under lighter traffic
- Easy to repair
 - Full panel repairs
 - Diamond grinding

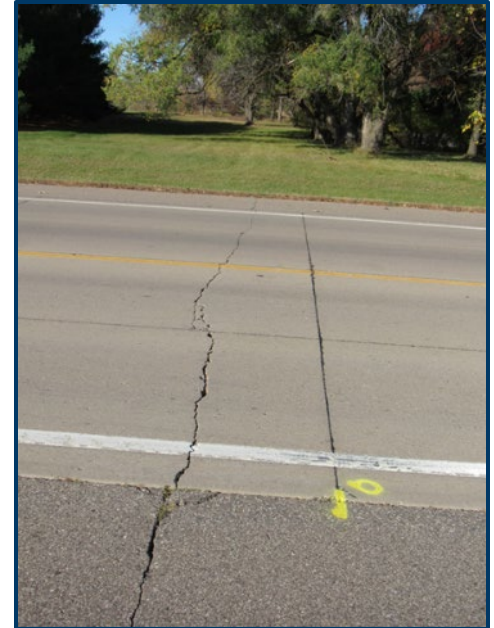
- **Northern climates can lead to reflective cracking**

- Even >6" inch thick COA can be breached
