# Making an Accessible Light Rail System More Accessible Under the Americans with Disabilities Act

Douglas J. Cross, *Sacramento Regional Transit District*

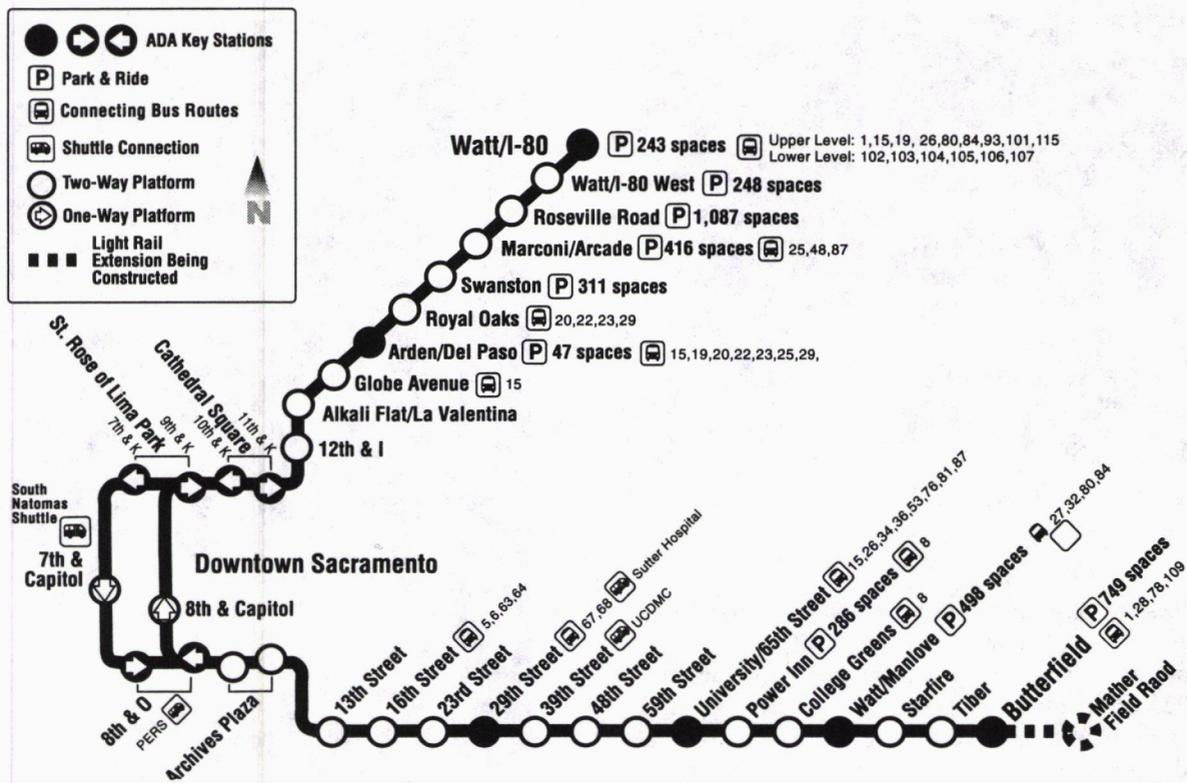
FIGURE 1 Sacramento Regional Transit light rail system.

The Sacramento Regional Transit District (RT) operates a 30-km (18-mi) light rail system with 30 stations.

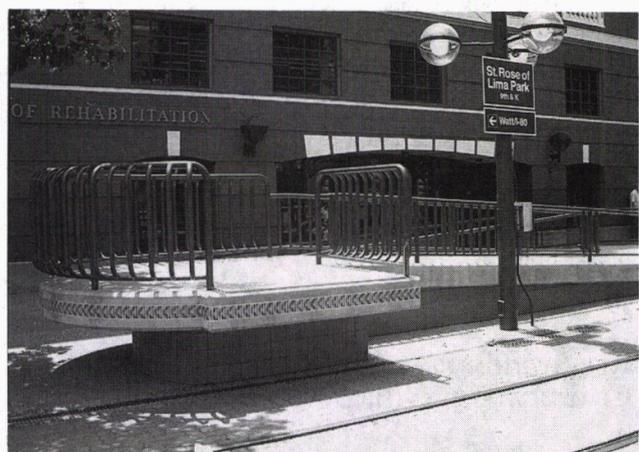
FIGURE 2 Minihigh platform with ramp.

The resulting stations feature minihigh platforms with ramps (Figure 2) or wayside lifts (Figure 3). The platforms combine with bridge plates on the rail cars that operators deploy manually to afford walk- or roll-

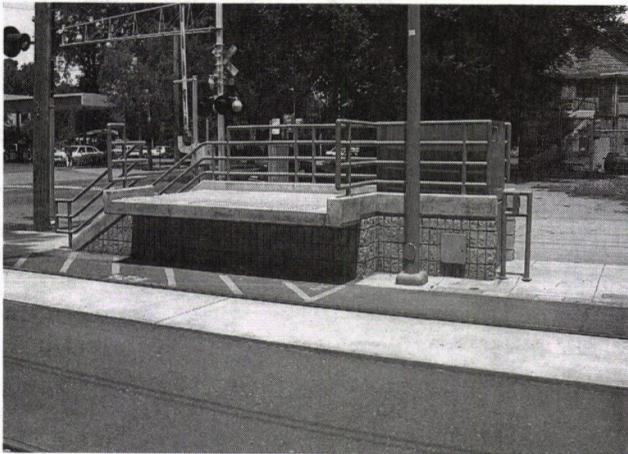
FIGURE 3 Wayside lift.

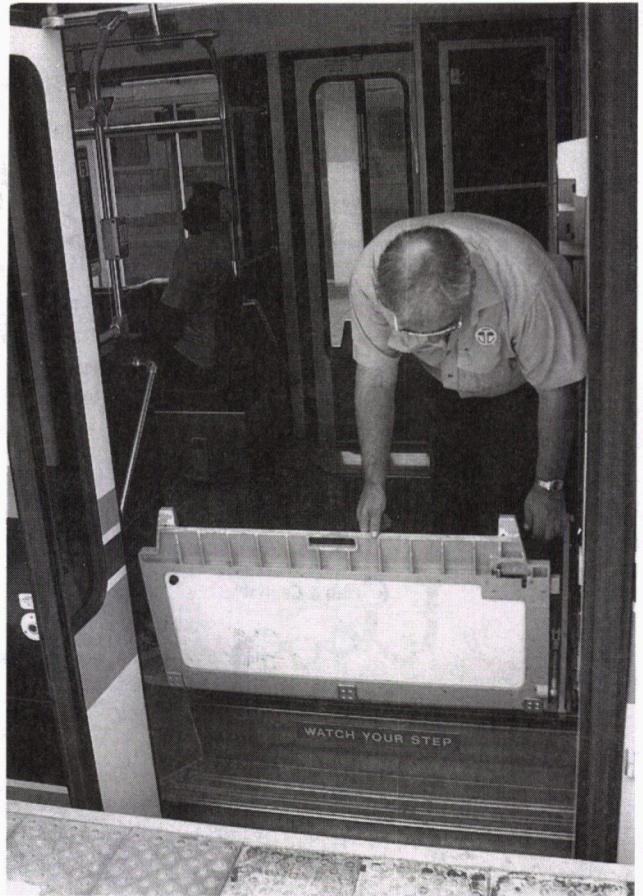
FIGURE 4 Operator manually deploying bridge plate.

on access to passengers with mobility restrictions (Figures 4 and 5). Color-contrasting resilient-overlay detectable warning strips of a truncated-dome design are installed at all platform and boarding area edges. The FVM's have been adapted for use by blind patrons with the addition of instructions in Braille. Other station accessibility features include parking for persons with disabilities, curb ramps, accessible paths to platforms and boarding areas, and elevators at a two-story station.

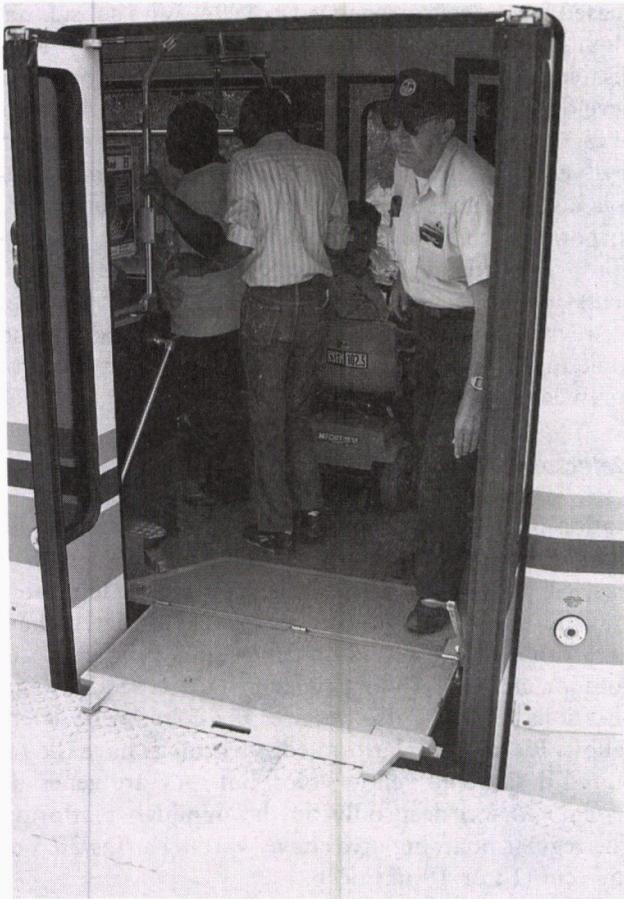
FIGURE 5 Bridge plate in position.

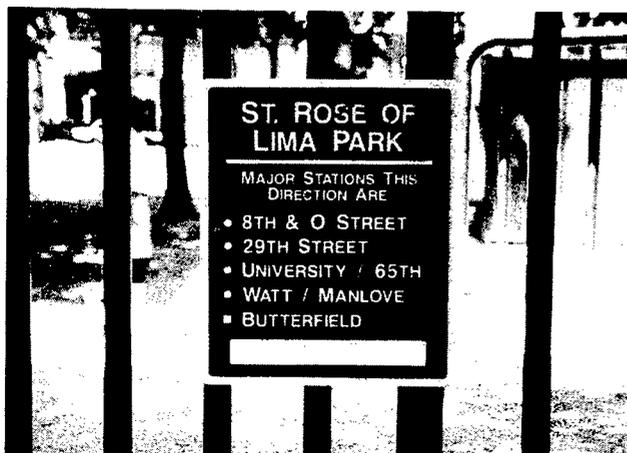
FIGURE 6 Destination sign with raised print and Braille (in white panel at bottom).

Searching for a tough yet cool material led RT to test signs made of Coryon, a high-density polymer that is sandblasted to create raised print characters. Braille is produced by sandblasting or by using inset beads (Figure 6). A prototype 6.4 mm (¼ in.) thick was broken by vandals, which led to further testing of 12.7-mm (½-in.) material and the use of an aluminum frame. RT expects either of these versions to last several years in the field.

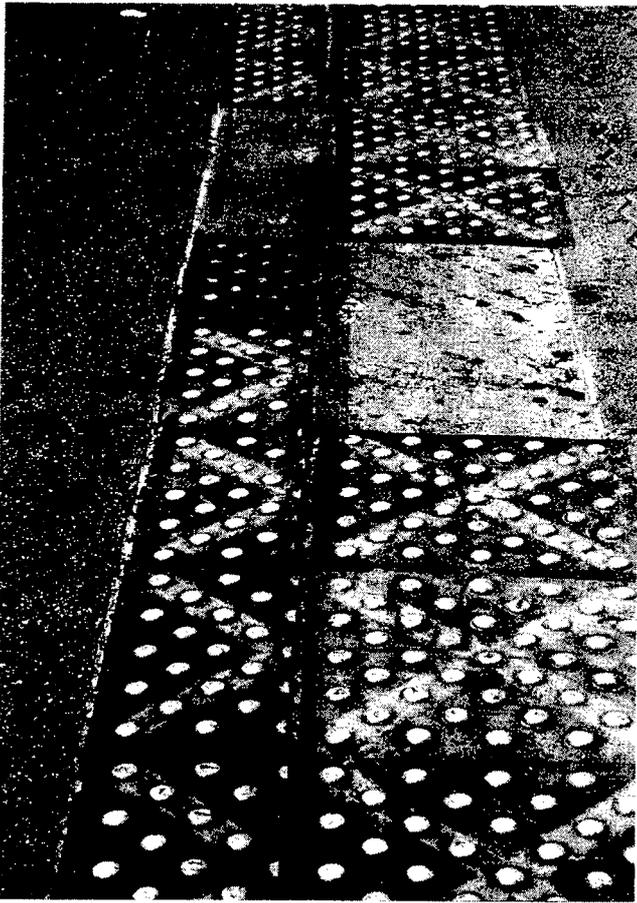
FIGURE 7 Rubber overlay tiles with truncated-dome detectable warning material.

RT was one of the first systems in the United States to install what later became ADA-standard detectable warning material. The original 1-ft<sup>2</sup> rubber overlay “tiles” were installed using construction-grade mastic. The combination of Sacramento's summer heat and the tendency of the material to stretch over time resulted in the closing of the original gaps between squares. The tiles then butted up against each other, causing some to pop up and curl (Figure 7). This created a tripping hazard for pedestrians, which resulted in a few injuries and in the need for RT to pull up curled tiles and replace them sooner than anticipated. On the other hand, RT has not had any major incidents or accidents in which visually impaired passengers or pedestrians have unknowingly walked in front of approaching trains in station areas. Whether this would have been different if the detectable warnings were not in place is uncertain.

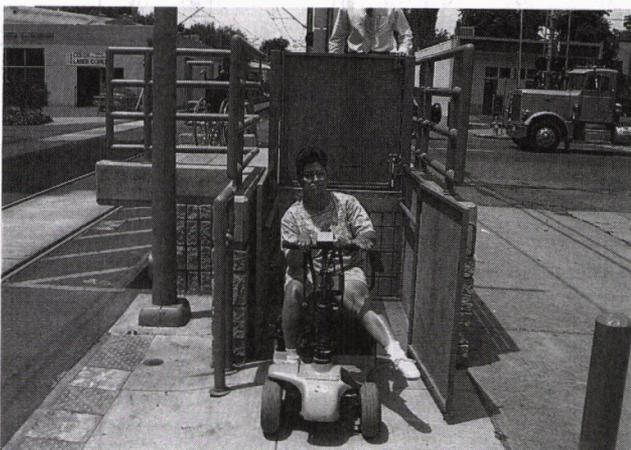
FIGURE 8 Wayside lift operated by passenger.

Unlike the wayside lifts on some other U.S. systems, Sacramento's were designed to be operated by the passenger without assistance from LRV operators (Figure 8; note passenger using foot to hold door open). Riders are required to be on the platform when the train arrives. Operators sometimes provide assistance if their schedules allow, but several users have complained about difficulty in opening the manually operated doors to the lift car or operating the control switches. RT plans to retrofit the controls with larger, paddle-type switches. Another possibility, for which technical solutions are not yet final, may be to convert the doors to open automatically and close when the up or down controls are activated.
