# Dynamic Studies of Two Continuous Plate-Girder Bridges

ROY C. EDGERTON, Research Engineer, and  
GORDON W. BEECROFT, Assistant Research Engineer,  
Oregon State Highway Department

This paper describes and presents partial results of tests conducted by the Bureau of Public Roads and the Oregon State Highway Department on two three-span, continuous plate-girder bridges in Oregon. Measurements include deflection of the girders and strain in the girders, stringers, and floor beams under test vehicles approximating the AASHO H20-S16-44 truck at speeds of 5 mph. to 45 mph. Test data are presented in curves showing variation of stress and deflection with speed. Comparisons are made with stresses and deflections calculated according to existing specifications. Measured stresses in general are found to be lower than calculated values. By comparison of the results from the two bridges, deck surface condition is considered to be an important factor in the vibration of one of the bridges.

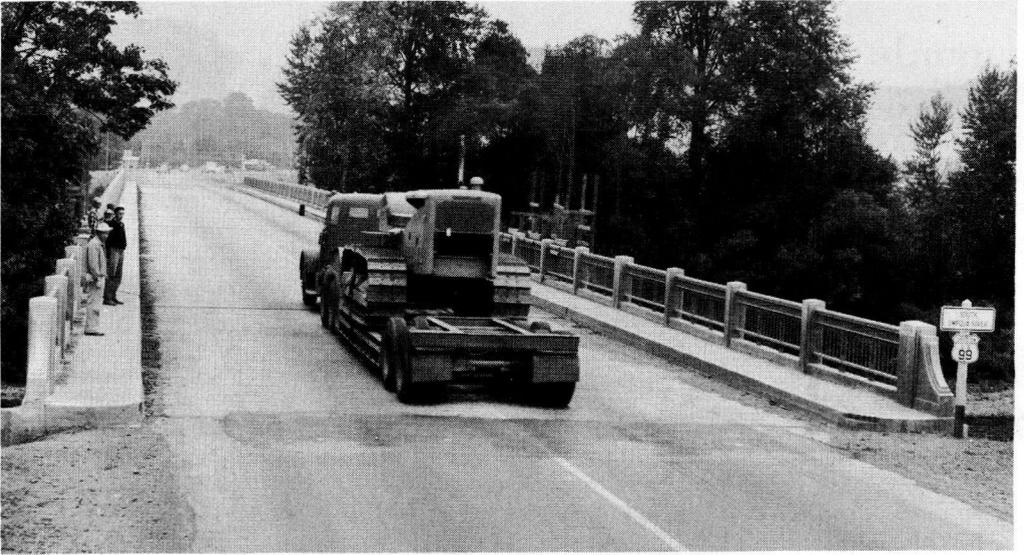
Figure 1. View of Vehicle A on North Dillard Bridge.

Two test vehicles were used. Vehicle A was a military-type,  $2\frac{1}{2}$ -ton truck chassis converted to a logging truck with a logging trailer. The vehicle was loaded with steel sheet piling. Vehicle B was a diesel truck-tractor with an equipment semitrailer. The load was a track-type tractor. Figure 4 shows critical dimensions and axle loads of the two vehicles. Vehicle B is shown on the bridge in Figure 1.

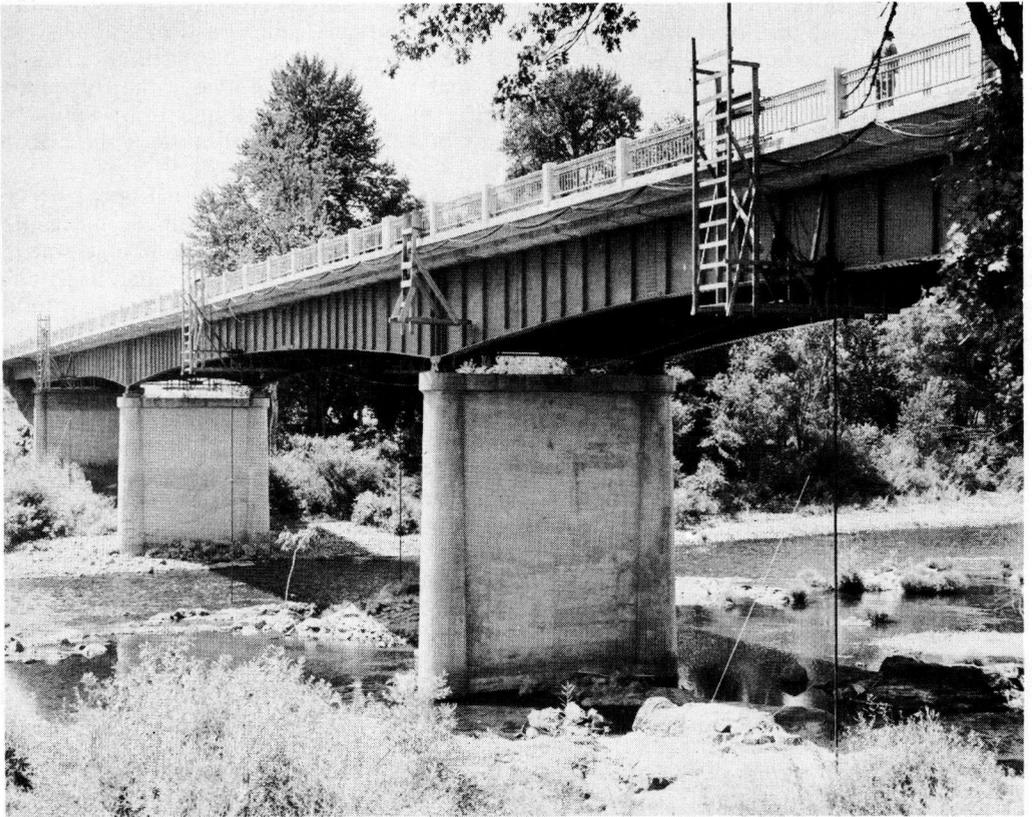
Figure 2. View of North Dillard Bridge showing girders and piers.

Figures 1 and 2 are views of the bridge. Figure 3 shows critical details of the structure. The bridge is on tangent. The profile of the bridge is a 600-foot convex vertical curve with the deck grade varying from level to 0.8 percent. The south end is 2.77 feet lower than the north end.

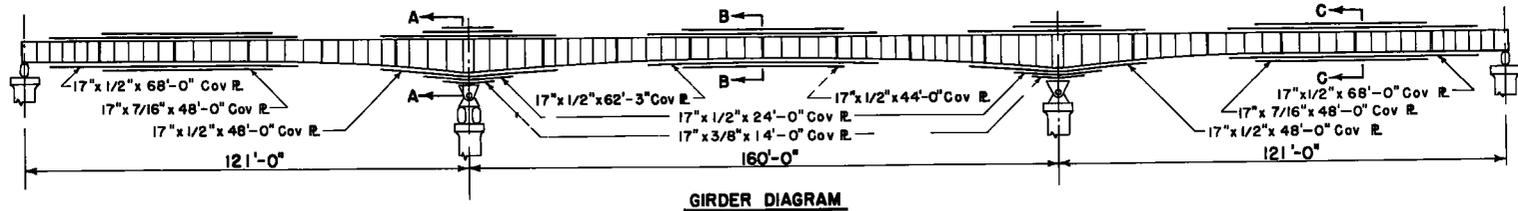
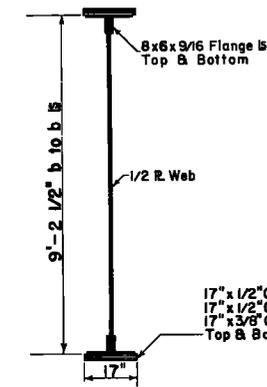
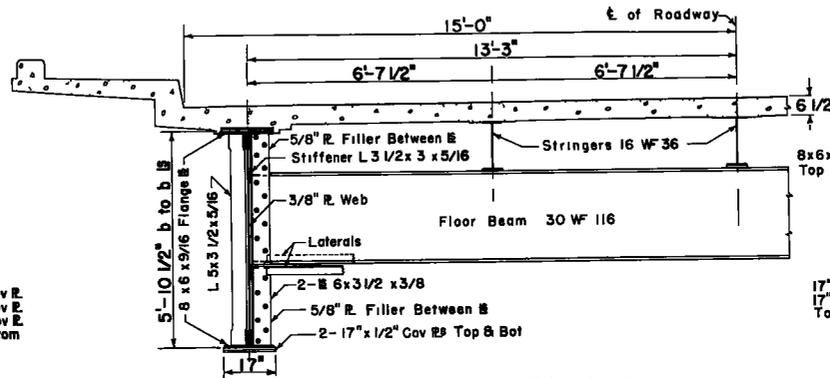
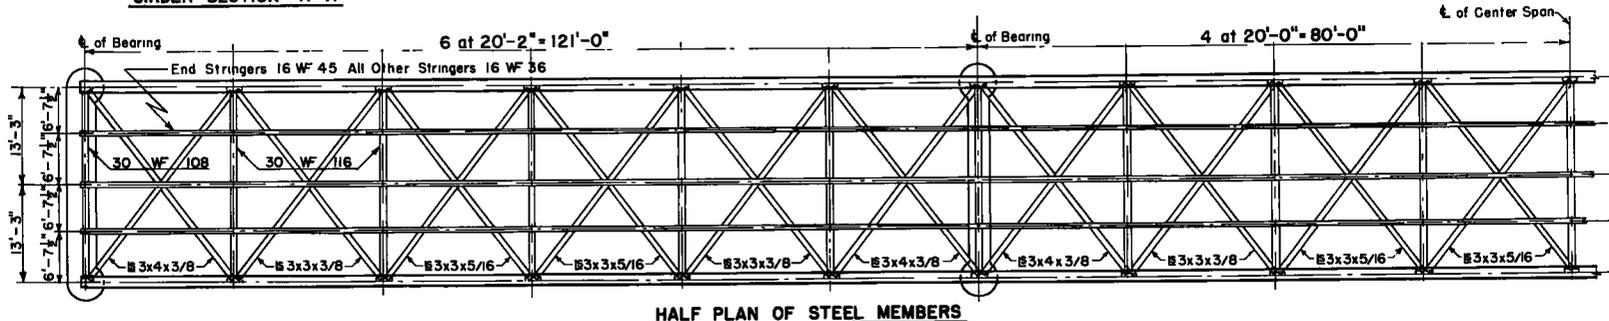
Figure 3. Details of bridges.

The spans are 121 feet, 160 feet and 121 feet, center to center of bearing. The girder depth, back to back of flange angles, varies from 5 feet 10½ inches at the outside ends of the side spans and at the center of the center span to 9 feet 2½ inches over the interior piers. The four piers, of dumbbell pattern, are founded on rock. The heights from footing to bearing are about 35 feet for the exterior piers, 43 feet for the north interior pier, and 38 feet for the south interior pier. There is a 50-foot 3-inch reinforced-concrete approach span at each end. The deck is 30 feet wide with two 3-foot 6-inch sidewalks.

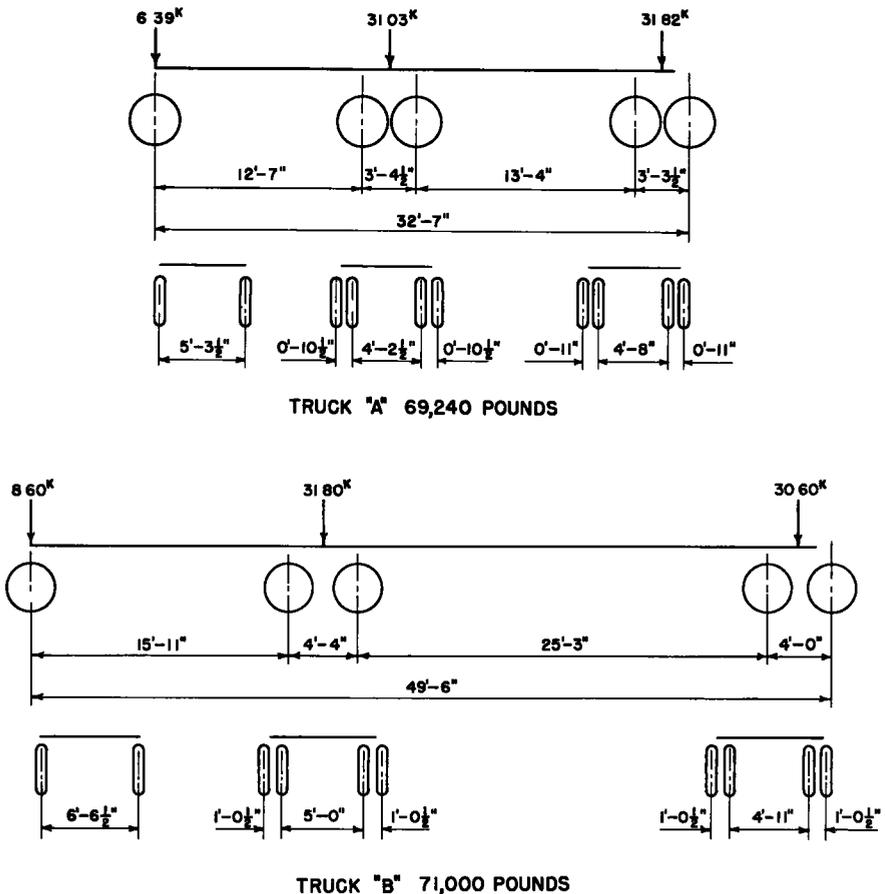
Figure 4. Dimensions and weights of test vehicles.

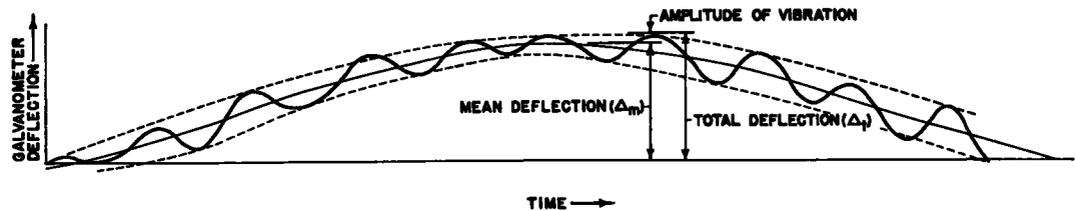
Figure 5. Typical deflection trace.

For an understanding of the terms used on the curves and in the discussion of the test results, attention is invited to Figure 5. This is a typical deflection trace from an oscillogram. The ratio of ordinate to abscissa from the trace has been doubled for clarity. The trace takes the form of a vibration curve with a frequency of about 2 cps. superimposed on a deflection curve representing the passage of the vehicle across the center span. To take the results from a trace, envelope curves to the vibration curve are drawn. The maximum ordinate of the upper envelope curve and the maximum ordinate of a line midway between the envelope curves are converted to deflection by the calibration curve and are termed the total deflection ( $\Delta_t$ ) and the mean deflection ( $\Delta_m$ ). The difference between the total deflection and the mean deflection is the amplitude of vibration. Strain traces are analyzed in an identical manner. Strains are converted to stress by an assumed modulus of elasticity of 30 million psi. The terms used are total stress ( $\sigma_t$ ), mean stress ( $\sigma_m$ ) and amplitude of stress oscillation.

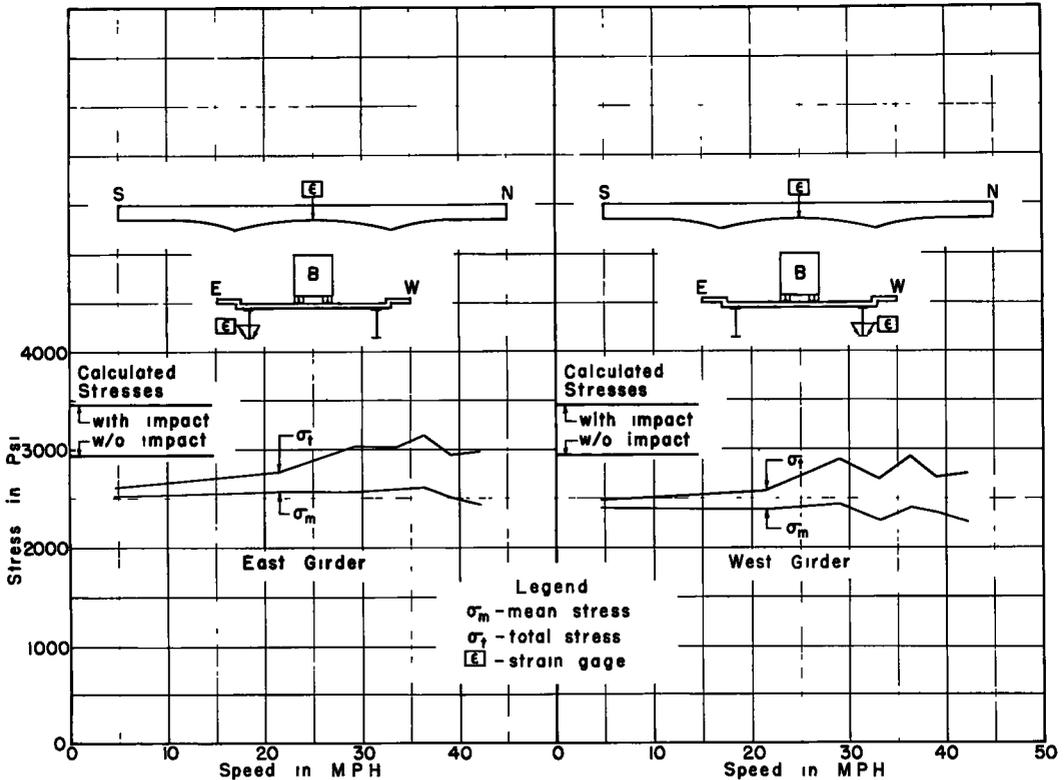
Figure 6. North Dillard Bridge stress curves, Series Ia, Vehicle B. center span.

In this preliminary report only the results from runs with Vehicle B will be presented. Vehicle A would add little to the picture. Only the stresses in the lower flanges will be presented. These are the critical stresses in each section. The total and mean stresses in the lower flanges of each girder in the center span for all Series Ia southbound runs and northbound runs were averaged separately to see whether or not the direction of the vehicle has an effect on the stress and deflection. Since no directional effect was evident, the results of the runs in the two directions were averaged to give a single stress curve and a single deflection curve for the center span of each girder for Series Ia. Figure 6 shows the stress curves for the two girders. The highest mean stress is about 90 percent of the calculated stress without impact, based on the current AASHTO speci-

The highest total stress is about 7 percent greater than the calculated stress without impact but about 9 percent less than the calculated stress with impact. The increase in total stress resulting from an increase in the amplitude of vibration between 20 and 30 mph. is typical of the span. Figure 7 shows the corresponding deflection curves. The deflection follows the same general pattern as the stress except that a sharp increase in amplitude in the east girder occurs about 29 to 35 mph. The greatest observed total deflection is 0.55 inch and the greatest amplitude of vibration is 0.13 inch, both occurring at 42.6 mph. in the east girder.

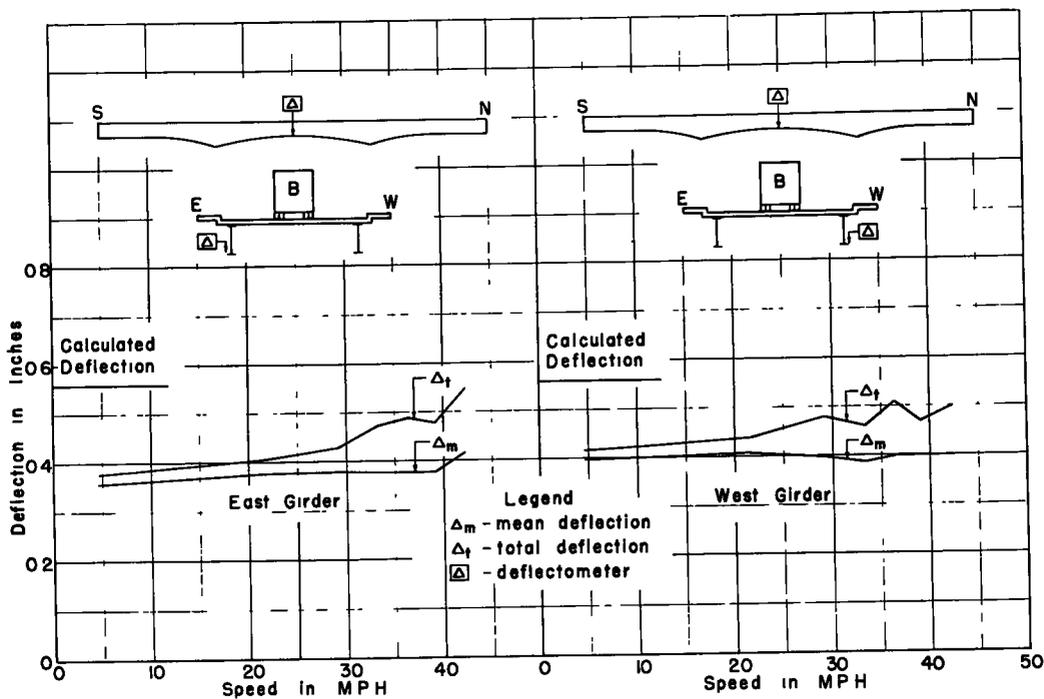
Figure 7. North Dillard Bridge deflection curves, Series Ia, Vehicle B, center span.

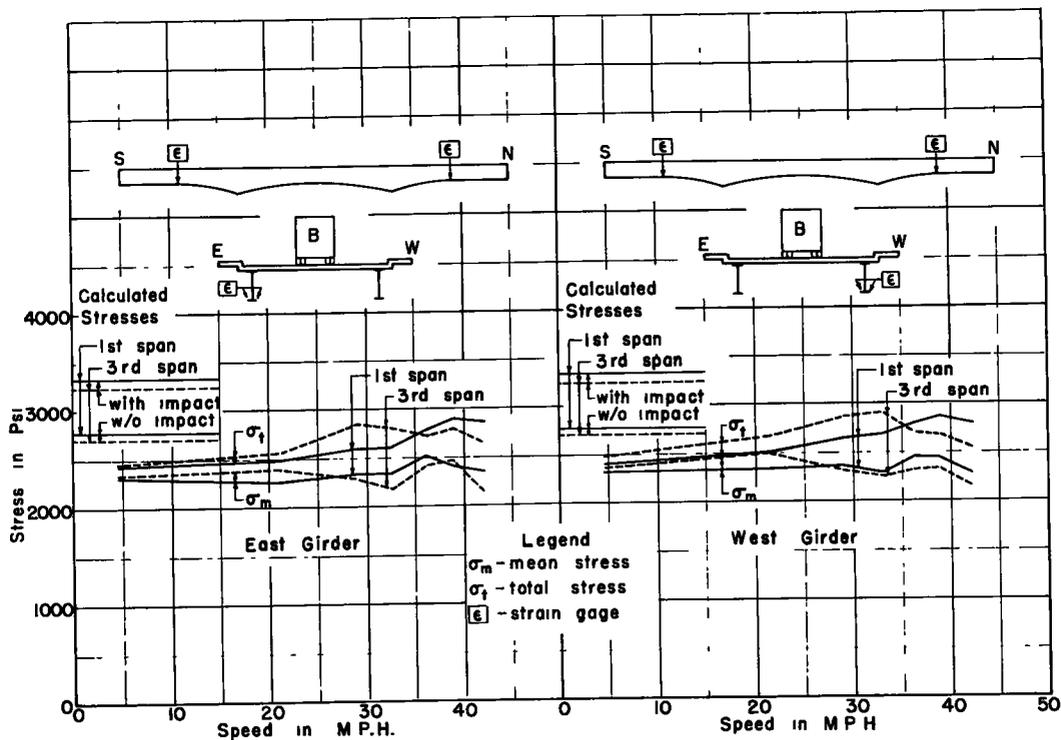
Figure 8. North Dillard Bridge stress curves, Series Ia, Vehicle B, side spans.

Figure 8 shows the stress curves for the side spans. First span and third span effects are shown by separate curves. While the highest total and mean stresses are similar, the reaction to speed is different. In the first span effect, where the structure is still until the vehicle enters the span, the highest stresses occur at about 40 mph.,

while in the third span effect, where the structure is vibrating from the passage of the vehicle across the other two spans, the highest stresses occur at about 30 mph.

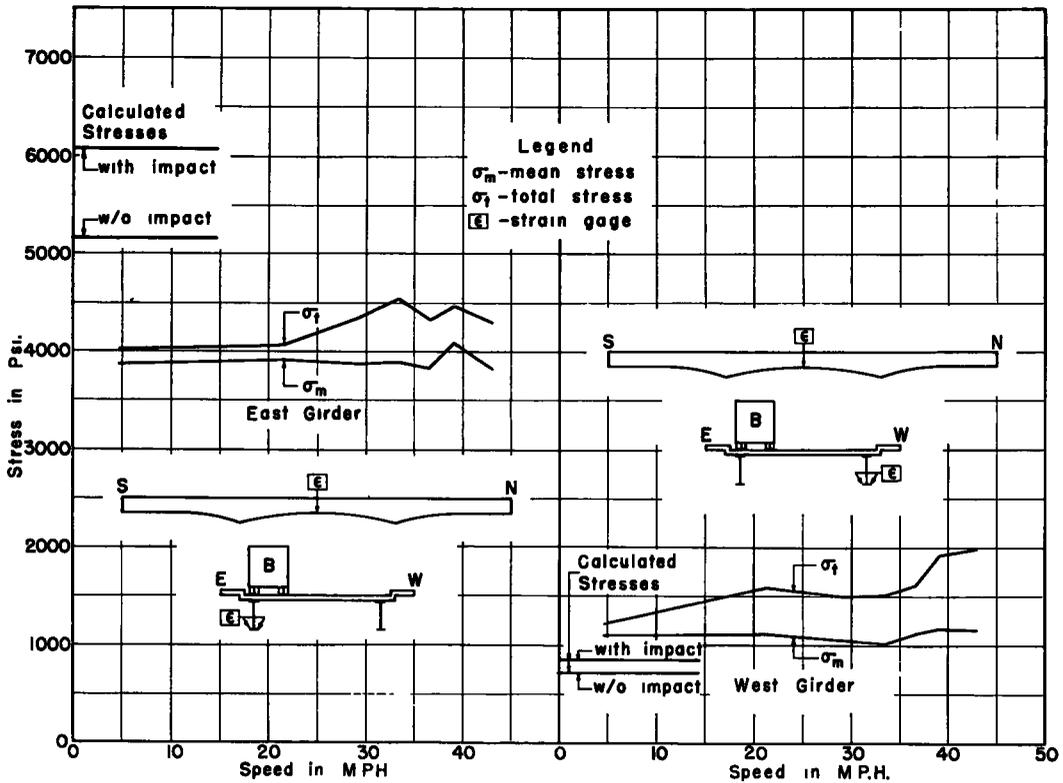
Figure 9. North Dillard Bridge stress curves, Series Ib, Vehicle B, center span.

Series Ib was a repetition of Series Ia, with the exception that all runs were made with the east tires of the vehicle a foot from the east curb. Figure 9 shows the stresses in the center span. The calculated stresses are based on simple beam distribution to girders. The curves for measured stress show that, due primarily to the torsional rigidity of the structure, a greater proportion of the load than assumed was transferred to the unloaded girder. The laterals are in the plane of the bottom flange of the floor beam and they, with the floor slab and main girders, form a box section over 4 feet deep having a significant torsional stiffness, the deep floor beams and their connections being stiff enough to prevent distortion of the cross section. Again, the abrupt increase in amplitude between 20 to 30 mph. in the loaded girder will be noted. The unloaded girder shows a greater amplitude of stress oscillation than the loaded girder.

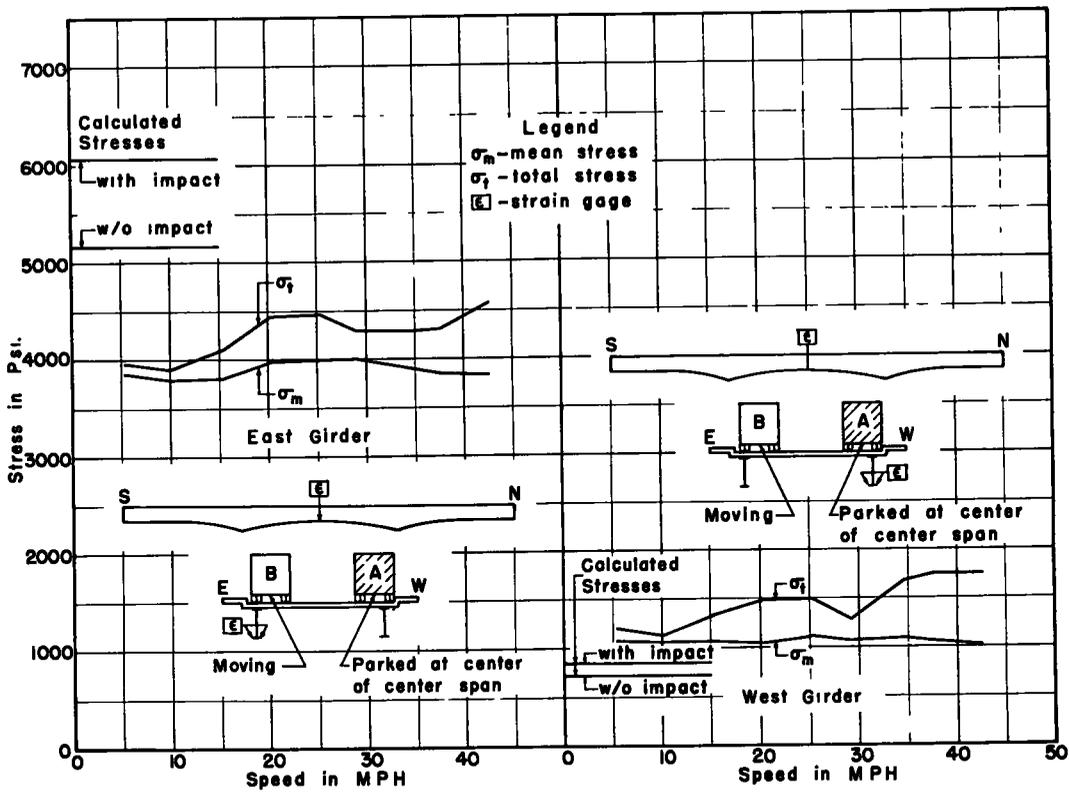
Figure 10. North Dillard Bridge stress curves, Series Ic, center span. Stresses from moving vehicle only.

To determine the damping effect of additional stationary mass or dead load on the vibration of the structure, Vehicle A was parked at the center of the center span with tires touching the west curb. Series Ib was then repeated as Series Ic with Vehicle B making all the runs. Figure 10 shows the stress curves under these conditions. New strain and deflection zeros were established after Vehicle A was parked on the span. The stresses in Figure 10 are those caused by the moving vehicle only. They do not include the stress caused by the parked vehicle. The highest total stresses occur at a different speed than in Series Ib, but the magnitude of these stresses is virtually unchanged by the parked vehicle.

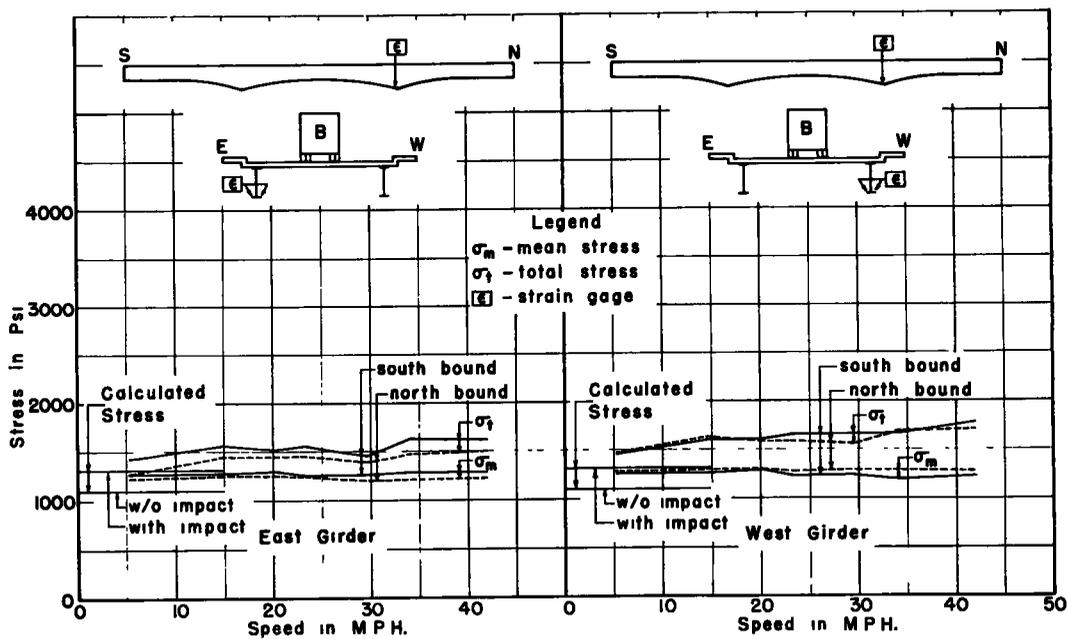
Figure 11. North Dillard Bridge stress curves, Series IIa, Vehicle B, center span.

For Series II, the twelve strain gages were removed from the inside girder flanges and were installed on the girder flanges near the north interior pier. Eight gages, inside and outside of top and bottom flanges on both girders, were installed in the center span. Four gages, outside of top and bottom flanges of both girders, were installed in the north span. All twelve gages were 2 feet 6 inches from the pier centerline. This distance was necessary to avoid the special girder details at the pier. Figure 11 shows the strain curves for the gages on the center span side of the pier. The negative moment stresses show a higher degree of uniformity than the positive moment stresses and less variation with speed. The measured negative moment stresses are consistently greater than the calculated stresses with impact.

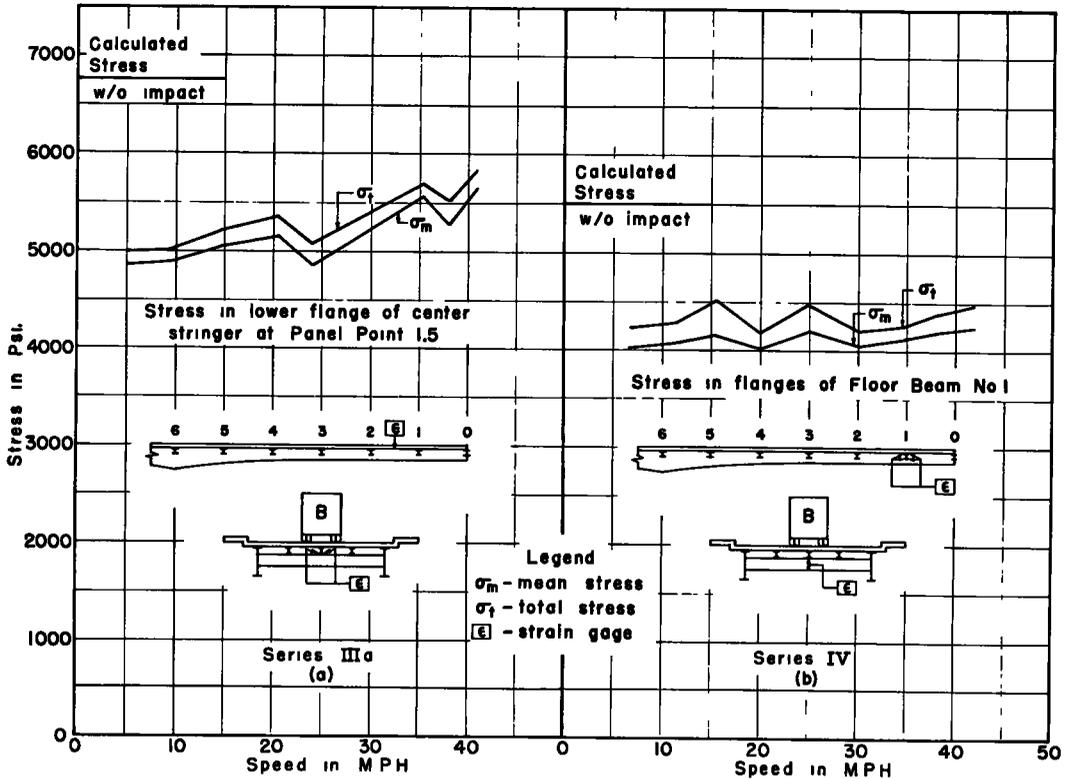
Figure 12. North Dillard Bridge floor-system stress curves, Vehicle B, north span.

For Series III, resistance strain gages were installed on both sides of the top and bottom flanges of the three stringers at two cross-sections of the bridge. One cross-section was at the center of the second floor panel from the north end of the north span and the other cross-section was over the floor beam next south. Runs were made with the vehicle centered on the deck, hence, centered over the center stringer and with the west wheels of the vehicle directly over the center stringer. At the center of the panel, maximum stresses were produced in the lower flange of the center stringer with the vehicle centered over the stringer. Figure 12a shows these stresses. The unusual feature of these curves is the variation of both mean and total stress with speed and the comparative uniformity of the amplitude of stress oscillation. The highest total stress observed is only about 87 percent of the calculated. Composite action of the concrete deck is not considered in the calculated stress, since no shear devices were installed. Composite action is evident in the magnitude of the lower flange stresses and in the relationship of upper and lower flange stresses.

Figure 12b shows the stress curves for Series IV, the flange stresses at the center

of the first floor beam from the north end of the north span. The floor beam showed a different response to speed variation than any other member tested. Here again the measured stresses are much lower than the calculated stresses. Preliminary analyses of the records of gages near the ends of the floor beams indicate that the low stresses at the center of the floor beam will be explained by partial fixity at the connection of the floor beam to the girder.

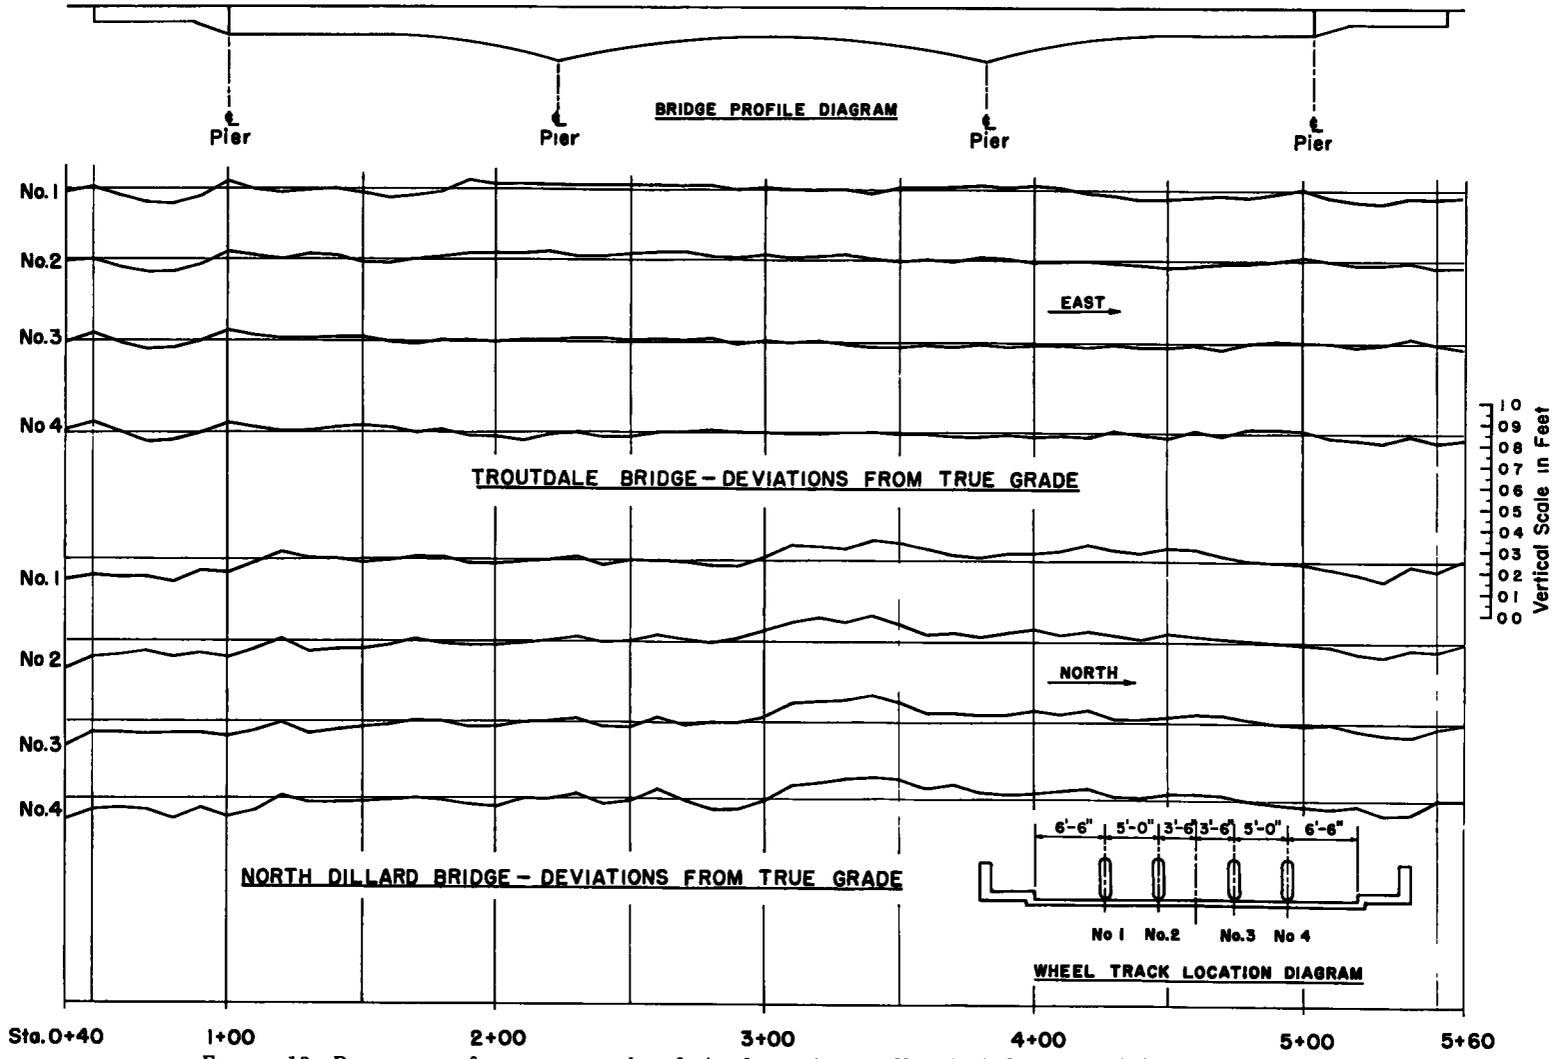
Figure 13. Deviations from true grade of wheel tracks on North Dillard and Troutdale bridges.

Profiles in each of the four wheel tracks were obtained on both bridges by taking elevations with a level at 10-foot intervals and making an accurately traced, graphical profile between each pair of level points. These profiles included 60 feet of roadway and approach structure at each end of the steel structure. Figure 13 shows the deviations of the 10-foot points from true grade, the true grade for each wheel track being represented by a horizontal line. To arrive at a numerical comparison of the roughness of the two structures, total deviation from true grade at the 10-foot points were computed. The total deviations in 520 feet for the four wheel tracks at North Dillard were 2.02 feet, 2.09 feet, 2.05 feet, and 2.00 feet (average, 2.04 feet). The deviations at Troutdale were 1.37 feet, 1.08 feet, 0.84 feet, and 0.84 feet (average, 1.03 feet). On the basis of this comparison, the Troutdale Bridge was selected for making comparable measurements of strain and deflection.

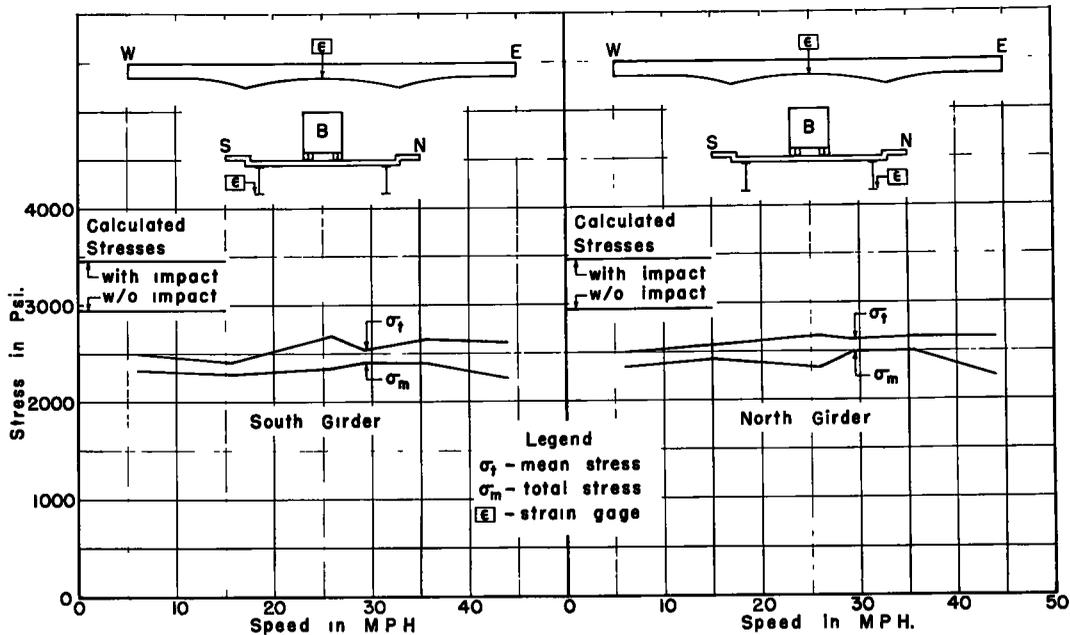
Figure 14. Troutdale Bridge stress curves, Series Ia, Vehicle B, center span.

Series Ia and Ib of the North Dillard tests were duplicated on the Troutdale Bridge, except that resistance strain gages were used and strain gages were placed only on the top and bottom outside flanges of the girders at the centers of the west and center spans. Figures 14 and 15 are the Ia and Ib stress curves for the center span of the Troutdale Bridge. The mean stress in the Troutdale Bridge averages about 5 percent less than those in the North Dillard Bridge. The amplitude of stress oscillation on the Troutdale Bridge is much less. Figure 16 shows the average variation in amplitude of vibration with speed for both girders in the center spans of the two structures as taken from Series Ia deflection records.

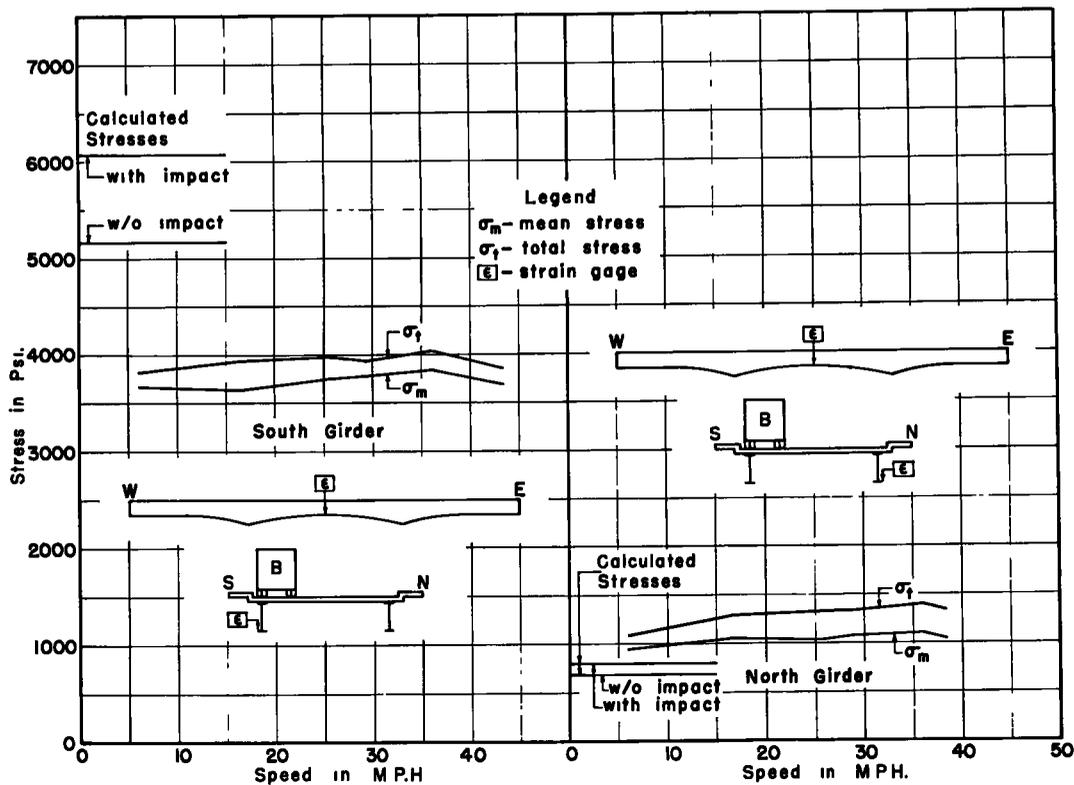
Figure 15. Troutdale Bridge stress curves, Series Ib, center span.

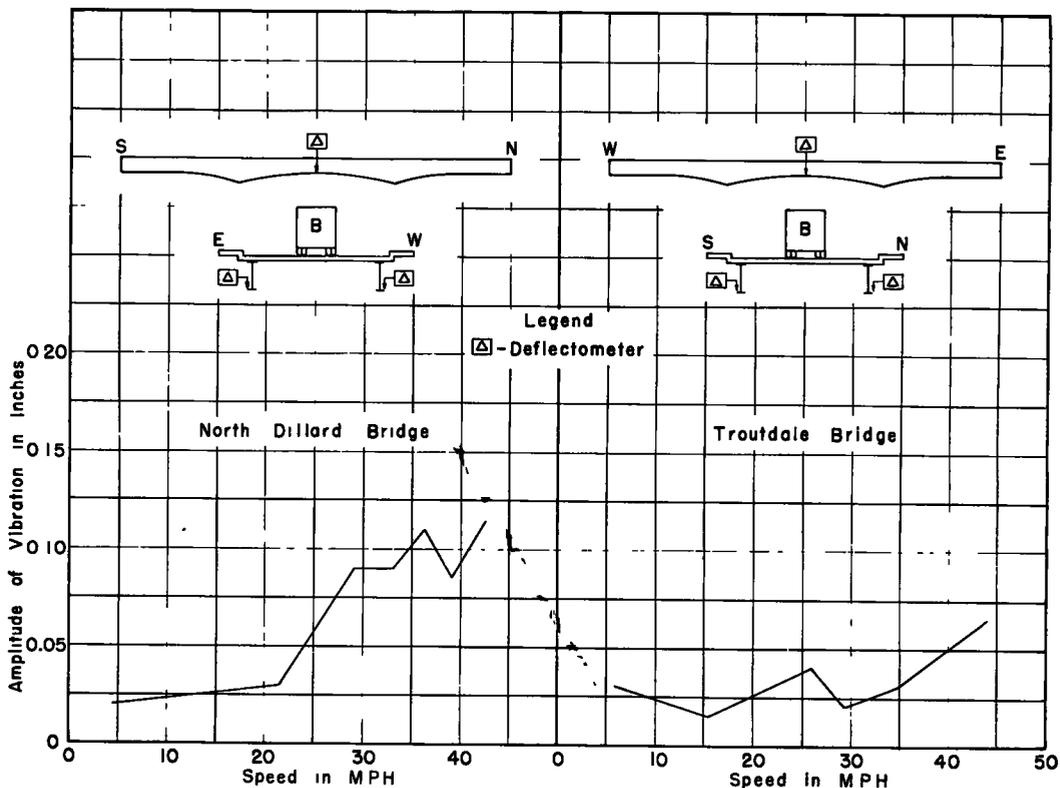
Figure 16. Amplitude of vibration curves, Series Ia, center span. Comparison between North Dillard and Troutdale bridges.
