A STUDY OF GLASS BEADS FOR REFLECTORIZING TRAFFIC PAINT

V H. LYON, *Laboratory Director* AND D. L. ROBINSON, *Senior Materials Engineer*,
Missouri State Highway Department

SYNOPSIS

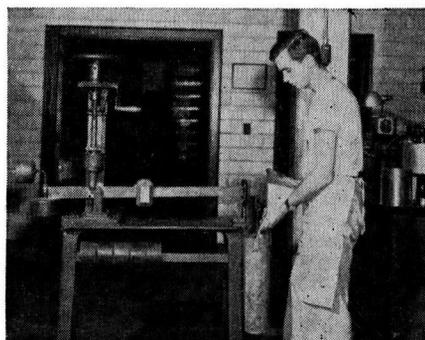
Figure 1. Apparatus for Determining Crushing Strength of Glass Beads

Because some of the beads contain bubbles and seeds in varying degrees, it was thought that a crushing strength test would yield information of value in connection with the useful life of the bead under traffic impact and wear. An apparatus was designed for this purpose by slightly modifying a Riehle cementation briquette-making machine as shown in Figure 1. The cylinder die and table of the machine were removed and the counter balance replaced with a metal bucket 4½ in. in diameter by 16 in. in length. A small hard steel plate placed under the plunger serves to hold the individual bead. Balancing the apparatus at no load is accomplished by moving the weight on the beam after the plunger is set on the bead. The load is applied by allowing free

flowing dry sand to run into the metal bucket through a glass funnel, having an inside diameter of the outlet of $\frac{1}{8}$ in., at a rate of approximately 2½ lb. per min. The flow of sand is stopped when the bead is ruptured and the sand is weighed in grams. For the described equipment the crushing strength is calculated by the following equation:

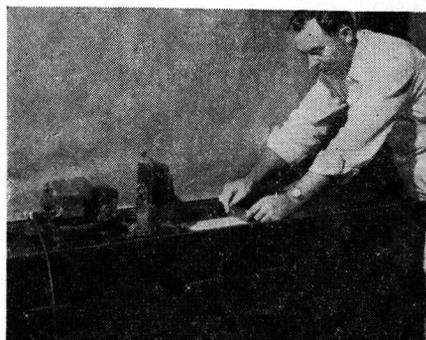
and the need for accuracy in bead application for comparative results is obvious. An apparatus for this purpose, shown in Figure 2, was designed during the investigation. The dispenser is a rectangular metal box 4 by 2 by 8 in. with a bevelled bottom having a variable opening across the width at the lower part of the bevel through which the beads flow by gravity. An outside gate which is held securely by a knurled screw can be raised or lowered to change the rate of flow. A sliding inside gate is used to start and stop the flow. The holder is a 4-wheeled carriage running on gear tracks

Figure 2. Laboratory Bead Dispenser

and propelled by a gearhead electric motor. The speed may be varied by changing gears although once the speed is set the dispenser gate may be raised or lowered to control the flow and quantity of beads. Glass panels 6 by 18 in. are used for paint application and are held on the metal base by raised lugs. Calibration of flow of the beads is easily accomplished by making "dry runs" over a metal pan 6 by 24 in. and weighing the beads. The operator slides the doctor blade just ahead of the movement of the dispenser so

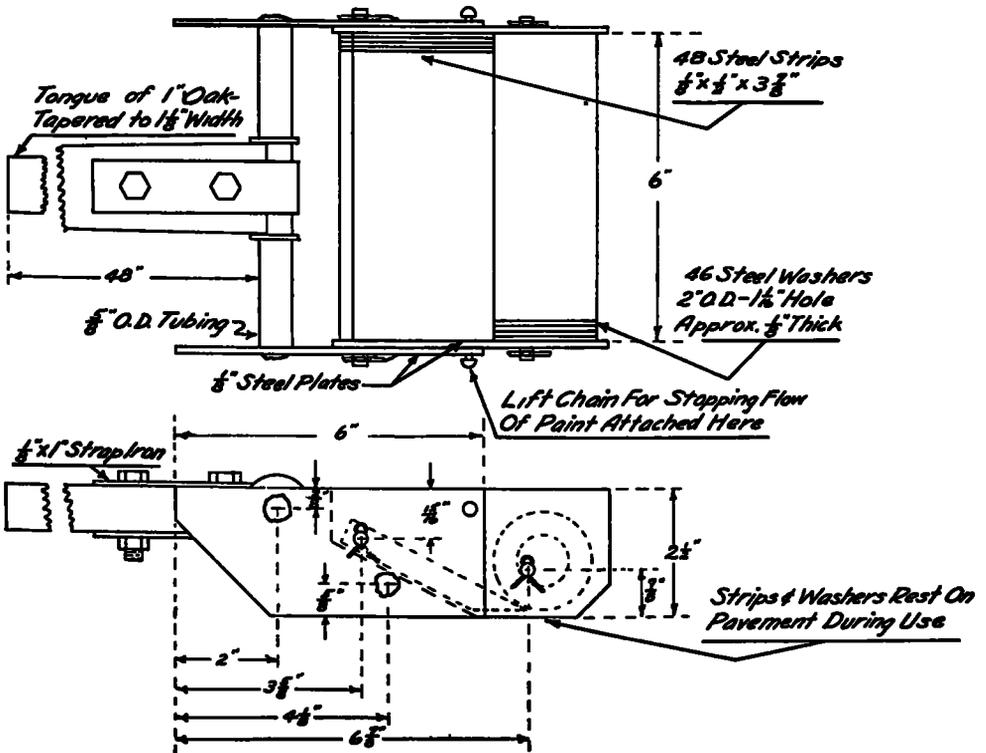
Figure 3. Design of Line-o-graph for Traffic Paint Application

and a hand operated flow type striper similar in principle to the regular pavement striping machine. The line-o-graph, shown in Figure 3 is a sliding applicator and applies the paint from a reservoir from which the paint flows under a series of freely moving washers. The film so produced averages 7 mils wet thickness. Unfortunately, the viscosity or the body of some paints causes them to remain ridged after flowing from the line-o-graph which adds a variable to the durability evaluation. Generally, most paints, including the Missouri standard, flow out to smooth uniform films. With the hand striper different film thickness may be applied. During the greater part of the investigation beads were applied with a hand

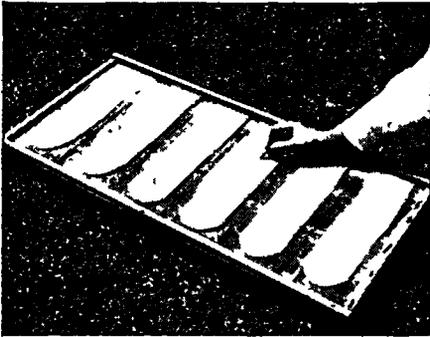
beads over a period of time are reported in Table 5. Figure 4 shows how the panels are mounted on the roof of the laboratory building during exposure.

Figure 4. Beaded Paint Stripes for Atmospheric Exposure

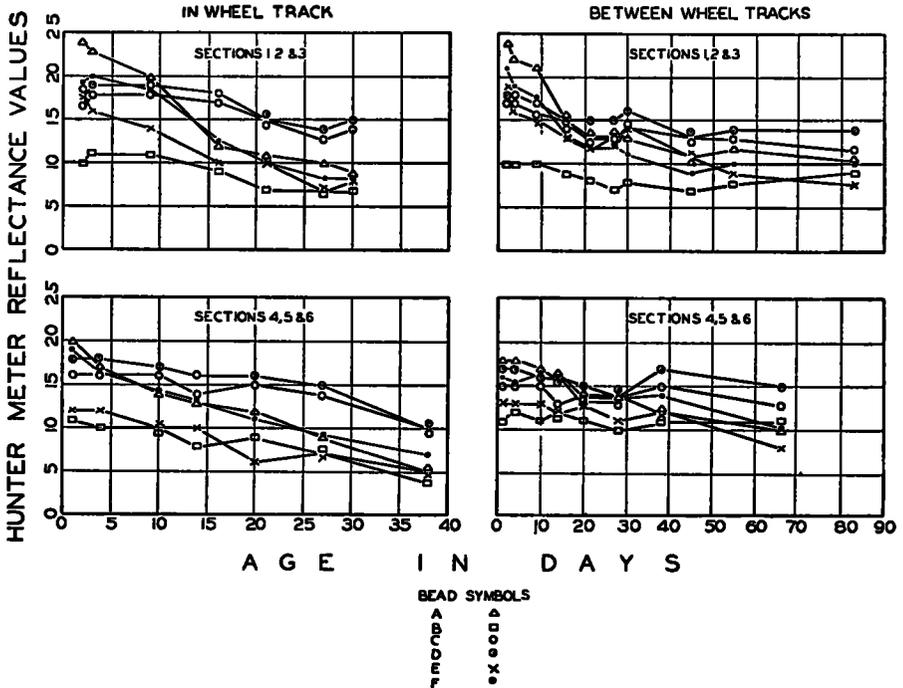
are shown in Table 6. Averages of Sections 1, 2 and 3 and of 4, 5 and 6 are shown graphically in Figure 6. No systematic examinations were made with the magnifying glass or in sunlight but it was noted that the bead application was not uniform in many lines. Variations from position to position ran as high as 4 or 5 points. Usually, however, they did not exceed 2 or 3, which could be considered

Figure 6. Reflectance Values—Routes 50, Cole County

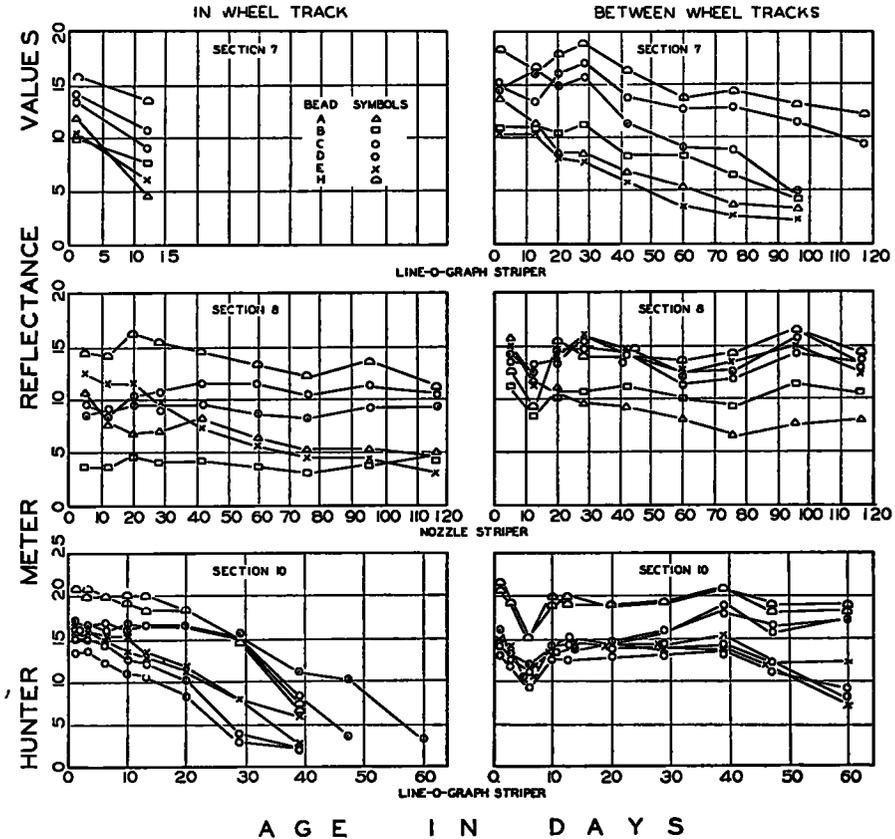
be readily duplicated. Five readings at 2-in. intervals were made in the wheel track and between the wheel tracks. The results obtained are shown in Table 7 and Figure 7.

Figure 7. Reflectance Values—Route 50, Cole County

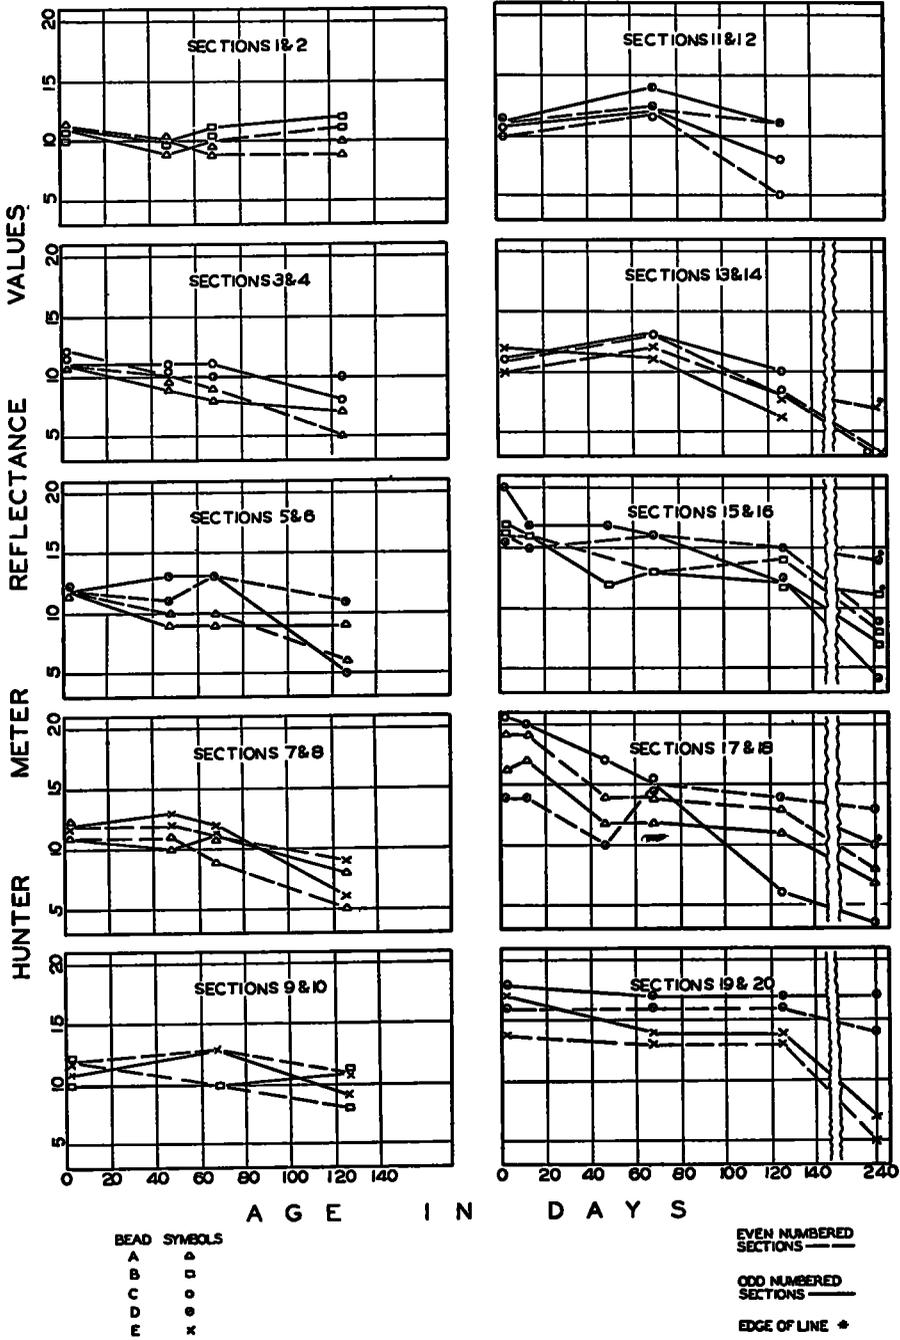
8 and Figure 8. The first reflectance measurements of these lines were made at 2 days. Since it was the first experience with the Hunter Night Visibility Meter on this work, generally two or three operators collaborated and any results which were obviously out of line were checked by rereading. It was found

Figure 8. Reflectance Values—Route 66, St. Louis County

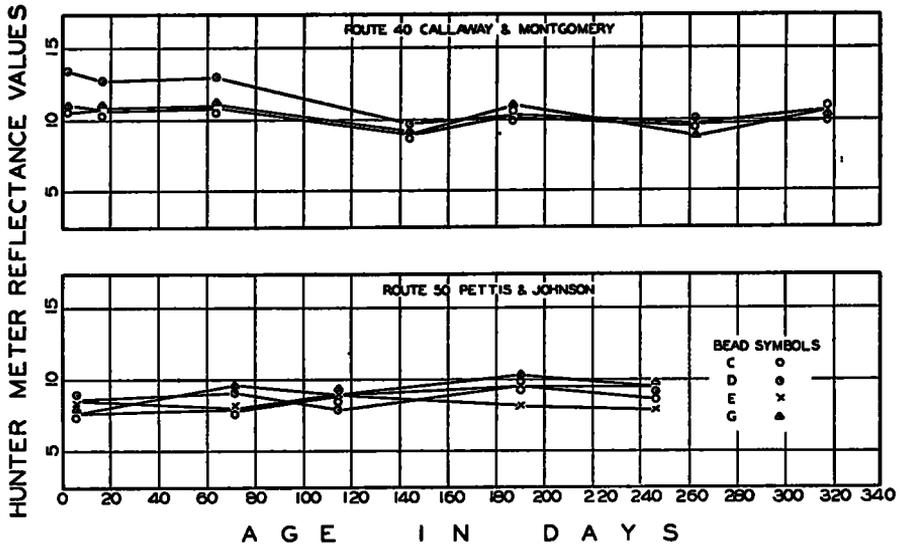
Readings at 187 days indicated recovery of reflectivity to approximately former values for Beads G & C and slight recovery for Bead D. Readings at 263 and 319 days revealed no significant reductions during that period, nor were there any significant differences in the appearances of the lines except that those on curves to the left were showing increasing wear and scaling of paint. The results obtained are shown in Table 9 and Figure 9.

Figure 9. Reflectance Values—Route 40, Callaway-Montgomery Counties
Route 50, Pettis-Johnson Counties

At both 191 and 246 days Beads C, D and G were approximately equal in reflectance while Bead E gave consistently slightly lower results. With the exceptions of those lines on hills and curves, the lines appeared to be in condition to give many more months of service. The results obtained are shown in Table 10 and Figure 9.
