## Secondary Minerals in Rock as a Cause of Pavement and Base Failure.

LEWIS E. SCOTT, *Chief Geologist,  
Oregon State Highway Department*

SECONDARY or alteration minerals were found in large percentages in the rock used in base and pavement of several highway sections which failed under use. The most common of these are kaolin clays, chlorite, serpentine, calcite, and limonite. Their presence causes rock in the  $\frac{3}{4}$ - to 0-inch size to disintegrate or dissolve when subjected to water and traffic loads. Rock in larger sizes does not seem to be affected, probably because of the sharp decrease in surface area. Microscopic study and field data indicate 0 to 20 percent of secondary minerals in a fine aggregate will have little effect; 20 to 35 percent will produce some failures and borderline results; and 35 percent and above will almost certainly cause failures.

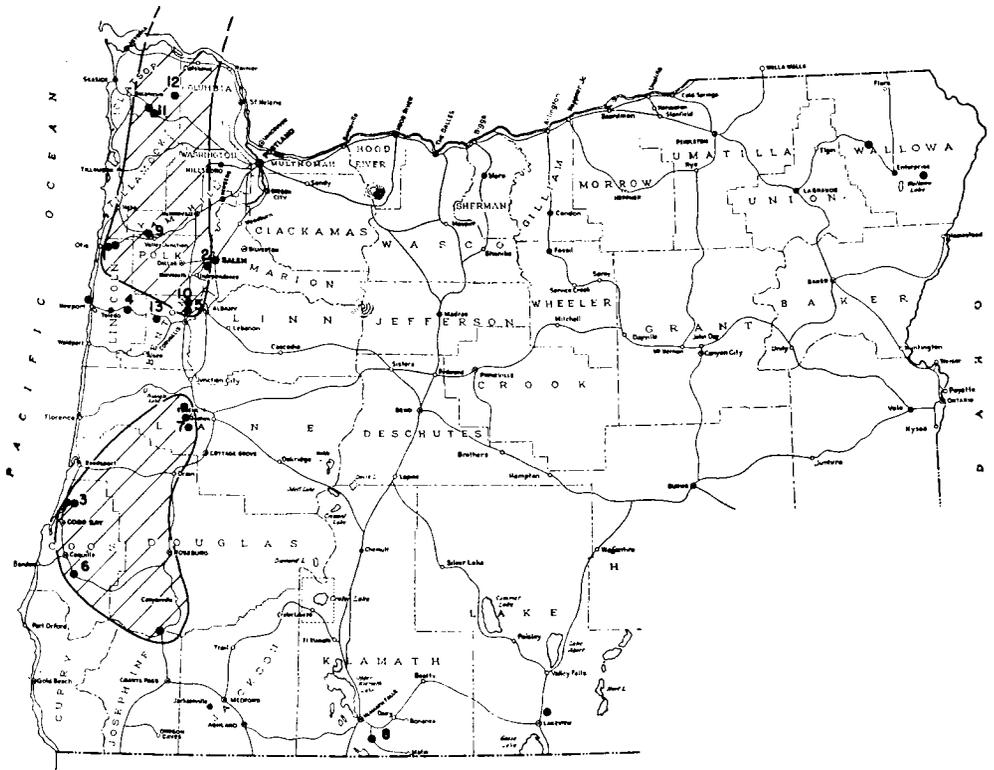
The distribution of the sites studied is shown on Figure 1. The lined areas indicate

Figure 1. Location of quarries known to contain secondary minerals as of September, 1954.

exposures of Eocene basalts in western Oregon; the area between them, covered by younger sediments, has only exposures of a later age. It will be noted that the Eocene exposures form a belt 50 to 60 miles wide, extending to the northern boundary of the state. The writer has personal knowledge of altered basalts of similar type and occurrence from western Washington as far north as Seattle. The deep, uniform weathering of the submarine Eocene basalts is due to an initial alteration of the feldspars by water during the cooling period. These weakened basalts have been protected by a thick cover of later sediments. Where erosion has exposed them, further weathering has been speeded by a warm, humid climate and low, rolling topography.

Note: The location of the above quarries is given in Figure 1 by number.
