# Vehicular Paths In Certain Types of Intersection Areas

BRUCE M. DAVIDSON, *Assistant Professor of Civil Engineering, University of Wisconsin, Madison, Wis.*

The design of rural highway interchanges has been based on the mechanical capabilities of the automobile, with the assumption that if the interchanges are properly signed the motorist can follow any set of directions. It was considered desirable to study various design features of Wisconsin interchanges in terms of the driver's reaction.

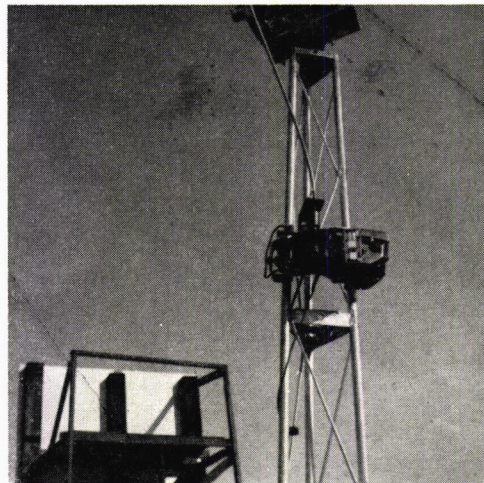
Figure 2. Camera mounted on 30-ft television tower with auxiliary tower for personnel.

shaped bracket to the top of the tower (Figures 1 and 2). The proper vertical angle was set on the vernier and the equipment was checked for operational difficulties. The tower was then raised.

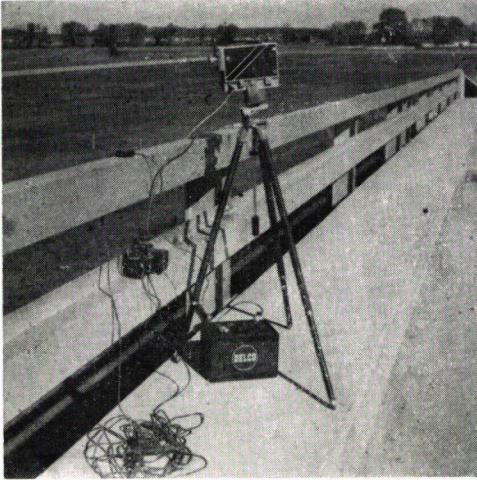
Figure 3. Tripod-mounted camera on overhead structure.

Use of an overhead structure was much simpler, because a tower was not required, and the field of view was obtained directly by using the viewfinder on the camera (Figure 3).
