Durability of Corrugated Metal Culverts

JOHN E. HAVILAND, PETER J. BELLAIR and
VINCENT D. MORRELL, Bureau of Physical Research, New York State
Department of Transportation

To provide data on corrosion and abrasion rates for corrugated pipe, two surveys were conducted—one for steel culverts with 2 to 35 yr of service, and another comparing aluminum and steel culverts installed for up to 4 yr in similar environments. Uncoated steel culverts are performing satisfactorily, being unaffected by properties of normal soil and water, but with significantly greater durability when bituminous coated or coated/paved. Uncoated aluminum culverts are proving durable, indicating no need for such protection. Abrasion was found to be of minor influence. A statistical method for estimating metal loss, and a design procedure are presented.¹

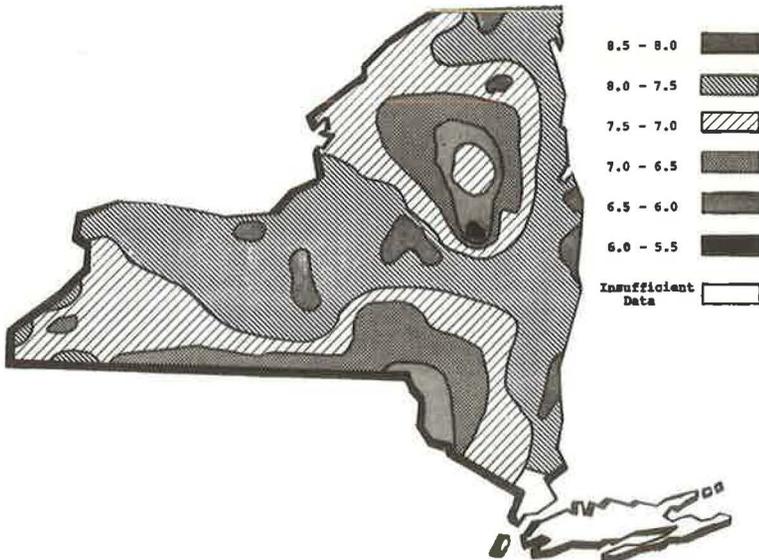
Figure 2. Composite iso-pH map of stream flow data (collected by USGS, NYS Department of Commerce, NYS Department of Health, and NYS Department of Transportation).

cluded mountainous, agricultural, wooded, industrial, and swampy areas. Under these varied conditions, pH was found to range within the narrow limits of 6.2 to 9.0. The majority of culverts (142) contained water with pH's of 7.0 to 8.9, while the extreme values each occurred only once. These results agree remarkably with similar tests conducted independently in small streams throughout the State by the New York State Departments of Health and Commerce, and the U. S. Geological Survey (7, 8). Data from all sources have been combined to form a composite iso-pH map of New York (Fig. 2), excluding the southernmost area where insufficient data were available.

It should be stressed that the distribution shown only distinguishes areas of generally similar pH, and is not applicable for precise determinations at specific locations. This is especially true when considering a culvert installation immediately adjacent to a chemically deleterious effluent, where proximity to the point of discharge, the volume of discharge, etc., will determine pH of the combined fluids carried by the culvert. However, the fact that no highly aggressive conditions were recorded, even though some culverts were as close as 20 ft from the discharge point of industrial effluent, suggests that dilution may occur rapidly.

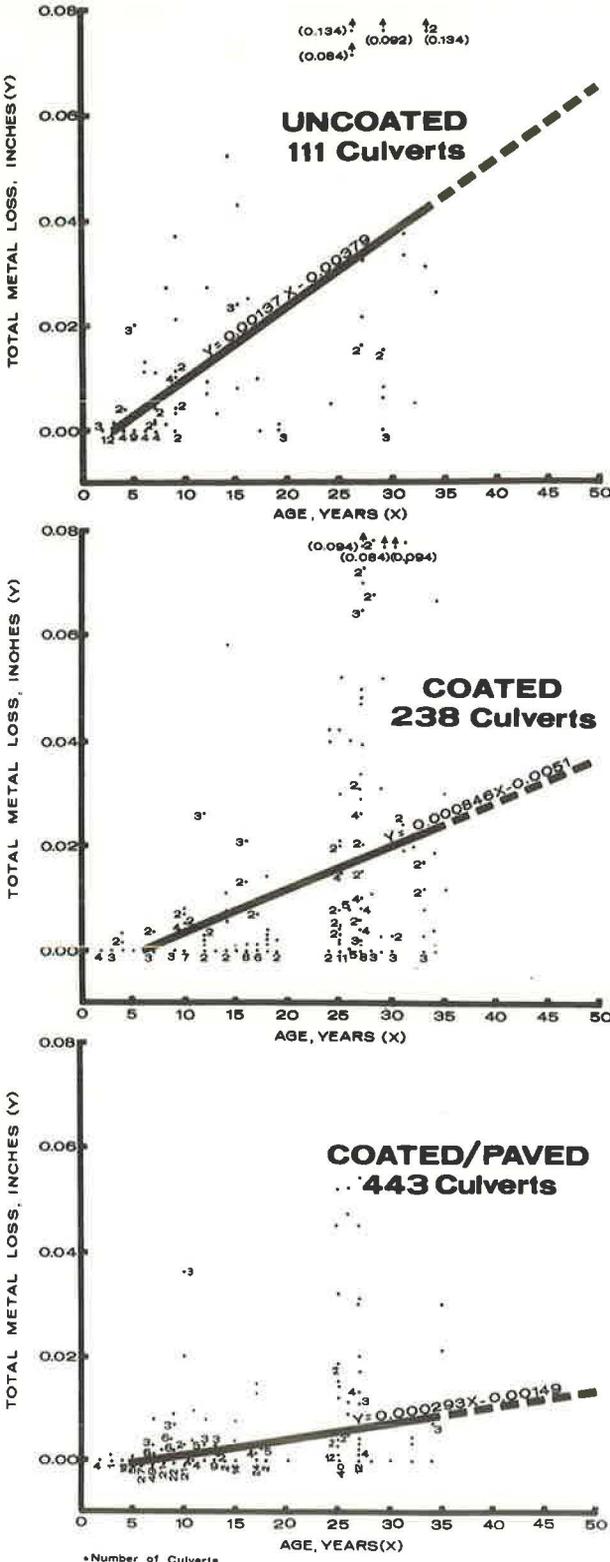
Figure 3. Metal loss with age.

These results suggested that a simple linear correlation between cumulative metal loss and the corresponding age of all culverts inspected in each class might provide a useful comparison. Figure 3 illustrates this relationship for uncoated, coated, and coated/paved culverts. The wide range in metal loss is immediately apparent. Many culverts in each category had no metal loss at ages through 30 to 35 yr, while others exhibited appreciable loss in much shorter periods. Such variations emphasize the importance of evaluating a statistically large sample to provide a satisfactory representation of the culvert population.

In Figure 3, the straight lines represent the best fit of the data based on a least-squares linear regression analysis. These lines denote the average relationship between total metal loss and age, and provide a useful means of comparing relative performance of the three classes of steel culvert. Referring to the coefficient of the "X" term in the equations of the lines, uncoated culverts exhibited an average metal loss of 0.00137 ipy, compared to 0.00085 ipy for coated pipes (or 62 percent as much), and 0.00029 ipy for coated/paved culverts (or only 21 percent as much). Stated another way, on the average, the rates of metal loss are in the ratios of 4.7:2.9:1.0 for uncoated, coated, and coated/paved pipe, respectively. This clearly demonstrates the long-term effectiveness of bituminous coatings, particularly the coated/paved combination. Other supporting evidence is the progressive reduction in maximum metal loss recorded (uncoated = 0.134 in., coated = 0.094 in., coated/paved = 0.054 in.), accompanied by an overall decrease in dispersion of the data. Due to the large number of culverts having little or no metal loss, the data points are not normally distributed, in the statistical sense, about the regression lines. Consequently, the standard error of estimate and the correlation coefficient are not applicable. A more rational method of predicting probable metal loss for design purposes is presented later.

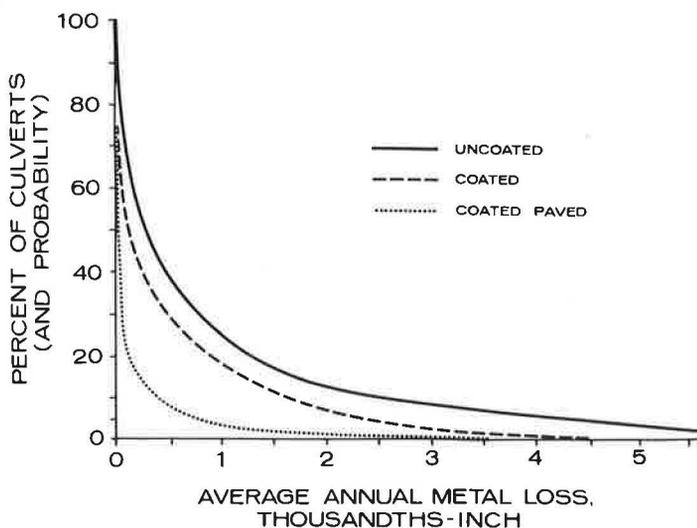
Figure 4. Distribution of average metal loss for galvanized steel culverts.

Figure 4 shows the idealized frequency distribution for the three classes of steel culverts. Each curve was constructed by plotting the percentage of culverts (ordinate), regardless of age, that equaled or exceeded successively greater average rates of metal loss (abscissa). The resulting graphs were then adjusted slightly to fit a continuous curve, with the general equation $y = e^{-fx}$ representative of the entire population of culverts.

An important characteristic of the frequency distribution is that it provides a direct means of estimating probability of occurrence of a selected rate of metal loss. To illustrate, 10 percent of uncoated culverts had a metal loss equaling or exceeding about 0.0025 ipy. One can predict, therefore, that 10 percent (1 of 10, 10 of 100, etc.) of future culvert installations exposed to the same range of environmental conditions will exhibit this rate of loss. Conversely, 90 percent will show lower losses. Such predictions are, of course, only as reliable as the data from which they are derived. Accordingly, site conditions differing from those encountered in this survey would require special consideration. For example, even though little evidence of severe abrasion is found, a site may be selected where excessive bed load abrasion is anticipated. Two cases where such abrasion is suspected are described in the comparison survey. In other instances, indications of corrosion associated with sedimentation were noted, but no valid correlations could be established. Except for these unusual situations, the curves in Figure 4 provide the Department with a more rational basis for estimating the life expectancy of steel culverts than has been available.

1. Assign a metal loss probability value commensurate with the intended use of the culvert, and select the corresponding design rate from Figure 4.
2. Compute estimated total metal loss as the product of design rate and design life.
3. Establish the thickness required to provide the minimum safety factor acceptable at the end of the design life. A safety factor of 1.0 is suggested.
4. If the sum of 2 and 3 equals or is less than the gage of the pipe selected, the design is acceptable.
5. If the sum of 2 and 3 is greater than the gage of the pipe selected, a deficiency of metal is indicated and a greater thickness is required.

1. The class of highway and the 30-yr culvert design life define a medium-risk situation. An appropriate probability value of 15 percent is chosen for this example.
2. Select the corresponding rates of metal loss from Figure 4, and compute the estimated total metal loss:

Table 1 gives estimated average metal loss for the three classes of steel culverts. Because these are very young installations (except Nos. 2-2 and 22-2), the results do not necessarily suggest future performance trends. For this reason, the results should not be expected to agree with Figure 4, which is heavily weighted by culverts that are considerably older. In support of this point, it is interesting to note that the two old culverts just cited, both of which are uncoated, exhibited corrosion rates compatible with Figure 4.
