LOESS

1. INTRODUCTION

The purpose of this chapter is to review the engineering character of loess and typical cut-slope stability problems that have been observed and to suggest design approaches with special consideration for cut slopes related to transportation facilities. The discussion relies heavily on the experience of state transportation departments in Missouri, Tennessee, Illinois, and Washington.

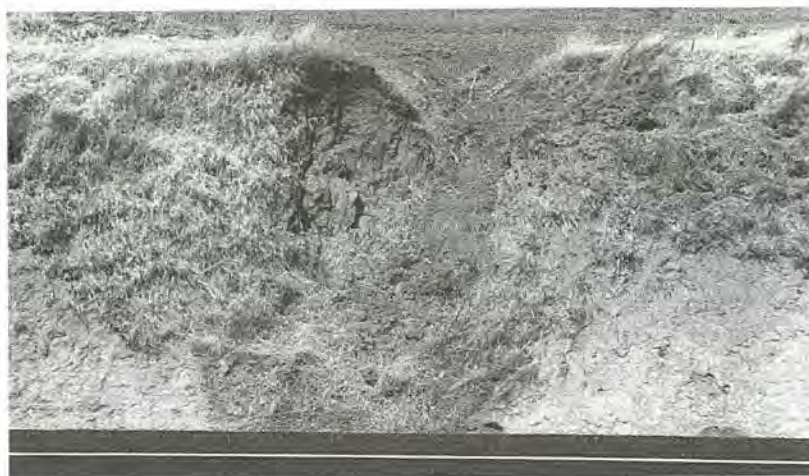
FIGURE 23-11
Gully erosion resulting from truncation of a small drainage basin near Dusty, Washington.

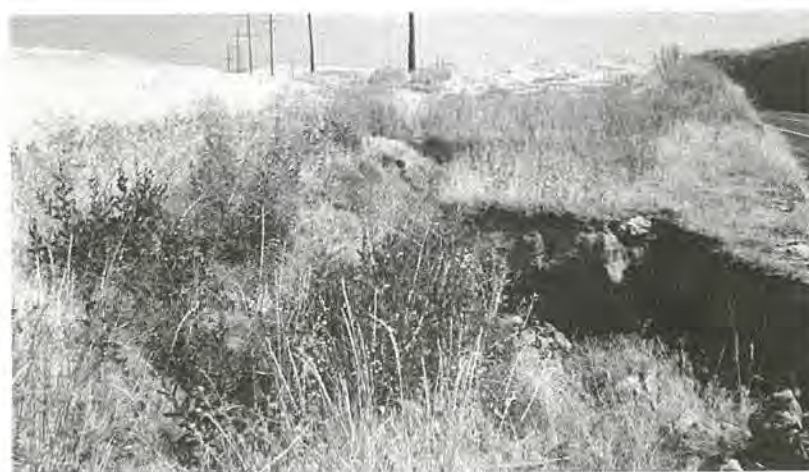
FIGURE 23-12
Gully erosion where small side drainage was truncated by highway cut to right of photograph, US-12 near Walla Walla, Washington.

Figure 23-12, which shows gully erosion along US-12 near Walla Walla, Washington, demon-

strates the progressive nature of erosion in loessial soils. Erosion was initiated where a small side drainage was truncated by the highway cut (to the right in the photograph) and has progressed rapidly up gradient. Erosion will continue until the overall gradient is decreased below that causing channel scour.

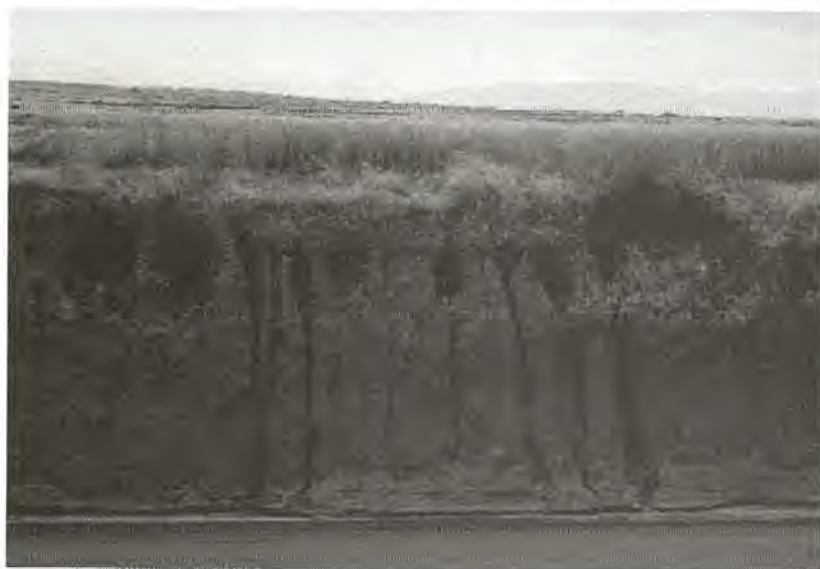
FIGURE 23-13
Piping erosion developing into gully erosion (US-12 near Walla Walla, Washington).

Figures 23-13 and 23-14 illustrate two important points. In Figure 23-13 the majority of the erosion in the left portion of the photograph is due to piping. To the right of the small pipes, gully erosion is beginning to develop. Vegetation in the

The second point is that extensive erosion problems may develop caused by runoff from extremely small drainage basins. Figure 23-14 shows the drainage area above the erosion shown in Figure 23-13. When the area was first examined in June, before the harvest of winter wheat in late July and August, there was no indication that drainage was concentrating flow toward the problem area. Figure 23-14, taken following harvest in the early autumn, shows a minor basin draining into the existing erosion zone.

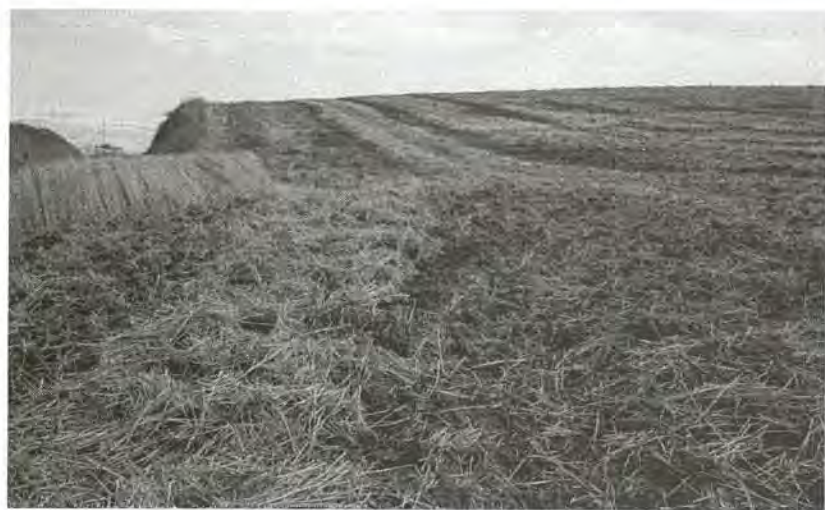
FIGURE 23-14
Runoff source causing erosion in Figure 23-13 (small depression at center of photograph).

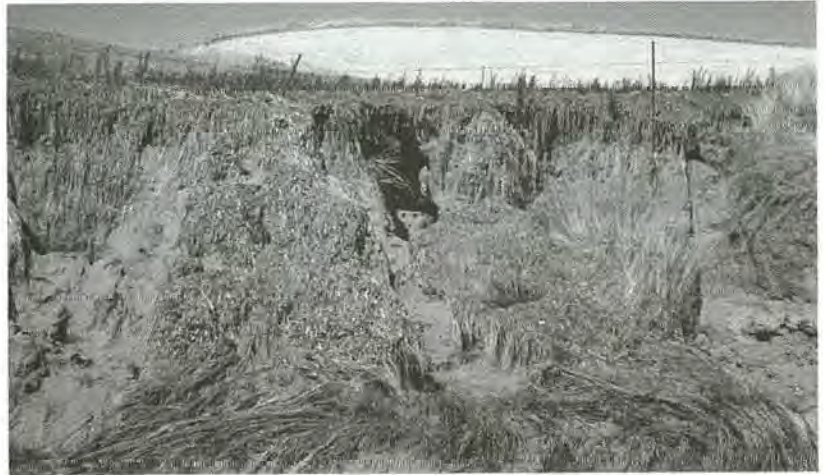
FIGURE 23-15

Area of large-scale piping near Endicott, Washington; flattened vegetation indicates flow over slope as well as piping.

Figure 23-15 demonstrates the extent of damage when proper drainage is not provided. The majority of the damage appears to be due to a single summer storm event; a combination of piping and surface erosion is taking place. Piping inlets originated a substantial distance behind the cut, which exemplifies the need for construction of drainage ditches an adequate distance behind the cut slope.

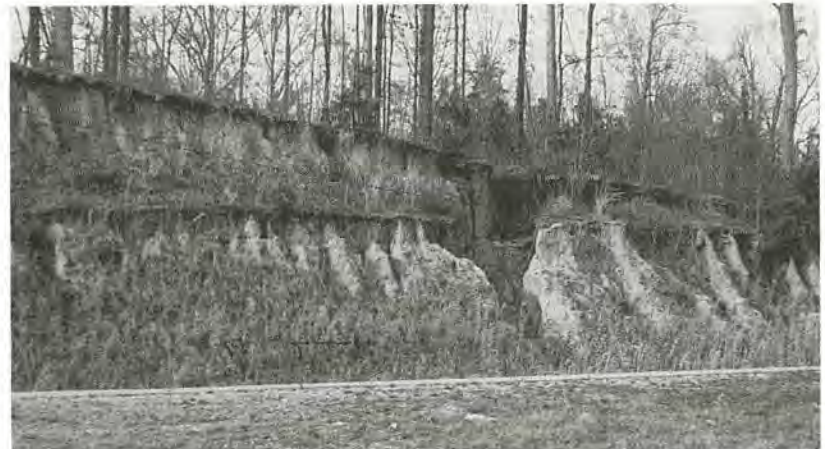
FIGURE 23-16

Erosion damage to near-vertical cut slope in Mississippi.

Figures 23-16 and 23-17 show erosion damage to near-vertical cuts in Mississippi and Louisiana where water ponded near the crest of the slope. If natural drainage is directed away from a loess slope, erosion is usually minimal (Figure 23-18).

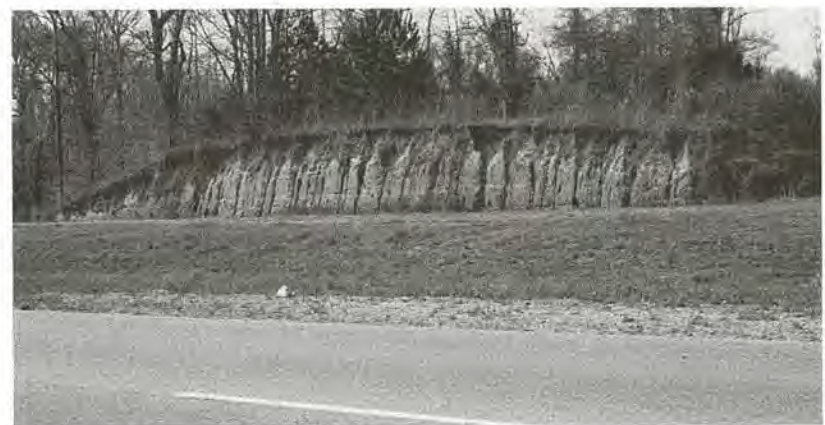
FIGURE 23-17

Erosion damage to near-vertical cut in Louisiana.

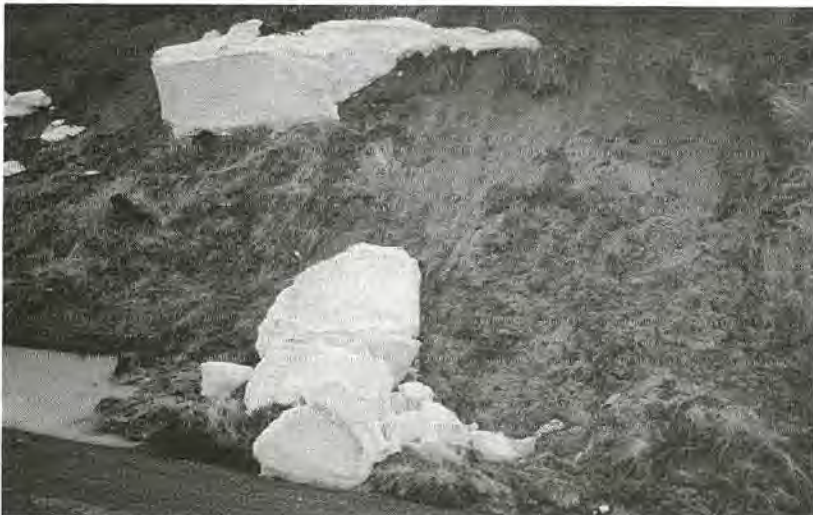
FIGURE 23-20 (below) Small-scale mud flow in highway cut on US-195 near Pullman, Washington; flow approximately 3 m long.

Small-scale slides, flows, or both, such as that in Figure 23-20, were found to be the most common form of failure in eastern Washington. Failures were typically 0.3 to 3 m wide with the depth of failure ranging between several centimeters and about a meter. The initial failure was normally followed by increased erosion due to the loss of vegetative cover, with severe gully erosion a common result. In some cases, failure is due to saturation of the soil under the snowpack as well as to weight of the snowpack on the underlying saturated slope (Figure 23-21).

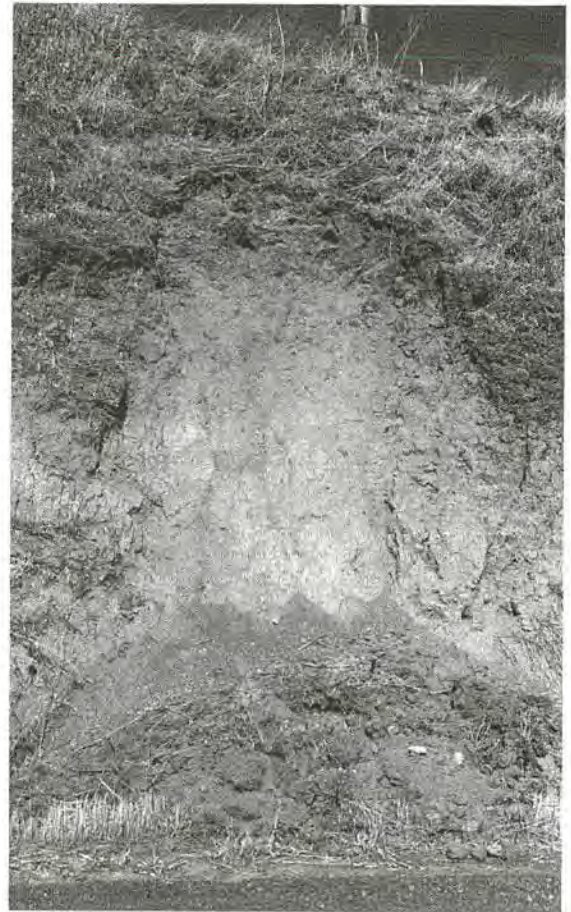
FIGURE 23-19 Fairly common shallow failures with arcuate scarps in silty loess near Colfax, Washington.

Two different forms of shallow slope failure have been observed in eastern Washington and appear to be related to soil type. In silty loess it is not uncommon to see sheets of vegetative cover 5 to 15 cm thick with an arcuate upper boundary move downslope (Figure 23-19). In this form, only minor damage was observed. However, over the years these small failures can expose large areas of soil to erosion, and damage increases considerably over time.

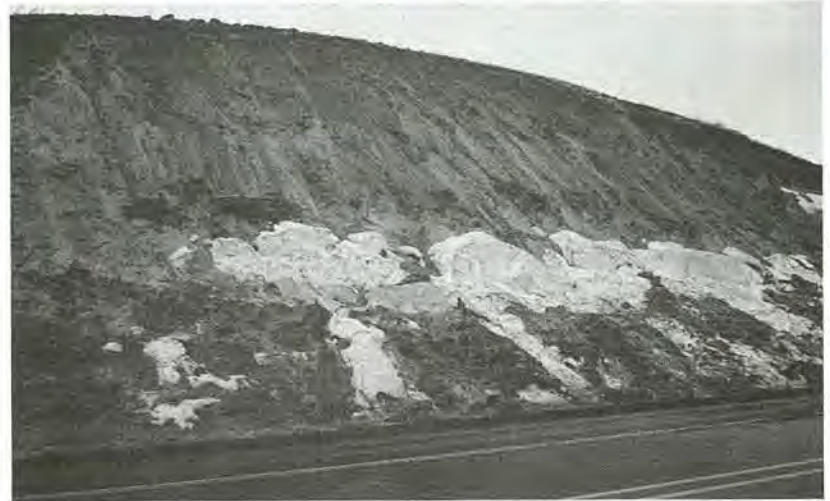
FIGURE 23-21 Failure of slope under melting snowdrifts on US-195 near Pullman, Washington.

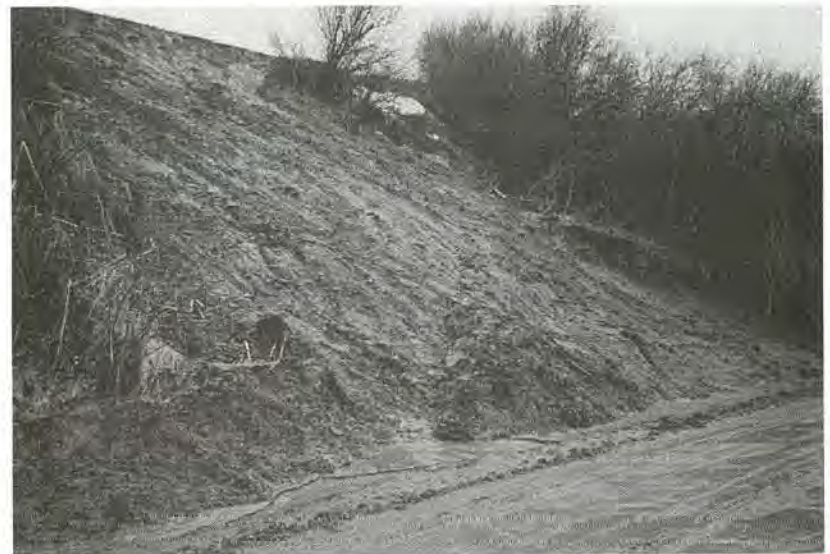
FIGURE 23-22 Relatively large-scale mud flow located near Pullman, Washington; undisturbed soil at right indicates depth of failure at approximately 1 m.

Although not as common, large-scale slides and flows have been observed in Washington. The failure mechanism is thought to be the same as that for small-scale failures with a low depth-to-width ratio for the failure surface. Figure 23-22 shows a relatively large failure. The effect of steepness on stability of slopes cannot be emphasized strongly enough. In all cases where extensive damage was observed in eastern Washington, slopes were approximately 2H:1V or steeper. No instances of failure were observed for slopes flatter than 2.5H:1V. These observations agree with experience in the midwestern United States, where slopes greater than 2.5H:1V have proven to be too steep to maintain good vegetative cover in loessial soils (Royster and Rowan 1968; Missouri State Highway Department 1978).

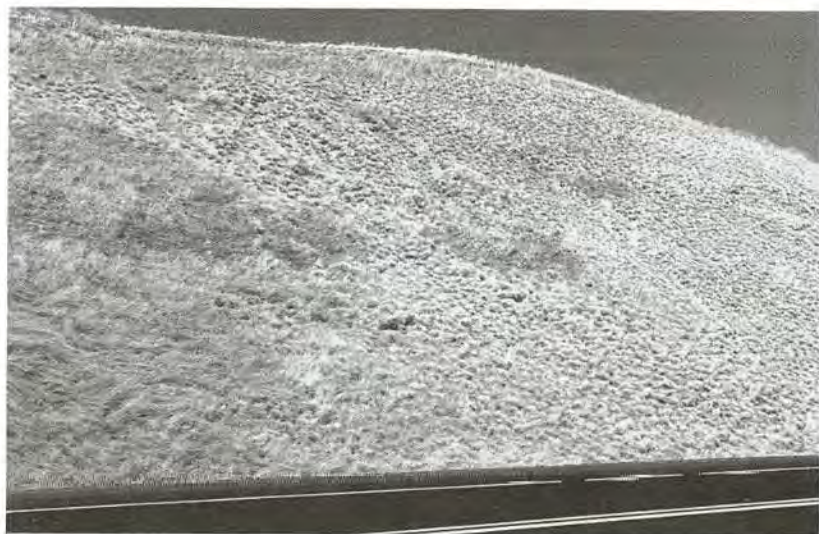
FIGURE 23-23
South-facing slope on US-195 near Pullman, Washington, showing little degradation.

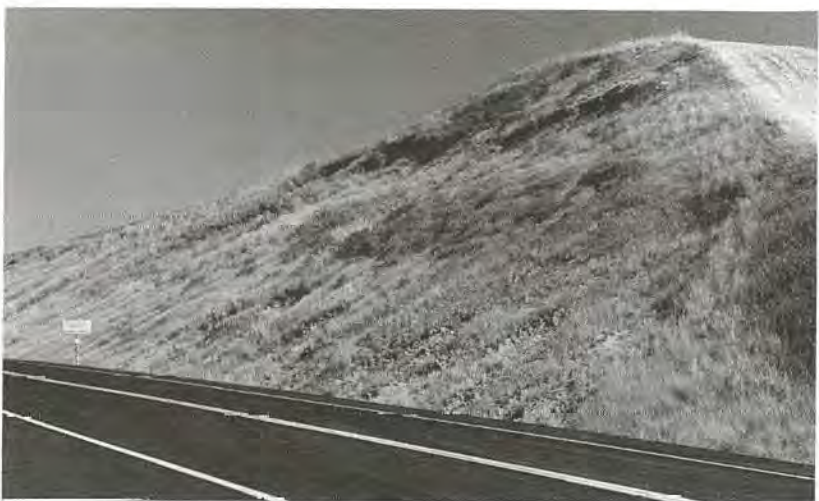
FIGURE 23-24
North-facing slope, opposite cut in Figure 23-23, exhibiting severe gully erosion.

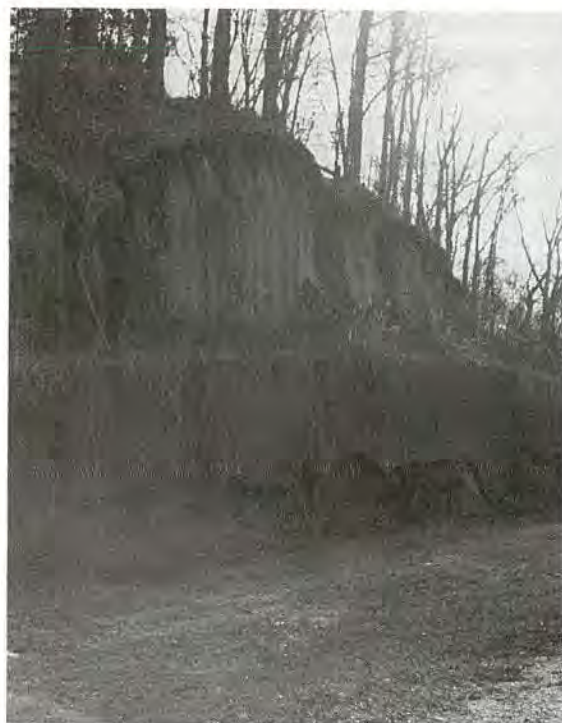
FIGURE 23-25
Slabbing of near-vertical cut along Mississippi State Highway 220.

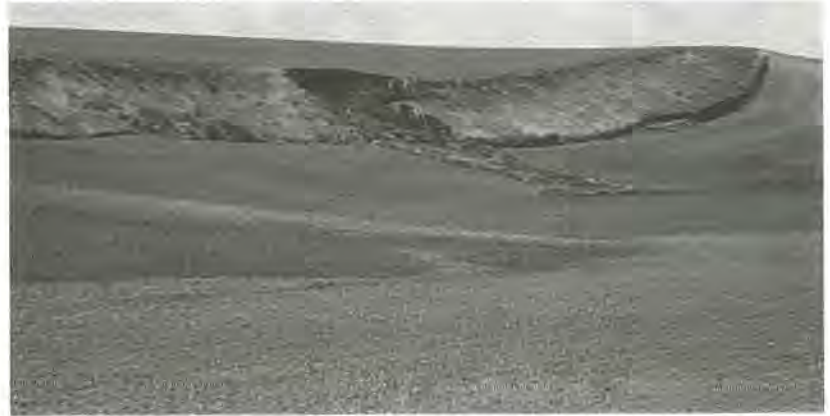
FIGURE 23-26 Rotational failure and earthflow in loess near Pullman, Washington.

Rotational slides on loess slopes have occurred in both moist and dry climates; however, they appear to be more common in the moist climate of the midwestern United States than in eastern Washington. Generally, this type of failure is associated with saturated (or nearly saturated) conditions on steep slopes. Occasionally, rotational failures occur in clayey loess in the Washington loess deposit. Water-table depths tend to be great throughout the loess deposit area. However, in the eastern section of the deposit where seasonal precipitation is relatively high and the loess has at least 20 percent clay content, some failures do occur (even on undisturbed slopes). Figure 23-26 shows an example of a rotational failure (a slump
