# Geologic Constraints on the Vail Pass Project

Charles S. Robinson, Charles S. Robinson and Associates, Inc., Golden, Colorado

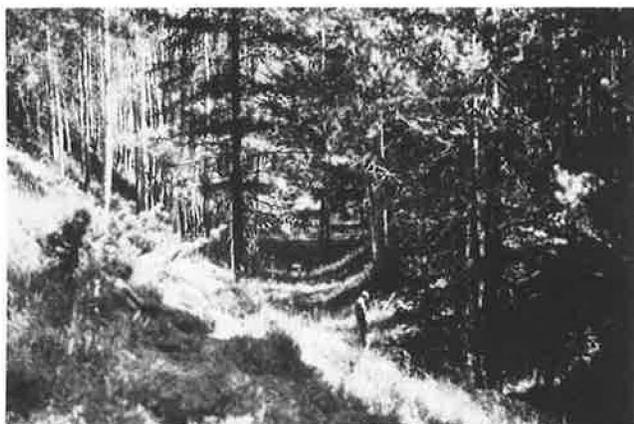
Figure 7. Trees growing in landslide scarp depression.

eter growing within their limits (Figure 7). Other landslides show, as evidence of recent movement, cracks in the sod in the bottom of the depression. Some of these cracks have been probed to depths of more than 5 m (16 ft).

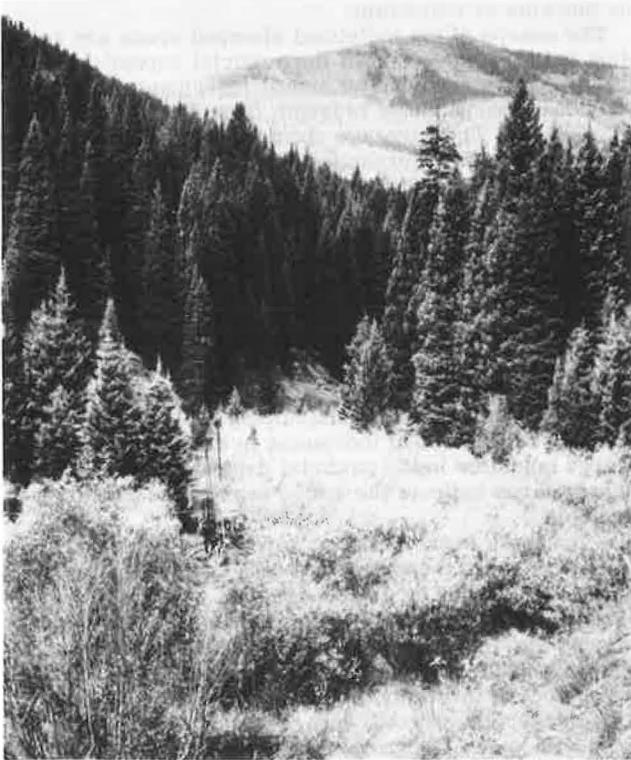
Figure 9. Alluvial deposits as result of damming of stream by landslides.

A landslide in the surficial deposits is the result of the deposition of these deposits on a bedrock slope that was oversteepened by glacial erosion. The deposits were poorly drained at the time of deposition, and many swamps developed. The permeability of the surficial deposits is different in different areas, and numerous springs occur throughout. During much of the year when the surface is not frozen, the deposits are saturated with water. With the spring runoff there is a period of rapid erosion during the time of maximum saturation. This results in minimum stability in a mass of poorly sorted and unconsolidated material on a steep slope, the lower edge of which is at a stream channel. Along Black Gore Creek, downcutting of the creek has not been able to keep up with the movement of the landslides into the valley. The gradient of the creek above the landslides has been lowered and alluvial deposits have formed because the landslides have partially dammed the creek (Figure 9).
