Development of Retrofit Railings for Through Truss Bridges

M.E. BRONSTAD, L.R. CALCOTE, C.E. KIMBALL, JR., AND C.F. McDEVITT

The design and development of bridge railing systems for through truss structures are described in this paper. The unique design of these structures makes rigid railings mandatory to exclude the errant vehicles from the truss members located behind the railing. The two systems were designed to meet different performance conditions. The high-performance system contained and redirected a 20,000-lb (9000-kg) bus impacting at 55 mph (90 km/h) and a 15-degree angle. The low-service-level system contained and redirected a 4,500-lb (2000-kg) car impacting at 60 mph (95 km/h) and a 15-degree angle. In addition, 2,250-lb (1000-kg) and 1,800-lb (800-kg) cars were used to evaluate the systems, including the bridge approach railing, for the high-performance system. The two systems meet the design criteria and are recommended for immediate implementation.

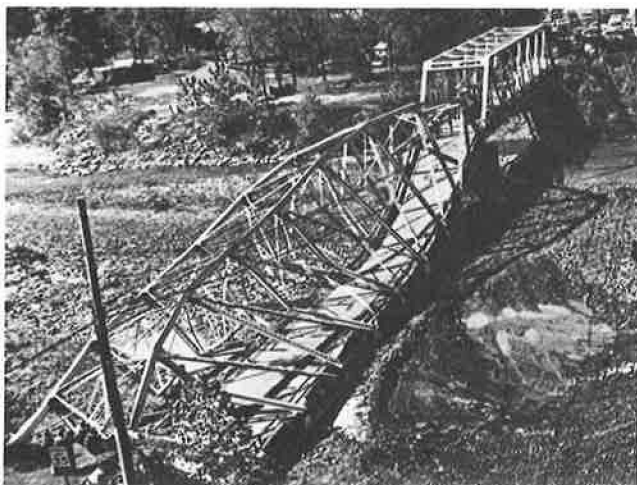
Figure 1. Through truss failure.

Catastrophic failures of these structures occur periodically, and some gain nationwide attention (see Figure 1). Structurally adequate bridges can collapse because of inadequate protection for bridge railings. Many of the older through truss structures have relatively long spans and would require large expenditures to replace them with more modern structures. For this reason FHWA considers the development of protective bridge railing systems for these unique structures as a cost-effective way to keep these otherwise structurally sound bridges in service and also to minimize the potential for catastrophic events.

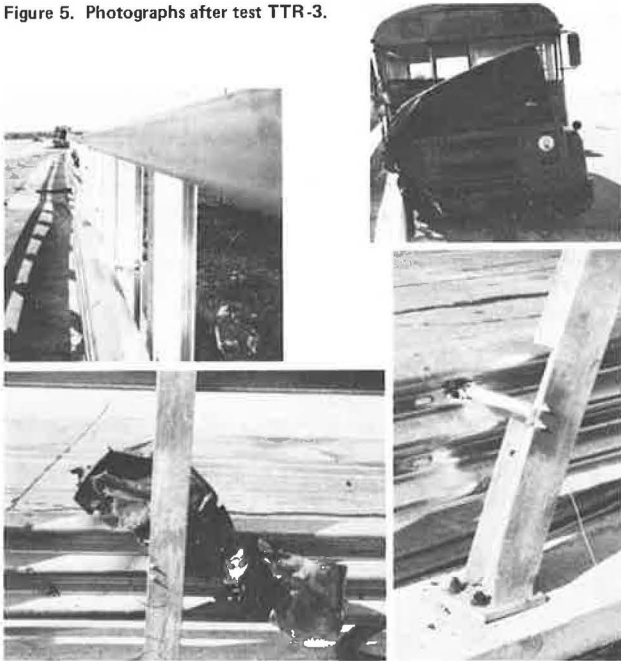
Figure 5. Photographs after test TTR-3.

The bus impacted the barrier at 53.9 mph (86.7 km/h) and a 15.3-degree angle. As shown in Figure 4, the bus rolled a maximum of 10.7 degrees toward the barrier as it was redirected. The right front wheel was pushed rearward by the lower rail, which caused suspension failure and forced the entire front axle to rotate. After losing contact with the barrier the vehicle dropped onto the now horizontal front right wheel and slid to a stop essentially parallel to the barrier (see Figure 5). The maximum deflections were such that the 3-in. (75-mm) en-

croachment goal beyond the rear post line was met. The roll of the vehicle and the exit conditions were also considered favorable. Some sheet metal snagged on posts at the opening between upper and lower rails (see Figure 5).

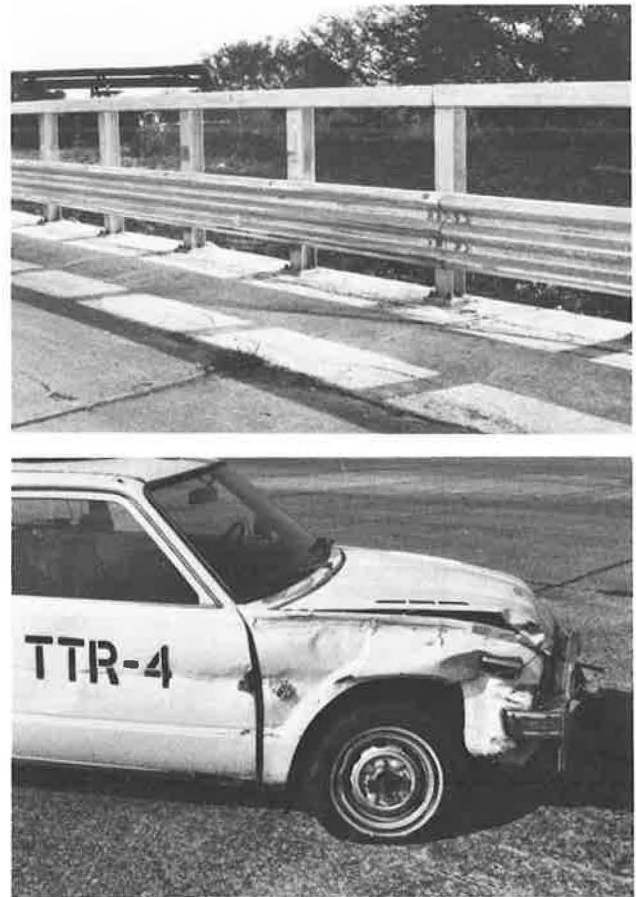
Figure 7. Photographs after test TTR-4.

In test TTR-4 the 1,840-lb (835-kg) vehicle impacted the barrier at 59.8 mph (96.2 km/h) and a 14.8-degree angle. As shown in Figure 6 the beam displaced up and back during the collision and then returned to the original position. The barrier systems sustained no discernible damage; damage to the vehicle was moderate (see Figure 7).

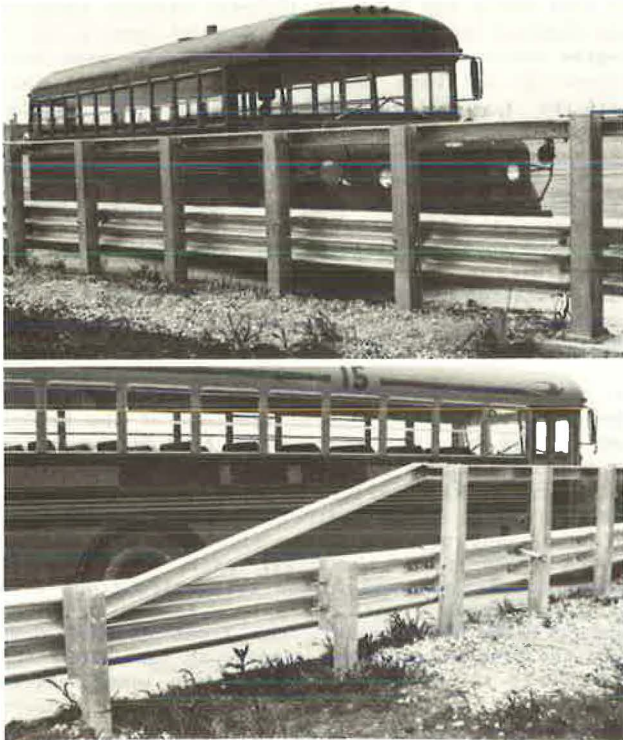
Figure 8. High-performance retrofit approach guardrail.

The basic bridge railing approach and terminal treatment are shown in Figure 8. The upper railing was carried full height beyond the structure for five post spans and tapered down and back behind the lower railing as shown. The self-restoring hinges were installed on intermittent W6 x 15.5 posts.

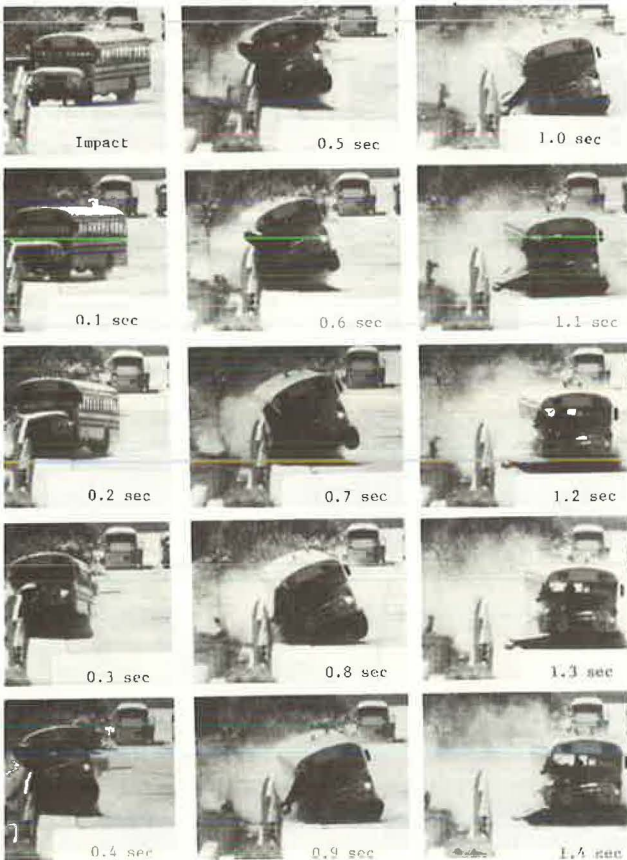
Figure 9. Test TTR-5 impact sequence.

In test TTR-5 the 20,000-lb (9070-kg) bus impacted the transition 15 ft (4.6 m) upstream of the bridge end at 59.6 mph (95.9 km/h) and a 15.9-degree angle. As shown in Figure 9, the bus pitched upward as it rolled toward the barrier (maximum roll angle was 15 degrees) while being redirected, and then returned to an upright position. The right front wheel was pushed rearward by the lower rail, which caused suspension failure and forced the entire front axle to rotate about a vertical axis. As the bus lost contact with the barrier, the front dropped down onto the right front wheel similar to test TTR-3 and slid 90 ft (27 m) past the end of the installation. A secondary collision with another barrier downstream caused additional front-end damage.

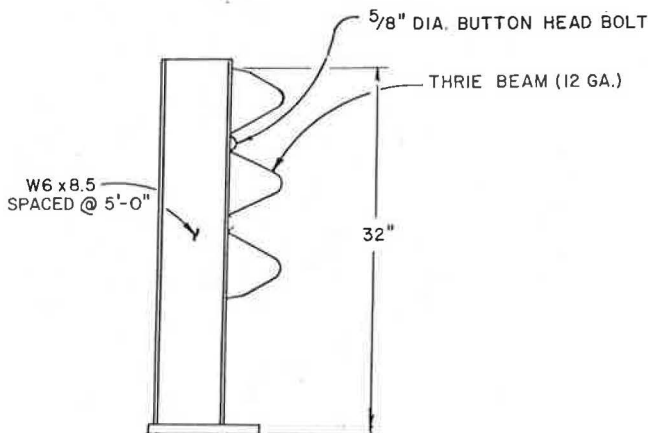
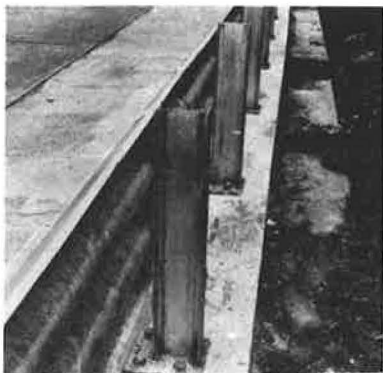
Figure 17. Low-service retrofit.

Based on computer simulations, a design described in Figure 17 was selected for crash-test evaluation. As part of the installation a readily installed anchor bolt detail was employed. This consisted of drilling into the bridge deck and driving commercially available anchor studs into the holes.

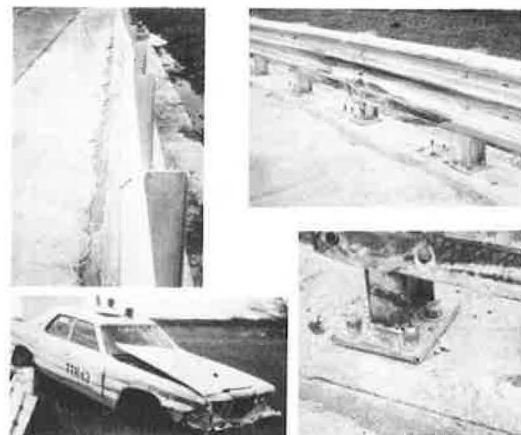
Figure 19. Photographs after test TTR-13.

Two rail sections and three posts of the barrier were damaged. Vehicle and barrier damage are shown in Figure 19. The lower right-hand photograph shows partly pulled anchor studs of post 7.
