# Evaluation of Freeway Crash Cushion Delineation Treatments

ROBERT C. WUNDERLICH

## ABSTRACT

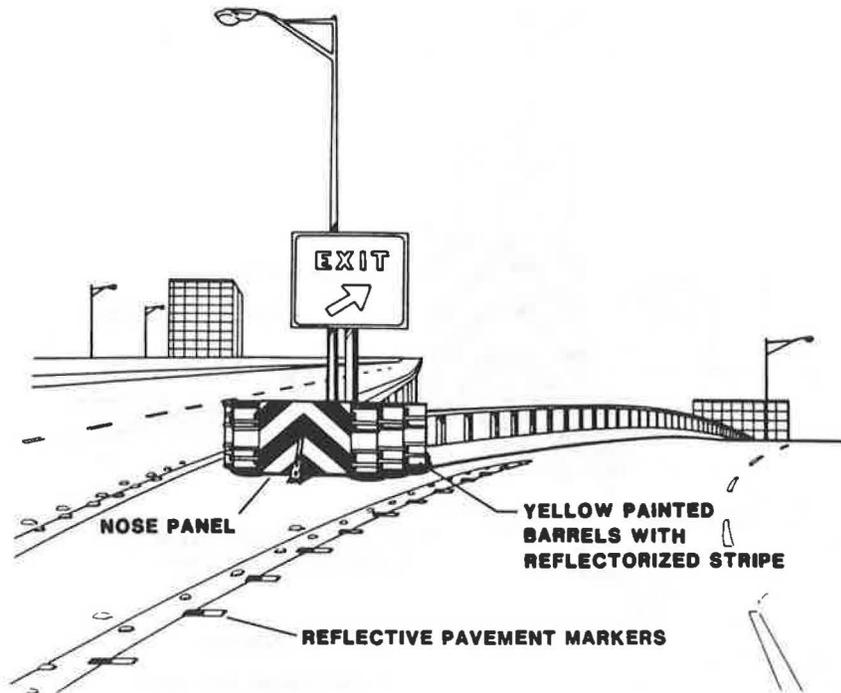
FIGURE 1 Treatment Level 1.

The base treatment, Level 1 (Figure 1), was made up of three elements that were common to all the treatment levels: (a) yellow and black reflectorized nose panel, (b) yellow painted barrels with reflectorized stripe, and (c) raised reflective pavement markers. The other three levels were formed by adding delineation elements to the basic configuration. As can be seen from Table 1 and Figures 1-4, Treatment Level 2 was formed by adding a yellow and black reflectorized back panel to Level 1. Level 3 consisted of the four elements of Level 2 and reflectorized chevron alignment signs. Level 4 included

Four delineation treatment levels were developed. Figures 1 through 4 illustrate the four treatment levels and demonstrate how delineation elements were added to form each successive level. The elements of each treatment are listed in Table 1.

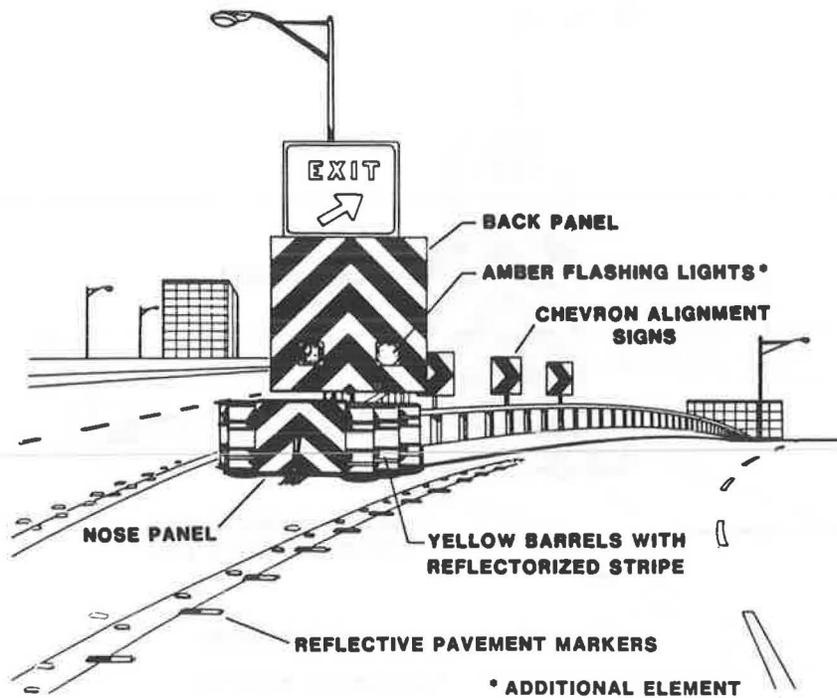
FIGURE 4 Treatment Level 4.

all the elements of Level 3 plus amber flashing lights. It is important to note the distinction between treatment Level 4 and all the other levels. Level 4 is the only level that included a dynamic delineation element, the flashing lights. All the other treatments included only static reflective elements.

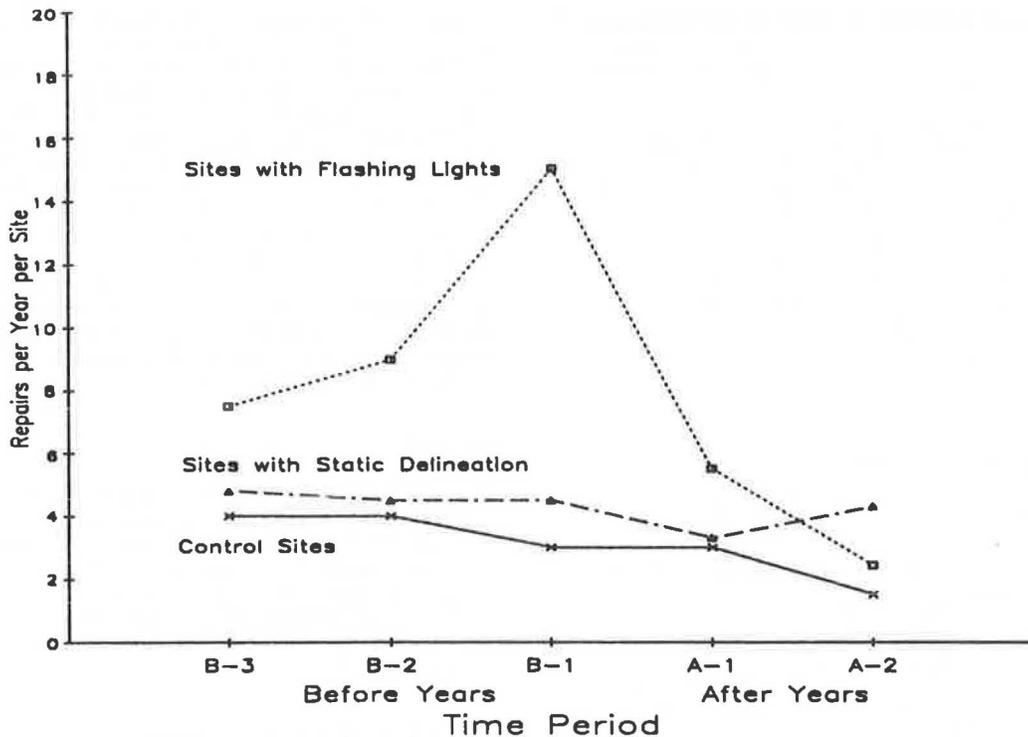
FIGURE 5 Repair rate trends.

The basis for these findings is clear after inspection of Figure 5. The "before" and "after" repair histories are shown for the two groups of sites: (a) those with moderate repair rates and static delineation treatments, and (b) those with high repair rates with flashing lights.

As can be seen in Figure 5, the average repair rate for the six sites with static delineation treatments changed only slightly over the study period. A slight decrease of about one repair per year per site occurred in the year after treatment installation, but the repair rate returned to previous levels in the second year after treatment installation.

A different pattern was evident, however, for the two sites where flashing lights were installed in conjunction with static elements. The average number of repairs per year increased during all three years before treatment installation, culminating with an average of 15 repairs per year in the year prior to implementation. The annual repairs per site decreased to about 5 in the year following installation. Importantly, repair rates continued to decline during the second year after treatment installation. The second year repair rates are based on 10 months of data for the group with high rates and an average of almost eight months for the group with moderate rates.

fect. On the other hand, the increasing repair rate trend before installation was followed by a consistent reduction to a level below the original average and this occurred at both sites where Level 4 was installed. Other explanations for the changes in repair rates are possible; however, there is evidence that the treatment was responsible for at least some of the reduction, especially if the trends in repairs are examined.
