# Three Full-Scale Experiments of French Project on Soil Nailing: CLOUTERRE

C. PLUMELLE AND F. SCHLOSSER

CLOUTERRE, a national research project on soil nailing, was performed in France during 1986–1990 to study the behavior of nailed soil retaining walls, develop design methods, and publish a French code of practice for building temporary and permanent nailed soil walls. Three full-scale experiments are described: a nailed soil wall pushed to failure, a wall built to study its stability during the excavation stages, and a simulation of failure due to the lack of adhesion on the bars. The nails, soil, and wall facing were instrumented to measure the displacements, forces, and stresses generated in the soil and reinforcements.

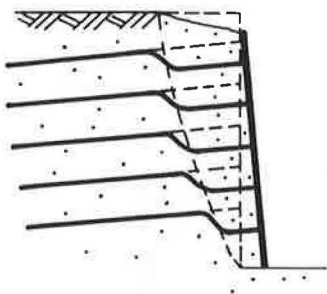
**FIGURE 1** Failure of nailed soil mass due to breakage of bars.

Several job sites were instrumented and monitored, and three full-scale experiments were conducted to study the three types of failure shown in Figures 1–3. This paper describes the significant results of these three experiments.

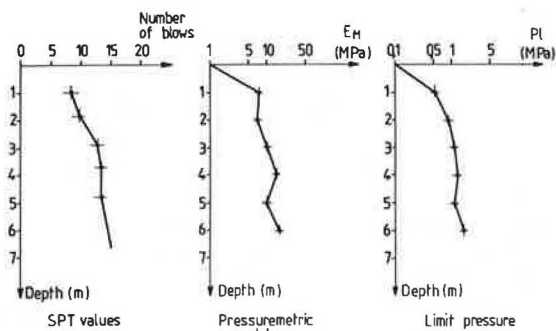
**FIGURE 4** Results from SPT and pressuremeter tests.

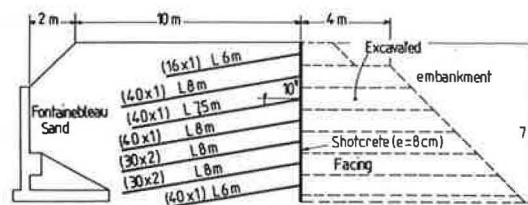
**FIGURE 5** Layout of full-scale experiment, Wall 1.

Before construction of the nailed wall, a soil mass 7 m high was created. The soil was excavated and the wall built in layers, meter by meter. The vertical distance between the nails was 1 m, and the horizontal spacing was 1.15 m (Figure 5).

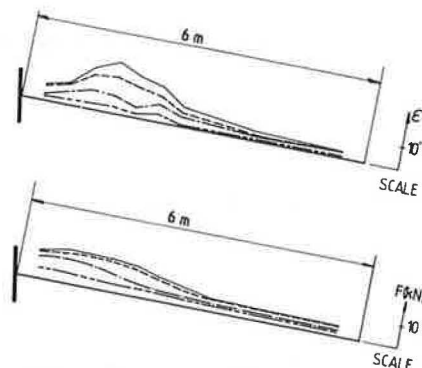
**FIGURE 6** Distributions of strains and strengths, Nail 3, Phases 4 to 7.

Figure 6 indicates that the ratio  $T_o/T_{max}$  between the tensile force at the head (at the facing) and the maximum tensile force decreased as construction progressed. At the beginning of construction the ratio was about 1 and at the end it was about 0.7.

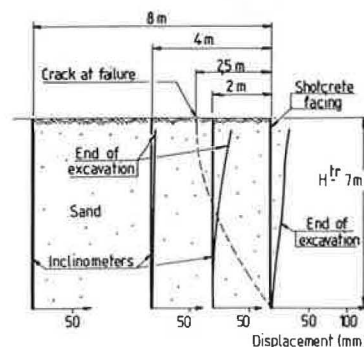
**FIGURE 7** Horizontal displacements and failure zone, Wall 1.

The flooding did not completely destroy the structure. The nailed wall, however, subsided 27 cm from its previous level. It advanced 8 cm at the top and 19 cm at the foot (3,4). During construction, knowledge of inclinometer displacements and the maximum tensile force line allowed the prediction of the failure zone (Figure 7). This conclusion is important because it shows that the failure design methods of TALREN (5,6) type are correct; thus, they will be adopted by the code of practice.

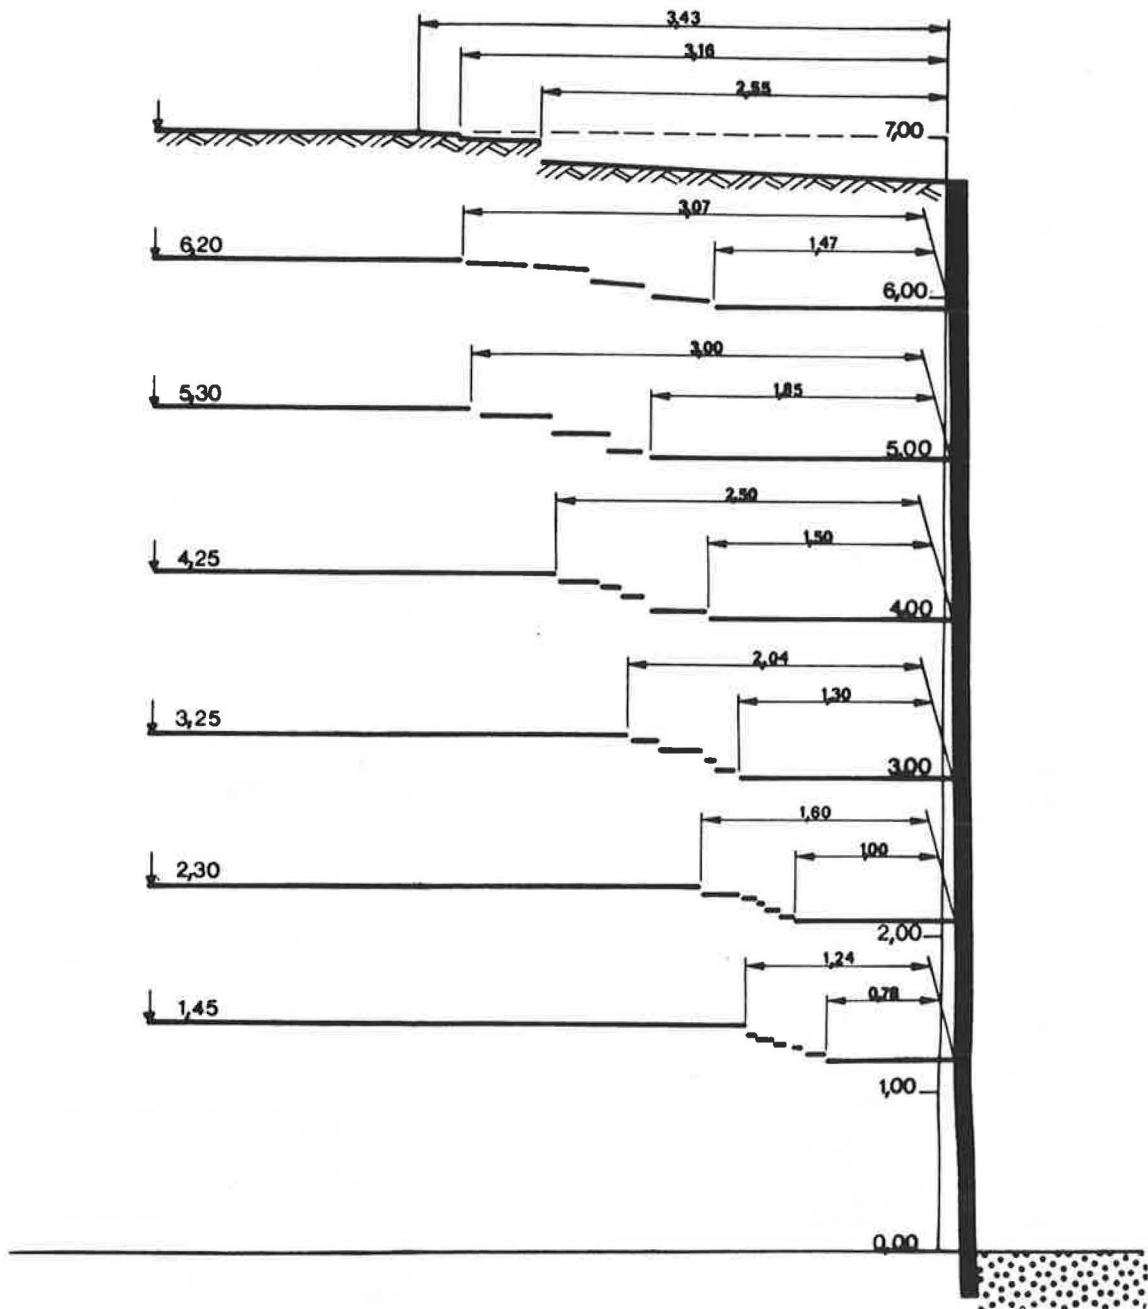
FIGURE 8 Displacements of bands of black sand after failure of nailed mass.

After failure, the nailed soil zone was excavated. The nails had suffered large bending deformations, and some of them were broken. Measured positions of the bands of black sand permitted reconstruction of the failure zone (Figure 8). One can note that the maximum tensile force line lies within the failure zone (Figure 9).

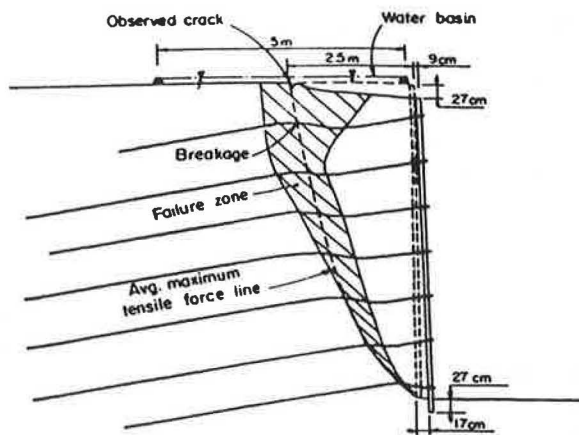
FIGURE 9 Failure zone developed in nailed soil wall.

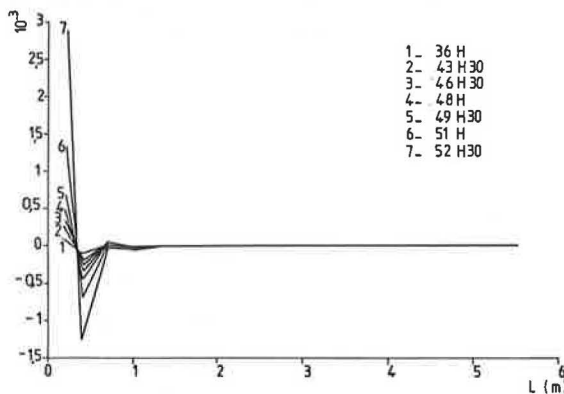
FIGURE 10 Bending moment strains just before failure.

During construction, the tensile force in the nail was the first resisting force to be mobilized. However, before failure and under large deformations, the bending stiffness of the nails was also mobilized (Figure 10).

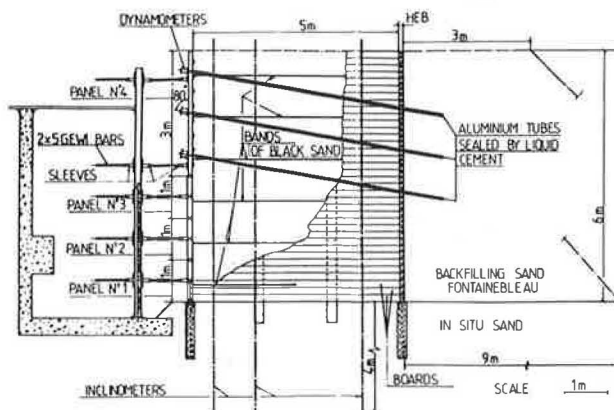
FIGURE 11 Layout of full-scale experiment, Wall 2.

The sand mass, 6 m high and 2 m wide, was constructed inside two walls made of boards. The boards were constrained by two lateral walls made of formworks and anchored by bolted rods on UAP embedded in the soil (Figure 11).

mass and two lateral walls. The board walls were covered inside with a greased double layer of plastic to prevent friction on the sides and to enforce plane strain conditions (Figure 11).

Panel 4 was nailed with six nails made of aluminum tube (40-mm diameter, 1-mm wall thickness) and sealed with liquid cement in a 63-mm-diameter borehole. Each nail was 6 m long (Figure 11).

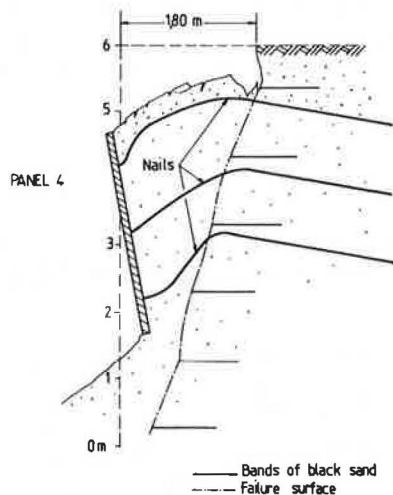
FIGURE 14 Cross section of failure.

the arch cracked, it induced a global instability in a few seconds. The nailed panel subsided 1.4 m but remained attached to the six nails, which did not break (Figure 14).

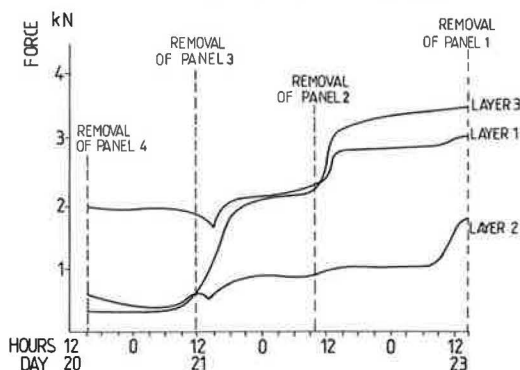
FIGURE 15 Evolution of strength at head for each phase.

Figure 15 shows the evolution of the force at the head of the nails during each phase. Notice during Phase 1 of panel removal that mainly the first layer of nails was under stress; the bottom of the nailed panel was lying on Panel 3.

During Phase 2, which simulated 1-m-deep excavation, forces on the first layer of nails did not significantly increase, but the nails of the third layer were rapidly put under stress.

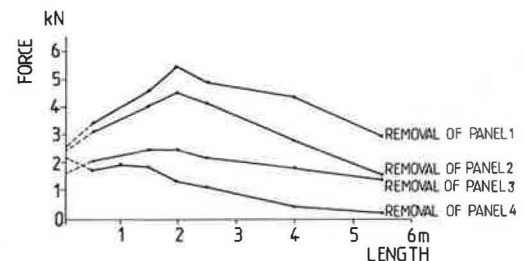
FIGURE 16 Load distribution along Nail 1 for each phase.

Figures 16–18 synthesize the evolution of the tensile forces along the nails of the three layers versus phases. The third phase represents the last stage before failure. Note that the creation of the arch involved an increase of the tensile force only in the first layer.

The maximum tensile force points were the same as they were in the first nailed wall. They were located in the back of the facing; before the failure they were 2 m from the facing for the first layer and 0.7 m for the last layer.

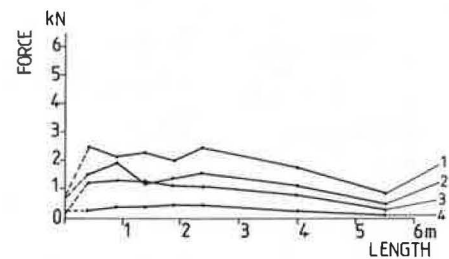
FIGURE 17 Load distribution along Nail 3 for each phase.

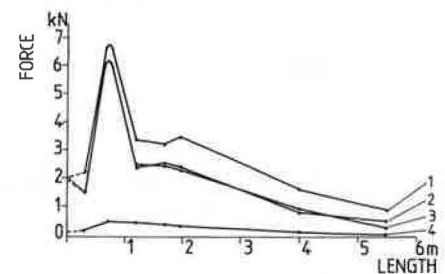
FIGURE 18 Load distribution along Nail 5 for each phase.

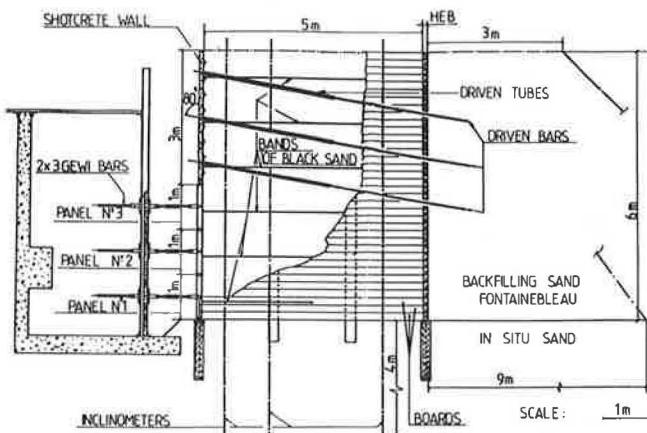
FIGURE 19 Layout of Wall 2 at end of Phase 3.

Construction of the sand mass backfilling, 6 m high and 2 m wide, was similar to that of Wall 2. Starting from the bottom, there were six removable panels 1 m high (Figure 19).

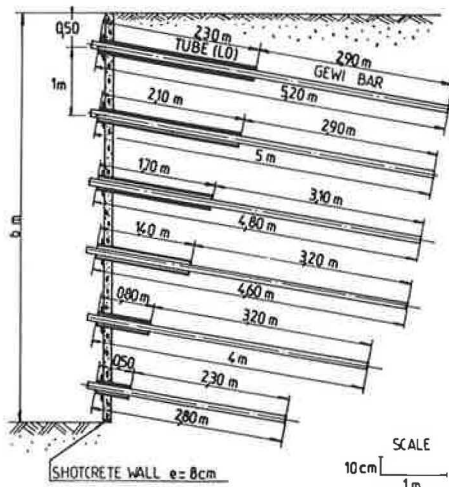
FIGURE 20 Scheme of Wall 3 at end of construction.

The wall was nailed by telescopic nails made of bars (50-mm diameter) inside tubes (71-mm diameter) driven into the sand, as shown in Figure 20.

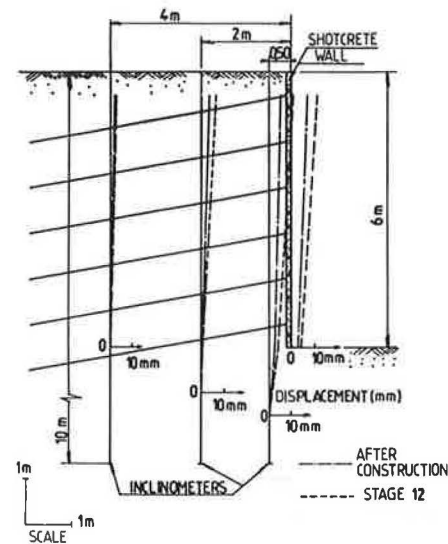
FIGURE 21 Measurements of horizontal displacements.

Displacements plotted on Figure 21 were measured at the end of the construction of the nailed wall and at the 12th stage of shortening of nails (4 stages before failure), for which nails

of the first layer were 2.3 m long; those of the second layer, 2.1 m; and those of four others, 1.8 m. These displacements were displacements of sand just behind the facing measured during excavation by inclinometers and displacements of facing after its construction. These measurements complete those carried out during execution of the Wall 1, during which only displacements of facing had been recorded.

For Wall 3, it should be noted that a horizontal displacement at the end of the construction, with a safety factor larger than 3, was 0.12 percent of total height of the nailed wall. Otherwise, significant displacements of mass of the sand beneath the foot of the facing were recorded.
