Trial Implementation of a Photoelectric Sensor System To Classify Vehicles

J. L. GATTIS AND CLYDE E. LEE

The development and field testing of an automatic vehicle classification (AVC) system in 1990 and 1991 are described. The system employs an inductance loop detector and a pair of photoelectric sensors emitting modulated infrared-spectrum light beams, which are reflected off raised pavement markers. The presence of a vehicle activates the loop detector, prompting the system to classify the passing vehicle. The pattern of the infrared light beam interruptions enables the system to infer the vehicle's speed, number of axles, and number of tires. The number of axles and tires defines the vehicle's class for assessing the proper toll. Signals from the activation go through a special microprocessor into a personal computer for interpretation, display, and recording. The system was tested initially at a high-speed (50 to 65 mph) Oklahoma Turnpike Authority site. Evaluation of the computer records and written field notes obtained during a 5-wk study indicated that the first-generation AVC system correctly classified about 95 percent of the 1,736 vehicles observed. After a review of th

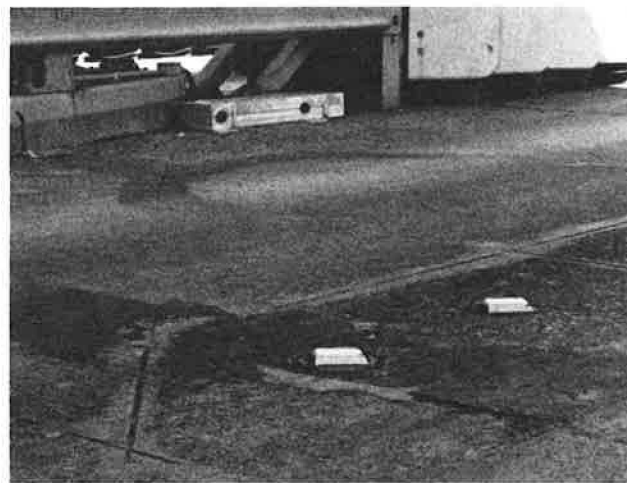
FIGURE 5 Loop, reflectors, and sensor housing box.

Figure 4 shows a pair of sensors installed in the aluminum box; the box cover has been removed. Figure 5 shows the box in the background and the reflectors and loop in the foreground.
