Reducing Wheel Climb at Switch Points to Reduce Derailments

Final Report for
Safety IDEA Project 23

Prepared by:
Dr. Allan M. Zarembski PE
University of Delaware

April, 2014

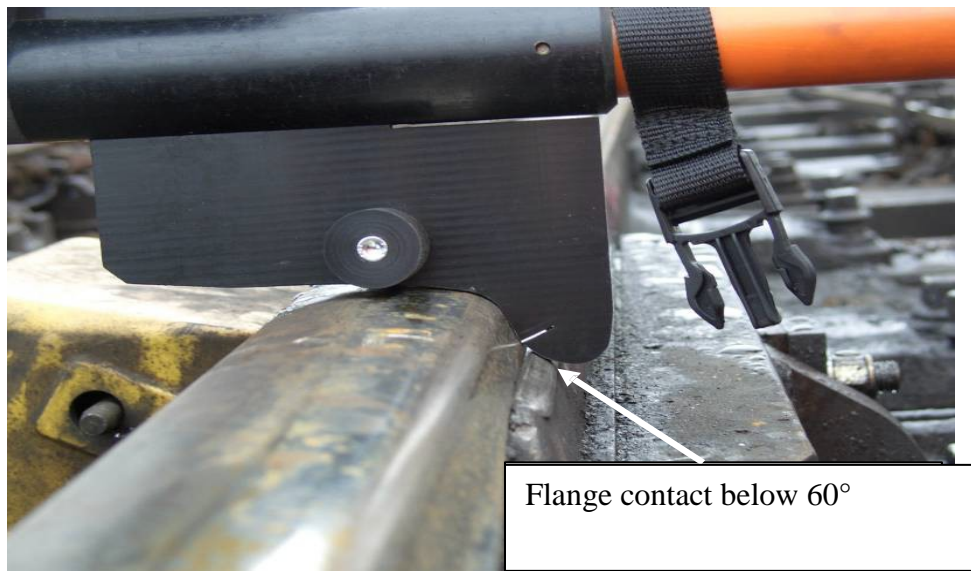
Figure 2: TGP8 Gauge showing switch point contact below the 60° mark – unsafe.

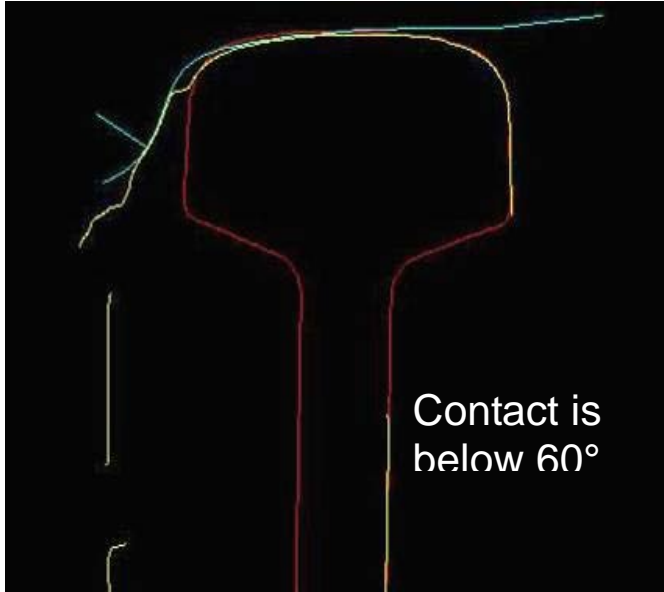
Figure 3 presents a digital representation of the wheel profile and the switch point as taken using automated switch inspection technology (5,6), and shows improper wheel flange contact, with contact occurring below the 60° mark.

Figure 3: Flange contact below 60° mark

The AAR1B new wheel profile and the moderately worn AAR 1B profile (Figure 22) were both judged to be very useful for determining conditions of switch points. The Expert Review Panel members agreed that if the wheel-switch point contact is below the 60° mark, then there is definitely a problem. (See Figure 3 on page 9)

The Expert Review Panel likewise evaluated the AAR1B new wheel profile (Figure 19) and judged it to be very useful for determining conditions of switch points. The Expert Review Panel members all agreed that if the wheel-switch point contact is below the 60° mark, then there is definitely a problem (See Figure 3 on page 9). The moderately worn AAR 1B profile was deemed to be less useful.

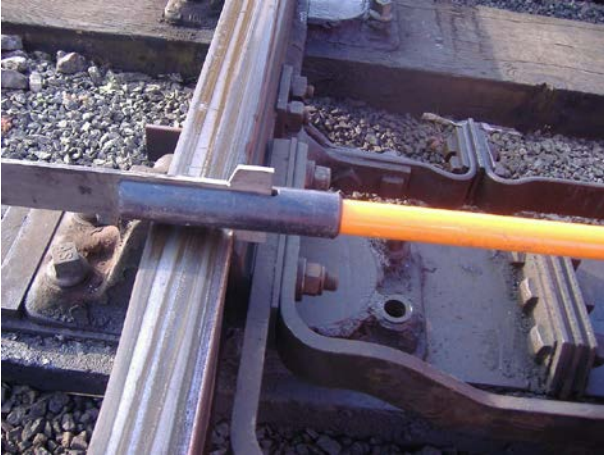
Figure 4B: Switch Gauge 1 used to inspect for stock rail headwear associated with a less worn switch rail.

- Network Rail Switch Gauge 1 used to monitor stock rail head wear (see Figures 4B)
- Network Rail Switch Gauge 2 used to monitor chipping of switch rail (see Figures 4C)
- A modified TPG8 based on a new AAR 1B wheel profile (see Figure 16, bottom gauge)
- A modified TPG8 based on a severe worn US wheel profile (see Figure 16, top gauge-upside down position)
- Network Rail Switch Radius Gauge used to monitor sharp tip radius on switch point (nicknamed “Pac Man” because of its shape – see Figure 9)

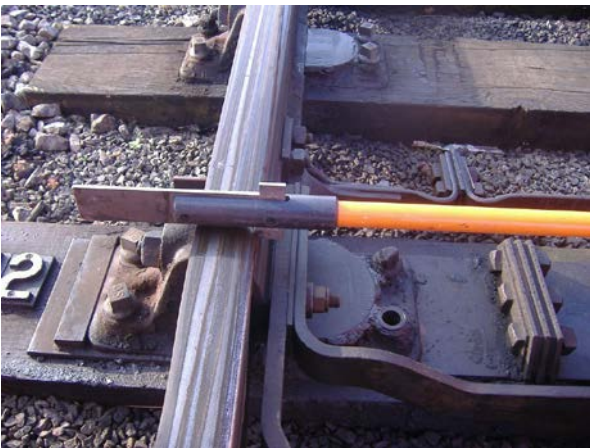
Figure 4C: Switch Gauge 2 used to inspect for switch rail damage.

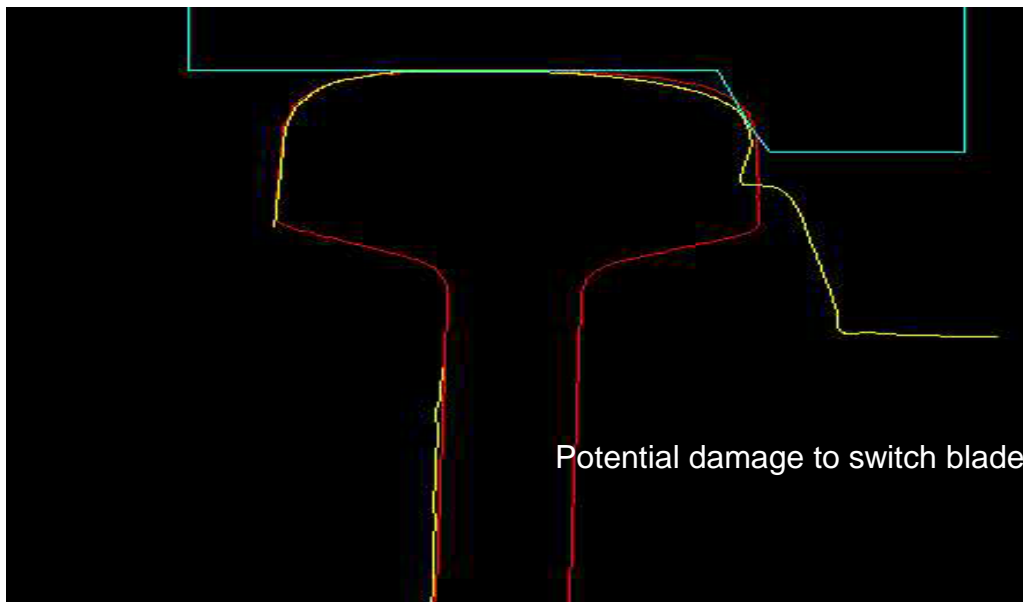
Switch Wear Gauge 2 is applied to switch rail in Figure 8. This profile fails the Gauge 2 condition because the bottom corner of Gauge 2 is both above and inside the top surface of the switch rail. In this image, the original rail section is traced in red, the measured rail profile is traced in yellow, and Gauge 2 is traced in green.

Figure 8: Switch rail with damage that fails Gauge 2 inspection

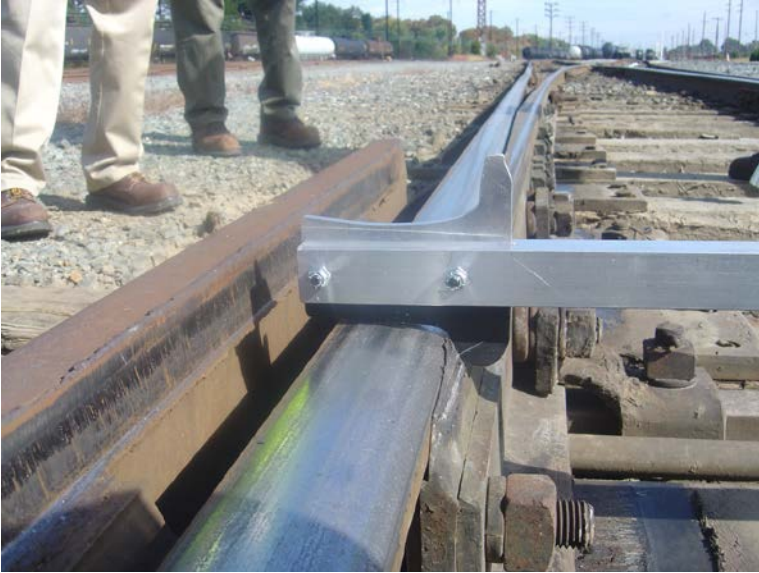
Figure 16: AAR 1B Wheel Profile Gauge as manufactured in the US by Norfolk Southern (bottom, on switch point) with severely worn US profile gauge in top position.

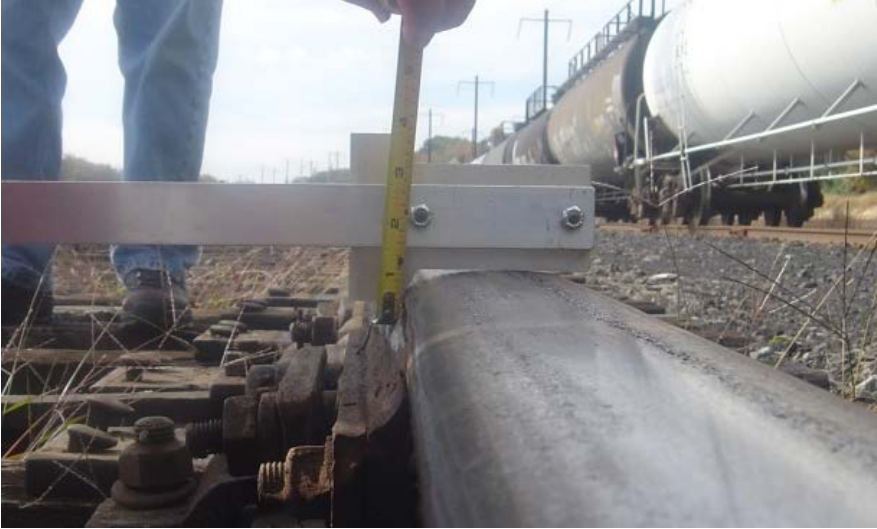
The study team evaluated the NS manufactured Network Rail Gauge 2 for chipped switch points (Figure 17) on October 23, 2013. While the go/no go gauge itself appeared to be both useful and practical, it appeared that the gauge was condemning switch points that were, in the opinion of several experienced railroad and transit maintenance officers on the Expert Review Panel, still functional and not ready to be removed from track. This suggested that the height of the gauge may not be appropriate for US conditions.

Figure 17: Chipped point as measured by Gauge 2

The Expert Review Panel judged the modified Gauge 2 (Figure 17), which reflects US practice and designs, to be very useful and recommended it for adoption by US rail systems.

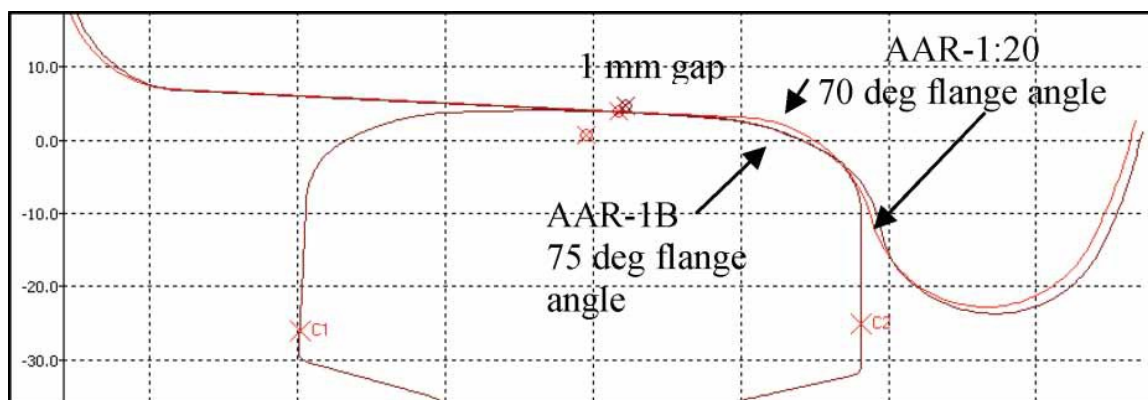
The Network Rail TGP8 gauge is based on a British P8 worn wheel profile and is designed to ensure that there is no improper wheel flange-switch rail contact, as designated by the 60° line or mark on the gauge (3C). The inspector uses this gauge to ensure that there is no wheel flange contact on the switch rail below the 60° line for the first 2000 mm past the switch point. This type of wheel-rail contact for several types of US wheel profiles is illustrated for conventional rail in Figure 18.

Figure18: AAR 1B vs. 1:20 wheel profile contact with new rail

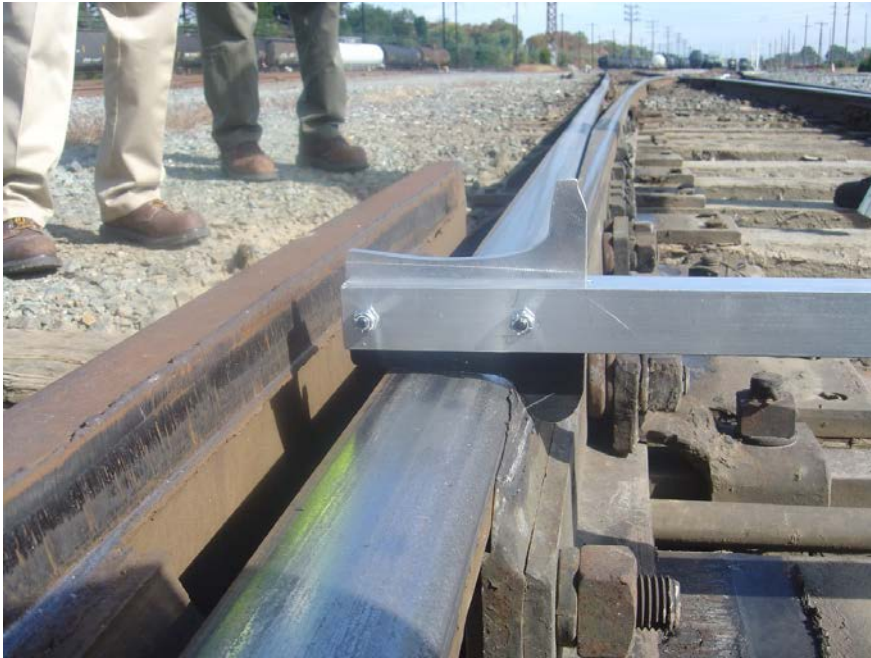
- Modified TGP8 gauge with AAR 1B wheel profile (bottom profile Figure 19)
- Modified TPG8 based on a severely worn US AAR 1B wheel profile (top profile Figure 19).

The NS-manufactured wheel profile gauges were evaluated in a NS yard on October 23, 2013 by the Study Team. Based on the evaluations in the field, the US version of the Network Rail gauge, using an AAR 1B new wheel profile and switch point contact below the 60° mark appears to identify an undesirable condition (Figure 19). Thus, the Study Team judged the gauge to be a helpful aid to inspection. The severely worn profile represents a condition in which derailments have, in fact, occurred (there was evidence of wheel climb at one of the measured switches considered during this field evaluation) and

was of real interest to the Study Team. However, analysis of the mechanisms of wheel climb suggested that the 60° check, by itself, may not be the most effective indicator of potential wheel climb for this severely worn profile. Thus, the Study Team recommended that the US severely worn profile gauge be further evaluated to see if a more effective measurement gauge or approach can be developed based on this profile.

Figure 19: Modified Wheel Profile Gauges during evaluation

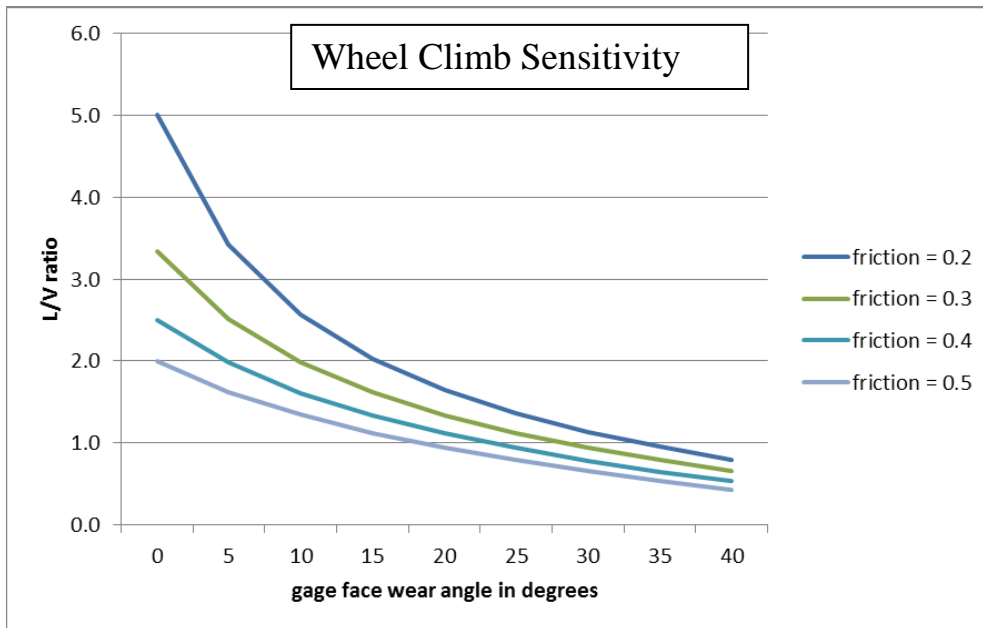
lateral (L) and vertical (V) wheel/rail forces, parallel to the rail gauge face, is greater than the resistance to that force due to the normal force component N and the corresponding coefficient of friction (13). Since the potential for wheel climb is directly related to the L/V ratio, those combinations of L/V ratio, gauge face wear angle (ϕ), and coefficient of friction which introduce an unacceptable level of risk for wheel climb can be defined (11, 12, 13). Figure 20 present such a sensitivity analysis, which shows the calculated L/V ratios associated with wheel climb as a function of different gauge face angles and coefficients of friction.

Figure 20: L/V Ratio vs. Gauge Face Wear Angle for different coefficients of friction

To illustrate this behavior, for a well lubricated condition, with a coefficient of friction of 0.2 and a gauge face wear angle of 28 degrees, the level of L/V required for wheel climb is 1.20, a very high level rarely seen in service. However, for a very dry condition, corresponding to a coefficient of friction of 0.5, the same amount of gauge face wear angle results in an L/V level required for wheel climb of 0.70. This is a level that has been measured in the field on a regular basis, and is, in fact, below the traditional Nadal wheel climb threshold of 0.8.

Likewise, increasing the allowable gauge face angle, i.e. allowing a flatter "slope" at the gauge face, while holding coefficient of friction constant, will result in a reduction in the L/V ratio required for wheel climb and consequently increasing the potential derailment risk. Thus, for a coefficient of friction of 0.4, a gauge face angle of 18 degrees requires an L/V ratio of 1.20 for wheel climb, an extremely high level which is difficult to reach, while a gauge face angle of 32 degrees requires an L/V ratio of 0.7. As noted above, this is a value that has been measured in the field for a range of vehicle types and operating conditions.

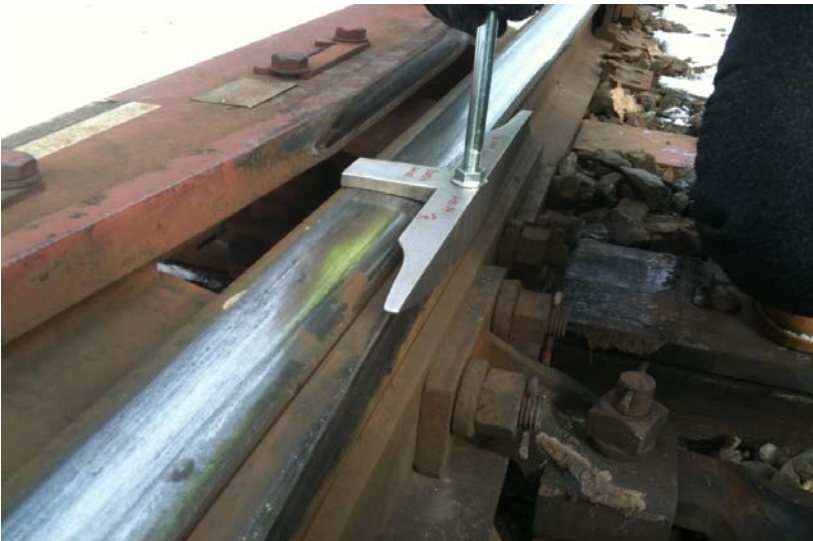
The extremely worn NS worn wheel gauge required further modification. A new gauge, referred to as the “half-moon gauge” was developed by NS from a wheel segment with the moderately worn wheel profile as shown in Figure 23.

Figure 23: “Half Moon” gauge with Moderately Worn Wheel Segment

The research team and Expert Review Panel also reviewed the severely worn AAR1B worn wheel profile but found that it did not give a good indication of potential wheel climb. "The half moon" worn wheel gauge produced by NS (Figure 23) was intended to replace this severely worn wheel gauge. This new gauge is a 3 dimensional inspection tool which is supposed to duplicate the wheel movement on the switch point. The gauge is applied by moving it back and forth along the switch point. However, review in the field indicated that it was not showing the wheel climb threshold as accurately as required for an effective gauge. That is because the point that the inspector needs to see (where the wheel starts to climb) is hidden behind the gauge. In addition, the gauge does not properly duplicate the angle of attack of the wheel to the rail which is the worst case scenario. As a result this gauge was not considered effective in its current shape, and again a modified version was developed for further field testing.

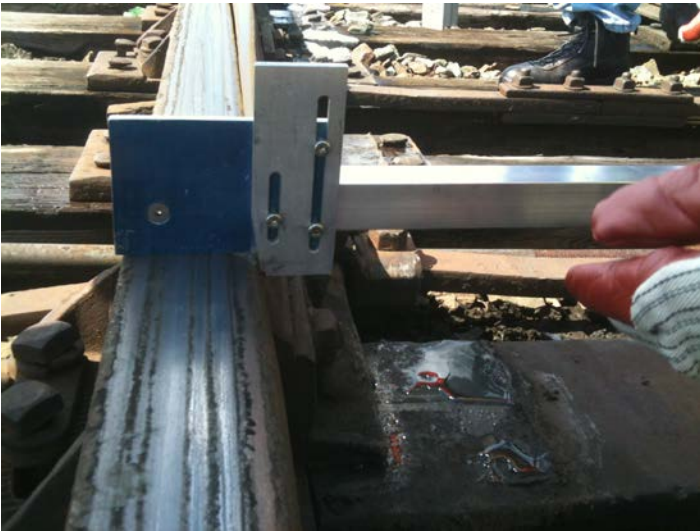
A final field evaluation was performed on March 26, 2014. A series of 5 switch points of several different design configurations and conditions were examined using the two versions of the SP gauge (Figure 24) as well as two versions of the TGAAR1B gauge; the new and moderately worn profile versions. Figure 25 shows the application of the SP Gauge on a switch point in the NS yard.

Figure 25: SP (80° notched) Gauge in use.

While both the 80° notched gauge and the 75° gauge Severe Profile Gauge (SP Gauge) were judged by the Expert Review Panel to be useful for determining conditions of switch points and providing an indication of potential for wheel climb derailments for a severely worn wheel (see Figure 25), there was still some concern regarding these as “final products.” The 75° gauge was deemed to be more conservative in that it may condemn marginally good points. The 80° notched gauge was considered non-conservative in that it may pass some marginally bad points. It also proved a little harder to use because of the size of the notch. Both gauges also had a question regarding actual alignment and placement, with the possibility that they did not accurately reflect the wheel flange position, particularly on the straight side of one of the turnout designs examined in the yard.
