DEVELOPMENT OF GUIDELINES FOR REHABILITATION OF EXISTING HIGHWAY AND RAIL TRANSIT TUNNELS

AASHTO Technical Committee for Tunnels (T-20)

Gannett Fleming, Inc.
207 Senate Avenue
Camp Hill, PA 17011

NCHRP HR 20-07/TASK 276
TASK 6 – Final Report
Development of Guidelines for Rehabilitation of Existing Highway and
Rail Transit Tunnels

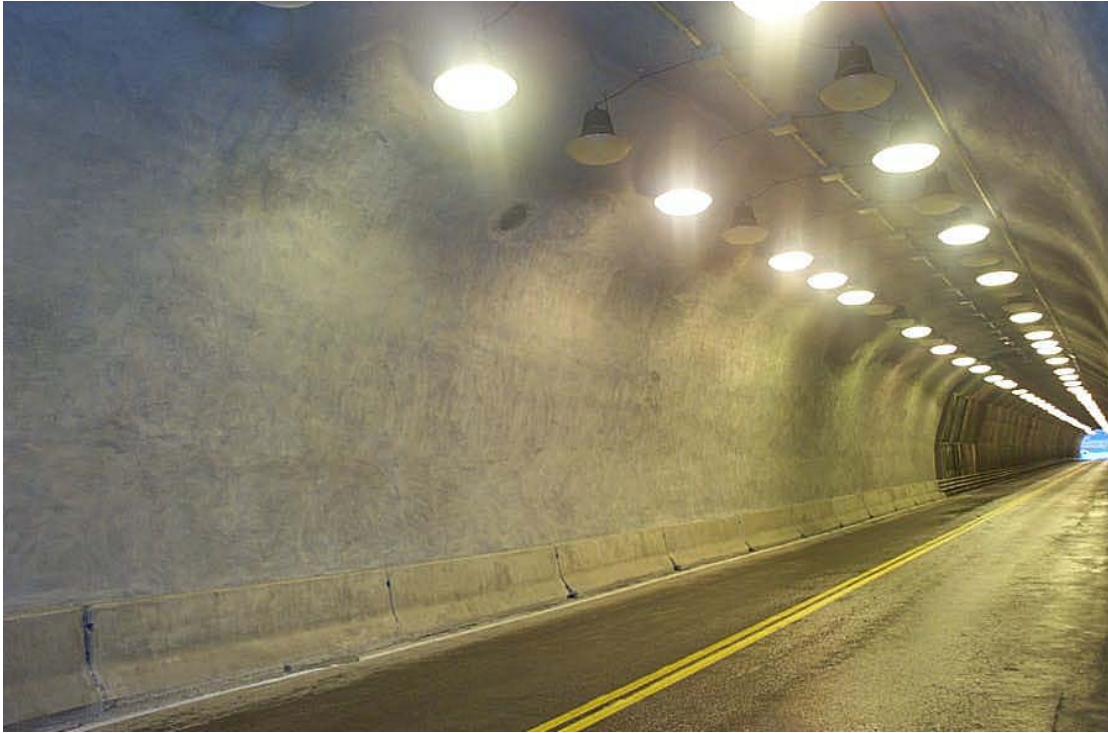
Photo 1 – New shotcrete lining over timber supports in rock tunnel.
Note timber lining in background.

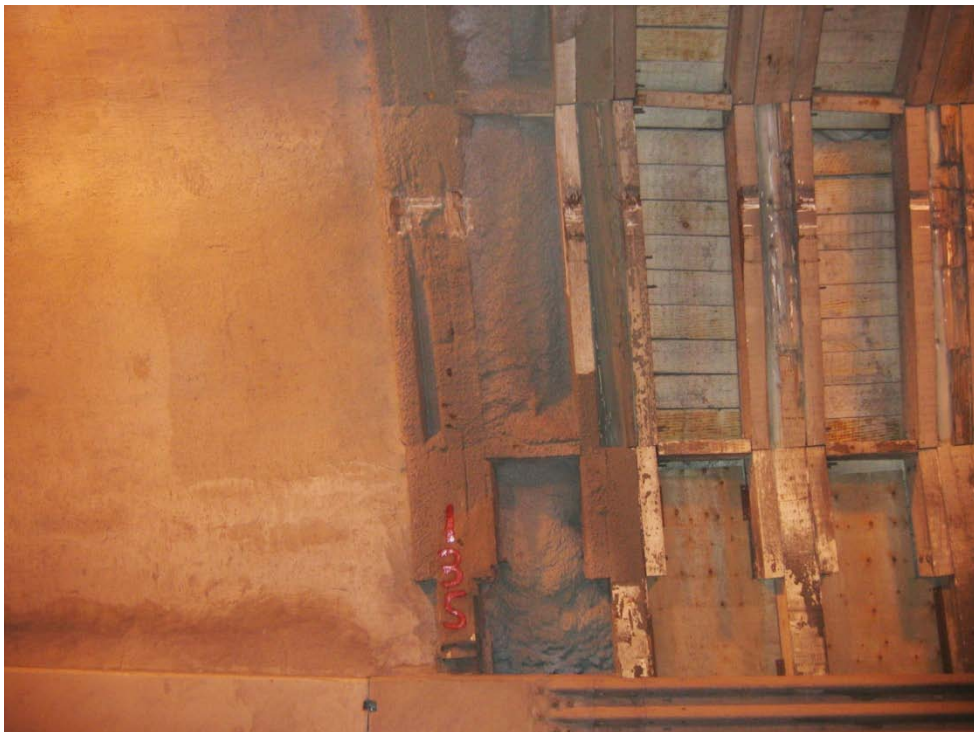
Photo 2 – Interface between timber supports and new shotcrete.

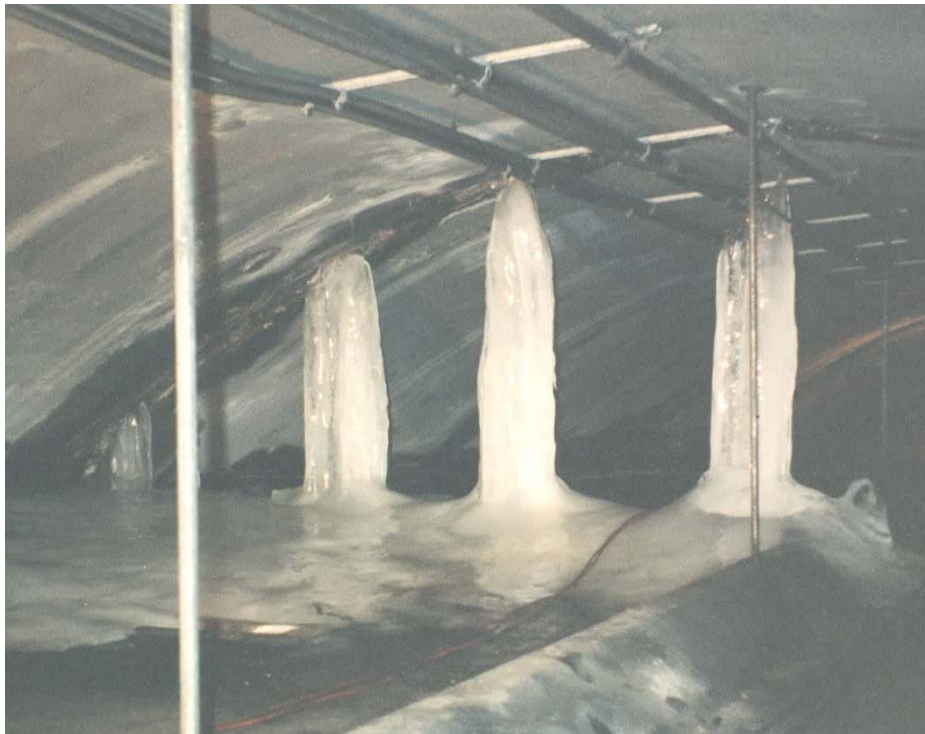
Photo 4 – Ice formation through liner in plenum area above roadway ceiling slab.
(FHWA, 2005)

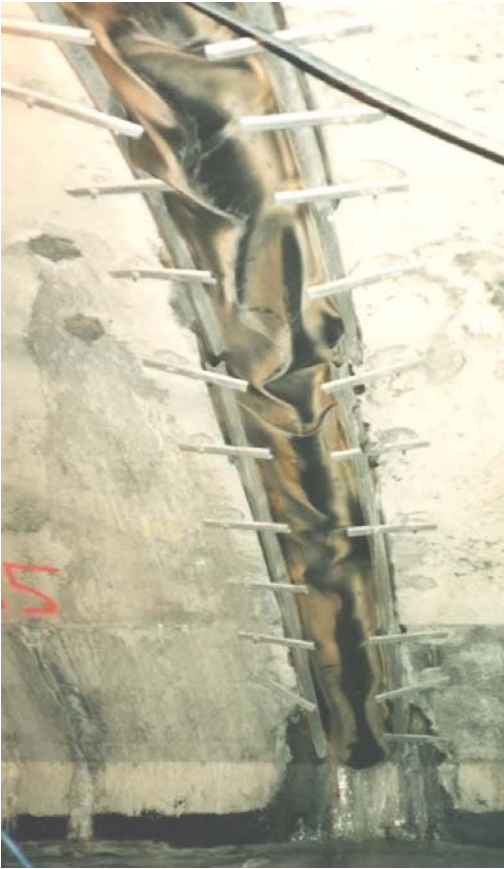
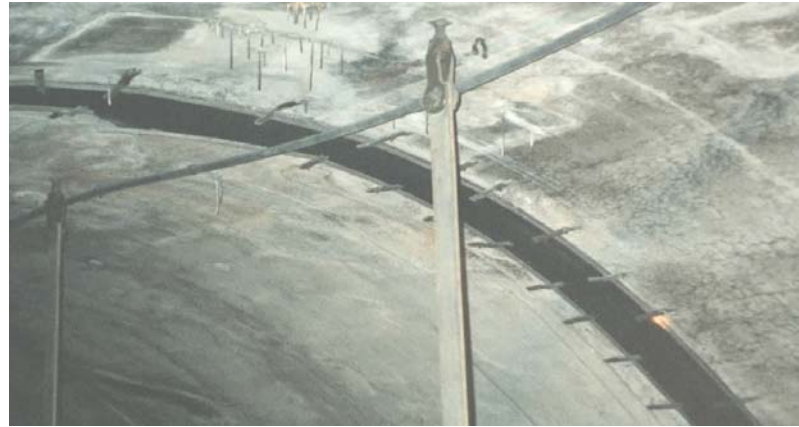
Photo 5 – Temporary drainage systems comprised of neoprene rubber troughs and 25 mm (1”) aluminum channels. (FHWA, 2005)

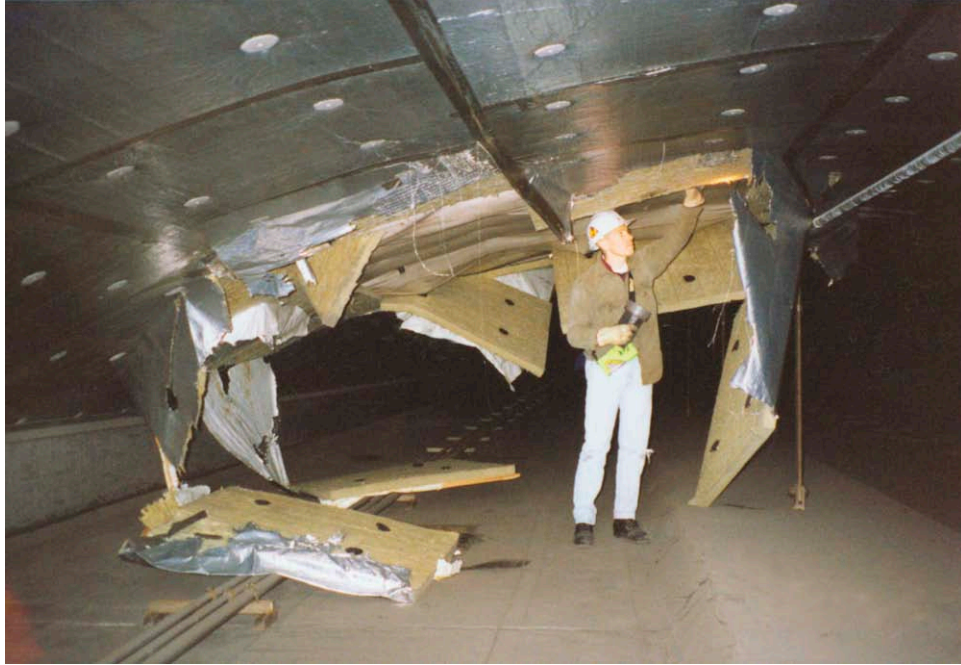
Photo 7 – Insulated panels under waterproofing membrane in air plenum region above roadway have dislodged in an isolated location.

Similar locations of such membrane uses without a fire retardant protective barrier are shown for both a highway and a rail tunnel (Appendix B, Photos 7 – 9). Please note for the highway tunnel that none of the anchorages for attaching the membrane to the plenum arch ceiling or attaching the insulated panels to the underside of the membrane penetrated through the materials. Anchorages for the membrane were attached to the underside of the arch ceiling with mechanical anchors; the membrane was then heat sealed to these attachments. Similarly, the anchorages for the insulated panels were also heat sealed to the underside of the membrane. As can be seen in the photos, there is a tendency for isolated insulated panels to detach from the underside of the membrane requiring reattaching. But, after more than a decade in operation, the system remains effective as a viable method to keep infiltrating water out of the plenum arch area and transferring it to the tunnel's existing drainage system for disposal. Also, the insulated panels in unlined rock tunnels may be used to keep infiltrating water from freezing and falling onto the tracks (Appendix B, Photo 9).

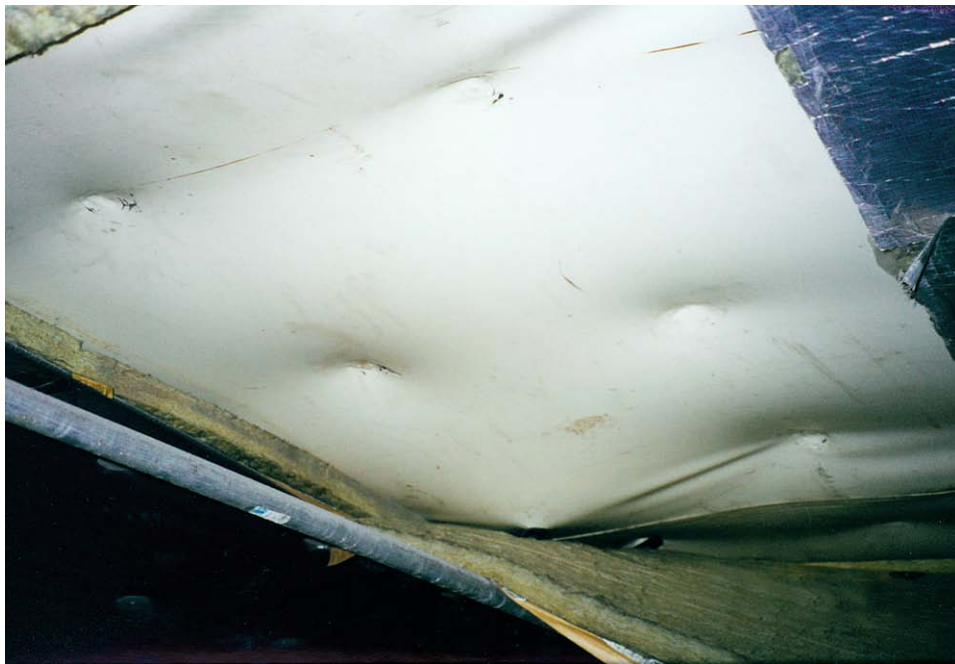
Photo 8 – Underside of waterproofing membrane in air plenum slab. Note that heat welded attachments on the underside of the white membrane receive the insulation panels' anchors without penetrating the membrane.

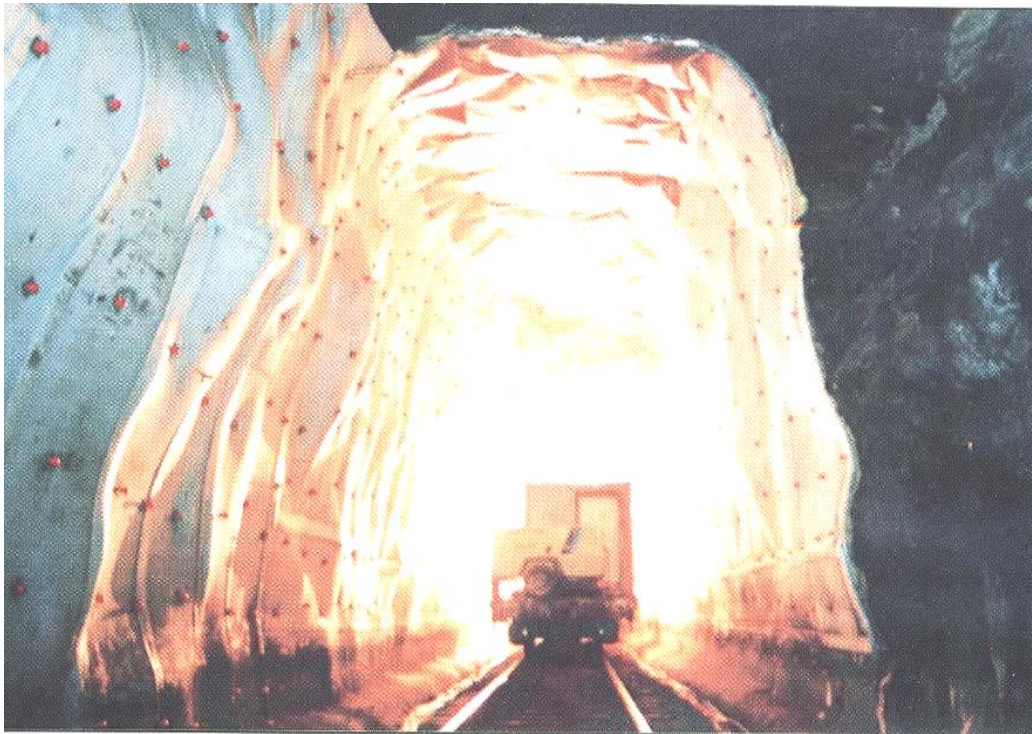
Photo 9 – Insulated panels used as a waterproofing lining to keep infiltrating water from freezing. (Photo courtesy of Tunnels & Tunnelling International) (FHWA, 2005)

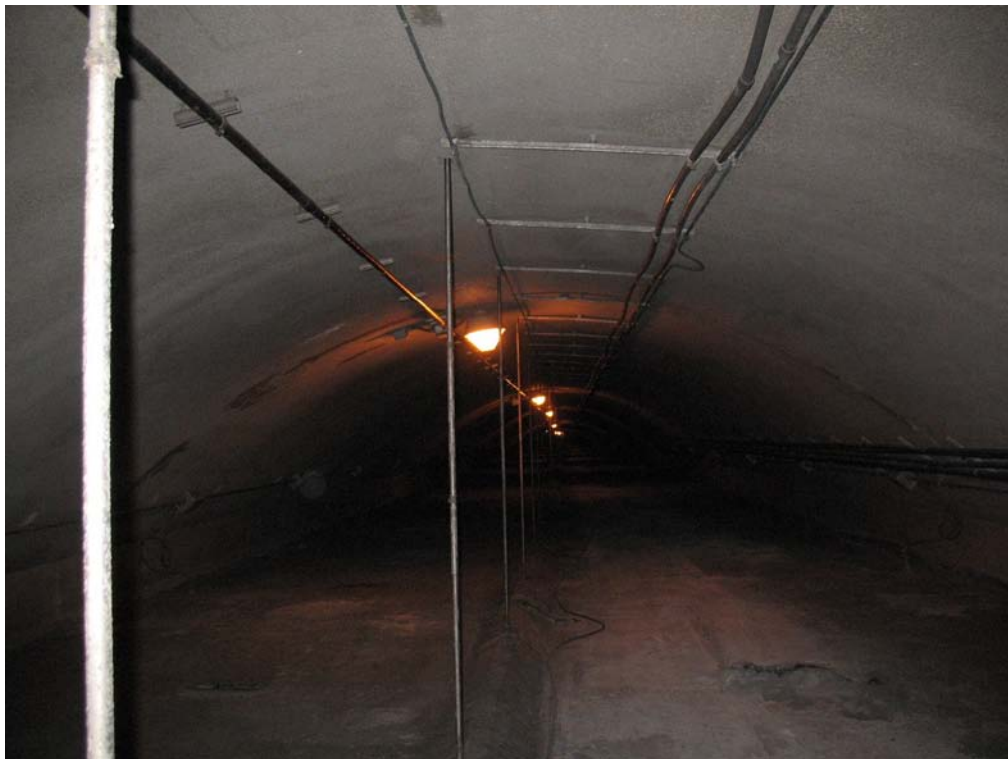
Photo 10 – General view of tunnel arch ceiling above plenum slab where a cementitious coating has been applied to the underside of the arch in a Pennsylvania tunnel.

- b. Installing a sprayed cementitious waterproofing membrane over the interior surfaces of the tunnel liner. This best practices method has been employed along with the sealing of cracks and joints in cast-in-place concrete tunnel liners to minimize water penetration through the concrete liner (Appendix B, Photo 10). This sprayed membrane was applied in 2005 in a Pennsylvania highway tunnel. This system is made of a blend of co-polymers and Portland cement. The co-polymers in the mixture reduce the pore size within the concrete substrate to impede the passing of water molecules through the cementitious coating, but do allow water vapor to pass through. This offers the advantage of fairly rapid installation thus minimizing disruptions to tunnel operations, can be performed with similar equipment to that for shotcrete, and is less costly than the total system described in Paragraph B.2.a. However, the disadvantages of this system are that it is rigid, is not self healing, and may crack if there is movement in the tunnel structure (Appendix B, Photo 11). Although most of the system is performing well for more than five years since its installation, there are several isolated locations of water leakage through the coating at crack/joint locations.

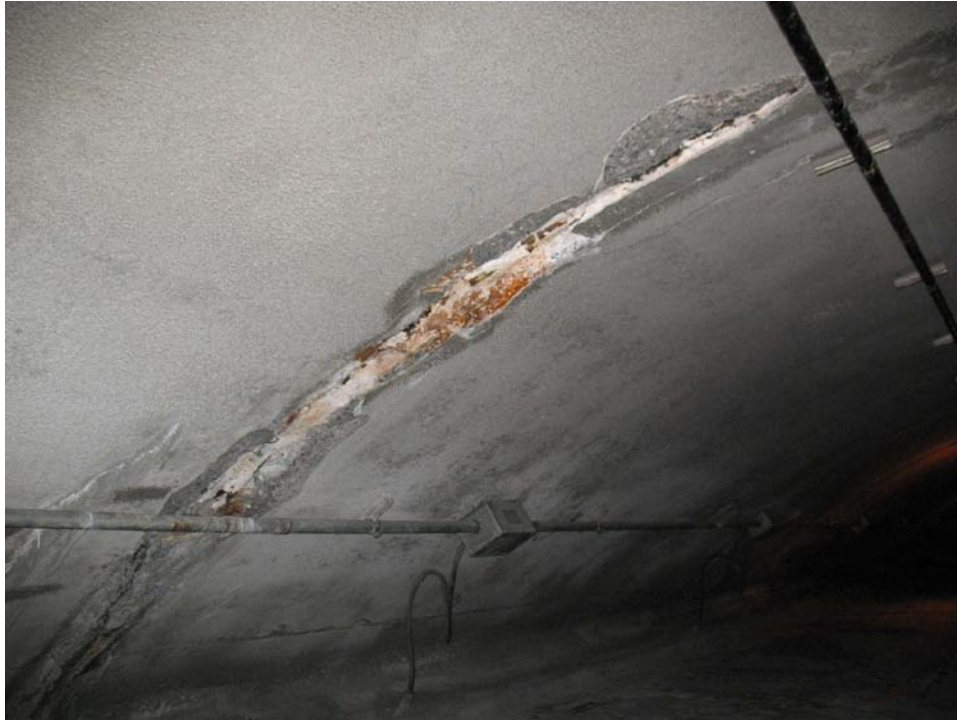
Photo 11 – Leakage at a construction joint through the cementitious coating that was applied on the underside of the tunnel arch in a Pennsylvania tunnel.

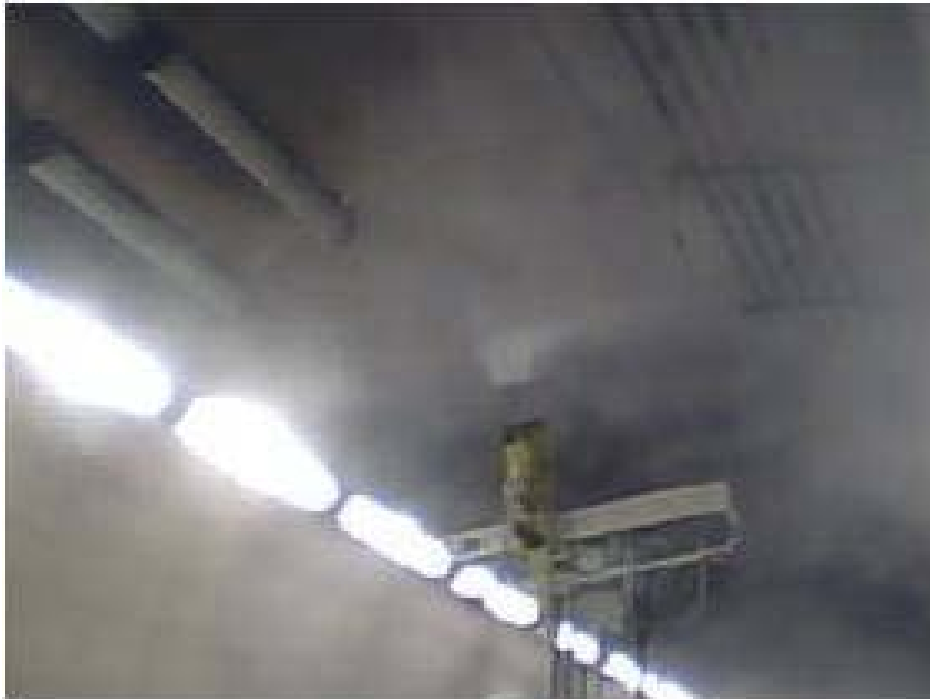
Photo 12 – Hydro demolition operations for removing deteriorated concrete in the Liberty Tunnel in Pittsburgh, PA.

Delaminated areas can be repaired by several methods. Depending on the depth of the delamination and the overall intent of the rehabilitation occurring in the tunnel, the delaminated area can be removed with a chipping hammer or by hydro demolition (Appendix B, Photo 12) to sound concrete. Then, depending upon the size and depth of the spalled area, whether reinforcing steel is present and/or whether the reinforcing steel has adequate area remaining, either polymer repair mortars can be used for small areas and small repair depths (Appendix B, Figures 8 and 9) or shotcrete can be used for larger areas and greater depths (Appendix B, Figures 10 and 11 and Photos 13 and 14). It is typically recommended that welded wire fabric attached by “J” bolts to sound substrate be used in greater depth shotcrete repairs as an additional anchorage for the shotcrete. Many shotcrete repairs include the addition of synthetic or steel fibers added to the mix to control shrinkage and strengthen the overall product, especially when no wire mesh is used. The repair contractor shall strictly follow manufacturer’s suggested installation procedures for the selected material to be used.

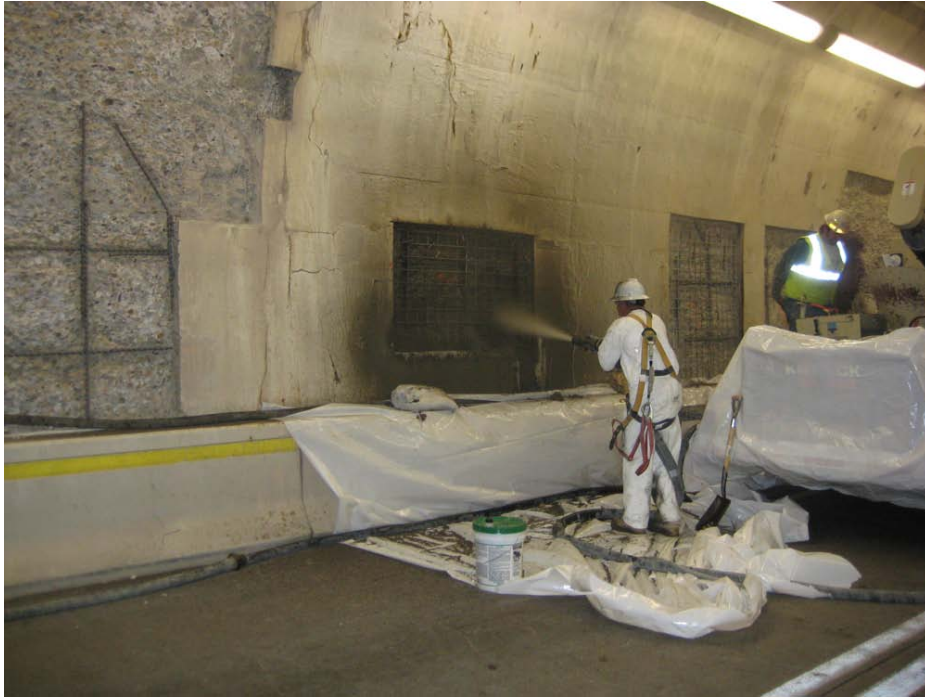
Photo 13 – Using shotcrete to repair large areas in walls of Liberty Tunnel in Pittsburgh, PA.

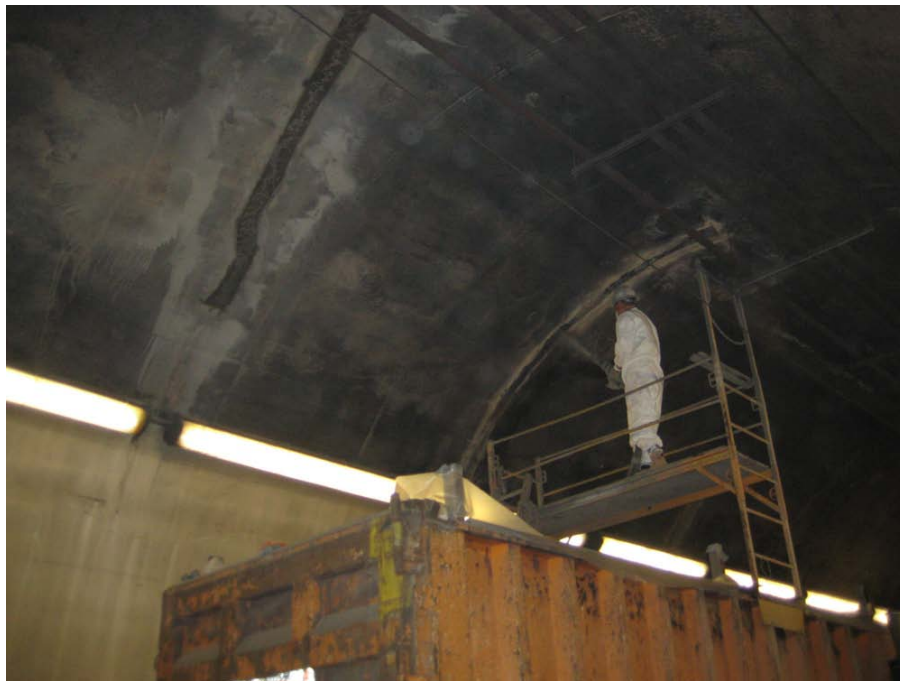
Photo 14 – Using shotcrete to make overhead ceiling repairs in Liberty Tunnel in Pittsburgh, PA.

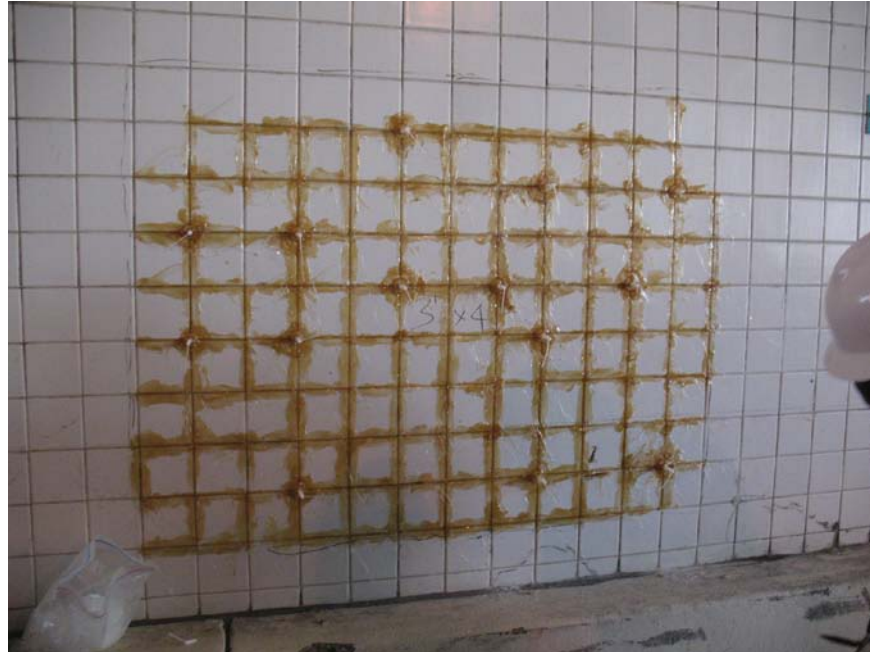
Photo 15 – Preparing 3' x 4' surface area on tunnel wall by installing ports and sealing grout lines with an epoxy gel prior to initiating a vacuum injection process.

But, it is not absolutely necessary to remove the delaminated area if a vacuum injection process is used to rebond delaminated surfaces together. This was used on a tunnel in Washington, D.C. where there were delaminations within the mortar depth under the ceramic tiles on the tunnel wall face. Rather than remove the tile, chip away the delaminated mortar to sound mortar, replace the deteriorated area with polymer repair mortar, and then reattach the tiles, the contractor elected to use a vacuum injection process to seal the cracked region in the mortar. This was done by vacuuming a methyl methacrylate resin through injection ports located at intervals on the face of the tunnel wall into the gap between the mortar surfaces (Appendix B, Photos 15 and 16). Please note from the photos that this method becomes less viable when the surface mortar between the tiles contains micro fissures and must be covered with an epoxy gel to create the vacuum needed for the repair process. Once the methyl methacrylate cures and hardens, subsequent tapping of the wall revealed no delaminations on the surface. Also note that it was verified by the taking of cores that the mortar truly was bonded together and provided a successful solution (Appendix B, Photo 17). This method may not be cost effective for fairly shallow repairs if every mortar joint between tiles must be sealed with an epoxy resin prior to commencing the vacuum injection process.

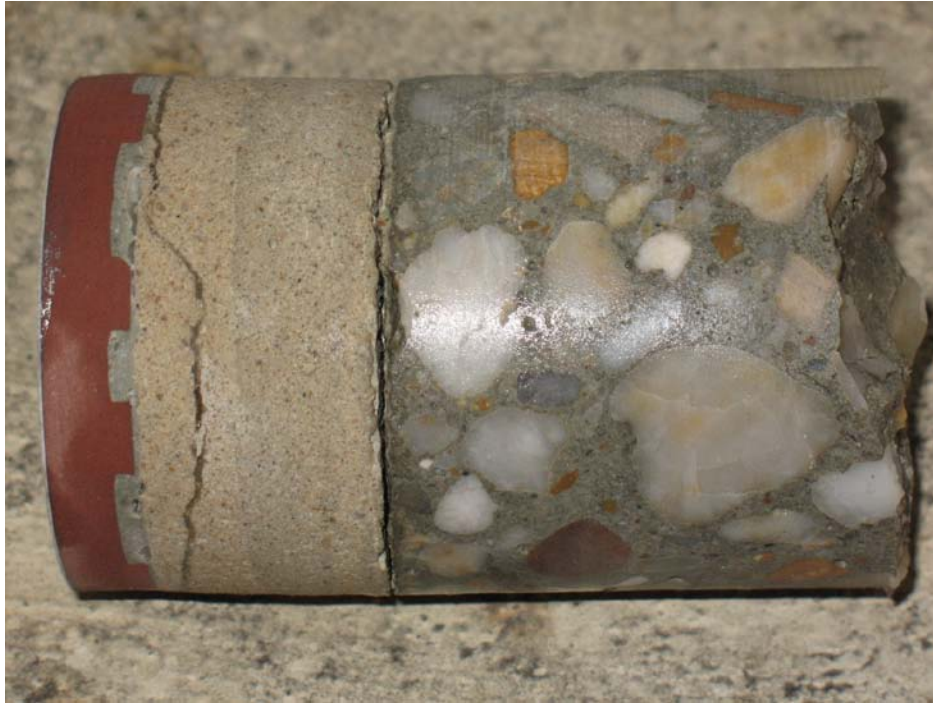
Photo 17 – 2” diameter core of region vacuum injected to validate that the methyl methacrylate filled the crack in the mortar. Please note that the red at the end of the core is the tile on the wall surface. Also, the bond between the mortar and the concrete substrate was sound, but debonded during the coring and extraction process.
