**COUNTERMEASURES TO PROTECT BRIDGE PIERS
FROM SCOUR**

FINAL REPORT

NCHRP 24-7

**Gary Parker, Carlos Toro-Escobar, Richard L. Voigt, Jr.
St. Anthony Falls Laboratory, University of Minnesota
Minneapolis, Minnesota**

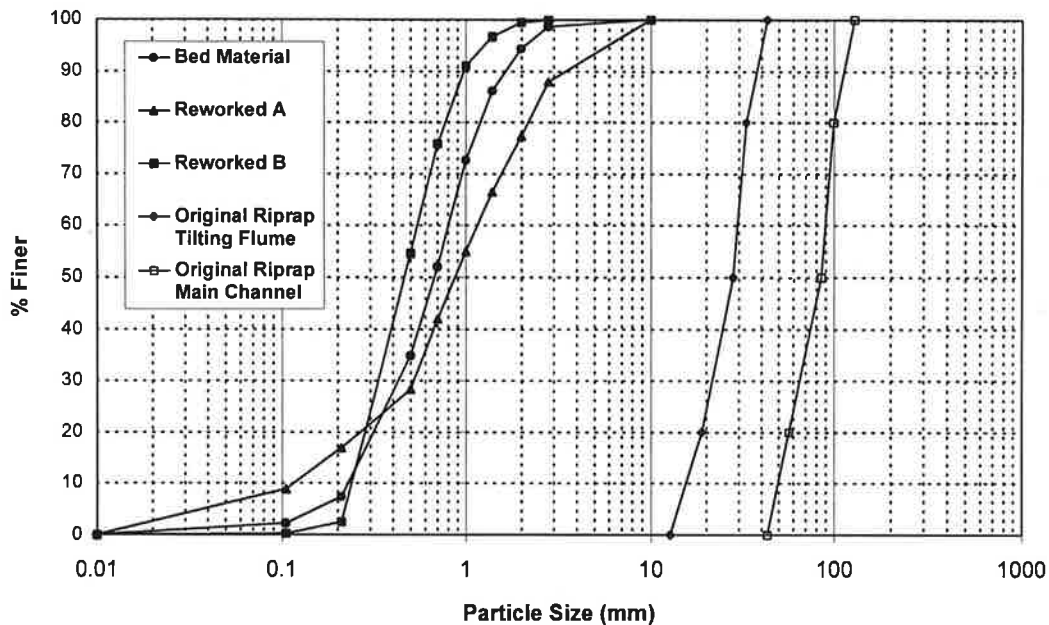
Grain Size Distribution

The ambient bed sediment was sized in order to allow for modeling of fairly typical sand-bed streams. The grain size distribution of the sand as installed is given in graphical form (Figure 3.5) and in tabular form (Table 3.2). In the course of the experiments a finer portion of this mix washed out, resulting in the somewhat coarser reworked distribution A of the same figure and table. The d_{50} size, for example, increased from about 0.7 mm to about 0.87 mm. Subsequently, a small but steady supply of 0.4 mm sediment from the Mississippi River caused the sediment to eventually become finer, according to reworked distribution B. The median size d_{50} for this distribution was near 0.50 mm, which was taken as characteristic of all the SAFL runs.

In general, the sediment is graded, with significant content between 0.2 and 4 mm. The size distribution is within the typical range for sand-bed streams. The specific gravity of the sand is close to 2.65.

Figure 3.5. Grain size distributions of the sediment and riprap.

Riprap was constructed from the same highly angular crushed limestone quarry run that is commonly used as riprap by the Minnesota Department of Transportation. This material has a specific gravity close to 2.7. Sizing was done using the relations of Parola (1991) and Quazi and Peterson (1973). The original size distribution is given in graphical form in Figure 3.5, and in tabular form in Table 3.3a (Main Channel) and Table 3.3b (Tilting Flume); the median riprap size D_{r50} was 3.1 in (79.5 mm) and 1.1 in (26.9 mm), respectively. It was found that this original distribution was too coarse to allow for consistent failure due to entrainment at the highest flows of the experiments. In order to ensure that this condition could be studied, the riprap was reconstituted using the finer two-grain size ranges in each case. The reconstituted median size of the riprap, D_{r50} , was 2.1 in (53.8 mm) in the Main Channel and 0.85 in (21.6 mm) in the Tilting Flume. The first two sets of experiments on riprap in the Tilting Flume were done using the original coarse riprap; the rest were done using the modified riprap. All of the riprap experiments in the Main Channel were done using the modified riprap. More details concerning the selection of experimental riprap size are given in the section, Run Protocol.

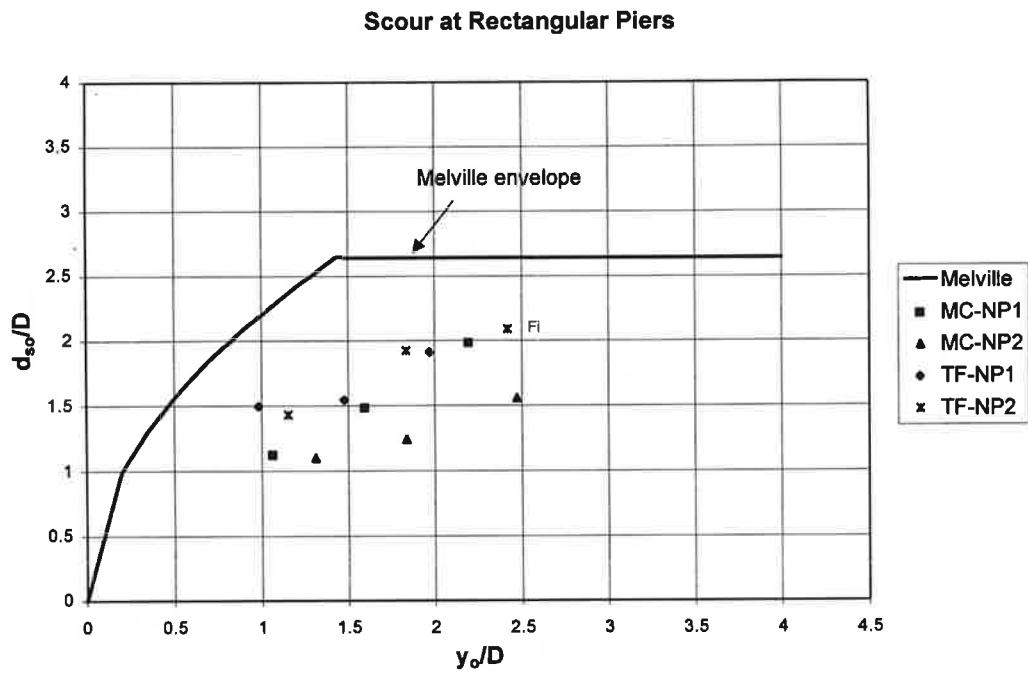
Figure 3.6b. Results for unprotected scour at rectangular piers.

The unprotected scour depth d_{so} as defined at the beginning of this chapter represents the maximum average scour depth below the mean elevation of the bed. This is the appropriate value to use in the Melville (1997) formulation. The Colorado State University predictor for maximum scour depth at unprotected piers is given in HEC-18 (Richardson et al., 1992). The scour depth it predicts is not d_{so} , but rather $d_{so} + \Delta$, where Δ denotes bedform height. This parameter can be computed from the values of d_{so} in Tables 3.9a – 3.10d and the dune heights given in Table 3.12. A comparison of the data against the Colorado State University predictor is given in Figure 3.6c. In that figure RM denotes the rectangular pier in the main channel, RT denotes the rectangular pier in the tilting flume, CM denotes the circular pier in the main channel and CT denotes the circular pier in the tilting flume. The comparison between the observed and predicted values is generally good, but scour depths are overpredicted in the case of the

circular pier in the Main Channel. This is likely because dunes were insufficiently developed at this point, as discussed subsequently.

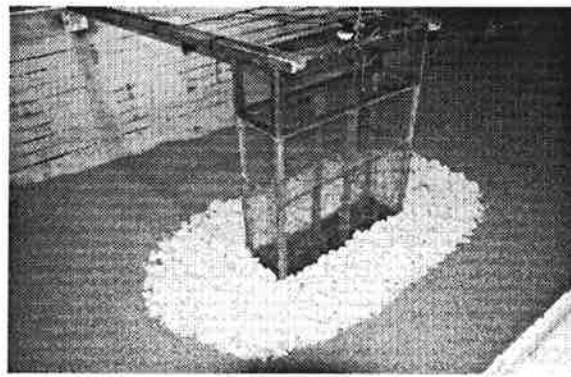
The above placement is illustrated below in Figures 3.9 and 3.10 with examples from both the Tilting Flume and the Main Channel. It is not as stringent as that recommended in HEC-18 (Richardson et al., 1992). There it is recommended that the riprap should extend horizontally out a distance of $2 D$ from any face. Here the corresponding values are $1.5 D$ in the case of a circular pier and $1.5 D$ laterally and $2 D$ longitudinally in the case of a rectangular pier. In HEC-18 it is recommended that the riprap thickness t be equal to $3 D_{r50}$, whereas a thickness of $2 D_{r50}$ is used here. As outlined subsequently, tests at St. Anthony Falls Laboratory and the University of Auckland justify this less stringent placement as long as a) a geotextile filter is placed below the riprap and b) the bed is excavated prior to riprap placement so that the top of the riprap is flush with the bed. To the extent that adequate protection against scour is realized here, implementation of the placement of HEC-18 would add a margin of safety in most cases.

Figure 3.9. a) View of riprap placement around the cylindrical pier in the Main Channel.
b) View of riprap placement around the rectangular pier in the Main Channel.

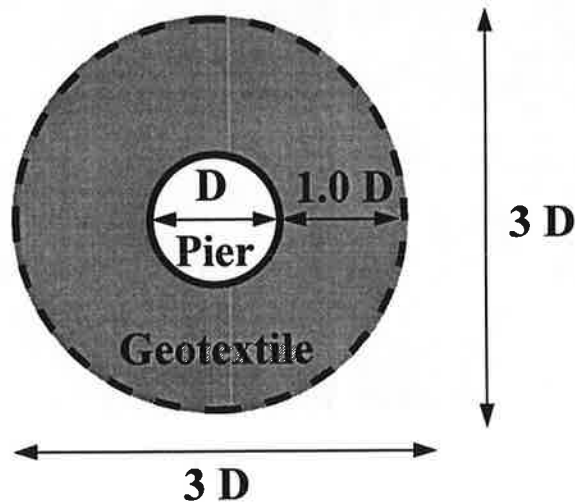
Figure 3.16a. Sketch of placement of geotextile around a circular pier.

In order to obtain the benefits of a geotextile without the above deleterious effects, it was decided to design the geotextile so as to cover less area than the riprap. In the case of the circular pier geotextile extended out to 1 D beyond the face of the pier itself, as opposed to 1.5 D for the riprap. In the case of the rectangular pier the geotextile extended 1 D out from a lateral face (as opposed to 1.5 D for the riprap) and 1.5 D out from a longitudinal face (as opposed to 2 D for the riprap). This is illustrated schematically in Figure 3.16.

The concept behind this partial coverage is as follows. Edge effects and dune migration can be expected to cause failure of the riprap by side slippage. As long as this riprap is not entrained by the flow, it should become buried and gradually anchor the geotextile in place. The partial coverage should thus encourage self-anchoring and prevent exposure of the geotextile.

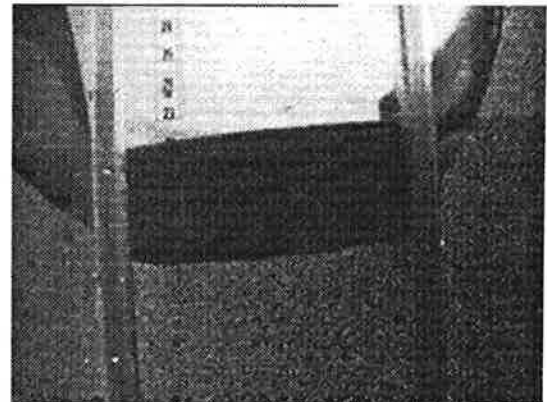
Figure 3.21. a) View of the riprap and geotextile upstream of the rectangular pier at the beginning of Run 4 of series MC-RPG. This and the subsequent views of the same pier for the same run were taken from videotape. The view is upstream from inside the pier. b) View a few minutes later, showing exposure of the geotextile as riprap is eroded away. c) Subsequent view showing the beginning of uplift of the geotextile. A scour hole is apparent below the geotextile. d) Subsequent view showing a deeper scour hole below the geotextile, with the leading edge of the geotextile flipped up against the pier. e) Frontal view showing some rearining of the scour hole by riprap from upstream. f) Final view showing riprap falling into the deep scour hole.

This failure occurred within minutes of the commencement of Run R-M4. It was documented vividly on videotape taken from inside the piers. Figures 3.21a-e, which were extracted from videotape, show the time sequence of failure for the rectangular pier. All the views are looking upstream from inside the pier. Figure 3.21a shows the riprap and geotextile at the beginning of the run. Figure 3.21b shows the riprap being eroded away from the geotextile a few minutes later. A cavity is apparent beneath the geotextile as sand is leached out. Figure 3.21c shows the leading edge of the geotextile beginning to lift up. Figure 3.21d shows the leading edge of the filter layer flipped up against the bridge pier, and deep scour below. Figure 3.21e shows an even deeper hole, with some riprap falling in to rearmor the scour hole.

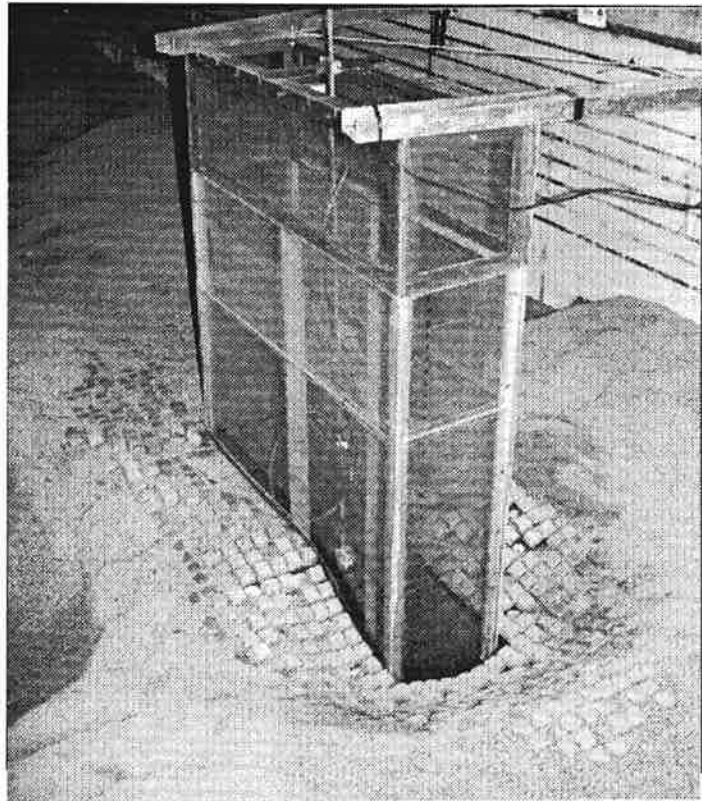
Figure 3.36. a) View of the circular pier at the end of Run 4 of series MC-CB2, showing the excellent performance of the cable-tied blocks in anchoring the geotextile. b) View of the rectangular pier at the end of Run 4 of series MC-CB2, showing the excellent performance of the cable-tied blocks in anchoring the geotextile.

Photographic documentation of the performance of the cable tied blocks is provided in Figures 3.36, 3.37 and 3.38. The first of these, taken at the end of Run 2 of series MC-CB2, documents the ability of the block mattress to anchor the geotextile. Note, however, the scour at the upstream end of the rectangular pier. This was caused by the leaching of sand from the gap between the geotextile and the pier. The second of these figures documents the state of the mattresses at the end of Run 4 of series MC-CB3. A better view of the uplift failure at the rectangular pier at the end of Run 4 of series MC-CB3 is given in the last of these figures.

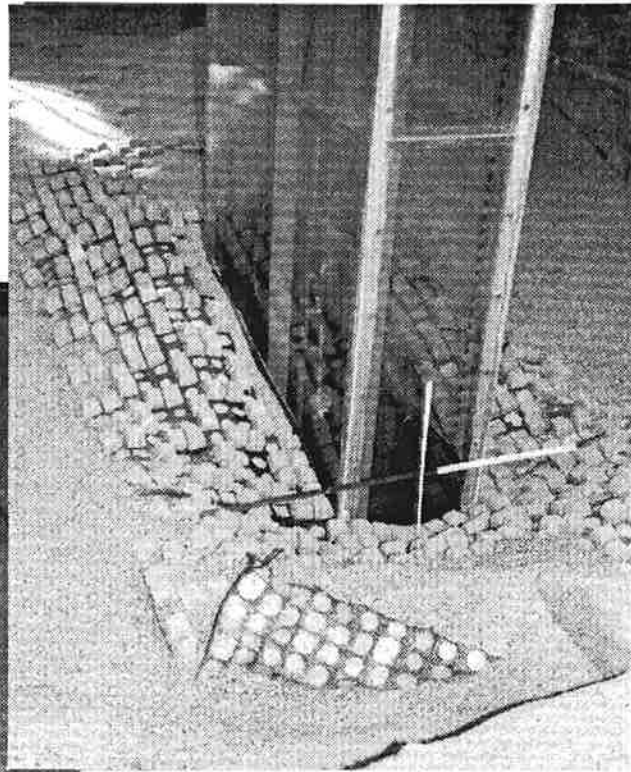
Figure 3.38. a) View of uplift failure at the rectangular pier at the end of Run 4 of series MC-CB3. b) Another view of the uplift failure.

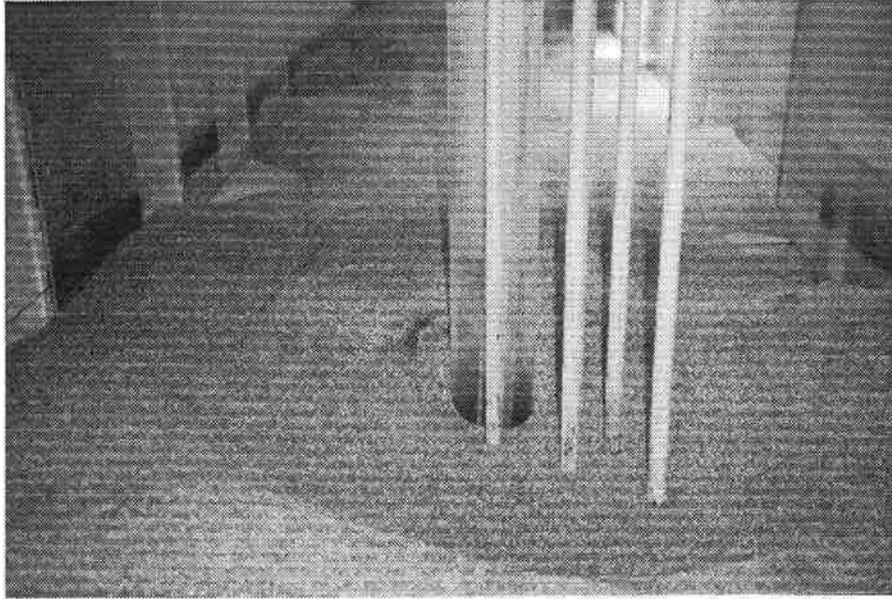
Figure 4.22. Illustration of a typical experiment on sacrificial piles under mobile bed conditions.

Each experiment was run for 24 hours to ensure that live bed scour depths had reached an equilibrium stage and bedforms were fully developed. Scour depths at the upstream face of the pier were recorded every minute for one hundred minutes, so that the average scour depth as well as the maximum and minimum could be determined. Figure 4.22 illustrates a typical sacrificial pile experiment under mobile bed conditions.

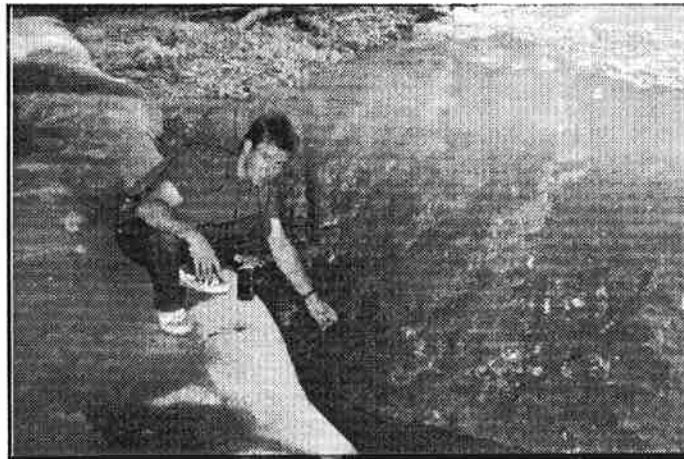
Figure 7.6. Shows grout mass undercut and cantilevered from the adjacent abutment.

A number of grout bag installations were evaluated at generally small bridges in Maryland. These appeared to be relatively successful as shown in Figure 7.4 of a typical installation. The primary problems noted concern the bag's size and its rigid nature vs. its ability to resist scour. As seen in Figure 7.5, some undercutting effects were noted at the sides and ends of bags when the bag was unable to settle effectively. The worst case noted was an installation where the contractor had, in an effort to make the finished product look good and use up available concrete, placed a thin coating of concrete on top of the bags and along the joints. Unfortunately, this layer effectively grouted the bags in place. At the time of the team's inspection, the grouted mass had been undercut by approximately 3 feet and was cantilevered from the adjacent abutment Figure 7.6.

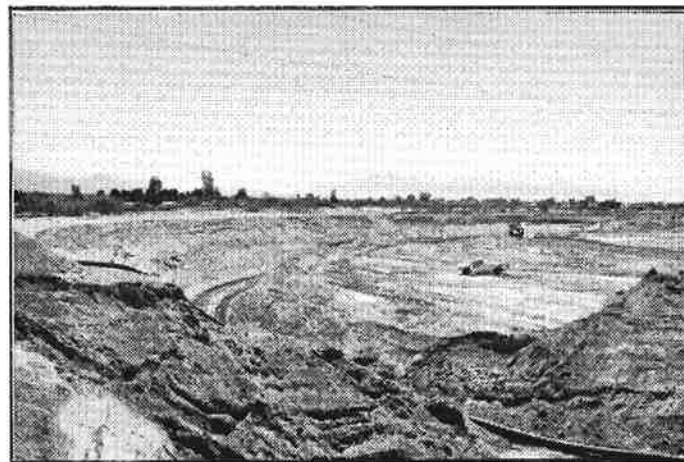
Figure 7.7. Shows a new soil-cement structure under construction.

Soil cement has proven effective near Tucson, Arizona where the typical soil conditions have a grain size distribution which, when mixed with cement, naturally forms a stable soil-concrete mixture. Figure 7.7 shows a new soil cement structure under construction, while Figure 7.8 shows an embankment which sustained damage but did not fail during a flood. Soil conditions in the Phoenix area are not as well suited to making soil cement. Some erosion to the soil cement was noted. However, the ephemeral nature of the rivers on which it has been installed to allow for relatively inexpensive repair. The opinion of the team is that it may have promise in similar areas such as Southern California, provided the soil conditions are favorable. It is doubtful that soil cement will be effective in regions were any soil moisture exists as even minor levels of moisture will affect performance.

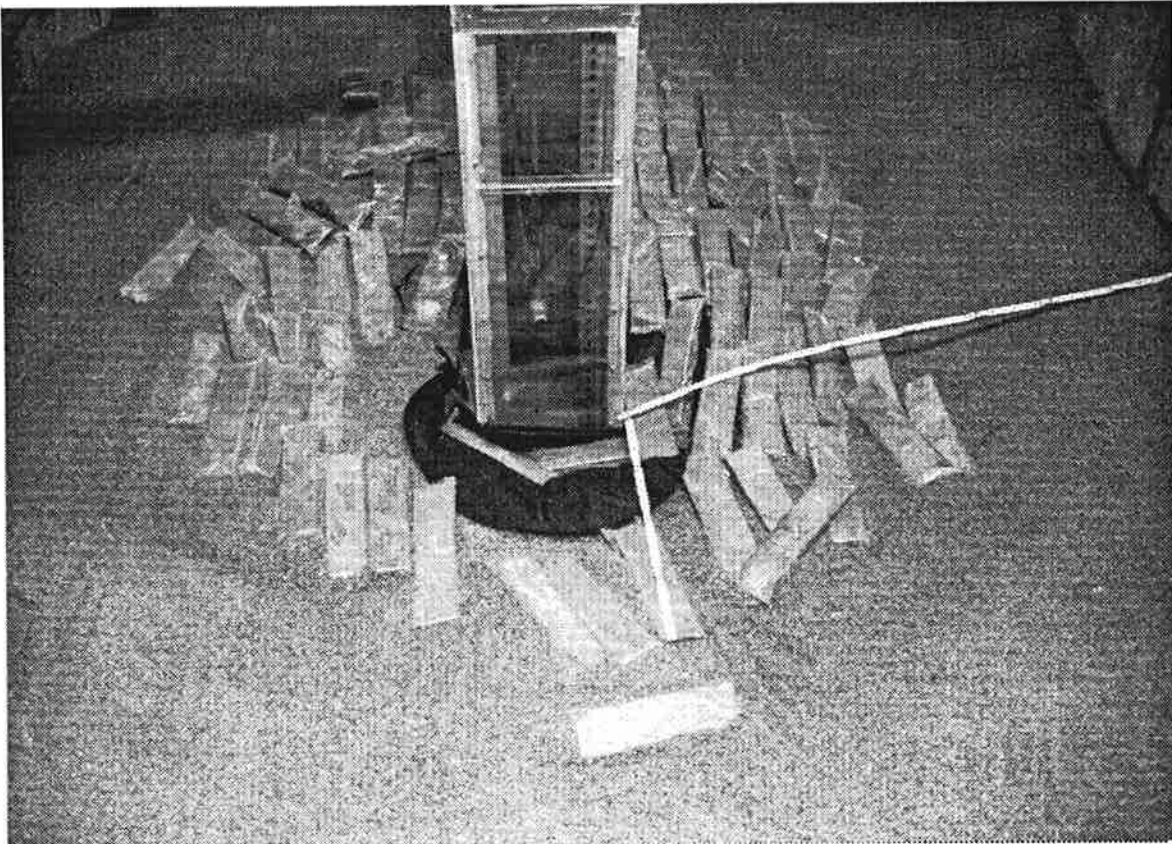
Figure 8.8c. Illustration of the dispersive sliding of grout filled bags under conditions for which the equivalent riprap did not fail.

One possible installation of grout filled bags is presented in Figures 8.8a and 8.8b. The potential problems with grout filled bags are illustrated in Figure 8.8c.
