## Appendix 5: Connection Details and Critical Inspection Points

### 1.0 INTRODUCTION

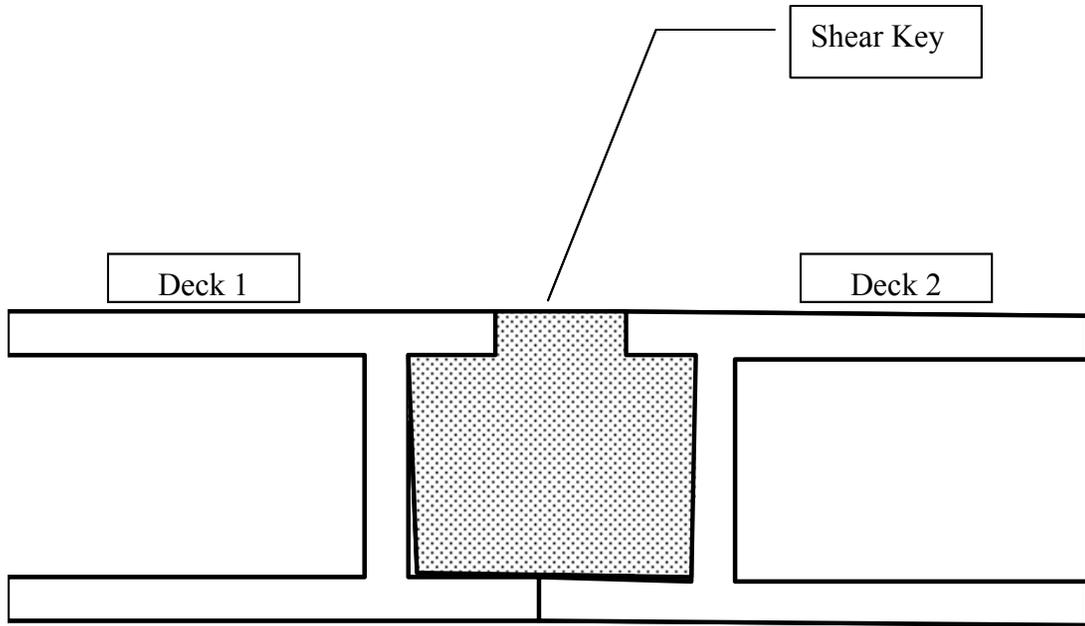
**Figure 2.2.1-1 Cast Shear Key Connection.**

This method uses an insert or filler material in between decks to affect a shear lock between decks. This is similar to interlocking used between precast concrete slabs where grout is poured between the channel cavities of adjacent slabs to serve as shear keys. This has been used on several early decks produced by Martin Marietta Composites (MMC); namely, the King Stormwater Channel Bridge. In this project, the connection is made with open C channels formed by adjacent decks as illustrated in Figure 2.2.1-1. Cement grout is cast into the channel to form a solid, interlocked shear key along the length of the mating faces.

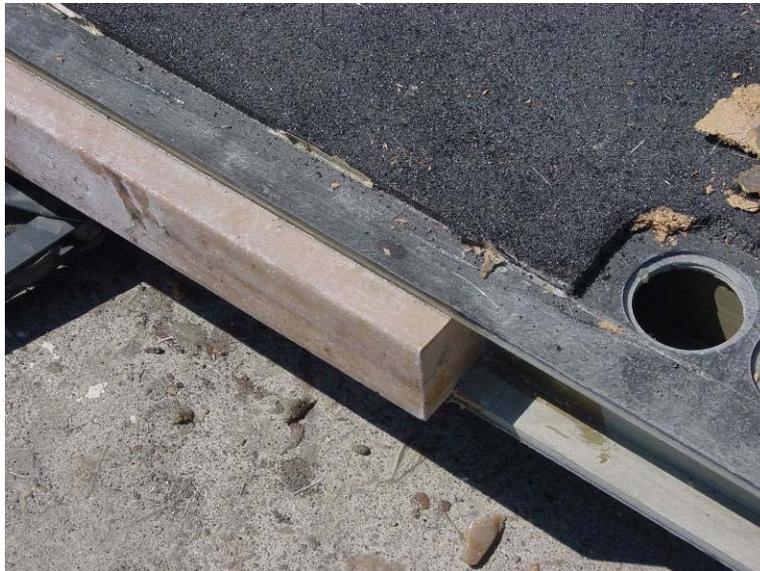
**Figure 2.2.1-2 Shear Key on Schuyler Heim Decks (MMC).**

Another example is the shear key connection used on the Schuyler Heim deck also produced by MMC, shown in Figure 2.2.1-2. This is a secondary bonded shear key made with FRP-wrapped wood core and bonded to the C section of the adjacent deck edge. The exposed faces are slathered with epoxy adhesive and bonded into place during installation.

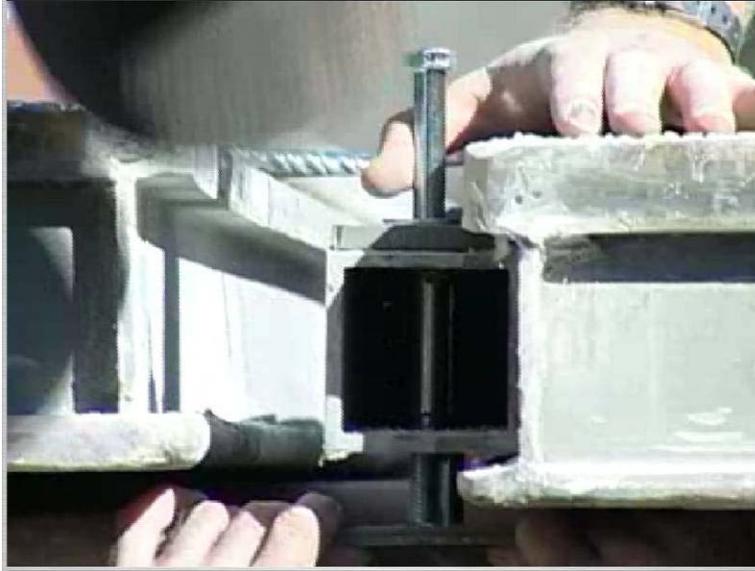
**Figure 2.2.1-3 Hollow Tube Shear Key on Jay Street Bridge (KSC).**

Finally, a dry-fitted shear key is used on the Jay Street Bridge and other bridges by Kansas Structural Composites (KSC) to lock the decks into place (Figure 2.2.1-3). For the KSI deck, the shear keys are bolted to the support girder at the crossover of the flanges, serving dual purposes.

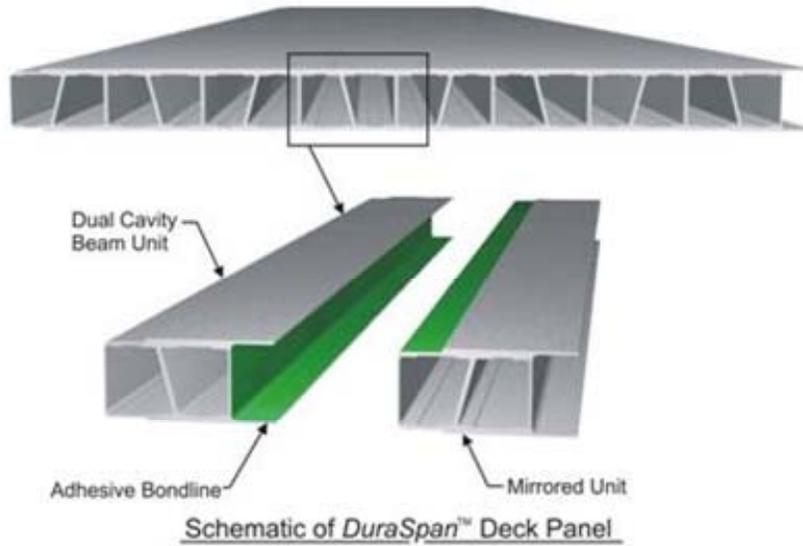
**Figure 2.3.1-1 Tongue and groove deck connection (MMC).**

This method uses a matched pair of edges similar to the set shown in Figures 2.3.1-1 and 2.3.1-2. The connection is an integral part of the deck units, so there is no separate shear key. Forces are transmitted between decks by direct contact. All the decks that have incorporated this field joining feature use adhesives to seal the connection. In the pultruded decks manufactured by Martin Marietta Composites (MMC) and Creative Pultrusions, Inc. (CPI), urethane adhesive is used to bond the pultruded units to form a deck. However, for field bonding MMC uses an epoxy where CPI uses a urethane adhesive at the connections.

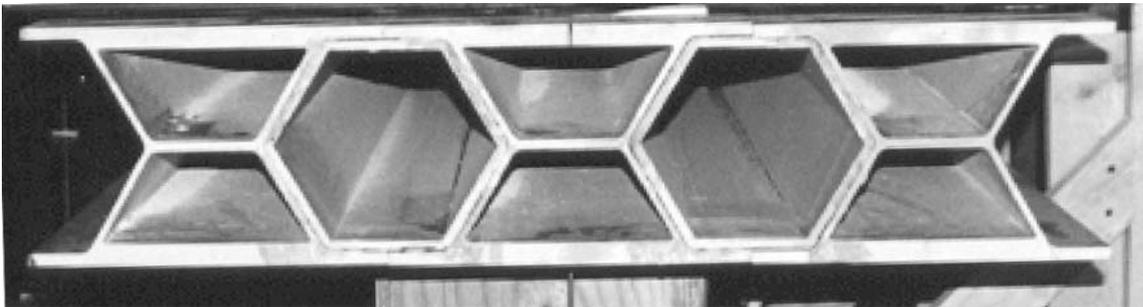
**Figure 2.3.1-2 Creative Pultrusion Deck.**

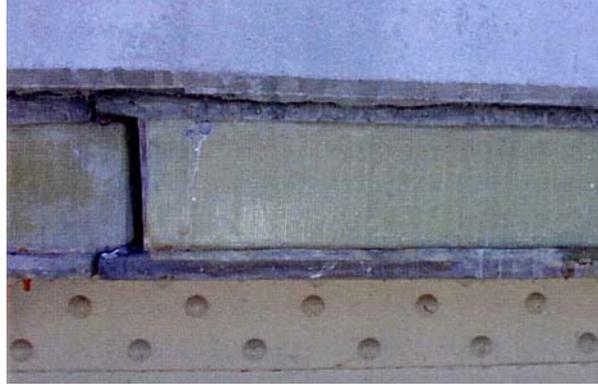
**Figure 2.3.1-3 Deck Connection on ICI Deck (Salem Avenue Project).**

Infrastructure Composites, Inc. (ICI), also used a tongue and groove connection on their decks for the Salem Avenue Project in Dayton, OH (see Figure 2.3.1-3). It is assumed this would be typical for other projects as well.

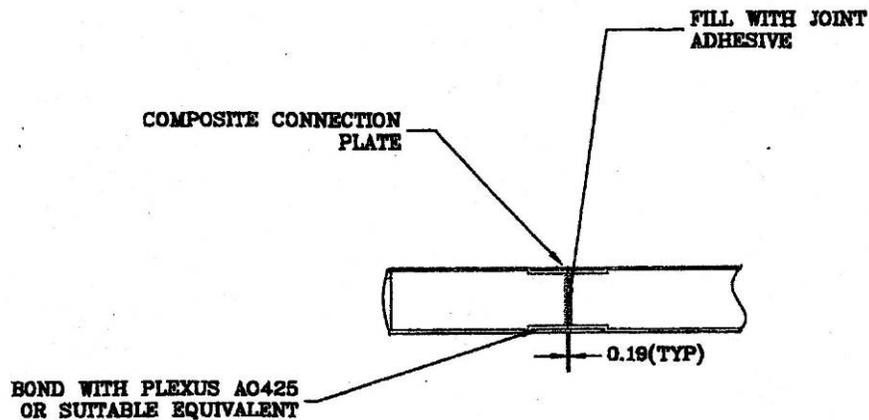
Figure 2.4.1-1 Detail of HCI Deck to Deck Joint (Salem Avenue Bridge).

This method uses a butt joint between adjacent decks with splice plates field bonded to the top and bottom of the decks to transfer load as shown in Figure 2.4.1-1. This technique was used primarily by Hardcore Composites, Inc. (HCI), on the Salem Avenue Bridge Project. The installation involved the application of adhesive to the edge of the decks to be connected (see Figure 2.4.1-2) followed by the bonding of splice plate strips on the top and bottom of the decks (see Figure 2.4.1-3). To keep the splice strips in place while the adhesive cures, self-tapping screws were used. As far as this team is aware, HCI is the only manufacturer who has used this type of deck-to-deck connection versus some form of embedded captive feature as described in the previous two connection methods.

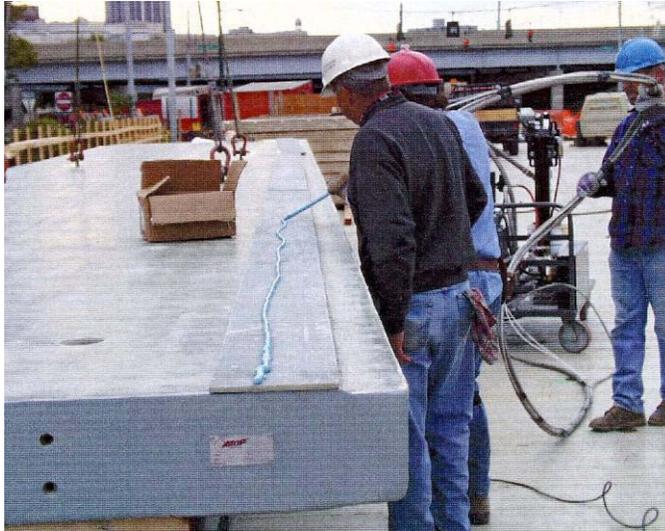
**Figure 2.4.1-2 Application of Adhesive on Splice Plates (Salem Avenue Project).**

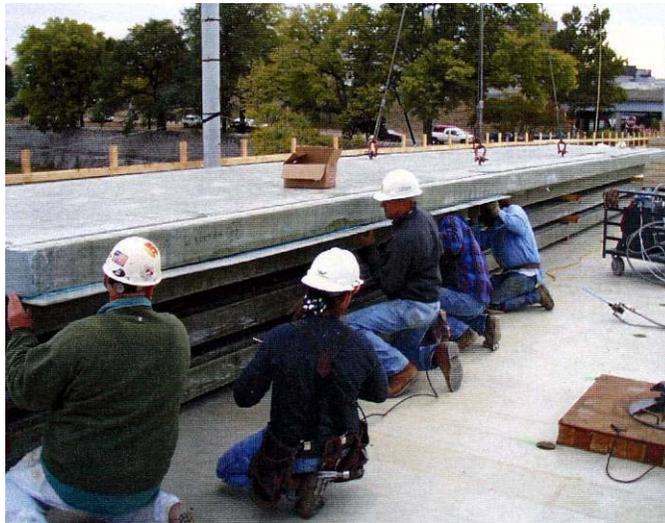
**Figure 2.4.1-3 Mounting Splice Plates onto HCI Deck (Salem Avenue Project).**

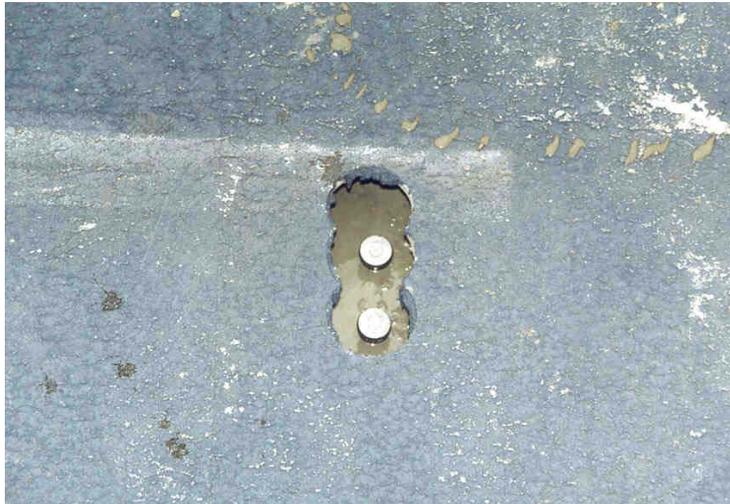
**Figure 3.2.1-1 Typical Shear Connection on MMC Deck.**

This connection is adopted from the method used to anchor precast concrete slabs onto steel girders using Nelson shear studs welded onto the top of the steel girders through holes bored into the top and bottom facesheets of the composite deck as shown in Figure 3.2.1-1. In the hollow-celled core of MMC's pultruded deck for instance, the open center lends itself to placing foam dams on the sides of the connection ports. One or more studs are used as required per connection pocket.

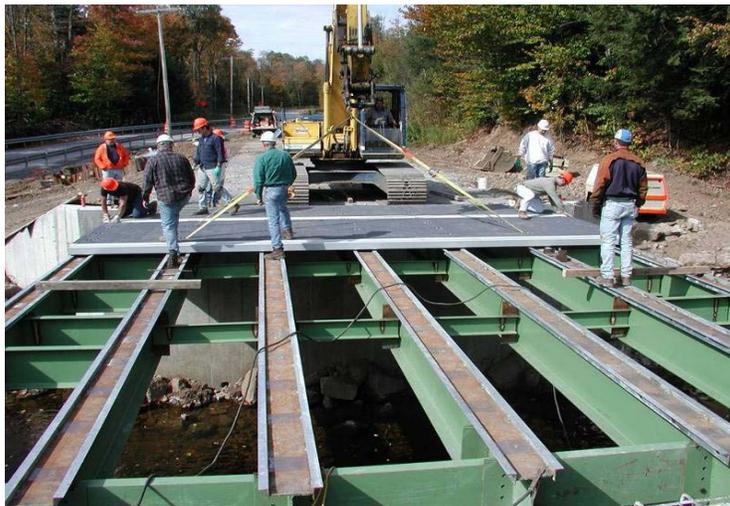
**Figure 3.2.1-2 Deck Being Laid Down on Steel Girders (MMC)**

To take up the irregularities between the girders and deck work, a haunch is typically built-up by flowing grout beneath the decks, into the cavity between the top of the girder and bottom of the deck as the preparation shows in Figure 3.2.1-2.

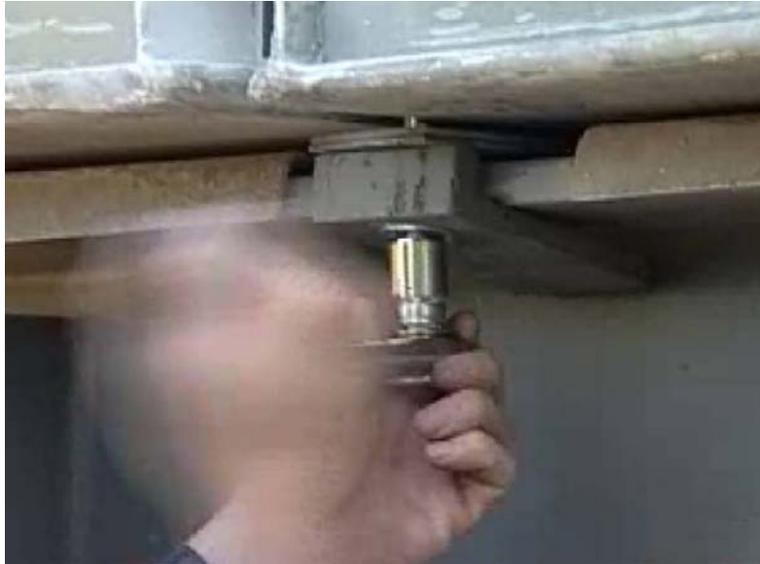
**Figure 3.3.1-1 Anchor Clips Used on Jane Street Bridge (KSC).**

This type of connection has been used by Kansas Structural Composites (KSC) and Hardcore to anchor their decks in some installations. This connection basically anchors the deck to the girders by vertically clamping it to the girder flange with side clips. Examples of these types of connections are shown in Figures 3.3.1-1 and 3.3.1-2 for KSC's Jane Street Bridge, MO. HCI has used similarly functioning clips in several deck installations, but the team was not able to discern which projects.

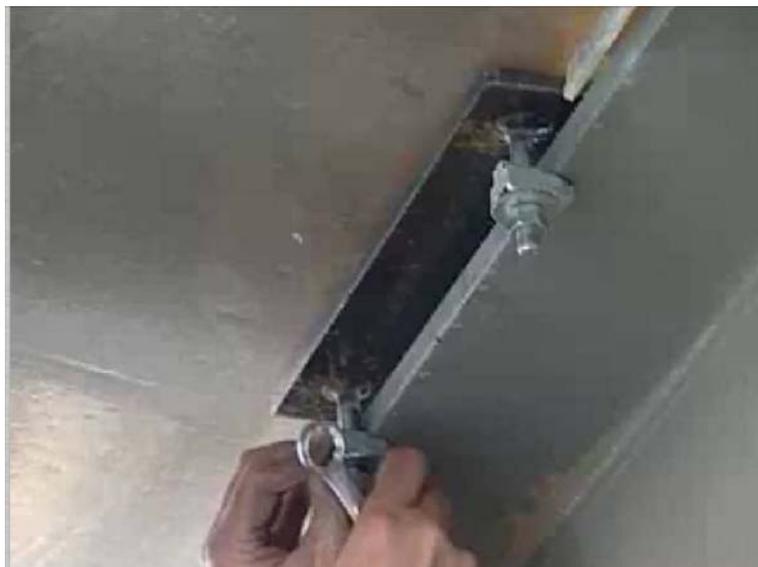
**Figure 3.3.1-2 Girder Clips for Jane Street Bridge (KSC).**

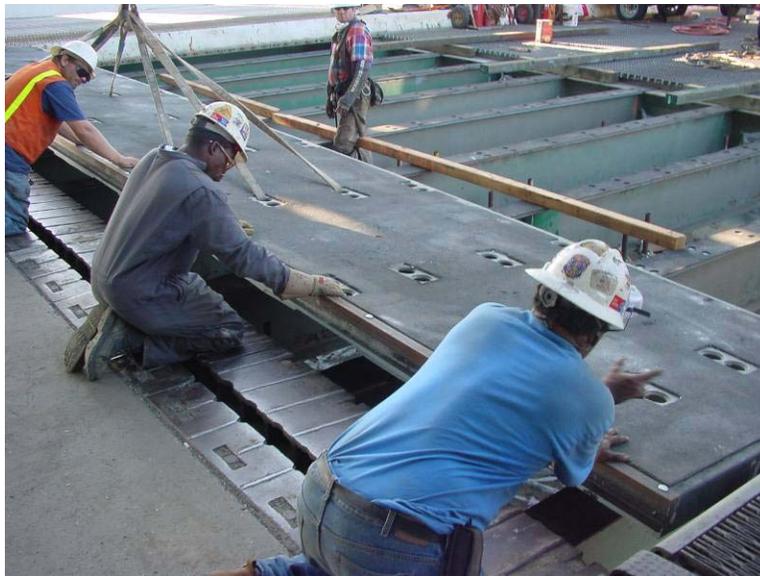
**Figure 3.4.1-1 Carbon/Fiberglass Deck Being Installed in the Schuyler Heim Bridge (MMC).**

This connection uses threaded Nelson studs to anchor the composite decks onto the steel girders. Like the shear stud, the threaded stud is resistance-welded to the girder through the predrilled holes in the deck, as seen in Figures 3.4.1-1 and 3.4.1-2. This was used on MMC's Schuyler Heim Lift Bridge Project, Long Beach, CA. After the stud is secured, nuts and washers are torqued onto the bolts to lock-down the deck. The nuts are secured with thread-lock, sealed, and the top facesheet holes are covered with a cap and wear surface.

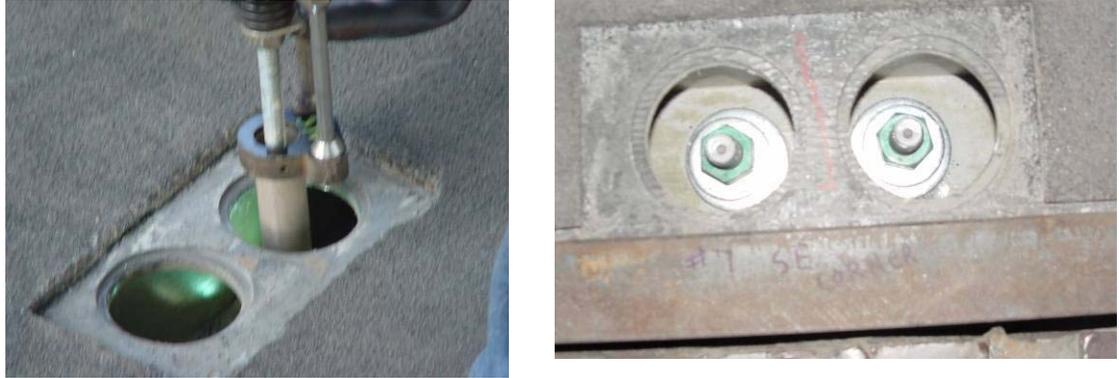
**Figure 3.4.1-2 Decks are Secured to Girders Through Bolted Connections.**
