## Use of Calcium Chloride for Soils Base Stabilization in Maryland

J. ELDRIDGE WOOD, Maryland State Roads Commission

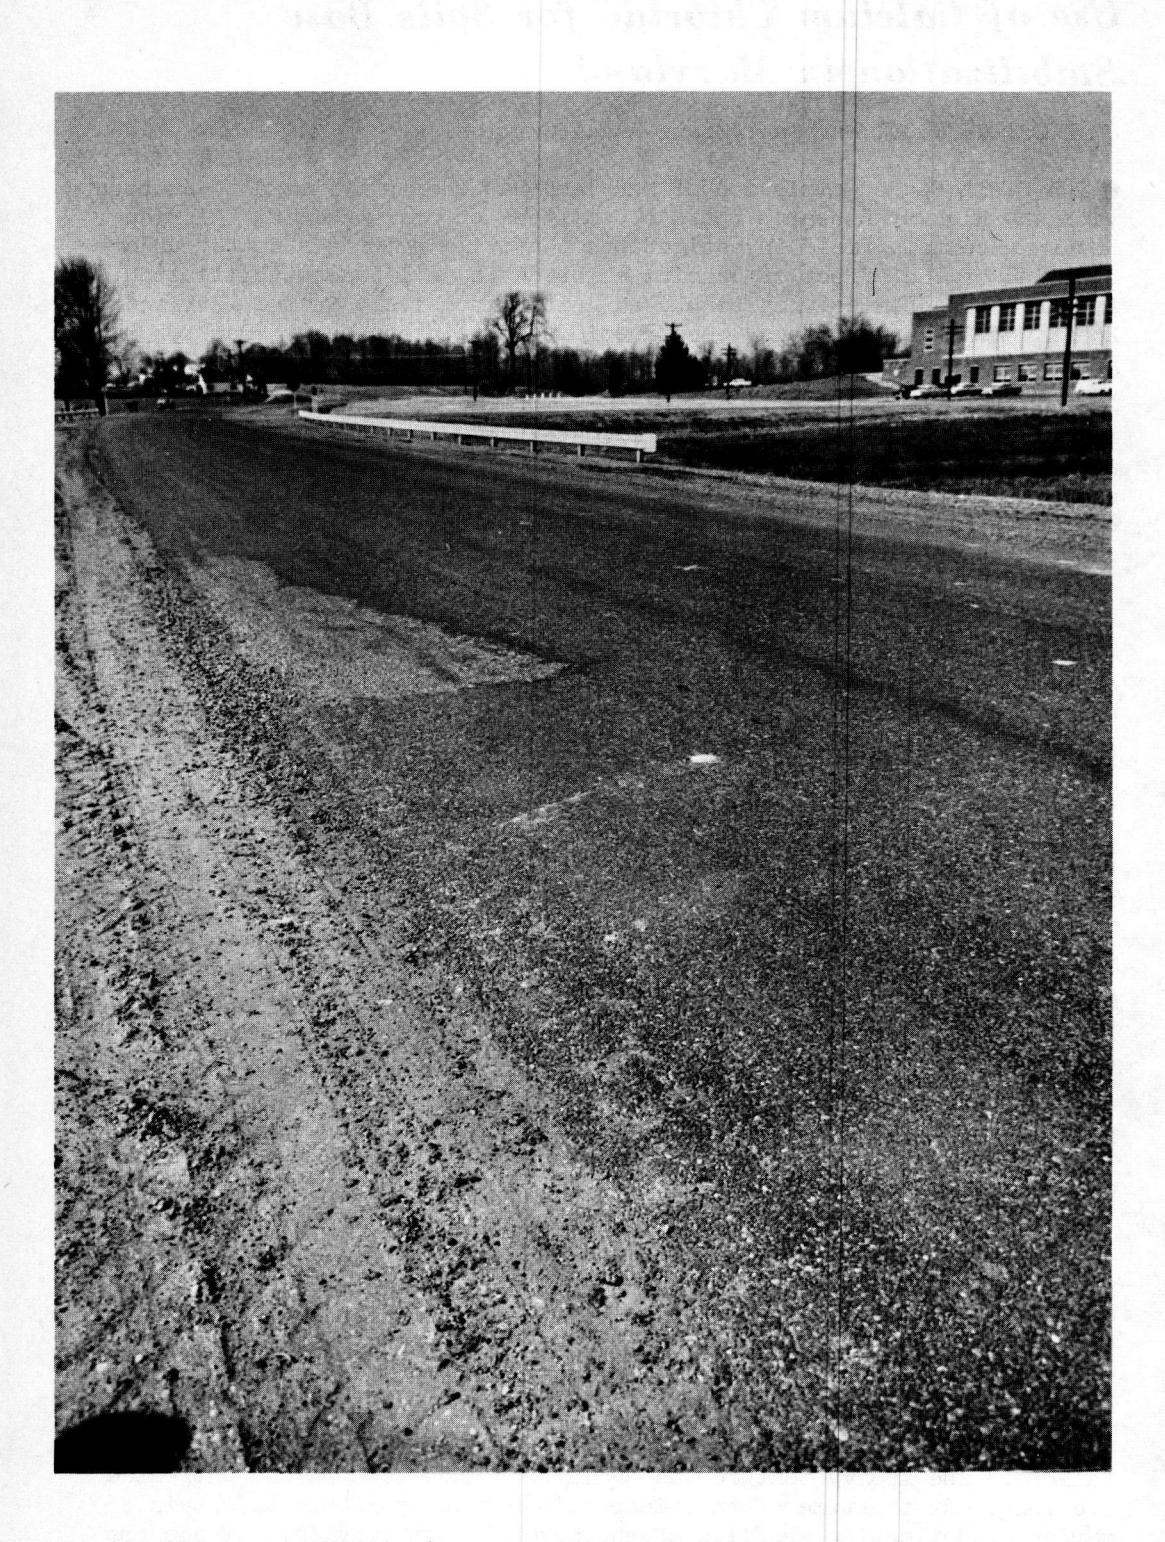
Figure 1. Route 2 test section after first spring thaw.

A visual inspection of the project in January 1958, during an early thaw following a period of cold weather, showed no signs of distress (Figs. 1, 2, 3). However, it was noted that in the untreated sections a cushion effect, or resiliency, was felt underfoot. In the latter part of February, following a similar period of cold weather, visual inspection indicated extensive damage in the form of alligator cracking in the untreated sections (Fig. 4).

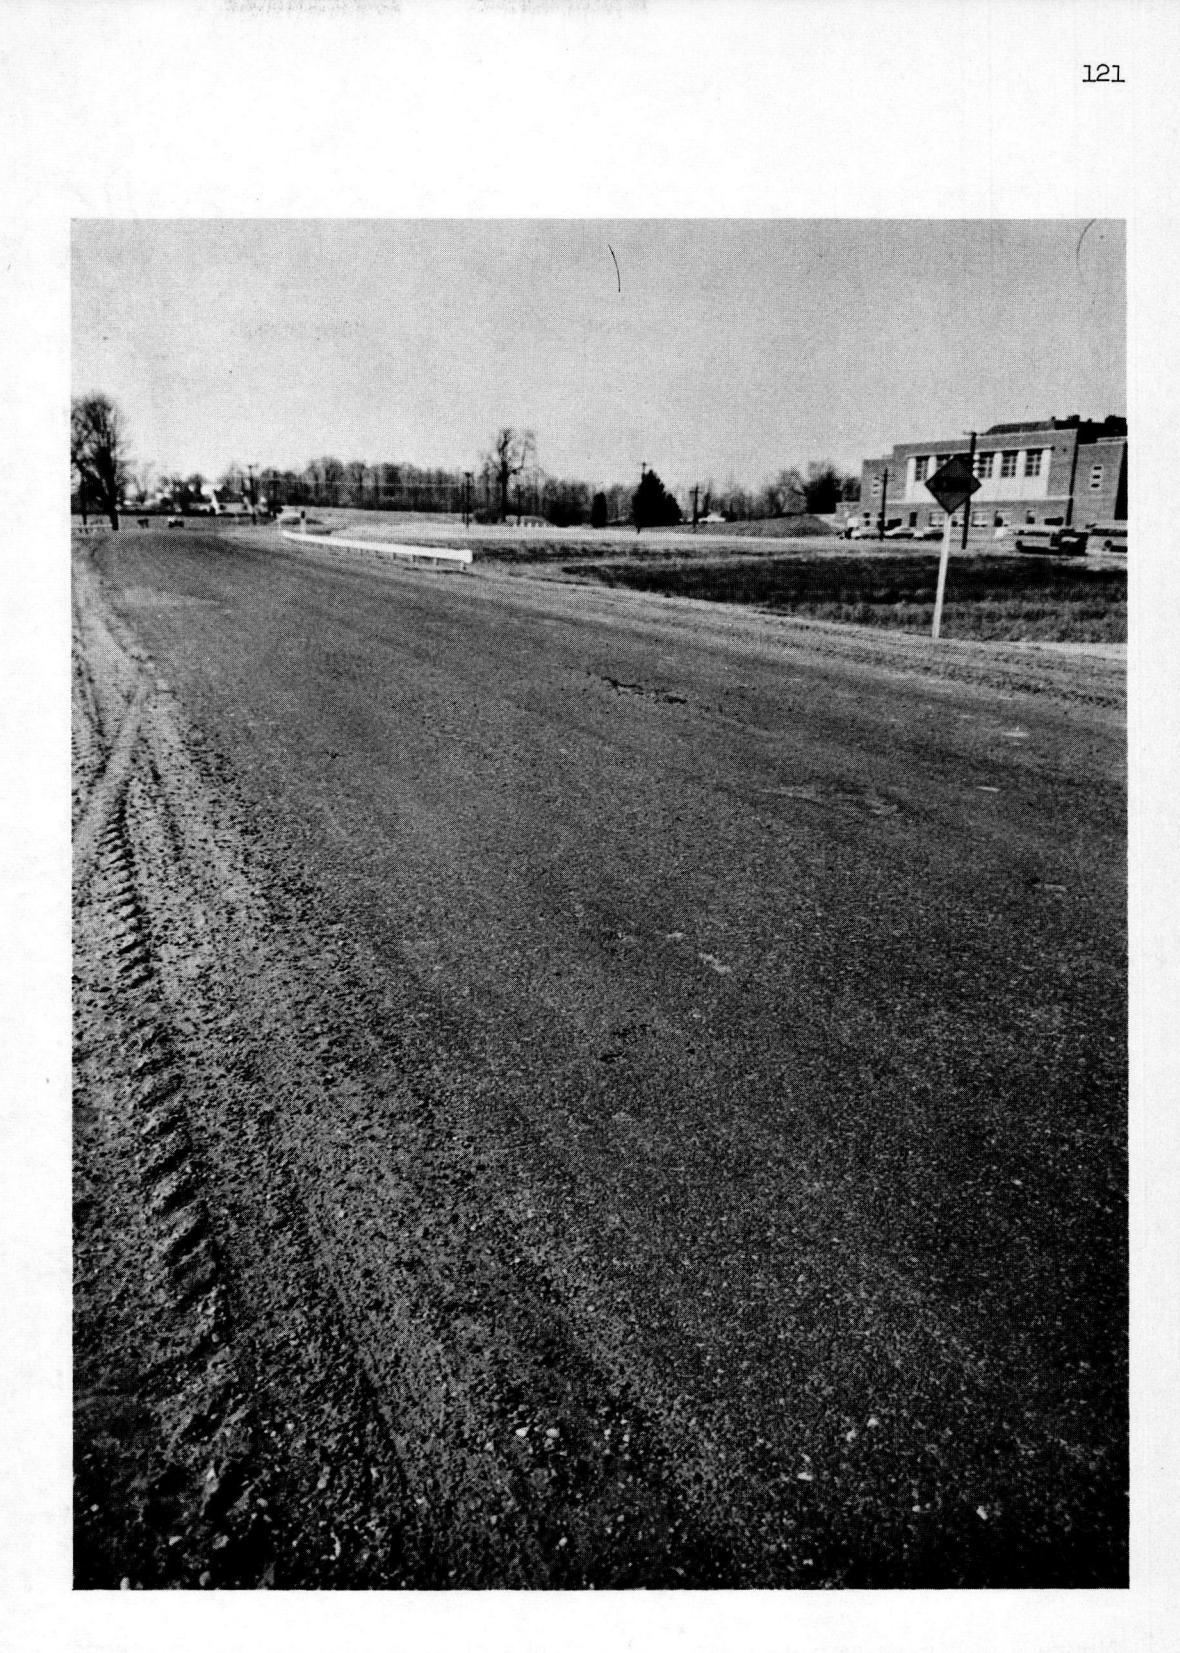
Figure 2. Limited distress area in Route 2 after first spring thaw.

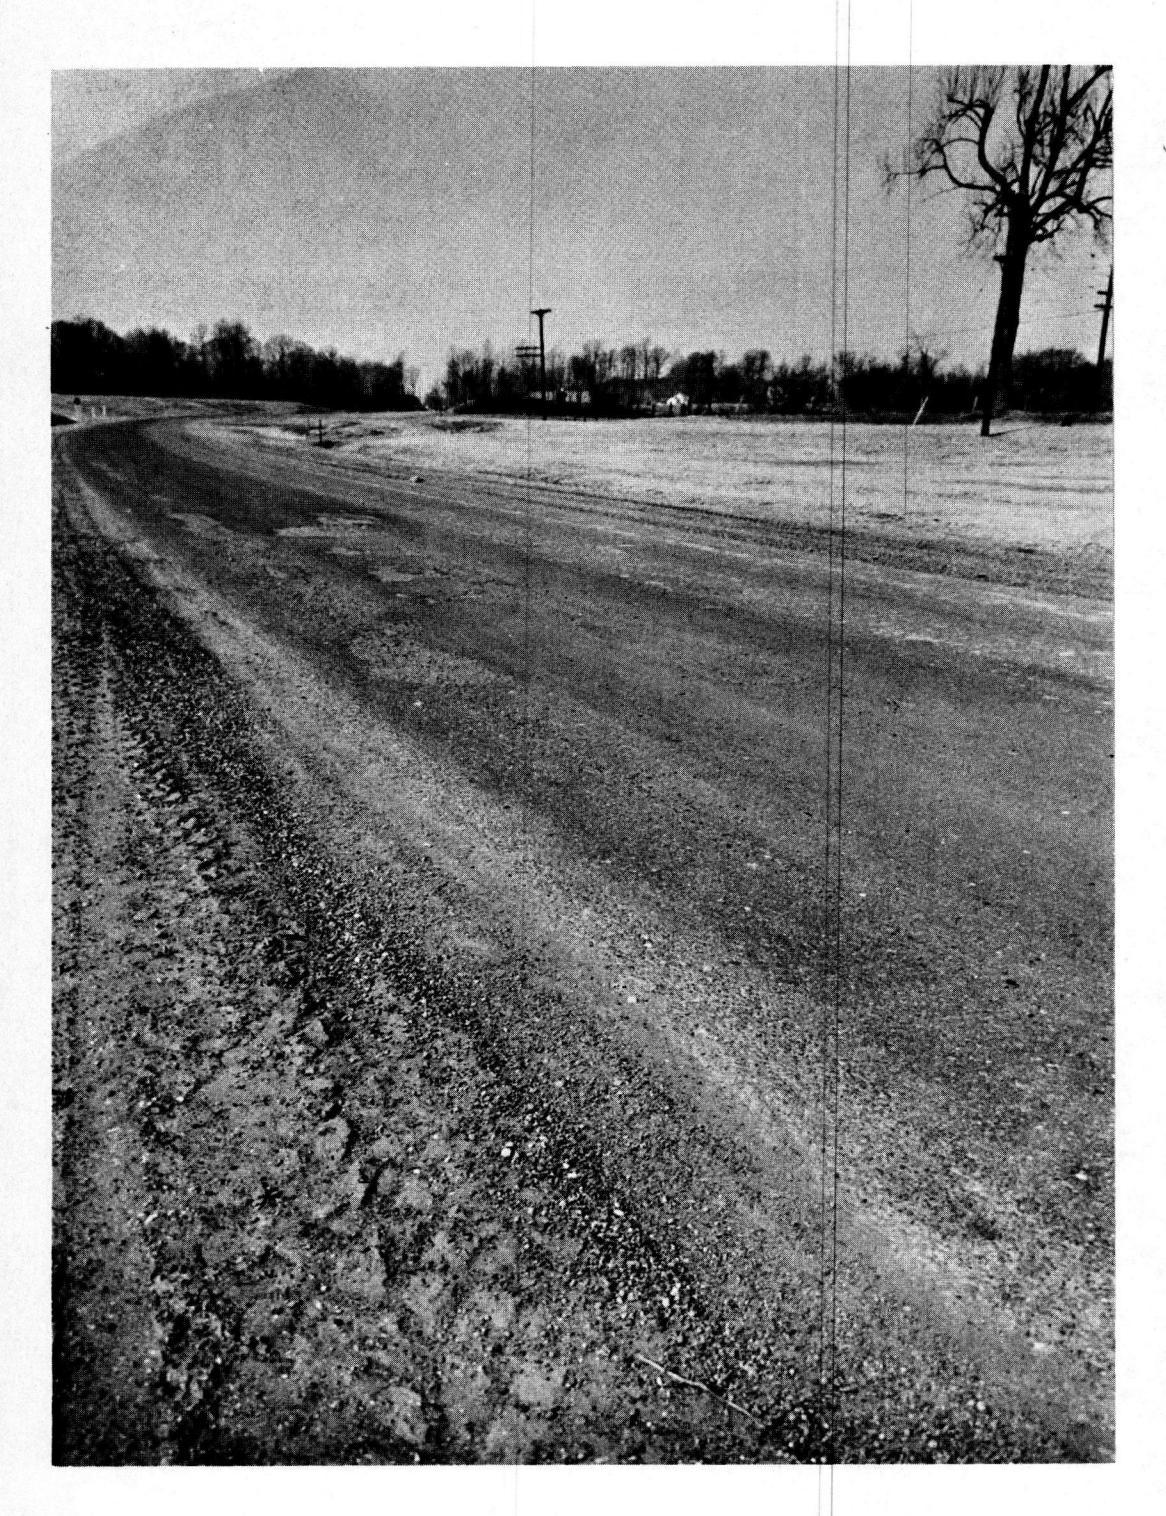
Figure 3. Distressed area in untreated section of Route 2 after second thaw period.

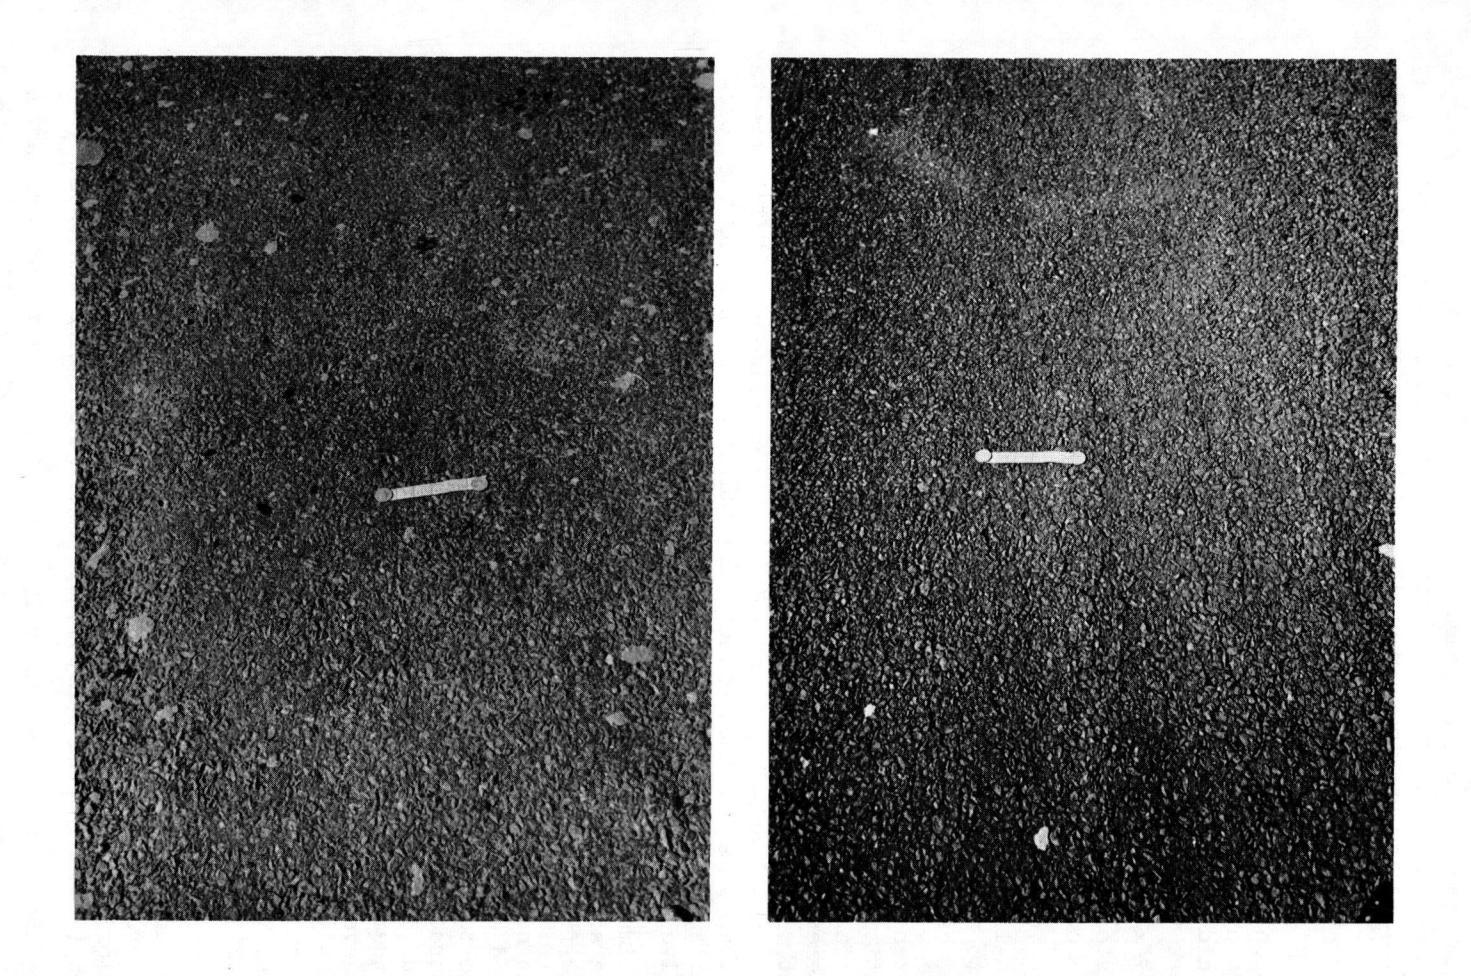
Figure 4. Comparison of calcium chloride treated section (left) and untreated section (right), showing alligator cracking in untreated section, Route 2.

The treated sections were found to be free of cracks and showed no failure. The spongy texture was again felt underfoot in the untreated sections. At the time of this inspection it was possible to obtain a series of deflection profiles of the several test sections. These pro-

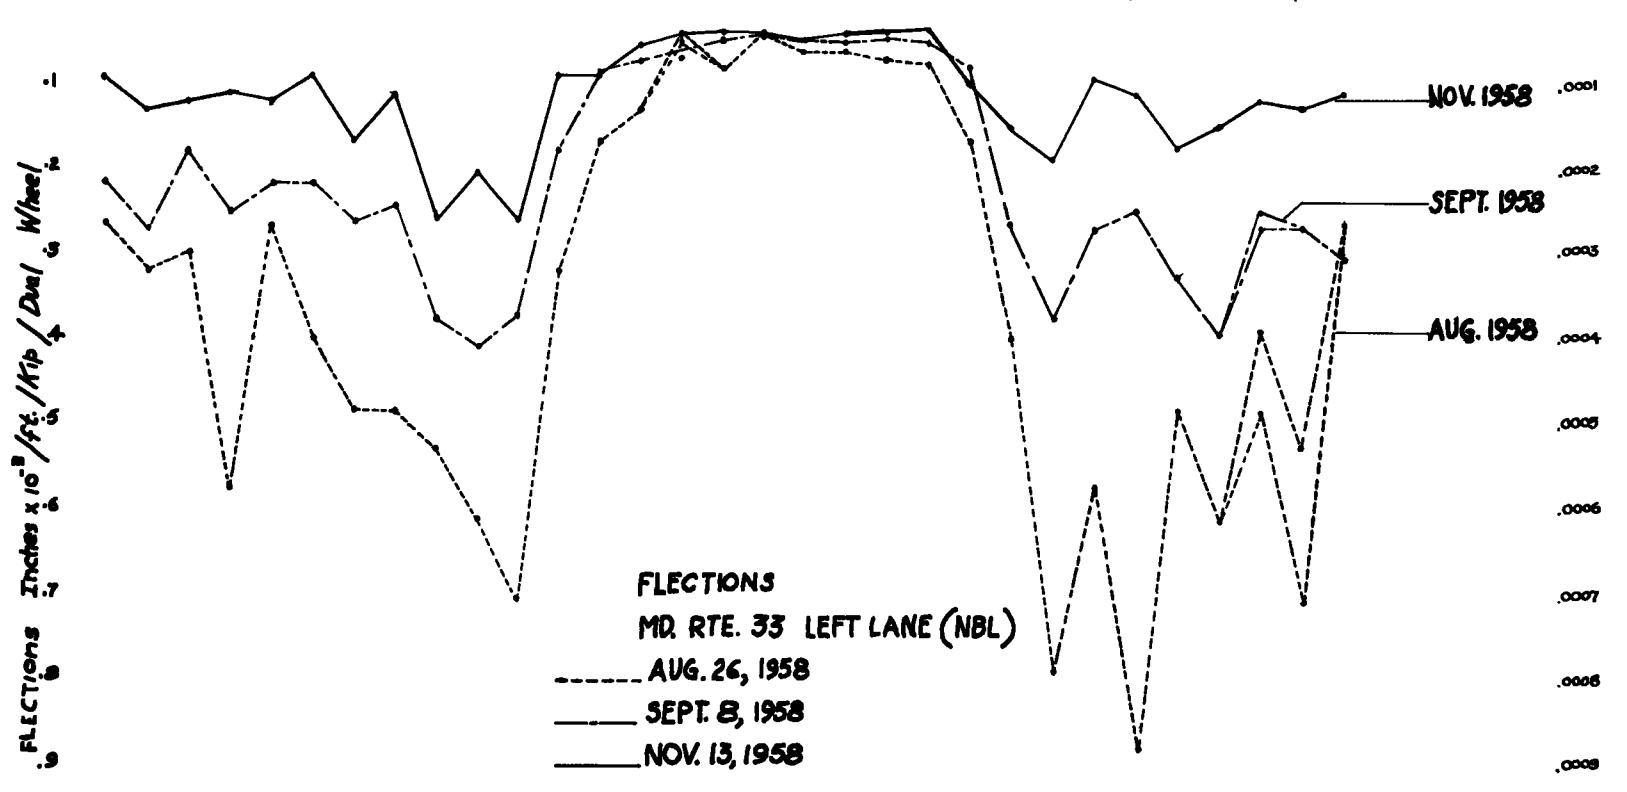
Figure 5. Graph indicating deflections on Maryland Route 33. Comparison of calcium chloride test section and untreated section.

Deflection profiles (Fig. 5) were obtained 14 days, 30 days and 90 days after placing. The deflection profiles indicated that near ultimate strengths were obtained at the 14 days or less in the test area containing calcium chloride. The profiles indicated a markedly accelerated consolidation action (probably pozzolanic) where calcium chloride was used.
