Structural Behavior of Driven Piling

DONALD L. YORK, The Port of New York Authority

A review of the structural behavior of driven piles is made, and it is shown that, except for piles that fail because of improper construction or piles that deteriorate in service, there are very few reports of structural failure. The various reasons for this excellent record are examined, and the conclusion is that one of the principal reasons is the remarkable loadcarrying capacity of damaged piling. Several case histories are described involving the behavior of damaged piling under load and load tests on pile groups. The implications of these findings are discussed in relation to the allowable stresses used in practice, and a few situations are cited where it appears that the allowable loading on driven piles could be safely increased.

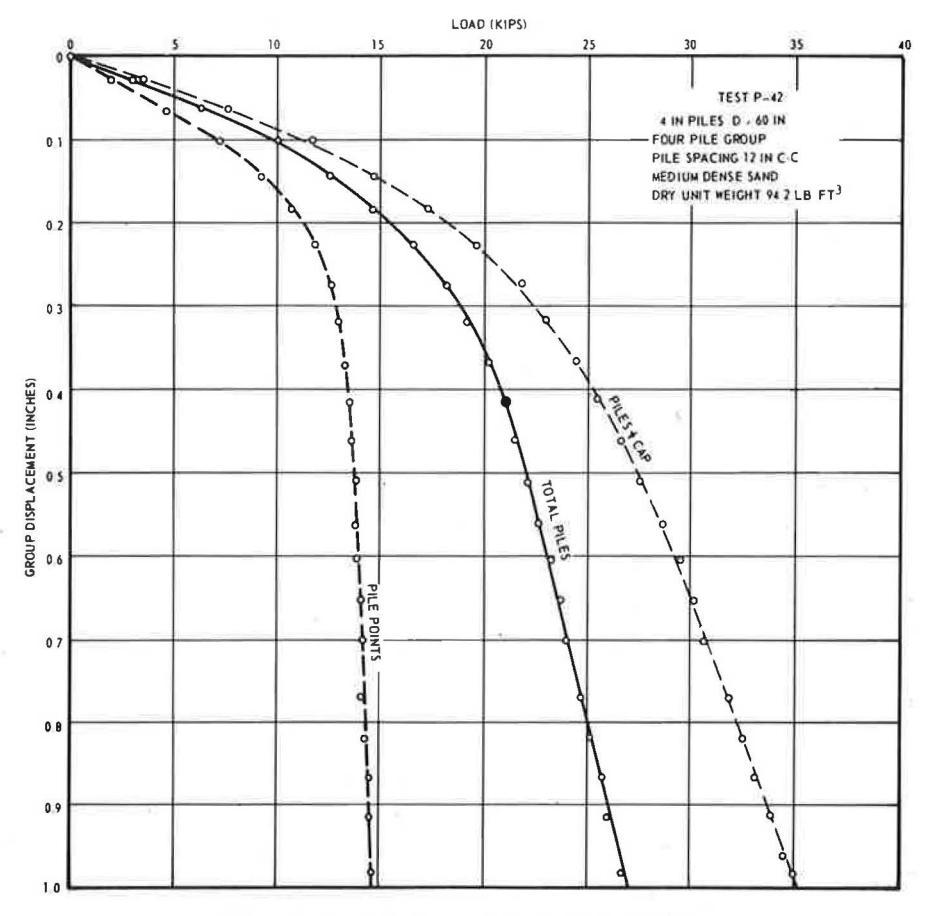
Figure 1. Load-displacement during Test p-42 (5).

ring, and the pile loads were measured with strain gages. Test results of a 4-pile group in medium-dense sand are shown in Figure 1. The proportion of the total load carried by the cap increased from about 19 percent at a displacement of 0.1 in. to about 23 percent at a displacement of 1.0 in. This test is fairly typical.

Evidence of this phenomenon is demonstrated in tests by Vesic $(\underline{5})$ on large-scale models of pile groups in sand. The model piles were 4-in. diameter aluminum tubes that were jacked into the sand to a depth of 60 in. A concrete cap was then cast directly on the sand surface. The test loads were regulated with an electronic proving

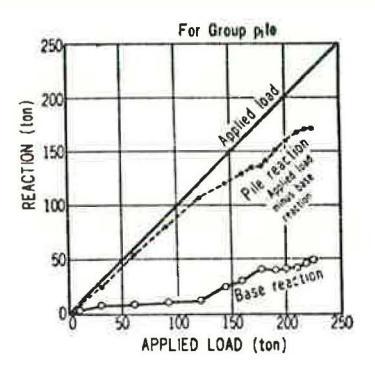
Very few field tests have been performed on pile groups. One of the few published reports ($\underline{6}$) concerns a 9-pile group of 12-in. pipe piles spaced at 3-ft centers. The piles were pushed 19 ft into a deep deposit of soft organic silt. A shallow excavation was made in order to place the cap directly on the organic silt layer. Test loads were applied with a hydraulic jack, and the soil reactions at the bottom of the pile cap were measured with 3 earth pressure cells. As shown in Figure 2, at loads less than 140 metric tons about 10 percent of the group load was carried by the base reaction on the cap. At this point the cap had settled about 0.6 in. As the load was increased further, yield occurred and the

base reaction increased rapidly. At failure, slightly more than 20 percent of the total load was carried by the bearing pressure at the base of the pile cap.

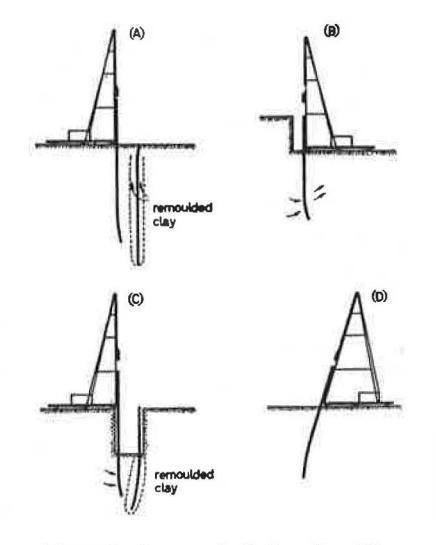
Figure 3. Causes of pile bending (9).

In trenches and shafts the displaced clay will primarily be squeezed up in the bottom of the excavation, and the piles will consequently

have a tendency of a curva-

ture against the centerline of the excavation.

Along the walls of an excavation, the displacement will take place mainly in the direction of the excavation; and the pile will tend to bend away from the wall.

Because of their weight, batter piles will tend to bend in a downward direction.

A bent pile usually results from hitting an obstruction, but it appears that bending can also be due to a variety of other causes. The driving of slender piles into soft soils has been studied at the Norwegian Geotechnic Institute (9), and some of the factors that may contribute to pile bending are shown in Figure 3. Bending will obviously increase the danger of buckling, and this can be a serious problem in soft clays because of the limited ability of the soil to provide lateral support.

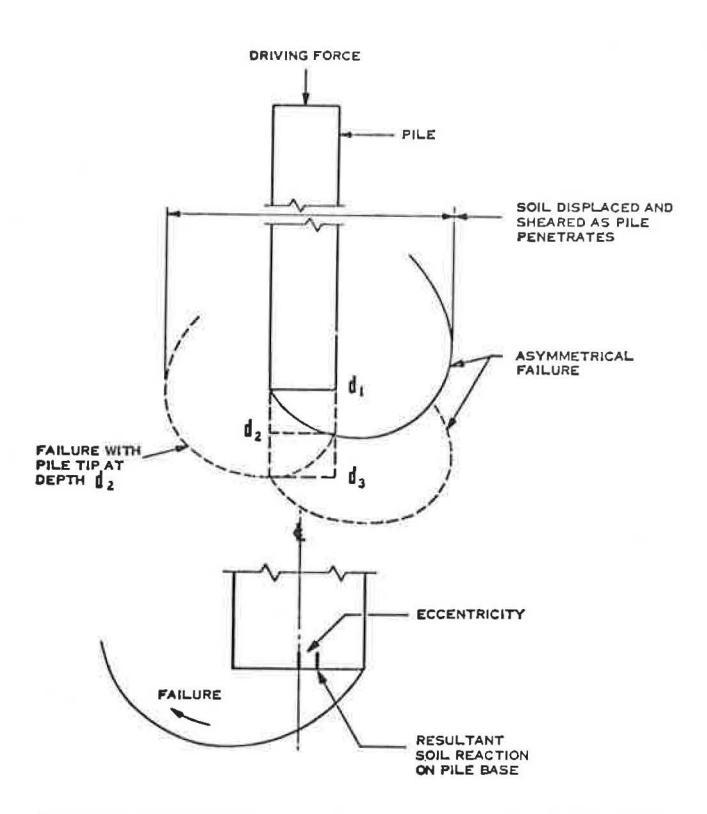
Figure 4. Idealized mode of soil displacement during driving (10).

Hanna $(\underline{10})$, based on a study of bending of long steel H-piles, suggests that bending results from a mechanism that is inherent in all pile-driving work (Fig. 4). As a pile punches through the overburden, an asymmetric failure pattern develops at the pile tip, and this results in an eccentric tip reaction. This causes a bending moment at the pile tip that may be sufficient to initiate bending even under light driving conditions in uniform soils. The pile will have a tendency to bend in the direction of newly driven neighboring piles around which the shear strength of the clay is previously reduced.

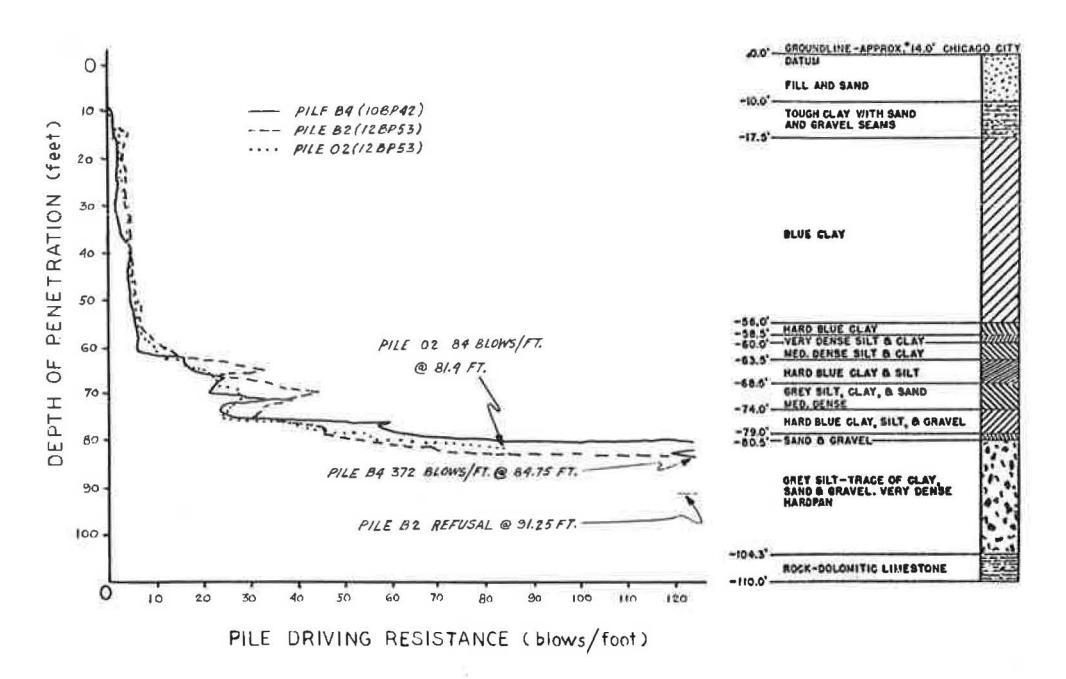
Figure 5. Pile driving records and typical soil profile for Piles B4, B2, and 02 (11).

Several steel H-piles, including one pile instrumented with strain gages, were driven through the Chicago blue clays and into a very dense hardpan (<u>11</u>). The driving records for 3 piles are shown in Figure 5 together with a typical soil profile. The piles drove easily to a depth of 60 ft, where the driving resistance began to increase steadily as the piles penetrated into the firmer clays. The hardpan occurs at a depth of 80 ft, and very hard driving was required to penetrate into this stratum. Pile 02 was driven to a resistance of 125 tons by the Engineering-News formula and penetrated less than 2 ft into the hardpan. The other 2 piles were purposely overdriven and penetrated deeper into the hardpan. A maximum driving stress of 17,000 psi is reported for the instrumented pile (Pile B4). The piles were driven with a single-acting hammer with a rated energy of 30,225 ft-lb and equipped with a helmet and hardwood block cushion.

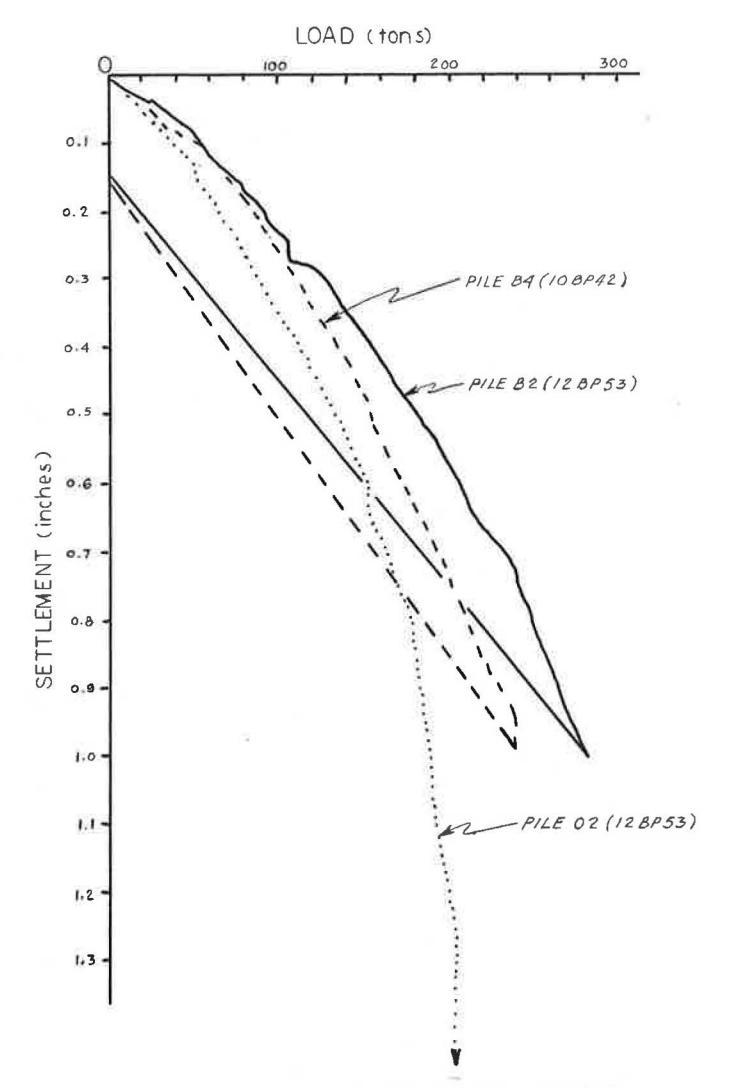
Figure 6. Load-settlement for Piles B4, B2, and 02 (11).

The load test results are shown in Figures 6 and 7. There are 2 significant points. The first is that the piles that were overdriven experienced less settlement and had greater load-carrying capacity than did Pile 02. The second is that the strain-gage measurements show a high rate of load transfer in the hardpan stratum.

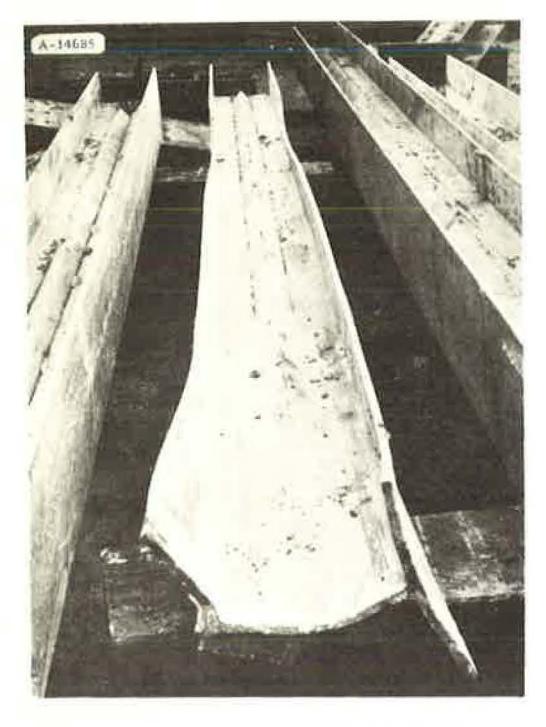
Figure 8. Lower end of Pile B4 after extraction (11).

At the conclusion of the load tests, the 2 piles that had been overdriven were extracted. The condition of the instrumented pile is shown in Figure 8. The manner in which the flange was folded at the pile tip would indicate that the pile hit a boulder, although no boulders were encountered in either of the 2 borings at the site. There is also a bend in the flanges about 10 ft from the pile tip. As shown in Figure 9, the bottom of Pile B2 is completely mangled, and it is difficult to believe that this pile supported a 300-ton load. However, this pile was driven deeper than the other piles and, based

on the strain-gage readings on Pile B4, it is likely that substantial loading did not reach the badly damaged portion of the pile.

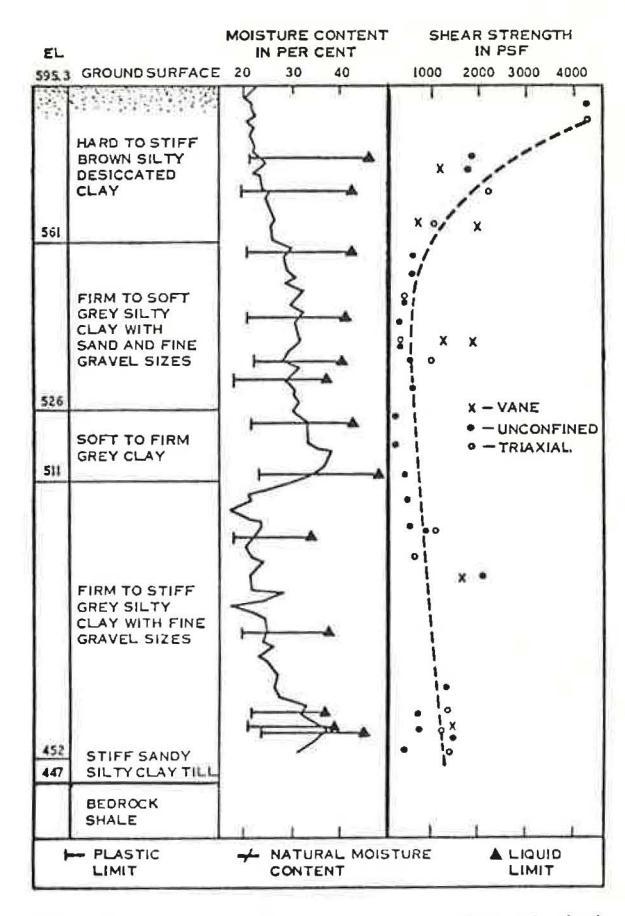
Figure 10. Geologic profile at Lambton generating station (10).

A very interesting series of load tests performed on bent steel H-piles in Ontario, Canada, is reported by Hanna (10). Three H-piles were driven through a 140-ft deposit of glacial-lake clays. Except for the upper 35 ft, which were desiccated, the soils appear to be normally consolidated. As shown in Figure 10, the soils just below the desiccated layer are quite soft, with shear strengths on the order of 500 psf. Bedrock, a shale, occurs at a depth of 150 feet. Overlying the bedrock is a thin layer of dense sandy till.

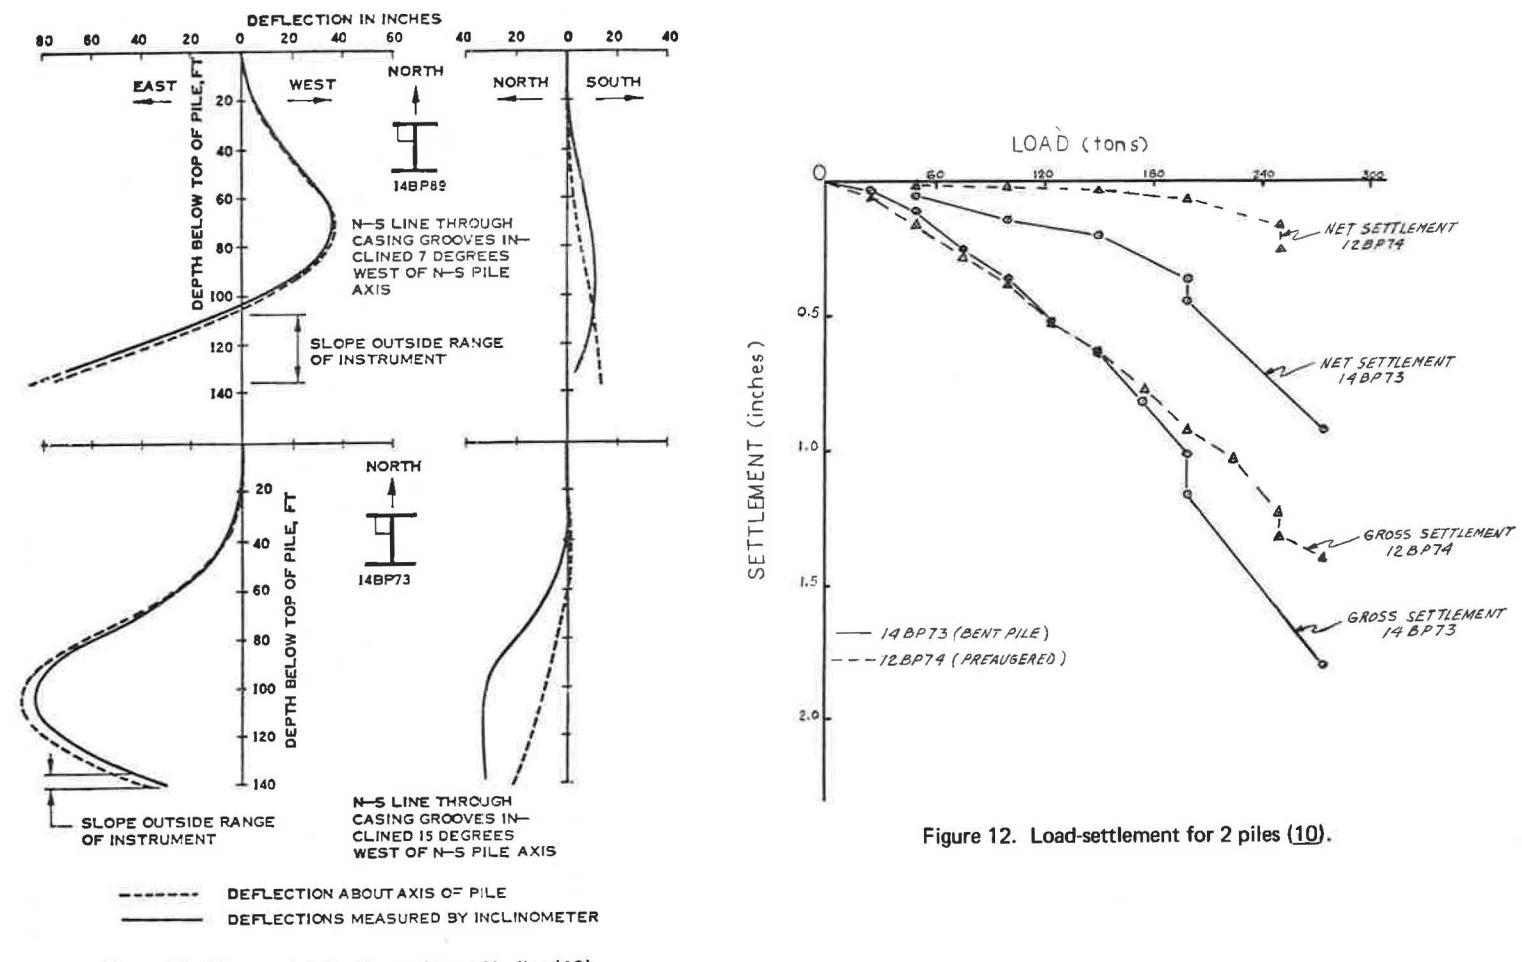
Figure 11. Measured deflections of bent H-piles (10).

Deflections were measured in 2 piles with an inclinometer. One leg of a 5-in. angle was tack-welded to the pile web and the other to the inside surface of the flange to provide a duct for the inclinometer casing. The duct extended to within 10 ft of the pile tip. The inclinometer readings (Fig. 11) show both piles to be severely bent around the weak axis, with each pile having a minimum radius of curvature of less than 200 ft. This places the stresses in the flange area well above the yield point.

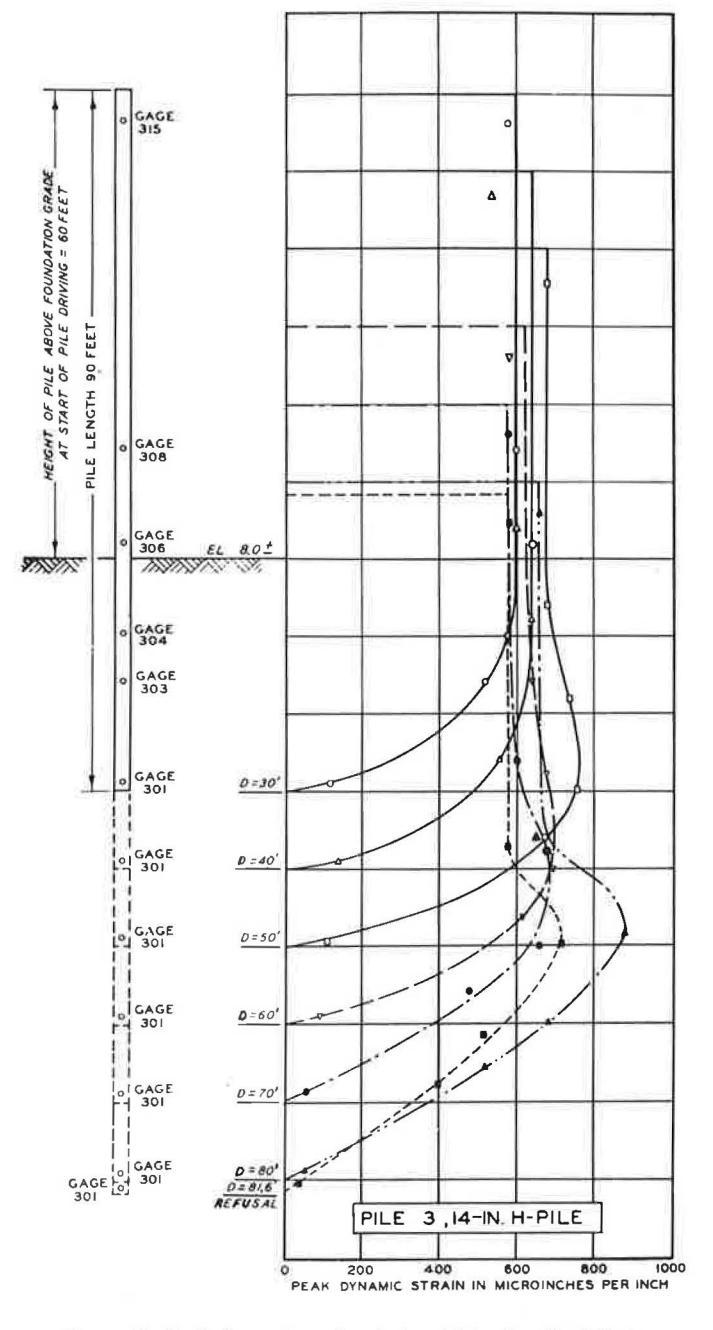
Figure 13. Peak dynamic strains during driving for Pile 3 (15).

The strain gages were read during driving and at the completion of the driving. A record was thus attained of both the peak dynamic strains during driving and the residual strains after driving. For Pile 3, the measured peak dynamic strains during driving are shown in Figure 13. The corresponding peak dynamic stresses were 26,100 psi for Pile 3 and 21,500 psi for Pile 2. For Pile 2 the measured residual strains were small. For Pile 3, however, strain gages mounted on the pile web recorded a residual strain of 3,000 microinches at a point about 25 ft above the pile tip. This is well above the yield point, and it was thought that the pile was bent.

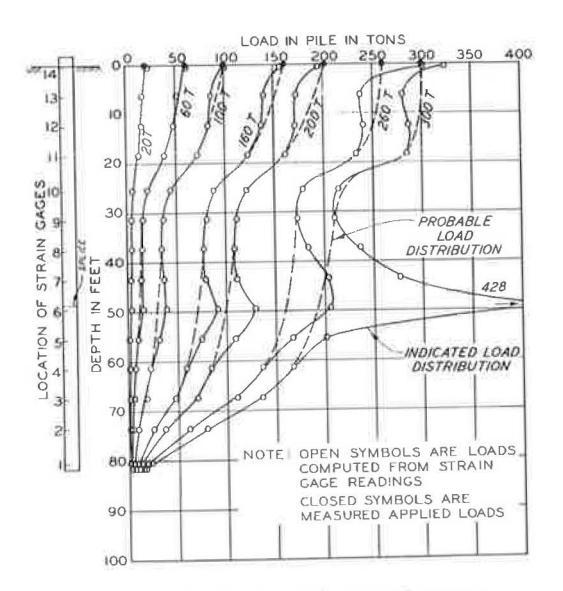
Figure 15. Distribution of load in Pile 3 (15).

obtained during the load test (Fig. 15), showed that the bent section of the pile carried a load of 200 tons.

Following the completion of the load tests the piles were pulled. The results are shown in Figure 14. Pile 2 was undamaged, but Pile 3 was badly bent, the tip being 6.1 ft from the axis of the straight portion of the pile. The strain gage measurements

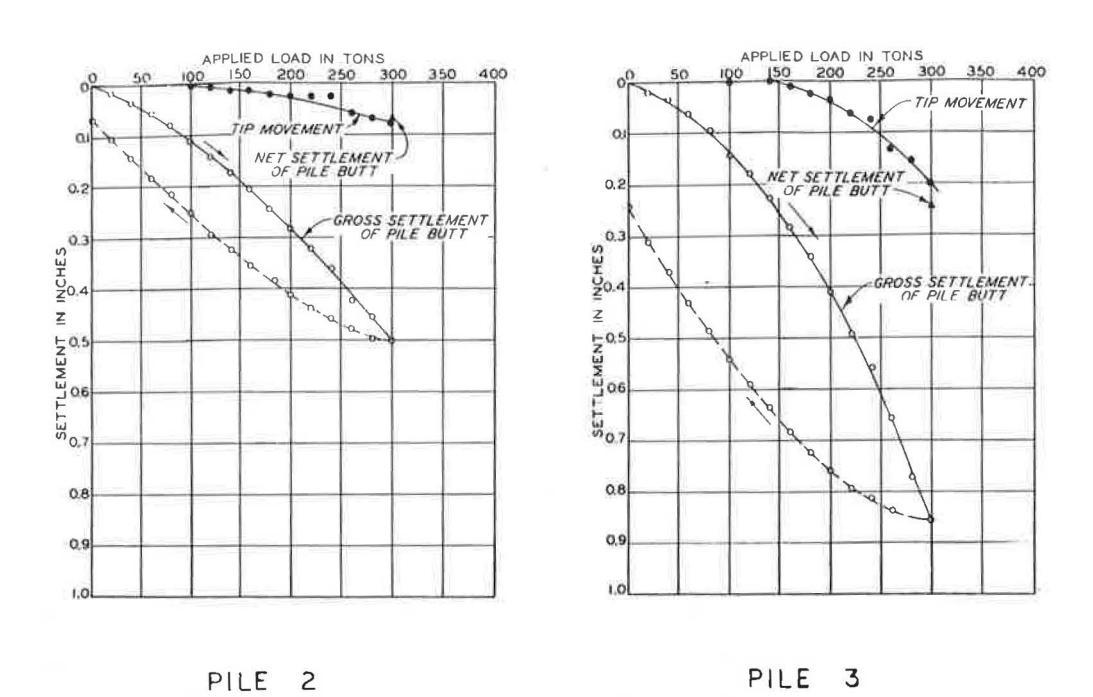
Figure 16. Load-settlement for Piles 2 and 3 (15).

The load test results are shown in Figure 16. The test results on the bent pile are quite satisfactory, but for Pile 2 the gross and tip settlements are both smaller. The load test results for the bent pile are also very similar to those for a pile that was load-tested during the construction of the lock. The construction piles were driven

to a depth of only 61 ft in an effort to avoid the severe bending that occurred with Pile 3.
