PRECAST, PRESTRESSED CONCRETE FOR BRIDGE DECKS

M. J. Gutzwiller, R. H. Lee, and C. F. Scholer, Purdue University

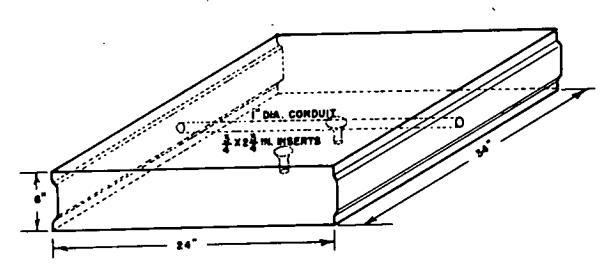
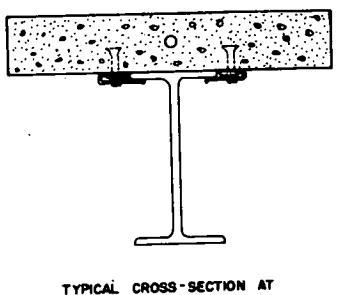
Figure 1. Concrete joint testing model.

TYPICAL TEST SECTION

TIE DOWN

The initial planning for this research project started in early 1967. The initial feasibility study soon showed that the project had promise and that a laboratory investigation of certain aspects was both warranted and technically desirable. The concept as further developed in the feasibility study is to use precast and pretensioned slabs that are placed on top of the bridge girders and then post-tensioned and tied mechanically to the underlying girders to achieve a deck of satisfactory structural characteristics. This is shown in Figure 1.

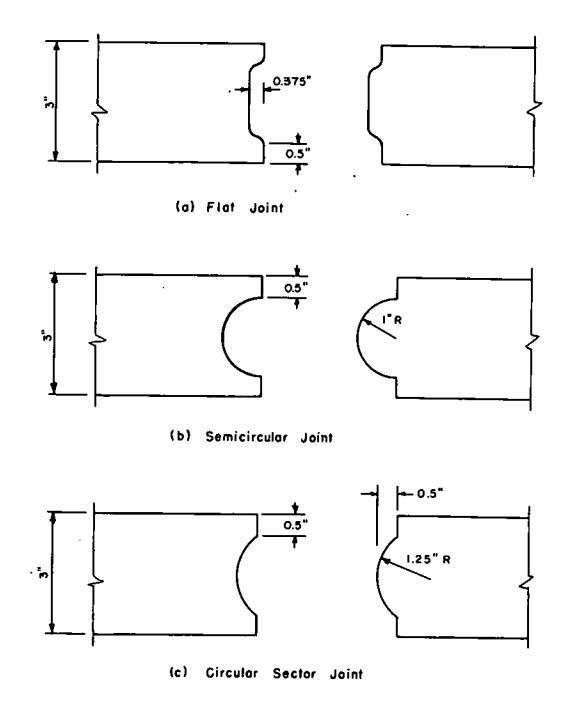
The shape of the joint was investigated by means of a photoelastic investigation that indicates that the "flat" joint shown in Figure 2a was superior to either a semicircular joint shown in Figure 2b or a circular sector joint shown in Figure 2c insofar as minimizing stress concentrations due to longitudinal loading. Laboratory tests of concrete joints were made by approximating the curvature of

a steel beam (30 WF 124) span of 50 ft. This simply supported beam was loaded with an HS 20-44 live loading, and a subsequent deflection calculation was made to develop a deflection curve. This curve was then used to develop the required deflection of the laboratory test beam. The joint test specimen was held as shown in Figure 3. The flat joint was tested under a 40-psi, post-tensioning stress with repetitive loads through $2\frac{1}{4}$ million cycles without distress.

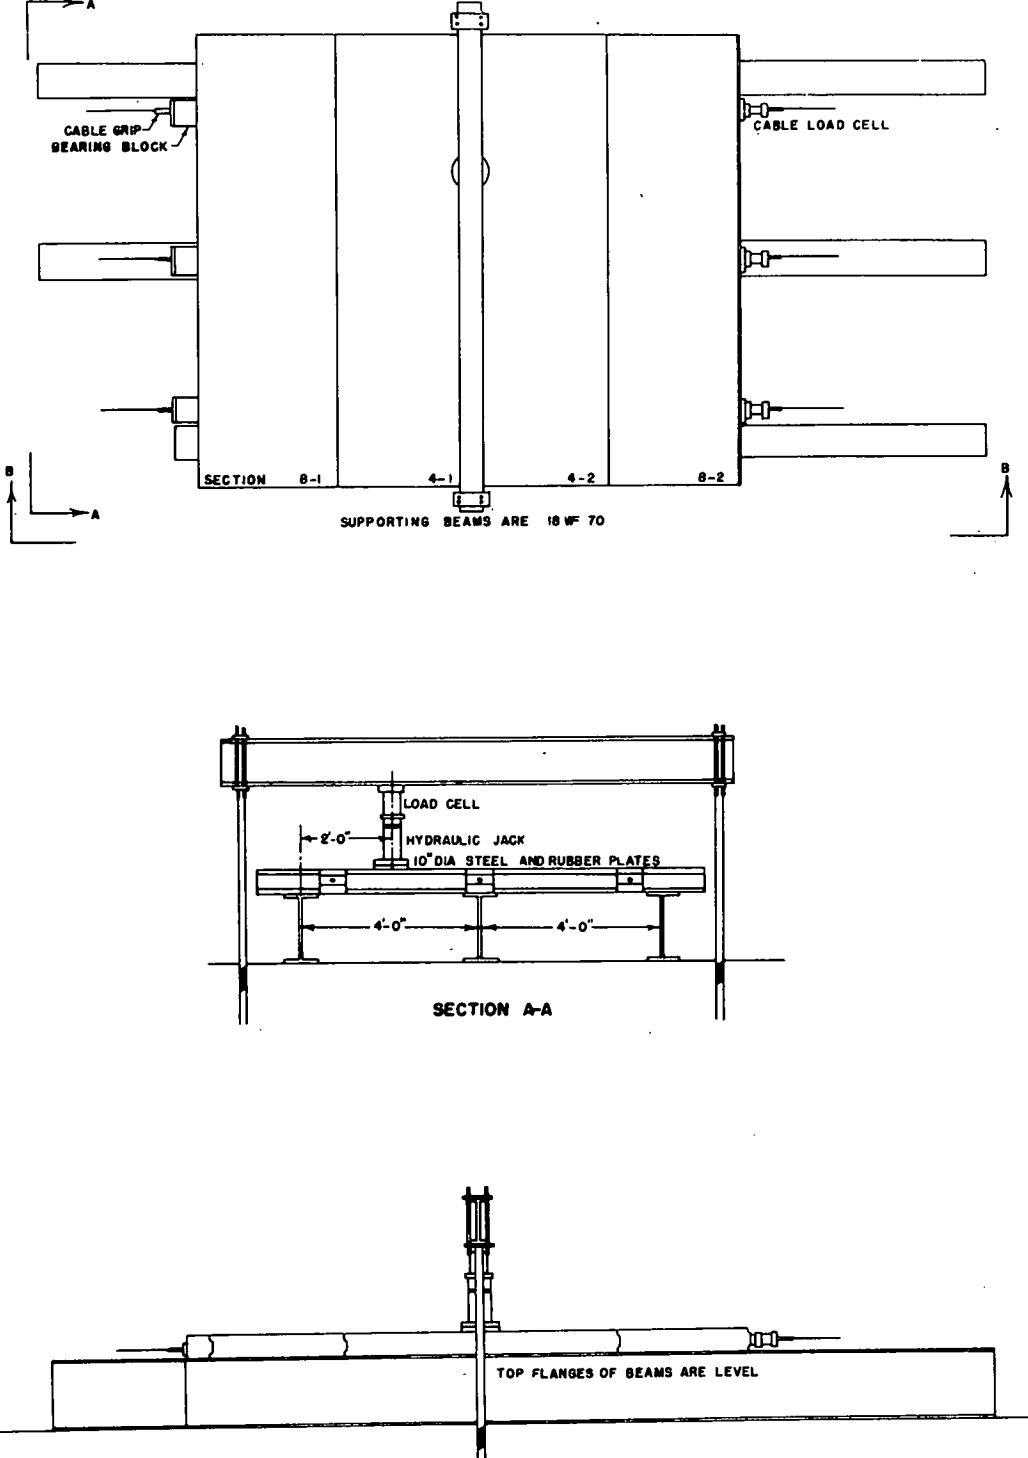
Figure 8. Static test for sections reinforced for 4-ft center-to-center beam spacing.

SECTION B-B

Figure 8 shows the loading arrangement used in the 4-ft beam spacing configuration. Vertical loads were applied directly over the joint between the center slabs, with circular steel plates and a neoprene pad providing pressure distribution. Strain gages mounted on the concrete surface at various points indicated little participation of the slab sections that were not loaded directly with the vertical load. In other word, shear transfer at unloaded joints was minimal. Continuous support was supplied for the beams, such that the deflections and strains were due to slab action alone.
