# NONMETALLIC PROTECTIVE COATINGS FOR CONCRETE REINFORCING STEEL

R. G. Pike and R. E. Hay, Federal Highway Administration; and

J. R. Clifton, H. F. Beeghly, and R. G. Mathey, National Bureau of Standards

The study reported here was conducted to determine the feasibility of using organic coatings to protect reinforcing steel embedded in concrete from corrosion accelerated by chloride ions. Coatings were evaluated on the basis of their chemical and physical durabilities, their protective qualities, their bond to steel, and the bond of the coated bars to concrete. These tests, including pullout and creep tests, indicate that 4 epoxies applied by electrostatic spray techniques are suitable for coating reinforcing steel.

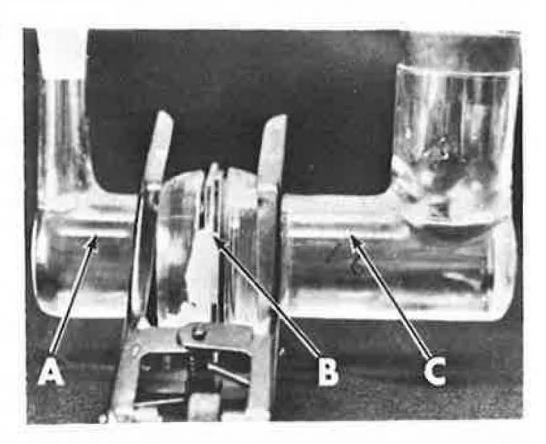
Figure 1. Permeability cell (A-compartment containing distilled water, B-epoxy film sandwiched between 2 glass plates, each having centered 1-in. diameter holes, and C-compartment containing 3M NaCl).

Cured films 3 to 7 mils (0.08 to 0.2 mm) thick were clamped in a permeability cell (Fig. 1), and the rate of passage of chloride ions was determined. This method and the results obtained have also been described in detail previously (8). All but 2 films (13 and 16) tested appeared to be sufficiently impervious to chloride penetration.

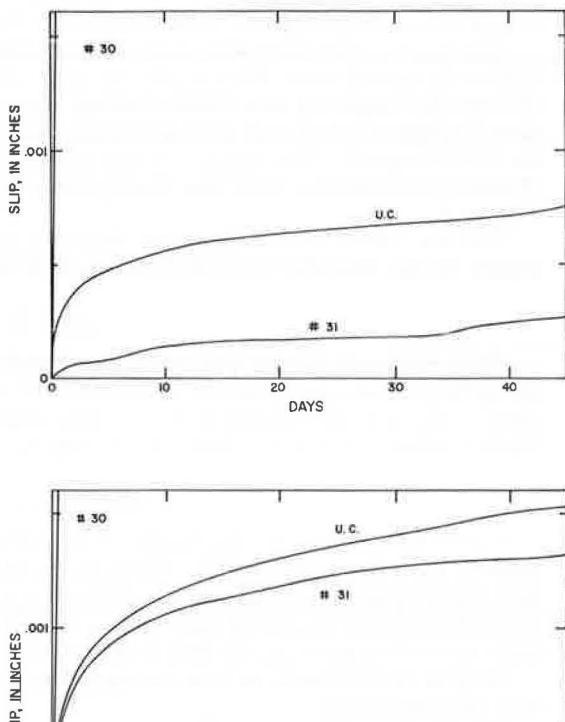
# Figure 2. Creep at free end under 30,000 lb/in.<sup>2</sup> load.

<u>Creep</u>—The creep or long-time slippage of the coated reinforcing bars in concrete under tensile stress can also be a matter for concern. Therefore, the creep of coated bars was compared with that of uncoated bars. Typical results are shown in Figures 2 and 3; bars coated with epoxy (code 31) exhibited even less creep than the uncoated bars. As might be expected, the bars heavily coated with polyvinyl chloride (code 30) show creep values several magnitudes greater than the uncoated bars. Also, coal tar epoxy had an excessive creep.

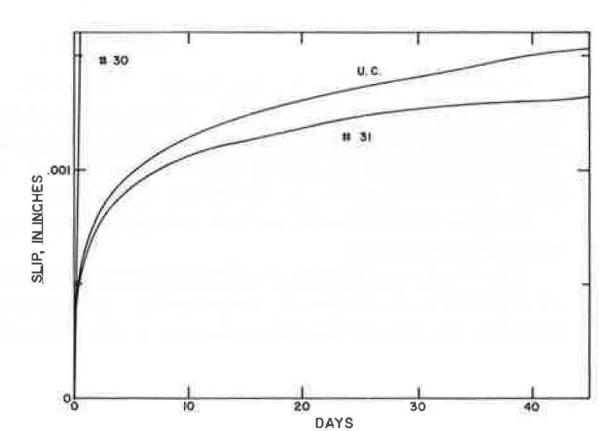
Figure 3. Creep at loaded end under 30,000 lb/in.<sup>2</sup> load.

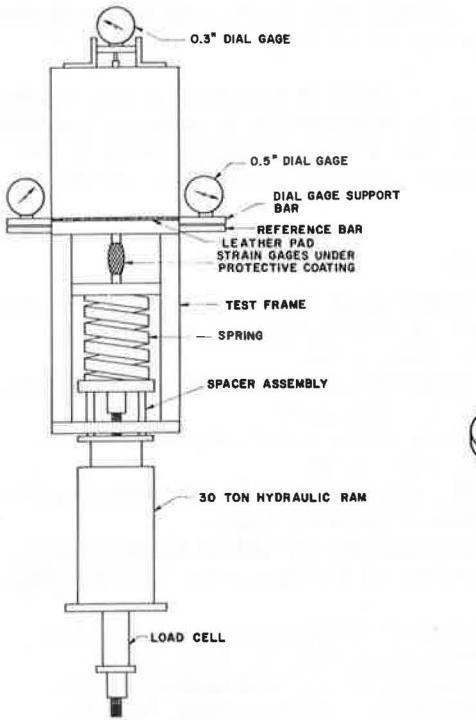
Figure 4. Assembly for measuring creep of bars in concrete.

The No. 6 reinforcing bars were embedded in the center of concrete prisms 10 by 10 by 12 in. (25.4 by 25.4 by 305 mm). These were mounted in frames as shown in Figure 4. The creep at the free end of the bar was measured by a dial gauge reading directly to 0.0001 in. (0.0025 mm) and mounted on a support attached to the top face of the concrete by bolts screwed into inserts cast in the concrete. The gauge was thus bearing on the exposed end of the reinforcing steel. At the loaded end of the specimen, 2 similar gauges were attached to a steel bar fastened to the lower face of the concrete by bolts secured to inserts cast in the concrete. These gauges bore on a steel yoke fastened to the reinforcing bar about 1 in. (25 mm) below the face of the concrete. This yoke was free to move in a recess in the base plate. The slippage (creep) of the loaded end of the reinforcing bar is then taken as the average reading of the 2 gauges.

The load on the bars was developed through large steel coil springs, also shown in Figure 4, which were first calibrated by measuring the load applied by a 60,000-lb (27,000-kg) capacity electromechanical universal testing machine versus the compressive displacement of the springs measured with dial gauges reading directly to 0.0001 in. (0.0025 mm). The setup for calibrations is shown in Figure 5. The compressive displacement versus load was nearly the same for all 24 springs tested as is shown in Figure 6.

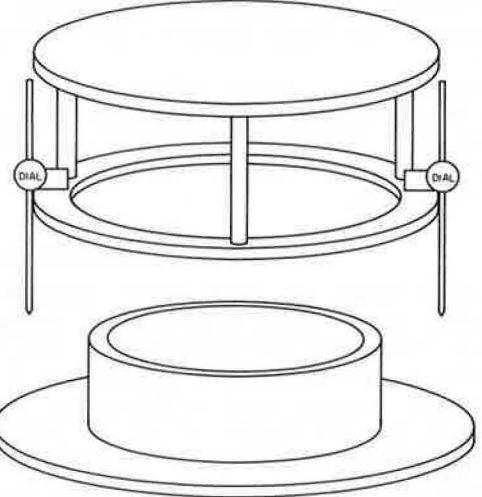
# Figure 5. Spring calibration apparatus.

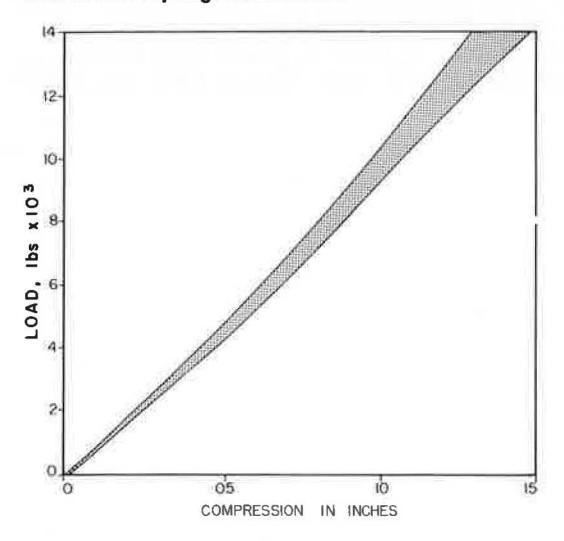
Figure 6. Range of compressive development versus load of all 24 springs used in tests.
