Abridgment Development and Testing of a Breakaway Support

Coupling for Light Poles

Arthur M. Dinitz, Transpo-Safety, Incorporated, New Rochelle, New York Douglas B. Chisholm, Federal Highway Administration

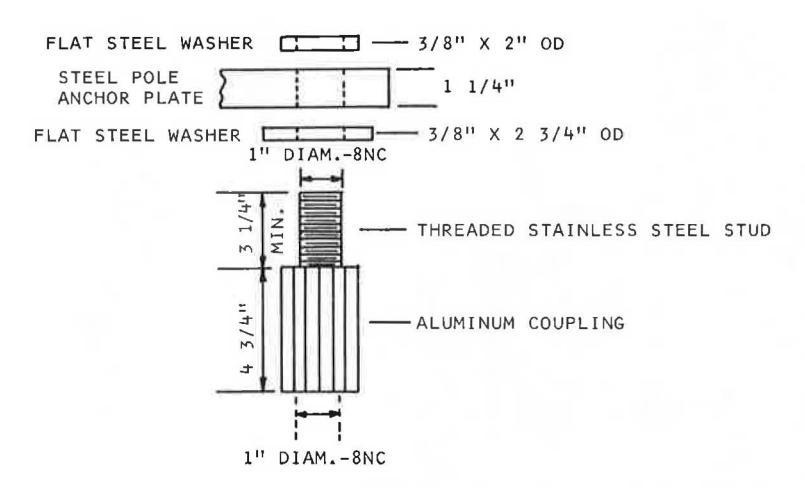
HEAVY HEX STEEL NUT

Figure 2. Diagram shows coupling's high tensile load capacity and low breakaway force requirement.

TENSILE OR COMPRESSIVE LOAD

The Pole-Safe breakaway coupling provides both a high tensile load capacity and a low breakaway force requirement (Figure 2). Under a tensile load, the longitudinal grooves do not become stress-risers since the stress field is parallel to the groove root. Under the loading induced by an impacting vehicle as shown in the previous force and moment diagram, the loads are perpendicular to the grooves. This efficiently concentrates the stresses at the groove root. A 1020-kg (2250-lb) Vega impacting a 15-m (50-ft), 308-kg (680-lb) luminaire support at 32 km/h (20 mph) equipped with four Pole-Safe couplings experienced a peak deceleration of 8.0 g or 80 100 nt (18 000 lb). Since each coupling requires about 20 025 nt (4500 lb), i.e., $4 \times 20 025 = 80 100$ nt ($4 \times 4500 = 18 000$ lb), it appears that there is a direct relationship between the peak fracture force of each coupling and the resultant vehicle deceleration. Every effort has been made to keep impact fracture loads low while maintaining the highest possible tensile load capacity.

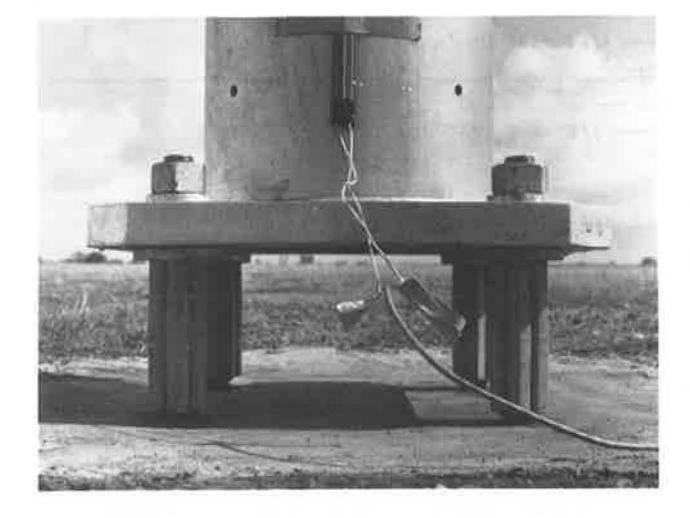
Figure 3. Footing and base of Pole-Safe coupling in place for production lot test.

A full-scale vehicle crash test was conducted at the Texas Transportation Institute, College Station, Texas, on July 20, 1977, in basic conformance with NCHRP Report 153 and AASHTO specifications (Figures 3, 4, 5, 6). The test data and results were as follows:

1. Couplings: 4 production lot Pole-Safe couplings -2.54 cm (1-in) in diameter;

2. Pole: a steel 15-m (50-ft) mounting height pole with a 228-cm (7.5-ft) mast arm and a 34-kg (75-lb) weight simulating luminaire, total weight = 306 kg (676.8 lb);

3. Footing: reinforced concrete 76.2 cm dia. \times 198 cm deep (30 in dia. \times 78 in deep) with 34.2-cm (13.5-in) bolt circle with four 2.54-cm (1-in) anchor bolts extending 6.98 cm (2.75 in) above concrete footing;

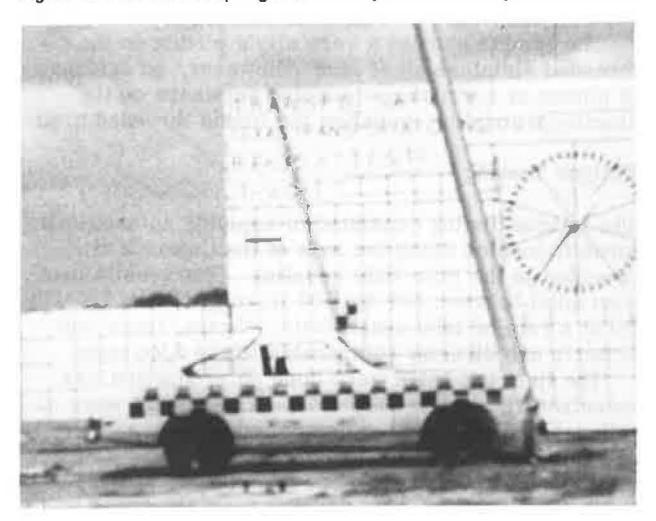
Figure 4. Pole-Safe coupling breaks away on vehicle impact.

4. Vehicle: Chevrolet Vega weighing 1020 kg (2290 lb);

5. Accelerometer data: approximate impact velocity, 33.1 km/h (20.6 mph);

- 6. Peak deceleration: 8 g;
- 7. Average deceleration: $\bar{0}.74$ g; and
- 8. Change in momentum: 2403 nt s (540 lb s).

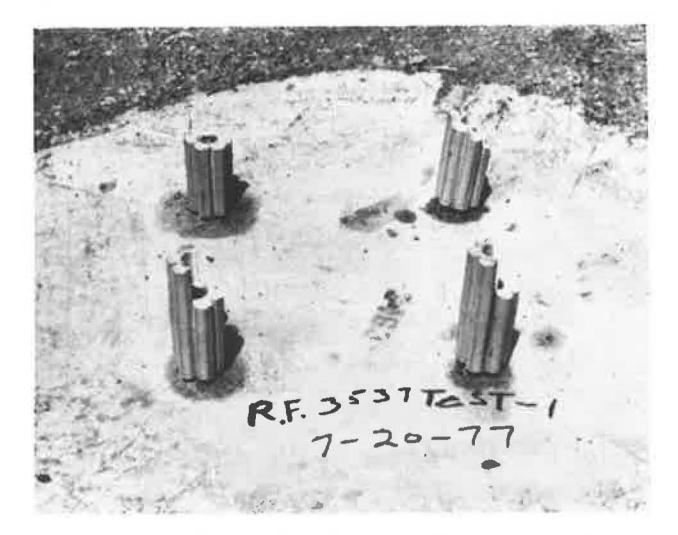
Test 3 (606) has the Pole-Safe couplings mounted under a Pfaff and Kendall TB-2A cast aluminum transformer base. The change of momentum resulting was 2968 nt^s (667 lb^s). No damage to the pole or the anchor bolts occurred in any of these tests. Figure 5. Coupling after breakaway.

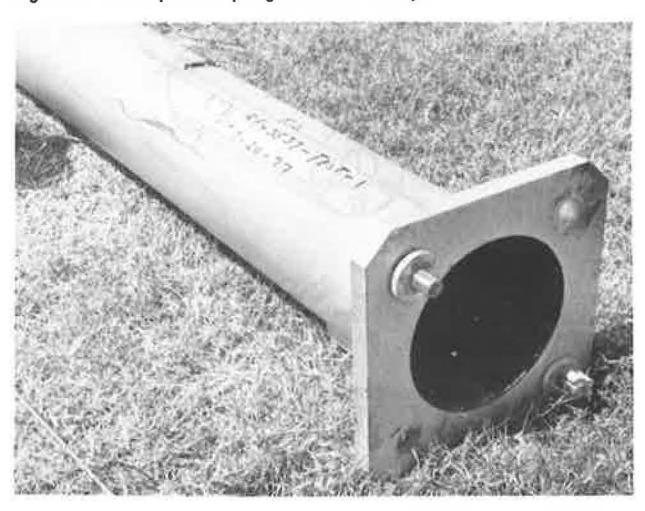
Figure 6. Closeup of coupling after breakaway.
