Scanning Rust Crystals and Salt Crystals with Electron Microscope

CARL F. CRUMPTON AND G.P. JAYAPRAKASH

Corrosion of reinforcing steel in concrete can create expansion pressures of 4700 psi. At 0° C, salt (halite) crystal growths can create pressures of 8140 psi at a supersaturation ratio of 2. Scanning electron micrographs of rust from corroding reinforcing steel in concrete show crystal laths and fretwork or boxwork crystals that eventually fill in and build up in layers. X-ray diffraction showed goethite and magnetite in the layers. Limonite, which is non-crystalline and does not show in X-rays, was also present. Halite crystal forms observed in air voids were fibers, columns, spirals, and ribbons. Entrained air voids help prevent or reduce salt crystals to grow into. Scanning electron micrographs of the rust crystals and salt crystals are included.

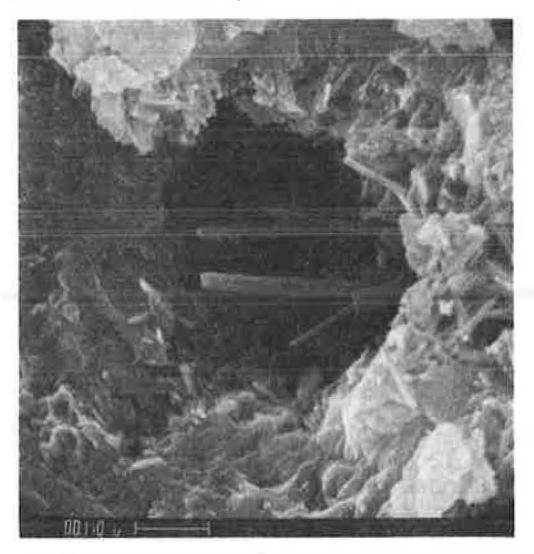
Figure 1. Lathlike crystals of rust from corroding reinforcing bar protruding into concrete void (scale = 1μ).

Kansas salt corrosion studies of concrete reinforcing steel were done to see how volume increases of up to 13 times (<u>1</u>) and expansion pressures of as much as 4700 psi (<u>2</u>) could occur from the corrosion process. Studies were made on the scanning electron microscope at Kansas State University with some concrete taken from as near a freshly corroding rebar as possible. Swordlike laths of rust were found growing into the concrete near the steel as seen in Figure 1. Concrete petrographers can recognize the potential for one-dimensional growth here and also see the shape similarity to minerals such as ettringite, the growth of which in hardened concrete is known to be detrimental $(\underline{3})$.

The lathlike and fretwork crystal forms shown in Figures 1, 2, and 3 are common forms for goethite $(\underline{4})$. The bulk of the massive or globular rust seems to be limonite, which would not show up in the X-ray because limonite is noncrystalline. The rust laths were found in rusty spots at the surface of concrete as much as 2 in above the corroding reinforcing steel. Figure 6 was made at such a location.

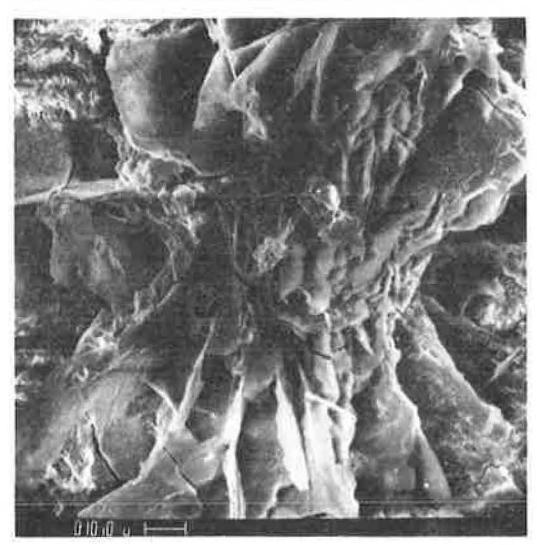
Figure 2. Boxwork of rust crystals in concrete (scale = 10μ).

Another form of rust observed was a boxwork (Figure 2) or a fretwork of thin, apparently triangular-shaped walls with one of the points of the triangles growing away from the reinforcing steel such as that shown in Figure 3. Eventually both the lathlike and the fretwork structures become filled in with massive rust as seen in Figure 4, in which a few laths can still be seen around the edges of the glob of massive rust. Eventually reddish-, brownish-, and blackish-hued layers of such rust build up. These often contain what appears to be drying shrinkage cracks as shown in Figure 5.

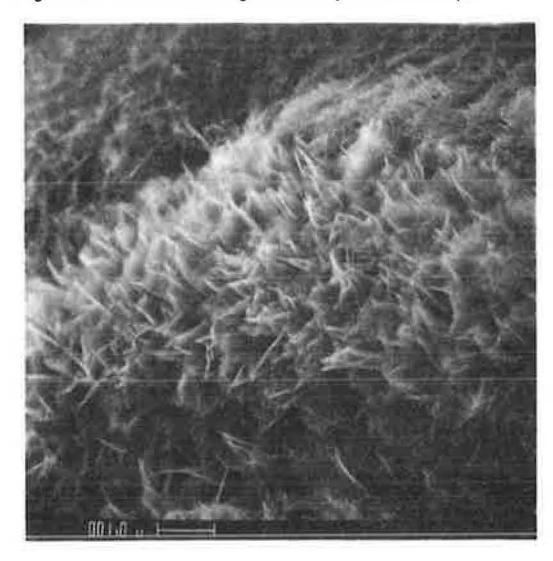
Figure 3. Fretwork of triangular rust crystals (scale = 1μ).

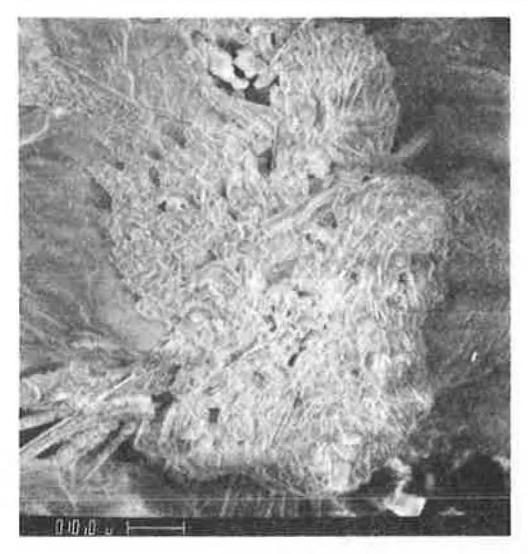
Figure 4. Cluster of rust crystal laths being filled in with more massive rust.

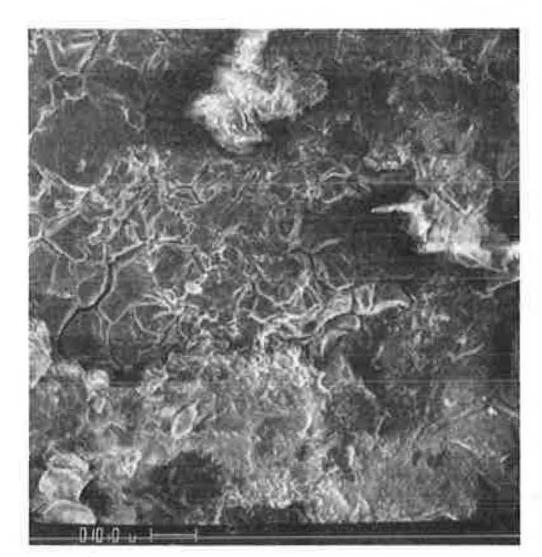
Figure 5. Built-up layer of massive rust obliterating original crystal forms.

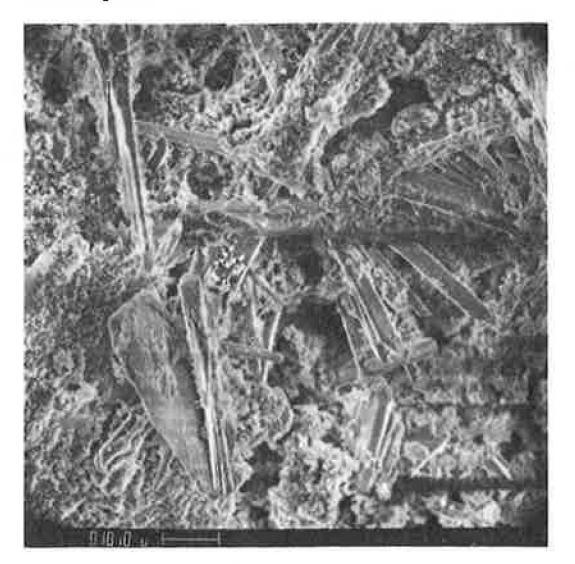
Figure 7. Fibrous crystal growths of salt (halite) in air void in concrete.

Helectites, stalactites, stalagmites, columns, crusts, and euhedral cubic crystals of common salt have been reported from caves in limestone and tubes in lava (12). In these studies, salt crystals were observed to grow in some of the salt-treated concrete as it dried. The salt crystals were first seen in air voids with a stereomicroscope but were studied in more detail with the scanning electron microscope. Sawed and polished faces of concrete cannot be used because the wet-preparation process would dissolve and wash away the salt crystals. Just as they do in caves, the halite crystals in concrete exhibit a wide variety of shapes, including fibers (Figure 7), columns (Figure 8), and spirals and ribbons (Figure 9). Similar fibers composed of

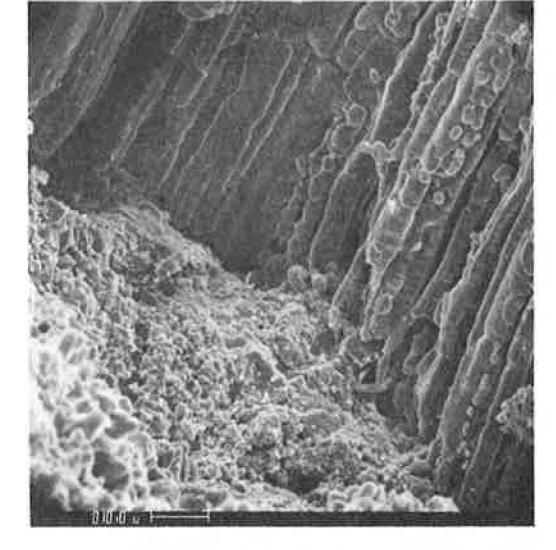
Figure 9. Spiral, ribbon, and fiber crystal growths of halite in concrete.

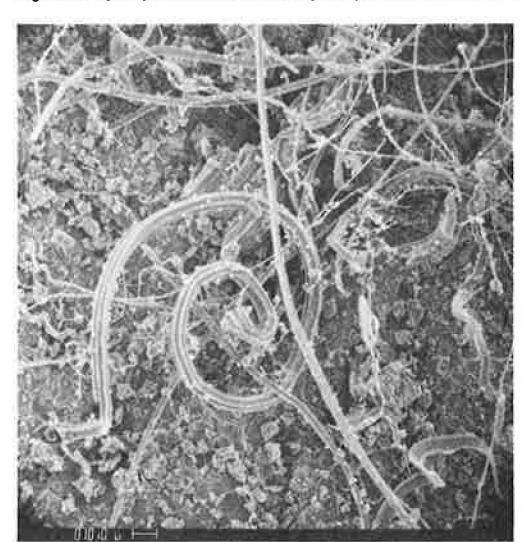
Figure 10. Ropelike cluster of halite fibers that look almost like extrusion from concrete pores (arrow points to same spot as arrow in Figures 11 and 12).

In a few instances, concrete particles and quartz grains were observed at the free end of the salt fibers. Some of the salt crystals, such as those shown in Figure 10, look as though they were extruded from the concrete pores. Closer views show surface structures that suggest some growth by accretion and the bundle of fibers does not appear to extend down into the concrete but rests on its surface (Figure 11). To verify this, a cluster of salt fibers was dislodged with a micromanipulator. The area below the salt showed quite small pores in the concrete (Figure 12). The pores were much smaller than the salt crystals, as can be seen by comparing Figures 10 and 12. This indicates that the salt crystals grew by accretion from their base at the concrete surface rather than being extrusions from concrete pores.

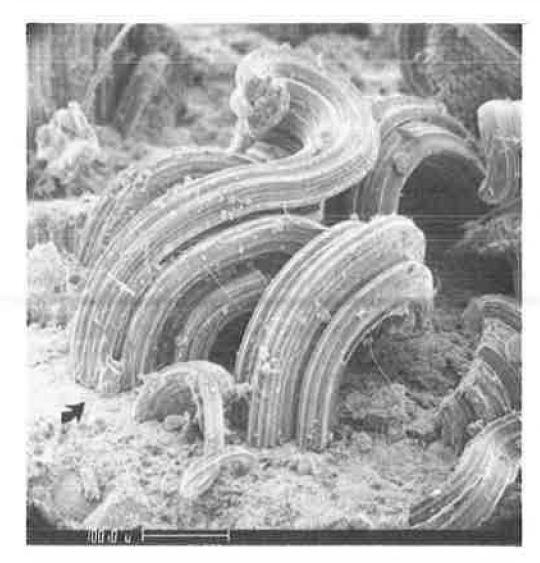
Figure 11. Enlarged view of interface of cluster of halite fibers with concrete at same location shown by arrow in Figure 10.

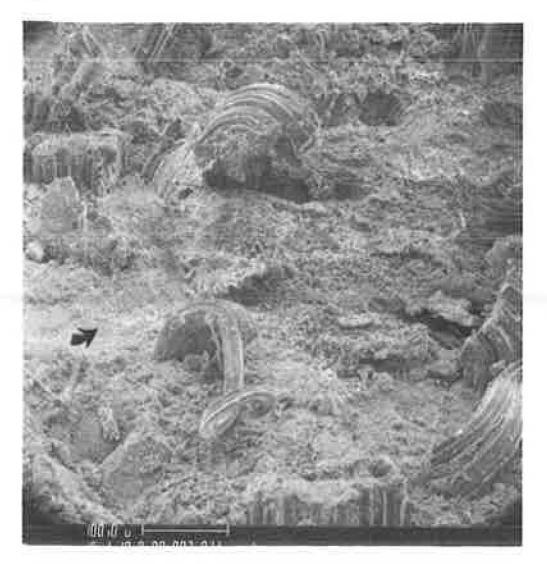
Figure 12. Cluster of salt fibers removed with micromanipulator (same scale as Figure 10).
