# HIGH CONTAINMENT SAFETY BARRIERS: STEEL AND CONCRETE

by Ivor B. Laker, Transport and Road Research Laboratory, Crowthorne, Berkshire, England

#### Abstract

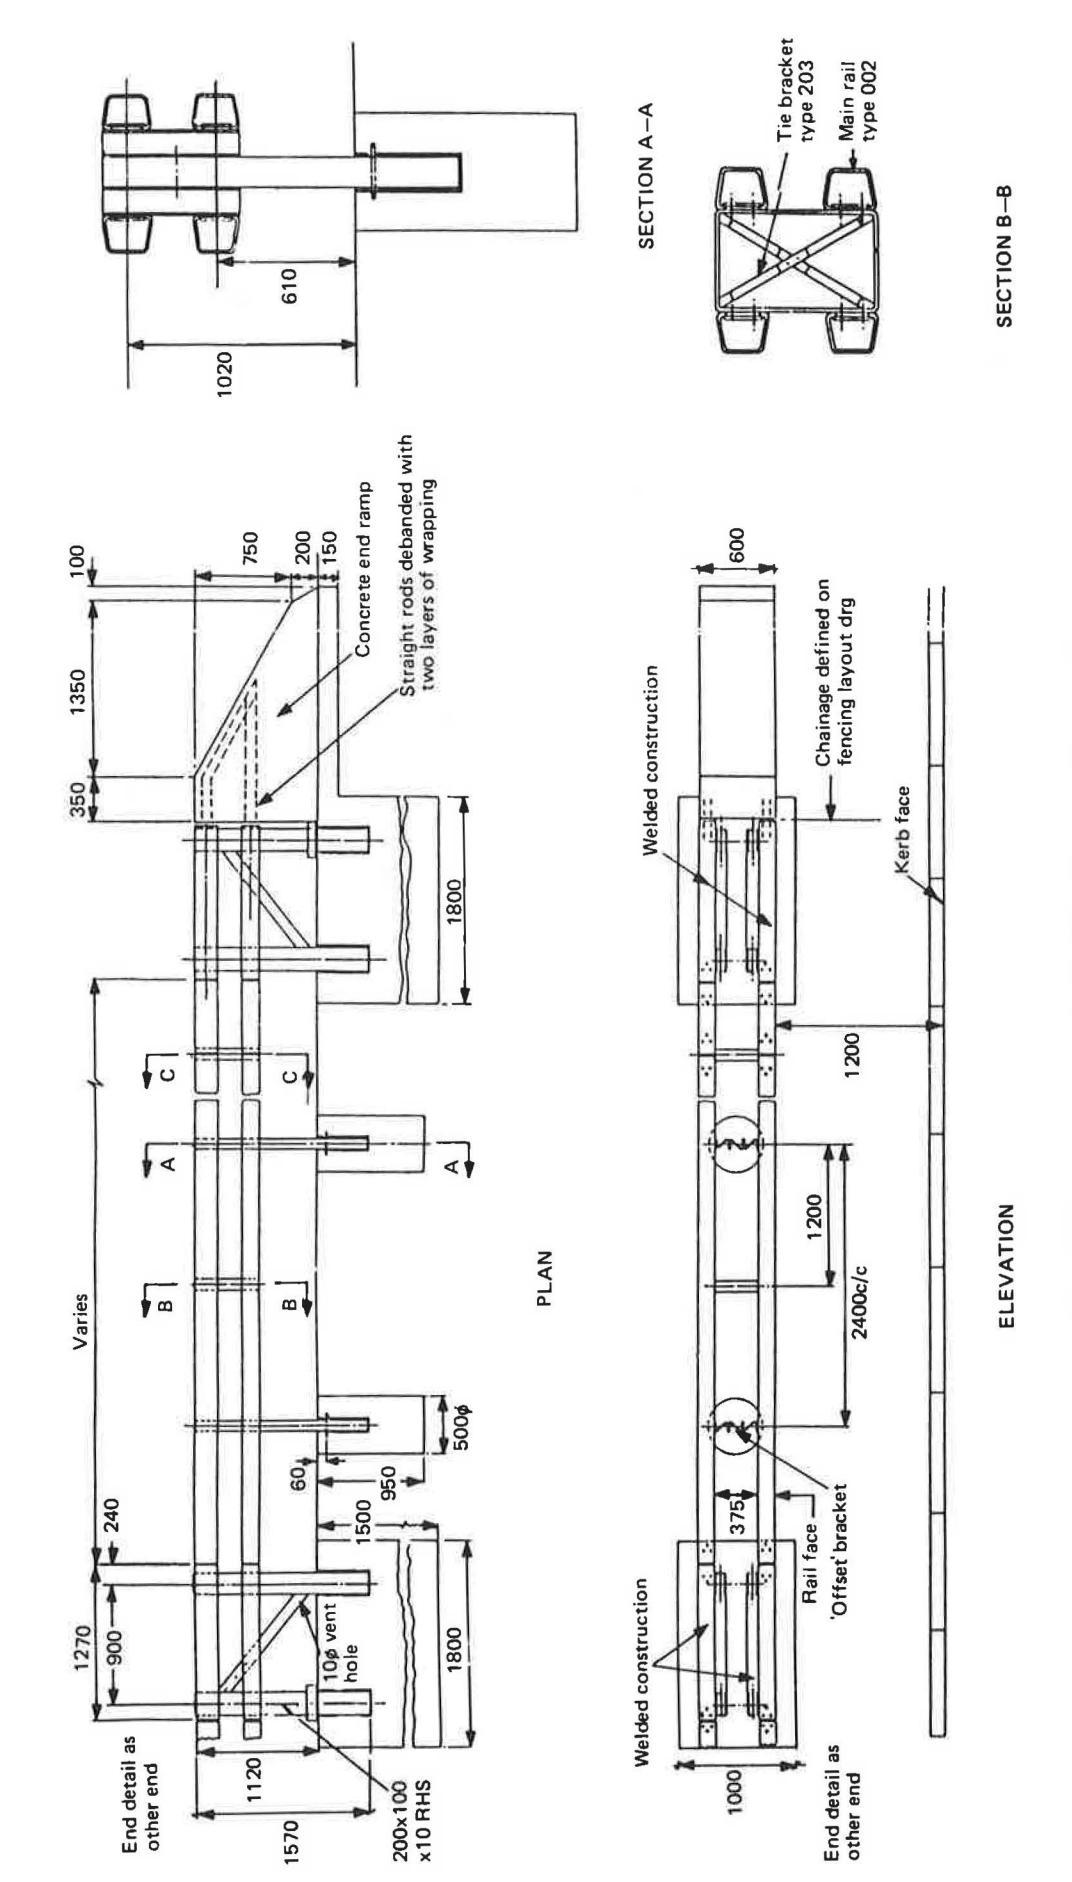
Fig. 1 The double height, double sided open box steel barrier

The high containment steel box beam barrier, called the double height double sided open box barrier (DHBSOB), has been designed to use, so far as possible, components from the safety barriers currently available in Britain. A cross section, plan and elevation of the barrier are shown in Figure 1. The barrier consists of four parallel open box beam set in pairs on either side of the barrier at heights of 610 mm and 1020 mm. These are supported by Z-section steel posts set 2.4 m apart, from which they are blocked-out by lengths of Z-section material. The blocking-out sections are attached to the posts by single bolts that are designed to fail during an impact. This is to allow the barrier beams to remain upright while the posts fold sideways. Between posts the four beam are connected by rectangular frames braced with cross-struts (Figure 1), placed at each mid-span to hold the beams in position during impact.

For impact testing a 115 meter length of the steel barrier was erected, supported at each end by full height steel anchors set in large concrete blocks (Figure 1).

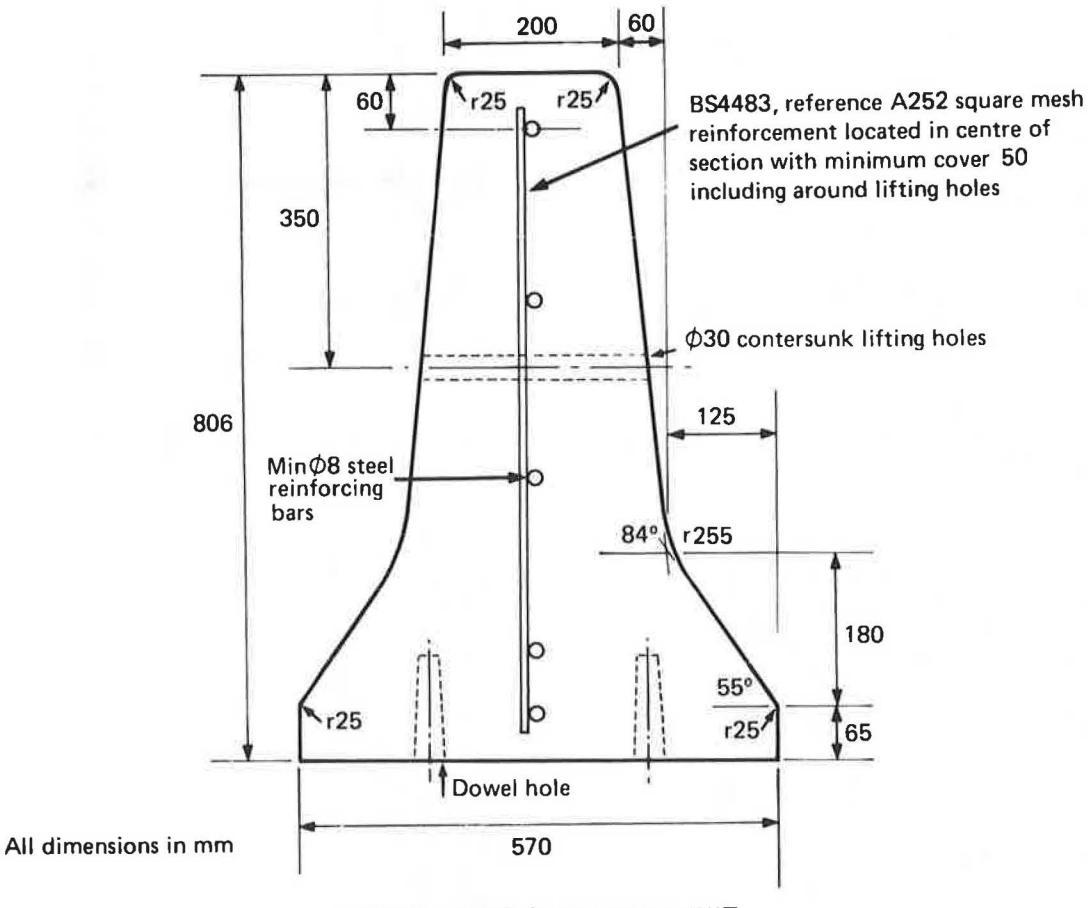
Fig. 2a British concrete barrier (BCB) - section

The barrier impacted in this series of tests, known as the British Concrete Barrier (BCB), is based on early work carried out at TRRL on shaped concrete profiles (5). A British Standard publication (4) gives the specification of the BCB. The barrier tested consisted of three meter long precast-concrete units fixed by six dowel pins per unit on to a concrete foundation flush with road surface (Figure 2a); alternative methods of mounting are given in the British Standard.

**PROFILE TYPE 4: PRECAST UNIT**

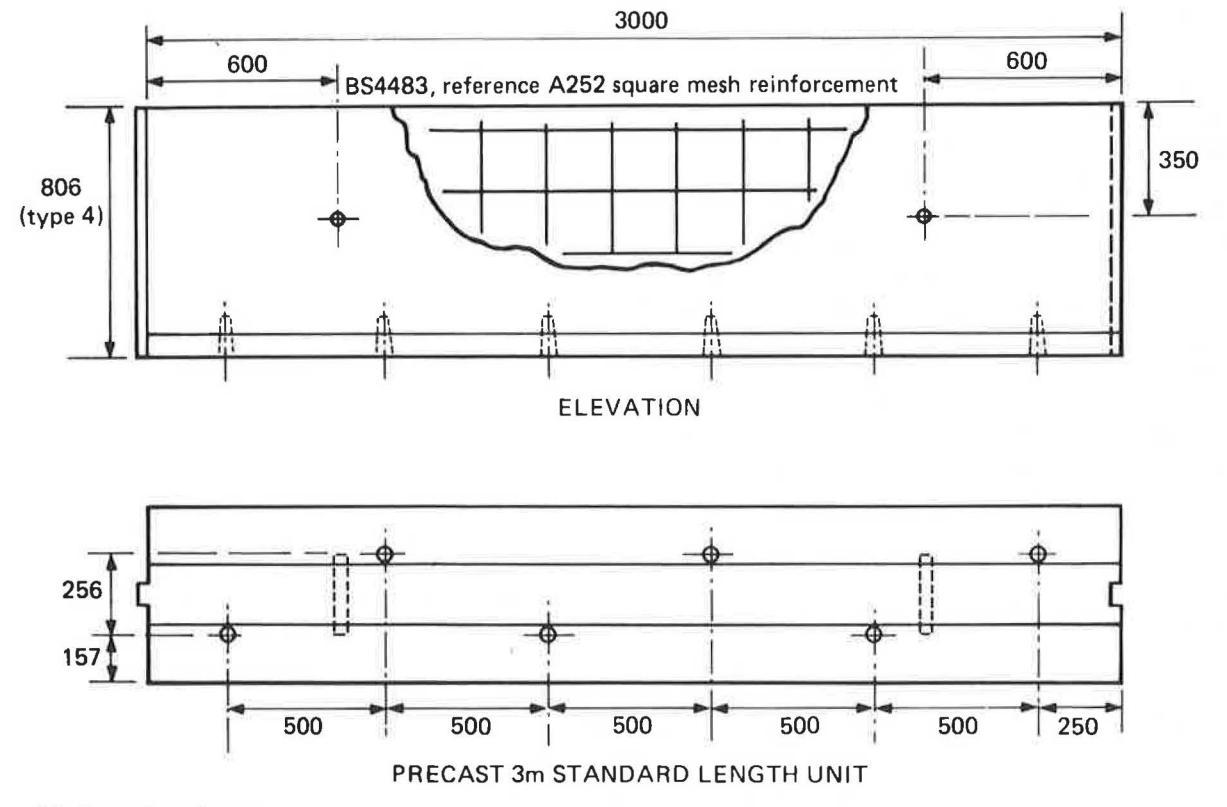
Fig. 2b British concrete barrier (BCB)

The Cement and Concrete Association funded the supply of the BCB: TRRL funded the installation and testing. The length installed was 60 meters in three meter precast units linked together longitudinally by simple tongued and grooved joints as shown in Figure 2b.

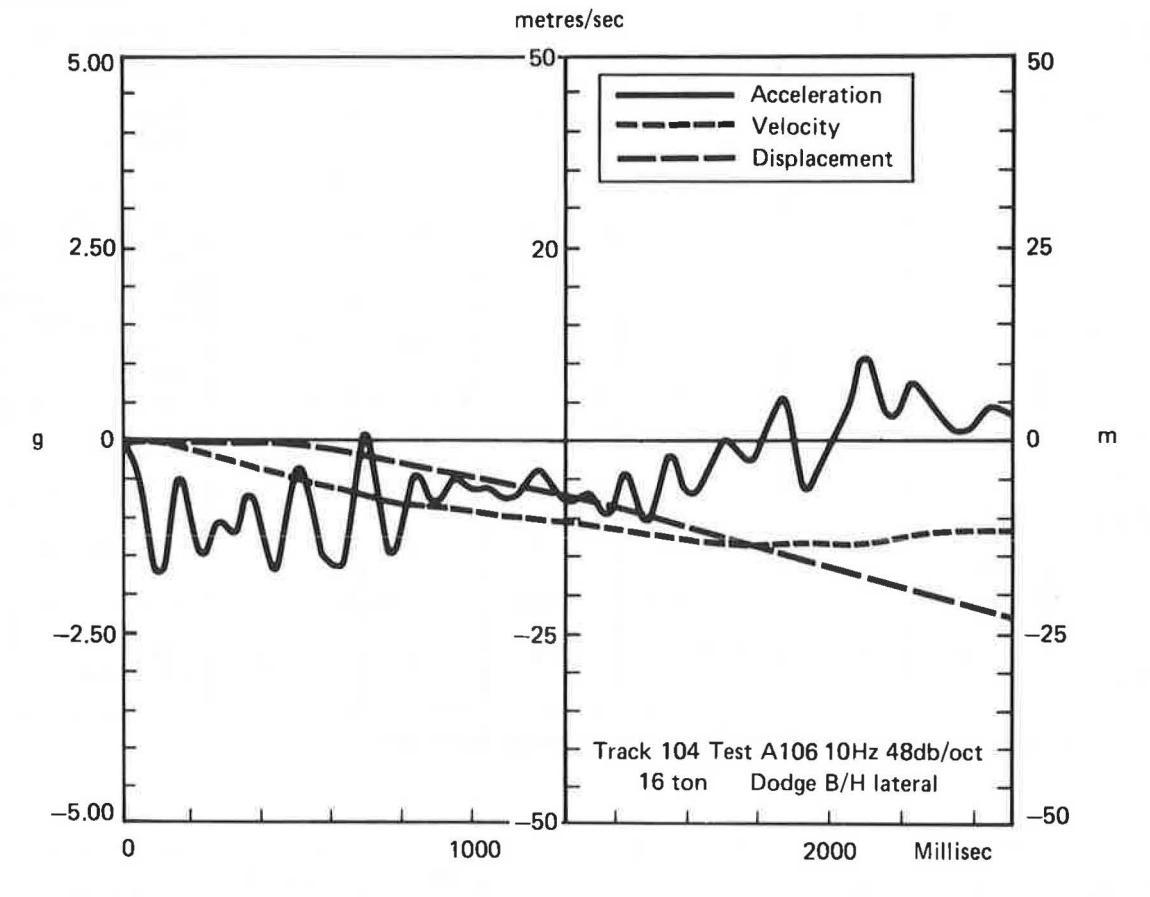
Fig. 3 Lateral accelerometer with 10Hz fitter

The transducer outputs were smoothed by a 60 Hz and a 10 HZ Butterworth filter. The 10 Hz trace revealed whole vehicle movements while the higher frequency content of the 60 Hz trace indicated vibration of the vehicle components. An example is given in Figure 3. An 85 m/sec delay introduced by the 10 Hz filer was compensated for by shifting the time base that amount.

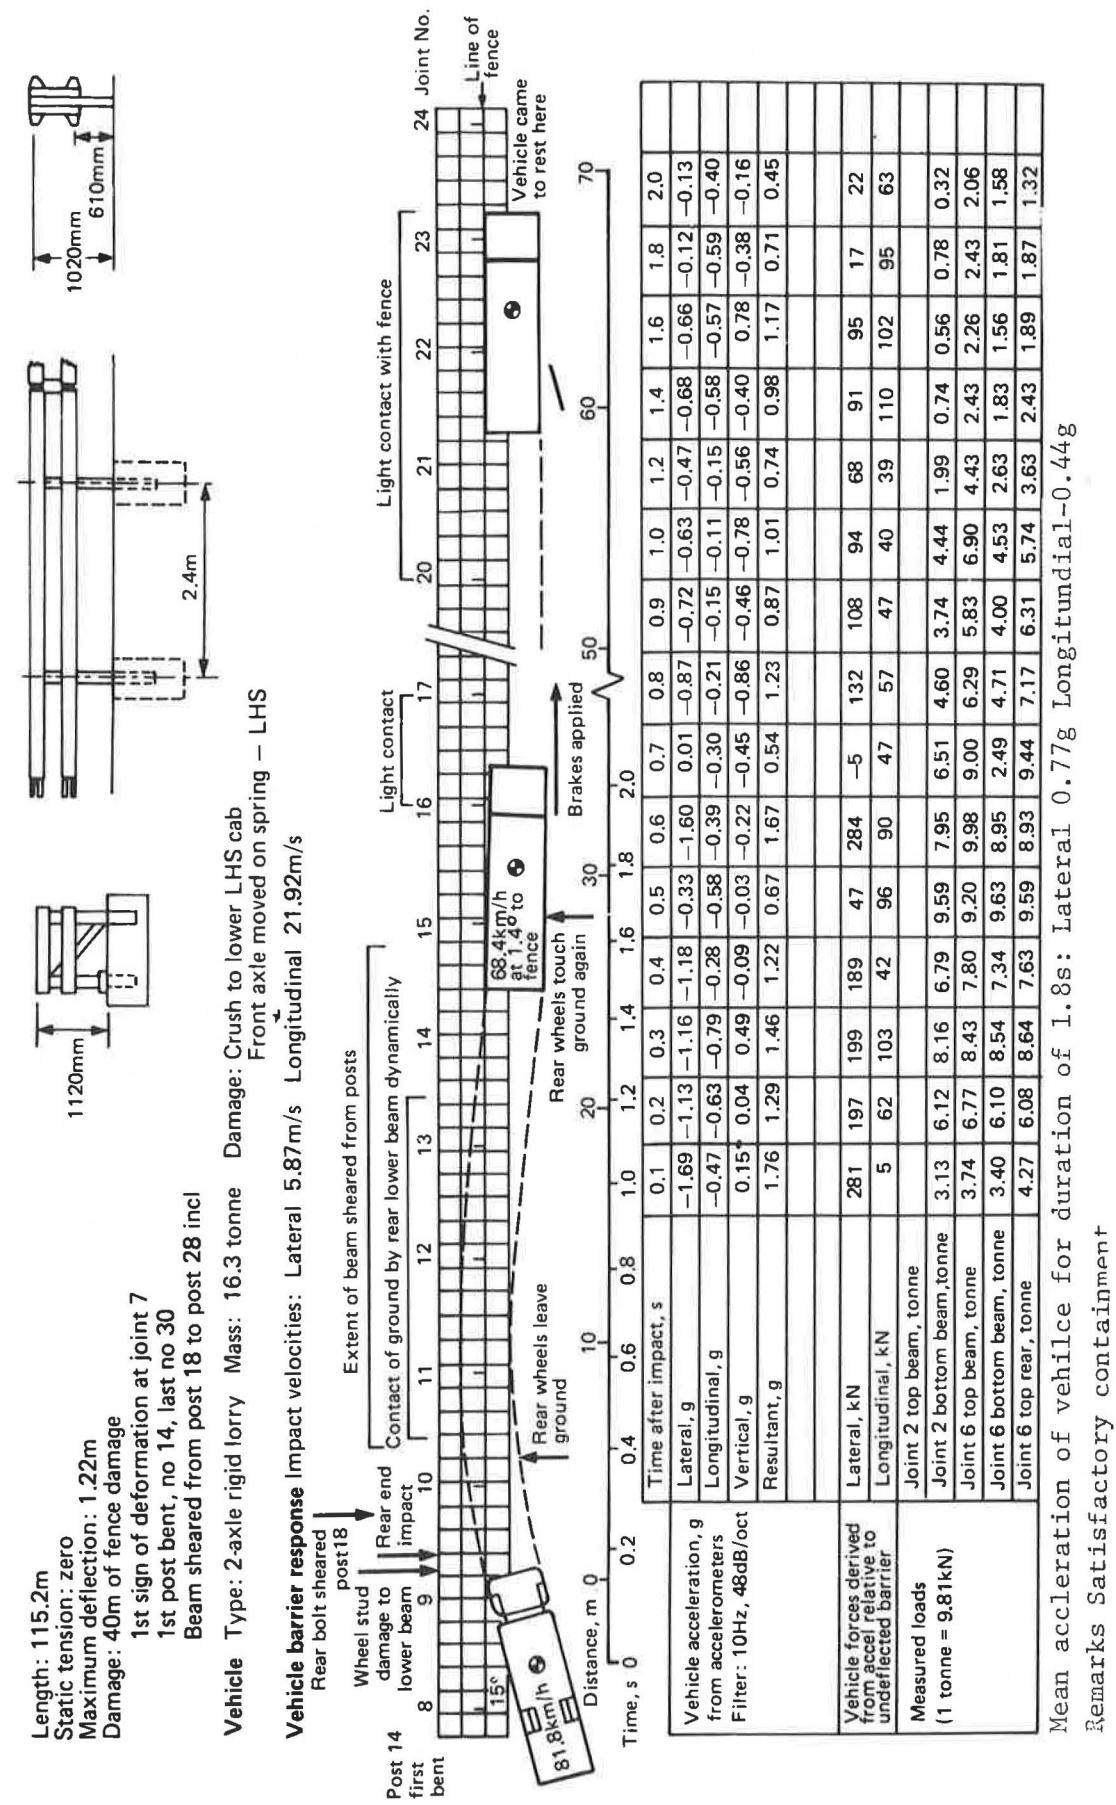
Fig. 4 Data from 16 tonne, 81.8km/h test on steel fence

Tables 1 and 2 give the main vehicle characteristics and Tables 3 and 4 give some important vehicle, box beam barrier and concrete barrier impact data. For each test a summary sheet was produced showing the trajectory and acceleration of the vehicle, the deflection and loads in the barrier and the damage to both the barrier and the vehicle. An example is given in Figure 4 of the 15 degree impact by the 16 ton HGV truck into the box beam barrier.

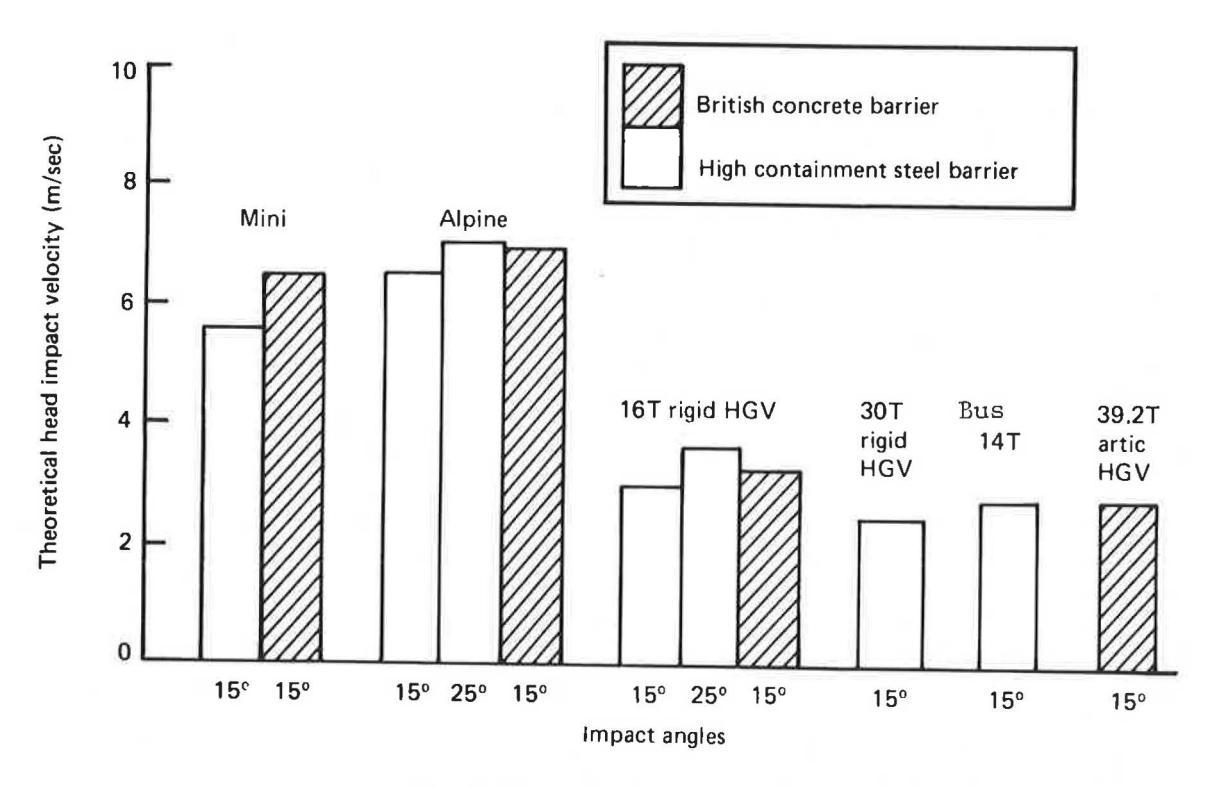
Fig. 5 Theoretical head impact velocities

Figure 5 shows a plot of theoretical head impact velocities (THIV) for all impacts into the steel box beam barrier and concrete barrier other than the articulated HGV truck into the box beam barrier for which there were no accelerometers installed. General conclusions from Figure 5 suggest that at the speeds tested the box beam barrier and concrete barrier offer similar impact severity to vehicle occupants in that they produce fairly similar THIV values for paired vehicles, and that passengers in private cars would experience an impact twice as severe as those in an HGV truck. The THIV values for the 25 degree impact into the box beam barrier are only marginally larger than the 15 degree impacts. The rather unexpectedly small differences may be accounted for by the extra crushing of the Alpine car in the 25 degree test, and the case of the HGV truck the box beam barrier was run down fairly early in the impact thereby offering reduced resistance.

Absolute interpretation of THIV values in terms of occupant injury is difficult. Early work indicates that head impacts in excess of about 5 m/sec could cause irreversible injuries. All the car derived THIV values exceeded this level and consequently on this criterion such impacts would be rated in a severe category; the HGV truck impacts produced considerably lower THIV values.

To summarize, THIV values confirm subjectively with the severity of impact that passengers in different types of colliding vehicle might experience. Simple analysis with THIV values may place vehicle impacts of differing weight, speed, and angle in an order of severity from a vehicle occupants viewpoint.
