## Chao Wei, Peter Hsu, and Stephen K. Leung, Caltrans

## ABSTRACT

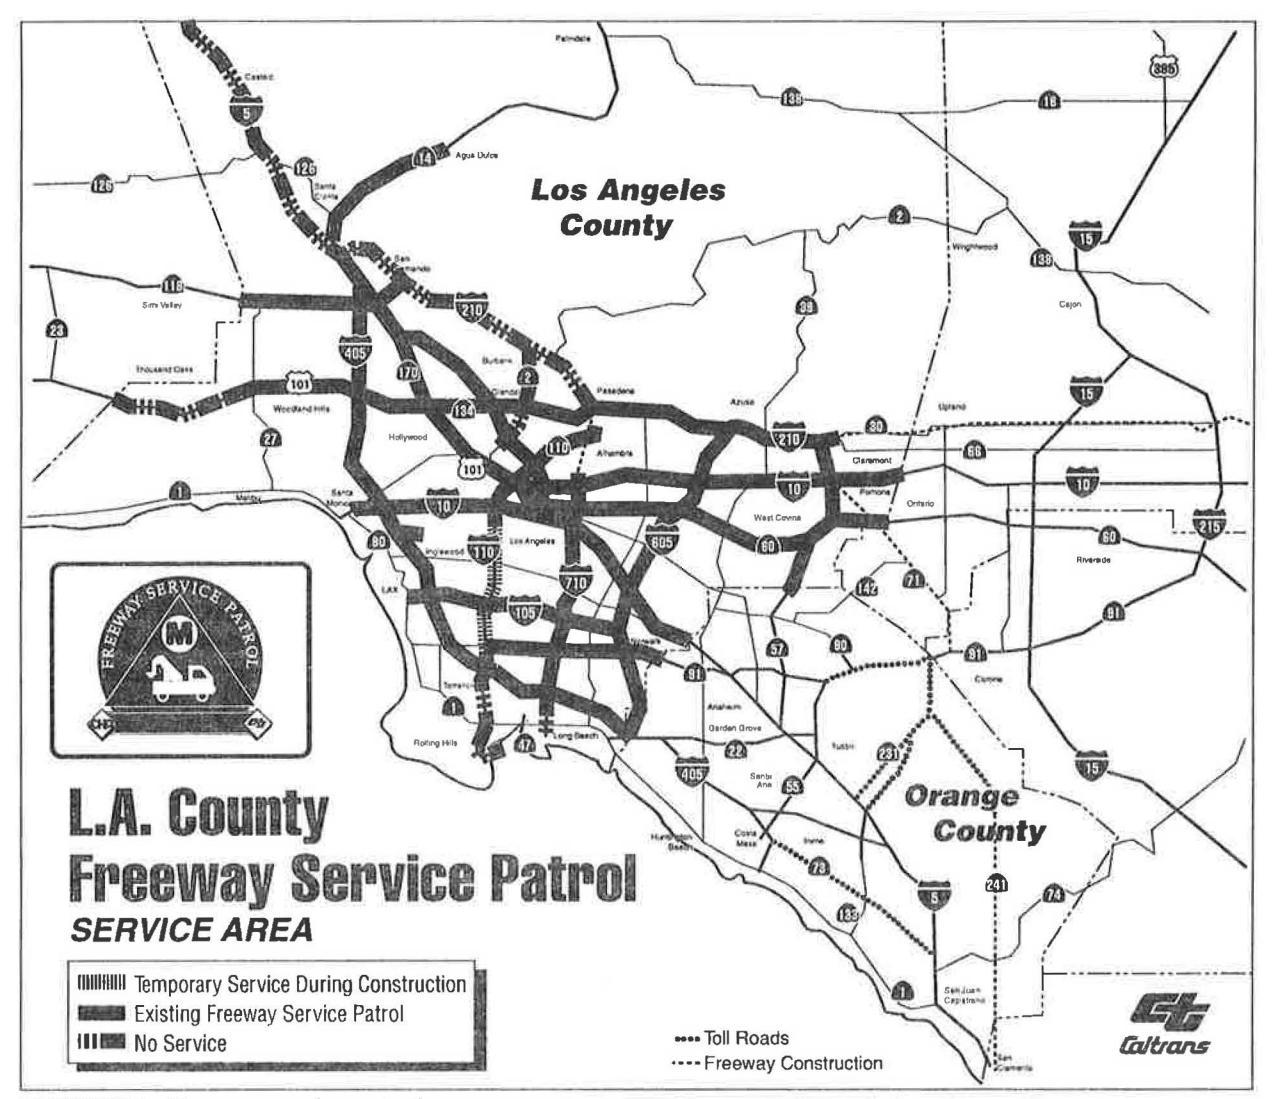
FIGURE 1 Freeway service patrol area map.

Before the January 17, 1994 Northridge earthquake, the FSP had 144 tow trucks patrolling 40 beats (a beat is sections of freeways) covering 381.3 centerline miles of freeways in Los Angeles County as shown in Figure 1. More than 550,000 incidents had been assisted by the FSP with an average annual assist of 220,000. The 144 tow trucks are from 20 private contractors, which can tow the vehicles with a gross weight up to 6,000 pounds. The FSP program has been very successful since its inception. More than 90 percent of returned survey letters rated the service as excellent and commended the program as a wise expenditure of the tax-payers' dollars. The 93/94 fiscal year budget is \$24 million. The

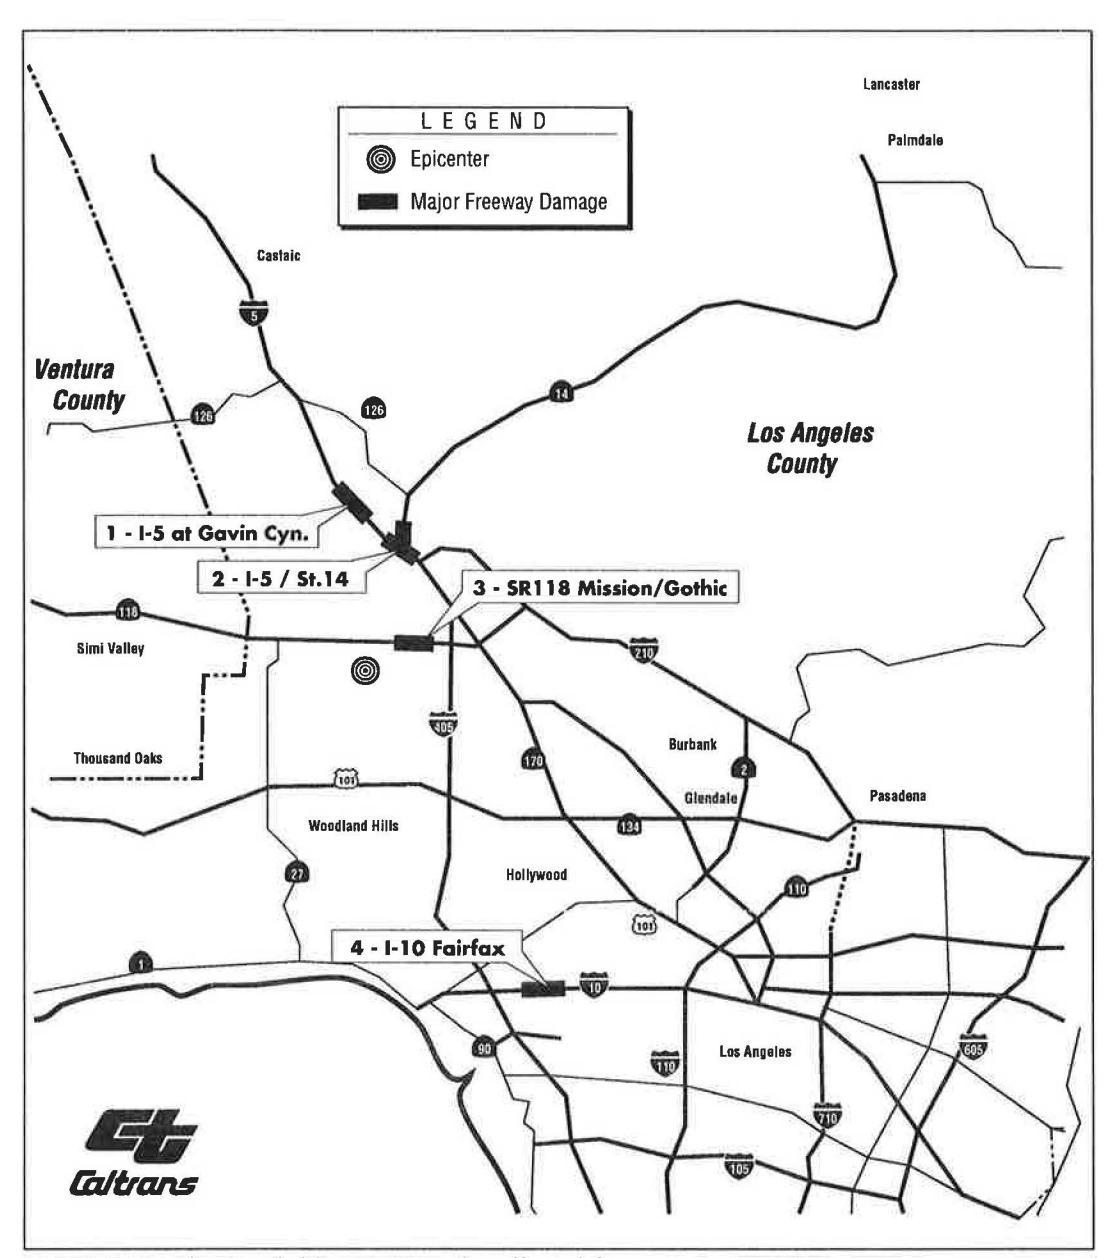
FIGURE 2 The Northridge Earthquake affected freeways and roadways.

Figure 2 shows the locations of the major freeways which were damaged during the January 17, 1994 Northridge earthquake. They included I-5 (the Golden

State Freeway), I-10 (the Santa Monica Freeway), SR-14 (the Antelope Valley Freeway), and SR-118 (the Simi Valley Freeway). Three of the four damaged freeways are located in the north-western portion of Los Angeles County, about 20 miles away from Downtown Los Angeles. The Santa Monica freeway is west of Downtown Los Angeles.

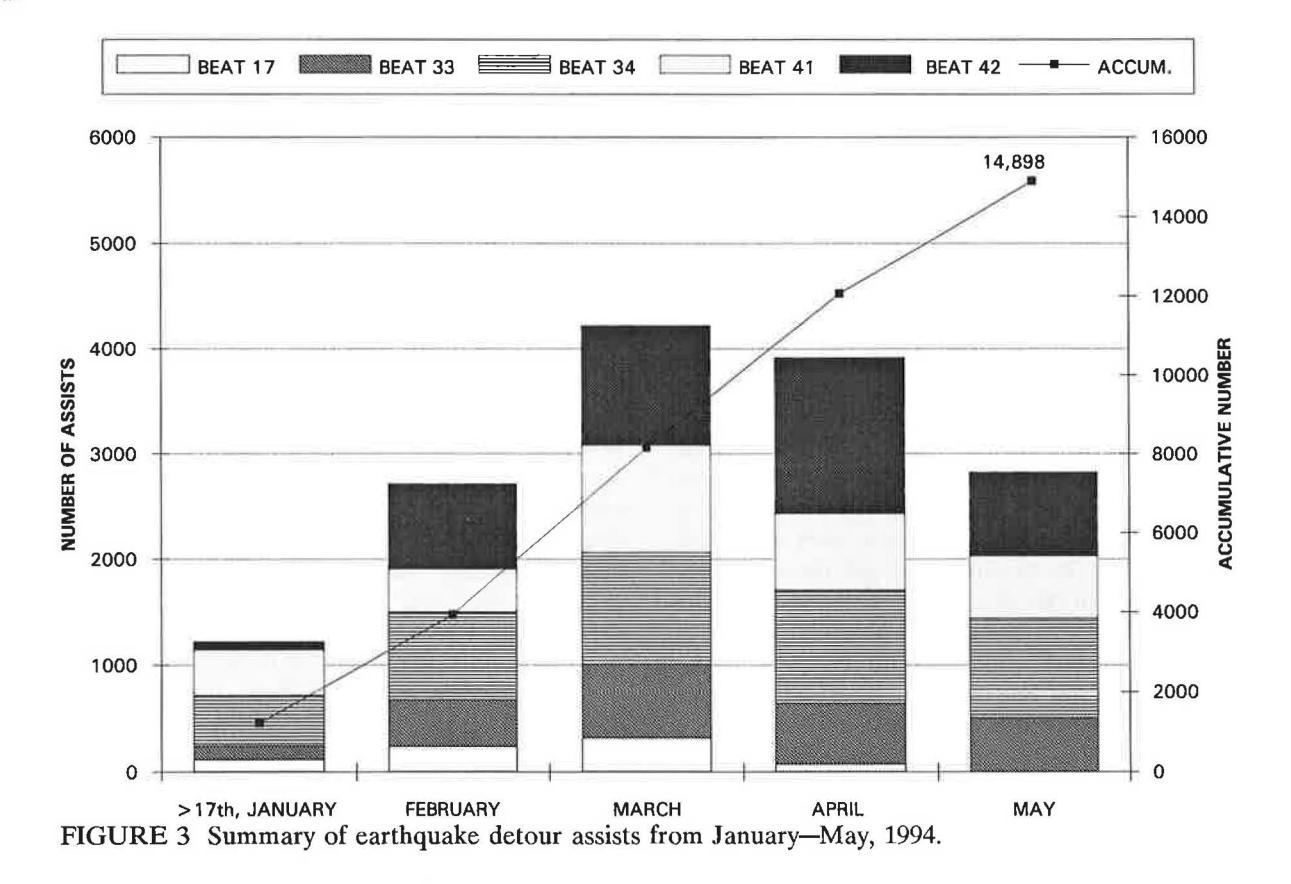
Figure 3 shows the total monthly and accumulative earthquake assists for Beats 17 (I-10), 33 (SR-118), 34 (I-5), 41 (I-5/SR-14) and 42 (I-5). Beat 42 had the highest number of incidents because of few parallel arterial streets available as alternate routes. Interestingly, Beat 17 (I-10), the most traveled freeway before the earthquake, had the lowest number of

incidents. Due to the urbanized setting, motorists were able to use the arterial streets parallel to the freeway as alternate routes. Similar low assist results were found on Beat 33 (SR-118). The total accumulative assists for these four beats by the end of May, 1994 was 14,898.

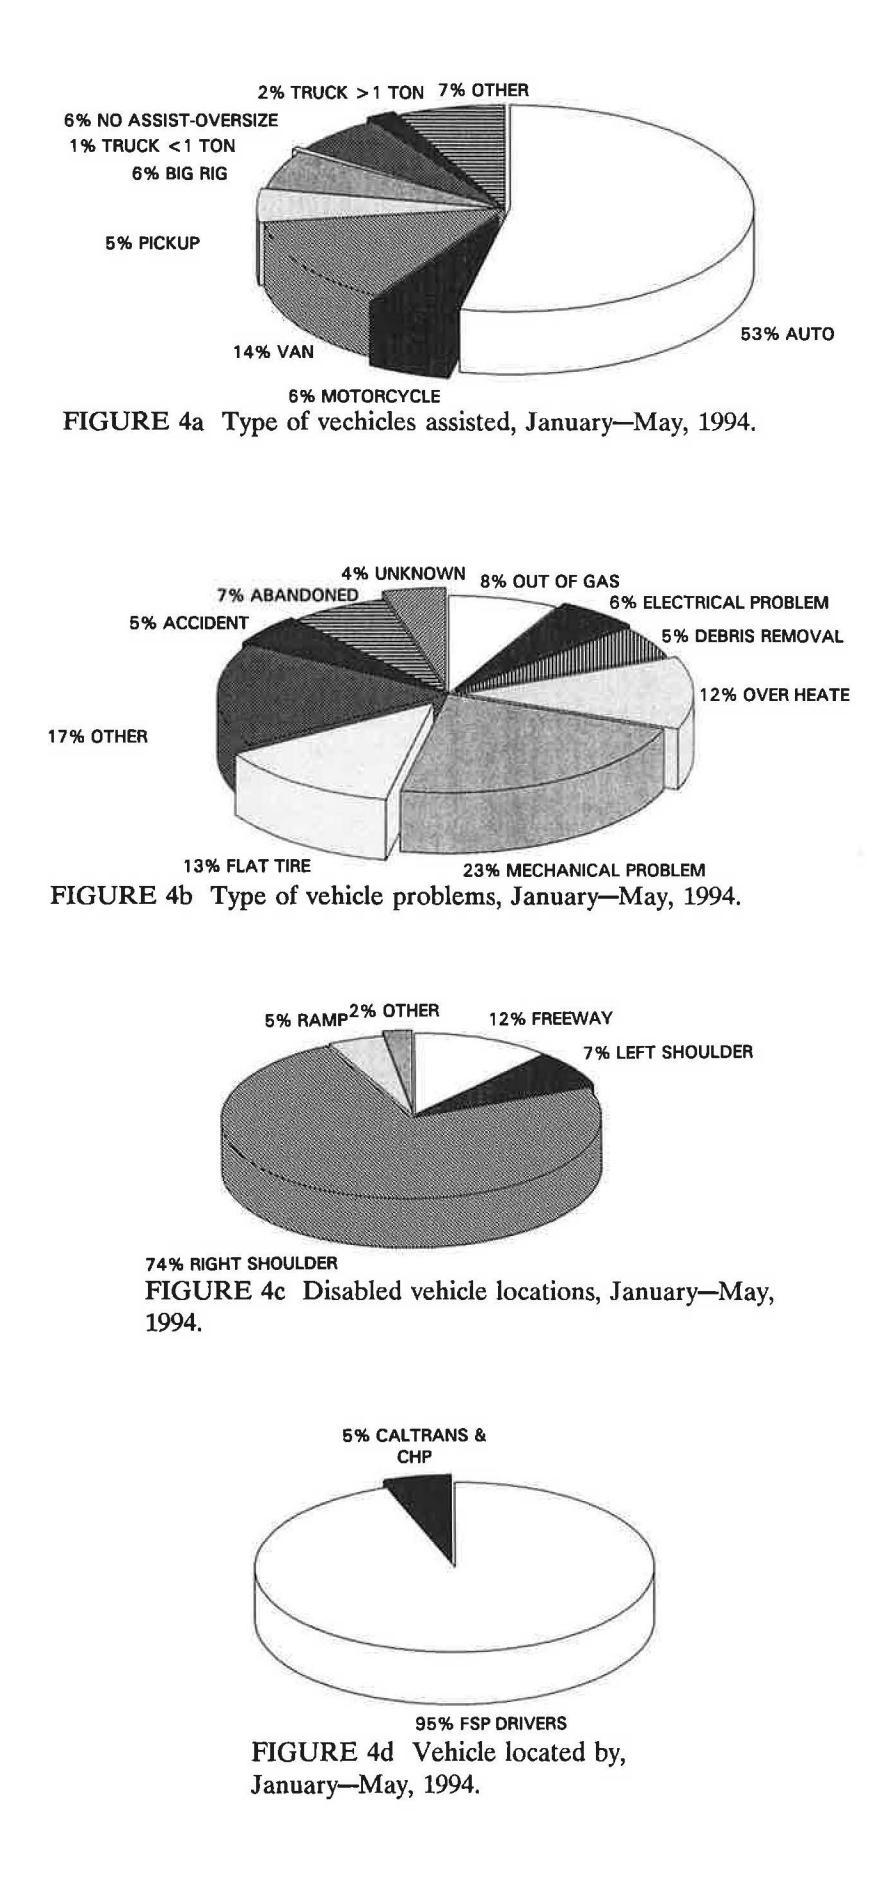
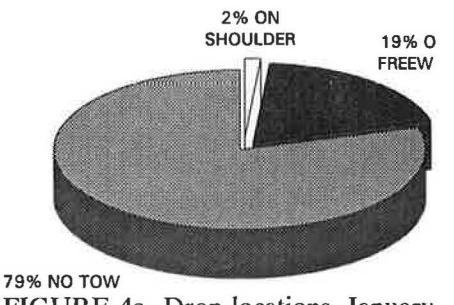
Figure 4 (a) shows the percentage of assists for each type of disabled vehicles. Fifty-three percent of assists are automobiles, 14 percent are vans, and 6 percent are Big Rigs-a three or more axles vehicle. Figure 4 (b) shows the percentage of assists for each type of vehicle problems. The mechanical problem led with the highest percentage (23), with accidents at 5 percent, flat tire 13 percent, overheat vehicles 12 percent, and out of gas 8 percent. Figure 4 (c) shows the percentage of assists for each type of locations of disabled vehicles. Twelve percent of assists were located on freeway lanes, and 74 percent on right-shoulders. Figure 4 (d) shows 95 percent of incidents were spotted by FSP drivers, and only 5 percent were dispatched by CHP and Caltrans. In addition, 19 percent of incidents (2830) involved towing, as shown in Figure 4 (e).

FIGURE 4e Drop locations, January-May, 1994.

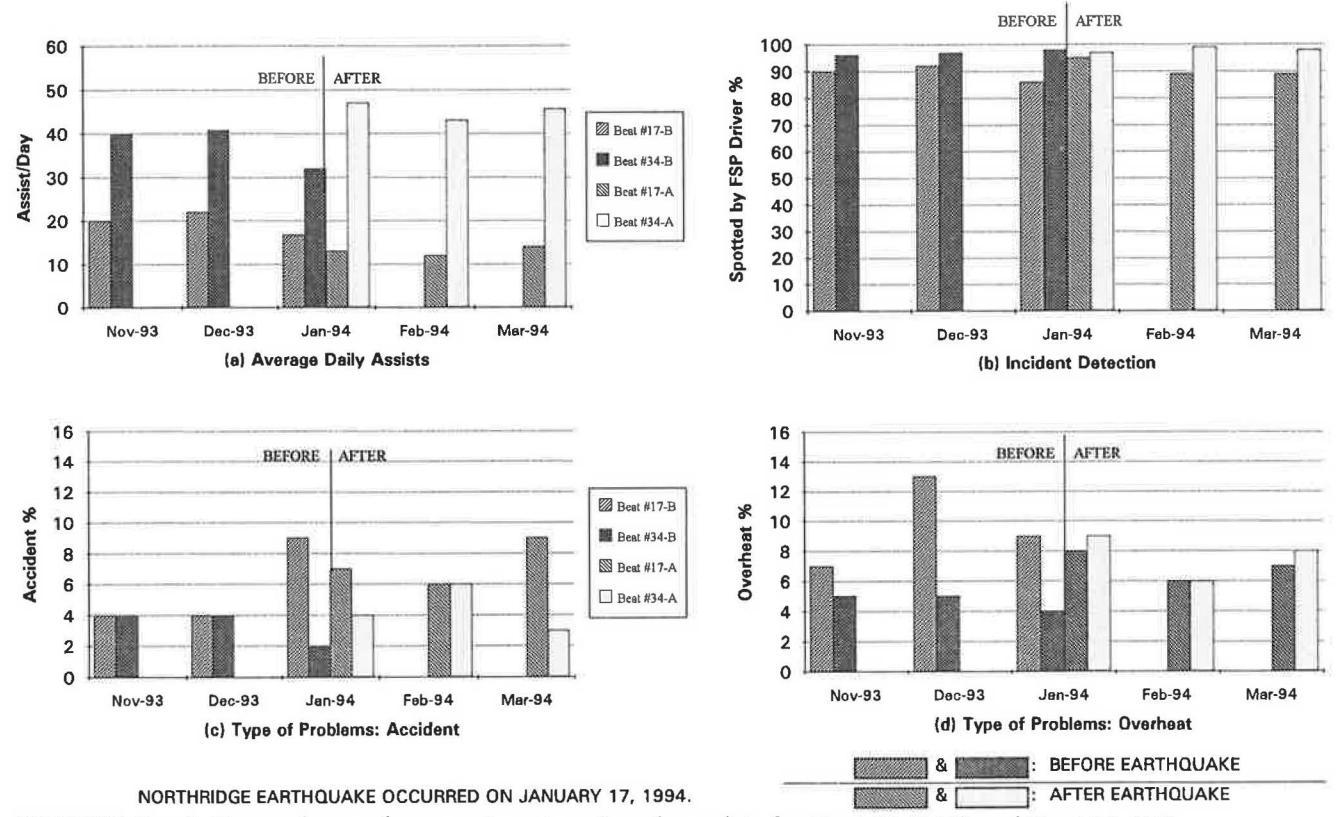
FIGURE 5a-d Comparisons of pre- and post-earthquake assists for Beat 17 (I-10) and Beat 34 (I-5).

Figure 5 (a) shows the average daily assists for November and December 1993, pre-earthquake

January, post-earthquake January 1994, February, and March 1994 for Beats 17 (I-10) and 34 (I-5). After the earthquake, the daily assists for Beat 17 (I-10) are lower than pre-earthquake. This is due to the fact that the motorists used the available parallel arterial streets as an alternate route. However, Beat 34 (I-5) shows an increase of average daily assists after the earthquake, probably because the motorists had fewer parallel streets as by-pass alternatives to the closed freeway section. Furthermore, Beat 34 (I-5) is south of the I-5 detour and congestion often backed up from this point which resulted in more incidents.

FSP is an effective traffic management tool in early detection of incidents. This tool is very valuable during the earthquake recovery when the detours directed traffic away from freeways and the surveillance system was not available yet. As shown in Figure 5 (b), the percentage of incidents spotted by FSP drivers increases just after the earthquake for Beat 17 (I-10). The percentage for Beat 34 (I-5) also increases slightly in February and March of 1994. Overall, for pre- and post-earthquake, more than 90 percent of incidents were spotted by FSP drivers.

Accidents due to traffic congestion and reduction in capacity are always our concerns in the sense that these accidents may prolong the delay and magnify the traffic backup. Figure 5 (c) shows the percentage of incidents that are involved in accident for the pre- and postearthquake. For Beat 17 (I-10), the accident percentage increases immediately after the earthquake. For Beat 34 (I-5), the accident percentage increases only in February by 50 percent comparing with November and December, 1993, but drops in March, 1994.

Figure 5 (d) shows the percentage of incidents for another type of vehicle problem: overheat, for pre- and post-earthquake. Long traffic delay often results in overheating problem for the vehicle. This is quite true for Beat 34 (I-5), which is south of and adjacent to the beginning of the detour and was often congested during peak commute hours. However less overheating problems were found for Beat 17 (I-10), which has less traffic volume because many motorists used surface streets as an alternate route.

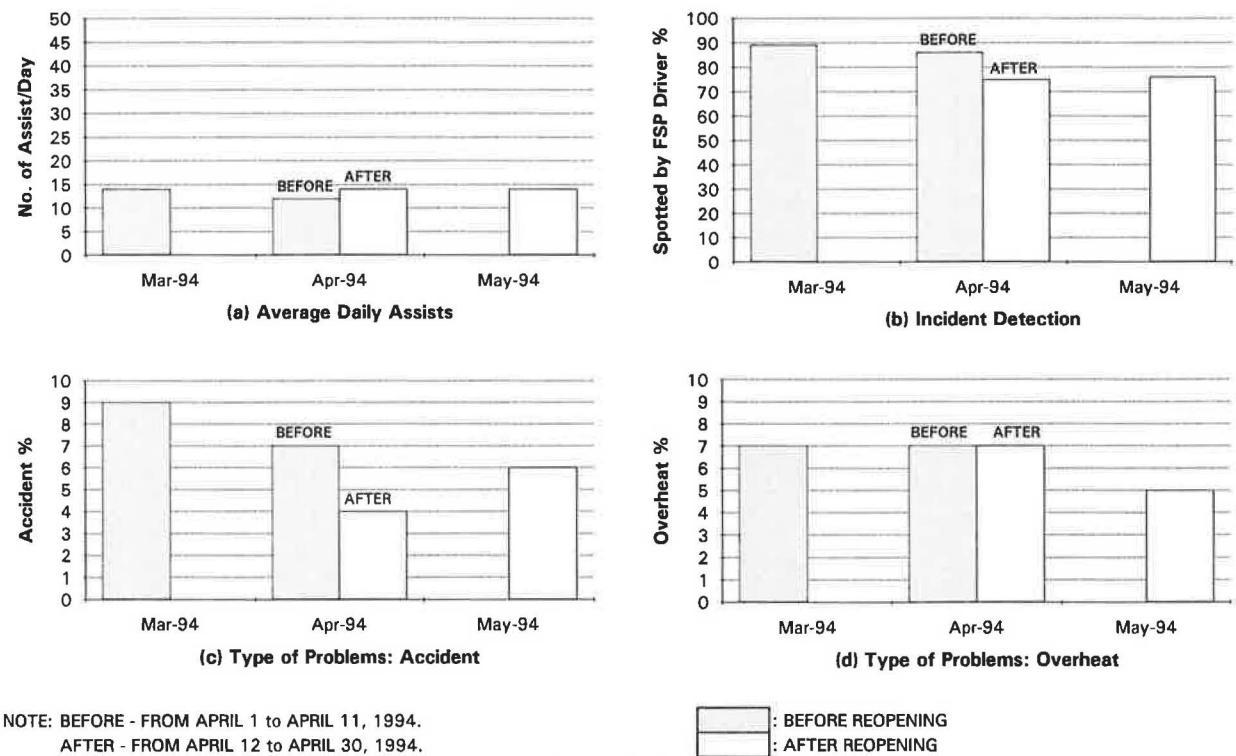
FIGURES 6a-d Comparisons of post-earthquake and after reopening assists for Beat 17 (I-10).

cation tools were available for the motorists, such as call boxes. The percentage after reopening is also lower than pre-earthquake [Figure 5 (b)]. The percentage of incidents involved in accident drops by 50 percent in May compared to March, as seen from Figure 6 (c), but is still slightly higher than pre-earthquake [Figure 5 (c)]. Overheating incident percentage decreases in May as seen from Figure 6 (d), which is also lower than preearthquake [Figure 5 (d)]. The percentage of automobile incidents is slightly higher in May as shown in Figure 6 (e), but is within the range of pre-earthquake [Figure 5 (e)]. The percentage of Big Rig incidents increases from 1 percent to 2 percent, as shown in Figure 6 (f), which is also higher than pre-earthquake [Figure 5 (f)]. The percentage of incidents located on freeway lanes is the same for March and May as shown in Figure 6 (g), which is also about the same as preearthquake [Figure 6 (g)]; however, the percentage of incidents located on right shoulder after reopening increases from 75 percent to 82 percent as shown in Figure 6 (h), which is about the same as pre-earthquake [Figure 5 (h)].
