# Evaluation of Rebar Corrosion in Concrete by Active Thermal Sensing

DANA E. POULAIN DENNIS R. ALEXANDER JOSEPH K. KRAUSE University of Nebraska–Lincoln

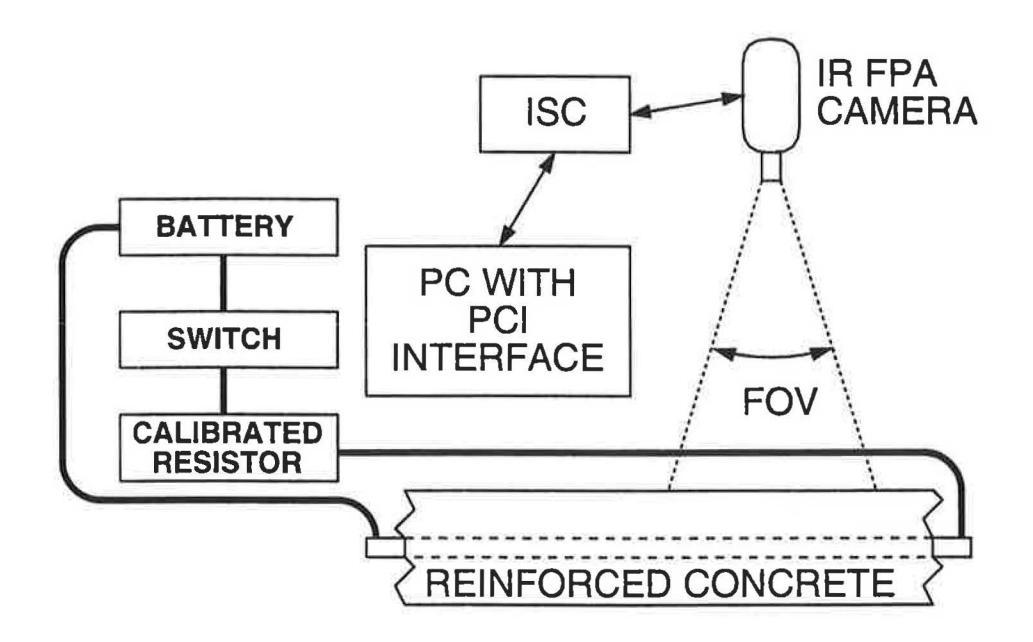
Figure 1: Block diagram of the EchoTherm hardware used to acquire infrared images from the Inframetrics camera.

Contained in Figure 1 is a diagram of the rebar assessment system. Infrared images were obtained in this work by an infrared focal plane array (IR-FPA) camera (Inframetrics,

The data acquisition system (Thermal Wave Imaging Inc., EchoTherm) consists of a program interface and three main hardware components: ISC-PCI interface card, Intelligent System Controller (ISC), and camera bus interface. The IR-FPA camera outputs image data at the rate of 60 frames per second. The bus interface converts the voltage levels of the IR-FPA data to the voltage used by the ISC data bus. The ISC transmits acquired data to the computer through the PCI interface, and transmits commands from the computer to the IR-FPA. If it is desired to collect data at less than 60 frames per second, the ISC can select every n<sup>th</sup> frame by specifying an index n. The stored data can be combined through software into a series of gates. Each gate consists of a prescribed number of frames averaged together. Up to 20 gates can be selected from a set of data. By averaging multiple frames together, the signal to noise ratio (SNR) can be reduced to provide clearer images. The infrared data acquisition system was originally designed with an emphasis on imaging relatively fast thermal variations, such as those associated with sheet metal and composite plates. With large concrete masses the characteristic time of the thermal processes is much slower. To increase the capabilities of the system to investigate much longer time frames, a manual data acquisition box was constructed. The box increases the length of time over which data can be acquired and permits a greater number of frames to be averaged together to reduce the SNR.

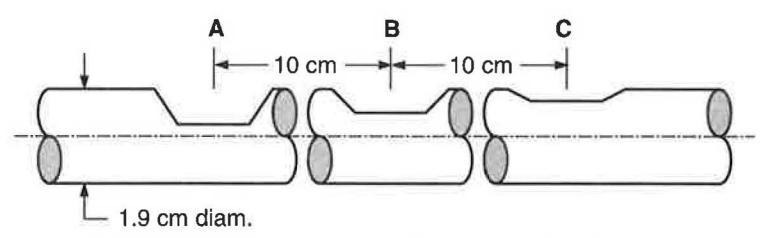
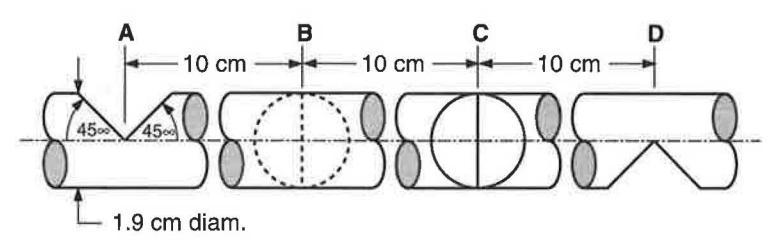
(a) Rebar with three reduced cross-sectional areas.

(b) Rebar with four defect orientations.

Figure 2: Schematic diagrams of two rebars with simulated defect regions. In (a), Sample 1 contains three defects, A, B, and C representing 60%, 75% and 90% of the normal crosssectional area of the rebar, respectively. In (b), Sample 2 contains four defects, A, B, C and D, each representing approximately 50% of the normal cross-sectional area, but oriented in 90° increments. In each case, the defect is back-filled with iron oxide paste or putty to simulate the thermal properties of corrosion products that would be present in the defect.

Concrete test samples were prepared with a commercially available "Redimix" small aggregate mixture. The dimensions of the samples were  $57 \times 20 \times 6$  cm ( $22 \times 8 \times 2.5$  in.). A single uncoated rebar was placed along the centerline of each sample. For test controls, a rebar, 1.9 cm (0.75 in.) diameter, was inserted in one sample. The typical depth of the rebar below the sample surface is 2.0 cm. Simulated defects were produced in two different rebars, shown in Figure 2. In the first sample, three degrees of cross-sectional area reduction due to corrosion were produced. Notches were milled into the bar, at 10 cm increments along the length, to depths such that the cross-sectional area of the bar was reduced to 60%, 75% and 90% of normal. The notched areas were filled with a paste composed of iron oxide powder and acetone and allowed to dry. The second test specimen contained four "v-shaped" notches, each representing a 50% reduction in cross-sectional area. The notches were oriented in  $90^{\circ}$  increments around the circumference of the rebar, as shown in Figure 2.

Tests were next conducted to determine the ability of the thermal imaging system to resolve reductions in rebar cross-sectional area. Such reductions could result from corrosion or cracking. A drawing of the rebar specimen used in this experiment is shown in Figure 2. The temperature distribution of the heated rebar was first obtained by imaging the rebar outside of the concrete. This was done to find the bar's actual surface temperature image before the image propagated through the concrete it would be embedded in. The electrical current resulted in a total power of 1500 W and was applied

A rebar with defects oriented in four different directions was prepared, as shown in Figure 2. The rebar was heated with 2460 W of electrical power applied for 30 s. The resulting thermal images are displayed in Figure 12. Defects B and C are visible in the infrared images as hot (light) and cool (dark) regions, respectively. However, defects A and D do not appear to be visible in these images. In these cases where the defect

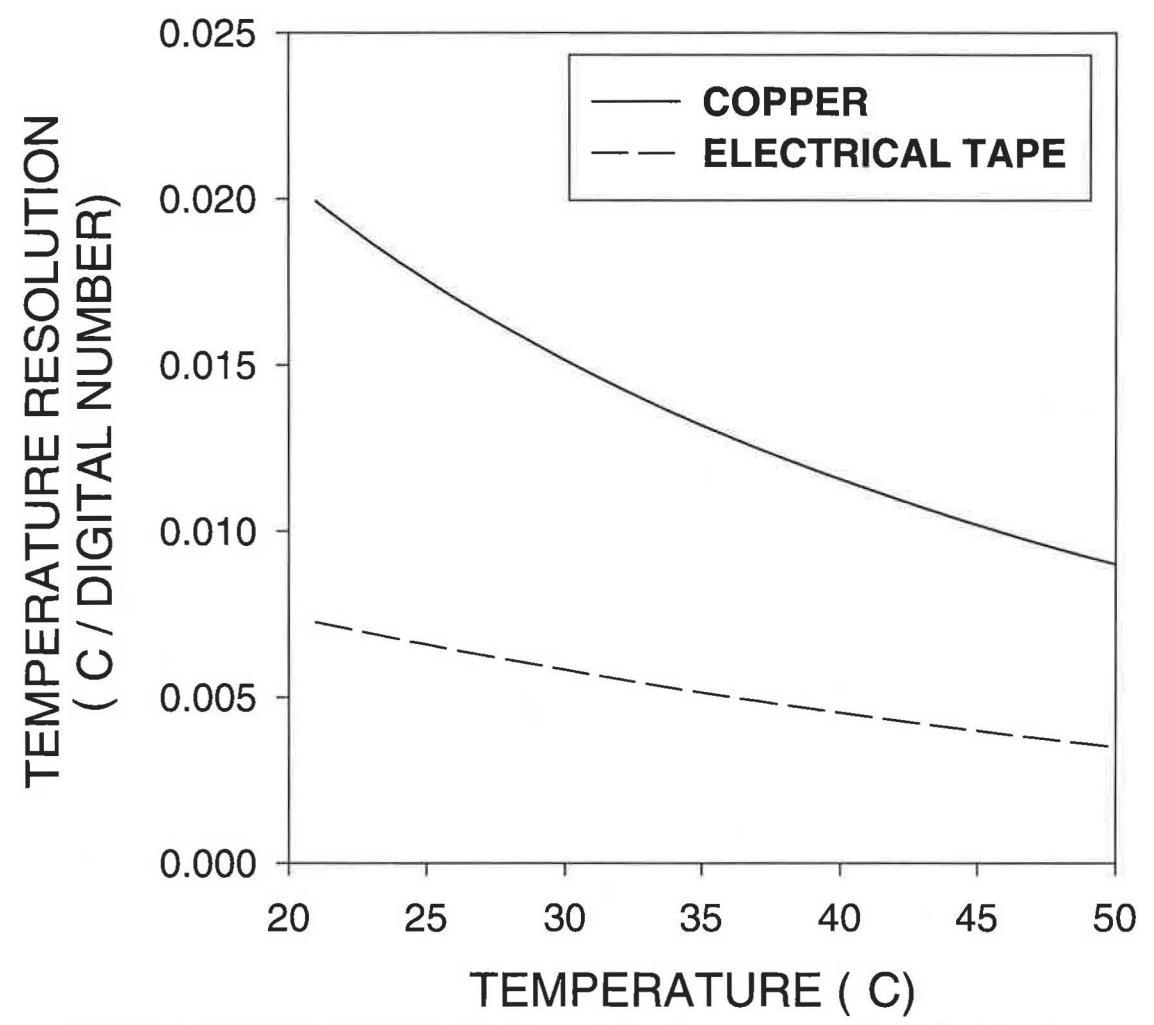
Figure 3: Plot of the estimated camera resolution for copper and black electrical tape.

The IR-FPA was first calibrated so that digital numbers (DN) from the camera could be converted to temperatures. Since the camera measures the temperature through the intensity of the infrared light reaching the detector, the approximate emissivity of the surface to be imaged should be known (7). A calibration was done for both copper ( $\varepsilon = 0.38$ ) (8) and black electrical tape ( $\varepsilon = 0.95$ ) (9). The experimental data was taken at an ambient temperature of 24°C. The temperature resolution of the IR-FPA for copper and black electrical tape as a function of temperature was derived from a quadratic approximation of the temperature calibration, and is shown in Figure 3. The temperature resolution is dependent upon both the temperature of the object and its emissivity. The difference in emissivity of copper and black electrical tape results in more than a factor of two difference in the temperature resolution. This means that if the maximum temperature resolution is desired, an object's surface should have an emissivity near one, and that the object's temperature should be as high as possible.

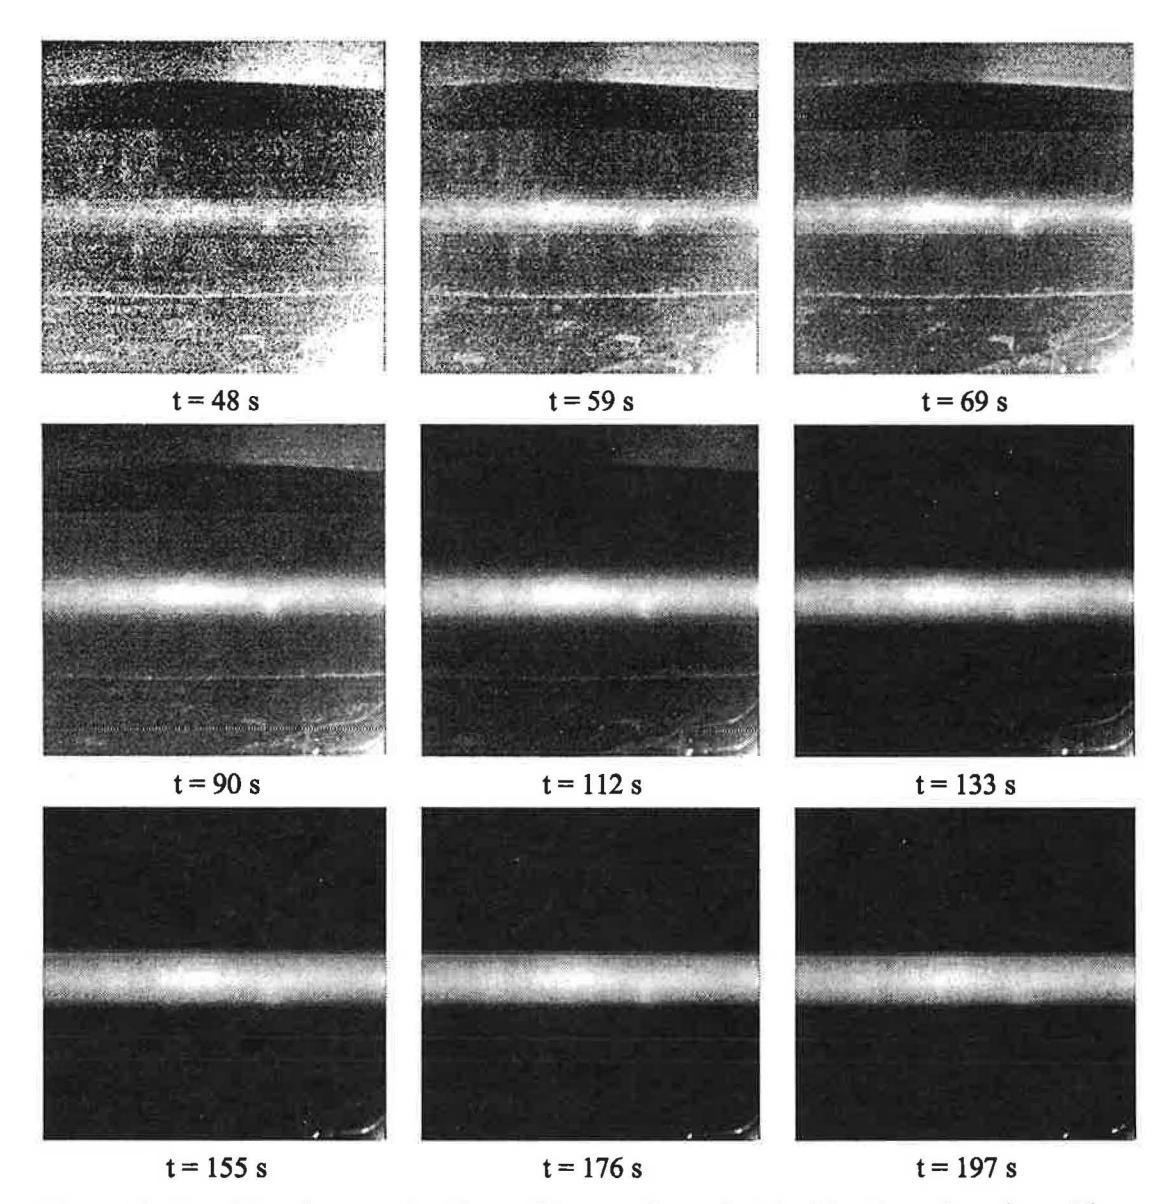
Figure 4: Resulting time varying thermal images from electrical heating of a rebar with no defects embedded 1.5 cm deep inside a test block of concrete.

shown in Figure 4. The thermal image times noted in the images are relative to the beginning of electrical heating. The observed temperature along the length of the control rebar is approximately constant, as expected. The slight variations seen in the pictures are probably due to the nonuniform nature of the concrete.

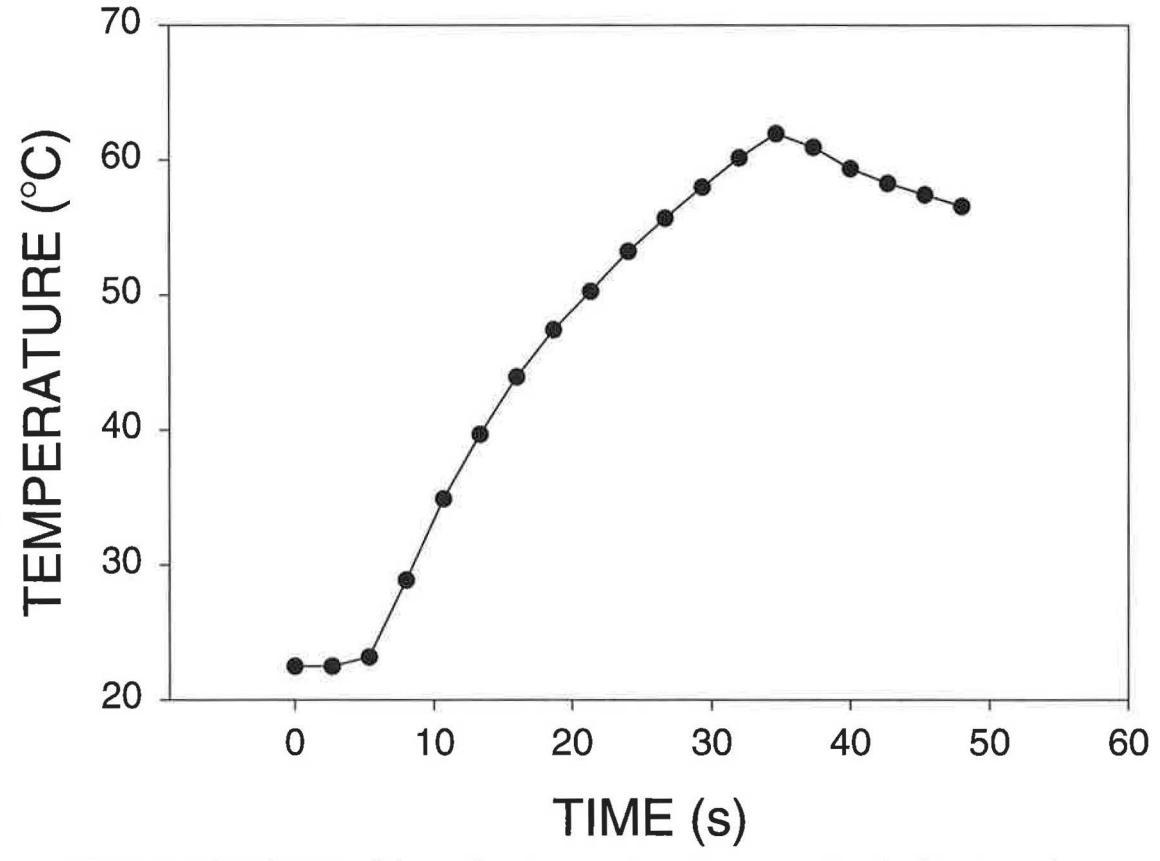
Figure 5: Time history of the surface temperature at cross-section A of the test rebar. Heating is seen to occur during the approximate time period 5–35 s.

for 30 s. At cross-section A, where the area is 60% of normal, the observed temperature increased from approximately 22° to 60°C, as shown in Figure 5. In Figure 6, temperature profiles along the exposed rebar are shown at four times during and after heating. At time t = 8 s, elevated temperatures are observed at cross-sections A and B. The maximum observed temperatures occur at time t = 32 s. The measured temperatures at cross-sections A, B, and C are approximately 15°, 7°, and 3°C greater, respectively, than neighboring undeformed portions of the rebar. The effects of thermal diffusion are apparent in the temperature profiles, as the temperature profile over the defects becomes less defined at later times. The increased "noise" in the temperature profiles at later times is attributed to variations in the surface finish of the rebar. An infrared image sequence of the unobscured rebar is shown in Figure 7.

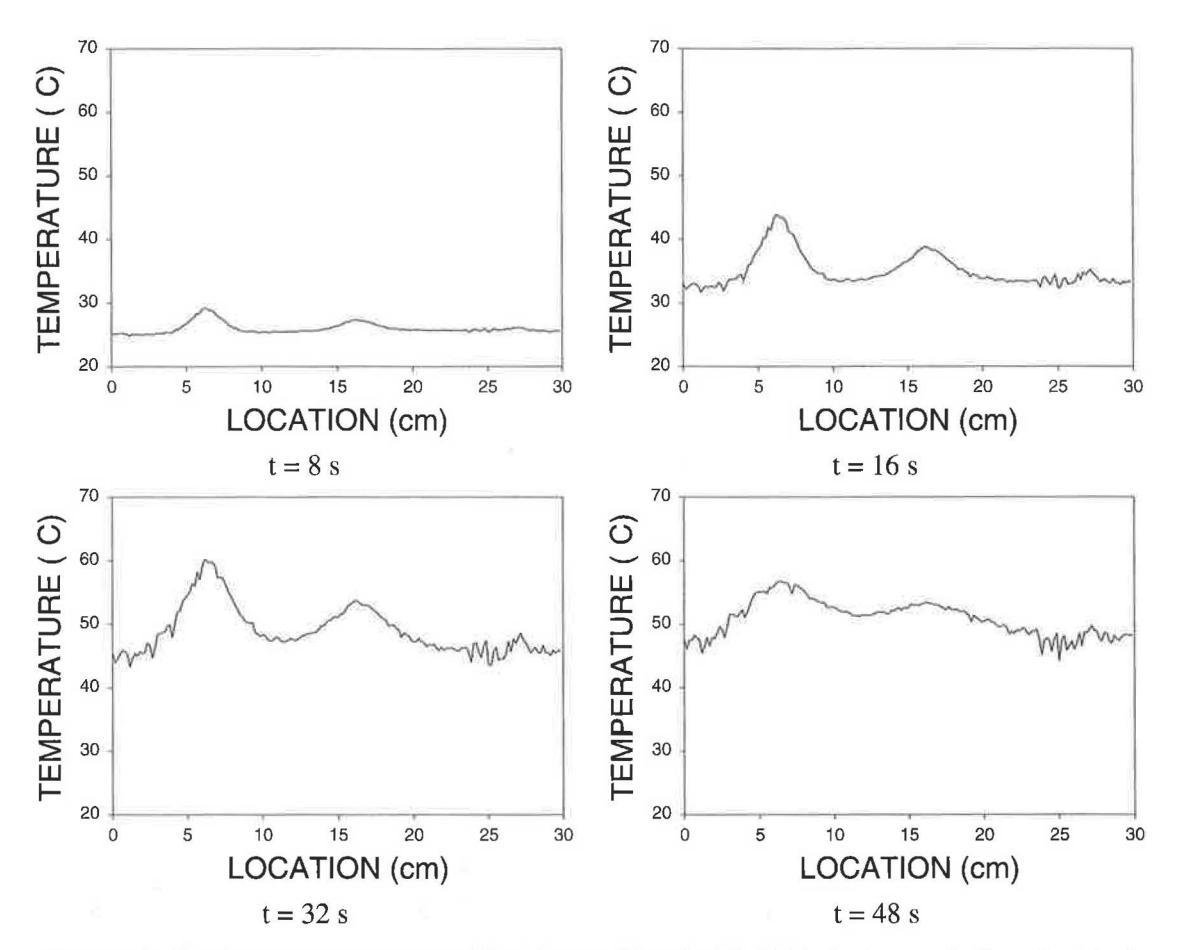
Figure 6: Surface temperature profiles observed by the IR-FPA during and after electrical heating of the exposed rebar. Heating occurred during the interval 0–30 s.

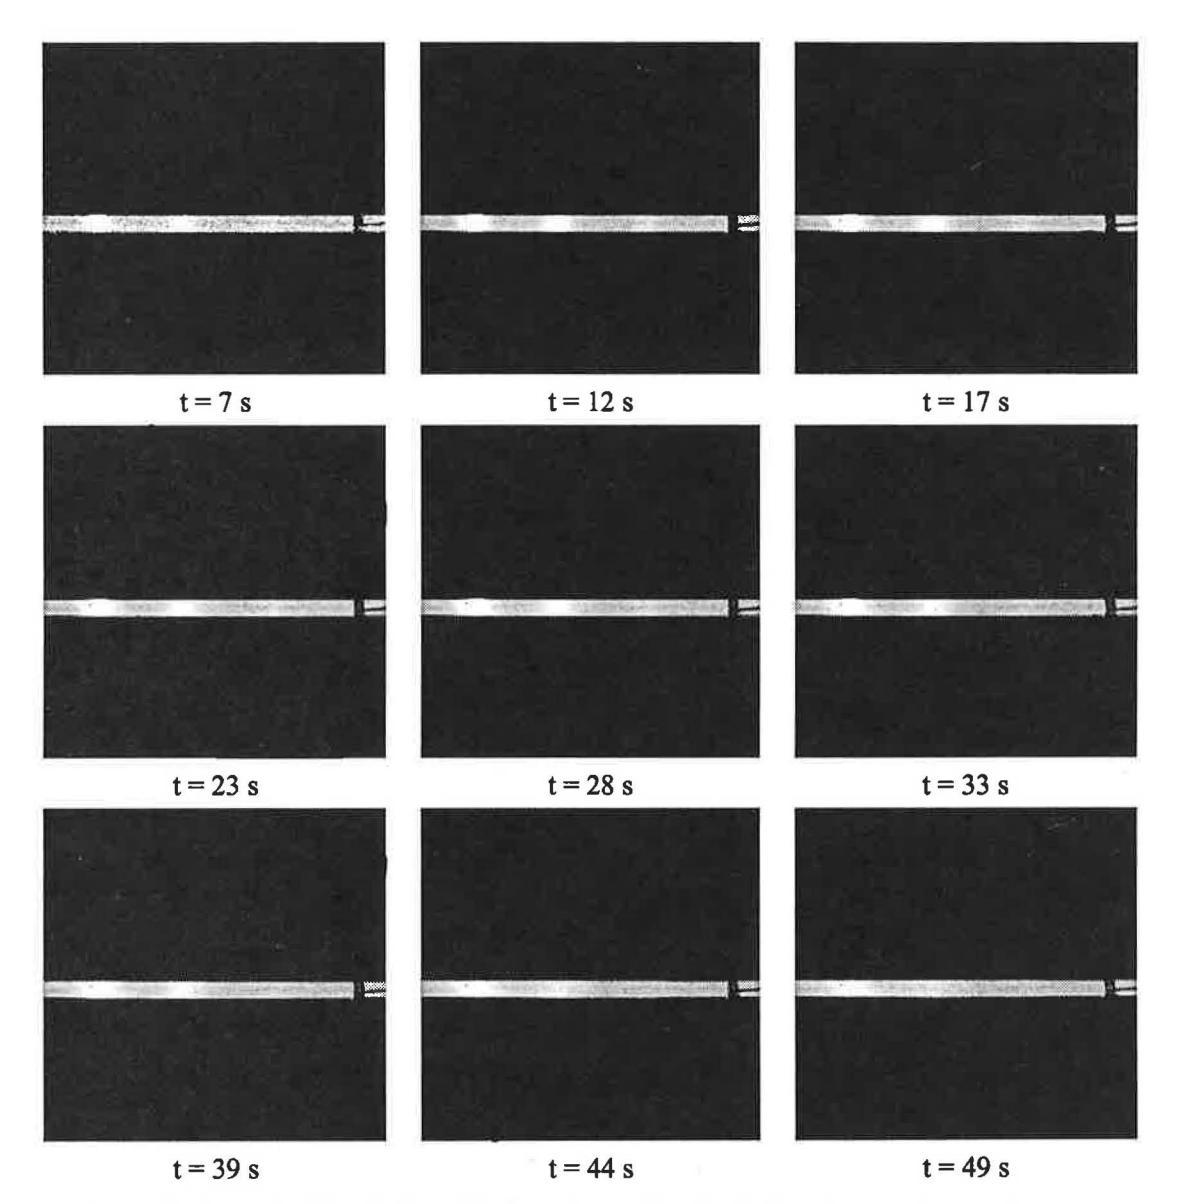
Figure 7: The resulting infrared images from electrically heating a rebar, with defects oriented away from the IR-FPA. Defect A is on the left.

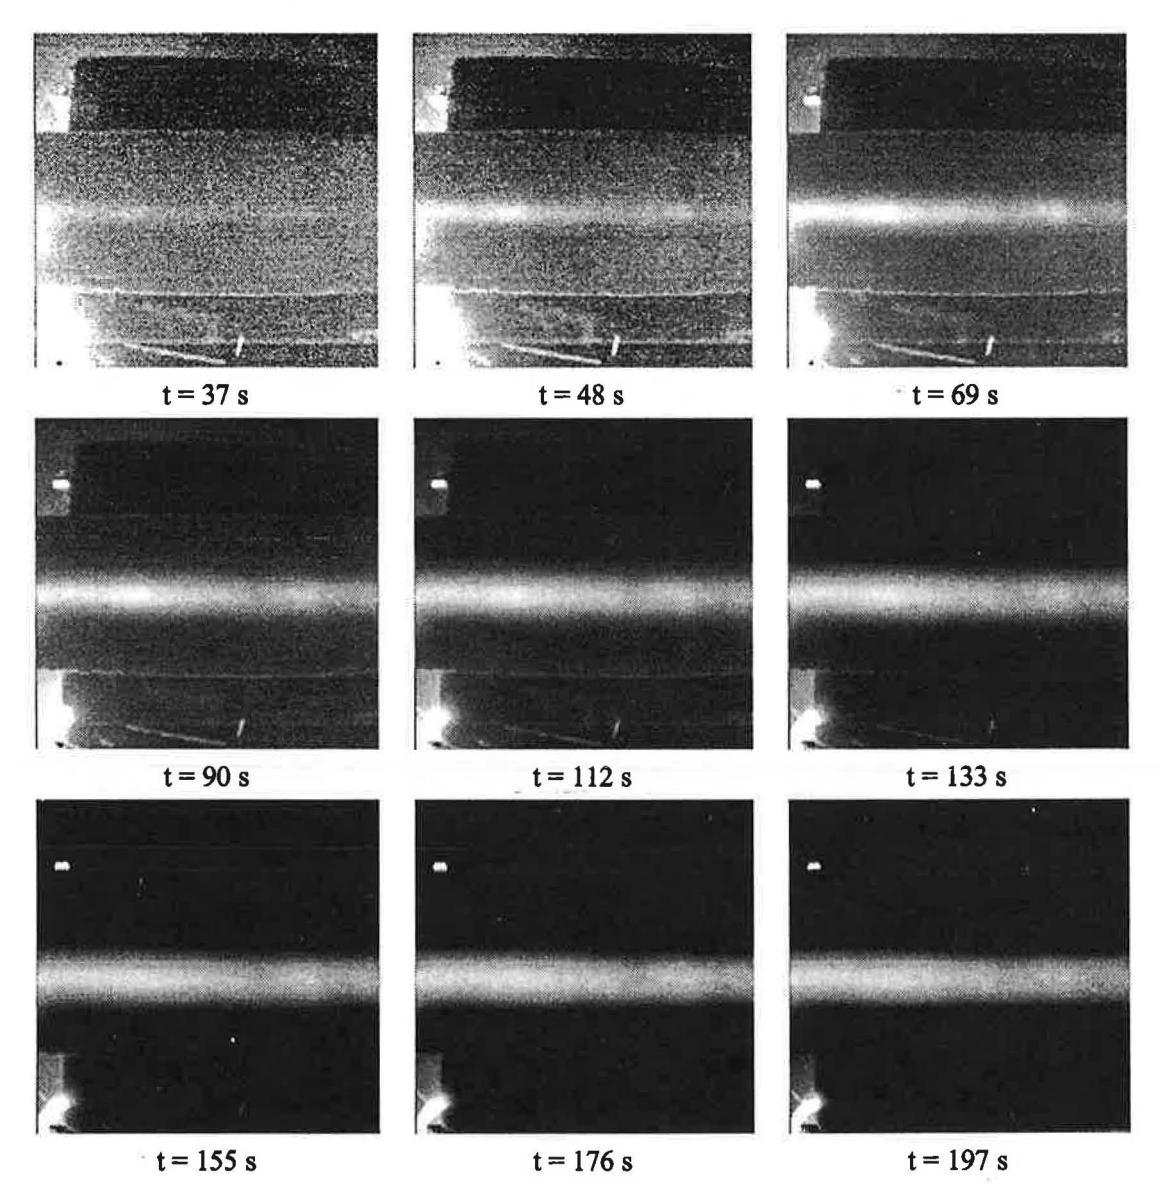
Figure 8: Resulting thermal images from electrical heating of a rebar with three defect depths, defect A to the left. The defect notches are oriented away from the camera 1.8 cm deep inside the test block of concrete.

The rebar with the three defects was then embedded in concrete with the defect regions filled with iron oxide paste. Two sets of thermal images were taken: one with the defects oriented away from the camera, the other with the defects facing toward the camera. The electrical power in both cases was 1230 W applied for 30 s. The thermal images collected for the embedded rebar with defects facing away from the camera are displayed in Figure 8. These defects are 1.8 cm below the surface of the concrete. Shown in Figure 9, is a surface temperature profile of the concrete above the rebar, with simulated defects oriented away from the IR-FPA, measured approximately 90 s after the beginning of heating. Only slightly higher intensities can be seen in the infrared images for cross-sections A and C. No apparent intensity variation can be seen in the vicinity of cross-section B. This is supported by the surface temperature profile in Figure 9. One possible factor for the defects not being clearly visible is the presence of air bubbles in the concrete near the rebar. When pouring the concrete into the form, the wet cement may not have been sufficiently agitated below the rebar to remove air bubbles. As previously mentioned, the presence of air bubbles would reduce the thermal conductivity of the concrete and inhibit the flow of heat from the rebar to the surface of the concrete.

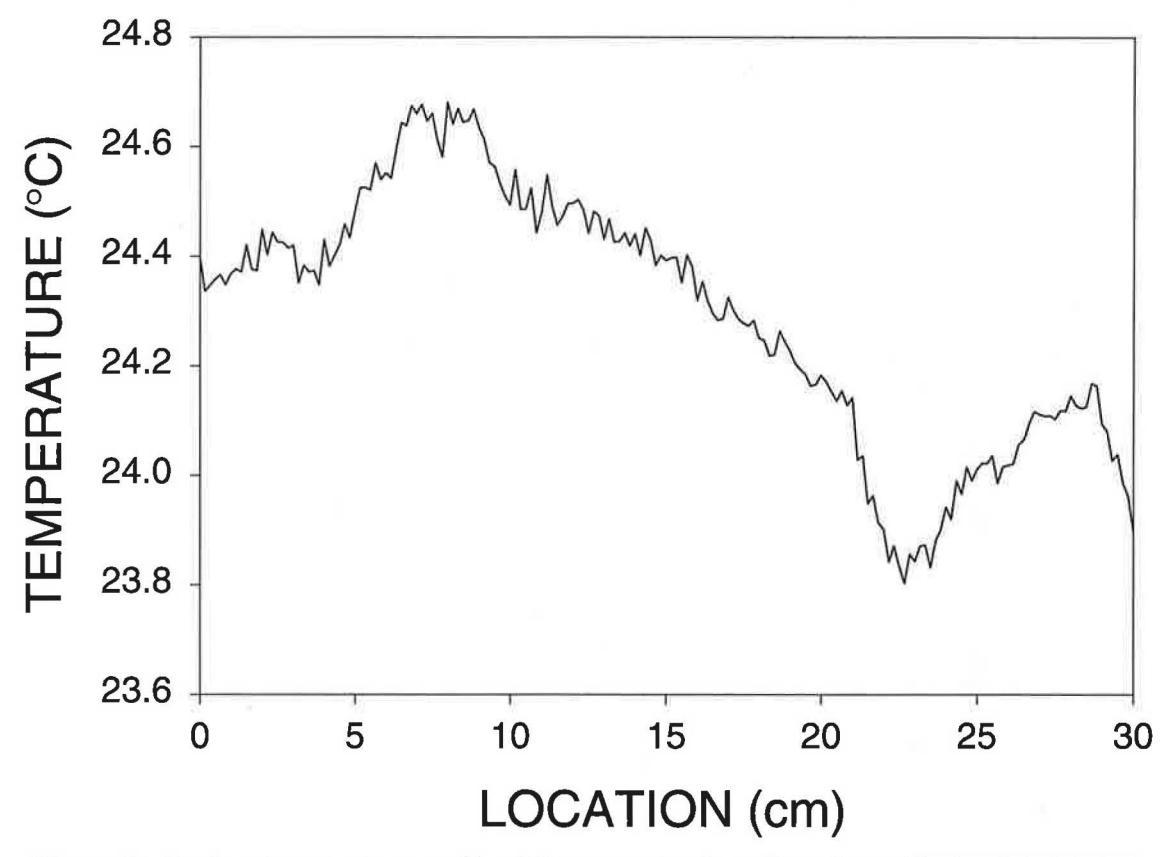
Figure 9: Surface temperature profile of the concrete above the rebar with simulated defects oriented away from the IR-FPA, approximately 90 s after the beginning of heating.

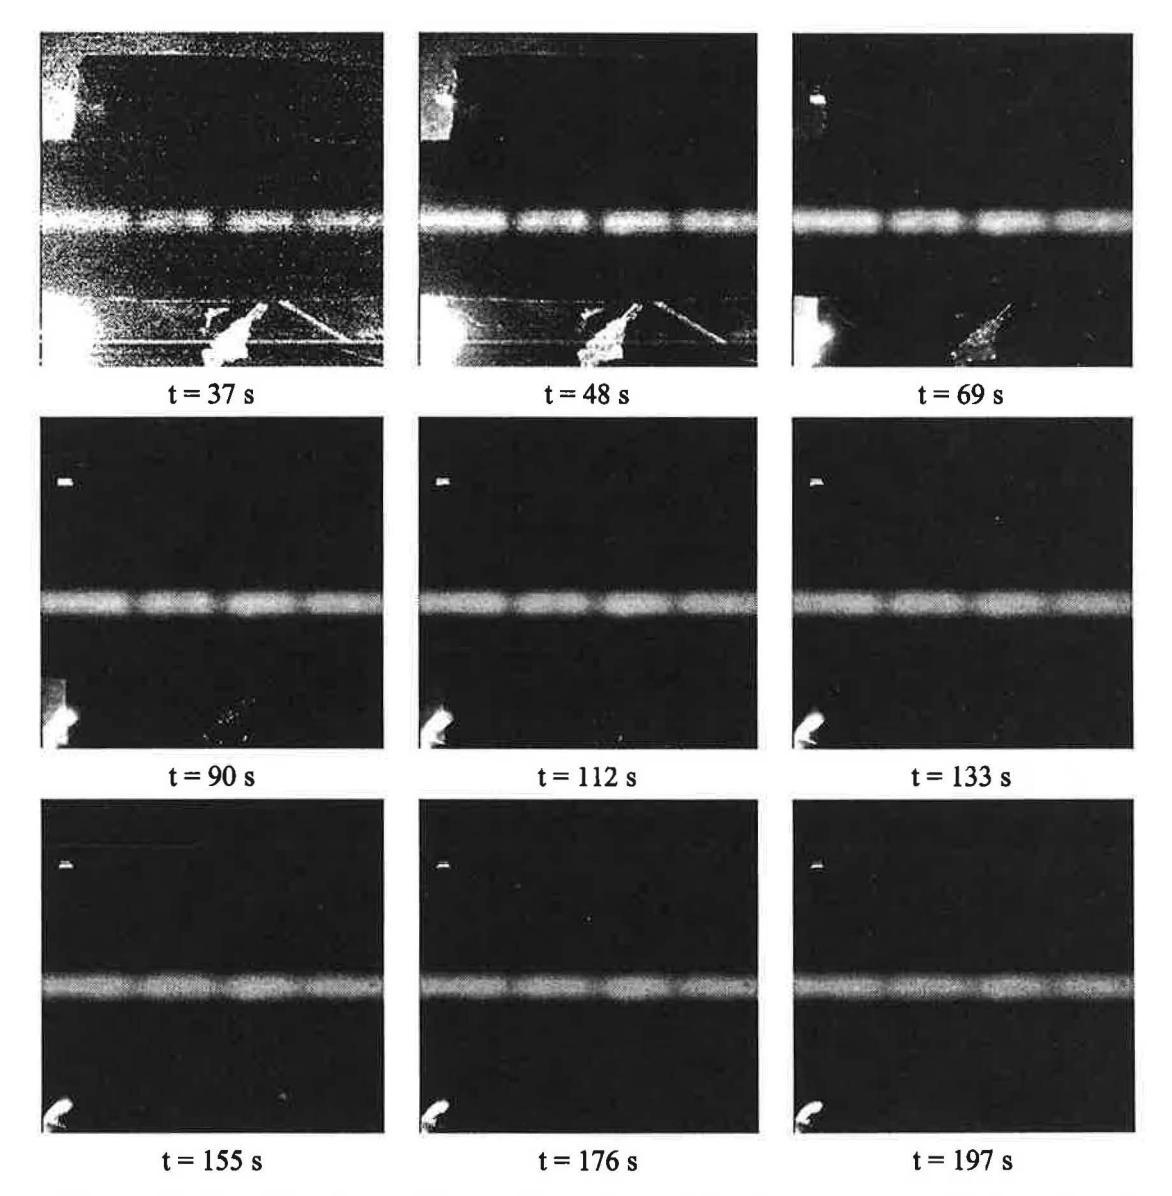
Figure 10: Resulting thermal images from electrical heating of a rebar with three defect depths with the defect notches oriented toward the camera buried 2.2 cm below the observed surface of the concrete. Defect A is on the left.

The thermal images collected for the embedded bar with defects facing toward the camera are displayed in Figure 10. These defects are 2.2 cm below the surface of the concrete. In this set of images, all three defects appear as dark (relatively cool) regions.

The defects are clearly evident in the image taken at time t = 37 s and remain visible for up to 3 minutes. Even cross-section C, 90% of normal cross-sectional area, is clearly visible during this time interval. Shown in Figure 11 is a surface temperature profile of the concrete above the rebar, with simulated defects oriented toward the IR-FPA, measured approximately 90 s after the beginning of heating. The three defects are clearly visible in the temperature profile. Temperature differentials between the concrete over the defects and adjacent concrete are in the range of 0.50–0.75°C. The reason all three defects show up as cooler areas is the iron oxide paste, with its relatively low thermal conductivity, impedes heat flow from the rebar to the concrete surface.

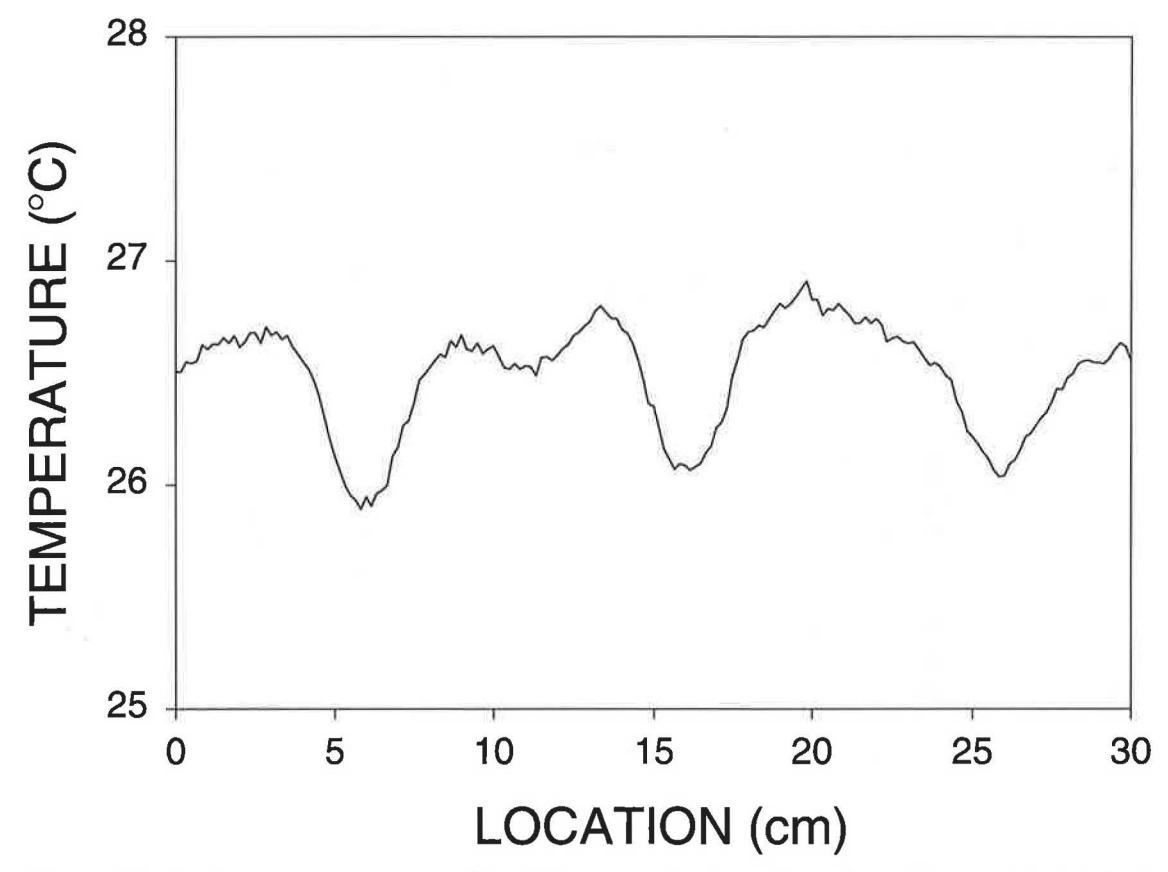
Figure 11: Surface temperature profile of the concrete above the rebar with simulated defects oriented toward the IR-FPA, approximately 90 s after the beginning of heating.

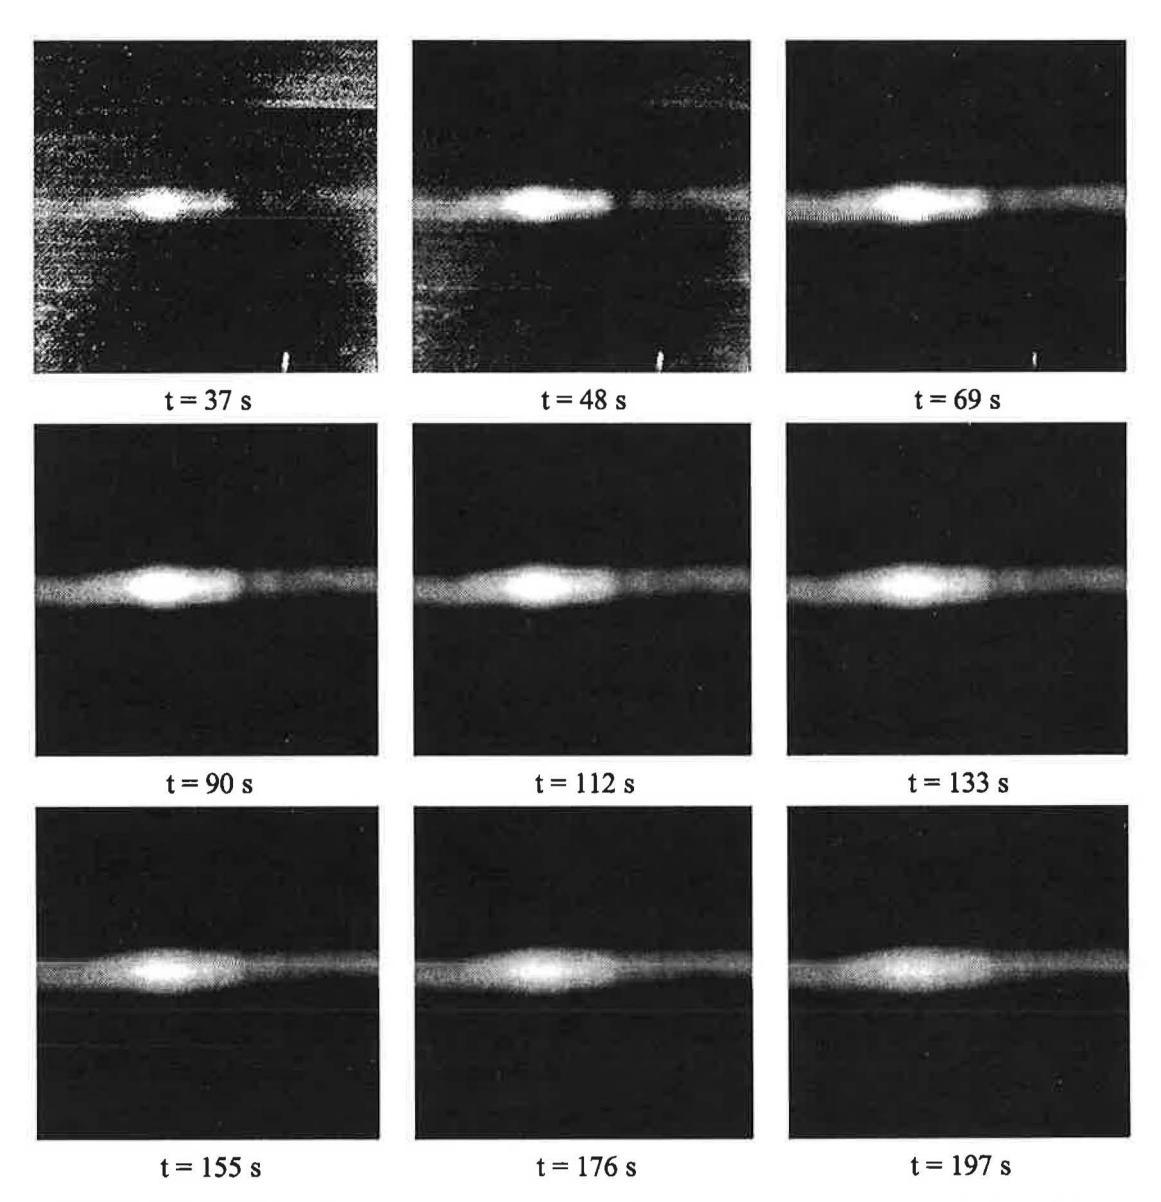
Figure 12: Resulting thermal images from electrical heating of a rebar with four defect orientations buried 1.1 cm below the surface of the concrete.

orientation is in the imaging plane, we believe thermal diffusion from the heated portion of the defect is being negated by the relative cool of the corrosion products in the defect. This results in what appears to be a "normal" image.
