APPENDIX D

RECTANGULAR BEAM SUMMARIES—STRANDS A&B

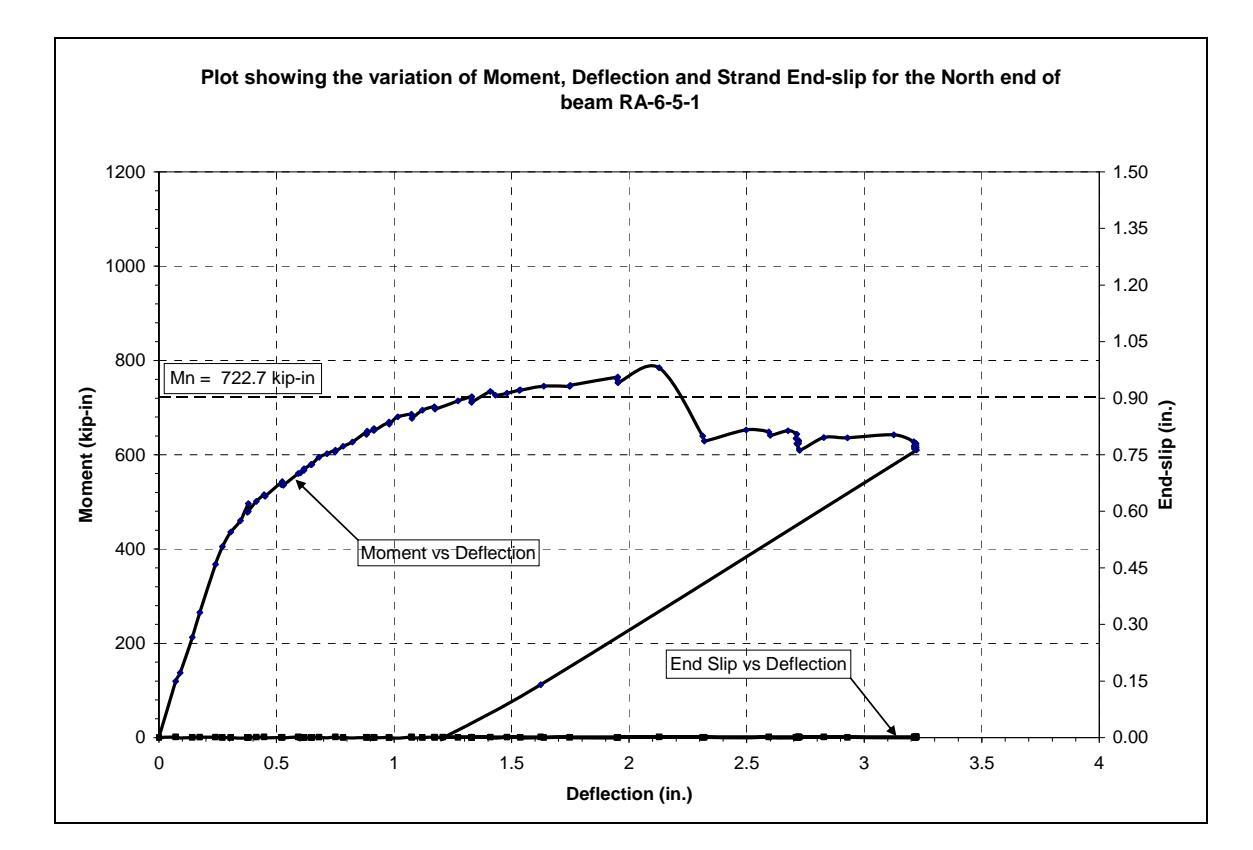
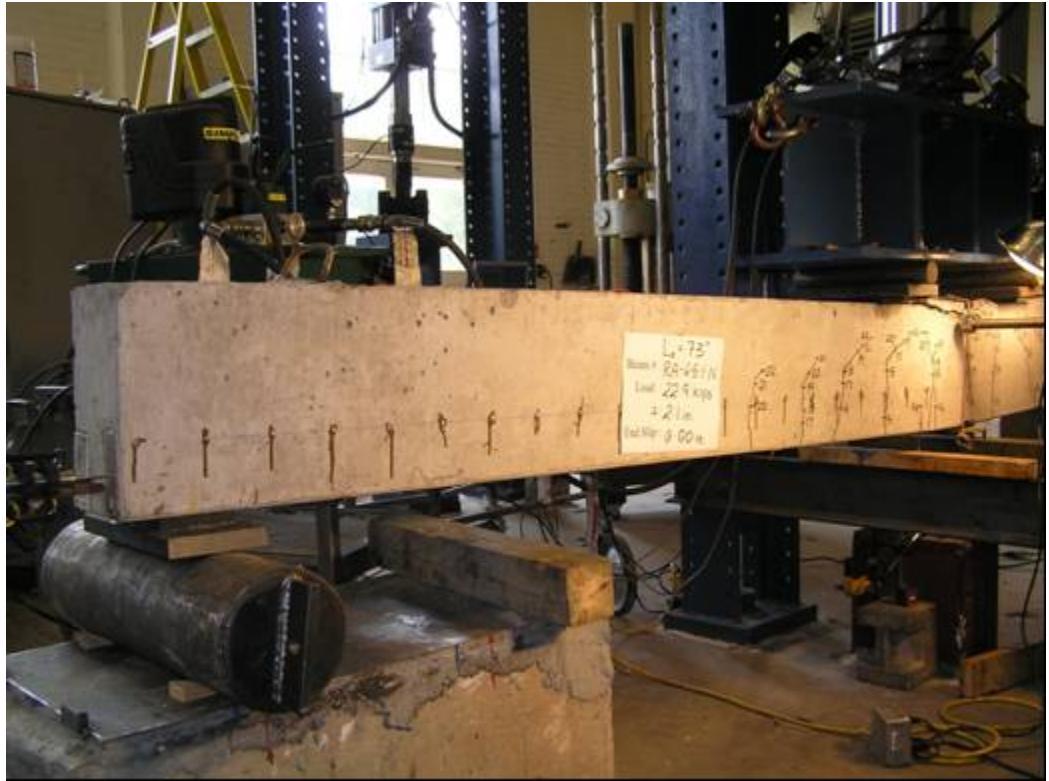
Cracking pattern for Beam RA-6-5-1 being loaded at North end

Cracking pattern included 11 cracks in the central 66 in. span. First flexural crack was noted at 52 in. from the North support. No inclined flexural crack was observed.

First flexural crack was observed at 13.7 kips at deflection of 0.3 in. Two pairs of symmetrically located cracks were seen at this load and deflection.

As the load reached 22.5 kips (1.9 in deflection), cracks lying between two point loads bifurcated near the top. Cracks were also audible from this and subsequent increments up to failure.

Concrete crushing failure was noted at 22.9 kips. (deflection = 2.1 in.). the beam was continued to be loaded till the deflection reached 3.0 in. End slip at both ends remained 0.000 in. throughout loading and unloading cycles.

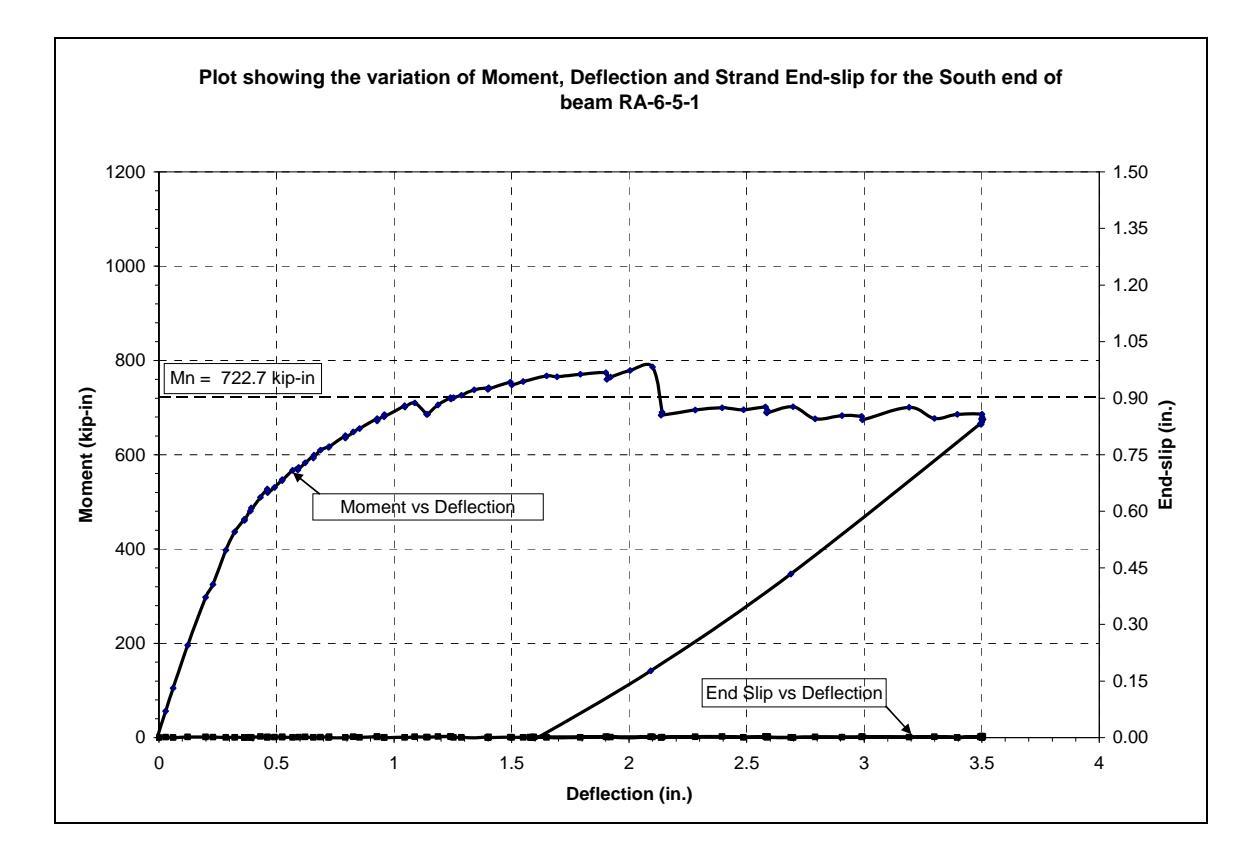
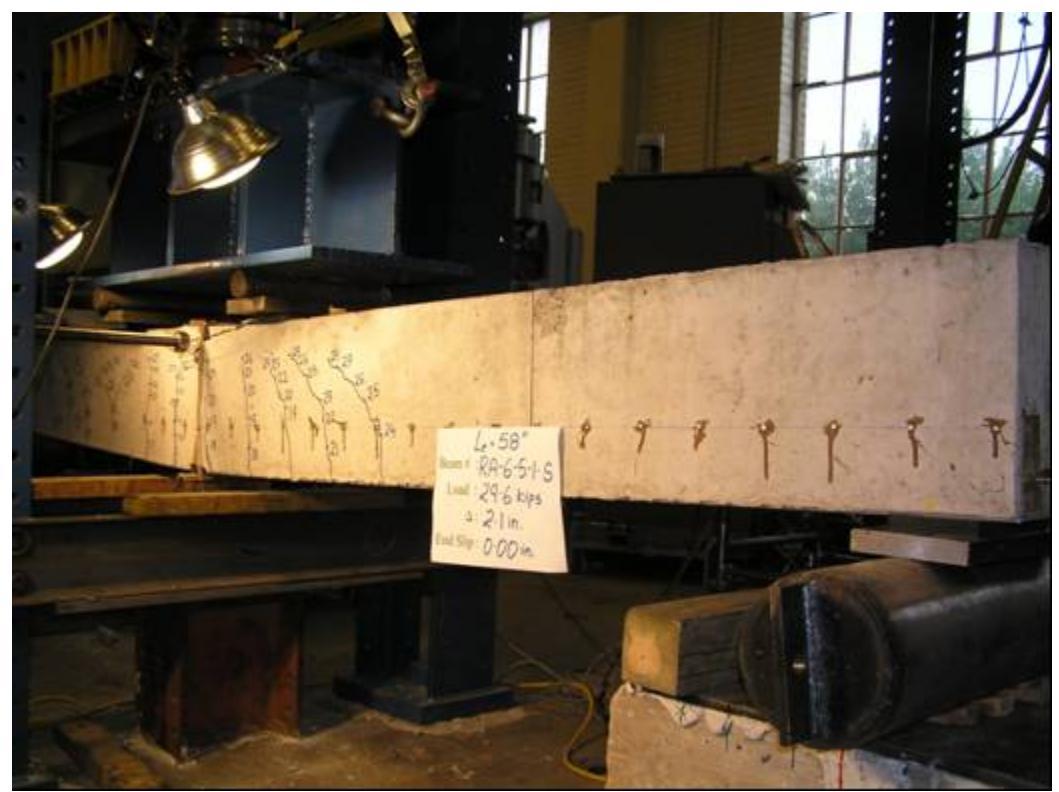
Cracking pattern for Beam RA-6-5-1 being loaded at South end

End-slip readings at both ends remained 0.000in. Cracking pattern included 9 cracks in the middle 50 in. span. First flexural crack was located at Stn. 44. No inclined flexural crack was observed.

First flexural crack was observed at 17.5 kips at deflection of 0.4 in. Two pairs of symmetrically located cracks were observed at the subsequent increment (load = 18.2 kips, deflection = 0.4 in.)

At 26.8 kips (deflection = 1.2 in.), concrete already crushed during North end testing started falling off, resulting in slight fluctuation of load. Cracking was audible at 29.1 kips (deflection = 1.9 in.)

Concrete crushing failure was noted at 29.6 kips (deflection = 2.1 in.) at the top surface of the concrete. Beam was loaded till deflection reached 3.5 in and then completely unloaded.

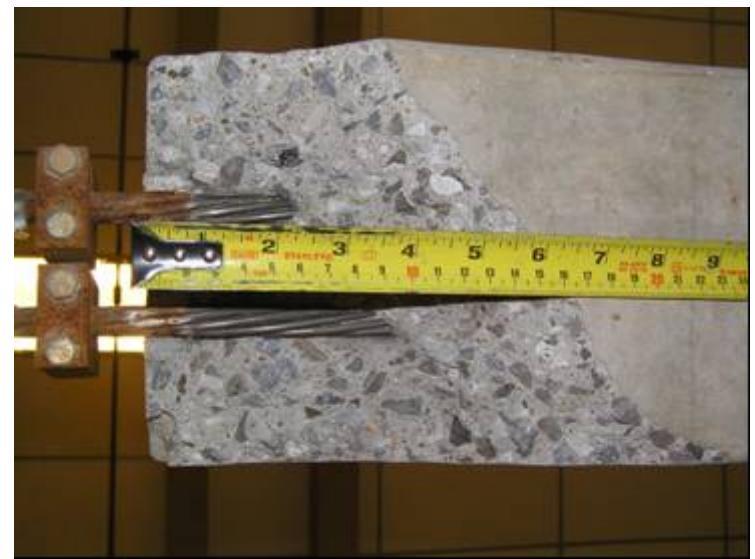
Damage caused during transportation at the North end (bottom).

Before starting the test it was discovered that the region of concrete below the strands at the North end was damaged and the strands were exposed from under up to about 2.25 in. (East) and 3.75 in (West). Support point was fixed at 11 in. (instead of 4 in.) from the North end. To adjust the symmetry the constant moment region was changed from 24 in. to 27 in. and the total span was kept 120 in.

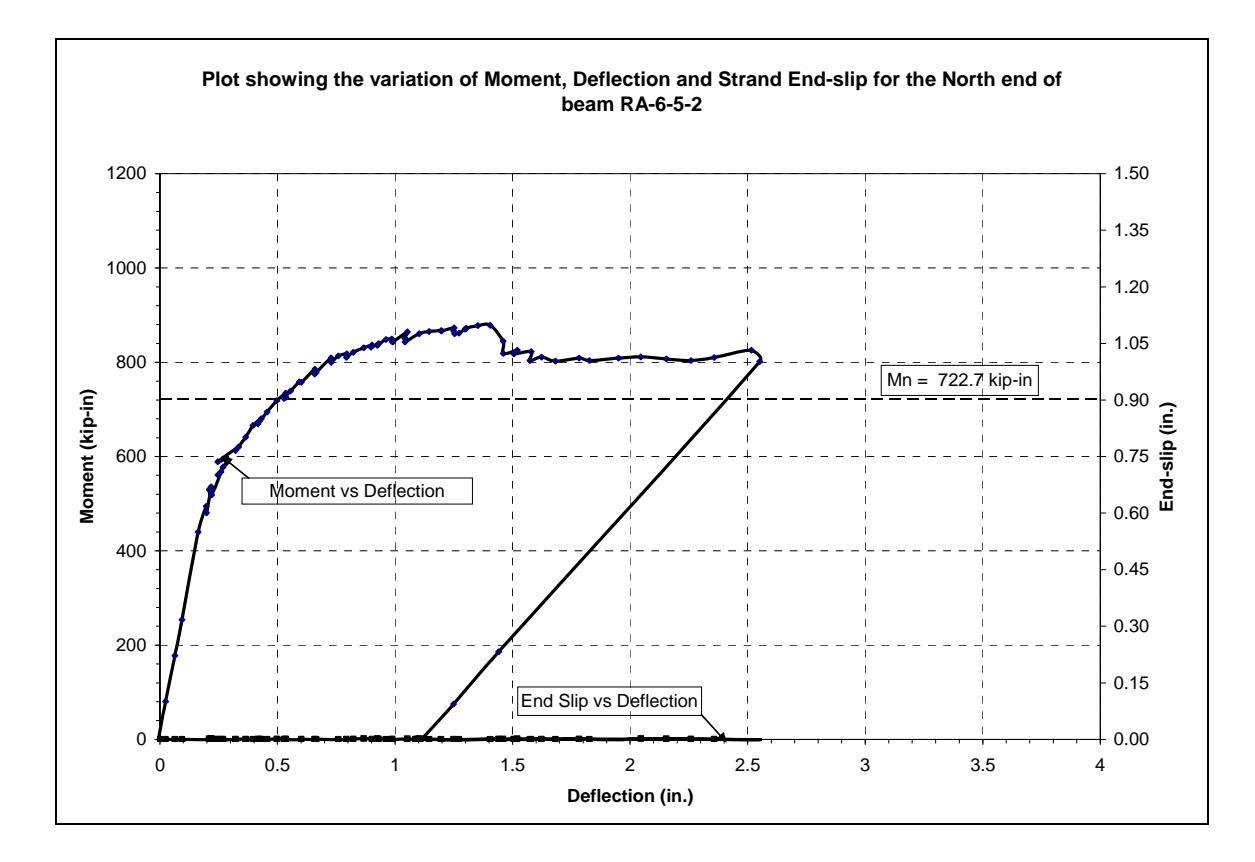
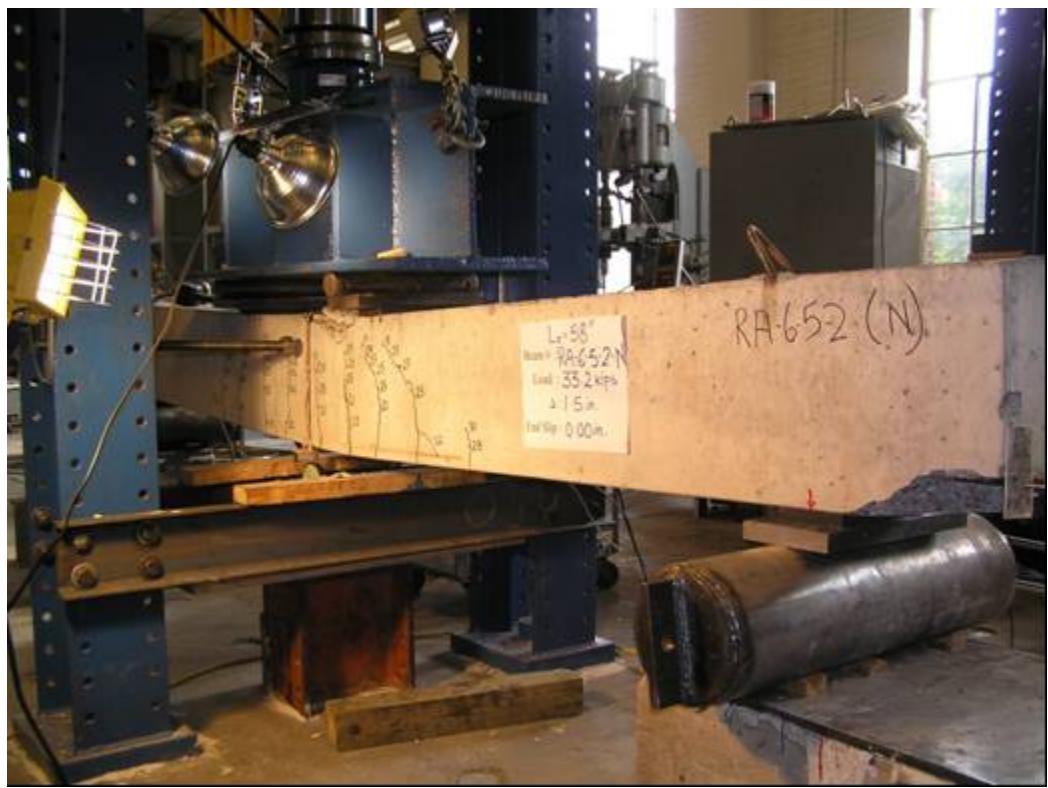
Cracking pattern for Beam RA-6-5-2 being loaded at North end

Cracking pattern demonstrated 9 cracks in the middle 50 in. span with average crack spacing = 6.3 in. Width of central crack at maximum deflection (2.5 in.) was $3/8^{\text{th}}$ in. First flexural crack was observed at Stn. 43 from the North end.

First flexural crack was observed at 20.0 kips at deflection of 0.1 in. First flexural cracks were formed in two pairs located symmetrically about the two point loads.

Cracking was audible at 29.1 kips (deflection = 0.6 in.). Beyond this load, at all further increments cracking was audible. Concrete crushing was noted at the load of 33.2 kips (deflection 1.4 in.) at the top surface of concrete. Crushing of concrete was violent with considerable spalling of concrete.

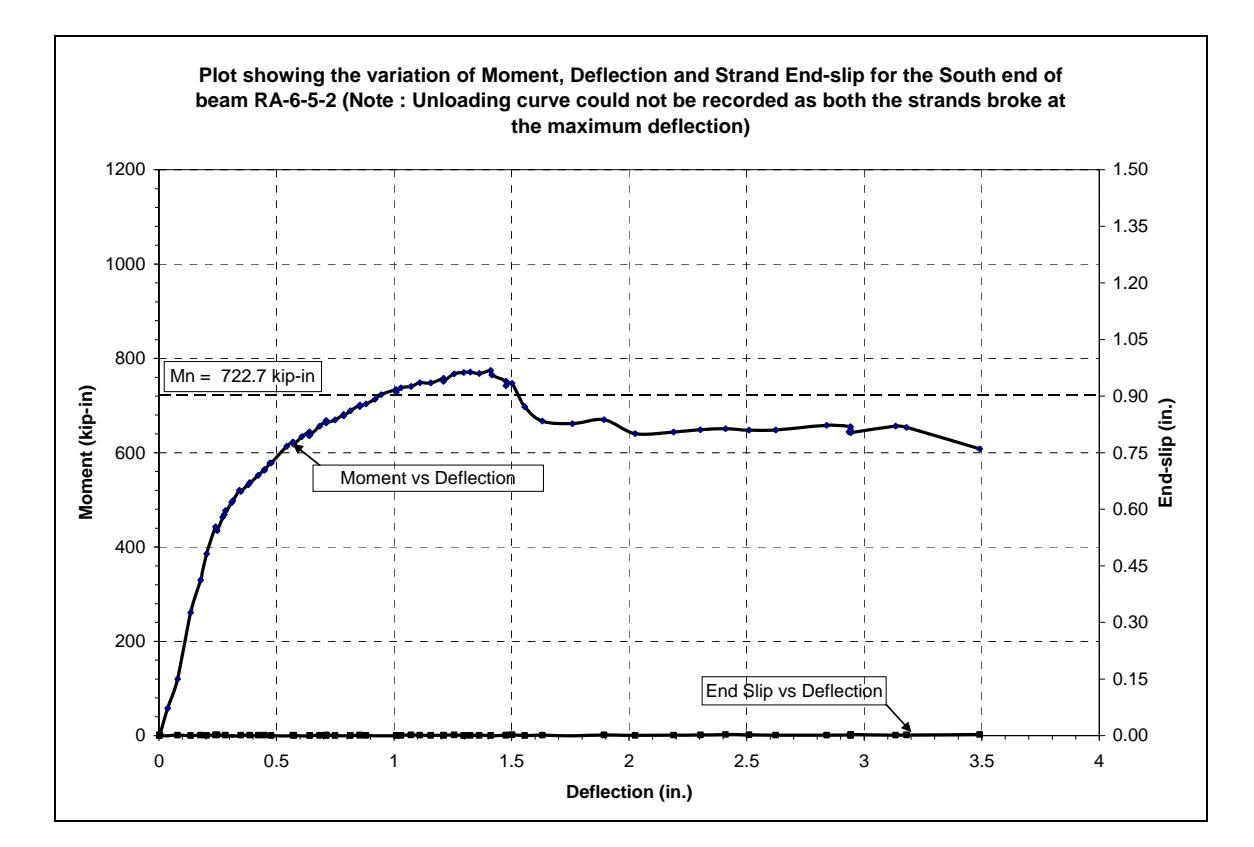
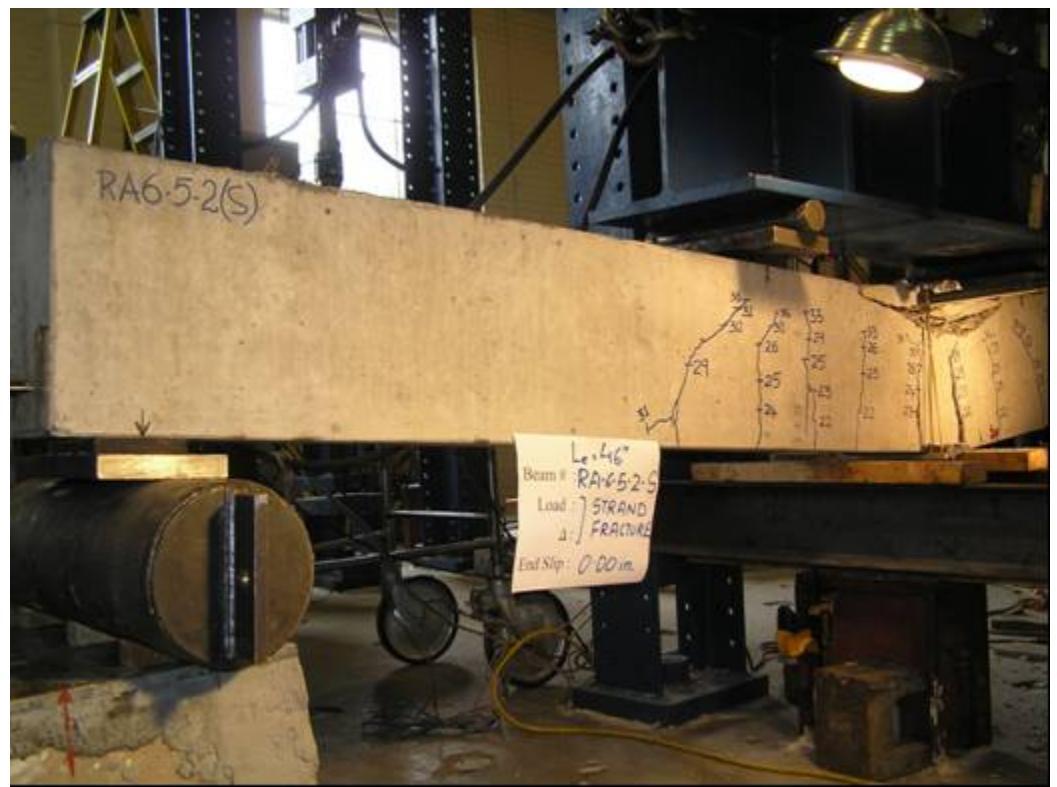
Cracking pattern for Beam RA-6-5-2 being loaded at South end

Cracking pattern included 9 cracks in middle 59 in span with average crack spacing = 6.6 in. First flexural crack was located at Stn. 37 from the South end.

First flexural crack was observed at 22.7 kips at deflection of 0.3 in. First flexural cracks were observed in two pairs located symmetrically about the two point loads. Central crack was formed at the net increment (Load = 23.8 kips. deflection = 0.4 in.).

Concrete crushing failure was noticed at the load of 37.0 kips and deflection 1.5 in. Crushed concrete became loose and started falling apart rapidly at the deflection of 1.9 in.

Deflection increments were continued up to strand fracture. Fracture was observed at the deflection of 3.3 in.

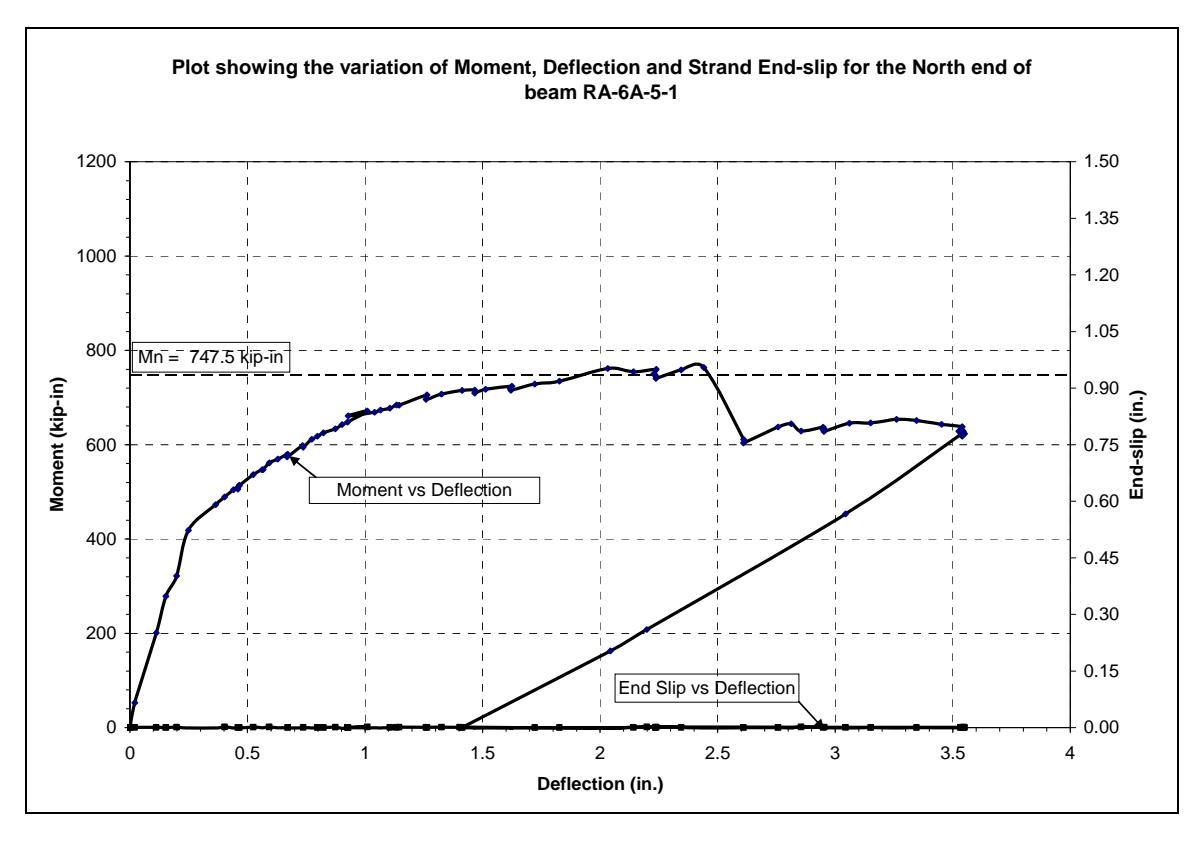
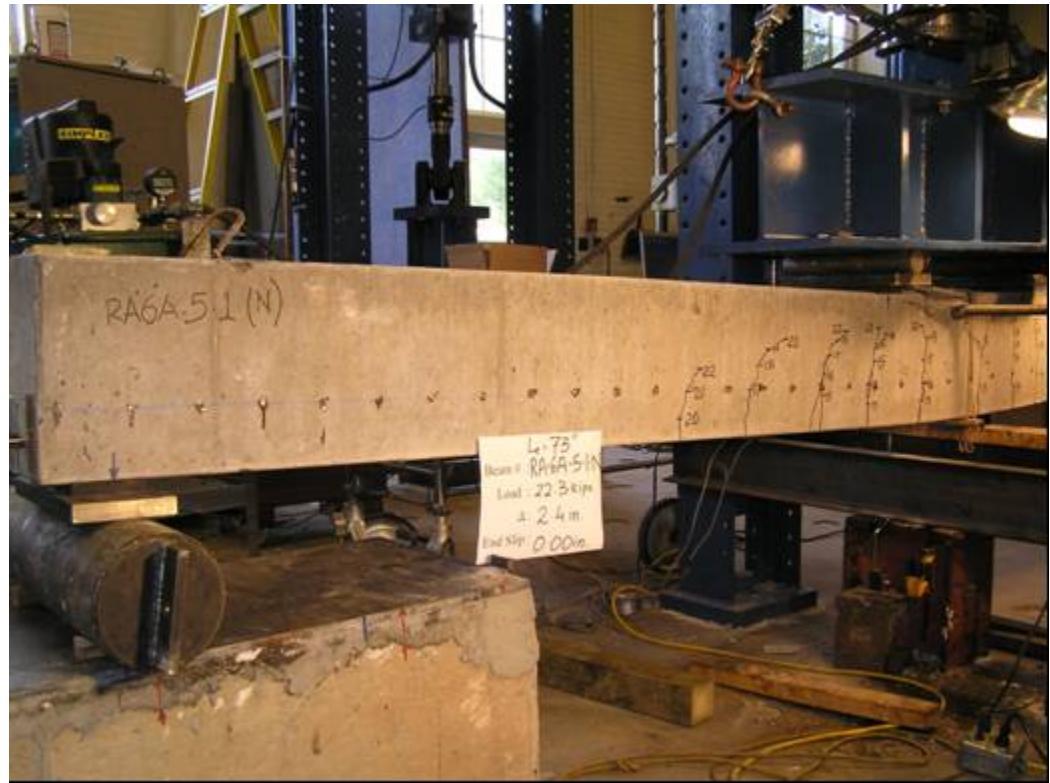
Cracking pattern for Beam RA-6A-5-1 being loaded at North end

The cracking pattern included 11 cracks in the middle 74 in. span. With average crack spacing = 7.4 in. First flexural crack was observed at Stn. 47. from the North end.

First flexural crack was observed at 12.8 kips at deflection of 0.3 in. First flexural cracks occurred in two pairs located symmetrically about the two point loads.

Cracks in the region between the two point loads started bifurcating near the top surface at the load of 20.2 kips (deflection = 1.2 in.) Audible cracks were observed at 22.1 kips (deflection = 2.3 in.) and finally concrete crushing failure occurred at 22.4 kips (deflection = 2.4 in.)

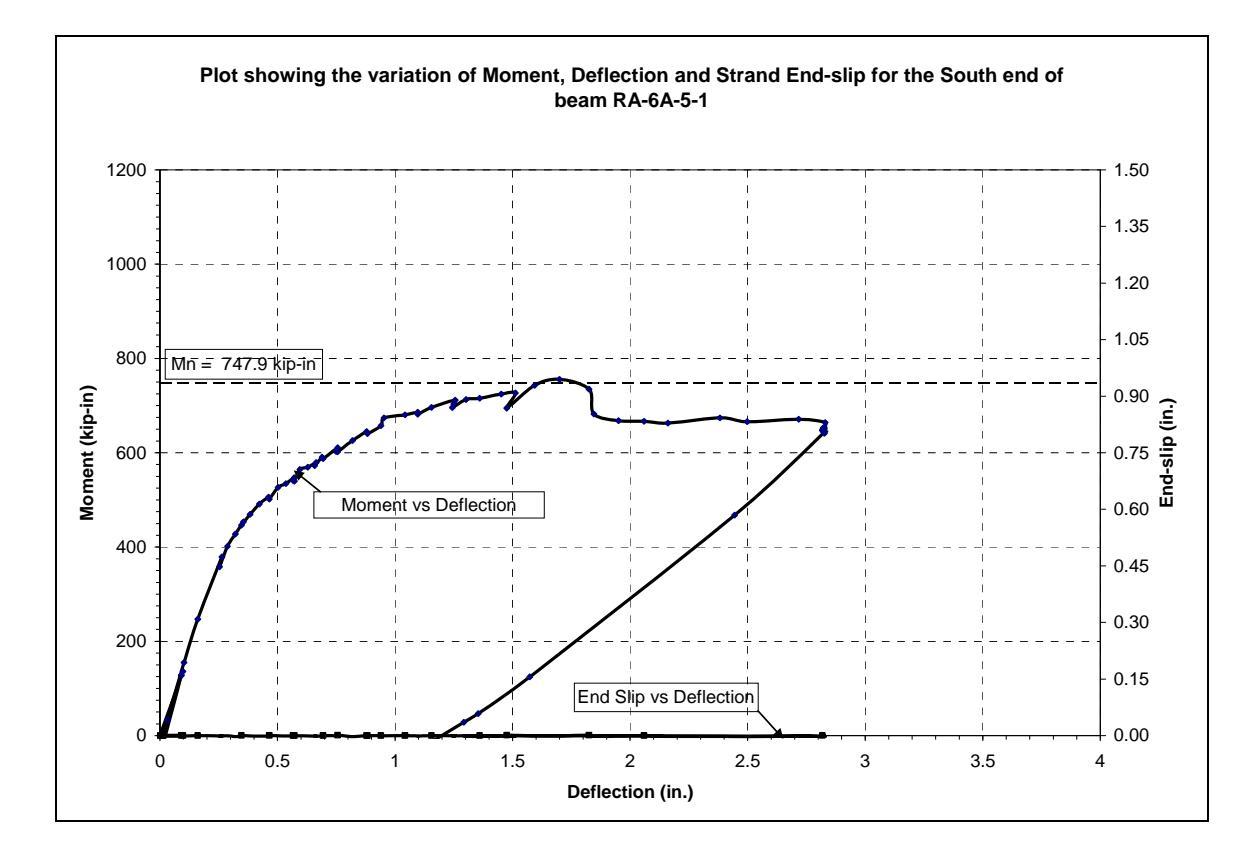
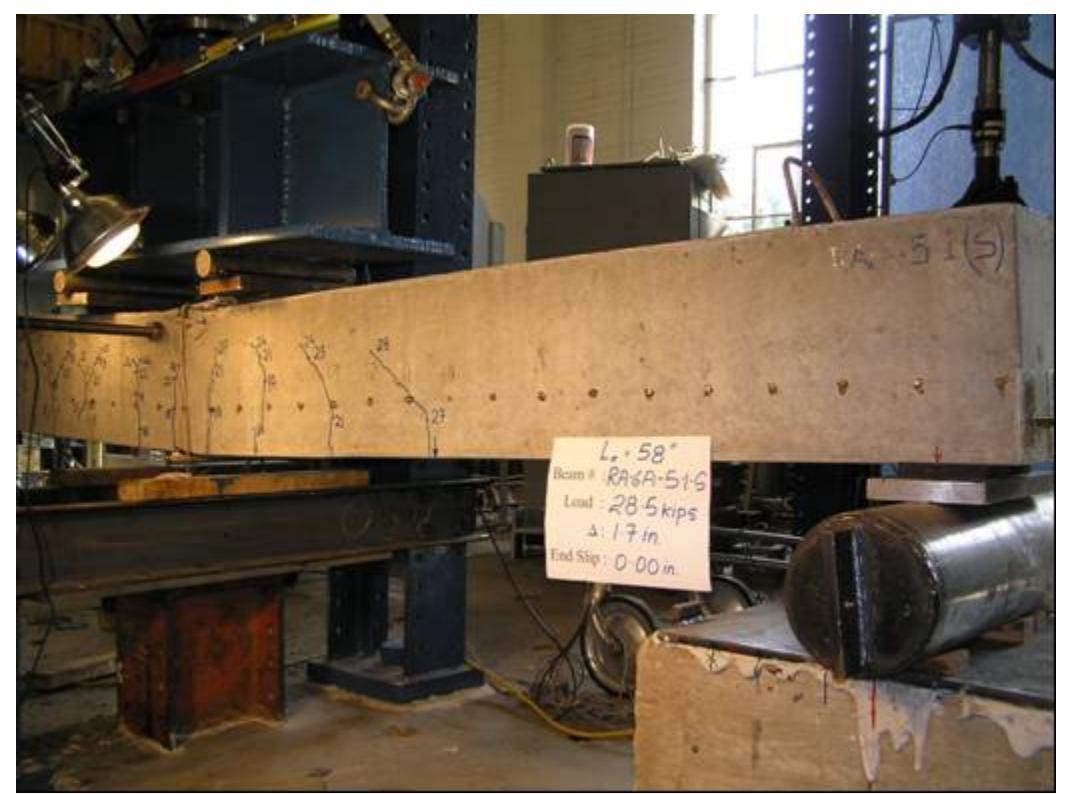
Cracking pattern for Beam RA-6A-5-1 being loaded at South end.

Pattern of cracking included 9 cracks in the middle 66 in. span with average crack spacing of 8.25 in. The first flexural crack was located at Stn. 39 from the South end.

First flexural crack was observed at 18.0 kips at deflection of 0.4 in. First flexural cracks were formed as a pair symmetrically located cracks about the two point loads. The second pair of cracks was observed just at the next increment (load = 18.5 kips. 0.4 in.).

At the load of 28.1 kips (deflection = 1.0 in.) the cracks became clearly audible. Cracking sound became louder at the load of 28.5 kips (deflection = 1.6 in.).

Finally concrete crushing failure was observed at the load of 28.6 kips (deflection = 1.7 in.). The deflection was continued to be incremented up to total deflection of 2.7 in.

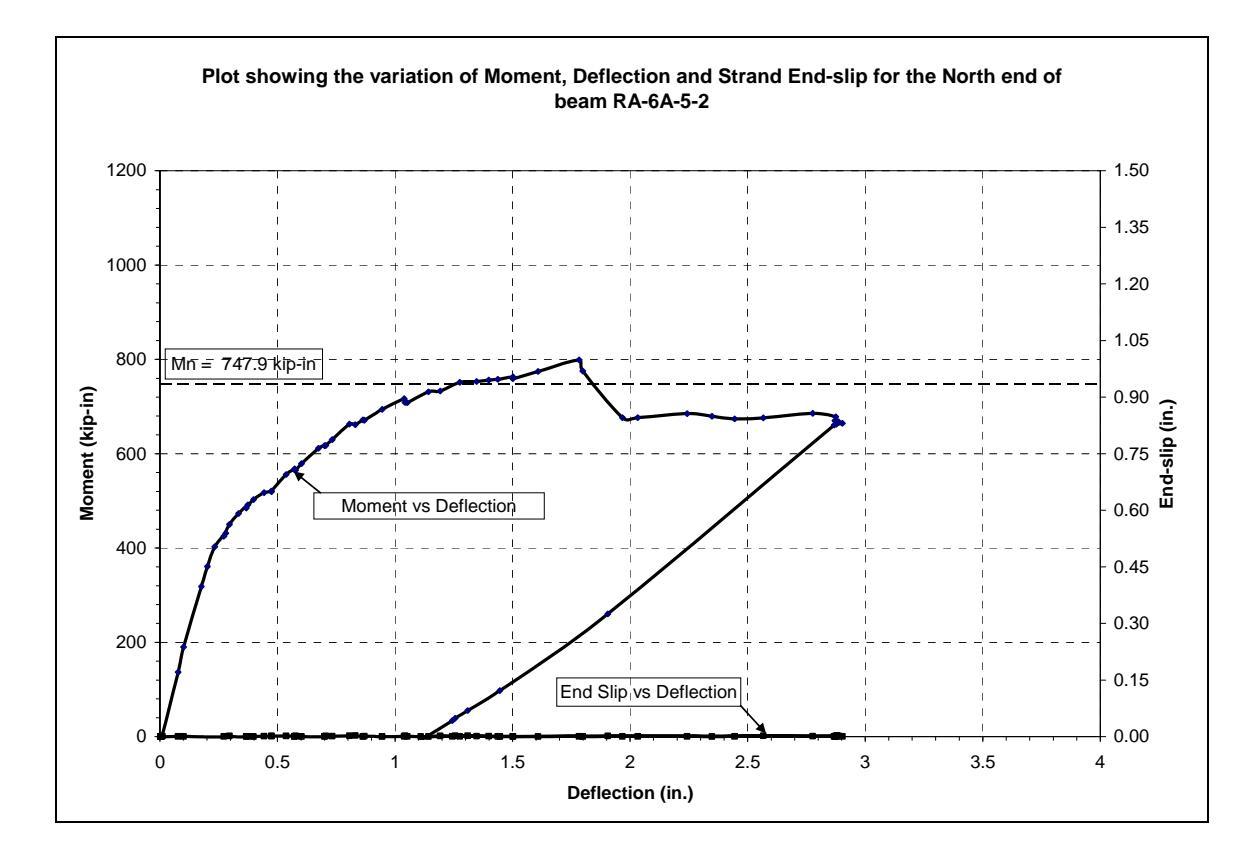
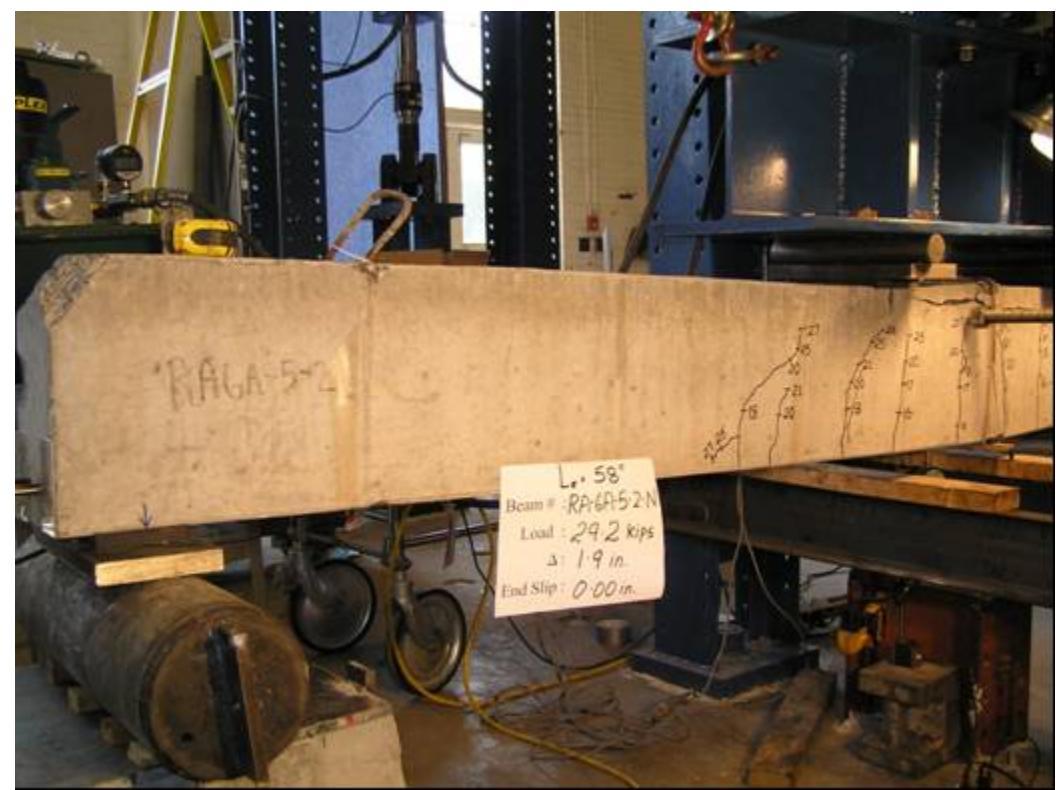
Cracking pattern for Beam RA-6A-5-2 being loaded at North end

Cracking pattern included 8 cracks in middle 50 in span. First flexural crack was noted at Stn. 42 from the North end. End-slip at both the ends remained at 0.00 in. No inclined flexural cracks were observed.

First flexural crack was observed at 16.5 kips at deflection of 0.3 in.

Cracks became audible at the load of 27.8 kips. (deflection = 1.3 in.). Flexural cracking was heard for a longer time at the load of 29.2 kips. (deflection = 1.8 in.)

Concrete crushing failure was observed at the load of 29.8 kips (deflection = 1.9 in.). Deflection was incremented up to total deflection of 2.8 in.

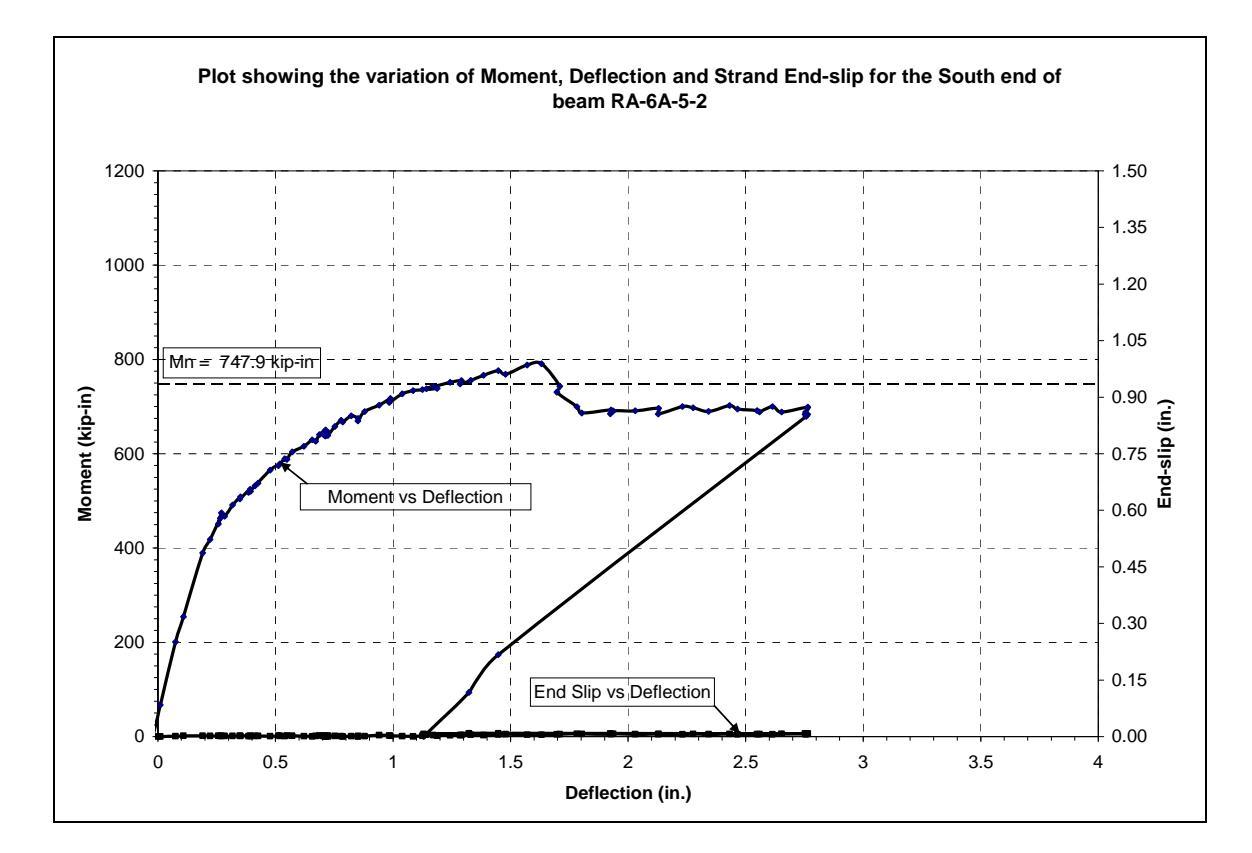
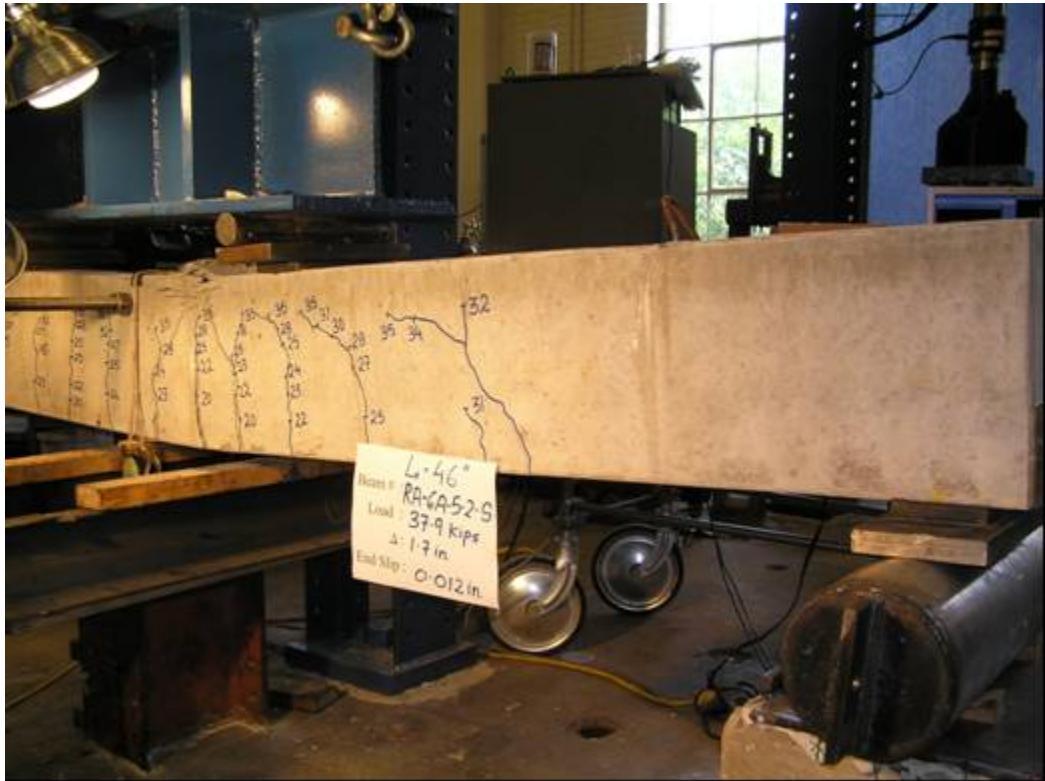
Cracking pattern for Beam RA-6A-5-2 being loaded at South end.

Cracking pattern included 11 flexural cracks in the middle 60 in. span. With average crack spacing of 6 in. Inclined flexural crack was observed at Stn. 26 from the South end.

At 33.1 kips. (deflection = 0.9 in.) a sudden inclined flexural crack was noticed at Stn. 26 from the South end.

Concrete crushing failure was observed at 38.1 kips. (deflection = 1.7 in) at the top surface. Concrete started spalling with every further deflection increment. Also it was noticed that only one of the central flexural crack was widening with each increment (final width at the highest deflection of 2.7 in. = $3/8^{\text{th}}$ in.)

Maximum end-slip = 0.01 in. End-slip at the North end remained 0.000 in.

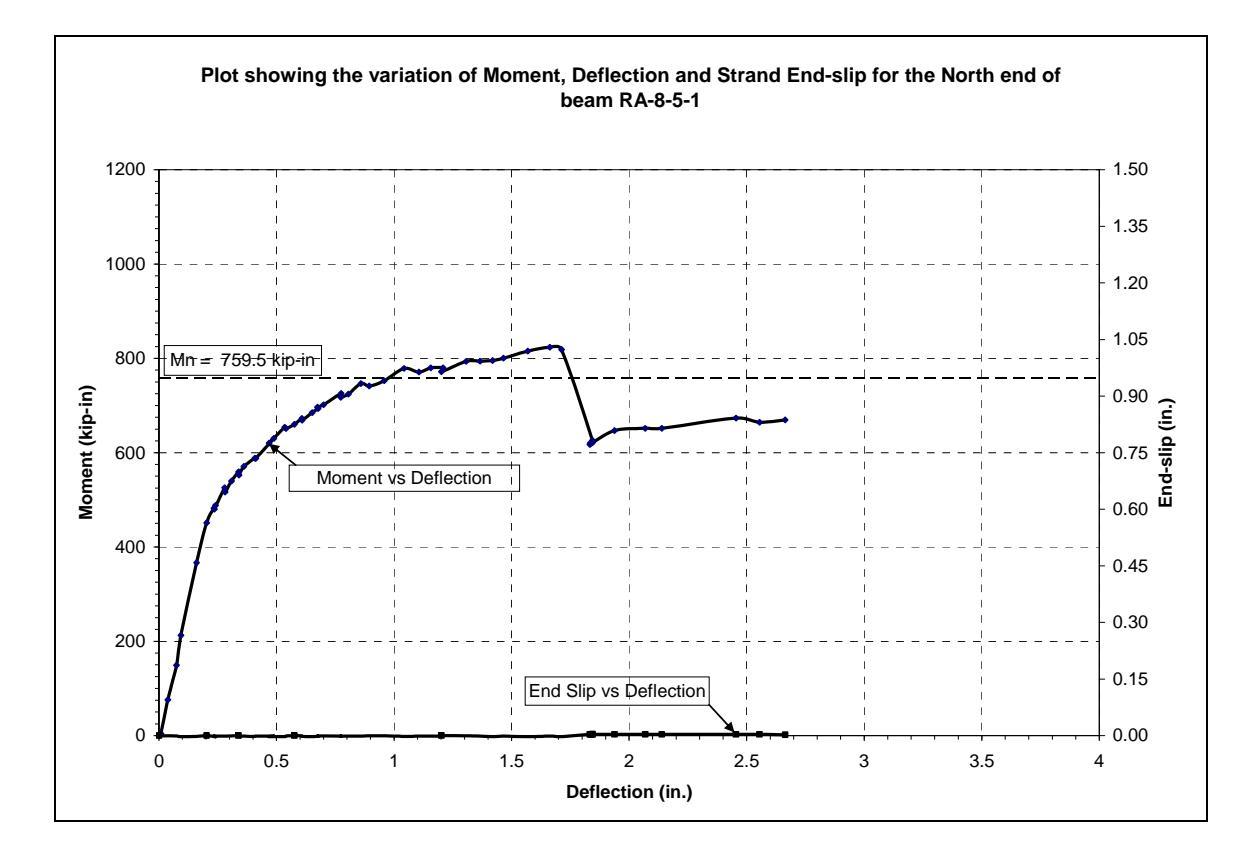
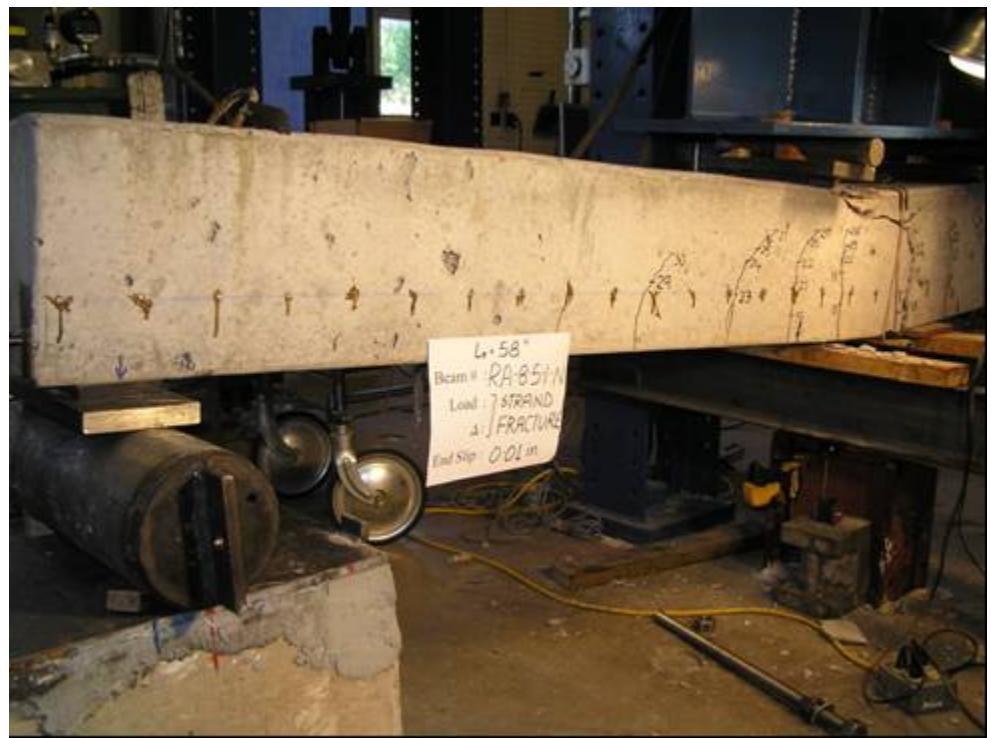
Cracking pattern for Beam RA-8-5-1 being loaded at North end

The cracking pattern included 8 flexural cracks in the middle 58 in. span with average crack spacing = 8.3 in. No inclined flexural crack was noticed. First flexural crack was at Stn. 39 from the North end.

First flexural crack was observed at 18.5 kips at deflection of 0.2 in. Initially three cracks were noted at two point loads and at approximately midpoint of the two load points.

At the load of 30.7 kips at deflection of 1.7 in. concrete crushing failure was observed along with the first East strand end-slip of 0.01 in. End-slip of the West strand remained 0.000 in. Also end-slip at the South end remained 0.000 in.

Deflection increments were continued until both the strands fractured at the total deflection of 2.6 in. End-slip of east strand at North end remained 0.01 in. while all other end-slip readings were 0.000 in.

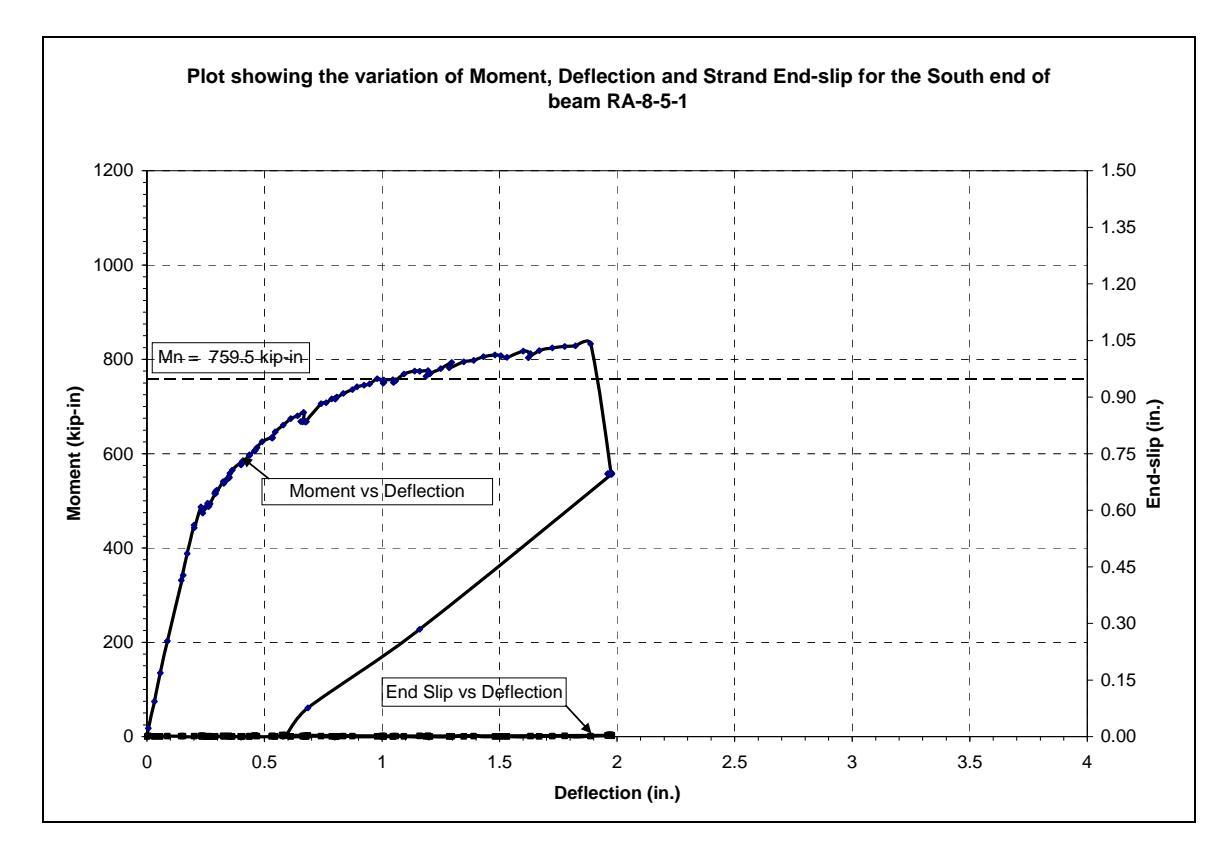
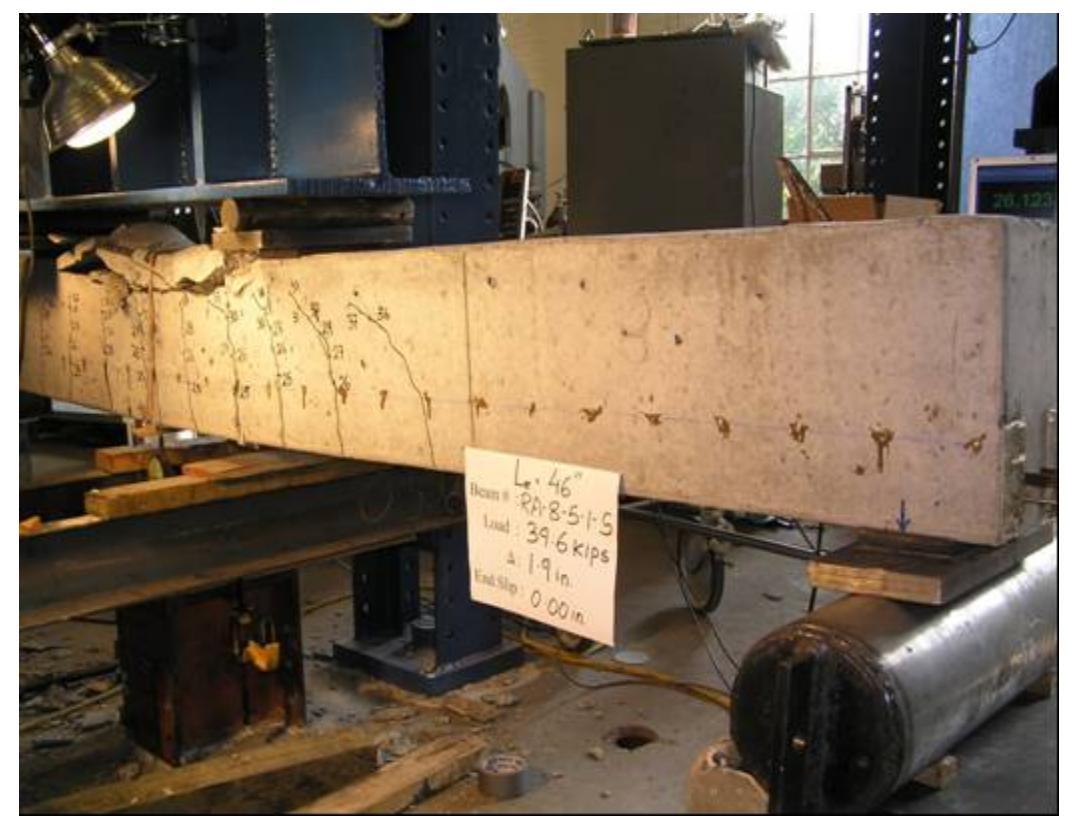
Cracking pattern at South end for Beam RA-8-5-1 (South side being tested)

End-slip at the South end remained 0.000 in. throughout the loading cycle. Cracking pattern at the South end shows 9 cracks in the middle 53 in. span with average crack spacing = 6.6 in. No inclined flexural crack was visible at the South side.

First flexural crack was observed at 25 kips at deflection of 0.3 in. Initially three cracks were noted, all within the two load points and located symmetrically about the midpoint. At the same load and deflection, a sudden jerk was observed and it was similar to one occurring when end-slip occurs. End-slip reading at the South end remained 0.000 and the reading at the North end could not be recorded as the strands had fractured during the North end testing.

Cracking was clearly audible at 37.9 kips (deflection = 1.4 in.) Concrete crushing failure was observed with a bang at 39.6 kips (deflection = 1.9 in.). Concrete at the top surface between the two point supports was completely crushed and fell out as the load reached its peak.

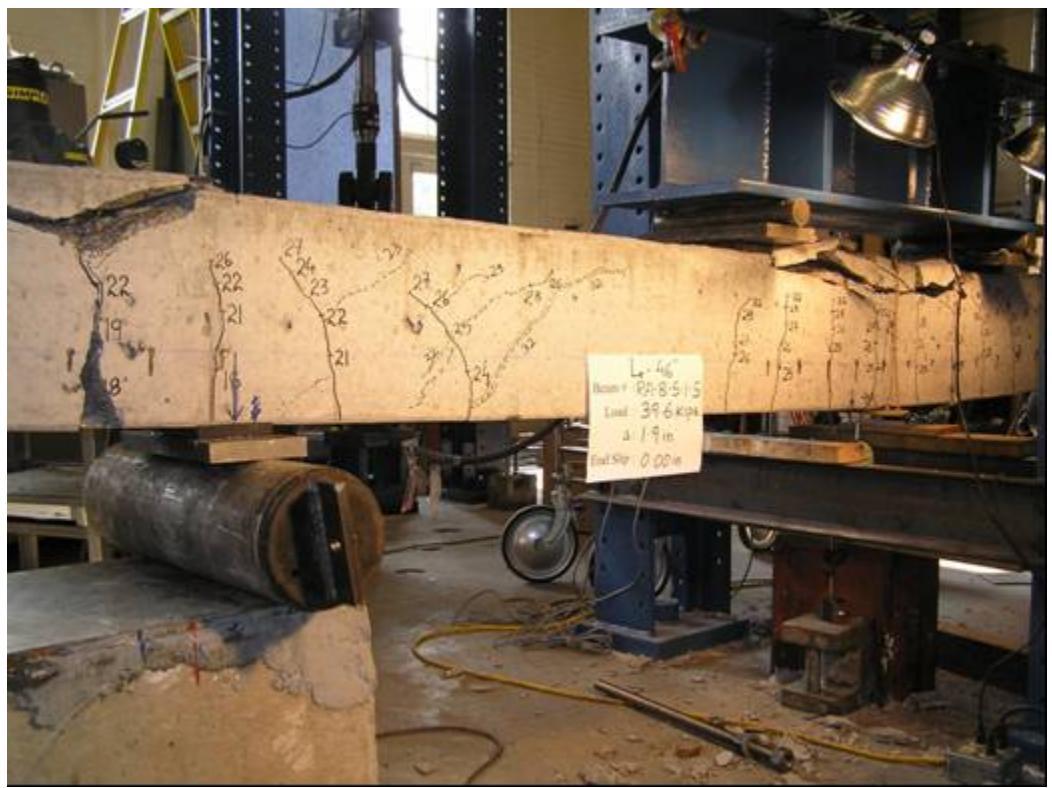
Cracking pattern at the North Support for Beam RA-8-5-1 (South side being tested)

A crack similar to an inclined flexural crack was observed suddenly at 32.3 kips. (deflection = 0.7 in.) at 15 in. from the North support, crossing the originally existing cracks formed during North end testing. (This crack marked with dotted line in the photograph)
