APPENDIX D

RECTANGULAR BEAM SUMMARIES—STRANDS A&B

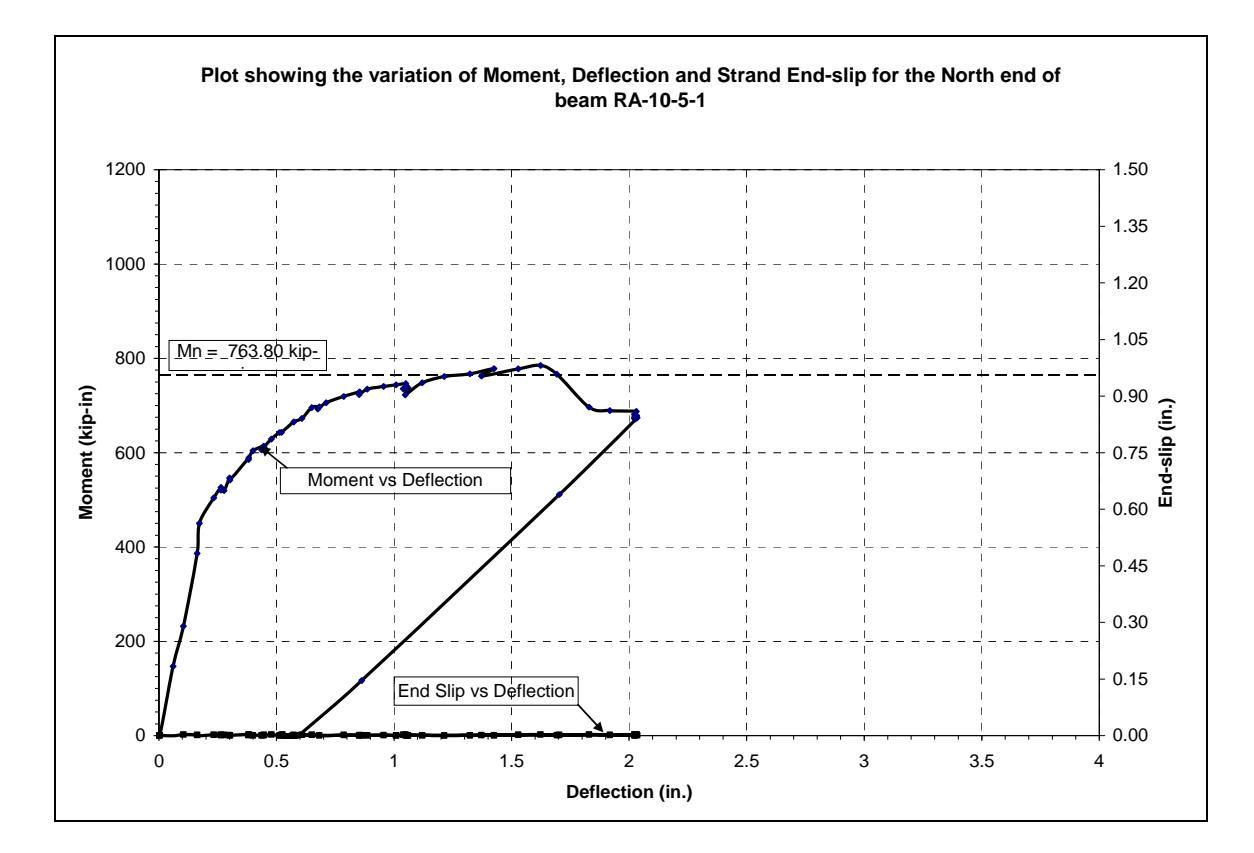
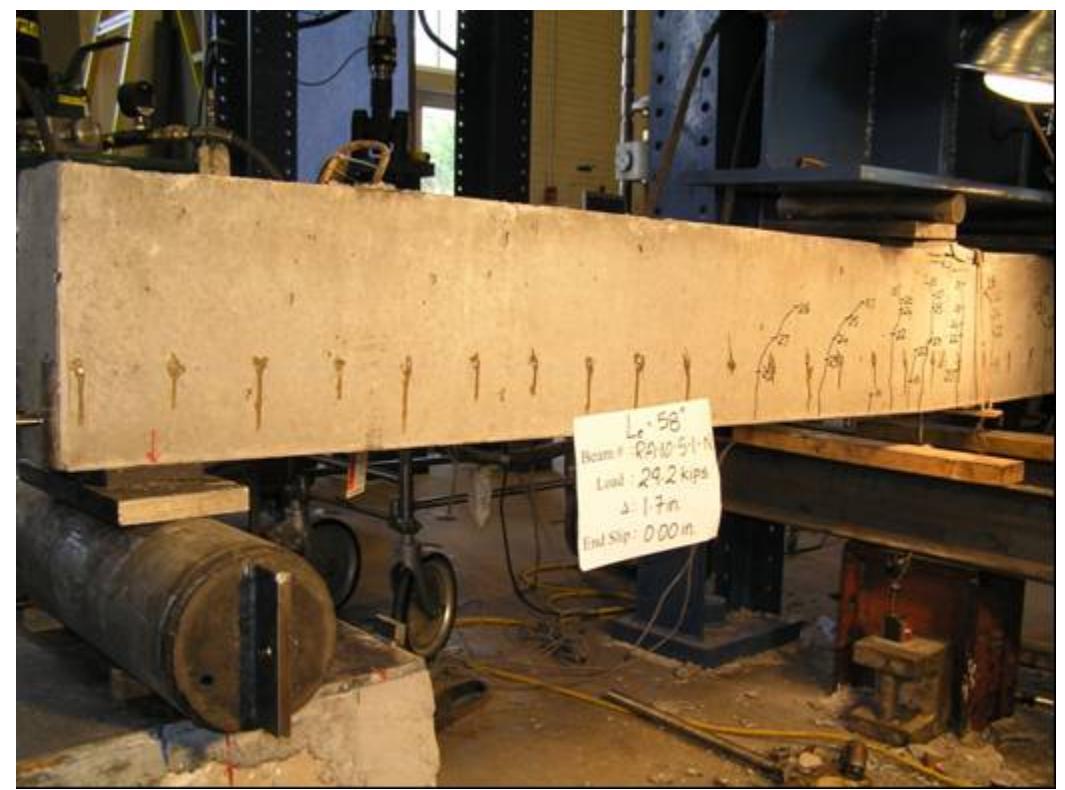
Cracking pattern for Beam RA-10-5-1 being loaded at North end

Cracking pattern shows 9 cracks in the middle 56 in. with average crack spacing of 7 in. The first flexural crack was at Stn. 43. No inclined flexural crack was visible.

First flexural crack was observed at 19.3 kips at deflection of 0.2 in. First flexural cracks were formed as two pairs symmetrically located about the midpoint.

No significant changes were noticed till the load reached 29.1 kips (deflection = 1.6 in.). At this point the cracks were clearly audible. Concrete crushing failure was noticed at 29.2 kips. (deflection = 1.7 in.)

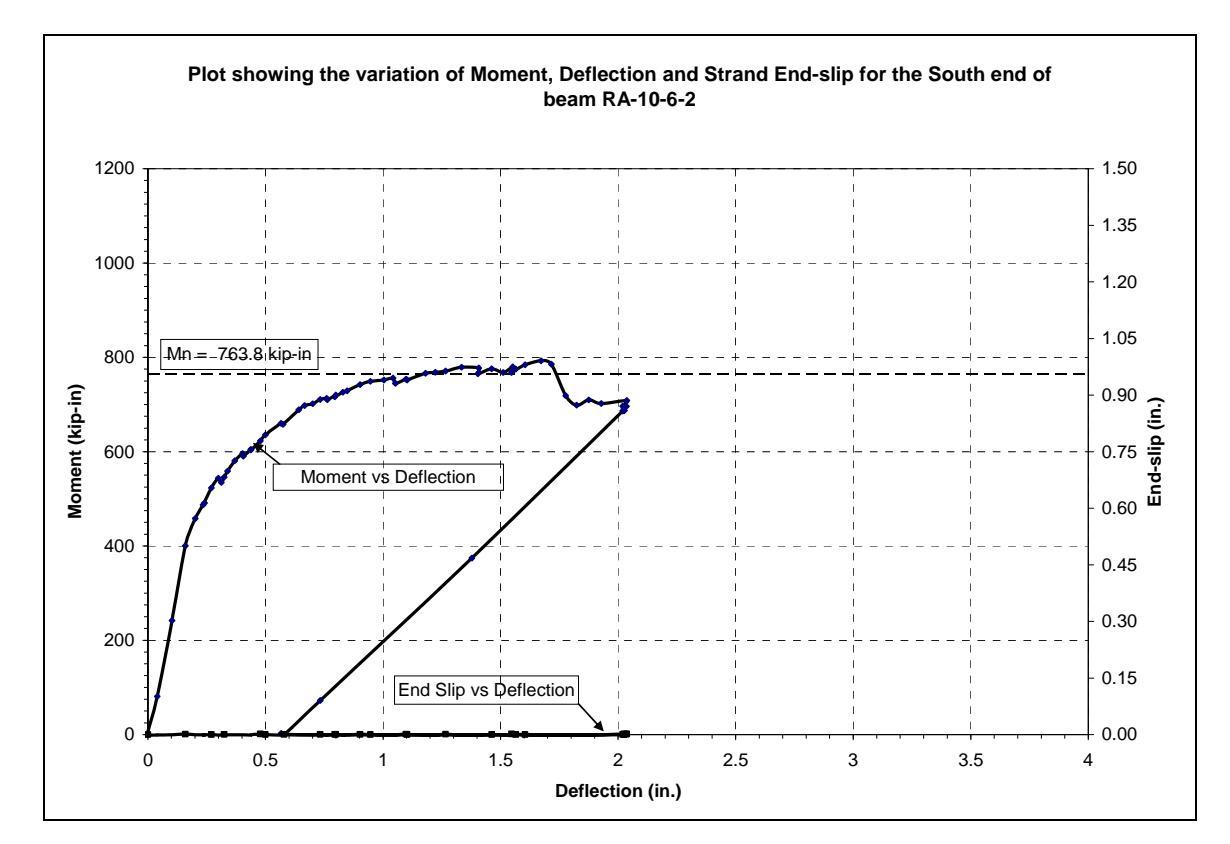
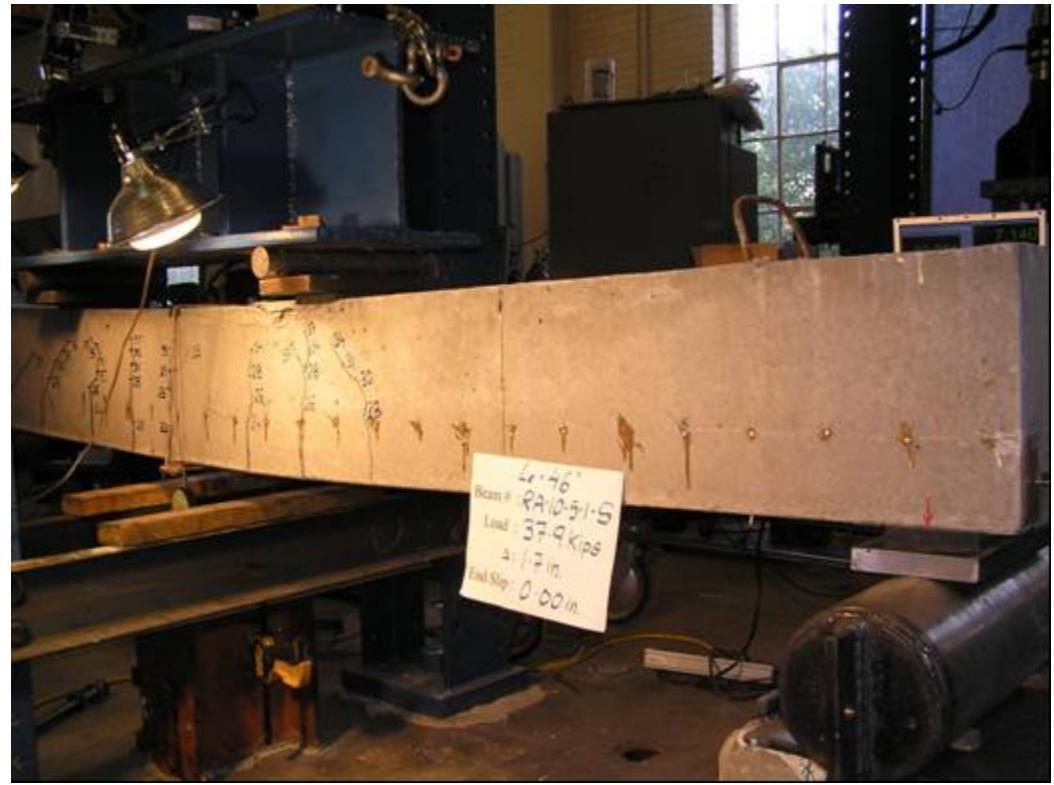
Cracking pattern for Beam RA-10-5-1 being loaded at South end

Cracking pattern included 8 cracks in the middle 55 in. span with average crack spacing of 7.9 in. First flexural crack was located at Stn. 41. No inclined flexural crack was visible.

First flexural crack was observed at 24 kips at deflection of 0.2 in. Initially three cracks were noted in between the two point loads located symmetrically about the midpoint.

Cracks became clearly audible at 34.3 kips (deflection = 0.8 in.) Concrete crushing failure was observed at 37.8 kips (deflection = 1.7 in.) Deflection was further incremented till the total deflection reached 2.0 in.

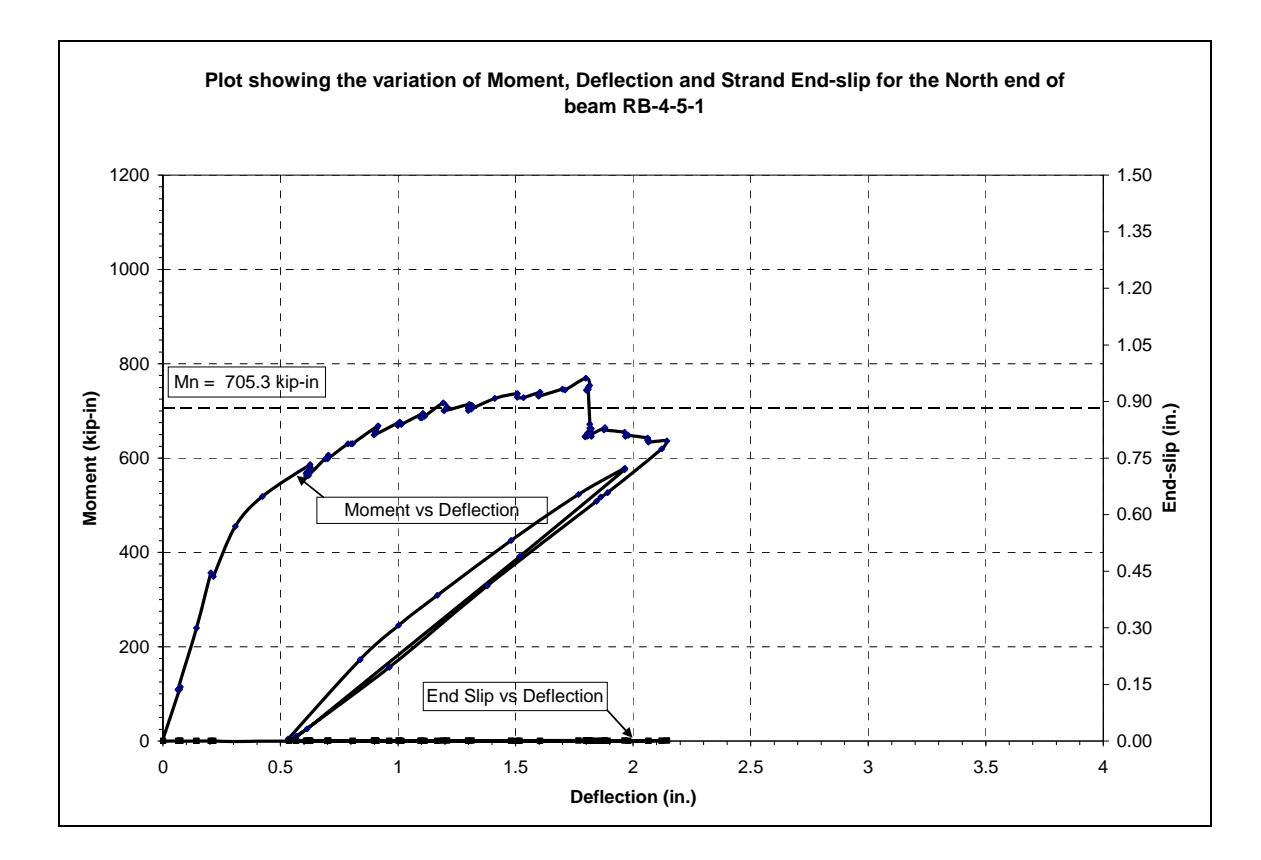
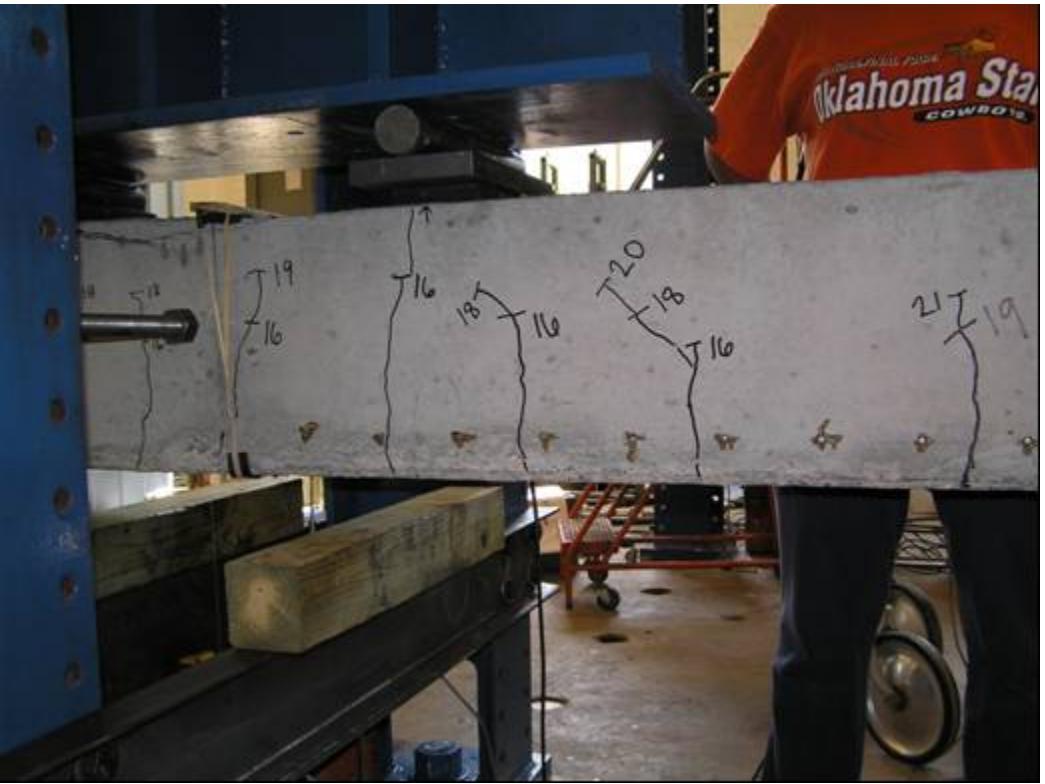
Photo Showing cracking pattern for Beam RB-4-5-1 being loaded at North end

Cracking pattern included 11 flexural cracks in the middle 70 in. span with average crack spacing = 7 in. No inclined flexural crack was observed.

First flexural cracking was discovered at a load of 16.8 kips while deflection at this point was noted as 0.5 in. The first flexural cracks formed at three locations, one of which was exactly under the point load whereas the other two were approximately equal distance from the central crack. With gradual loading these cracks propagated upward and diagonally towards the top rollers which were acting as two point loads.

At the load of approx 20 kips (deflection 1.0 in.) fourth crack was observed while the first three cracks grew gradually in width and length.

Peak load attained was 22.5 kips (deflection 1.9 in.) at which concrete crushing failure occurred with audible sound. Concrete spalling was clearly observed at the top surface.

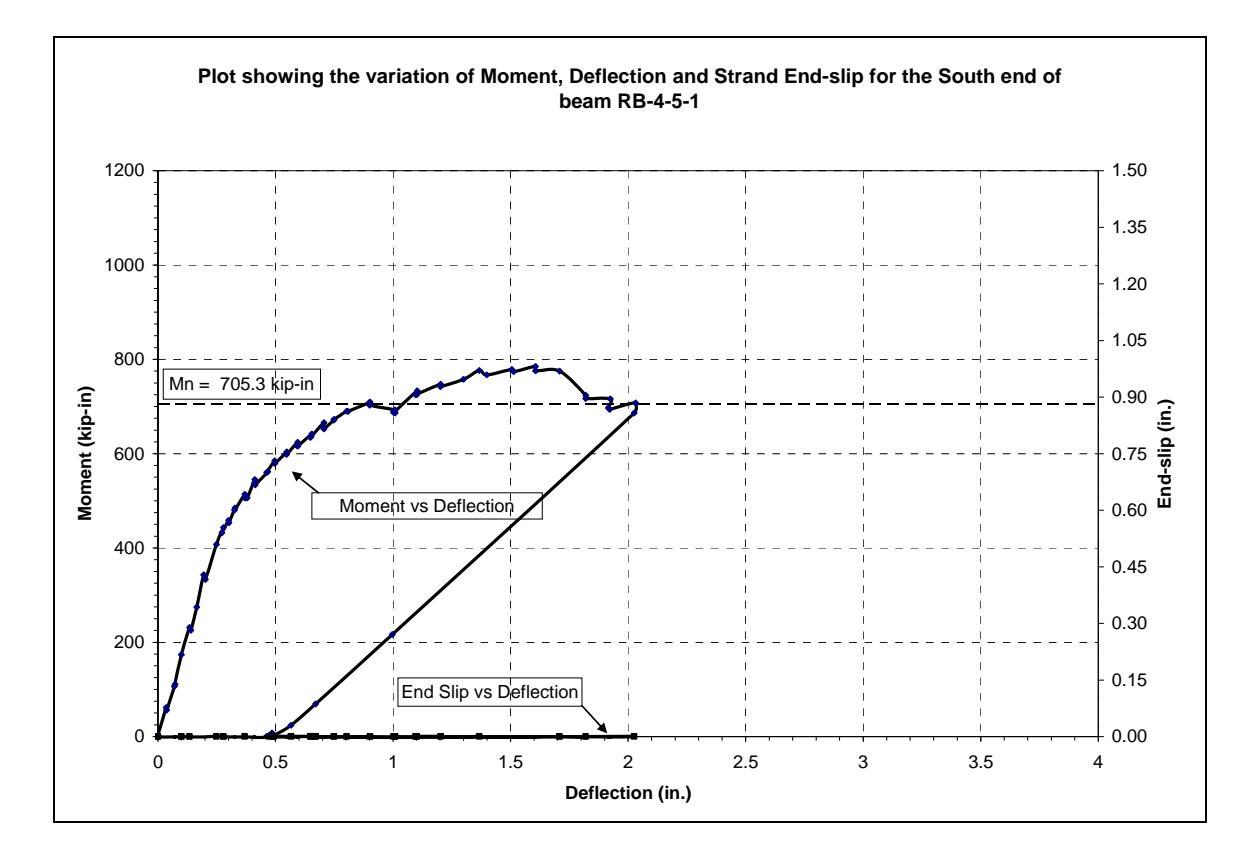
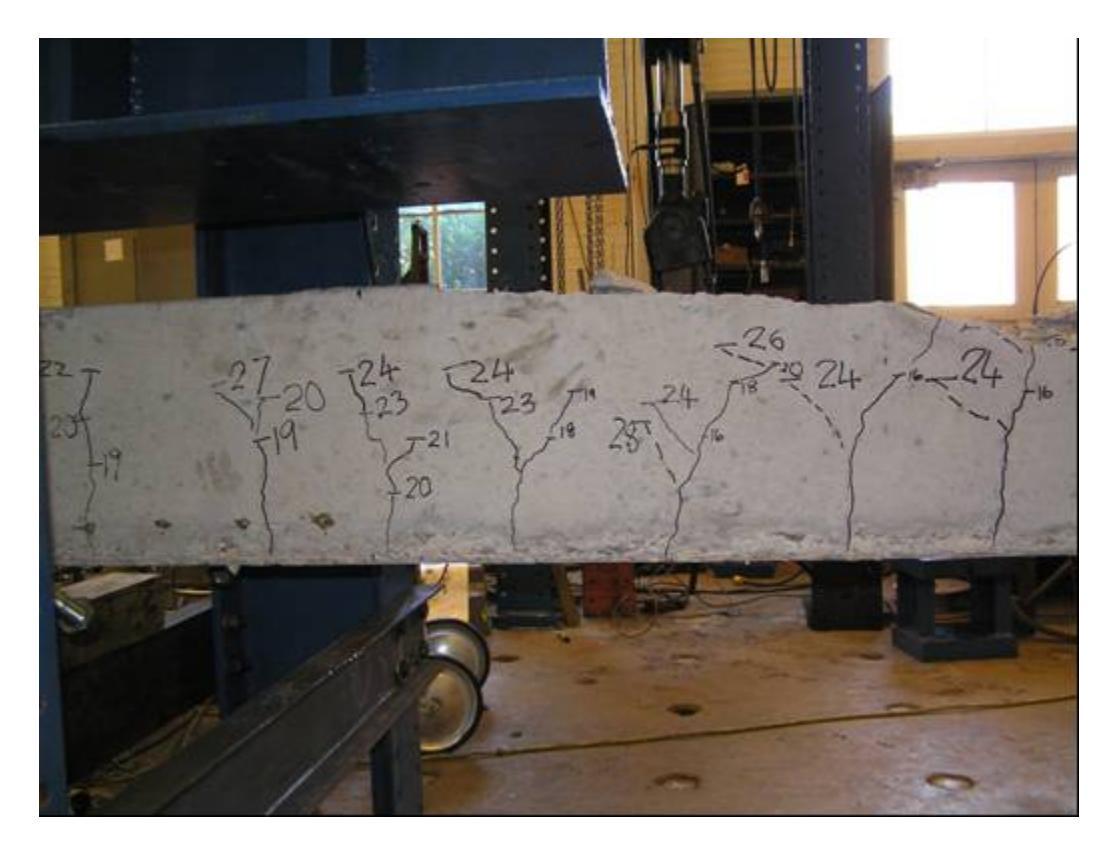
Cracking pattern for Beam RB-4-5-1 being loaded at South end

Cracking pattern shows 9 cracks in the middle 69 in. span with average crack spacing = 8.6 in. No inclined flexural crack was observed.

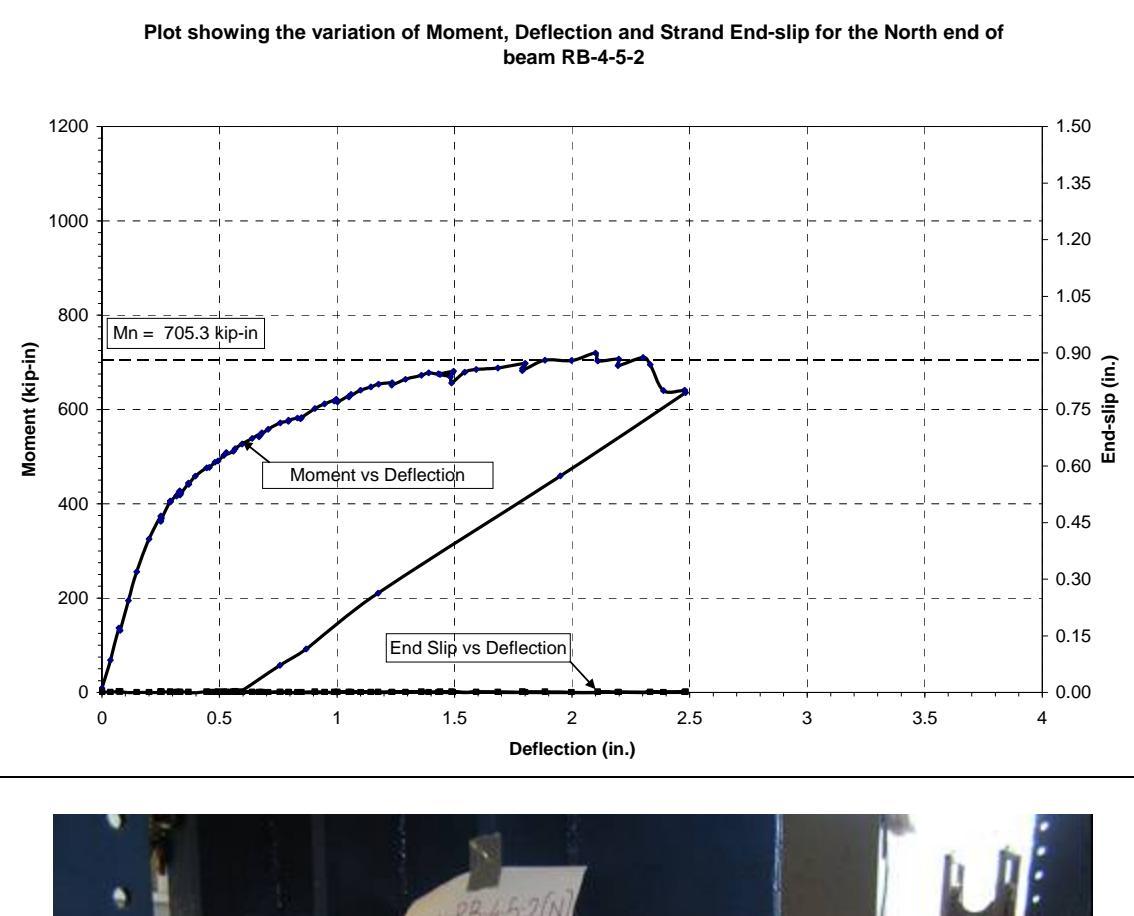
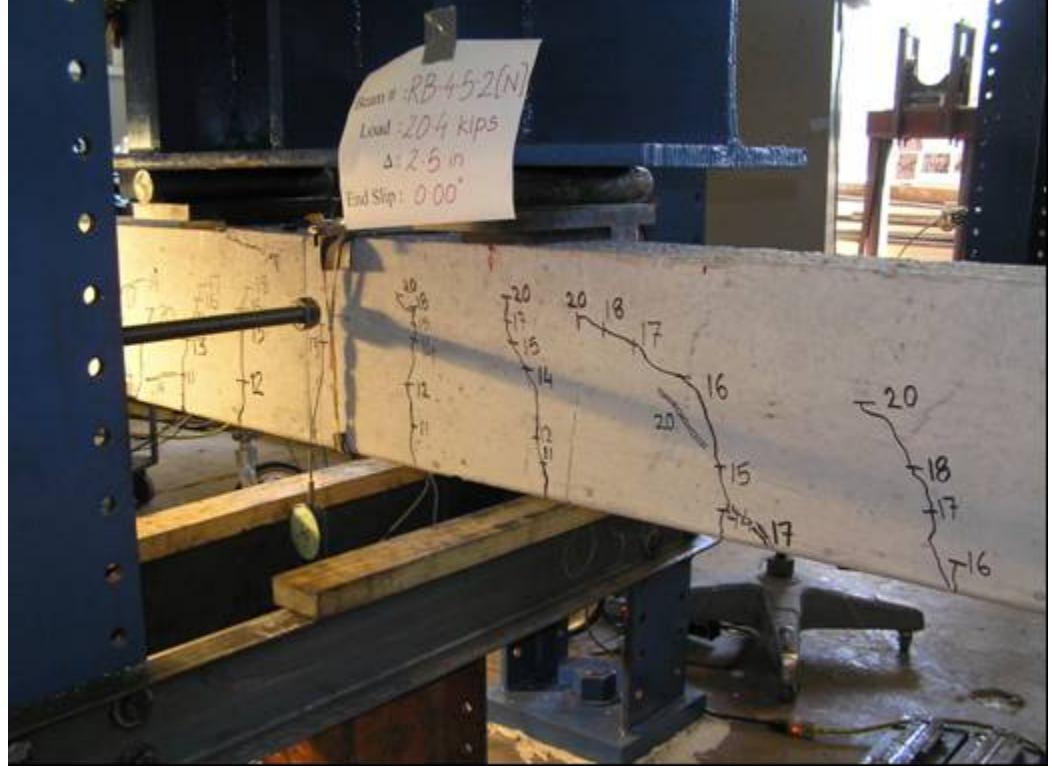
Photo showing cracking pattern for Beam RB-4-5-2 being loaded at North end

Pattern of cracks displayed 10 cracks in the middle 68 in span with average crack spacing = 7.6 in. No inclined flexural crack was observed.

At the load of approx 14.5 kips (deflection 0.5 in.) a pair of cracks was observed approximately symmetric about the point loads and beyond the first three cracks.

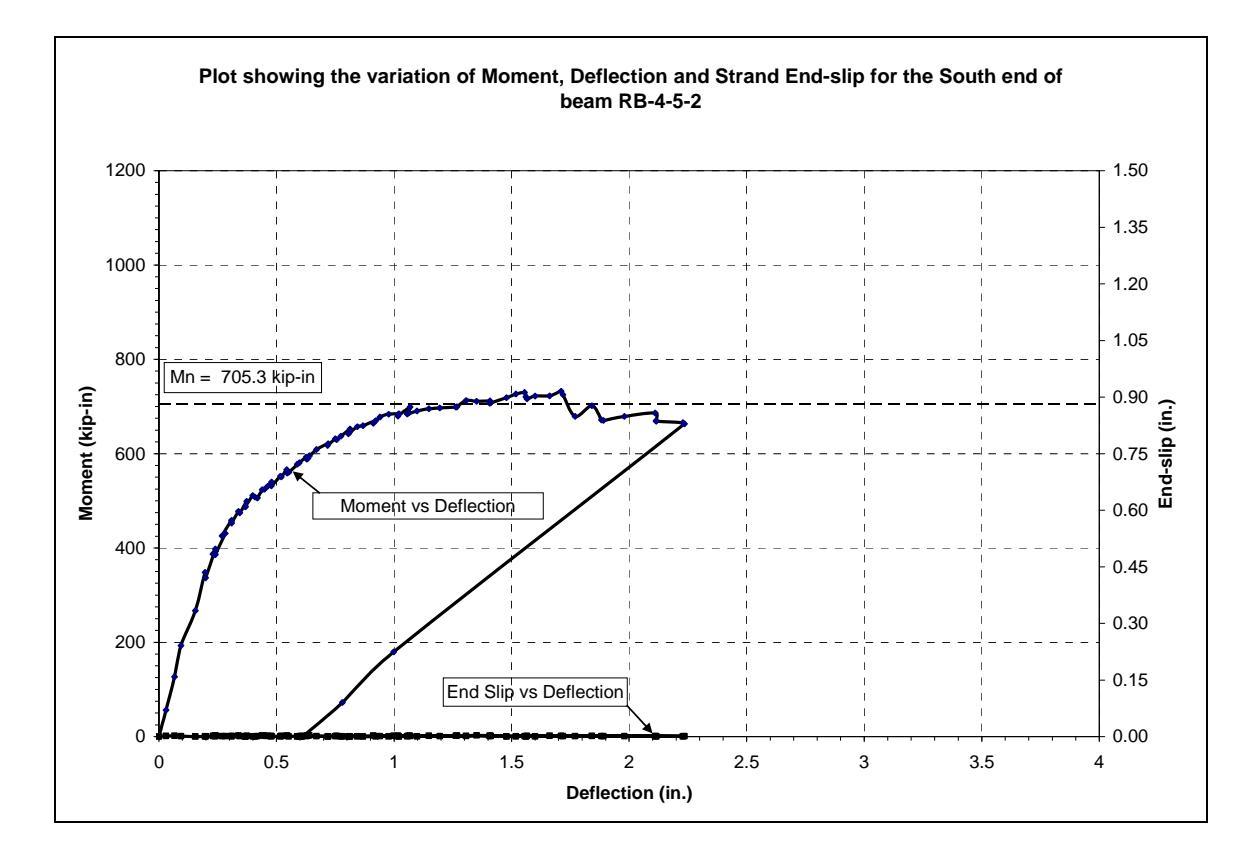
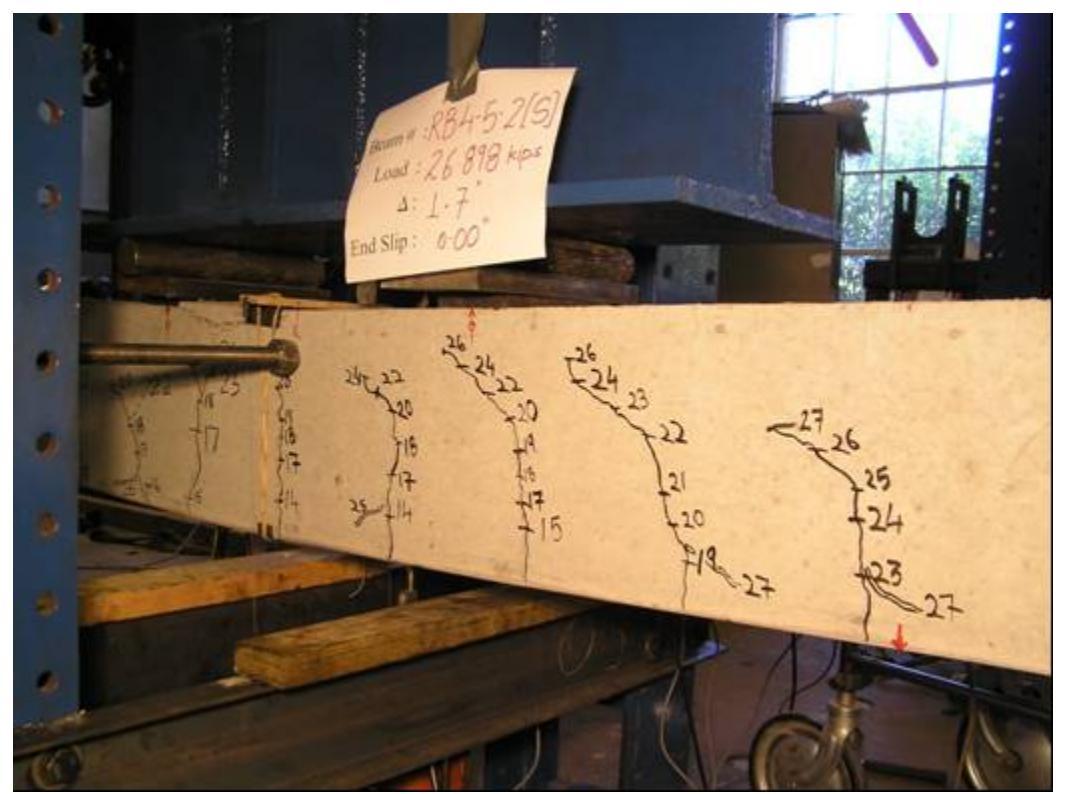
Photo Showing cracking pattern for Beam RB-4-5-2 being loaded at South end

There were 7 cracks noticed in the middle 45 in. span with average crack spacing of 7.5 in. No inclined flexural crack w observed.
