APPENDIX E

RECTANGULAR BEAM SUMMARIES- STRAND A (0.6 IN)

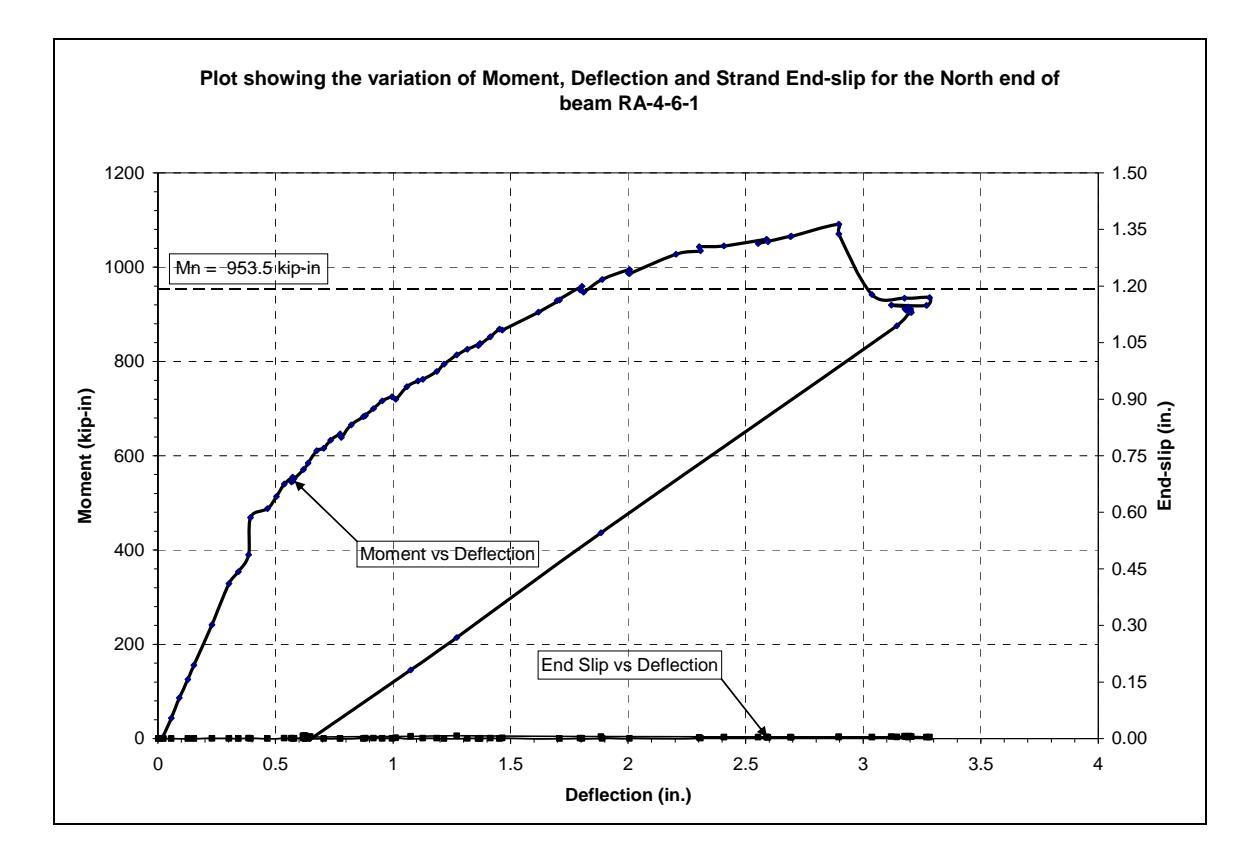
TEST PARAMETERS	
Concrete Compressive Strength	7050 psi
Embedment Length(L _e)	88 in.
Span	192 in.
Failure Mode	Flexure
Maximum Load	25.8 kips
Maximum Moment	1084 kip-in
Deflection @ Failure	3.0 in.
Rebound after complete unloading	2.6 in.
Average Transfer Length (L _t) @ release	33.4 in.
@ time of testing	41.8 in.
Average NASP P.O value for strand 0.6 in. "A"	[18.29 kips

Cracking pattern included 15 cracks in the middle 90 in. span with average crack spacing of 6.4 in. Distance between the first flexural crack and the inclined flexural crack was 15 in.

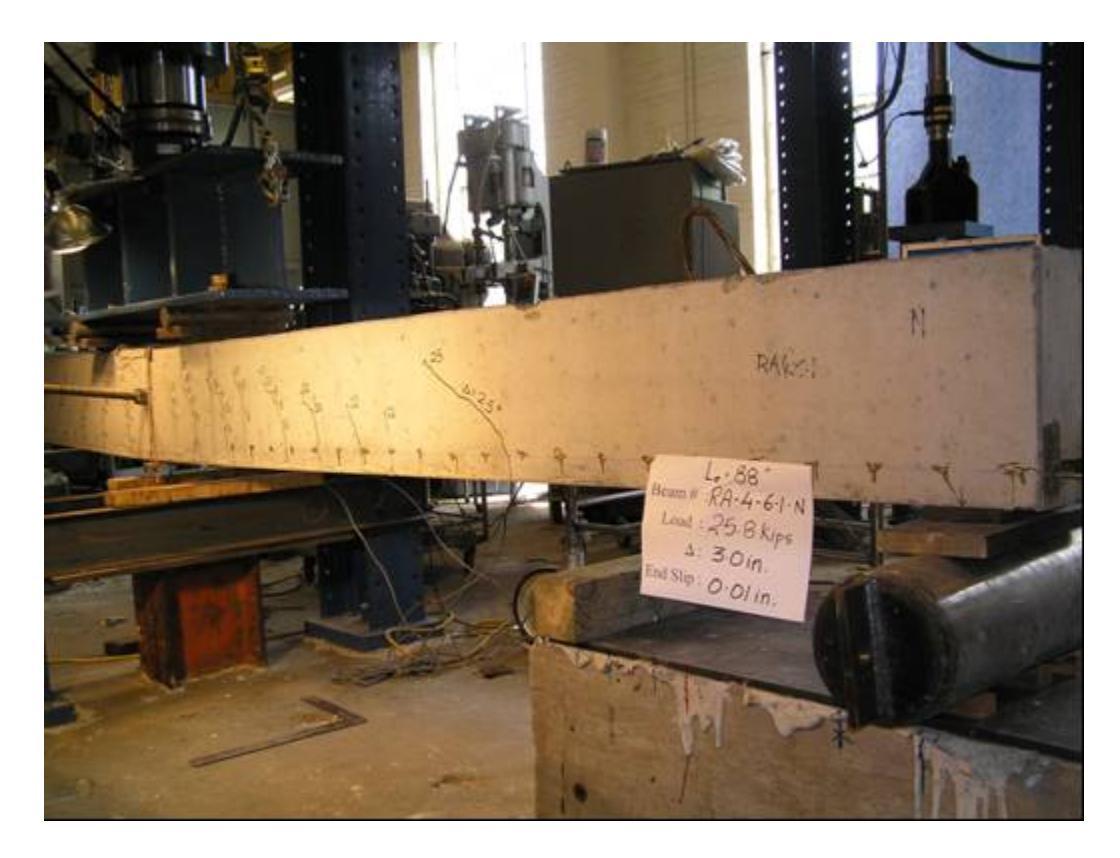
Cracking pattern for Beam RA-4-6-1 being loaded at North end

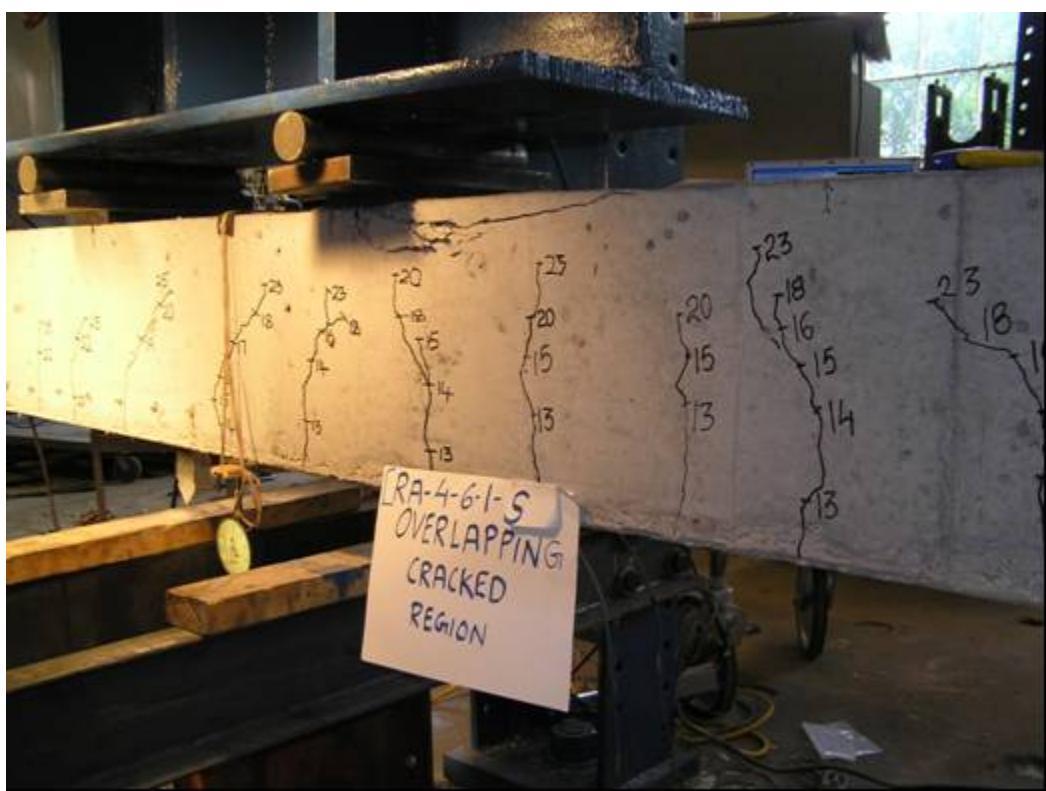
Photo taken before starting the loading cycle for the South end.

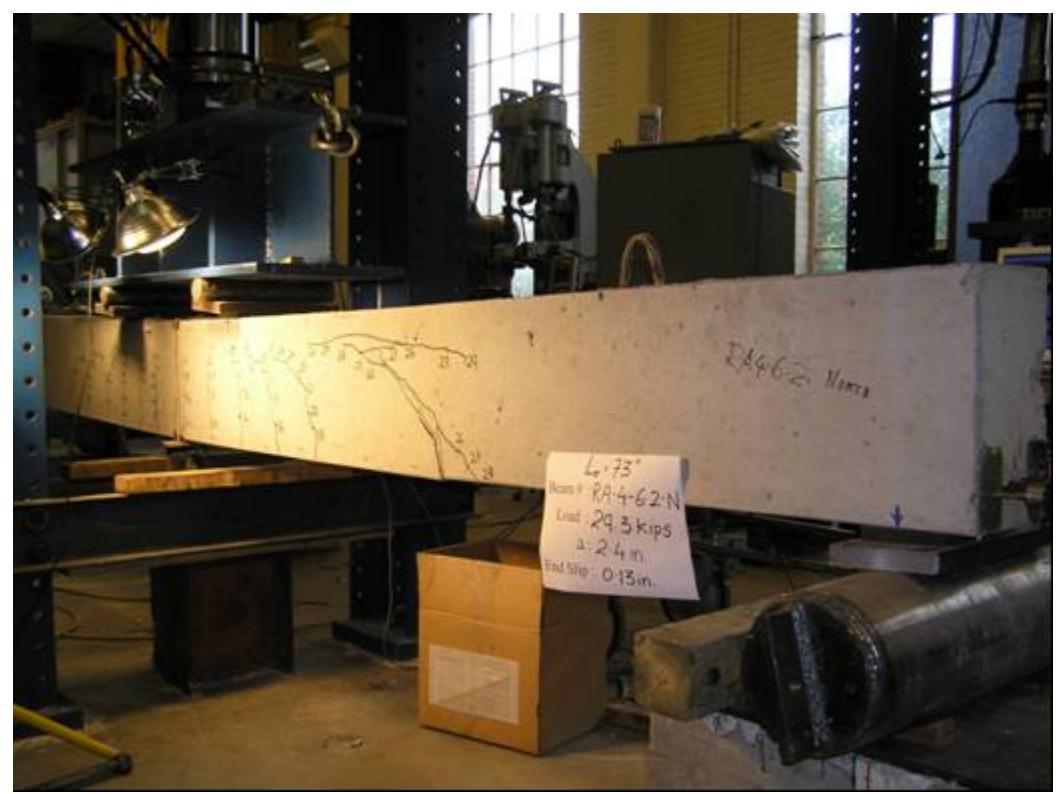
Cracking pattern includes 11 cracks within the middle 62 in. span with average crack spacing of 6.2 in. The inclined flexural crack originated at Stn. 40 and it bifurcated to touch the bottom surface at Stn. 36. Distance of the first flexural crack and the inclined flexural crack was 17 in. Width of the inclined flexural crack at the deflection of 2.6 in was $1/4^{\text{th}}$ in.

Cracking pattern for Beam RA-4-6-2 being loaded at North end

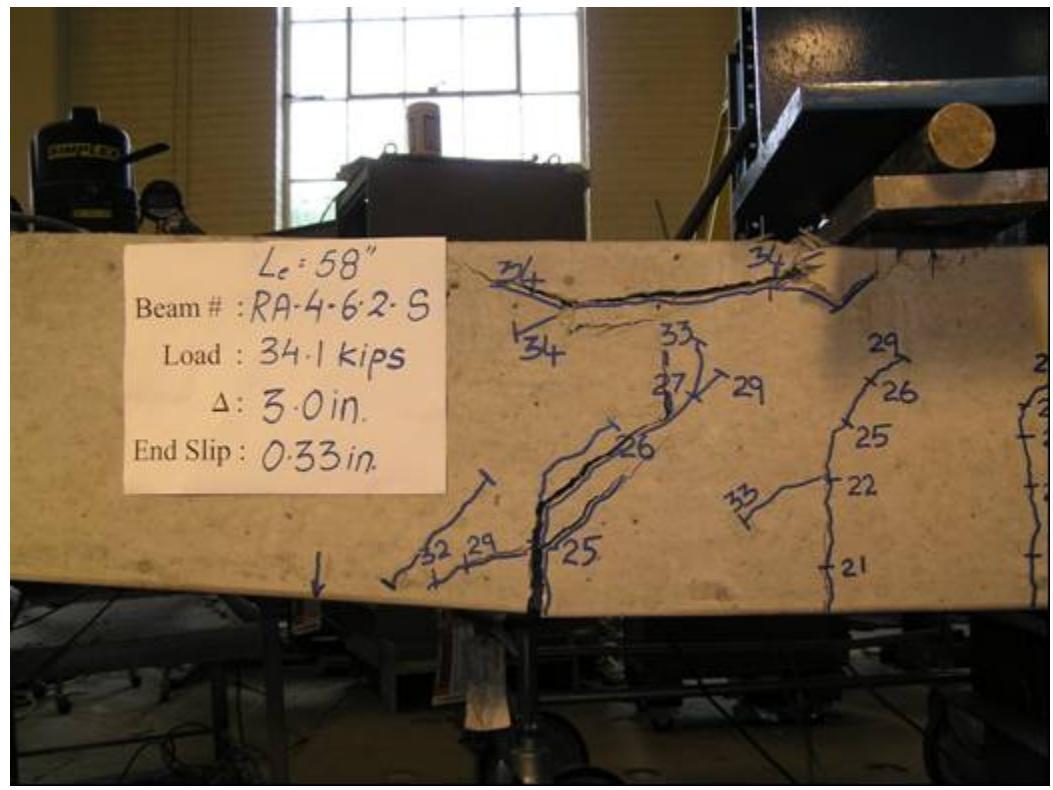
The first flexural crack had a few more cracks moving outwards in diagonal directions giving it an appearance as of an inclined flexural crack. This crack was formed at 45 in. At deflection of 3.0 in. the width of this crack was $\frac{1}{2}$ in. No concrete crushing failure was observed in the constant moment region.

Photo showing the first flexural crack later developed as an inclined flexural crack.

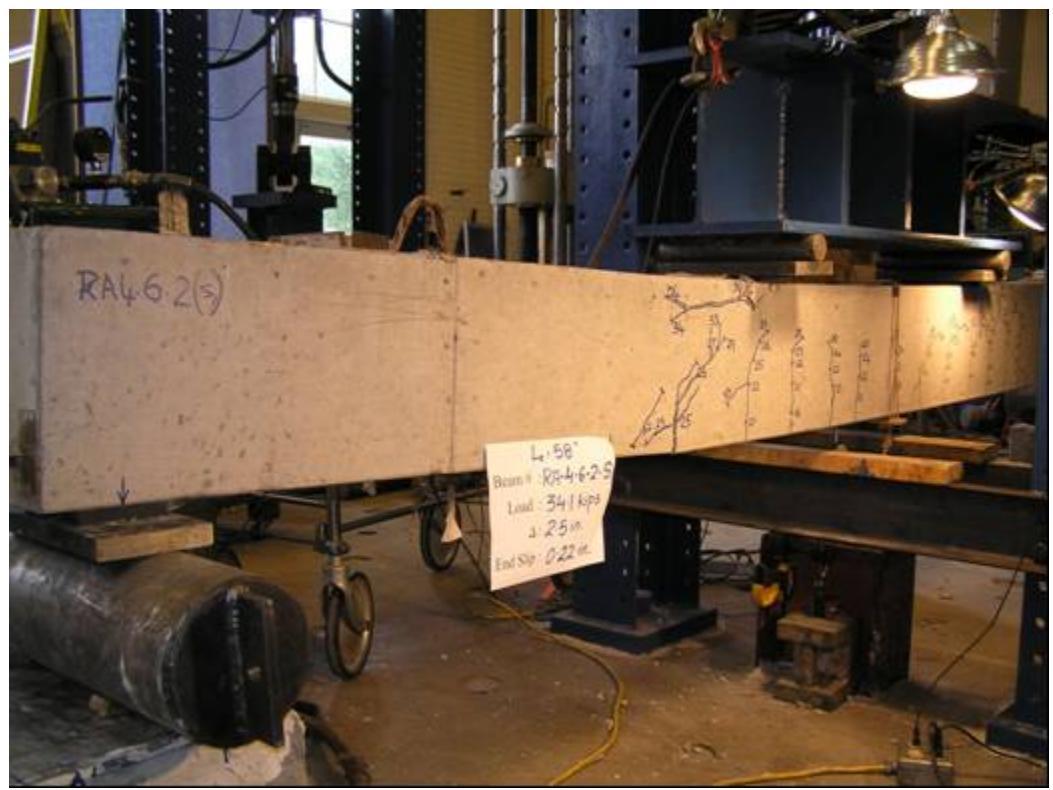
Cracking pattern for Bea m RA-4-6-2 being loaded at South end

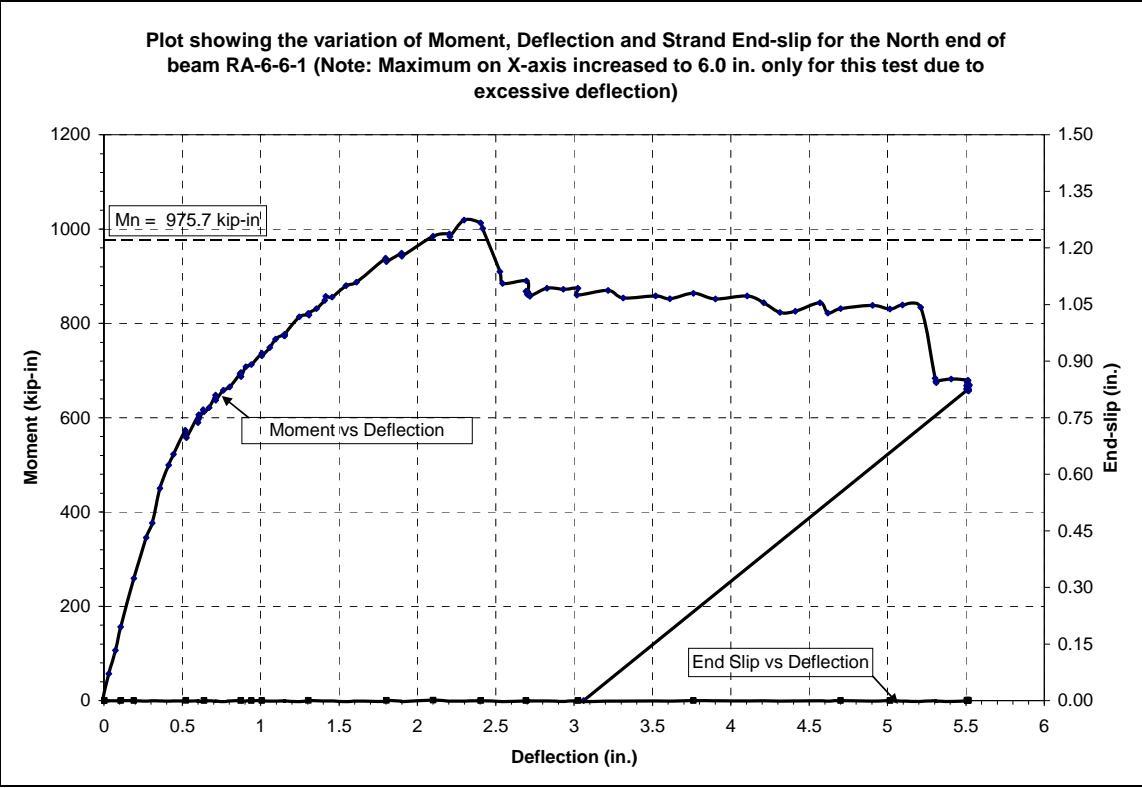
(For the above graph intermediate points for unloading curve could not be noted)

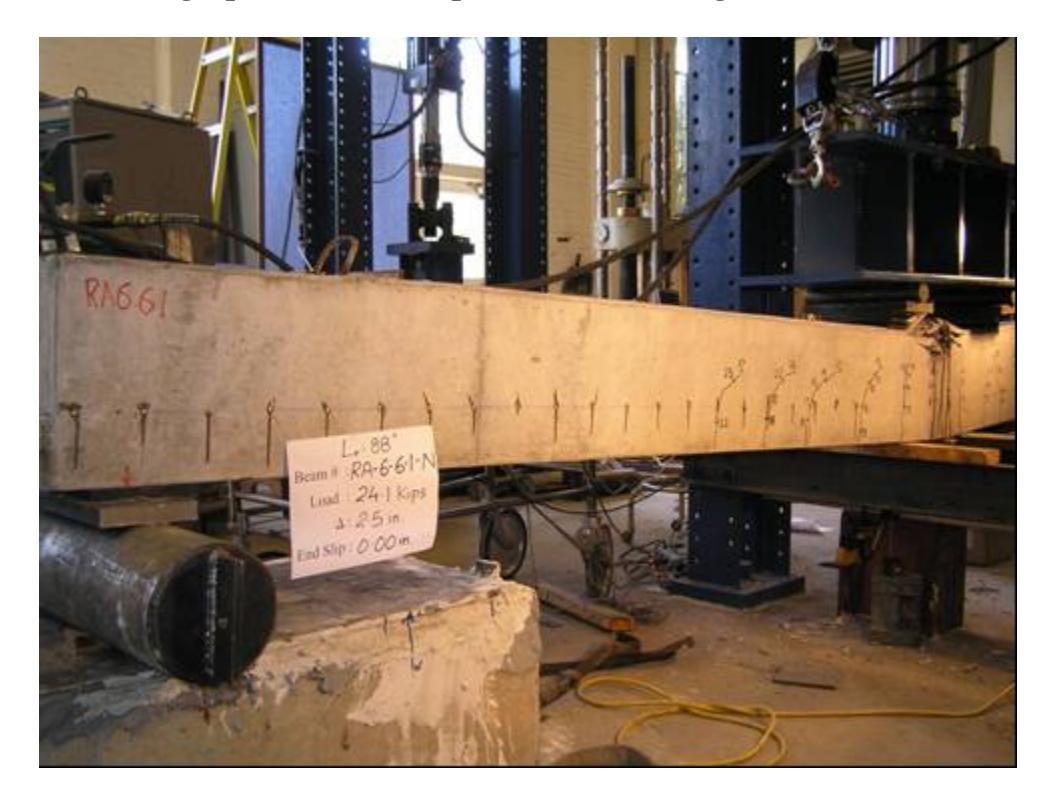
Cracking pattern shows 13 cracks in the middle 90 in. span with the average crack spacing of 7.5 in. No inclined flexural crack was observed. Crack width of the central crack was $\frac{1}{2}$ in.

Cracking pattern for Beam RA-6-6-1 being loaded at North end

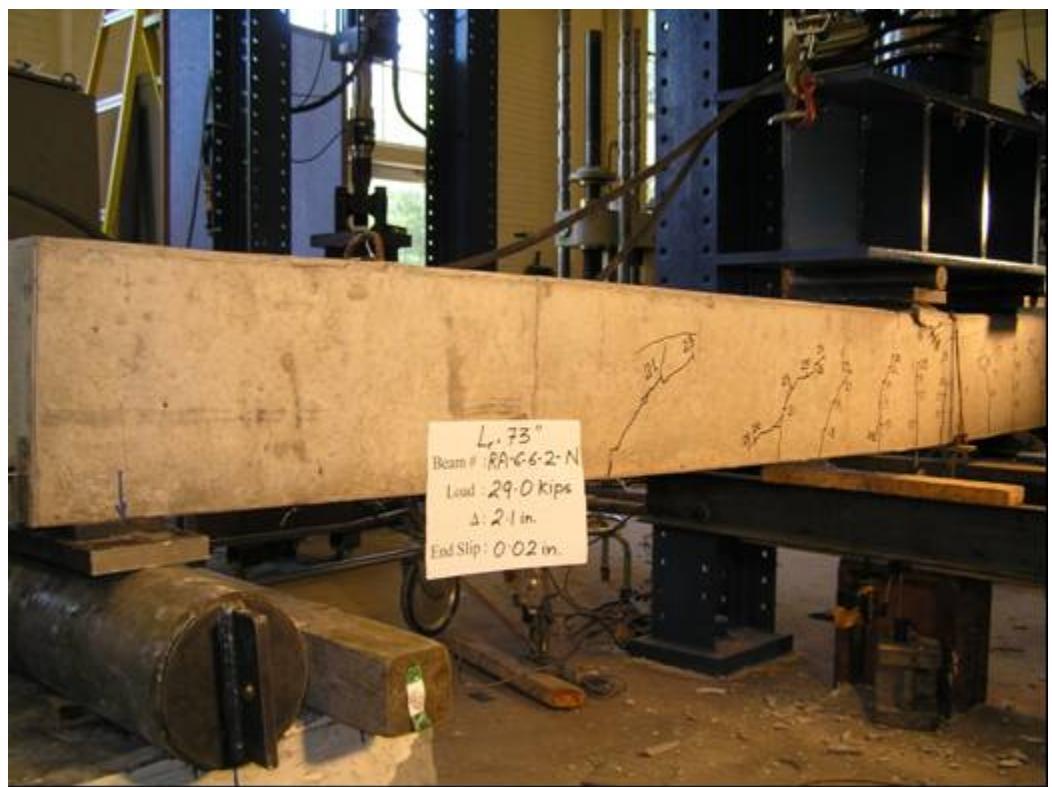
Cracking pattern included 10 cracks in the middle 71 in. span with the average crack spacing of 7.9 in. Distance between the first flexural crack and inclined flexural crack was 19 in. Inclined flexural crack was located at Stn. 36.Maximum end-slip at deflection of 2.7 in was 0.03 in.

Cracking pattern for Beam RA-6-6-2 being loaded at North end

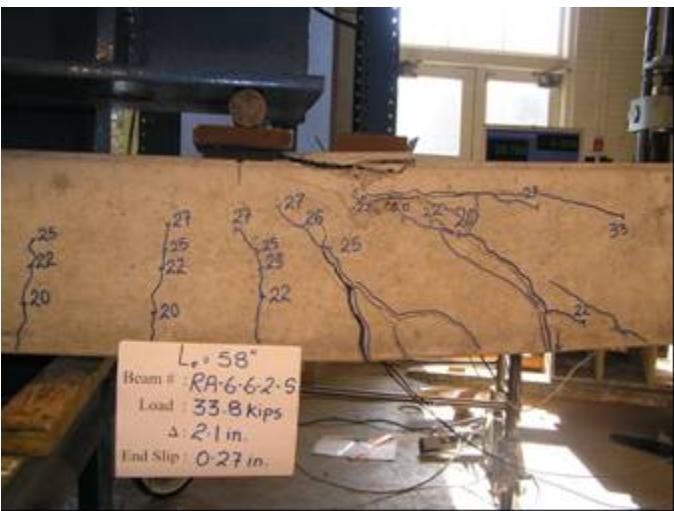
Concrete crushing observed outside the constant moment region.

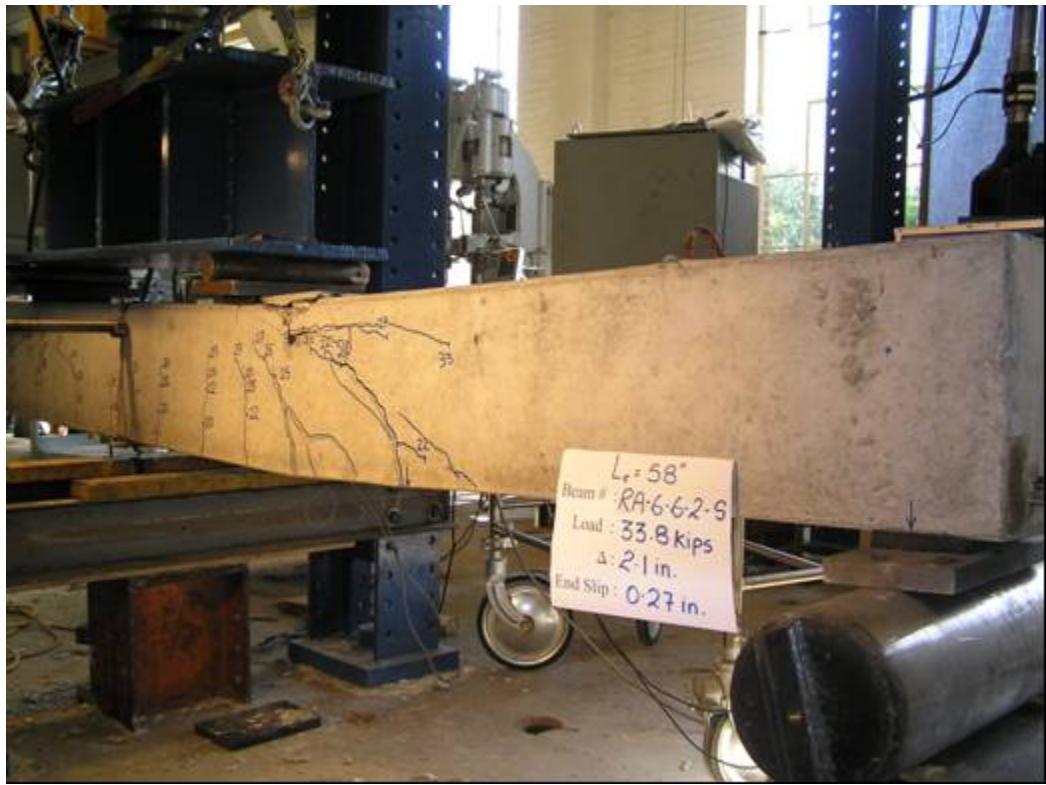
Cracking pattern included 10 cracks in the middle 54 in. span with average crack spacing of 6in. Inclined flexural crack first formed at Stn. 38 bifurcated to touch the bottom surface at Stn. 31. Crushing of concrete was evident outside of the constant moment region.

Cracking pattern for Beam RA-6-6-2 being loaded at South end

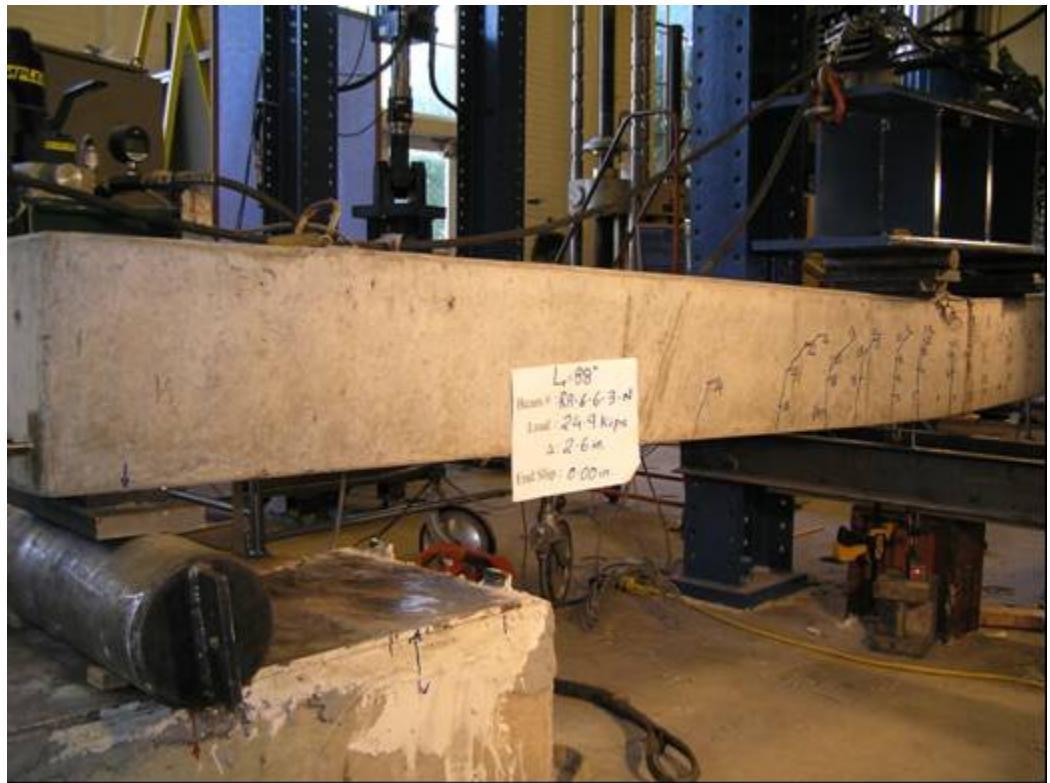
Cracking pattern included 15 cracks in the middle 101 in. span with average crack spacing of 7.2 in. No inclined flexural crack was observed. The first flexural crack was observed at Stn. 50.

Cracking pattern for Beam RA-6-6-3 being loaded at North end

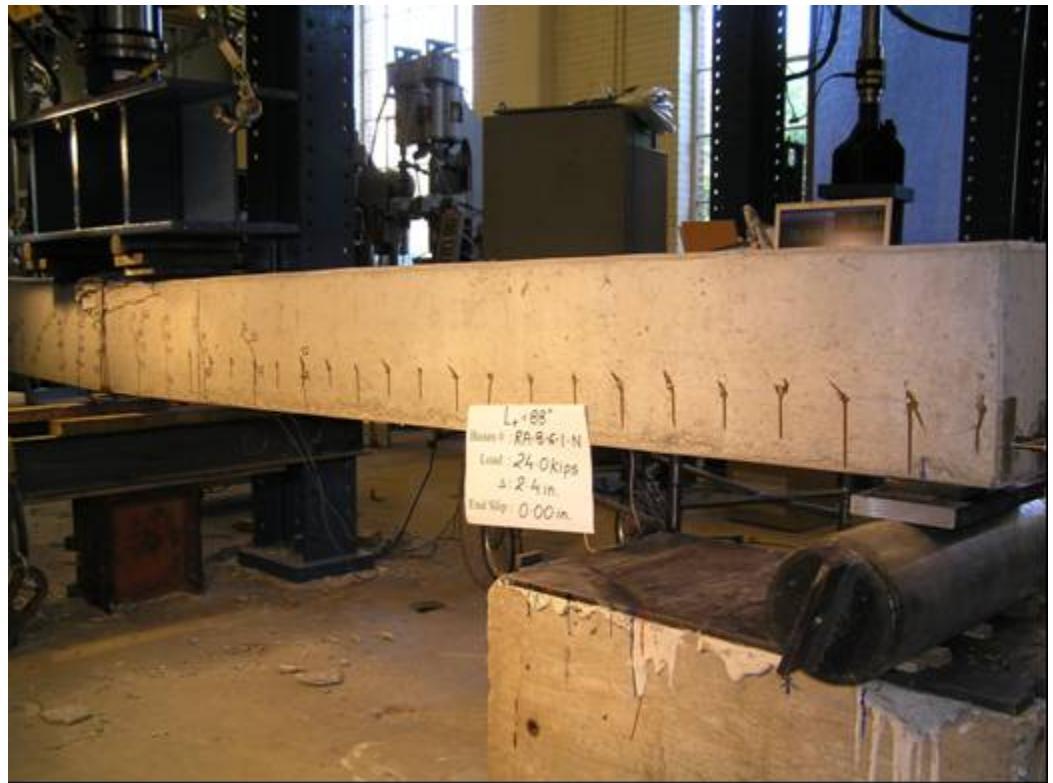
No inclined flexural crack was observed. The cracking pattern included 11 cracks in the middle 82 in. span with average crack spacing of 8.2 in. The first flexural crack was located at Stn. 59.

Cracking pattern for Beam RA-8-6-1 being loaded at North end

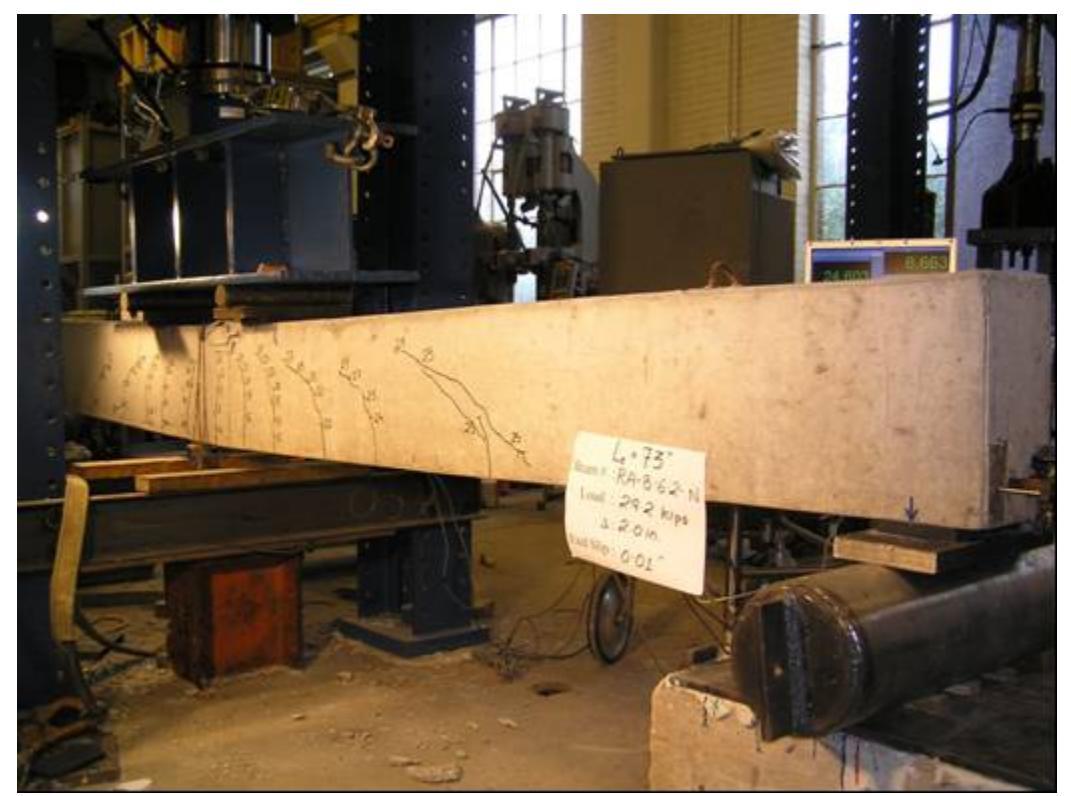
Cracking pattern included 11 cracks in the middle 73 in span with average crack spacing of 7.3 in. Inclined flexural crack was at Stn. 38, with the lower end bifurcated without touching the bottom surface approx. 3 in from bottom. End-slip at the south end remained

Cracking pattern for Beam RA-8-6-2 being loaded at North end

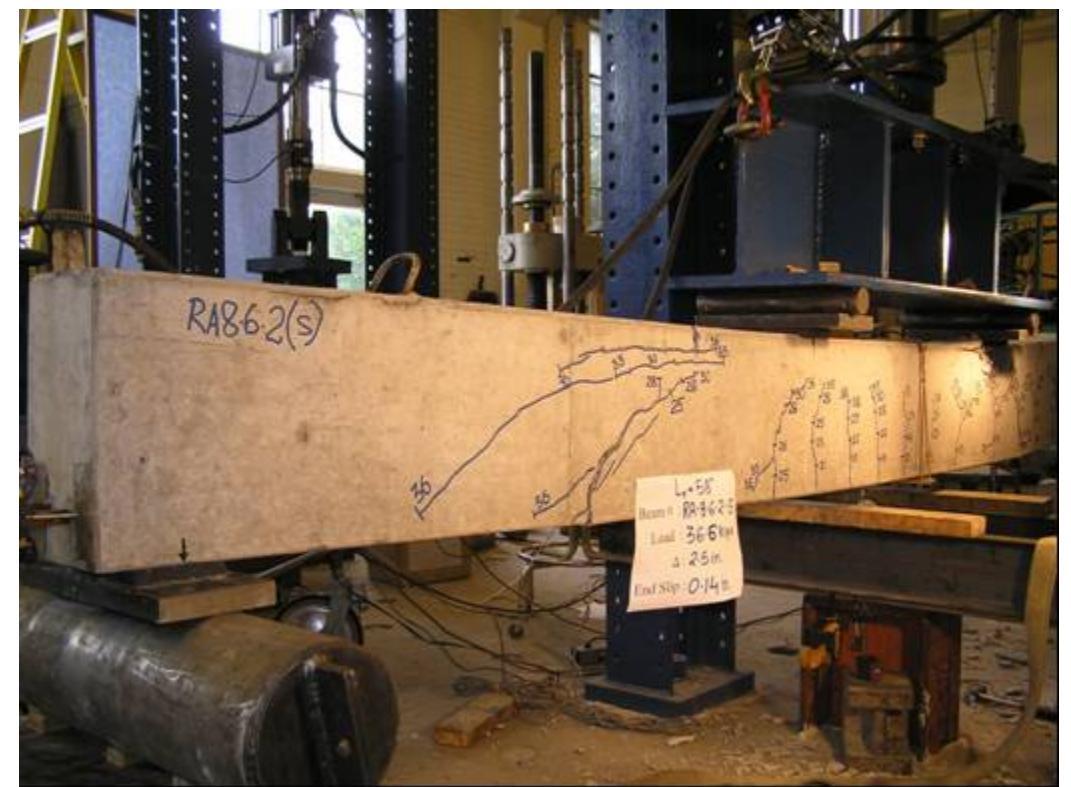
Cracking pattern included 6 cracks in the 27 in. span towards the South end with average crack spacing of 5.4 in. Maximum end-slip at the deflection of 2.9 in. was 0.15 in.

Cracking pattern for Beam RA-8-6-2 being loaded at South end

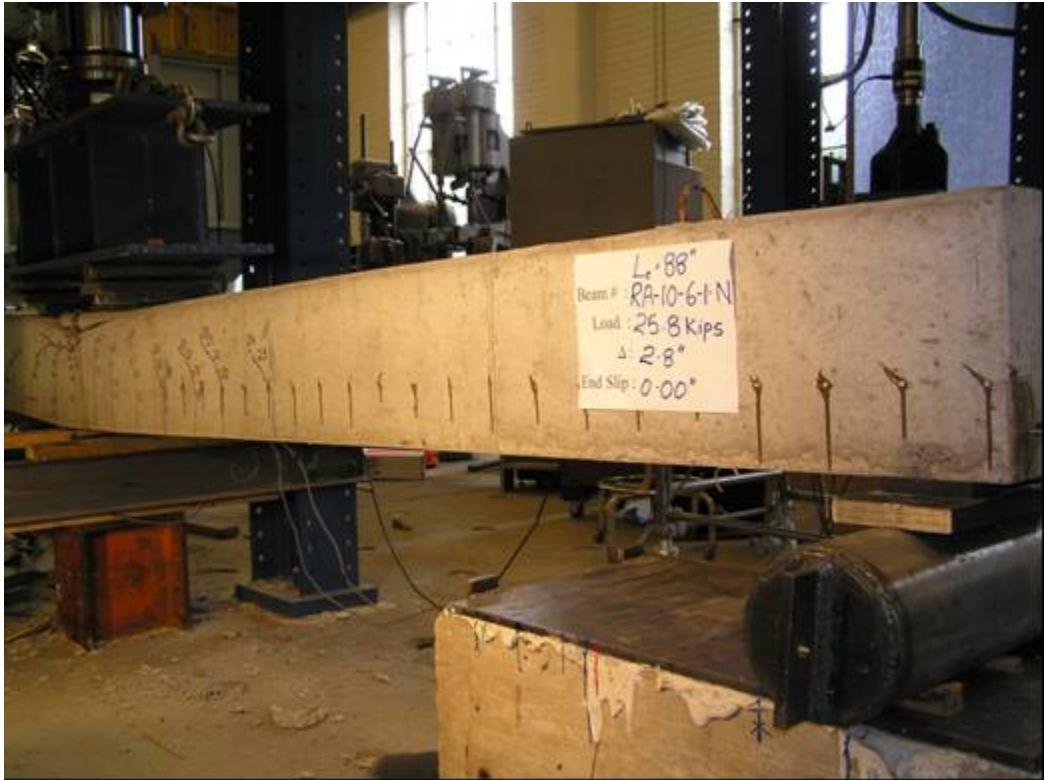
Cracking pattern included 13 cracks in the middle 84 in. span with the average crack spacing of 7 in. No inclined flexural crack was observed. The first flexural crack was located at the St. 59.

Cracking pattern for Beam RA-10-6-1 being loaded at North end

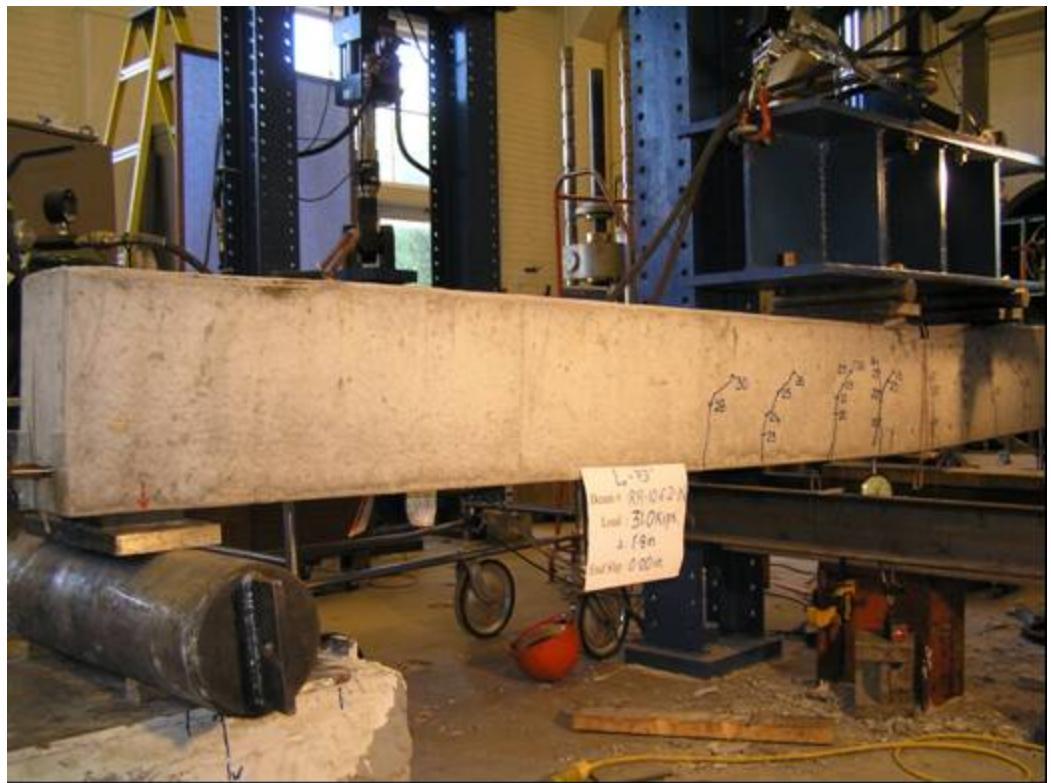
Cracking pattern included 9 cracks in the middle 70 in. span with the average crack spacing of 8.8 in. The first flexural crack was observed at Stn. 49. No inclined flexural crack was observed.

Cracking pattern for Beam RA-10-6-2 being loaded at North end

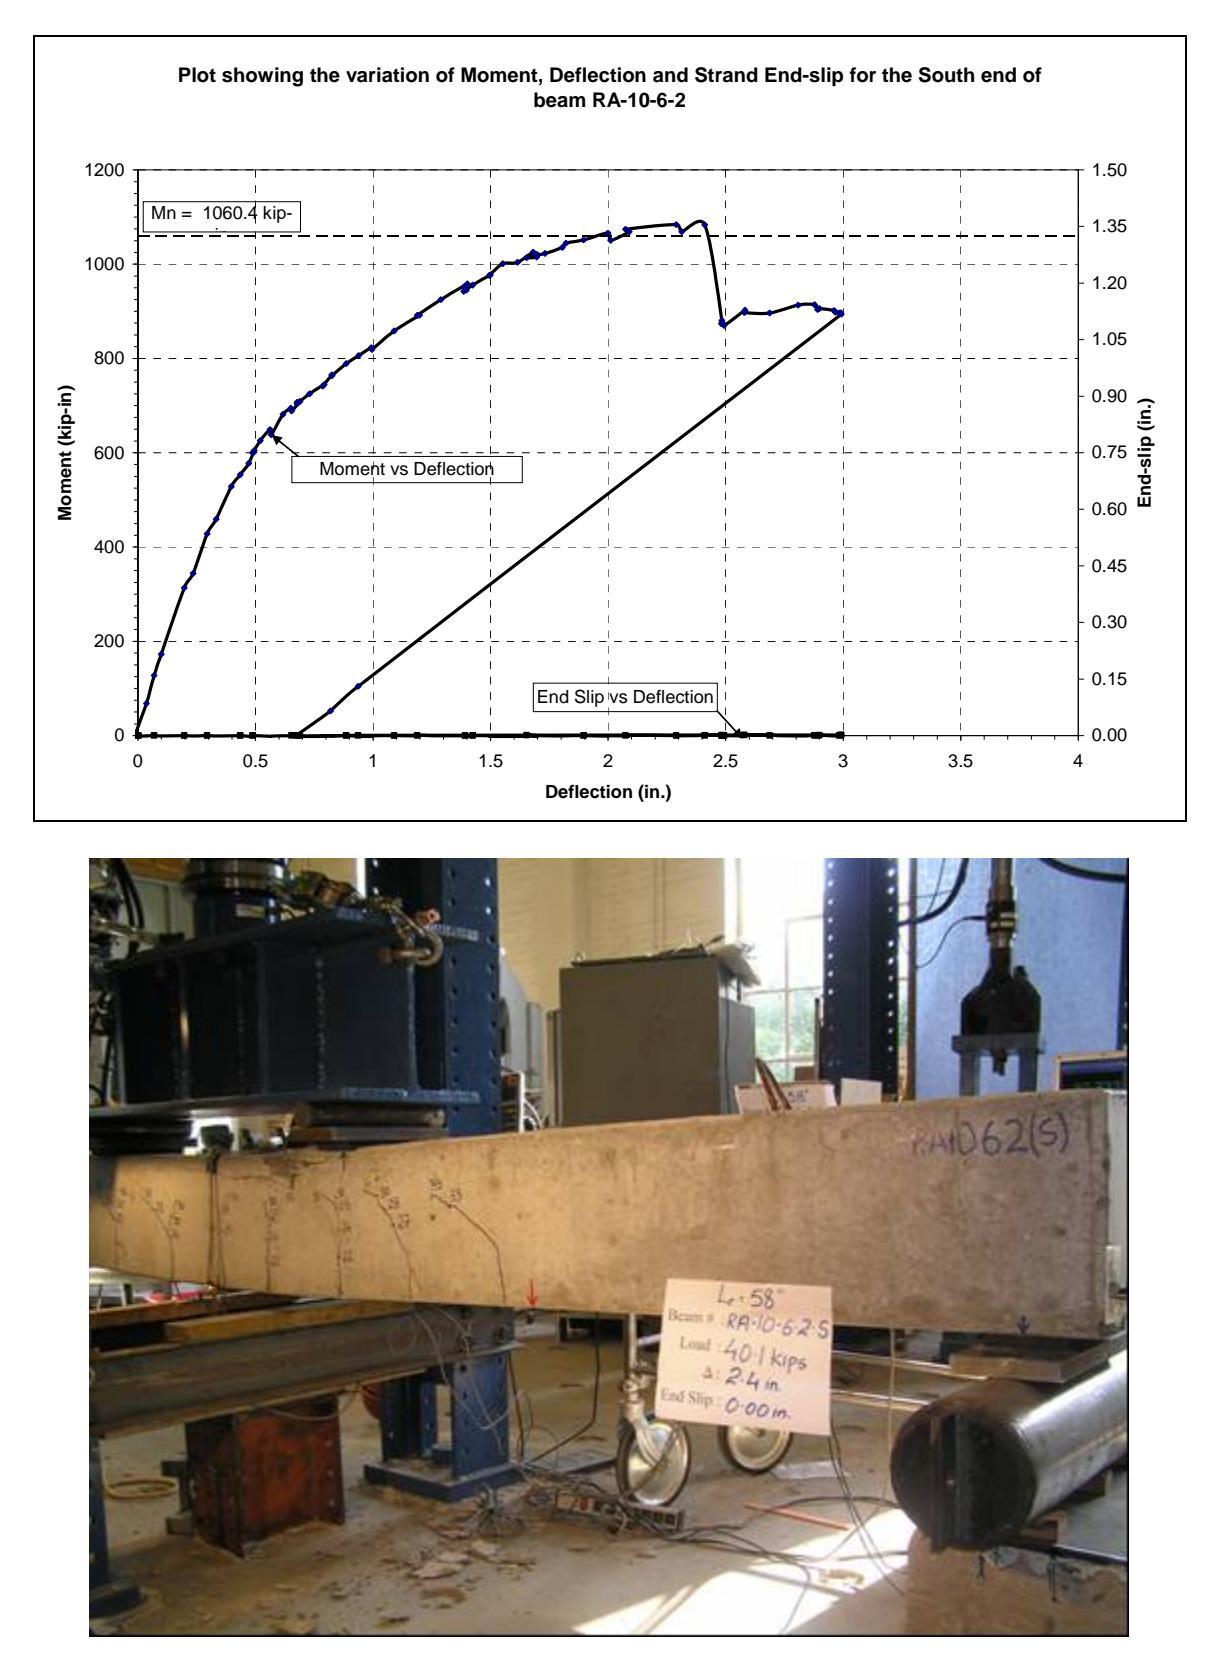
Cracking pattern included 9 cracks in the middle 73 in. span with the average crack spacing of 9 in. No inclined flexural crack was noticed. First flexural crack was located at Stn. 41.

Cracking pattern for Beam RA-10-6-2 being loaded at South end
