An Examination and Recommendation for Current Practices in Roundabout Lighting

July 31, 2004

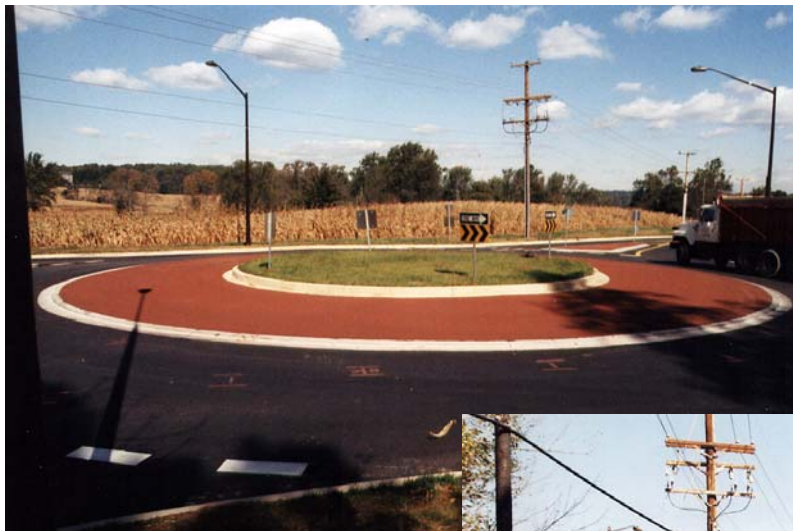
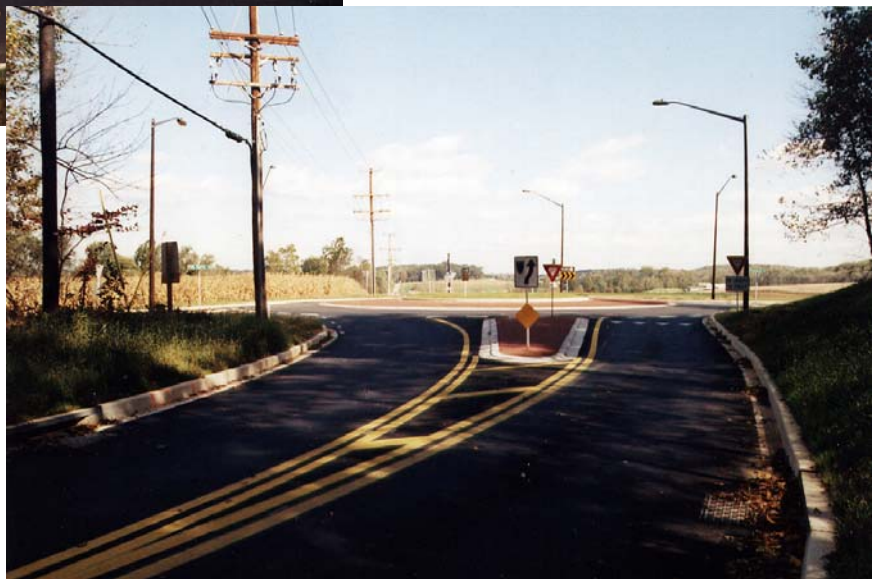
- Intersection of Woodbine Road and Route 40 in Lisbon, Maryland. This rural single lane roundabout is in close proximity to Interstate 70. It was chosen because it has only two light fixtures located diagonally across from each other as shown in the Figure 1. It provides a good example of a roundabout with minimal lighting.

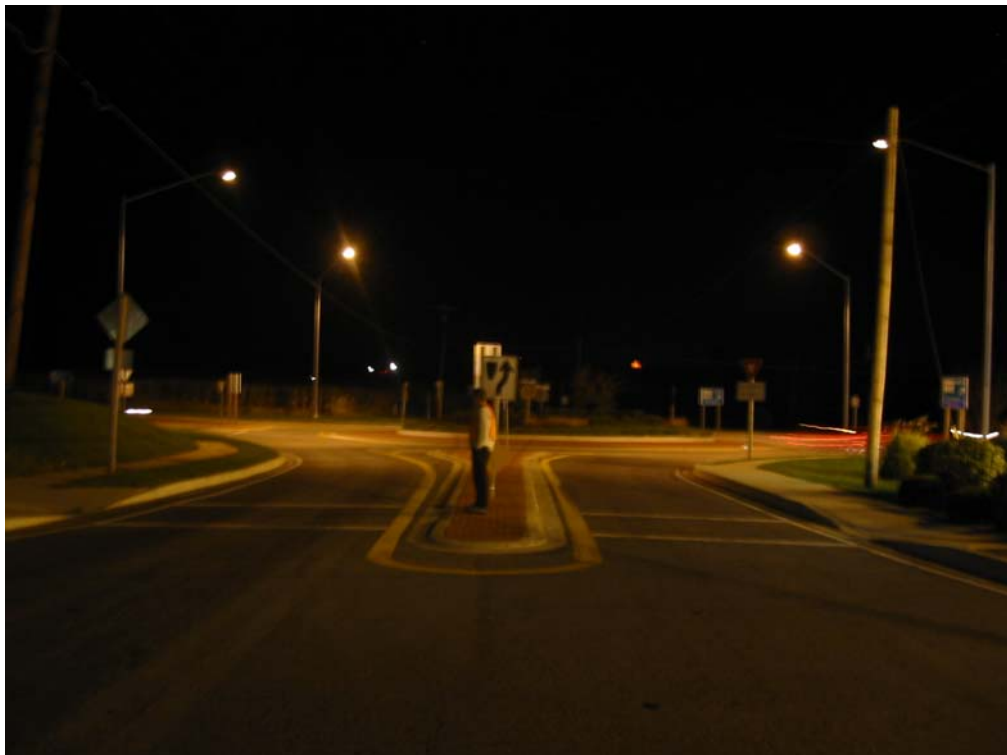
- Intersection of MD 180 and MD 17 in Brunswick, Maryland. This single lane rural roundabout was chosen because it has four light fixtures placed

symmetrically around the roundabout as shown in Figure 2. It provides a good illustration of uniform lighting of the circulatory roadway.

Four 250 watt high pressure sodium cobra head lighting fixtures were placed symmetrically around the roundabout. Lighting levels measured between 18lux to 60 lux because of some spill light but in general averaged between 30lux and 40 lux. The vertical illuminance at some of the approaches ranged from 5 to 10 lux. However, a gas station with a high level of flood lighting caused significant glare that affected the entire area around the roundabout. After close evaluation of photos, videos and CCD meter output, it was determined that the site was not suitable for drawing meaningful conclusions with regard to the roadway lighting and environment.

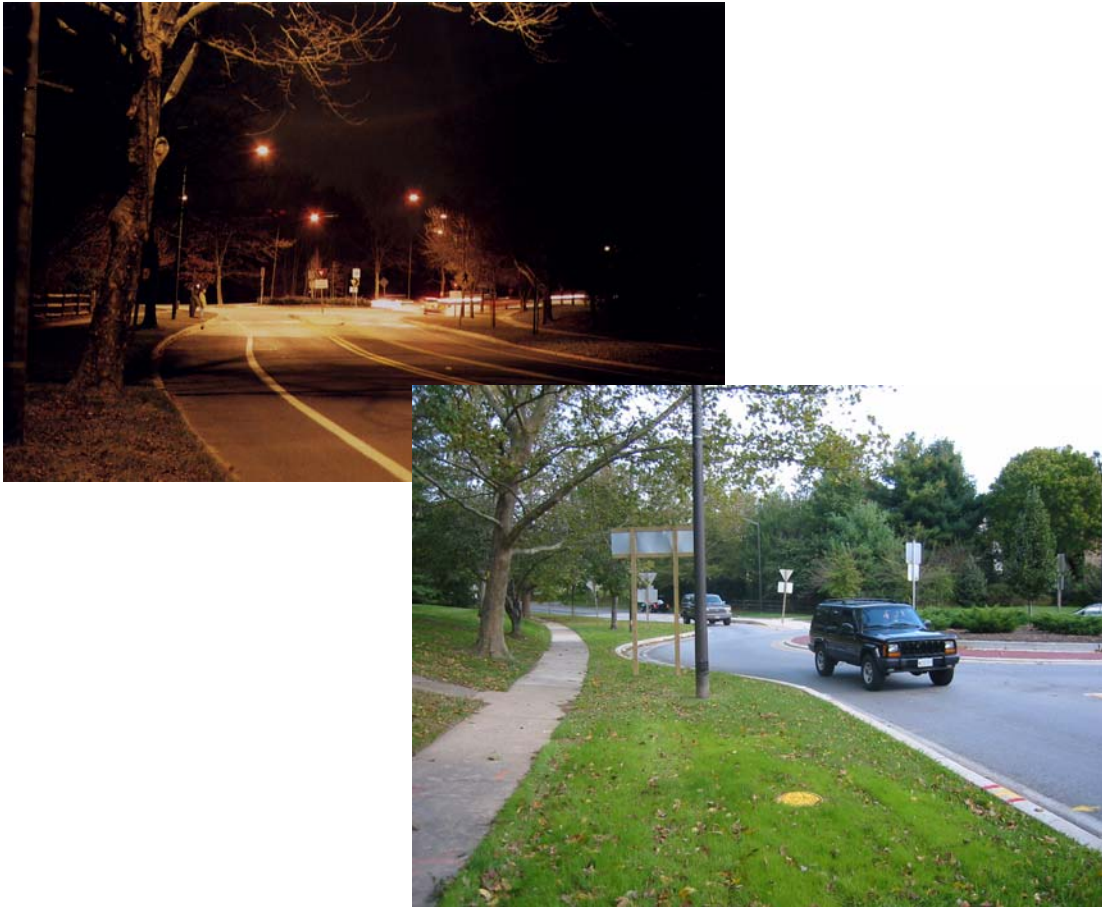
- Intersection of Cradlerock Way and Homespun Drive in Howard County, Maryland. This single lane, 3-leg, suburban roundabout was chosen because it has light fixtures placed in close approximation to the French Roundabout Lighting Guide as shown in Figure 3. It provides a good illustration of lighting the roundabout approaches, crosswalks and circulatory roadway.

This suburban roundabout has three approaches with pedestrian crosswalks on all legs. Lighting is symmetric around the circular roadway and includes approach lighting in advance of all crosswalks. Four 250 watt high pressure sodium cobra head luminaries are placed around the roundabout with one unit on each of the approach roads. Lighting levels averaged 30 lux to 40 lux in the roundabout and vertical illuminances at the crosswalks ranged from 20 lux to 40 lux. Observations from analysis of this roundabout include:

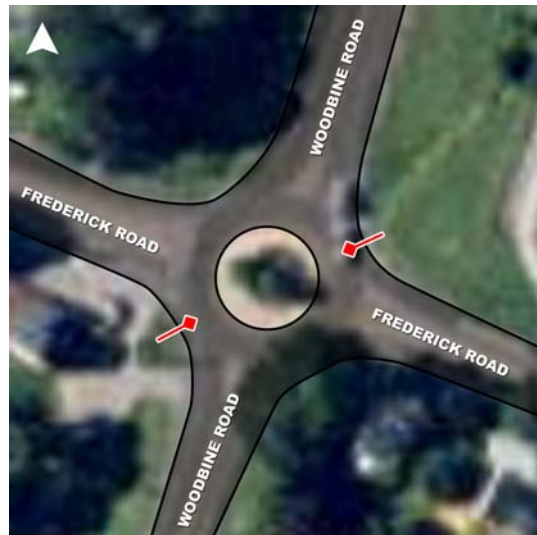
This roundabout in Lisbon, MD is lit with two 250 watt high pressure sodium cobra head fixtures and illustrates a step up from no lighting to what could be considered “minimal lighting”. The lighting levels at this location averaged between 8 lux and 12 lux. This level of lighting does overcome the worst aspects of no lighting – i.e. providing some preview distance to the driver circulating in the roundabout. Other observations include:

- Lack of uniformity in the lighting does not provide a comfortable or reliable driving environment.
- In locations where crosswalks would be available, this lighting does not provide adequate lighting to make the pedestrian visible in at least half of the crosswalks. As such, driver and pedestrian expectancies are not matched in all situations.
- Considering typical maintenance cycles, if one light goes out, the negative effects are far greater than they would be with other, more extensive lighting configurations.

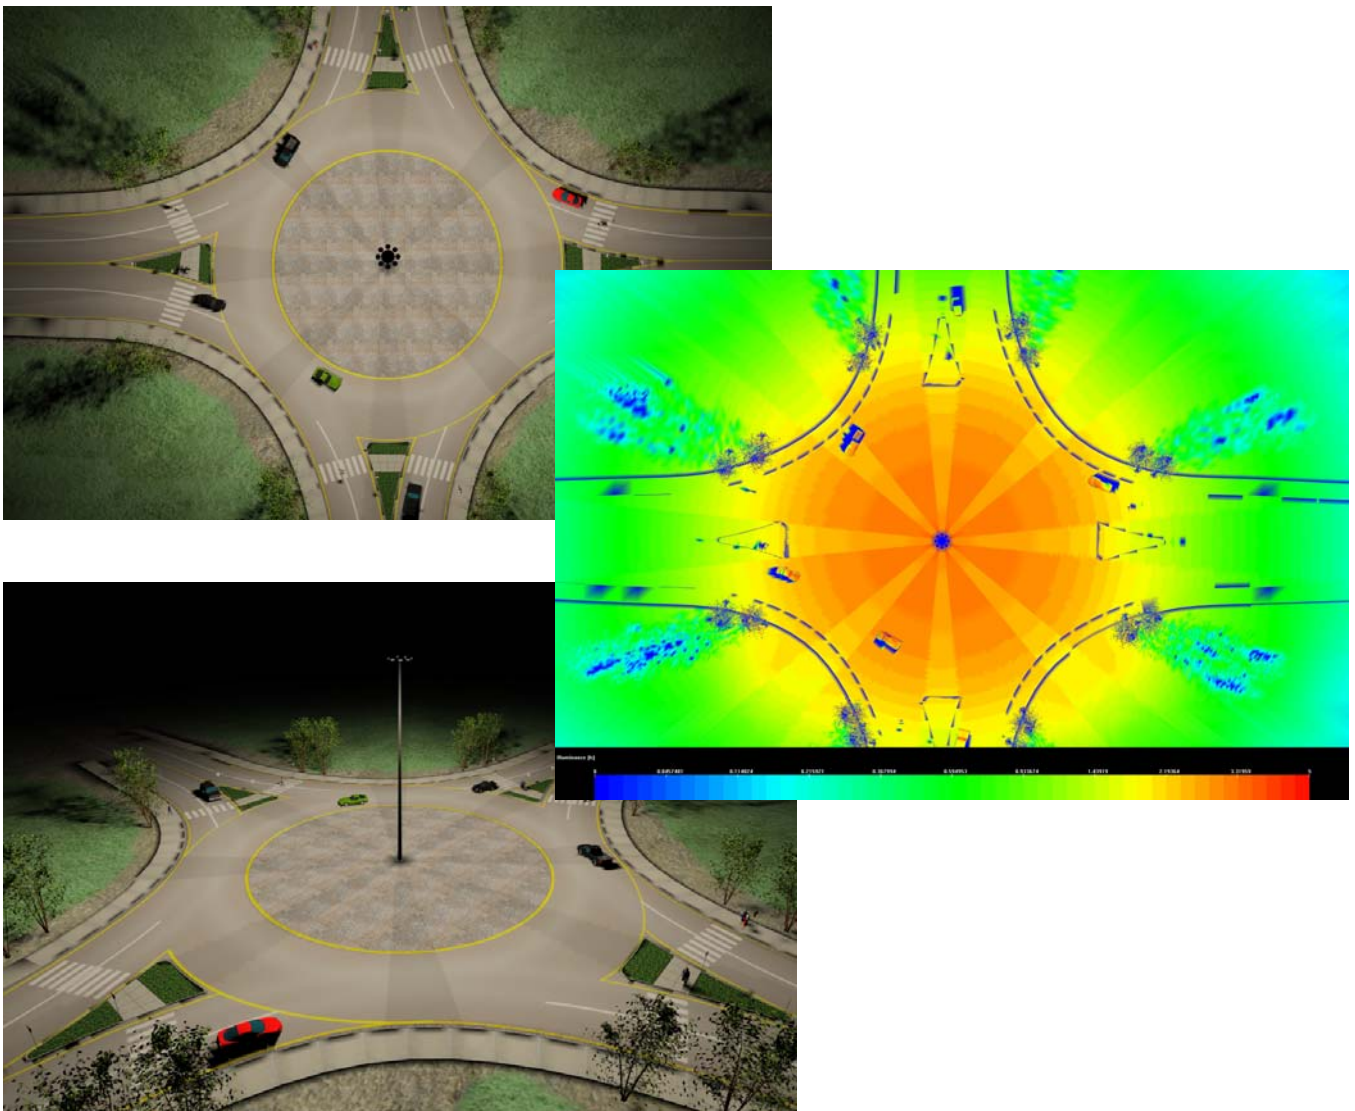
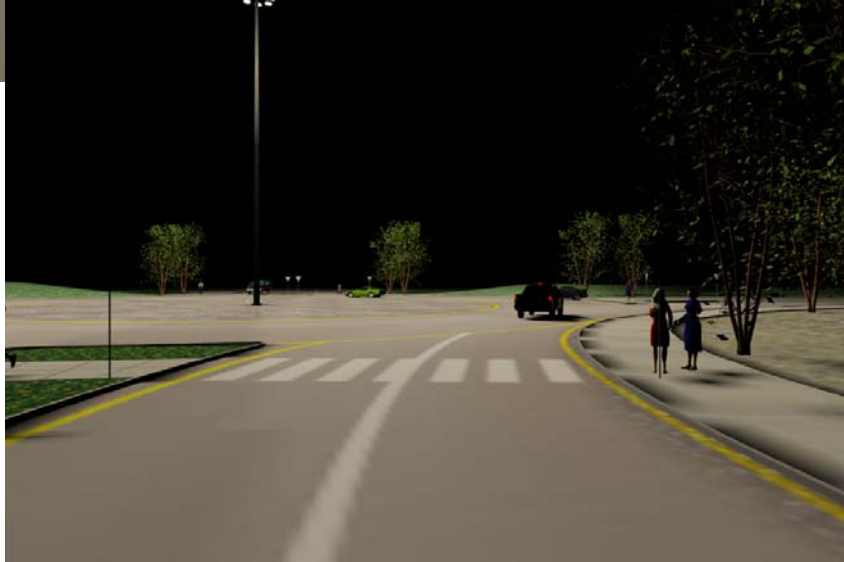
To simplify some of the visibility complexities we also prepared computer models to compare roundabout only lighting and a roundabout that also had approach lighting. For the roundabout only system we used a 24 meter pole with 8-400 watt high pressure sodium luminaires.

The images generated by the computer models as well as the calculated values of all of the surfaces seemed to show preferable pedestrian visibility with an approach lighting system.

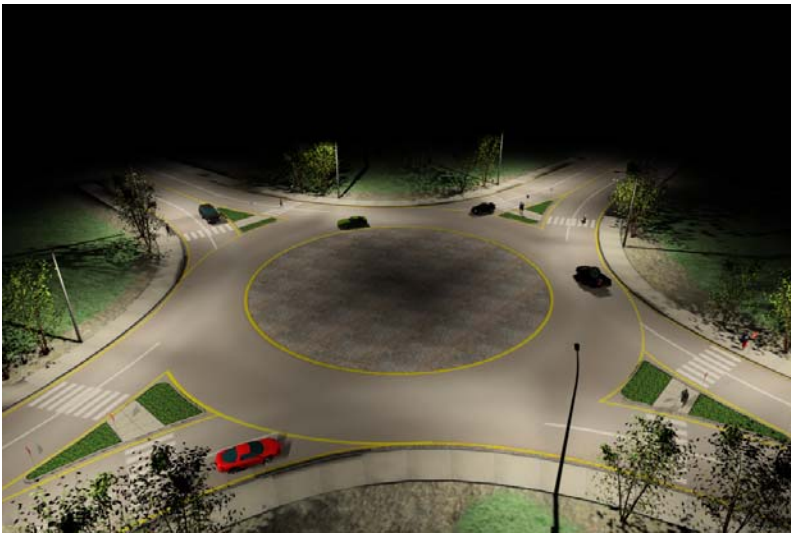
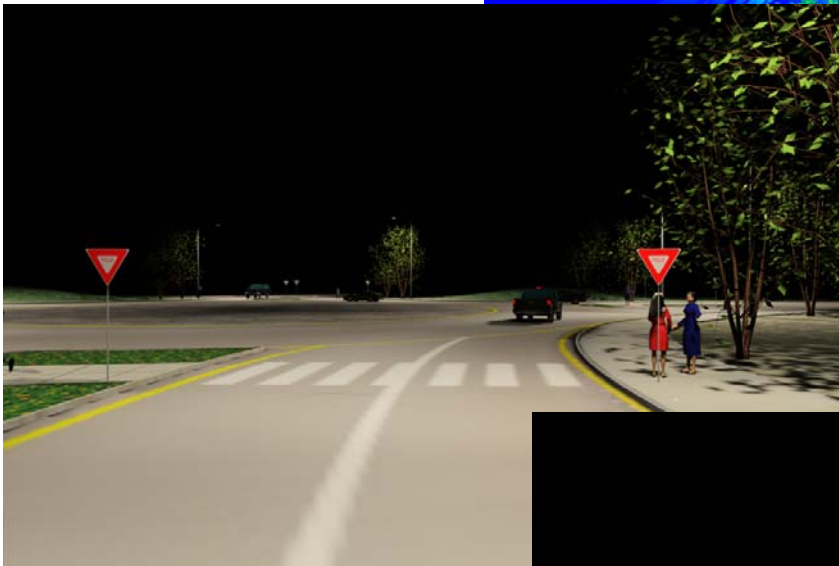
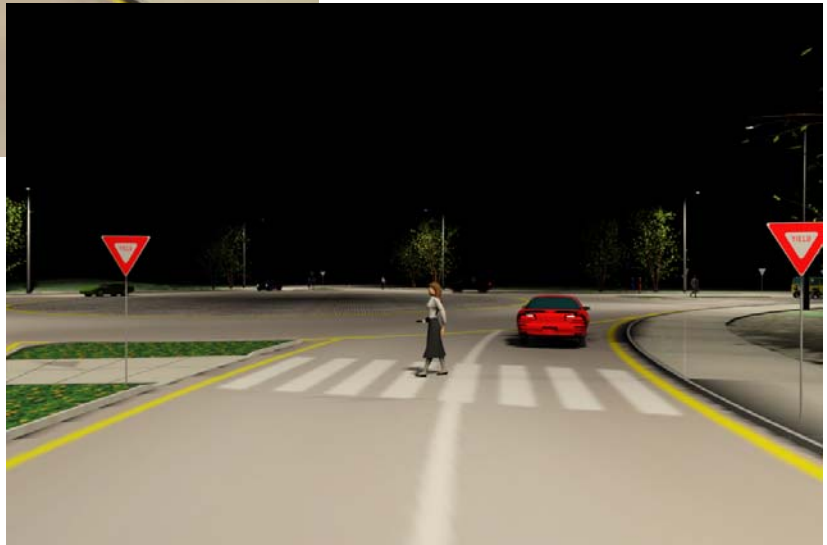
For the roundabout with approach lighting we used 8-10 meter poles with 250 watt high pressure sodium full cutoff cobra head luminaries.
